Beyond Basic Preservation:

REHABILITATION

CASE STUDY: St. Simons Island Lighthouse Lantern Glass Replacement

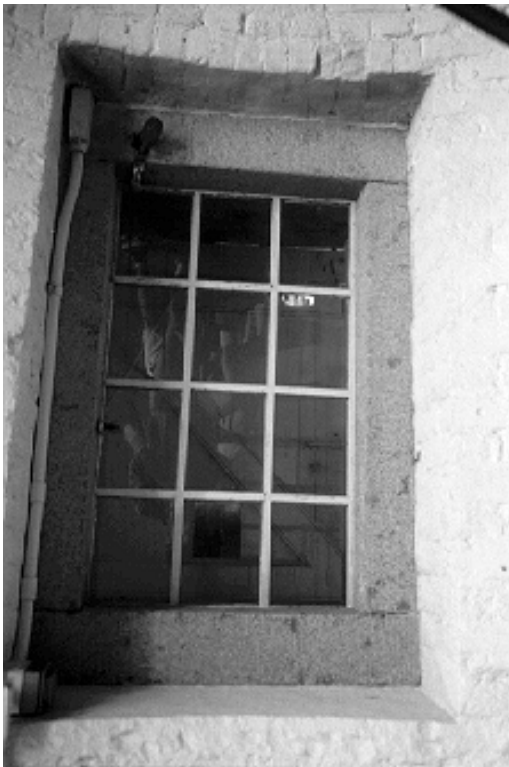
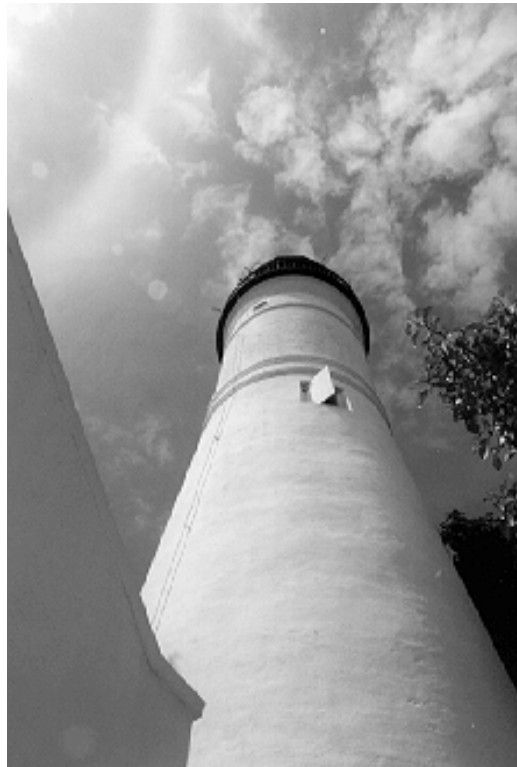
Figure 2.

Figures 2 through 5 illustrate successful replacement window designs. These solutions can be easily adapted to most historic lighthouse window designs. During the rehabilitation of the lighthouse shown in Figures 2 and 3, the metal multiple-light windows were reproduced based on the remnants of the original windows and on historic lighthouse construction documents from a lighthouse built in the same region during the same time period. During the restoration of the window opening, the granite window frame was also replicated from remnants found in another window opening. Even the tooling pattern on the stone surface was reproduced. A single-leaf, vertical-plank shutter can be seen on the lighthouse in Figure 3. This detail was also based on existing evidence. Not only is this detail historically accurate, but it has protected the lighthouse during hurricane-force winds.

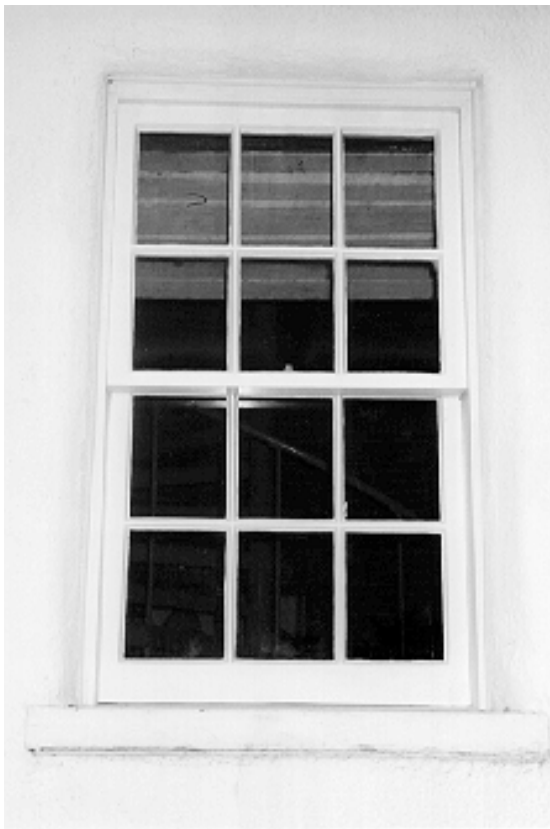
Figure 4.

The wooden, double-hung, six-over-six window were reproduced from historic photographs. Subtle details such as molding profiles and hardware that could not be determined from historic photographs were based on lighthouses constructed by the same builder during the same time period. Figure 4 shows a close-up of the exterior side of the window; note the simple detailing and lack of profiled trim. These characteristics are typical of lighthouses constructed before the Civil War. Figure 5 shows the lighthouse after the installation of the replacement windows.

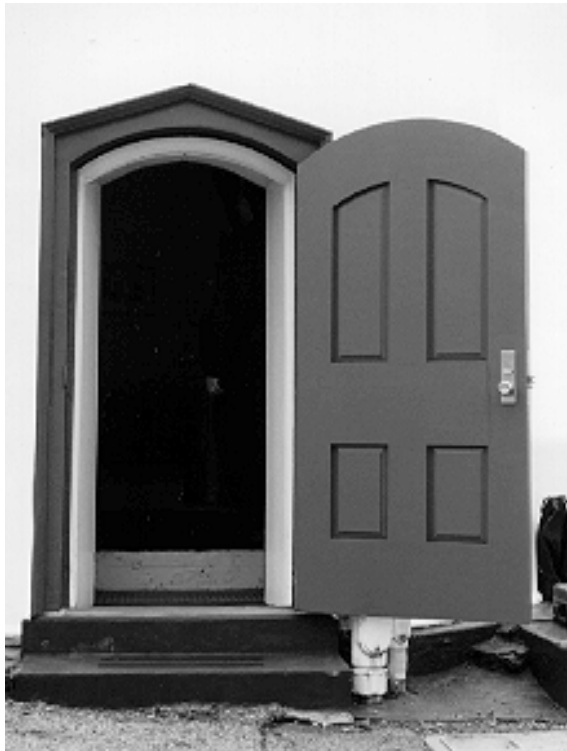
Figure 6.

Figures 6 through 9 are examples of successful replacement door designs. The solutions displayed here can be easily adapted to most historic lighthouse door designs. The wood replacement door design in Figure 6 was based on wood-frame and panel-construction-style doors commonly used when this lighthouse was constructed in 1928. The only difference made to the c. 1928 design was the upgrade of the hardware to stainless steel components. This door design was based on information from historic photographs from the U.S. Coast Guard archives and

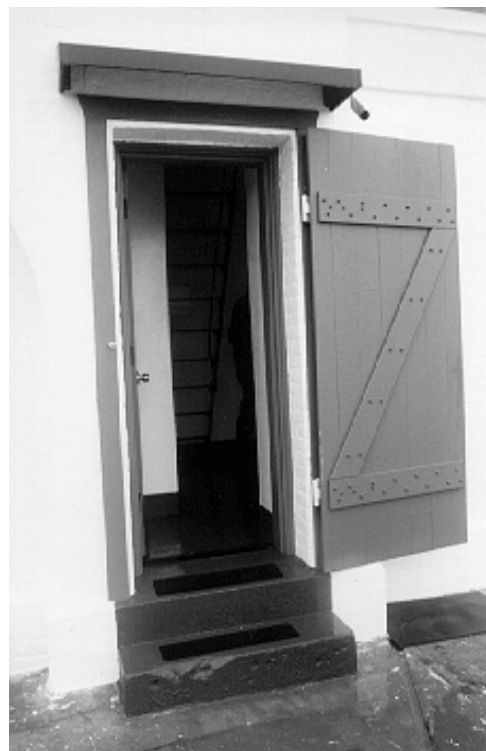
Figure 7.

Vertical wood plank door: The design for the door in Figure 7 was based on the information in the historic photographs. The materials used during the construction of this door were chosen for their durability. The wood chosen was fir, which was primed before assembly to ensure all surfaces would be coated to deter rot caused by damp wood. The planks were joined to the 'z' batten with stainless steel screws to decrease maintenance and eliminate the possibility of rusting fasteners. The hinges are salvaged bronze strap hinges that will also require minimal maintenance. The copper hood or awning above the door is another traditional protective measure for historic lighthouse doors.

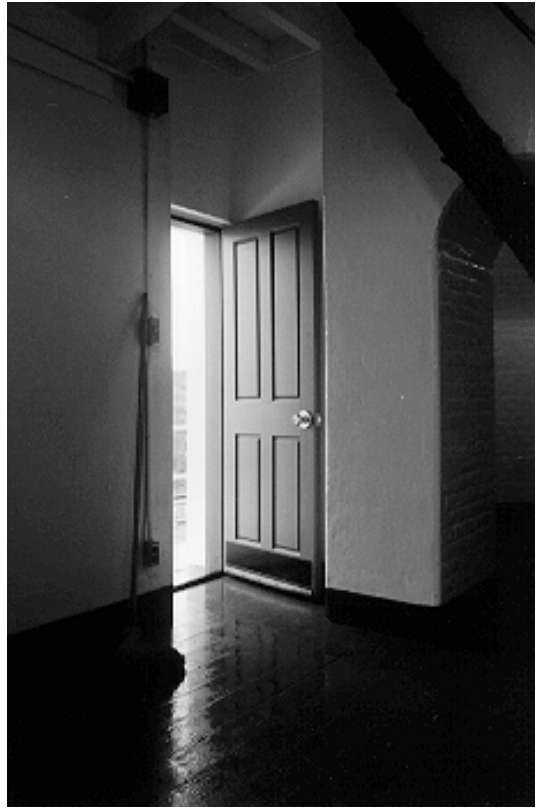
Figure 8.

Wood frame and panel door: Partial remains of a wood frame and raised panel was found inside the structure during rehabilitation. This evidence was used in conjunction with historic construction drawings to develop this design. The door shown in Figure 8 was made by a local mill from Douglas fir. The hardware is all stainless steel to minimize maintenance and to extend the serviceable life of the door. As an added weather protection measure, a traditional drip edge has been installed along the bottom of the door to shed water away from the door opening.

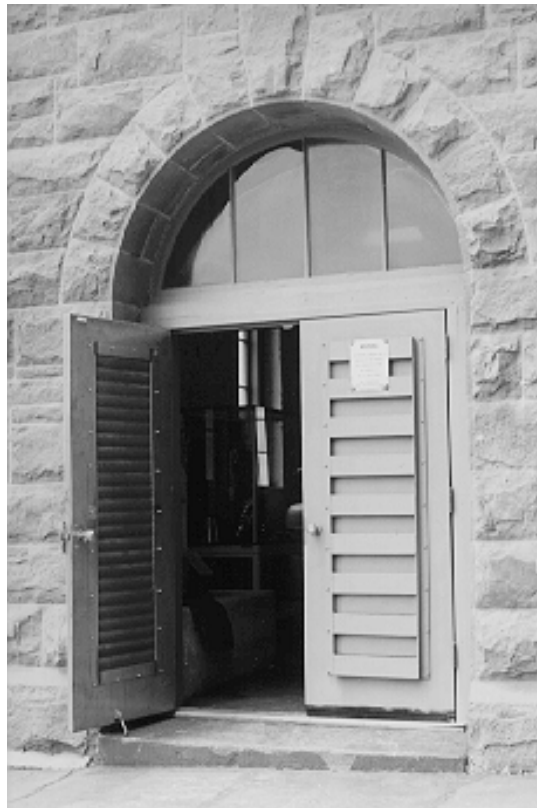
Figure 9.

The door in Figure 9 is designed to minimize the problems at a lighthouse that does not see regular visitation because of its remote location. Four factors took precedence over historical correctness: weathertightness, ventilation, security, and maintenance. The door had

to be weathertight to withstand the seasonal driving rain storms. At the same time the door had to provide adequate ventilation to minimize condensation buildup during hot and cold temperature changes. The door had to be secure because the remote location did not allow for regular security patrols; vandals or trespassers had to be effectively deterred. The rest of the structure required minimal annual maintenance; therefore the door should not require any more than annual routine maintenance.

The solution to the problems associated with the mothballing of this lighthouse was to use high-quality materials and sound design. The doors are made of Type 304 stainless steel. The louvers are baffled to allow for more than adequate air exchange, which will minimize interior condensation buildup, while at the same time preventing water infiltration. The louvers are also screened to prevent animal infiltration. The locks and hinges are also stainless steel to prevent corrosion and ensure long-term use. The installation of this type of door should not permanently affect the historic door frame.

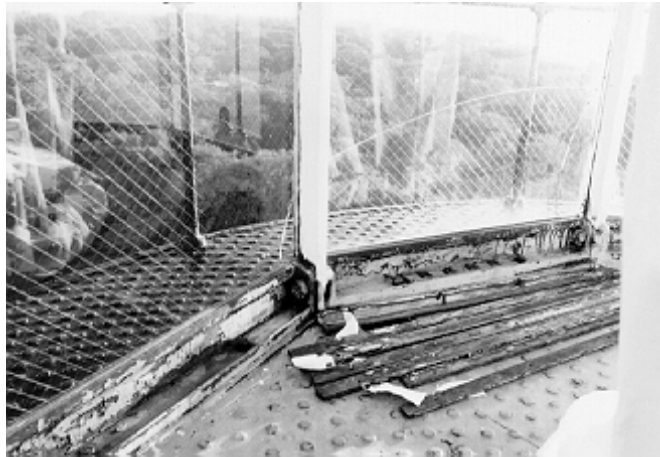
Figure 10. Oblique of the interior of the lantern room with exterior bronze astragals stored in the foreground before cleaning and removal of the extent wire-glass panels.

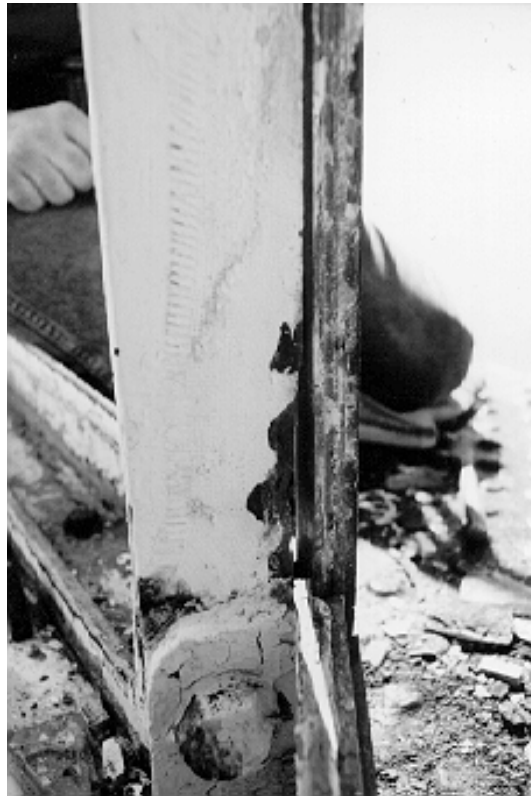
Figure 11. The extent of the damage to the cast-iron column through exfoliation can be seen in profile after the removal of loose rust and the lower bronze mullion.

Damage to the lantern glass was the result of exfoliation or ‘rust-jacking’ on every exterior face of the cast-iron columns. Each bronze mullion fastened to the cast-iron column had been deformed, with complete failure of the lowest fastener. The exfoliating rust exerted forces on all ten glass panels, breaking the ¼-inch-thick annealed wire glass across the base of the panels. This allowed for water infiltration and endangered the classical lens. The glass was removed in two to three panels at a time so that rehabilitation of the fasteners and bronze mullions could be completed before placement of the new glazing system.

The rehabilitation of the cast-iron posts was limited to treatment of the exposed surfaces with rust-inhibiting coatings. Any further treatment would have required the removal of the bronze sill and cast-iron deck. The perimeters of the treatment were

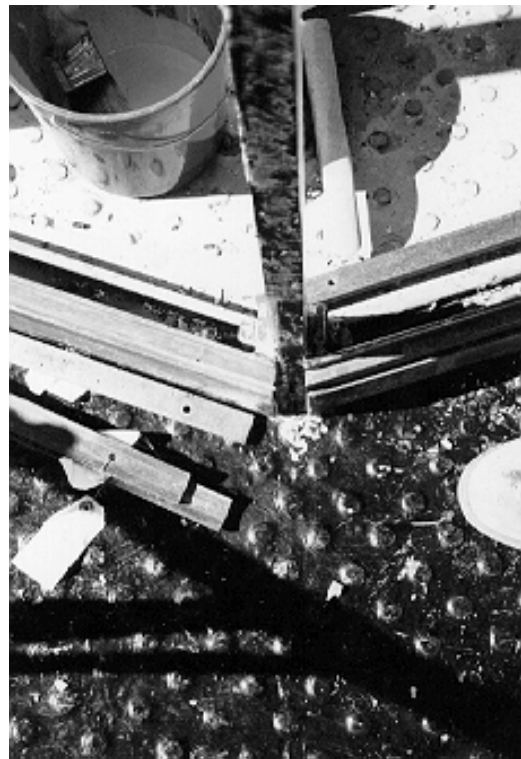
Figure 12. Detail of the bronze sill when the lower mullion is removed; the fastener is re-tapped and the cast-iron column is treated with a rust converter. Note that the bronze astragals have been cleaned and are ready to accept the glazing system.

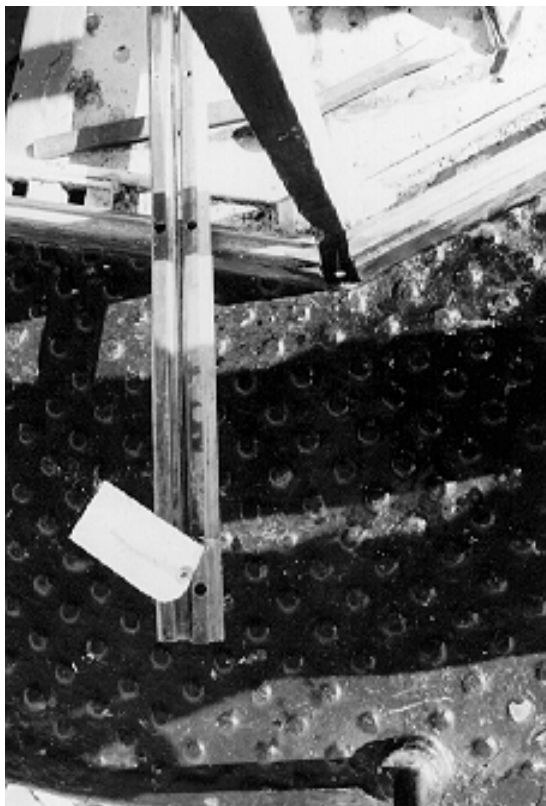
Figure 13. This detail of the bronze sill shows the location of the new lower fastener before its removal and resetting with the lower bronze mullion.

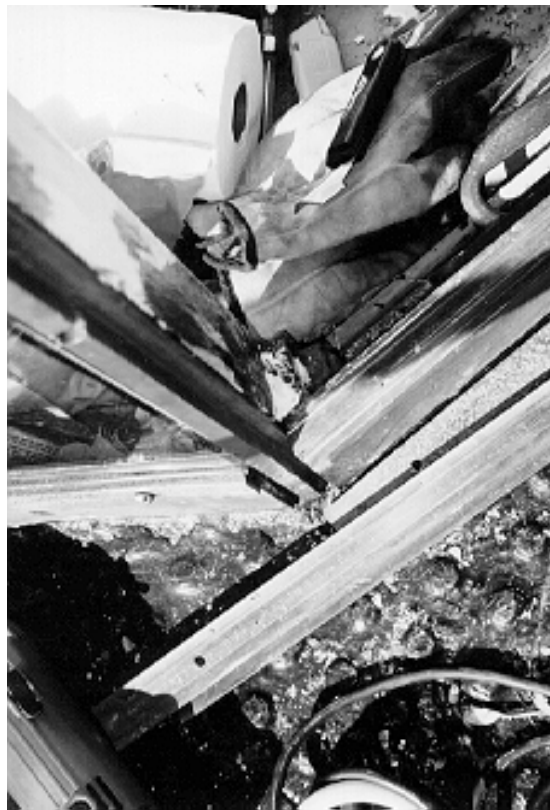
Figure 14. Following placement of the restored bronze mullion, the fenestration is ready to receive the new glazing system.

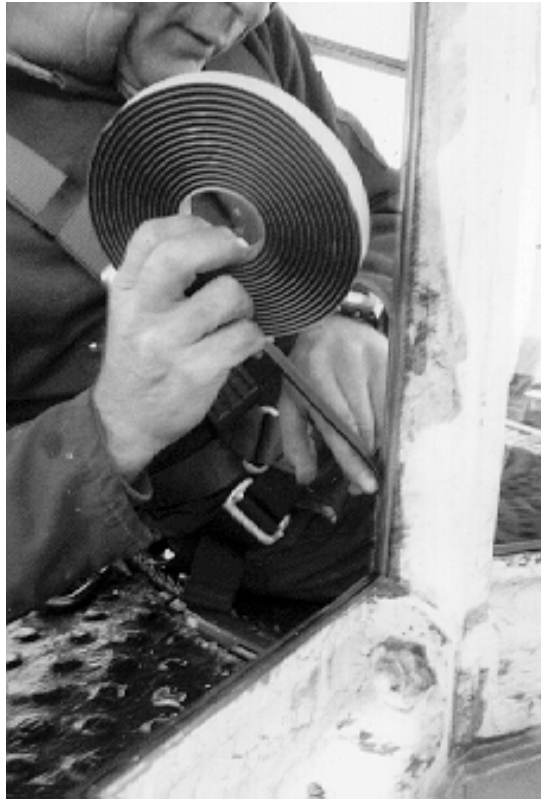
Figure 15. The polybutyl sealant tape was placed on all receiving surfaces on the plane of the interior face of the glass and on the inside faces of the exterior astragals.

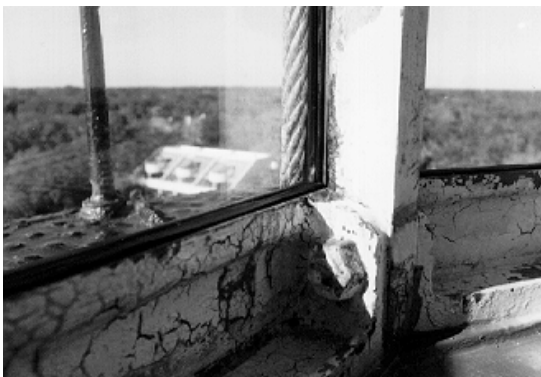
Figure 16. This detail shows the new glazing system in place with associated cast-iron post and bronze sill available to receive additional cleaning and paint removal.

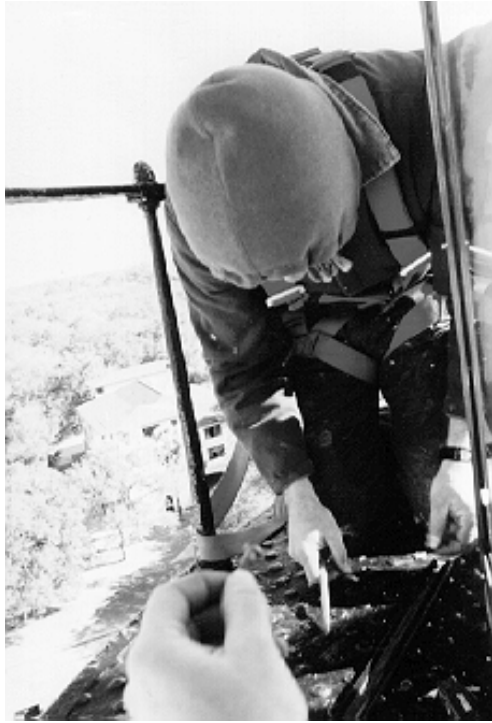
Figure 17. Note the detailing of the finished exterior astragal in place and the polybutyl sealant tape visible in profile.
