Lincoln Memorial circle and radial roads

Map 14
RADIAL ROADS - VEGETATION
LINCOLN MEMORIAL CIRCLE &
RADIAL ROADS
 CULTURAL LANDSCAPE REPORT
 LINCOLN MEMORIAL GROUNDS
 PREPARED BY: M. JOSEPH DATE: OCTOBER 1996 FEB. 1997

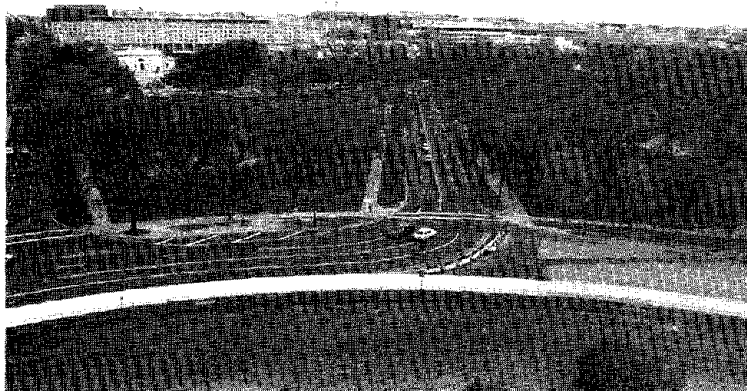
Figure 61 - Remnant concentric row of elms around Lincoln Circle, between 23rd Street NW and Bacon Drive, March 1996. LINC 6-27.

Unlike the radial roads, the original planting pattern around the outer circle is almost entirely lost. Only a few remnant elms remain to suggest the old design. While the quadruple band on the eastern part of the circle is evident between 23rd Street NW and Bacon Drive and 23rd Street SW and French Drive, the areas between the two drives and the Reflecting Pool no longer show any evidence of the old tree pattern. In these two areas, the distinctive landscape plans for Constitution Gardens and Korean War Veterans Memorial have encroached upon the old concentric design for the elms. Here newer plantings of native understory trees are clustered beneath a mixed

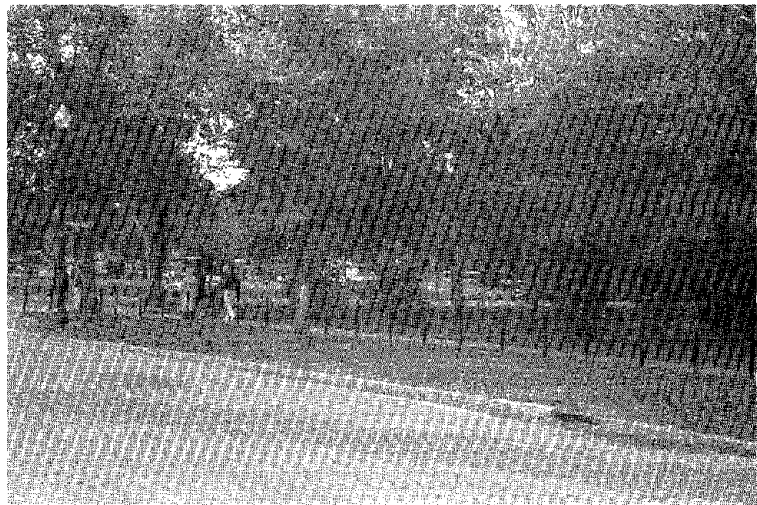
canopy of oaks, zelkovas, and maples (*Quercus* sp., *Zelkova serrata*, *Acer* sp.). The development of these other sites with such different plant selections has significantly altered the character of the overall design for the Lincoln Memorial grounds and has compromised the integrity of the original plan. West of 23rd Street, only a remnant of the old double band of elms is in place. The single circular band of elms between the 23rd Street NW west to the Watergate area is entirely lost because of the realignment of the outer circle curb for the 1940s on-ramp road. However, the single circular band of trees between the roadway and the sidewalk is mostly intact for the southwestern portion of the outer circle.

Figure 62 - Inappropriate trees and shrubs, planted under canopy of American elms, November 11, 1996. LINC 11-27.

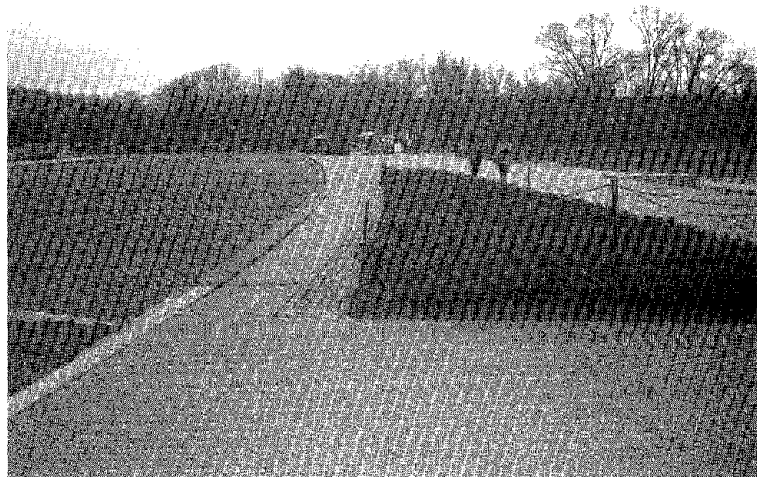
The only significant alteration to the original landscape plan occurred in 1953 when the outer edge of the circular roadway near the sidewalk above the Reflecting Pool was changed. Here a rectangular curb cut was eliminated, the circle was made continuous, and a pair of planting beds were installed on the north and south side of the sidewalk in the areas formerly shaped by the old squared-off curb. The park appears to have planted dwarf boxwood in the beds, which were replaced in 1977 with a little leaf holly, also known as inkberry (*Ilex glabra*.) At subsequent intervals, the park replaced the inkberry with Japanese hollies (*Ilex crenata*.) which occupy the planting bed today.

Figure 63 - Shrub planting at top of Reflecting Pool steps, December 1996. LINC 17-35.

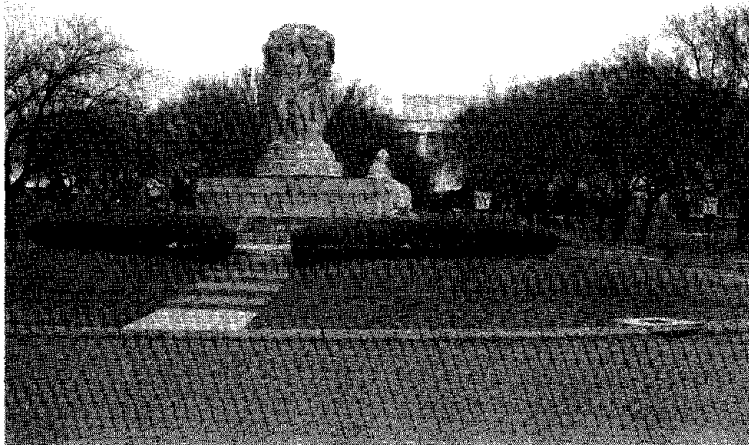
Around the Ericsson Memorial, the planting plan was changed substantially. Japanese holly replaced the original junipers, which once encircled the granite platform. Four walks, which radiated from the granite platform, also were lined with junipers, but these shrubs were also removed and now the walks are surrounded by grass. These changes have further downplayed the connection of the Ericsson Memorial to the Lincoln Memorial landscape.

Figure 64 – Replacement shrubs around Ericsson Memorial changes the character of the original planting, February 1997. LINC 18-8.

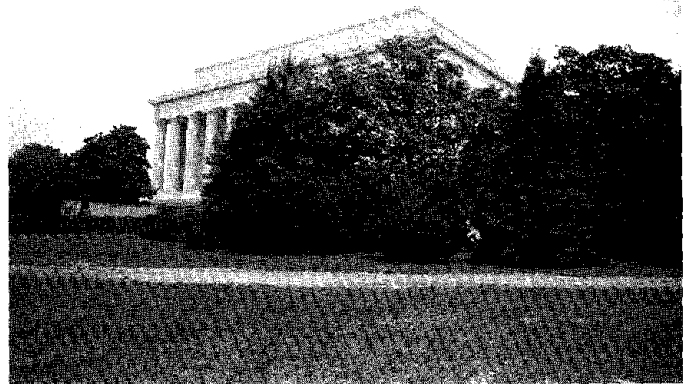
The trees and shrubs surrounding the memorial currently exhibit different degrees of health and reflect a range of growing conditions. Along the front or east side, the plantings have suffered greatly from the effects of repeated construction activity and preparation for large-scale public events that have occurred in this area over time. The 1995-96 construction on the approachway has caused further damage to the foundation plantings. The lack of routine maintenance and regular pruning has also caused some of the plantings to appear ragged or

Figure 68- Existing west side foundation plantings, July 23, 1996. LINC 10-17.

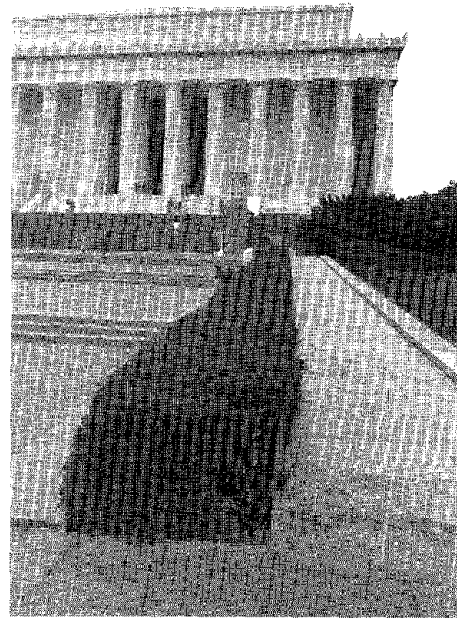
overgrown. When the park revised the original plans by replacing the boxwood hedges with yews in 1945, they altered the character of the entry planting, yet retained some of the historic integrity by keeping a band of green hedge growing on both sides of the approachway. However, the addition of an American holly and the Japanese hollies to the front side and massings of yews to screen floodlights have further compromised the character of the planting design. Because replacement plantings have deviated from the original design, the landscape on the front side retains a lower degree of integrity. On the sides and rear of the memorial, the integrity of the plantings is mostly intact, although some boxwood planted near the magnolias and close to the raised terrace have been shaded out and are unhealthy, or have died. At the midpoint of the north and south sides, two thick masses of *Taxus cuspidata* 'Nana' provide the horticultural transition between the character of the two different planting areas. Even though these yews were planted to replace the original mugo pines, the design intent of keeping a lower growing conifer mass in this area is still evident. In other areas overgrown plant material, like some American hollies that were planted on either side of the horizontal-growing yew mass on the north face of the memorial, are encroaching upon the designed opening above the raised terrace. See Map 15 and Map 16 *Lincoln Circle - Vegetation* for the graphic representation of the front and back plantings.

Figure 69 - Existing yew hedge along approachway and accessible ramp, January 3, 1997. LINC 16-21.

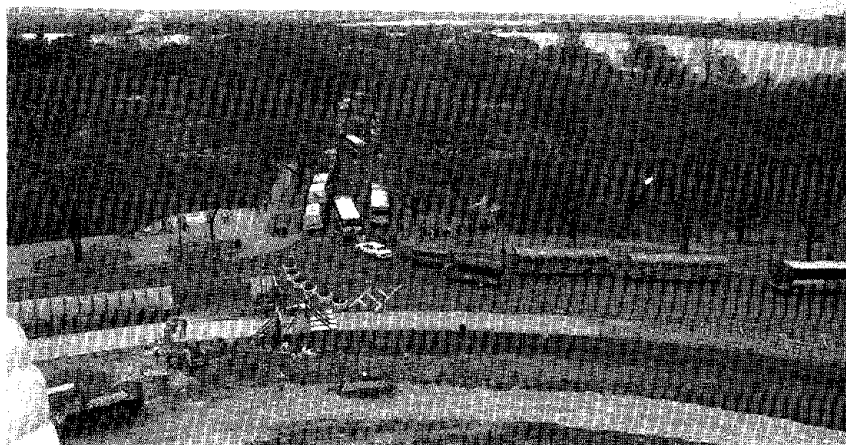
Figure 71 - Traffic congestion on French Drive and Lincoln Circle, March 1996. LINC 6-34.

Changing the circulation patterns around the circle had both a positive and negative impact on the site. By restricting vehicular access to the circle between Bacon and French Drives, park officials provided visitors a safer crossing point from the Reflecting Pool area and the memorial. But by closing part of the circle, all the traffic was concentrated on the western side, which created additional difficulties and hazards for pedestrians crossing the road from the inner circle to the Watergate plaza area. See Map 17 *Lincoln Memorial circle and radial road - Vehicular Circulation* for graphic representation of contributing and noncontributing features.

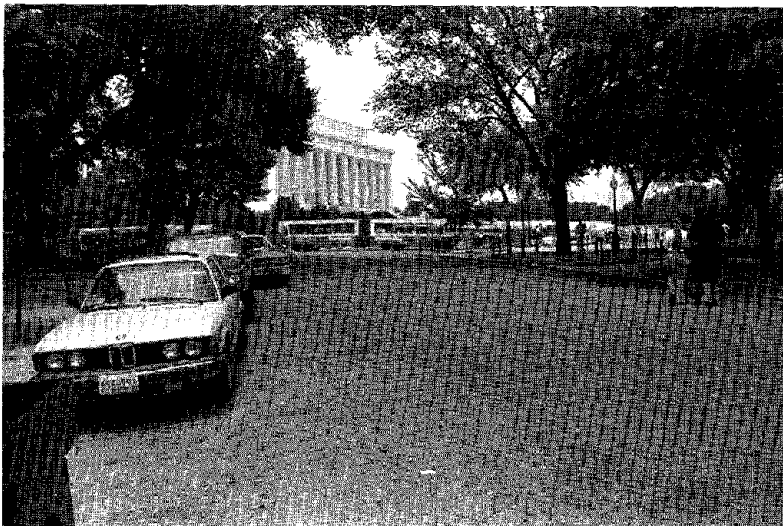
Figure 73 - Bus and taxi drop off along French Drive, July 23, 1996. LINC 10-14.

and French Drive and along the eastern side of 23rd Street SW. Other tour buses and taxis are directed to French Drive for all dropoffs and pickups, making this area very congested. See Map 17 *Lincoln Memorial circle and radial roads - Vehicular Circulation* for location of parking areas.

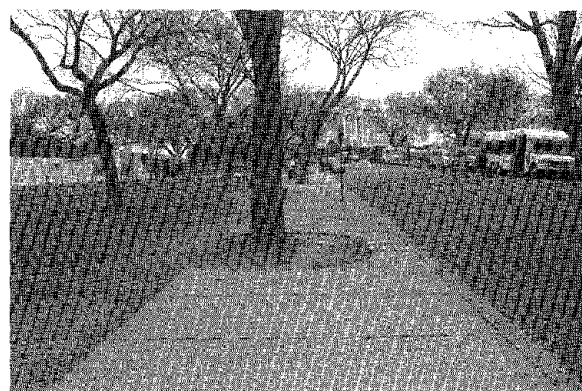
Figure 77 - Nonhistoric layout of sidewalk along west side of French Drive, December 5, 1996. LINC 13-13.

changes included extending sidewalks to the curb edge, the creation of individual tree planting beds with raised curb edges, and the addition of post and chain barriers to protect both the trees and the adjacent lawn. Many of the changes to the outer circular sidewalk and French Drive have been compounded with further additions brought on by the Korean War Veterans Memorial and by the perpetuation of nonhistoric site features. On the opposite side of the Reflecting Pool steps, at the Vietnam Veterans Memorial, the sidewalk width has been maintained, but it too is edged

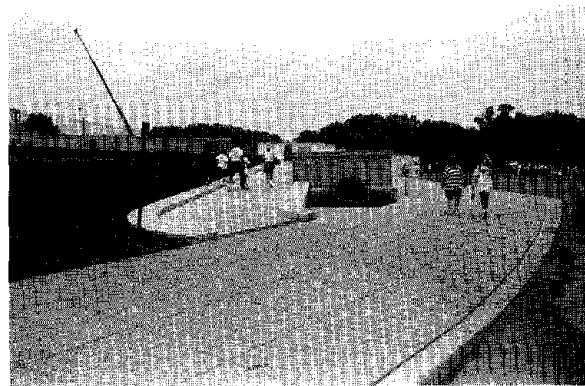
Figure 79 - Reconfigured accessible ramp to Lincoln Memorial, July 23, 1996. LINC 10-7.

Through the years the cobblestone panels have deteriorated, mostly due to freeze-thaw cycle. Park maintenance has responded by patching the deteriorated areas with a variety treatments. The unsightly appearance of this repair work for the cobblestone and safety concerns for visitors walking on the irregular surface, in addition to the structural problems, poor drainage, and lack of expansion joints, prompted the National Park Service to restore the entire approachway structure in 1995-1996. A few additions and alterations were made to the approachway area during this project. The cobblestone panels were removed and constructed in the same fashion as the original, with the exception that the stones were set to a greater depth in mortar to deter the

stones from dislodging. Also the ramps were redesigned to meet current accessibility standards according to the Americans with Disabilities Act (ADA) and provide a wider path for visitors. The new ramps have a more gentle slope (5%) and are 9 feet wide, 3 feet wider than the old ramps. As a result of the reduced slope of the ramps, the coping on the planting bed retaining walls needed to be raised 11 inches. Another course of granite and new granite coping (due to the deteriorated state of the original coping) were placed on top of the existing walls. The last change to the structure was the realignment of the ramps where they met the inner circle sidewalk. The previous ramps had a blind curve where the ramp and sidewalk came together. This situation was corrected to give visitors a clearer view when descending the ramp. Although the ramps are not historic, the National Park Service treated this area with the same respect for the historic fabric as they did for the main entrance steps by integrating the redesign of the ramp into the original approachway design. By using granite paving instead of exposed aggregate for the ramp surface, and by defining the edge of the ramps with granite coping, the ramps appear to be a part of the approachway.

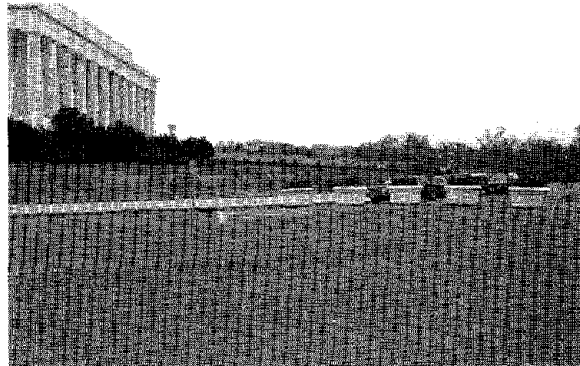
Traffic and Pedestrian Barriers. A variety of traffic barriers are used to control vehicular traffic around the circle. These include concrete planters, jersey barriers and flexible delineators. All the barriers add visual clutter and detract from the formal and geometric setting around the circle.

Figure 89 - Planter barriers on Lincoln Circle, December 5, 1996. LINC 13-20.

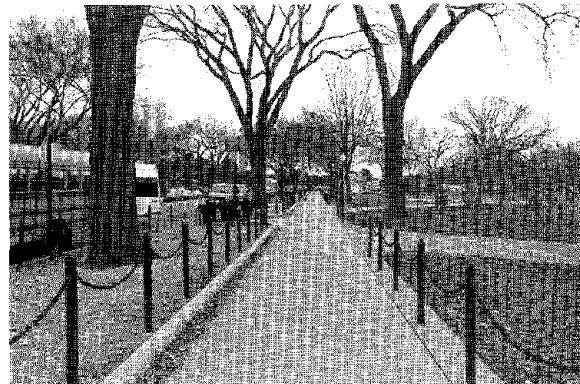
For pedestrian areas, four different types of barriers are used: post and chain; stake and chain; stake and rope; and snow fence. Park maintenance has installed these fences for a variety of reasons, but overwhelmingly for the control of visitor circulation. The most formal and most predominant is the post and chain. Most of the posts are installed in a metal sleeve set in the ground for easy removal. Although the second type, the stake and chain, is less widely used, it also prevents pedestrians from walking on grass and in planting beds. The other types, the stake and rope and/or snow fence, provide temporary protection of newly seeded areas and control circulation during special events.

Figure 90 - Stake and chain barrier along French Drive, December 5, 1996. LINC 13-15.
