# CULTURAL LANDSCAPE REPORT FOR EISENHOWER NATIONAL HISTORIC SITE

VOLUME 2: TREATMENT

Prepared by  
Jeffrey Killion  
Margaret Coffin Brown  
J. Tracy Stakely

Olmsted Center for Landscape Preservation  
National Park Service, Boston, Massachusetts 2006

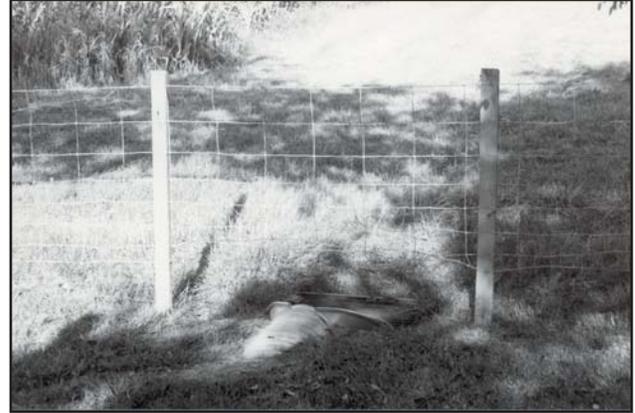
Figure 2.8. Gap under fence used by deer along entry drive to Farm #1. (Photo by OCLP, 2001)

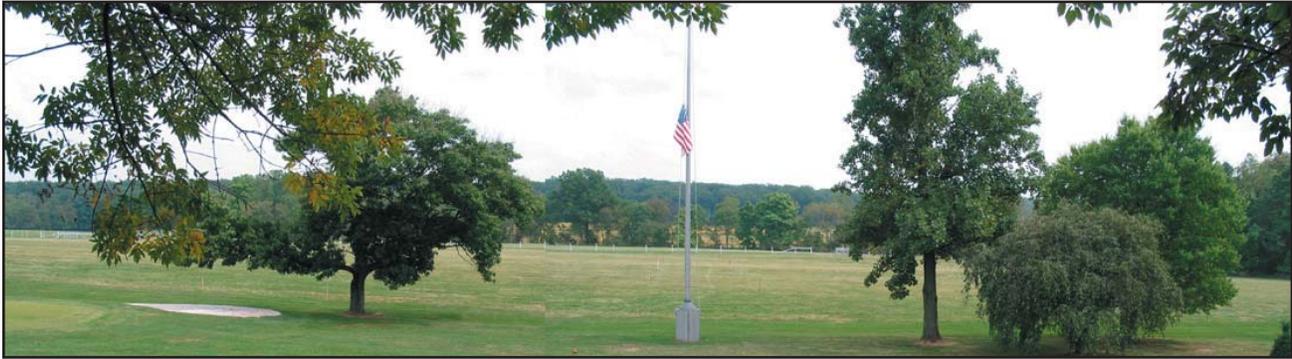
Figure 2.10. View from the Eisenhower home at the corridor of vegetation along the stream east of Nevins Lane. The plants are much taller than they were historically. (Photo by OCLP, 2005)

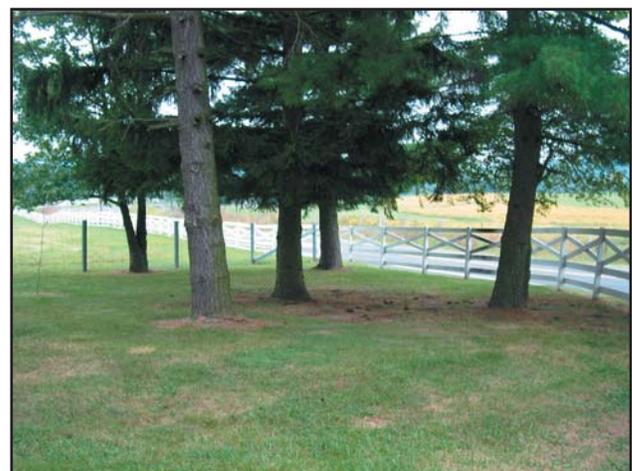
Figure 2.18. Mature planting behind the fence at the entry gate have crowded out replacement plants such as the sassafras at far left. (Photo by OCLP, 2005)

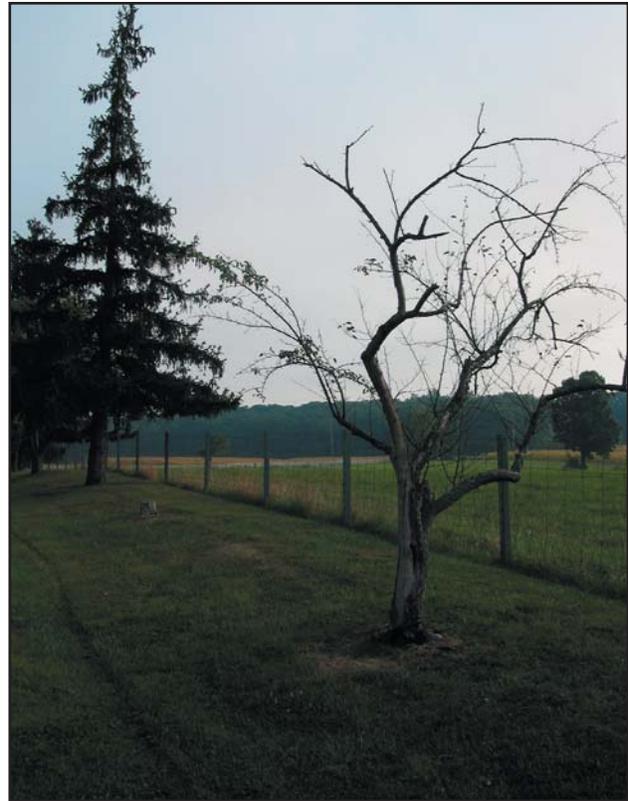
Figure 2.21. Several crabapples along the entry drive are dying or are missing as shown in this view looking north. (Photo by OCLP, 2005)

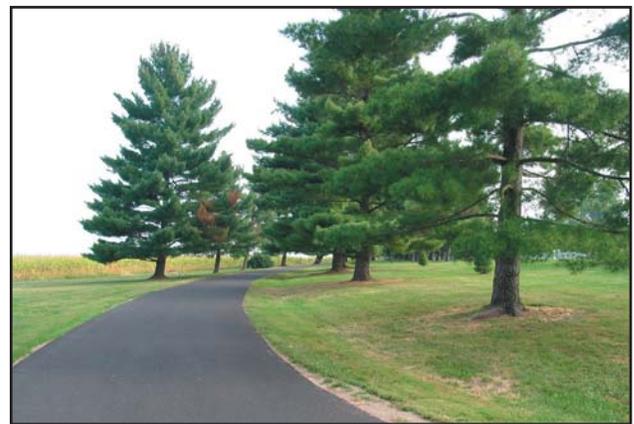
Figure 2.23. View looking north at the entry drive from west of the guest house. Note the size of the white pines and the lean caused by the prevailing west winds. (Photo by OCLP, 2005)

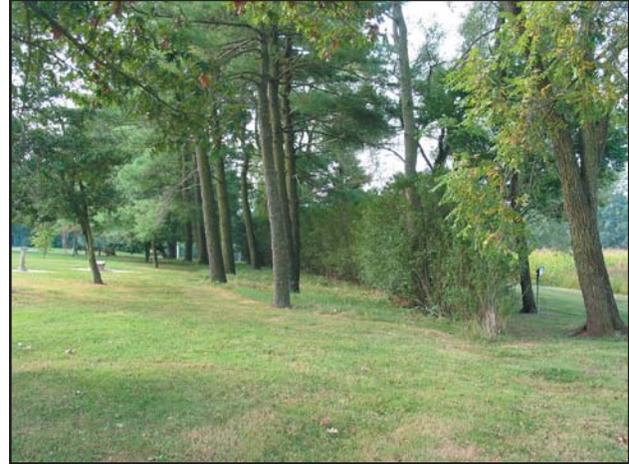
Figure 2.25. View looking south at the windbreak southwest of the house. The privet hedge is taller than it was historically. Like the pines along the entry drive, many of the plants display a conspicuous leeward habit. (Photo by OCLP, 2005)

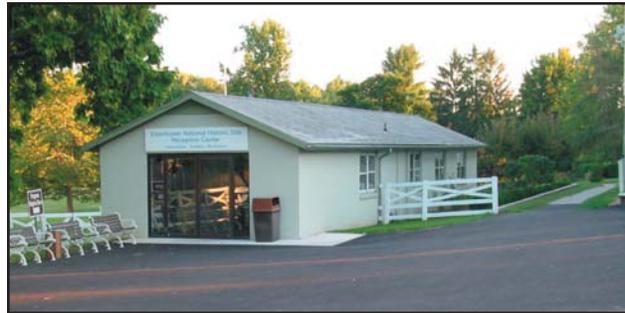
Figure 2.47. View looking south at plantings around the visitor reception center and missing Canadian yews next to the fence. (Photo by OCLP, 2005)

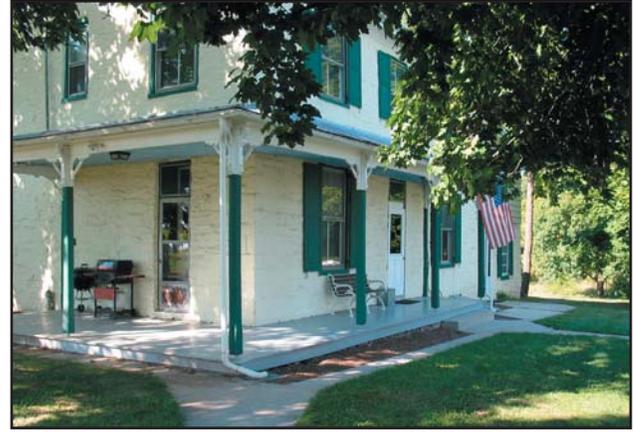
Figure 2.72. View of south and east sides of Farm #2 farmhouse. Note missing shrubs along the porch that were present in 1967. (Photo by OCLP, 2005)

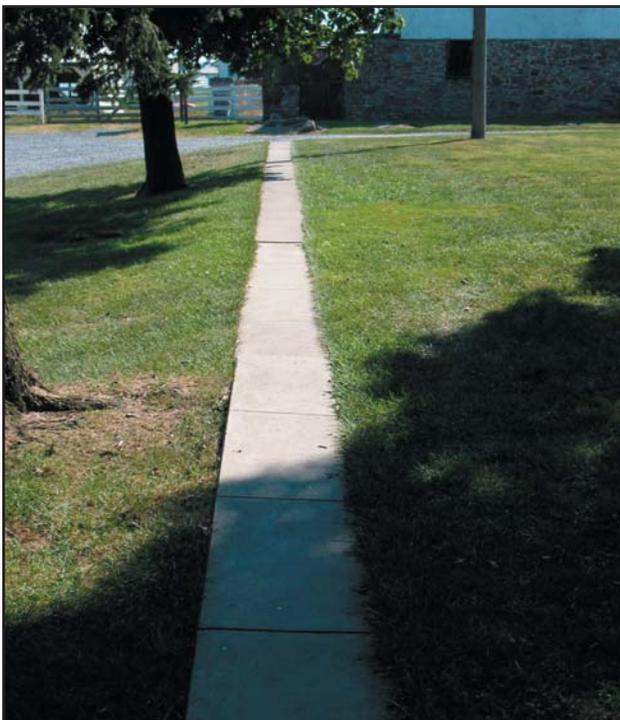
Figure 2.97. This historic concrete path at Farm #2 connects the farmhouse to the bank barn. It is not wide enough for a wheelchair user. (Photo by OCLP, 2005)

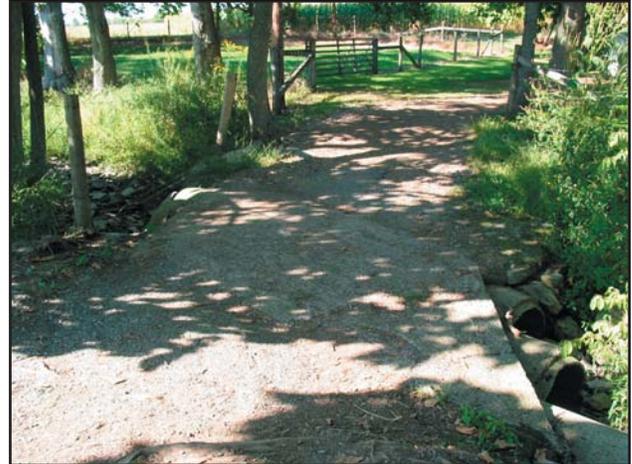
Figure 2.98. The pipe culvert bridge between Farms #1 and #2 is historic but has exacerbated erosion by channeling water. (Photo by OCLP, 2005)

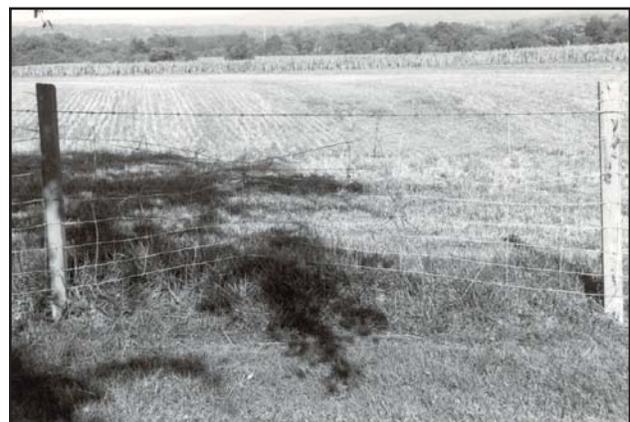
Figure 2.100. Fence section along Eisenhower Drive damaged by a mower. (Photo by OCLP, 2001)

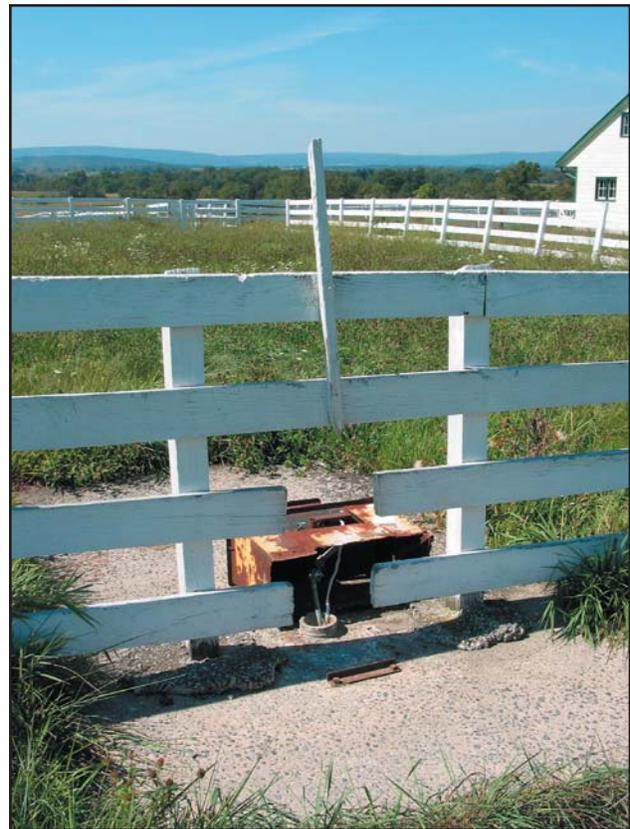
Figure 2.105. View looking west at the toppled Ritchie fountain in the south paddock on Farm #2. (Photo by OCLP, 2005)

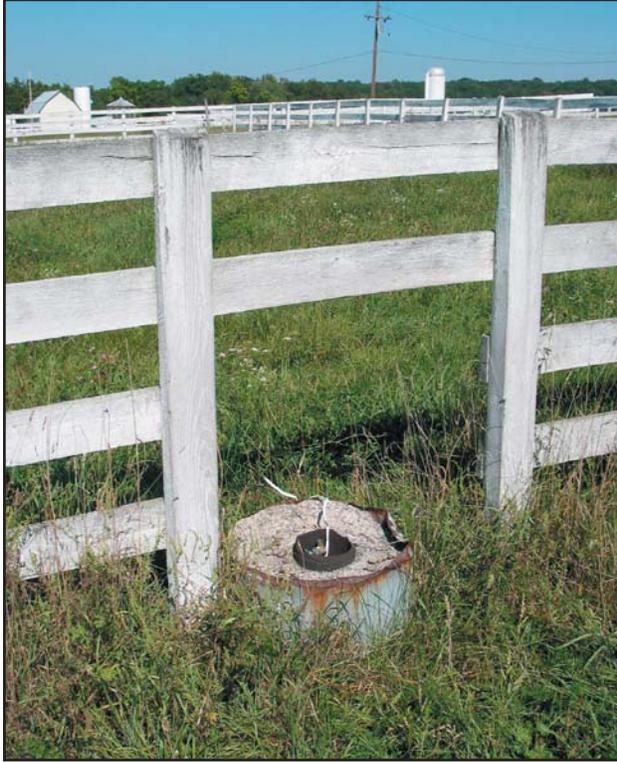
Figure 2.106. View looking north at a missing Nelson water bowl in the southwest paddock on Farm #2. (Photo by OCLP, 2005)
