# Tech Notes

## LYNDHURST GATEHOUSE

Tarrytown, New York

### Exterior Storm Windows: Casement Design Wooden Storm Sash

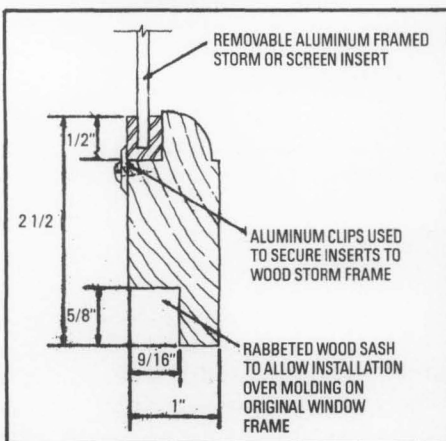
**Figure 1.** The single casement, wooden storm window had two removable panels for screen and glass inserts. This custom design fulfilled a variety of requirements established for the project with minimum physical damage and visual changes to the historic windows. Drawing: Martha L. Werenfels

dows and attached to the existing frame (see figure 1). The arched-headed wooden storm window with one-over-one glass panes matched the size of the original double-hung sash. Molding details similar to the original were incorporated in the new storm sash. Each of the two panes in the storm sash was set in thin aluminum frames and secured in the wood storm window with standard clips. This installation technique enables the storm panels to be easily removed by a person on the inside of the house and replaced during the summer with screens (see figure 2).

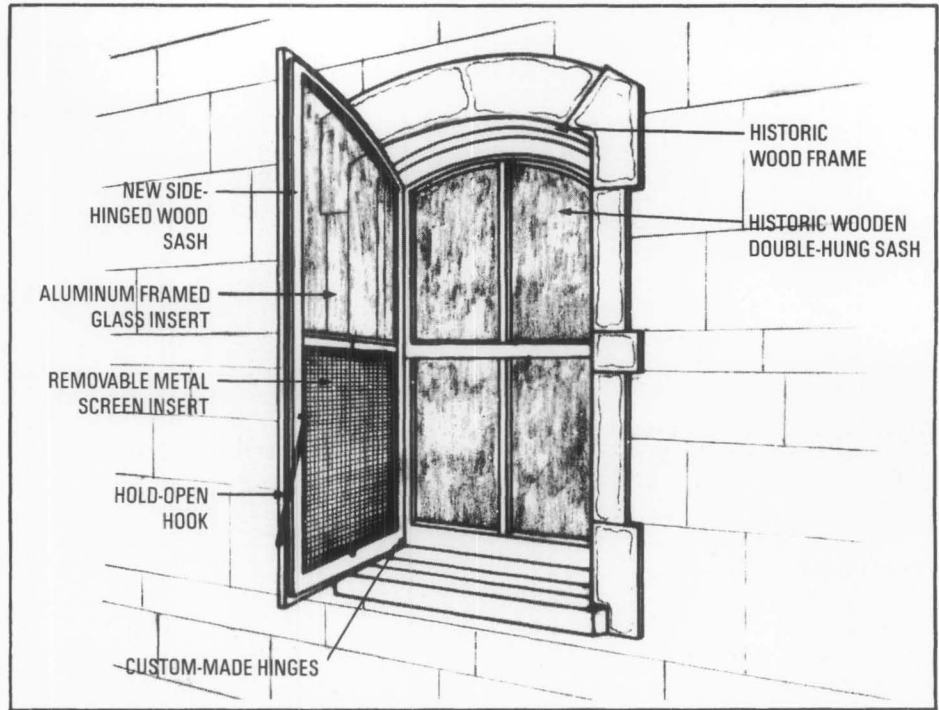
**Figure 2.** Section of the wood stile shows how the removable screen and storm panels are secured by use of aluminum clips. Also note that the storm sash was rabbeted along the inside edge to allow retention of original window molding. Drawing: Martha L. Werenfels

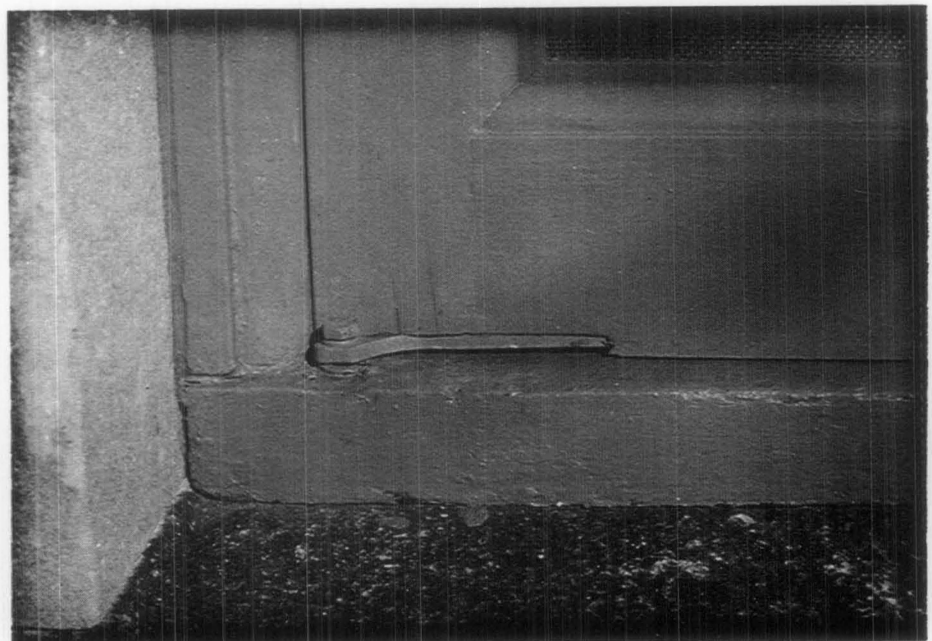
**Figure 3.** The only feature of the storm window that required expensive custom work was the pin-in-socket hinges (bottom one shown in photograph). Commercially available hardware could have been used; however this project sought to minimize physical damage to historic woodwork and thus tested a prototype design. Stainless steel was used for reduced maintenance costs. Photo: Richard Bierce, AIA

Mounting hardware consisted of pin-in-socket hinges which required the drilling of only two holes in the existing frame (see figure 3). The hinges allow the window to open casement-style for egress and ventilation purposes.

Custom-made stainless steel hinges of a pin-in-socket design were attached to the left side, top and bottom, of each window. The windows were then sanded, treated with a non-toxic preservative, and primed with an oil-alkyd paint.

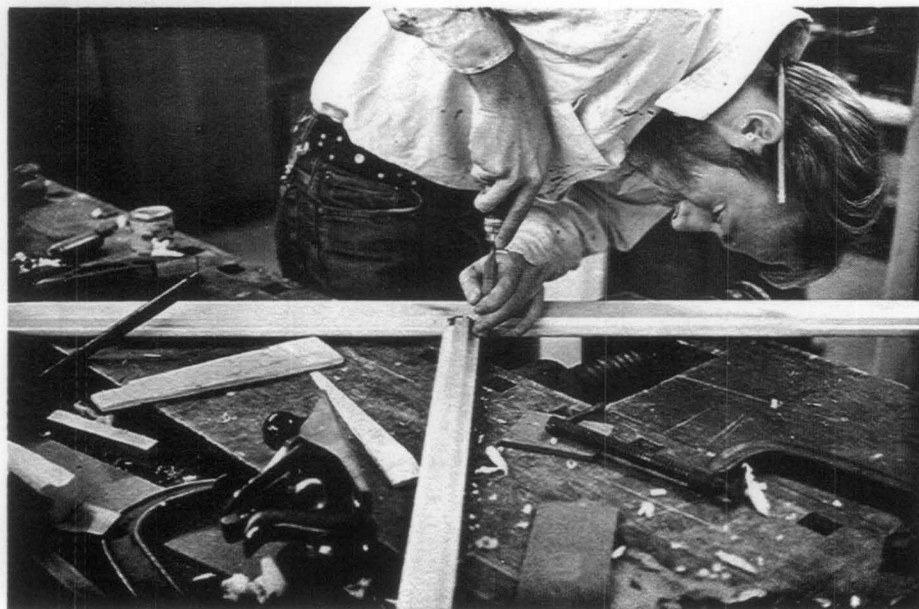
**Figure 4.** The center muntin in the storm window lines up with the meeting rail on the historic sash and is shown here being fitted to the wood stile. Photo: Courtesy, National Trust for Historic Preservation

In fitting the windows together, the parts were glued at the joints with resorcinol glue, dowels inserted, and the clamps attached while the glue hardened overnight (see figure 4). After the joinery was completed, the tops of the stiles were cut to fit the curvature of the arch. For the first floor windows, a 5/8" by 9/16"

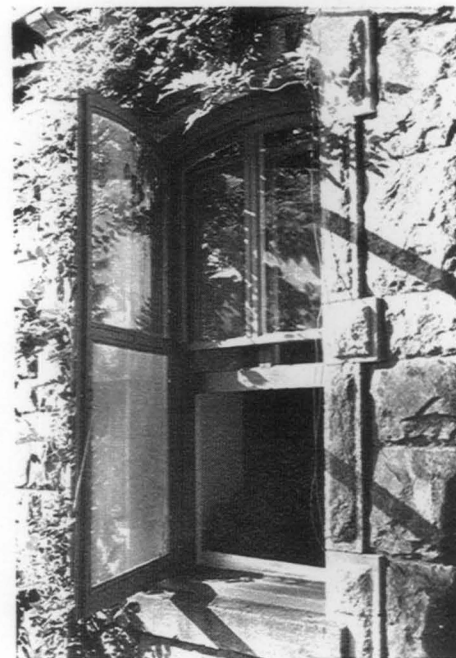
**Figure 5.** The new wooden storm sash was installed in the historic frame; the edge of the storm frame was rabbeted to accommodate the historic molding on the old wood frame. Photo: Richard Bierce, AIA

wood preservative used on the sash, then filled with a polysulfide caulk before the anchor was inserted. After the windows were installed, 1 inch hook-eyes were attached to secure the windows shut while a second hook-eye, 1 foot long, was installed on each window to hold it in a fixed position when opened (see figure 5).
