## FLORIDA STATE CAPITOL

# Tech Notes

NUMBER 7

### Window Awnings

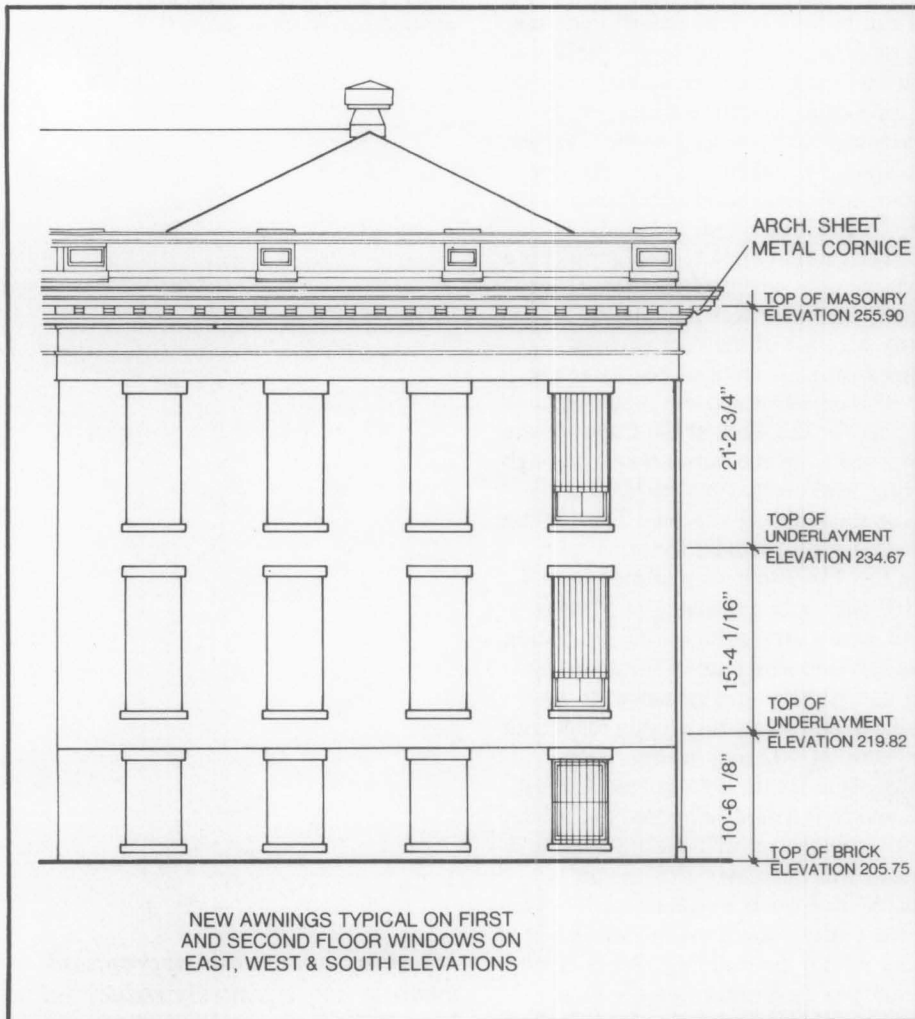
**Figure 1.** Large awnings were specified for all but the north elevation in order to reduce solar gain. Drawing: Courtesy, Shepard Associates, Architects and Planners, Inc.

Since the primary facades of the Capitol faced east and west, awnings were needed on the two main floors on all but the north side (see figure 1). Solar heat gain, which originally would have consumed 54% of the required cooling load, was now estimated to be 31.5% of the equipment load, and allowed a downsizing of the HVAC system by 25 tons. In typical first floor offices, the exposed glass surface would now only account for 46% of the required cooling load down from 72%. On the second floor, there was a similar change from 56% down to 30%.

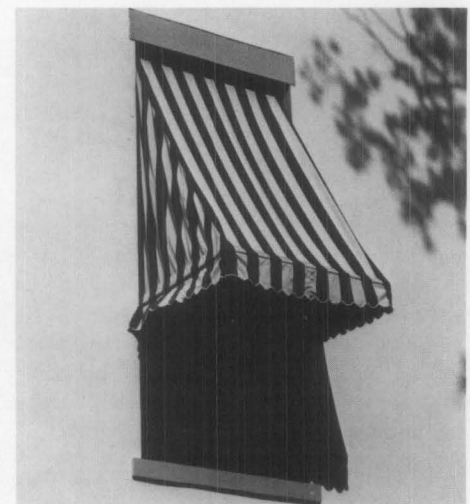
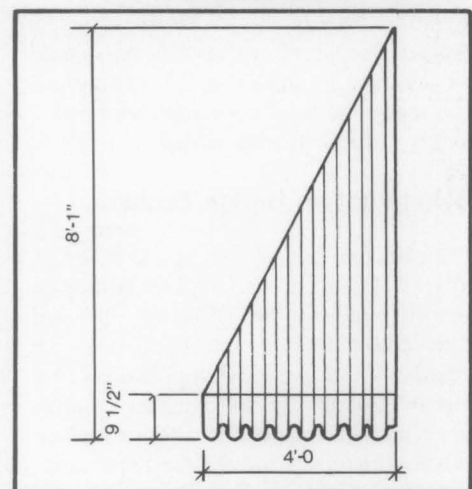
The awnings were fabricated to the architect's design of 4' wide by 4' deep with a height of 8'-1" and a 9 1/2" scalloped valance (see figure 2). The 100% acrylic fabric has vertical stripes four inches apart. Regrettably the production of the acrylic weave did not allow for pure color separation, and as a result the striping is in reality red and a very light pink; still the impression of red and white is maintained.

**Figure 2.** Early photographs were used in determining the appropriate design and size of the new awnings shown in the photograph. Drawing: Courtesy, Shepard Associates, Architects and Planners, Inc.; Photo: Courtesy, Florida Bureau of Historic Preservation.
