Improving Watershed Health at John Muir National Historic Site

The Question: What are the factors contributing to exacerbated erosion and flooding within the Mt. Wanda-Strentzel Canyon watershed? What are the possible remedies?

John Muir National Historic site has recently completed a study to address erosion and flooding concerns in Strentzel Canyon. This briefing summarizes the issues and highlights some of the possible actions to improve watershed health.

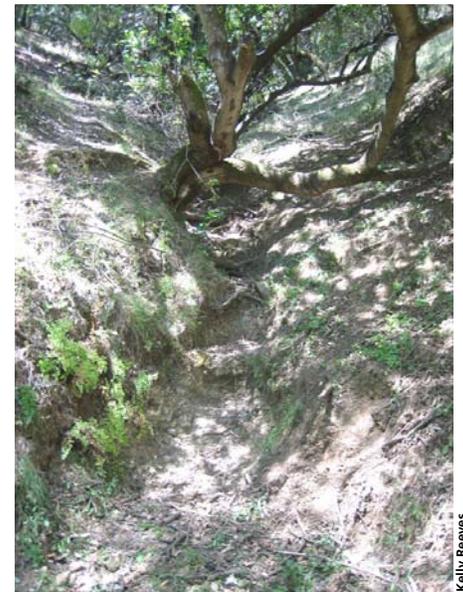
The network of ephemeral streams on Mt. Wanda carries eroded hillside sediment to the mouth of Strentzel Canyon, and Alhambra Creek.

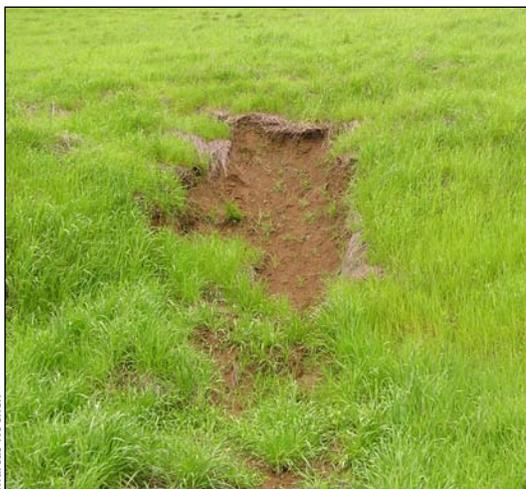
The shallow roots of non-native grasses accelerate erosion on Mt. Wanda. Dynamic creek channel erosion in the watershed and related downstream flooding prompted John Muir National Historic Site to begin a study that would determine the cause.

During the mid-1800s, the combination of the grazing pressure, disturbance by agriculture and drought forced a significant change in vegetation. Shallow-rooted exotic grasses replaced deep-rooted native bunch grasses. This shift in vegetation composition likely contributes to erosion seen today along ephemeral creeks in the watershed. The shallow roots of exotic grasses do not hold soil as tightly or hold as much water in the soil as the deeper roots of native grasses. The resulting increase in soil moisture allows precipitation to run more rapidly downslope, eroding the stream banks into deeply incised gullies.

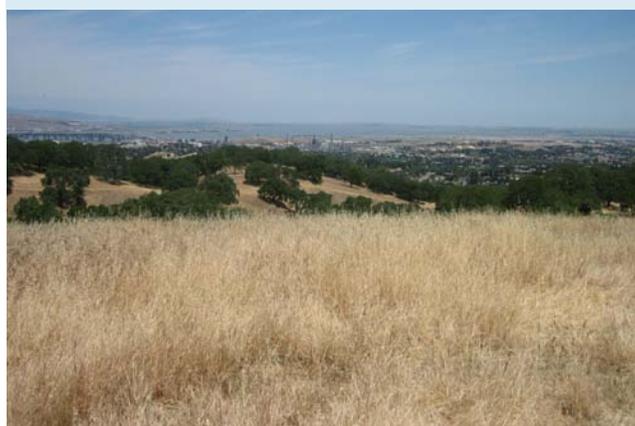
By the time John Muir strolled on Mt. Wanda, non-native grasses had replaced the native grasses. The vegetation shift likely contributes to the accelerated hillside and stream channel erosion seen today.
