# Coastal Adaptation Strategies: Case Studies

National Park Service Report 2015

Edited by Courtney A. Schupp<sup>1</sup>, Rebecca L. Beavers<sup>1</sup>, and Maria A. Caffrey<sup>2</sup>

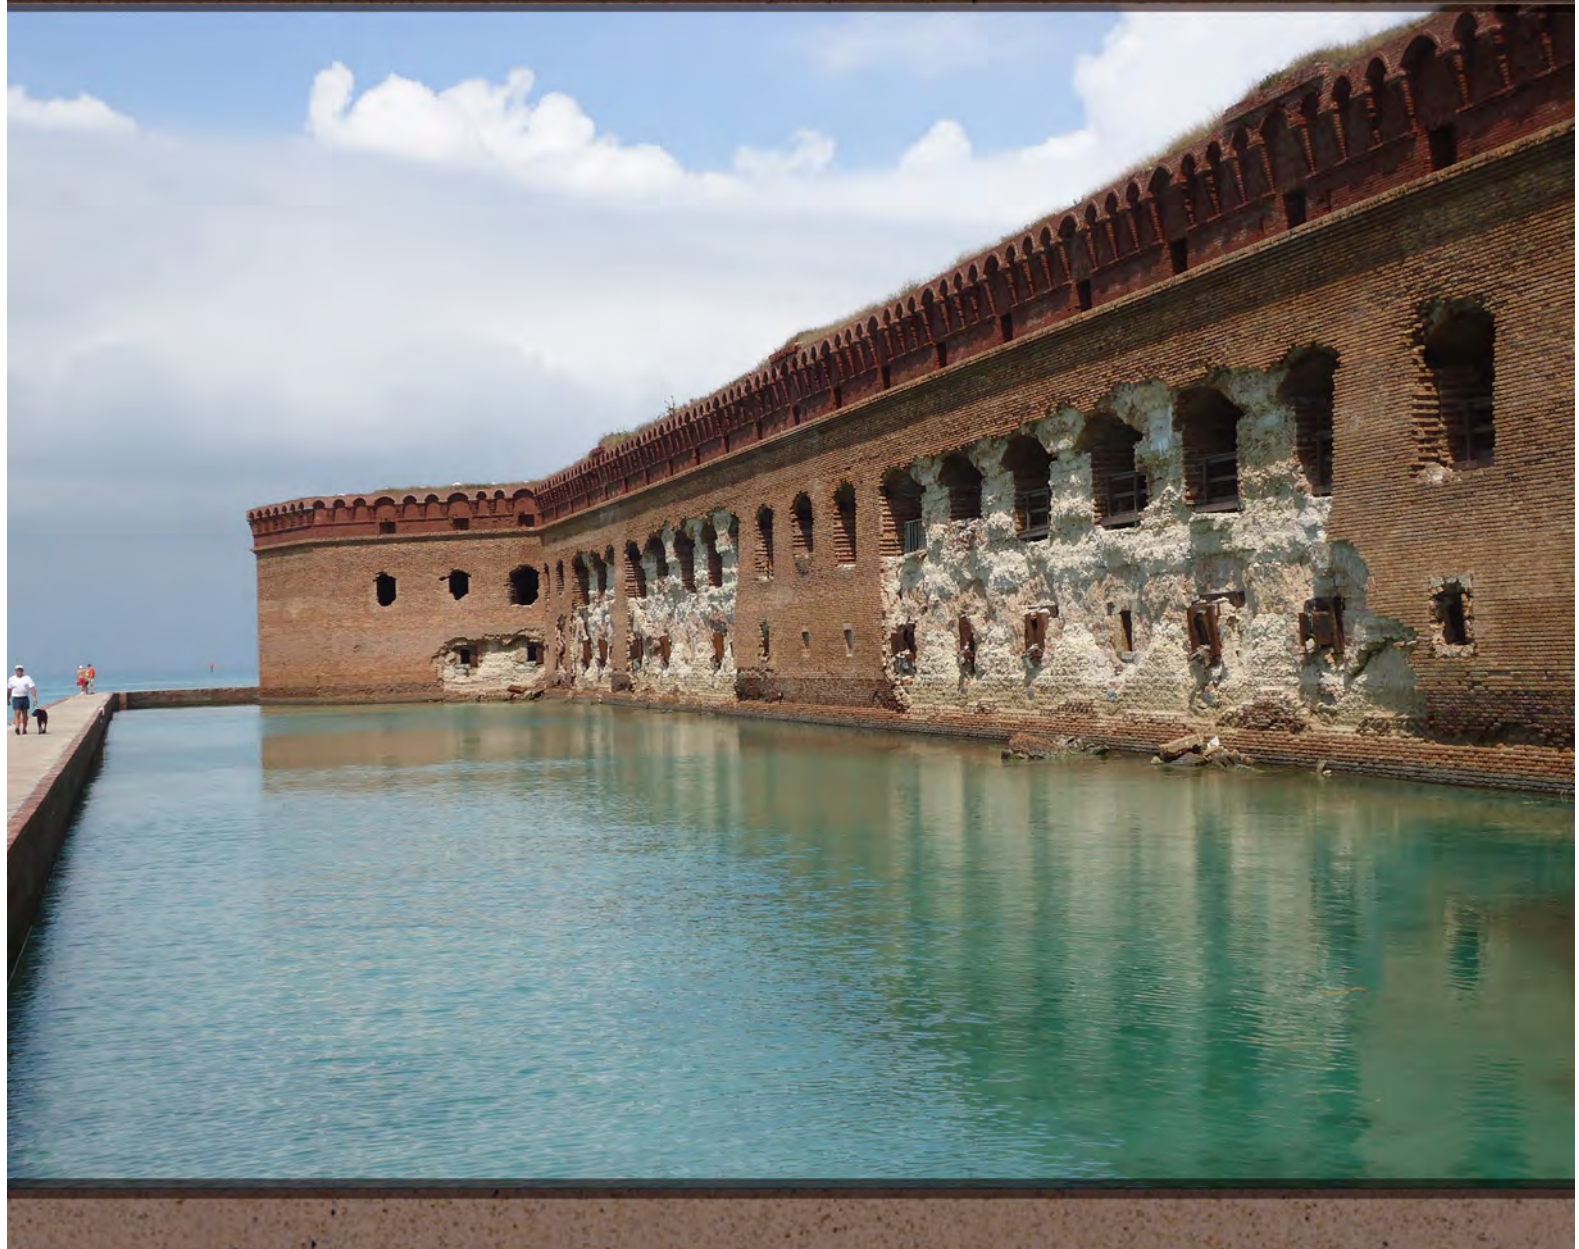
Investment in repairs to Fort Jefferson, at Dry Tortugas National Park, should consider historical integrity and long-term sustainability of the structure and the island, which are both vulnerable to climate change impacts.

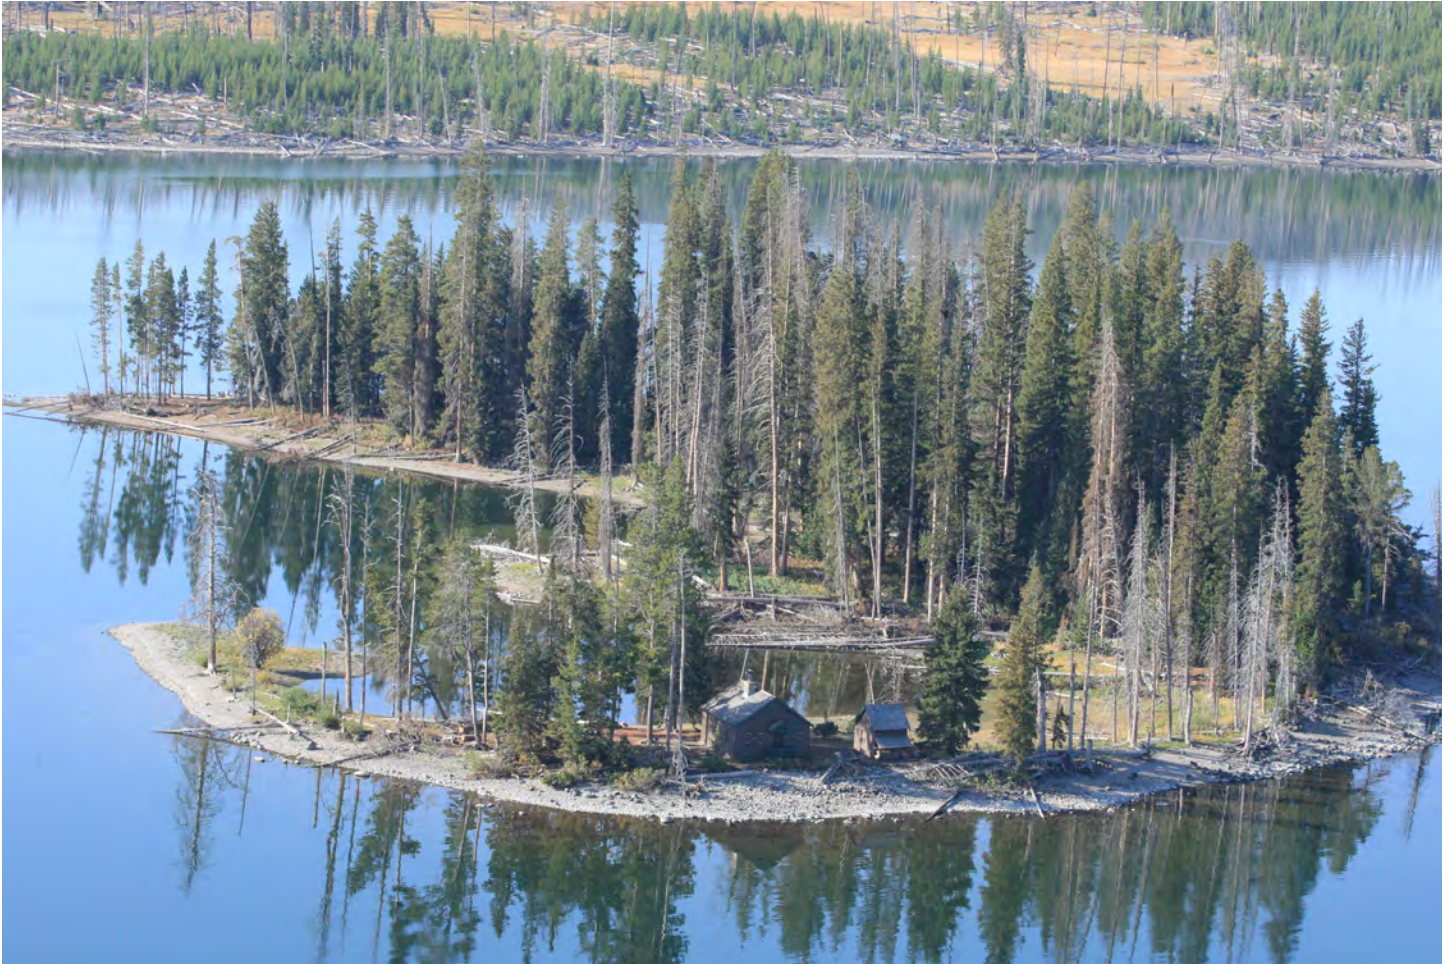
The historic Peale Island Cabin in Yellowstone National Park is threatened by shoreline change that may be accelerated by tectonic uplift, tree death, and longer ice-free periods. Photograph courtesy of Yellowstone National Park.

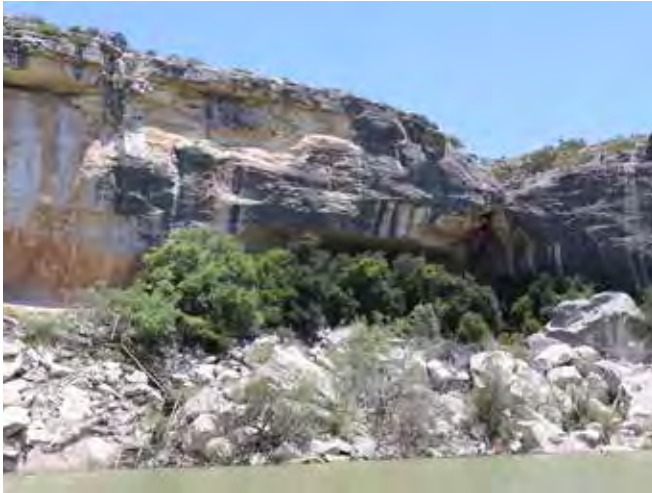
Panther Cave contains extensive pictographs, which are threatened by fluctuating water levels tied to storm events and (indirectly) to siltation. Reservoir level in the photo is about 332 m (1,089 ft) above mean sea level, with 2.4 m (8 ft) of water covering the silt bed. Image credit: Jack Johnson, NPS.

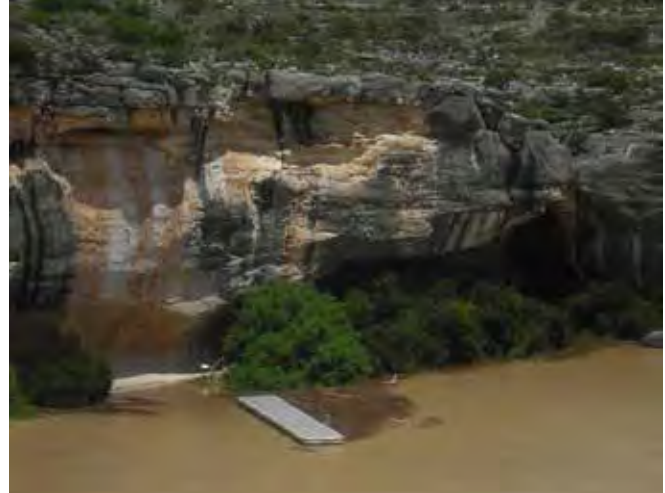
The reservoir level was 344 m (1,130 ft) above mean sea level in July of 2010, nearly reaching the base of the pictograph panel. By May of 2013 the reservoir had dropped to a record low of 322 m (1,055.9 ft) above mean sea level, leaving the canyon bottom completely dry. Image credit: Randy Rosales, Texas Parks and Wildlife Department.

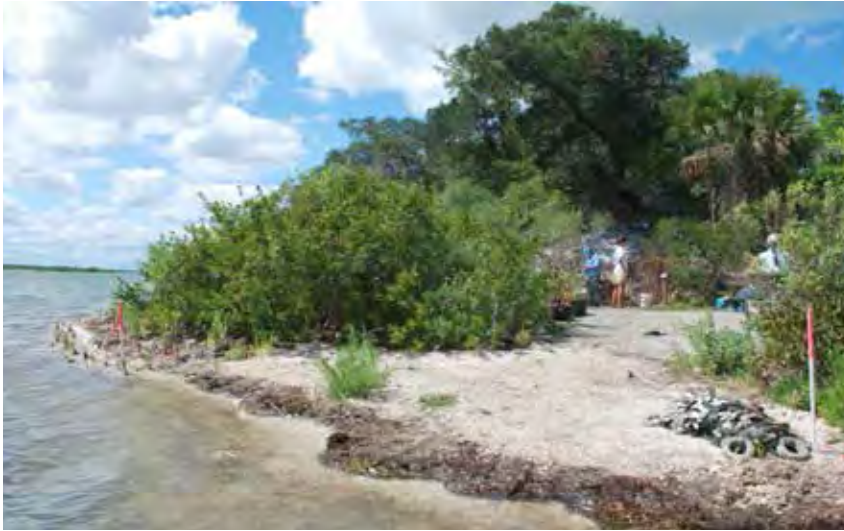
Building a living shoreline with volunteers at Castle Windy mound site, Canaveral National Seashore. Image credit: Margo Schwadron, NPS.

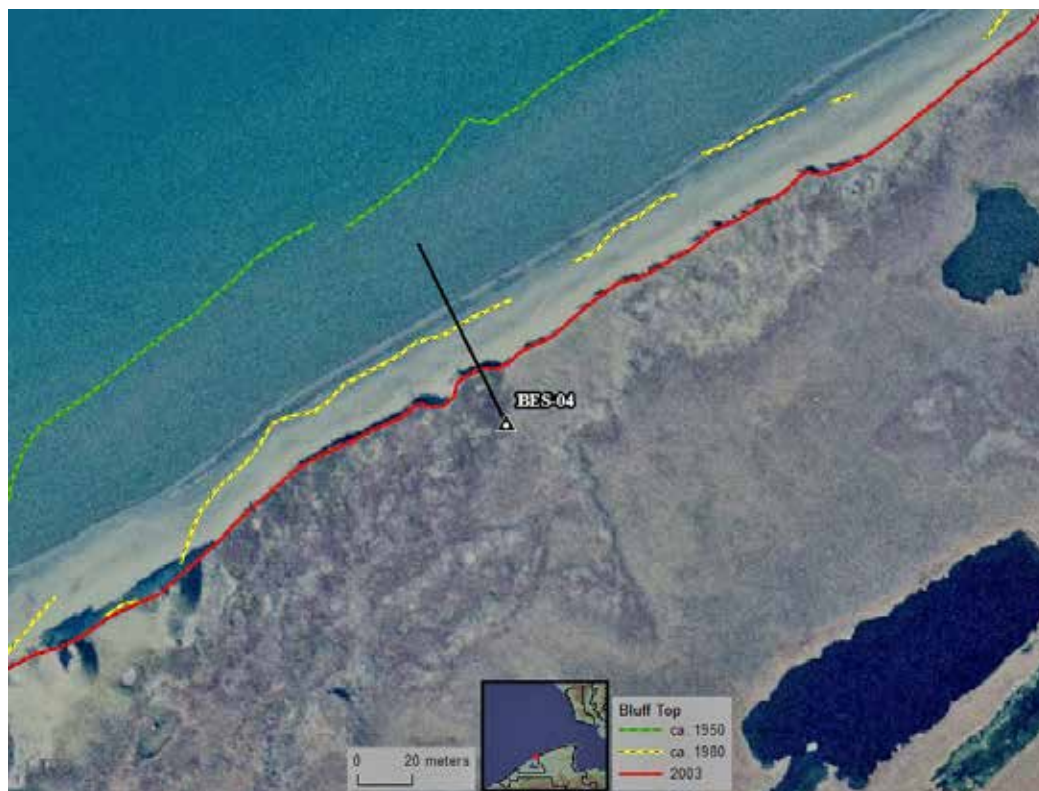
Bluffs along the coast eroded 78 m (256 ft) in only 54 years. Image credit: NPS I&M Program.

The 1,600 km (1,000 mi) of coastline along the parks are experiencing increased storm impacts due to climate change effects including rising sea level, melting permafrost, increasing storminess, and the failure of shore ice to form its usual protective barrier against wave erosion during open water season, including storms in the late fall. The Alaskan Arctic has experienced average temperature rise at twice the rate of the rest of the world, and precipitation patterns are changing. Seasonal (winter) sea ice is not forming to its previous extent and thickness, and thick multi-year ice has mostly disappeared. Satellite data indicate that the extent of the sea ice is decreasing by 3% per decade, and submarine data show that the thickness has decreased by up to 1 m (3.3 ft). The ice plays a role in surface reflectivity, cloudiness, humidity, exchanges of heat and moisture at the ocean surface, and ocean currents. Summer ice is projected to disappear over most of the Arctic Ocean by 2020. Permafrost, which protects cultural resources by preserving organic materials, has warmed by up to 2°C (3.6°F) and is melting.

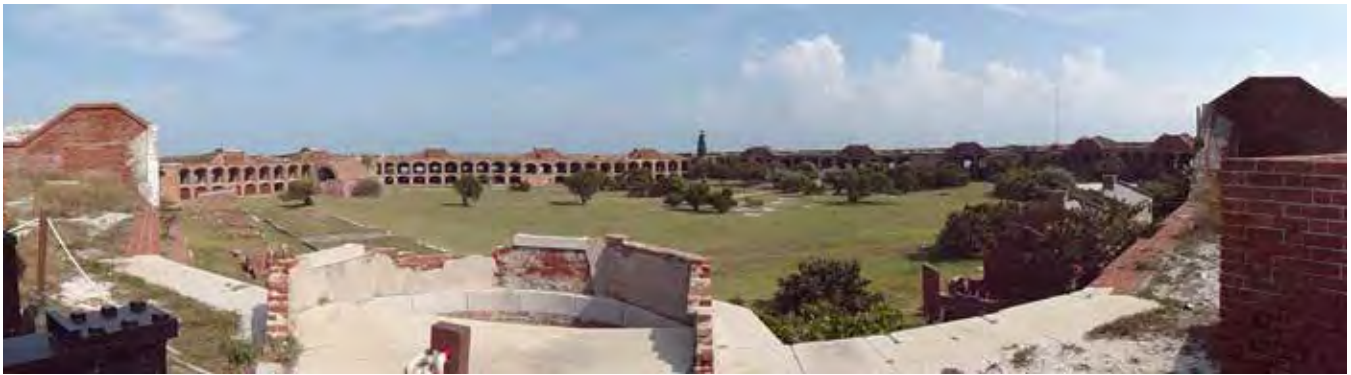
Historic Fort Jefferson is a six-sided structure built on a landform that is impacted by coastal processes. Image credit: Marcy Rockman, NPS.

For more than 165 years, Fort Jefferson on Garden Key has exhibited incredible resilience to storms and the marine environment of the Dry Tortugas. Still the structure is deteriorating. The fort is a mid-19th century Third System Coastal Defense. It is an unreinforced masonry structure composed of coral concrete faced with

Throughout the architecture of the fort, there are iron components embedded within the masonry that served various functions, including water collection, supports for catwalks, and, most importantly, protection against enemy fire. In this salt water environment, the wrought-iron has rusted and expanded, pushing the brick apart and causing serious structural damage to Fort Jefferson's exterior scarp walls; large sections of the fort walls have collapsed into the moat.

The moat wall surrounding the fort also needs repairs in many places. Because it is an integral part of the site design and protects the fort from wave forces, it also protects the investment in stabilization of the fronts.

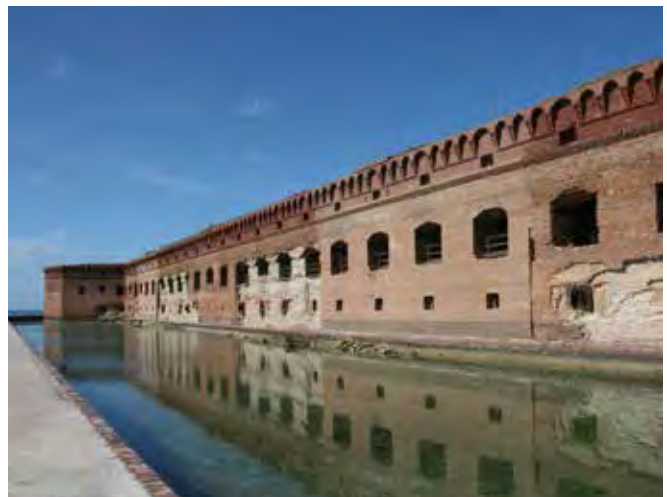
Fort Jefferson needs repairs to its front and moat wall. Image credit: Kelly Clark, NPS.

brick, with six sides and three tiers. It is surrounded by a 21 m (70 ft) wide wet moat that is separated from the open waters of the Gulf of Mexico by a masonry wall, formally called the counterscarp. The counterscarp sits approximately 2 m (6 ft) above the low water line and 1 m (3 ft) above high tide. The moat and counterscarp were designed to keep would-be attackers at bay and to provide a structural first line of defense for the fort against the sea.

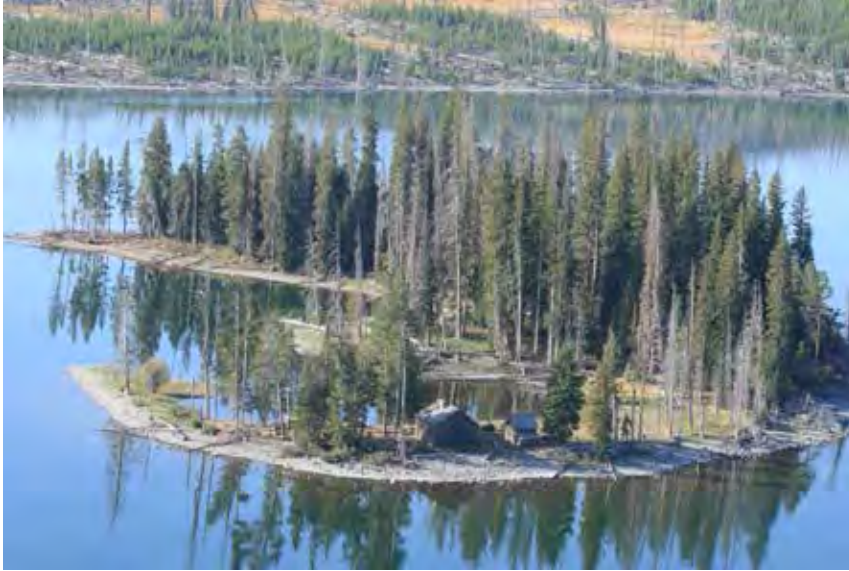
Peale Island Cabin is located on a small spit of land on the northwest corner of Peale Island. Image credit: Yellowstone National Park.

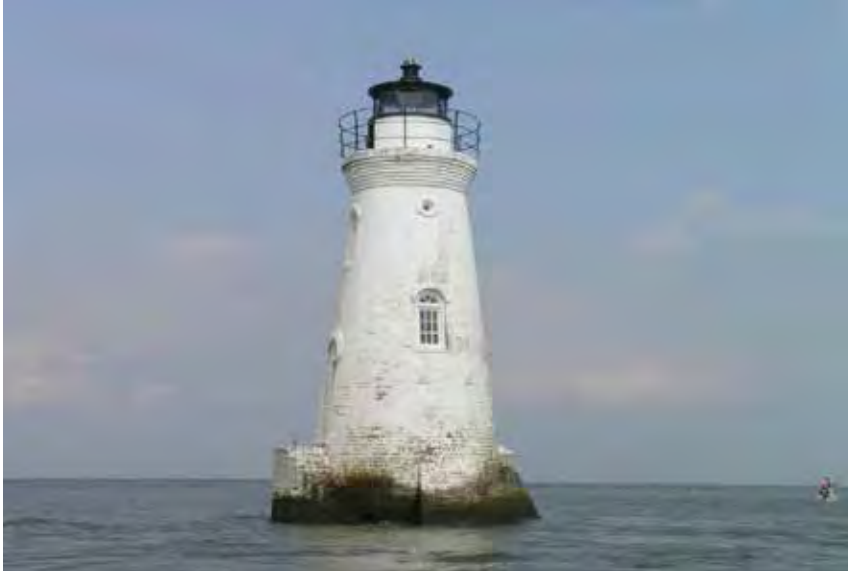
The Cockspur Lighthouse at Fort Pulaski National Monument needs to be stabilized. Image credit: Mike Eissenberg, NPS.

The historic revetment around the Cockspur Lighthouse has eroded away in the past 30 years, and a portion of the original wooden foundation has been exposed to shipworm damage. Ongoing erosion around the revetment has led to concern about the possibility of severe structural damage in the next few years.

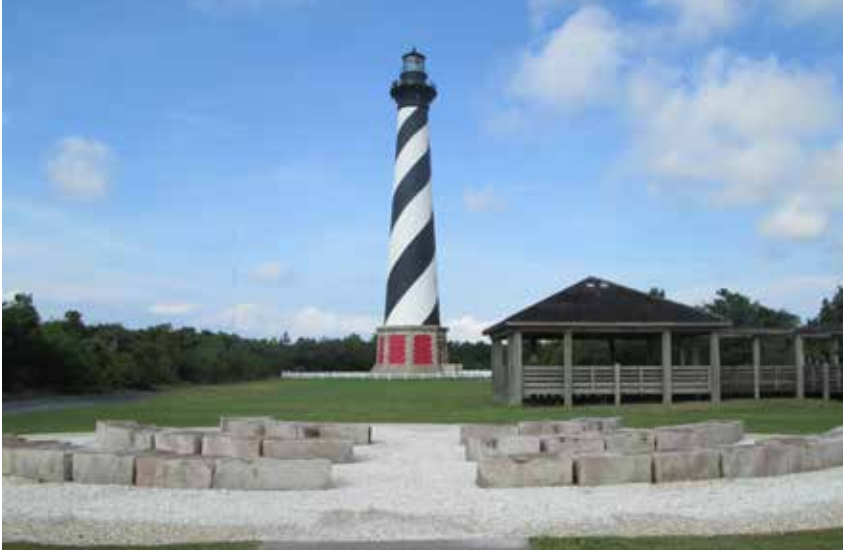
The Cape Hatteras lighthouse was moved inland using a railway in 1999. Image credit: NPS.

Following so many unsuccessful attempts to protect the lighthouse with hard structures, the “Move the Lighthouse Committee” was formed in 1986 and became strong proponents of relocating the lighthouse inland. In 1988 the National Academy of Science also recommended that the lighthouse be moved. The National Park Service (NPS) released a statement in December 1989 formally announcing the decision to move it.

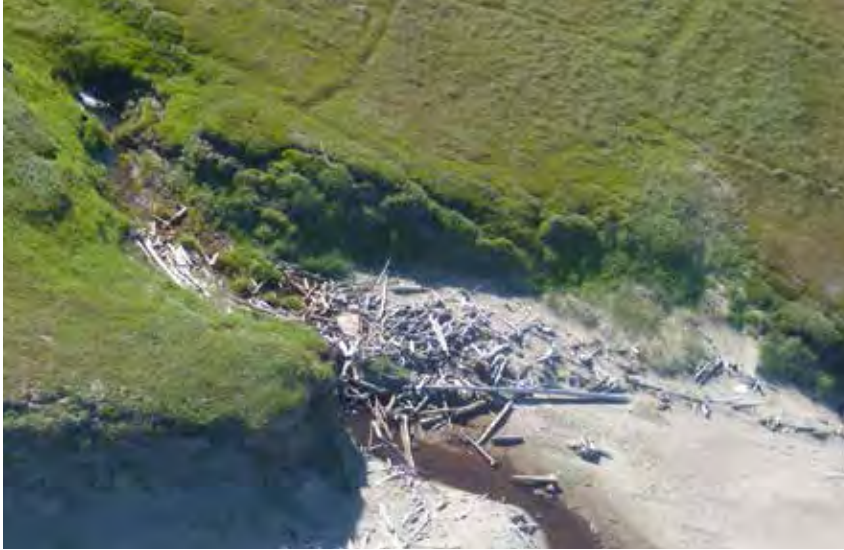
Coastal bluffs are eroding as a result of permafrost thawing and coastal storm erosion. Image credit: Tahzay Jones, NPS.

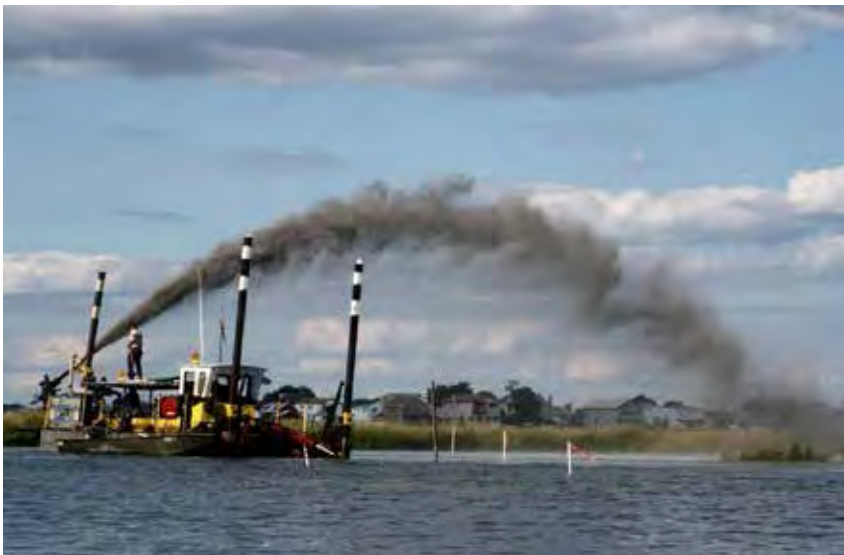
Salt marsh restoration in Jamaica Bay has tried a variety of experimental techniques to increase marsh elevation, including spraying the marsh surface using a swing-ladder dredge. Image credit: USACE New York District.

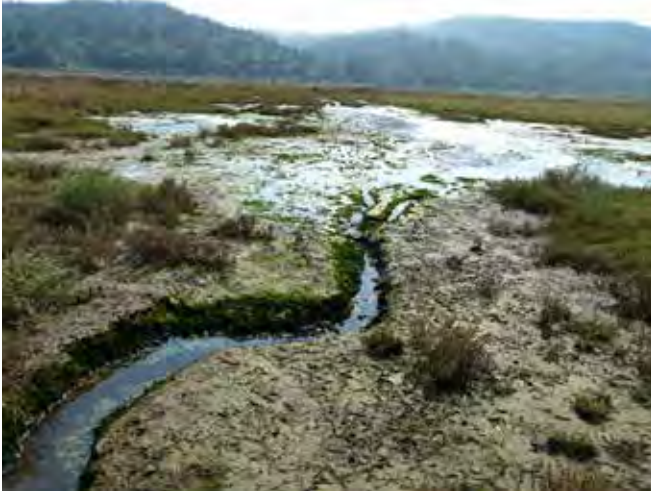
A new channel forms on East Pasture marshplain, part of the restoration of agricultural lands to wetlands. Image credit: Lorraine Parsons, NPS.

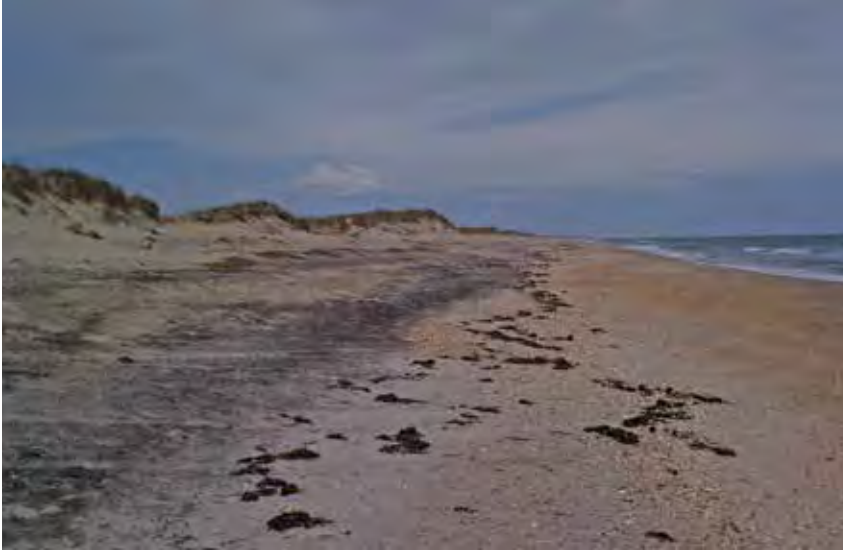
Shoreline erosion along the western portion of Shackleford Banks is accelerating due to adjacent channel dredging. Image credit: NPS.

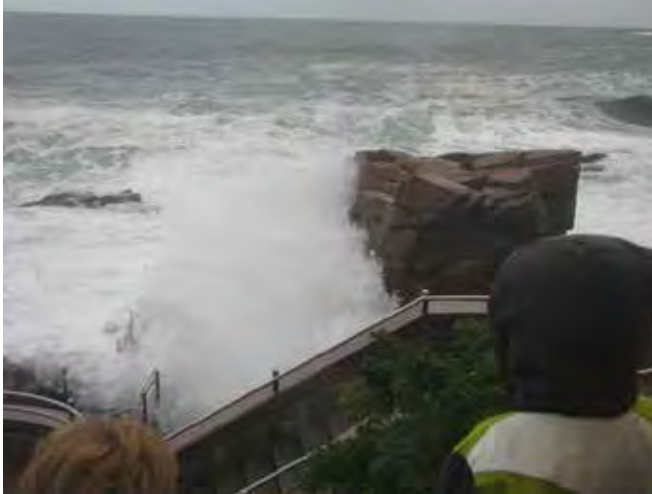
Hurricane Irene produced storm surge at Thunder Hole viewing platform, a popular visitor facility. Image credit: Rebecca Cole-Will.

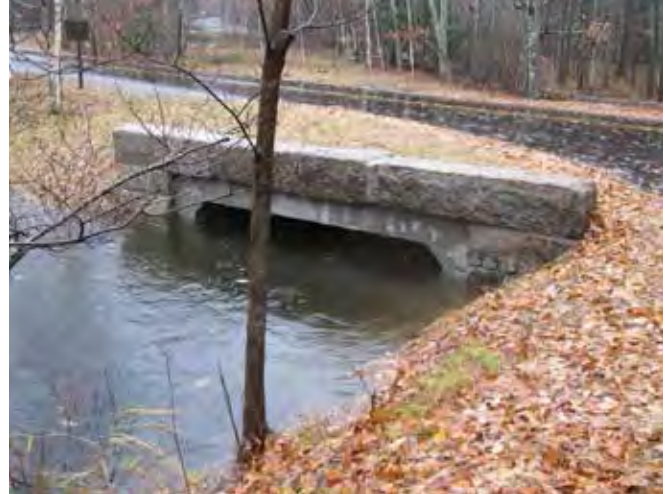
Headwall and culvert after rehabilitation at Sieur de Monts Spring site. Image credit: Rebecca Cole-Will.

Acadia National Park in Maine is working to rehabilitate historic road systems and culverts that have been damaged by increasingly frequent flooding and erosion events that were causing maintenance and visitor use closures.

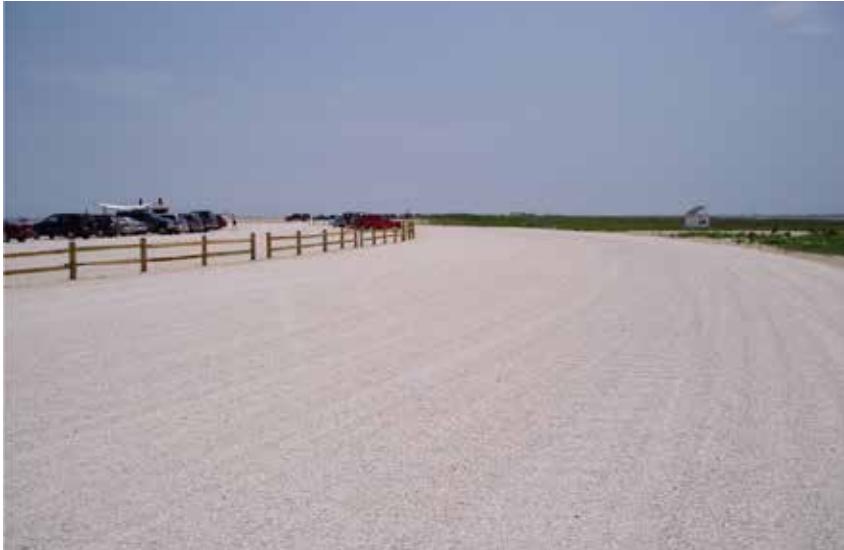
The Virginia visitor parking lot is constructed with native materials including clay and clamshell that can be reused in post-storm repairs. Image credit: Ish Ennis, NPS.

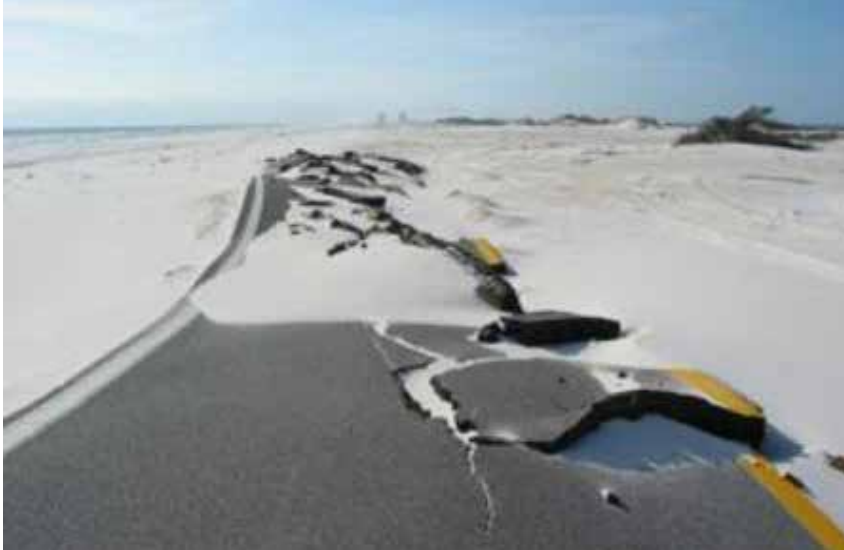
Storms regularly damage the Fort Pickens Road, resulting in extended road closures and high repair costs. Image credit: Federal Highway Administration.

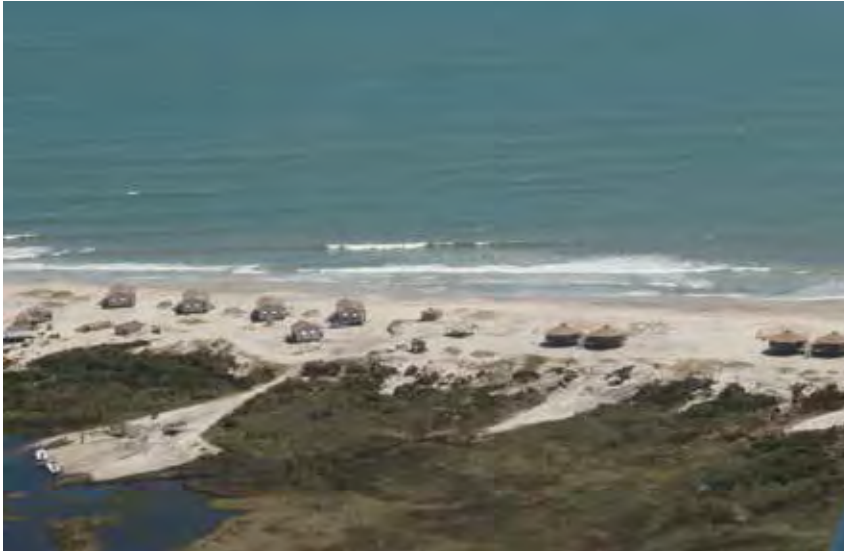
Overwash during Hurricane Irene impacted infrastructure on Long Point. Image credit: Rebecca Beavers, NPS.

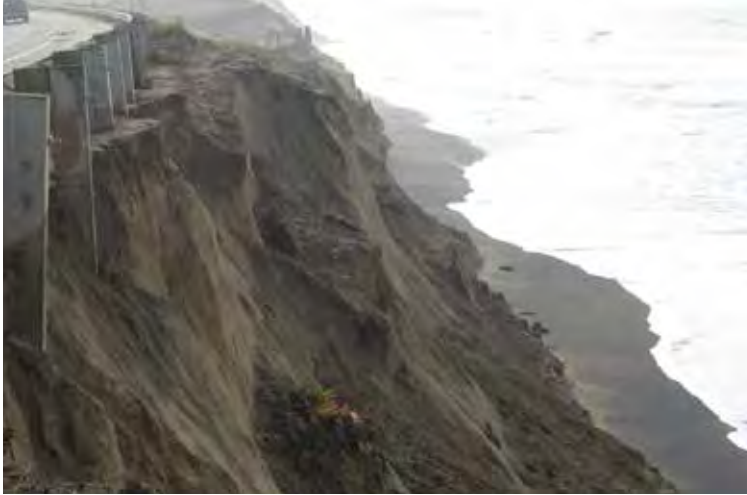
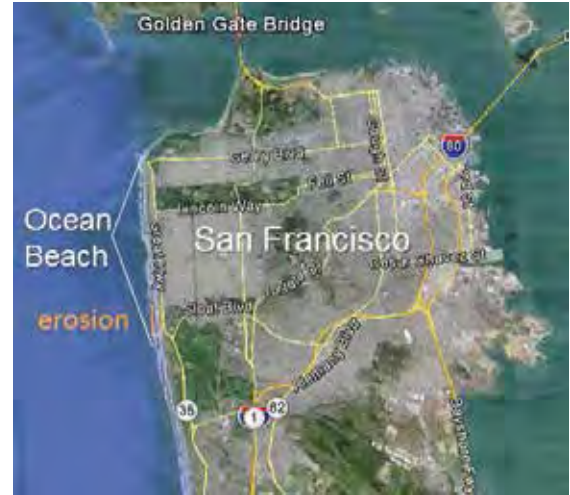
**Left:** The south end of Ocean Beach is eroding. Image credit: Steve Ortega, NPS. **Right:** Erosion below the Great Highway along Ocean Beach is believed to be exacerbated by development around San Francisco Bay. Image credit: NPS with photo from Google Earth 2013.
