Basis of Design Report

Merced River Restoration Project - Phase 3

June 30, 2020

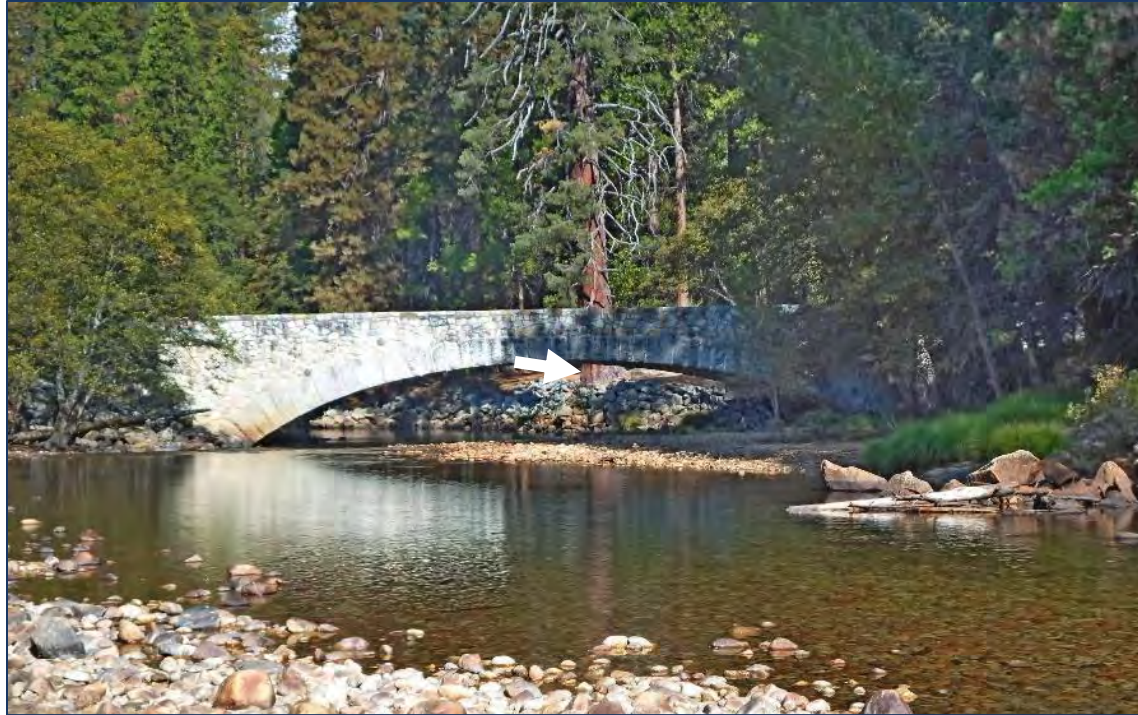
Figure 1-1 Sugar Pine Bridge, looking downstream from the left bank gravel bar. The eponymous sugar pine is visible through the bridge opening (shown with the white arrow), protected by a rock bank.

Completed outcomes of this project include the characterization of the physical, biological, and social dimensions of the reach; engagement of key stakeholders in the scope, timeline, and anticipated products of the work; guidance on riparian restoration projects planned for implementation within the reach; and preparation for a variety of monitoring efforts to be conducted opportunistically by the NPS during any high-flow event that might occur during this or subsequent years. The UCSB-led team has already designed and assisted the NPS in the implementation of site-specific riparian restoration projects, with four projects constructed between 2016 and 2019. This Basis of Design Report represents a comprehensive presentation by the UCSB team of design recommendations and analysis of the next phase of restoration work along the river, addressing a study component specifically called for in the final MRP, namely restoration actions in the reach that includes Sugar Pine Bridge (Figure 1-1).

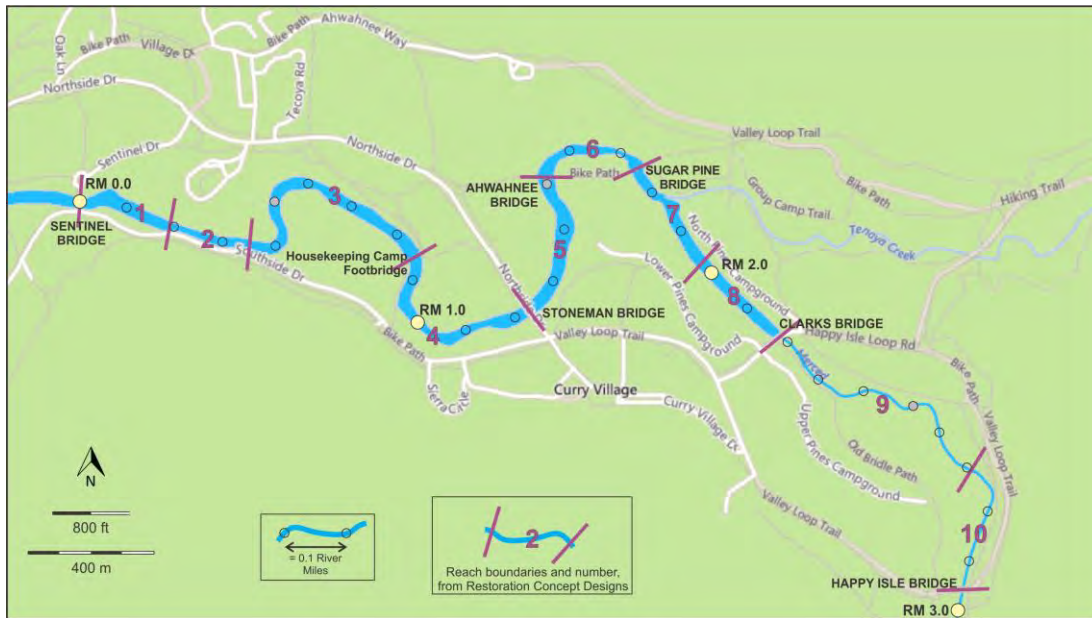
Figure 1-2 Overview map of the Study Area, highlighting the bridges within this part of the Merced River. Numbers reference the individual “reaches” into which the river has been subdivided; this Basis of Design report addresses Reaches 6 and 7, straddling Sugar Pine Bridge.

Conditions within the watershed and along the Merced River through the Study Area (Figure 1-2) have direct consequences for the impacts that have occurred, and they provide significant implications for reversing those effects through active restoration. The following findings are summarized from Booth et al. 2018):

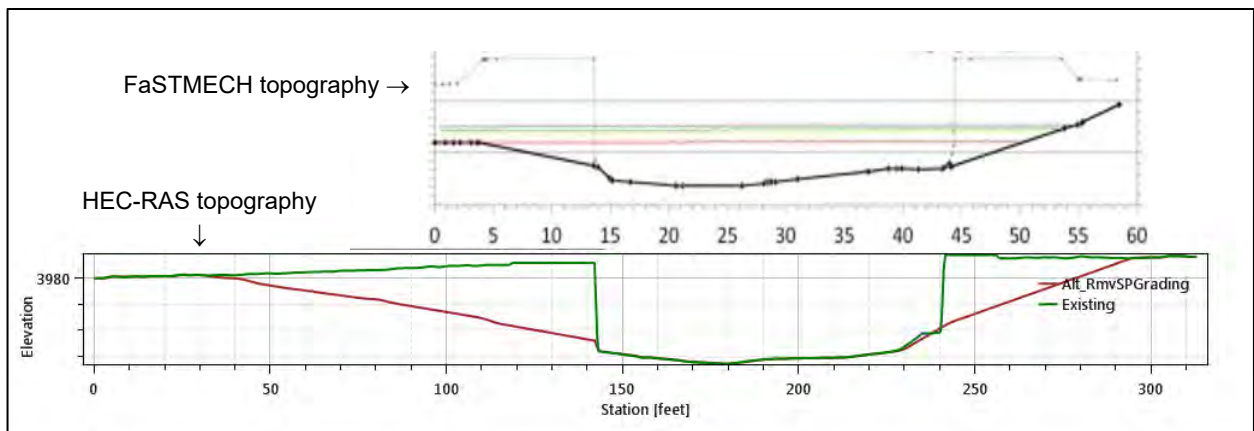
Figure 2-6 Comparable cross-sections of the existing and proposed topography at Sugar Pine Bridge from the FaSTMECH model (top; horizontal scale in meters) and the HEC-RAS model (bottom; horizontal scale in feet).

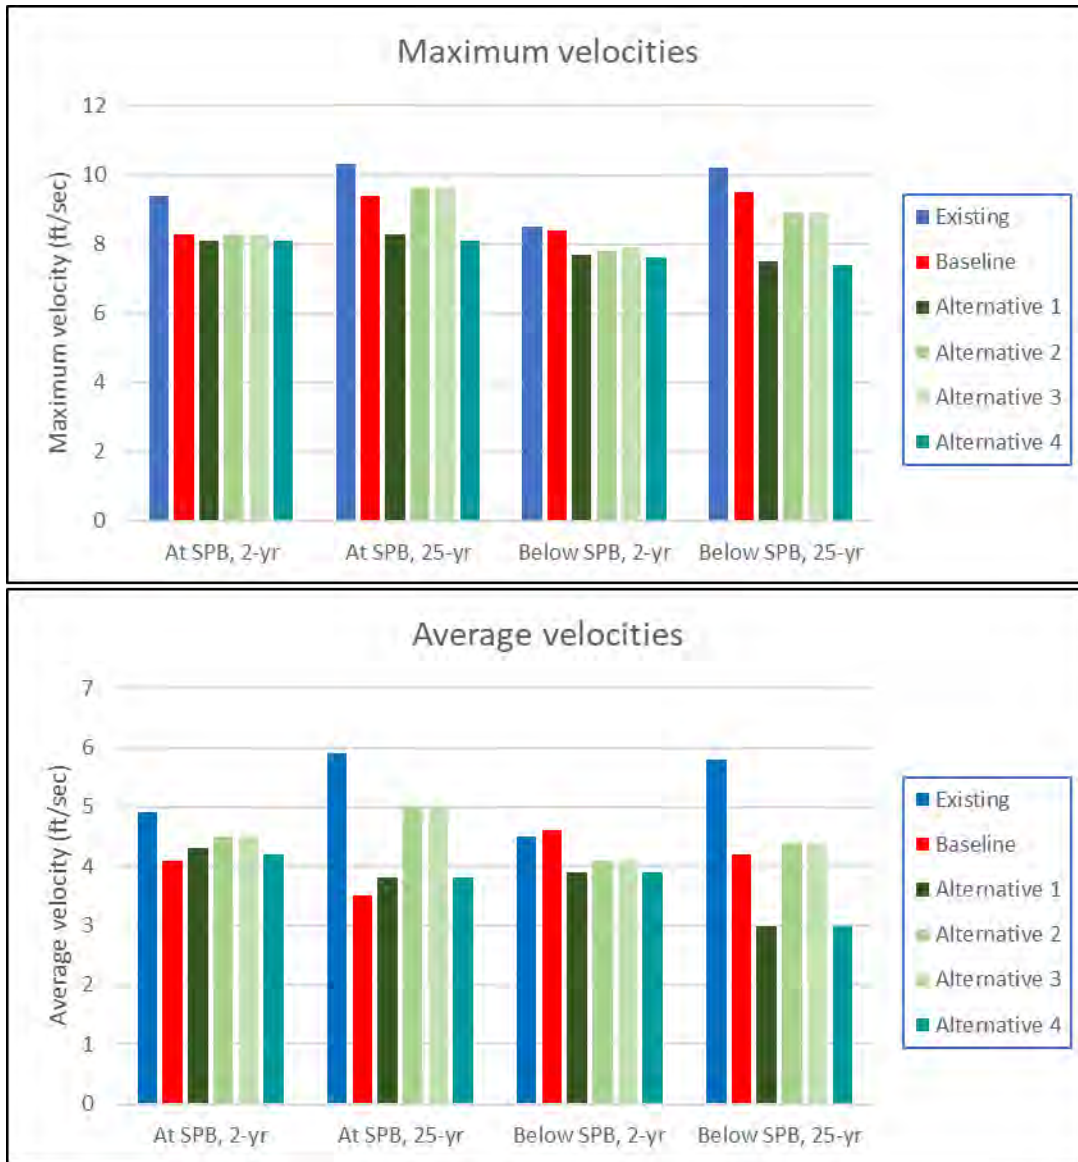
Figure 3-2 Graphs of simulated maximum and average velocities, plotted from the data in Table 3-3 and Table 3-4.

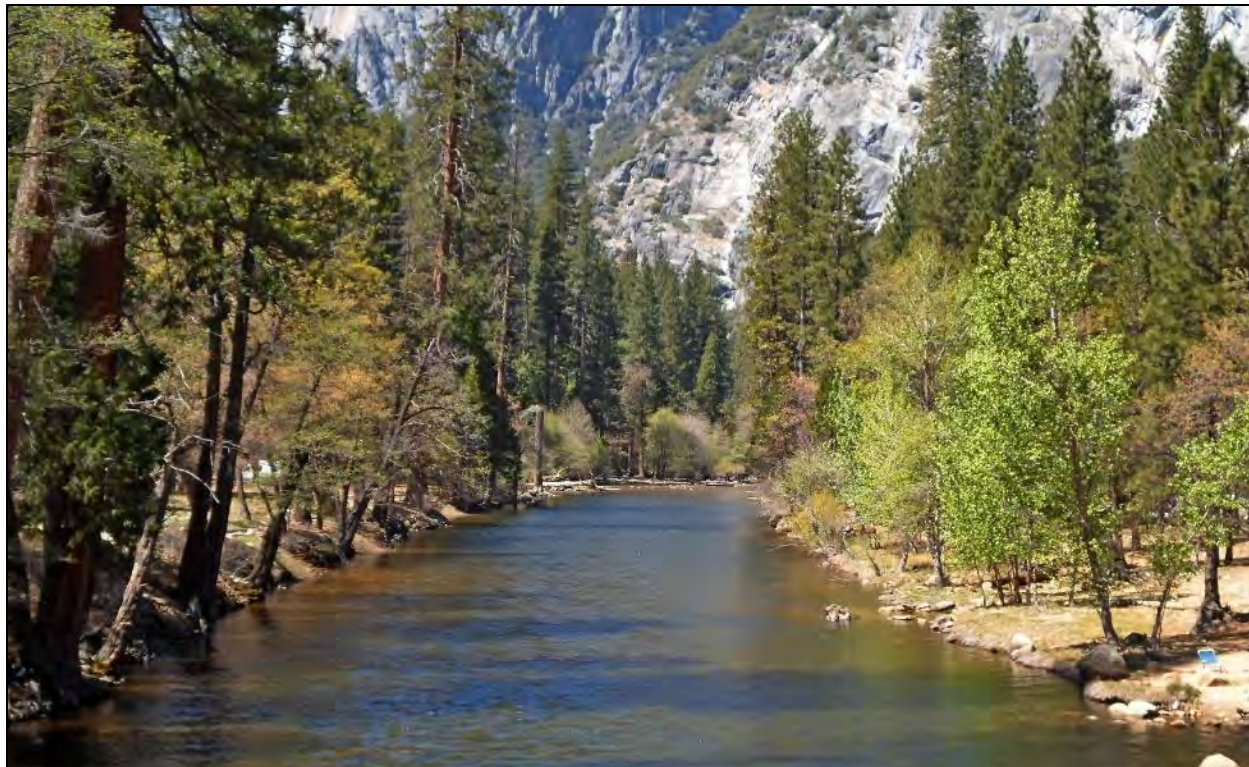
Figure 4-2 View downstream of about 1,000 feet of the homogenous channel of the Merced River along Reach 7, between Clarks Bridge (about 400 feet upstream of the foreground channel) and Sugar Pine Bridge (about 1,900 feet downstream of the camera).

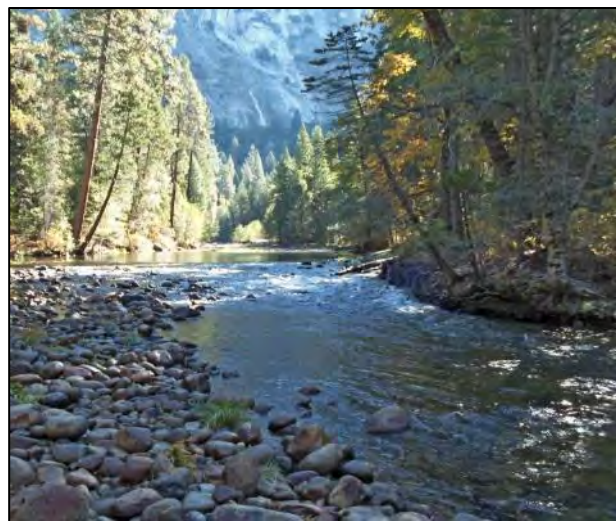
Figure 4-3 Recommended reference reach for evaluating future project performance. Left, red circled area above Clarks Bridge in Reach 9 indicates area; right, view upstream near the lower end of the circled area.

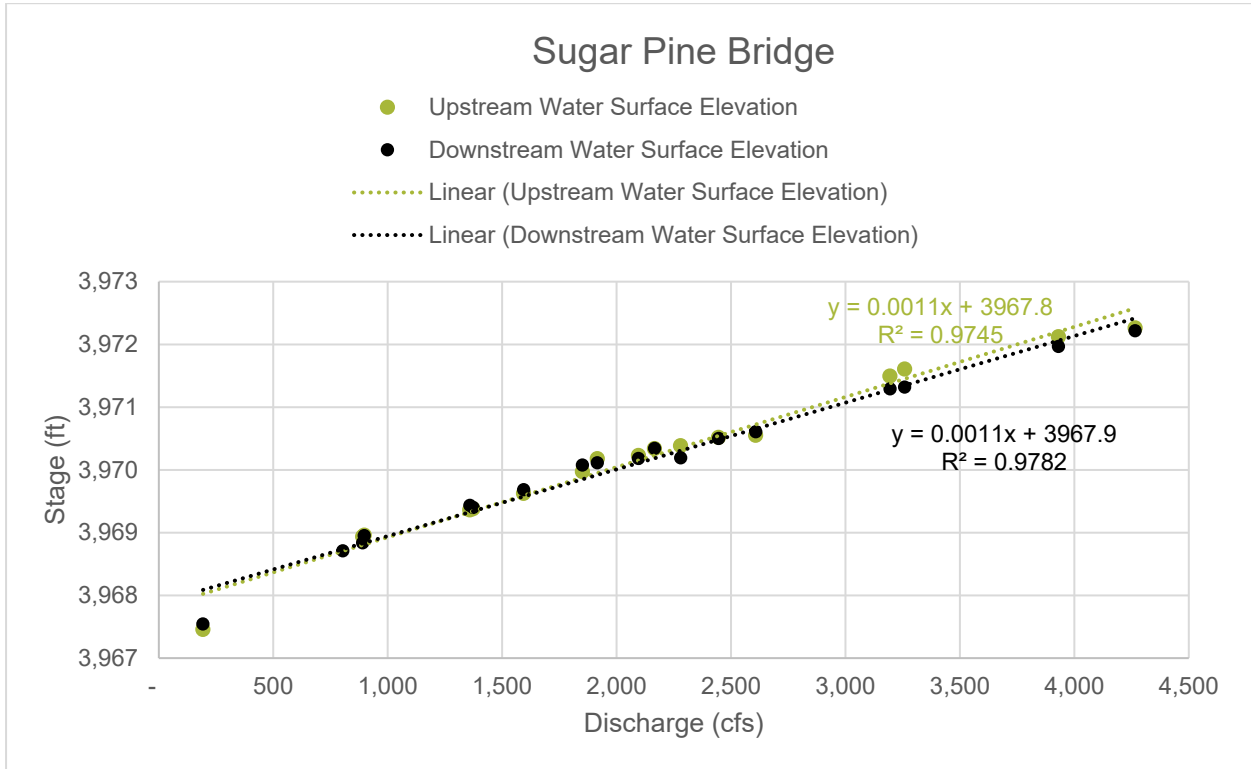
Figure A.1 Stage-discharge equation for Sugar Pine Bridge.

The existing conditions model was calibrated using stage-discharge equations derived from bridge tape-down measurements of water surface elevations (WSEs) collected by YNP for flows ranging from 193 to 4,266 cfs (see Figure A.1, Figure A.2, and Figure A.3 in Appendix A). Simulated WSEs at various flows within the calibration range were compared with the calculated stage derived from the stage-discharge equations at six locations—upstream and downstream of Sugar Pine, Ahwahnee, and Stoneman bridges. (Table A.1, Table A.2, and Table A.3 in Appendix A). On average, the difference in simulated minus calculated WSEs is approximately 0.0 feet at Sugar Pine Bridge, 0.3 feet at Ahwahnee Bridge, and 0.7 feet at Stoneman Bridge. In order to achieve these model results, the initial bed roughness was reduced from a Manning’s n of 0.035 to a Manning’s n of 0.030; all other roughness values were unchanged from the initial assumption.

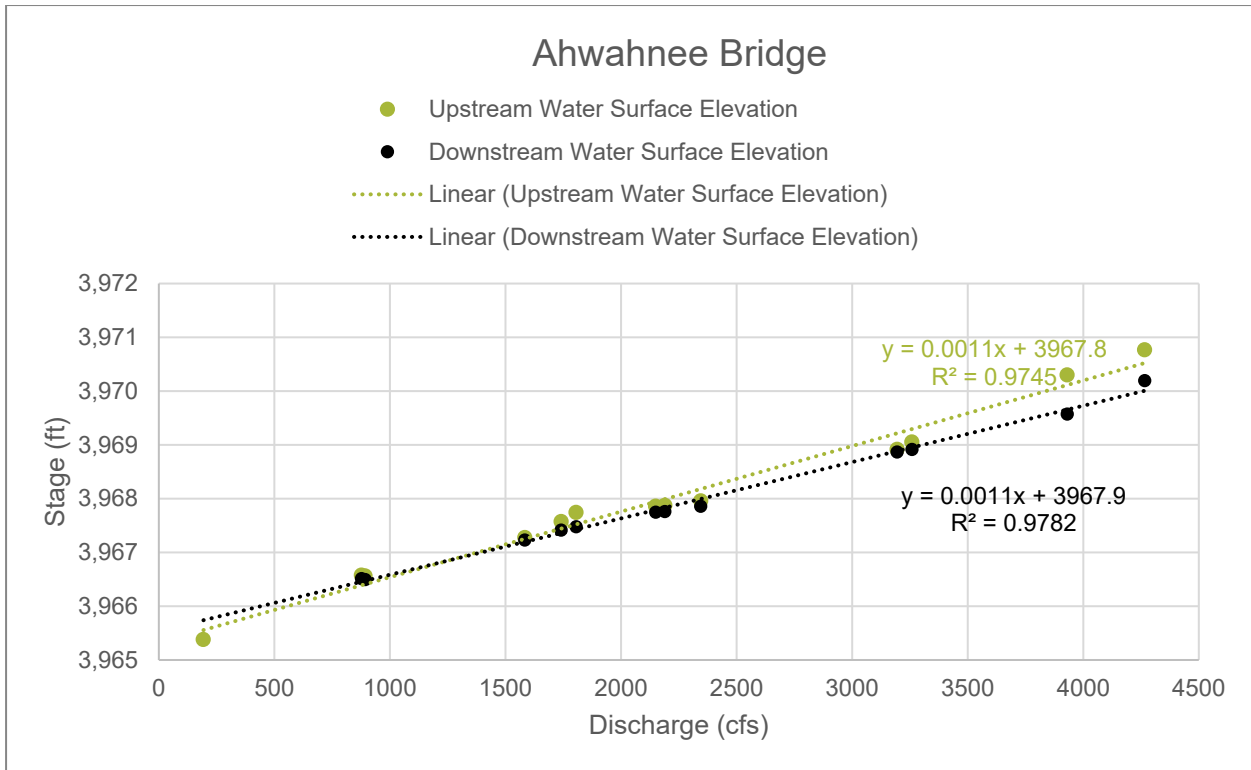
Figure A.2 Stage-discharge equation for Ahwahnee Bridge.

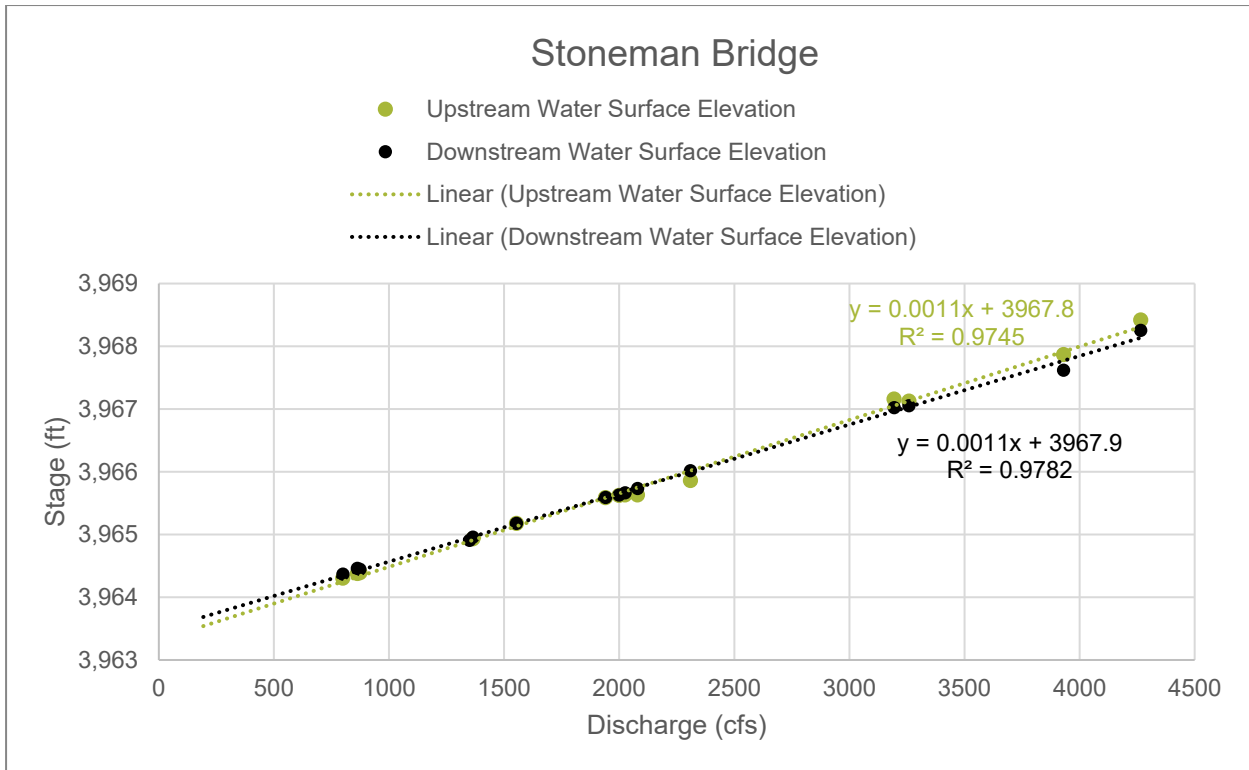
Figure A.3 Stage-discharge equation for Stoneman Bridge.

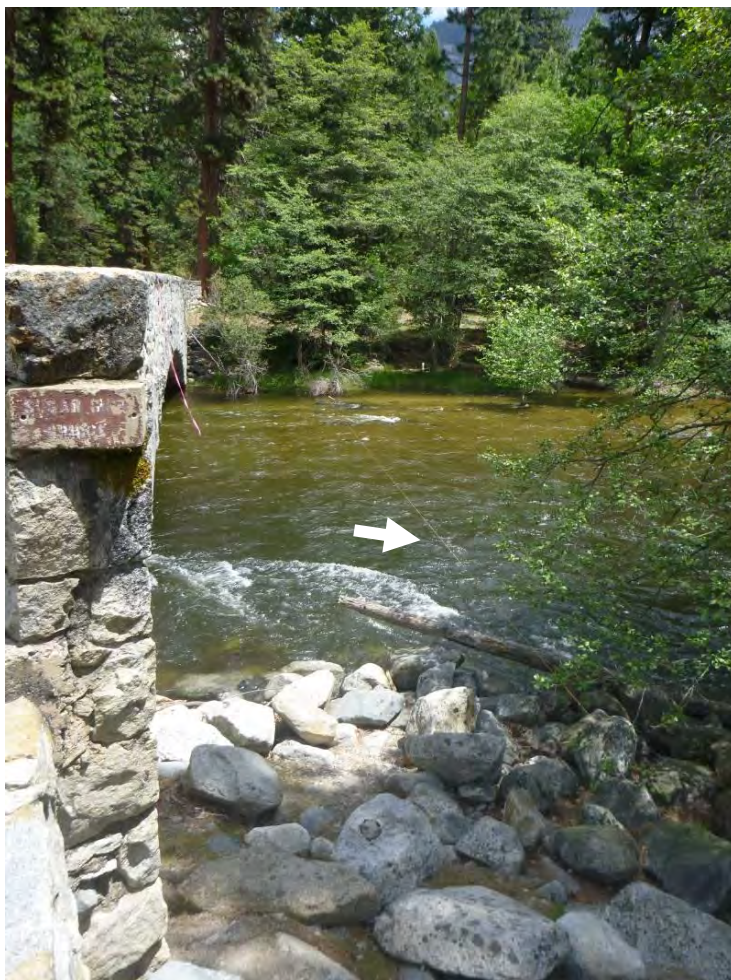
In the photo above, the “line” is the orange line nearly parallel to the bridge, and the “tether” (not shown) is the orange line extending perpendicularly from the “line.” At this cross-section, the right bank line distance upstream of the bridge was 18 feet and left bank line distance upstream of the bridge was 21.2 feet. The tether length was 1 foot.

Table A.7 Measured flow and velocity data for selected flow range at cross-section upstream of Sugar Pine Bridge.

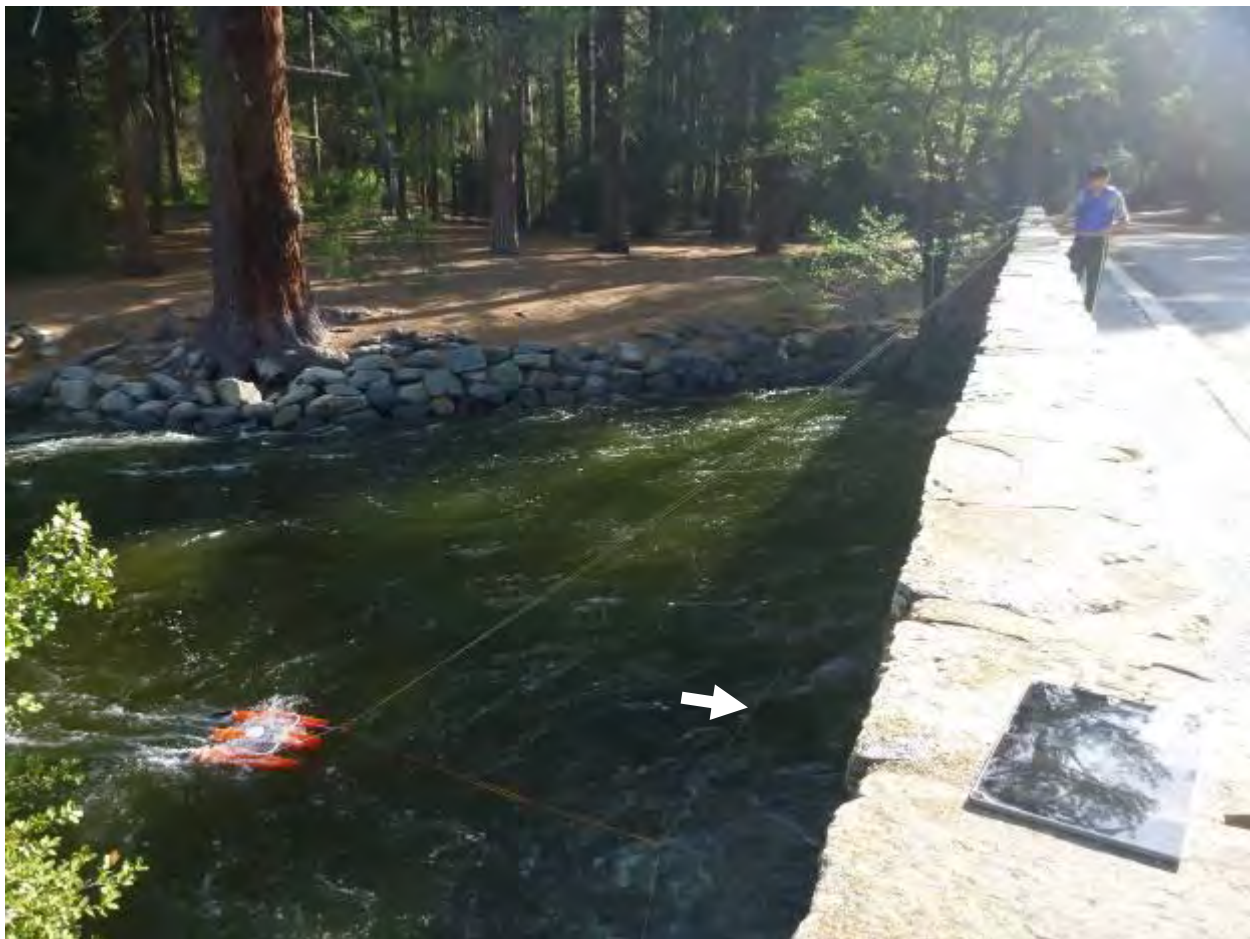
Figure A.7 Cross-Section location downstream of Sugar Pine Bridge where velocity measurements were collected.

YNP has collected acoustic Doppler current profiler (ADCP) data at multiple bridges along the Merced River. In order to validate the velocity component of the calibrated existing conditions model results, ADCP data were compared to model predictions from two cross-sections of the Merced River—upstream and downstream of Sugar Pine Bridge (see Figure A.6 and Figure A.7 in Appendix A for cross-section locations).

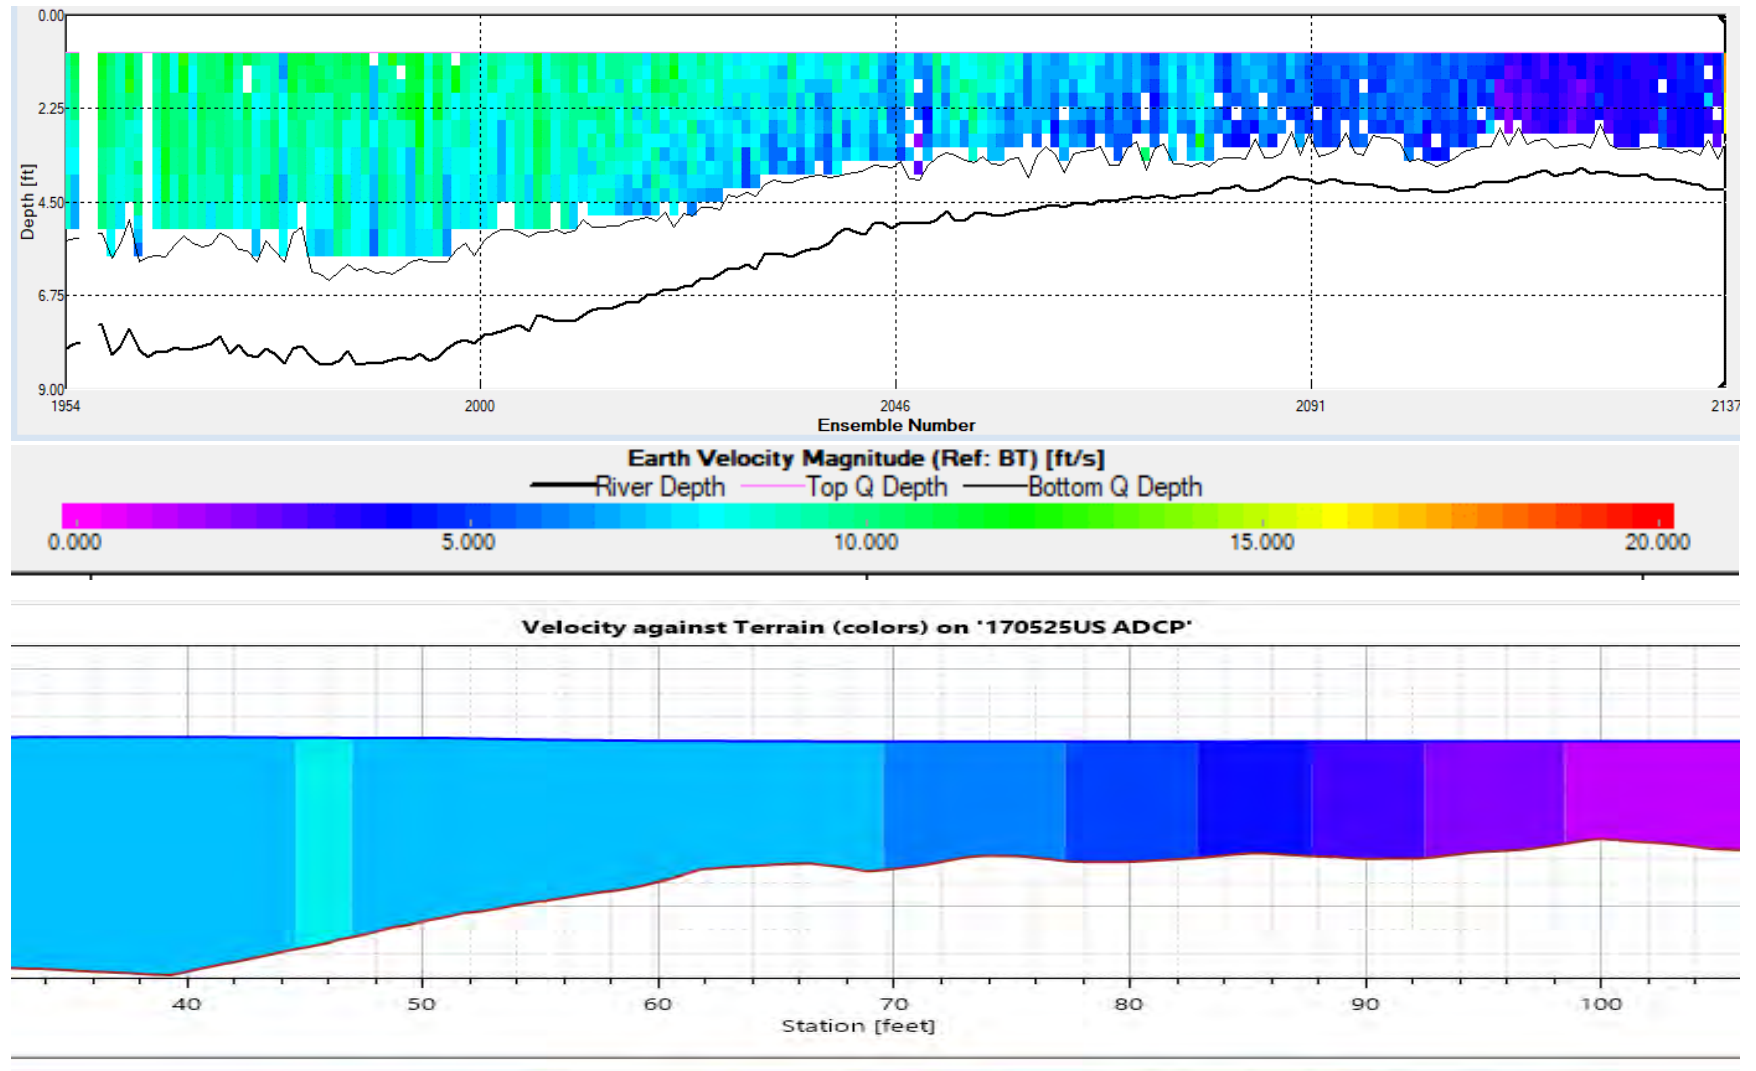
Notes: Legend applied to both measured and modeled cross-sections. See Figure A.6 for photograph of measured cross-section location and Figure A.8 for plan view of modeled cross-section location.

Figure A.9 Raw ADCP velocity data at cross-section upstream of Sugar Pine Bridge (top) and model output showing simulated velocities at cross-section upstream of Sugar Pine Bridge (bottom)

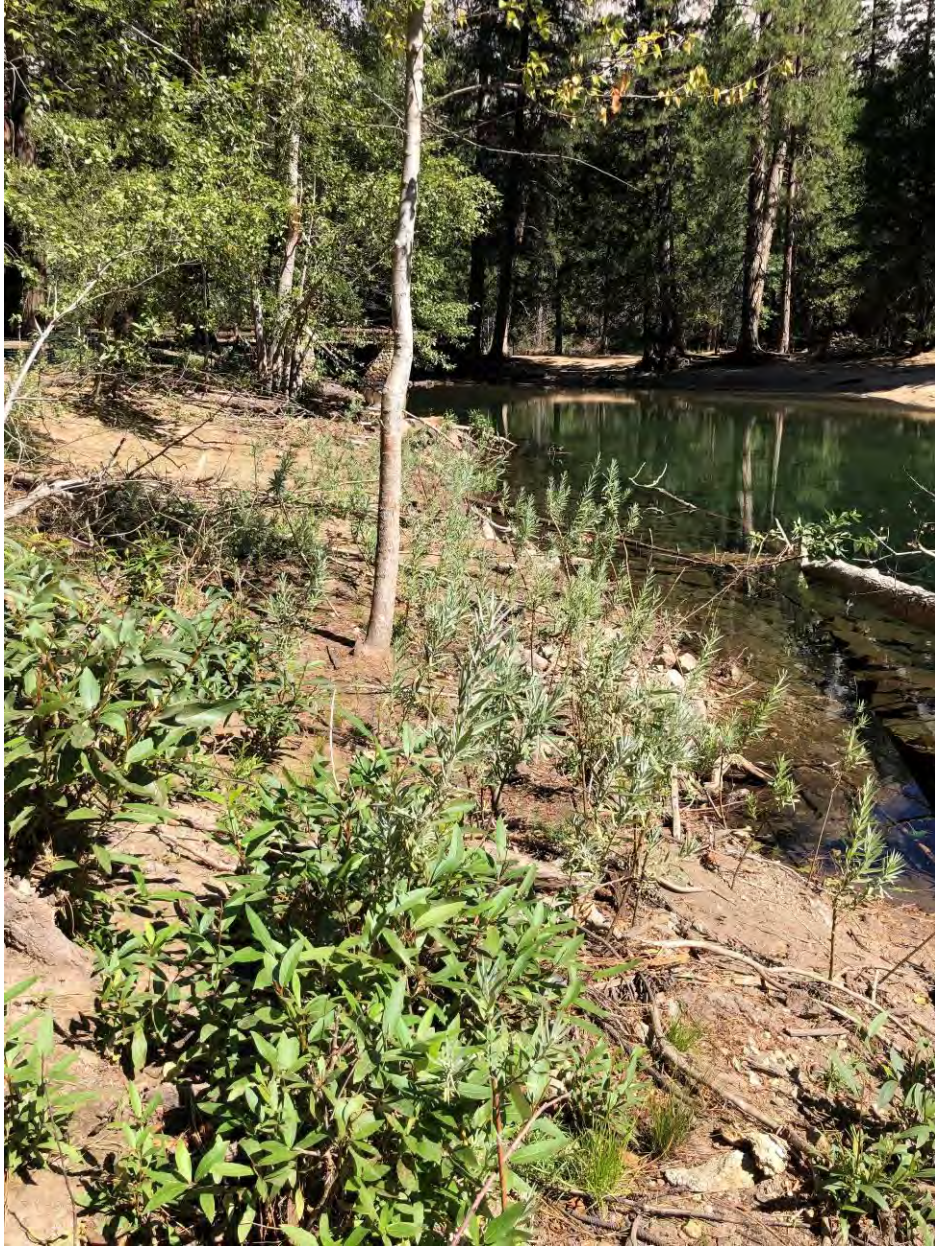
Figure B.10 Example photograph of revegetation after selective riprap removal.

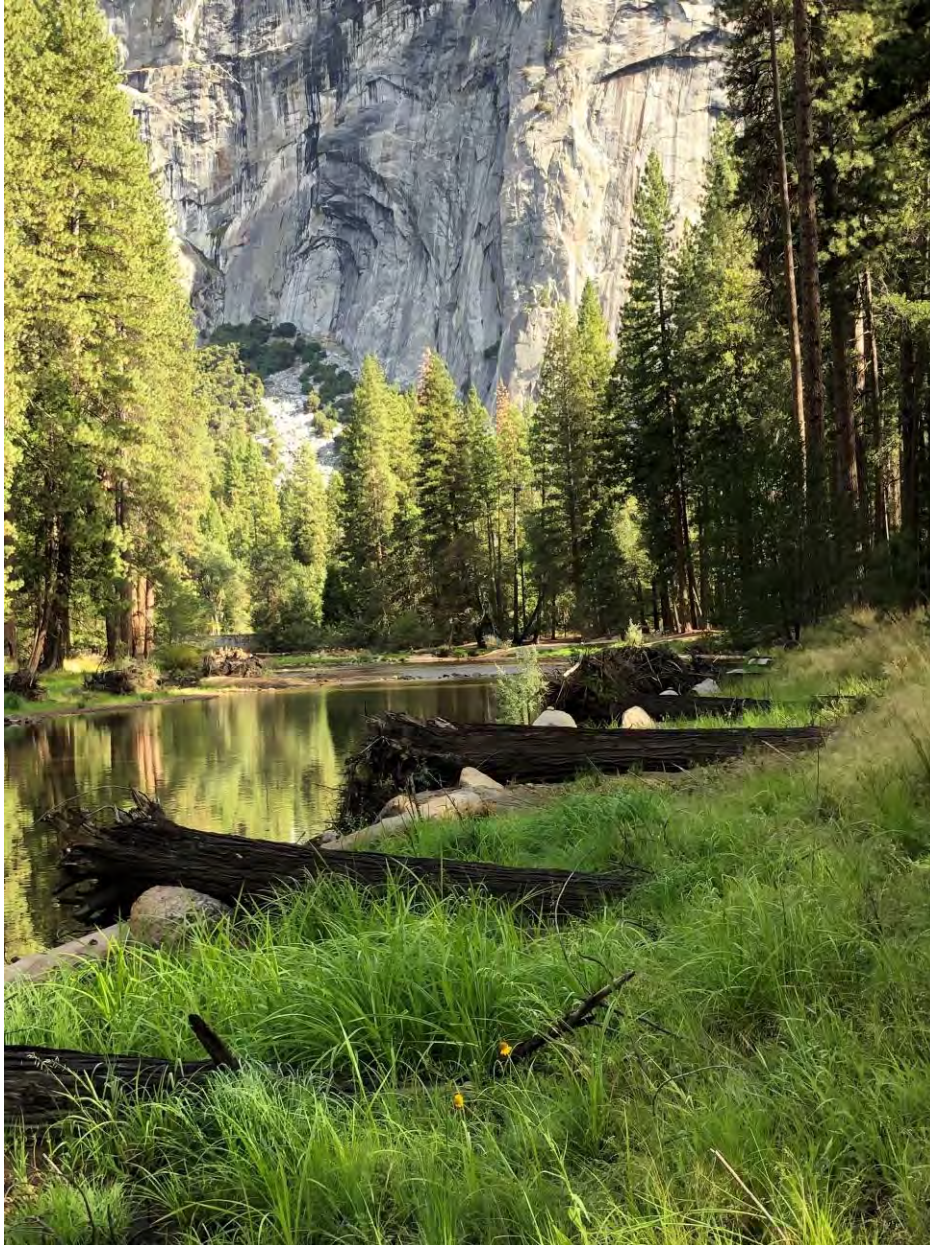
Figure B.15 Example photograph of floodplain-building logs with revegetation.

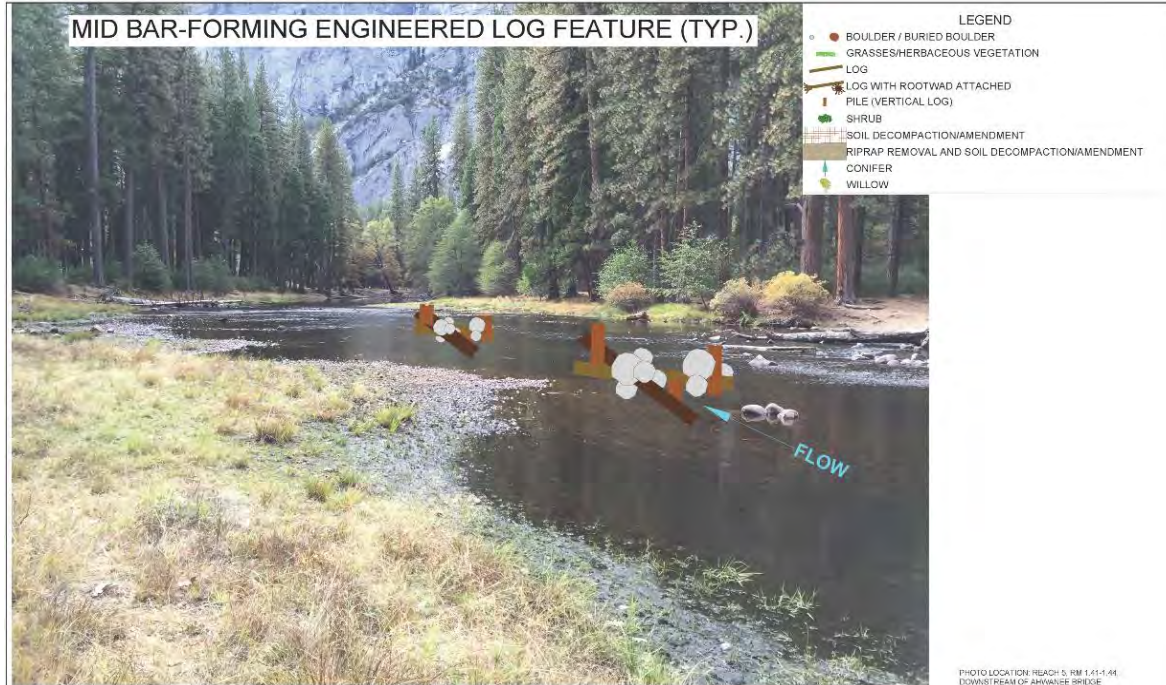
Figure B.16 Example graphic of mid bar-forming ELJs.

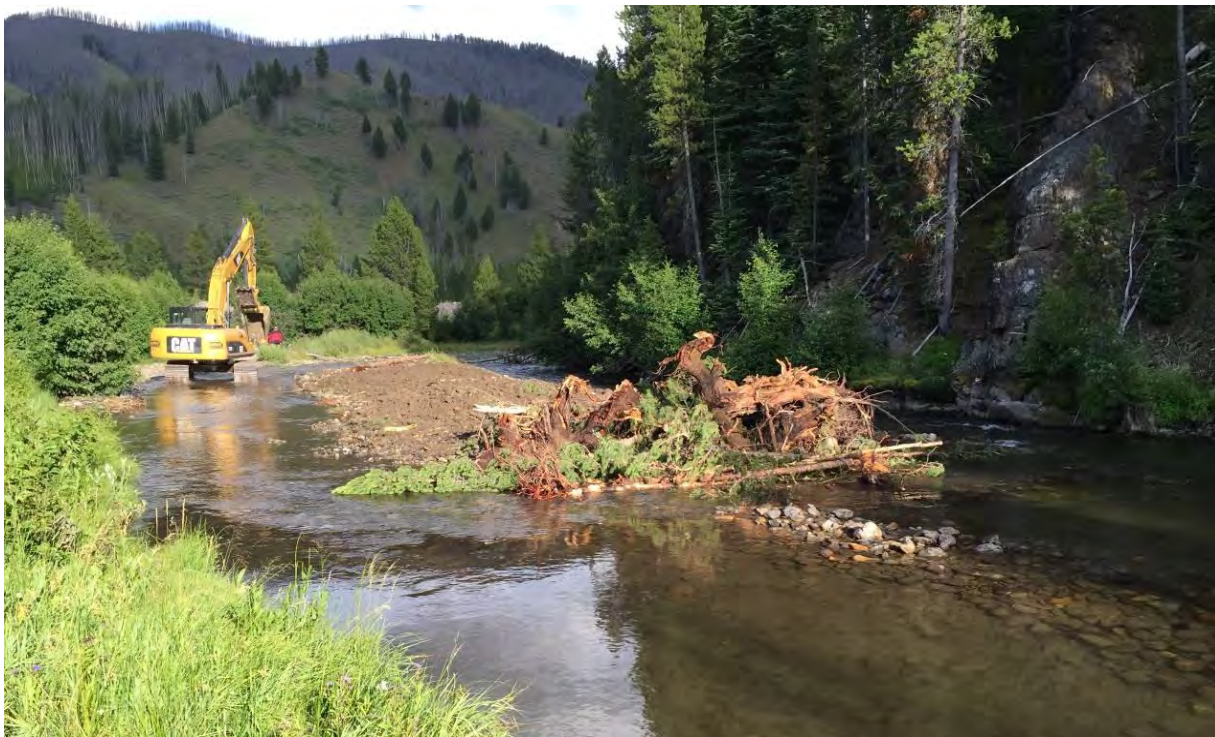
Figure B.17 Example photo of mid bar-forming ELJs.
