FINAL REPORT, PHASE 2:

Restoration of the Merced River through Yosemite Valley, Yosemite National Park

June 30th, 2018

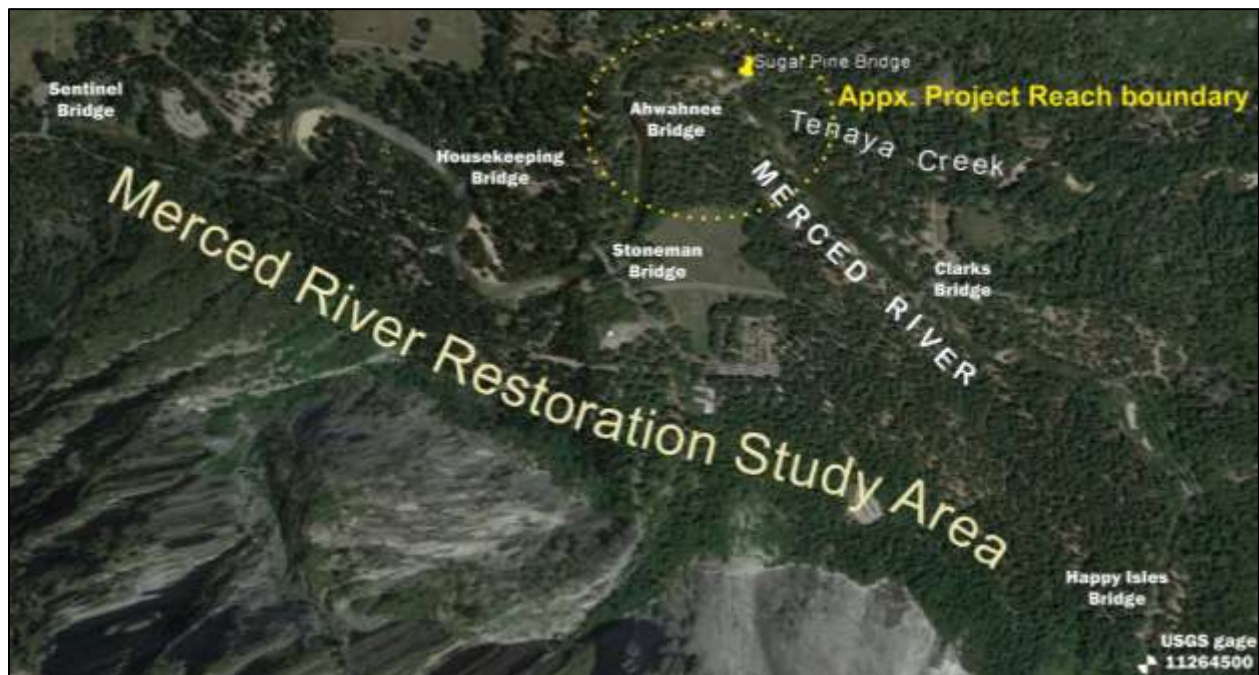
Figure 1-1. An overview of the Study Area, the focus of this report. The subsequent phase of this project will emphasize an analysis and potential treatments to improve conditions in the Project Reach.

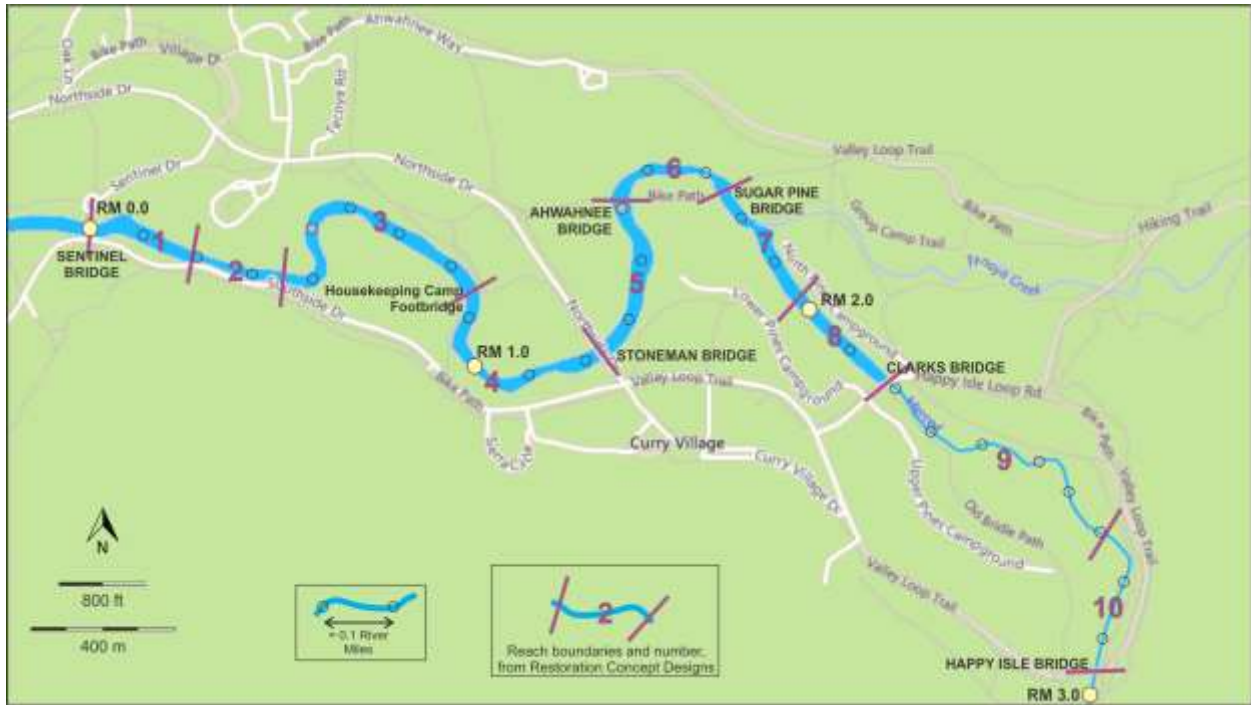
Figure 2-1. Overview map of the Study Area, highlighting the bridges over this part of the river and the numbered segments referenced in several of the subsequent analyses.

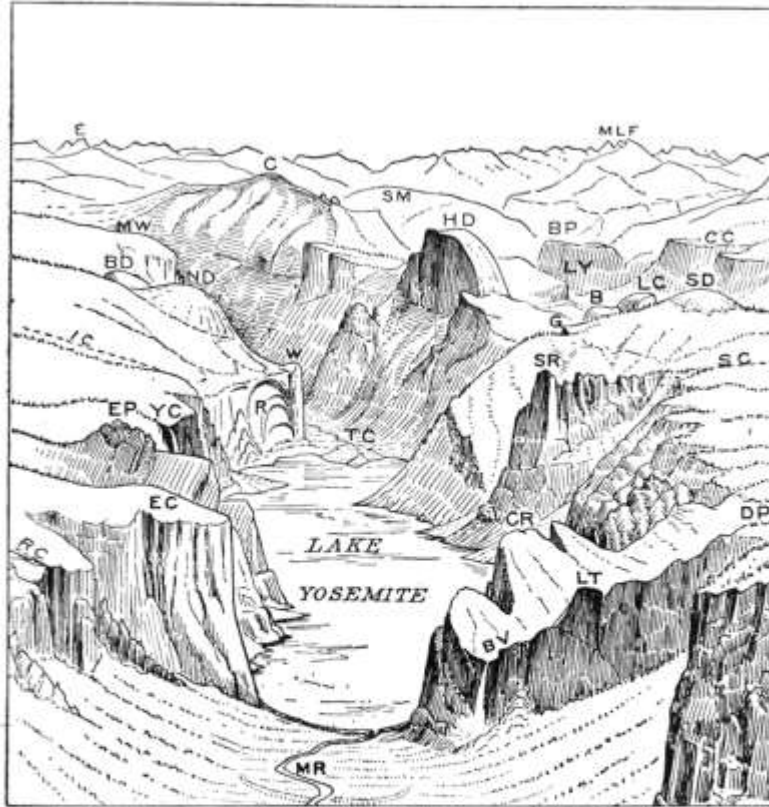
FIGURE 16.—Bird's-eye view of the Yosemite Valley as it probably was immediately after the ice age. The valley had been broadened and deepened to essentially its present proportions. The deepening accomplished by the ice ranged from 600 feet at the lower end to 1,000 feet at the upper end. A third set of hanging valleys had been added, and the Bridalveil Fall was produced. A lake 3½ miles long occupied a basin gouged into the rock floor of the valley and dammed in addition by a glacial moraine. The vegetation consisted in the main of types now prevailing. The drawing is based primarily on a systematic survey of the moraines and the other glacial features of the valley.

This reconstruction emphasizes that today’s overall valley topography is not “fluvial”—it has been inherited from the last glaciation of the Sierra Nevada, modestly reworked by hillslope and riverine processes over the last 15,000 years since deglaciation. Matthes (1930) believed that the retreat of the ice from its terminal position at the foot of El Capitan (marked by the El Capitan moraine) resulted in the occupation of the valley by a widespread, continuous lake that persisted for an indeterminate period of, presumably, some centuries. The upstream end of the lake began filling by sediment transported from farther upvalley, forming a prograding delta whose front progressively advanced downvalley. Matthes believed that the moraine breached before the lake had been completely filled by sediment, resulting in an abrupt 14- to 16-foot drop in river level that extended upstream from the location of the breach. Continued lateral migration of the river created the modern valley bottom at this lower elevation, with only a few localities retaining fragments of this prior lake-filling surface (Matthes identified them as sites overlooking Tenaya Creek near the head of the valley, the level plain in front of Camp Curry, and north of the Cathedral Spires and the Cathedral Rocks).

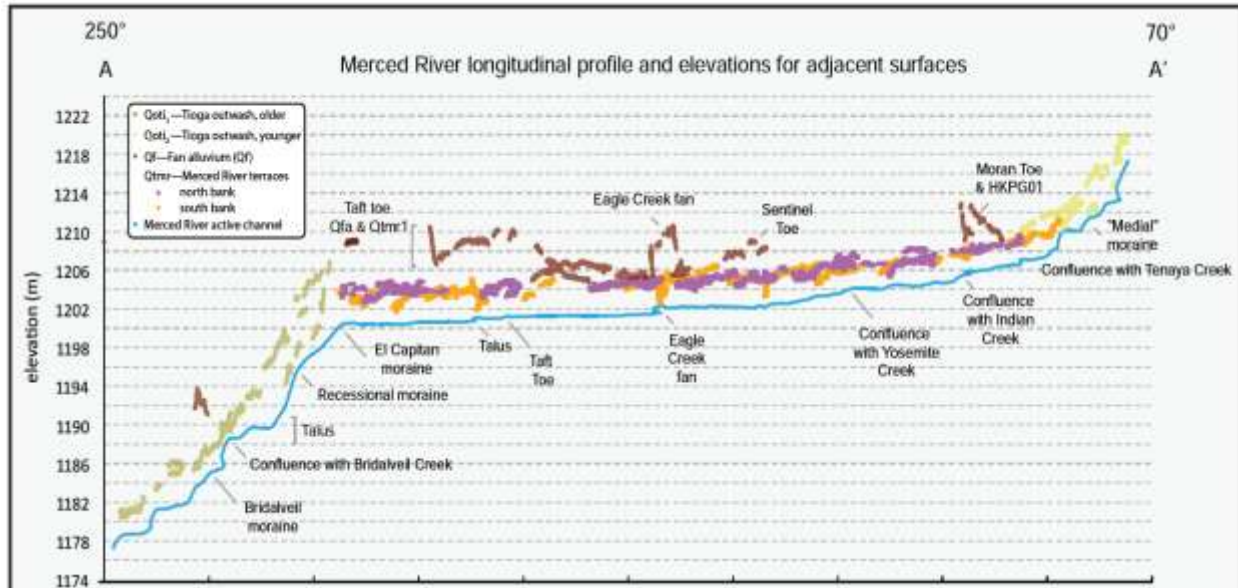
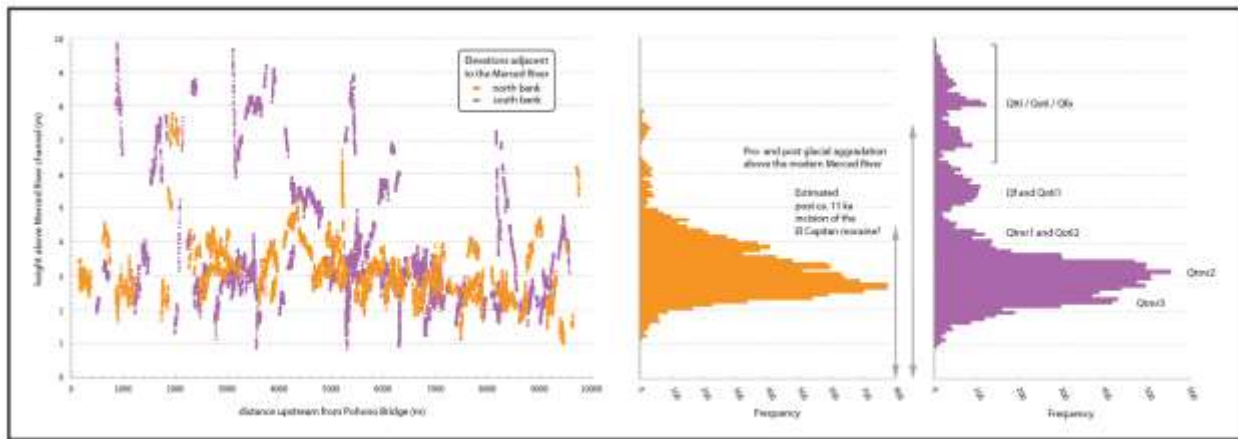
Figure 3-5. Terrace levels above the Merced River from Pohono Bridge (left side of both graphs) upstream to Clarks Bridge (from Haddon et al. 2017). The Study Area covers about km 8–10 on the x-axis (which is measured along the valley axis, not along the river channel itself). On the top panel, note the modest convergence of the terrace with the river from about km 2.5 (at the El Capitan moraine) to km 7.5. This pattern apparently continues up to at least km 9.5, above Milestone’s (1978) zone of moraine-lowering influence, suggesting that it cannot provide a complete explanation for the presence of the terrace. Note also the systematically higher south (i.e., left) bank terrace, likely a reflection of the river’s preferential position on the south side of the valley, closer to valley-wall sediment sources.

The apparent recent, partial abandonment of this floodplain surface is not consistent across all flood recurrences (Figure 3-5), and it cannot be readily explained by the lowering of the El Capitan moraine. Milestone (1978) reported this event (in 1879) as constituting a 4.5-ft (1.4-m) lowering of the river at the moraine itself, with effects attenuating over the next 5 miles (8 km) upstream. Although there is some suggestion of an upstream reduction in terrace height above the modern river (Figure 3-6), Milestone’s limit-of-effects lie well downstream of the present study area. We tentatively infer the underlying cause to be primarily a result of de-snagging the river of its large woody debris, reducing roughness and so enhancing the efficiency of flows to transport sediment. A secondary element may be related to long-term changes in climate patterns, particularly the relative sediment-transport competence of high-magnitude winter rain-on-snow floods and the more moderate snowmelt-dominated floods. Minear and Wright (2013, p. 30) note that substantial bedload movement and deposition in the vicinity of the Tenaya–Merced confluence was associated with the 1997 flood, the last major rain-on-snow flood. Subsequent years have resulted in a progressive (re)expansion of the channel, suggesting that flows associated with all flood types are competent to move sediment, but that only the large rain-on-snow events can move significant quantities of coarse, channel-forming sediment down through the channel network. A long-term change in the distribution of these flood types could thus impose systematic, long-term changes in channel response.

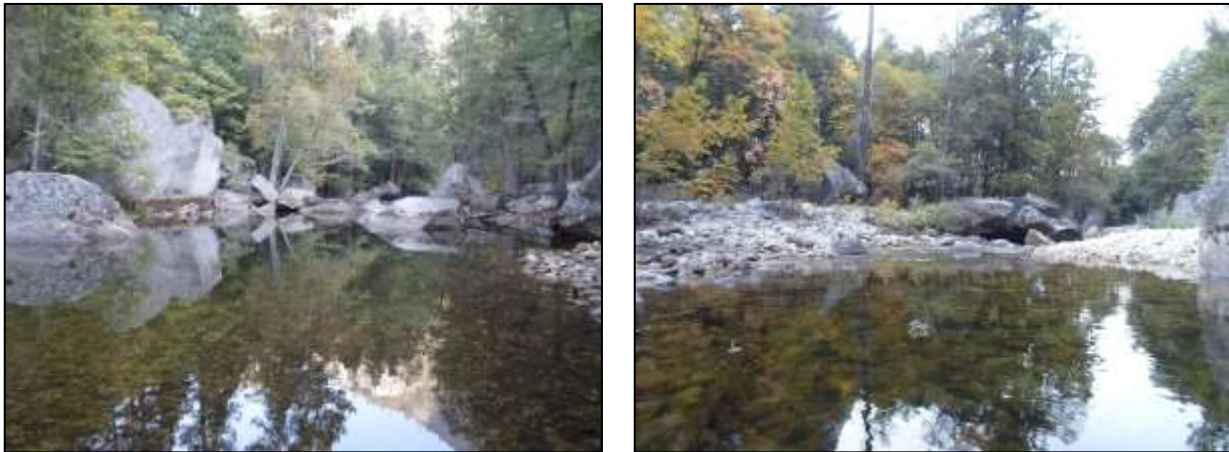
Figure 3-6. Views upstream (left) and downstream (right) along the Merced River from the same location, on the alluvial fan of Illilouette Creek (gravel deposit on the left side of the right panel). The character of the Merced River changes abruptly at this location, from a sediment-starved, boulder-choked cascade to a gravelly plane-bed and pool-riffle channel.

Field investigations conducted as part of the present project confirm these inferences. The confluence of Illilouette Creek with the mainstem Merced River marks an abrupt and dramatic change in river morphology. Upstream, the river channel is nearly devoid of bedload, with the sediment load overwhelmingly composed of 1-4 m angular blocks delivered to the valley bottom by rockfalls; immediately downstream, abundant gravel-sized clasts delivered from Illilouette Creek line the bed of the river channel and form extensive bars (Figure 3-6).

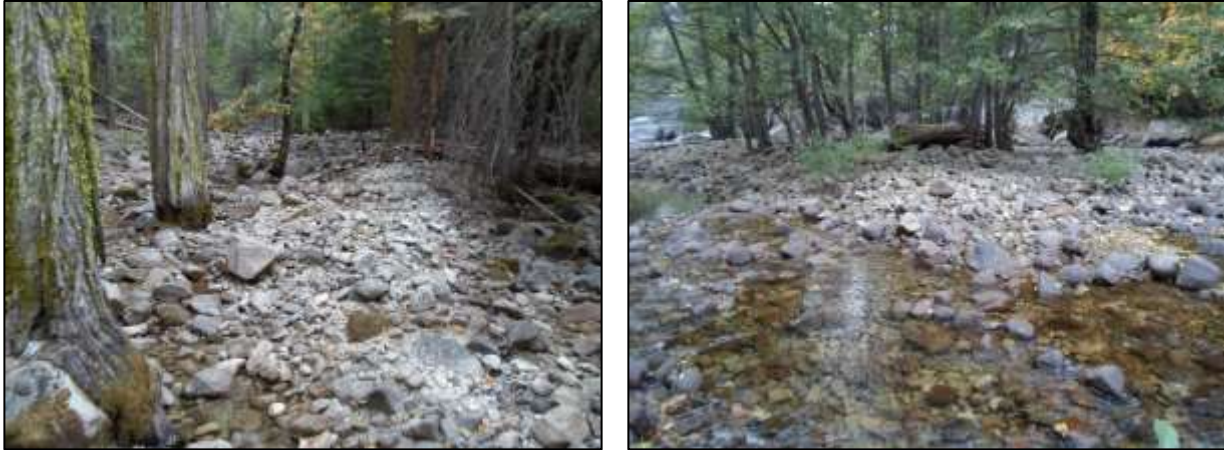
Figure 3-7. Views of Illilouette Creek upstream of its confluence with the Merced River. Left, looking upstream (south) about 70 m from the Merced River confluence. Median grain diameter 12 cm, largest clasts visible in this view about 60 cm. Right, view east from the downstream-most distributary on the Illilouette Creek fan (right side of photo). Junction with the Merced River (visible in the upper left corner) is just off the left side of the photo.

Upstream along Illilouette Creek, the source of the sediment is obvious (Figure 3-7). This tributary stream is a steep but rapidly flattening gravel step-pool channel that has built a massive alluvial fan at its confluence with the Merced River, several hundred meters on a side.

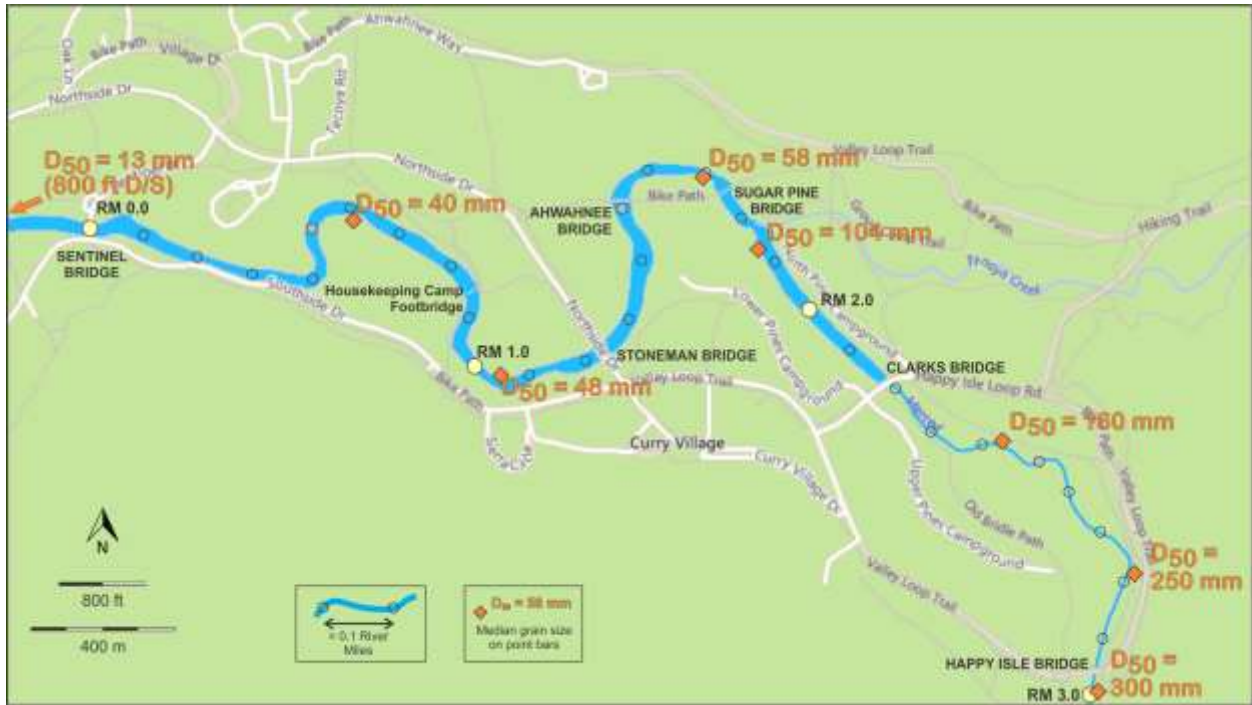
Figure 3-8. Median grain diameters (D_{50}), measured on the upstream low-water margin of point bars or mid-channel bars, sites where the clasts are most likely to reflect the active bedload during transport events (Kondolf et al. 2003). Note the progressive, monotonic decline in median size, with particularly rapid changes where the river emerges from confining bedrock and talus fields downstream of Happy Isles Bridge, and as it passes through the short reach that includes Sugar Pine Bridge.

In addition to the massive influx of sediment and the abrupt change in the alluvial character of the Merced River, other geomorphic indicators demonstrate the fundamental importance of this source to the sediment load of the river through the Study Area. The channel gradient changes substantially across the Illilouette Creek fan--upstream, the river descends at a gradient of about 2%; downstream, it steeps abruptly to about 8%. The bed sediment sizes also decline monotonically from the confluence downstream, reflecting not only the declining competence of the river with a progressive flattening of its gradient, but also the lack of any significant lateral sediment inputs (Figure 3-8).

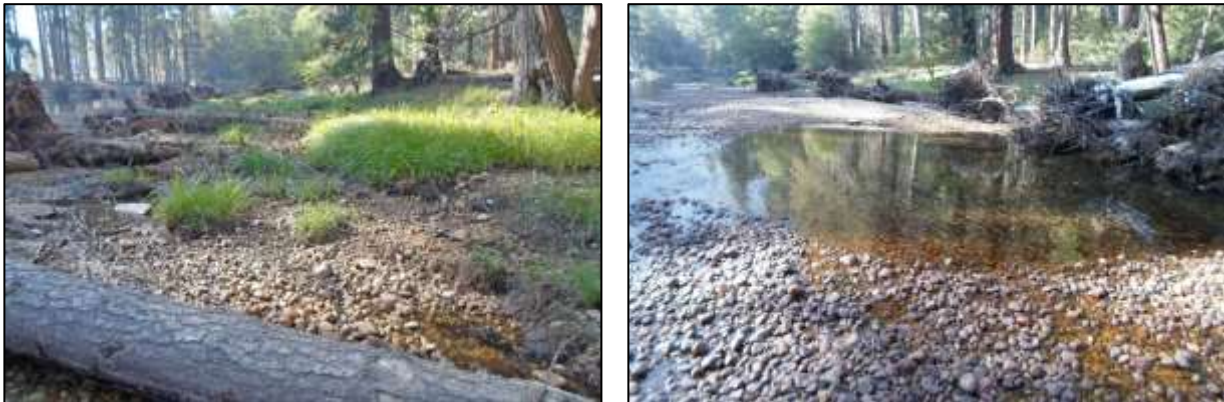
Figure 3-9. Channel-narrowing and riparian-recovery project on the right bank of the Merced River just downstream of Ahwahnee Bridge, one year after project construction. In the intervening year (Oct. 2016–Oct. 2017), bedload sediment had filled in behind the projecting logs (left panel) and had developed bedforms immediately riverward of the structures (right panel).

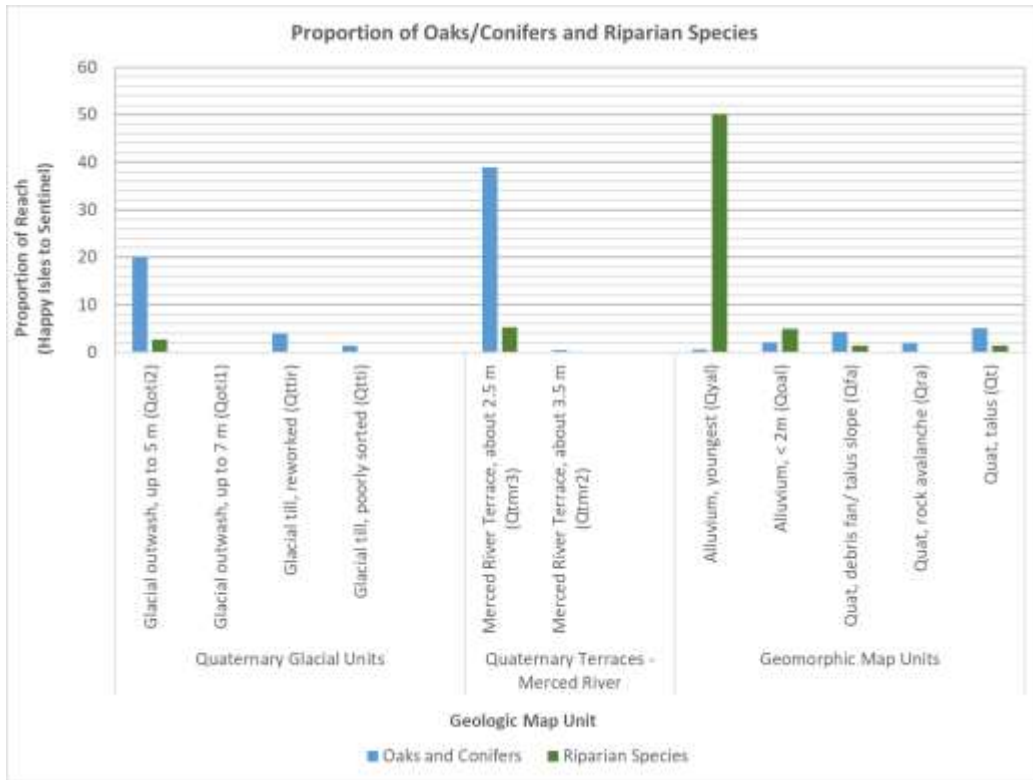
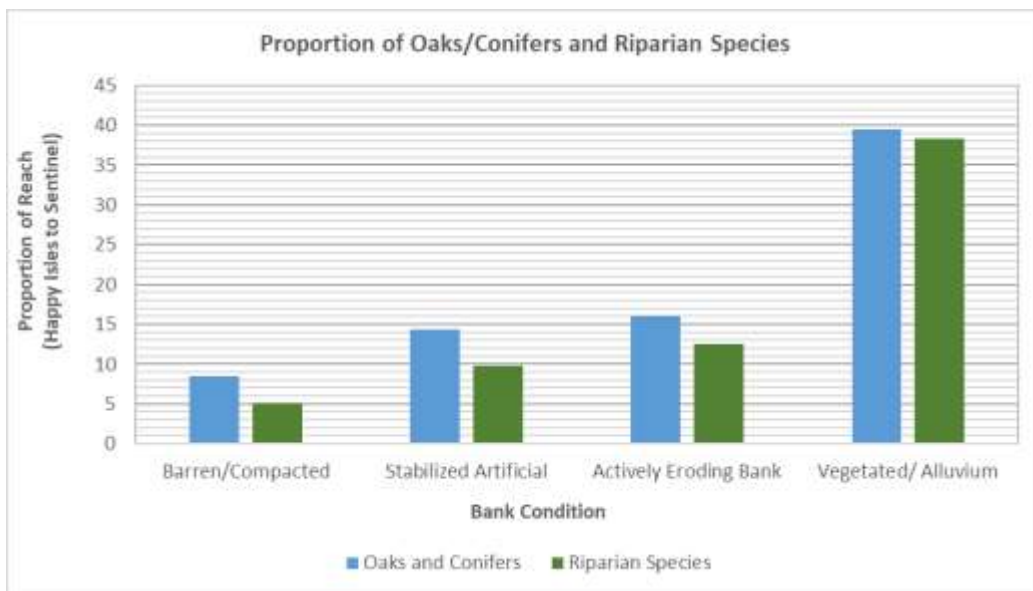
Figure 4-4. Comparison of the distribution riparian species and oaks/conifers in relation to geologic map unit (top) and bank condition (bottom). Barren/compacted – banks with barren compacted soil due to human impact; Vegetated/Alluvium included both vegetated, deformable bank and alluvium and naturally barren banks due to geomorphic processes.

Along the Merced River, riparian species primarily occurred on channel bars and floodplains, less than two meters above the active channel (Figure 4-4). In comparison, oaks and conifers were primarily mapped on higher elevation terrace and glacial outwash surfaces. At a local scale, both oak/conifer stands and riparian species were mapped along impacted banks, with a slightly greater proportion of oak/conifer stands on impacted banks (Figures 4-4 and 4-5). Within stands comprised of riparian species, alder-dominant stands were most common. Alders occurred along natural alluvial reaches but were also established along banks impacted by various human activities, including actively eroding banks, barren areas with compacted soil due to human impacts, and artificially stabilized banks (Table 1-1). In comparison, stands dominated by willows or cottonwoods were infrequent, primarily established on young alluvial surfaces, and were not established in areas with compacted soils.

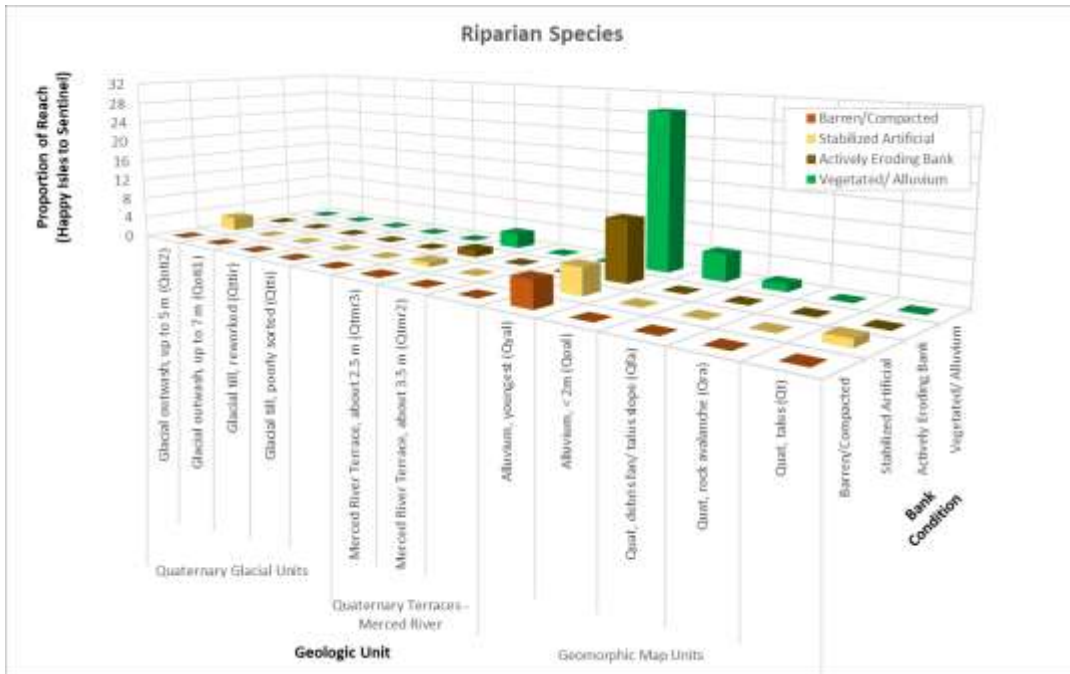
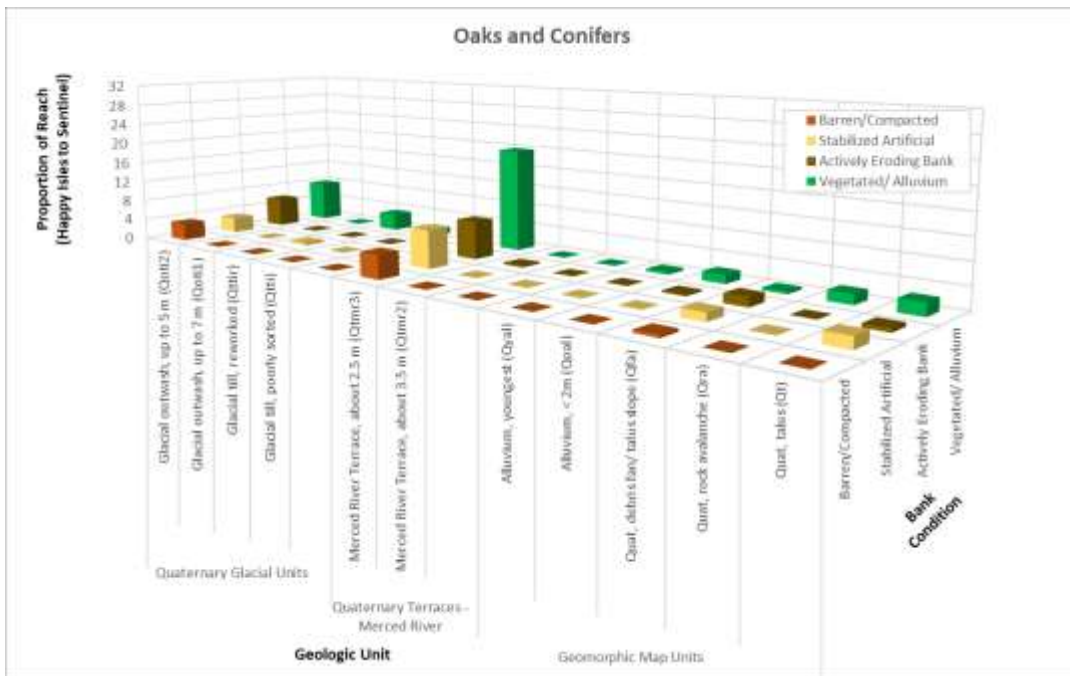
Figure 4-5. Comparison of the distribution riparian species (top) and oaks/conifers (bottom) in relation to geologic map unit and bank condition. Barren/compacted – banks with barren compacted soil due to human impact; Vegetated/Alluvium included both vegetated, deformable bank and alluvium and naturally barren banks due to geomorphic process.

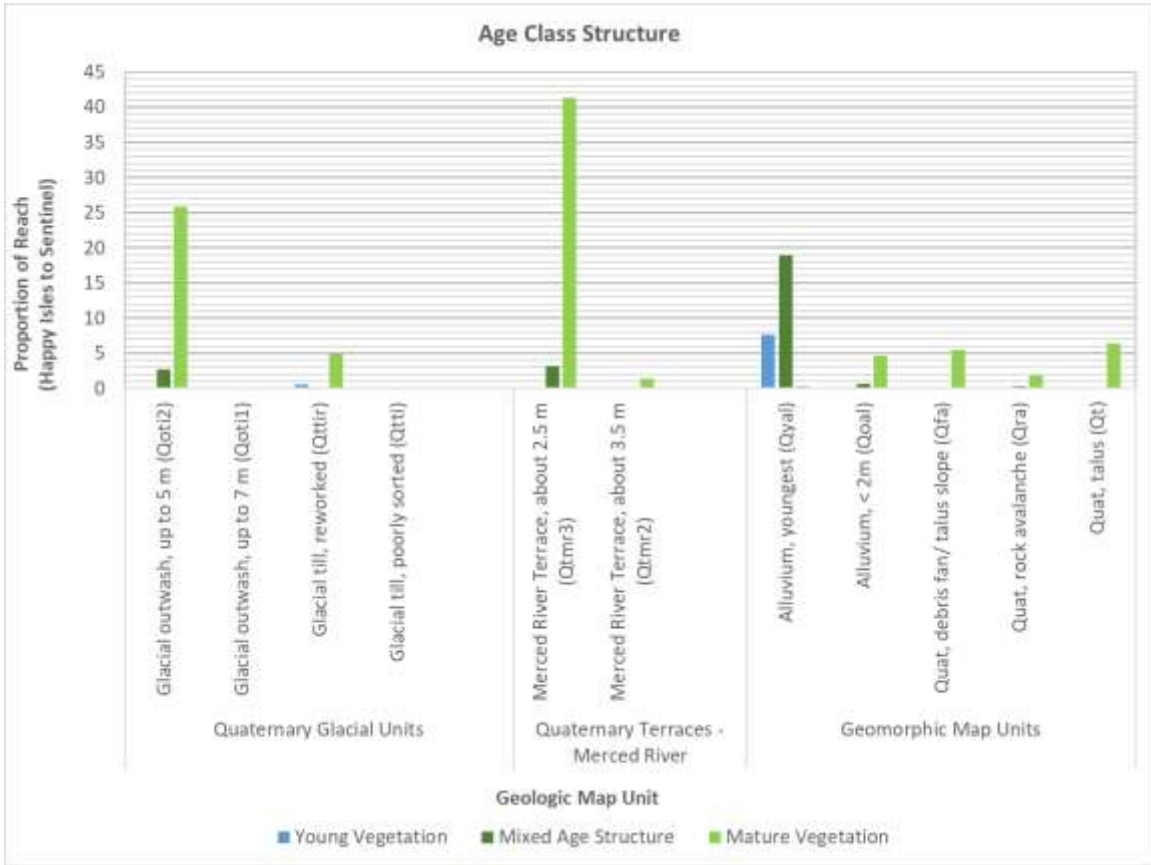
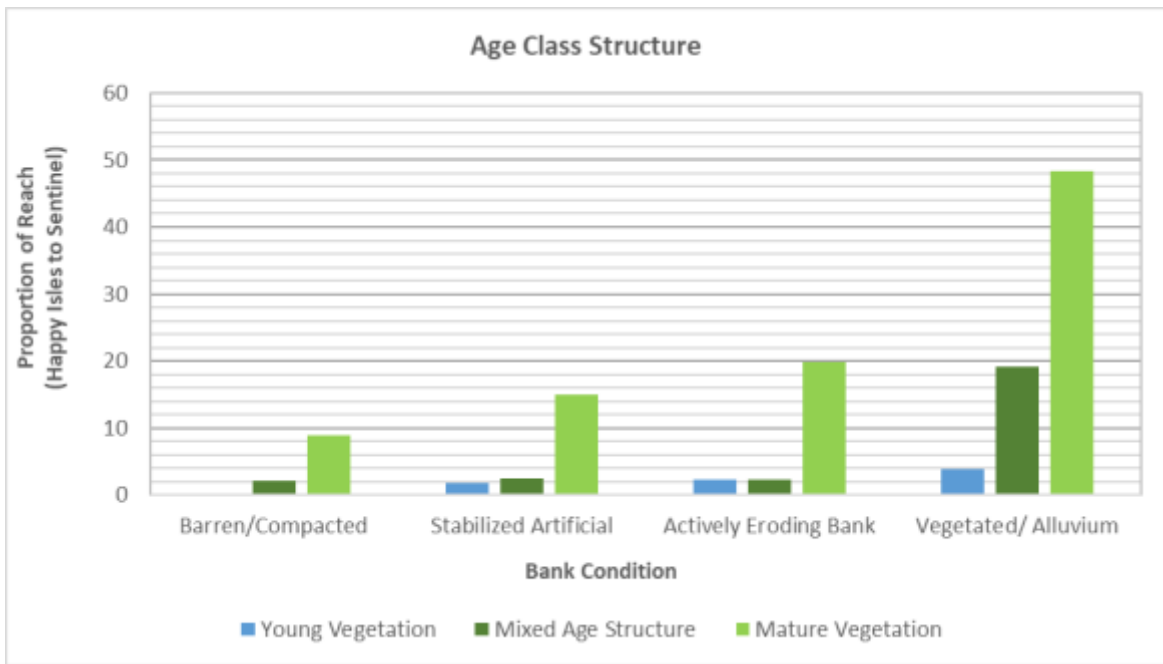
Figure 4-6. Comparison of age class structure in relation to geologic map unit (top) and bank condition (bottom). Barren/compacted – banks with barren compacted soil due to human impact; Vegetated/Alluvium included both vegetated, deformable bank and alluvium and naturally barren banks due to geomorphic processes.

Age structure diversity of all vegetation communities along the Merced River is strongly influenced by fluvial geomorphic processes (Figures 4-3 and 4-6). Younger vegetation occurred on alluvial surfaces, with limited recent recruitment on higher and older surfaces that have limited lateral connectivity to the channel, as well as on impacted stream banks (Figures 4-6 and 4-7). Mature communities were mapped on several geologic map units but were primarily mapped on the youngest Merced River terrace surfaces positioned about 2.5 meters above the active channel and on glacial outwash comprised of poorly sorted glacial conglomerate with boulders up to five meters above the active channel. Recent recruitment was minimal along stream segments with revetments, eroding banks, and compacted soils.

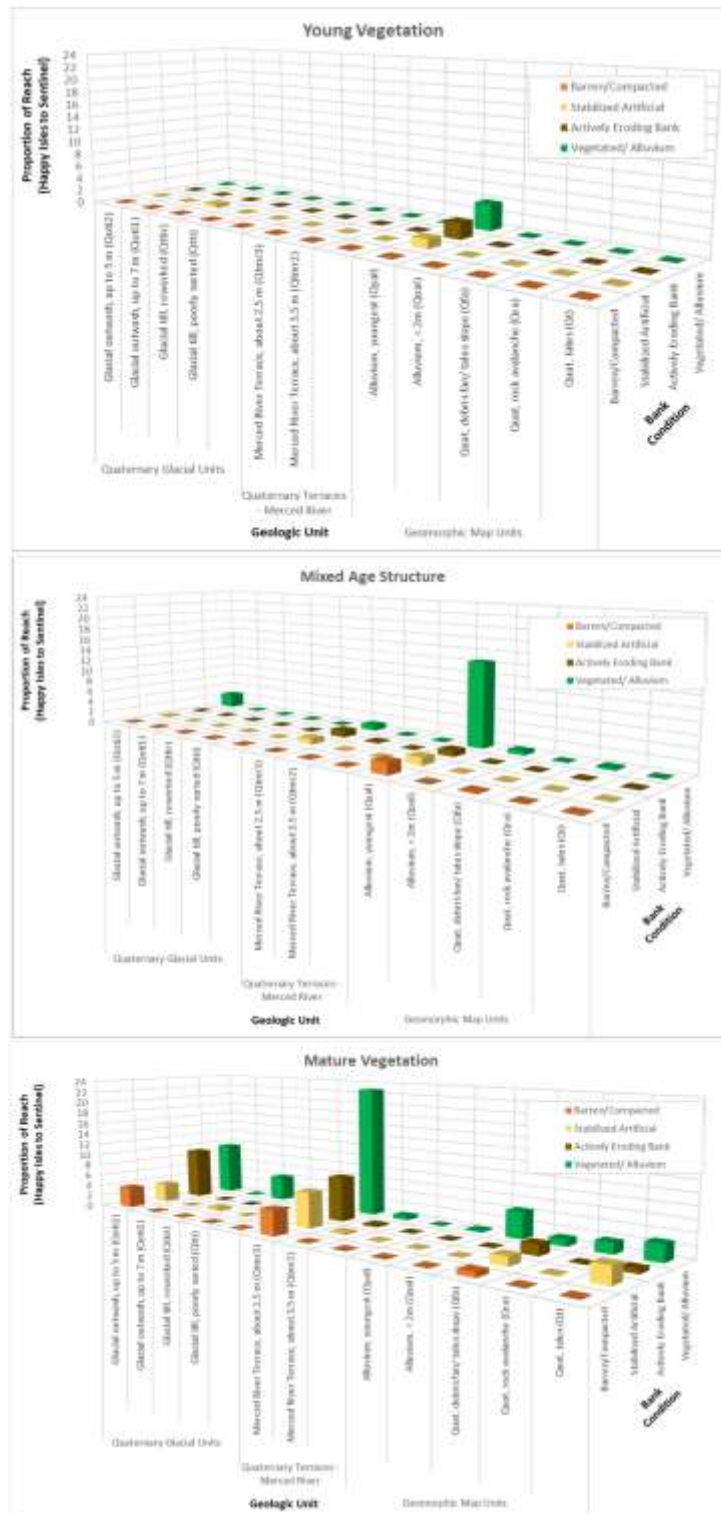
Figure 4-7. Comparison of the distribution young (top), mixed age classes (middle), and mature (bottom) vegetation in relation to geologic map unit and bank condition. Barren/compacted – banks with barren compacted soil due to human impact; Vegetated/Alluvium included both vegetated, deformable bank and alluvium and naturally barren banks due to geomorphic processes.

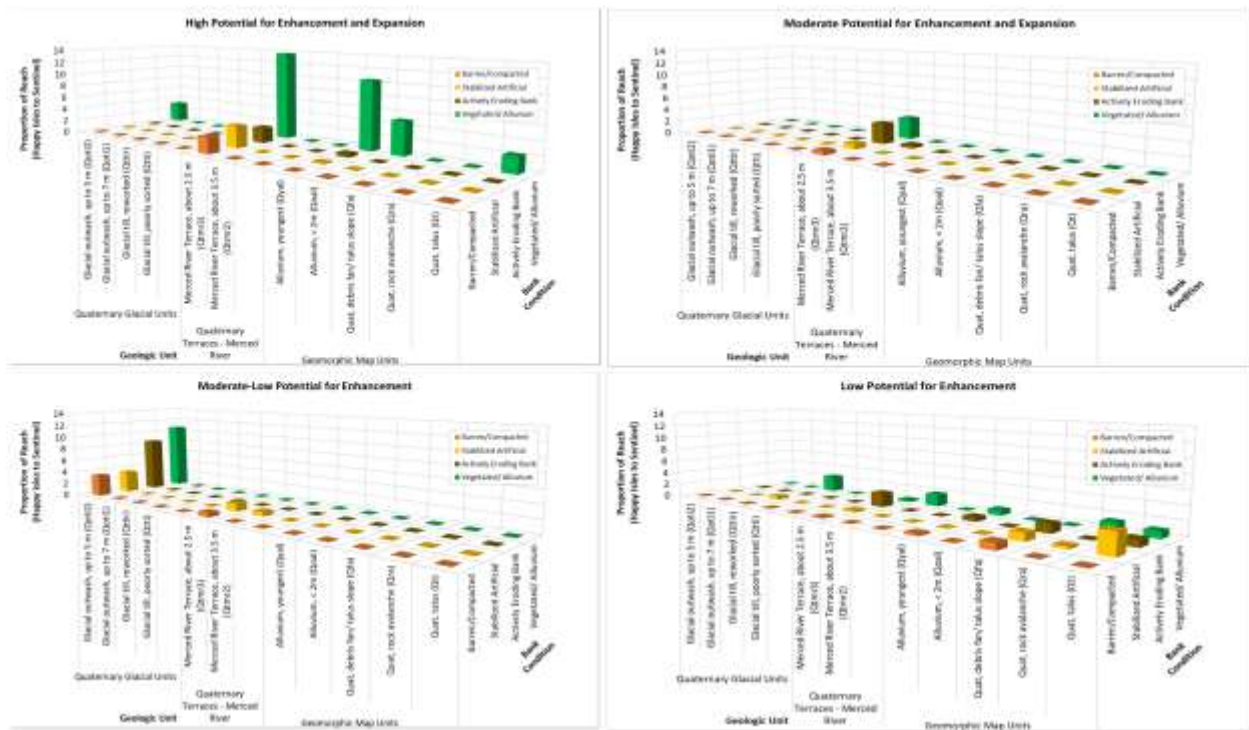
Figure 4-9. Potential for riparian enhancement and expansion: high potential (top, left), moderate potential (bottom, left), moderate-low potential (top, right), and low potential (bottom, right) in relation to bank condition and geologic map unit. Barren/compacted – banks with barren compacted soil due to human impact; Vegetated/Alluvium included both vegetated, deformable bank and alluvium and naturally barren banks due to geomorphic processes.

Identification and categorization of reaches with potential for enhancement and expansion of the riparian corridor considered the underlying geology and fluvial geomorphic processes interacting with the life history strategies of the dominant species that largely determine the vegetation characteristics of the corridor. Geology constrains the potential for enhancement along some sections of the river. In some areas, recruitment of woody riparian species is limited by past and ongoing impacts to the banks, such as revetments and high recreation use. Alluvial surfaces with bank conditions that can be addressed are recommended for higher potential for enhancement. Banks identified as low potential for enhancement include those that are high terraces and lack alluvial surfaces; as well as those along which it may be difficult to remove revetments or reduce recreation use due to protection of infrastructure and proximity to recreation facilities and roads. Based on information collected from the field inventories, the potential for enhancement and expansion within the reach were categorized into four groups (Figures 4-8 and 4-9), as follows:

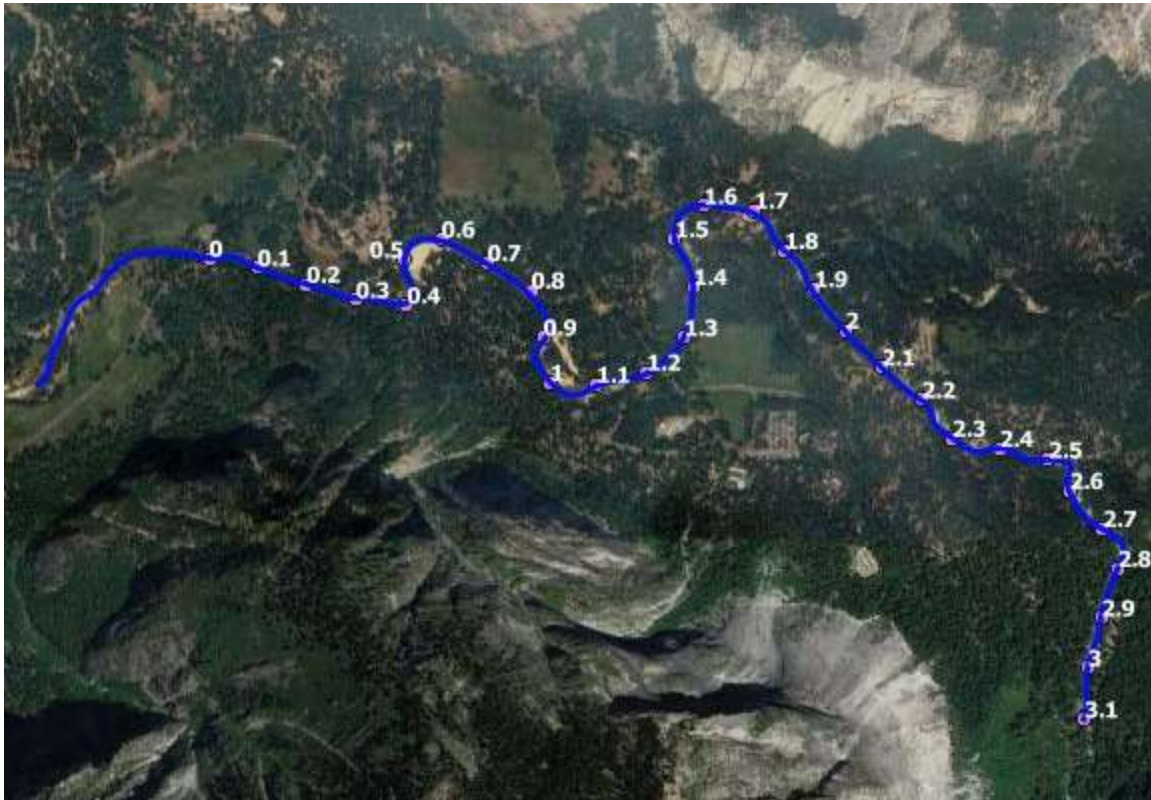
Figure 5-1. Study reach used for meander migration modeling.

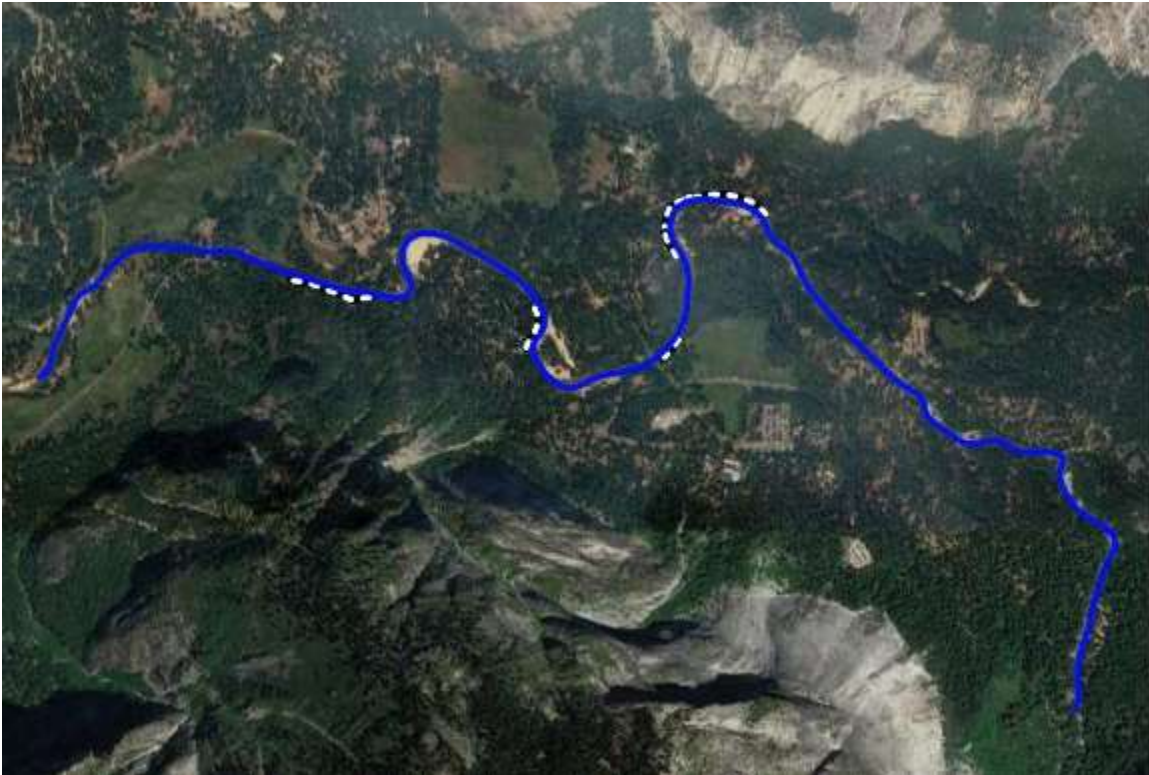
Figure 5-1. Selected revetments (white dashed lines) used for modeling migration.

The effect of revetment on channel migration was investigated by using a GIS coverage of existing revetments. Of the currently existing revetments in the study reach, four discrete areas appeared to predominately restrain the existing channel. A GIS coverage was developed that included only these four areas (**Error! Reference source not found.**) To explore the impact of this revetment on channel migration, migration was modeled with, and without, revetments.

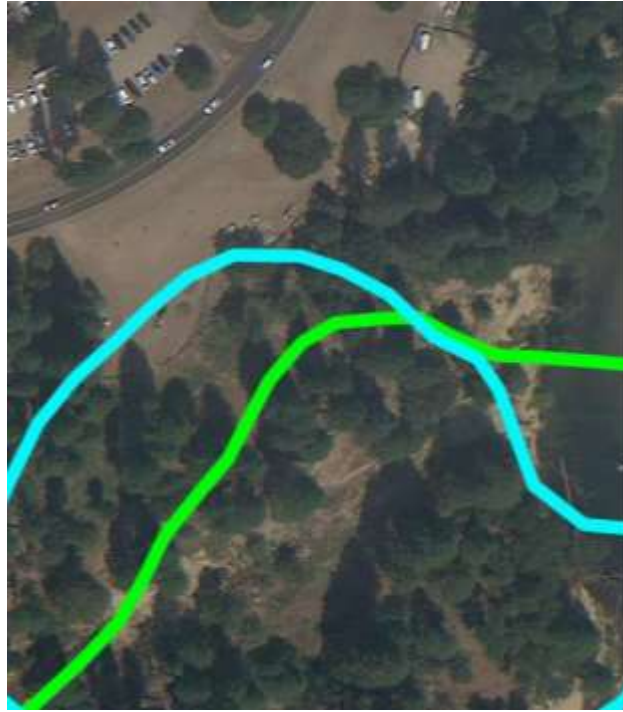
Figure 5-2. Historical progressive migration 1870-1883 at RM 0.3 to 0.4. The channel migrated from green to blue.

The final calibration was done with centerlines from 1870 and 1883. This calibration utilizes 13 years, during which time the flows were not investigated. A longer time period over which to average the migration rate might be more effective. Therefore, the *migration rate* determined with these values may be different, but the *pattern* of migration should be representative. This is true of all meander migration modeling, because the annual patterns of flow and storm events are not predicable. The meander migration model simulated a nominal 50 years of migration. However, the patterns should be relied on more than the specific duration of time—no one can say for certain “where” or “when” a channel will migrate to a specific location.

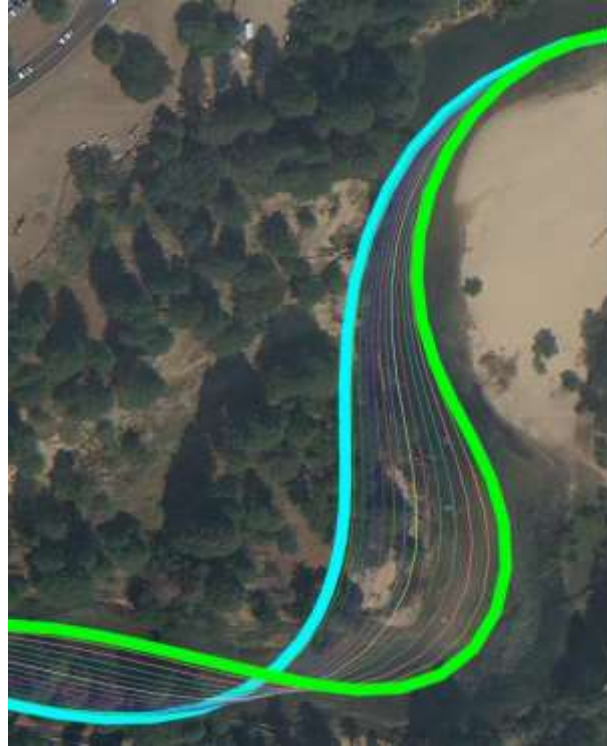
Figure 5-3. Calibrated 13-year migration at RM 0.4 to 0.5. The channel migrates from green to blue in this simulation.

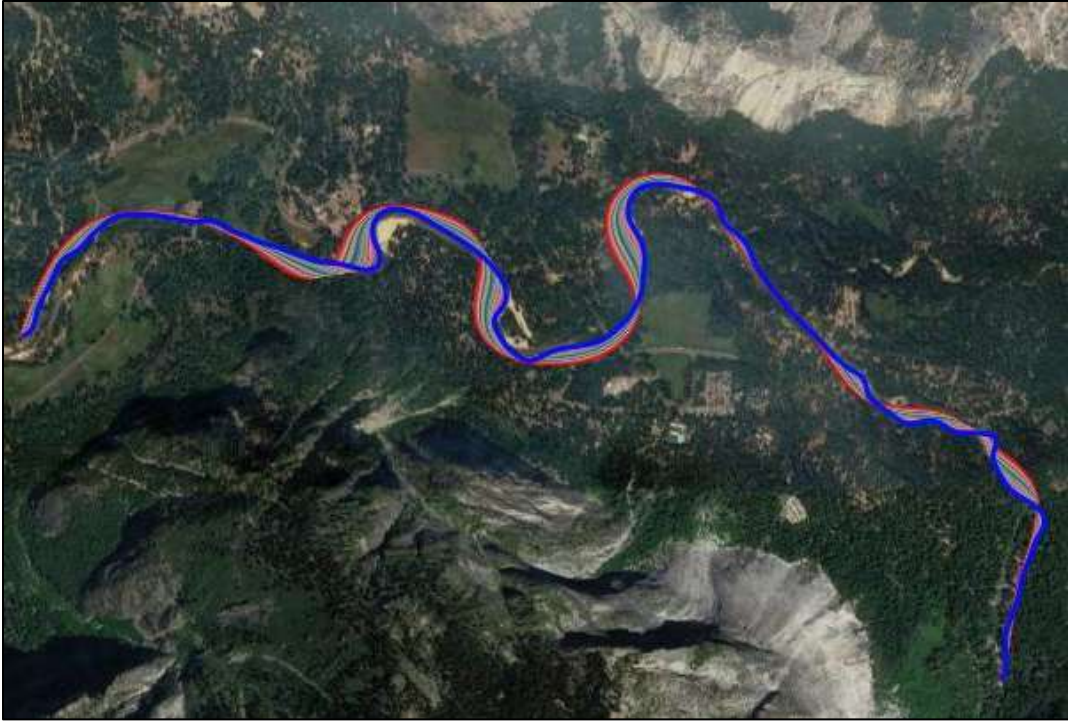
Figure 5-5. Channel migration 2016 to 2067 without revetments in place. The blue line represents the channel centerline in 2016; the red line represents the channel centerline in 2067 modeled with no revetments.

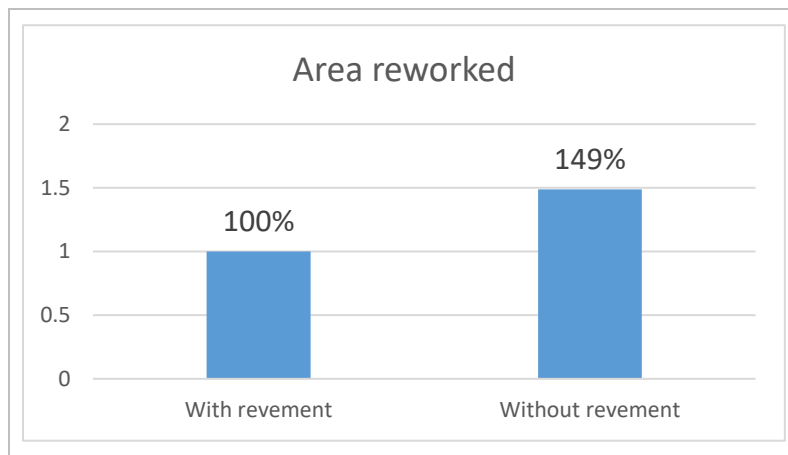
Figure 5-7. Total area reworked with and without revetments.

With revetments:	Area (m ²):	118,190
Without revetments:	Area (m ²):	161,260
Percent of area reworked, without/with:		149%

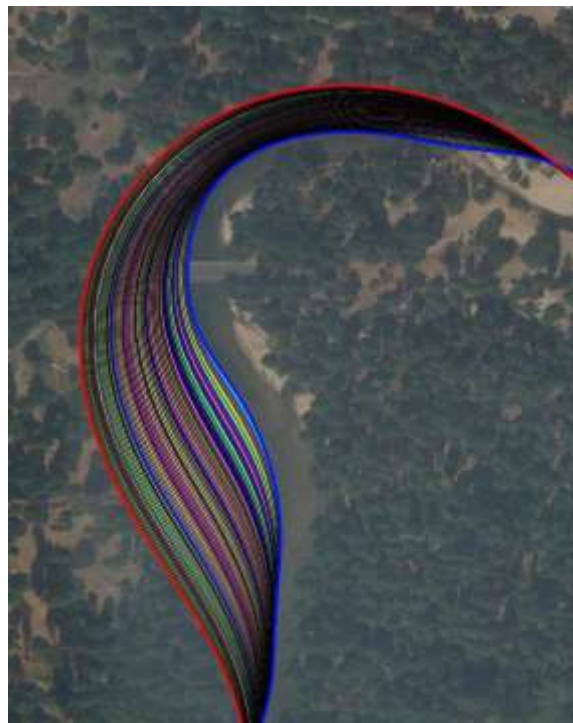
Figure 5-12. Modeled migration at RM 1.4 to 1.9 without revetments.

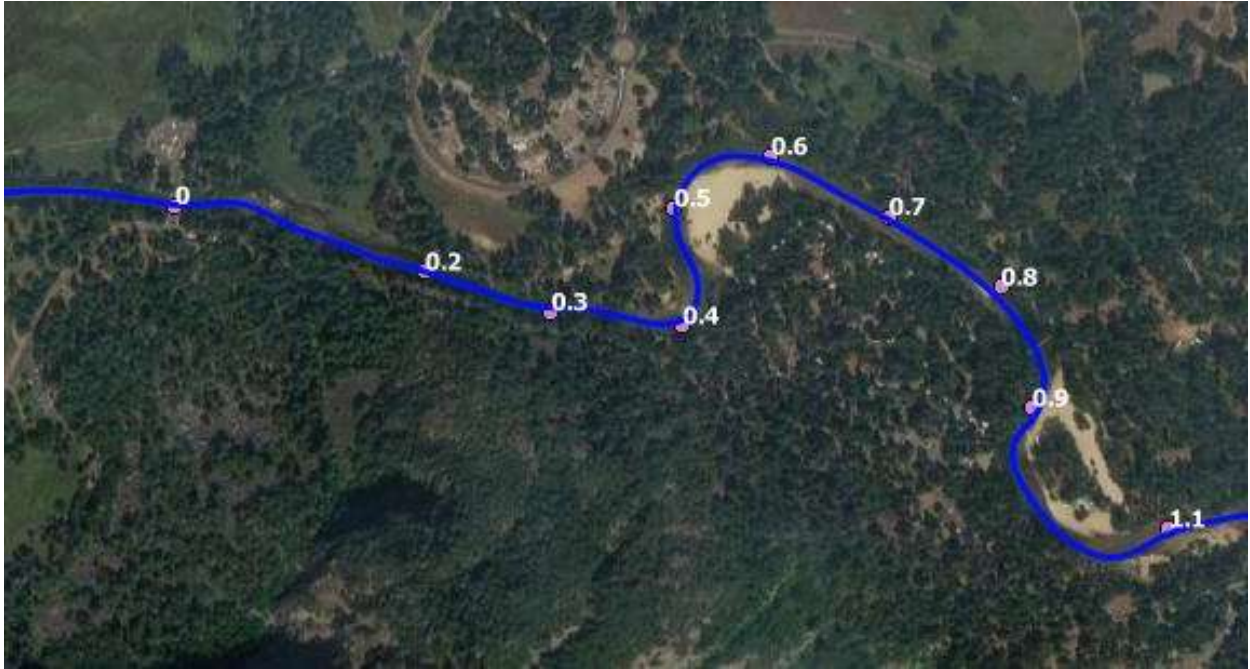
Figure 5-14. Location of cutoff modeling.

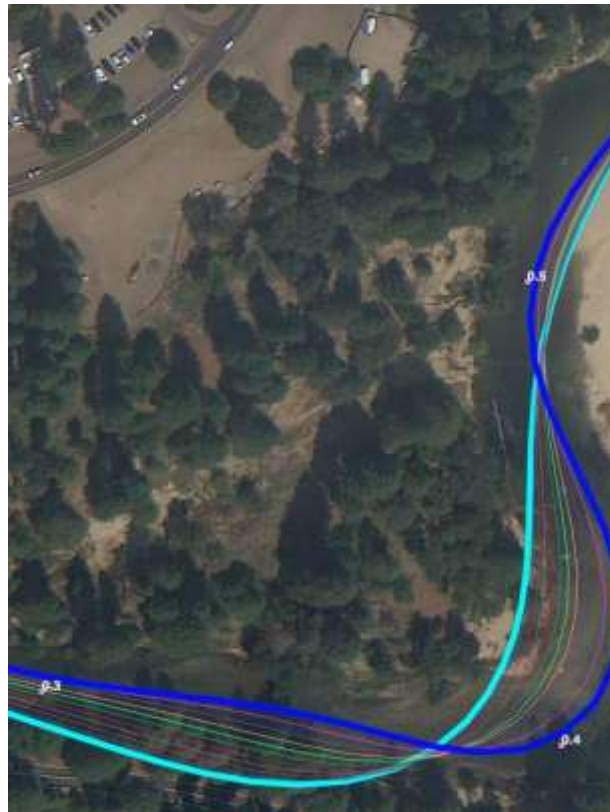
Figure 5-15. Progressive migration at RM 0.3 to 0.5. Current channel position is dark blue, migrated centerline is light blue.
