FINAL REPORT, PHASE 2:

Restoration of the Merced River through Yosemite Valley, Yosemite National Park

June 30th, 2018

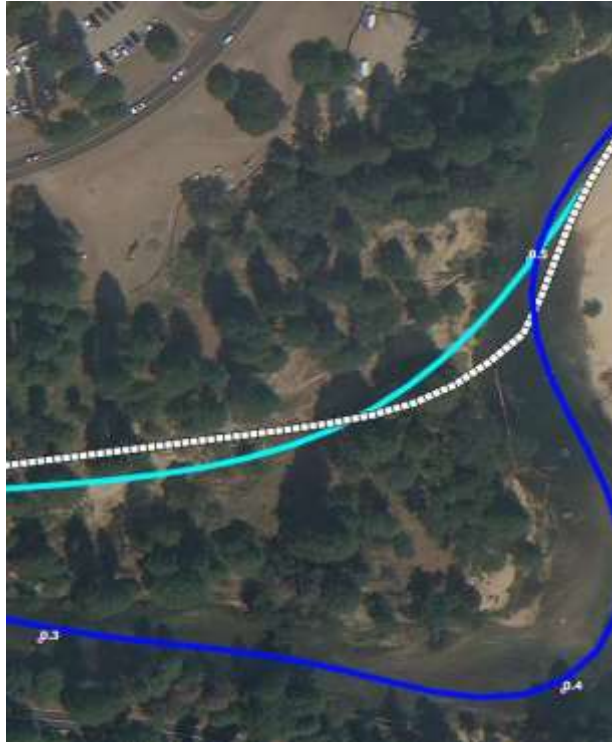
Figure 5-16. Cutoff and migration at RM 0.3 to 0.5. White dashed line shows the path of the most probable cutoff; light blue line indicates the centerline of subsequent migration.
