Part II. Deterioration and Methods of Preserving Metals

by John G. Waite, AIA

Chapter 9: Preservation of Architectural Metals

Chapter 10: Causes of Metal Deterioration and Failure

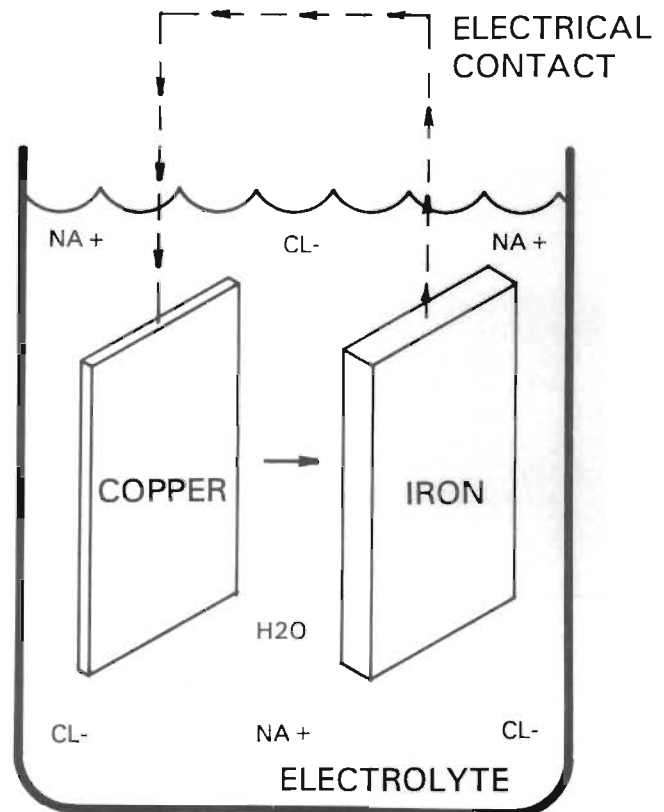
MECHANISM OF COPPER / IRON GALVANIC CORROSION

ARROWS INDICATE ELECTRON FLOW PATH

Figure 116. Galvanic Corrosion. A galvanic action occurs between the copper and iron with the water serving as the electrolyte. (Texas Instruments)

Galvanic Corrosion is an electrochemical action that occurs between two different metals in electrical contact in the presence of a common electrolyte forming an electrical couple (where there is a flow of electrons). Positive ions can travel through an electrolyte such as ionized water (which must be present). A galvanic action will occur only (1) when there are two dissimilar metals having a difference in a potential, (greater and lesser degree of nobility), (2) when the two dissimilar metals are in electrical contact so there can be a flow of electrons, and (3) when there is an electrolyte so that ions can move from one metal to the other (figure 116). In some cases, the electrolyte may be moisture or condensation on the surfaces of the metals. If any of the three conditions are not present, then galvanic action will not take place.⁷

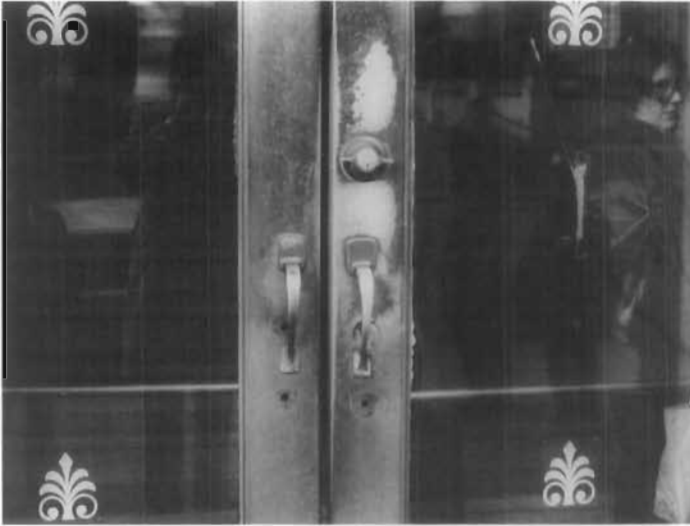
Figure 117. Human Abrasion. At the Old Post Office in Baltimore, Maryland, the bronze and glass doors show the abrasive effect of human hands on the natural patina combined with a residue of dirt and oil (from skin, which contains a minute amount of acid). This wear with accompanying superficial discoloration is only a minor problem. Over the years, these doors have received inadequate maintenance and inappropriate changes (to the hardware) and repairs. Such doors should be thoroughly cleaned to the bare metal; the holes plugged, ground down, and polished; and new chemical artificial bronze patina applied and protected by a lacquer with a corrosion inhibitor and/or with periodic applications of wax or oil (see section on bronze Chapter 15). (David W. Look)

ing the protective corrosion deposits from the metal surface. Abrasion is an especially critical problem with metal flashings and valleys used on slate roofs. As the slate deteriorates, particles break off and are washed down the valleys, causing erosion. Other examples of abrasion are when the patina, push plates and rail on bronze and brass doors (figure 117), chrome plating on railings, and brass thresholds are worn by pedestrians.

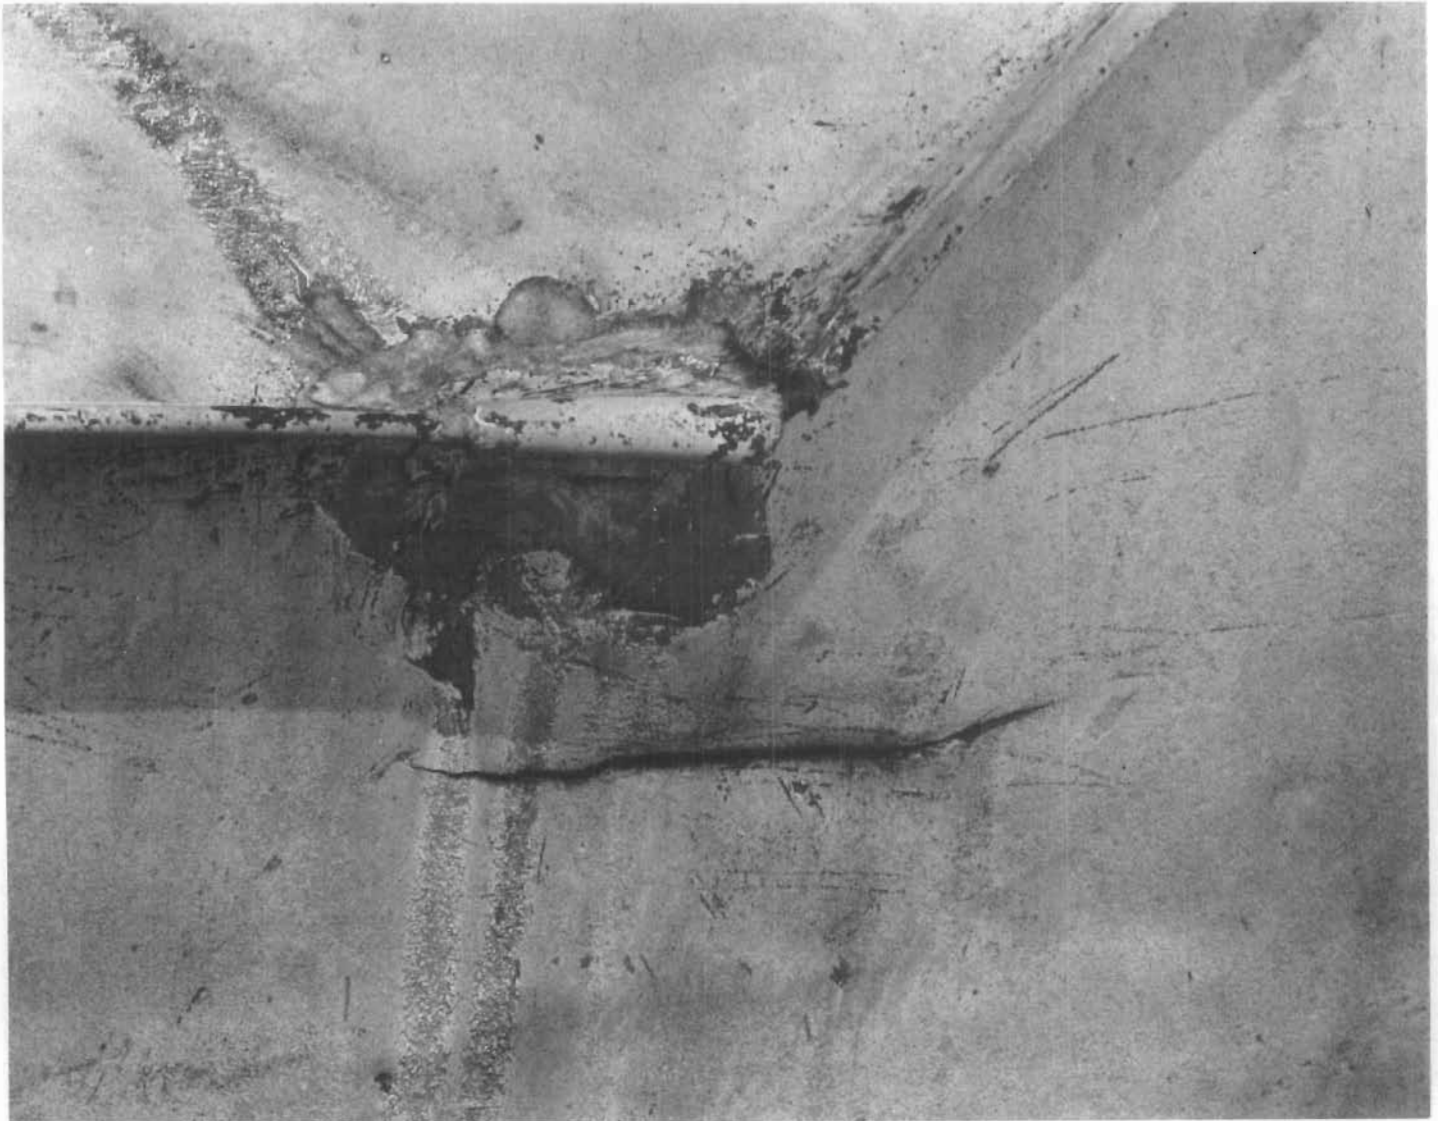
Figure 118. Fatigue Failure. This is an example of fatigue cracking of the copper roof of the Senate House, Kingston, New York. Repeated expansion and contraction due to daily and seasonal temperature changes has caused this sheet-copper roof to crack. Note cracking both at the joint and on the planar surface. (John C. Waite)

cracking caused by lack of provisions to accommodate thermal expansion and contraction (figure 118).

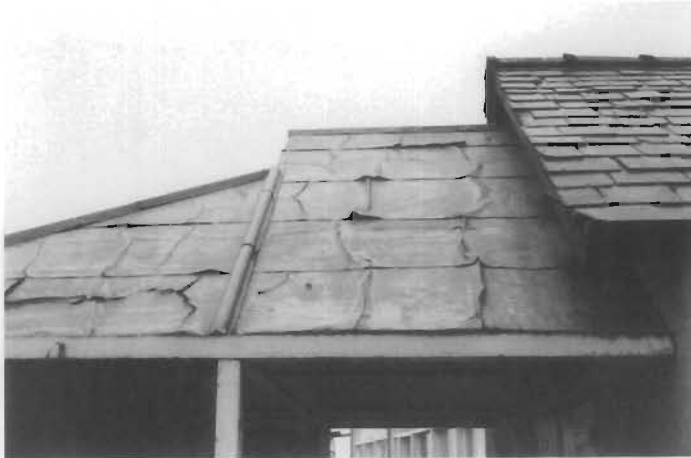
Figure 119. Creep. Deterioration of milled sheet lead roof on a 19th century canal warehouse and office at Nantwich Basin of the Shropshire Union Canal at Nantwich, Cheshire, England. The failure has been caused by creep and the expansion and contraction of the lead. (John G. Waite)

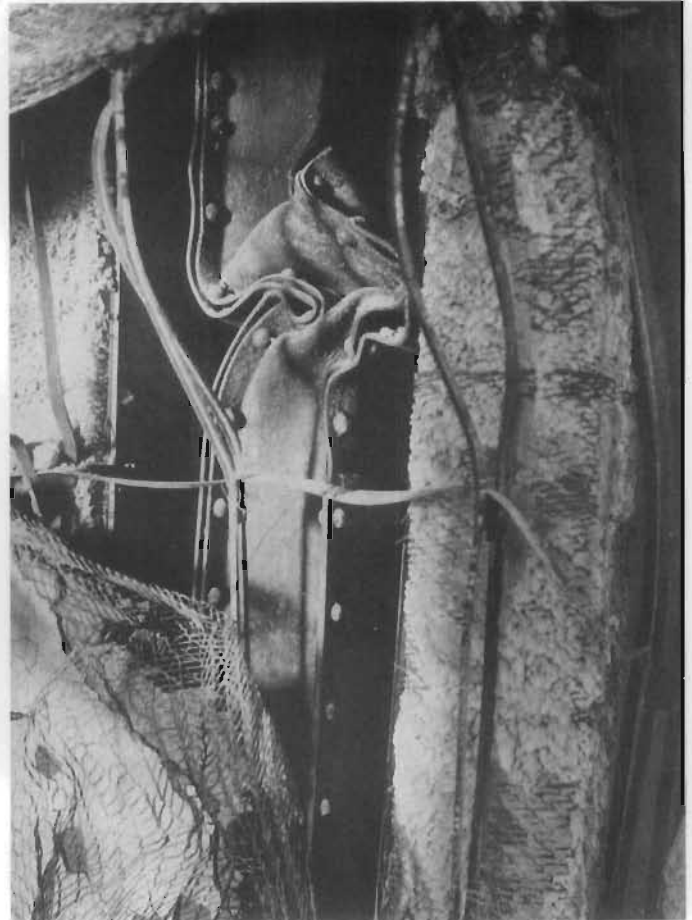
Figure 120. Column Buckling from Fire. In 1906 San Francisco was shaken by a severe earthquake, followed by fires that raged out of control for hours. In the Fairmont Hotel, the metal lath and plaster that covered the columns was probably damaged by the earthquake and was not sufficient to protect the steel from the intense heat. Portions of this building settled down approximately 7 feet from their original position because 37 columns buckled from the heat in this manner. (From *Trial by the Fire at San Francisco: The Evidence of the Camera, 1906*, Library of Congress.)

Fire can cause unprotected metal (iron and steel) framing members to become plastic and fail rapidly (figure 120). Lead roofs have melted during fires, and sheet metal decoration can buckle from heat and fall off buildings when its anchorage is lost. Structural iron or steel that has survived a fire without deformation is usually safe to reuse, but any questionable member should be load tested.

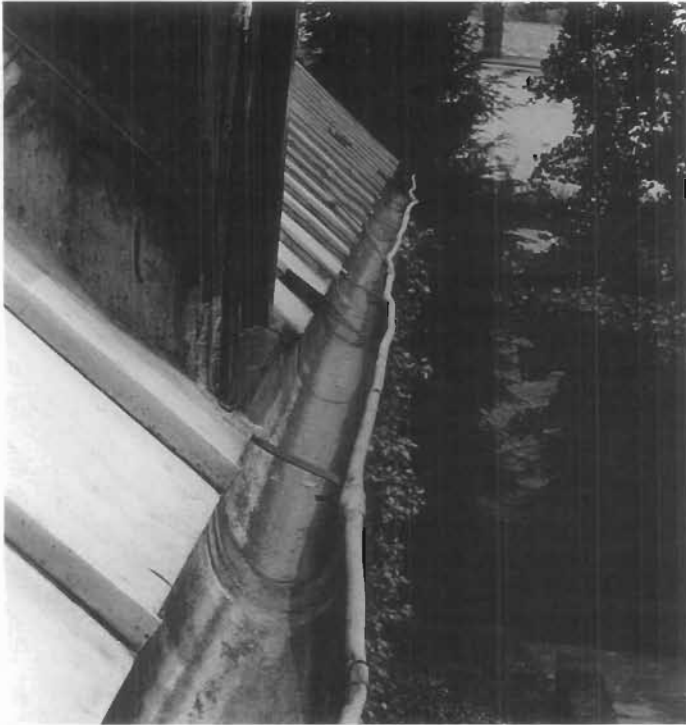
Figure 121. Overloading. The copper gutter on the Senate House, Kingston, New York, installed in the 1920s, has been distorted by ice and snow; the seams between gutter sections have opened. The problems were compounded by the lack of stiffness of the gutter and the absence of adequate provisions for expansion and contraction. The steel retaining straps are deteriorating because of an electrolytic reaction (galvanic corrosion) with the copper (the more noble metal). (John G. Waite)

Overloading is the stressing of a metal member beyond its yield point so that permanent deformation, fracturing, or failure occurs. The member can fail through the application of static loads, dynamic loads, thermal stresses (figure 121), and settlement stresses either singly or in combination. "Buckling" is a form of permanent deformation from overloading which is usually caused by excessive weight but can also be caused by thermal stresses. Members can also be overloaded if their support is removed and loads are redistributed to other members which can become overstressed and deformed (figure 122).

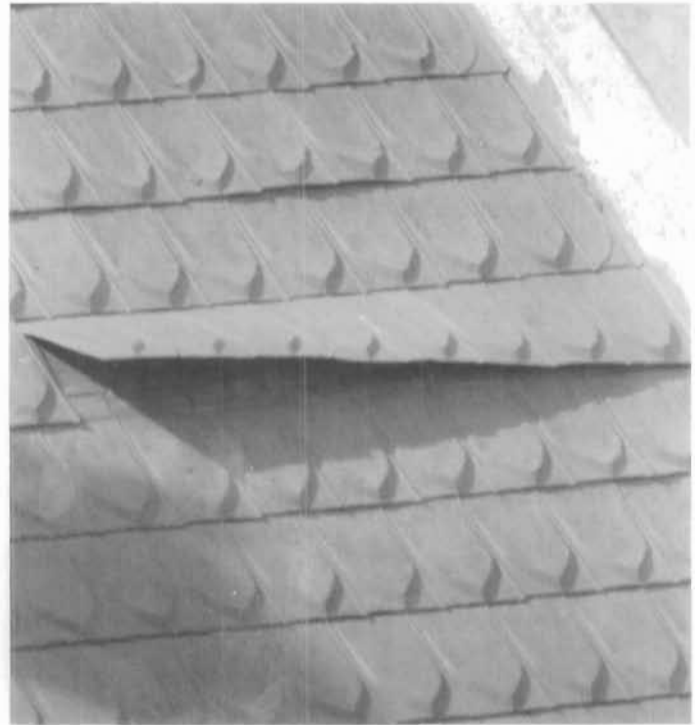
Figure 123. Anchorage Failure. The nails holding down this section of embossed galvanized sheet-iron roofing have deteriorated and the wind has lifted up the corner of the sheet, allowing water to leak through the roof sheathing. Other sections (not shown in the photo) had flapped in the wind until the sheet metal cracked with fatigue failure and tore loose. In 1977 this roof at St. Edward's University in Austin, Texas, was cleaned and supplemented with reproduction "shingles" where needed. (St. Edward's University)

Proper design and installation is very important with galvanized iron or steel roofing and flashing. Special care should be taken to insure that the roof has adequate expansion joints to accommodate thermal expansion and contraction and adequate anchorage to guard against wind damage (figure 123).

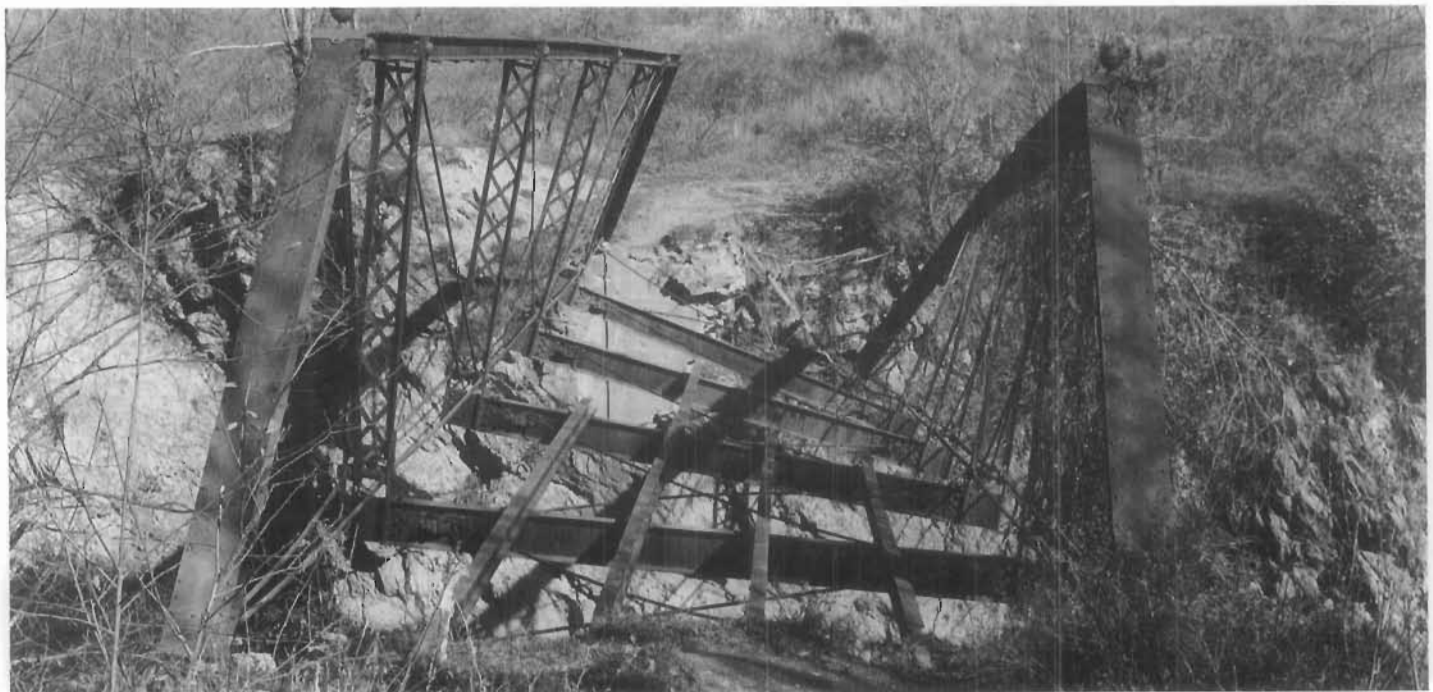
Figure 122. Structural Failure. This 19th-century wrought-iron truss bridge at Brunswick, New York, partially collapsed because the cut-stone abutment supporting it washed away. Once the support was removed, the bridge twisted. (John G. Waite)

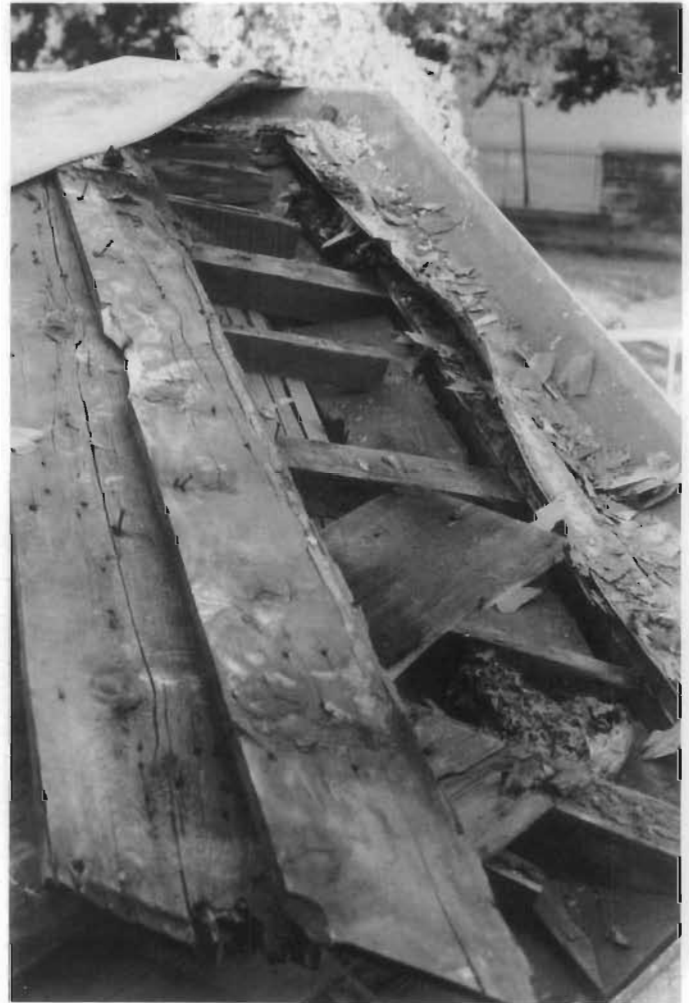
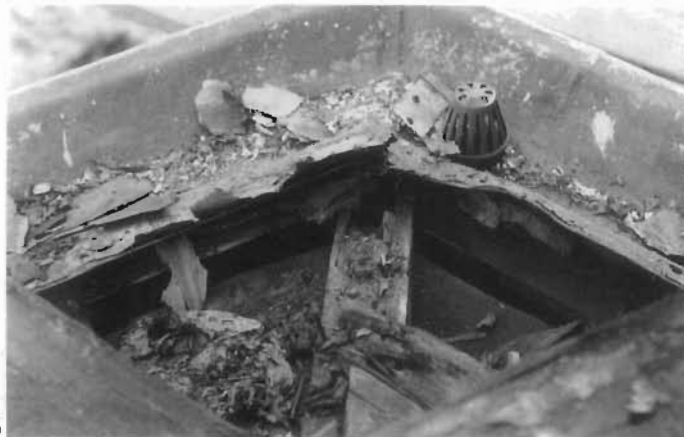
Figure 124. Successive Failure. If a metal architectural element such as a tinplate roof fails, more than just the tinplate may be destroyed. (a) Deterioration is evident in the original framing and roof sheathing of the Schuyler Mansion entrance wing in Albany, New York. The entrance wing was added to the building about 1817 and reroofed with tinplate sheets during the 19th century. The tinplate gutter liners eventually deteriorated and were replaced with copper during the 1930s. However, the tinplate roof remained and electrolysis occurred along the roof perimeter where the copper and tinplate were in contact. (b) Consequently, the tinplate was completely corroded away (as seen here) when the deteriorated roofing was removed. This resulted in major damage to the sheathing, framing, and masonry walls of the entrance. (John G. Waite)

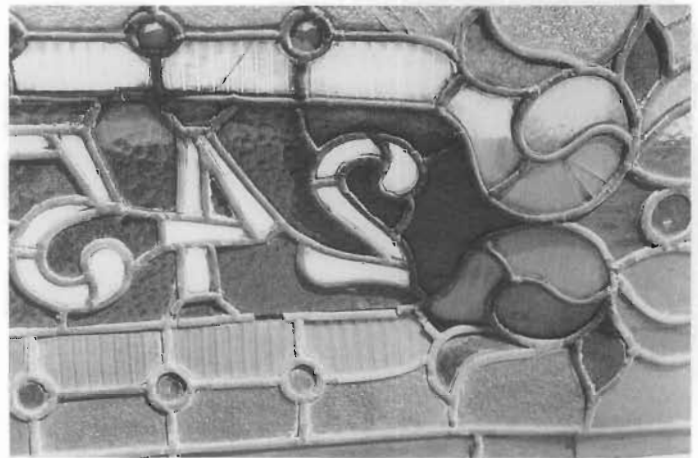
Figure 125. Lead Came Damage. *One of the most common uses of lead is the comes in stained glass windows, transoms, and skylights (see figure 8). Although lead comes are sometimes damaged by corrosion, especially where rain or condensation might collect at the bottom border came (a very slow process), they usually are damaged by creep and fatigue. The weight of the lead and glass in the entrance transom pictured above has caused the comes to creep, resulting in a noticeable sag and outward bulge. This transom did not have iron support bars found on many stained glass windows. The bars (sometimes called saddle bars) were usually set into the frame and attached to the lead comes with copper wires. Transoms are adversely affected by the vibrations of slammed doors and the outward force of compressed air in a vestibule. To complicate things further, the difference in the expansion and contraction coefficients of the lead comes and lead-tin solder has resulted in fatigue cracking, usually at joints. (H. Weber Wilson)*

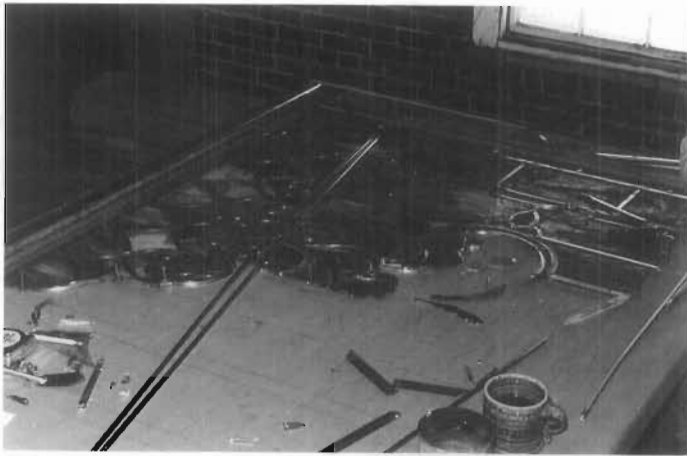
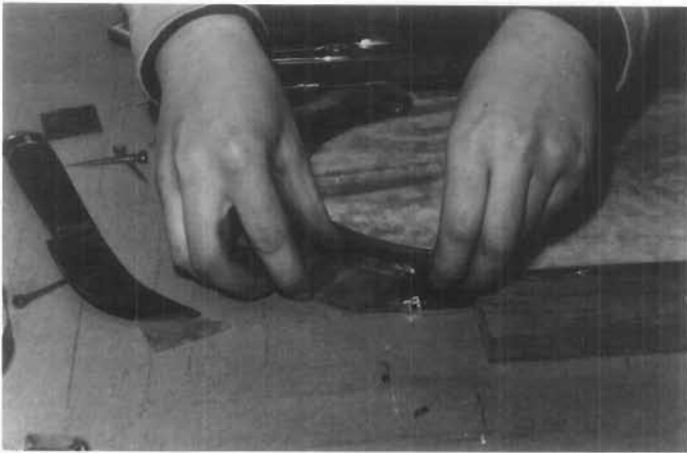
Figure 126. Lead Came Replacement. (a) On the table is a tracing of the original pattern of the lead comes of a late 19th-century stained glass window from the Pilgrim Congregation Church, Cambridge, Massachusetts. Because of the severe deterioration of the original lead comes, it was necessary to replace them with new comes that matched the original configuration. (b) This is a detail of the fitting of the new comes around the original glass. (Cummins Studios)

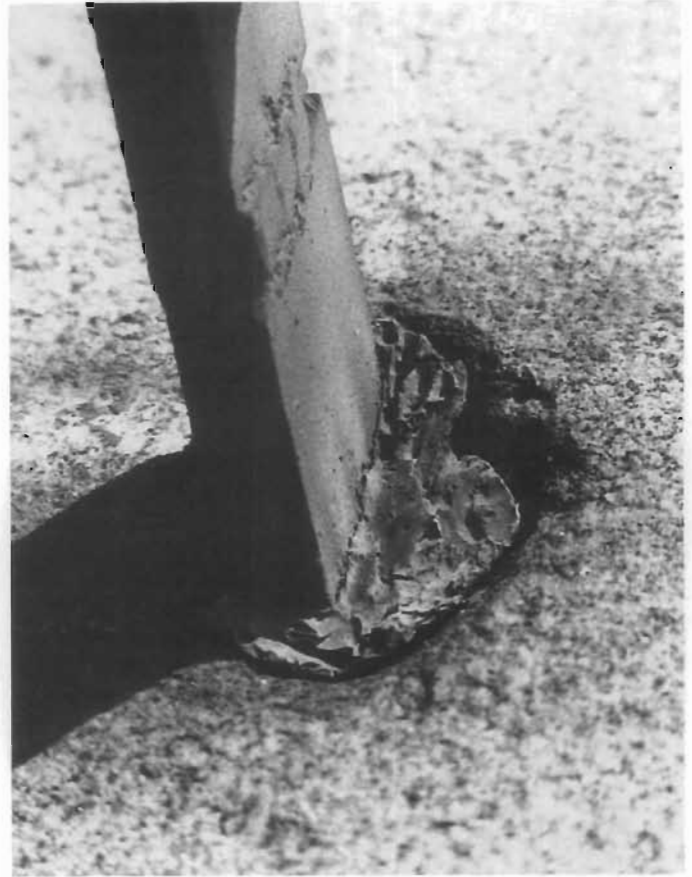
Figure 127. Lead Packing. *At the U.S. Treasury Building in Washington, D.C., the iron fence is supported by stone posts. The iron rails are fitted into pockets in the stone. Water seeped into the pockets and the iron rusted, causing it to expand. Rust, plus freezing and thawing action, caused the stone to spall. To remedy the situation, the iron fences were removed; the ends of the rails were cleaned of rust and repainted; and the fence was re-erected with lead packing. This lead is soft enough to accommodate thermal expansion and contraction of the iron. It also waterproofs the ends of the bars. (John Myers)*

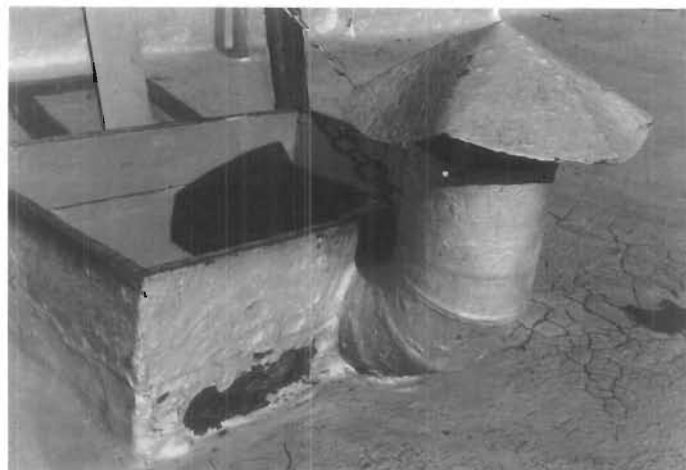
Figure 128. Deterioration of Tinplate by Asphalt Coating. The tinplate flashing of the roof hatch has been corroded away (between the corner and the vent) by the action of the asphalt coating and water. (John G. Waite)

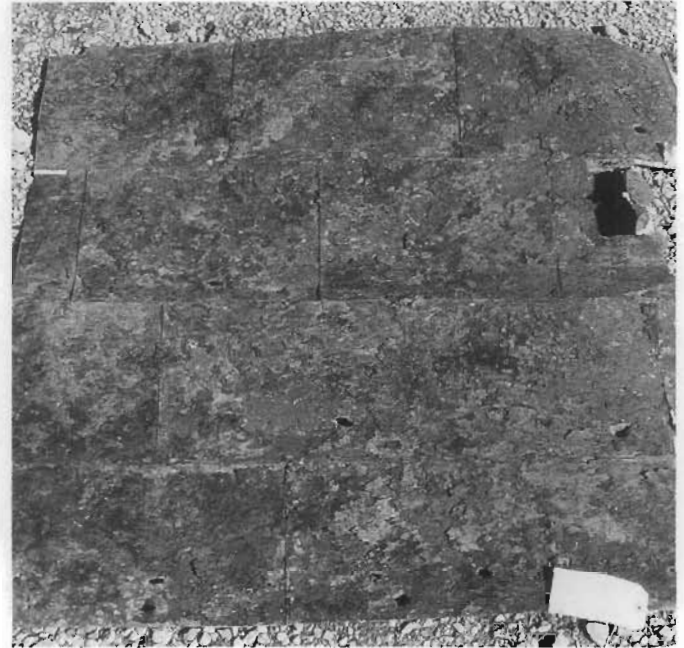
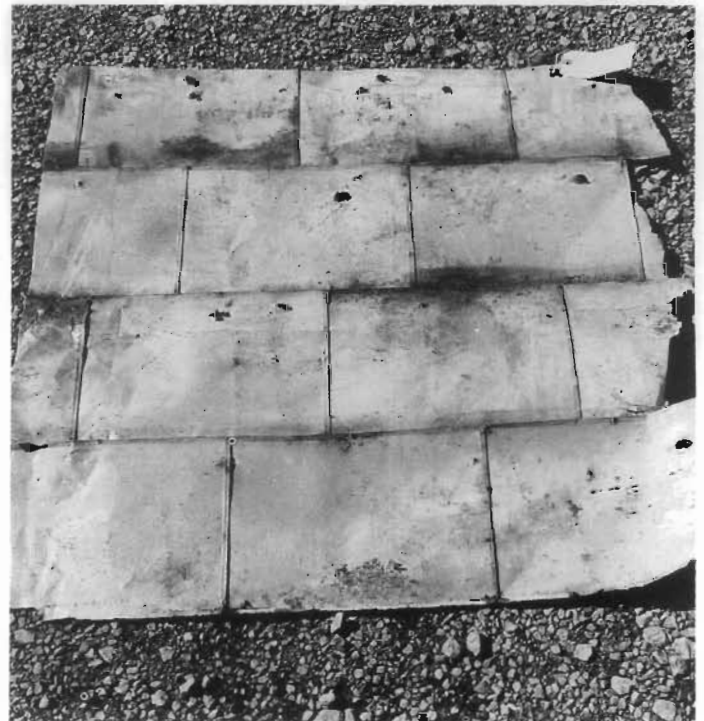
Figure 129. Corrosion Failure of Terneplate Roofing. *Hyde Hall, built between 1817 and 1833, near Cooperstown, New York, was roofed with flat-seam terneplate. (a) The plates have deteriorated because of a lack of proper maintenance. Unfortunately, the exposed (top) surface of the terneplate was painted with asphalt coating, which accelerated the corrosion of the roofing. (b) The terneplate also corroded from the underside. When installed, the terneplate was not painted on the underside as it should have been. Condensation formed on the unprotected bottom side of the metal roof and could not evaporate, an ideal situation for corrosion. (John G. Waite)*

When exposed to the atmosphere, tin readily develops a thin film of stannic oxide, which helps resist corrosion. Although pure tin is mildly corroded by exposure to acids, marine atmospheres, and certain alkalis, tinplate roofing is generally very durable as long as the tin or terne coating maintains its integrity. Once the plating has been broken and the iron or steel is exposed to oxygen, the deterioration begins and is accelerated by the galvanic action between the tin and iron. The more active tin acts as a cathode to the iron. This protects the iron from corrosion but accelerates the deterioration of the tin, exposing more of the iron to be corroded. Tin and terneplate roofing and flashing will deteriorate when in contact with copper, for instance, in gutters. Also they can be corroded by asphaltic and bituminous roofing compounds and building paper (figures 128 and 129a), as well as by paints containing acids, bitumen, asphalt, or aluminum. Tinplate roofing can corrode on the underside from water vapor condensation if the tin is not protected by a coating of paint and/or a nonacidic vapor barrier (figure 129b).

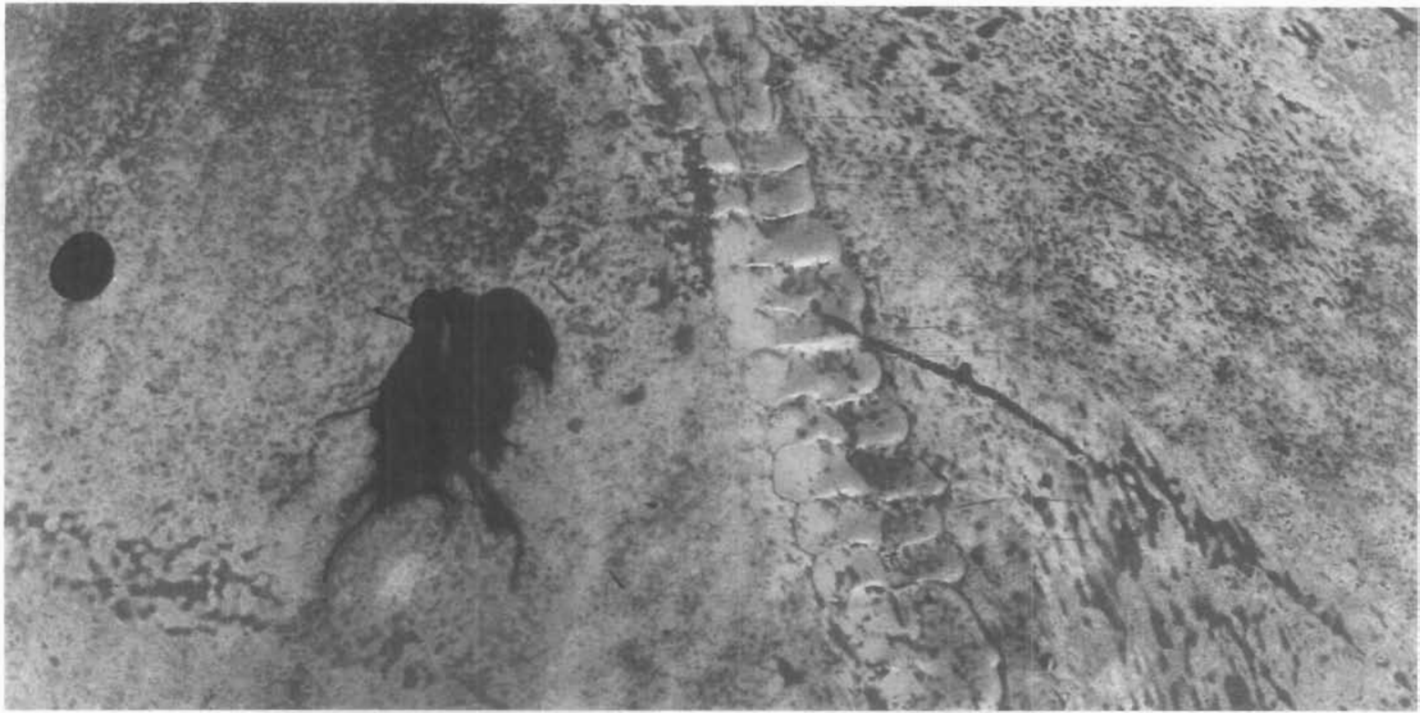
Figure 130. Modern Solder Joint on a Terneplate Roof. Solder was used to make watertight joints at the edges of terneplates on flat-seam roofs. Nineteenth-century soldered joints were almost invisible, that is, the solder was confined to the seam. These wide-soldered joints are on the Old Pension Building in Washington, D.C. The problems with wide-soldered joints are: (1) they facilitate galvanic corrosion because they provide a wider surface area with which the plates can react, and (2) they tend to fail because of the different coefficients of expansion and contraction of the solder and the terneplate. The black spots to the right of the solder are asphalt or a bituminous roof patching compound, which may cause deterioration of the terneplate and should be removed. (David W. Look)

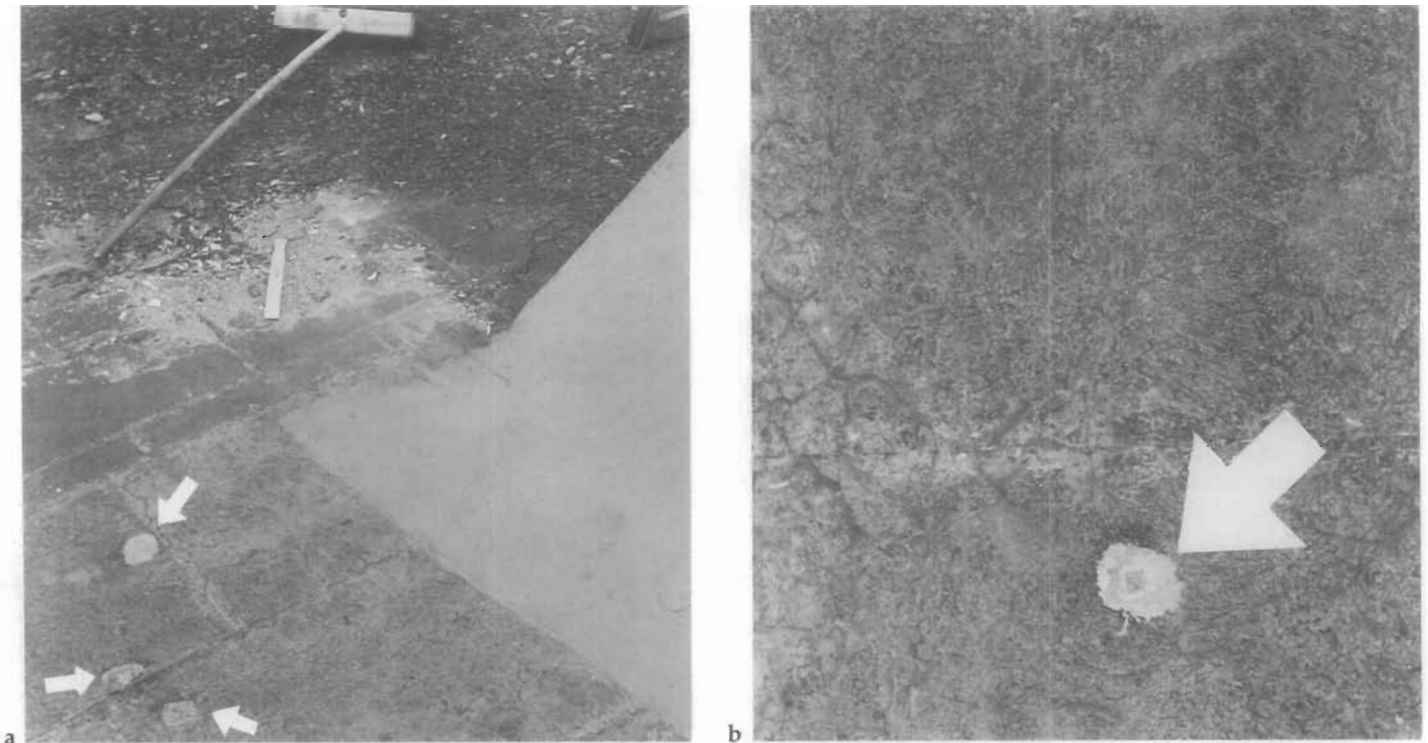
Figure 131. Salvaging a Flat Seam Terneplate Roof. (a) The roof of the Henry E. Bradford House Carriage Barn (c. 1860s) in Bennington, Vermont, had been covered with an asphalt coating (background) which obscured the true cause of the leaking roof. Once the asphalt coating was scraped from the surface (foreground left), it was noticed that the nails in the sheathing had "popped up" (light spots) and had cut through the terneplate. (b) After the asphalt coating had been scraped away and the nail holes repaired with solder (left foreground), the roof was then painted with red-lead primer (right foreground). The primed roofing was given two finish coats of iron oxide paint. (John G. Waite)

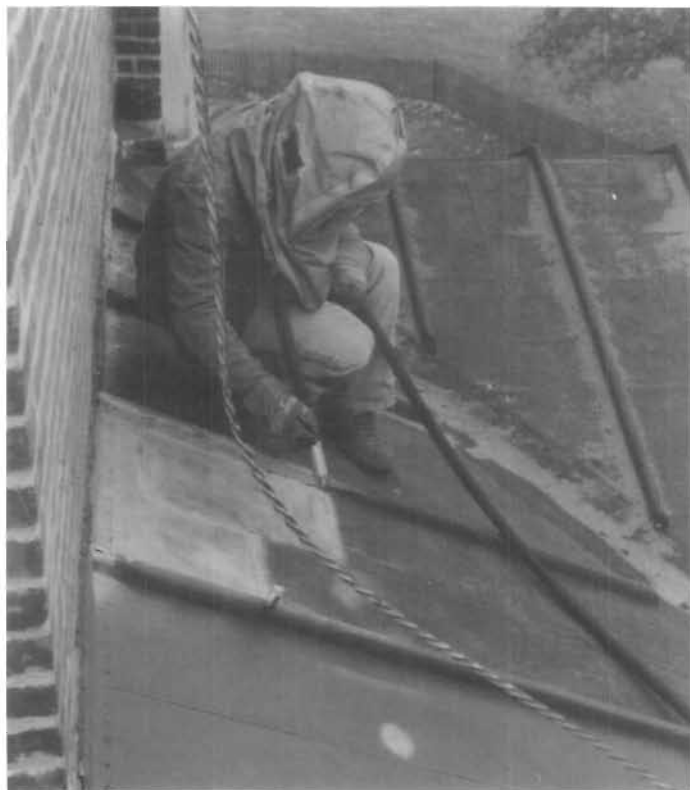
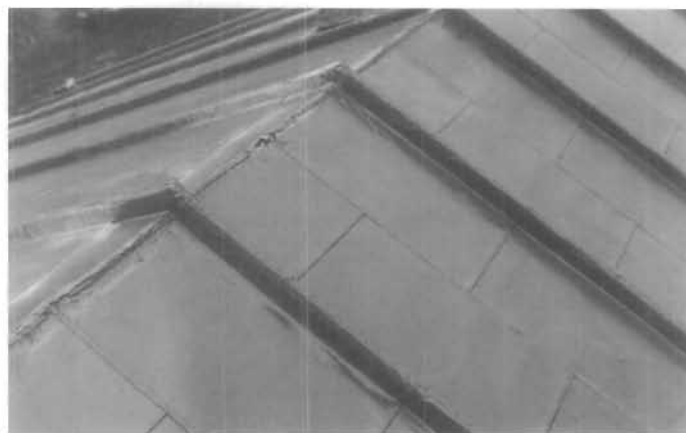
Figure 133. Abrasive Cleaning of Terneplate Roof and Replating. (a) Sections of the original terneplate roof at Lindenwald (Martin Van Buren National Historic Site) in Columbia County, New York, designed by architect Richard Upjohn in 1848, were cleaned with a low-pressure blasting of crushed walnut shells to remove accumulated paint and rust before replating with a lead/tin alloy. (b) The new terneplating was applied in localized areas (only where the original terne had been damaged by falling slates or removed because the sheet iron underneath had corroded). The new terneplating was applied where the bare iron was exposed using a soldering "copper" (a large soldering tool) fabricated for the project. After cleaning and replating, the restored roof was painted. (John G. Waite)

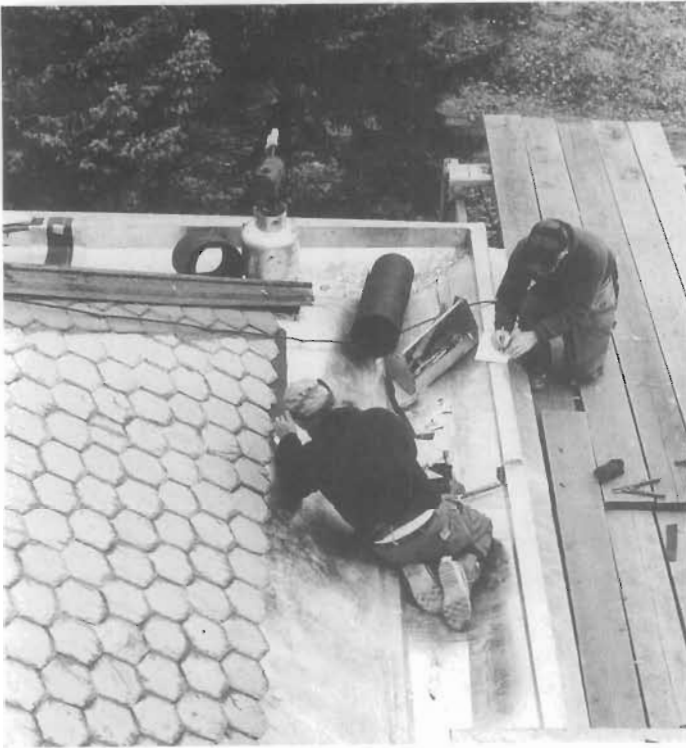
Figure 134. Replacing Flashing and Gutters. Workmen replaced the deteriorated terneplate flashing and gutters at Olana, built between 1870 and 1874 near Hudson, New York, for the noted artist Frederic E. Church. The polychromed slate roof was restored to the original pattern, and lead-coated copper was substituted for the original terneplate flashing and gutters because of ease of maintenance - it does not require painting, unless there is a need to match the terneplate in color. The original terneplate was painted. (John G. Waite)

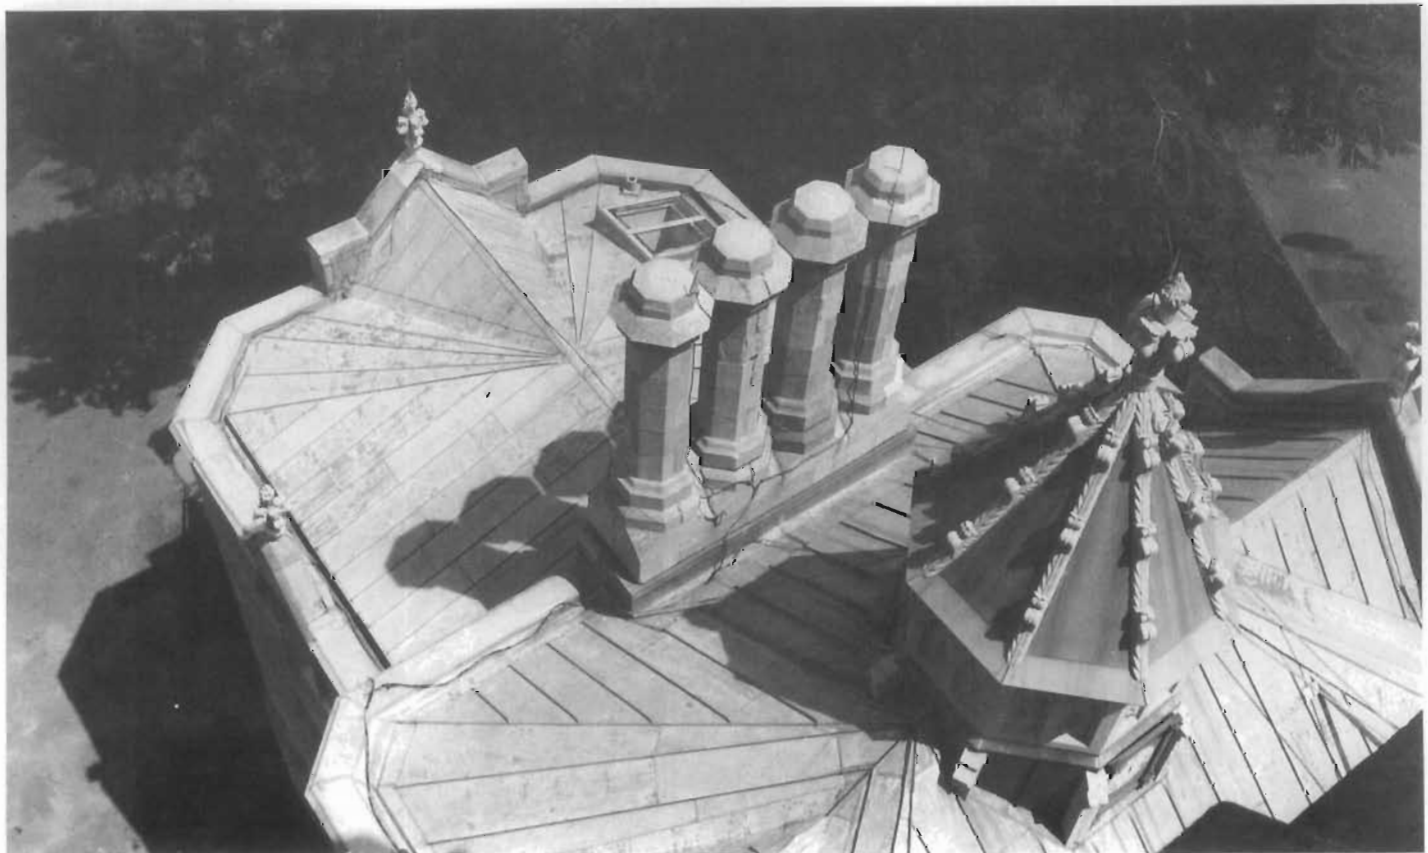
Figure 135. Complete Substitution of Lead-Coated Copper Roofing for Terneplate Roofing. The 1864 wing addition of Lyndhurst, Tarrytown, New York, originally had a terneplate roof. In an attempt to find a more permanent roofing material, a lead-coated copper roof was substituted for the terneplate, duplicating the pattern and sheet sizes of the original roof. In such substitutions, details may have to be redesigned because of differences in expansion and contraction rates and differences in workability of the material. The color of lead-coated copper is not the same as terneplate because terneplate roofing was never left unpainted. Therefore, lead-coated copper roofing substituted for terneplate should also be painted if it seen from normal viewing angles (usually from street level). (John G. Waite)

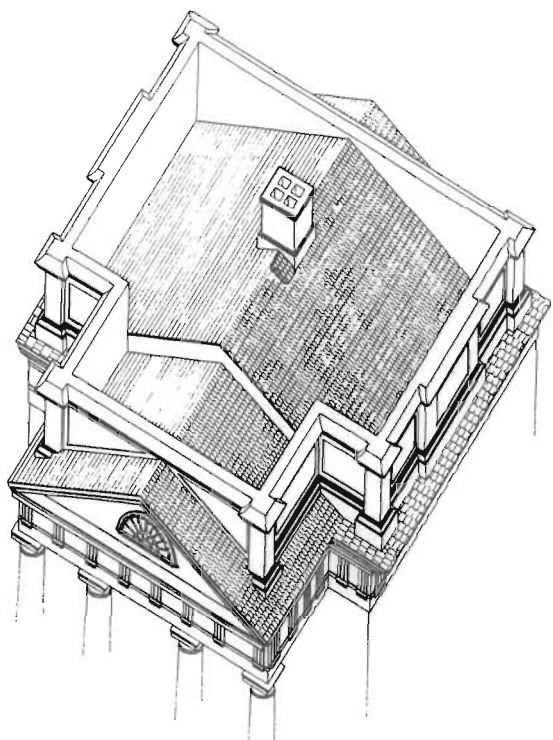
a. Pavilion X roof (Mesick•Cohen•Waite Architects)

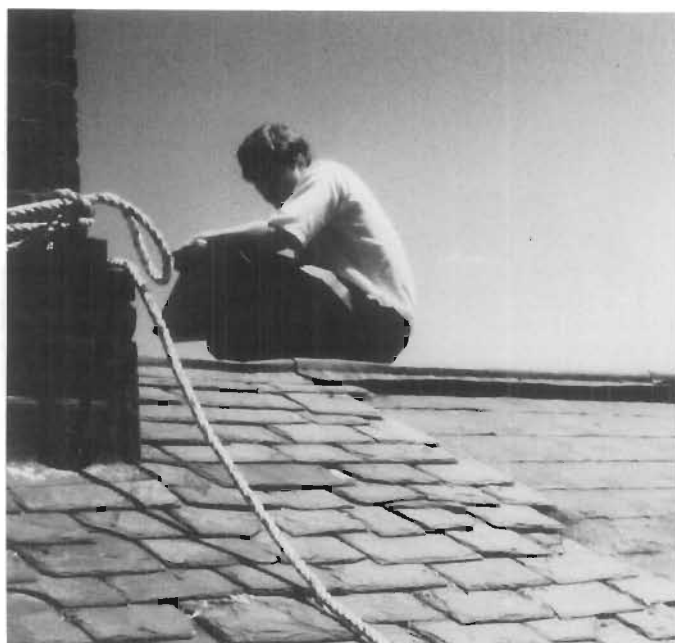
c. Original tinplate roof beneath slate (John G. Waite)

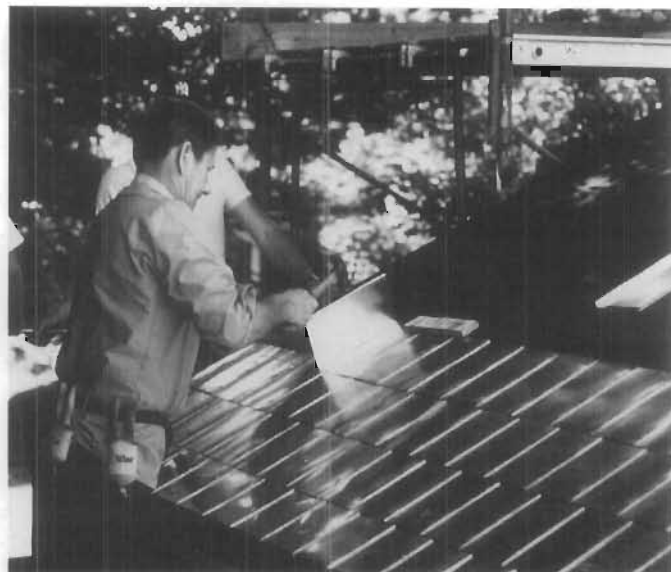
d. New roofing (Clay S. Palazzo)

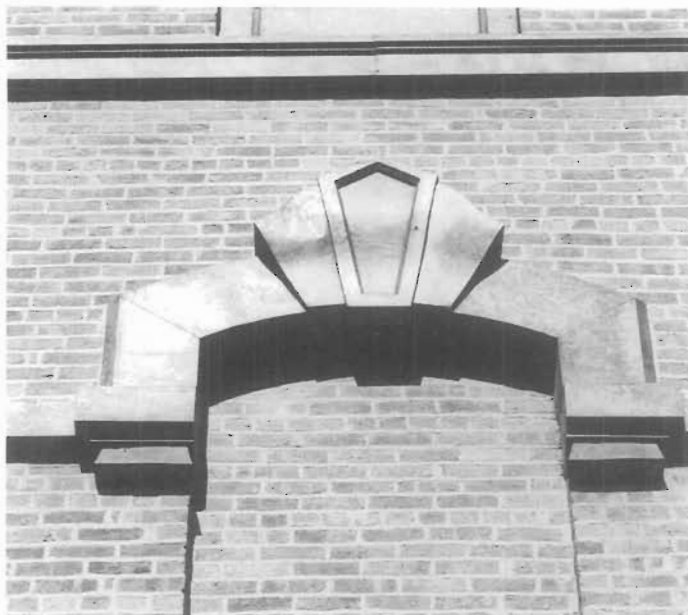
Figure 137. Deterioration of Zinc. At the 1874 Cohoes Music Hall, Cohoes, New York, the original zinc window lintels and belt course were cleaned by sandblasting, resulting in pitting and corrosion of the metallic surface. Note the whitish corrosion products caused by the abrasive cleaning and subsequent exposure to the weather. The lintels had been painted originally but were left bare after the cleaning. Zinc and galvanized sheet iron should always be primed and painted with paints especially formulated for zinc. (John G. Waite)

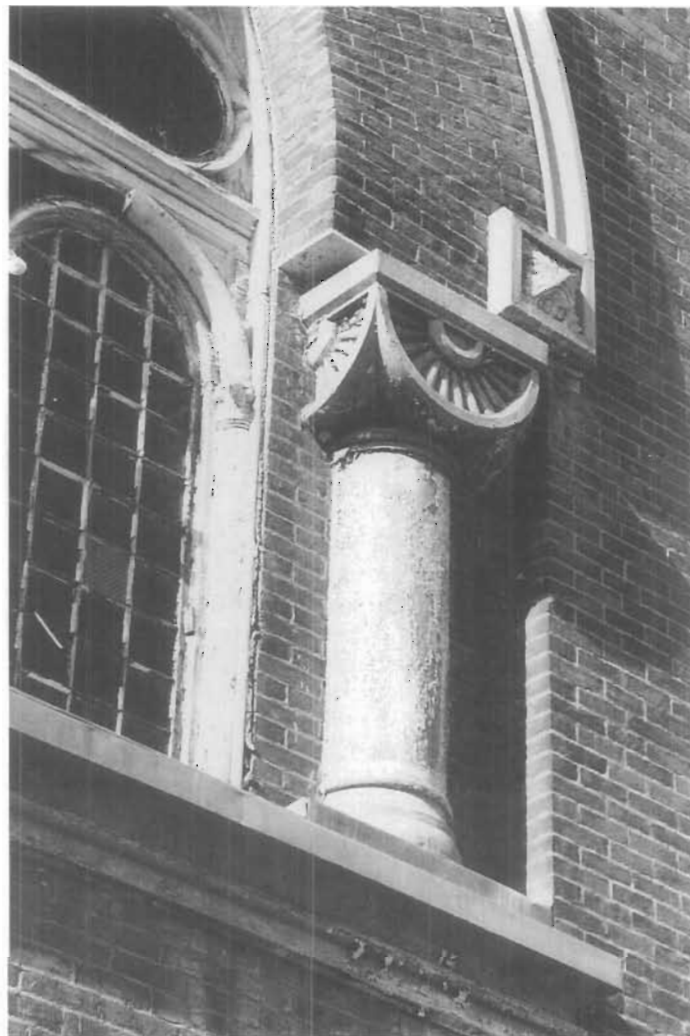
Figure 138. Zinc Deterioration and Staining. On the First Presbyterian Church in Alexandria, Virginia, the engaged columns, arch molding, corner blocks, and the sill molding are fabricated of cast zinc and galvanized sheet iron (the windows and frames are wood). The paint has deteriorated, leaving the surface of the metal bare in some places. The zinc or zinc coating on iron has oxidized. Notice the whitish corrosion stain on the brick from the zinc carbonate coating which continues to wash over the surface of the bare metal and then down over the bricks. The metalwork should be scraped down to remove all loose zinc carbonate. Joints should be caulked and/or resoldered, and repainted with a zinc chromate primer. (Baird M. Smith)

Although zinc is not damaged by electrical contact with lead, galvanized iron and steel, tin, or aluminum, it is damaged by galvanic corrosion when it comes in electrical contact with copper and pure iron in a common electrolyte (figure 138).

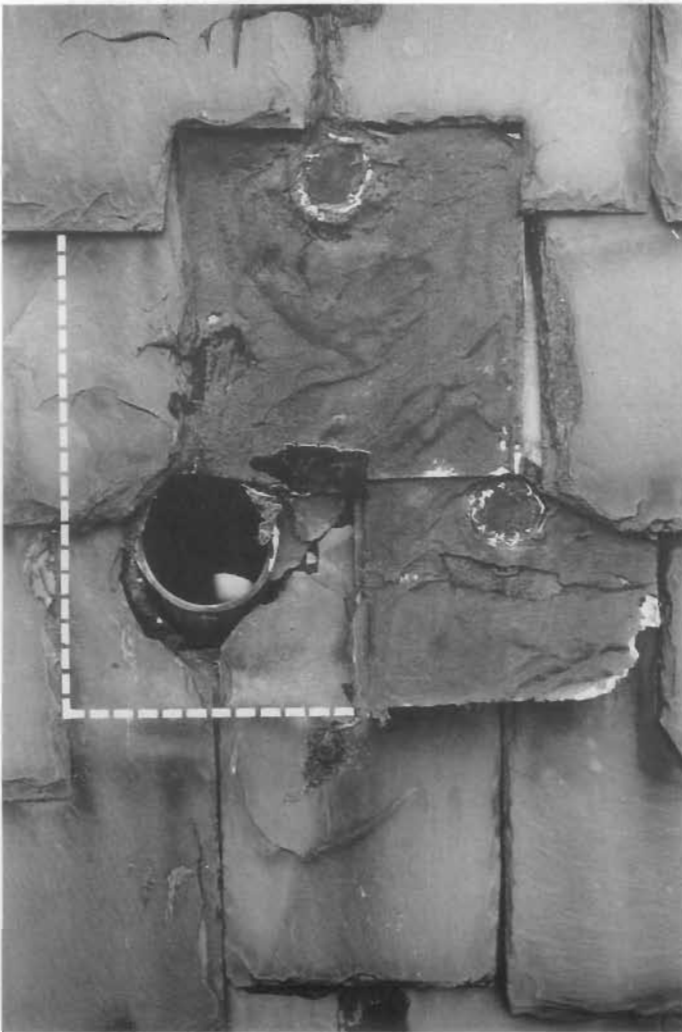
Figure 139. Zinc Corrosion, Erosion, and Inappropriate Repairs. In construction of the Nott Memorial at Union College in Schenectady, New York, during the 1870s, architect Edward Tuckerman Potter used “illuminators” in the ornamental slate roof. These were slate-sized zinc plates with a small colored-glass disc 1 3/4 inches in diameter inserted in the center. Barely discernible from the outside, they transformed the vaulted dome within a “heaven” of red, yellow, purple, orange, and green stars. Shown here is a cluster of three illuminators, each consisting of a zinc plate with a small colored-glass insert and the connecting tube through the metal deck and plaster to the interior. The zinc was inaccessible and not kept painted. Small fragments of slate broke off and tumbled down with gravity. The wind and rain eroded the layer of corrosion from the zinc surface. The left plate is missing (see dotted line), showing the connecting tube. The corner of the lower right plate is missing because it became brittle and fractured off. Unfortunately, modern roofing cement applied over the zinc plates is accelerating the deterioration. (John I. Mesick, *The Nott Memorial: A Historic Structure Report Schenectady, New York: Union College, 1973. p. 65*)
