Part II. Deterioration and Methods of Preserving Metals

by John G. Waite, AIA

Chapter 9: Preservation of Architectural Metals

Chapter 10: Causes of Metal Deterioration and Failure

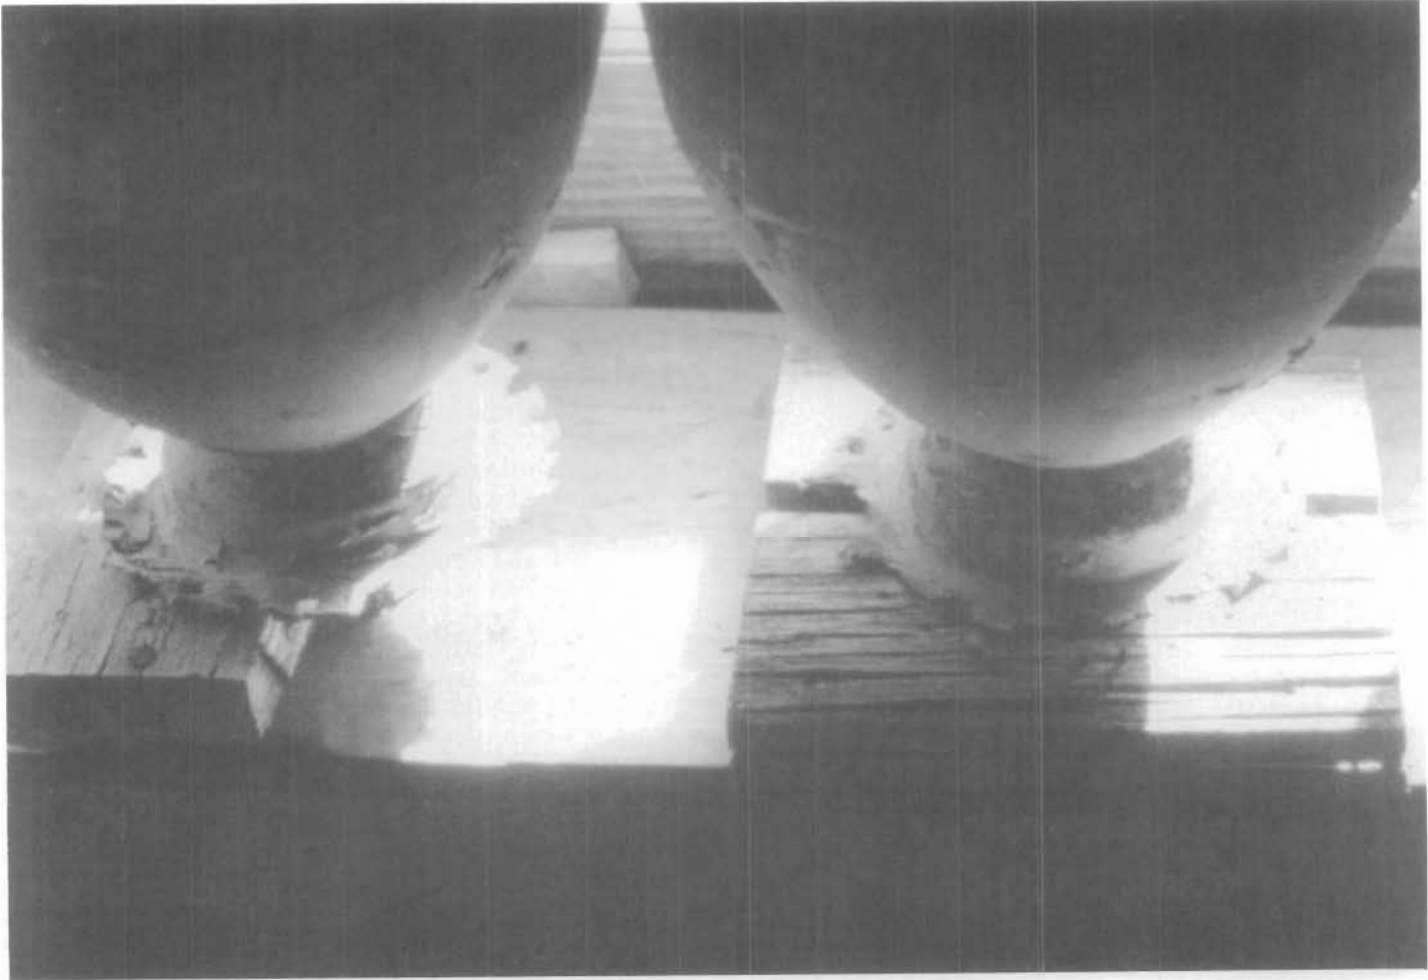
Figure 140. Galvanic Deterioration. Bases of zinc vases from the roof balustrade of Lorenzo, Casenovia, New York, have deteriorated because of the electrolytic action between the zinc and the machine-cut iron nails used to fasten the vases to the balustrade. The zinc was sacrificed in favor of the iron because the iron is more noble than the zinc. (Douglas Clinton)

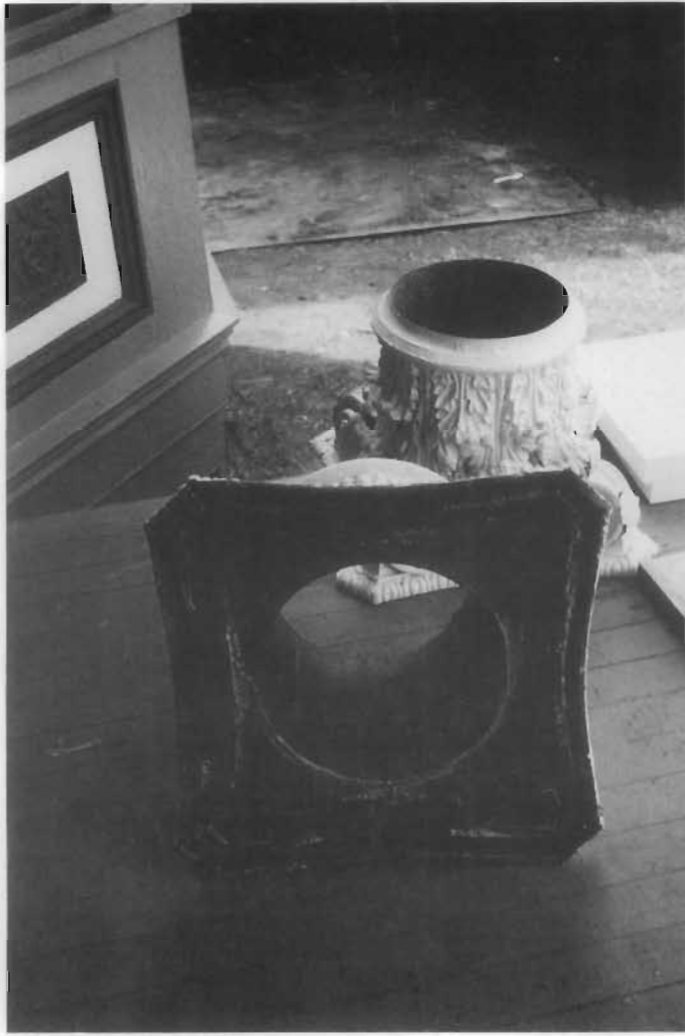
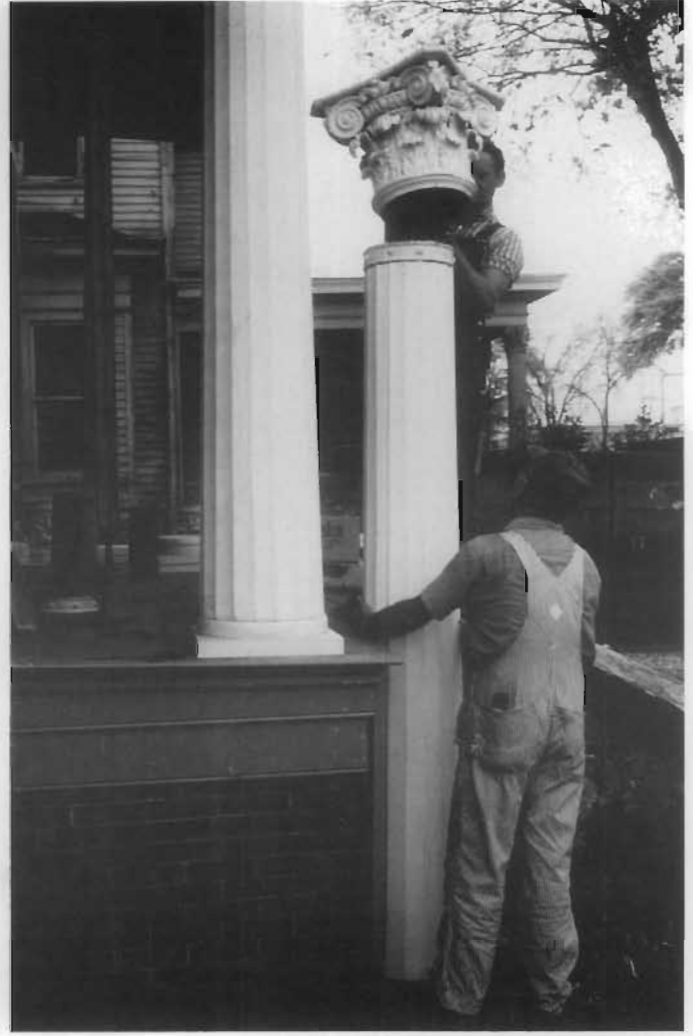
Figure 141. Repair of Galvanized Sheet Metal Capitals. (a) Fabricated for the 1890 Bullard-Hart House, Columbus, Georgia, these Corinthian capitals were originally assembled from many pieces of pressed sheet metal, which were soldered together to form the acanthus leaves. (b) The capitals were in salvageable condition and were taken to a sheet-metal shop where they were cleaned. Loose pieces were resoldered and caulked; missing pieces were replaced with new stamped pieces; and the completed capitals were repainted. The deteriorated wooden column shafts were repaired and repainted. The restored capitals were refitted onto the shafts and the entire columns were then returned to their original positions. (Thomas Taylor)

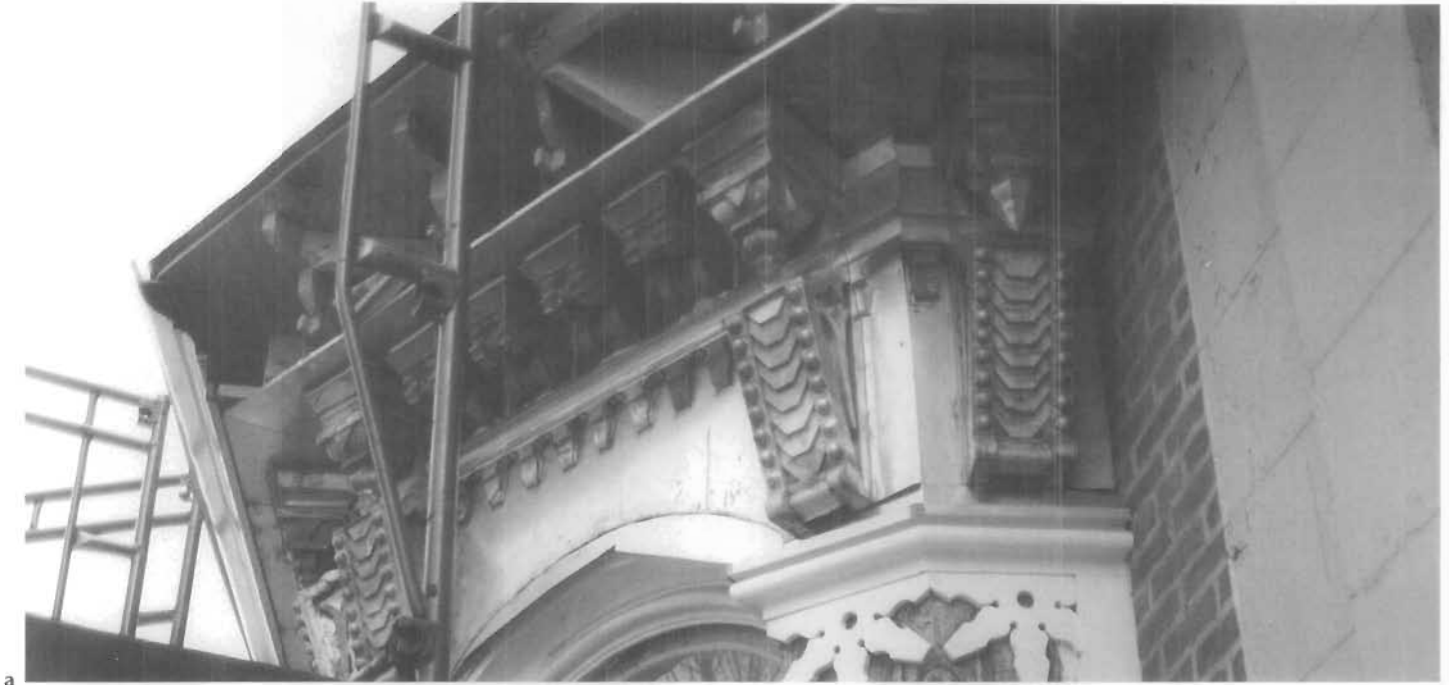
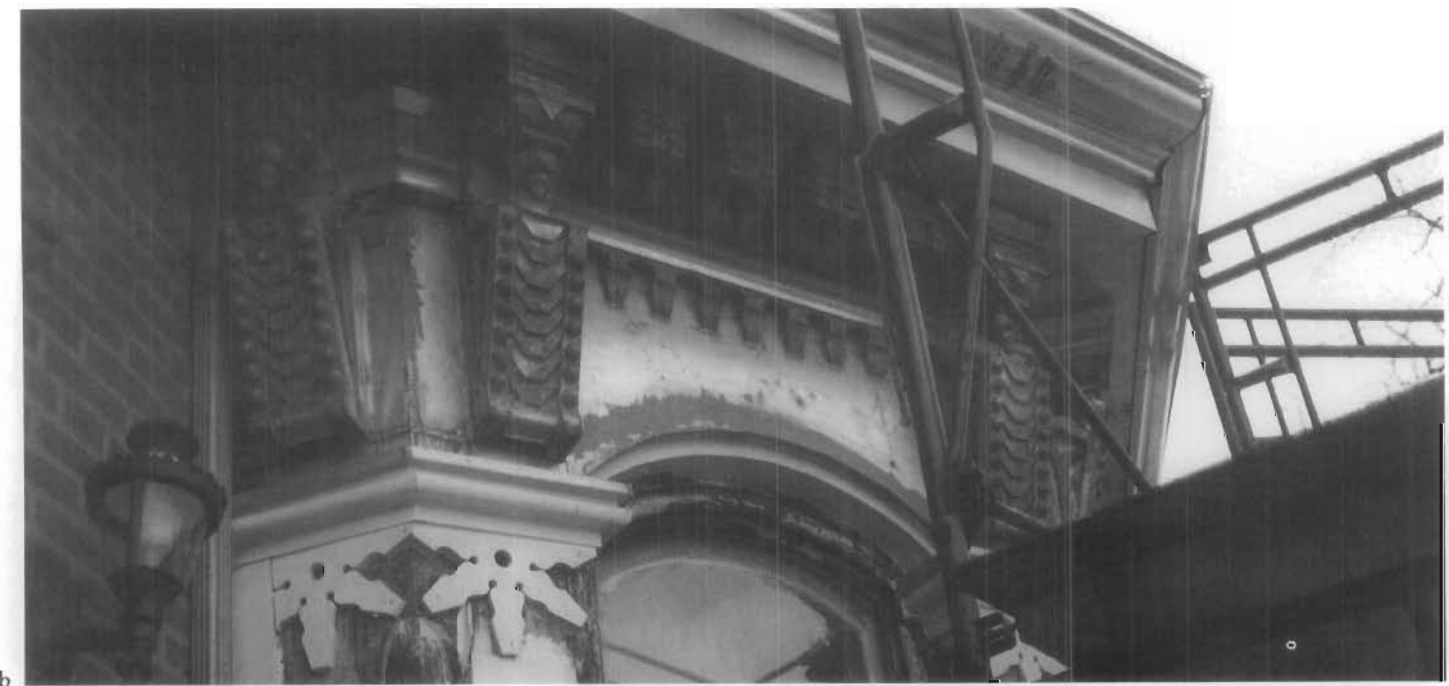
Figure 142. Restoration of Galvanized Sheet Iron and Cast-Zinc Cornice. *This is the upper third of a wooden bay window on a Second Empire brick rowhouse in the Logan Circle Historic District of Washington, D.C. (a) From the window down, the bay is wood and glass. The roof of the bay had leaked for years and the wooden roof rafter and projecting supports for the cornice had rotted. The bay window was carefully disassembled and rebuilt replacing all deteriorated lumber. The surviving pieces of galvanized sheet-iron and cast-zinc cornice were taken to a sheet-metal shop. The pieces that were repairable were cleaned; missing portions of brackets on the right were replicated of galvanized sheet iron using the originals as a model. (b) On the opposite side of the bay, all of the brackets and modillions are repaired originals but all of the flat and molded sections are new 26-gauge galvanized steel. The 65-year-old sheet-metal worker on this job said that the only two major advances in metal cornices in his lifetime are the use of pop rivets for fasteners (used also in leatherwork) and the use of autobody putty to patch holes, mold small missing details, and waterproof joints. The putty dries hard and can be sanded. (David W. Look)*

Figure 143. Preassembling Cornice. As illustrated in figure 142, most sheet-metal cornices were supported by wooden support members projecting out from the facade of the building either as an extension of the roof framing or as a cantilever from a parapet wall. In either case, these wooden support members are often found to be rotten and have to be replaced. For large cornices high above the street level, it may be economically unfeasible to use scaffolding for in situ repairs and reconstruction unless the scaffolding is also needed for other work. The entire galvanized sheet-iron cornice of the ZCMI Store in Salt Lake City, Utah, was preassembled on the ground with repaired original parts and some new pieces onto a new support system fabricated on small steel angles. Fifty-foot sections of the preassembled cornice were then hoisted to the top of the facade and bolted onto the building without the need for scaffolding. (Steven T. Baird)

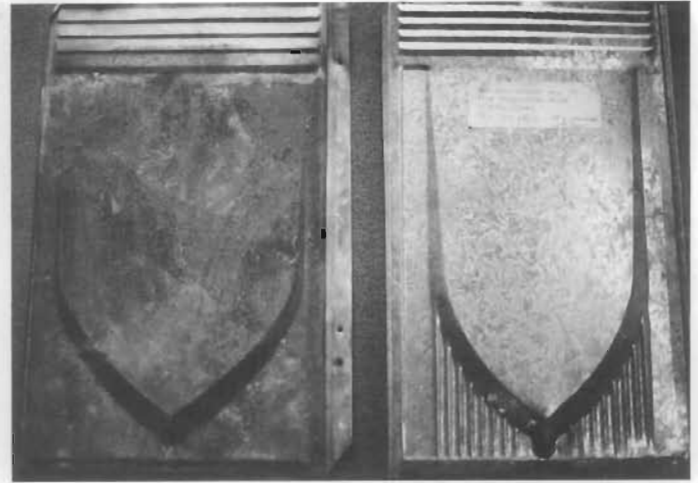
Figure 144. Reproduction of Galvanized Sheet-Iron Shingles. Wind and hail had damaged many of the sheet-iron shingles at St. Edward's University in Austin, Texas (see Figure 122). Mass production of replicas was economically feasible. A die was made with the pattern of the original shingle and new galvanized sheet-steel shingles were stamped. The new, unpainted shingle (right, notice spangled appearance) is a reproduction of the other shingle (left). These shingles are from the private collection of Charles E. Fisher, III. (John Myers)

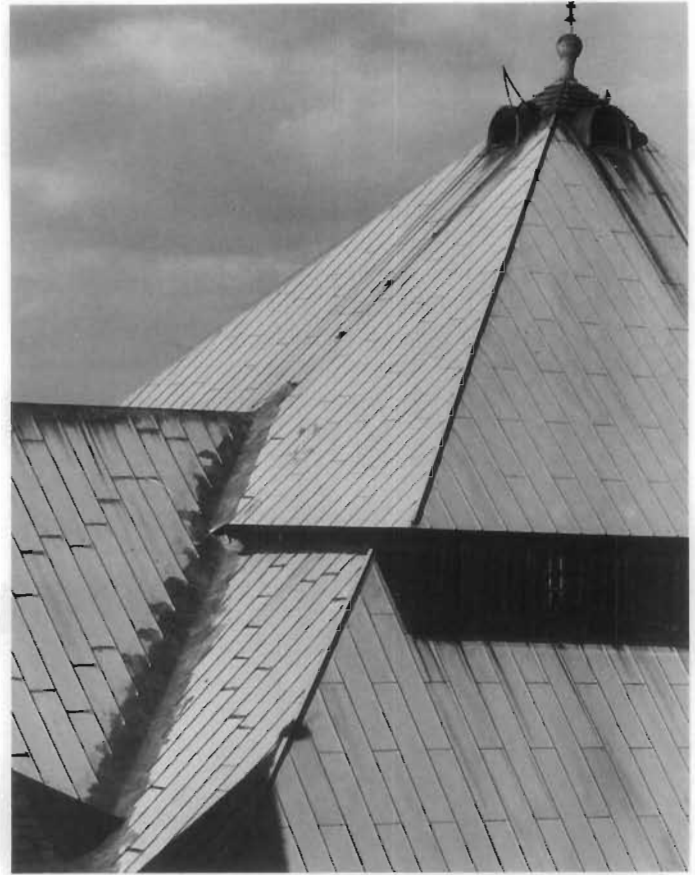
Figure 145. Galvanic Deterioration. An electrolytic reaction between the copper roof and the cast-iron roof finial and monitor window frames on the former Temple Beth Emeth, Albany, New York, built in 1887, is causing extensive deterioration of the iron. The corrosion products are staining and streaking the copper. Another area where deterioration is occurring is the valley, which has been coated with an aluminumized asphalt roofing compound. Electrolysis is occurring between the copper and aluminum (causing the less noble aluminum to corrode) and between the aluminum and cast iron of the monitor window frames (causing the less noble aluminum to corrode). (John G. Waite)

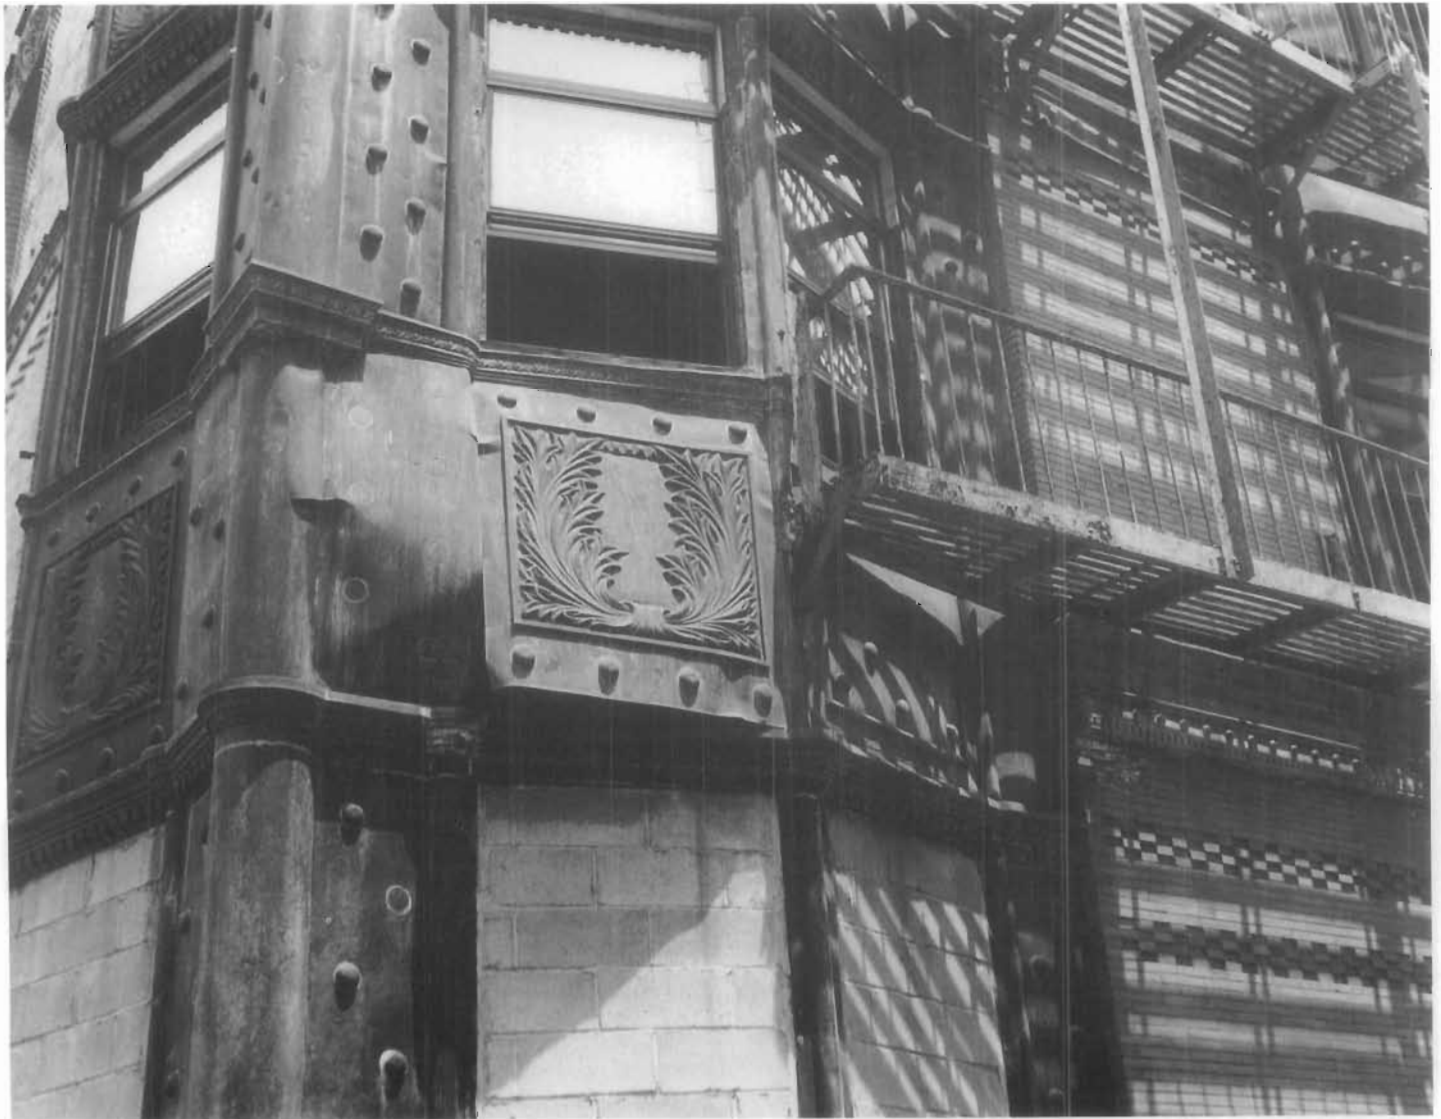
Figure 146. Loose and Damaged Copper Cladding and Deteriorated Steel Fire Escapes. *The corner bay of the Hotel Margaret (1889) in Brooklyn Heights, New York, was clad in ornamental panels of pressed sheet copper. Anchors have deteriorated and the wind has lifted the corners. Galvanic action between the noble copper and the baser steel (in the fire escape) has caused the steel to deteriorate.* (David W. Look)

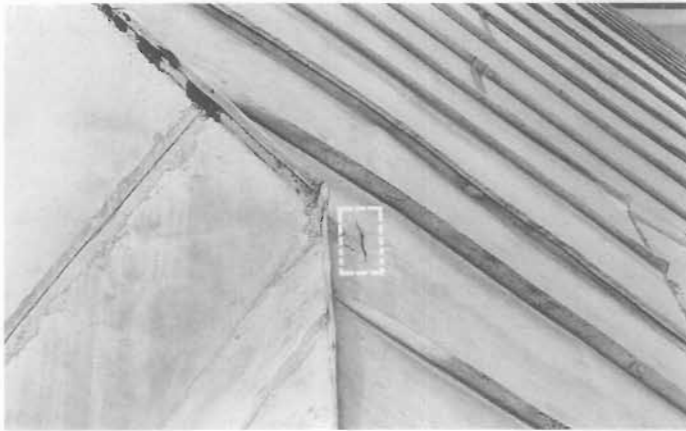
Figure 147. Fatigue Failure. Fatigue failure occurred on the copper roof installed during the 1920s on the Senate House in Kingston, New York. (a) Failure was caused by cyclical expansion and contraction of the copper without adequate provisions for it. Additionally, the copper sheet was too thin and not rigid enough to resist buckling and sagging between the too-widely-spaced roof sheathing. The use of bituminous roofing paper between the copper and sheathing also contributed to the failure; when the paper was heated by the sun, it adhered to the copper, further restricting its movement (see figure 117). (b) The drawing shows the actual roof installation and the correct procedure, which allows for expansion and contraction. (John G. Waite)

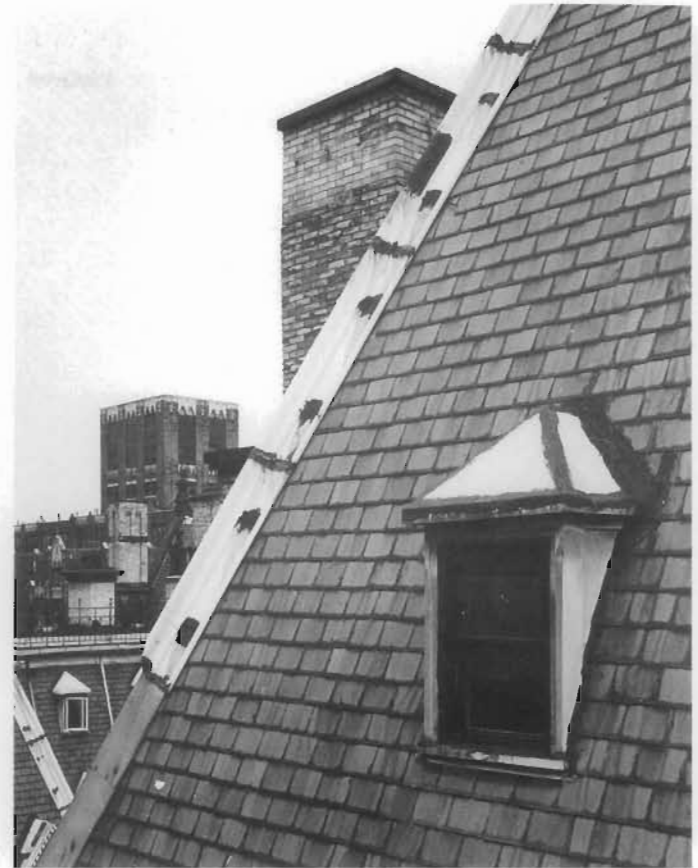
Figure 148. Inappropriate Patching Compounds. Corrosion of a copper roof ridge on the Dakota Apartments (1884), New York City, was caused by the use of an asphalt roofing compound for temporary patches over nailheads and joints between ridge sections. (John G. Waite)

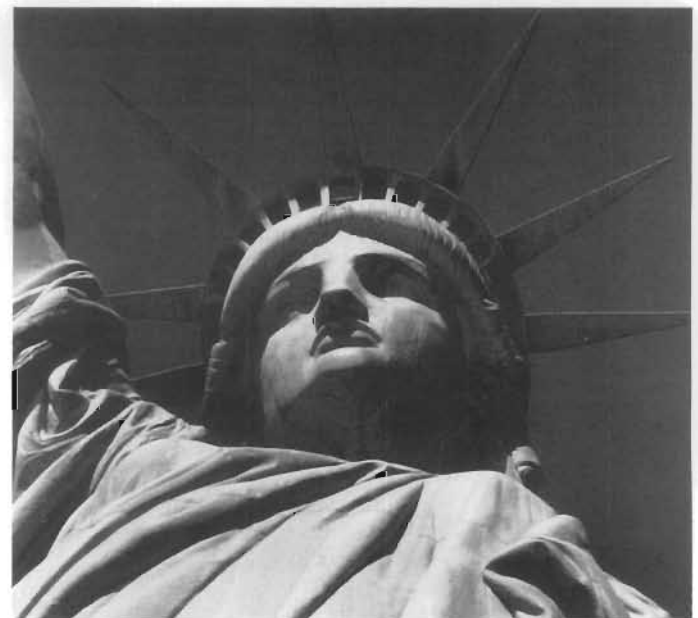
Figure 149. Resistance to Corrosion. Little damage had occurred to the copper at The Statue of Liberty. Galvanic corrosion, however, occurred where saline rainwater provided the electrolyte between the copper and the iron armature, resulting in considerable loss in the cross-section of the armature. (Robert Baboian)

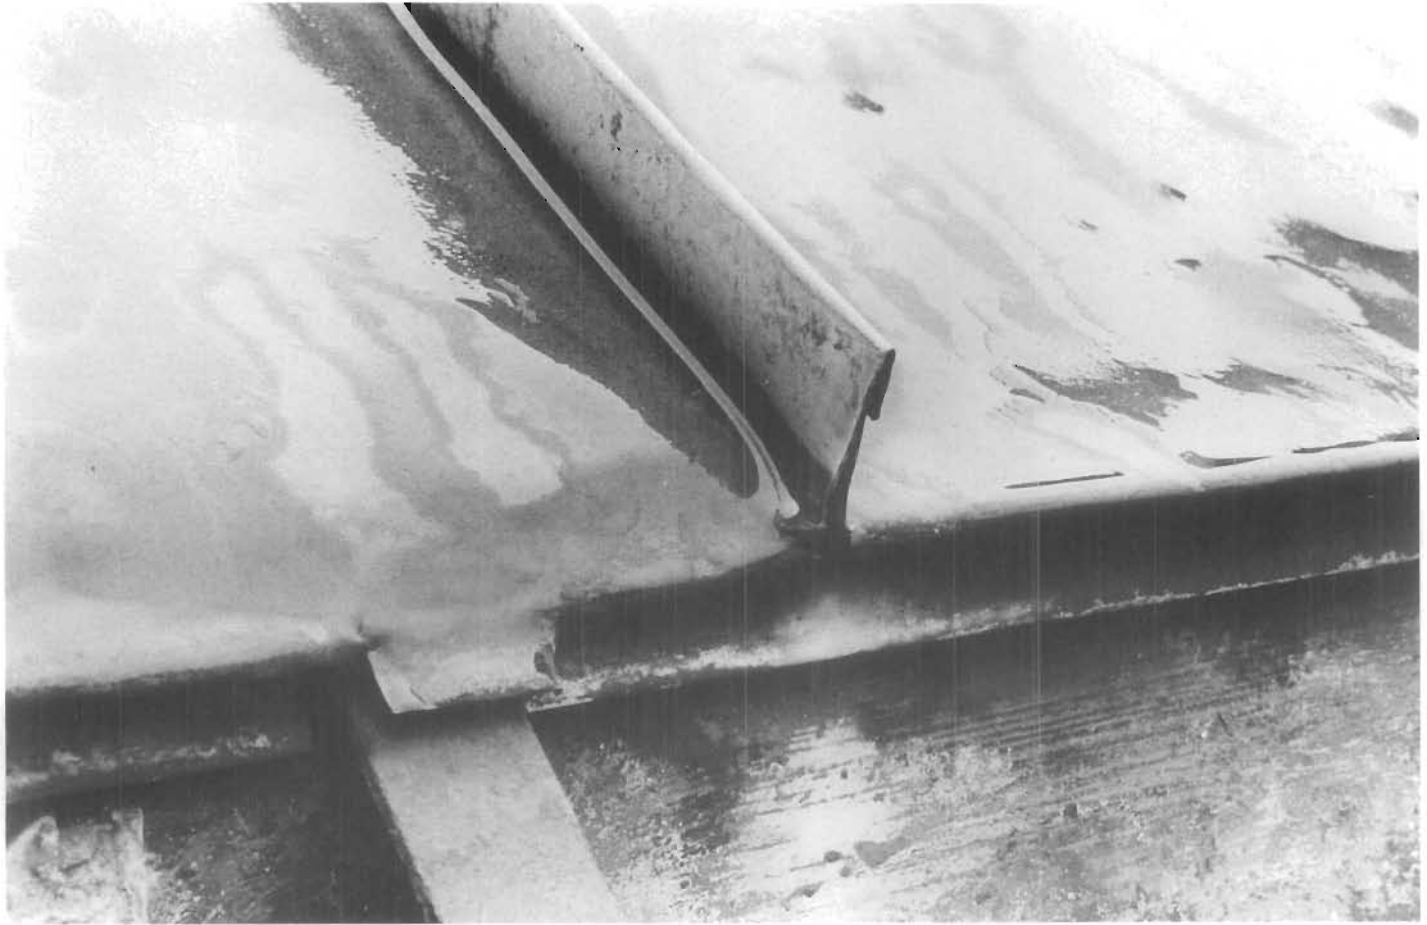
Figure 150. Erosion of Copper. *This eaves detail of the 1920s copper roof on the Senate House State Historic Site in Kingston, New York, illustrates erosion of the copper at the edge of the roof caused by continued exposure to rain and snow, which scoured the roof as it flowed to the gutter. Fatigue failure has also occurred at the base of the standing seam, resulting in a tearing of the copper. This failure was caused by the lack of provision for expansion and contraction, as well as the use of bituminous roofing felts, which restricted the movement of the copper. (John G. Waite)*

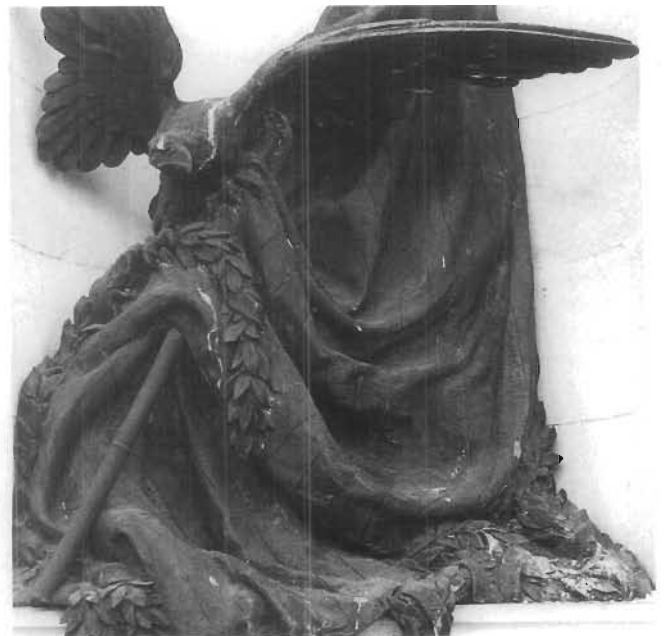
Figure 151. Bird Droppings. *The 1914 bronze memorial to the writing of the "Star Spangled Banner," which is located in a niche on the porch of the Baltimore City Hall, is a favorite roost for birds. Bird droppings contain acids which are harmful to bronze and should be removed periodically. (David W. Look)*

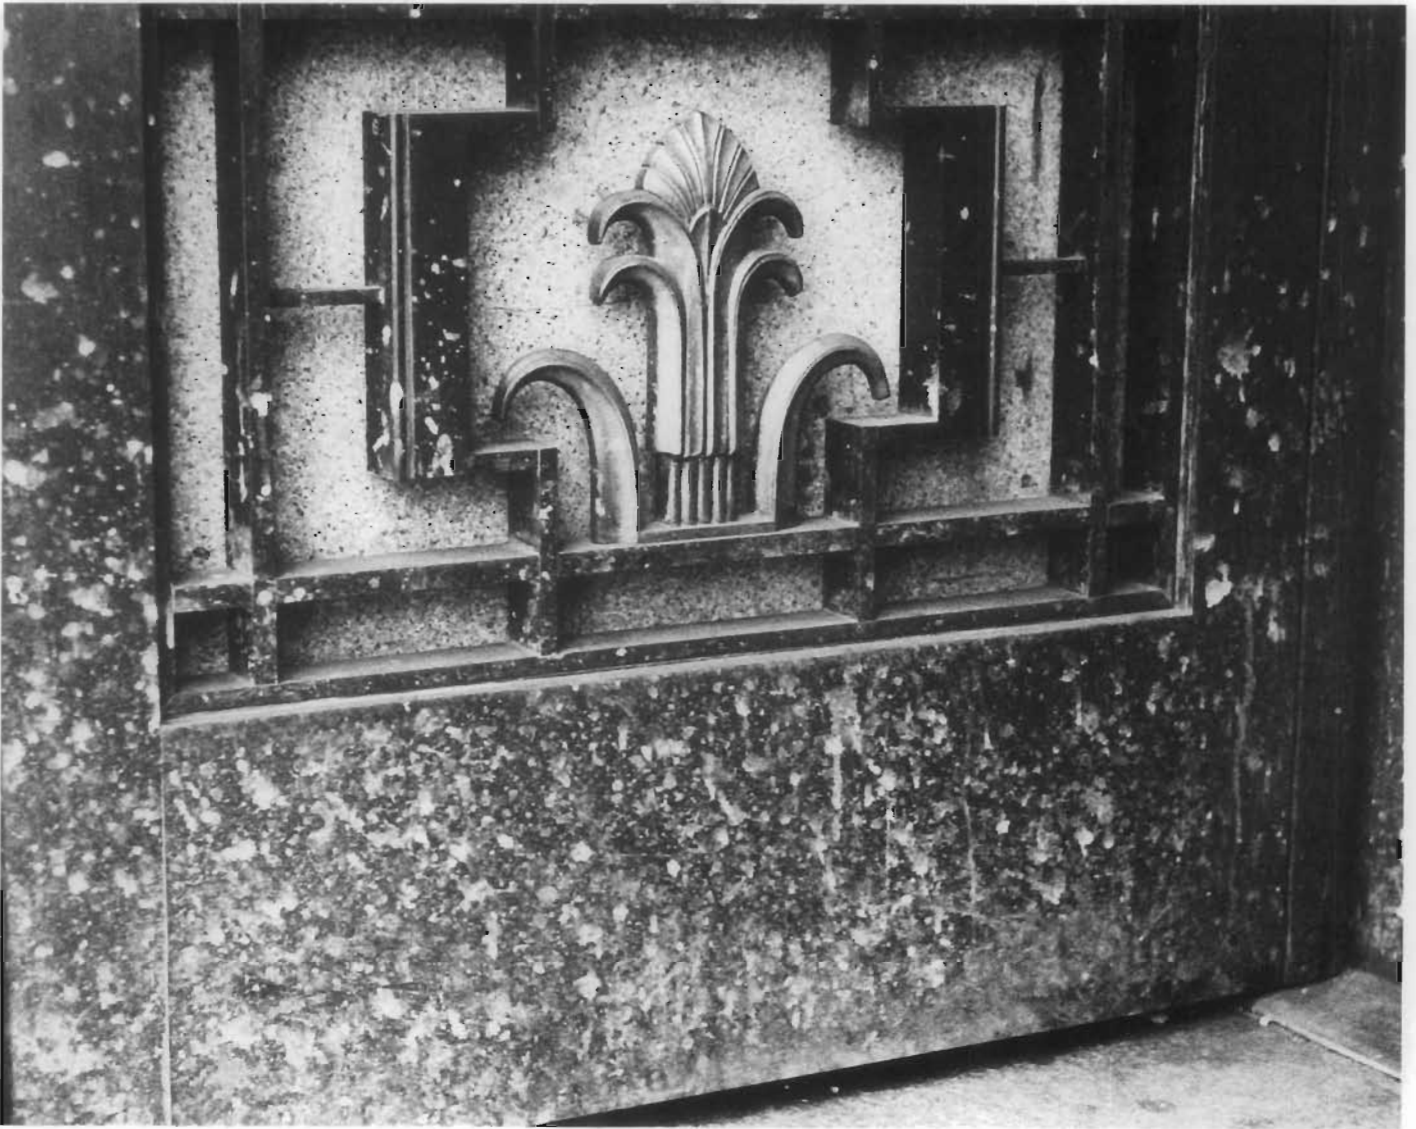
Figure 152. Snow Salt Damage. *On the Circuit Court of Appeals Building in Washington, D.C., the lower extremities of the exterior-bronze gates are discolored and unsightly from repeated splashing of snow-removal salt. As long as the salt remains on the gates, the bronze will continue to deteriorate and its surface may even become pitted. (David W. Look)*

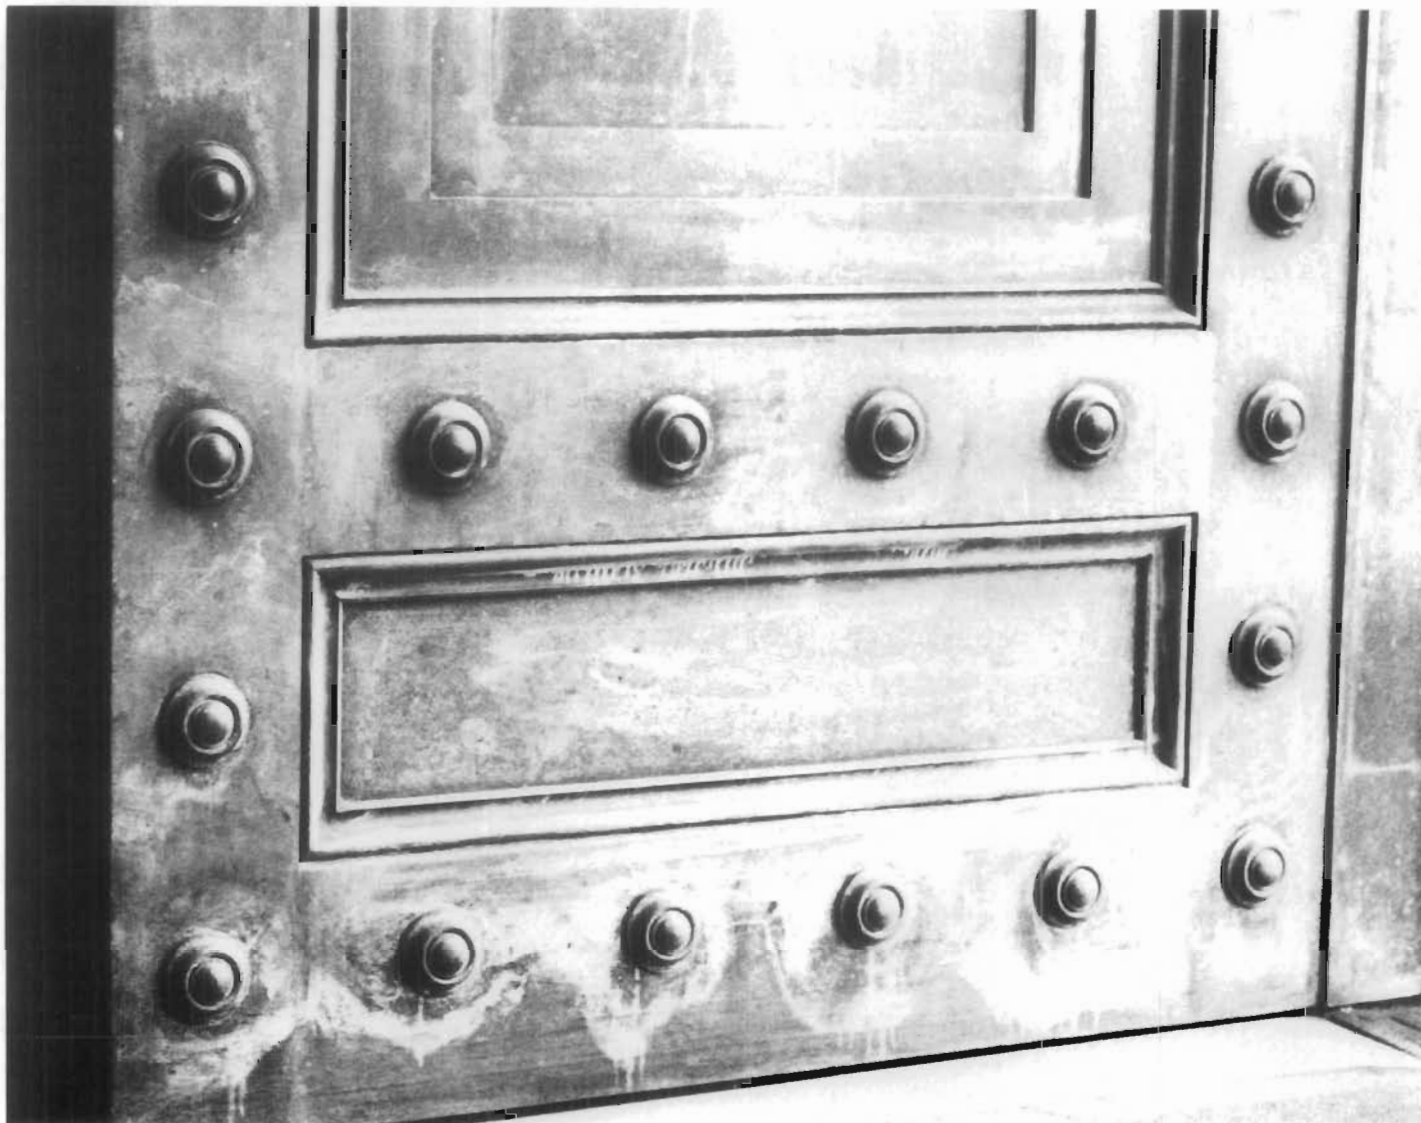
Figure 153. Improper Cleaning of Bronze. *The bronze doors on the Pennsylvania Avenue side of the National Archives in Washington, D.C., were cleaned improperly. They now vary in color from a golden bronze to green to copper orange and brassy yellow. Some of the original artificial patina applied at the foundry has been removed, leaving a blotchy appearance. Part of the corrosion from the deicing salt remains, and the doors have a streaked, unattractive appearance. At this point, the only feasible treatment would be to clean the doors thoroughly (down to the bright metal), by mild chemicals or soft abrasive cleaning. A new artificial patina could be applied to return the doors to their original appearance. To protect against future damage, the doors should be given a barrier coating of wax which will need to be renewed periodically. The maintenance staff should be notified not to use salt near the doors and not to clean or polish the doors other than washing them down once a year with a nonionic detergent. When washed, the doors should be thoroughly rinsed with distilled water and wiped dry with a clean cloth to prevent water spots and streaks. (David W. Look)*

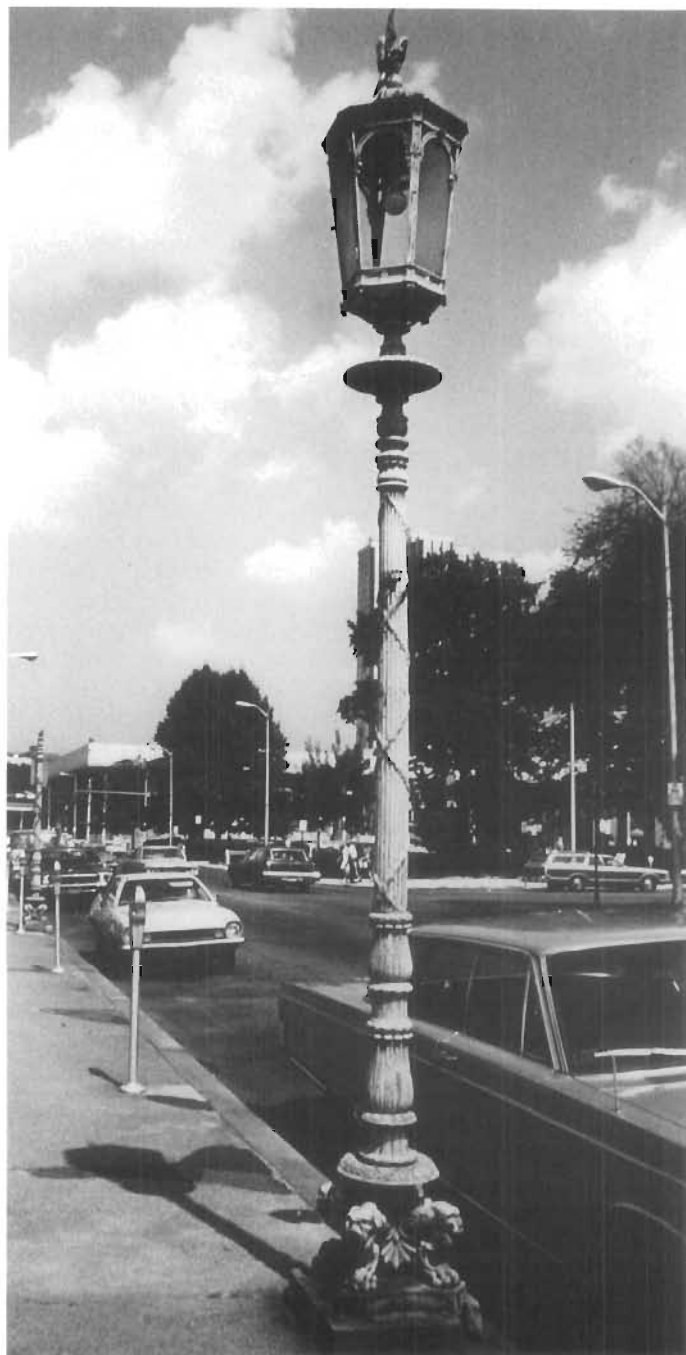
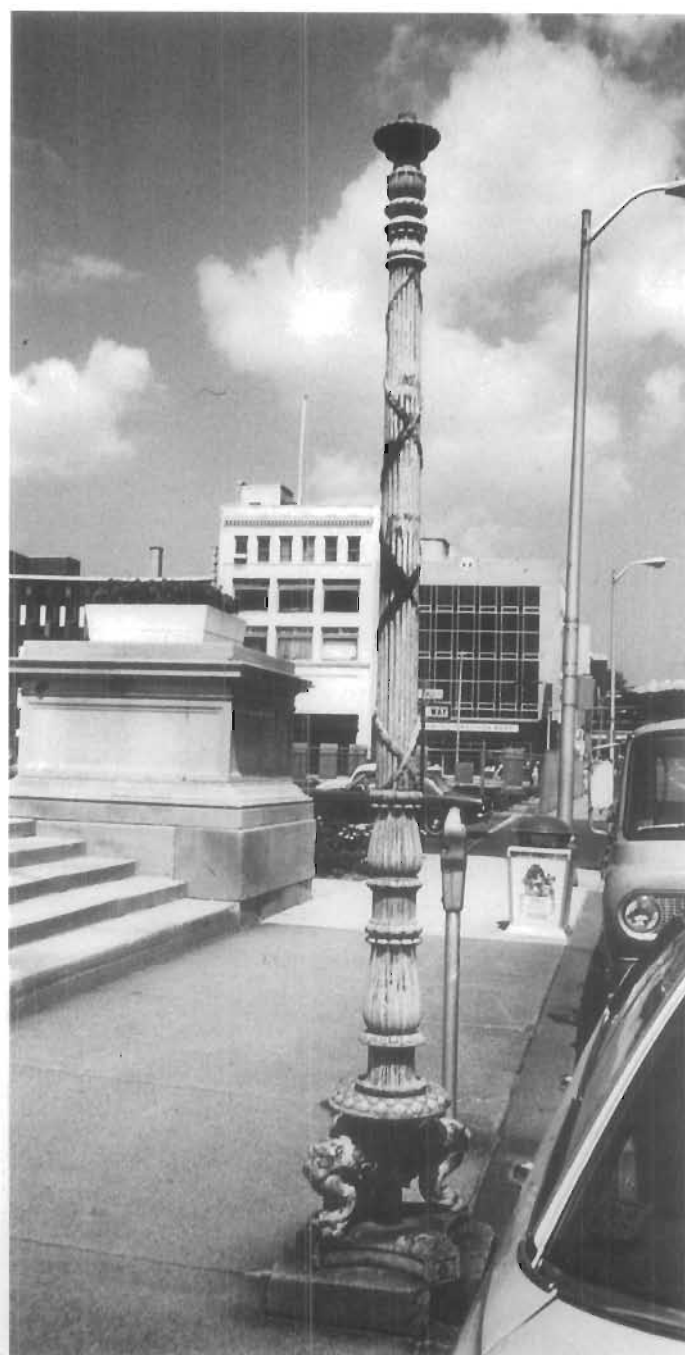
Figure 154. Damage to Bronze. *In the Court Square Historic District in Springfield, Massachusetts, five of six bronze street lamps were vandalized or accidentally damaged by automobiles backing into parking spaces. (a) The one lamp that survived intact was used to make new molds. (b) The missing leg and lamp were recast (not shown) and/or repaired with funds from a matching grant from the National Park Service in 1976. The recast pieces were chemically treated to obtain a green patina that matched the weathered appearance of the original sections of the lamps. A plan was drafted to relocate the lamps 12 inches from their previous position at the curb to prevent any further damage from parking automobiles. (Thomas Taylor)*

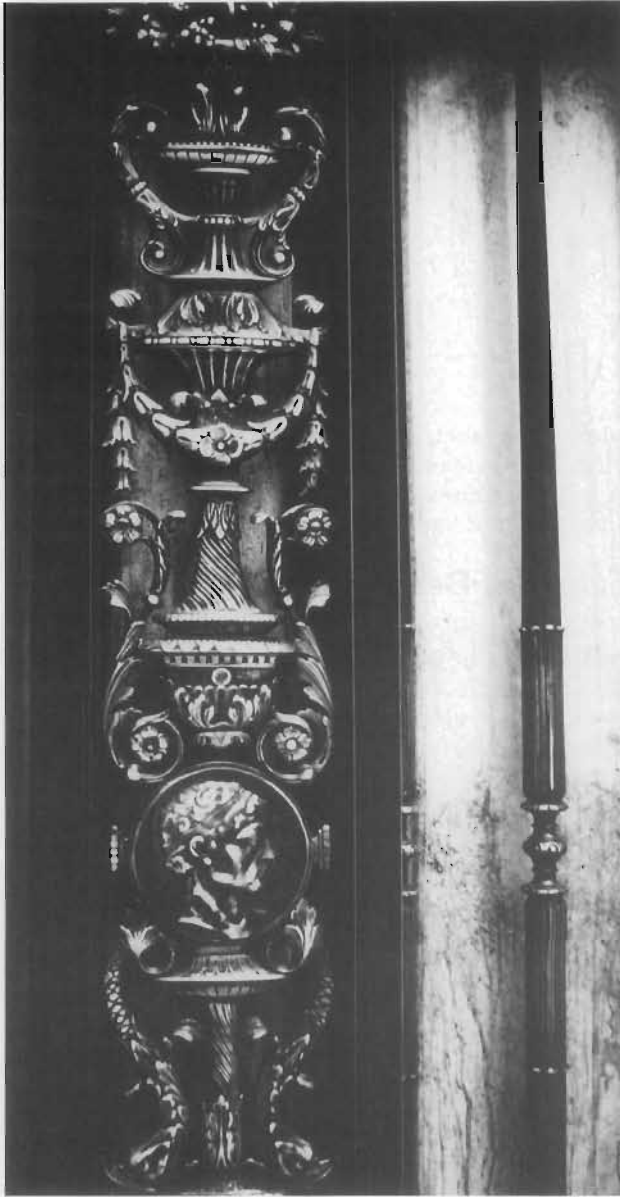
Figure 155. Cleaning Bronze. *Recently, the exterior bronzework was cleaned on the Morgan Guaranty Trust Company on the corner of Wall and Board streets in Manhattan. The original finish of the bronze was a statuary brown artificial patina (a chemical process developed in the 19th century) with the bas-relief sculpture highlighted in a lighter pinkish-gold color, probably just the natural color of bronze without artificial or natural patina. The bronzework was cleaned and sealed with a clear coating. Without a coating, a natural patina would form, causing slow color change from pinkish gold to brown to black and eventually to green over an 8-10 year period. The colors are usually uneven and streaked because of the local pattern of wind and rain. The formation of a natural patina would eventually destroy the contrast between the statuary brown and pinkish gold, which was the original intention of the architects, Trowbridge and Livingston, when the bank was built in 1913. (David W. Look)*
