32 PRESERVATION BRIEFS

Making Historic Properties Accessible

Thomas C. Jester and Sharon C. Park, AIA

U.S. Department of the Interior
National Park Service
Cultural Resources
Heritage Preservation Services

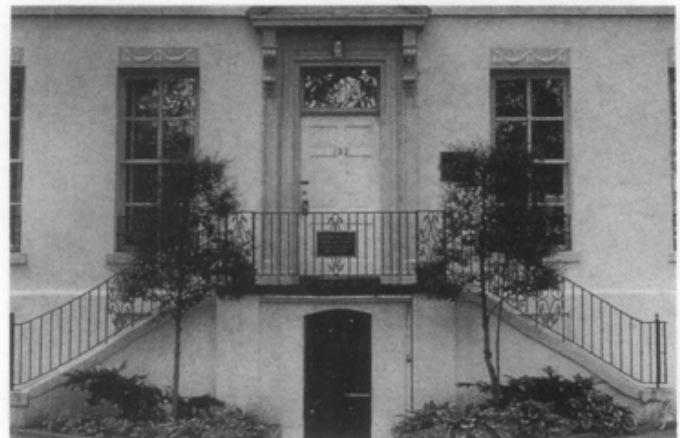
Figure 1. It is important to identify the materials, features, and spaces that should be preserved when planning accessibility modifications. These may include stairs, railings, doors, and door surrounds. Photo: National Park Service files.

decorative ornamental hardware, and narrow pathways and corridors, pose barriers to persons with disabilities, particularly to wheelchair users (See Figure 1).

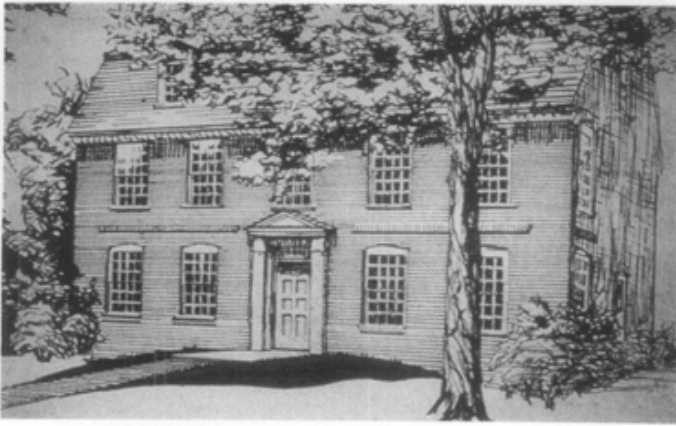
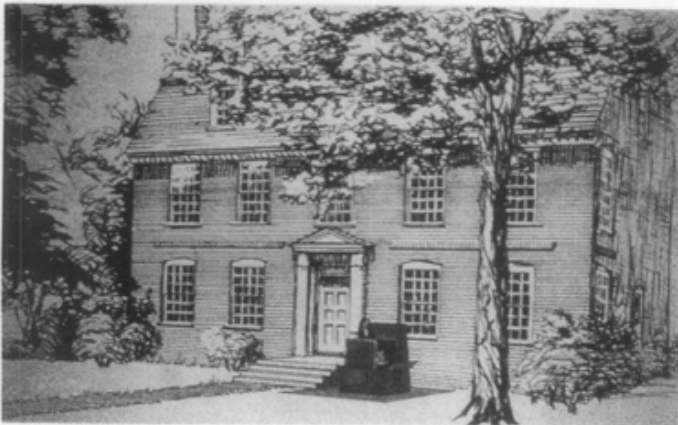
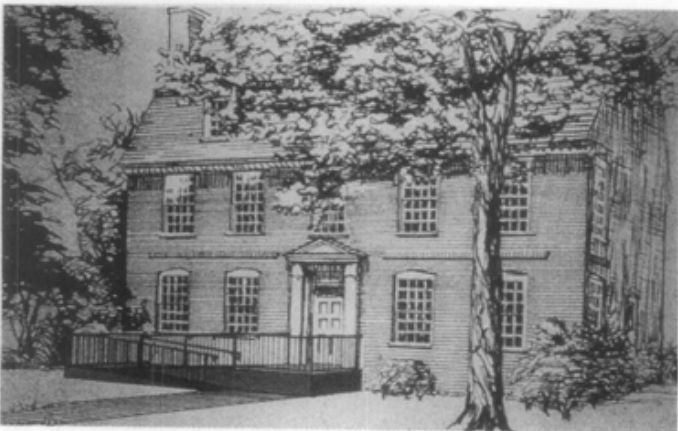
Figure 3. Before implementing accessibility modifications, owners should consider the potential effect on their historic property. At the Derby House in Salem, Massachusetts, several solutions to make the entrance accessible were considered, including regrading (a); a lift (b); and a ramp (c). The solution, an entrance on a secondary elevation, preserves the building's architectural significance and is convenient to designated parking. Drawings: National Park Service Files..

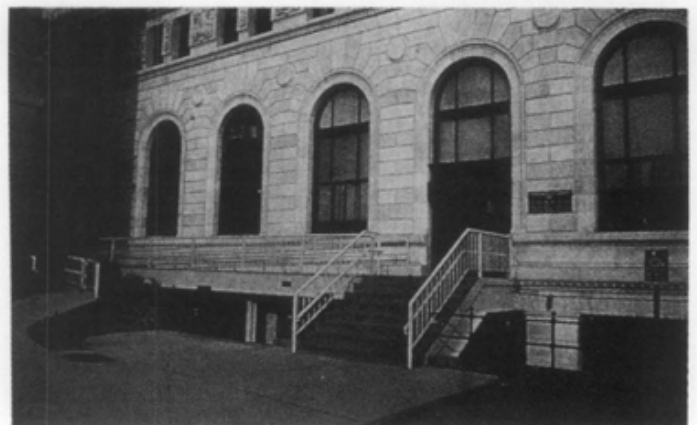
Figure 4. Parking designated for people with disabilities is provided near an accessible entrance to the Springfield Library in Springfield, Massachusetts. Photo: William Smith.

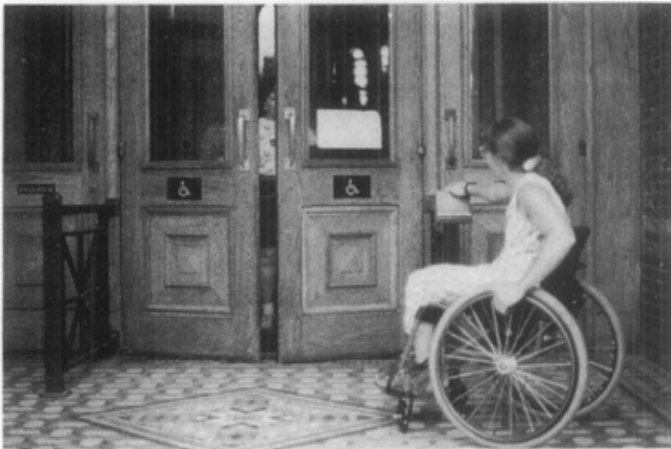
Figure 5. A universal access symbol clearly marks the Arts and Industries Building in Washington, D.C., and a push plate (right) engages the automatic door-opener. Photo: Thomas Jester.

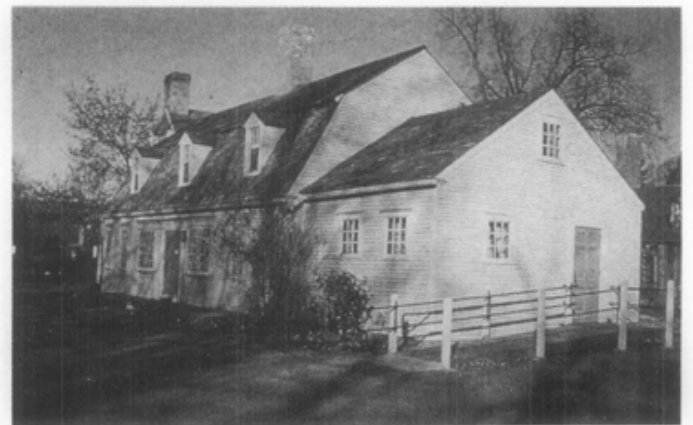
Figure 7. This ramp is convenient for visitors with disabilities and preserves the building's historic character. The design is also compatible in scale with the building. Photo: William Smith.

Incorporating Ramps. Permanent ramps are perhaps the most common means to make an entrance accessible. As a new feature, ramps should be carefully designed and appropriately located to preserve a property's historic character (See Figure 7). Ramps should be located at public

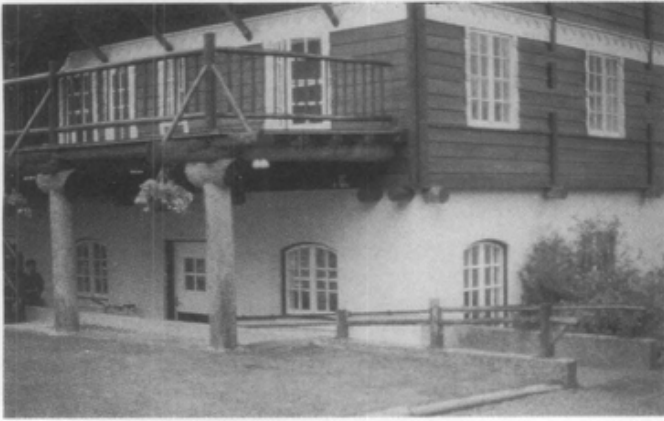
Figure 8. A new below-grade ramp provides access to Lake MacDonald Lodge in Glacier National Park. Photo: Thomas Jester

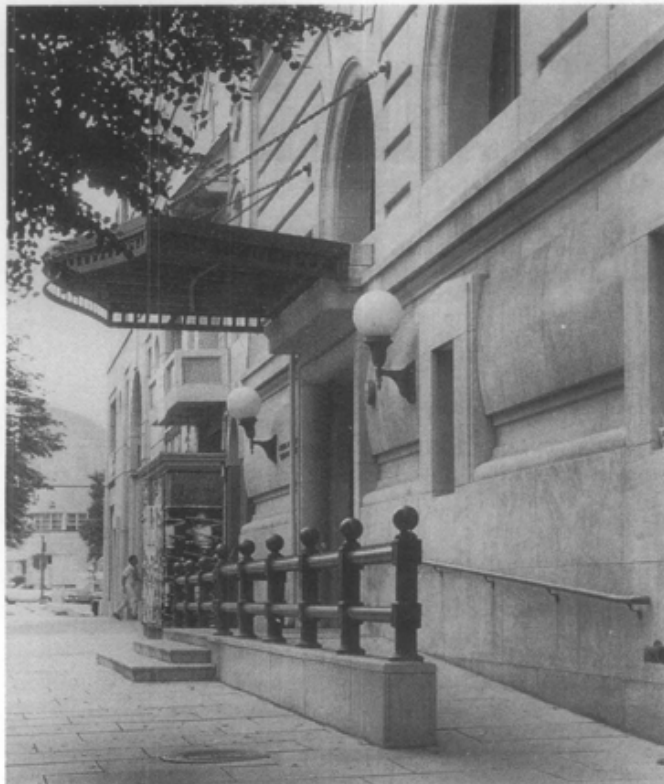
Figure 9. This ramp was created by infilling the window-well and slightly modifying the historic railing. The ramp preserves this building's historic character. Photo: Thomas Jester.

historic features, such as cheek-walls or railings, to minimize the visual effect (See Figure 9).

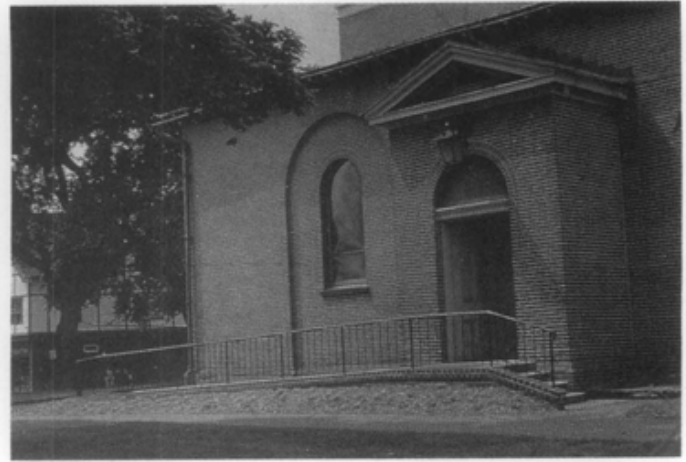
Figure 10. This brick ramp provides access to St. Anne's Episcopal Church in Annapolis, Maryland. Its design is compatible with the historic building. Photo: Charity V. Davidson.

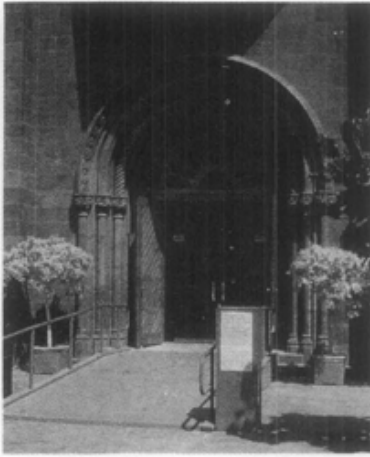
Figure 12. The Smithsonian Institution installed a temporary ramp on its visitor's center to allow adequate time to design an appropriate permanent ramp. Photo: Thomas Jester.

Temporary or portable ramps are usually constructed of light-weight materials and, thus, are rarely safe or visually compatible with historic properties. Moreover, portable ramps are often stored until needed and, therefore, do not meet accessibility requirements for independent access. Temporary and portable ramps, however, may be an acceptable interim solution to improve accessibility until a permanent solution can be implemented (See Figure 12).

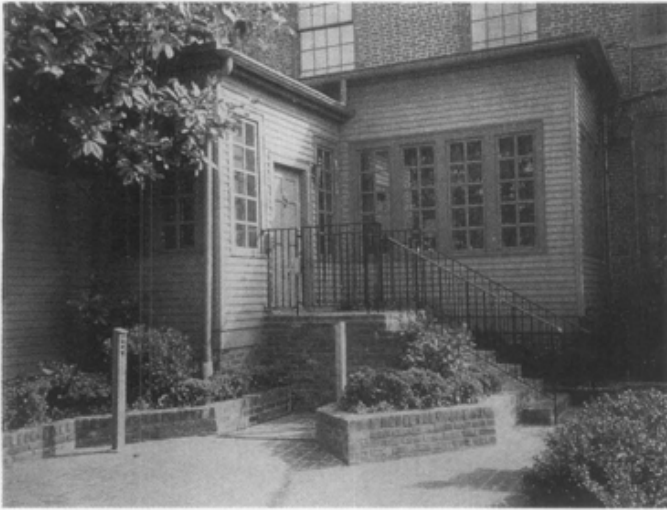
Figure 14. At the Lieutenant Governor's Mansion in Frankfort, Kentucky, a retracting lift (b) was installed to minimize the visual effect on this historic building when not in use (a). Photos: Aging Technology Incorporated.

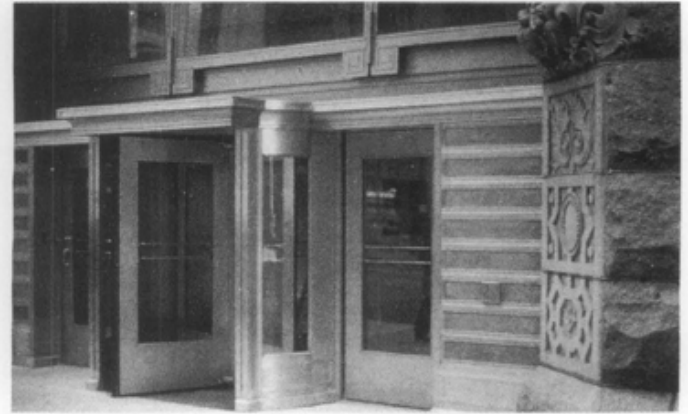
Figure 16. During the rehabilitation of the Rookery in Chicago, the original entrance was modified to create an accessible entrance. Two revolving doors were replaced with a new one flanked by new doors, one of which is operated with a push-plate door opener. Photo: Thomas Jester.

(operated by push buttons, mats, or electronic eyes) and power-assisted door openers can eliminate or reduce door pressures that are accessibility barriers, and make single or double-leaf doors fully operational (See Figure 16).

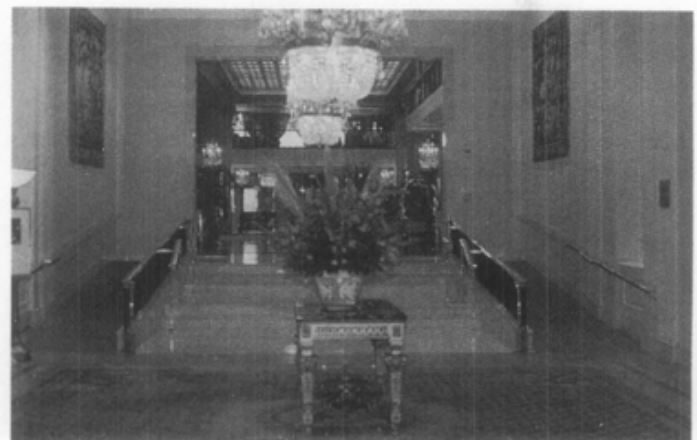
Figure 18. Symmetrical ramps at the Mayflower Hotel in Washington, D.C., provide access to the hotel's lower level. The design for the ramps respects the historic character of this landmark building. Photo: Thomas Jester.

Installing Ramps and Wheelchair Lifts. If space permits, ramps and wheelchair lifts can also be used to increase accessibility inside buildings (See Figures 18 & 19). However, some States and localities restrict interior uses of wheelchair lifts for life-safety reasons. Care should be taken to install these new features where they can be readily accessed. Ramps and wheelchair lifts are described in detail on pages 4-6.

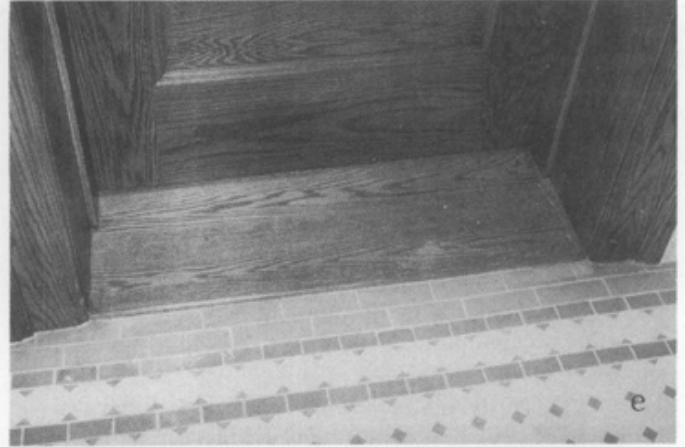
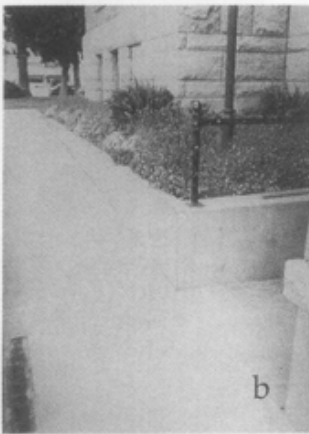
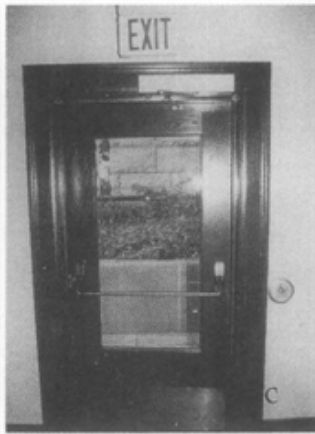
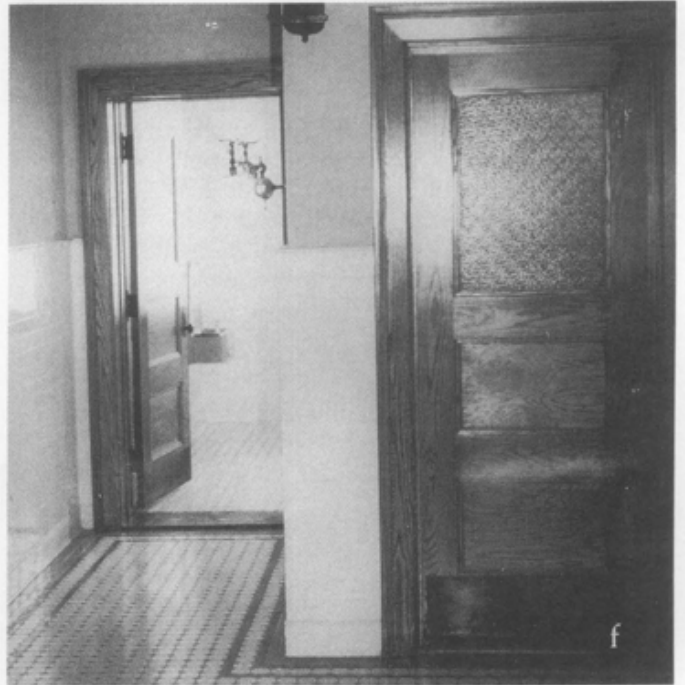
MAKING A HISTORIC BUILDING ACCESSIBLE

The Orange County Courthouse (a), located in Santa Ana, California, was rehabilitated in the late 1980s as a county museum. As part of the rehabilitation, the architect sensitively integrated numerous modifications to increase accessibility. To preserve the building's primary elevation, a new public entrance was created on the rear elevation where parking spaces are located. A ramp (b) leads to the accessible entrance that can be opened with a push-plate automatic door-opener (c). Modifications to interior features also increased accessibility. To create an accessible path of travel, offset hinges (d) were installed on doors that were narrower than 32 inches (81.3 cm). Other doors were rethreaded to reduce the door pressure. Beveling the 1" high thresholds (e) reduced their height to approximately 1/4 inch (.64 cm). The project architect also converted a storeroom into an accessible restroom (f). The original stairway, which has open grillwork, was made more accessible by applying slip-resistant pressure tape to the marble steps (g). And the original elevator was upgraded with raised markings, alarm lights, and voice floor indicators. Photos: Milford Wayne Donaldson, FAIA.

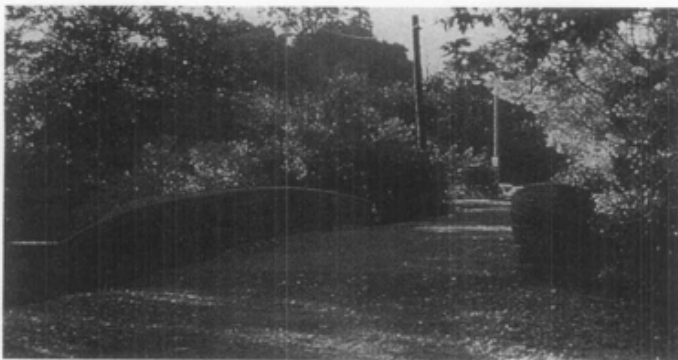
(a.) To improve accessibility in Boston's Emerald Necklace Parks, standard asphalt paving was replaced in selected areas with an imbedded aggregate surface that is more in keeping with the landscape's historic appearance. Photo: Charles Birnbaum.

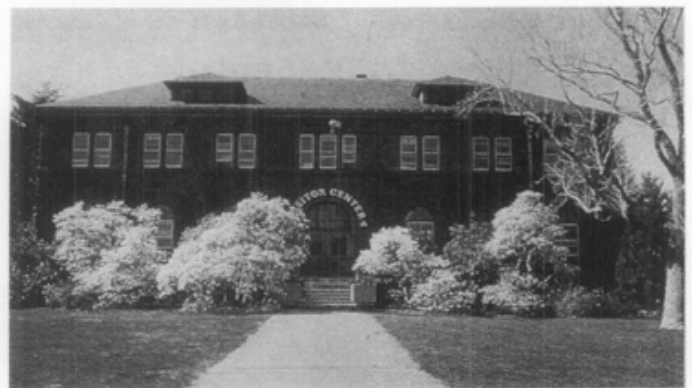
(c.) Hunnewell Visitor's Center before rehabilitation, revealing the altered landscapes. Photo: Jennifer Jones, Carol R. Johnson and associates.

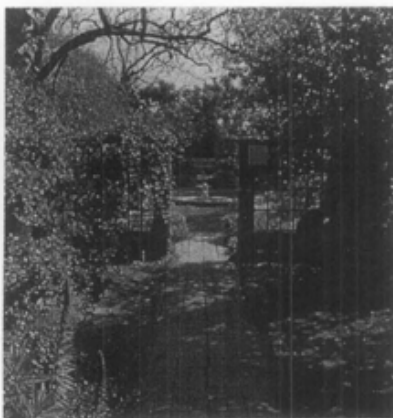
(b.) The Friendly Garden at Ranchos Los Alamitos, a historic estate with designed gardens in southern California, was made accessible with limited widening of its existing approach path. Photo: Ranchos Los Alamitos Foundation.

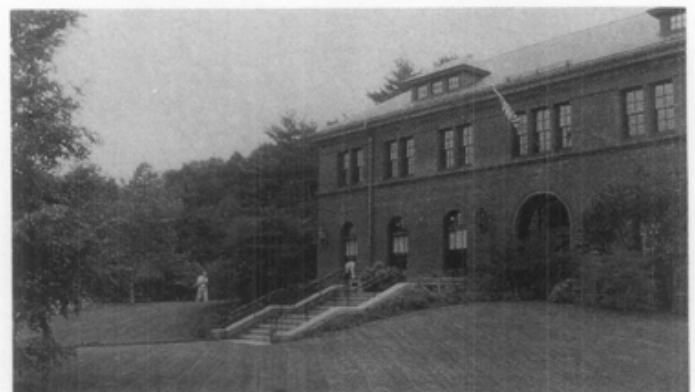
(d.) Hunnewell Visitors Center's entrance following rehabilitation, integrating an accessible path (left), platform, and new steps. Photo: Charles Birnbaum.

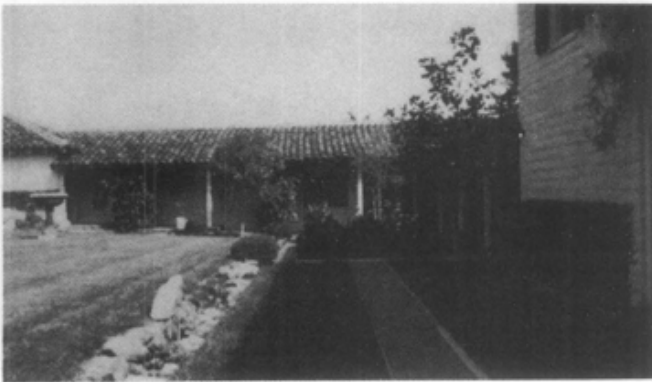
(e.) This view shows the new reinforced turf path at the Eugene O'Neill National Historic Site that preserved the narrow Historic Path. Photo: Patricia M. O'Donnell.

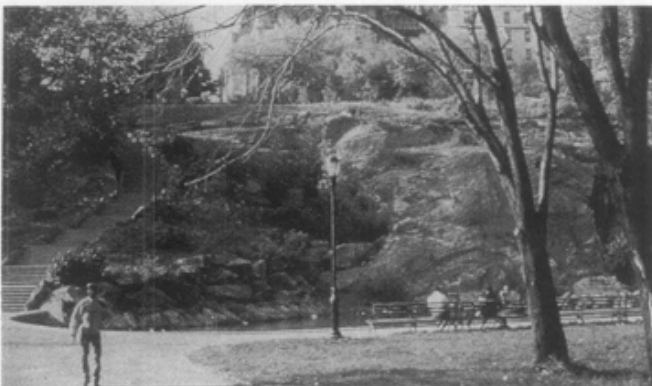
(f.) Steep terrain at Morningside Park in New York City cannot be made accessible without threatening or destroying this landscape's integrity. Photo: Quennell Rothschild Associates.

3. Morningside Park in New York City, New York, designed by Frederick Olmstead, Sr., and Calvert Vaux in 1879, is sited on generally steep, rocky terrain (f). Respecting these dramatic grade changes, which are only accessible by extensive flights of stone stairs, physical access cannot be provided without destroying the park's integrity. In order to provide some accessibility, scenic overlooks were created that provide broad visual access to the park.

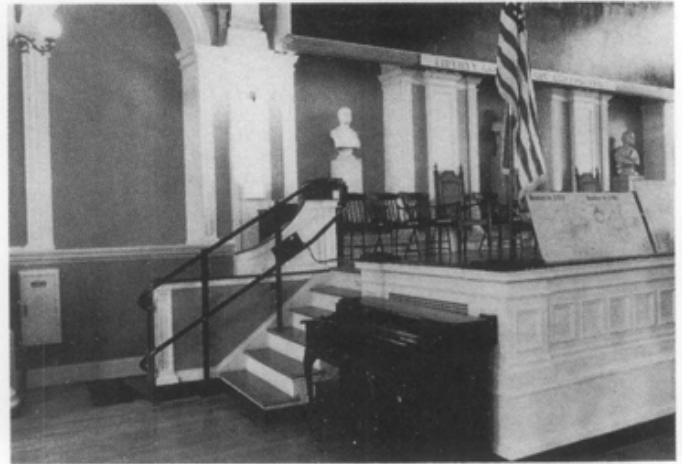
Figure 19. Inclined lifts can sometimes overcome interior changes of elevation where space is limited. This lift in Boston's Faneuil Hall created access to the floor and stage level of the State Room. Photo: Paul Holtz.

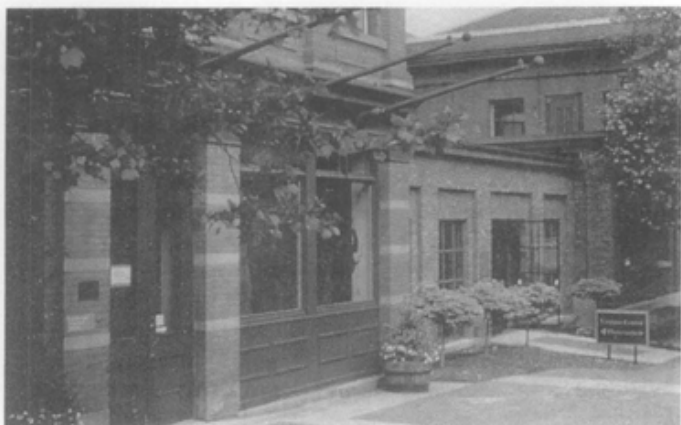
Figure 23. New additions to historic buildings can be designed to increase accessibility. A new addition links two adjacent buildings used for the Albany, New York, Visitor's Center, and incorporates an accessible entrance, restrooms, and signage. Photo: Clare Adams.
