49 PRESERVATION BRIEFS

Historic Decorative Metal Ceilings and Walls: Use, Repair, and Replacement

Kaaren R. Staveteig

Technical Preservation Services

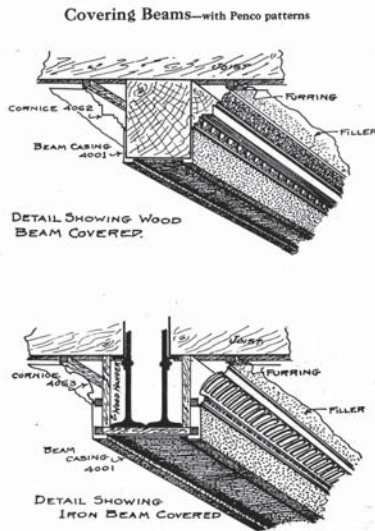
Early catalogs provide how-to instructions for “fire-proofing” beams of both metal and wood, incorporating them into decorative ceiling patterns.

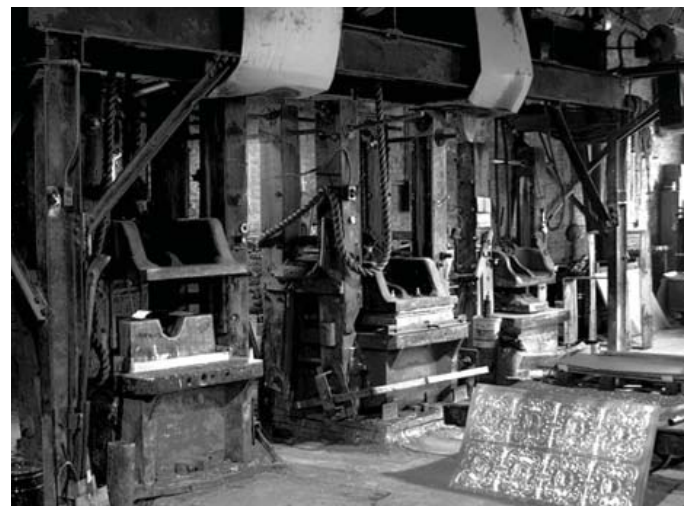
Rope drop hammers at the turn-of-the-century factory in Nevada, Missouri, that W. F. Norman Corporation still uses to stamp individual panels, resulting in high quality pressed metal sheets. (Photo: W. F. Norman Corporation)

The production process began with flat sheets of steel that large manufacturers made themselves and that smaller companies purchased from suppliers. Presses or stamping machines formed the decorative metal components, after which shearsmen trimmed the pieces to size. Each piece was then checked for “squareness.”

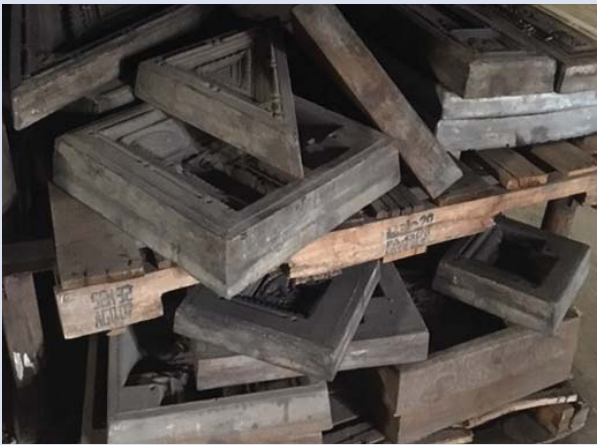
Stamping molds used in drop-hammer presses began on the artist's design table. Once a design was approved, it was transferred from a full-sized paper drawing to a slab of molding clay and sculpted into a 3-dimensional model. The artist then cast it into plaster, first in a shell cast making a negative, and from that a positive, replicating the original clay model. This last mold was carefully leveled and smoothed and coated with shellac. Molten iron was next poured over the positive plaster mold to create a negative metal die. After the iron die was cooled, milled, and smoothed, workmen poured liquid zinc over the bottom die to make a separate positive metal mold. When cooled, the 2-part die was fastened to the hammer heads of the press with the strong iron die on the bottom and the more malleable zinc die on the top. (Photo: W. F. Norman Corporation)

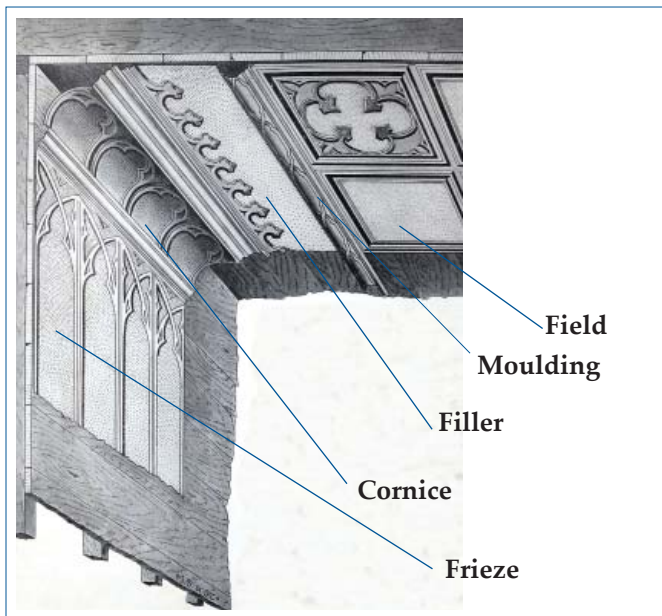
Anatomy of a decorative metal ceiling and upper wall.

Many ceilings included a cornice, which could have a wide range of elaboration. While most cornices were stamped from a single strip of sheet metal, cornices could extend a considerable length down the wall by adding additional moldings and borders. Cornices helped dress any protruding structural beams and reinforced the sense of depth. Coffered elements could also be incorporated into the design of the ceiling that likewise could incorporate the cornice.

As the industry grew, wall treatments, including special pieces for partially enclosed stairs, were also marketed. Usually referred to as “side walls” or “sidewalls” to differentiate them from ceiling components, they were commonly based on the traditional tripartite wall design of frieze, field, and wainscot. Walls could incorporate a chair rail, and even a metal baseboard, though more often a wood baseboard was used for practical reasons. Decorative metal walls were mostly used in tandem with metal ceilings. While never matching the popularity of metal ceilings, metal sidewalls did enjoy varied applications, from homes to factories to even churches. Certain pressed-metal wall patterns, particularly beaded boards, ceramic tiles, and stucco finishes, were successfully marketed for use in bathrooms, kitchens, and similar applications where there were special sanitary concerns. Wall pieces tended to be larger than those commonly used in ceilings. A simple grid pattern that emulated the concave grout lines of square ceramic tile was available in sheets as large as 24” x 96” for ease of installation and to minimize seams.

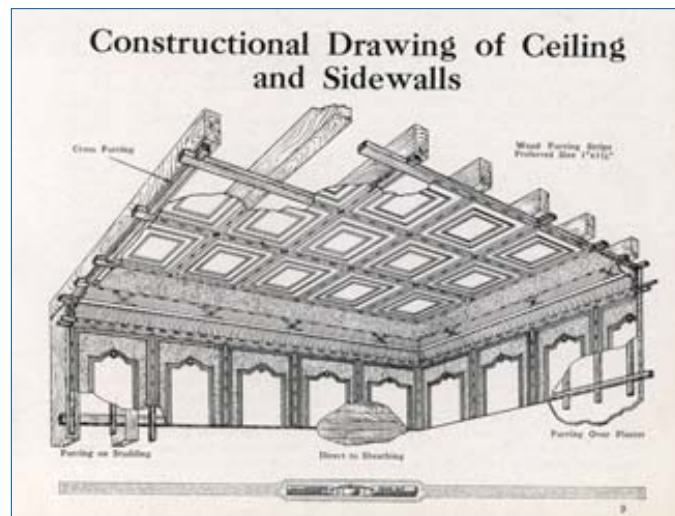
A 1928 Berger Manufacturing Company catalog shows the recommended ceiling and sidewall support structure beyond the pressed metal tiles.

Decorative pressed-steel ceilings were mostly laid over lathing strips that were nailed to joists and beams. The lathing was nailed in grids that matched the locations of the panel seams. Steel ceilings could be laid directly over existing wood ceilings and even over plaster that was attached to lathing. If the plaster was deteriorated, lathing strips for the metal ceiling could be applied directly over the plaster. For small rooms, manufacturers recommended applying 1/2” wood sheathing over the whole ceiling for ease of installation. Common lathing sizes included 7/8” x 7/8” and 7/8” x 1 1/4”, though in fact they typically ranged from 5/8” to 1 3/4” in thickness and from 1-1/4” to 1-7/8” in width.

Installing the lathing correctly was critical both for optimum appearance as well as for sound attachment.

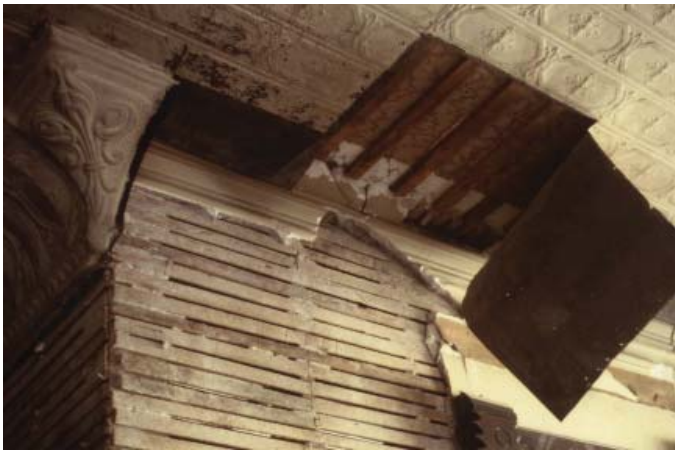
Prior to repair, a section of the pressed metal was removed to expose the condition of the plaster and lath and to document the earlier finish. (Photo: Kaaren Staveteig, NPS)

The structural integrity of ceilings can be negatively affected by other conditions. When metal ceilings were applied directly over older plaster ceilings in poor condition, installers were instructed to use a different installation technique. By installing

wider and more narrowly spaced lath over the existing ceiling, and anchoring it with nails long enough to grab the joists, the wood grid would also help secure the existing plaster ceiling. Where this was not done, and the metal was placed directly on the plaster, the weight of the deficient plaster ceiling can place pressure on the metal ceiling, causing sagging and other problems.

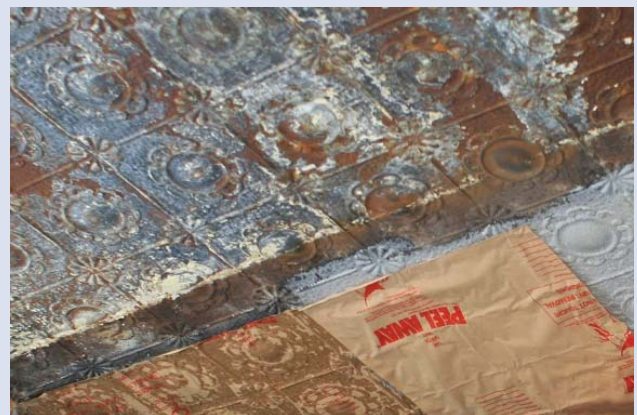
After applying a solvent-based paint to the metal, a laminated cloth/paper is applied during the chemical-peel process. (Photo: NPS)

An alternative approach relies on multiple applications of chemical stripper, using a nylon brush (4" typical)

or specialized spray equipment. The paste is left on from four to 24 hours, depending on the required activation time. To remove, scrape the softened paint and chemicals from the surface. Repeat this process until the metal surface is exposed. Scrub clean with water and a stiff nylon brush; thoroughly wipe dry; neutralize, if needed; and then coat with a rust inhibitor such as a zinc-rich primer.

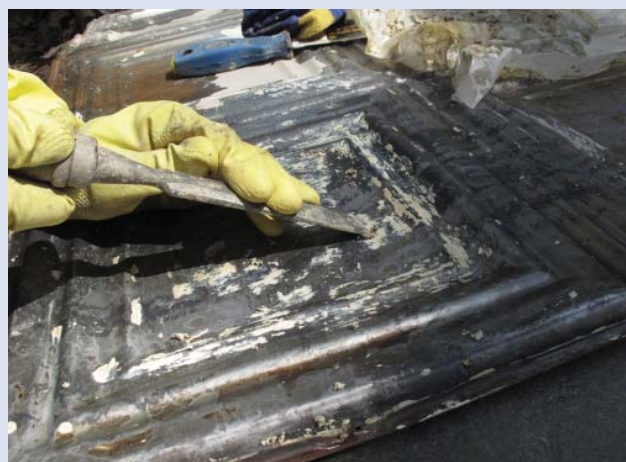
Thermal contraction — freeze/flex method

Freezing techniques have been successful in removing paint from pressed metal (see Fort Baker case study). The demounted pressed-metal panels are frozen in commercial-sized freezers. The metal contracts at a greater rate than the paint, which breaks the adhesion bond between the paint and the metal. When sufficiently frozen, the panels are removed and gently flexed by hand and tapped with brushes to flake off the paint. Hand picks, small scrapers, and other small tools then are used to remove paint remaining in deep crevices. On any project, this process must be tested on one or more panels to determine efficacy.

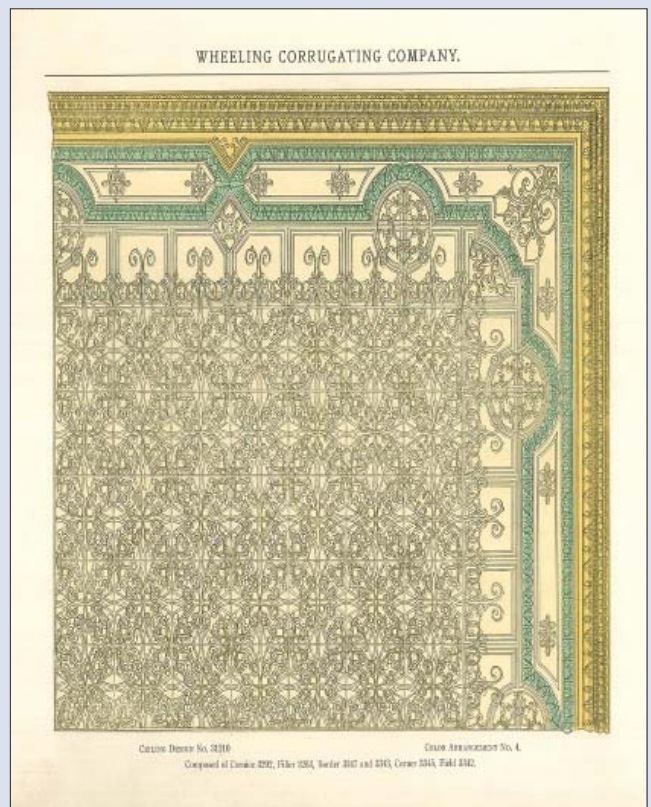
Pattern page for color arrangement No. 4 encaustic metal ceiling design from the 1906 Wheeling Corrugating Company, WV.

In an effort to offer a distinctive line of ceilings and sidewalls, the Wheeling Corrugating Company (WV) offered, as early as 1906, encaustic metal ceilings with a baked-on enamel coating to hold its color and porcelain-like finish for years. The field, cornice, moldings, and fillers could each be ordered in a range of colors. For a more striking appearance, the raised and flat areas of each component could have complementary colors. Once installed, the result would be a richly decorated polychrome scheme combined with a pressed relief that would rival the appearance of ornate, decoratively painted plasterwork.

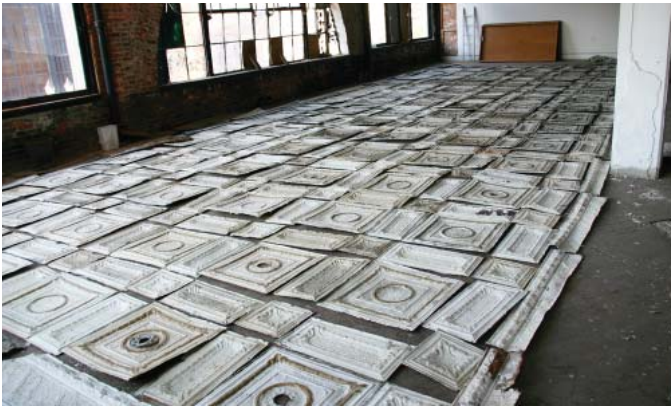
When carefully removing the historic pressed metal from the original ceiling above, the pieces were numbered and later arranged on the floor in the same way they appeared on the ceiling to aid in their reinstallation. (Photo: NPS file, 423 N Market St., Wilmington, DE)

pattern documented. Individual pieces should be saved for reference when selecting appropriate replacement units.

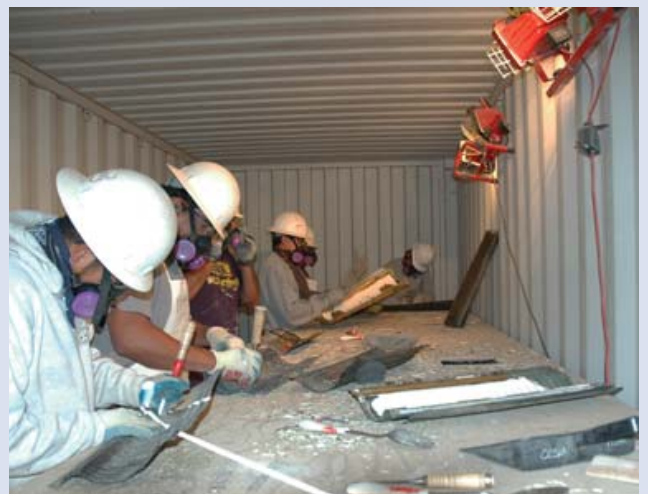
Figure b. On pieces where paint remained after the freezing/flex process, workers carefully hand-scraped with chisels to finish the clean-up. Because lead paint was present, workers were required to wear NIOSH approved-respirators.

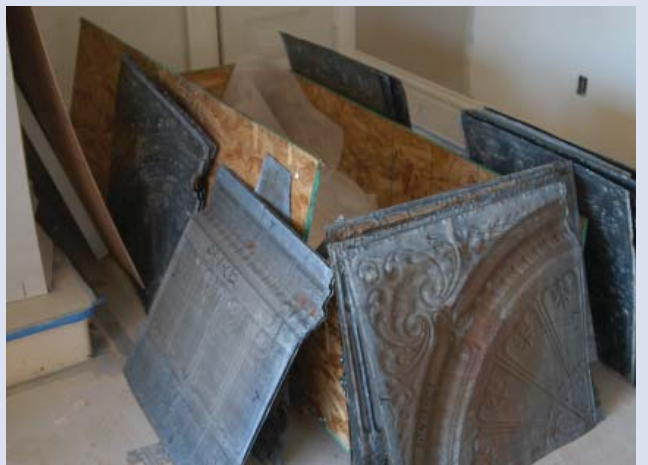
Figure c. Once the metal was cleaned of over 100 years of paint, it was easy to see the detail of the original design.

each room. The underlying construction system, however, was the same for each room. All panels were nailed to a grid of wood strips (7/8" x 2"). The panels overlapped each other with indentations (or buttons) at the corners to conceal the nail heads within the patterns.

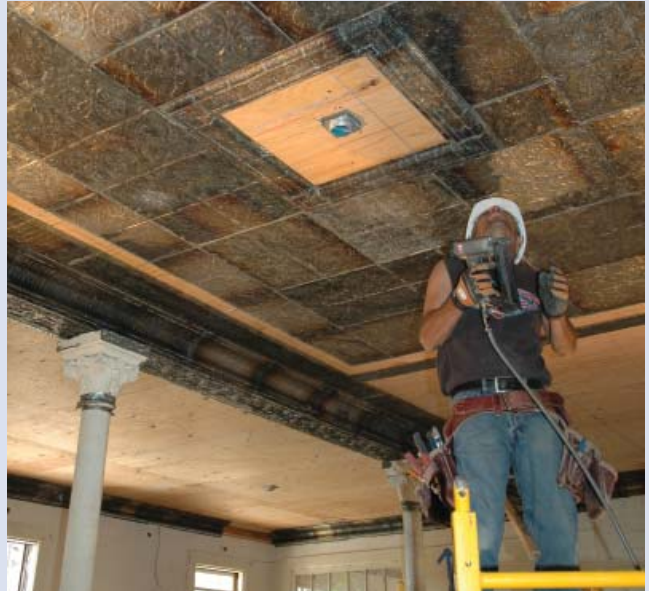
Figure d. Following the installation of the sound-proofing materials and drywall, the pressed-metal pieces were reinstalled using brads and a pneumatic gun. Matching the numbered pieces to the placement diagrams made the reinstallation easy.

the numbered pieces to the placement diagrams made the reinstallation an easy process. New replacement pieces matching the historic Fort Baker design elements were purchased to replace any damaged or missing pieces. Once installed, the room ceilings were painted, completing the successful preservation and renewal of the historic pressed metal.

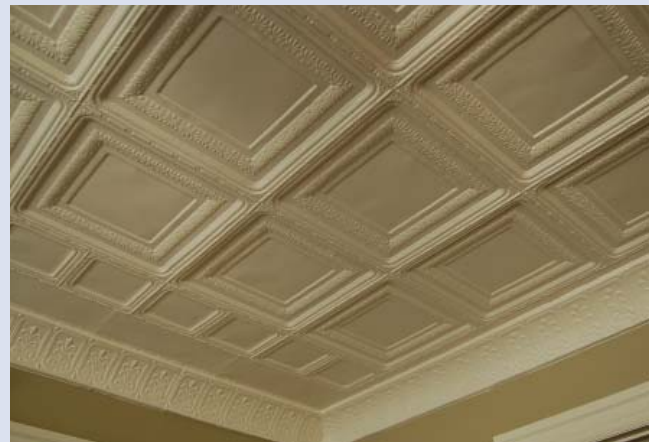
Figure e. The ceilings were finished with a fresh coat of paint. (Photos a-d courtesy of Kristin Baron, NPS; Photo e: Kaaren Staveteig, NPS)

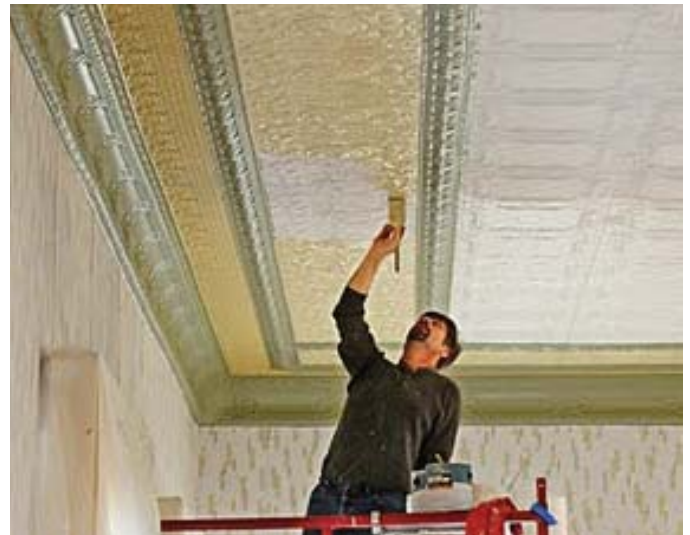
The historic polychrome appearance is being recreated and enhances the depth and complexity of the decorative metal ceiling. (Photo: The Madison Courier)
