Funter Bay Cannery

Current Condition

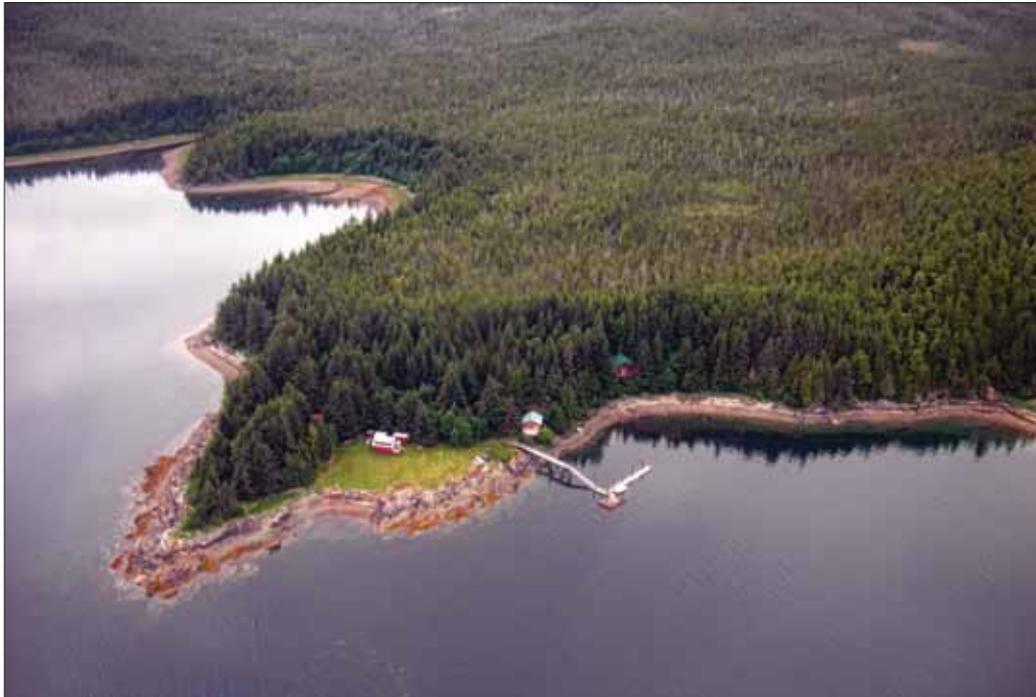
Figure 8.

By 2008 the forest had reclaimed most of the Funter Bay cannery site. Here looking northwest are the public floats and several dwellings. From left to right are: a small part of the roof to the watchman's cabin, a private dwelling (in the clearing) where the power house once stood, a cabin at the former mess hall location, and a cabin where the China house used to be. At far right is the edge of former cannery caretaker Harold Hargrave's home.

where the old mess hall used to be. A two-story cabin belonging to Randall Gray resides where the China House once stood (Figures 8, 29). And the cannery's former power house site is now occupied by Gordon Harrison's one-story frame cabin and several small sheds all painted a bright red (Figure 30). Whereas the two log cabins feature milled logs of obviously recent construction, the frame cabin is a gabled dwelling with a shed-roofed dormer facing the bay, a metal roof, and wood shingles, together giving the appearance of an older building (Figure 30).

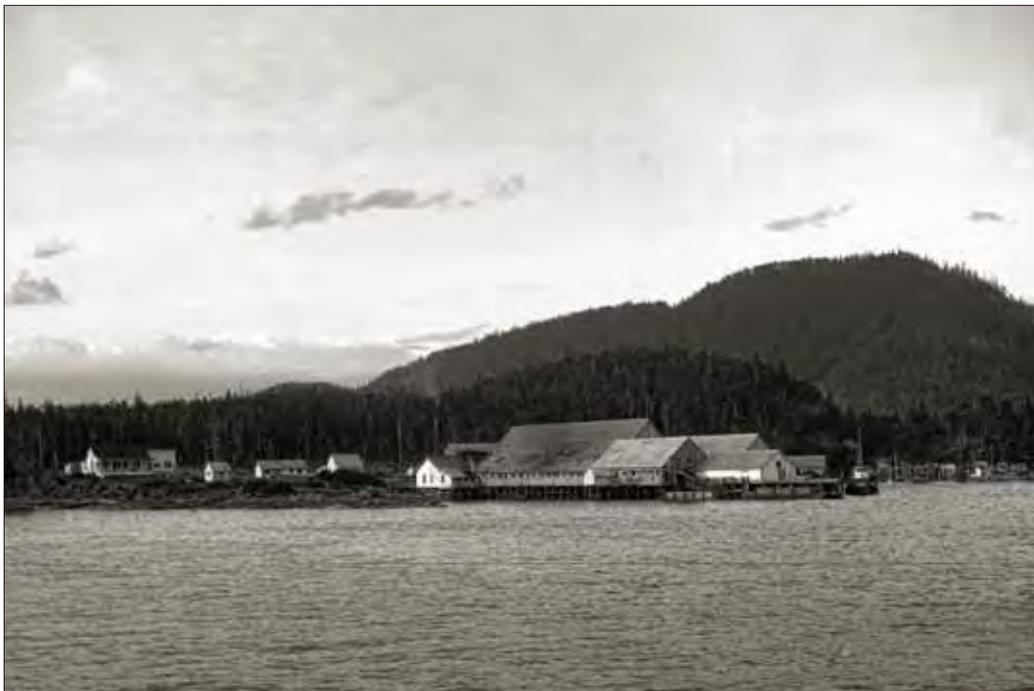
Figure 14.

The power house (center, looking southeast) held oil-fired boilers that provided steam for the retorts and ran the system of overhead axles, pulleys, and belts that operated the cannery's many machines.

Attached behind the central warehouse was a machine shop, and across a decked platform behind the cannery was the boiler room, or power house (Figure 14). The power house’s west

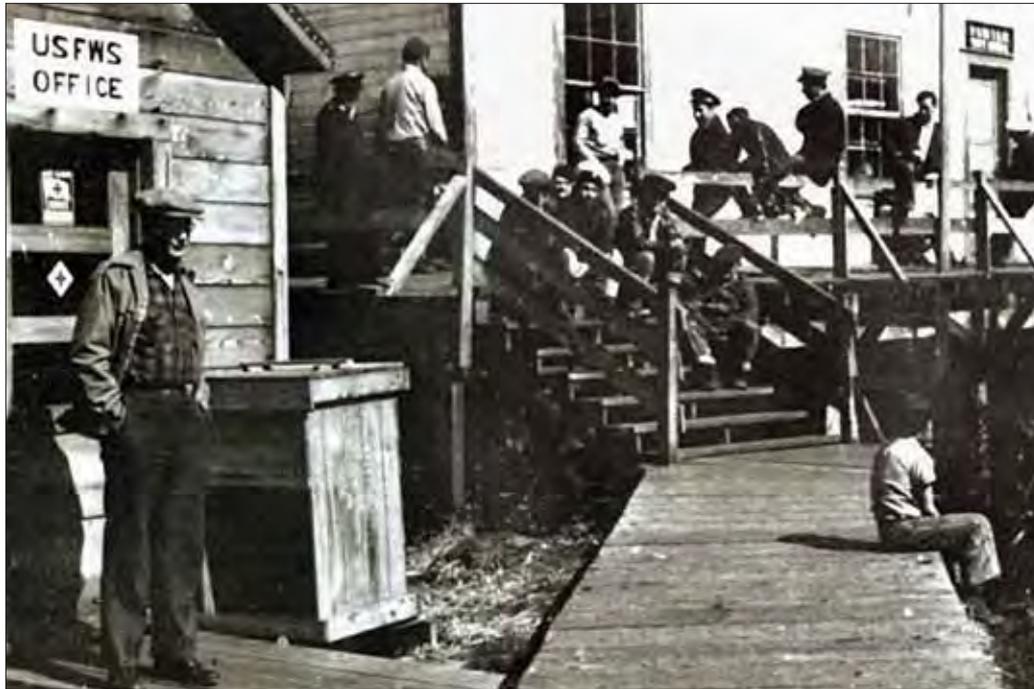
Figure 15.
Federal authority over the Funter camps was administered from a small frame office building prominently located between the cannery's store (at the photographer's back in this wartime image) and mess hall (at center).

low a sign reading "FUNTER POST OFFICE." During the war a small cabin connected to the boardwalk by the mess hall was used as the USFWS office (Figure 15), contributing to the social importance of the building cluster. The next nearest building to the mess hall was the tool headquarters, or carpenter shop, located centrally to serve the entire cannery complex (Figure 16) and still standing in 2008.

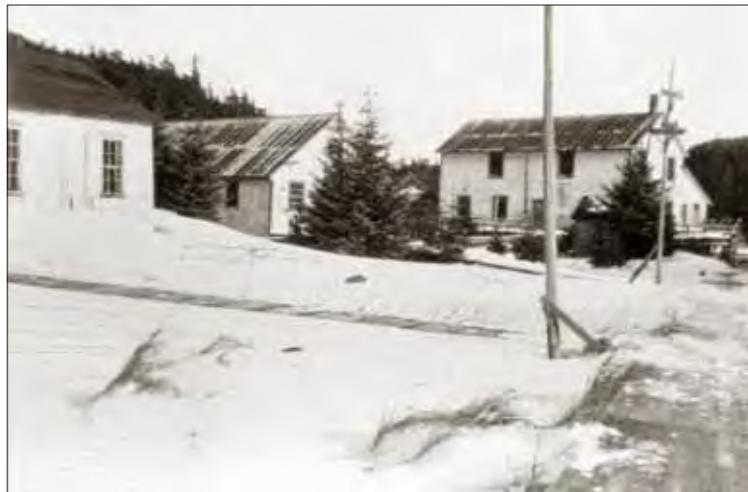
Figure 16.
Here looking east are the mess hall at right, carpenter shop left of center, and a frame cabin at left. Second-growth trees and absence of the "USFWS Office" (Figure 15) date the view to just before 1942.

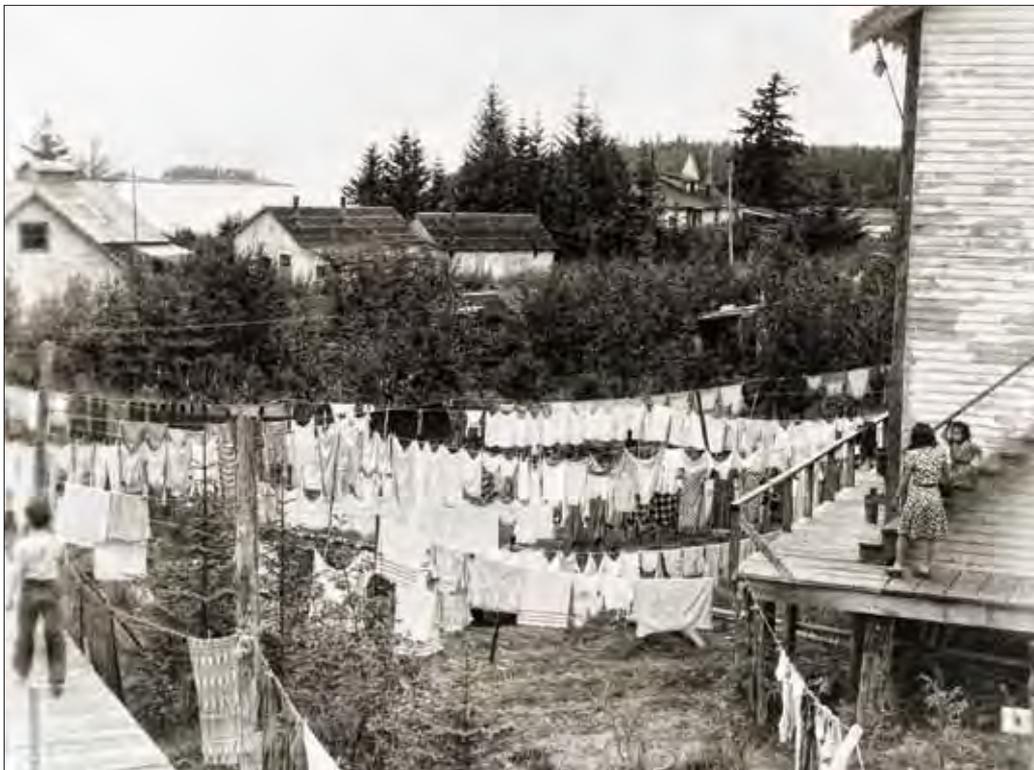
Figure 17.

The superintendent's house, here viewed towards the southwest from an upstairs west window of the China House across a sea of laundry during St. Paul villagers' time there, is half hidden by trees in the background right of center.

the building locations, and the archival photographs show some of their architectural details (Figure 17). The superintendent's house was a composite building at the west end of the main cannery boardwalk consisting of a central one-story block with a shed-roofed

Washing clothes must have been an ordeal (Figure 17). Food preparation was made more complicated by the lack of adequate kitchen facilities and

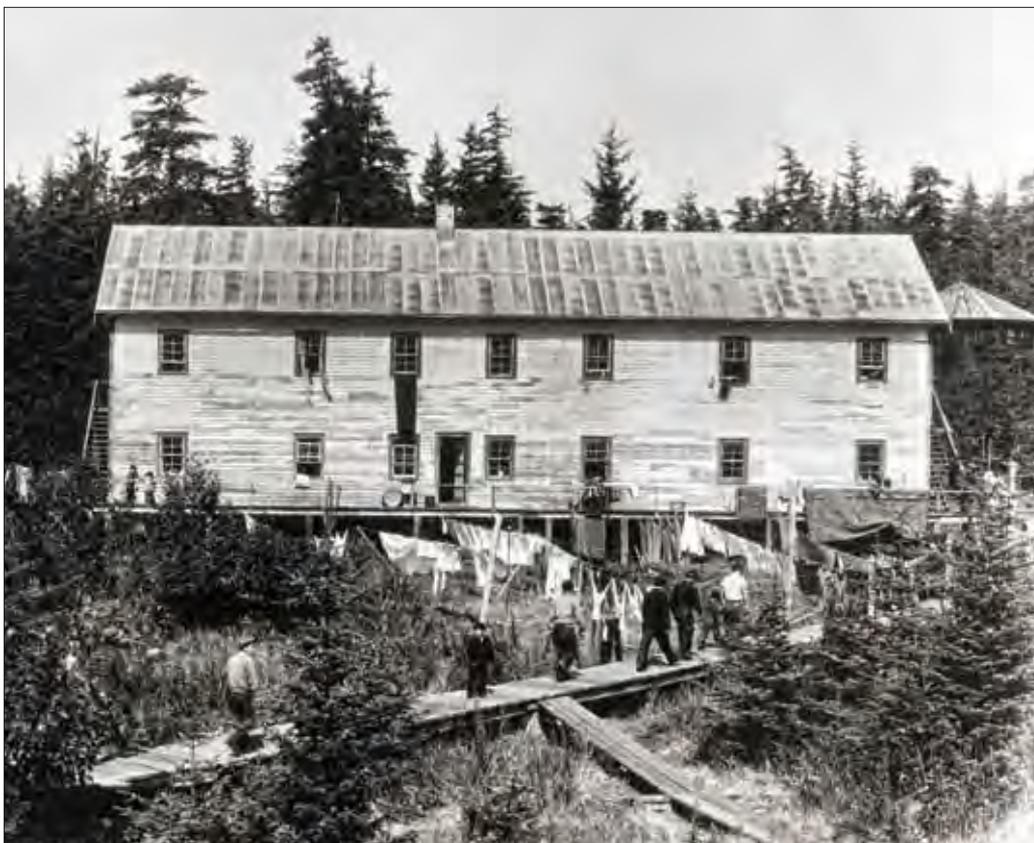
Figure 18.

Seen here looking northwest from the railing of the mess hall during the war, the Filipino House was a twin to the nearby China House immediately right of photo. The cannery water tank can be seen at upper right.

were two large two-story bunkhouses, each about 24' wide and 96' long, one labeled "Filipino House" (Figure 18) and the other "China House." Since the cannery's "Oriental bunkhouses" reportedly burned in 1929, the Filipino and China houses mapped in 1942 may have been built immediately that year or the year after to replace

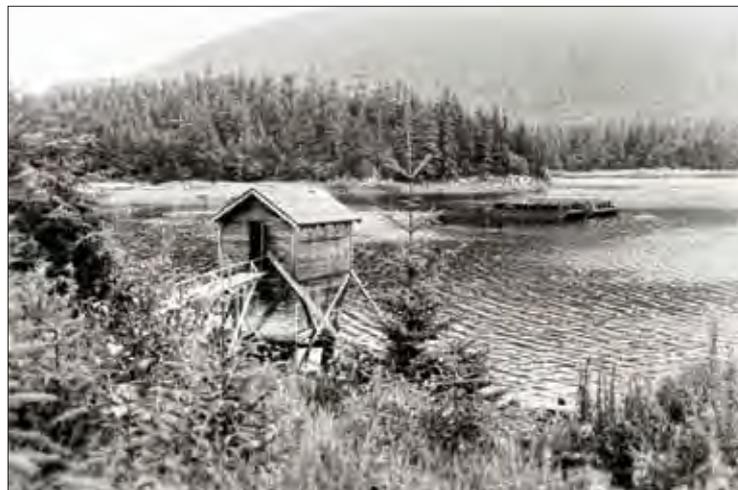
Figure 19.
During WW II a community privy was built over the beach east of the cannery.

Systems serving the cannery complex consisted of water, sanitation, electricity, and the boardwalk. A small creek to the north (near the Aleut cemetery) was dammed with a simple timber crib, from which water was sent via a 4” steel pipe to a large wood-stave tank located between and upslope from the two large bunkhouses. From there at least one smaller line likely ran along the boardwalk to the industrial complex, with spigots along the way. Whether any of the original buildings had independent sewer/septic systems is unknown, but at least three outdoor privies were built out over the intertidal zone. One was attached to a storage shed immediately north of the mess hall, another served the Filipino and China Houses (Figure 19), and a third was located at the far end of the boardwalk past the three

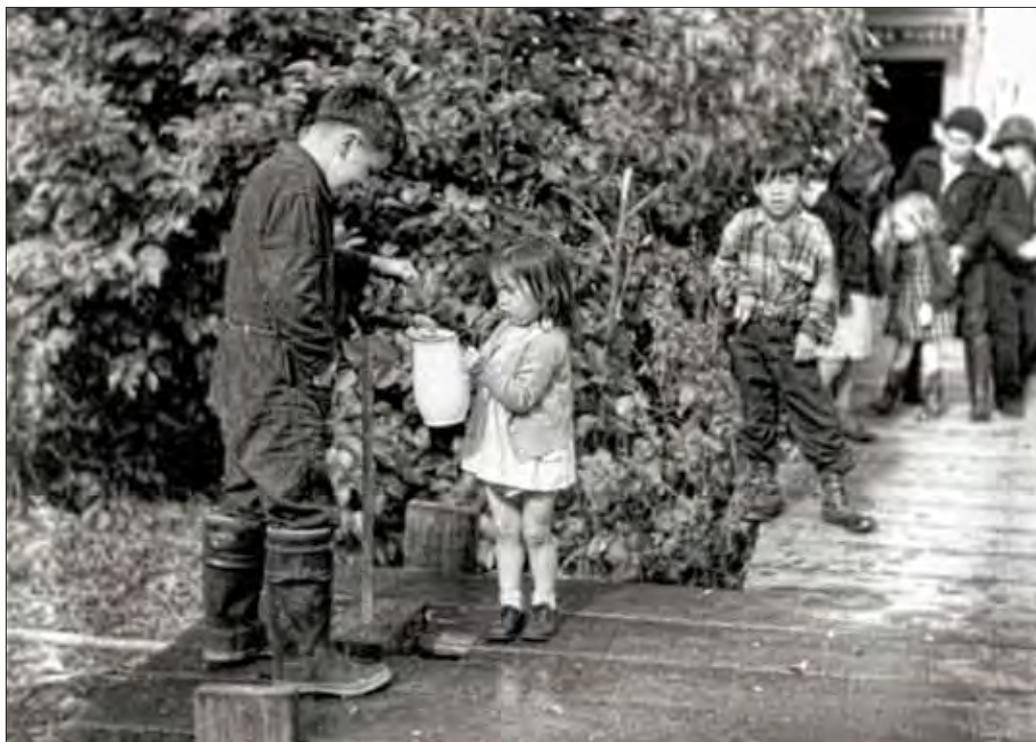
Figure 22.

The water system at the Funter Bay cannery wasn't designed to support a large community through all seasons, and spigots were few. This tap was east of the China House (upper right).

Ordinary domestic tasks became difficult under the circumstances. Potable water was often in short supply due to freezing, poor pipes, inadequate flow, and contamination (Figure 22).

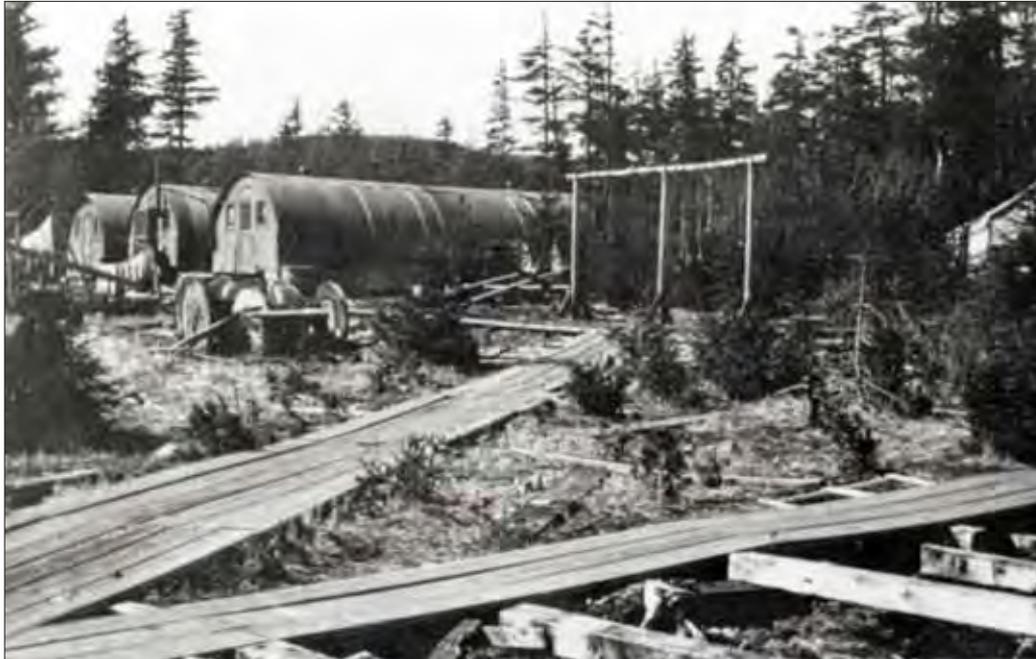
Figure 26.
Five Quonset huts including these three were erected at the Funter Bay cannery to house Aleut families. A note with the image states Dora Dushkin's family lived in the first Quonset, and the Melevedov family lived in the second.

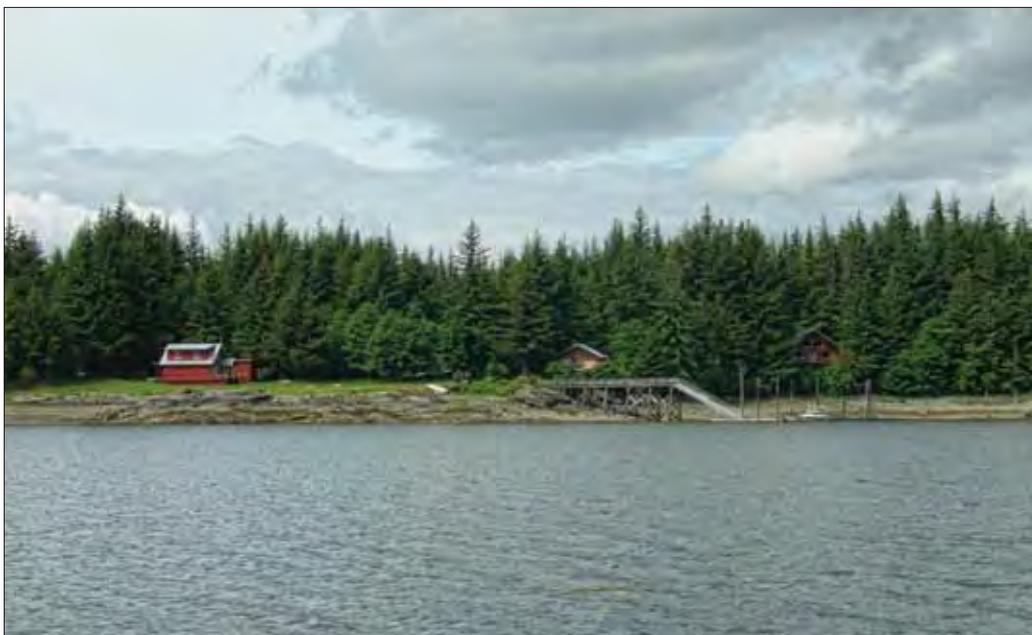
Figure 29.

As viewed approaching the public floats, the Funter Bay cannery site is now occupied by four dwellings, of which the three modern examples are visible: Gordon Harrison's cabin with a shed-roofed dormer (left) built in the late 1990s where the power house used to be, the 1990 cabin (center) built by Reed Stoops where the mess hall once stood, and Randall Gray's two-story log cabin (right of center) constructed over the China House site.

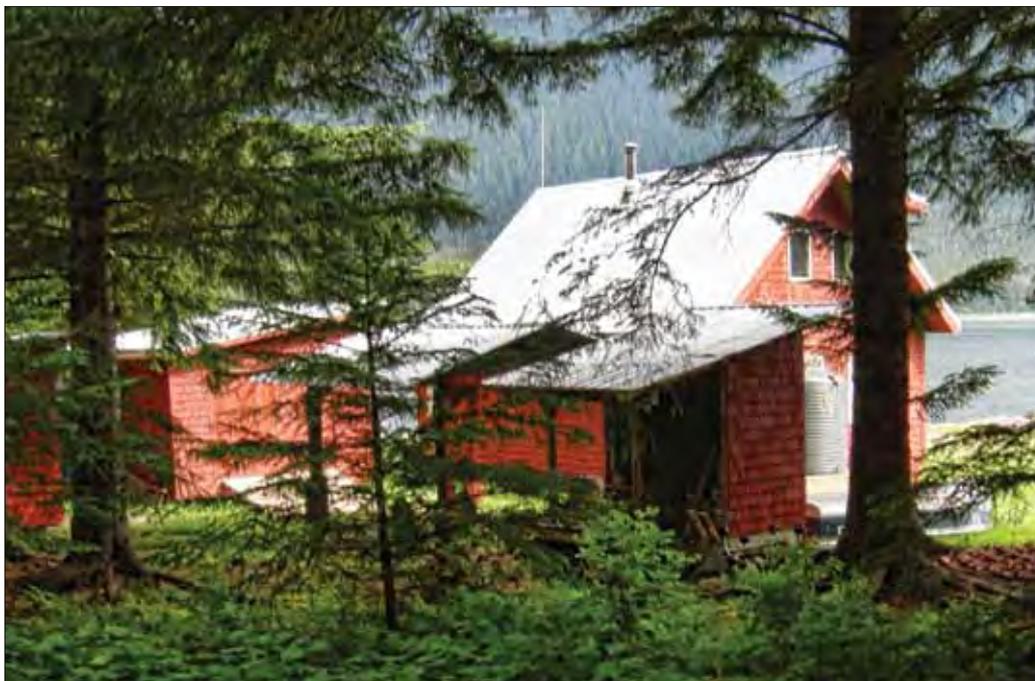
Figure 30.
The cannery power house site now holds a cabin and several small sheds built by Gordon Harrison between 1994 and 1999.

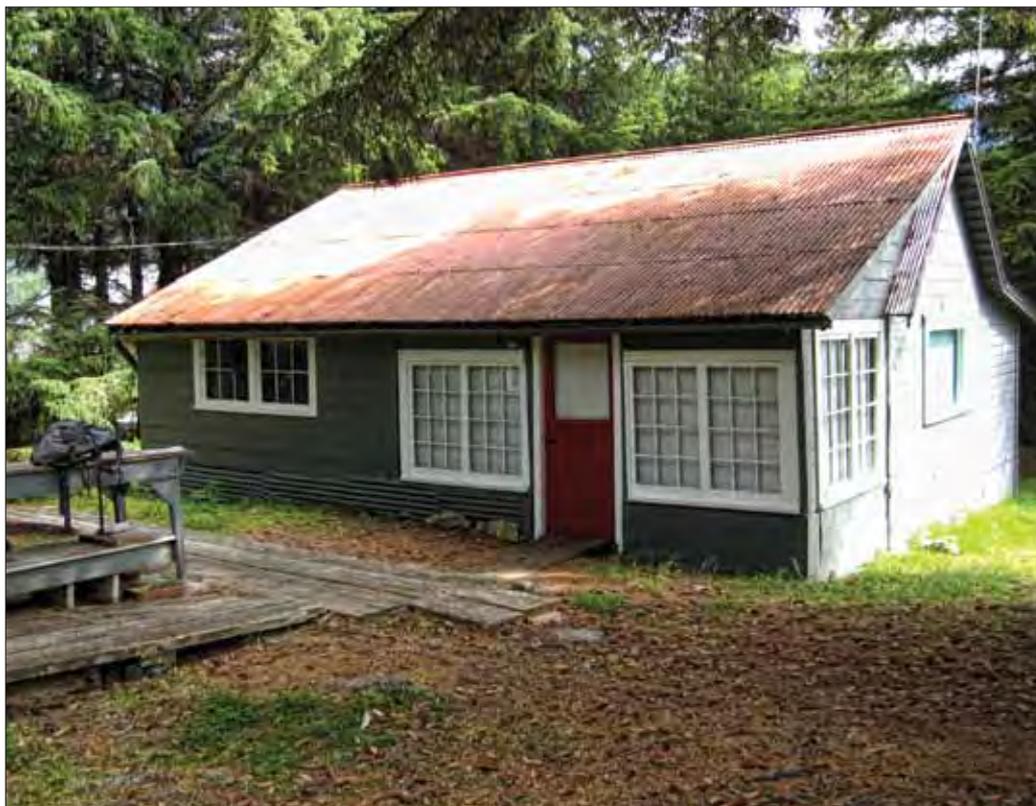
Figure 31.
The cannery's watchman's cabin is an original building maintained as a private residence.

cabins and a water tank enclosure – are standing in fair or poor shape. The only original dwelling still used for that purpose is the former watchman's cabin. Prior to 1942 the watchman occupied a multi-roomed house at the west end of the main boardwalk (Figure 12), but later that dwelling was enlarged for the new superintendent, and the watchman moved into a smaller cabin immediately east (Figure 25). In 2008 the building displayed one large gabled block measuring about 14'x25', with a small 4'x6' shed-roofed block appended to the south corner (Figure 31). Remnants of different roof pitches and vertical seams in the siding attest to a sequence of building modifications, and comparison of the 1942 and 1962 plans (Figures 12, 25) indicate that a 6' addition across the entire northwest elevation was

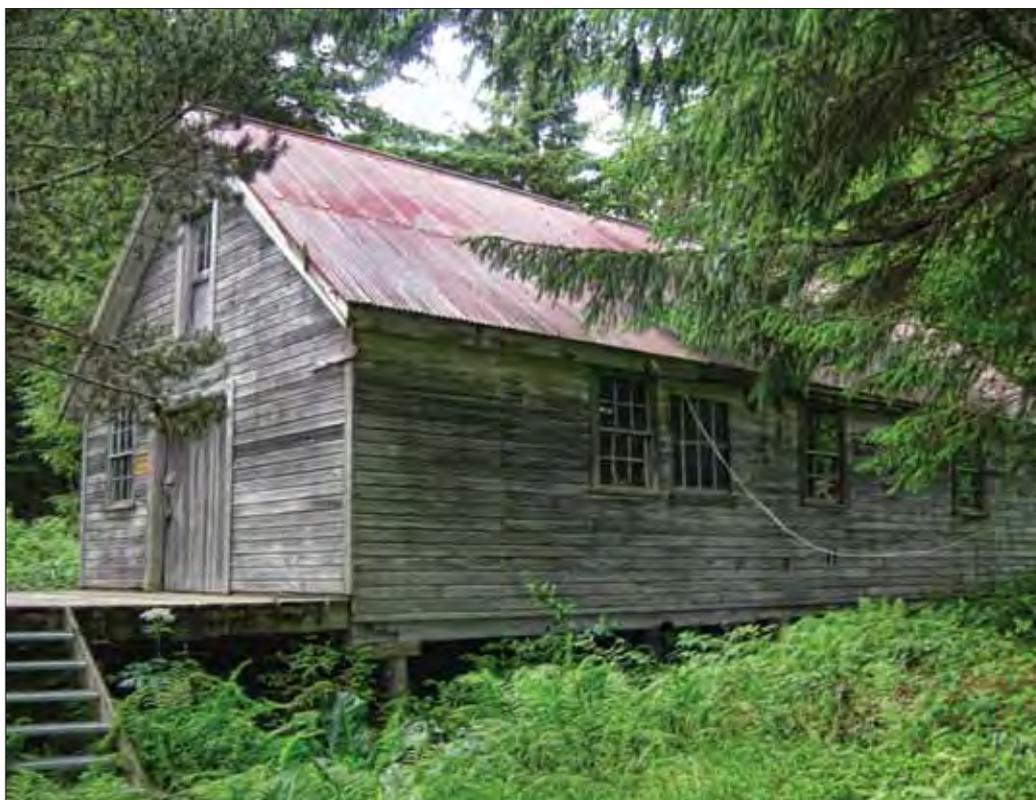
Figure 32.
The cannery's carpenter shop is still standing thanks to new pilings and a roof installed in the 1990s.

The cannery's old carpenter shop (Figure 32) is in good shape in its original location on creosote pilings installed in the early 1990s. In replacing the foundation the building was probably elevated above its original floor level. The building is a long wood-frame

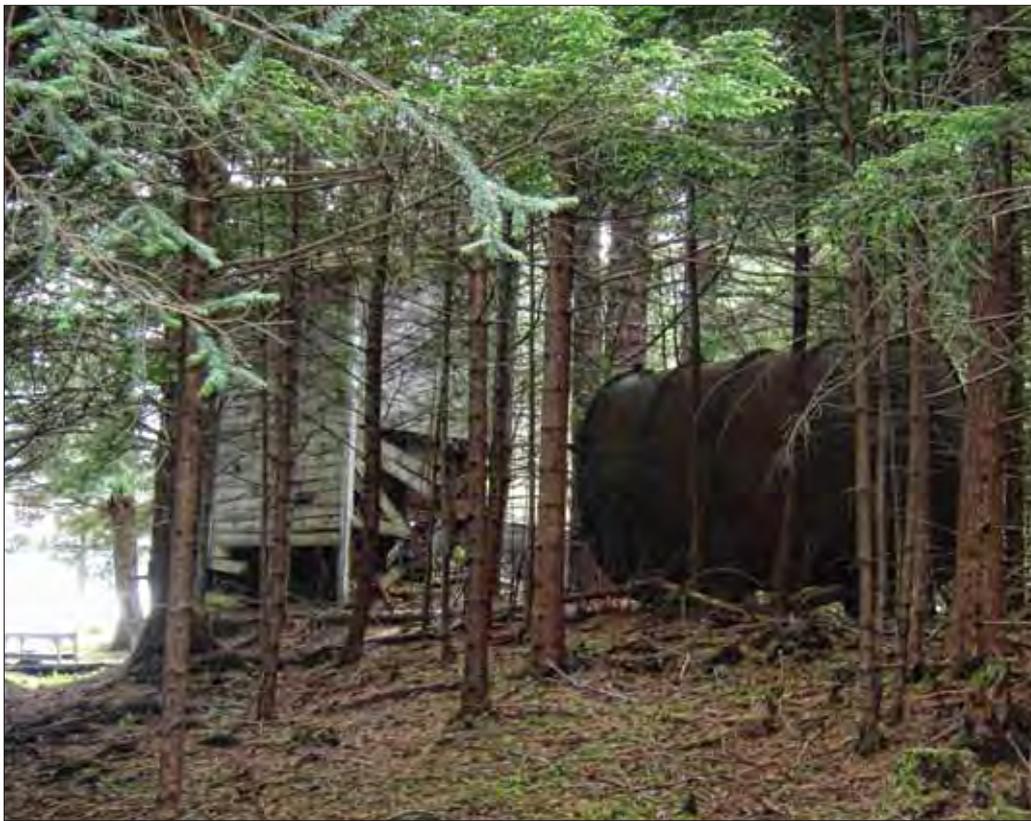
Figure 34.

A ramshackle cannery cabin at the west edge of the cannery, on USFS land, has a ceiling papered with pages from *The Saturday Evening Post* and *Collier's Weekly* magazines.

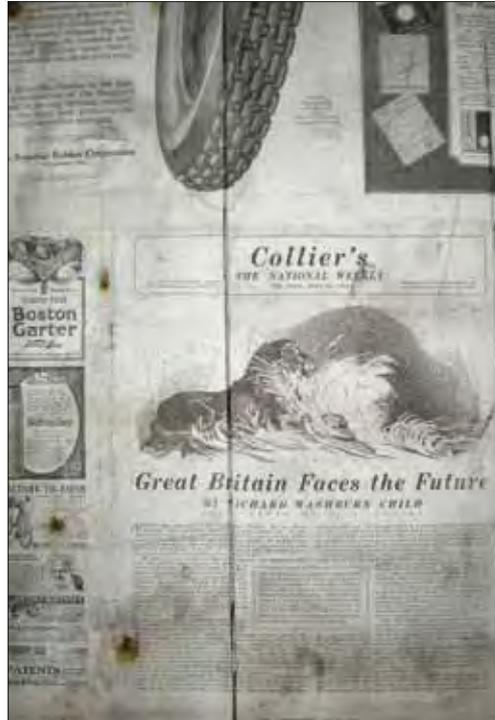
Figure 35.
The cabin papered in old magazines has pages as old as 1919.

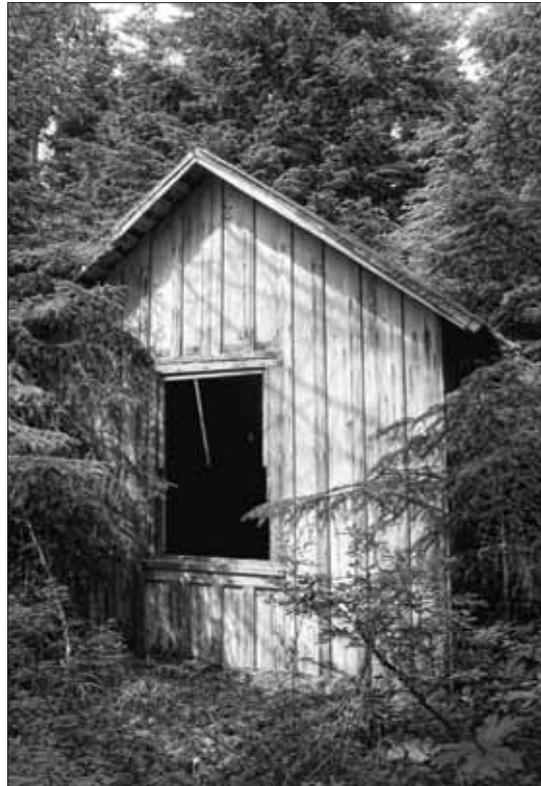
Figure 36.

Centrally located on the cannery site is a small frame board-and-batten cabin from the cannery era.

Corresponding to either the centrally located "GUEST HOUSE" or "CABIN" plotted on the 1962 map (Figure 25) is a small one-story frame building missing its windows. The cabin measures approximately 12'x20' and has board-and-batten siding (Figure 36), but was not inspected further.

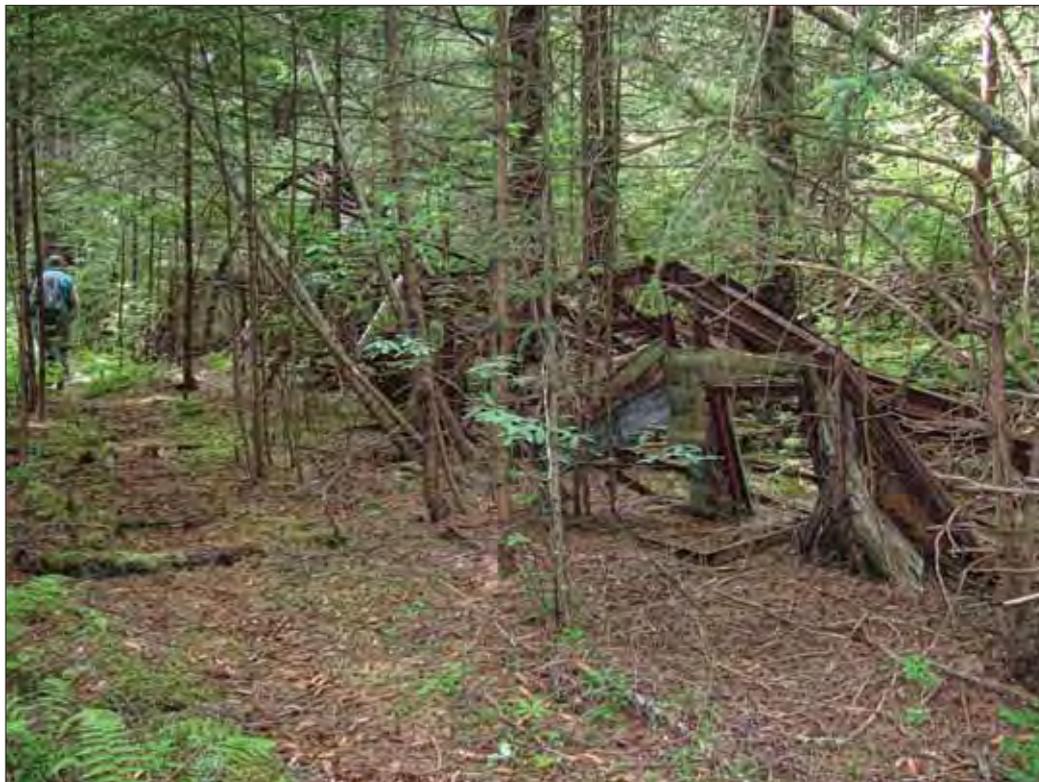
Steel frames of three Quonset huts were found where they were erected for Aleut housing during World War II. Compare with the almost identical wartime view (Figure 26).

Of the wartime buildings erected at the Funter Bay cannery, the Quonset huts are easily identified by their steel metal frames. A group of three and a group of two Quonset huts were plotted on the 1962 map (Figure 25), and the remains of all five were found in 2008. The trio appear in an archival photograph (Figure 26), and were found in their original location (Figure 38). The other two were found in their plotted 1962 locations (which likely represent their 1942 locations as well). None of the Quonsets have any corrugated metal roofing or siding left, and likely the sheets were salvaged by locals long ago. The steel frames have mostly collapsed, and scraps of plywood and beaverboard are visible among the debris.

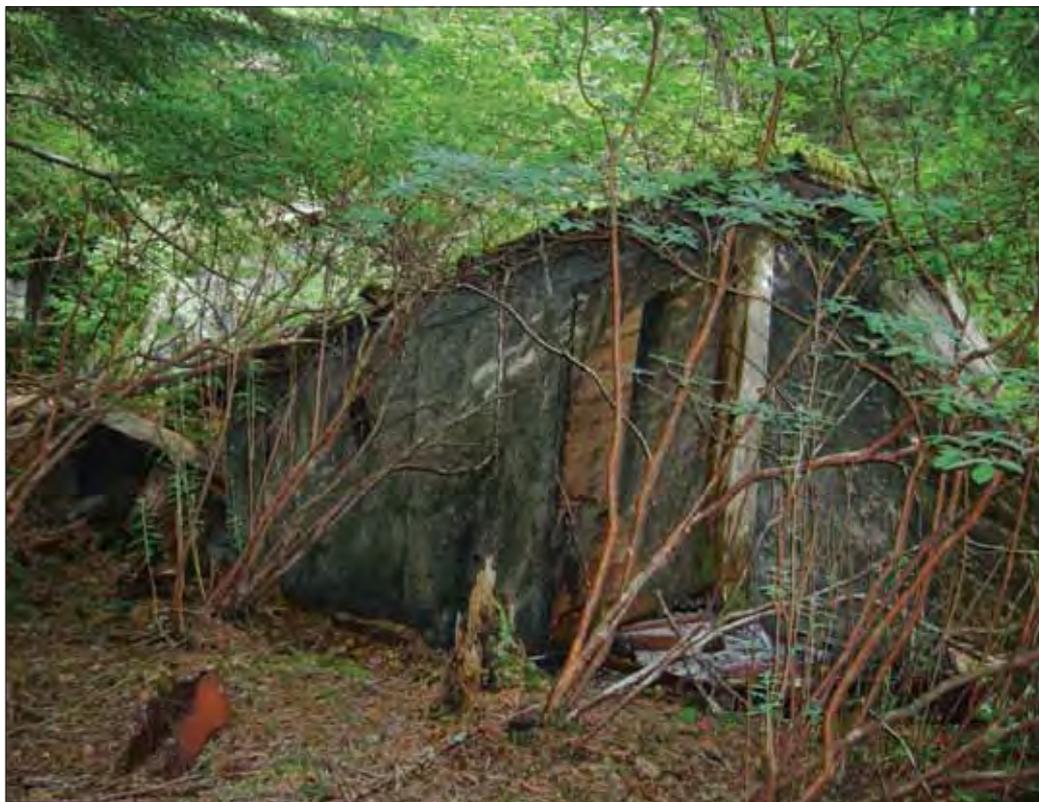
Figure 39.

A group of five cabins built for Aleut occupation during the war are now ruins, though several have at least one standing wall.

Two sets of cabin ruins were found corresponding to the two rows of “HOUSES” built for Aleut evacuees in 1942-43 behind the Filipino and China bunkhouses (Figure 25). A group of five buildings near the pair of Quonset huts are tumbling down but most still have at least one standing wall (Figures 39-41). More deteriorated ruins of another three are located to the northeast. Judging from the more intact examples the cabins were constructed of 2”x4” studs, 2”x6” rafters, and 1”x8” plank walls and roofs covered with tarpaper. Traces of beaverboard are visible nailed to the interior studs and ceiling joists.

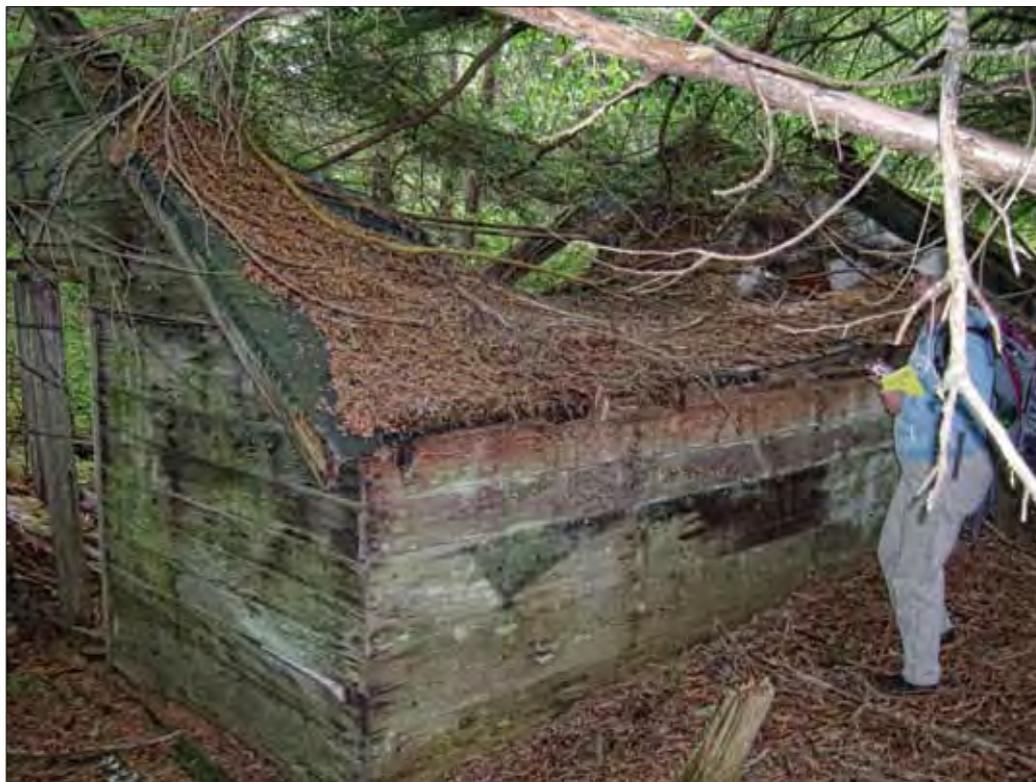
Figure 40.
The most intact Aleut cabin is simply constructed of horizontal 1"x8" planks covered with tarpaper, with a central door on a gable wall and few windows.

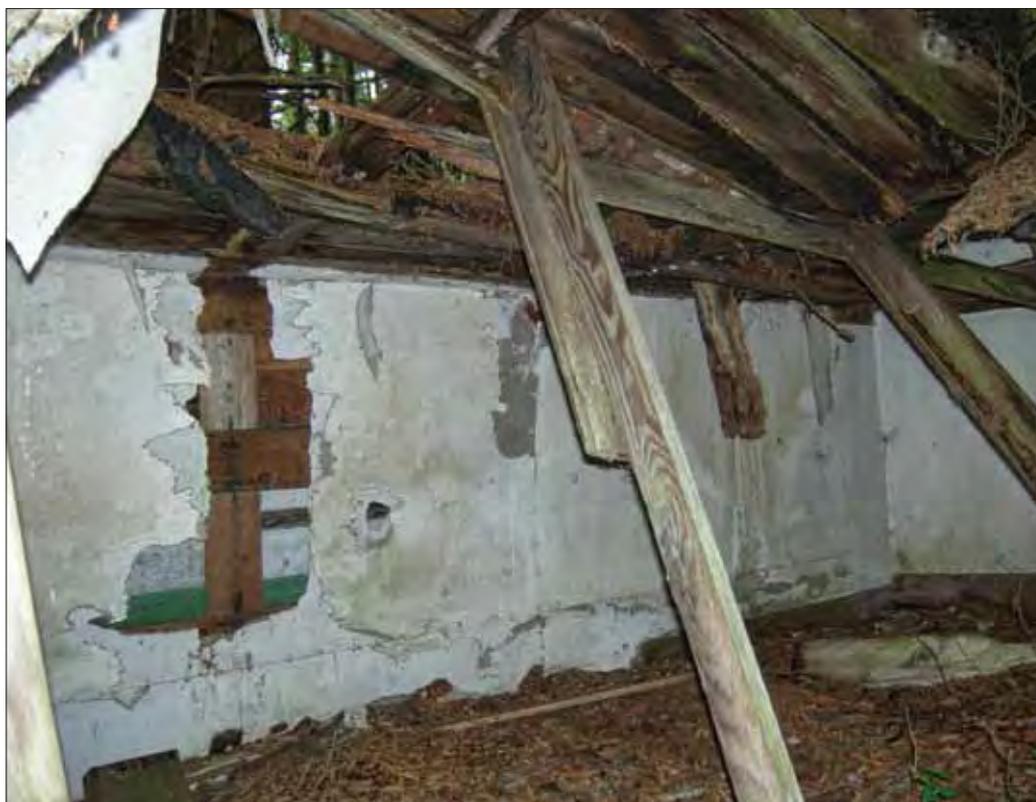
Figure 41.
The interior walls of the most intact Aleut cabin are covered with beaverboard painted white.

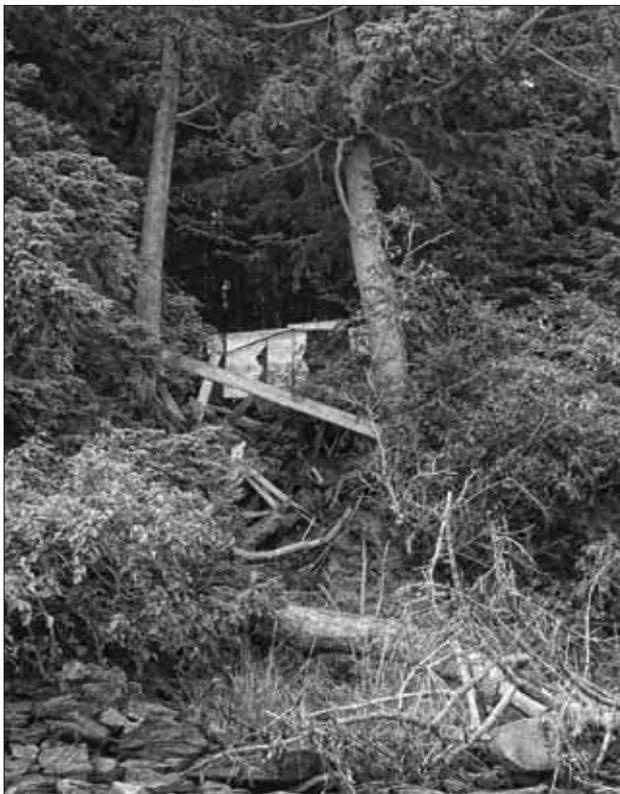
Northeast of the industrial area is a small building ruin (likely an outhouse) hanging off the rock cliff overlooking the intertidal zone.

in Figure 19. One of two small building ruins hanging off the bluff northeast of the industrial area in 2008 (Figures 42-43) likely represent the second outhouse mapped in 1942 – the one further to the northeast (Figure 12).

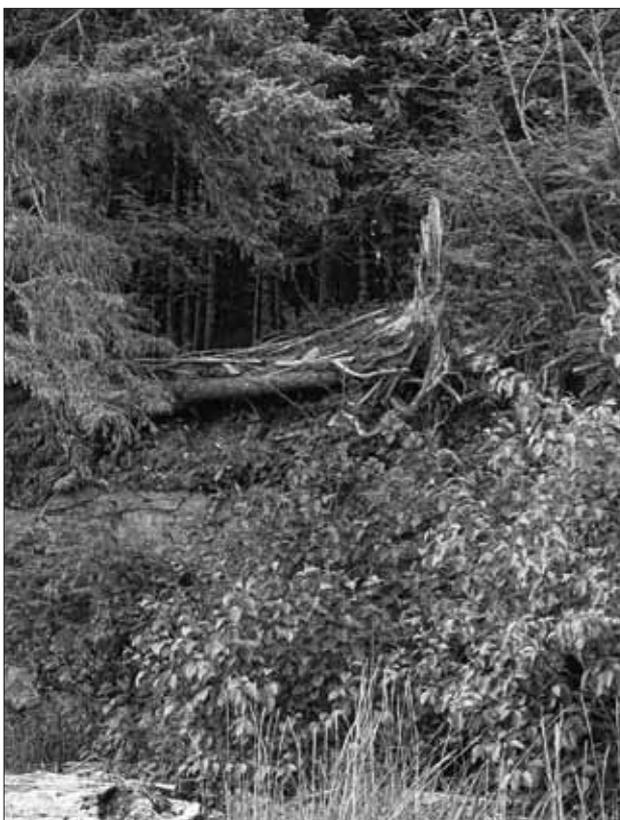
Figure 43.

A second small building ruin near the first (Figure 42) likely represents another former outhouse built over the intertidal zone.

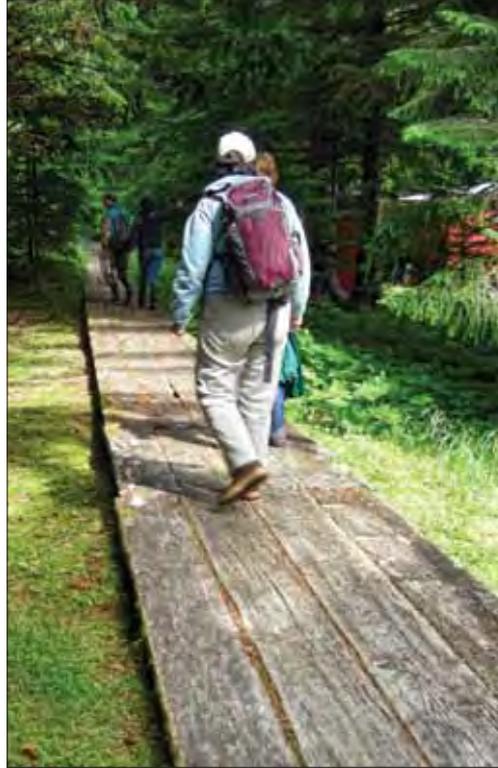
Figure 44.
Most of the central boardwalk from the floats to the watchman's house is still usable.

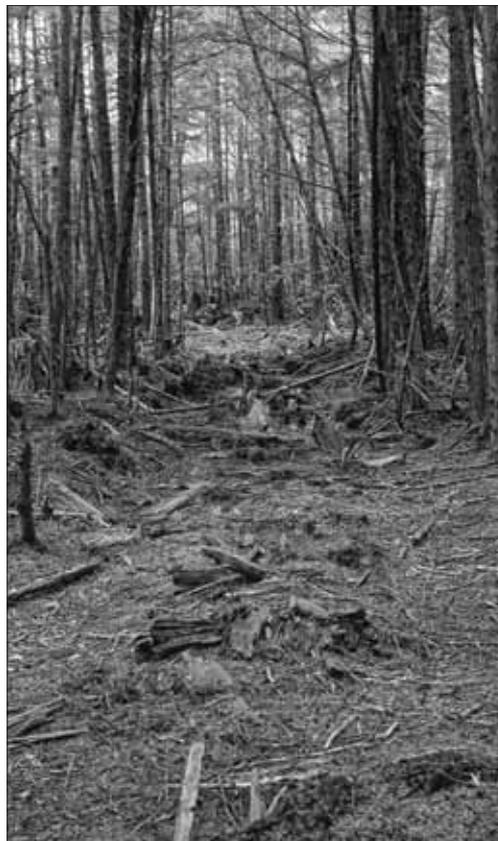
Figure 45.
A boardwalk once lead north from the site of the superintendent's house towards Scow Bay – a small cove to the northwest.

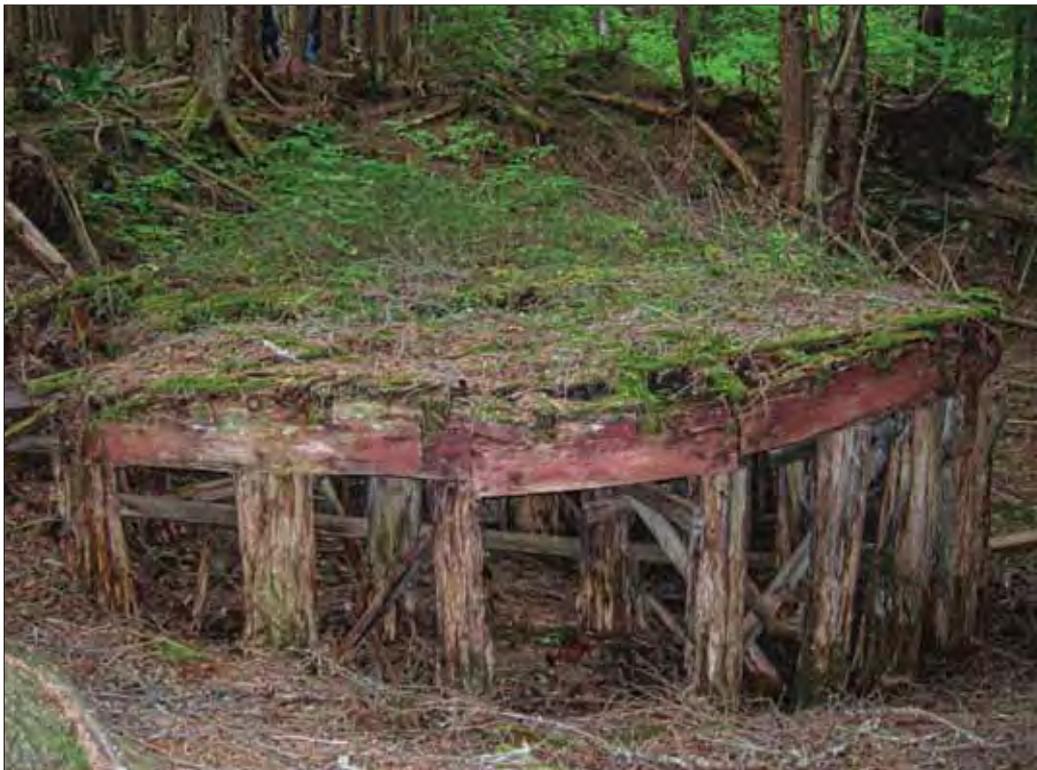
The cannery's redwood-stave water tank was salvaged years ago, leaving the foundation remains – now in very poor condition.

The huge wood-stave oil tank once located at the peninsula's point (Figure 14) and the water tank upslope from the two-story bunkhouses (Figure 25) were both demolished years ago, but the water tank foundation remains in place. It consists of about two dozen untreated round pilings supporting heavy timber stringers, which in turn supports a circular plank platform (Figure 46). Moss and small trees and shrubs have gained a footing on the rotten platform, which sags over the pilings in several places.

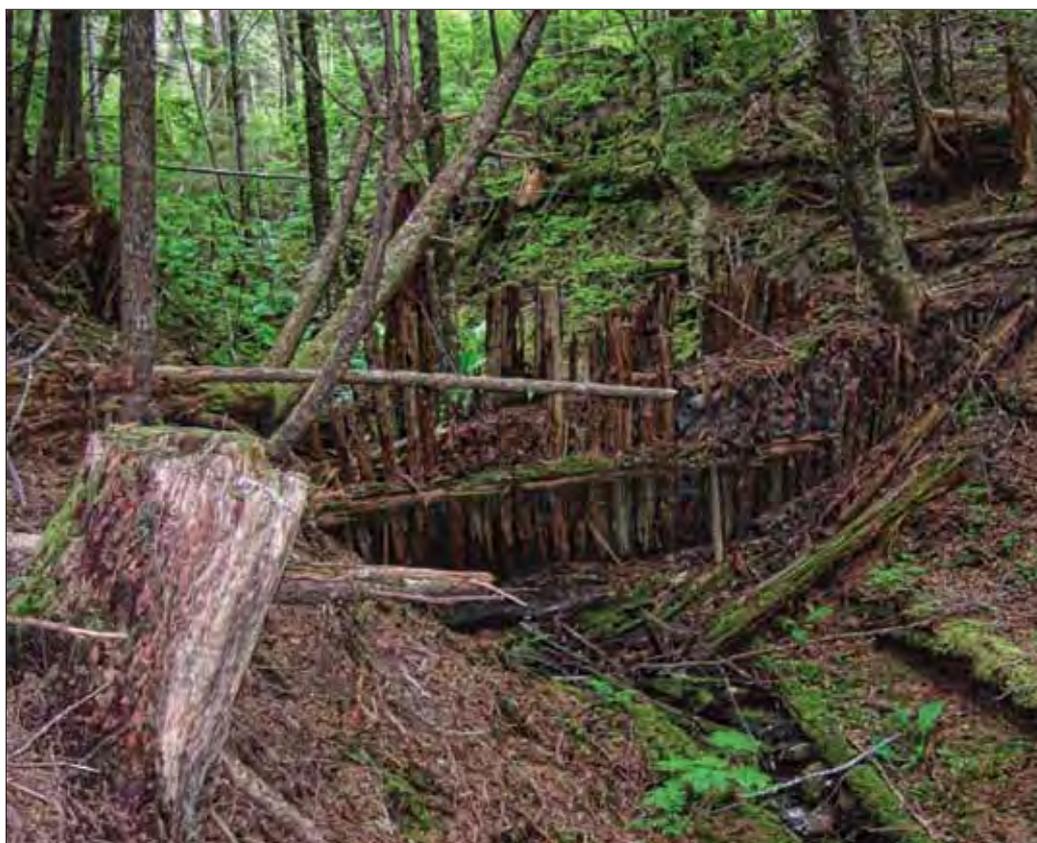
Figure 47.

The cannery's water supply came from this small earth-and-timber dam located to the northeast, a little upstream from the Aleut cemetery.

The cannery had at least two and possibly more water sources – all inadequate for the cannery's commercial operation. Near the carpenter shop the water table is high and a dark pool of water about 14' across with a low berm around it obviously represents an improved source, but the dark muskeg water was not potable. A dam was also built to tap a creek at the far northeast edge of the 1962 cannery map (Figure 25, upper image), near the Aleut cemetery, and it was still in place in 2008. The modest structure consists of two parallel rows of small pilings stretching across the bottom of the creek, each held in place by a horizontal log (one upstream and another downstream), with gravel filling the space between (Figure 47).

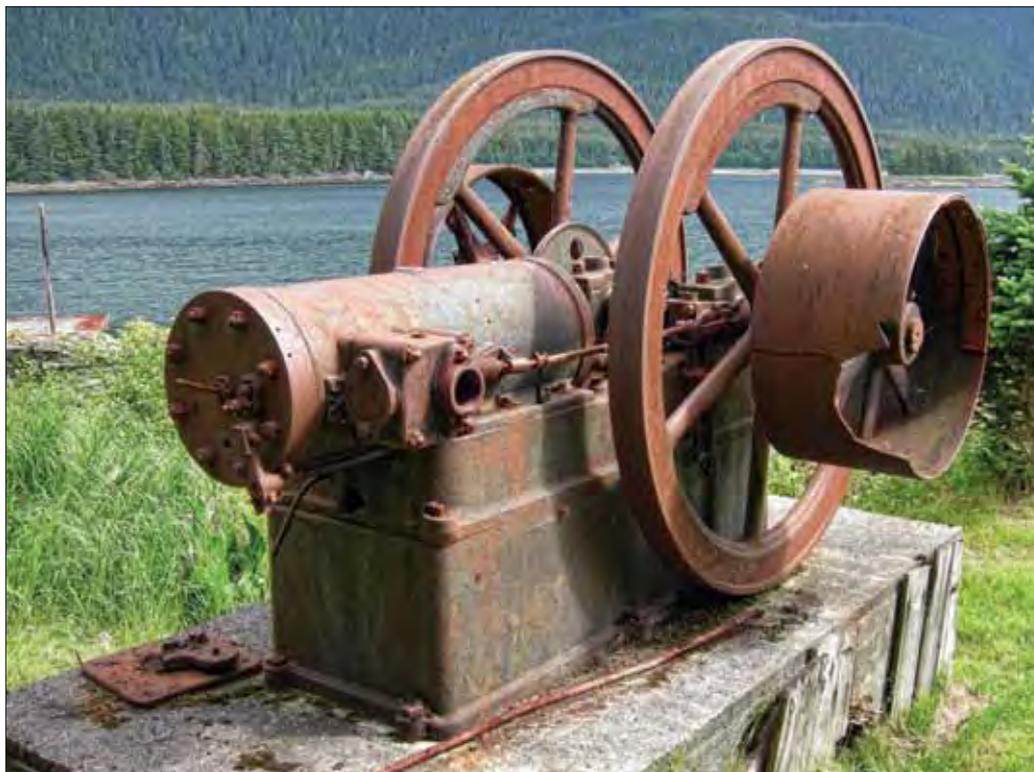
Figure 48.
A large Fairbanks Morse gasoline engine still attached to its concrete pedestal is located where the cannery's machine shop once stood.

each a low-horsepower (10-20 hp range) gasoline engine affixed to a concrete pedestal. One large Fairbanks Morse engine sits prominently in a grassy clearing to mark the machine shop's location (Figure 48). A second Fairbanks Morse engine missing its cylinder is located at the

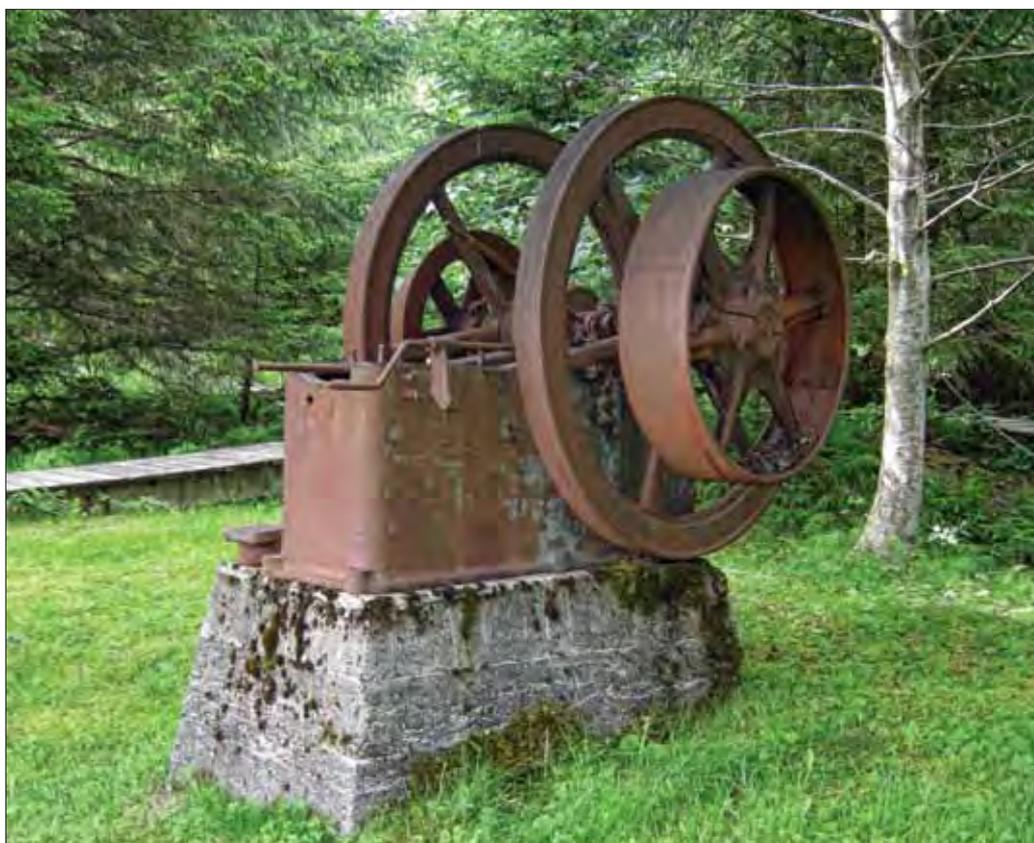
Figure 49.
A second large Fairbanks Morse engine – this one missing its cylinder – marks the former power house location.

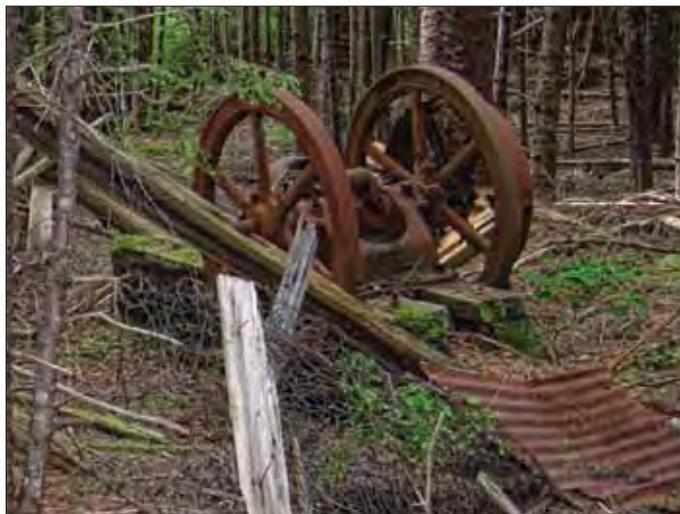
Part of an engine assembly is still mounted on its concrete pedestal in the forest.
