Funter Bay Cannery

Current Condition

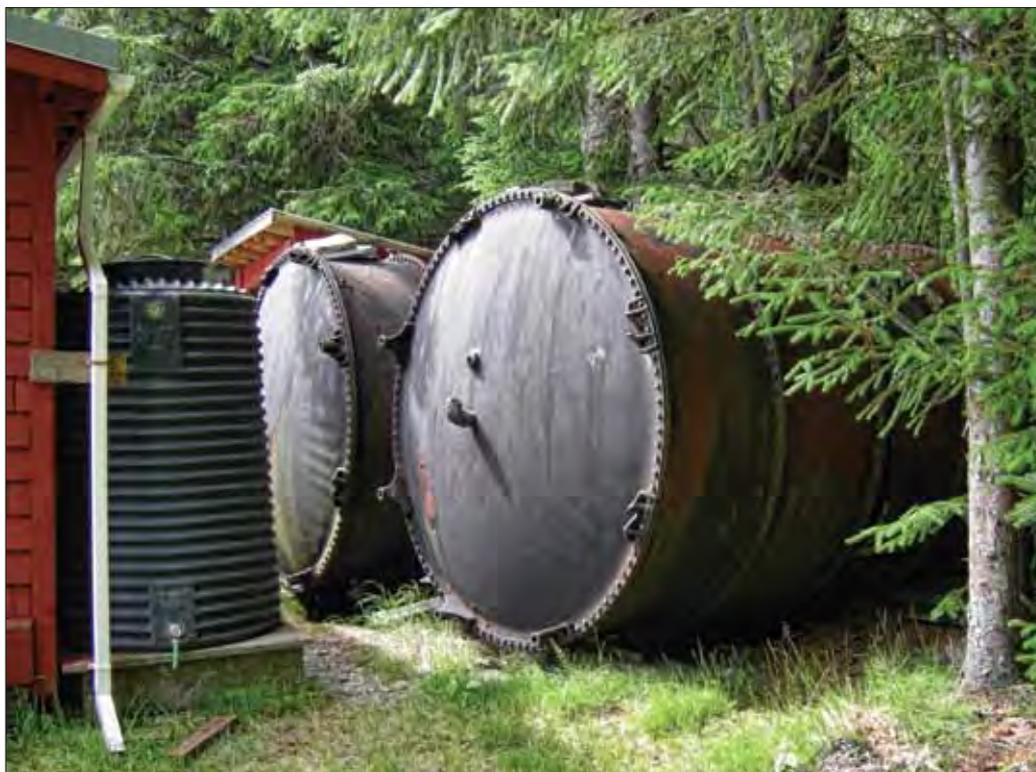
Figure 51.

Two large fuel oil tanks of about 1000 gallons each are located behind Gordon Harrison's cabin (left), probably in or close to their original position from the cannery days.

Several other features at the cannery are large but not stationary. Two cylindrical fuel oil tanks of about 1000 gallons each are located behind Gordon Harrison's house (Figure 51). They may be in their original position (Figure 25). The tanks are identical to the one beside the enclosed little water tank near the old watchman's cabin

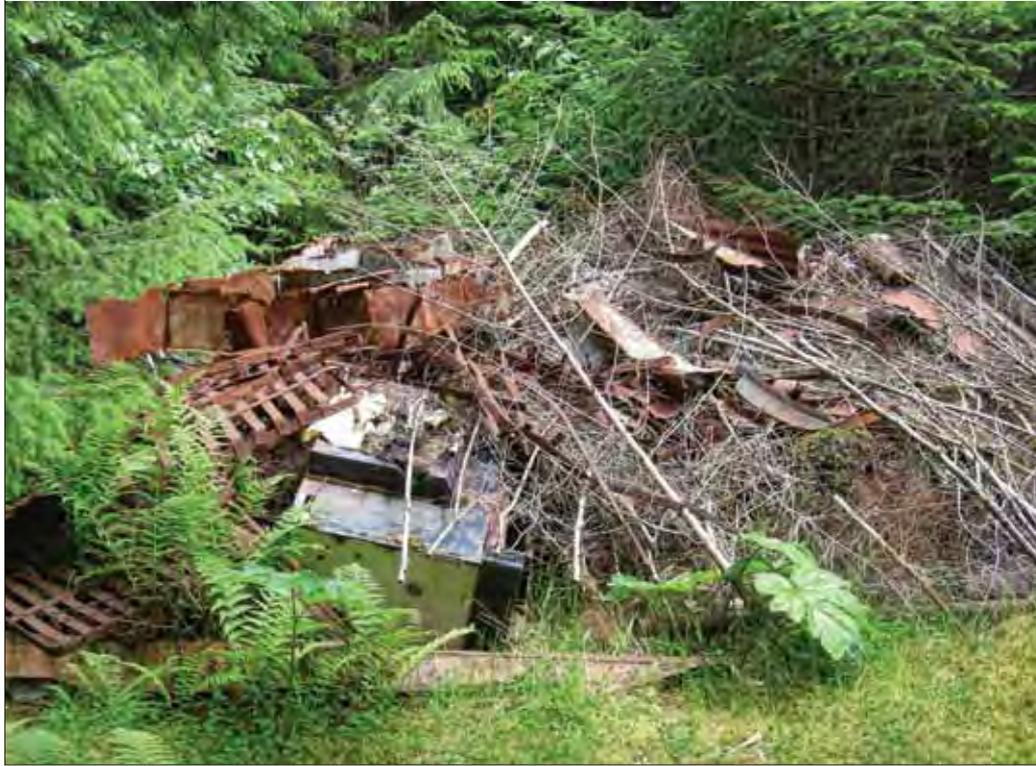
Figure 52.
North of the watchman's cabin is a large pile of metal cannery debris including the remains of many strap-steel trays or racks used to hold cans for loading into the retorts.

(Figure 33). A debris pile north of the superintendent's house site contains mangled strap steel representing dozens of racks to hold cans in the cannery retorts (Figure 52). The cannery grounds undoubtedly hold smaller features like coal scatters (Figure 53) that escaped observation during the brief 2008 investigation.

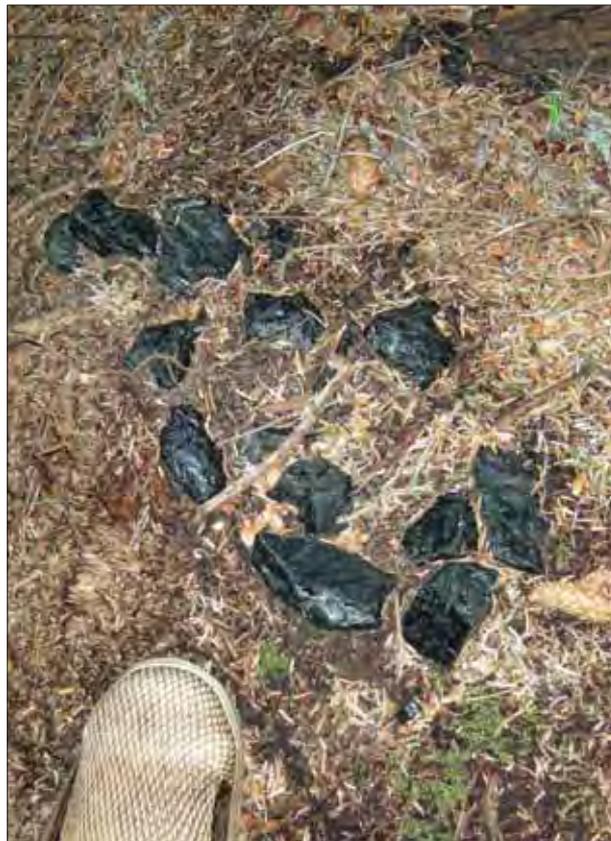
Figure 53.
Coal was used for domestic heat, as indicated by this small scatter noted in 2008 near the cabin with the magazine-papered interior.

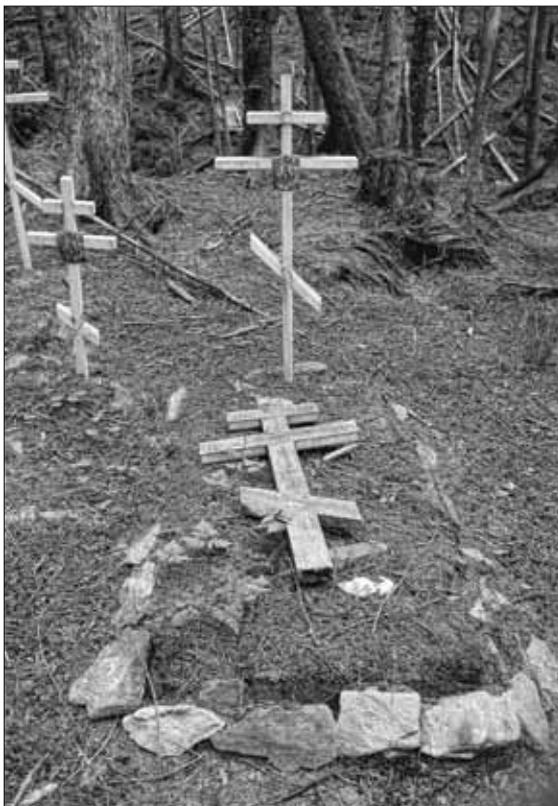
Figure 55.

Wooden Russian Orthodox crosses were replaced in 2000, and the originals were left inside the grave boundary.

white-painted wood Russian Orthodox crosses (Figure 54). The graves are roughly parallel and each has a marker at the end nearest the creek. Vertical wood plank borders that once outlined the graves (according to archival photographs) are gone and most of the graves are now outlined with rocks placed there in 2000 (Zacharof 2002). The wood cross at the head of each grave is made of 2"x2" stock, to replace older wooden markers made of 2"x4" stock which have been left inside the grave outline (Figure 55). Colorful paper-and-plastic icons have been affixed to the centers of most crosses, and at least one plastic flower arrangement was noted. Associated with five individual graves are stone monuments (of which at least one postdates WW II). The Aleut cemetery at Funter Bay is well-maintained under the remote circumstances. The 2000 "restoration followed Orthodox Church doctrine..." (Zacharof 2002). As part of this investigation, AHRS number JUN-975 was acquired for the site to distinguish it from the cannery property.
