**Funter Bay Mine**

### Early Years

### Current Condition

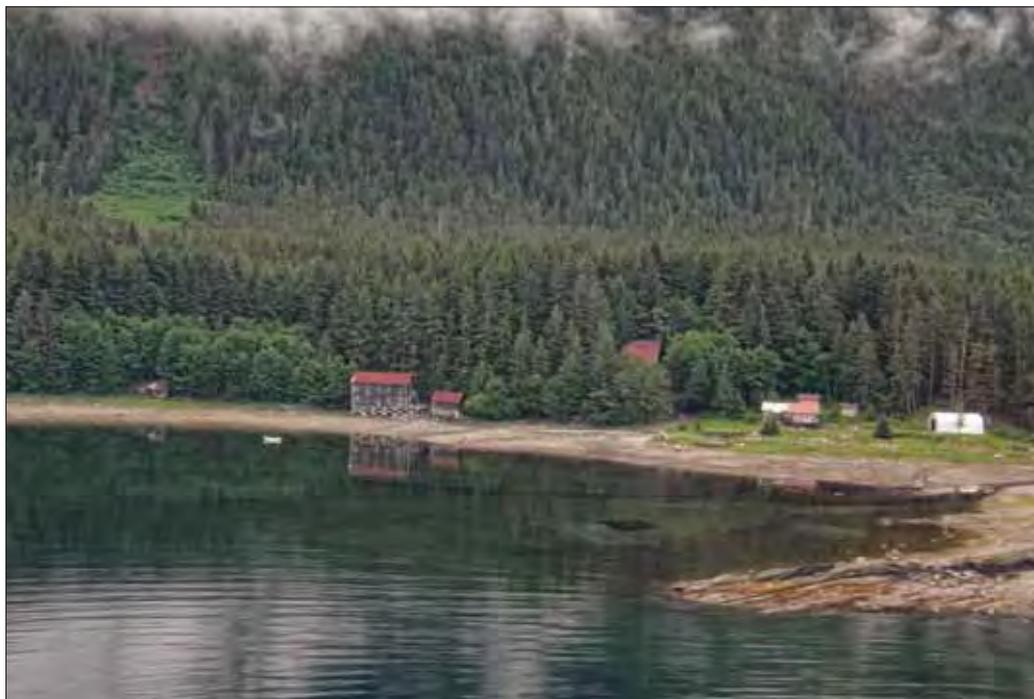
**Figure 57.**

*Historic buildings and building ruins of the Admiralty Alaska Gold Mine are visible along the shore of Funter Bay. From left to right are: the wash house ruin, the two-story bunkhouse, the shop, the roof of the mill (in trees right of center), the Sam Pekovich residence, and a modern prefabricated metal utility building.*

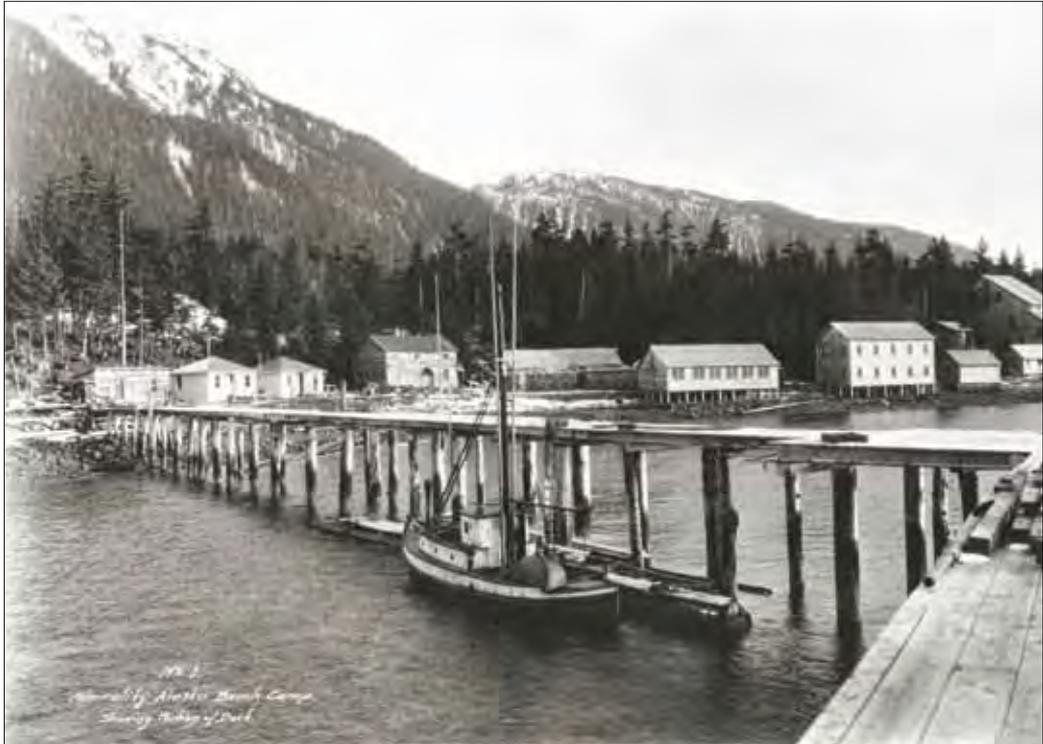
**Figure 58.**

Looking south from the dock around the early 1920s, the mill building of the Admiralty Alaska Gold Mine stands at far right. The two-story bunkhouse right of center was still in use in 2008, as was the tool shed immediately to its right.

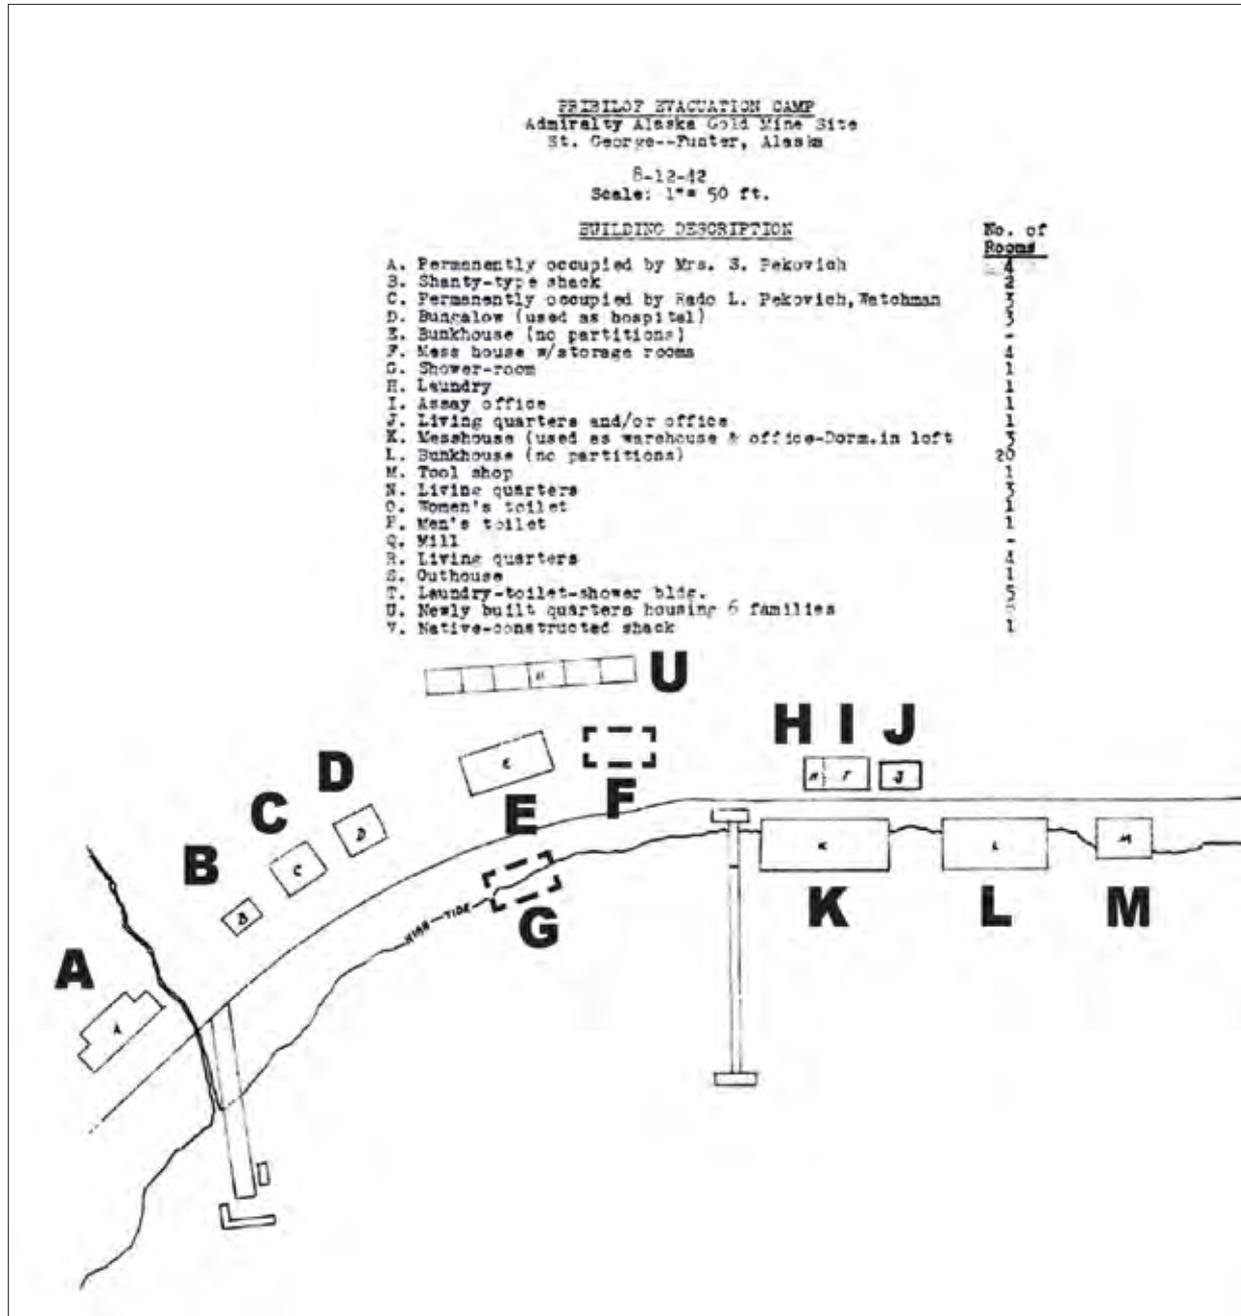
**Figure 59.**

A map of the Admiralty Alaska Gold Mine's mill and camp buildings made in August of 1942 (with bold letters added) shows a six-room building (U) built for St. George evacuees upslope from the original alignment of buildings. Building F is listed in the legend but was not originally plotted – it burned down soon after St. George villagers arrived. Building G was listed but not plotted – it was soon constructed at the tideline across from Building E. The tram and boardwalk alignment is indicated by a single line that parallels the shore and jogs inland at the corner of the mill (Building Q). The dotted line represents a domestic water pipe.

A map made in August of 1942 shows most of the original shoreline buildings described by Chipperfield seven years earlier (Figure 59). All the buildings were of frame construction. Dominating the shoreline was the tall mill building, measuring 40'x60', with its steep, conspicuous roof. A tram track from the upland workings dumped ore from a cart into the top of the mill to begin the processing system. In a typical mill of the period, the ore would fall onto a "grizzly" or grate and be sorted for feeding either directly into a battery of stamps or through a crusher first and then the stamps; from there the finely crushed ore would progress down through the mill across amalgamating plates and on to concentration tables (Sagstetter 1998:56). In 1935 Chipperfield noted that the ten stamps once operating at the mill had been removed. A photograph of a building said to be the assay office incidentally shows a pile of vanner rollers (Figure 60), providing more detail about the ore concentrations and sorting systems. Other major industrial features on the shoreline were a shop and an assay office, plus

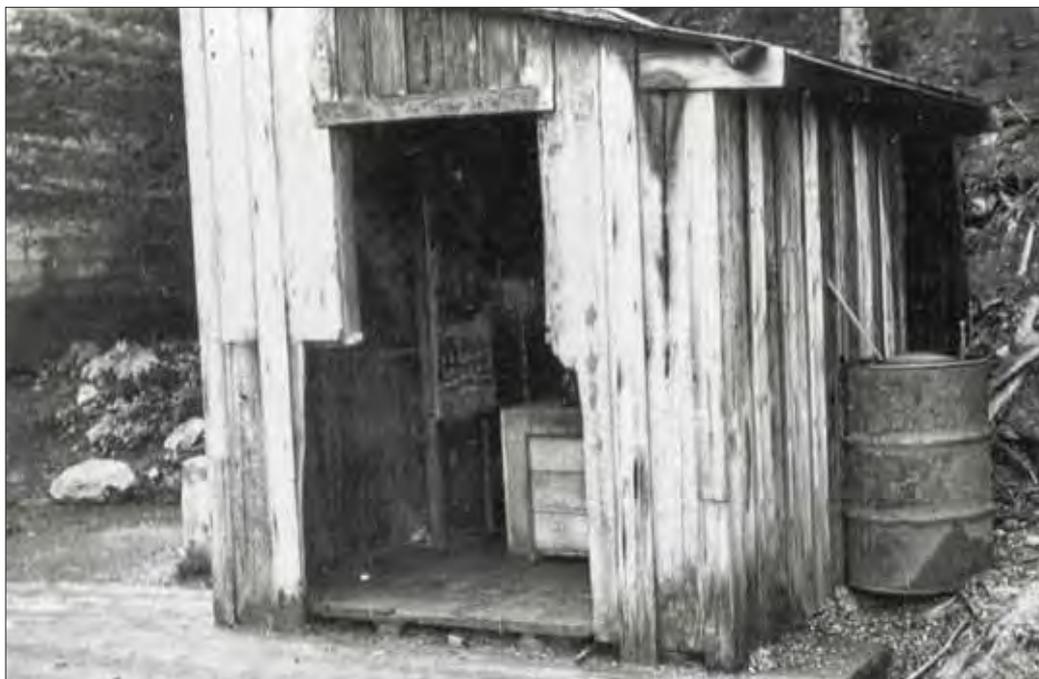
**Figure 64.**

*In contrast to the cannery's known outhouses on pilings over the intertidal zone, the Funter Bay mine had at least one outhouse on land.*

map and may have been attached to one or both wharfs extending into the bay. Two small buildings near the tide line identified as women's toilet and men's toilet (Figure 59) were almost certainly constructed for the mine's new wartime occupants. A wartime photograph shows a third outhouse on land upslope (east) of a shoreline boardwalk (Figure 64).

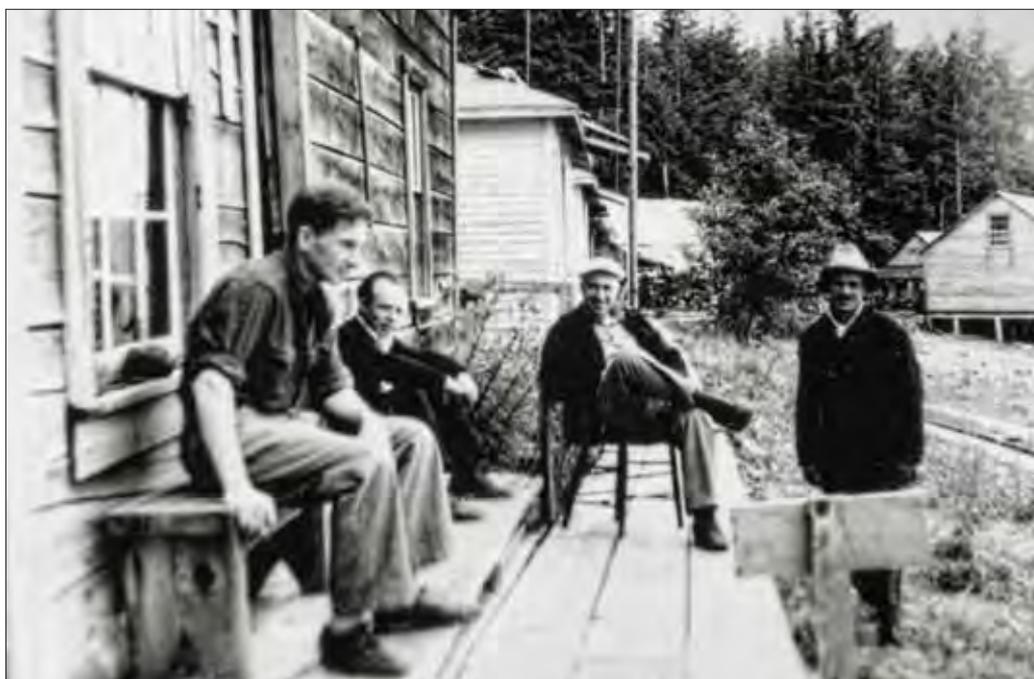
**Figure 65.**

*Mine watchman Rado Pekovich (right) talks with USFWS agents Lee McMillan (center), Carl Hoverson (left of center), and Roy Hurd (far left). At far right is the mess house (Building K). At far left is Building B with Buildings C, D, and E behind and center.*

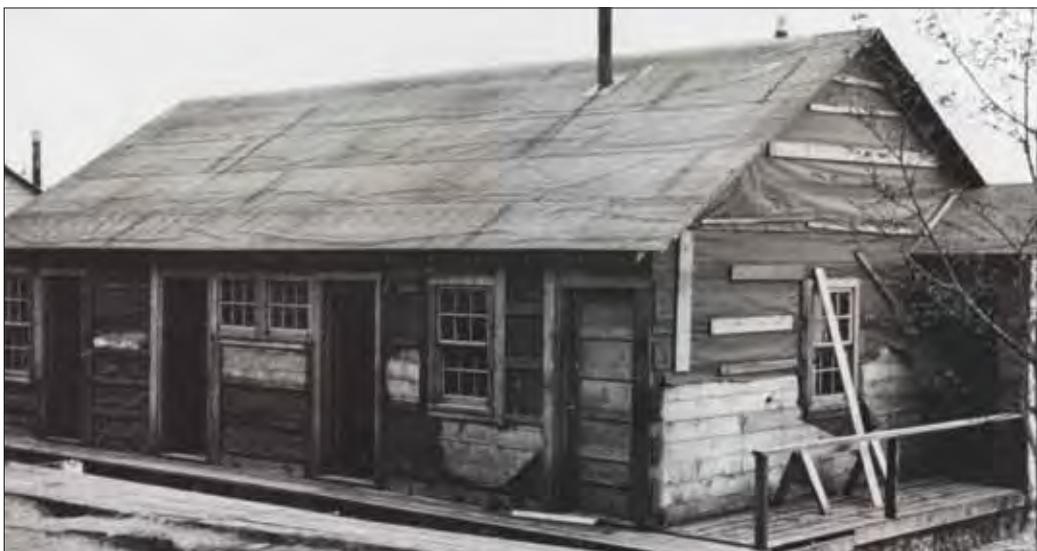
**Figure 70.**

The *Penguin's* 1942 shipment included materials to build a wash house (Building G) with showers, toilets, and a wood-fired hot water heater.

for a wash house (Building G) built on pilings at the high tide mark across from Bunkhouse E (Figure 70). The building had four doors facing east towards the boardwalk. Based on his post-war familiarity with the building, Sam Pekovich described the south room as containing a wash room and a one-hole privy against the wall over the beach. The next room north contained three toilets. The room after that contained three showers. The north room contained a woodstove and boiler, a 300-gallon wood water tank, and a 4-kw generator that likely postdated the war period. In 1944 ten surplus Army Quonset huts were brought to Funter Bay, of which two were erected at the mining camp on the water side of the boardwalk across from the assay office or Building N (Zacharof 2002).

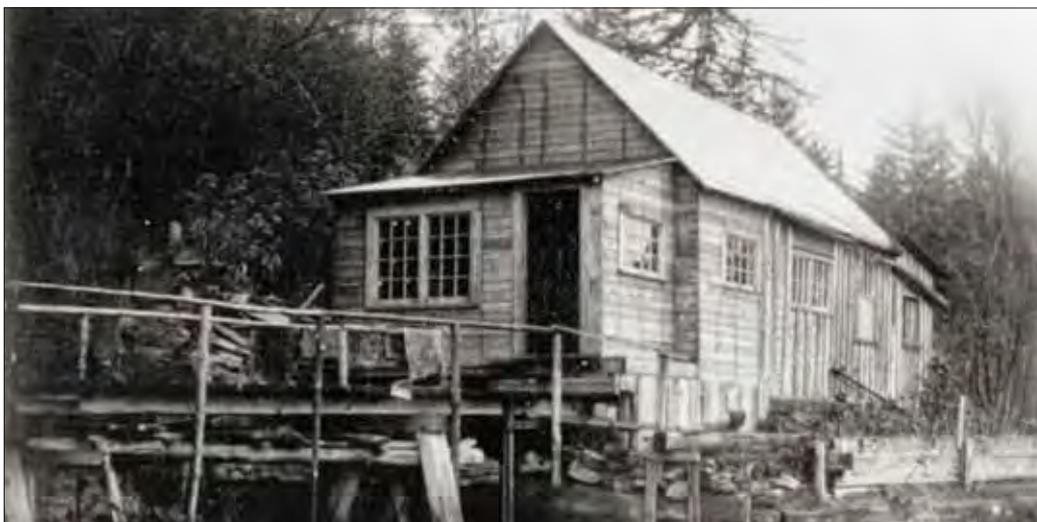
**Figure 71.**

A house (Building R) above the tide line at the far south end of the mining camp was the home after the war of Pekovich family matriarch "Smiley" Jukich. It was moved to make room for a prefabricated metal utility building erected in about 2005.

The camp has seen some changes in its building inventory in recent decades. Building T at the south end of the camp was remodeled and enlarged by Sam Pekovich as a second residence to his home in Juneau. The dwelling (Building R) at the far south end of the complex (Figure 71) was removed and a modern prefabri-

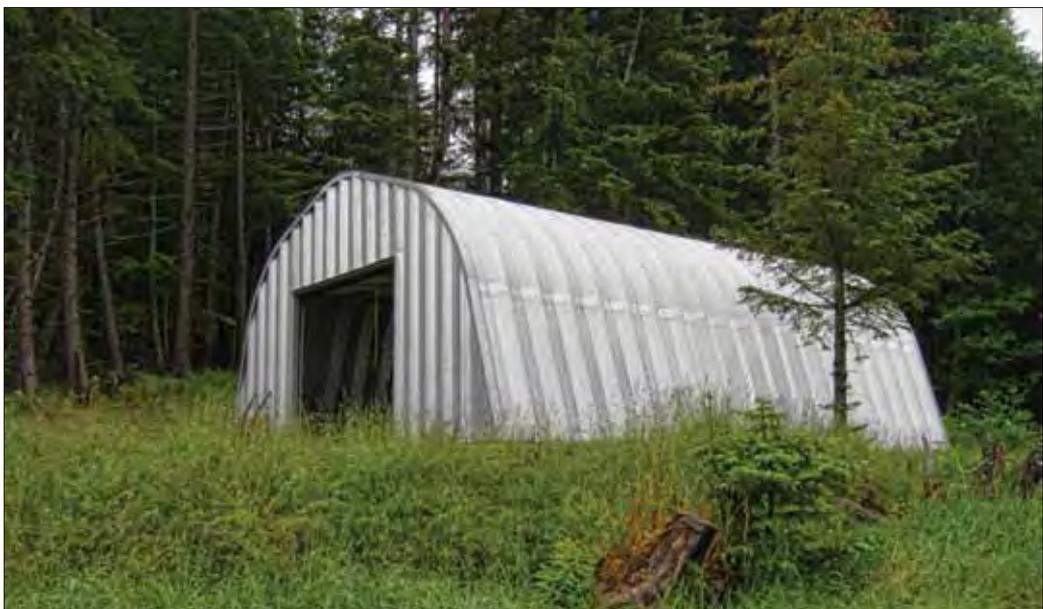
**Figure 73.**

A prefabricated metal utility shed stands near shore at the far south end of the mine camp.

ic Building T that has been remodeled into a home, the two-story bunkhouse (Building L), a small shop (Building M), and three small sheds. The prefabricated building has an arched roof and walls made of windowless metal panels with ribbed joints, with a vehicle entrance at one end (Figure 73). The building was erected 20’-30’ from shore at the south end of the site in about 2005. Other storage sheds consist of two small gable-roofed buildings clad in T-111 serving Building T, and an older (but not wartime) gable-roofed shed immediately southwest of the Quonset hut. The latter building is sided and roofed with corrugated metal sheeting, and is windowless (Figure 74).

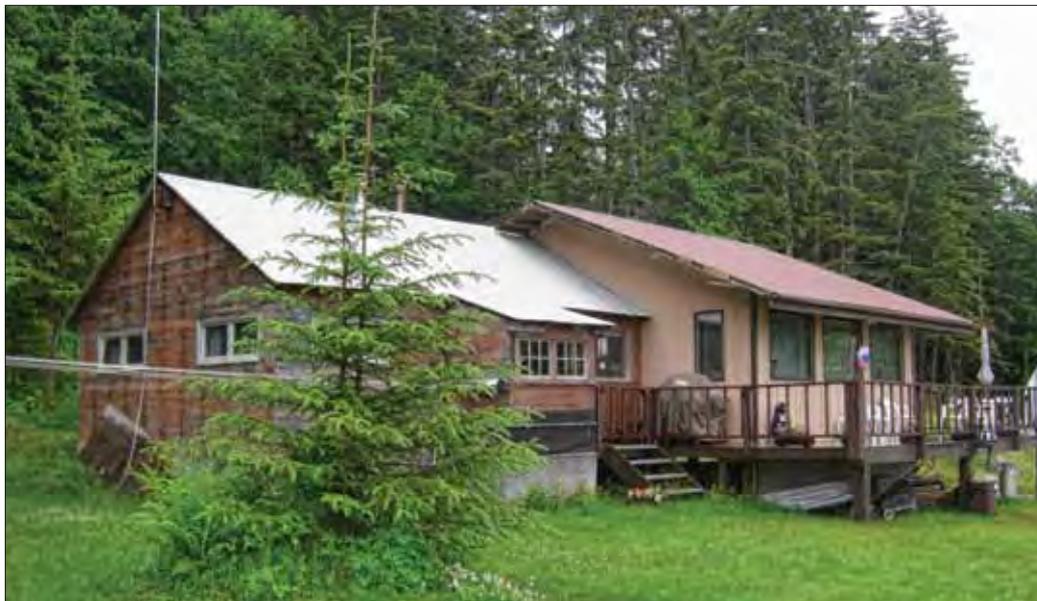
The modern home of mine caretaker Sam Pekovich is composed of a modern addition (right) attached to original Building T (left). View is south.

components have a metal roof. The addition is clad with T-111, while the original building is unclad and has nail-stains on the weathered horizontal boards that show the stud patterns. The older building has an enclosed entry facing the water and another facing inland, each with a simple plank

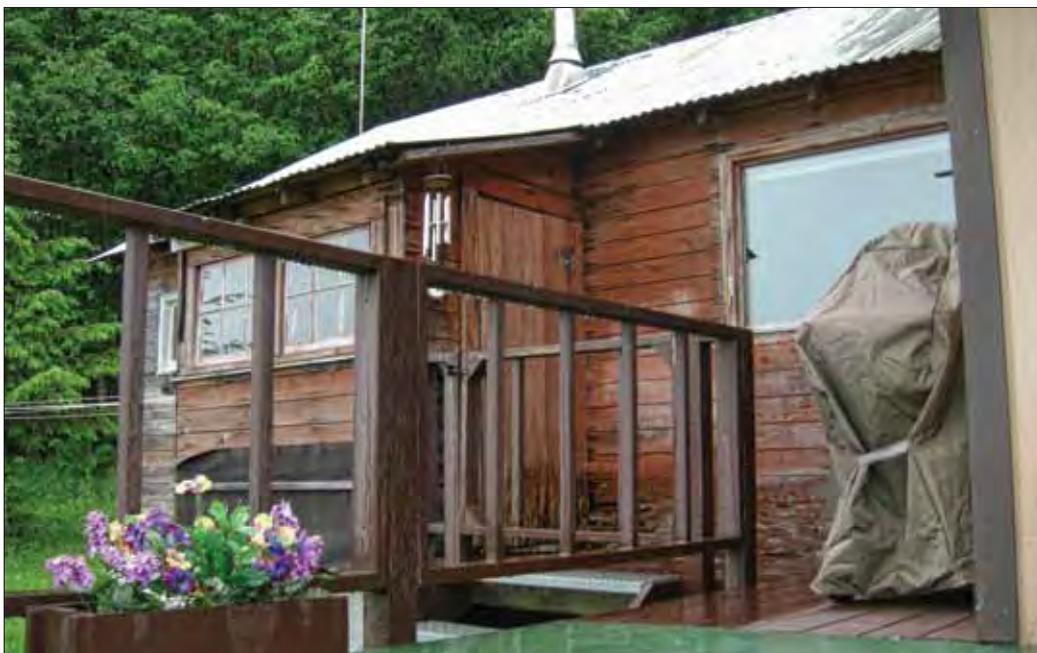
**Figure 76.**

In 2008, Building T still retained two original plank exterior doors, including this one (compare with Figure 62).

exterior door. Both front and back doors are original wartime fixtures (compare Figures 62 and 76). Whereas the building once had only six-pane fixed windows (Figure 62), now all but two in the front entry have been replaced with single-pane windows (Figures 75-76).

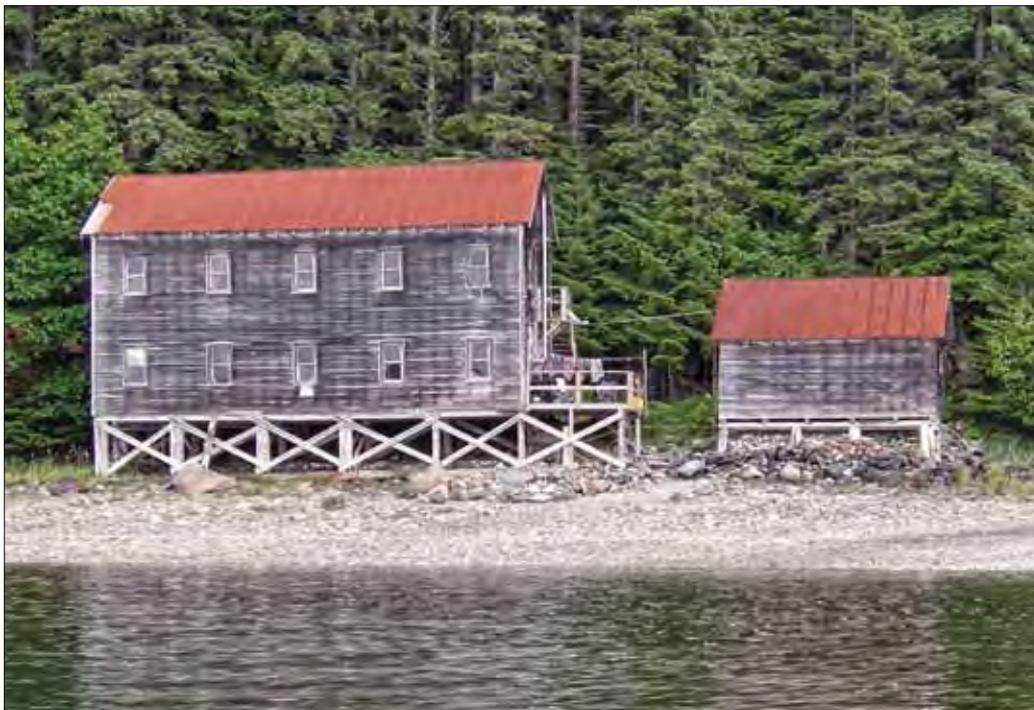
*Conspicuous reference points in Funter Bay are the mine's original two-story bunkhouse (Building L) and warehouse or shop (Building M) – both on pilings over the intertidal zone.*

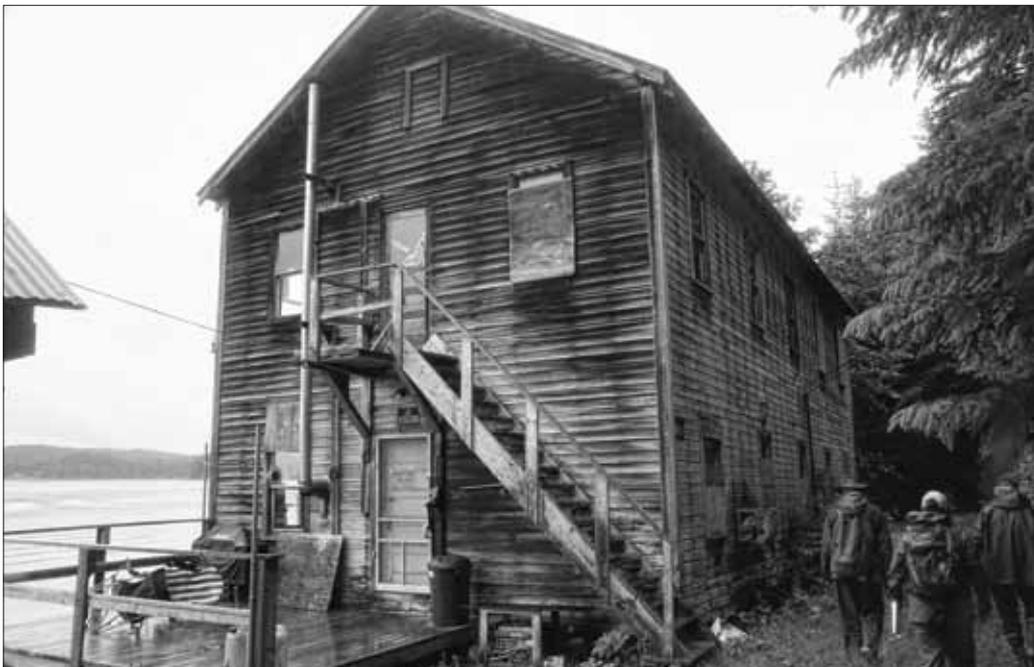
**Figure 78.**

*The bunkhouse (Building L) was home to one full-time resident in 2008.*

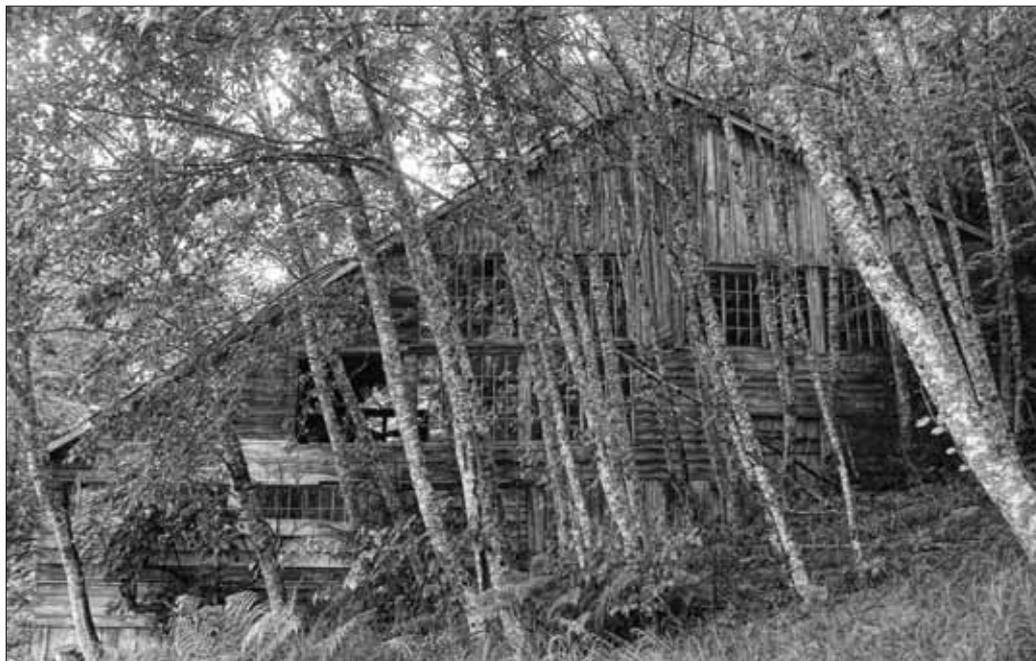
*In 2008 the mill (Building Q) was a large frame building full of original equipment, but collapsed timbers and flooring made it too dangerous to enter beyond a couple steps inside one door. Snow the following winter collapsed the building.*

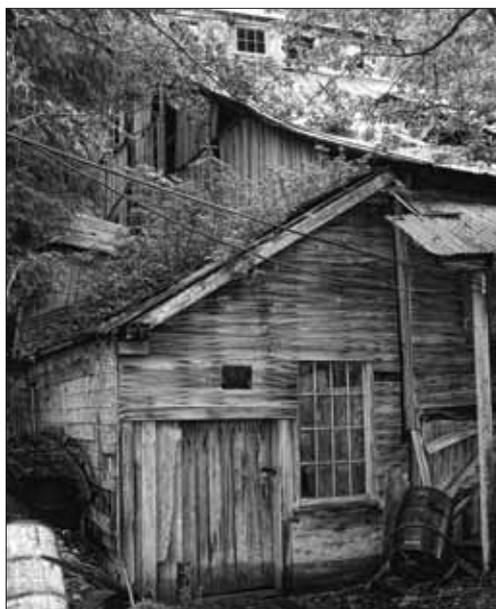
**BOTTOM LEFT**

*The mill's windows were relatively intact and still held most of their glass panels.*

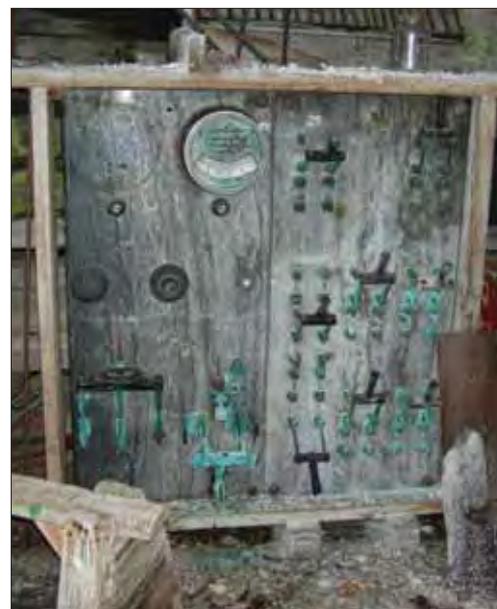
**BOTTOM RIGHT**

*The mill contained a Westinghouse electrical switchboard with copper breakers.*

place in 2008, on the bottom floor midway along the south wall. A large Westinghouse switchboard with copper breakers remained in the building (Figure 83). A large metal lathe

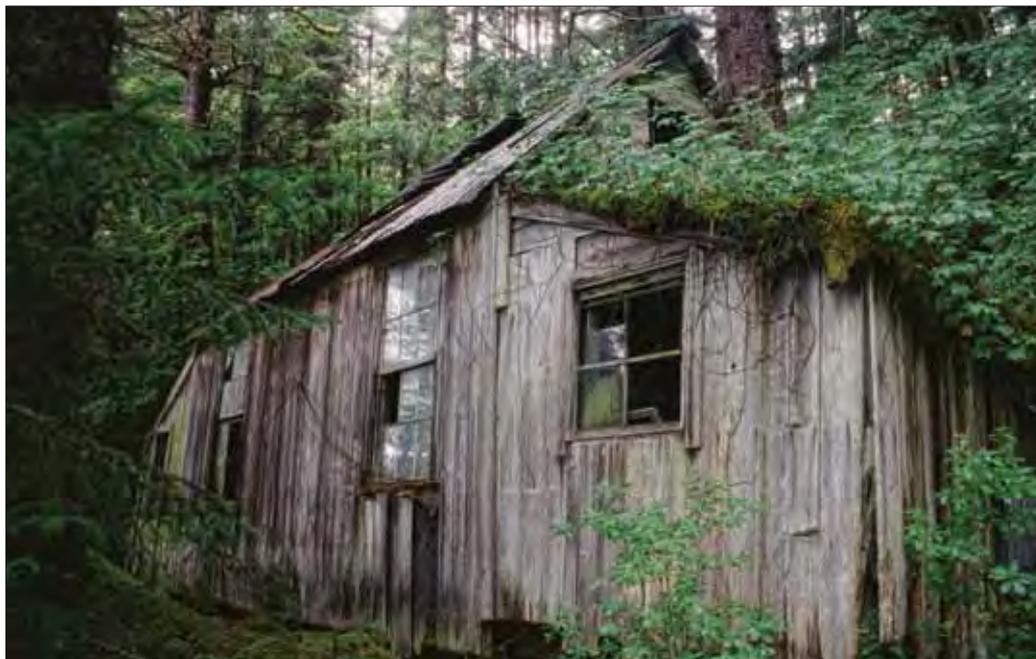
**Figure 84.**

*Building A is an unused one-story gable-roofed cabin with shed-roofed rooms at each gable end.*

shore and a shed-roofed entry facing south (Figures 84-85). One of the two (Building A) has a second shed-roofed room on its north end (Figure 84). Each of the cabins has vertical plank siding, corrugated metal roofing, and windows with four and six panes. The

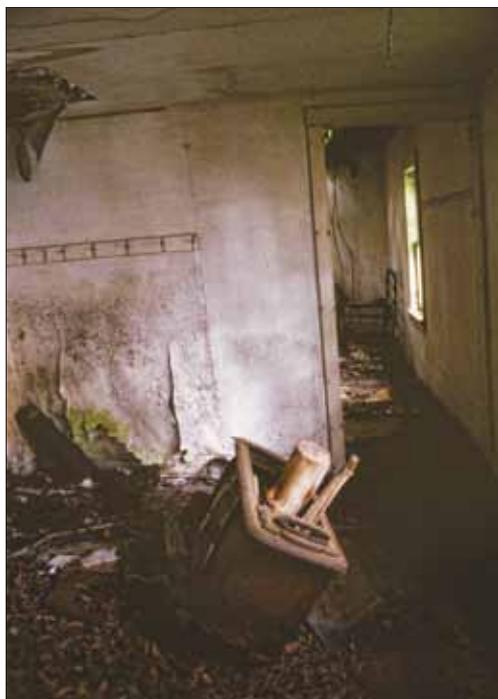
**Figure 86.**  
*Dilapidated beaverboard covers the walls and ceiling of Building A.*

second of the two cabins (Building J) still shows remnants of red paint (Figure 85). Building A's interior (Figure 86) is similar to that of Building J, with tattered beaverboard walls and ceilings. Its domestic function is evidenced by a derelict wood stove, a built-in ironing

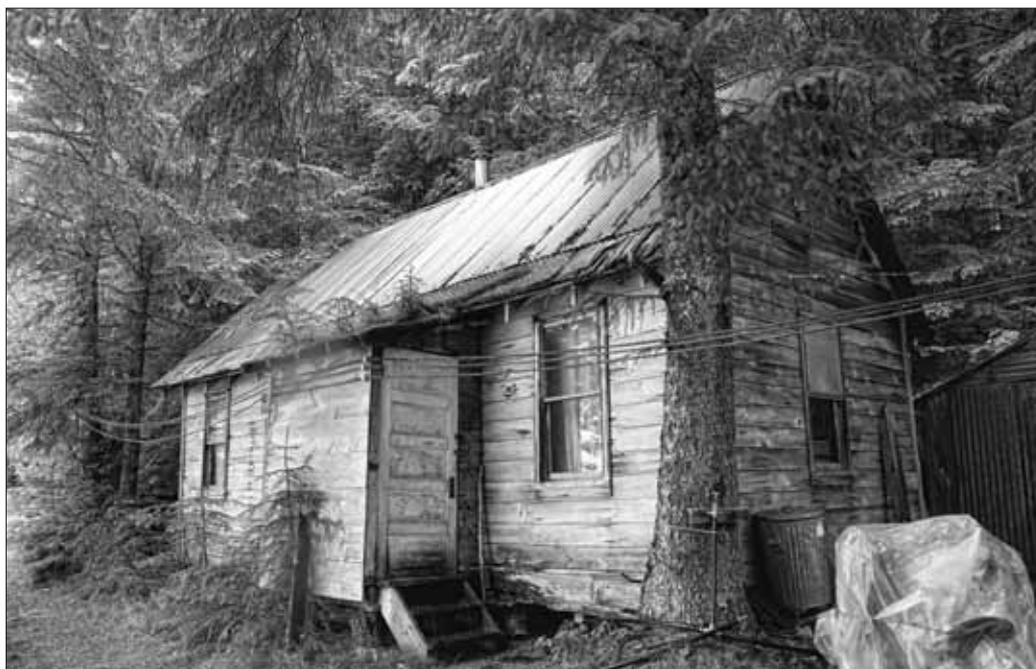
**Figure 87.**  
*Building N is an unused one-story building ruin once serving as a residence and an office.*

Plotted as Building N in 1942 is a one-story building variously used as a residence and an office. The building is of

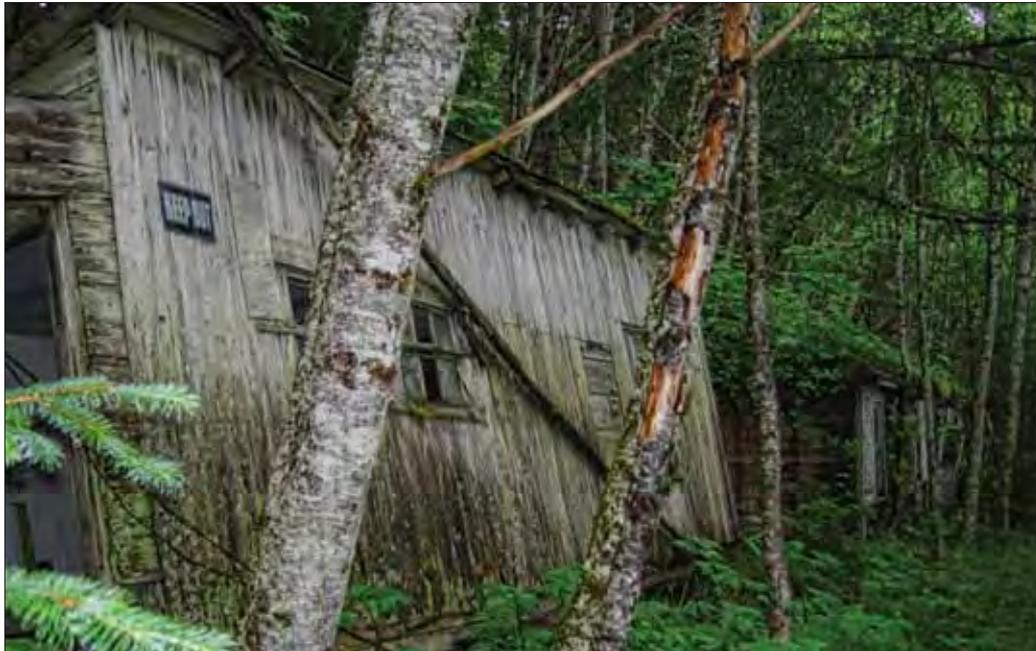
**Figure 88.**

*Building B at left lists inland due to a failing foundation. At right are the pair of hip-roofed cabins – Buildings C and D.*

During the Aleut experience the main approach to the mine was by way of the north dock (Figure 58), which disembarked passengers to the tramway/boardwalk running the length of the camp and deposited them before three buildings in a row. Remains of the three – Buildings B, C, and D – were easily distinguishable in 2008. Building B is a shed-roofed building with vertical plank siding and a decided list away from the water due to foundation failure (Figure 88). The porch upon which federal officials were photographed in 1942 (Figure 65) is no

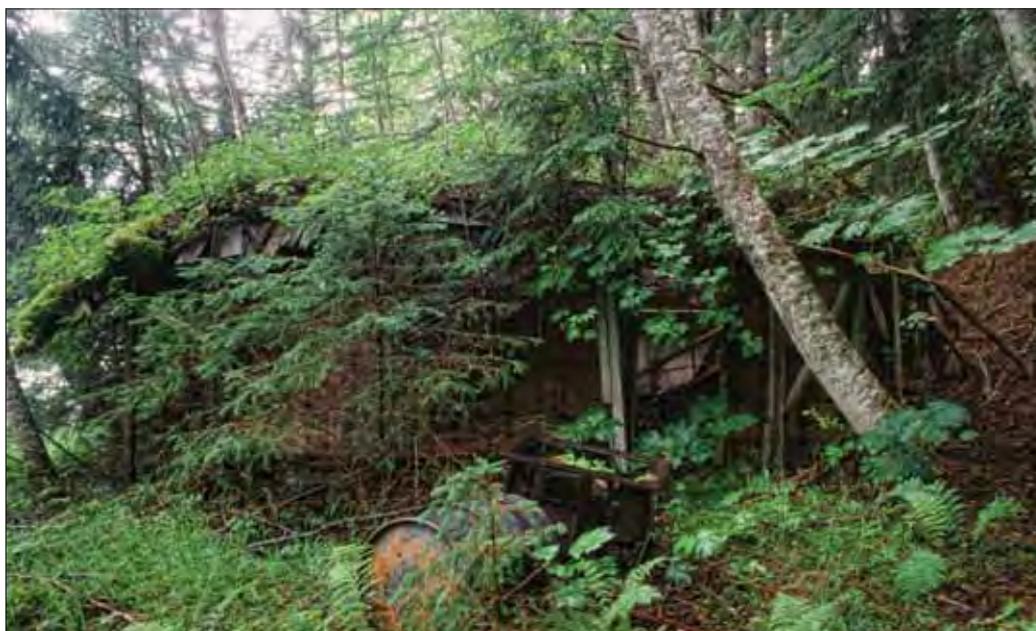
**Figure 92.**

*The remains of Buildings C and D, here looking north, are overgrown with vegetation.*

Immediately south of Building B are the remains of Buildings C and D – a pair of pyramidal hip-roofed residences that stand out from the mining camp’s other gable-roofed buildings (Figure 58). Both have failing foundations, roofs, and walls, and both are being reclaimed by forest vegetation (Figure 92). The 1942 map (Figure 59) says Building D was “used as hospital,” but nothing inside would suggest that function.

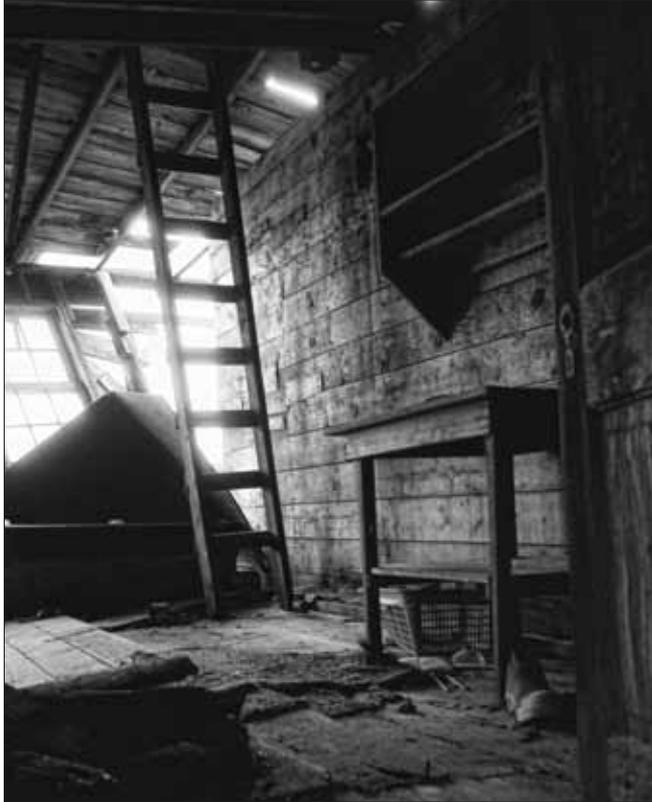
**Figure 93.**

*The foundation of the 1942 wash house (Building G) is failing and the north third is mostly destroyed, but the south two-thirds (shown here) are relatively intact. Compare with Figure 70.*

*The wash house still holds remnants of its interior furnishings.*

The wash house built in late 1942 for St. George villagers (Figure 70) is slumping into the intertidal zone north of the two-story bunkhouse. The one-story frame building’s foundation is

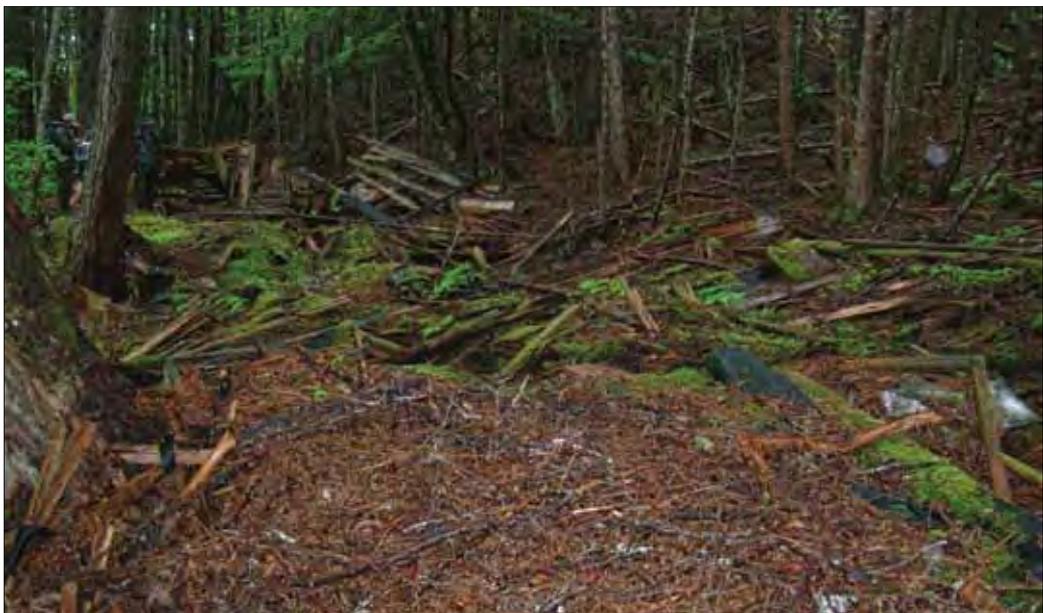
*The ruin of Building U is a rectangular jumble of planks on a bench 40' above the waterfront buildings. Compare with the same perspective in Figure 69.*

Another ruin of a building constructed during the war is on a bench upslope, or east, of the boardwalk alignment. Building U is listed on the 1942 map

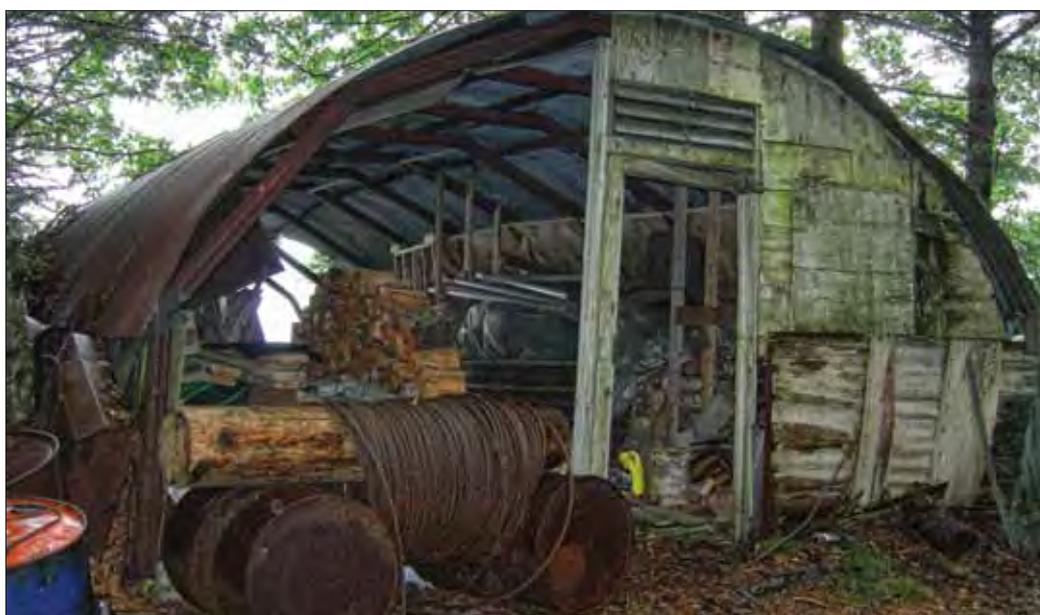
**Figure 96.**

*One Quonset hut is located between the boardwalk and the shore of Funter Bay.*

One Quonset hut is located along the waterfront side of the shoreline tramway/boardwalk, between Building M (Figure 74) and a post-war corrugated utility shed. The exterior wooden partitions at each end are badly deteriorated, and the building leans to the north (Figure 96).

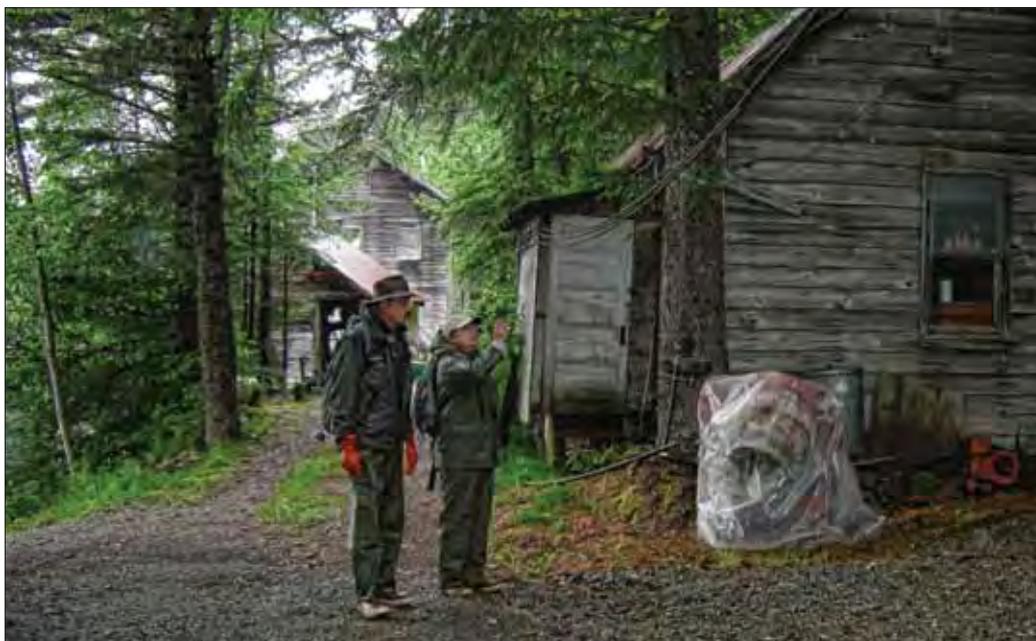
*The tramway and boardwalk alignment connecting the shore buildings is now a narrow gravel track, visible here behind Joe Giefer and Becky Saleeby. Behind them is the shop (Building M) and two-story bunkhouse (Building L). At right is Building N.*

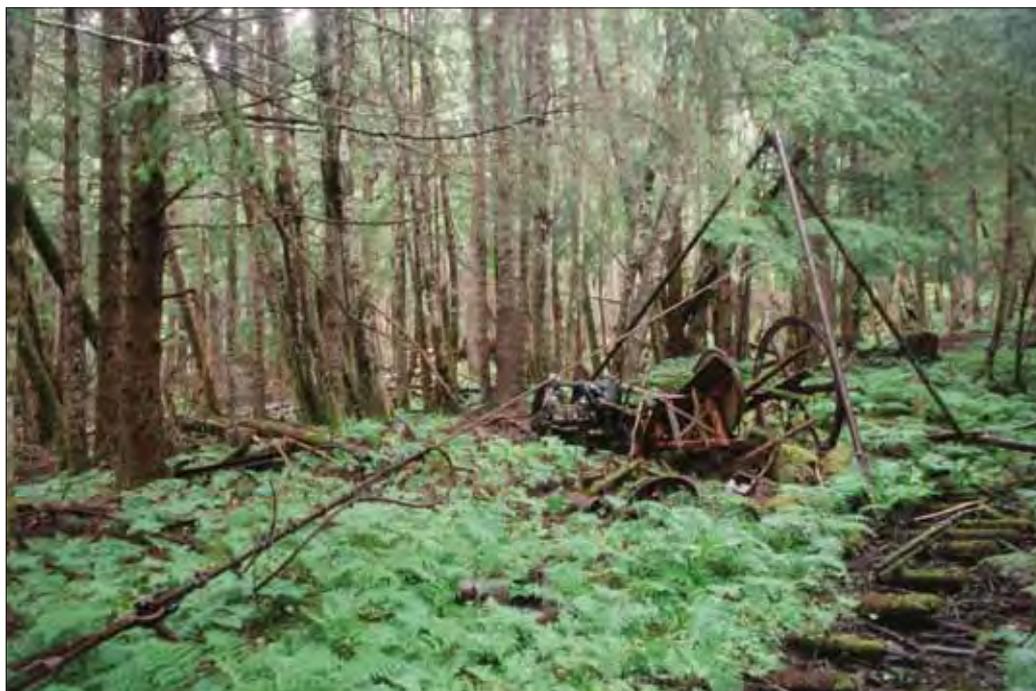
**Figure 98.**

*The tramway's steel rails lead inland from the mill building to an overhead tramway station, consisting of hoisting equipment and a still-taut steel cable leading to workings high on the side of Robert Barron Peak. Note ties and rail at lower right.*

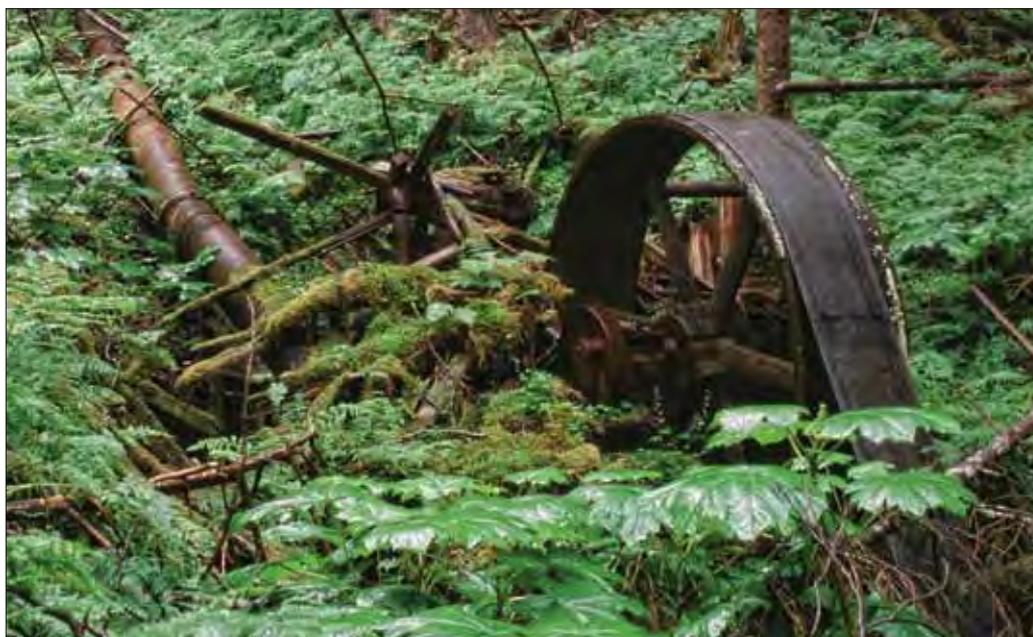
*The forest is reclaiming a large Pelton wheel that once provided electricity for the mining camp and the lower workings.*

While the overhead tram appears to have been powered by a gasoline or diesel engine, evidence of two other power systems was observed inland

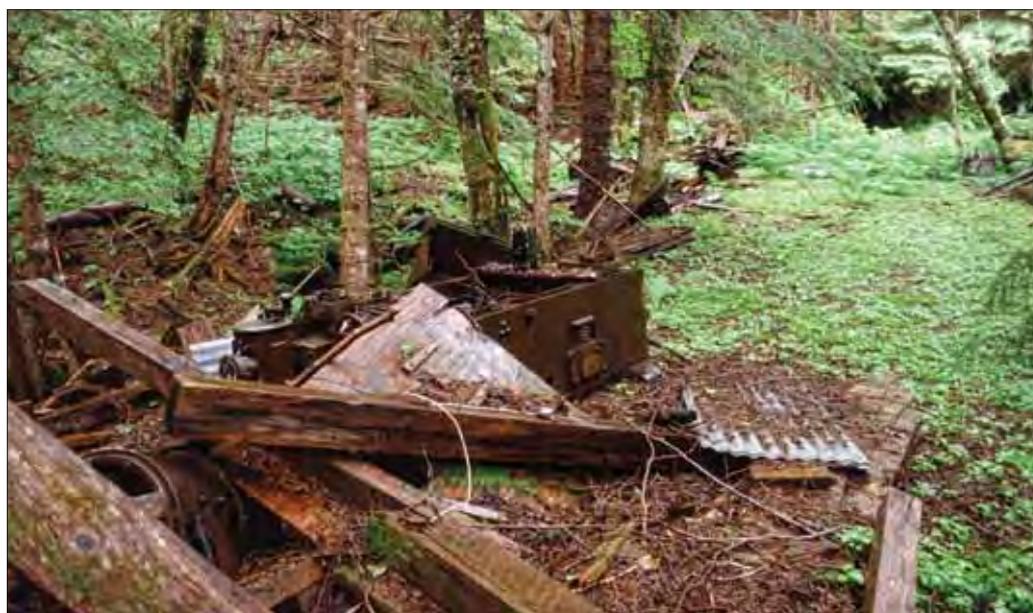
**Figure 101.**

*Buildings around the two adits (upper right) of the lower workings have collapsed, leaving mounds of rusty mining equipment. At center is an electric locomotive.*

The lower workings consist of numerous mining features centered around two adits (Figure 101). Each adit entrance contains steel rail from the tram system, and one has an ore cart blocking the way. Both are obviously too dangerous to enter and are signed to that effect. Waste rock from the adits forms an artificial bench upon which the remains of buildings can be discerned, but in 2008 they consisted of little more than rotten plank piles over metal equipment and debris. That equipment includes an electric locomotive (Figure 101), a mucker, and drills and bits. Off the waste rock at a slightly lower elevation are other building ruins, one of which contains an air compressor. Vehicles noted in the vicinity included a tractor and a two-ton Chevrolet dump truck with dual wheels.
