HISTORIC STRUCTURE REPORT

CAPTAIN EDWARD PENNIMAN HOUSE

Cape Cod National Seashore
Eastham, Massachusetts

1985

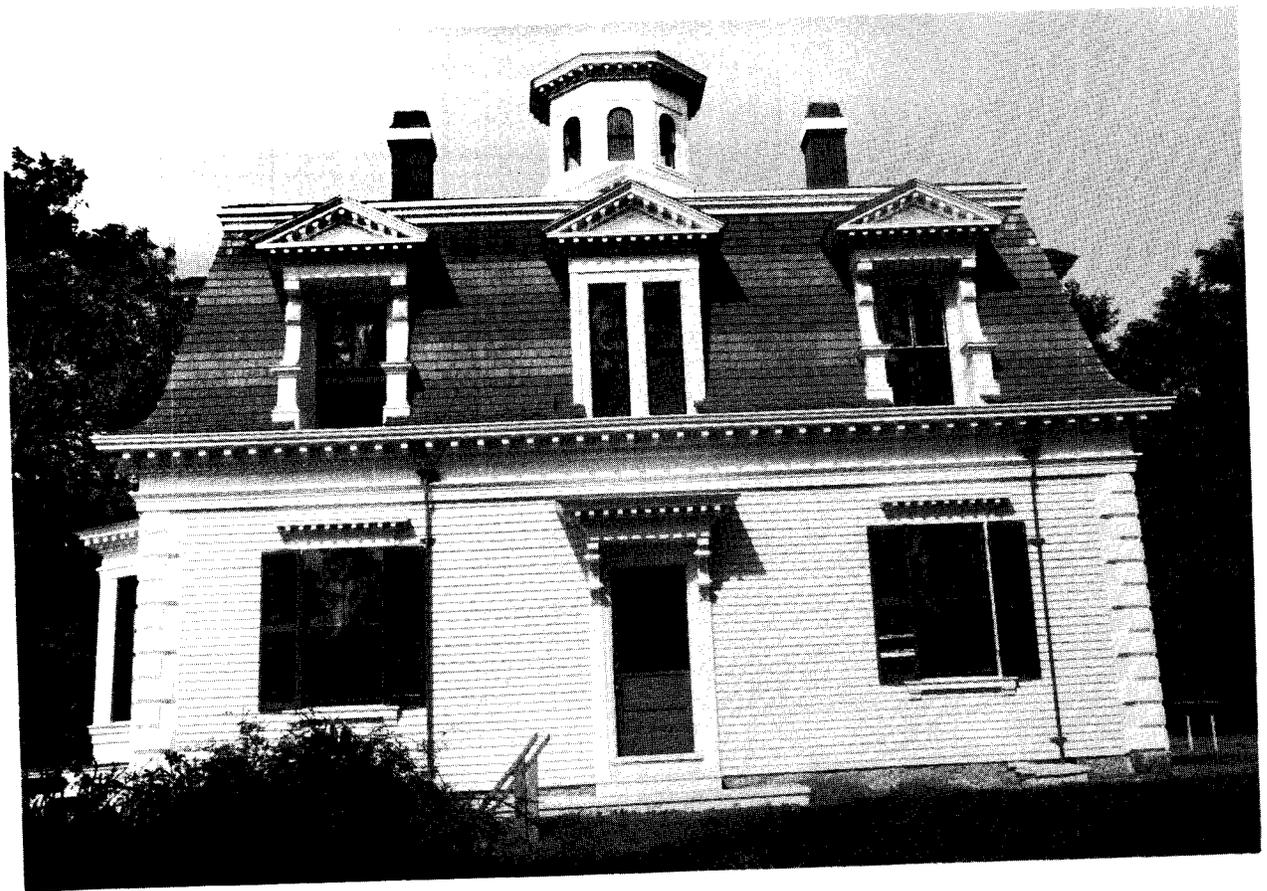
Illustration 2. Penniman House: East Facade (1984).

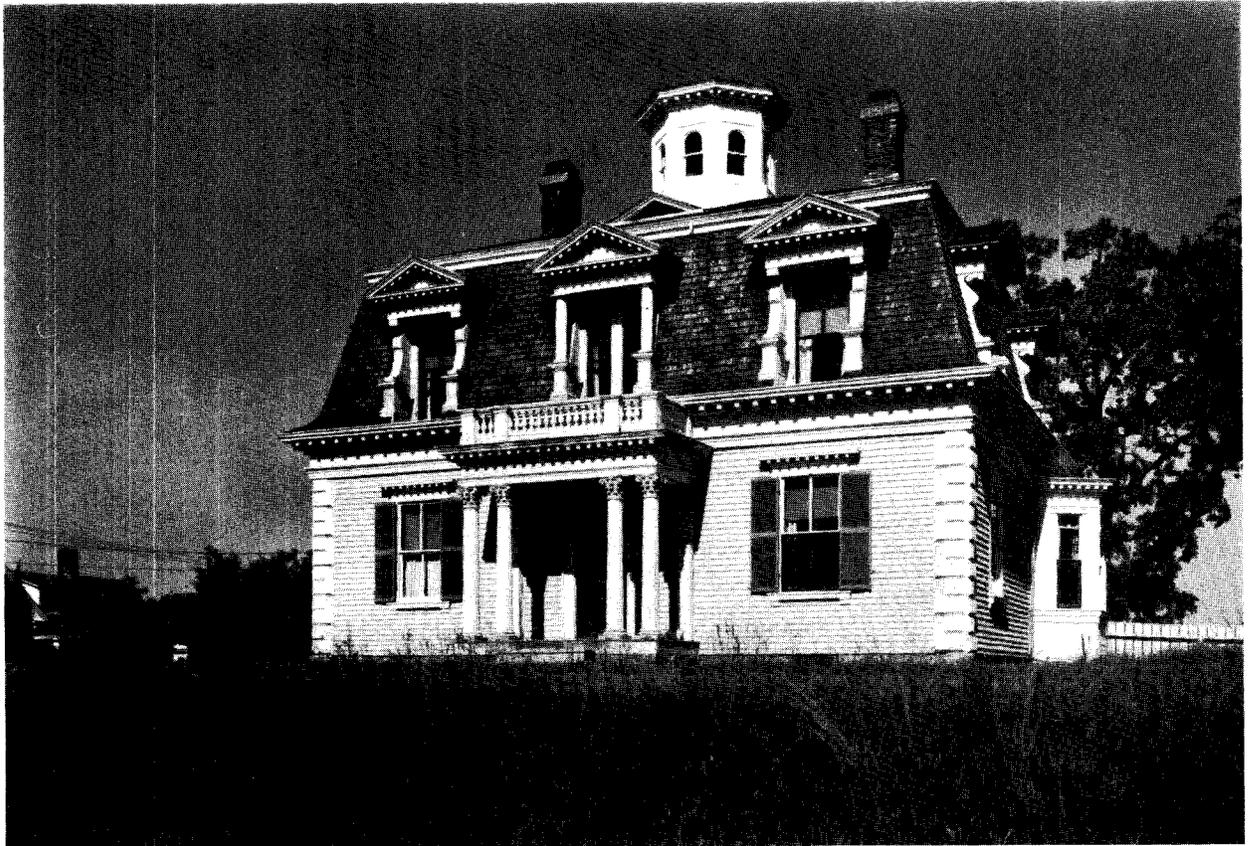
Illustration 20. Diagram of Colored-Glass Panes in Upper Sash
of North-Facade Bay Window (1984).

Sash. The bay windows contain three double-hung windows (Ill. 19). The upper sash in the side windows measures 1 foot 7 inches wide and 2 feet 11-1/4 inches long. The single panes of glass in the side windows measure 1 foot 3-1/2 inches wide and 1 foot 8 inches long. The center bay windows are the same size as the single, first-story windows. Originally, both the north and south bay windows had clear glass (Ill. 8). By ca. 1890, the glass in the upper sash in the north bay window had been replaced with small panes of colored glass. The shapes and colors of the panels of glass are shown in Illustration 20.

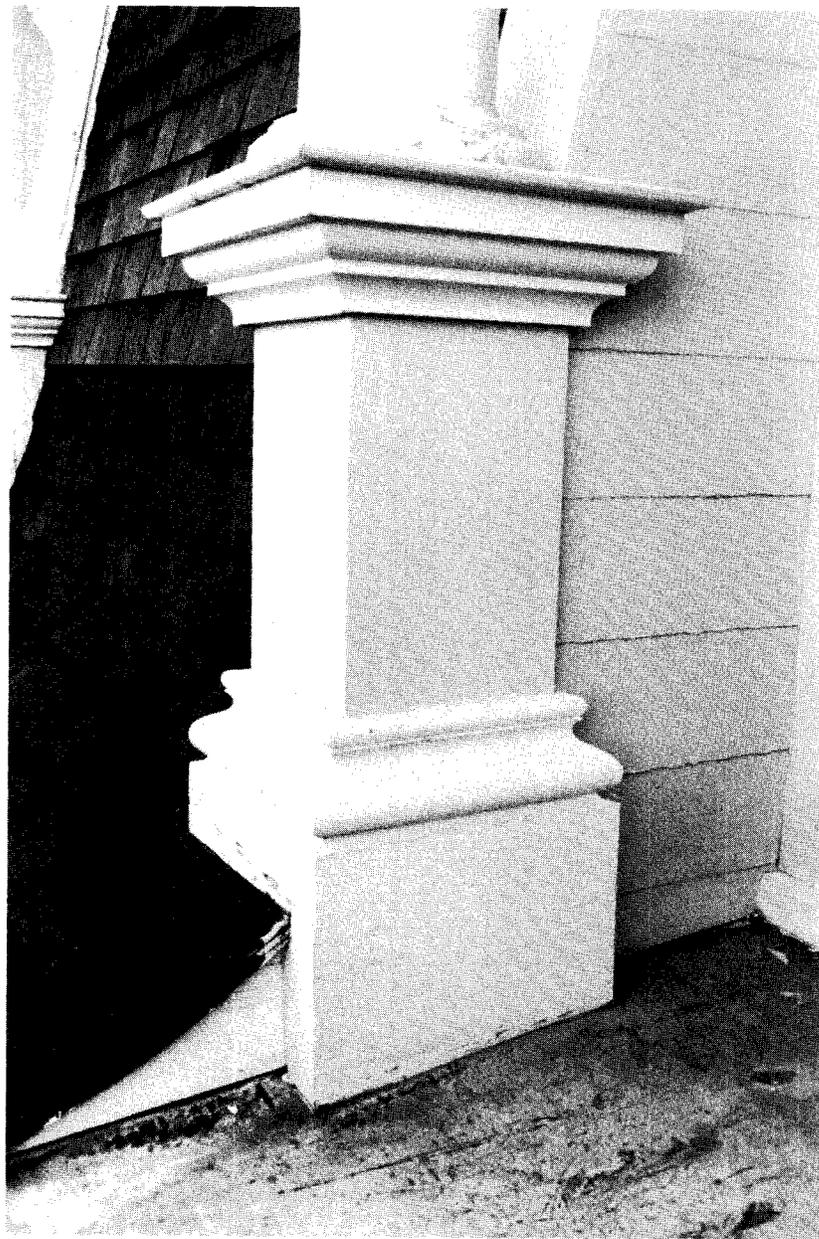
Illustration 29. Penniman House: West Facade, Pedestal
for Colonette of Center Dormer Window (1984).

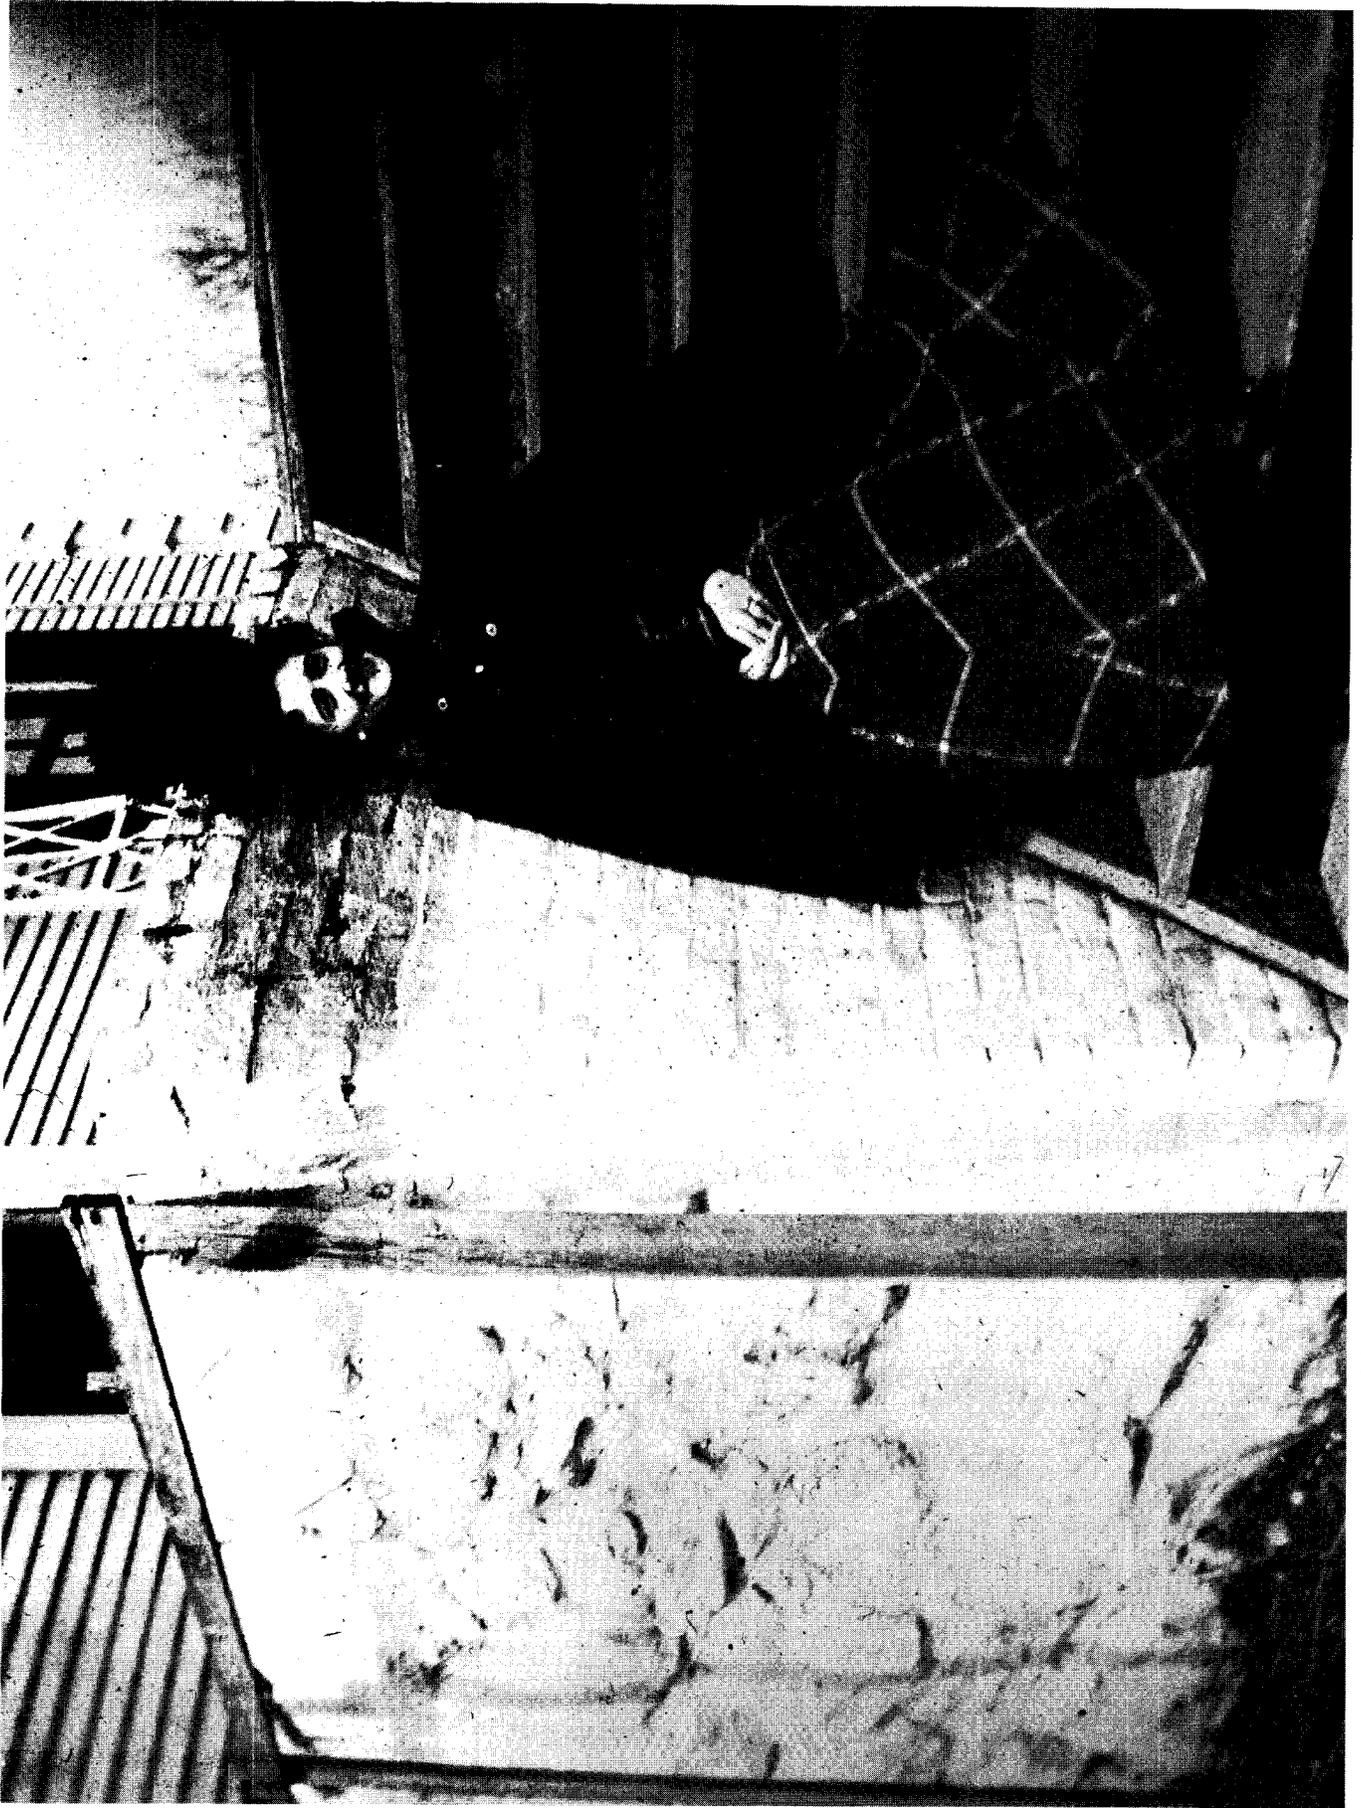
Illustration 38. Penniman House: East Facade and Courtyard,
Showing Part of East-Entry Door (Circa 1890).

The original east entry door has been replaced, and the only reference to it in the specifications is that the "back door to be 1-3/4 inch thick." Therefore, most of the information about this door must be gleaned from the historic photographs. The opening for this door measures 3 feet by 6 feet 11 inches. Illustration 38 shows the door with four panels, the lower two of wood and the upper two glazed. The wooden and glazed panels are surrounded by a wooden molding. The profile of this molding is unknown, but probably either matched the molding on the west exterior door or on the interior doors. Nothing is known about the original back door hardware.

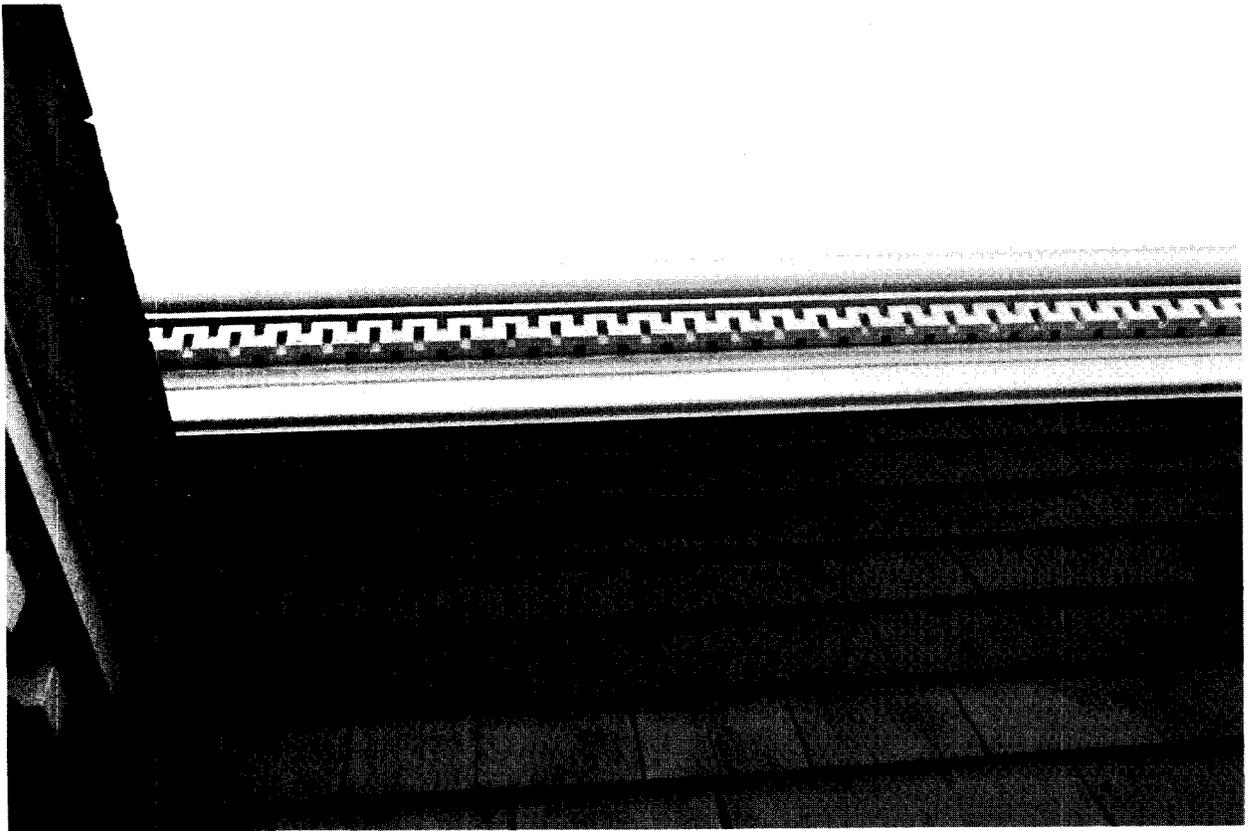
Illustration 39. Penniman House: Trim at Curb of Mansard Roof (1984).

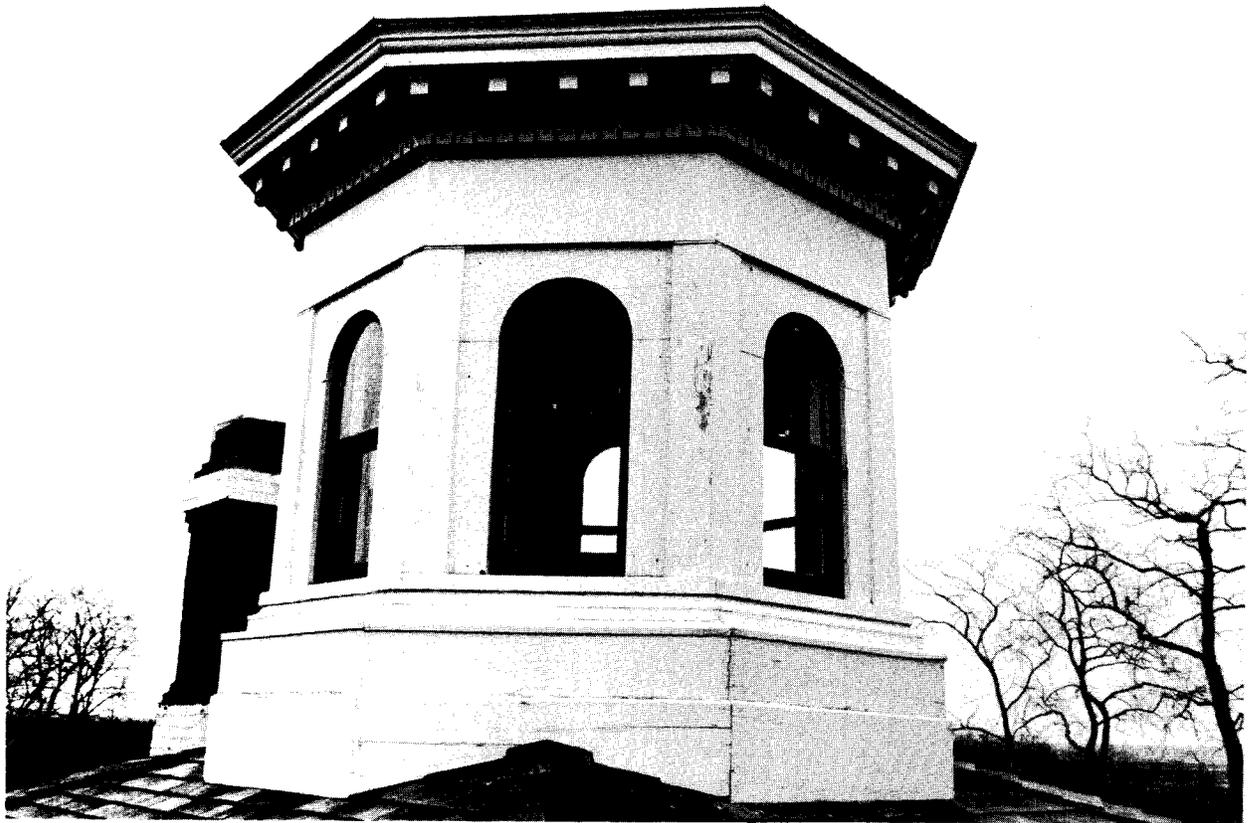
Illustration 42. Penniman House: Cupola (1984).

The original tin covering was replaced with modern sheet metal at some point--probably lead-coated copper in 1964-65.

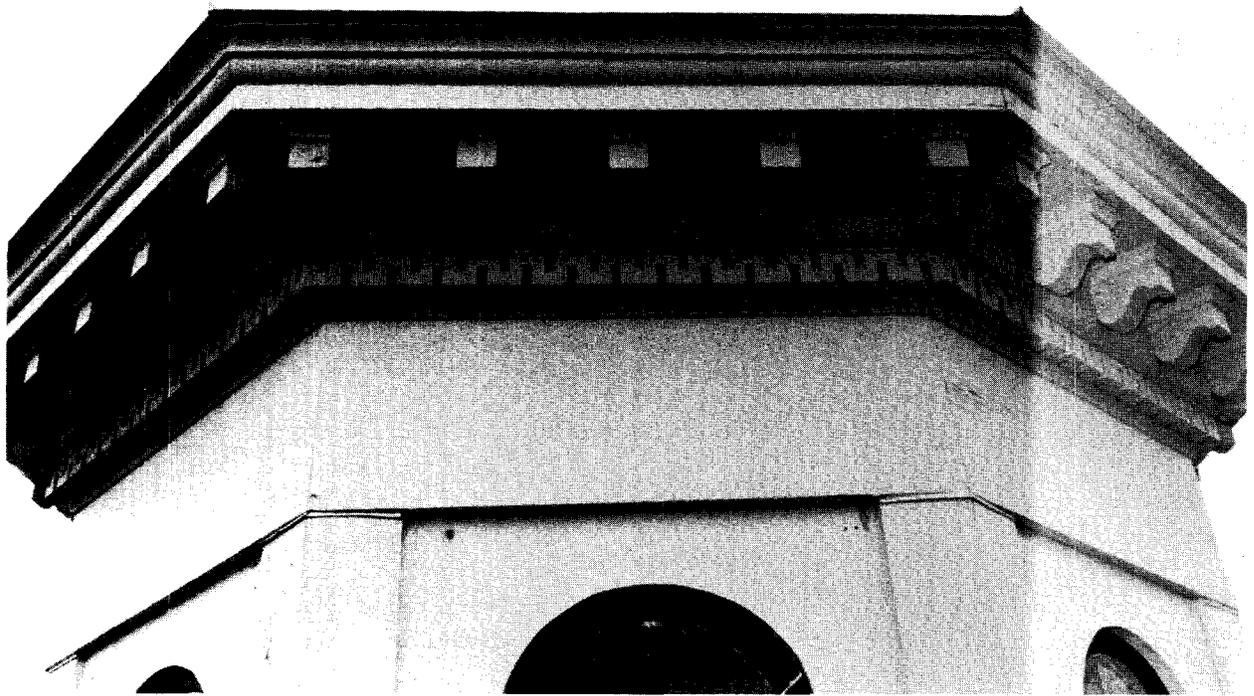
Illustration 44. Penniman House: Cornice of Cupola (1984).

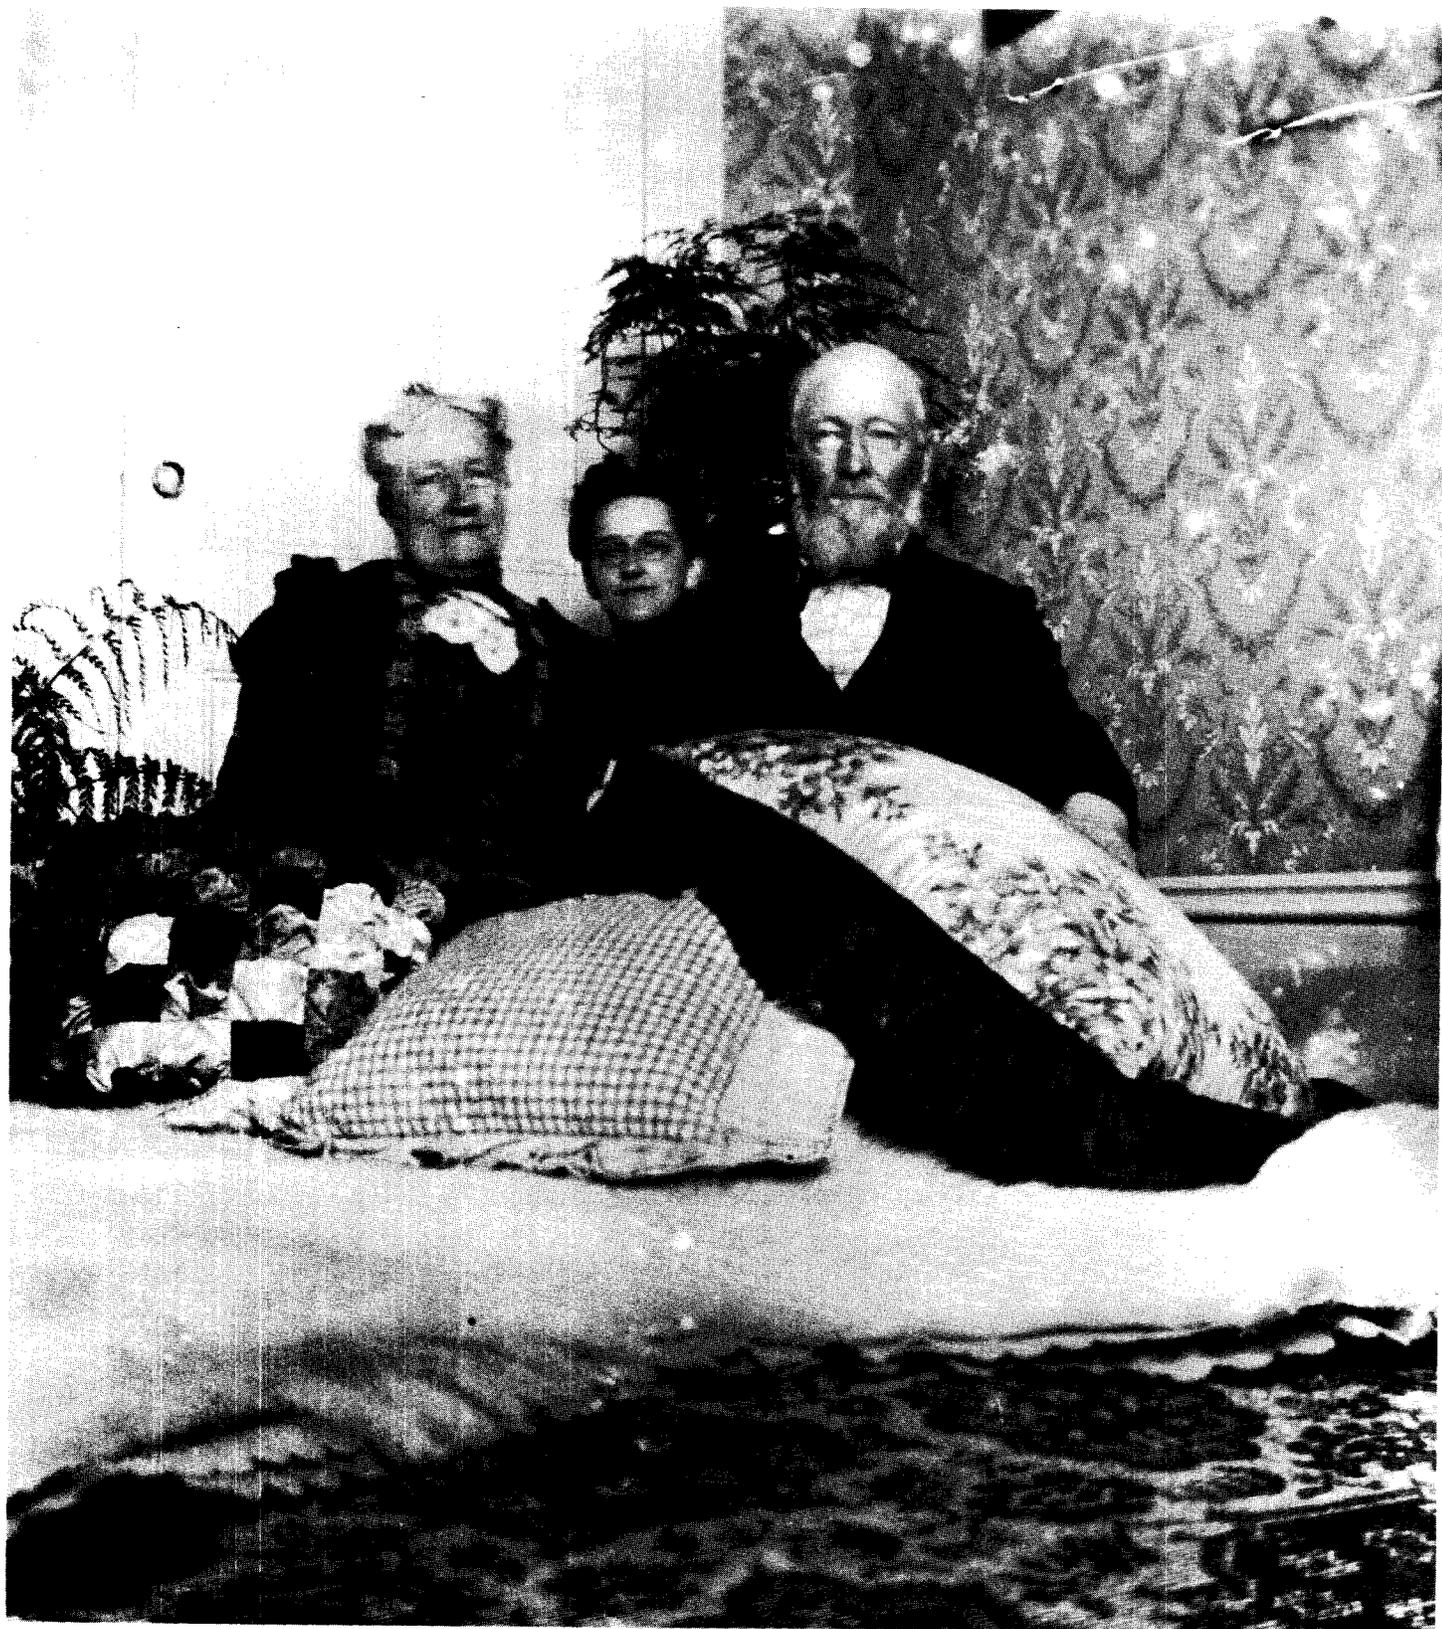
Illustration 57. Penniman House: Southwest Parlor (Room 101), Southeast Corner, Showing Hot-Air Register Installed in Front of Mantelshelf (Circa 1890).

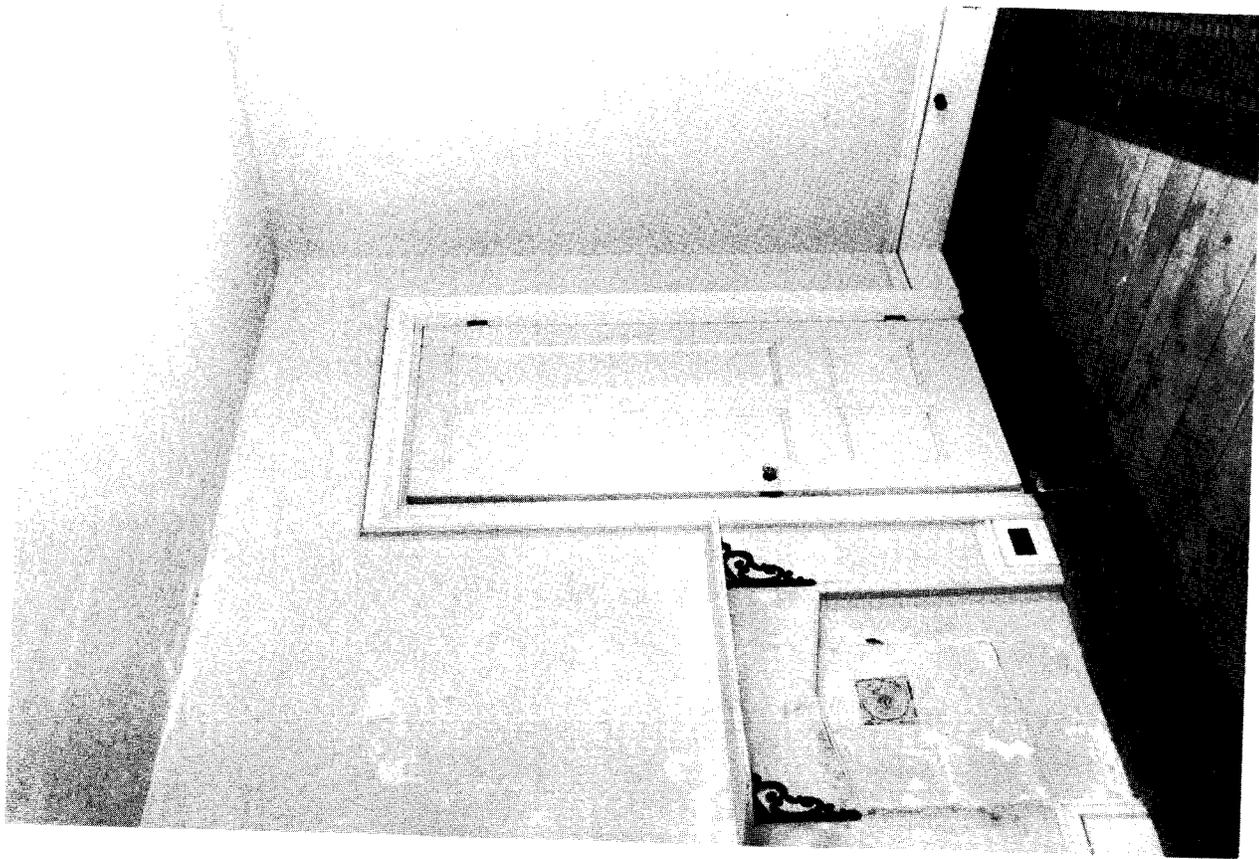
Illustration 67. Penniman House: Southwest Parlor (Room 101), East-Wall
Mantelshelf, Stovepipe Thimble, and Cover (1984).

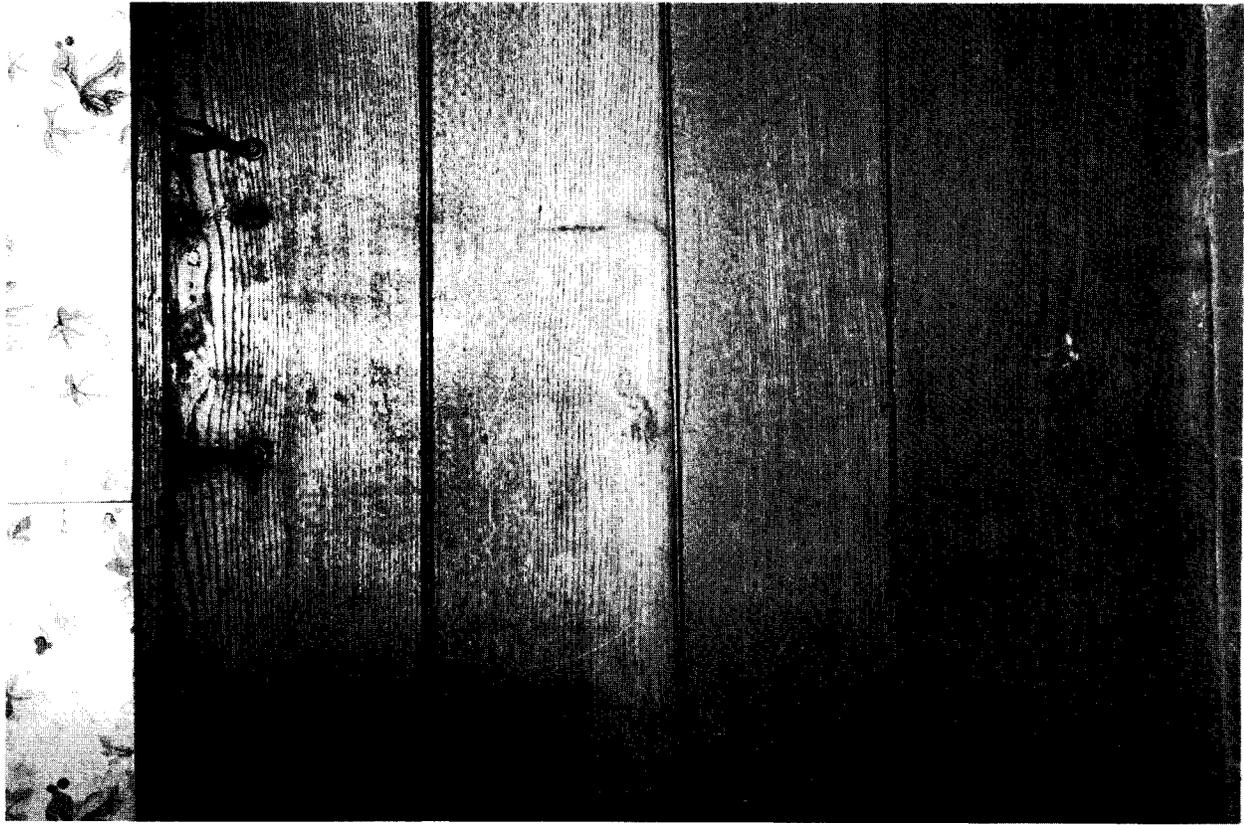
Illustration 96. Penniman House: Back Hall
(Room 105), Wainscot (1984).

The floor in the back hall is the same as the floor in the kitchen, pine boards 4-1/2 to 5 inches wide. This floor was originally stained and shellaced (P069). Directly in front of the east entry doorway, no finish floor was laid. The area not covered with finish flooring measures 3-1/4 inches by 3 feet 6-3/4 inches long, and is trimmed out with a quarter-round molding. Since this area does not encompass the full door swing, it is not obvious why this area was recessed.

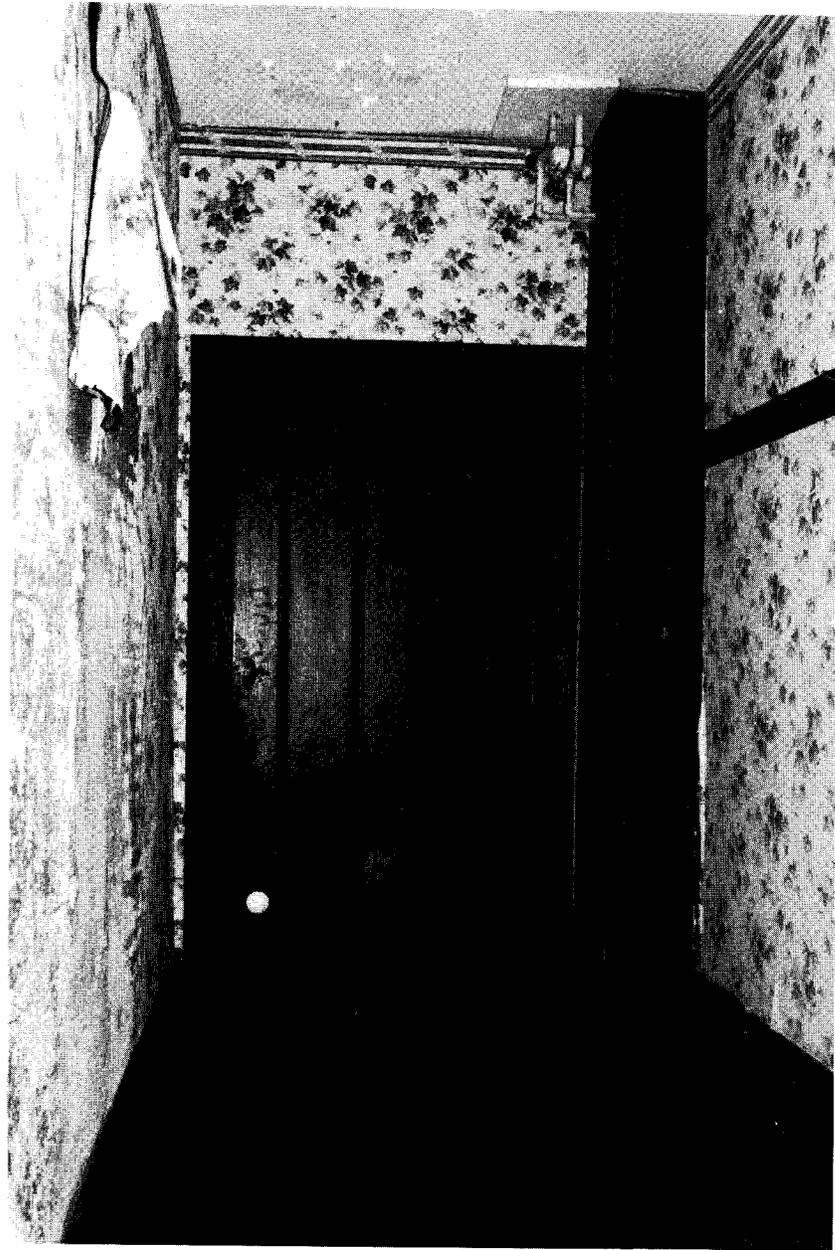
Illustration 98. Penniman House: Back Hall (Room 105), Hole in Ceiling, Showing Drains of Bathroom Sink and Tub (1984).

corner along the south wall into the closet of Room 203. This closet is located right above the west-wall kitchen cupboard; a hole in the ceiling of the cupboard suggests that the lead pipe once dropped down here to feed cold water to the cookstove. The outflow pipe from the hot-water storage tank would still have run along the south wall of the kitchen: there is only one layer of modern paint (P130) within the outlines of the brackets' "ghosts" on the south wall, which indicates that at least one run of pipe was here originally.
