CHAPTER 2

STABILITY OF THE GUT AND ITS RELATIONSHIP TO THE HERRING RIVER

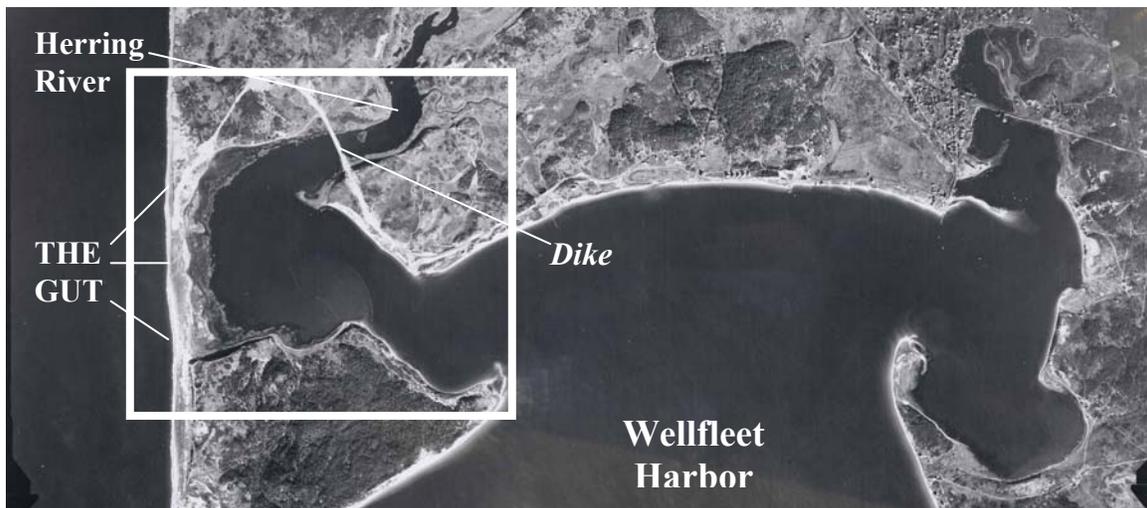
Figure 2.1: Location of The Gut in relation to the Herring River & Wellfleet Harbor

People frequently ask whether opening the Herring River Dike would threaten the stability of The Gut or cause it to breach. This is of great concern because this strip of land channels the Herring River outflow into Wellfleet Harbor rather than directly into Cape Cod Bay (Figure 2.1). It is commonly thought that a breach might threaten shellfish resources in and around Wellfleet Harbor from an influx of bay water changing salinity, temperature and nutrients within the shellfish-rich inner basin.

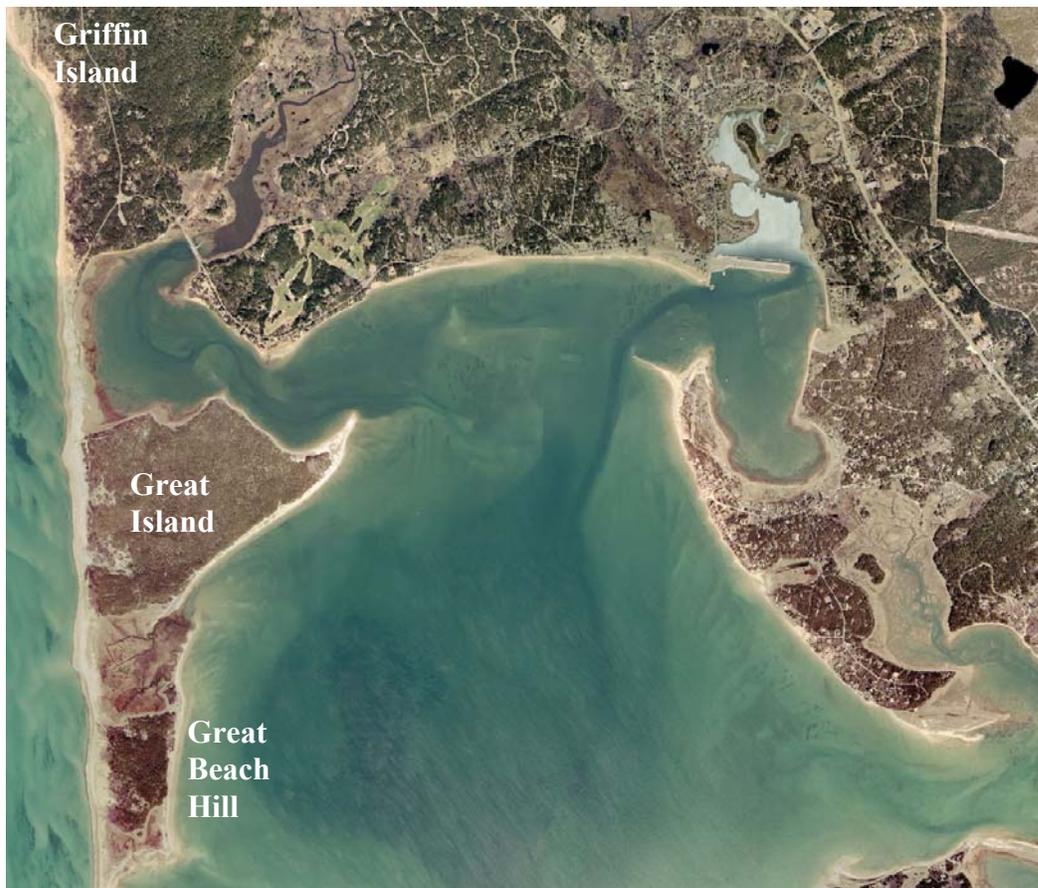
Figure 2.4: This 2001 air photo of Wellfleet Harbor shows the present day connected nature of the Wellfleet Harbor Islands.

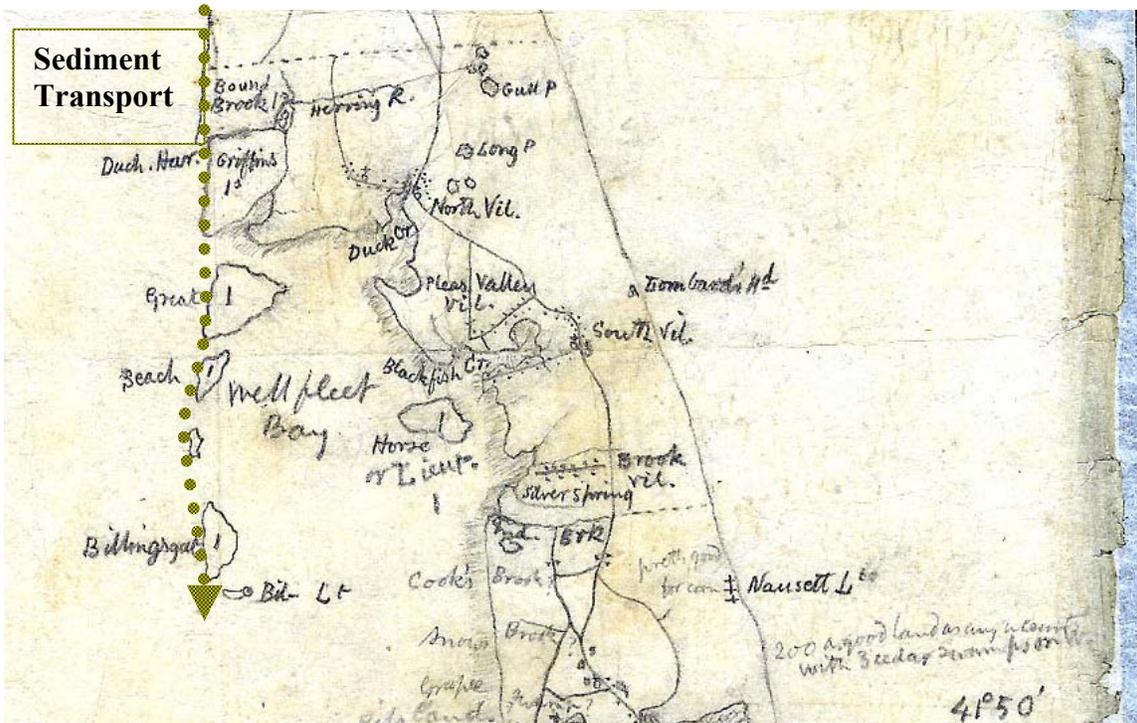
Figure 2.8: Map of sediment transport superimposed on Thoreau's sketch showing the formation of tombolos that connect the islands.

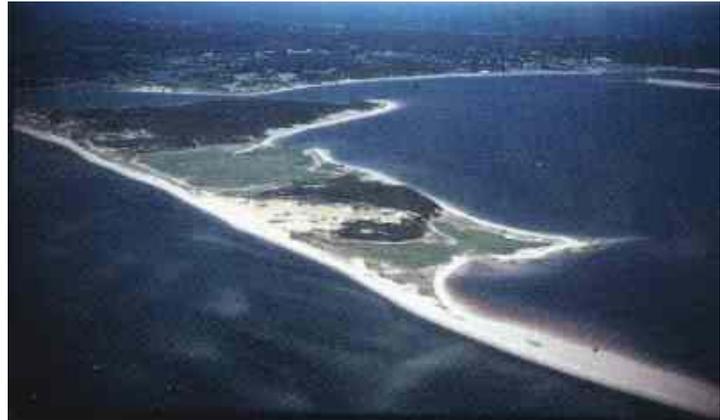
Figure 2.9: Top left is a cartoon schematic showing the evolution of the area directly south of The Gut, which is how it would have formed without the existence of the Herring River. First the islands are created by glacial deposits (A) then sand transported southward forms tombolos connecting them (B) and as a result of the quiet water environment behind the spits and tombolos a thick marsh forms (C). The bottom right image is a photograph of the area illustrated above. (Oldale, 2001)

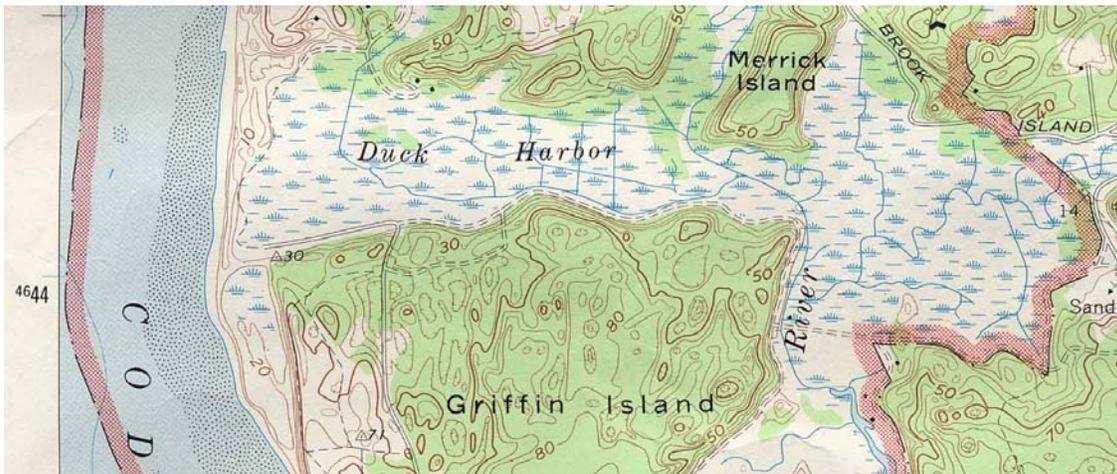
Figure 2.10: 1974 coastal chart showing the presence of marsh where Duck Harbor once existed.

On the ocean side of the outer Cape, continued sea-level rise and persistent erosion took sand from the glacial sea cliffs and transported it north (Figure 2.6) to form the Provincetown Spit (Figure 2.7). A spit is a peninsula-like accumulation of sand that extends off the mainland, sometimes curving at the end to form a recurved spit. The formation of the Provincelands prevented sediment transport to the Cape Cod bay beaches from the Atlantic (Figure 2.6). However, sediment from the eroding bay-side uplands continued to supply sand to the bay side beaches by long shore drift. The sand moving south formed a spit of land off of the Wellfleet mainland. Eventually this spit connected to the northernmost island and then each successive island to the south (Figure 2.8). This accumulation of sand that ties two landmasses together is known as a tombolo. Once these tombolos were in place, they provided protection from waves and formed the sheltered environment of Wellfleet Harbor. As a result of this quiet environment, marshes formed behind these tombolos (Figure 2.8). The newly formed marshes became so extensive north of The Gut that they actually filled in Duck Harbor landlocking Merrick Island (Figure 2.10).

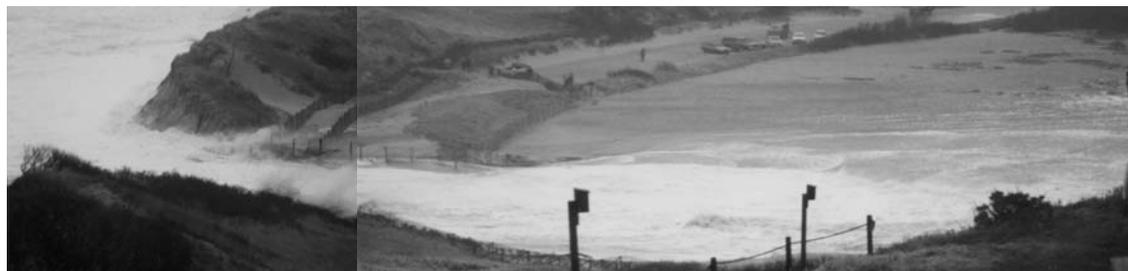
Figure 2.13: Above is a cartoon showing the aerial view of a washover forming on a barrier. Below is a photo taken at Ballston Beach during an overwash in 1991. Even this large overwash on the highly dynamic Atlantic shore did not result in a permanent inlet.

Given that The Gut influences the Herring River rather than the converse, what factor controls the stability of The Gut? The continued stability of The Gut, like its formation, is primarily dependent on longshore sediment transport on the Cape Cod Bay beaches and aeolian (wind) transport of finer sand to make and maintain the barrier's dune system. Erosion of The Gut is most likely to occur as a result of a storm; however, the wide salt marsh that backs this beach and dune system provides formidable resistance to erosion. It is highly unlikely that a channel would be cut through these thick and cohesive marsh peats; therefore, there is little chance of a permanent inlet forming from a breach in The Gut. It is more probable that in the case of a high-energy storm, an overwash from the bay would occur through a low in the dunes. An overwash transports sand from the Bay beach through a breach in the dune system to form a fan-shaped sand deposit on the back-barrier salt marsh surface (Figure 2.13). Natural post-storm processes that bring sand back onshore and rebuild dunes (Figure 2.14) to subsequently heal the breach.

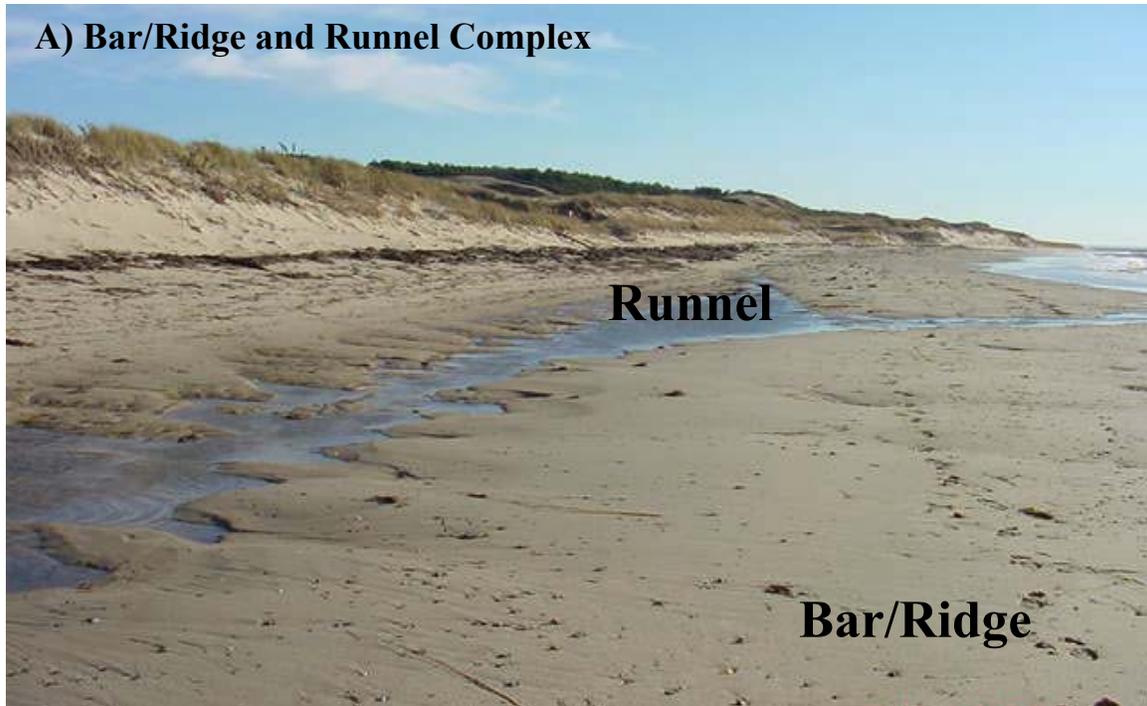
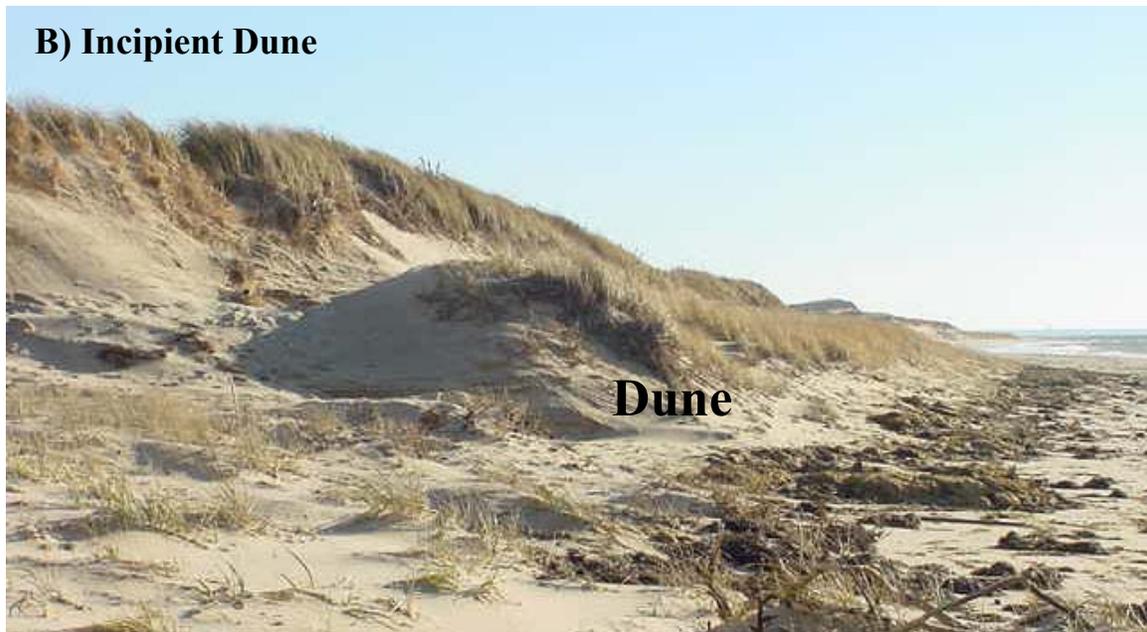
Figure 2.14: Present day pictures along The Gut showing barrier recovery mechanisms that occur after a storm to rebuild the beach. A) Shows a bar or ridge of sand that is reworking back onshore after being eroded by waves from a high-energy storm event. The topographic low landward of the ridge is known as a runnel, where water tends to pool after a high tide. B) Is a picture of a new dune that is forming from fine-grained particles of sand that are moved by wind.

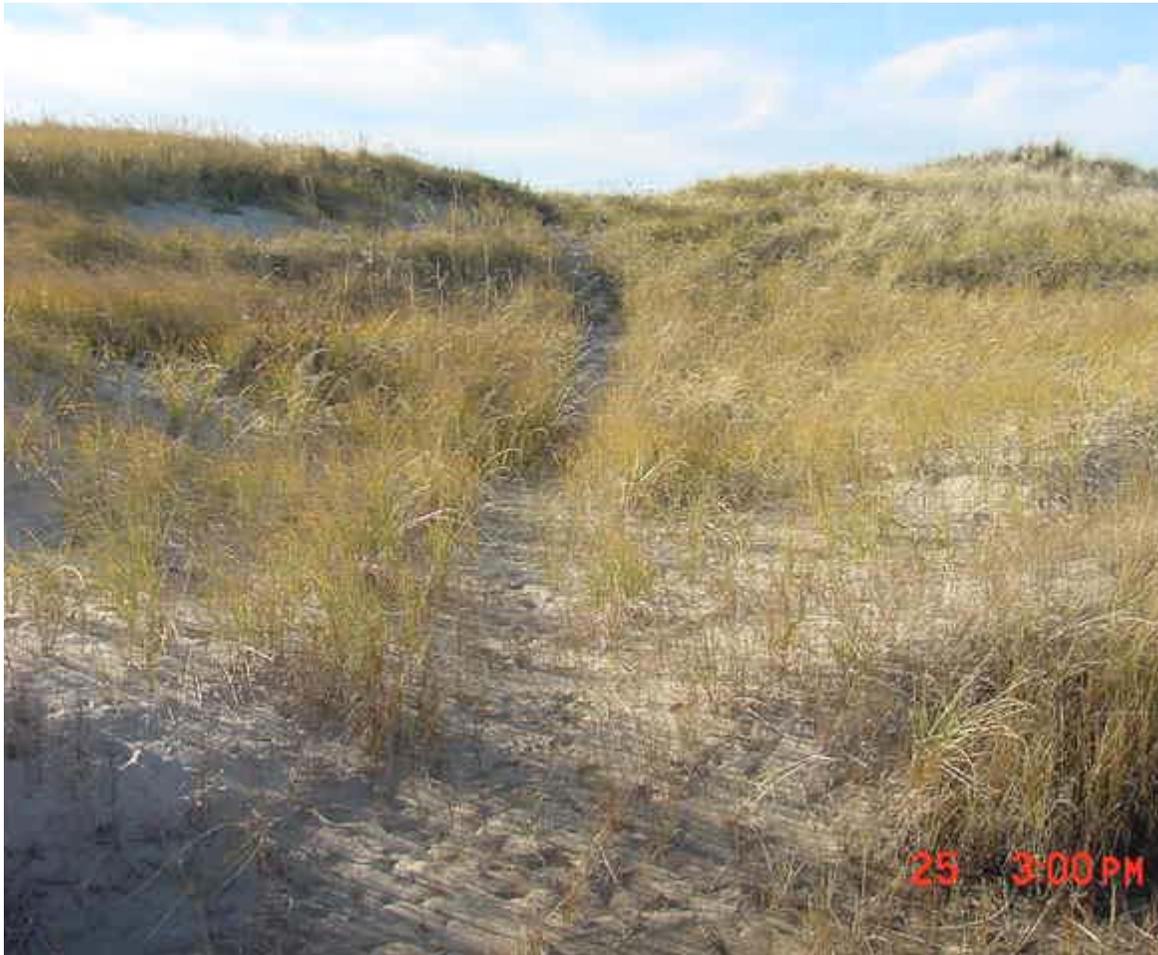
Figure 2.15: Vegetation loss on the dune due to pedestrian traffic.

Both sea-level rise and a deficit in the sand supplied to this system are the main natural forces of erosion along The Gut. However, anthropogenic factors such as pedestrian traffic are exacerbating this erosion. The mere act of walking over the dunes to gain beach access results in the trampling of vegetation that is vital in stabilizing the dune sand (Figure 2.15). Loss of vegetation remobilizes sand and, where a path may form from cross-dune traffic (Figure 2.16), the wind is focused and causes downward erosion (Figure 2.17). These low-lying devegetated areas are ideal sites for blowout formation (Figure 2.18) and subsequent washovers during storms.

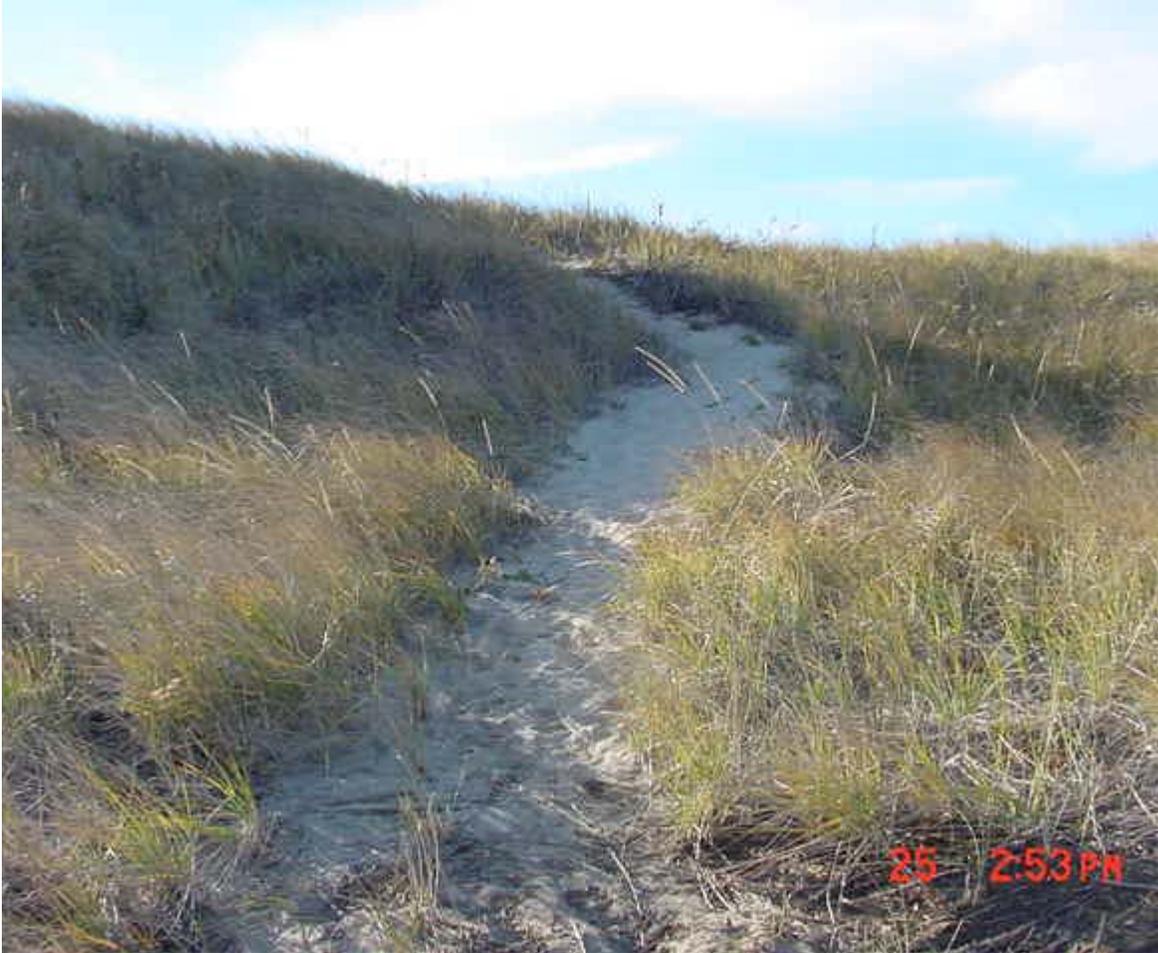
Figure 2.16: Established path has caused complete elimination of vegetation.

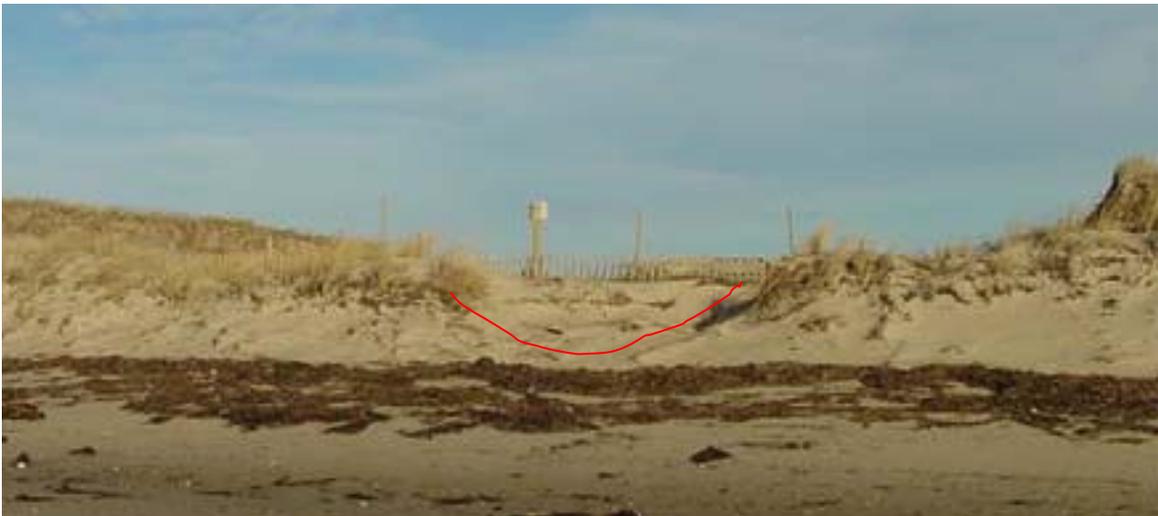
Figure 2.17: Severe erosion, outlined in red (black), which can develop over an established path.

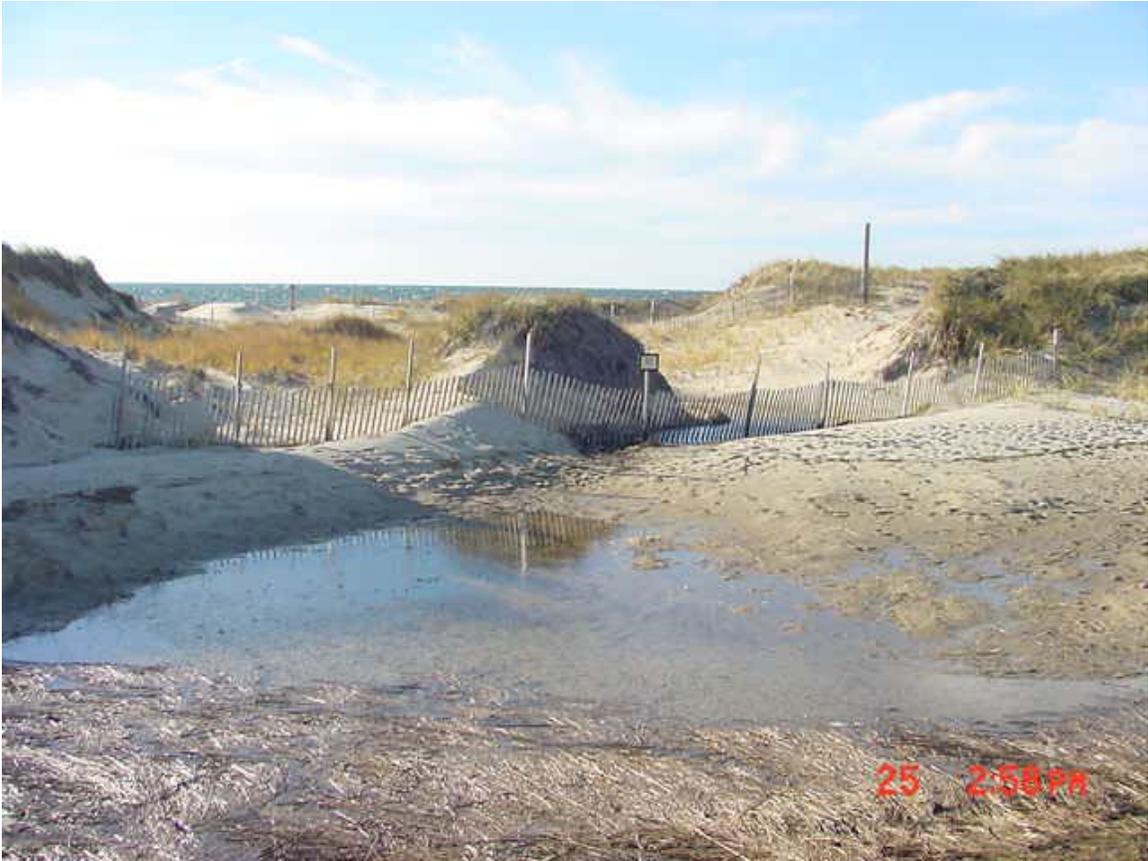
Figure 2.18: Dune blowout on the southern end of The Gut. These blowouts form as wind is funneled through topographic lows between dunes as a result of erosion.

In areas that have formed paths or blowouts in the more vulnerable central portion of The Gut, restoration projects were undertaken. The largest blowout, located on the southern portion of The Gut, has been sectioned off with dune/snow fencing to both block traffic and capture sand (Figure 2.18). In addition to posting signs (Figure 2.24), dune grass was planted to promote sand accumulation and stabilize the dunes (Figure 2.25). These management practices should minimize erosion due to pedestrian traffic on The Gut.

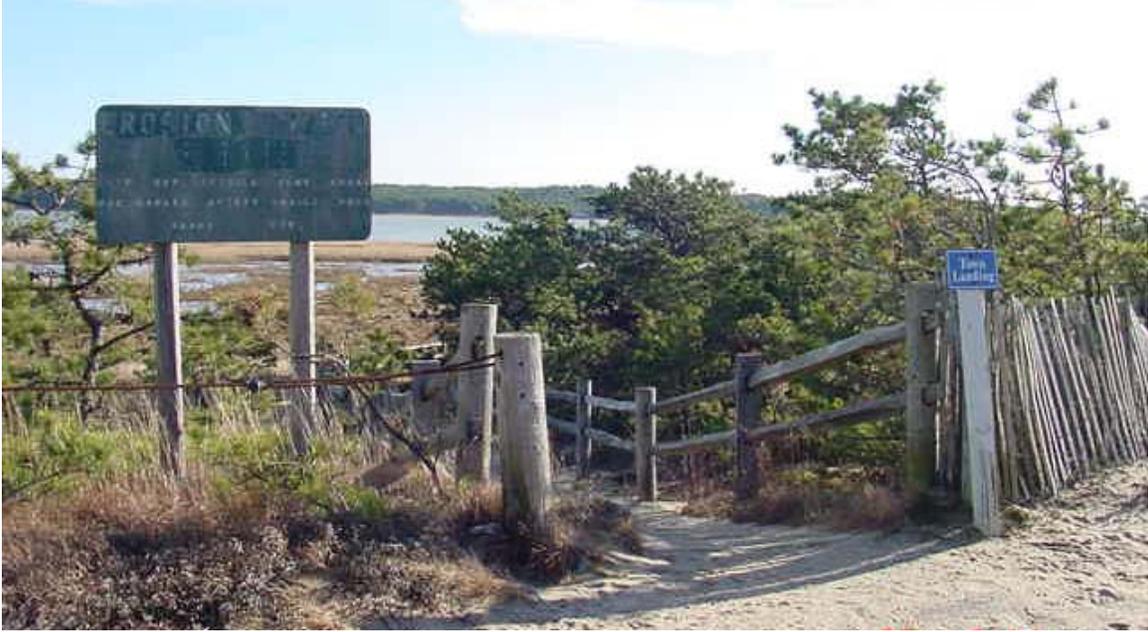
Figure 2.19: Wooden fence that leads to path/road behind the barrier.

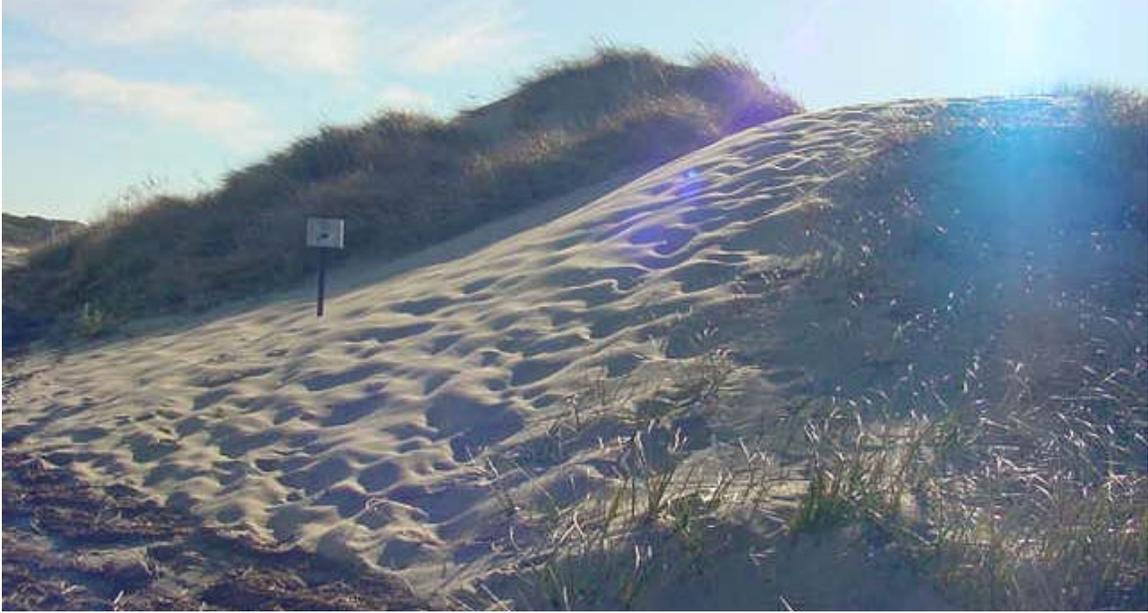
Figure 2.20: Northern beach access on The Gut as indicated in posted sign.

In reaction to the degradation of the dune system by pedestrian traffic, steps have been taken by the Town of Wellfleet and Cape Cod National Seashore to monitor this erosion and lessen the anthropogenic impact. Mitigation projects include road and path crossover closures utilizing signage and fences. As a result of the serious problem of blowouts related to foot travel, dune cross-overs for beach access will be limited to only two locations. These formalized crossovers are marked with signs (Figure 2.20) and string to provide “symbolic” fencing (Figure 2.21) making the accepted routes more obvious to encourage their use. The Town of Wellfleet established the northern route (Figure 2.20), located just south of the old Gut parking lot, many years ago. A second crossover was recently selected at the south end of the tombolo (Figure 2.21). The placement of these walkways at the ends of the Gut is not only convenient, i.e. closest to the parking area and to Great Island, but also environmentally optimal, i.e. adjacent to the widest expanses of storm-resistant salt marshes (Figure 2.22). In addition, the paths have a meander or zigzag pattern that should minimize erosion by wind and water (Figure 2.23).

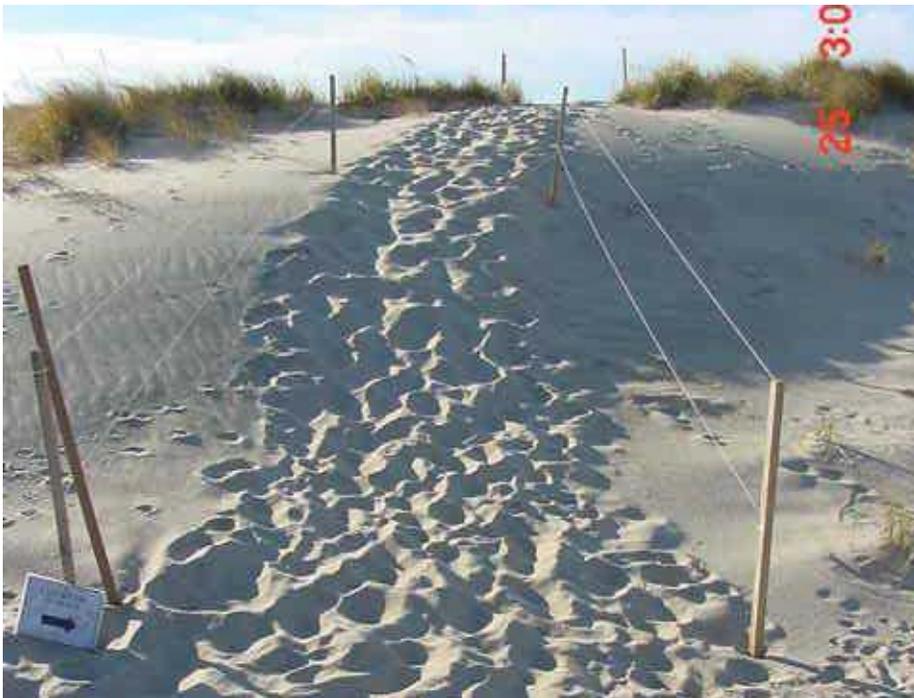
Figure 2.21: Southern beach access marked by signs and symbolic fencing.

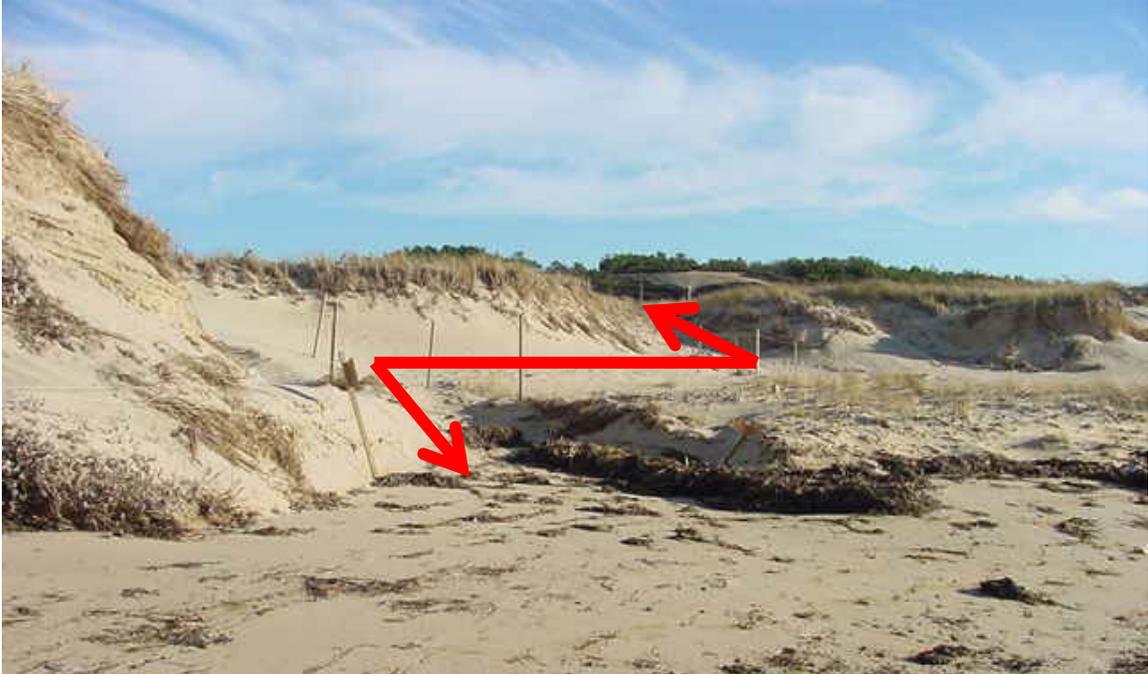
Figure 2.23: Photograph looking east of the southern beach access on the Gut. Note the meander or zigzag pattern of the path, highlighted in red.

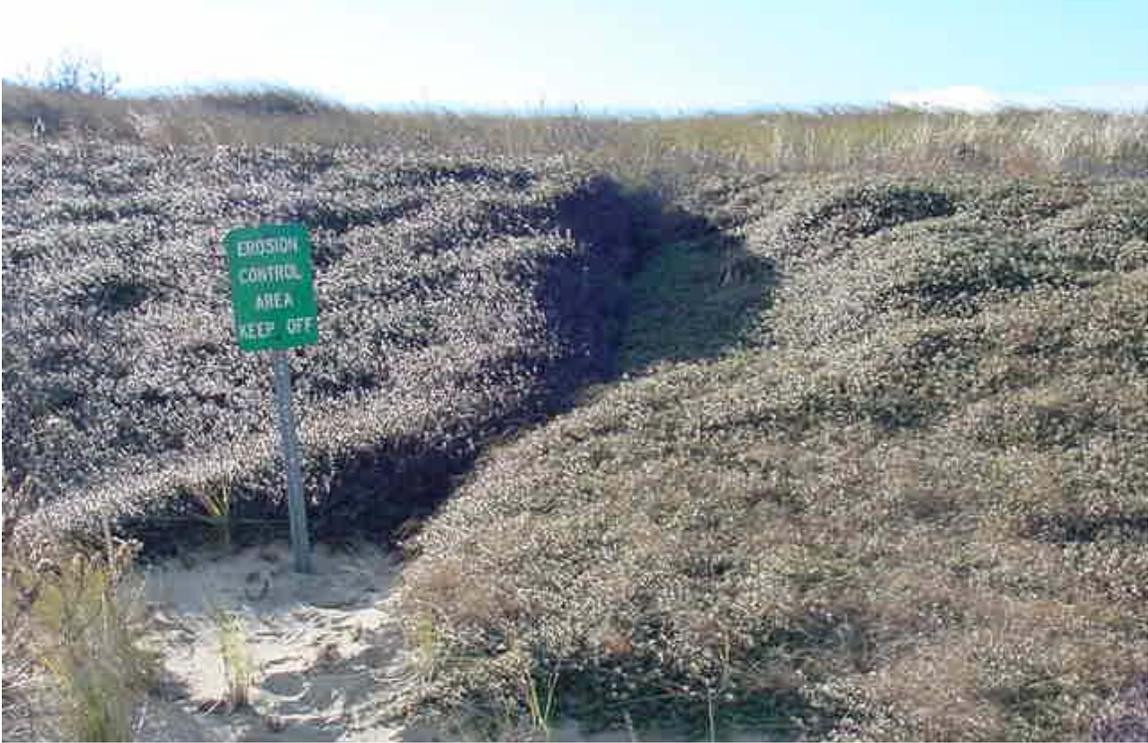
Figure 2.24: Signs successfully deter pedestrians and promote natural revegetation.

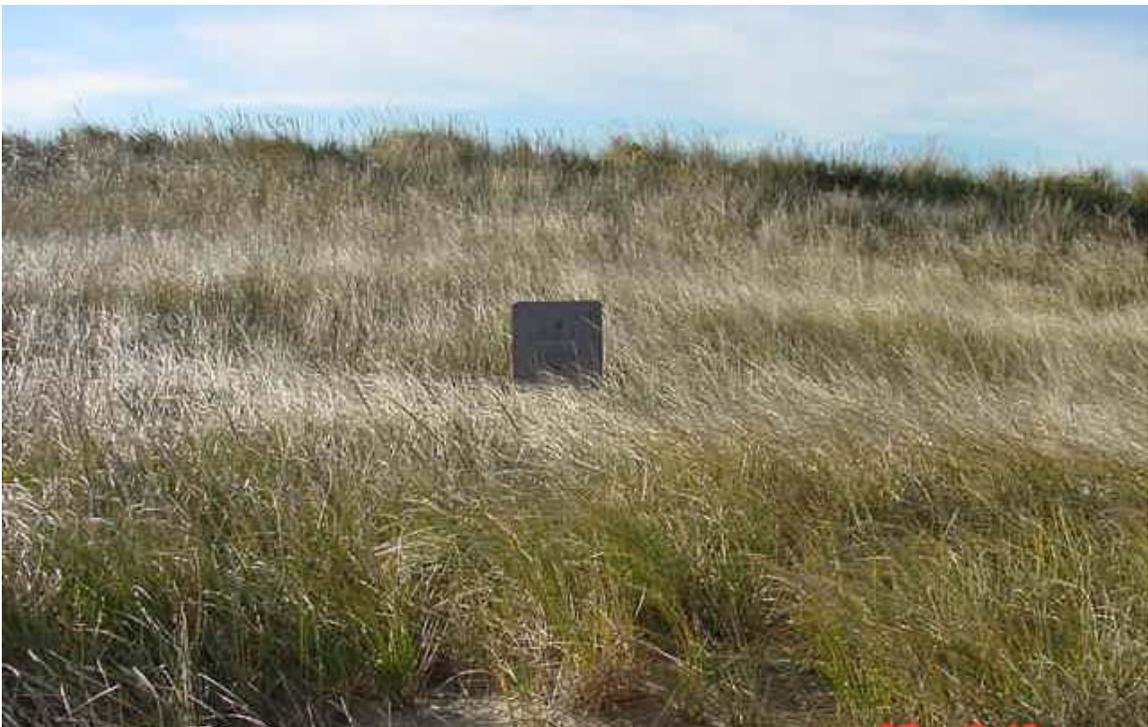
Figure 2.25: A dune stabilized through signage and revegetation programs.
