CHAPTER 3

SEDIMENTATION IN THE LOWER HERRING RIVER

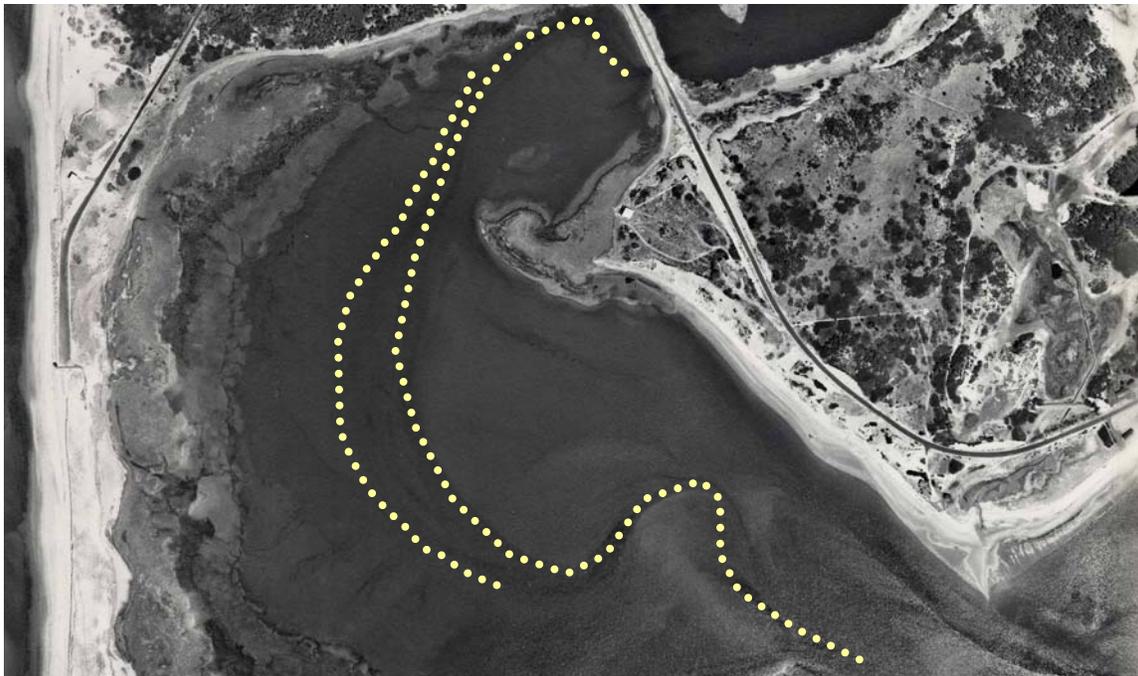
Figure 3.7: This 1960 air photo was taken at a slightly lower tide and you can start to see the whole length of the main ebb channel and the possibility of a second channel. For reference this is the last photo taken before the dike breach in 1968.

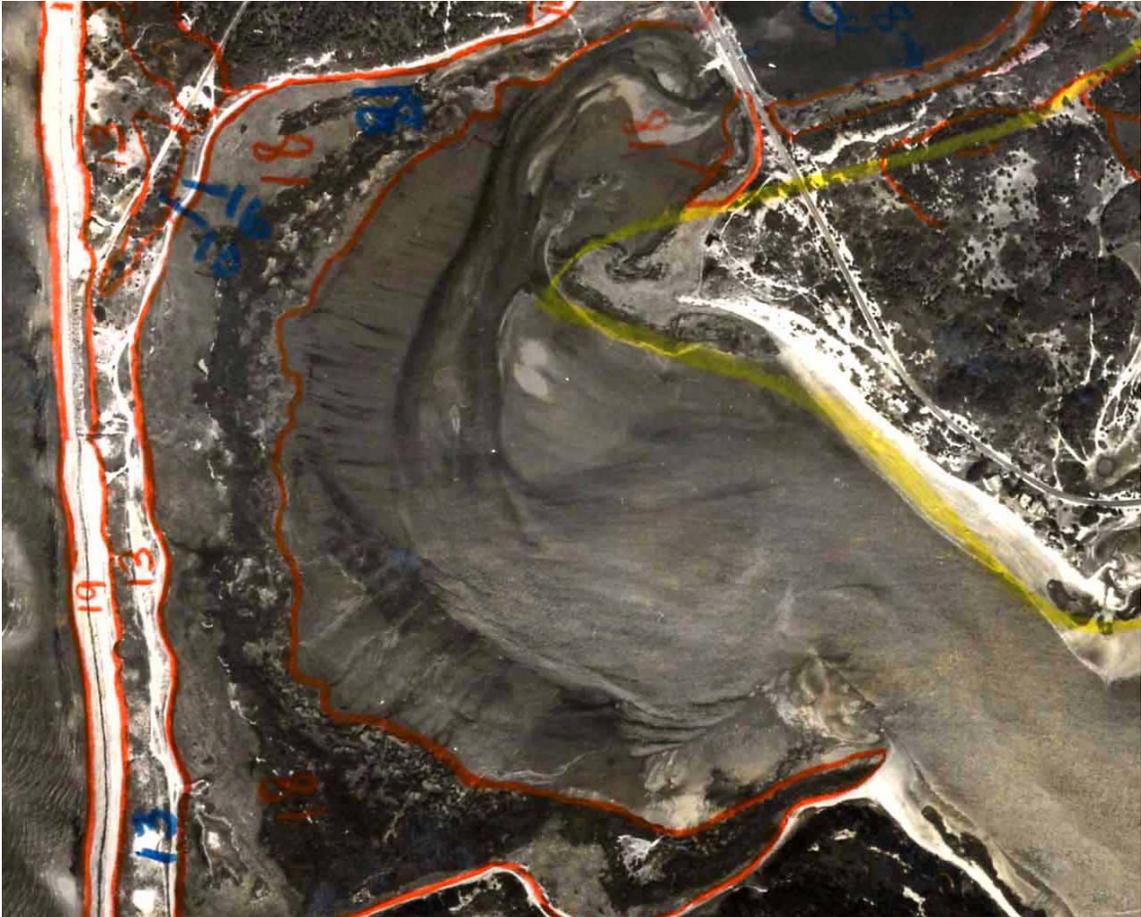
Figure 3.8: 1977 air photo taken just after the dike was rebuilt following the breach. This low-tide shot shows that the main ebb channel, while maintaining the same shape, actually splits in two just below the dike.

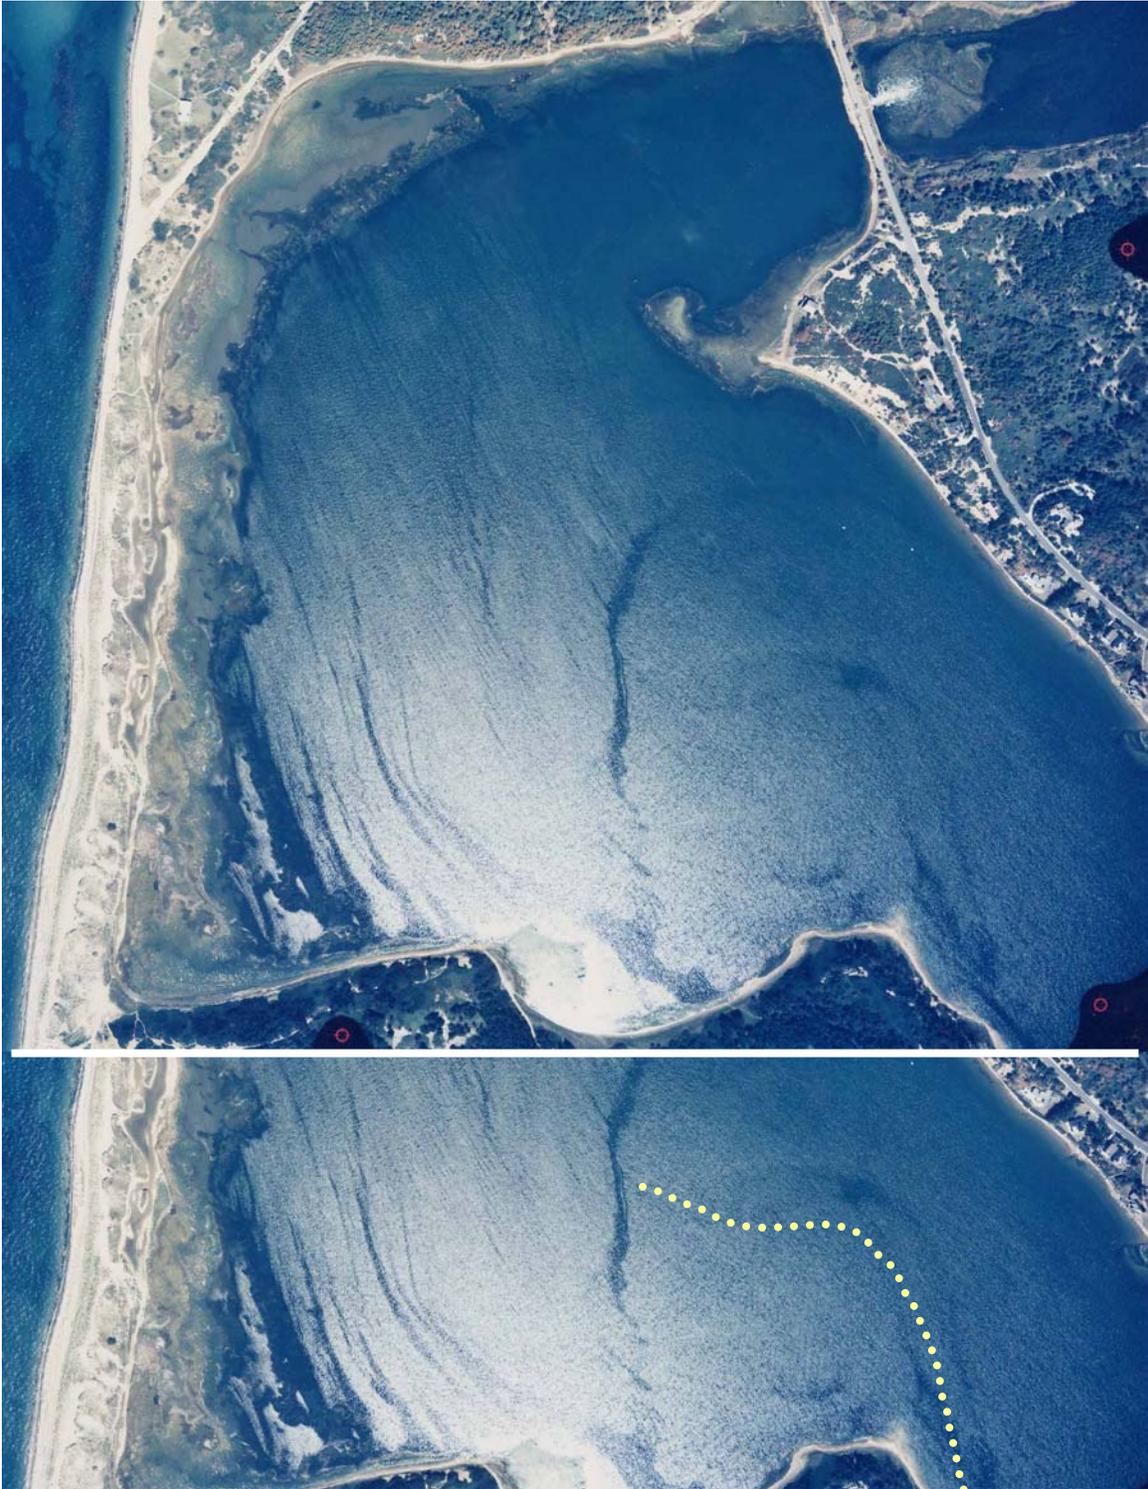
Figure 3.10: This 1991 air photo was taken at high tide, thus restricting the view of the intertidal morphology with the exception of possibly the lower channel like 1848 (Figure 3.13).

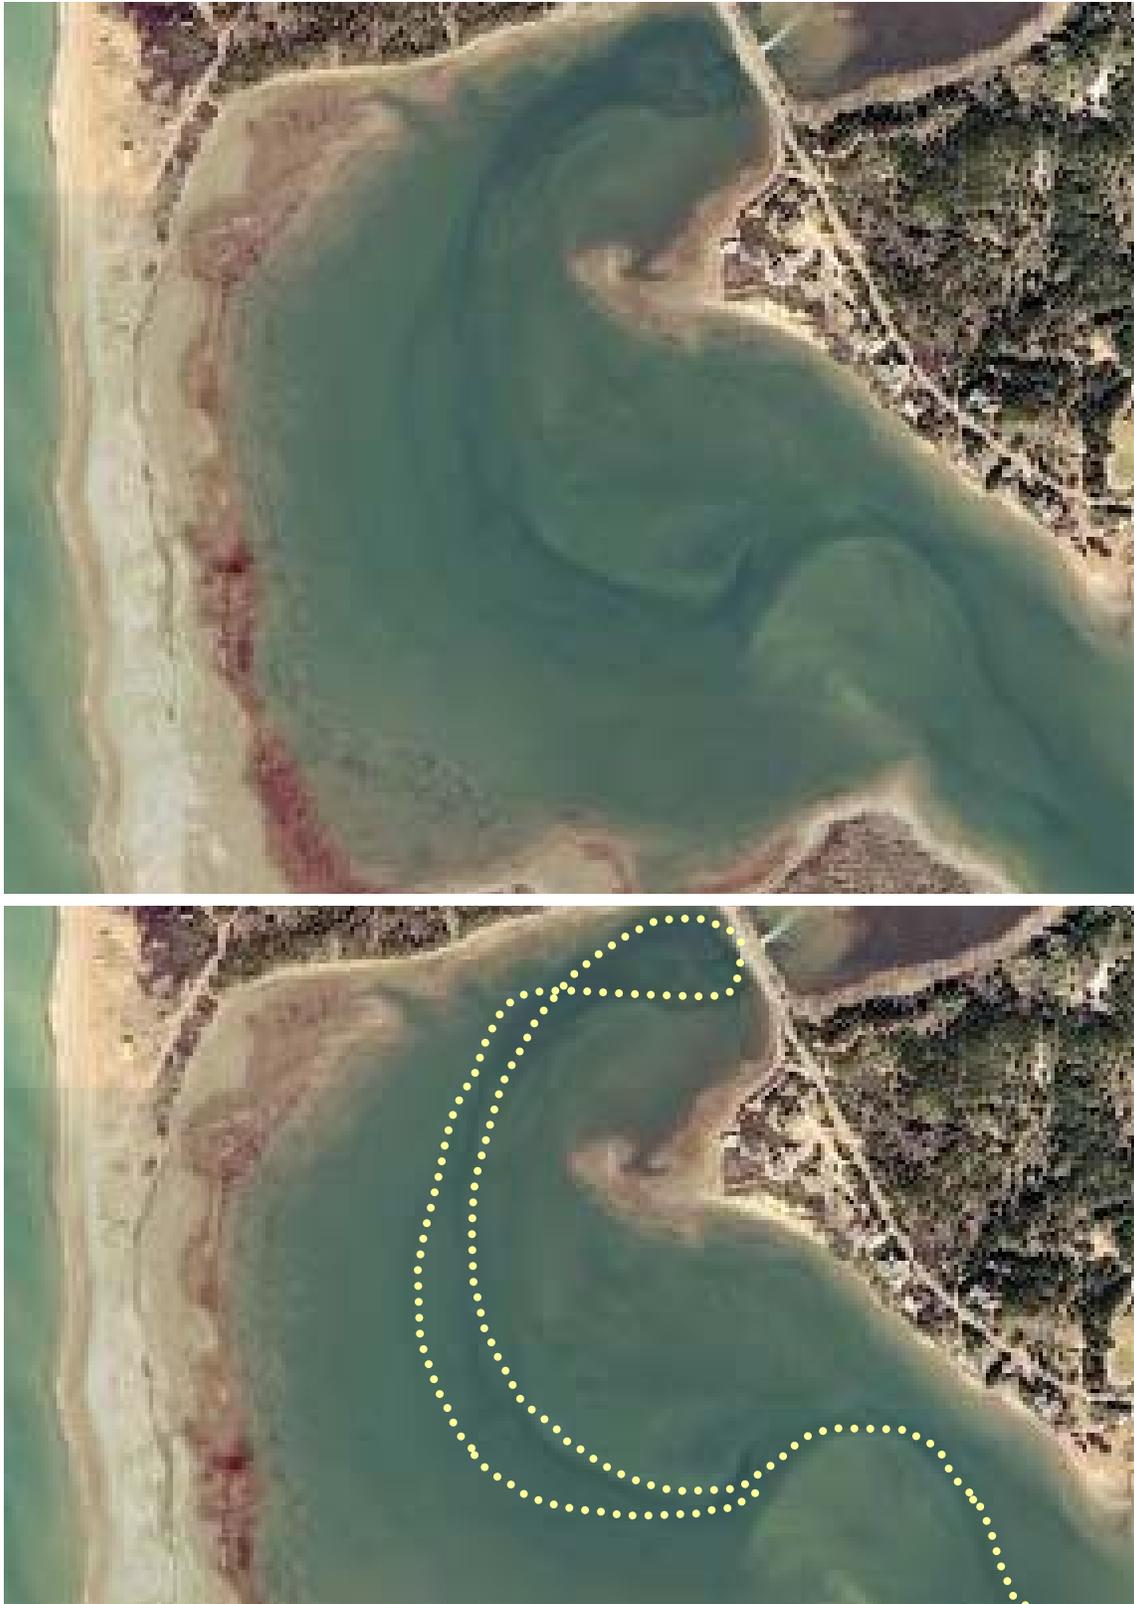
Figure 3.11: This 2001 air photo was taken at about mid-tide revealing the same configuration and faint impression of the duel channels as seen previously.

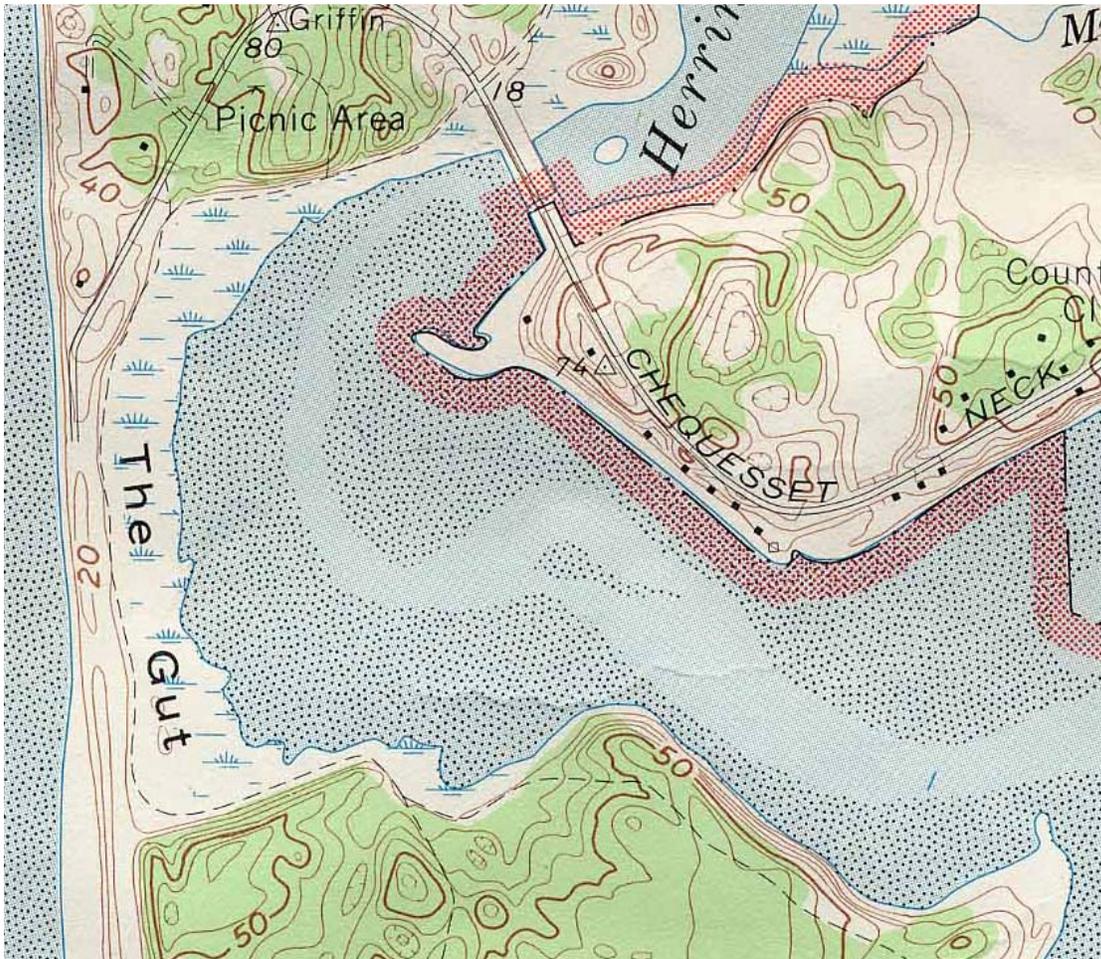
Figure 3.12: 1974 USGS topographic map showing the configuration of the intertidal bedforms in the stipple pattern. This depiction reveals the same main ebb channel geometry that was evident in the air photographs.

recent of these maps was made in 1974 (Figure 3.12). By comparing the 1974 map to the aerial photograph closest to that time (1977) (Figure 3.9), it can be seen that the main ebb channels are identical in shape. Since the main ebb channel in 1977 appears to be the same in all the rest of the air photographs, the 1974 coastal chart is representative of the post-dike morphology in the intertidal region of the lower Herring River.

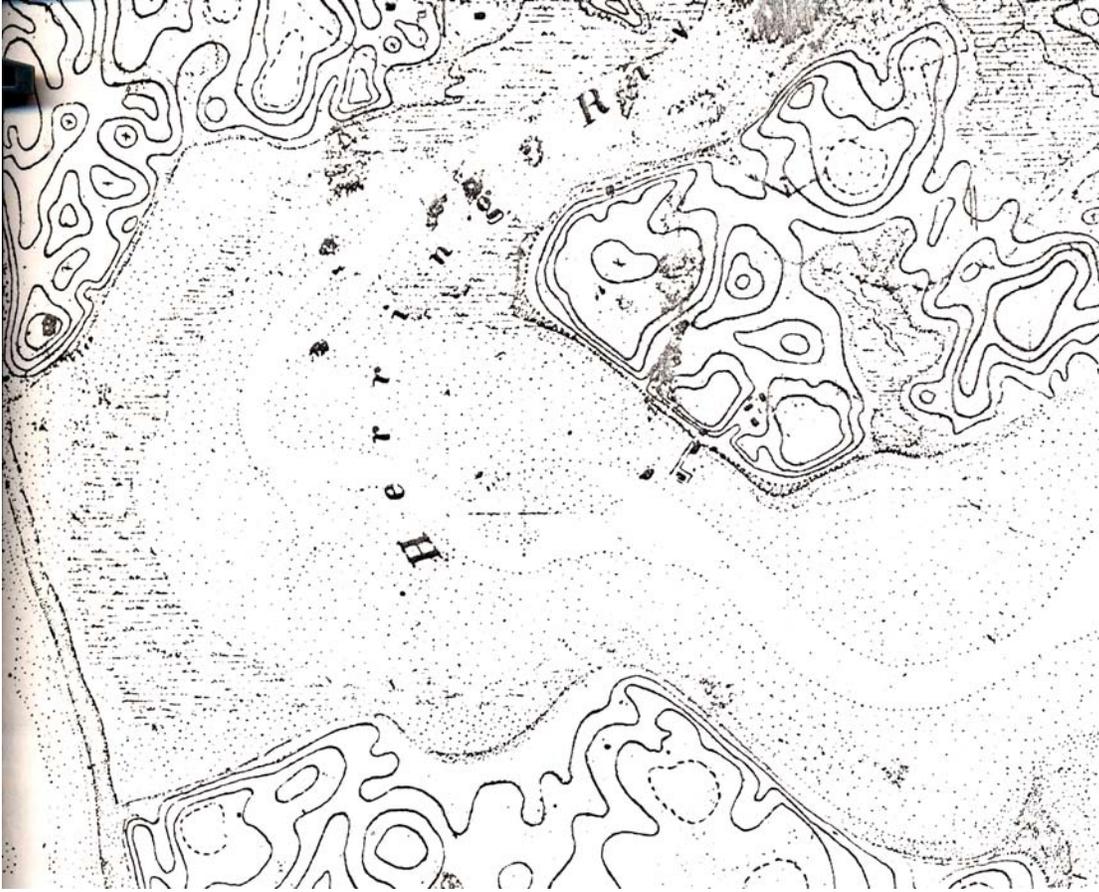
Figure 3.13: This t-sheet (coastal topographic map) from 1848 shows the intertidal morphology that existed prior to the dike's construction in 1908-1909. The configuration of the main ebb channel has the same s-shape geometry as the post-diked scenario depicted in the 1974 coastal chart.

Even though no real change appears to have occurred after the installation of the dike, the question still remains as to whether original dike construction in 1909 affected sedimentation downstream. To address this question, an 1848 t-sheet / coastal topographic map was acquired (Figure 3.13) and compared to the 1974 map (Figure 3.12). This comparison revealed that despite the establishment of ebb-and flood-tidal deltas proximal to the dike, sedimentation did not change because of dike installation. Conversely, it is logical to predict that any future adjustment to the dike's configuration, including complete removal, would affect sedimentation very little and only very near to the dike itself. This lack of change in channel morphology and sedimentation below the dike is reasonable considering that the harbor's hydrodynamic regime (e.g. tidal range) was hardly affected by the emplacement of the Herring River Dike. In other words, any changes that have taken place below the dike have been minimal and are most likely a result of harbor dynamics that occur regardless of the dike's existence.

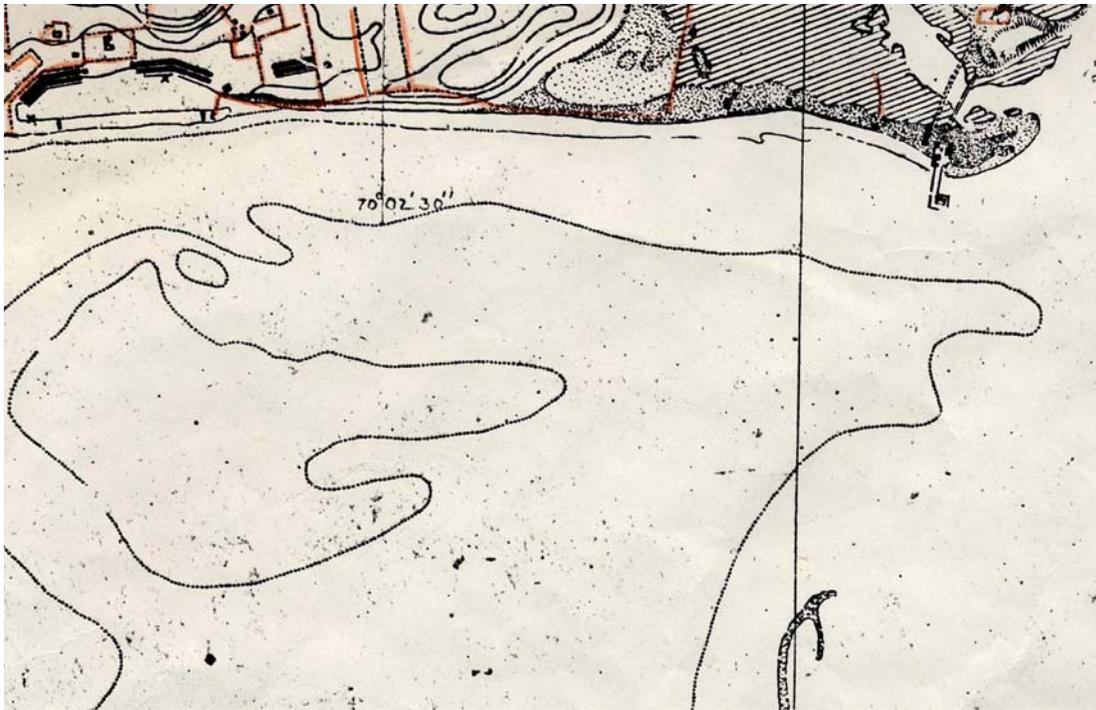
Figure 3.17: Comparison of maps from 1848 and 1974 in the area of Egg Island and the northeast part of Wellfleet Harbor reveals similar intertidal morphologies.

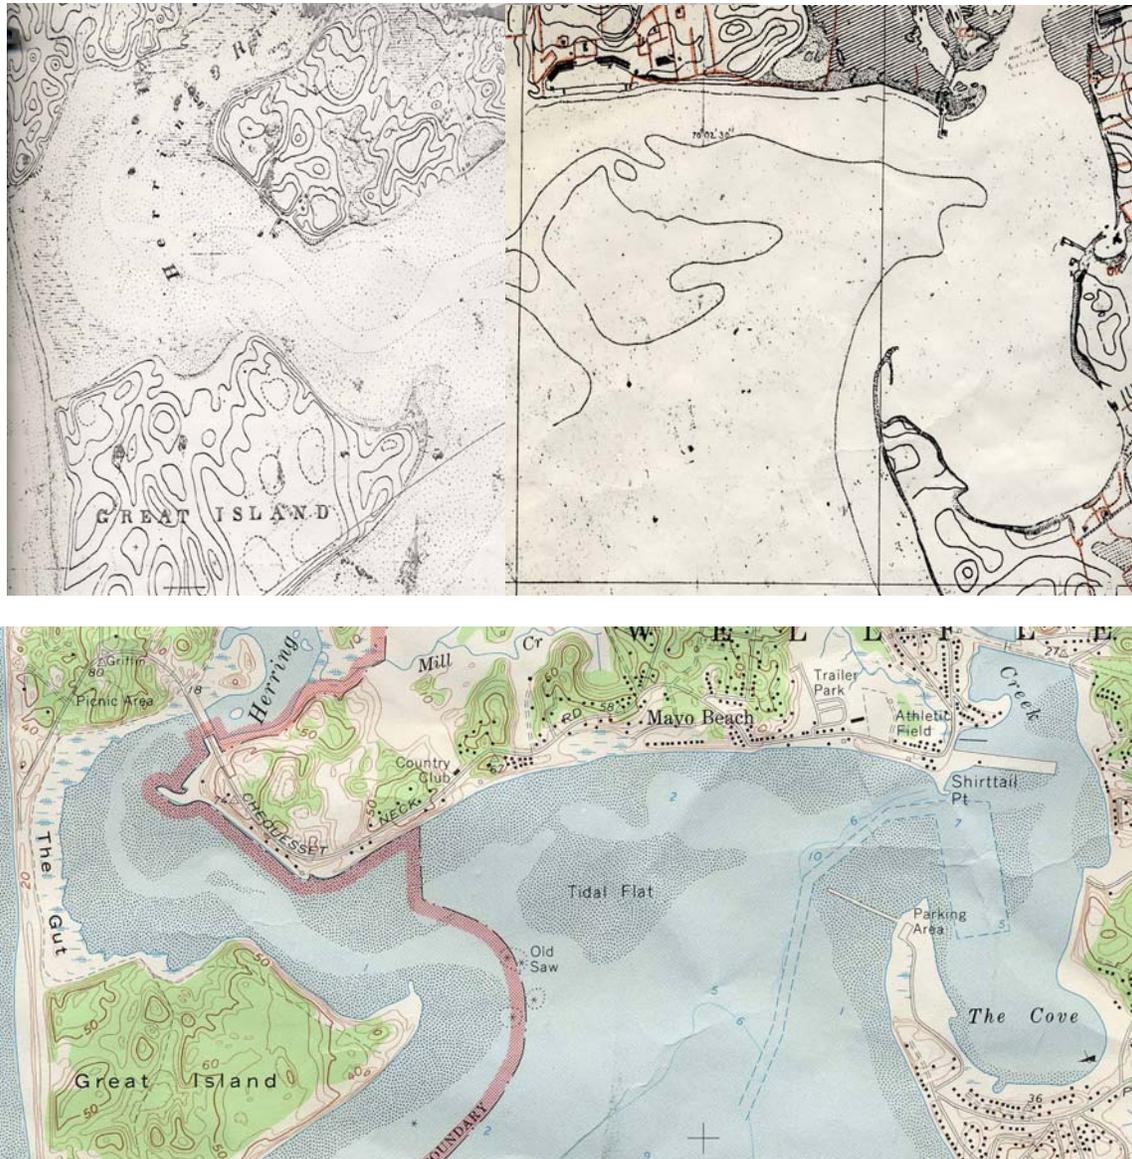
Figure 3.19: Comparison of coastal topographic maps of Wellfleet Harbor from 1848 and 1974 shows similar intertidal morphology over the past 155 years.

associated with the restoration (Figure 3.16). Shellfisherman that worked Egg Island during the dike breach in 1968 report no change in sedimentation. That is not to say that sediment is not accumulating on Egg Island, but any change in the tidal flats is a result of tidal dynamics in the Harbor and Cape Cod Bay rather than any influence of the Herring River. Indeed, if we compare the configuration of Egg Island from 1848 to 1974 (Figure 3.17), it appears that little has changed. By virtue of the fact that sea level is rising on an average of 2.5 mm/year in this area, sediment must be accumulating on these intertidal flats to keep them from becoming subtidal. Thinking back to sediment movement along the Cape, which was discussed in the previous chapter, sand is moving southward along Wellfleet's Cape Cod Bay beaches. The sand that is not incorporated into the barrier beaches connecting the Wellfleet Harbor islands is carried either into the harbor or the bay. Looking at a sediment transport map (Figure 3.18), large bedforms, known as sand waves, indicate the direction that sand is moving. This movement is indicated on the map with arrows sized to represent the sizes of the bedforms. All of these arrows show that the net landward movement of sand is coming along Cape Cod Bay beaches and into the harbor. Close study of these bedforms suggests that over time these sand waves have been stationary, indicating that the harbor has reached an equilibrium in which the sediment transported into the harbor is simply keeping up, or building vertically (aggrading), with sea-level rise. It is the tidal forcing of bay and harbor, and not the Herring River, that shapes Egg Island and the rest of the intertidal flats in Wellfleet Harbor (Figure 3.19).

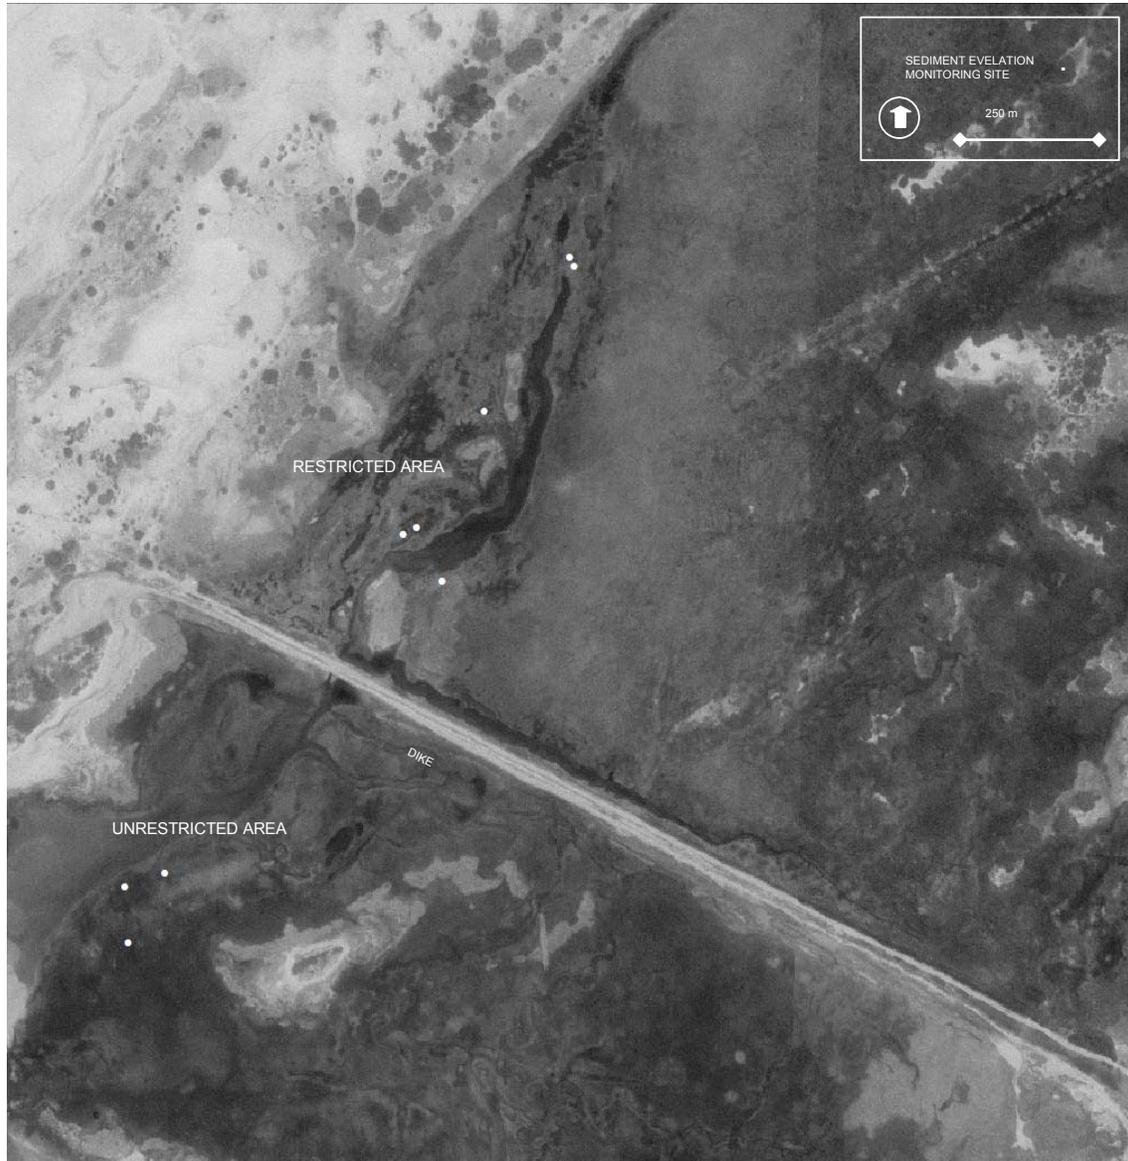
Figure 3.20: Location of Sediment Elevation Tables (SETs) located within Hatches Harbor (Portnoy, Gwilliam & Smith, 2004).

dike in the unrestricted marsh, whereas six are above the dike in the restricted marsh (Figure 3.20). Of the six located above the dike, three are near the dike structure and three are located farther away. Looking at a graph of the data for the unrestricted marsh (Figure 3.21), there is a 3 mm/year accumulation of sediment within the marsh, compensating for the local rate of sea-level rise. However, the graph of all the data from the restricted marsh shows considerably more sediment accumulation above the dike (Figure 3.22). This increased upstream accumulation is a result of the dominance of landward sediment transport, just what is predicted for Herring River in the event that it undergoes restoration.
