Analysis and Evaluation

Portsmouth Village
 Cape Lookout National Seashore, NC
 Cultural Landscape Report
 Map Prepared by John Milner Associates, Inc.

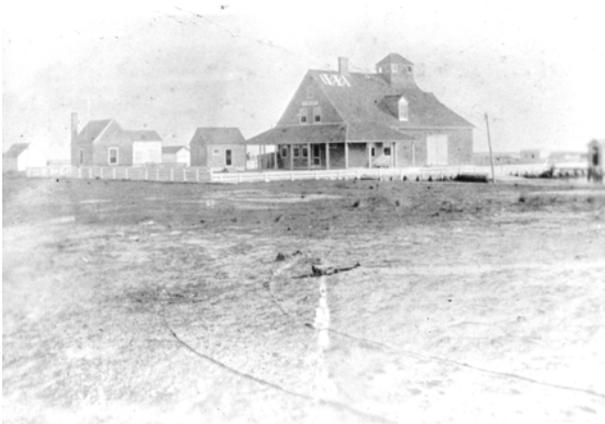
FIGURE 157A. Looking north toward the Portsmouth Life-Saving Station complex, circa 1920s.

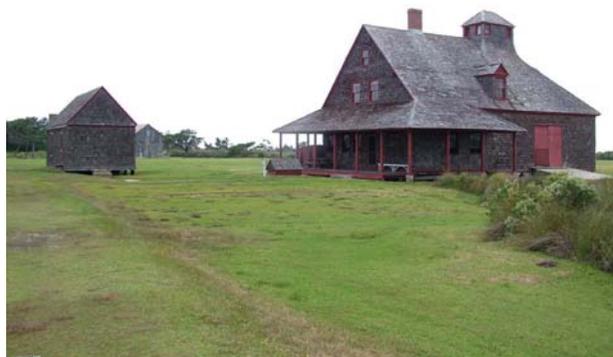
FIGURE 157B. The same view in 2006 illustrating the loss of various buildings, such as, from left to right, the carriage or cart house, boathouse, oil house, and privy (far right), as well as the board fencing around the station precinct. The summer kitchen and stables survive.

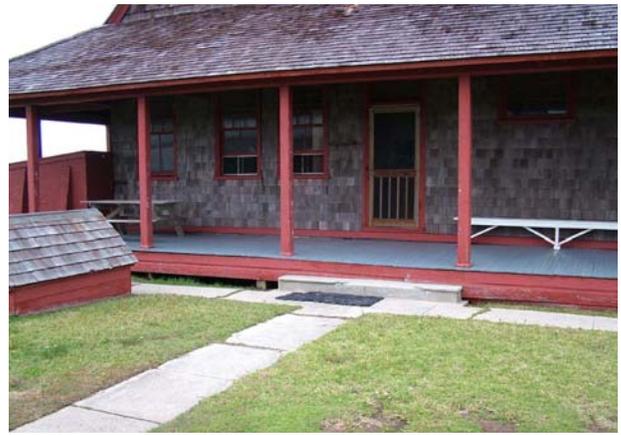
FIGURE 158B. The same view today. Note the addition of the pump house. Most of the other features remain remarkably similar.

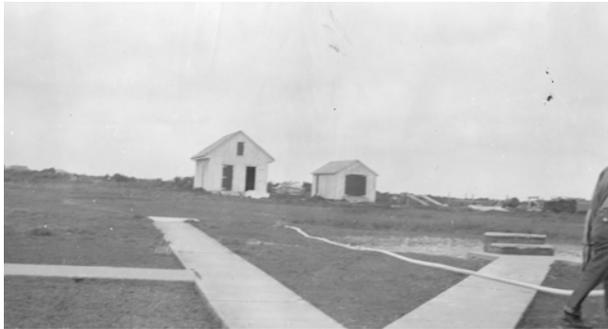
FIGURE 159A. Looking northwest toward the stable from the western corner of the Portsmouth Life-Saving Station, circa 1935.

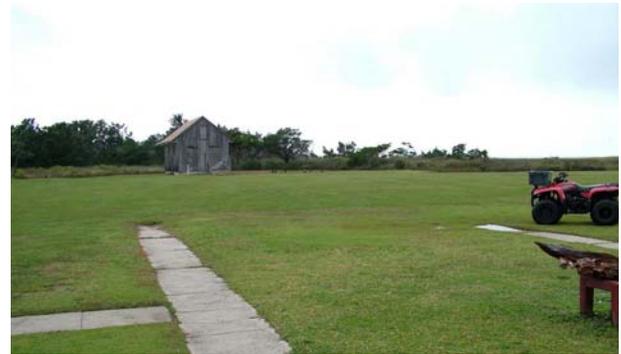
FIGURE 159B. The same view in 2006. The paths and the stable remain relatively similar, but the shed that once sat to the right of the stables is no longer extant. There is much more vegetation in the vicinity of the complex today than during the period of significance. A portion of the concrete walk above has been lost since the earlier photograph.

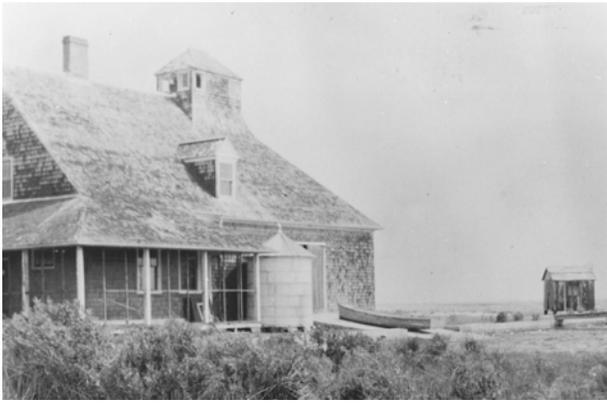
FIGURE 160A. View toward the southeast side of the Portsmouth Life-Saving Station, circa 1942.

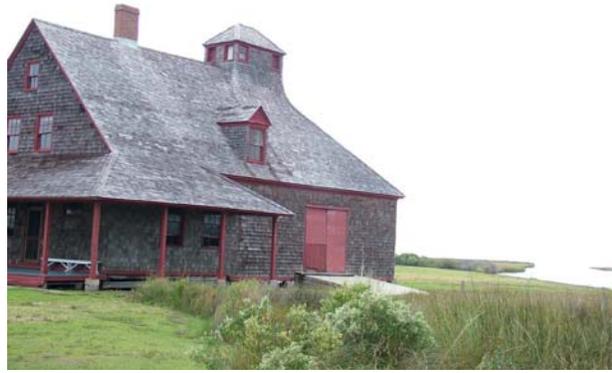
FIGURE 160B. The same view in 2006. Changes apparent in the contemporary photo include the loss of a water tank near the ramp, and a small shed to the right of the station. This building is one of ten surviving examples of numerous Quonochontuag-style stations built during the late nineteenth/early twentieth centuries.

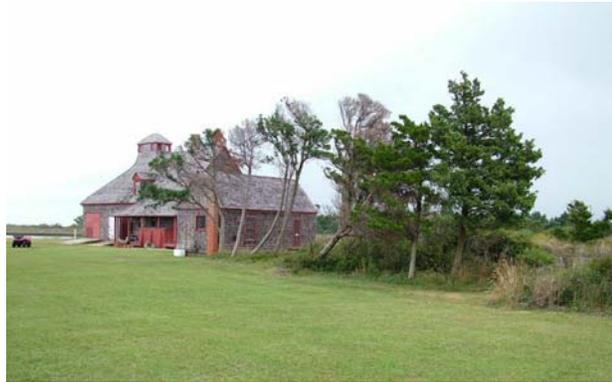
FIGURE 161B. The same view in 2006 indicating the loss of the wreck pole, warning tower, board fencing, and oil house. There is more vegetation within the vicinity today than during the period of significance.

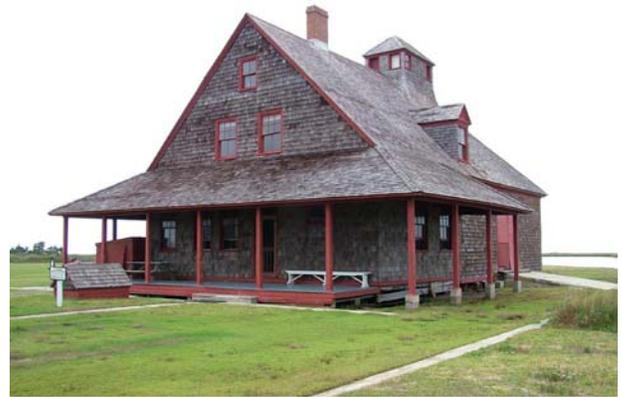
FIGURE 162B. The same view in 2006, indicating the filling of Coast Guard Creek that has occurred.

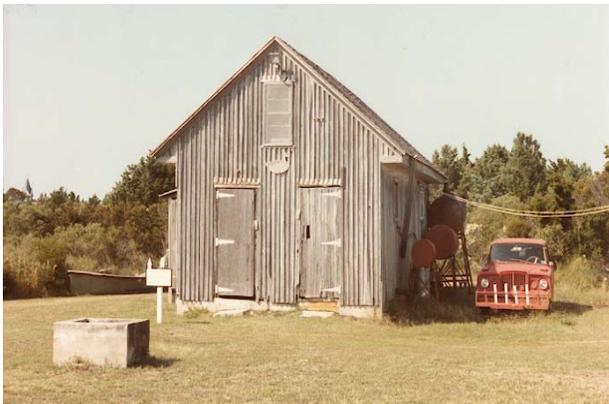
FIGURE 163A. The Portsmouth Life-Saving Station stable looking west toward Portsmouth Village, circa 1983.

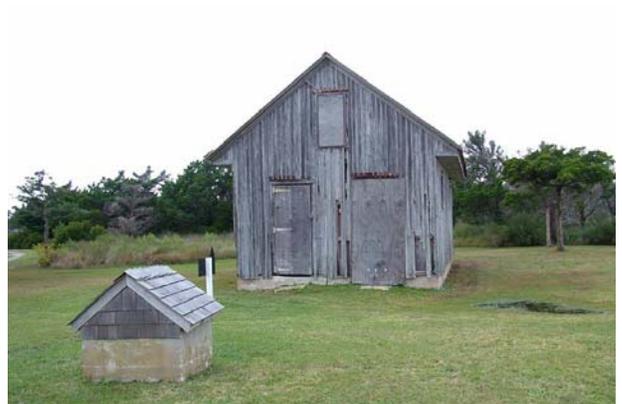
FIGURE 163B. The same view in 2006, showing that the well house has been covered with a small wood roof.

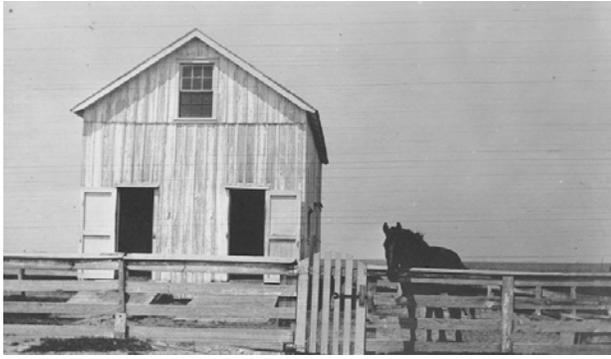
FIGURE 164A. Looking west toward the Portsmouth Life-Saving Station Stable, circa 1916.

Ophelia in 2005. The LCS prepared in 2006 noted damage from Hurricane Ophelia in 2005 to exterior siding, sills, and wall framing, and the need for repair of three windows and doors at this building.

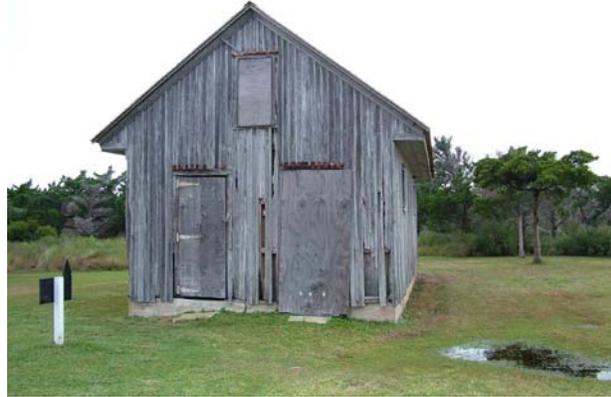
FIGURE 164B. The same view in 2006 showing the 1928 stable built in the same location as previous stables. This view illustrates the loss of the four-board fencing associated with the use of the building as an active stable for horses.

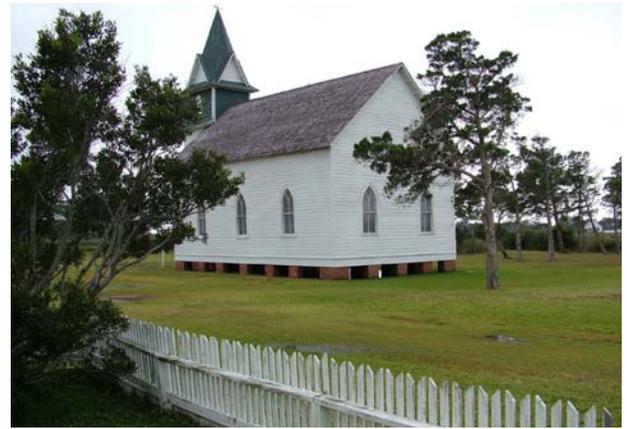
FIGURE 166B. The same view in 2006. Note the loss of shrubby vegetation around the church today, and the increase in trees.

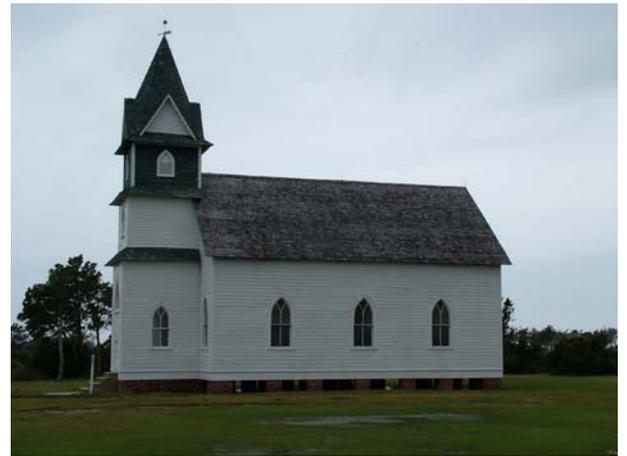
FIGURE 167B. The same view in 2006. Note the loss of the low fence near the base of the church, and foundation vegetation. Mown grass characterizes the landscape around the church in both photographs.

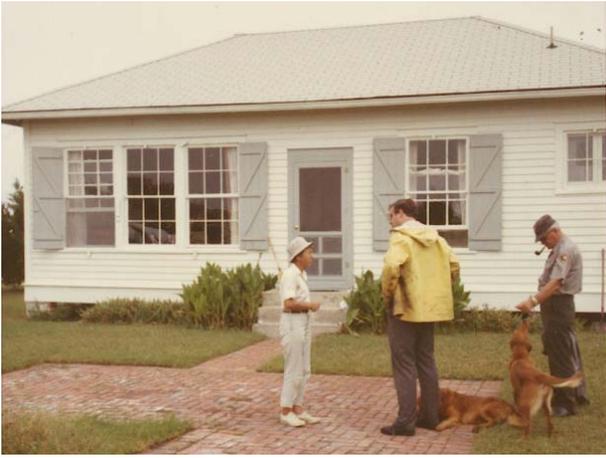
FIGURE 168A. The north facade of the Schoolhouse, circa 1969.

acquisition of the structure in the mid-1970s. This building is currently vacant. A funding request was submitted for 2008 to restore the Schoolhouse, including leveling, reinforcing, and repair of walls, and repair or replacement of the roof, windows, and doors. Two outbuildings survive in association with the Schoolhouse: the cistern and a shed. A privy mentioned in the National Register nomination is no longer present.

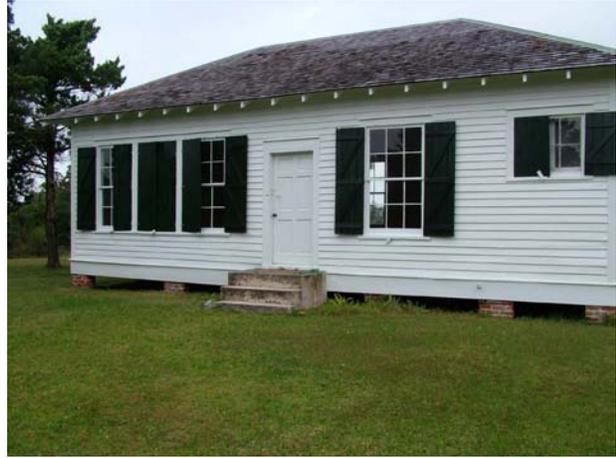
FIGURE 168B. The same view in 2006. Note the loss of the brick landing and walk, changes in paint color on the door and shutters, the reconfiguring and reshingling of the roof, and the loss of foundation plantings since 1969.

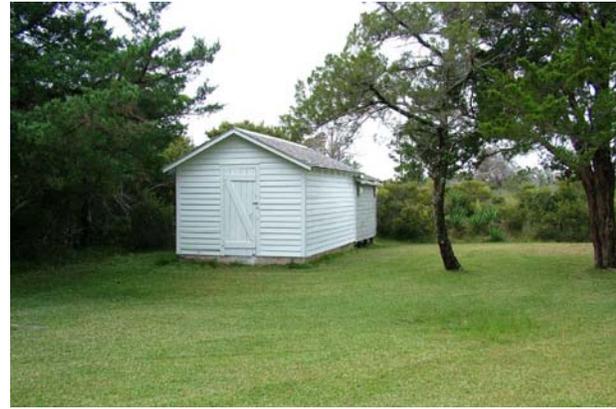
FIGURE 169B. The same view in 2006. Although the door appears to have been replaced and the roof resingled, the shed looks very similar today.

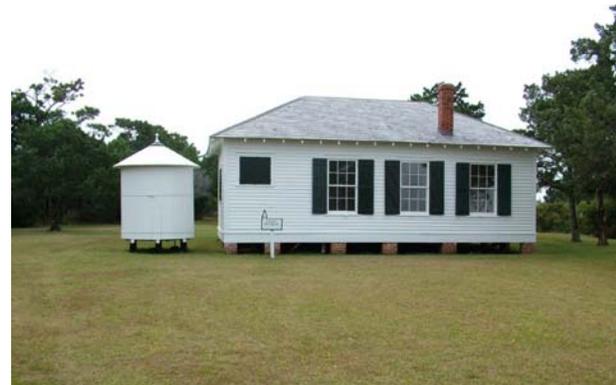
FIGURE 170B. The same view in 2006. Note that the windows are no longer boarded up and the antenna has been removed. Otherwise these features look very similar today.

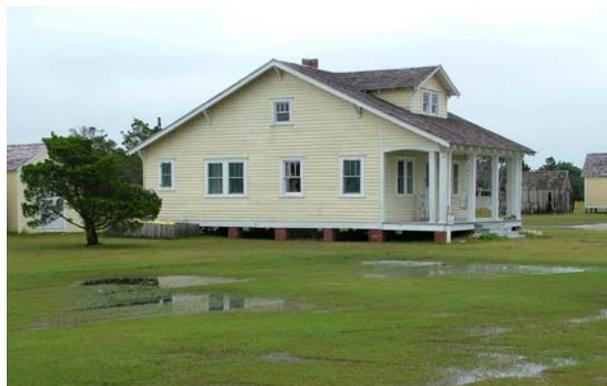
FIGURE 171B. The same view in 2006. Changes to the property include the loss of the low fencing, similar to that shown at the church, and the loss of the plantings edging the fence. The septic tank has been added since the earlier photograph was taken.

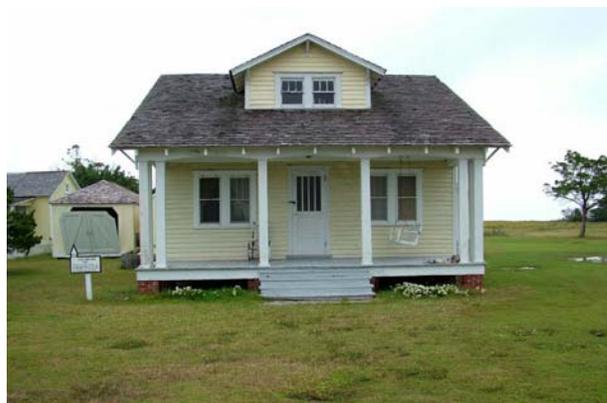
FIGURE 172B. The Jesse Babb House is very similar today to its earlier appearance as shown left, although the picket fence is missing. Note also the loss of vegetation behind the house.

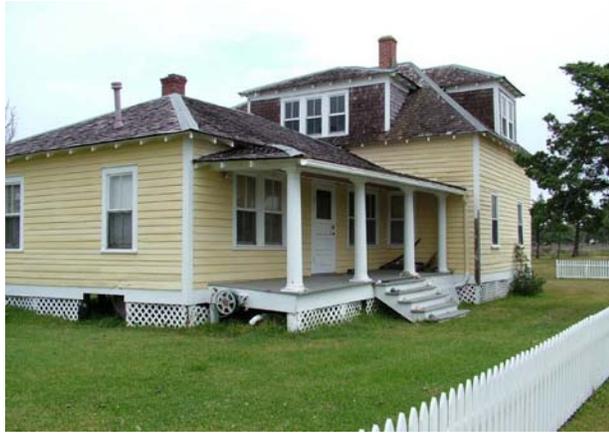
FIGURE 173B. The same view in 2006. Changes to the building include shingling of the dormers and removal of the screened porch. The picket fence has been painted white, and many of the trees are gone.

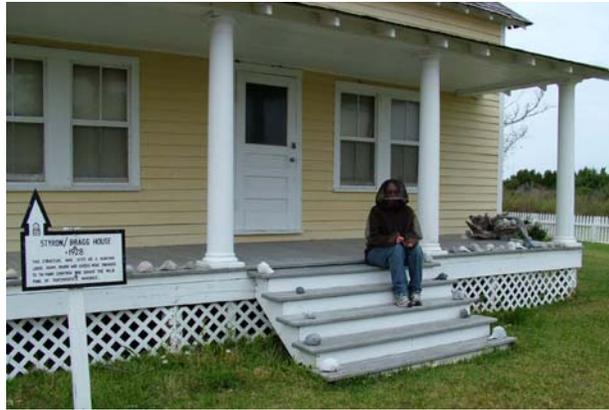
FIGURE 174B. The same view in 2006. Changes to the building include the removal of an air conditioning unit beneath the left-hand window, and the addition of new steps and lattice work under the porch.

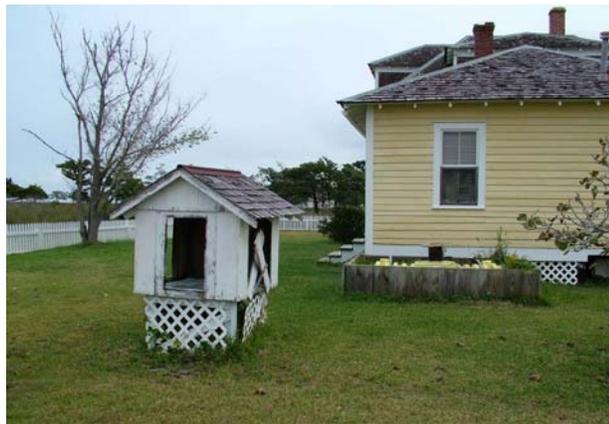
FIGURE 175B. The same view in 2006. Note the loss of the picket fence, as well as much of the vegetation around the house precinct.

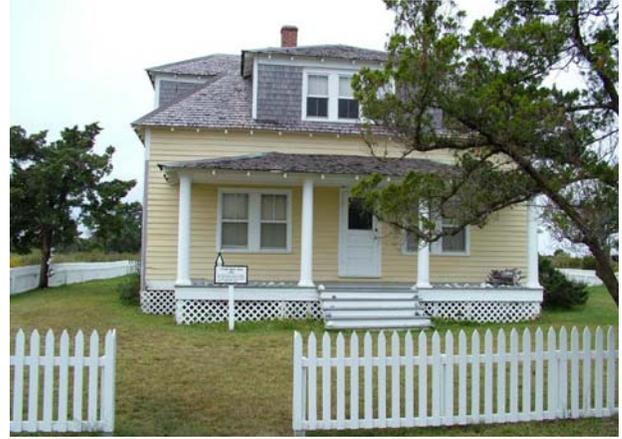
FIGURE 176B. The same view in 2006. Note the shingling of the second story, change in lattice under the porch, the addition of the picket fencing, and the loss of some

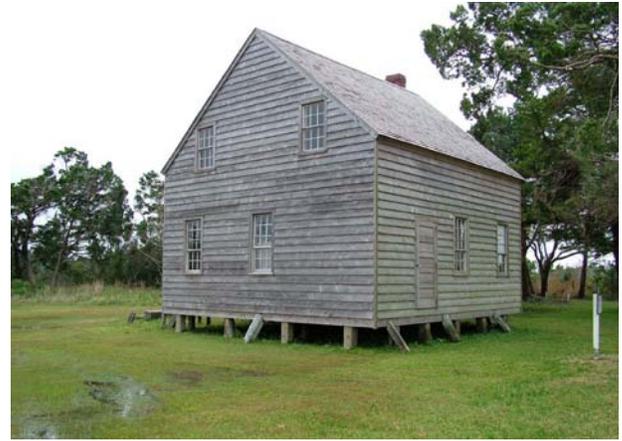
FIGURE 177B. The Washington Roberts House in 2006 is no longer boarded up. Many of the trees around the house have been lost, however.

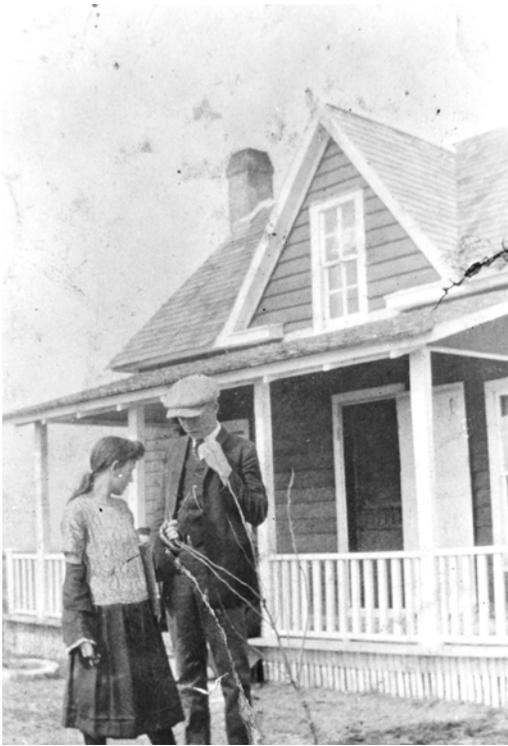
FIGURE 178A. Looking northwest across the south facade of the Robert Wallace House, circa 1930.

constructed circa 1850. It is currently vacant and under repair. A new roof was put on the building in 2005. In 2006, the house required leveling, reinforcement, repair and painting of some walls, and repair and replacement of windows and doors.

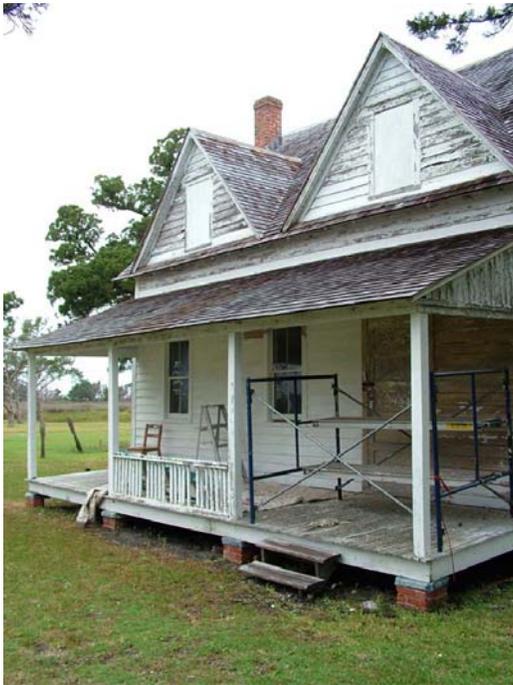
FIGURE 178B. The same view in 2006. Note the replacement of the central dormer with two dormers and alteration of the porch posts and railing. Woodwork beneath the porch is no longer present.

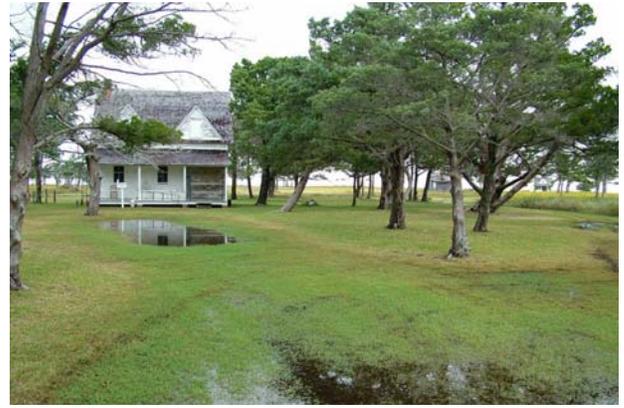
FIGURE 179B. The same view in 2006, illustrating changes in vegetation, and the loss of the long building extension (kitchen wing) to the right of the Robert Wallace House.

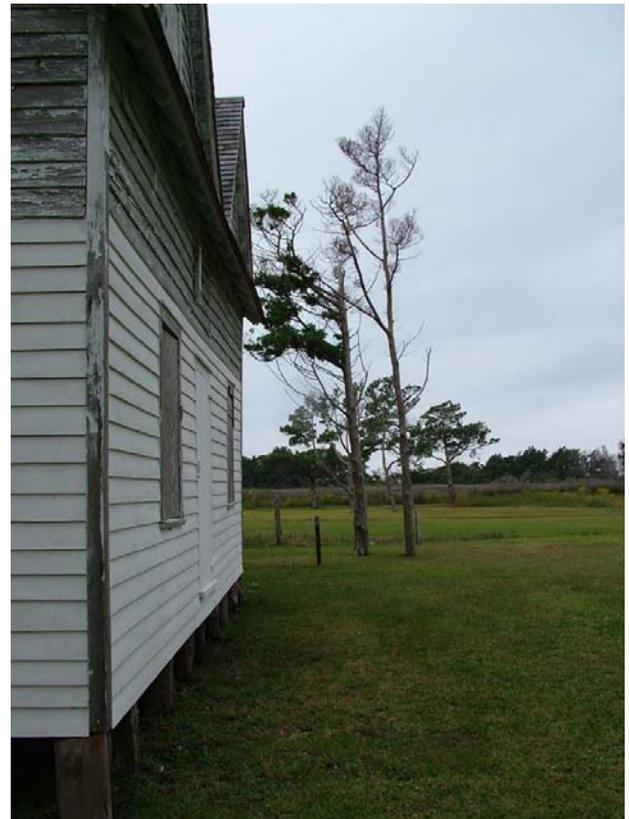
FIGURE 180B. The same view in 2006. The contemporary photograph illustrates changes in the building roof line, the loss of a step leading out of the building, and the dramatic loss of vegetation behind the house.

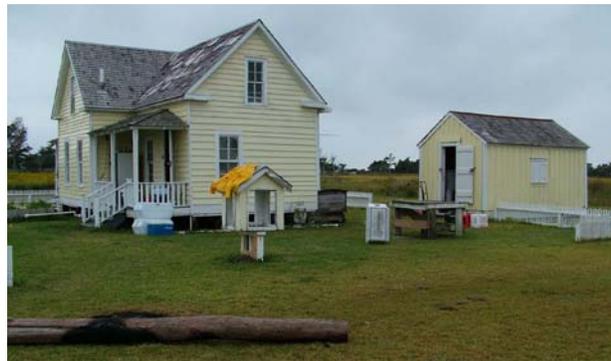
FIGURE 181B. The same view in 2006, illustrating changes to the property such as the loss of picket fencing in the rear, the chimney on the outbuilding, and the tree along the fence; deterioration of the Cool House; and replacement of the pink

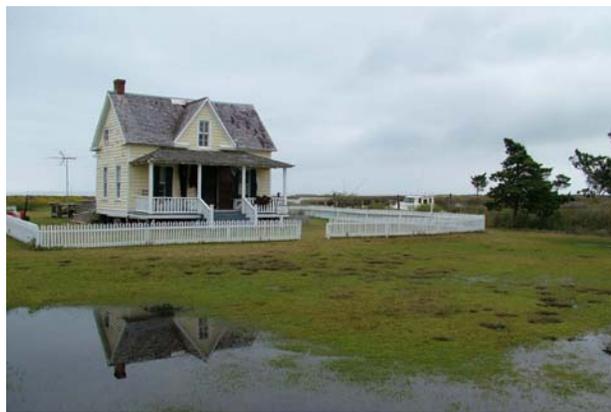
FIGURE 182B. The same view in 2006 illustrates that the property is much the same except for the exterior paint color, and the loss of the radio tower behind. NPS management of building precincts has led to a change in vegetative cover including replacement of warm-season grasses with cold-season grasses.

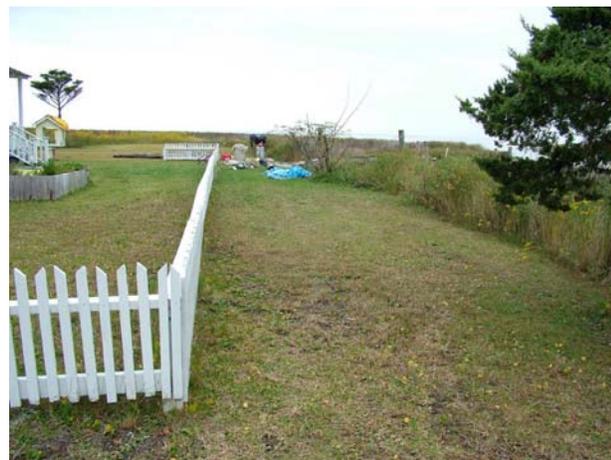
FIGURE 183B. The Henry Pigott House yard is relatively similar in 2006, with the primary exception of the loss of vegetation to the exterior of the fence. Segments of the picket fence are missing in the rear.

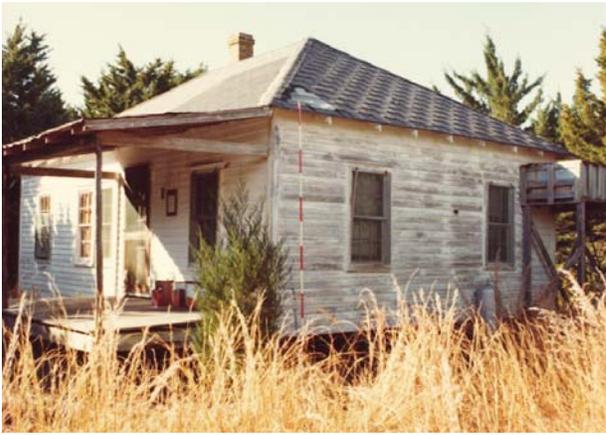
FIGURE 184A. Looking southwest toward the Frank Gaskill House, circa 1979.

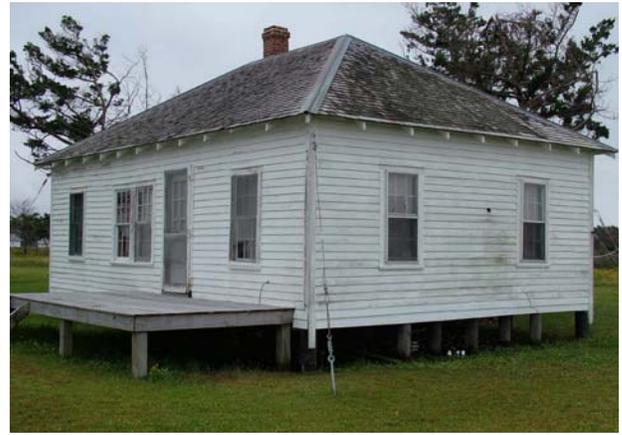
FIGURE 184B. The same view today. Note the loss of the roof overhang associated with the porch and the wood stair and landing along the side/rear of the house. The vegetation is now mown cool-season grass, whereas the earlier view suggests native warm-season grasses were present previously. Cabling is currently stabilizing the structure.

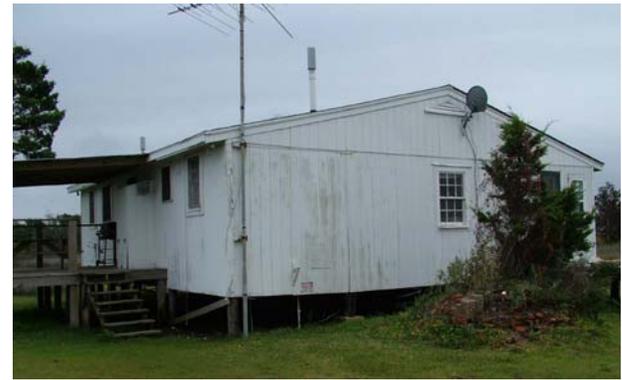
FIGURE 185B. The same view in 2006. Note the addition to the building along its rear facade, the removal of the screened porch, replacement of the siding, and the addition of a deck.

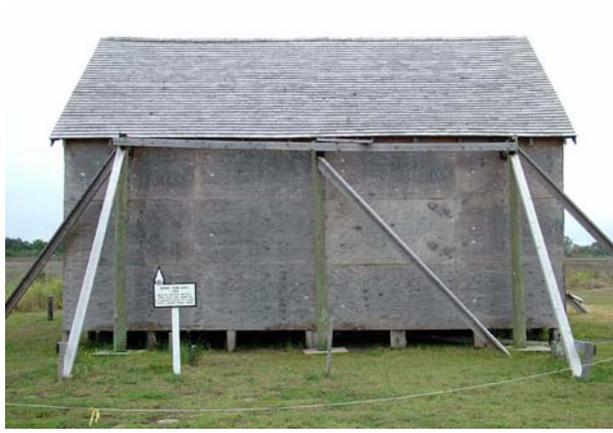
FIGURE 186B. The George Dixon House in 2006 is mothballed following severe hurricane damage.

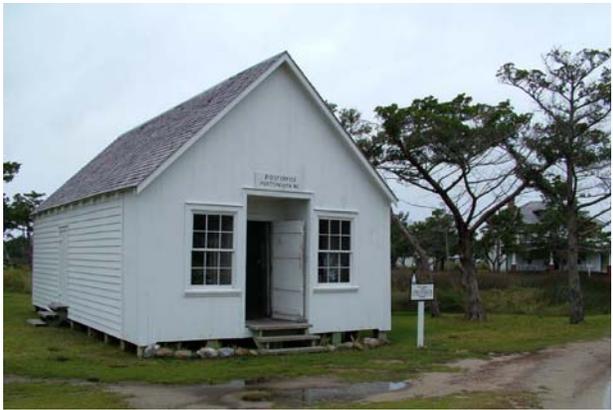
FIGURE 187B. The same view today. Changes since the 1930s include the loss of the addition, and removal of the porch and overhang. The vent pipe in the rear is also gone. The side door indicates the former connection between this building and the missing addition.

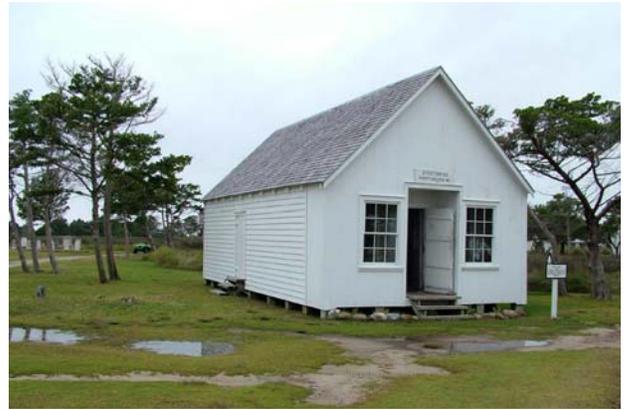
FIGURE 188B. The same view today. Changes since the 1930s include the loss of the addition, and removal of the porch and overhang. The vent pipe in the rear is also gone.

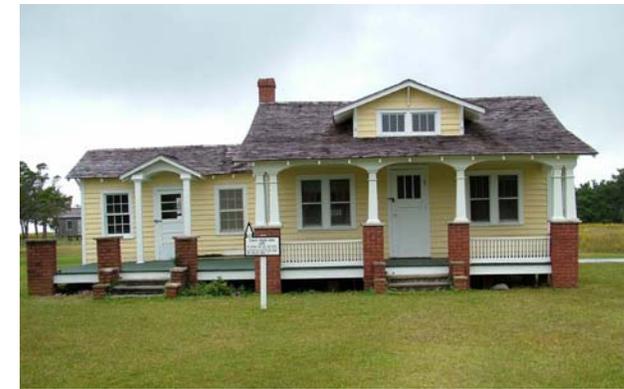
FIGURE 189B. The same view in 2006. Note the loss of the decorative trellis on the porch, the pickets along the side addition, the low fencing like that at the Babb House, and the change in mortar associated with the brick.

1920s. The house was restored in 1980–1985. Several capstones on the brick pillars on the front of the house have cracked or are missing material. One outbuilding is associated with the property.

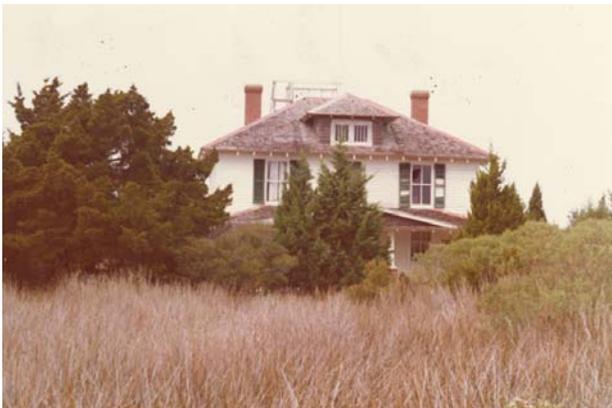
FIGURE 190A. The Dixon-Salter House, circa 1974.

Dixon-Salter House. This structure is also known as the Theo Salter House and the Salter Gun Club (Fig. 190 and Fig. 191). Constructed circa 1900–1909, this house is thought to have been moved to its present site circa 1930. The Salter Gun Club was established in 1965–66. The building is currently utilized as the site's visitor contact station and has exhibits and a comfort station inside. The NPS

submitted a funding request in 2004 to repair storm-related damage to the building, primarily interior flooring, flooring on the porch, and siding on the summer kitchen. This work appears to have been completed in 2005. There are three outbuildings associated with the property: a cool house, shed, and privy.

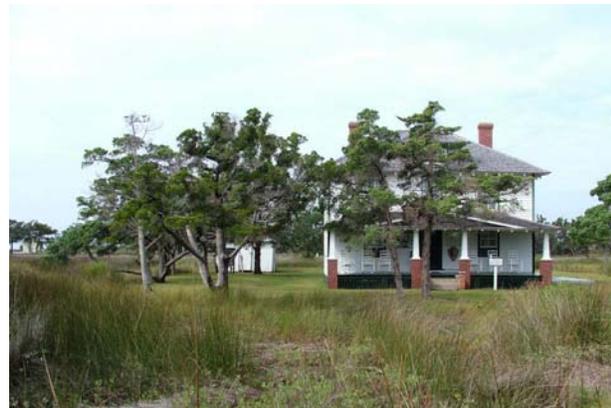
FIGURE 190B. The same view in 2006. Note the change in vegetation.

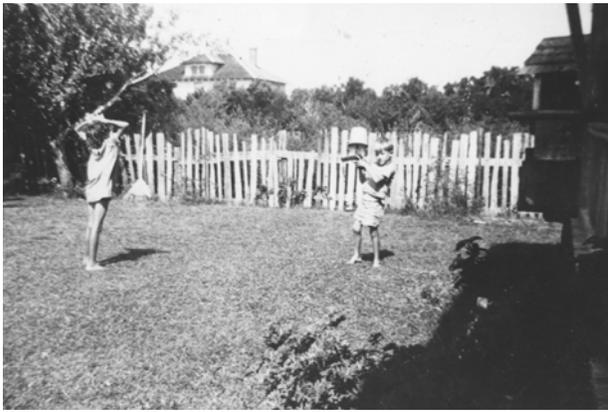
FIGURE 191A. Looking toward the Dixon-Salter House from the immediate front of the Robert Wallace House, circa 1943.

FIGURE 191B. The same view in 2006, illustrating the loss of the picket fence, growth of Eastern red cedar trees, and loss of shrubby growth between the two houses. An unidentified structure to the right is no longer present.

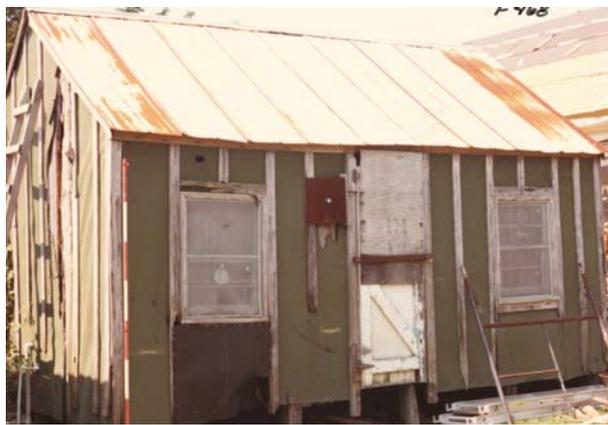
FIGURE 192A. The north facade of the outbuilding east of the Carl Dixon House, circa 1979.

FIGURE 192B. The same shed in 2006. Changes visible between the photographs includes the boarded window, different cladding of the shed, the addition of a vent pipe, replacement of the door, addition of wooden steps, lack of paint, and the addition of the widow's walk to the roof of the adjacent Carl Dixon House.

Carl Dixon House. Constructed circa 1930s, this house is occupied through the historic lease program (Fig. 192 through Fig. 194). A net house mentioned as part of the property in the National Register nomination appears no longer to be extant. There is a summer kitchen associated with the property, however.

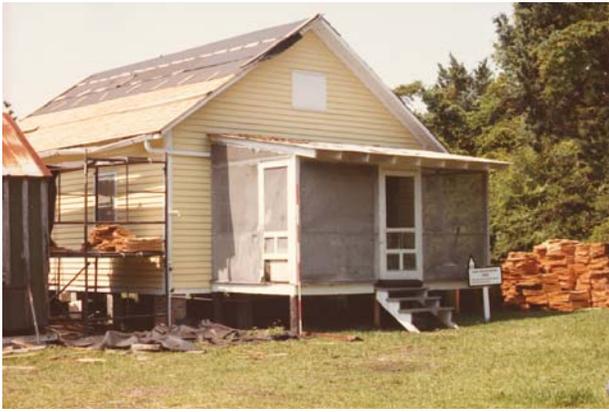
FIGURE 193A. The north facade of the Carl Dixon House, circa 1979.

FIGURE 193B. The Carl Dixon House in 2006. Changes since 1979 include loss of the front porch, addition of the widow's walk, replacement of the roof, and a change in paint color.

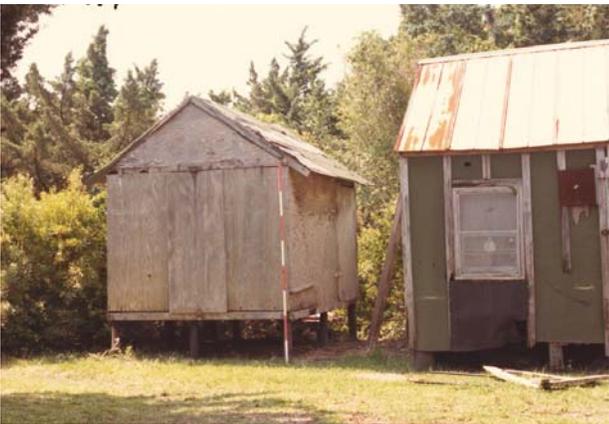
FIGURE 194A. Looking southeast toward a storage shed east of the Carl Dixon House outbuilding, circa 1979.

FIGURE 194B. The same view in 2006. Note the loss of the shed to the left of the existing outbuilding, as well as the dense vegetation behind.

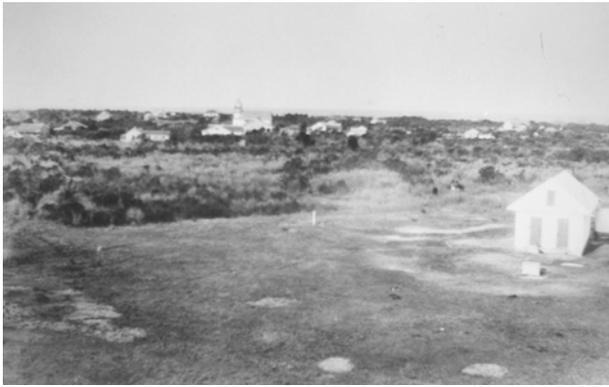
FIGURE 195A. View of Portsmouth Village looking west from the Portsmouth Life-Saving Station watchtower, circa 1986.

Very little is known about historic views and viewsheds at Portsmouth Island. Mount Truxston is marked on an 1806 map and was likely used for lookout purposes. The village was generally sited to view Wallace's Channel and the lightering activities occurring there. Earthen fortifications were constructed on the mud flats and beach front to the east of the village to protect Ocracoke Inlet and were likely to have included good views of ocean approaches to the inlet. The Life-Saving Station includes an elevated lookout tower to support life-saving endeavors (Fig. 195). This view survives today.

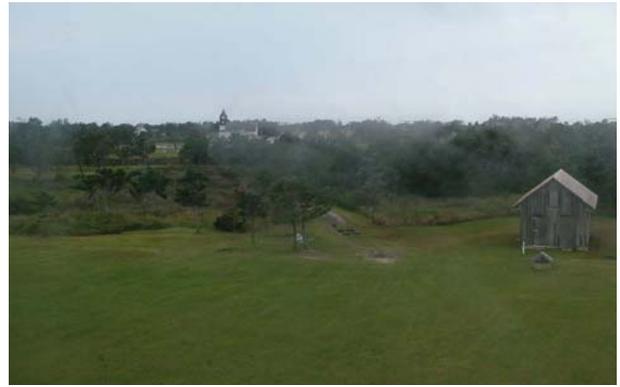
FIGURE 195B. The same view in 2006, indicating that there is more woody vegetation today that serves to obscure views present in earlier years between the two areas.

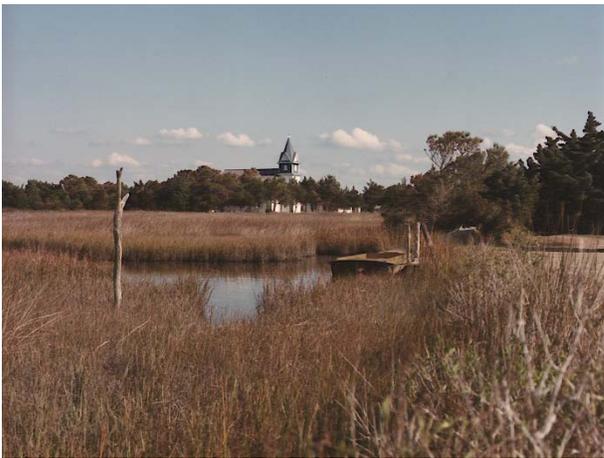
FIGURE 196A. The view east along Doctor's Creek toward the Portsmouth Methodist Church, circa 1983.

FIGURE 196B. The same view in 2006, which is very similar. A small dock or other type of structure visible at the edge of the water in the earlier photograph is no longer present.

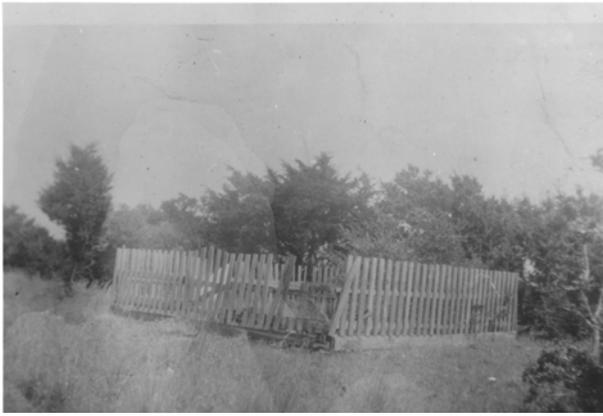
FIGURE 197A. View northeast toward Grace Cemetery, date unknown.

FIGURE 197B. The same view in 2006. Note the loss of much of the vegetation behind the cemetery, the addition of the interpretive marker, and the repair and painting that has been done on the fence.

Grace Cemetery. This cemetery is enclosed within a perimeter picket fence (Fig. 197 and 198). There are two single headstones and one double headstone. The cemetery was established in 1872.

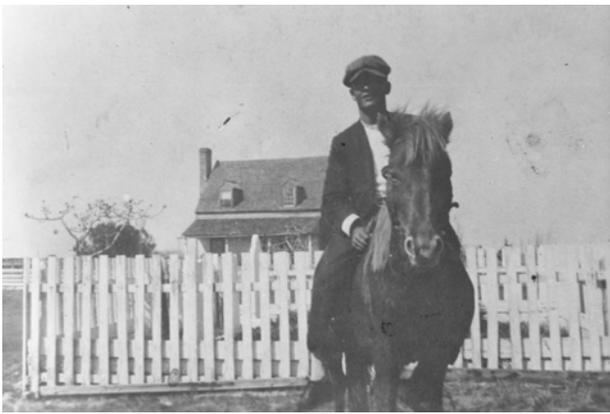
FIGURE 198A. View across Grace Cemetery toward the Robert Wallace House, circa 1917.

FIGURE 198B. The same view in 2006. Note the growth of Eastern red cedar trees currently blocking the view to the house.

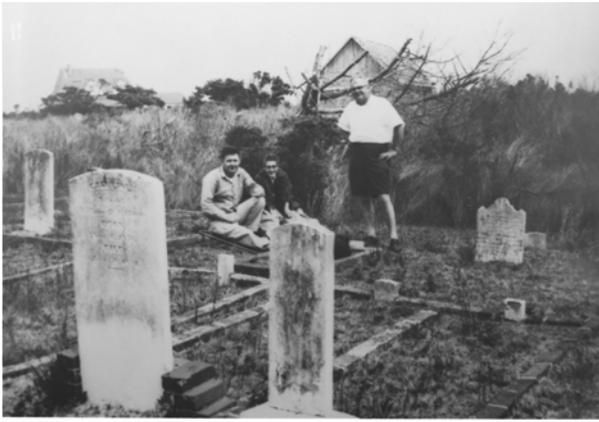
FIGURE 199A. The Community Cemetery, circa 1960.

FIGURE 199B. The same view in 2006. Note the deteriorated condition of some of the headstones, and the change in the view behind the cemetery.

Community Cemetery. This cemetery includes thirty headstones associated with the graves of members of the Babb, Dixon, Styron, Williams, Daly, Gilgo, and Roberts families. There are twenty-four commercial headstones and associated foot markers and grave plots edged by brick and concrete borders (Fig. 199 and Fig. 200). The cemetery was established in 1885. Many features are in need of repair.

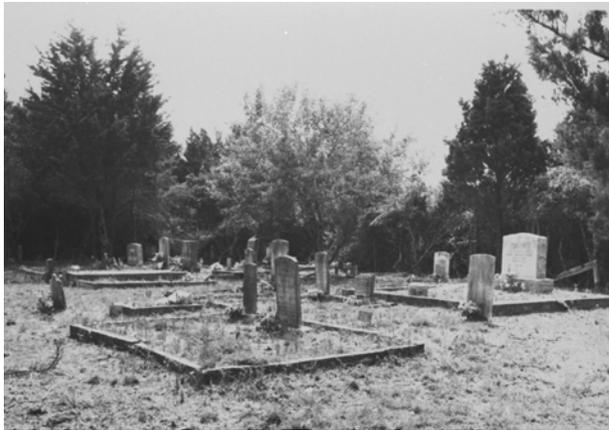
FIGURE 200A. View southwest across the Community Cemetery, circa 1978.

FIGURE 200B. The same view in 2006. Although the cemetery appears to have changed little since the 1978 view, the vegetation behind the cemetery has changed dramatically.

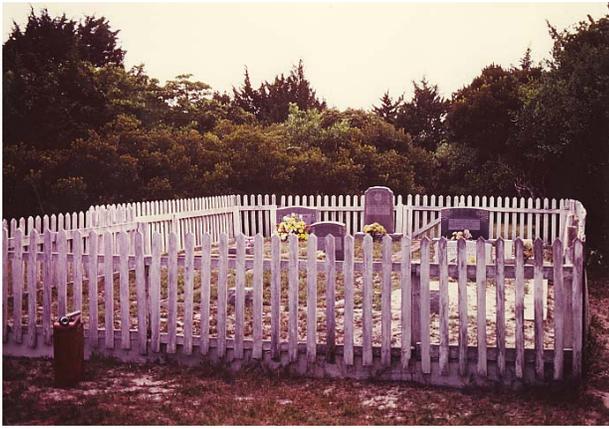
FIGURE 201A. View west across the Babb-Dixon Cemetery, circa 1978.

FIGURE 201B. The cemetery today is very similar in appearance. The vegetation behind the cemetery is no longer extant, however.

Babb-Dixon Cemetery. Also known as Babb-Dixon-Pigott Cemetery, the cemetery includes perimeter picket fencing, the headstones of five

burials, and two family pet graves (Fig. 201). This cemetery was established in 1945. Henry Pigott is buried here.
