## Conserving

# Earthen Architecture

**PUBLISHED BY THE  
NATIONAL PARK SERVICE**

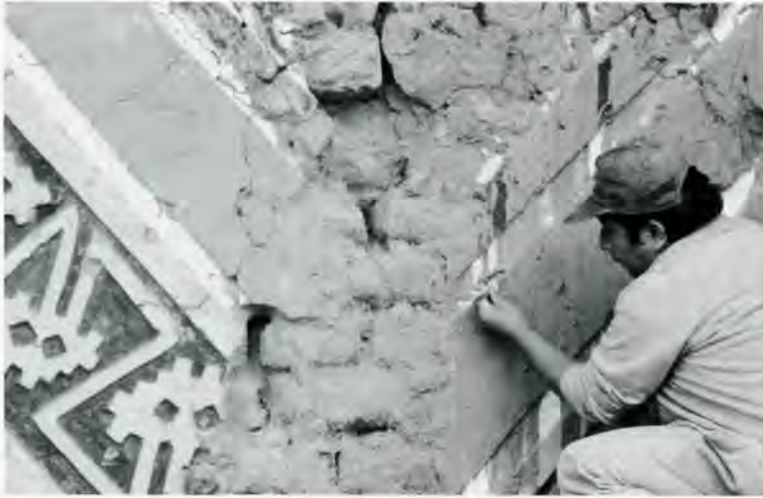
*Huaca de la Luna, Trujillo, Perú. Cleaning and conservation of murals on recently excavated earthen architecture. Photo courtesy Michael Romero Taylor.*

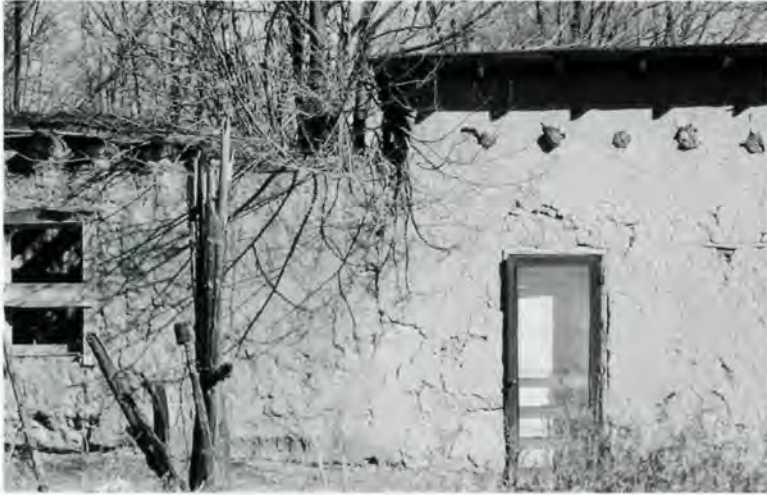
*Deteriorating adobe buildings, Taos County, New Mexico. Photo courtesy New Mexico State Monuments, Museum of New Mexico.*

servicing adobe buildings, but the techniques that work best are keeping the adobe dry, providing routine maintenance, and using compatible materials when replacing deteriorated sections of wall.

In New Mexico, practitioners of adobe preservation are realizing that the cement plasters that were applied almost universally to adobe structures after the Depression and World War II have their drawbacks, one of which is the inhibition of the evaporation of moisture that enters through cracks. Cracking is common, and it is caused by the differential expansion/contraction coefficients inherent in the two dissimilar materials. Practitioners are also realizing that earthen plasters are the best renders as long as they are protected from the elements by a roof overhang, or cyclically maintained every two to three years if left exposed. A renaissance of sorts is taking place in New Mexico with the re-introduction of lime plaster, which was used to protect the surfaces of adobes during the Spanish Colonial and Territorial periods. This traditional technique is being re-introduced from Mexico.

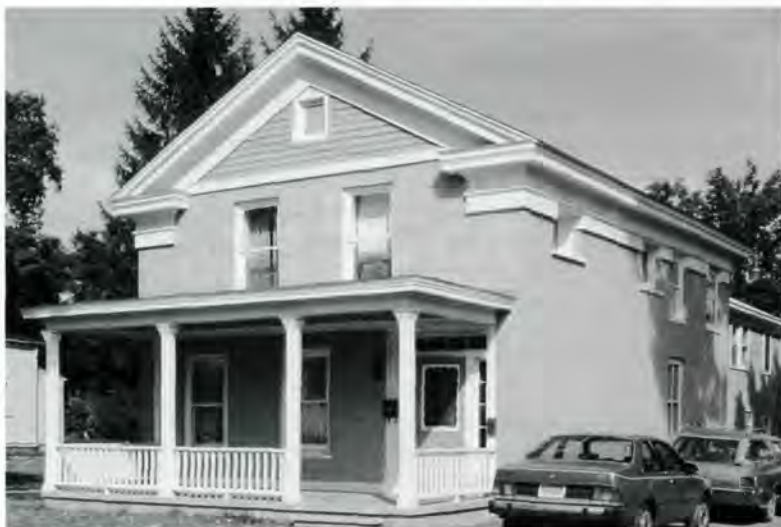
*Greek Revival style mud brick residence in Bath, New York. Nearly all of New York State's mud brick buildings were constructed between 1840 and 1851 and reflect the Greek Revival, Gothic Revival, and Italianate styles popular at that time. Photo by the author.*

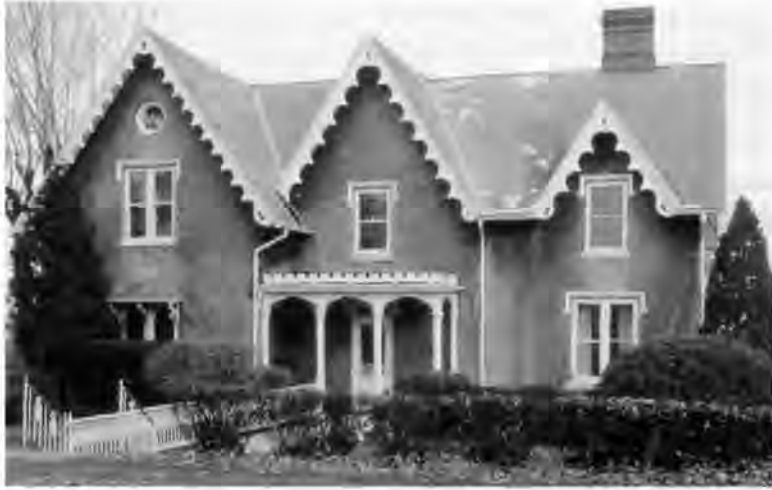
This Gothic Revival style residence in Geneva, Ontario County, New York, is typical of earthen buildings constructed in Geneva. Over 20 mud brick buildings had been constructed in Ontario County by 1855. Photo by the author.

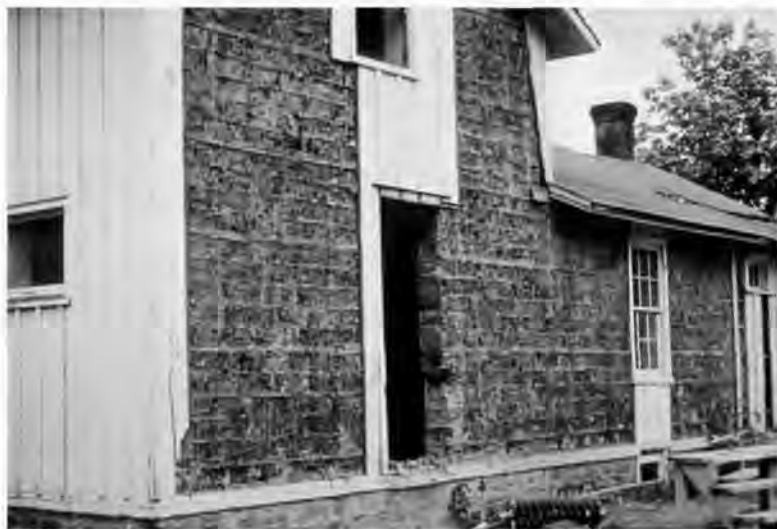
When it was demolished in the 1970s, this board-and-batten sided building in Geneva was found to be load bearing mud brick construction, originally sided with wood. Photo by David Brumberg.

By the early 1850s, the mud brick vogue was slowing considerably, no doubt prompted in part by the difficulty of preventing exterior stucco finishes from failing. The stucco problem had been mentioned frequently in early accounts, and prompted at least two New York State builders to include horizontal wooden members within the walls between alternate layers of brick, so that the completed masonry building could be sided with wood.

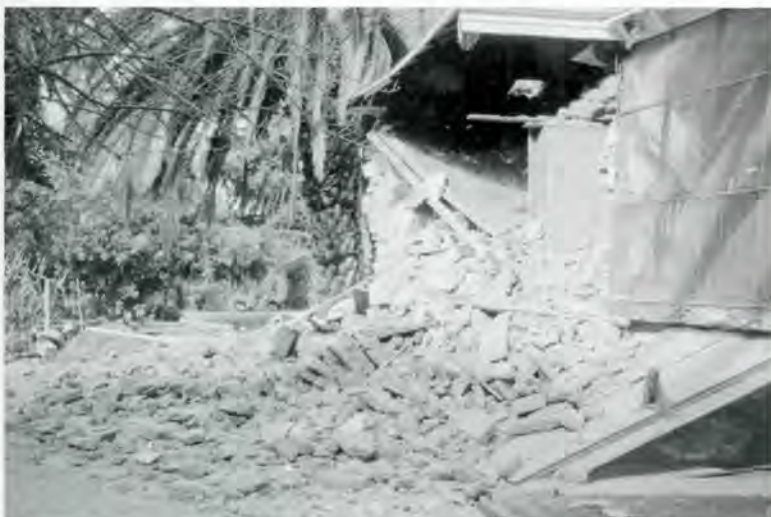
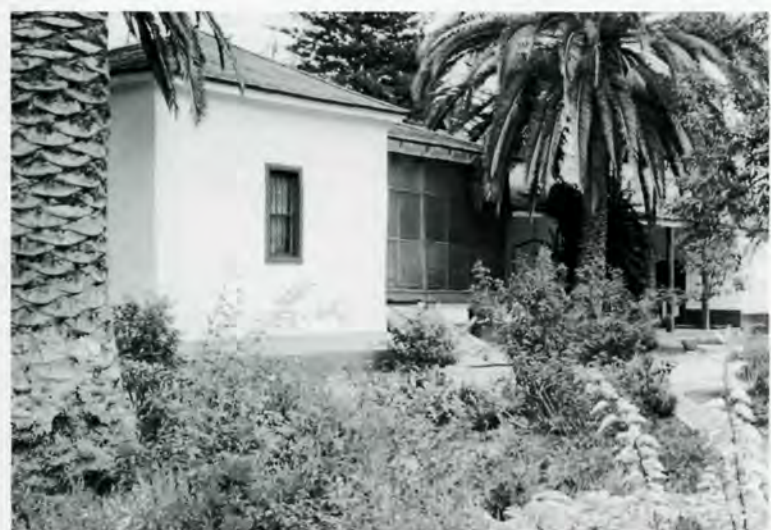
*After being heavily damaged during the Northridge Earthquake, Rancho Camulos was seismically strengthened by less invasive approaches than usual. Photos courtesy the author.*

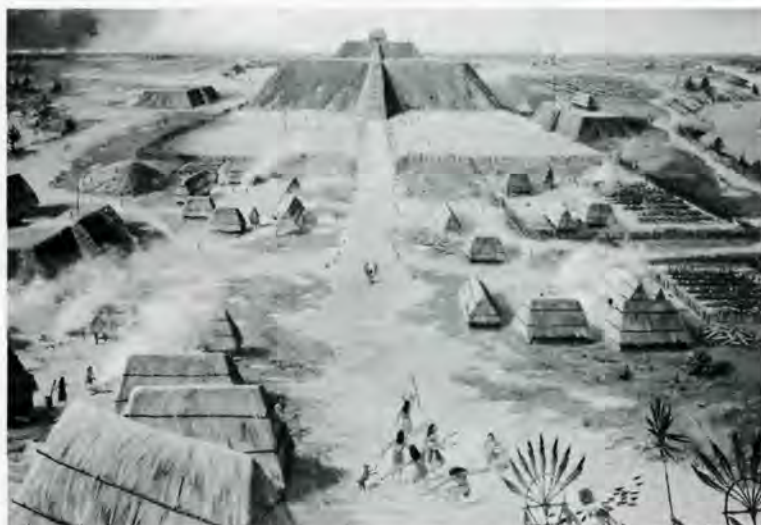
*Typical Mississippian temple mound complex c. 1200-1450, southeastern United States.*

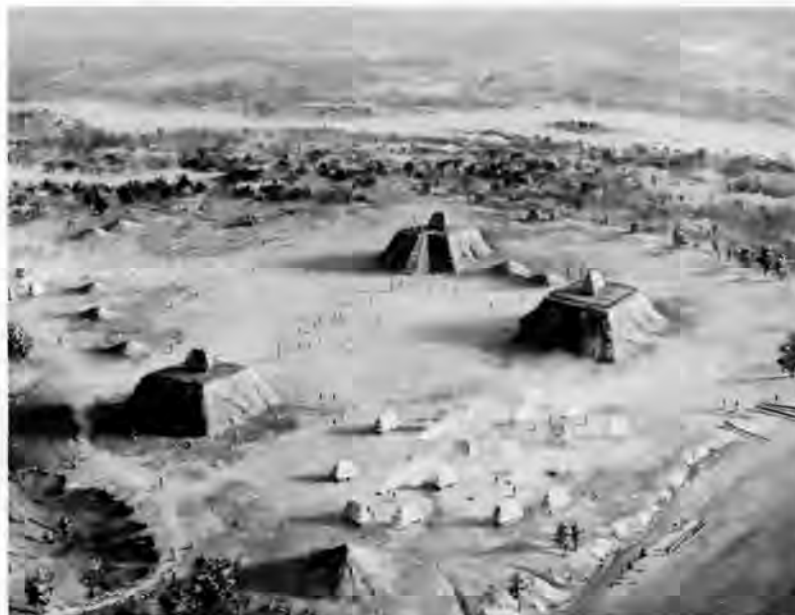
*Pritchard Landing, a Middle woodland mound complex c. A.D. 800, Ouachita Valley, Louisiana.*

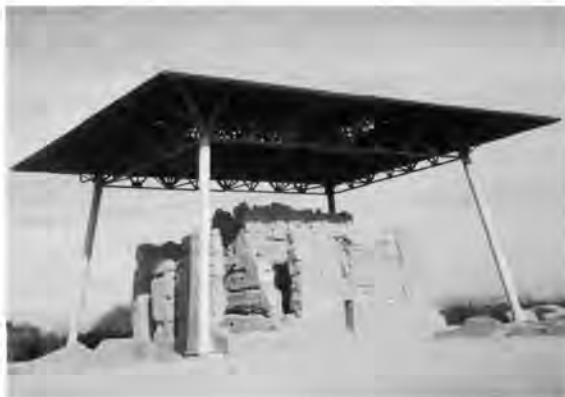
*East elevation,  
The Great  
House, Casa  
Grande ruins.*

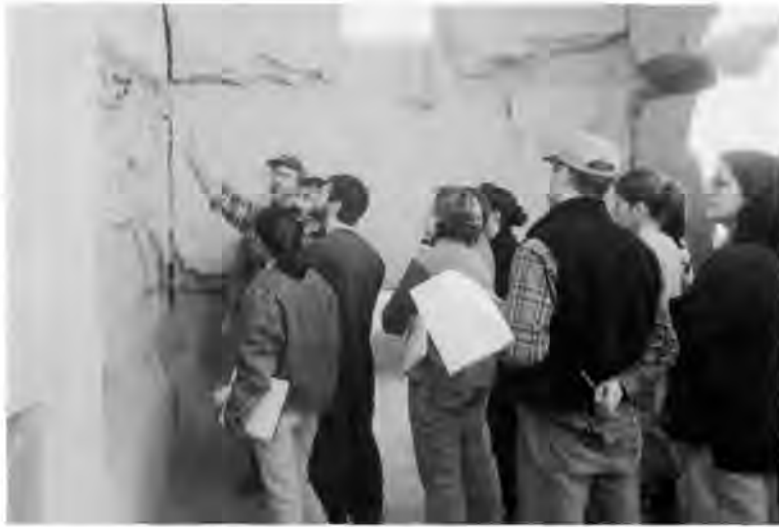
University of Pennsylvania  
1998 Field School surveying interior walls.

At Casa Grande two concurrent winter field schools documented, surveyed, and assessed conditions evident from surface observations. Students mapped details of conditions across the surfaces, a complete 100%-coverage photo-documentation was accomplished, and an engineering assessment was made. Throughout these campaigns the Arizona State Historic Preservation Officer and staff participated in planning. Analysis sessions were periodically held at the park and at the University; during these forums, participants stood in front of scaled digitized color annotated elevations considering patterns, clues, and other information pertinent to the ruin's condition. Two graduate students undertook thesis topics that involved researching fundamental questions about material, architecture, and deterioration mechanisms. Engineers simultaneously engaged in assessing the structure. In addition, seismic evaluations of the structure in relation to potential earth tremors were made.

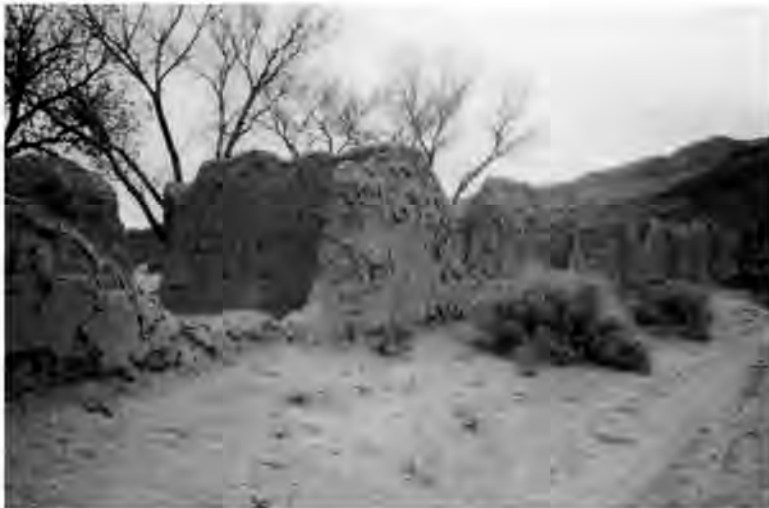
Wall fragments at Ft. Selden, New Mexico State Monument.

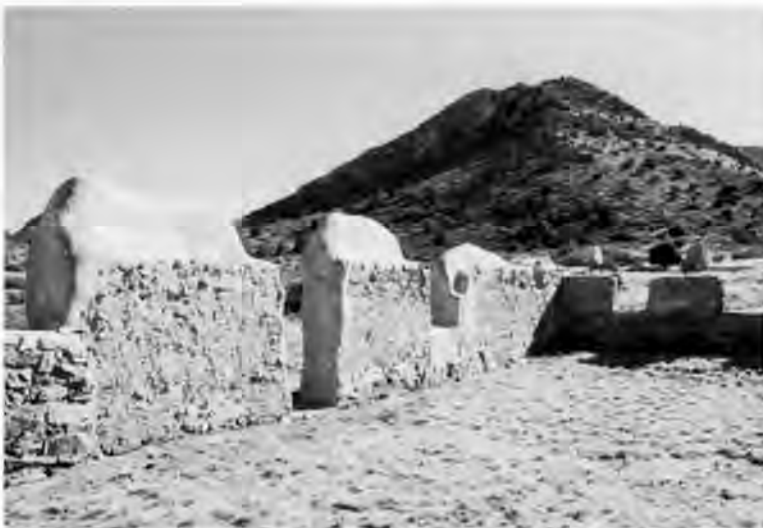
*Lime plaster shelter coats over adobe and lime concrete foundation walls of the Cavalry Barracks, Ft. Bowie NHS.*

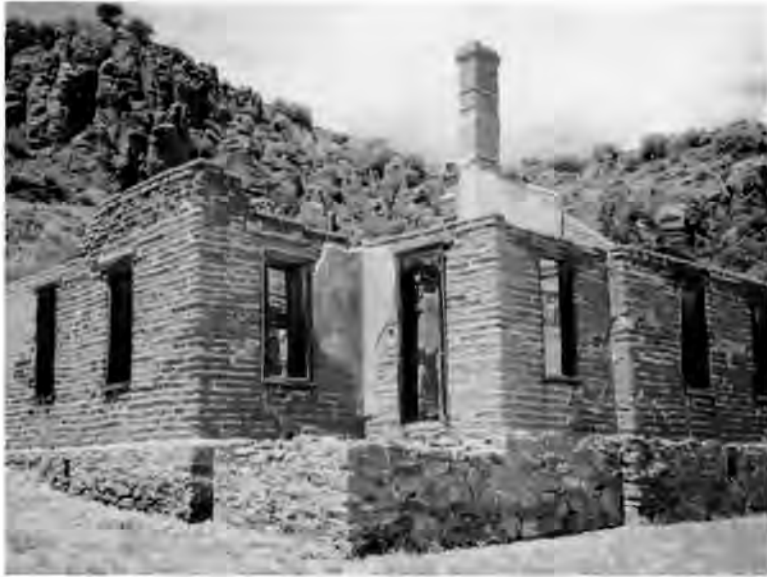
Non-commissioned Officers' Quarters, Ft. Davis National Historic Site.

The Park Service made a bold decision to reconstruct missing portions of the adobe buildings that were at least 70% intact and to replace missing roofs. Concrete bond beams were installed around adobe perimeter walls, and the porches were reconstructed. Exterior plasters were renewed on the structures on officers' row.

Sheltering the structures with new roofs has slowed deterioration significantly. Consolidating chemicals also appeared at Fort Davis, but today the unroofed adobe ruins are treated with unamended adobe caps and veneers. Some water repellants are used on modern adobe veneers to lengthen their life.

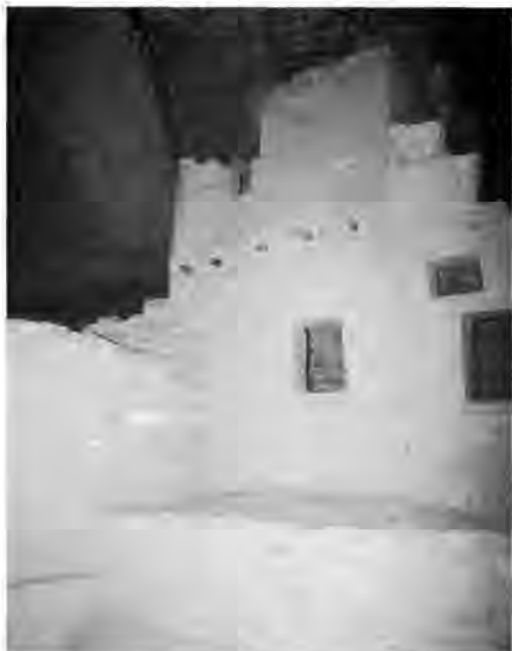
Architectural finishes on the Speaker Chief Tower in Cliff Palace, Mesa Verde National Park.

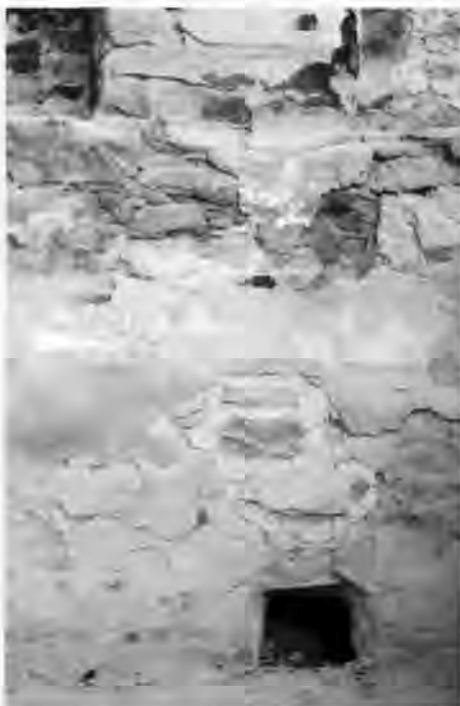
*Kiva "C" finishes, Mug House, Mesa Verde National Park.*

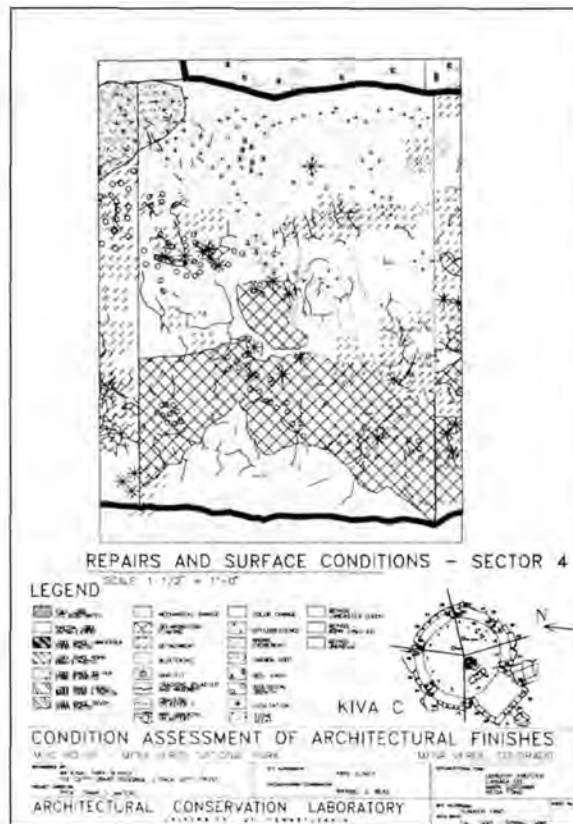
Condition assessment of architectural finishes, Mug House, Mesa Verde National Park.

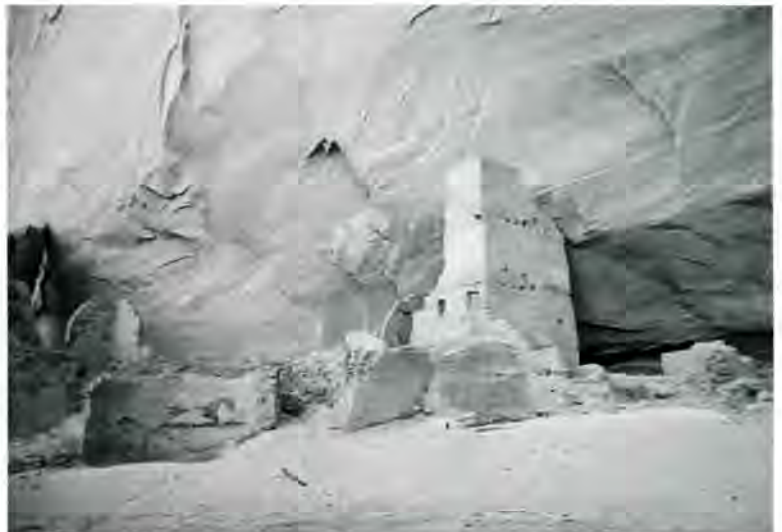
*Antelope House Ruin, Canyon de Chelly National Monument, Arizona. A large multi-story ancestral puebloan village dating from AD 800 to AD 1275 located in Canyon del Muerto. The site exhibits numerous kivas, multi-story structures, intact plasters and decorative paint on walls, stratified archeological remains, and numerous rock art images. Photo by Al Remley.*
