Disaster Management

Information for parks, federal agencies, Indian tribes, states, local governments, and the private sector that promotes and maintains high standards for preserving and managing cultural resources

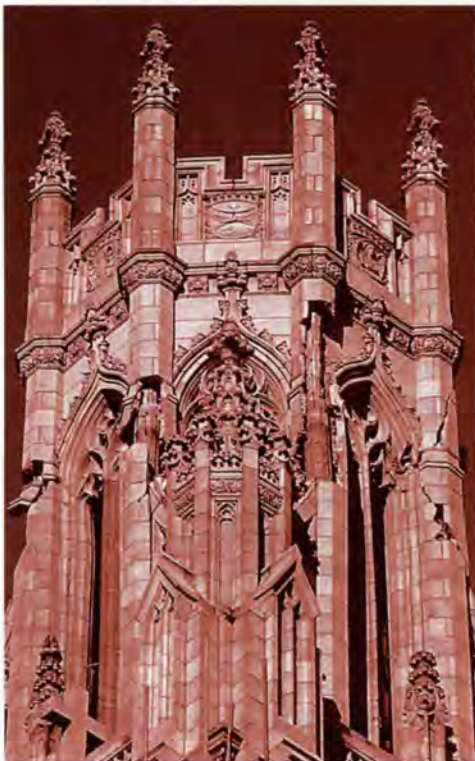
The octagonal terra cotta turret on the tower of St. Dominick Roman Catholic Church in San Francisco was severely damaged by the Loma Prieta earthquake in 1989. Although the rest of the church was saved and retro-fitted with new flying buttresses, the turret was removed and never rebuilt.

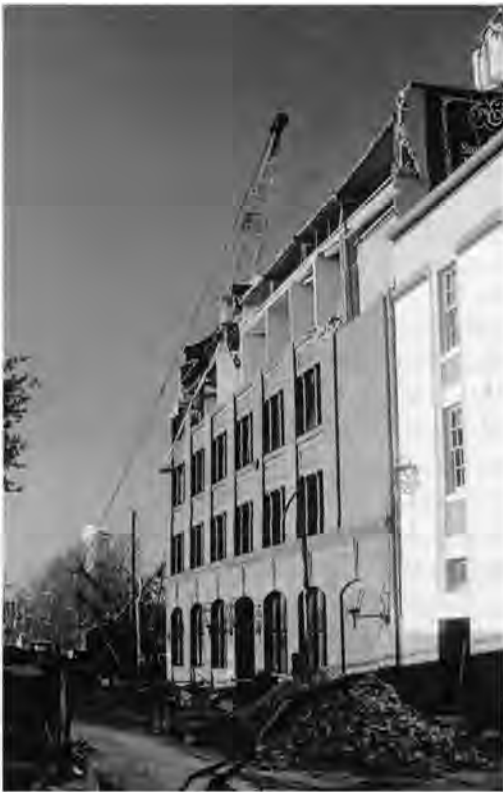
By progressive failure the unreinforced-brick parapet and fourth-floor façade of this building on Bluxome Street collapsed onto the sidewalk and street during the Loma Prieta earthquake killing six people in a car pool.

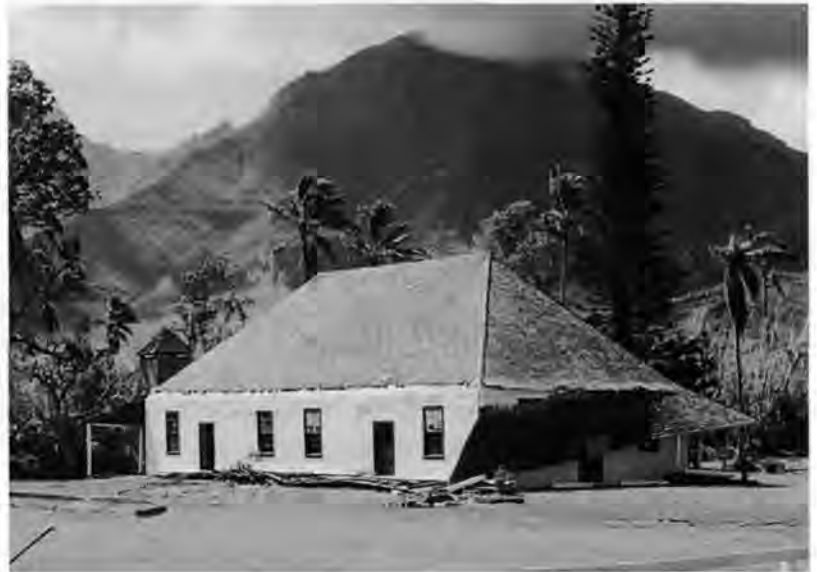
Waioli Mission Hall (c. 1830), Hanalei, Island of Kauai, Hawaii. Damage from Hurricane Iniki in 1992 destroyed the lanai (covered porch) that ran completely around the building. The building was restored and structurally strengthened using FEMA funding. Photo by Randolph Langenbach, FEMA.

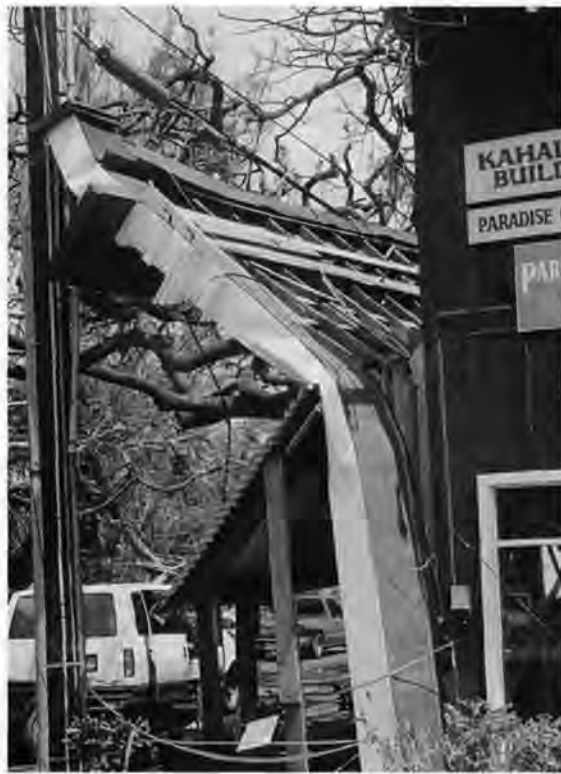
Hurricane Iniki in 1992 ripped the façade from this one-story vernacular store building on Kauia, Hawaii. The utility pole prevented the façade from falling onto the sidewalk and road. Photo courtesy David W. Look.

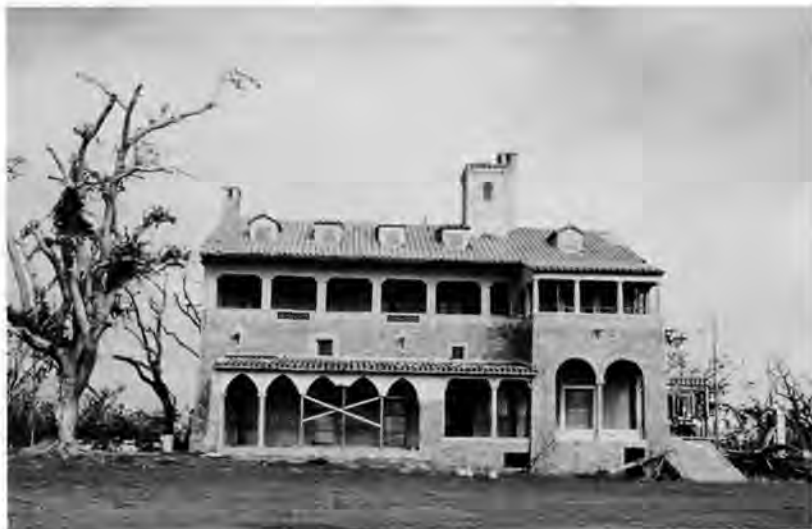
Richmond Inn, Miami, Florida. This building suffered extensive damage from Hurricane Andrew in 1992. Photo courtesy FEMA.

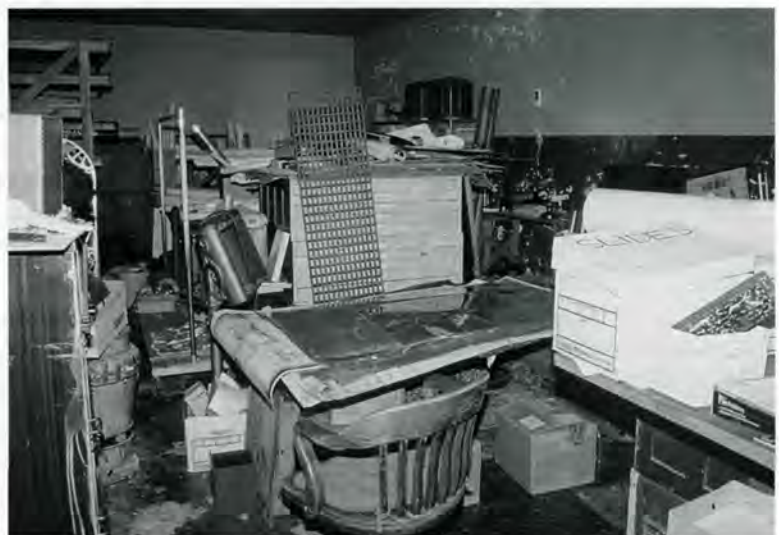
Fox Theatre Collections Room before the fire in 1996.

The 1996 fire did not severely damage the old collections storage space, but it did destroy the office of the Restoration department, which is the staff group responsible for the management and care of the archives. The reconstruction of the Restoration office provided an opportunity to create a new archives space designed to fit the security and safety needs of a valuable collection.

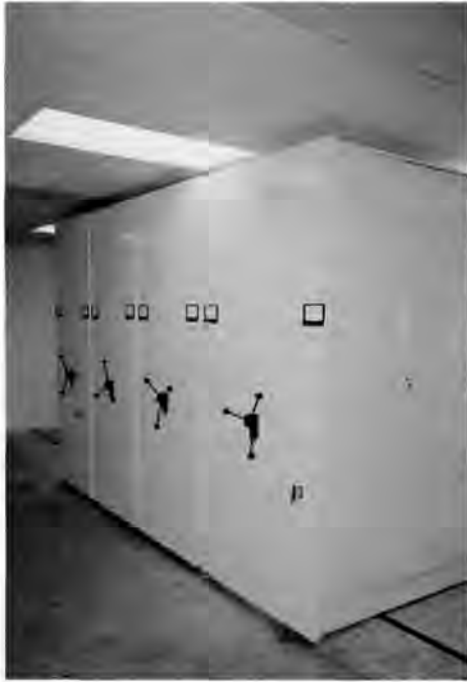
Fox Theatre collections room now.

The new collections space measures roughly 28 by 14 feet, with a 12-by-6-foot corridor on one side (slightly smaller than the old space, but designed with an eye toward efficiency). The safety features of the new space include a sprinkler system, two perimeter walls of four-hour masonry construction with one-hour rated gypsum wall board on metal-stud furring, and two perimeter walls of two-hour rated metal stud and gypsum wall board.

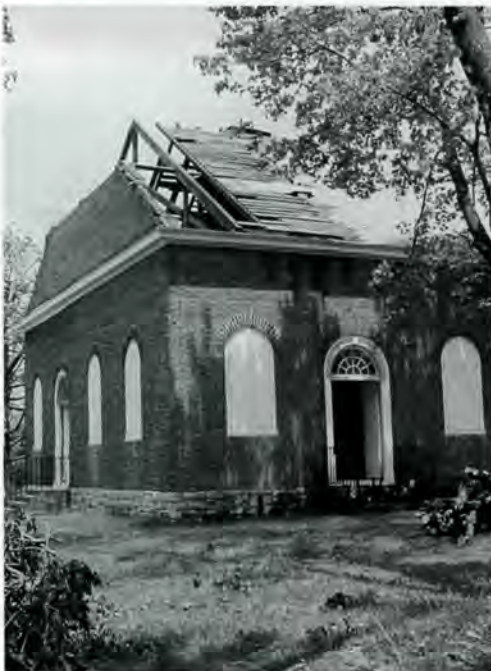
Rocky Spring Presbyterian Church near Chambersburg, Pennsylvania, a few days after the F-0 rated tornado with 110 mph winds topped the south gable and tore off 22 squares of roofing and rafters. Photo taken May 23, 1996.

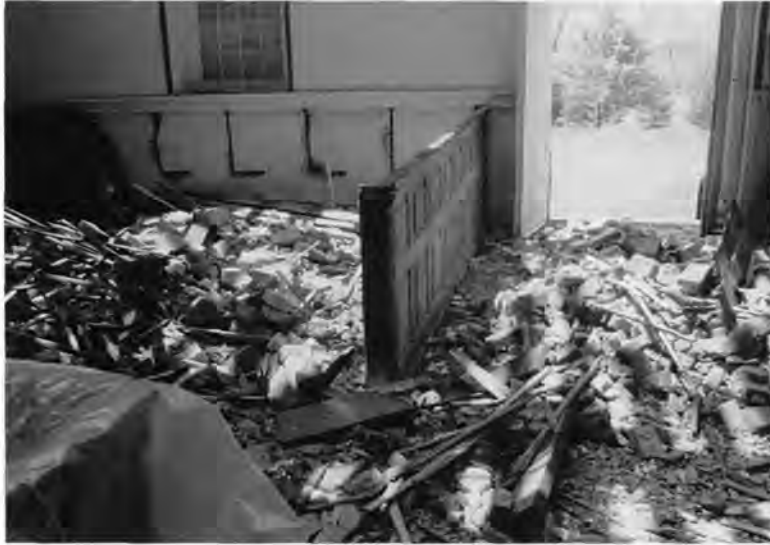
Twenty-two tons of brick, mortar, plaster, lath, and framing fell to the sanctuary floor crushing four box pews and two original deacon benches. The debris was carefully sifted for all salvageable materials. Photo taken May 23, 1996.

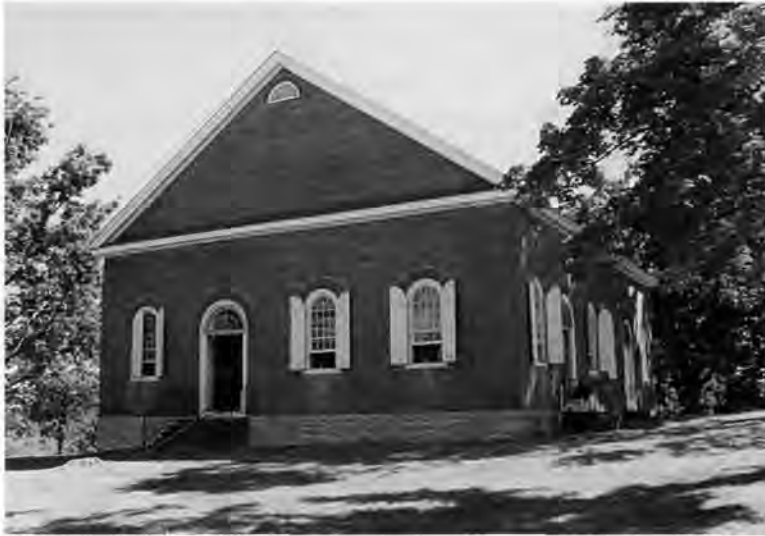
The 1794 Rocky Spring Presbyterian church with the original bricks reset with a soft mortar, all the trim work restored, and the pent roof restored. Photo taken July 3, 1997.

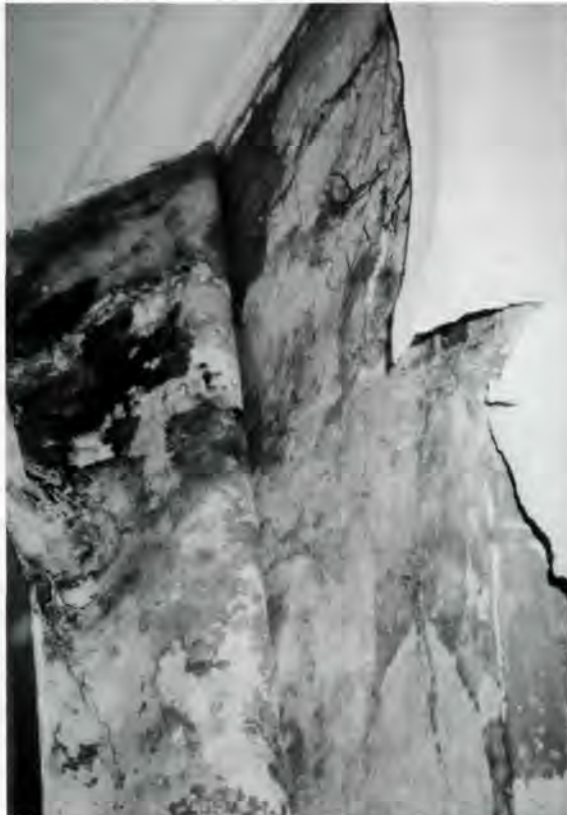
Inside the house in the central corridor immediately beneath the cracked and leaking gutter (see next photo) the wallpaper over a doorway was found to be peeling off the wall, with a massive fungal attack growing on the soaking wet wall paper paste and animal protein glues of early distemper paints.

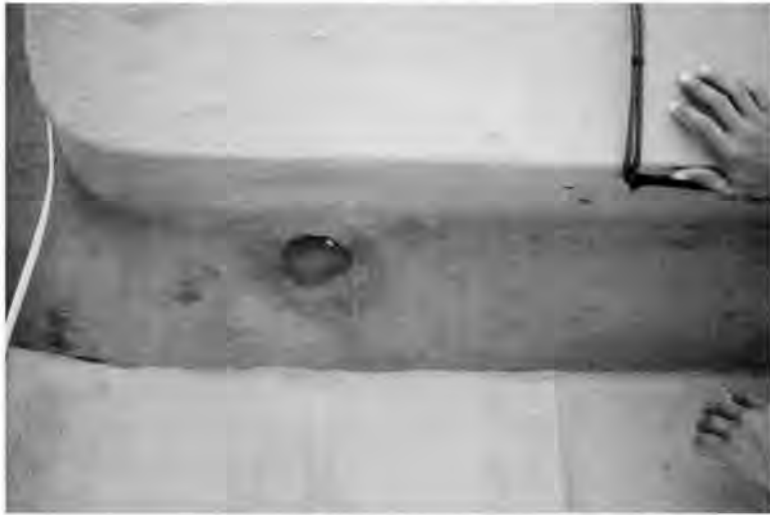
Painted many times, the corroded galvanized steel roof had many leaks. Here a gutter is cracked and leaking badly next to a critical rainwater outlet. The outlet was one half the size that it should have been. This causes overflowing and even worse leaks during tropical down-pours.

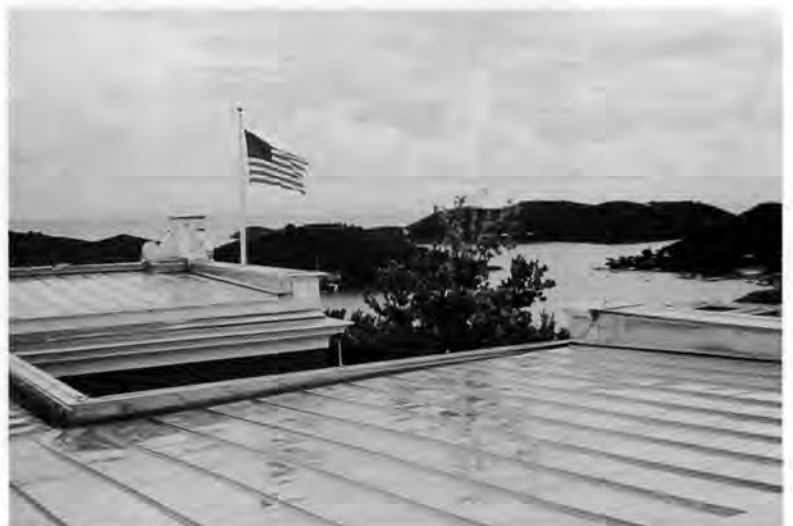
New stainless steel sheet roofing with complete cap flashings on all parapets and roof ornaments. Note new lighting protection system. All rainwater drains have been doubled in size.

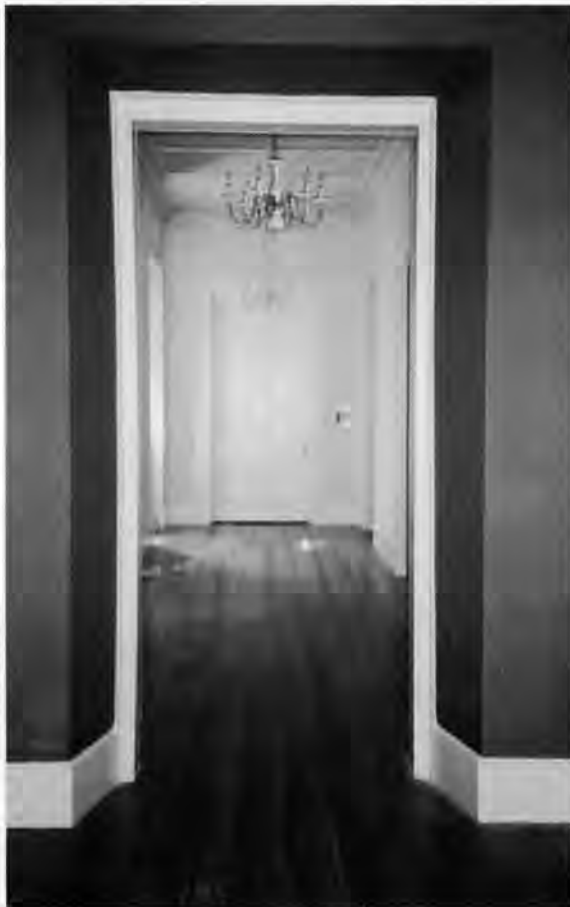
Less than a year later, after the installation of new roofing, the interior is fully restored. The fine timber beams and flooring were restored using the same pitch pine that was originally used. The colors and distemper paint finishes are precise reproductions of the originals from the 1830s.

Taking another lesson from the building, the writer has restored the fine timber beams and flooring using the same top quality pitch pine that was used originally. It was noted that wherever the high quality pitch pine had not been used, the wood had usually been consumed by termites and hence the need for restorations.

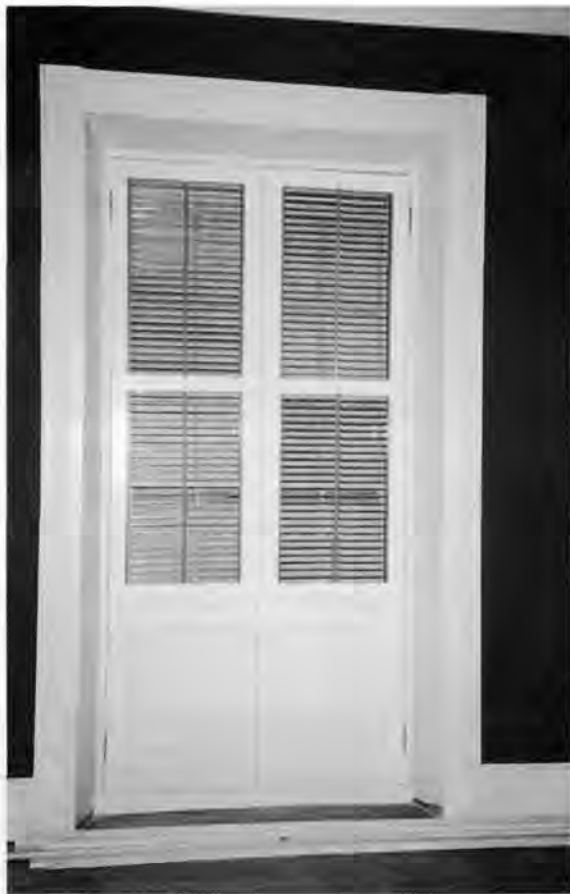
Typical, accurately restored historic jalousie doors that provide natural cross ventilation.

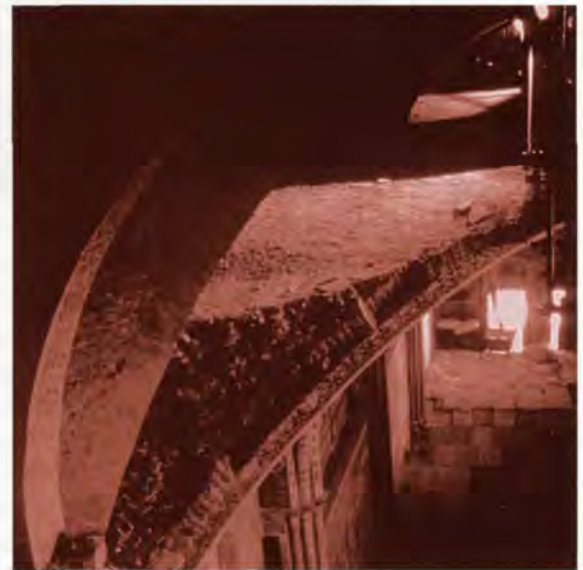
The fill accumulated through the centuries over the vaults.

springer zones. During earthquakes, this non-cohesive fill alternatively acts only in one direction because there is no connection in the opposite direction. In addition, the loose fill follows the movement of the vaults, opposing their recovery and facilitating increasing permanent deformations. When the quake of September 26 hit the basilica, it is very likely that there was already some permanent deformation, reducing the curvature and, therefore, the bearing capacity as the result of previous earthquakes.

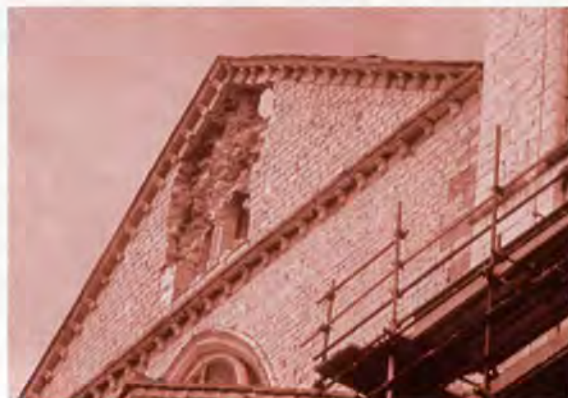
Damage in the tympanum on October 7, 1997.

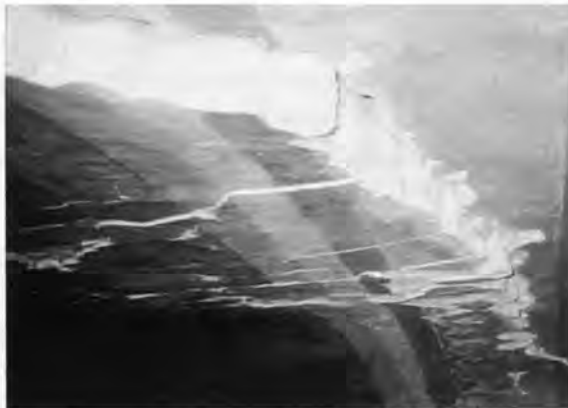
Large cracks in the vaults with relative movements of around 25 cm.

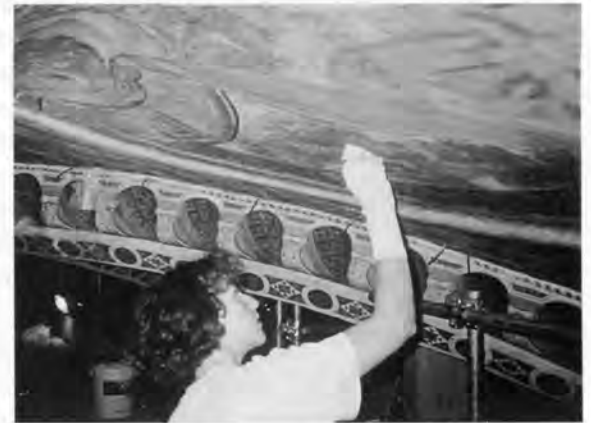
Suspension of the deformed kerbs (restraining straps) to the roof.

- Removing the huge load of the fill in the springer zones of the vaults;
- Filling the cracks with a salt-free mortar to limit possible damage to the frescoes, first taking the precaution of inserting a strip of polyurethane in the larger cracks to prevent the mortar from flowing out;

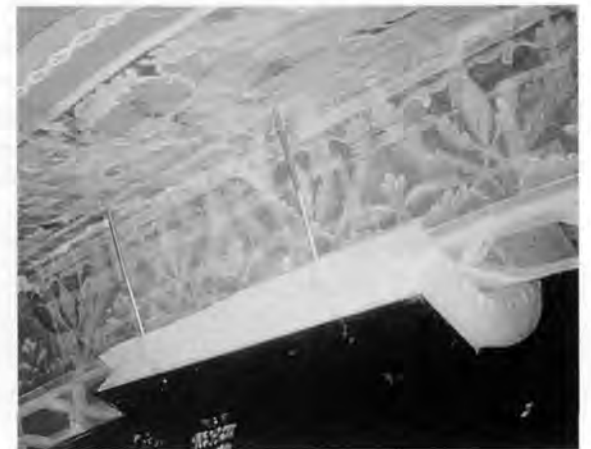
- Applying bands of synthetic fibres over the cracks of the extrados;
- Suspending the vaults from the roof framing with a system of tie bars, having first inserted two springs to maintain the force at the design value, independent of thermal effects and minor vibrations; and
- Suspending the ribs from the roof with a system similar to the previous one after having placed a kind of steel cradle filled with soft rubber underneath in order not to damage the frescoes.

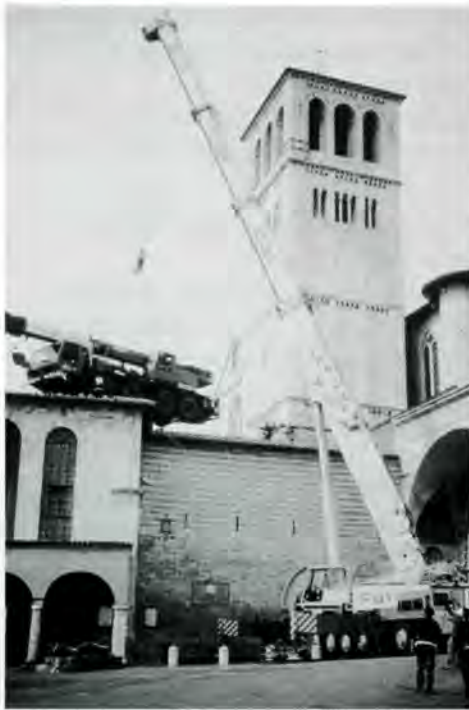
A crane in front of the convent lifts a second crane over the wall into the courtyard.

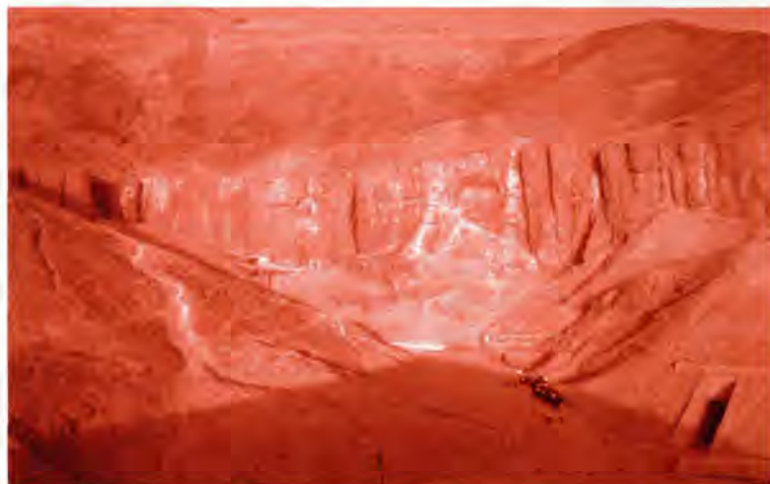
General view of the Valley of the Kings looking south. The peak at upper left is the Gebel el-Qurn, the high point of the drainage area, 283 meters above the floor of the Valley. At lower right is the entrance to the tomb of Ramesses VI, labeled KV-9. Left of that tomb, a crowd of tourists is queued in the main walkway, entering the tomb of Ramesses III, KV-11. Photo by James McLane.

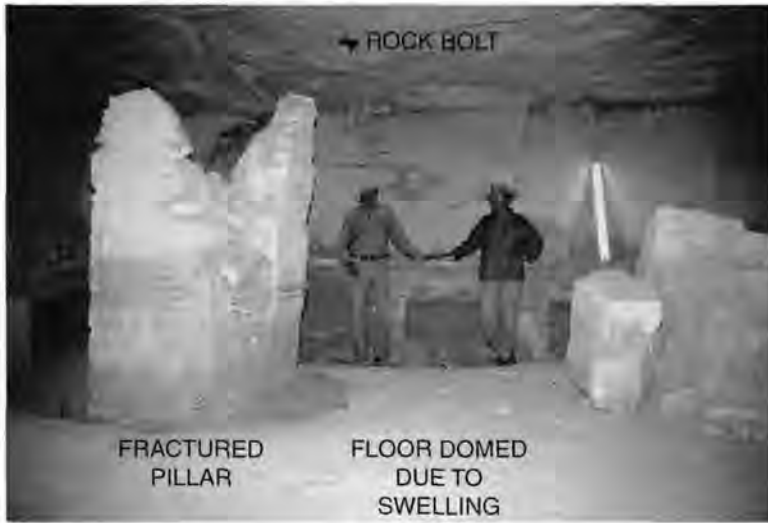
Interior view of a lower chamber in the tomb of Ramesses II, KV-7, an example of the damage caused by successive flood events. Virtually all of the decorative plaster reliefs are lost, and the rock structure has been heavily impacted by swelling of the underlying shale. The floor obscures the two team members' feet because it has swelled in the center. There are two rock pillars on either side that have fractured and collapsed. At the top is a rock bolt installed by another project in a recent effort to forestall further spalling of the ceiling. Photo by James McLane.

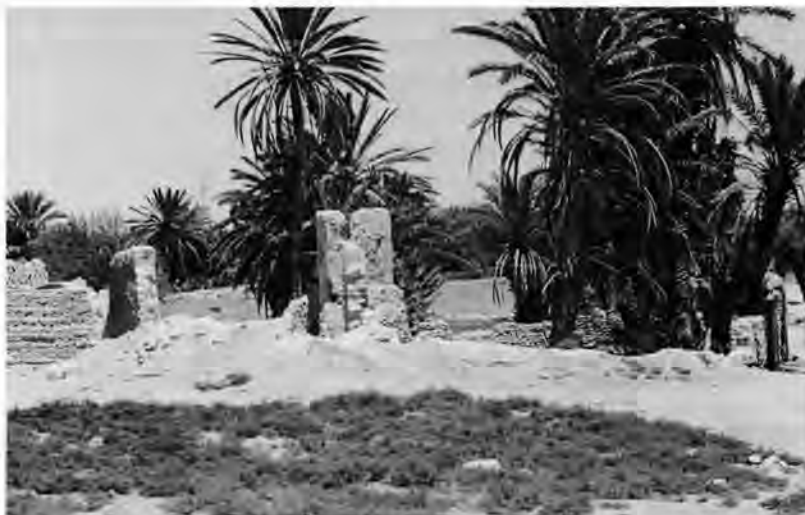
Remains of the Shamiah Residential Quarter in Ma'an, southern Jordan, after the 1927 earthquake.

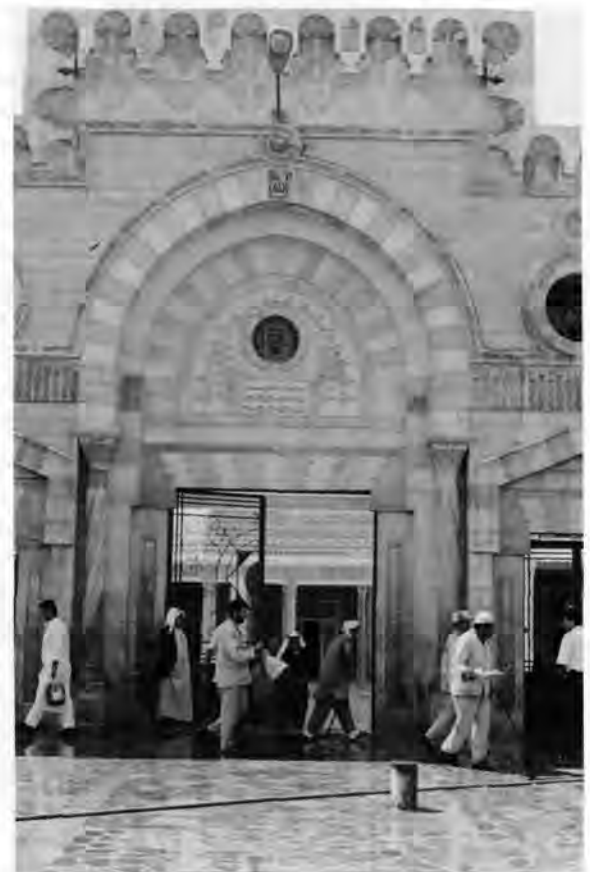
The Hussieni Mosque in central Amman. The mosque has been renovated several times since the 1927 earthquake damaged it.

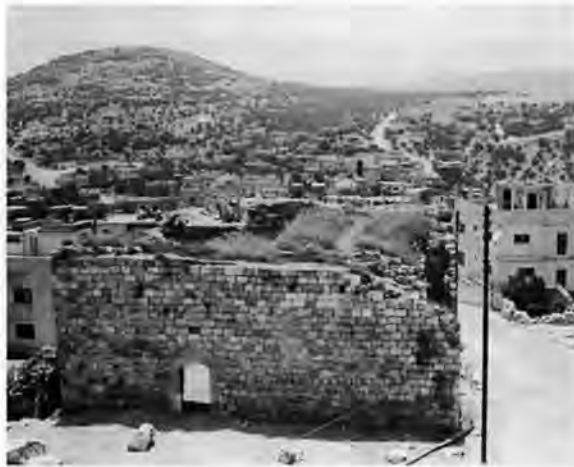
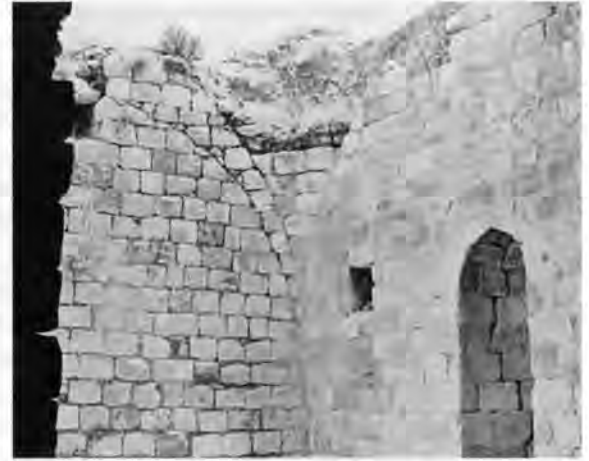
Exterior and interior views of the Zaidani Mosque of Tibneh in northern Jordan. The roof of the mosque has been severely damaged after the 1927 earthquake. The mosque, stands deserted, still waiting funding for its rehabilitation.

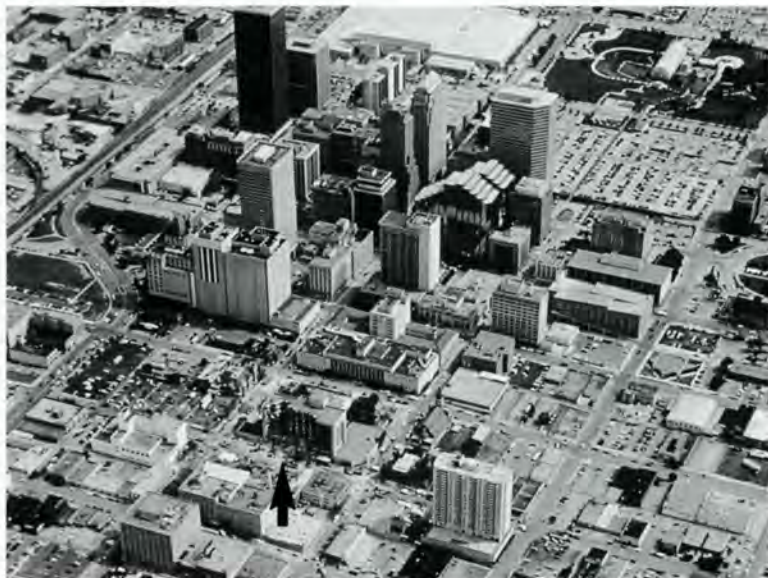
The city center of Oklahoma City after the bombing. The Alfred P. Murrah Federal Building is located in the left foreground.
