BULLETIN

Cultural Resources Management • A National Park Service Technical Bulletin

July 1984

Management Issues in the Field of Cultural Resources

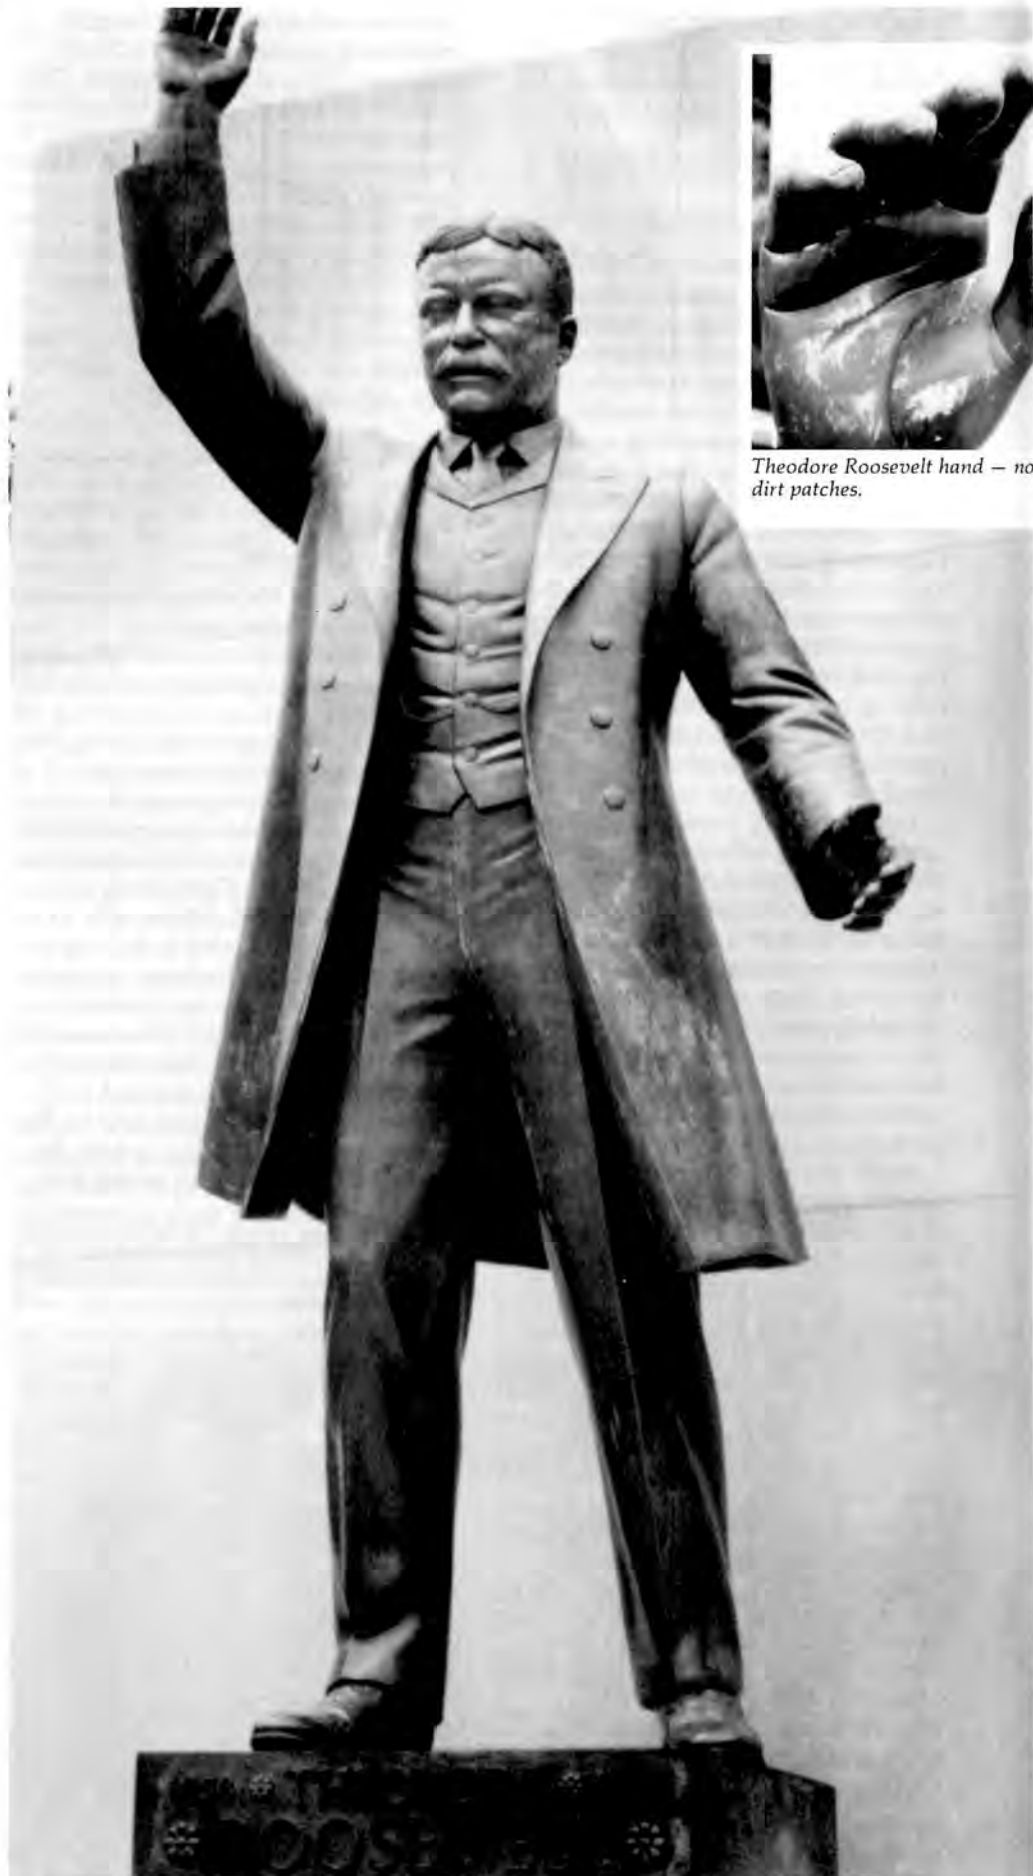
Theodore Roosevelt hand — no dirt patches.

Statue of Roosevelt after cleaning.

For a number of reasons, *Theodore Roosevelt* remained untreated until the early summer of 1983. At that time, areas such as the coat skirt, shoulders, head, and upraised arm exhibited large patches of moderately green corrosion, minus the four year old wax coating. Waxed areas were removed with Varsol, followed by washing with a solution of Igepal CO-630 in water.

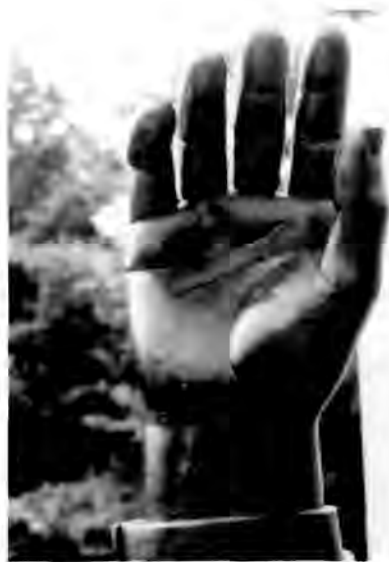
Hand one year after treatment. Note lustrous tones.

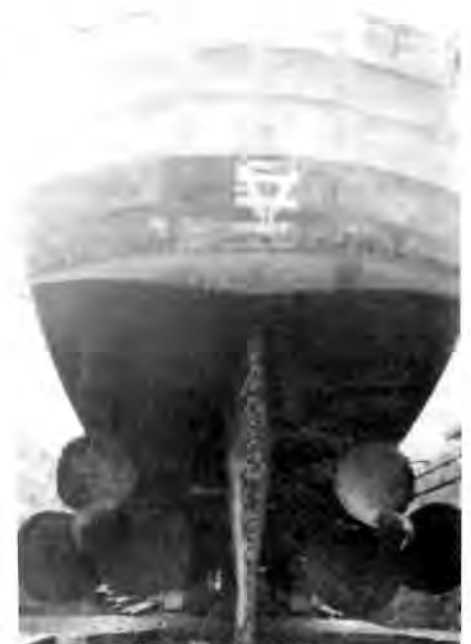
CASSIN YOUNG in dry dock, Charlestown Navy Yard, prior to rehabilitation.

Corrosion can kill any metal ship. Prior to rehabilitation, CASSIN YOUNG looked very sick, marred with extensive and severe rust, missing parts, and "mothball" equipment. The last Navy diver inspection of the underwater hull, in 1965, reported marine fouling, paint failure, and corrosion of metal over 30% of the underwater surface. The surface experienced 15 years of continuous corrosion since that time. Boston National Historical Park was fortunate to have a dry dock (one of the nation's oldest) and a maintenance crew with the skill and dedication to successfully dry-dock a warship. With the ship in dry dock, we inspected, tested, and prepared the hull for many more years of service with minimum loss of fabric.

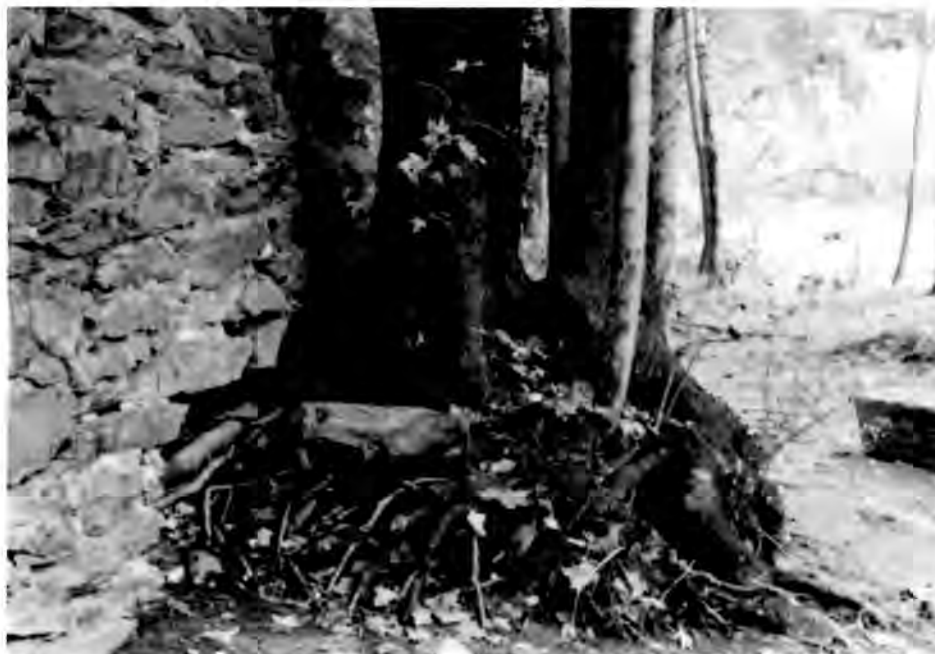
Tree invasion, Virginius Island, Harpers Ferry NHP.

Trees which gain great heights and have extensive root systems may pose a severe threat in proximity to an historic landscape. Management options for well established invasive trees are relatively few, generally requiring a decision to remove the tree or face continued damage to a structure.

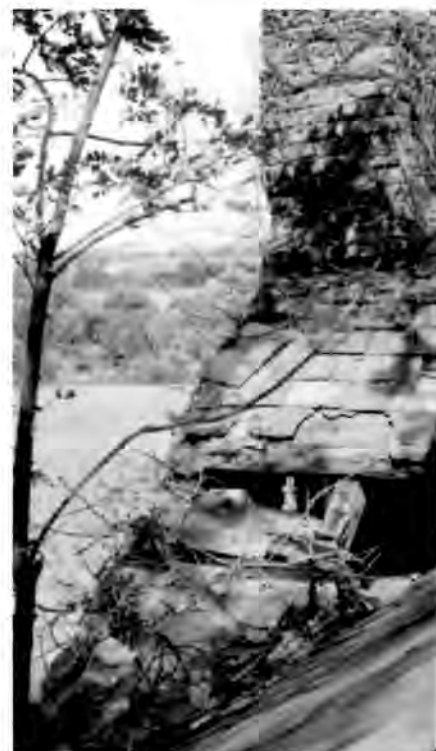
Worthington House, Monocacy NB. Note vine and tree invasion.

Vines cause severe damage since they create a damp area between their leaves and the walls of a building, while sending out invasive root systems. Vines growing directly on a wall may strangle a wooden or masonry structure, forcing apart its components (i.e., wisteria lifting off a wooden porch roof or the balusters from a limestone balcony). They may insert tendrils or aerial roots in the mortar or brick, weakening the mortar and masonry by increased exposure to freeze-thaw actions, or enlarging the openings and dislodging stone or brick from a moisture damaged wall (poison ivy, English ivy, Boston ivy, honeysuckle). A root enzyme which attacks the stability of lime may disintegrate the mortar until only the sand remains (all

Vines may be controlled by girdling or by cutting at the base (left to dry, they should be carefully removed from the structure within a few weeks). Great care must be taken in removing vines so as not to disturb mortar and masonry. Digging up roots will discourage further growth, but elimination of habitat will be required to eliminate all growth. Organic debris should then be cleared from around a structure allowing the surface to be exposed to sunlight and free air circulation. In some cases, a systemic herbicide may be recommended when a vine is severely damaging to a structure, and should be applied to roots and stems. Where a vine is to be used as a part of the historical interpretation of a site, a strict grooming design and schedule should be followed. In such a case, intensive maintenance is the only acceptable solution.

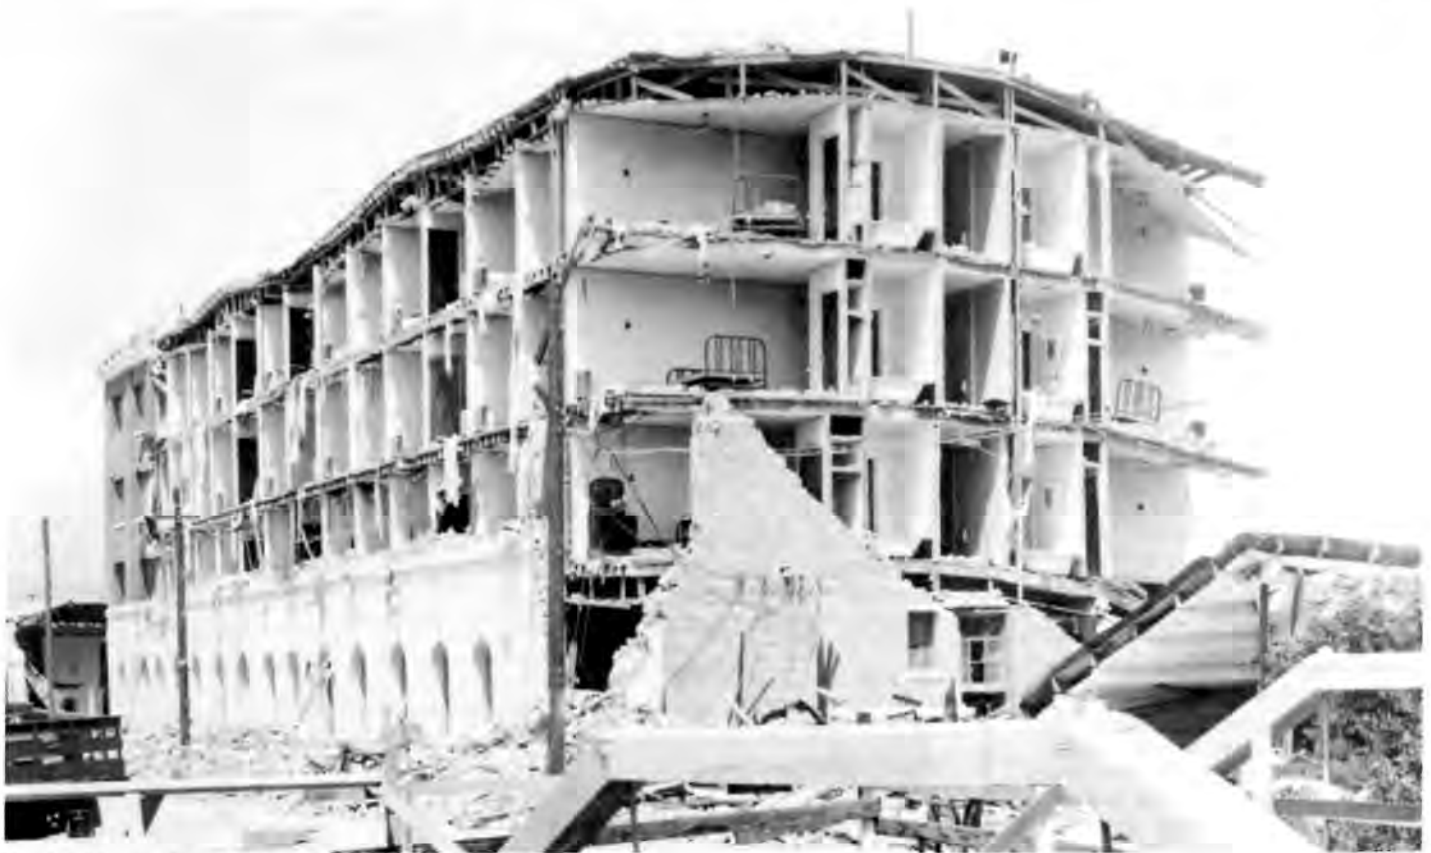
Hotel California after 1925 Santa Barbara Earthquake.
