2015 Florida Bay Seagrass Die-Off

National Park Service
U.S. Department of the Interior

South Florida Natural Resources Center
Everglades National Park

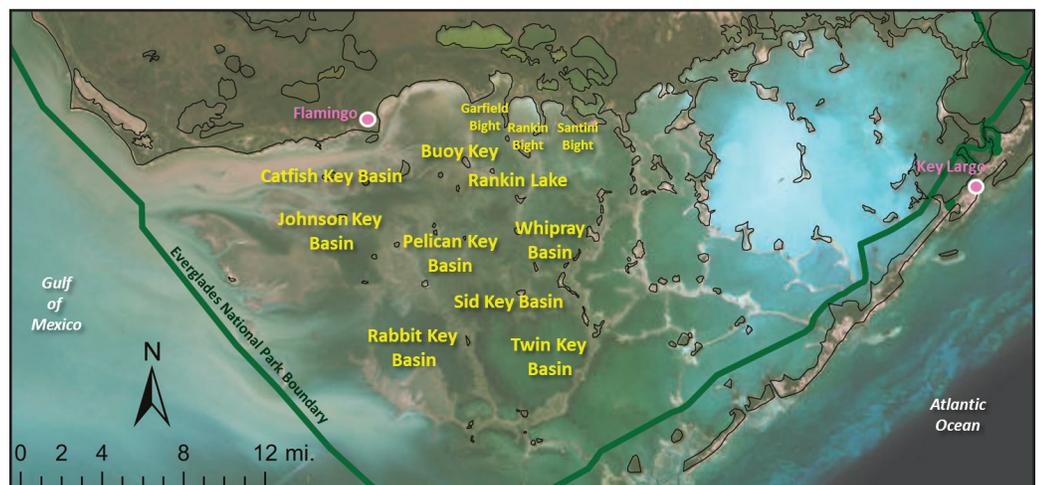
Figure 1. Darker areas in the named basins above indicate seagrass distribution prior to the 2015 die-off.

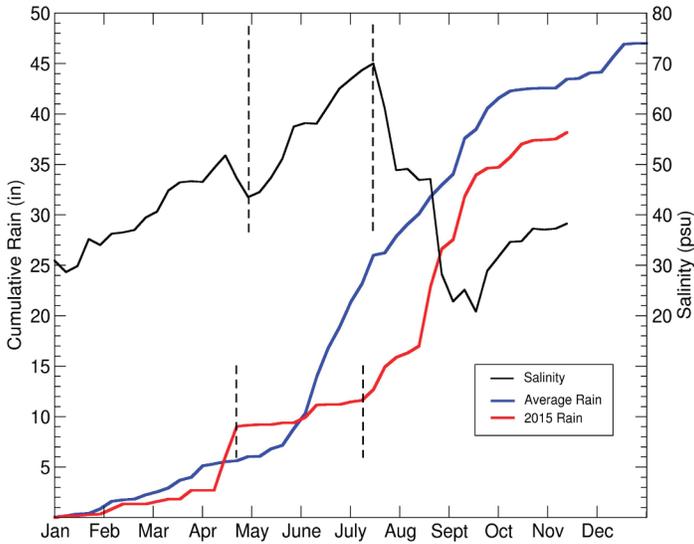
Figure 2. Cumulative rain in inches (red line) and the corresponding salinity in practical salinity units (psu, black line) at Garfield Bight in Florida Bay. Calendar year rainfall by mid-July 2015 was less than 50% of the average cumulative rainfall (blue line).

In 2015, the dry season, typically November through April, lasted well into the summer, delaying seasonal summer rainfall over the south Florida region and Florida Bay by three months. The period of low rainfall from May through mid-August resulted in record low coastal freshwater discharges into the bay in August (Figure 2).

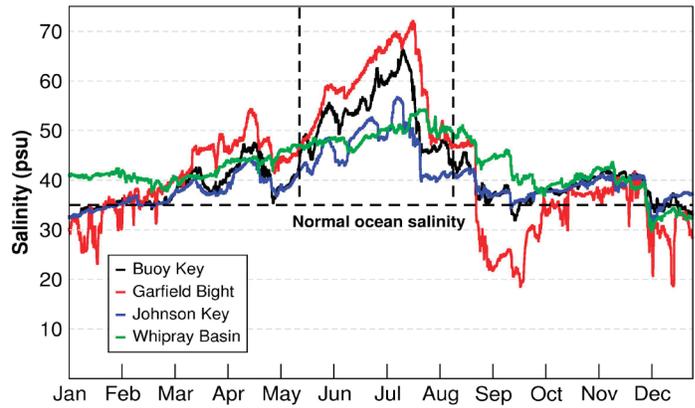
Figure 3. Daily averages of continuous readings of Florida Bay salinity at Garfield Bight (red), Whipray Basin (green), Johnson Key (blue), and Buoy Key (black) monitoring stations during 2015. Ocean water averages 35-37 psu.

In June 2015, water monitoring stations revealed daily average salinity levels exceeding the maximum values of the last decade in the north-central portion of Florida Bay (Figure 3). By mid-July, salinity values at Garfield Bight peaked at 72 psu (practical salinity units), twice normal ocean salinity, and the highest salinity value ever reported in Florida Bay (the record spanning the last 68 years).

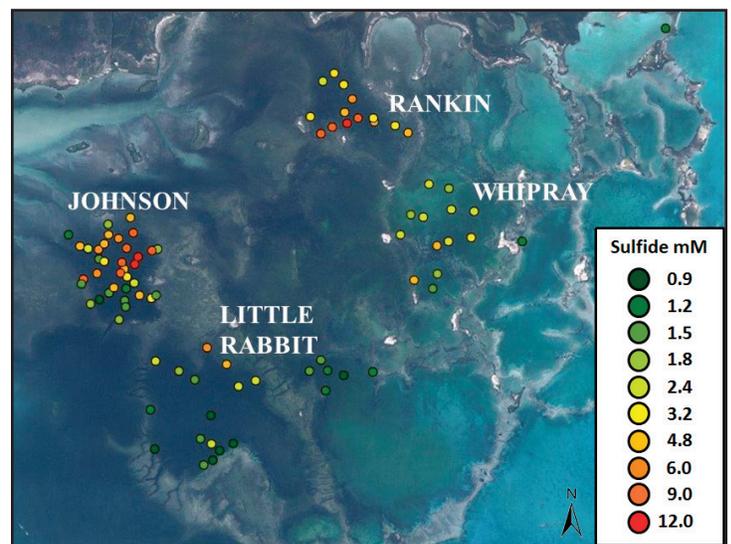
Figure 4. Sulfide concentrations measured in sediment pore water in Rankin Lake, Johnson Key Basin, Little Rabbit Key Basin and Whipray Basin. Yellow, orange, and red dots mark sampling locations where concentrations threaten the viability of turtle grass.

When oxygen is absent, some bacteria in the water column and sediments use sulfur for respiration instead. However, the consequence is hydrogen sulfide production, which is toxic to seagrass. A working hypothesis proposes that prolonged anoxic periods led to sufficient sulfide production to cause extensive areas of turtle grass to die. The anoxia was initiated by low oxygen solubility caused by high salinity and temperature combined with high respiration rates. Bottom waters and sediment pore waters (waters extracted from a wet sediment sample) contained high concentrations of sulfide, 12 milliMolar (mM), levels toxic to turtle grass (Figure 4). The presence of a “rotten egg” odor in the area of the seagrass die-off and observations of a yellow haze in the bottom waters among the seagrass provide further evidence for the role of sulfide in the die-off (Figure 5).

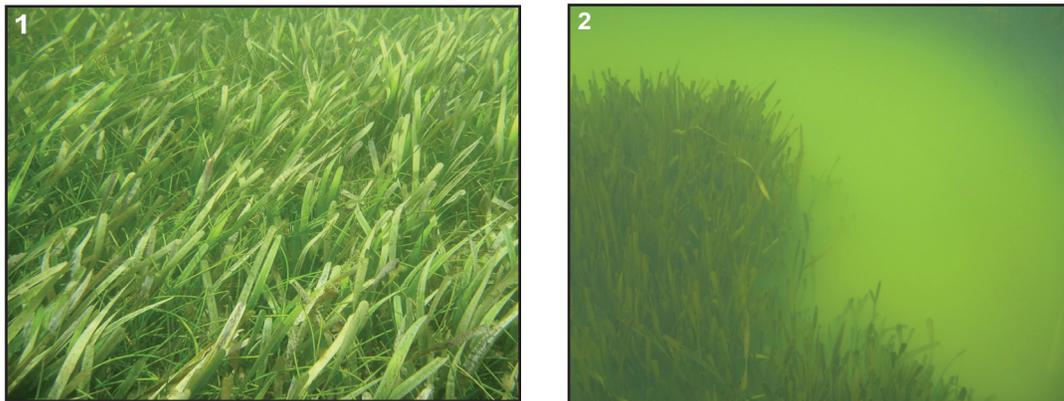
Figure 5. Associated with high sulfide concentrations measured in sediment pore water, a yellow haze was observed on the bottom of die-off areas of Florida Bay in Rankin Lake, near Buoy Key, and in parts of Johnson Key and Whipray Basins. (1) Healthy Seagrass. (2) Yellow haze in waters with high salinity, low oxygen, and high sulfide.

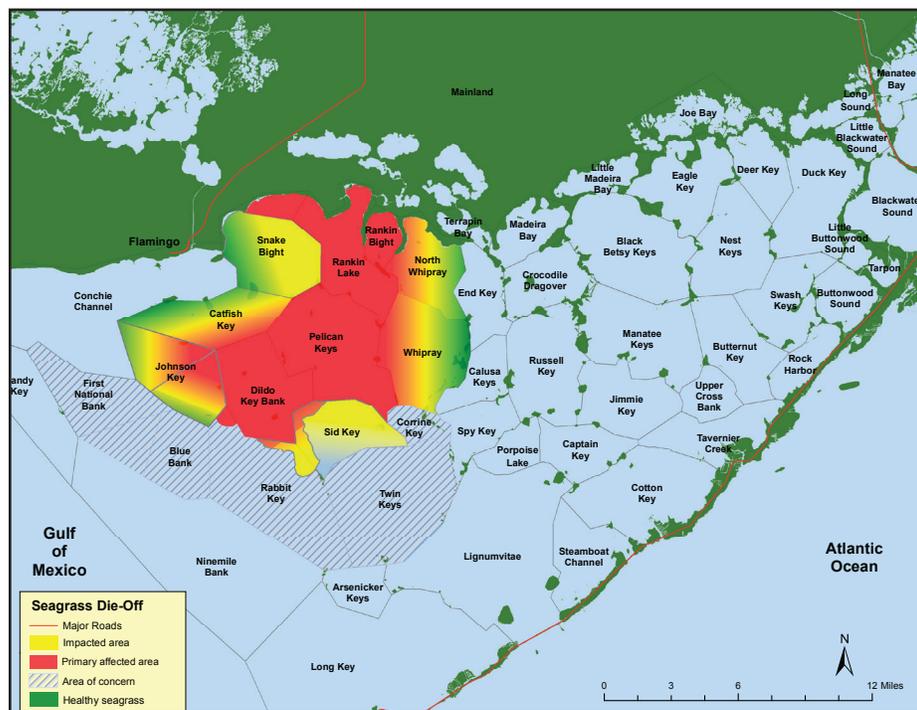
Figure 6. Area of Florida Bay turtle grass die-off event in July 2015 through February 2016. Red = area containing dead turtle grass in patches of varying size; not 100% dead. Yellow = mixed live/dead impacted areas. Green = healthy turtle grass. Striped area = dense seagrass most at risk of die-off expansion.

Key Basin was greatly affected, with nearly all of the northern portion dead, and the southern portion containing small patches of surviving grass. Initial assessments indicate the die-off zone includes the following areas: Snake Bight, Garfield Bight, Rankin Bight, Santini Bight, Rankin Lake, western Whipray Basin, Pelican Key Basin, Catfish Key Basin, Johnson Key Basin, and small parts of northern Rabbit Key and Sid Key Basins (Figure 6).

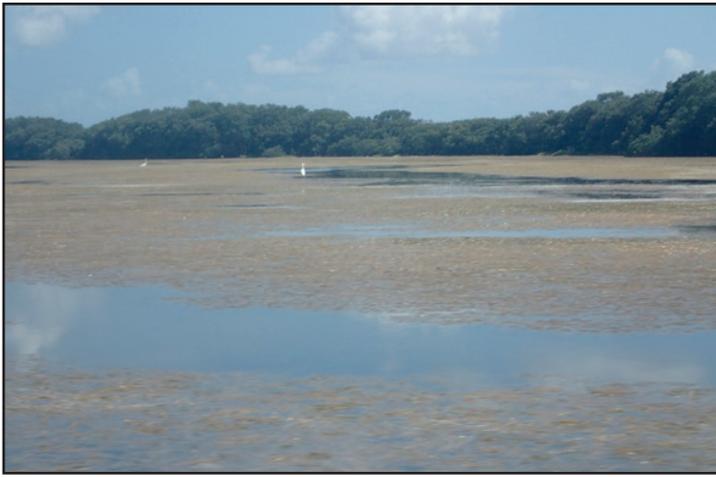
Figure 7. The die-off produced mats of floating seagrass on the surface of the water and plant litter decaying on the bay bottom. Bacterial decomposition of large amounts of organic matter can lead to anoxia and algal blooms.

At the beginning of the event, in July 2015, thick mats of floating dead seagrass were found along the shores and extending offshore in the bights (Snake, Garfield, Rankin, and Santini), and along the mangrove islands and shallow banks (Figure 7). As of January 2016,

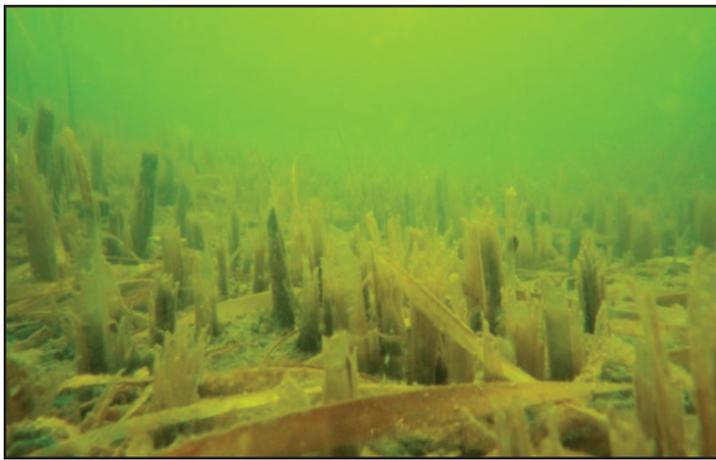
Figure 8. Many areas of former beds of seagrass have been denuded. Only stubble of the turtle grass remains.

some parts of the affected areas had dead leaf blades standing in place; while in other areas only leaf sheaths remained, with seagrass roots and rhizomes (“runners”) dead beneath the sediment (Figure 8). Previously floating dead plant material covered large areas of the bottom in the die-off zone. Once a die-off is underway, the decay of seagrass on the bay bottom and accumulated in mats along the shoreline consumes even more dissolved oxygen and further contributes to sulfide production. The result can be a continuation of anoxic conditions, fueling even more seagrass die-off.
