Cultural Landscape Report

Fort Scott National Historic Site
Fort Scott, Kansas

December 9, 2010
NPS Task Order # R6068090029

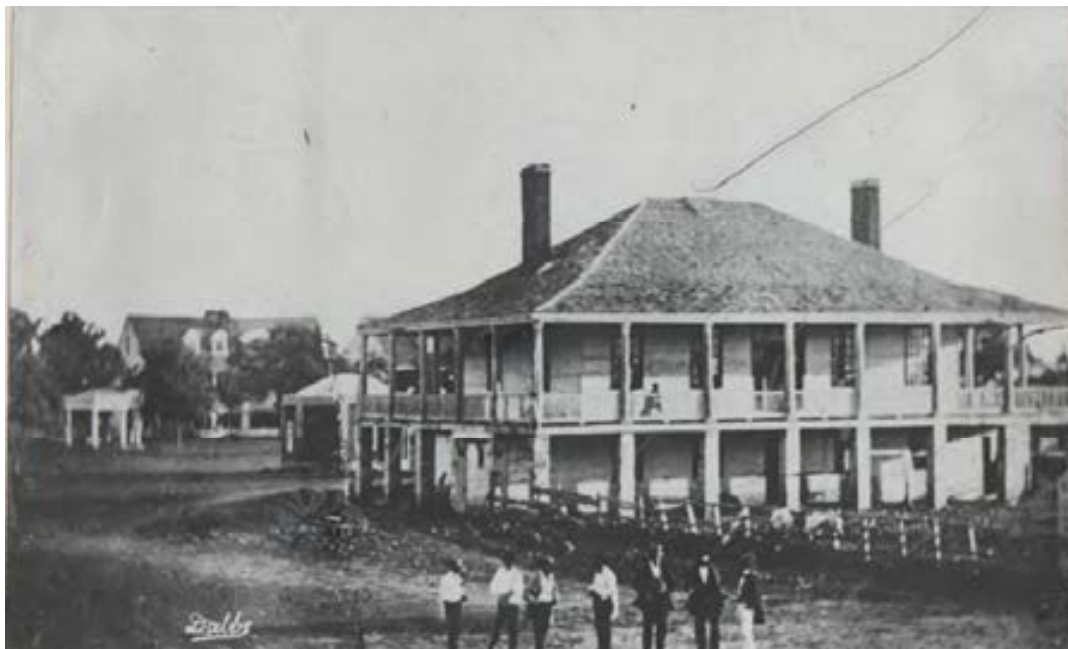
Figure 5. Hospital and fenced area taken between 1855-1861, by J.A. Dabbs, a long time Fort Scott photographer. (FOSC Archives, box from NPS MWRO, 50.)

between 1863 and 1865. The former Dragoon Stables (HS-10) became a commissary warehouse. The three large buildings that anchored the southern edge of the fort - the Infantry Barracks/Western Hotel (HS-7), the former post Hospital (HS-8), and the Guardhouse (HS-9) - were converted to a hospital complex. A view of the hospital taken ca. 1860 (Figure 5), shows the large rear fenced area that extended to Bigler Street.

Earlier gardens include one for the ordnance sergeant and a three-acre hospital garden, producing well by July 1844, which was one of the earliest planted spaces at FOSC. This garden may have been located directly behind the Hospital, an area which was fenced with rails and is documented in photographs (Figure 5) and written sources. It was planted with vegetables such as cabbage, sweet potatoes, and onions, and plants with medicinal properties such as bugbane for mouth pain, yarrow for the "malarious fever" and thistle for the digestive problems Asst. Surgeon Joseph K. Barnes treated due to Fort Scott's "abundance of vegetable."⁵⁵

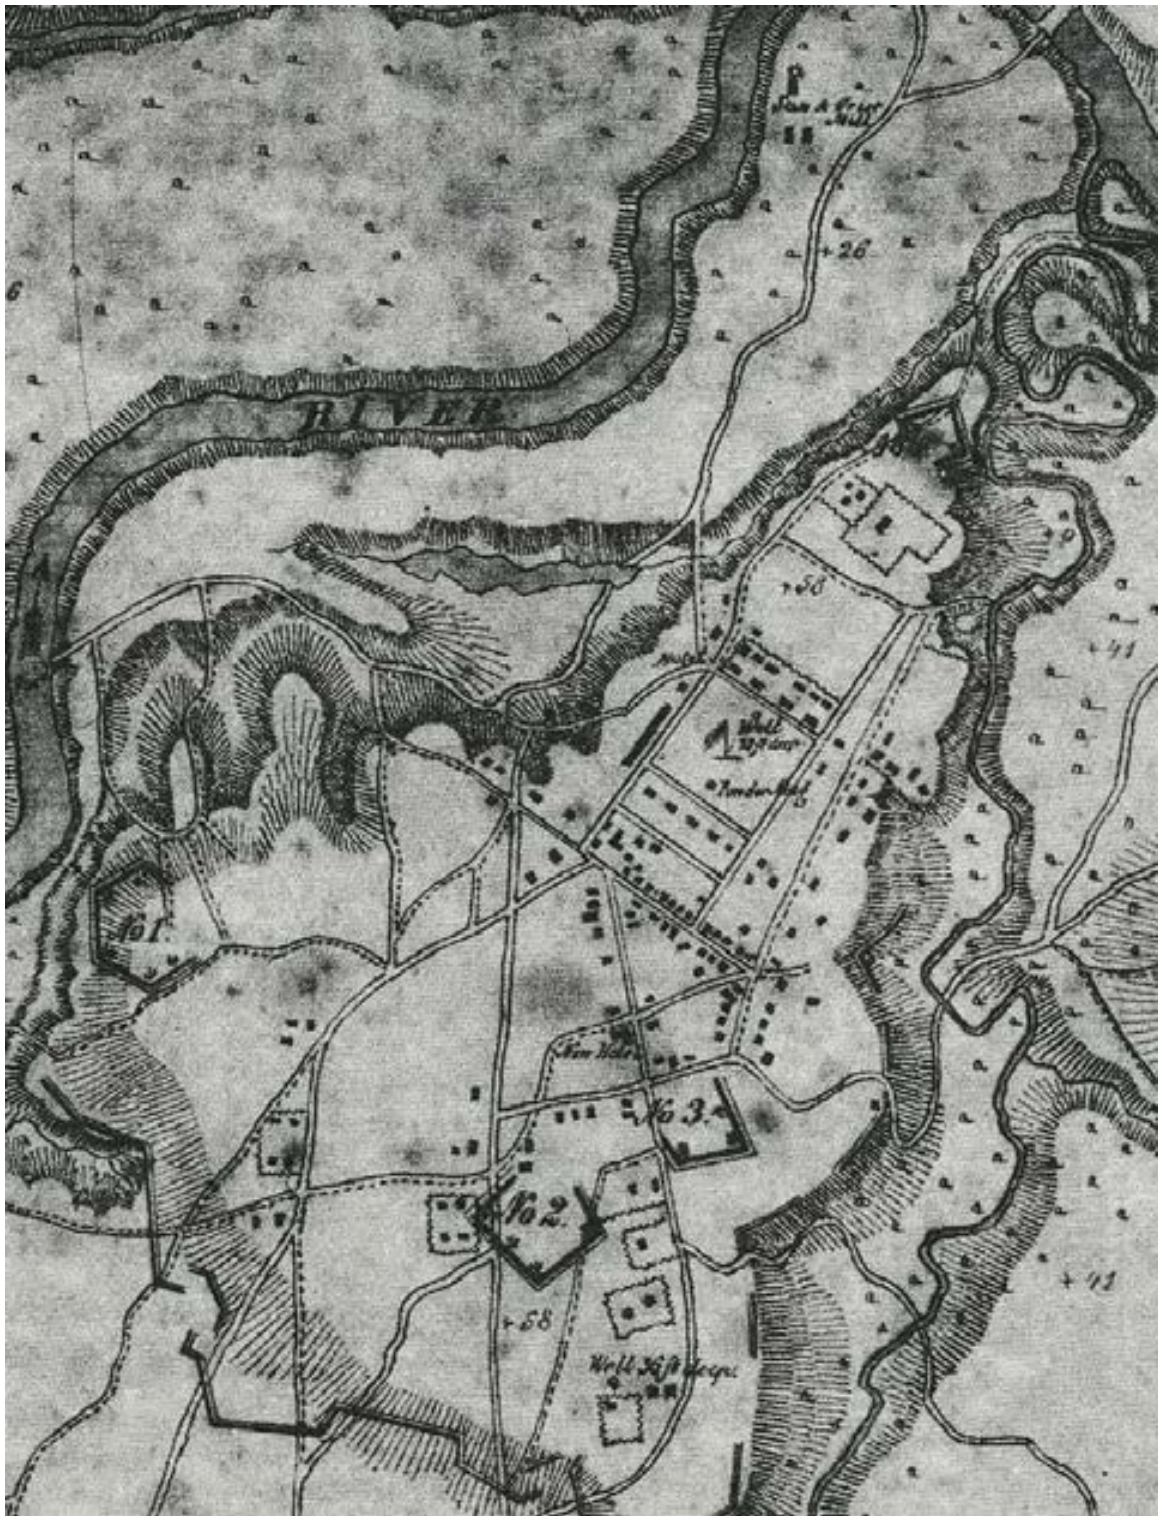
Figure 6. Map of Fort Scott, Kansas and Vicinity. January 28, 1863. Surveyed and Drawn by Capt. William Hoelcke. (Replica on sale at FOSC.)

The Civil War-era Union military complex extended beyond the old fort proper, with some activities located on 80 acres throughout town that had been donated to the Army. Several city blocks were converted to Quartermaster and commissary functions, stables, mess house, military prison, forage yard, manager's office, corn cribs, and assorted lots and yards for wood, hay, etc. (the exact location of each these buildings and sites is recorded in the 1865 Army Auction account). Four blockhouses, or lunettes, were constructed as part of a defensive perimeter around Fort Scott. Three of these lunettes (Henning, Blair, and No.1) were in the present downtown area and protected the southern approach to the city; Lunette Insley was near the point of the bluff overlooking the Marmaton River. A map of Fort Scott and vicinity, drawn by Captain William Hoelcke in 1863, records the area and the surrounding landscape (Figure 6). Clearly represented is the former Parade Ground (its location noted by an American flag) with roads surrounding all four sides, main transportation arteries and footpaths, buildings used by the Quartermaster's and Commissary Departments, wells, and arsenals. It gives a sense of the whole—the topography, the bluff, the river bottoms, fenced lots and huge fields, all set within the context of high prairie. Also delineated are the batteries and rifle pits “to be erected.”

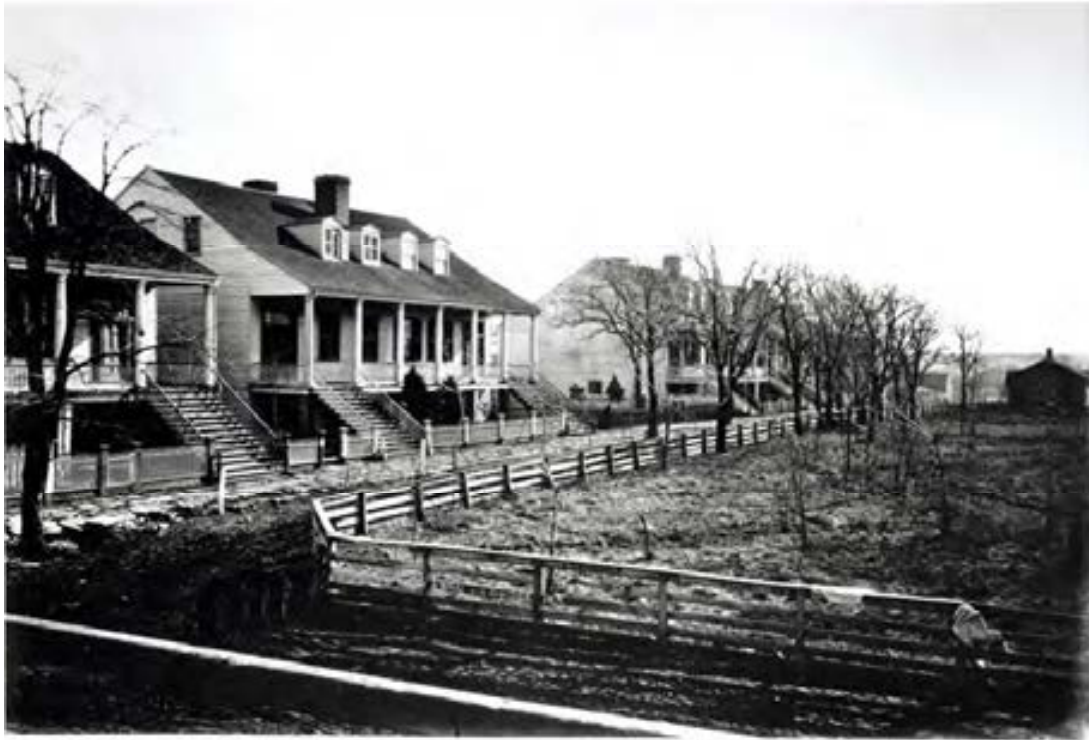
Figure 7. Officers' Row at Fort Scott, 1873. (Stevens Family Papers #1210, Division of Rare Manuscripts Collection of Cornell University.)

As Fort Scott transitioned to a civilian community, additional trees were planted on Carroll Plaza and other general improvements were made, one example being the City Council's 1861 decision to plant additional trees and Bluegrass. The 1873 photograph (Figure 7) reveals new trees planted at the edge of the plaza. These may possibly be the first of plantings that mature and eventually shade the diagonal walks added during Works Progress Administration (WPA) improvements in the 1930s. In the 1860s local newspapers record general improvements made by citizens with the planting of Osage Orange (hedge apple) trees throughout town and the planting of several hundred trees along the streets south of the old government compound. In the first decade of the twentieth century, maples and elms were added to the plaza, as were gravel walks, benches and a bandstand, and it is, once again "reclaimed" as a city park. WPA

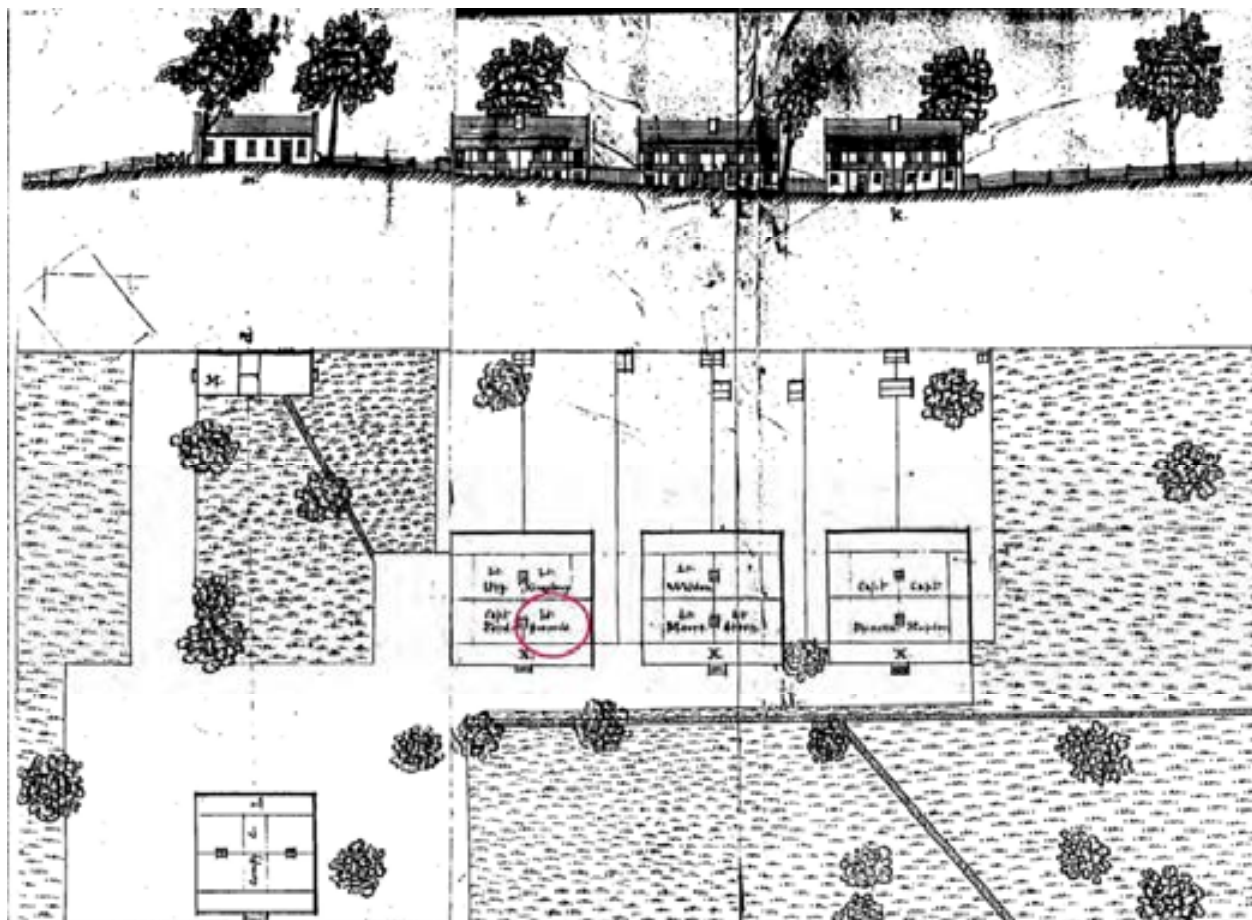
Figure 9. Detail of 1834 Site Plan of Fort Leavenworth with Swords duplex indicated.
(Map from the US Army Frontier Museum, Fort Leavenworth, KS.)

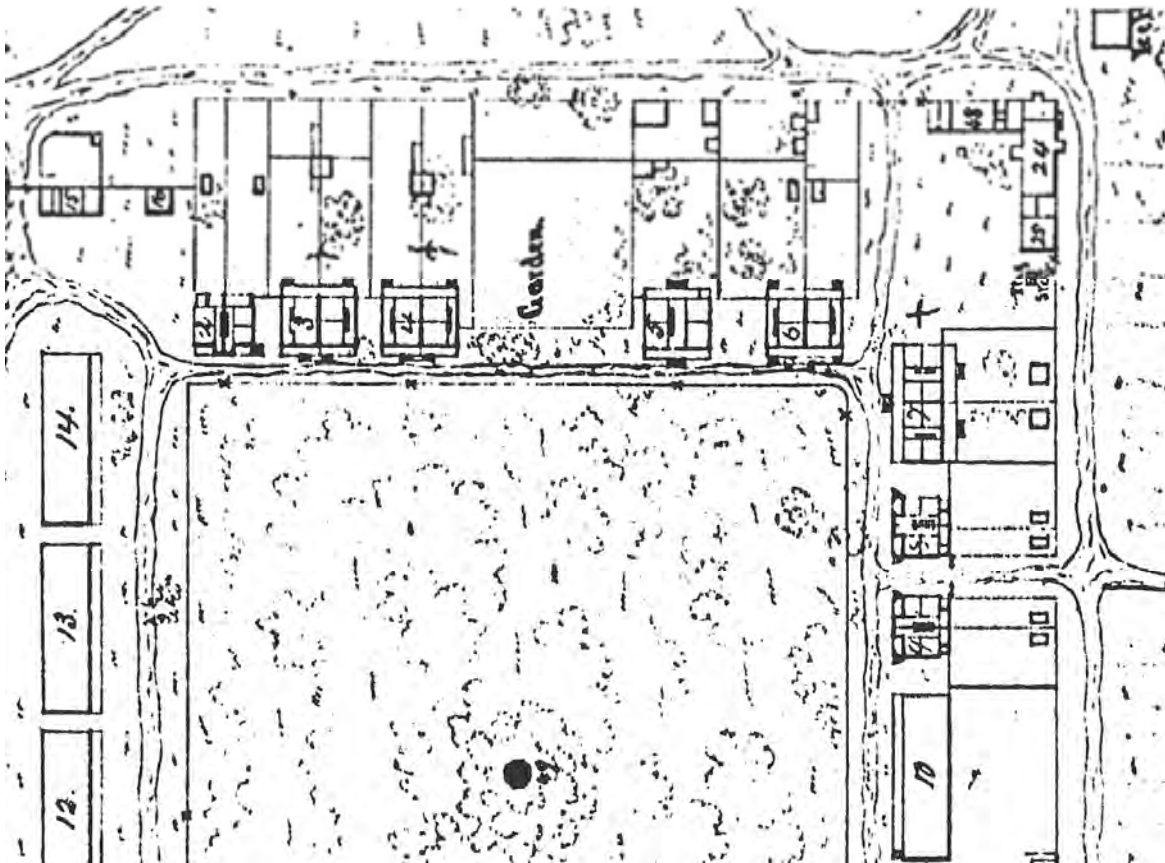
Figure 14. Detail of Fort Leavenworth showing garden in the center lot of Officers' Row. Site Plan of Fort Leavenworth, ca. 1861. Detail of the north side of the Parade Ground (Map from the U.S. Army Frontier Museum, Fort Leavenworth, KS.)

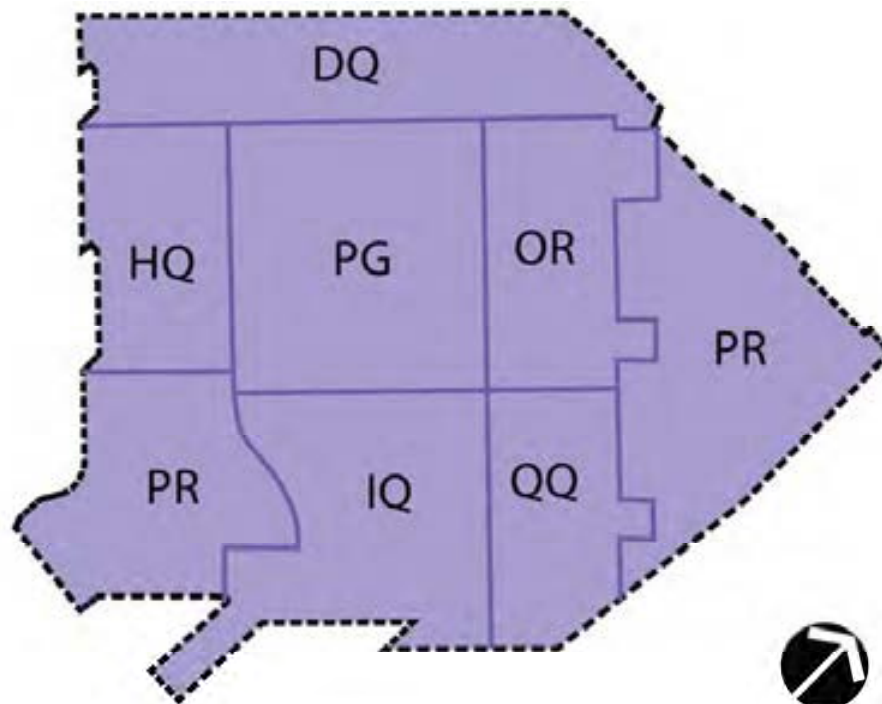
LANDSCAPE AREAS

PG Parade Ground (Landscape Area 1)	IQ Infantry Quadrangle (Landscape Area 5)
OR Officers' Row Quadrangle (Landscape Area 2)	QQ Quartermaster's Quadrangle (Landscape Area 6)
DQ Dragoon Quadrangle (Landscape Area 3)	PR Prairie Restoration Quadrangle (Landscape Area 7)
HQ Hospital Quadrangle (Landscape Area 4)

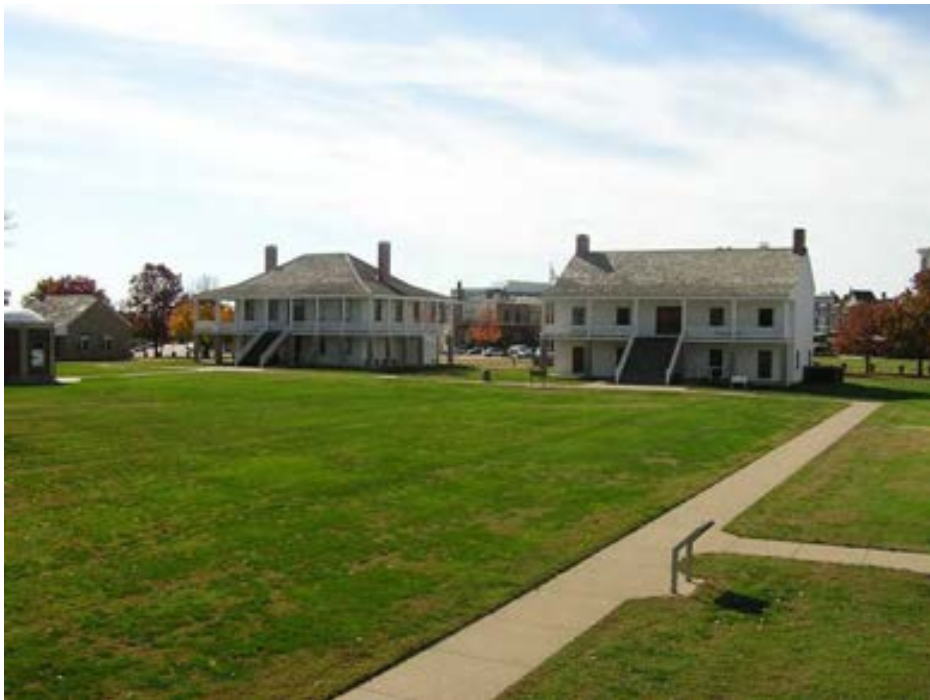
Figure 19. View of Hospital Quadrangle depicting Infantry Barracks HS-7 (right), Hospital HS-8 (center), Guardhouse HS-9 (top left), and the Powder Magazine HS-17 (left center). (PBA 2009)

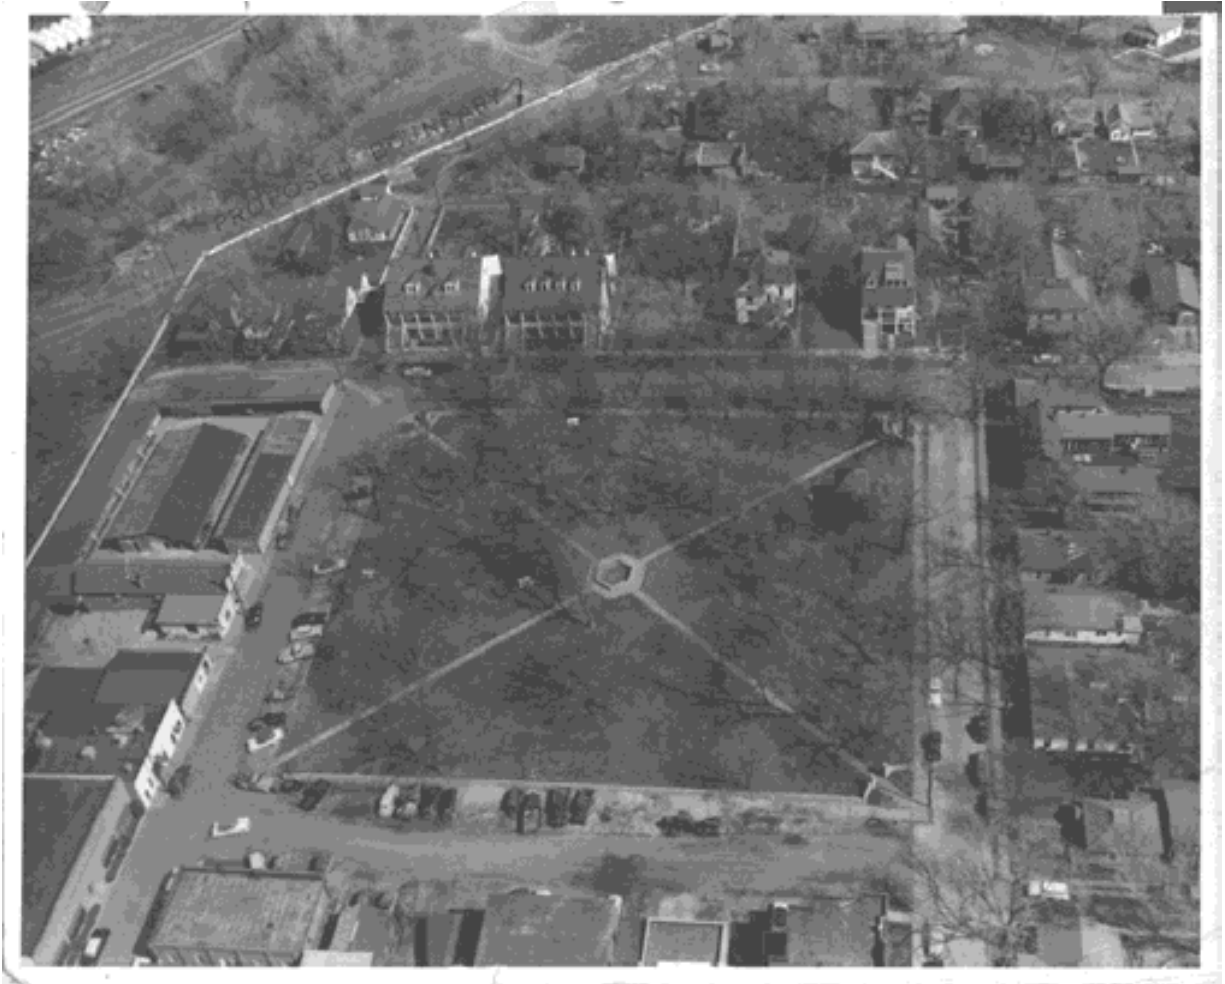
Figure 23. Aerial photograph of FOSC looking north (ca. 1959), illustrating the former Parade Ground (renamed Carroll Plaza) bounded by the community of Fort Scott with residential homes placed on lots of the old fort buildings that had been dismantled or demolished. Roads were also constructed along the perimeter of the former Parade Ground. (FOSC Archives, FOSC Riverfront Collection, Image Parade Ground Looking north.)

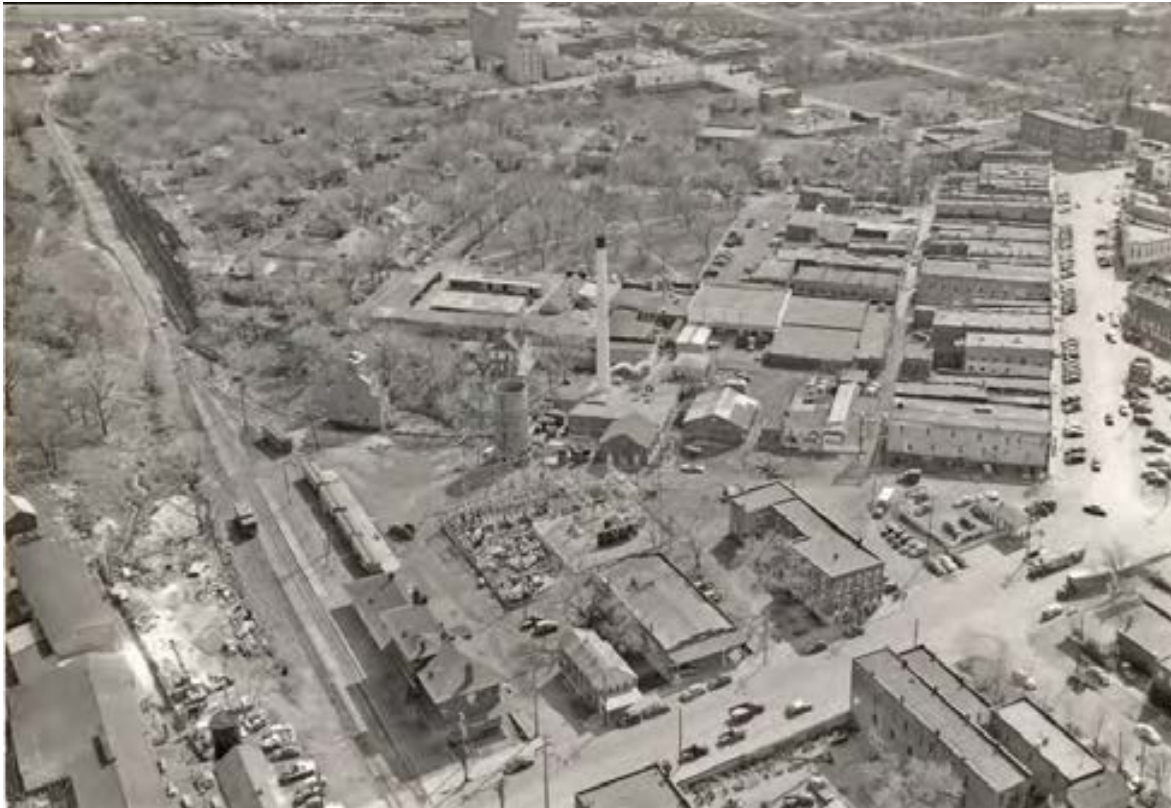
Figure 24. Aerial photograph looking northeast, taken before 1959.
(FOSC Archives, FOSC Historic Photographs, Aerial from WSW before 1959, 14.)

Prior to 1959 (Figure 24), the Site appears as an integrated component of the city landscape with modern urban and industrial development realized by 1970 (Figure 25). Between 1970 and 1971, demolition and frontier fort reconstruction efforts were undertaken, resulting in a cleared and vacant landscape (Figures 26 and 27). The Downtown Historic District remains adjacent to FOSC, thereby retaining the integral connection between the two.

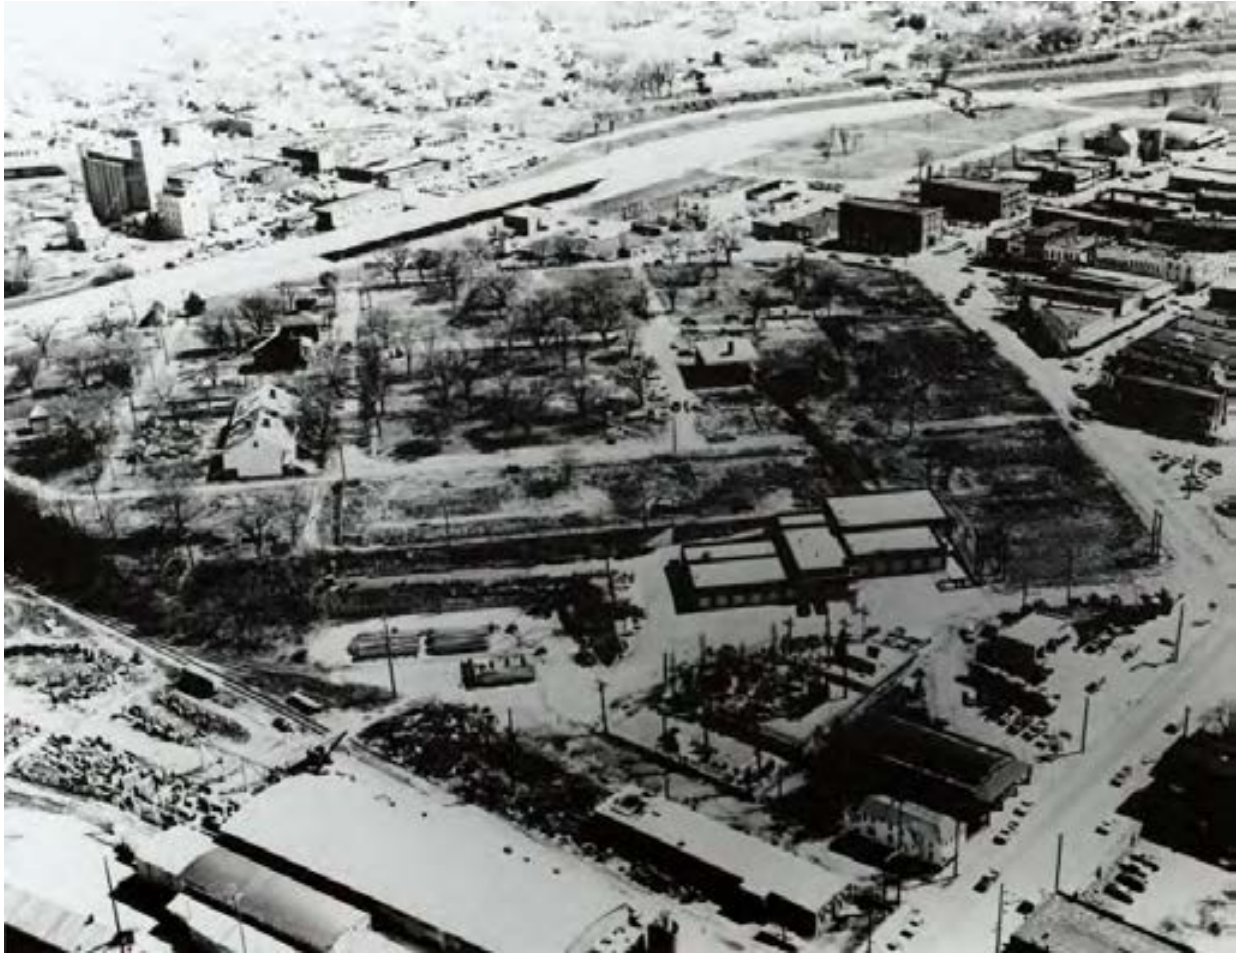
Figure 26. Aerial photograph looking southeast, taken between 1971 and 1972.
(FOSC Archives, FOSC Historic Photographs, Oblique Aerial 1971-72, 50.)

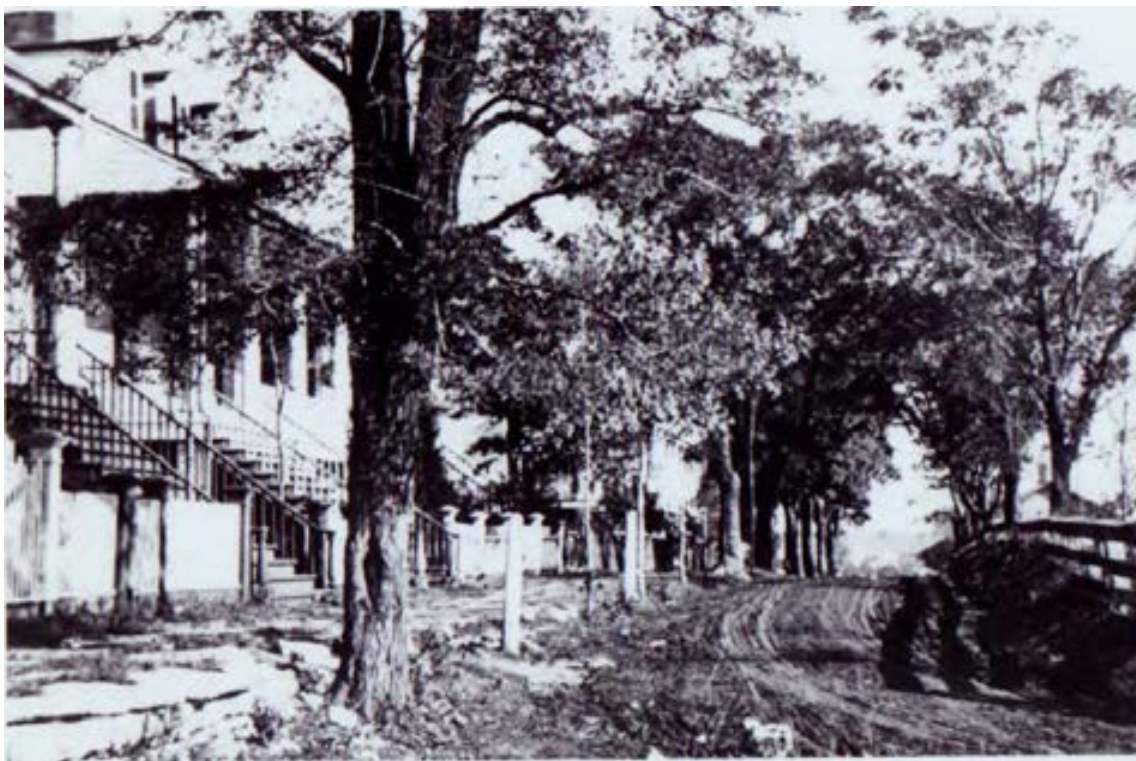
Figure 28. Road in front of Officers' Row with fenced Parade Ground to the right, ca. 1877. (FOSC Archives, Don Miller, 16.)

Existing Condition: The shape of the land within the Site has remained relatively unchanged over the period of significance. The most recent changes to topography were made during NPS restoration and reconstruction (1968-1981) through site grading on the Parade Ground and around building foundations. Improper grading around some of the buildings is contributing to drainage issues around building foundations, particularly in the Officers' Row and Quartermaster's Quadrangles. Also noted is the difference between the historic grade of the site and the current grade which appears to be much higher than circa 1865-1873 (evident in Figure 28).

In 1858, two sources reported on the trees that stood on the former Fort Scott Parade Ground. The *Fort Scott Democrat* writes of mature “sweet sixteen” trees and Joseph Trego describes in his letters a clump around the Well and trees on the Parade Ground of “probably eighteen years growth,” likely the locusts a Squire Redfield mentioned buying ca. 1842 (note that cottonwood trees were the choice used at other forts). Late period of significance photographs document a double row of mature trees in front of Officers’ Row and young trees on the Parade Ground (Figures 28 and 30).

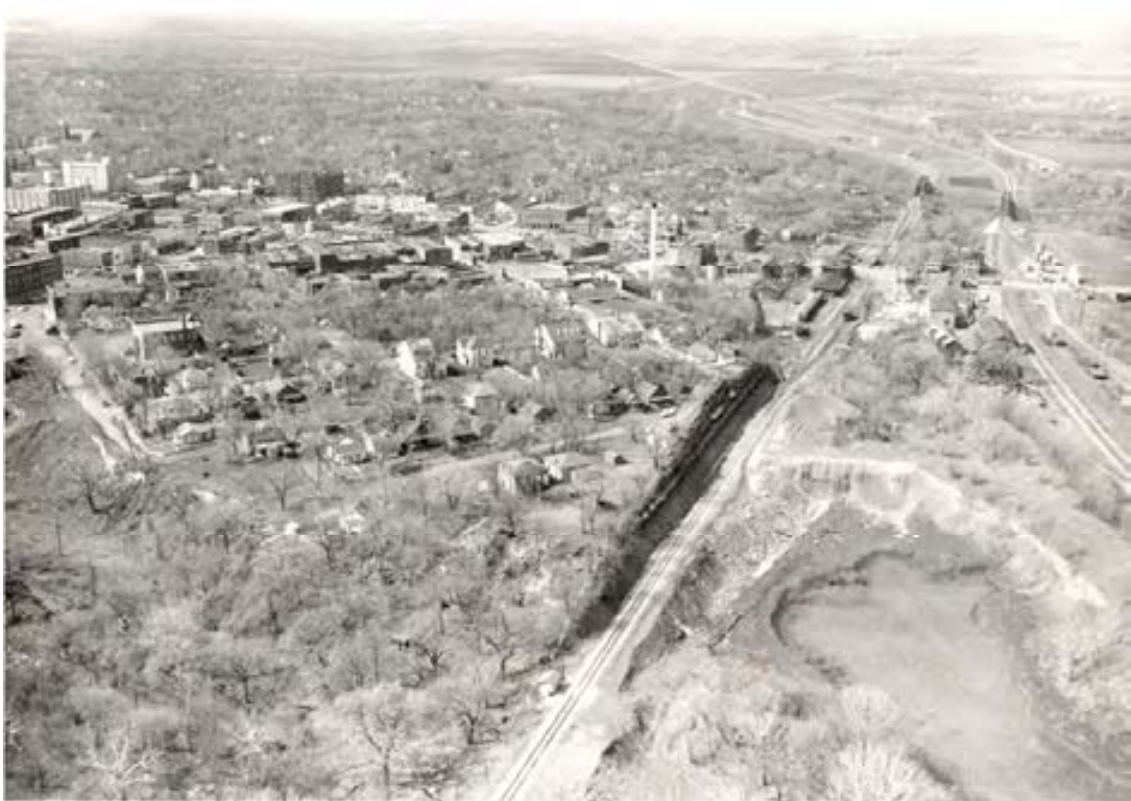
Figure 29. Aerial view of FOSC looking southwest (ca. 1953). Photograph depicts Missouri Pacific Railroad cutting the northeast bluff, open space on the northeast and east, and the City of Fort Scott on the western and southern sides of the fort. (FOSC Archives, FOSC Historic Photographs, Aerial From NNE before 1959, 13.)

Although conditions have been altered, the basic relationship of the topography and viewsheds of the specific areas (the general Site and Parade Ground/Carroll Plaza) to the whole of the landscape remain. Entrance to the Site at the location next to the Dragoon Stables (HS-10) replicates one nineteenth century stage traveler experience. From it they would have experienced the inward focus of the fort (later, houses and businesses ringed around the public park) and the secondary structures related to daily activity that existed at the edges of the property. The topographic relationship of the Parade Ground/Carroll Plaza to the adjacent downtown area (discussed further below) also remains as it did in the nineteenth century. The condition of these features and their relationship to the context of the landscape as a whole remain intact, therefore, site topography and viewsheds contribute to the significance of the historic Site (Figure 29).

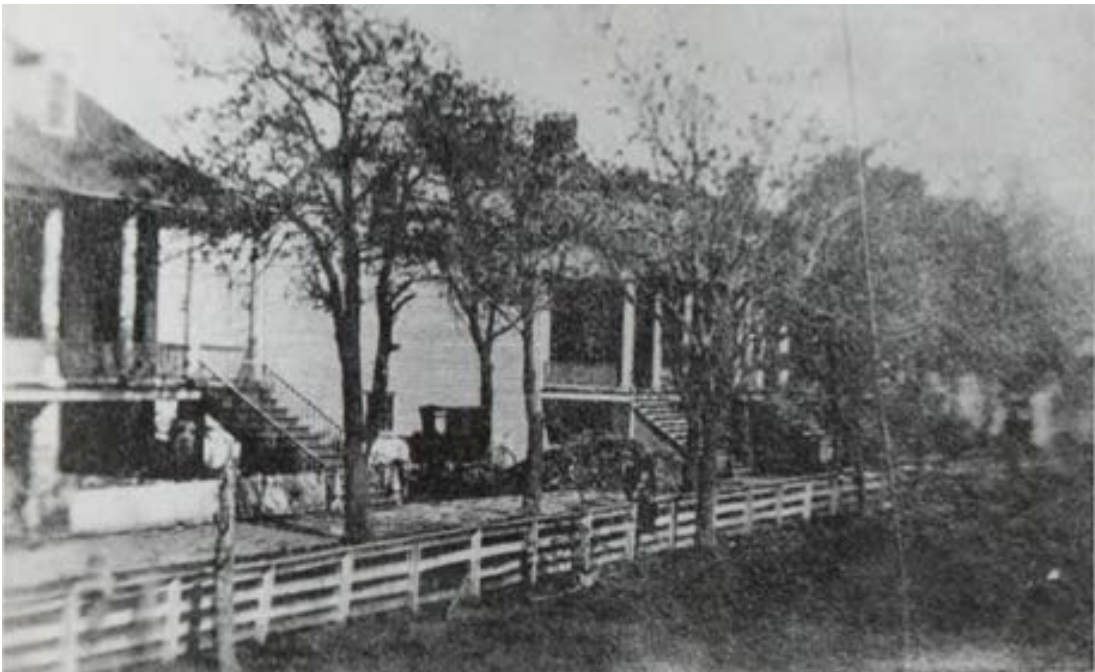
Figure 30. Officers' Row with double row of trees, ca. 1870.
(FOSC Archives, FOSC Historic Photographs, View of Officers' Row 1870s, 78.)

Photographs of Leavenworth illustrate this practice; a similar corridor existed along the front walk of Officers' Row, along the fenced Parade Ground (Figures 10, 30, and 44).

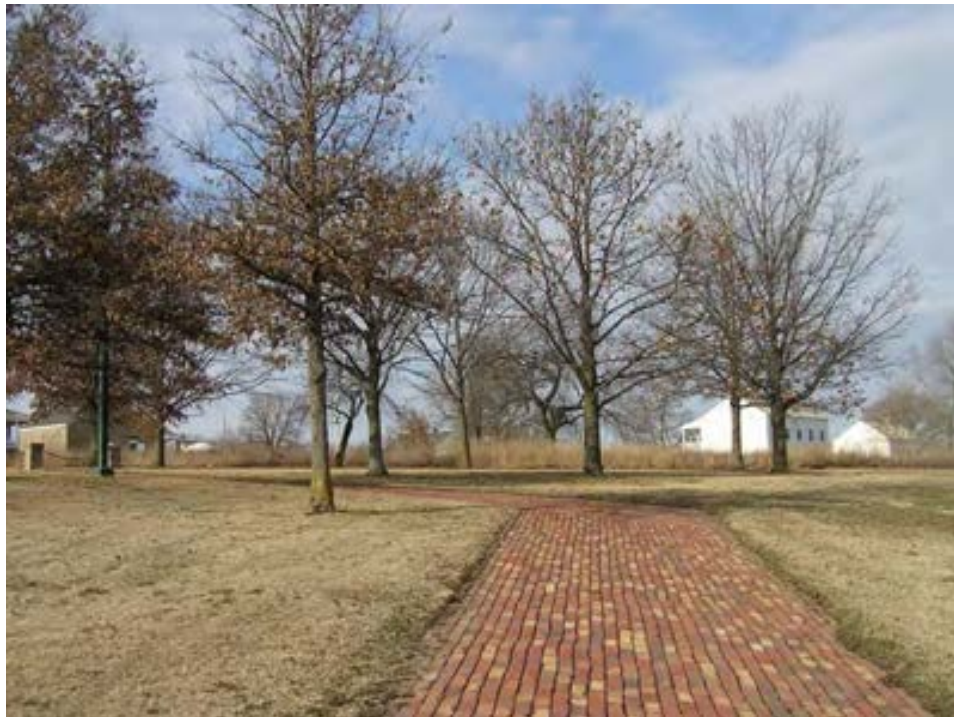
Figure 31. View looking northwest along the brick entry walk toward the grouping of red oak trees. Part of the restored native prairie area is in the background. (PBA 2009)

Trees masses along both sides of the FOSC entry (Wall Street) (Figure 31) are predominantly northern red oak (*Quercus rubra*) and white oak (*Quercus alba*).

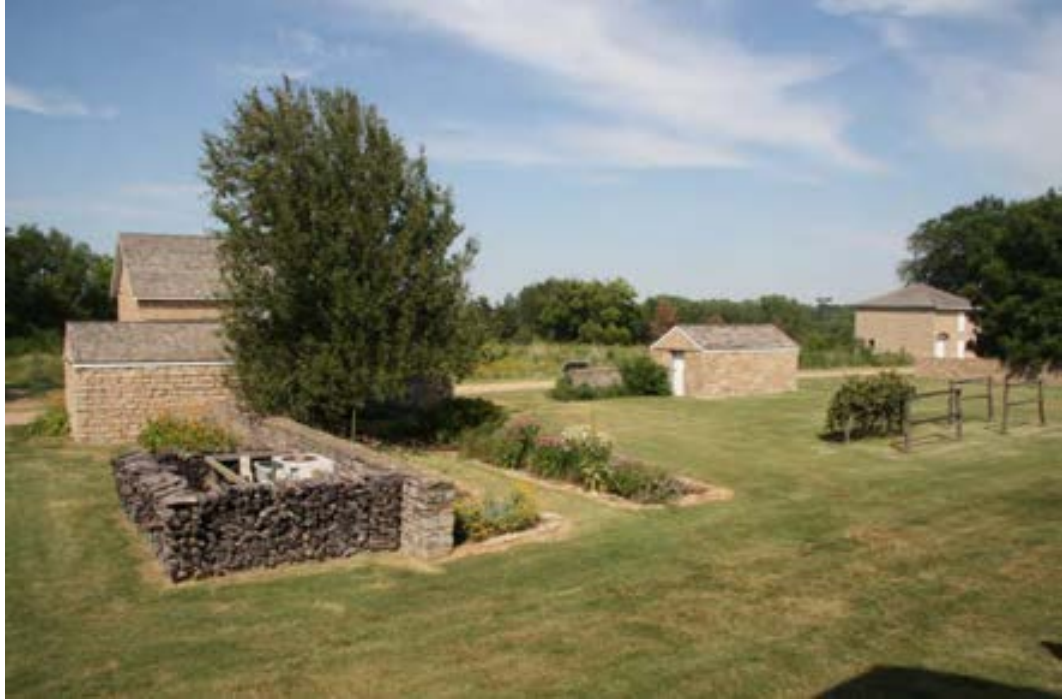
Figure 32. Flower gardens and fruit trees have been re-established in the backyard of Officers' Quarters HS-2. (PBA 2009)

Existing Conditions: The only remaining gardens are two garden beds edged with stone behind the west half of HS-2 (one of these beds is adjacent the historic stone wall in the yard) and two sets of paired grape arbors (Figure 32).

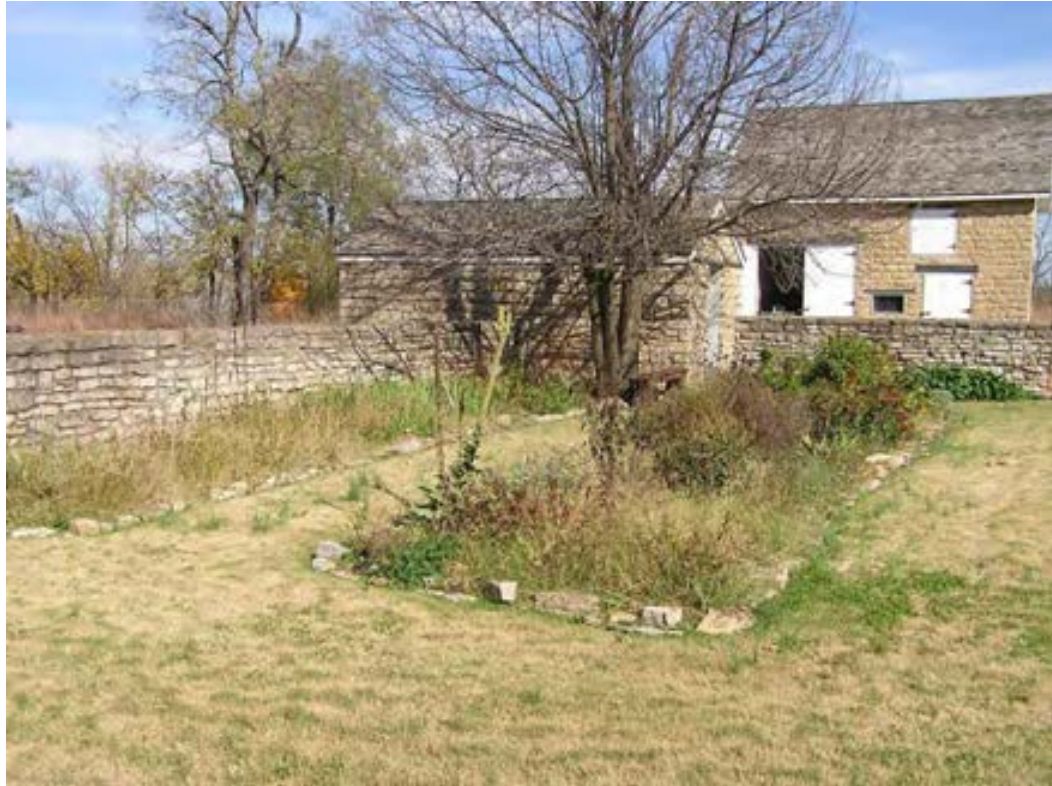
Figure 33. Rear of HS-2 in 2009. (PBA 2009)

Existing Condition: The smooth sweep of lawn that exists currently is a twentieth century invention and the result of using modern seed mixes, watering during dry spells, and regular mowing. Turf grasses exist on the Parade Ground and around all of the extant buildings. In locations where there are drainage or erosion issues, especially on the east side and along the northern perimeter fence, the turf grass is minimal or absent. Past efforts by FOSC staff to convert the Parade Ground to native Buffalo grass were unsuccessful. Bermuda grass present in the turf areas around the buildings is particularly problematic for the gardens behind HS-2 (Figure 33).

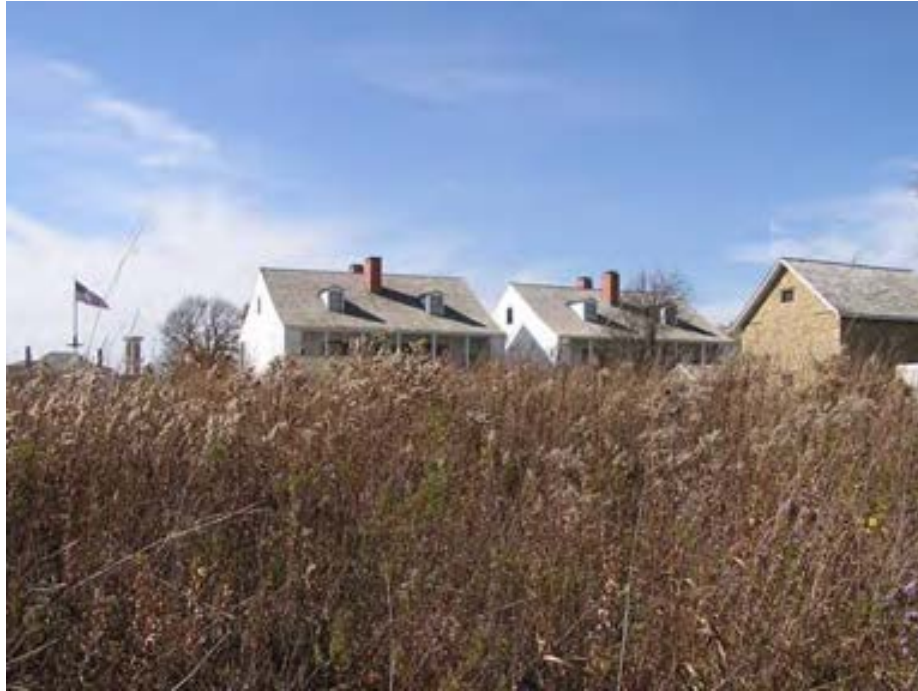
Existing Condition: Patches of prairie grass were planted ca. 1978 to provide the visitor with a sense of the historic prairie landscape that surrounded Fort Scott during its early years, ca. 1842-1853. An area along the east and northeast sides has been restored to native prairie (Figure 34). The prairie plantings were implemented from the NPS approved 1978 landscape plan by Shetlar Griffith Shetlar. Craig Hahn provided a detailed inventory of existing conditions in the 1993 “Field Survey/Inventory of Existing Conditions”, that included a list of prairie plants present in the prairie restoration areas and references Jackson and Knoblauch’s 1985 report for additional species composition and management recommendations. The dominant prairie species visible at the time of this report included: Indian Grass (*Sorghastrum nutans*), Little Bluestem (*Schizachyrium scoparium*), Big Bluestem (*Andropogon gerardii*), Pitcher Sage (*Salvia azurea*), Compass Plant (*Silphium laciniatum*), New England Aster (*Symphotrichum oblongifolium*), and Maximillian Sunflower (*Helianthus maximiliani*). The prairie is currently being invaded by a number of woody and undesirable species.

Figure 34. View of the restored prairie area, looking southwest to Officers' Quarters HS-2 and HS-1. Carriage House HS-33 is pictured on the far right. (PBA 2009)

Evaluation and Analysis: Native grasses and wildflowers have the potential to contribute dramatically to the Site. Such plantings could be located in front of and behind Officers' Row and in spaces adjacent to HS-2 – HS-4. Consultation with a knowledgeable conservation ecologist or landscape architect can provide FOSC with a list of appropriate plant choices and can help implement planting. Proper planting methods that reflect nineteenth century design aesthetics can be found in user-friendly publications such as the *Farmers Almanac* or one of many similar publications of the mid-nineteenth century, some of which were specialized for the Midwest.

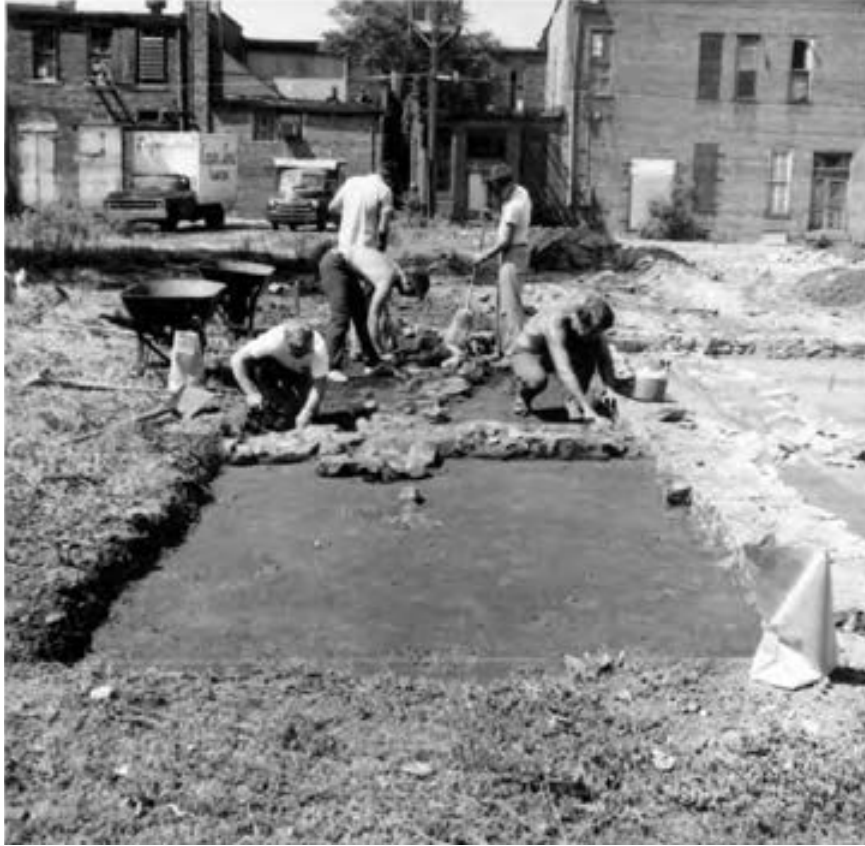
Figure 35. *Kansas State Historic Society 1970–1975, HS-7.*
(FOSC Archives, FOSC Archeology Photographs, Kansas State Historical
1970 to 1975, FOSC 13116 RG112 Photo #4.)

Archeological resources (Figure 35) are an integral component of the Site and are vital to the proper management of the park. Past FOSC archeological studies have been limited to areas of proposed reconstruction/construction activities. Lykowski’s findings reveal this in her archeological overview:

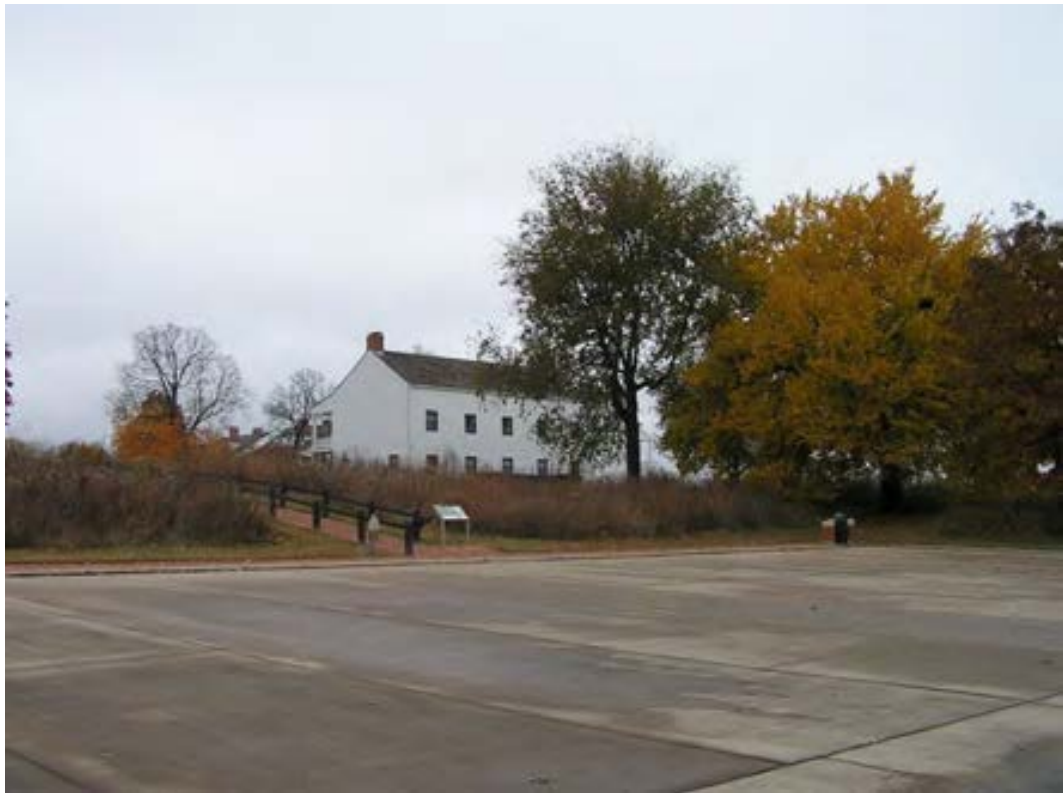
Existing Conditions: Primary vehicular and pedestrian access to FOSC is through Wall Street and Old Fort Boulevard/Skubitz Plaza on the south. Limited bus/RV parking (Figure 36) is available in a small lot on the southeast side of the Site behind the Chamber of Commerce. The concrete parking lot has very limited capacity for use and provides limited ADA accessibility. It is in good condition. Additional bus/RV parking is available along Old Fort Boulevard/Skubitz Plaza. Skubitz Plaza, owned by the city, provides the main parking for the Site.

Figure 36. View of the bus/RV parking lot and the brick pathway leading into FOSC. The Infantry Barracks (HS-6) is in the center. (PBA 2009)

A brick pathway provides Site access from the concrete bus/RV parking lot on the southeastern side (Figure 36). The brick walkway is in good condition; although, it is too rough and the grade is too steep to accommodate proper ADA accessibility.

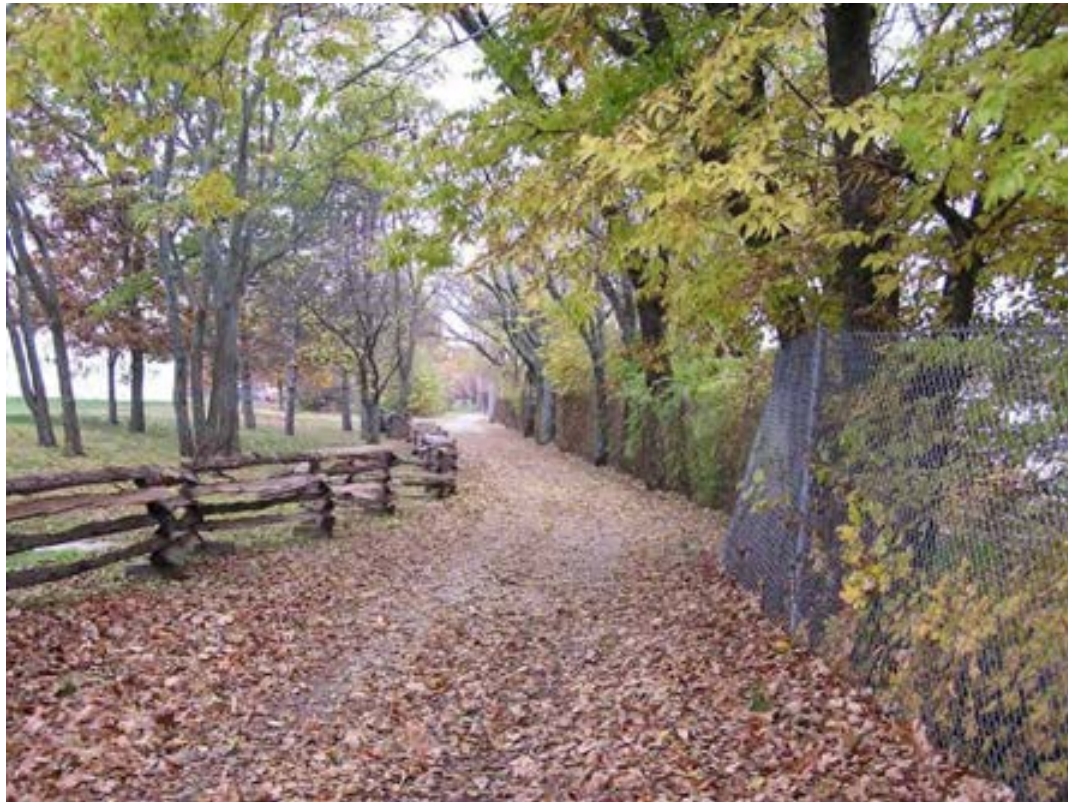
Figure 37. View of the service road and perimeter fence on the northwestern corner of FOSC looking south. (PBA 2009)

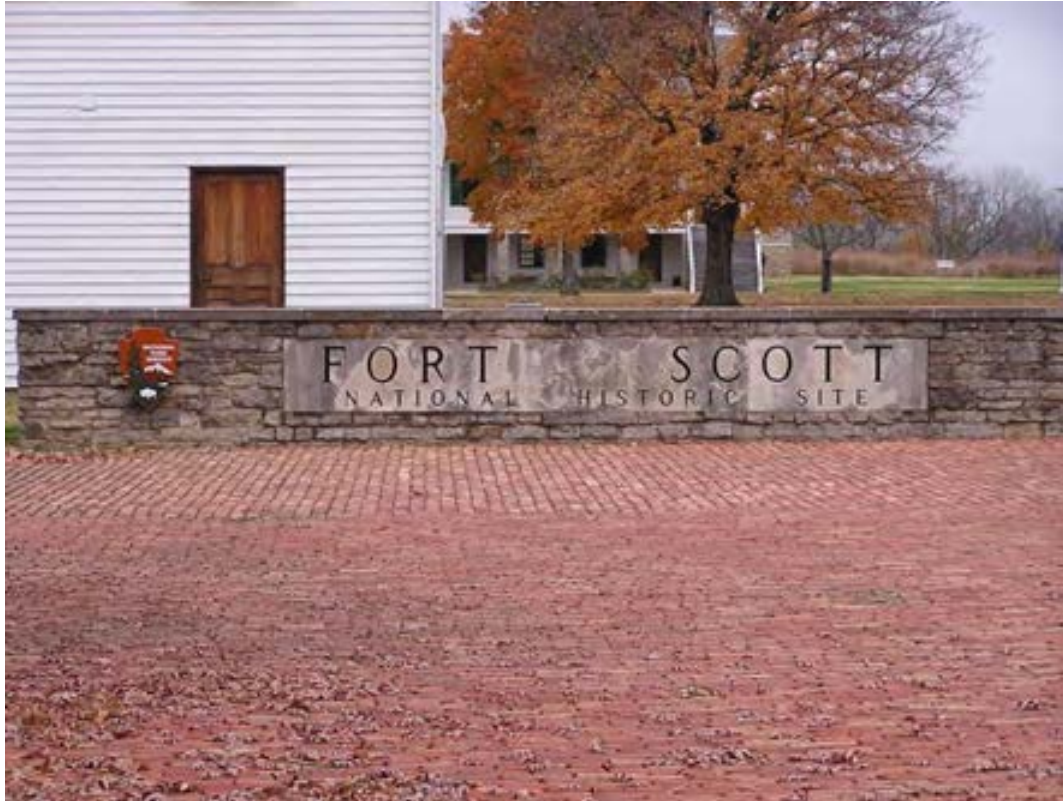
The main pedestrian entry to the Site consists of brick and concrete sidewalks (Figure 38).

Figure 38. View of the brick entry walkway and sign for FOSC. (PBA 2009)
