Cultural Landscape Report

Fort Scott National Historic Site
Fort Scott, Kansas

December 9, 2010
NPS Task Order # R6068090029

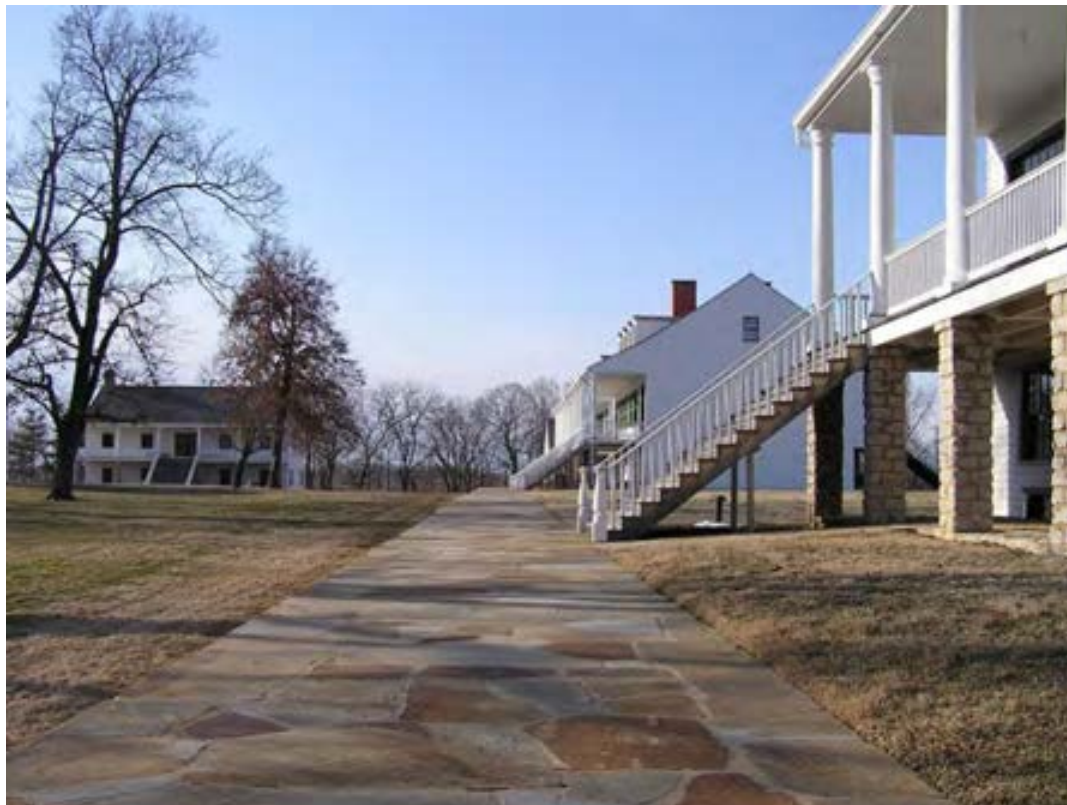
Figure 39. Flagstone walkway on the northeastern side of the Parade Ground that parallels Officers' Row. (PBA 2009)

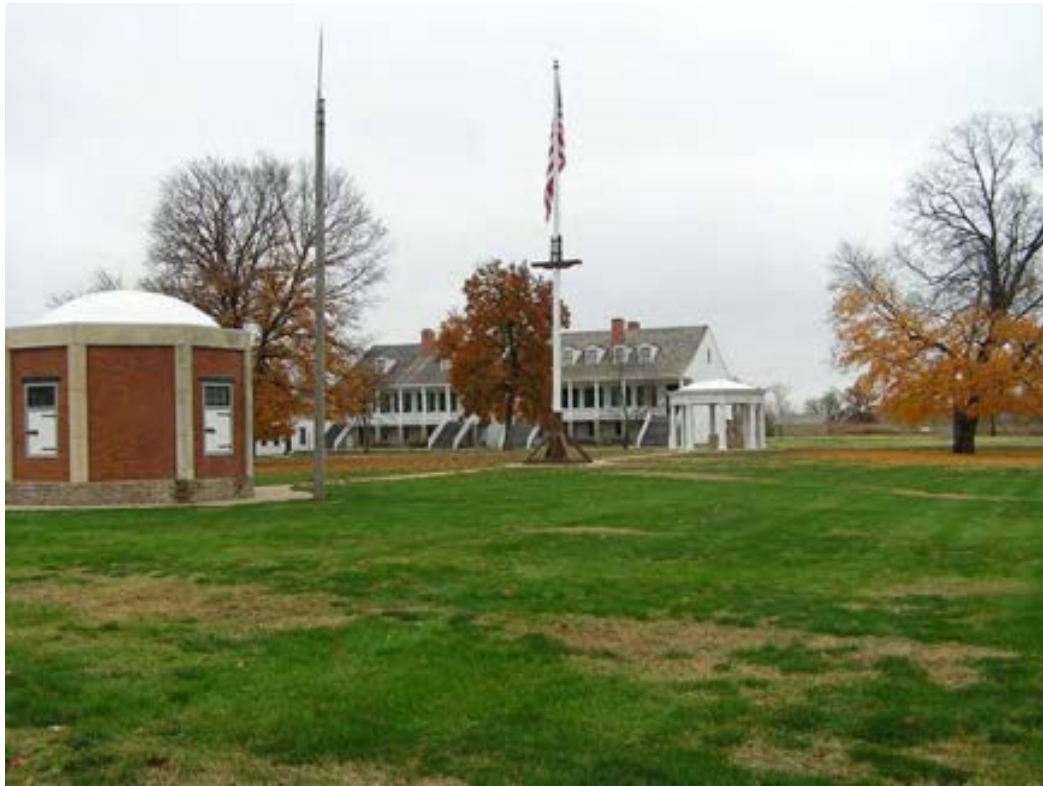
Historic Condition: There are numerous historic structures located throughout FOSC. The Powder Magazine (HS-17), the Flagpole (HS-16), the Well and Canopy (HS-15), are primary structures located in the center of the Parade Ground that are visible to visitors upon entrance into the Site (Figure 40). Stone walls are located within the Officers' Row Quadrangle. A cistern and the Company Latrine (HS-22) are present on the southeast side of the Infantry Quadrangle.

Figure 40. View of Parade Ground looking north depicting the Powder Magazine HS-17 (left), Flagpole HS-16 (center), and Well and Canopy HS-15 (top right). Officers' Quarters HS-1 and HS-2 are pictured in the background (top left). (PBA 2009)

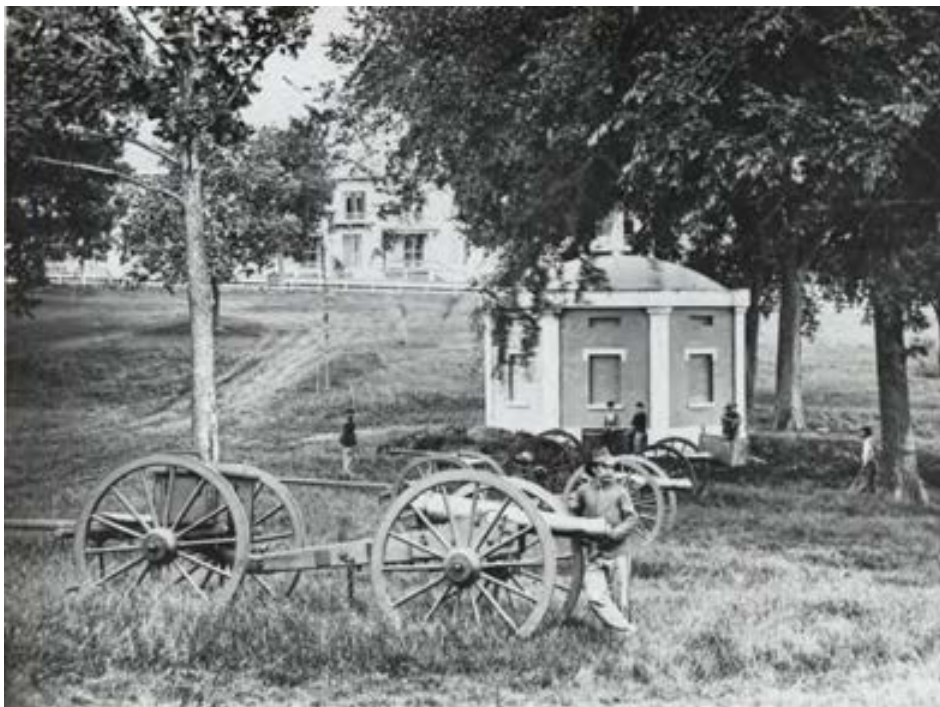
Figure 42. Fort Leavenworth Parade Ground. Note fence in the background and man cutting or raking grass to the right of the magazine. (US Army Frontier Museum, Fort Leavenworth, KS, FO SC Archives, FO SC Historic Photographs, 1899 Ft. Leavenworth, 26.)

During the initial military period (1842-1853) the Parade Ground was surrounded by a wooden fence (Auction Account 1855) and precedent, as at Fort Leavenworth, dictates it to be of four horizontal boards (Figure 42). A Civil War-era photograph of the Parade Ground/Carroll Plaza (Figure 41) clearly shows such a fence, extant after the City Council's beautification project of 1860-61 when the plaza was reseeded, trees were planted, and the fence (absent since the Army auction) was replaced.

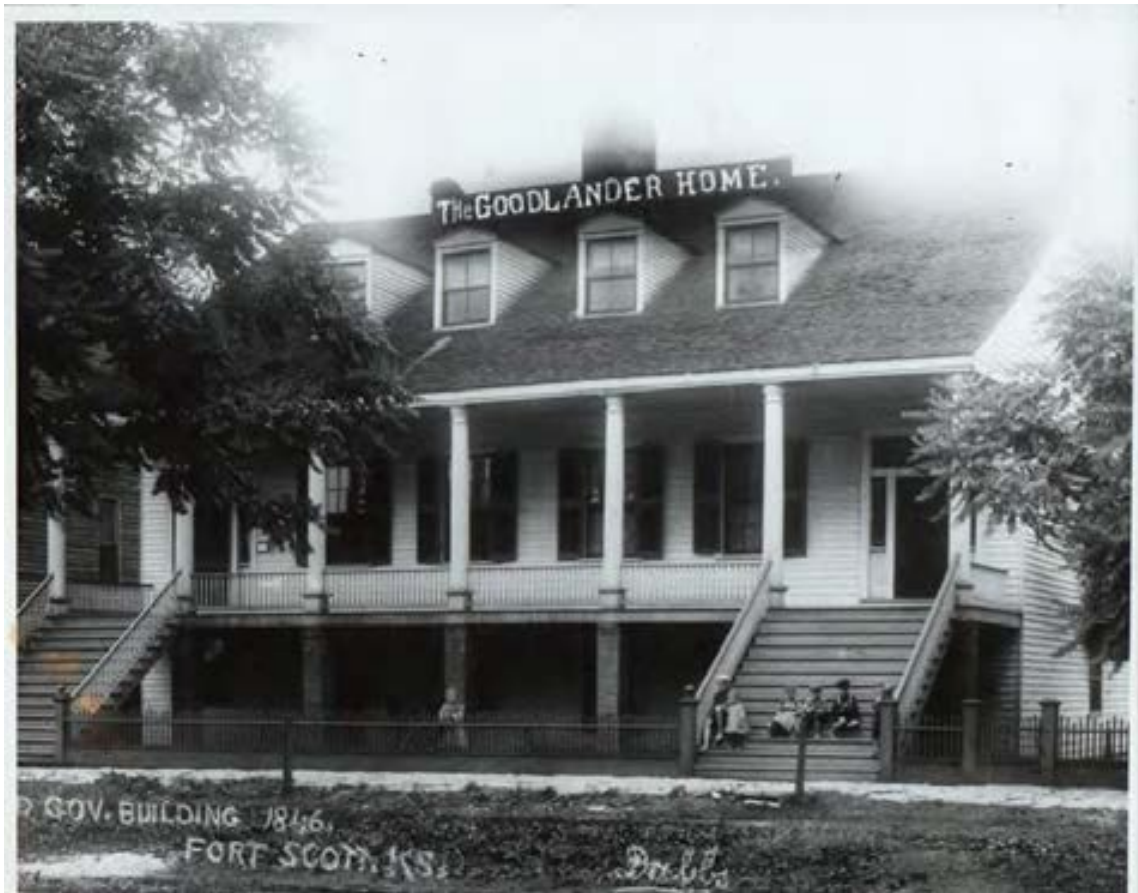
Picket fences defined the front yards and linked the duplexes of Officers' Row (Figure 43). These are similar to those on Officers' Row at Fort Leavenworth (Figure 44) and are an example of Army quartermasters' practice of repeating design elements and plans based on standardized experience and training. The fences in front of HS-1, HS-2, and HS-3 are nearly identical; it is unlikely that they were built when different individuals owned each property and more likely that they were constructed when all the properties were under single ownership - that of the Army - which dates the fences prior to 1855.

Figure 43. HS-2 as the Goodlander Orphanage, ca. 1903, with picket fences in front that date to military period, ca. 1850. (FOSC Archives, Box From NPS MWRO, 65 Officers' Row Folder 1840-1900 Historic Photo Box, DABBS.)

Missing features in Landscape Area 2 include the picket fences that lined the walk along the front of HS-1 and HS-2 (Figure 43) and Elizabeth Wilson's garden that existed as early as 1860 (extensive by 1873) between HS-2 and HS-3. Running the full length of the lot, from the "public square" (the former Parade Ground) to the "alley" at the rear of the backyard (as described in the 1860 deed), it was planted with fruit trees, shrubs, evergreens, and flowers. Also missing is the row of trees planted along the walk directly in front of HS-1 and HS-2 (Figure 30). This row, coupled with the row of trees planted around the perimeter of the Parade Ground, created a corridor of trees at the front of the quarters. Extensive archeological excavations in 1993 recorded missing backyard features such as the original perimeter wall (as indicated in the 1848 plan), walks, curbs, gutters, and a flagstone patio that extended beyond the back stairs.

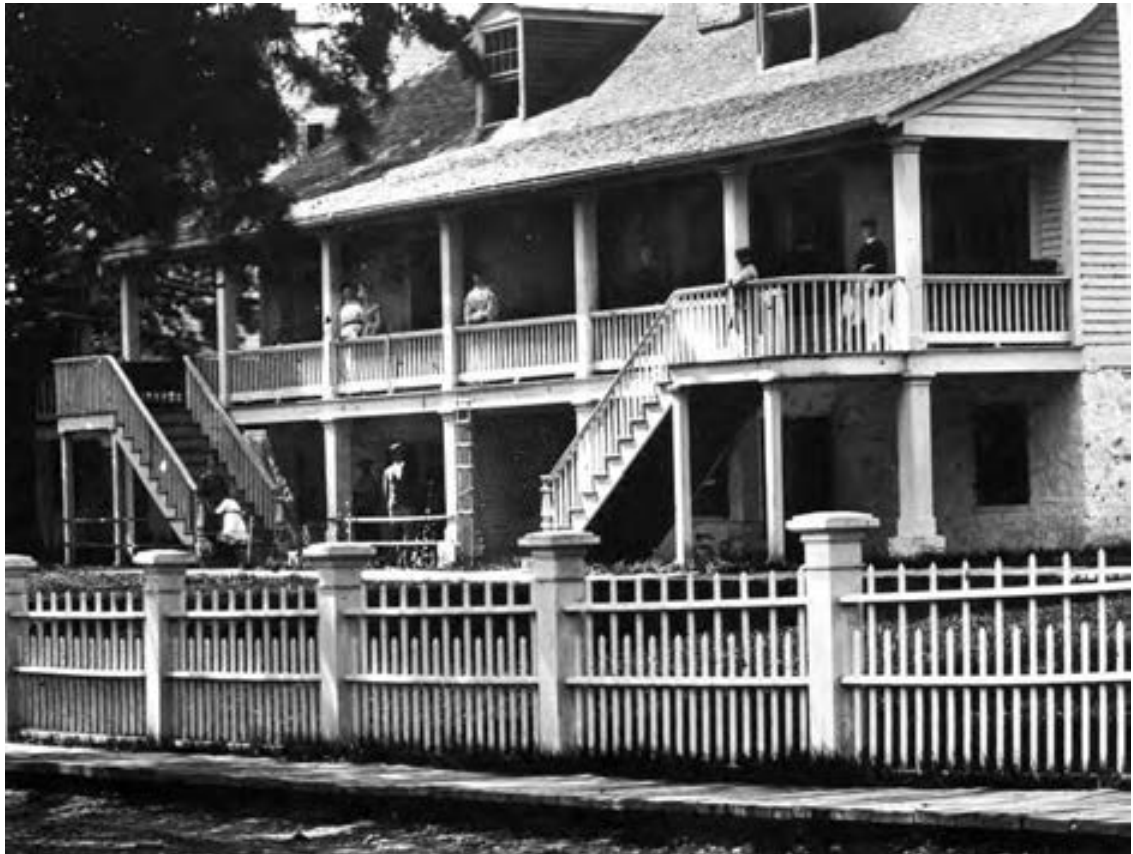
Figure 44. Fort Leavenworth Officers' Row, ca. 1869.
(US Army Frontier Museum, Fort Leavenworth, KS.)

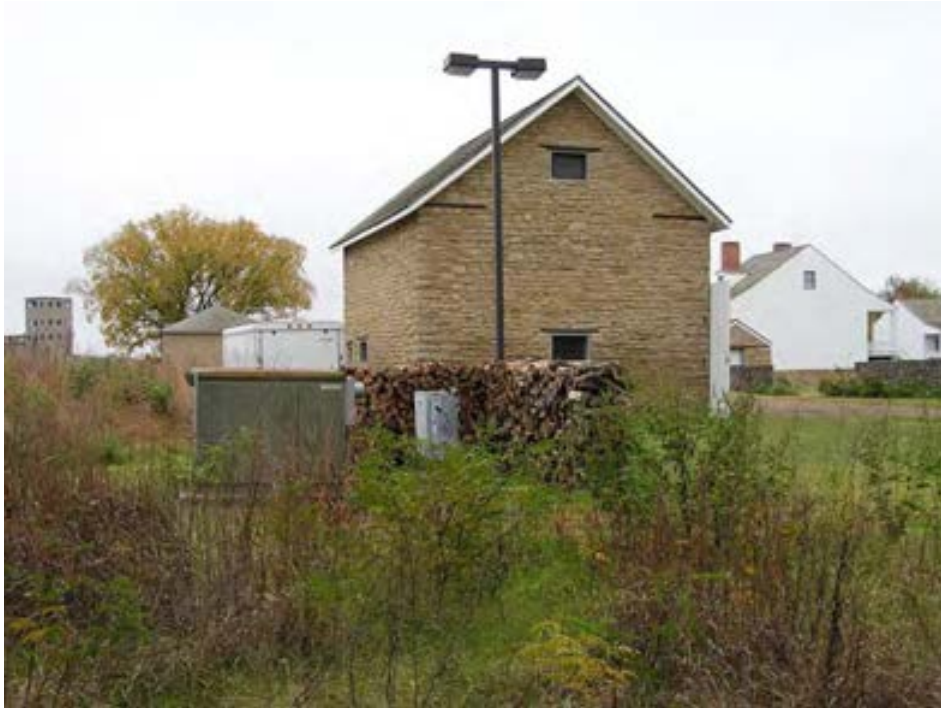
Figure 45. Wood piles used to minimize the visual intrusions of present day utilities such as mechanical units. (PBA 2009)

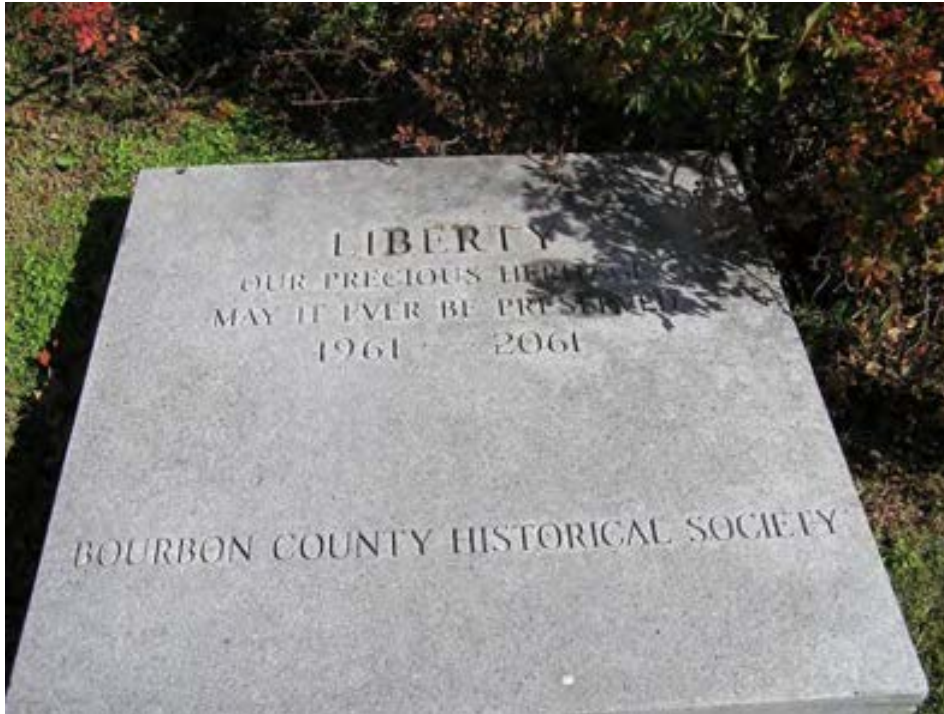
Figure 46. Time capsule present in front of Officers' Quarters HS-1.
(PBA 2009)

Some necessary small scale features that cannot be hidden from view include: chain-link fence, contemporary street/site lighting, curb cuts and stormwater drain inlets, service road gate, signs (interpretive and directional), split rail fence, stone piers and chain fence, pop-up sprinkler heads, and a time capsule monument (Figure 46).

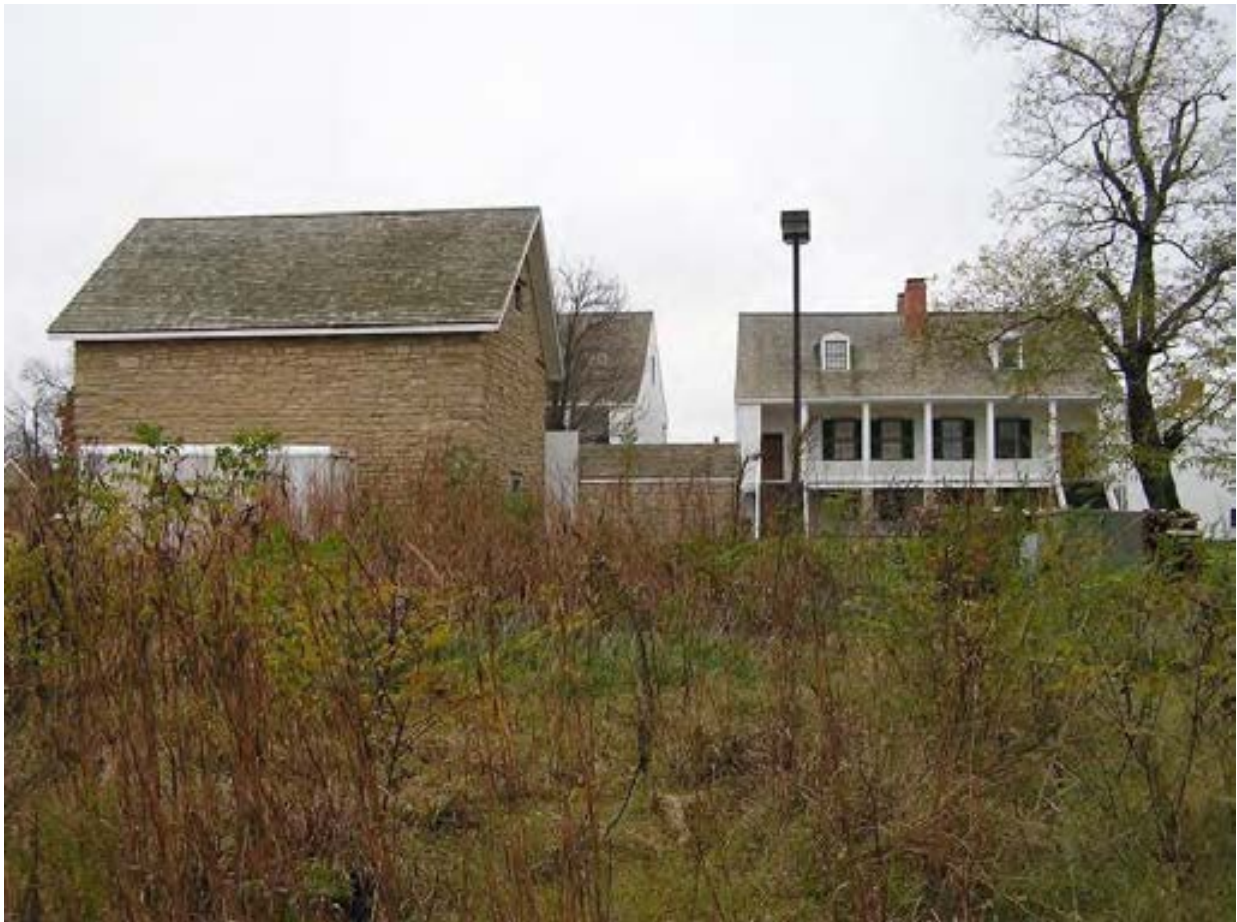
Figure 47. Mixture of stone and wood buildings and structures provide unique views and textures within the Site. (PBA 2009)

FOSC has 20 buildings and structures listed in the 1993 GMP designated as principal cultural resources, 11 are original and 9 reconstructed (Figure 48, Chart of Park Resources). These resources define the historic character of FOSC by their collective relationship within the landscape. The spatial arrangement of the buildings around the Parade Ground is critical to the visitor experience. This arrangement also makes it possible to view most buildings from multiple locations throughout the Site. There is an interesting contrast between the primary buildings which are wood and the outbuildings which are stone (Figure 47).

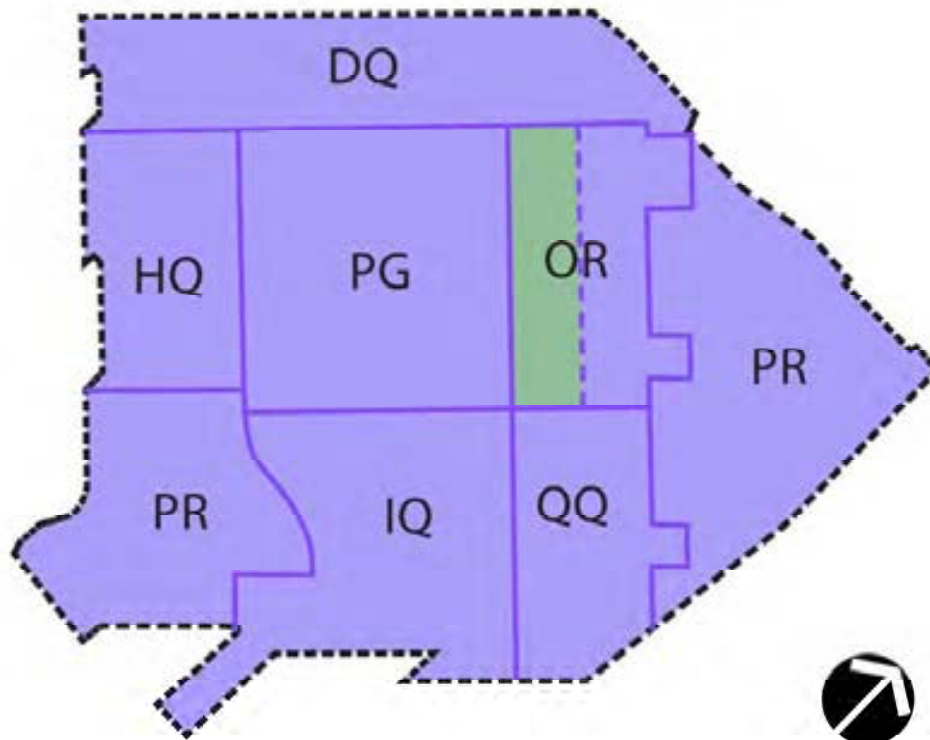
PG Parade Ground (Landscape Area 1)	IQ Infantry Quadrangle (Landscape Area 5)
OR Officers' Row Quadrangle (Landscape Area 2)	QQ Quartermaster's Quadrangle (Landscape Area 6)
DQ Dragoon Quadrangle (Landscape Area 3)	PR Prairie Restoration Quadrangle (Landscape Area 7)
HQ Hospital Quadrangle (Landscape Area 4)	Restoration
	Rehabilitation
