FORT VANCOUVER EXCAVATIONS - V

Flagstaff and Belfry

United States Department of the Interior

National Park Service

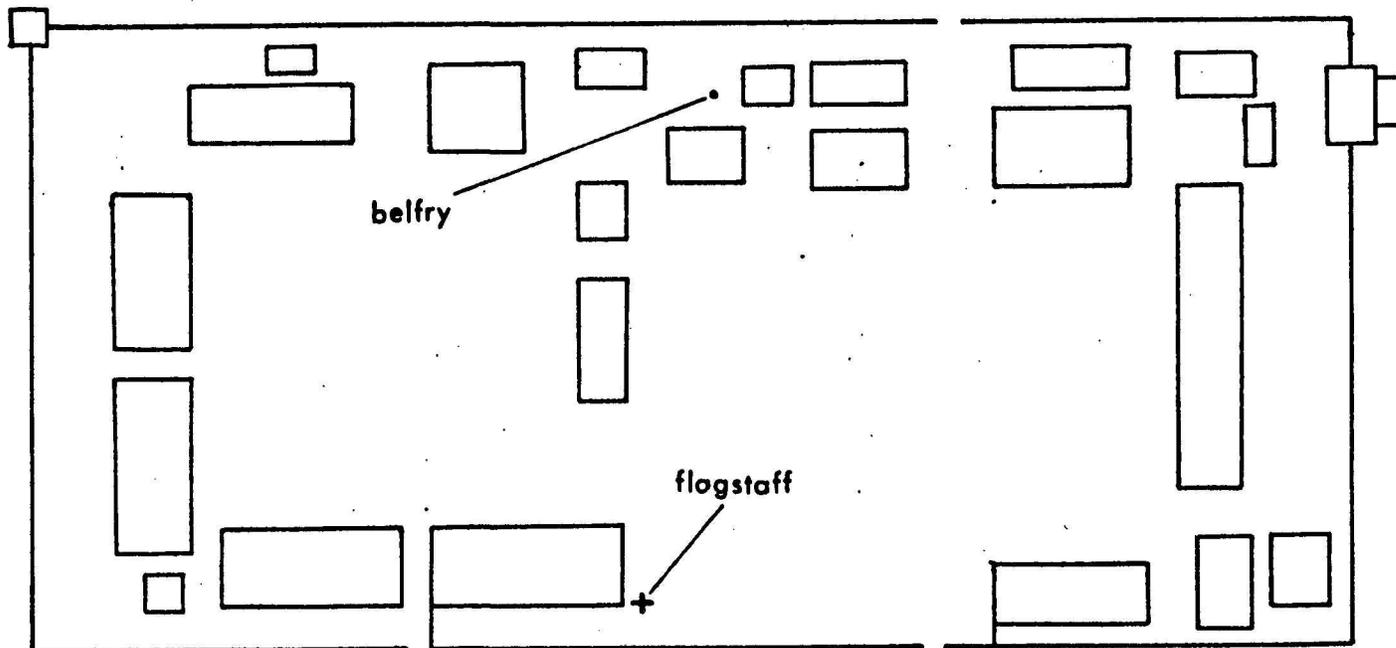
Fig. 1 - Archeological locations of the Flagstaff and Belfry in relation to major buildings of 1845 as plotted by Lt. M. Vavasour of the Royal Engineers (redrawn from Hussey 1972:Pl. VII).

Subsurface remains of the Flagstaff were found immediately east of the 1845 period Fur Store (Fig. 1). Distance from the center of the Store's southeastern corner footing to the center of the staff was 9 ft. east and one ft. north. This location was about 22 ft. north of the centerline of the 1845 period Stockade trench, and less than 9 ft. east of the actual east wall of the Fur Store.

Remains of the Belfry were found in the north central sector of the Fort. By reference to a map of past explorations (Caywood 1955:sheet 8 of map 2), we determined this location to be about 32.5 ft. south of the northern Stockade, about 18 ft. north of the New Office north wall, and about 15 ft. west of the presumed west wall of the Jail (Fig. 1).

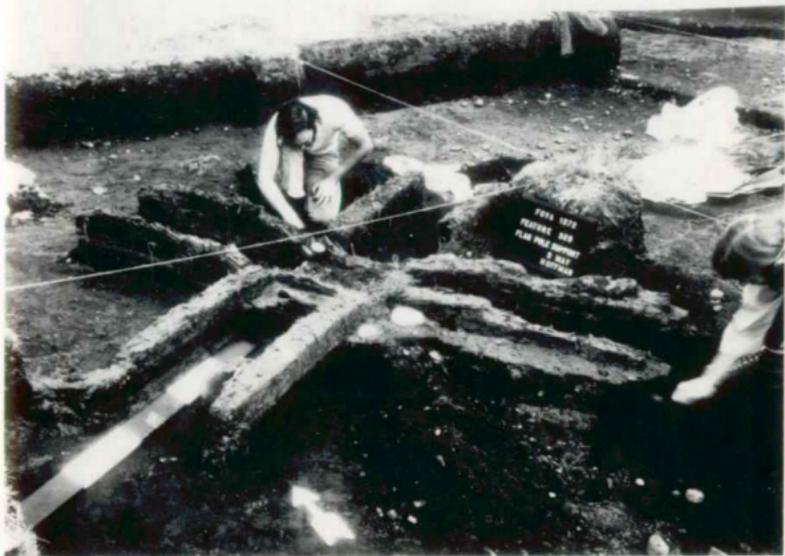
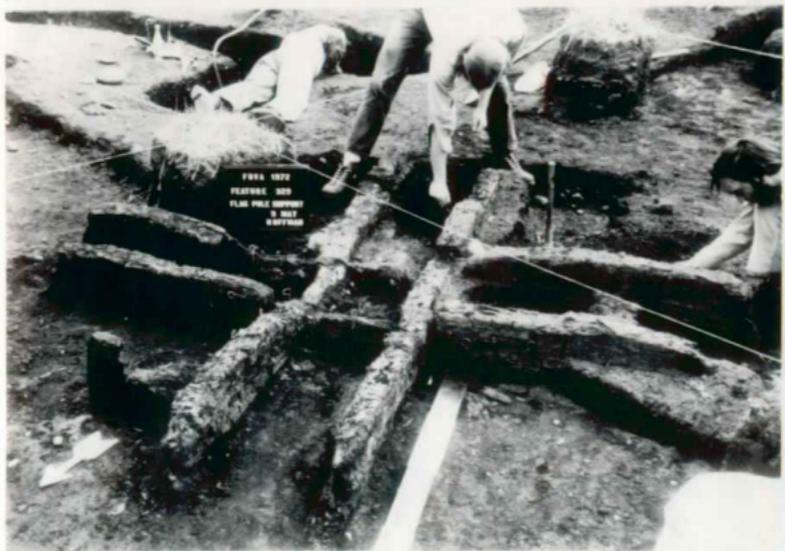
Fig. 2 - Crossed timbers of Flagstaff support.

a - Excavating timbers from HBC matrix
(FOVA neg. 069.51-72/14)

b - View of rectangular collar at center
of crossed timbers (FOVA neg. 069.51-72/13)

Remains consisted of 4 wooden timbers laid horizontally and notched to intersect each other. These were set slightly under the top of the HBC surface (Fig. 2). Field records indicate that the old surface was a compacted level immediately below modern sod. Tops of the timbers were slightly deeper than the tops of other HBC features in the immediate area. Center of the crossed timbers formed a rectangle that contained a cast and fragments of the wooden staff butt. Under the timbers and surrounding the butt remains was a large hole originally dug to set the butt (Fig. 3).

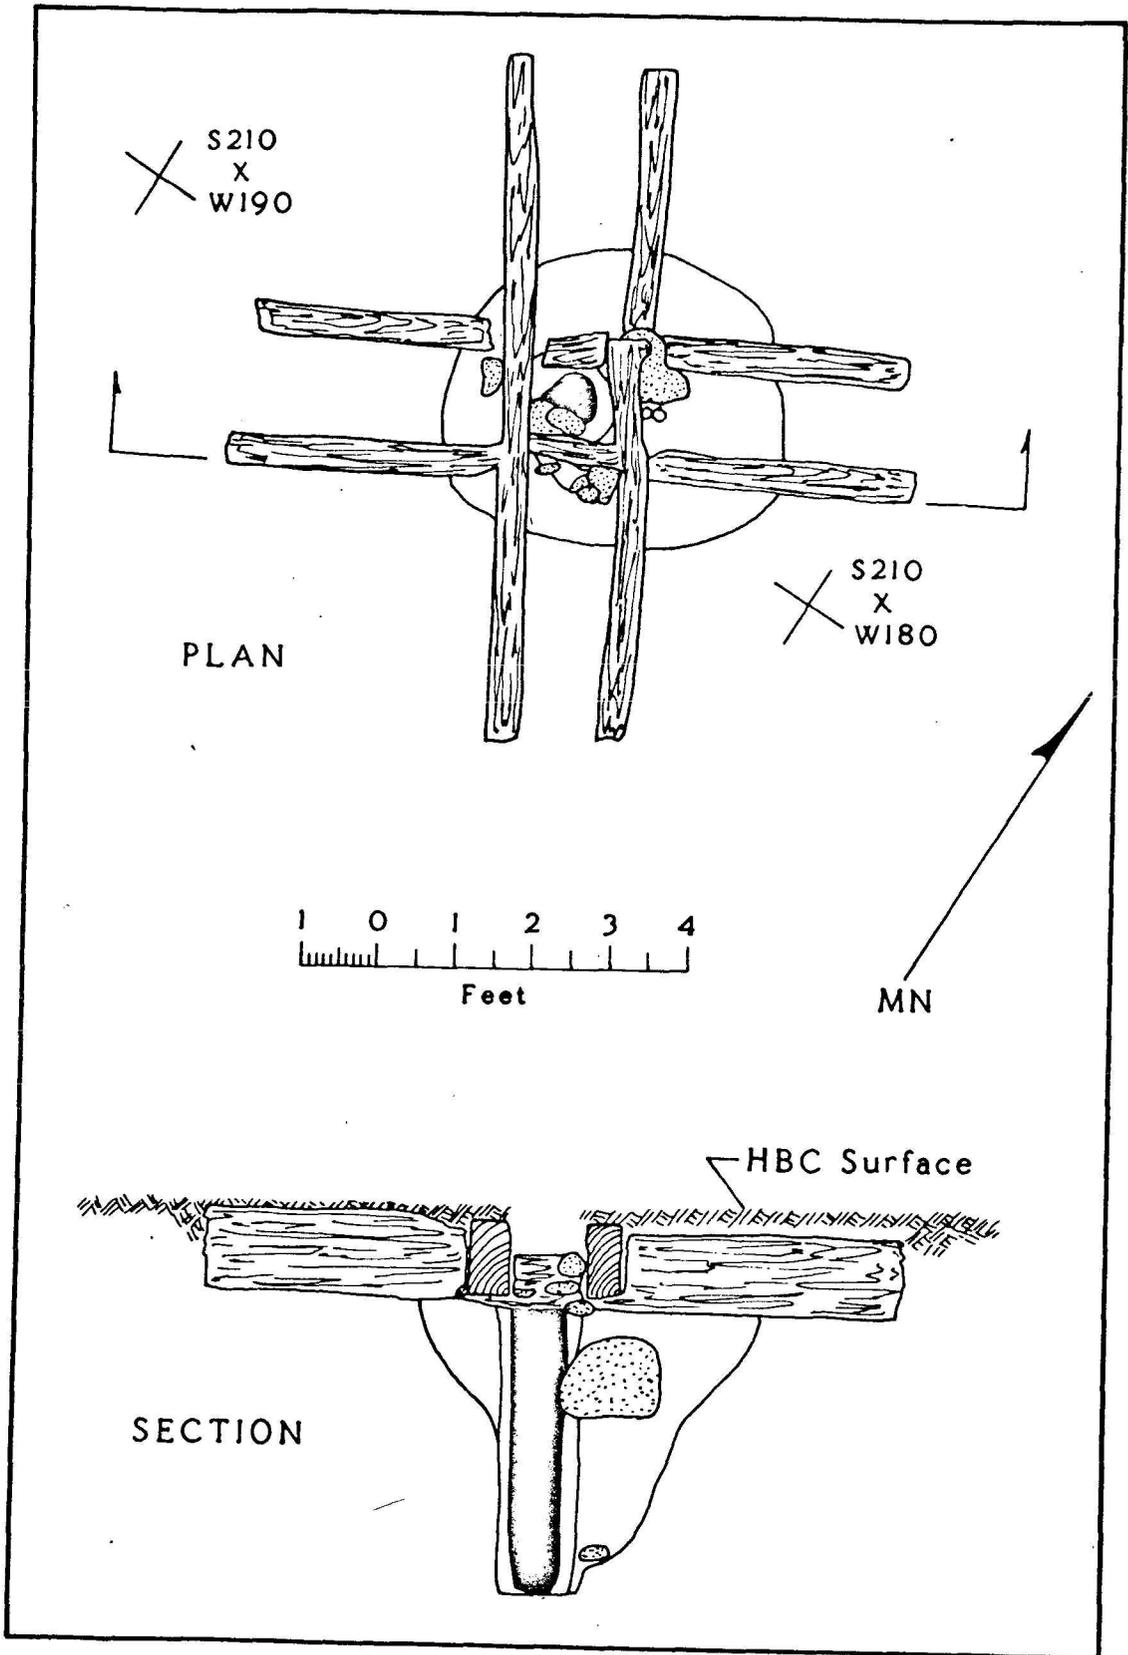
Fig. 3 - Archeological plan and section of Flagstaff remains.

Intersection of the timbers formed a rectangular area that varied from 0.95 to 1.20 ft. on a side. This area formed the supportive collar for the Flagstaff. Remains of the wooden butt were badly rotted; however, a well-preserved cast of the butt indicated the original diameter to have been one ft. Evidence of the cast and butt fragments were found within the collar but they extended only 3.55 ft. below the timbers (Fig. 3).

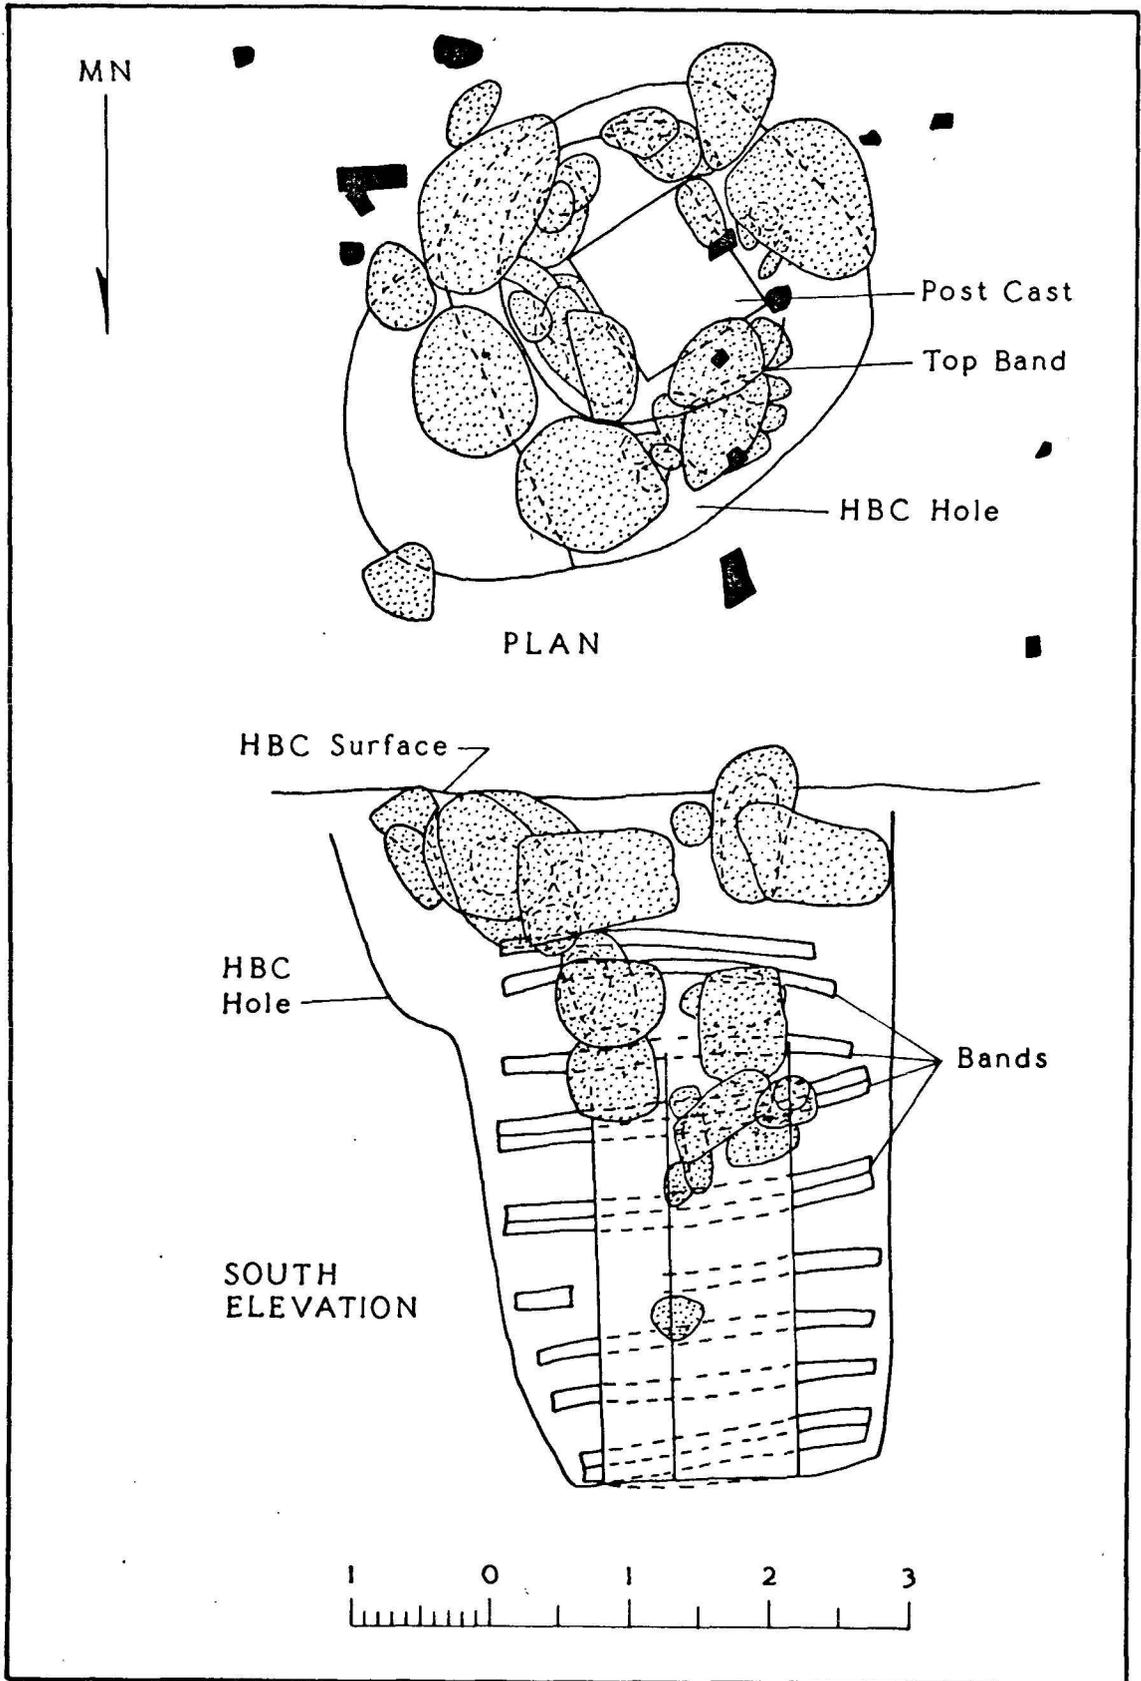
Fig. 5 - Archeological plan and section of Belfry remains.

Base of the Belfry consisted of an iron-hooped wooden barrel set 4.80 to 4.95 ft. below the HBC surface (Fig. 5). Top of the barrel was ringed with large, rounded stones which were partially exposed at the HBC surface (Fig. 7a). The only remnant wood of the barrel was found adhering to a series of iron hoops that remained in place after rotting of the barrel. However, partial stave casts were found in the earthen matrix. Within the barrel was the vertical cast of a one-ft. square wooden timber that was the butt of the bell mast (Fig. 7b). The butt had been packed in the barrel with black silty clay and, in its upper portions, large rounded stones (Fig. 5). In addition to the archeologically

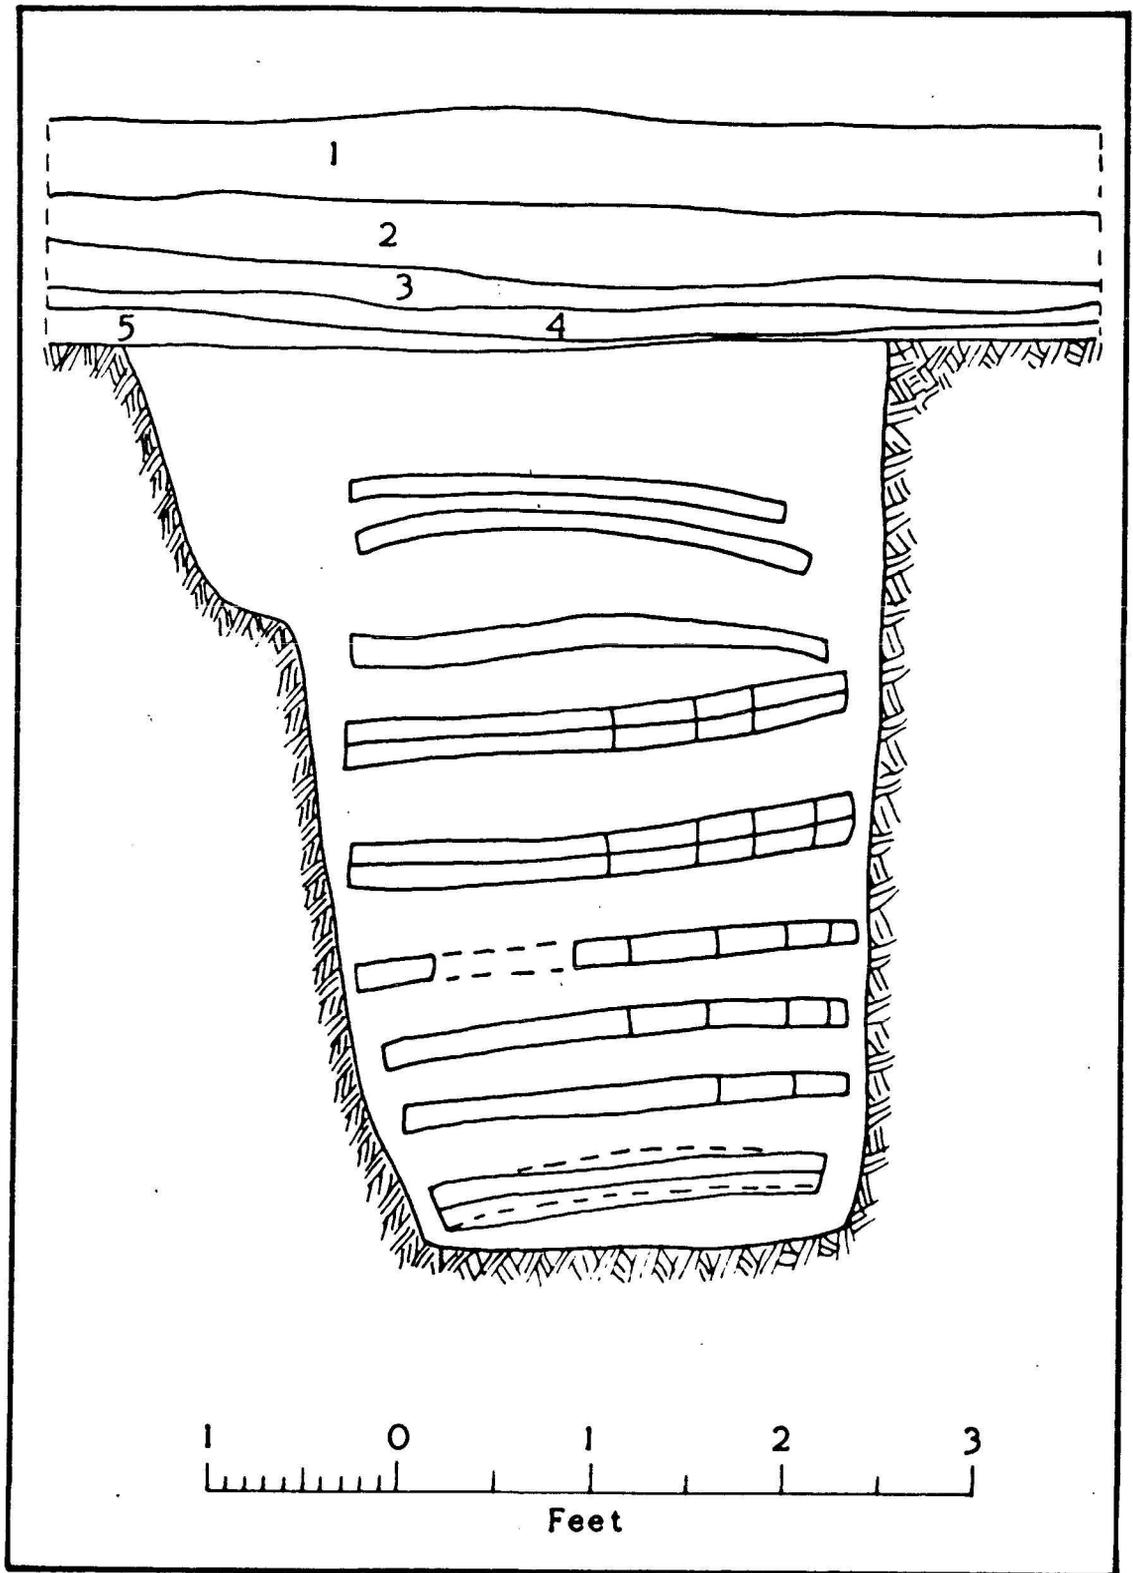
Fig. 6 - Soil stratigraphy and hoop positions of the Belfry base.

Several 10-ft. square units were opened in this general area before finding the Belfry location. These exploratory efforts revealed modern U.S. Army trash, a short section of railroad spur, scattered and mixed HBC trash, and outlines of past explorations. Fortunately, the subsurface remains of the Belfry were undisturbed by modern intrusions, and soil stratigraphy was quite clear (Fig. 6).

The first layer over the Belfry base was a mixture of gravelly, silty clay 0.35 to 0.45 ft. thick. Top of this modern layer was the grass-covered surface of 1973. The second layer consisted of fine and coarse sands 0.2 to 0.4 ft. thick slightly mixed with clay at its upper portion. This appeared to be deliberate fill from USA activities of 1918-19. The third layer was a moist band of silty clay mixed with small amounts of gravel. It was 0.10 to 0.25 ft. thick and represented deposition from a late 19th Century river flood. The fourth layer, the main HBC cultural deposit, was 0.05 to 0.20 ft. thick. It consisted of moist, brown silty clay mixed with buff pea gravels and HBC specimens. Since this layer was sealed by a historically known flood, we assume the top of layer 4 to be the last HBC occupation surface. The fifth layer was a moist mixture of brown and buff silty clay with gravel no more than 0.2 ft. thick. It appeared to be a combination of general HBC deposit and fill from the excavation prepared for the Belfry base. In turn, the base was set into the culturally sterile buff gravels of the floodplain (Fig. 6).

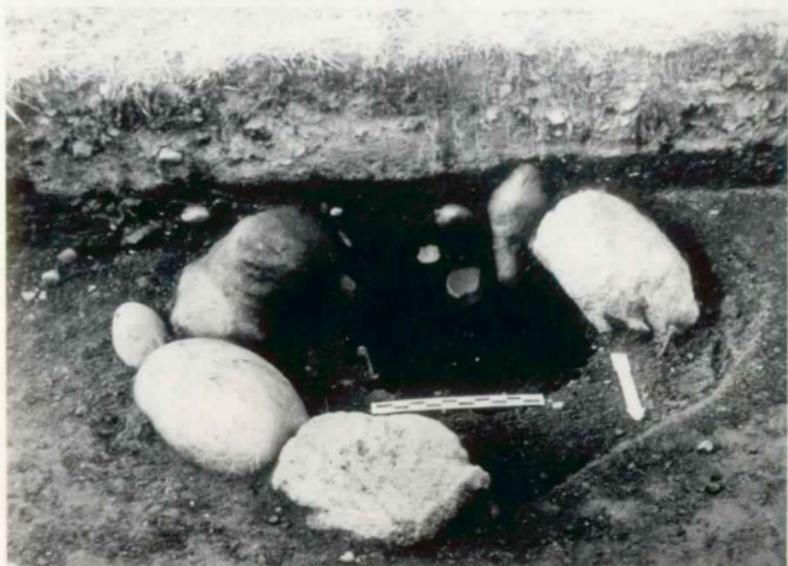
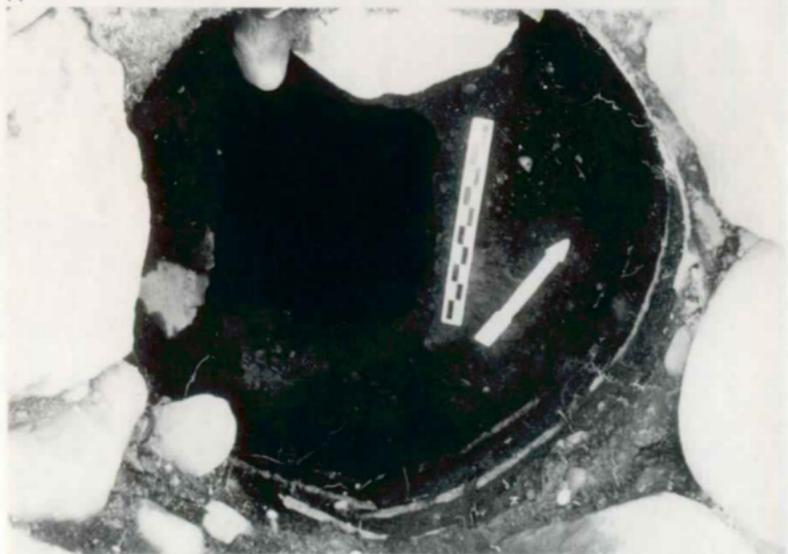
Fig. 7 - Belfry remains.

a - Stone ring outlining mouth of barrel
(FOVA neg. 069.51-73/6)

b - Interior of barrel showing hoops and
cast of bell mast (FOVA neg. 069.51-73/13)

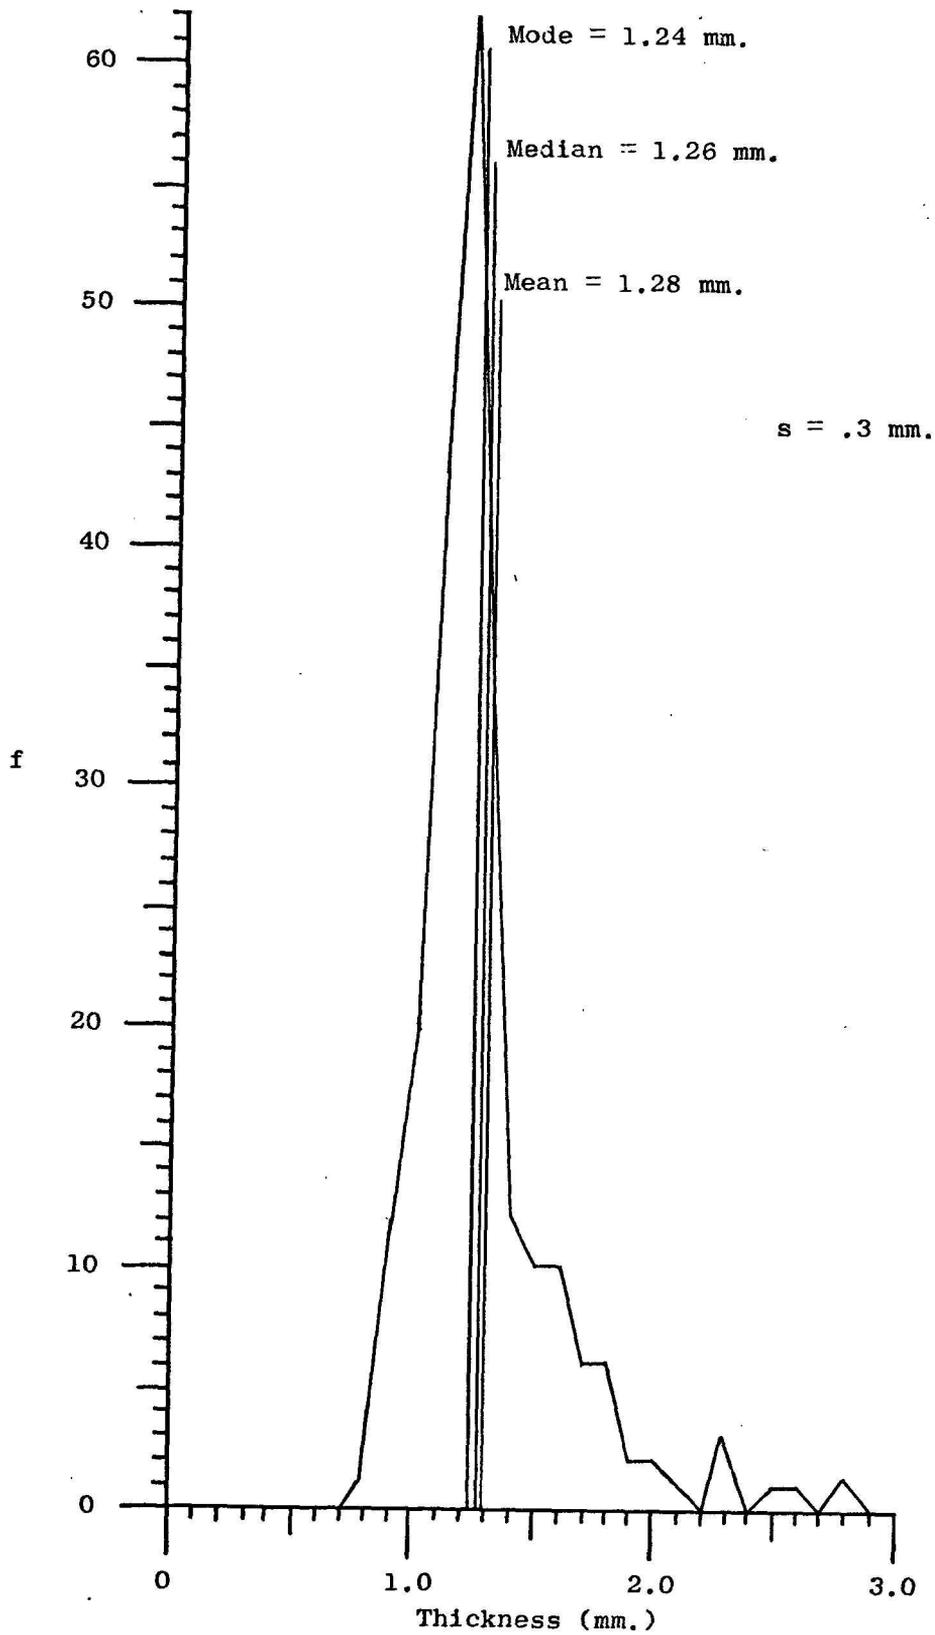
Fig. 8 - Frequency of window glass thickness for the area of the Belfry (N=225).

As with previous reports, the only attribute of window glass found to be significant was thickness, and the frequency distribution for the Belfry area (Fig. 7) was similar to that of the Chief Factor's House. This glass probably came from the New Office.

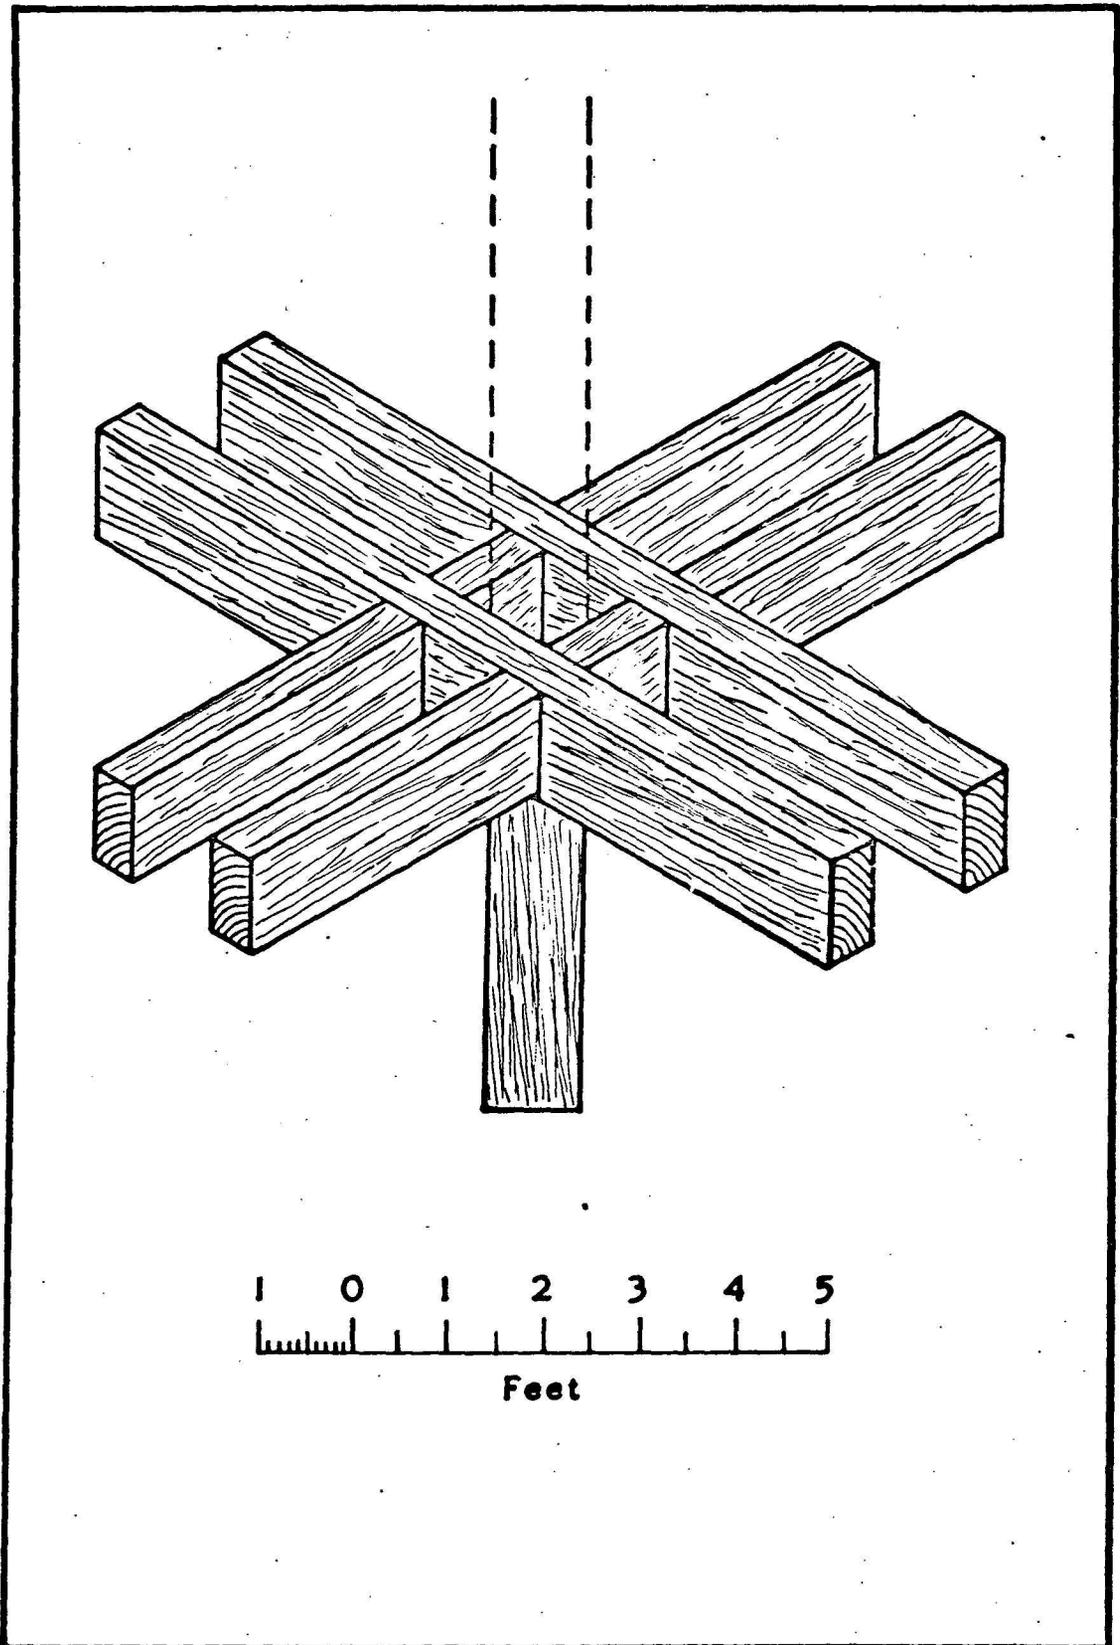
Fig. 9 - Inferred construction of Flagstaff support.

The archeological evidence of the Flagstaff is subsumed in the schematic drawing of Fig. 9. With the staff butt packed in rock, it is possible that the subsurface crossed timbers were sufficient support for a single wooden pole 103 ft. long. While this length is not extraordinary for local Douglas fir trees, the butt diameter is. If the Flagstaff was a single tree, its butt must have been extensively trimmed to obtain the even diameter of one ft.

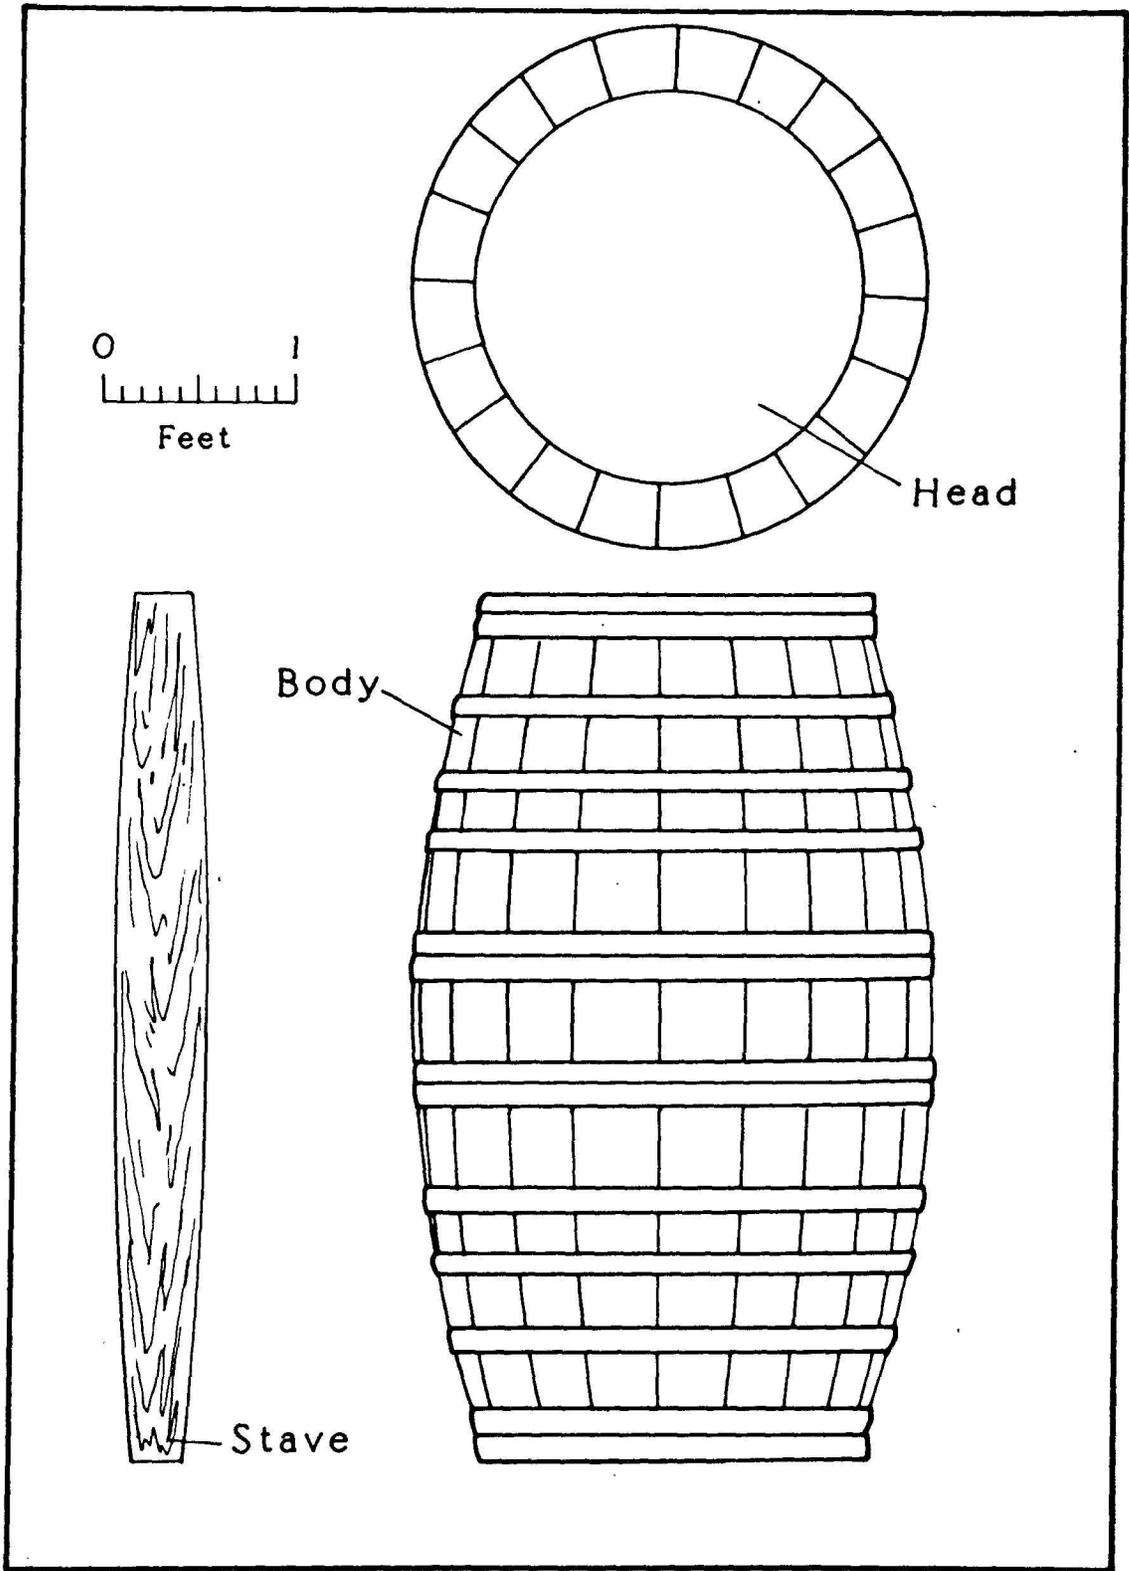
Fig. 10 - Inferred appearance of the salt barrel used for the Belfry base.

a 50 ft. pole into "a large cask of salt." A reconstructed view of this cask appears as Fig. 10, and if it was indeed a cask for salt, then its reconstructed volume indicates that it was a 1/2 avoirdupois ton salt cask (i.e. 1120 avoirdupois lbs. of salt) which would have held an equivalent of 138.5 imperial gallons (based upon 1 imperial gallon = 8.08 avoirdupois lbs. of salt; British). Since salt was commonly sold by the avoirdupois hundred-weight (i.e. 112 avoirdupois lbs.; British), this 1/2-ton cask would have contained an even 10 avoirdupois cwt. of salt.

As depicted in Fig. 10, the cask consisted of 20 staves (oak?) held together by 14 iron bands. Each band was made from strap iron measuring 1 3/8 inches in width and ca. 1/8 inch in thickness, and each was formed from a single piece of strap iron bent in a circle, overlapped and joined with a single rivet. Apparently, the inner bands were held in place without the use of fasteners, but the method of attaching the end bands could not be determined due to the loss of these bands through corrosion.

barrel or cask buried in the ground. The barrel was 4.5 ft. high and 2.65 ft. in diameter at its girth. The heads were 2 ft. in diameter and the circumference of the girth was about 8.32 ft. These measurements indicate that the barrel had a salt capacity of 1/2 avoirdupois ton. As discussed in Chapter III, this capacity is better expressed as 10 avoirdupois cwt. of salt.

While the archeological evidence was fragmentary, we believe the barrel consisted of 20 wooden staves, each 4.5 ft. long. Assuming symmetry of the staves, they were about 0.416 ft. or 5 inches wide at their girths and about 0.312 ft. or 3 3/4 inches wide at their ends. Thickness could not be determined. Twelve metal bands or hoops were found in situ, although only 8 could be collected due to fragmentation. Each hoop was made of 1/8 inch stock, cut 1 3/8 inches wide, and joined at the ends by a single rivet. The archeological evidence indicates that the barrel heads were hooped by double bands and the barrel girth held by 2 sets of double bands. Intervening hoops were single bands. Thus, the barrel was originally hooped with 14 bands (Fig. 10). Apparently, the bands were held by pressure alone; we have no clear evidence for other means of attachment.

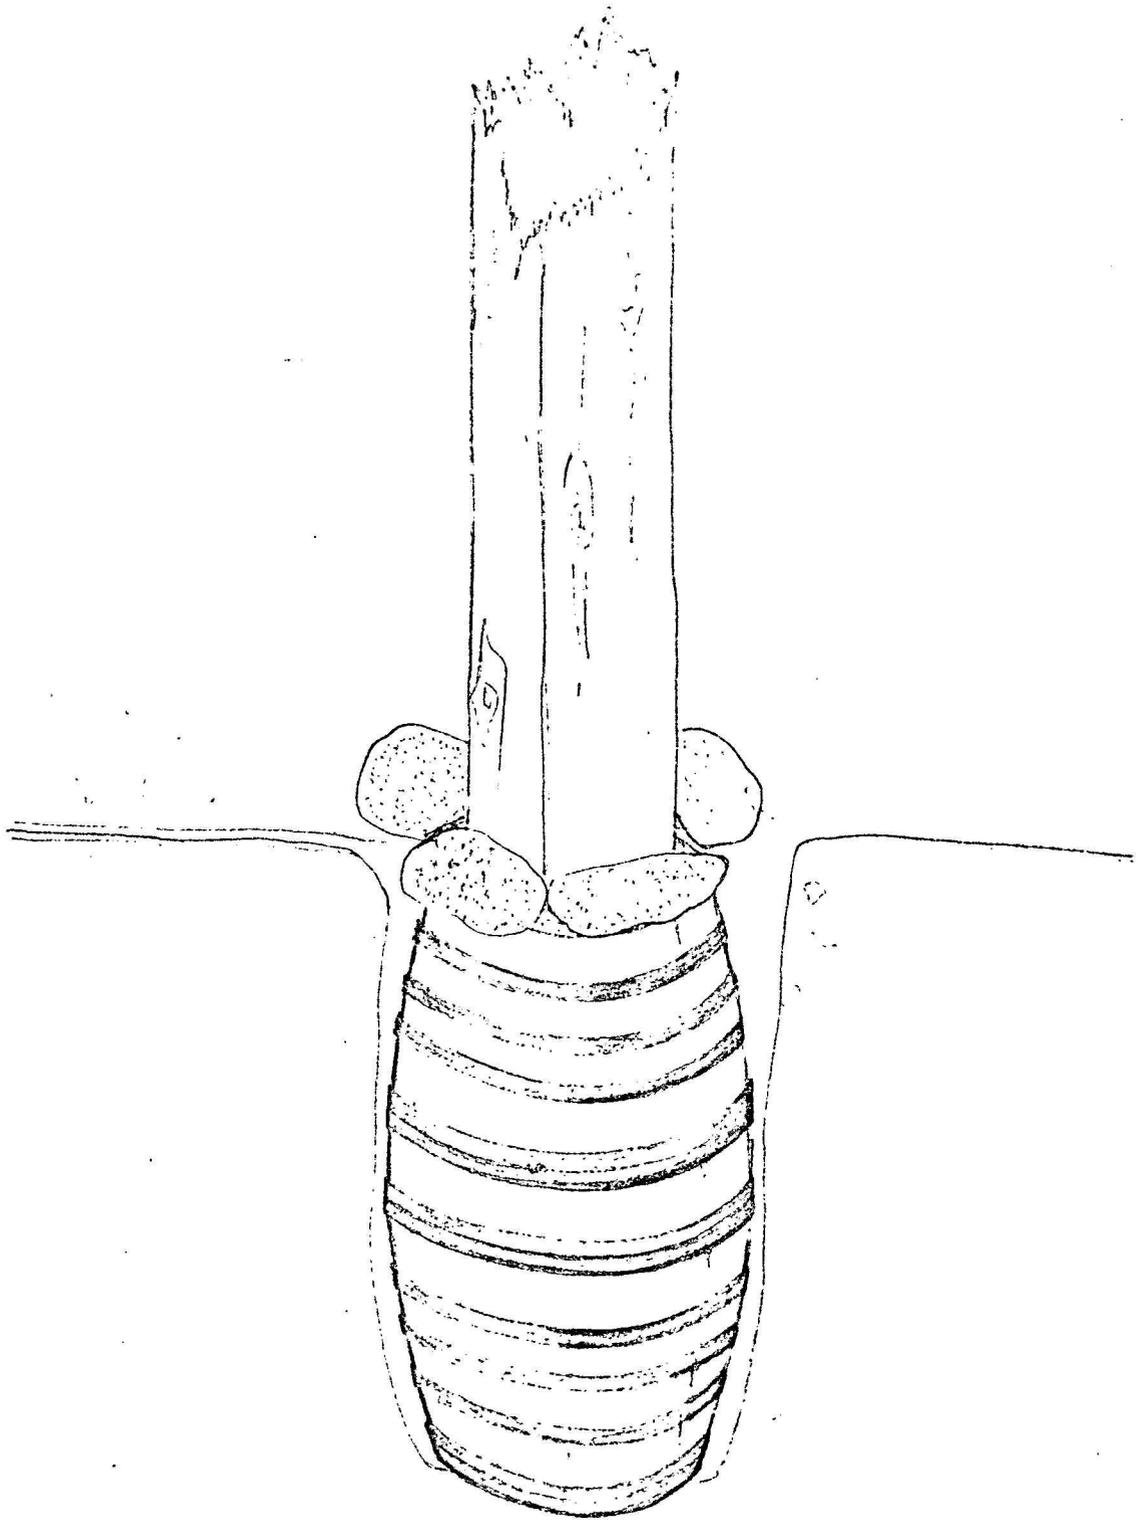
Fig. 11 - Inferred construction of Belfry base.

The height of the bell mast or "spar" was reported to be 45 ft. above ground at the time of construction. Archeology shows that the butt of the mast extended 4.80 to 4.95 ft. below surface at the time of use. For practical purposes, we can say that the bell mast was originally 50 ft. long. As shown in excavation, the mast butt was one ft. square; presumably, the entire mast length was one ft. square. The upper portion of the butt was packed with large stones both inside and outside of the barrel. Some of these stones protruded through the old surface producing a ringed, decorative appearance (Fig. 11). While soil contents of the barrel were not chemically tested, we have no reason to question the historically recorded salt-packing of the mast butt.
