FORT VANCOUVER EXCAVATIONS - VI

Sales Shop and Powder Magazine

United States Department of the Interior

March 1974

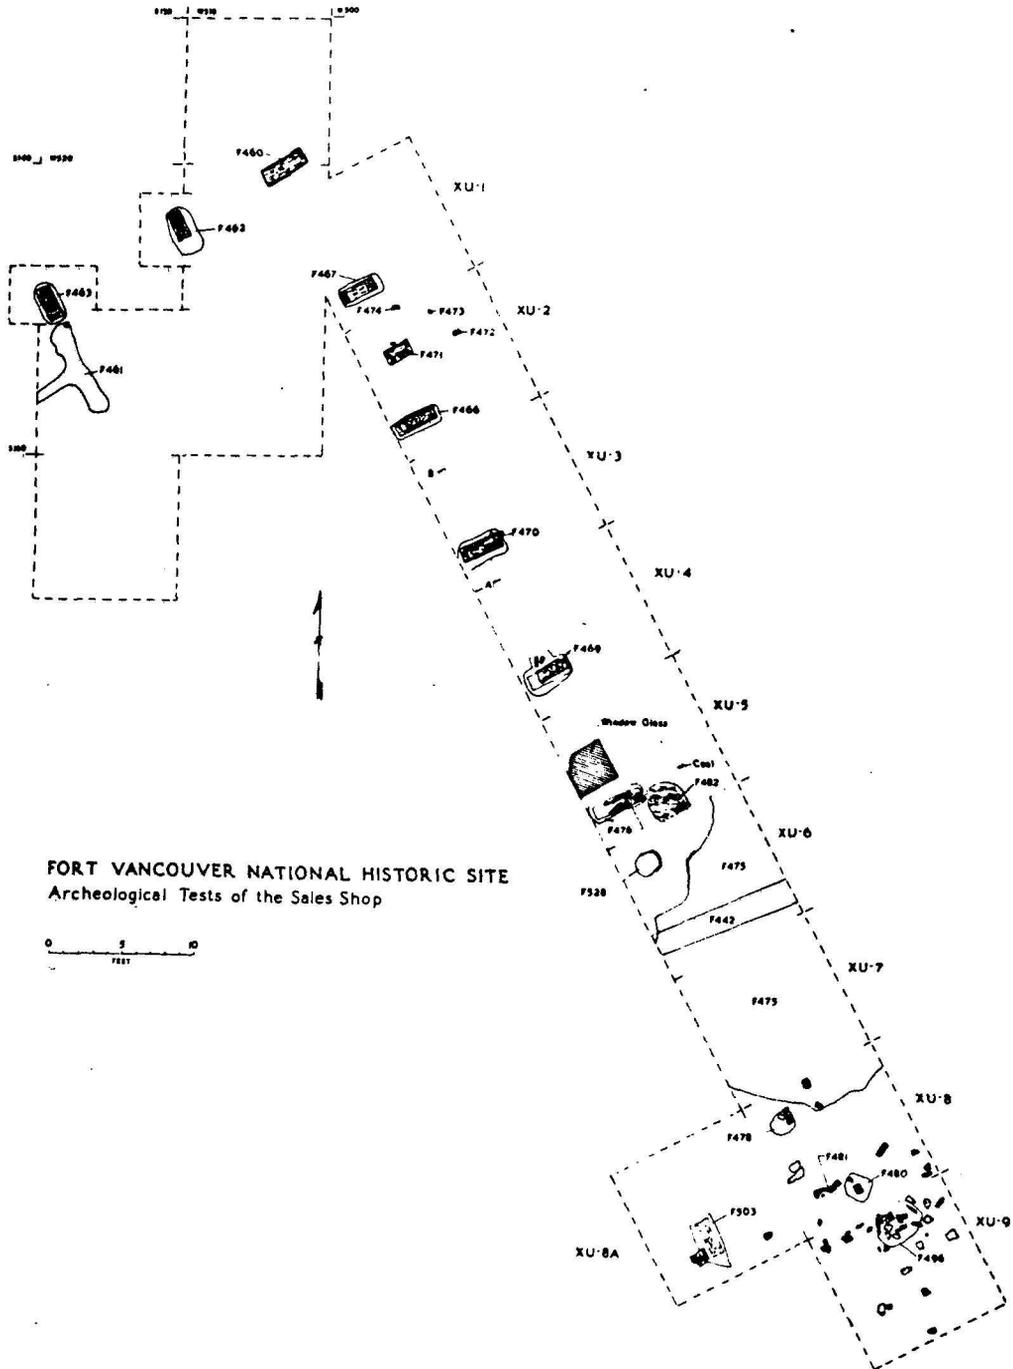
Fig. 2

Three sizable intrusions of Vancouver Barracks were found in the Sales Shop area (Table 1). The largest was a shallow trash pit that destroyed portions of the Shop east wall (Fig. 2). The pit was filled with stove pipe, rain spouts, pieces of corrugated and smooth sheet metal, large diameter wire cables, an Army style bed frame, loose wire of various gauges, as well as a wooden and wire screen object that appeared to have been the door of a pyramidal tent. Smaller items were collected, as were the HBC materials mixed in the trash, but large items were left in place. The pit was only 1.5 ft. deep, but this was sufficient to destroy any pre-existing HBC evidence. No attempt was made to define the horizontal limits of the trash deposit. Evidently, the trash was concentrated during a USA cleanup of the area after dismantling a 1918-19 lumber mill.

A straight-sided and flat-bottomed trench was found under the trash pit (Fig. 2). A portion of this same trench was observed during our excavation of the western Stockade line of the 1845 period. There, the trench contained a waterline made of long, curved wooden pieces fitted to form a continuous cylinder. The line was tarred and held together by a continuous spiral winding of heavy, ferrous wire. Undoubtedly, the line was laid by either the Army or the City of Vancouver. Its absence in the trench below the USA trash indicated its removal prior to dismantling of the WWI lumber mill.

Another possible repair footing of the eastern wall was located 25 ft. north of the southeastern corner and labeled F528 (Fig. 2). The feature was a rectangular basin 1.6 ft. in diameter that extended 1.05 ft. below the HBC surface. No footing cast or wood was found within the hole. However, its alignment, spacing, and depth were similar to other footing holes of the Shop walls.

A debris-filled basin, F496, was found outside of the southeast Shop corner (Fig. 2). Located within the HBC level, the irregularly shaped basin was only 0.7 ft. deep. A good part of the basin's fill under the burned debris consisted of water-laid silts. Wooden fragments as well as stone and brick rubble surrounded and covered the basin at a slightly higher elevation. A similar basin, F482, was located along the east wall 33 ft. north of F496 (Fig. 2). F482 was one ft. deep within the HBC level and filled with washed pebbles. Coal fragments and dust from a surrounding deposit overlay the pebbles. The southern basin may have marked the location of a rainbarrel or downspout from the Sales Shop.

Several wooden post and stake butts were found along the eastern wall. The largest, F480, was located at the southeastern corner (Fig. 2). The rectangular butt was 0.4 by 0.6 ft. and set into a prepared hole that extended one ft. below the HBC level. Butts of 4 wooden stakes were found driven well below the HBC level in the northern part of the eastern wall. These were labeled F472, 473, 474 and one was included with footing F471 (Fig. 2). The stakes were rectangular or triangular at their tops and had maximum widths of 0.10 to 0.45 ft. They varied from 1.00 to 2.05 ft. in length, and all were pointed or tapered. Spacings and alignments of the stake butts did not form recognizable patterns. At least 2 of the stakes were probably concealed under the east wall of the Shop during the latter's existence.

A concentration of fragmented pane glass was found between footings in Excavation Unit 5 (Fig. 2). Sherds of window glass were noted throughout the eastern wall length, but this concentration was sufficiently dense to warrant mapping in the field. A concentration of coal fragments and dust was defined immediately east and south of the window glass. The coal lay in the HBC level and covered basins F482 and F528, as well as the eastern portion of footing F476. At its southern edge, the coal deposit was truncated by F475, the large USA trash pit (Fig. 2). Masses of small wooden fragments were found on and in the HBC level throughout the Sales Shop excavations. These were mapped in the field as an effort to determine structural patterns, such as floor joists. Despite the extensive deposit of fragments, no patterns were identified.

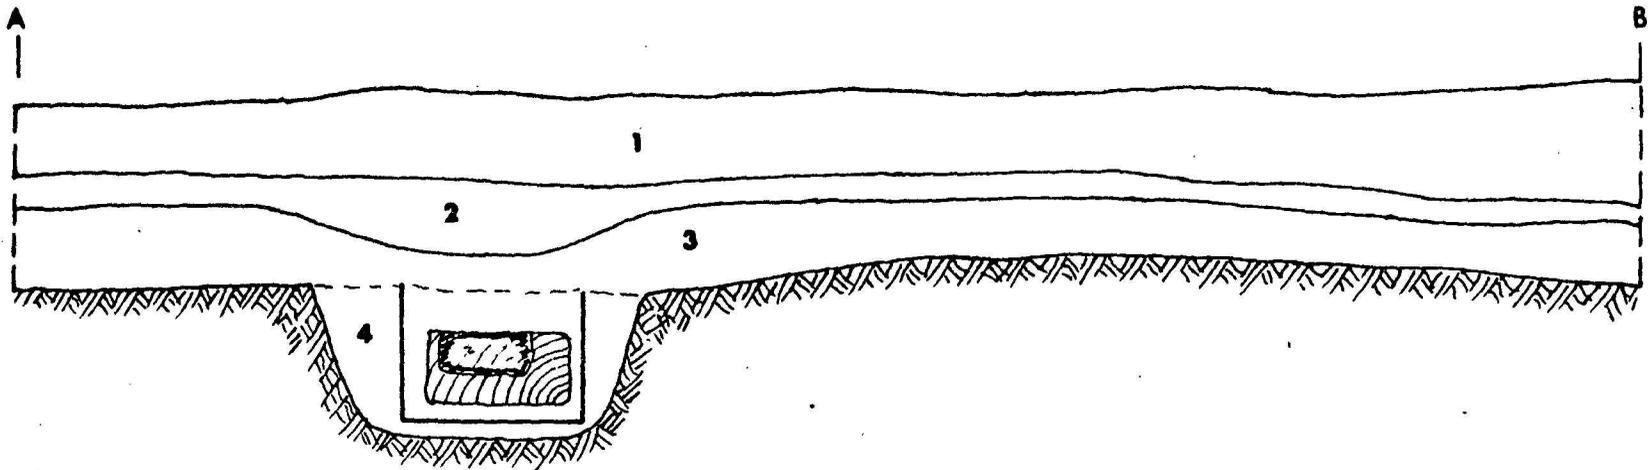
footing section and soil profile
A-B in XU-3 of the Sales Shop

As with all areas of the Fort excavated to date, the Sales Shop and Magazine positions included evidence of Vancouver Barracks activity dating from post-Hudson's Bay Company occupation. A selected soil profile from the Sales Shop excavation is typical of the general deposits found at this locale (Fig. 3).

The modern sod line and recent deposits were removed for installation of an asphalt pad over the Sales Shop during the 1960's. After removing the asphalt, the intact layers of Fig. 3 were distinguishable. Layer 1 consisted of coarse sand and gravel laid by Vancouver Barracks during World War I as part of the construction of a lumber mill. Layer 2 was a thin band of water-laid silts attributable to a late 19th Century flood of the Columbia River. Beneath was layer 3, the HBC deposit, which was essentially native soils mixed with organic material and cultural debris. This deposit rested on culturally sterile, native soils. Holes were dug along the east wall of the Shop for the setting of subsurface footings. These holes were partially open during destruction of the building. The upper portions of layer 4 consisted of burned debris and soils deposited either by destruction or the subsequent cleanup of the Shop area by the USA. In time, the HBC deposit (layer 3) eroded over the post-HBC deposit (layer 4) at the footing holes, and produced natural dips in the old HBC surface. These dips were largely filled with sediments of the late 19th Century flood (Fig. 3).

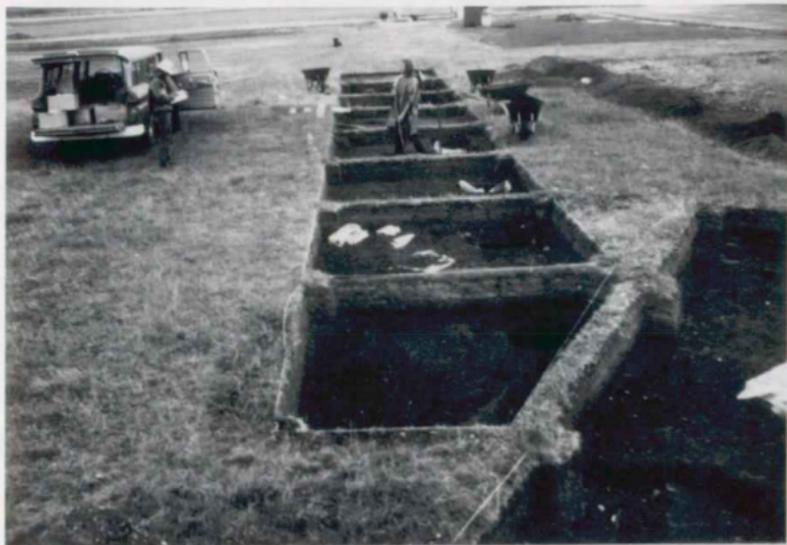
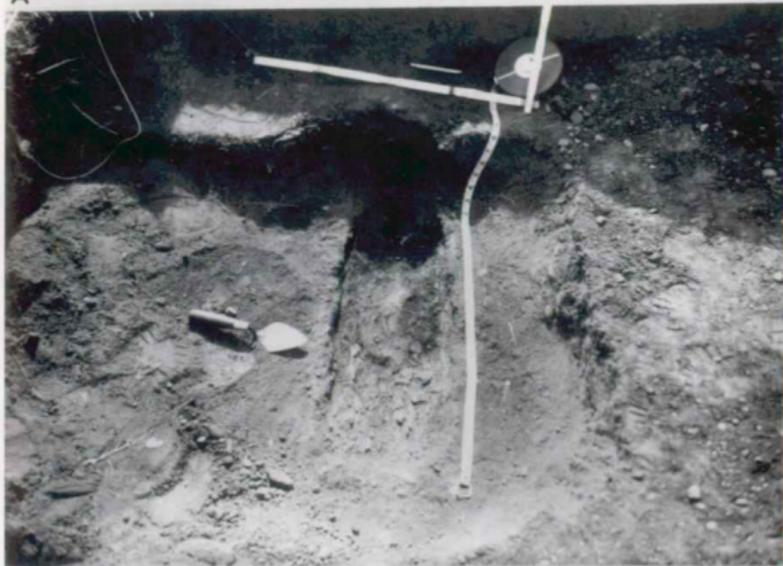
a - View south along the wall. Prepared footing holes can be seen as dark rectangles within the excavation units (FOVA neg. 069.51-73/107)

b - Cast and wooden remains of a footing (FOVA neg. 069.51-73/102)

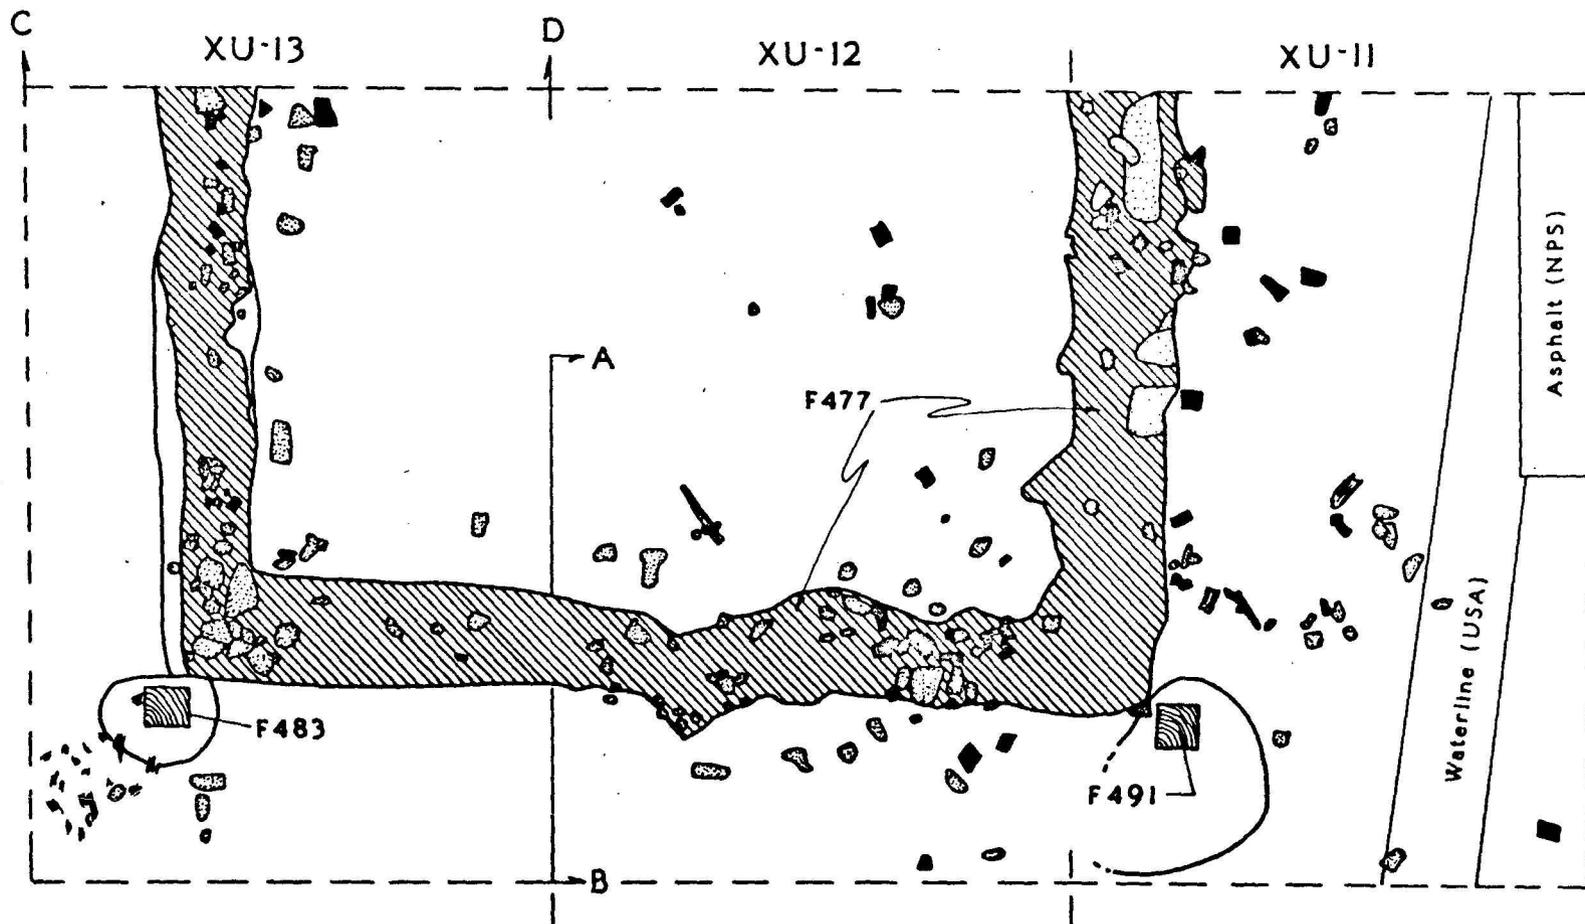
Fig. 5

**Archeological Tests of the
Powder Magazine**

Few archeological features were found in the Magazine excavation (Table 3). Hudson's Bay Company features consisted solely of the Magazine foundations and 2 post casts at corners of the foundations (Figs. 5, 7). A shallow trench paralleling the interior of the foundation was recorded in the field as an archeological feature (Fig. 7a). Complete exposure of the trench indicated it to be an artifact of previous archeological testing.

A shallow trench filled with silty clay was found directly under the rubble (Figs. 5, 6). True dimensions of the trench could not be determined due to disturbances. However, the observable dimensions generally matched those of the rubble. After field mapping, a portion of the southern wall rubble was removed and found to have been wholly confined to the horizontal limits of the trench. The silty clay of the trench was layered and appeared to have been deliberately laid with water. From these observations, we believe that the foundation was laid in a prepared, water-soaked trench. A crude cement of coral-derived lime and odd-sized stone was poured into the trench and allowed to set. Curing of the foundation was aided during setting by the moisture of the trench. While brick fragments were among the rubble, we are not certain that brick formed part of the foundation. More likely, the brick were unsalvaged remains of the Magazine walls.

Casts of 2 large, square posts were found immediately outside the northeastern and southeastern corners of the foundation (Fig. 5). Corners of the posts nearly coincided with corners of the foundation. The casts were each 0.83 ft. (10 inches) square and set into prepared holes 1.4 to 1.5 ft. below the foundations (Fig. 7b). Very little

A thorough search was made at the interior of the Magazine for flooring and additional HBC features. No evidence of a prepared surface was found in the remnant HBC layer. Other than scattered pieces of rubble, the interior was completely vacant (Fig. 5). A large iron doorbolt was found outside the northern foundation near the northeast post cast. Historically, the Magazine door was located in the north wall (Hussey 1957:184), presumably near the center of the wall. Putative evidence of the door sill may be represented by an exceptionally large stone set lengthwise into the northern foundation at the latter's approximate center (Fig. 5).

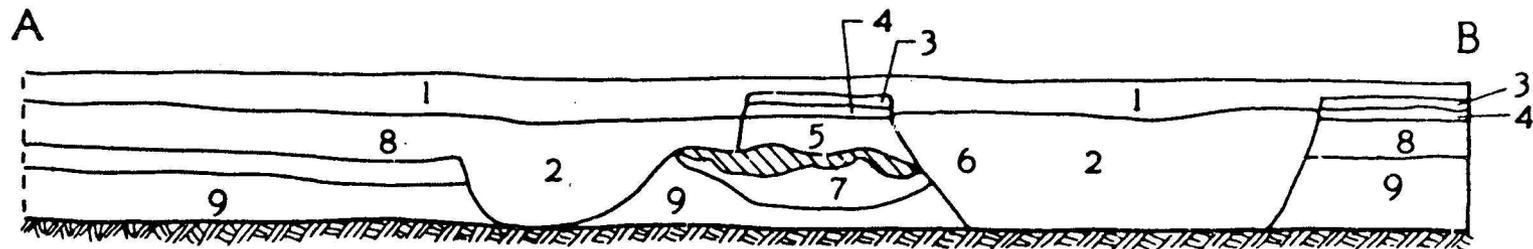
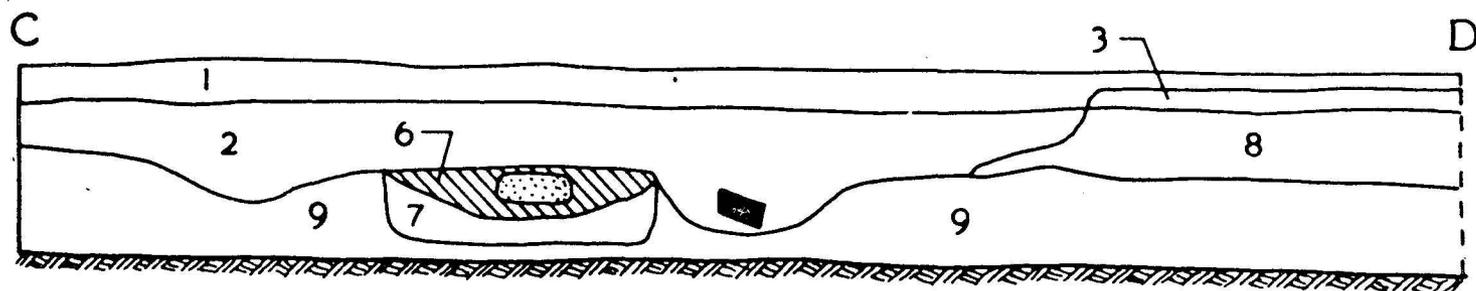
1. Sod Line 1973
2. Excavations of 1947
3. Sand, USA 1918
4. Flood Deposit, Late 19th C.
5. Mixed Coral & Soil
6. Coral, Rock & Brick Rubble
7. Silty Clay
8. HBC Layer
9. Native Soils

Soil stratigraphy in the Magazine was basically the same as in the Sales Shop, but with certain complexities. Two sections were recorded at the eastern and southern foundations (Fig. 5) and detailed on Fig. 6. Layer 1 of the sections consisted of a rather thick, present-day sod cover. Where in contact, the sod covered a thin layer of WWI Vancouver Barracks activity, layer 3, which overlaid a thin flood deposit of the late 19th Century, layer 4. Very little of the flood deposit was noted.

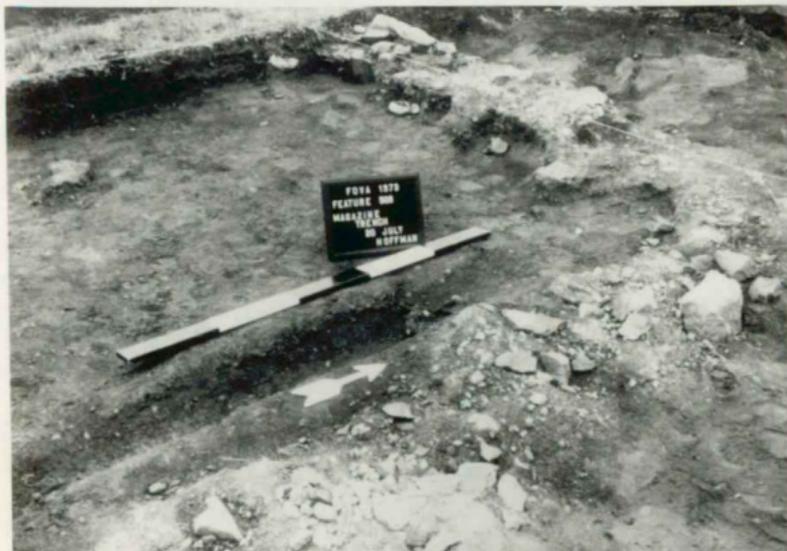
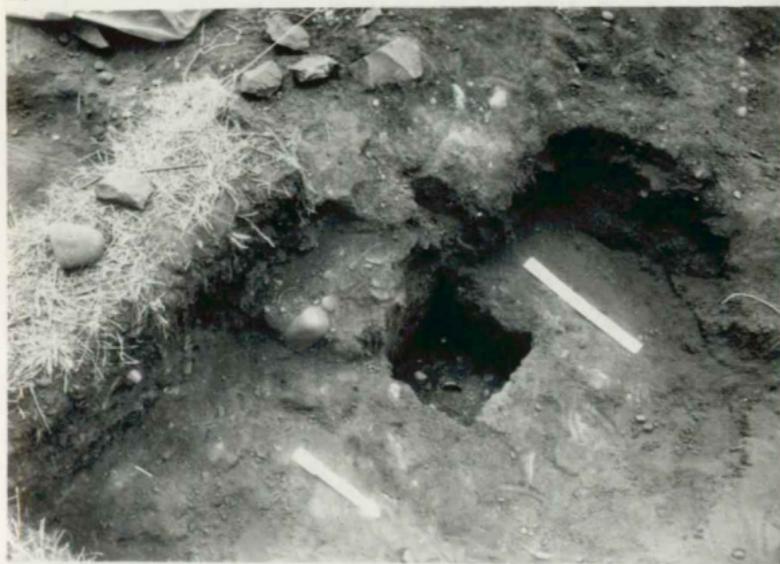
a - Northeastern corner of the foundation
showing the rubble fill (FOVA neg.
069.51-73/122)

b - Cast of square post outside the north-
eastern corner of the foundation; scale
is in inches (FOVA neg. 069.51-73/115)

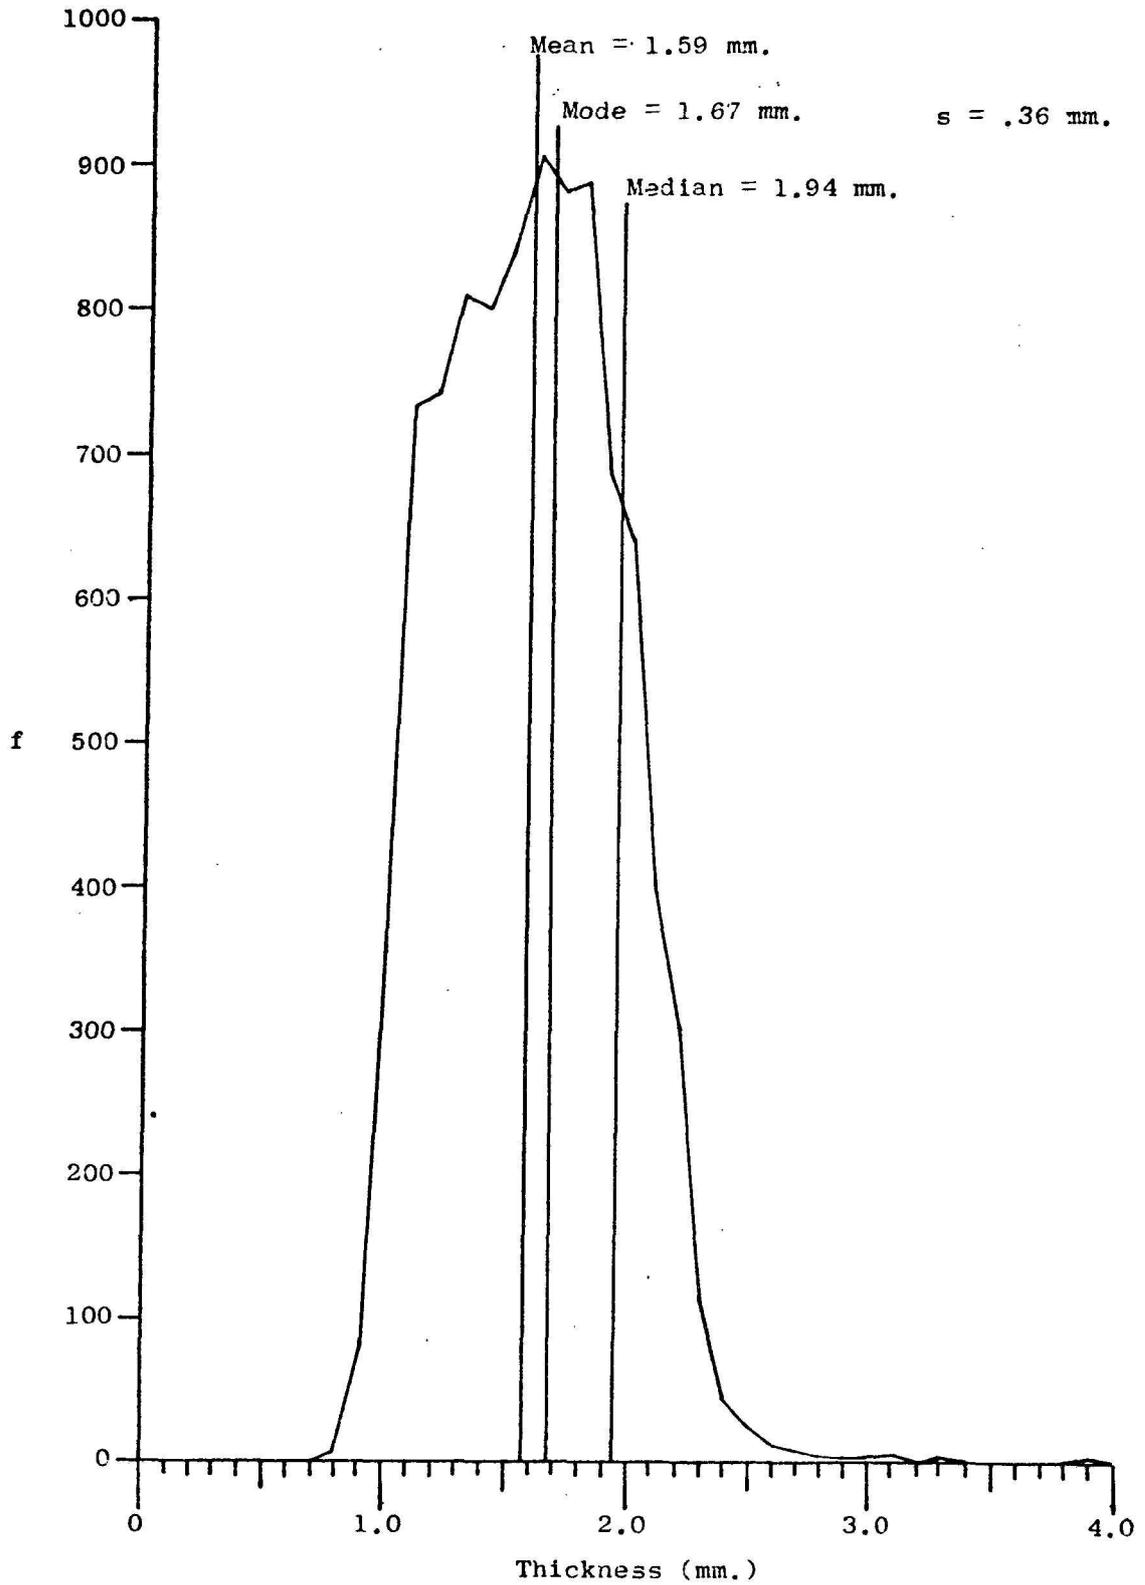
Fig. 9 --Frequency of Window Glass Thickness for the Sales Shop area (N = 9306).

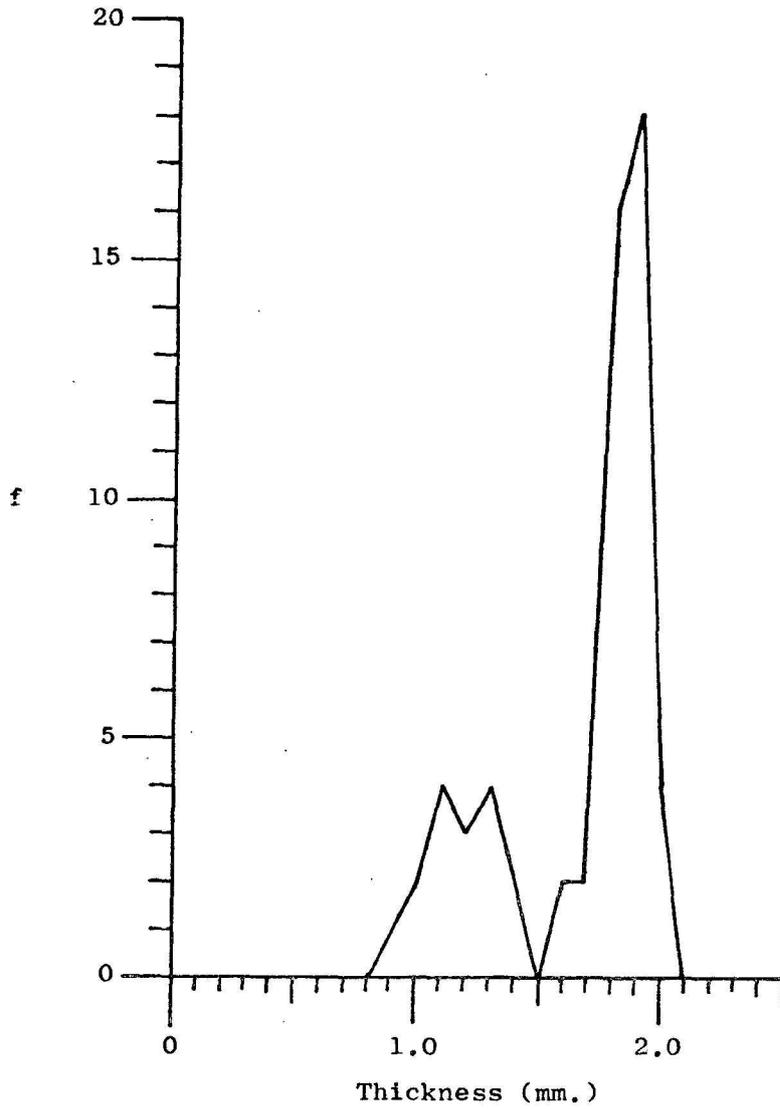
Fig. 10 --Frequency of Mirror Glass ("Looking Glass") Thickness for the Sales Shop area (N = 58).

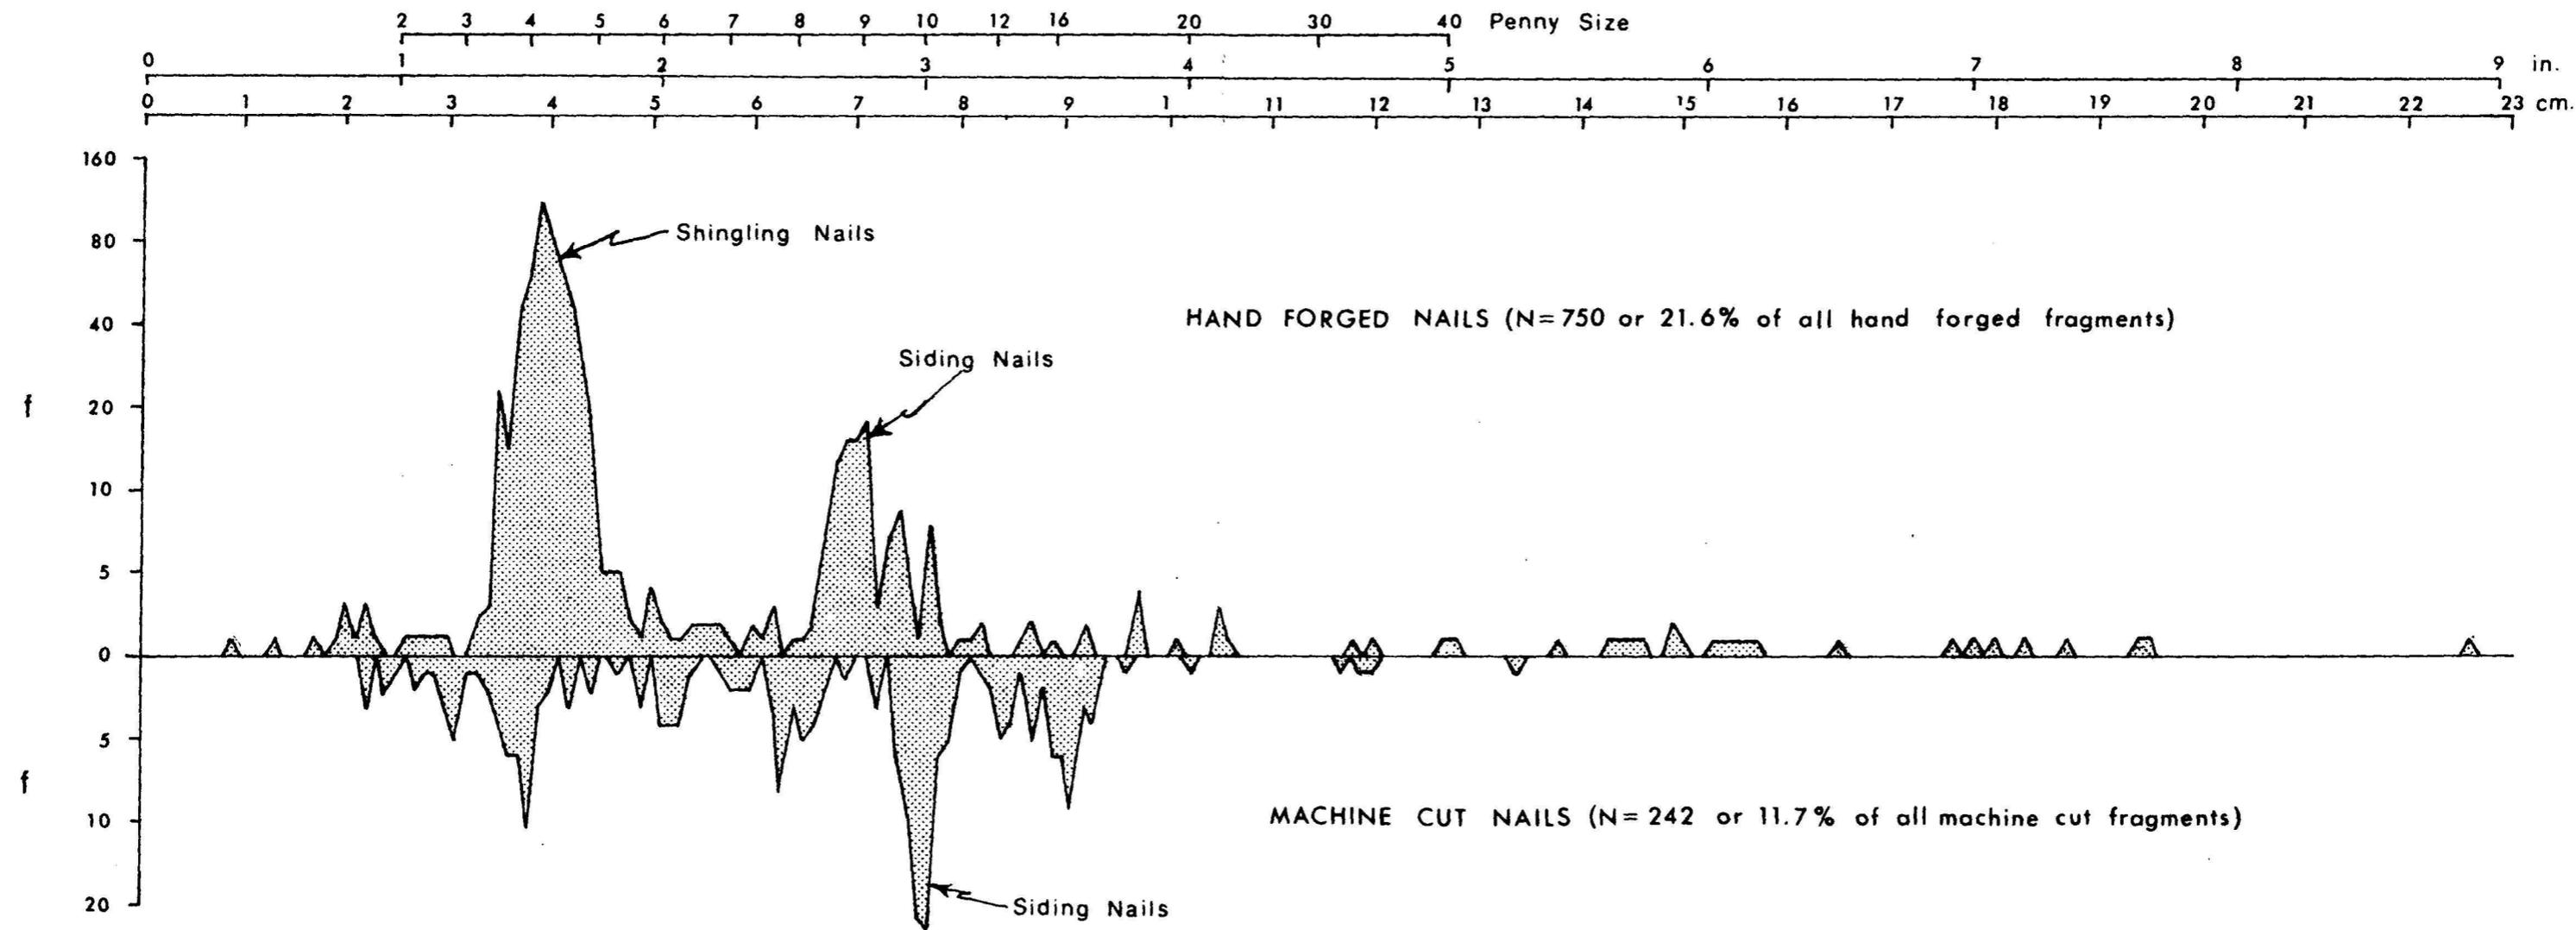
Fig. 11 - Frequency distribution of all complete Hand Forged and Machine Cut Nails(Sales Shop).

Of the 6961 square nail fragments found, there were 3466 hand forged, 2040 machine cut and 27 cast nail fragments. All complete specimens were measured, and the distribution of such measurements for hand forged and machine cut nails appears in Fig. 11.

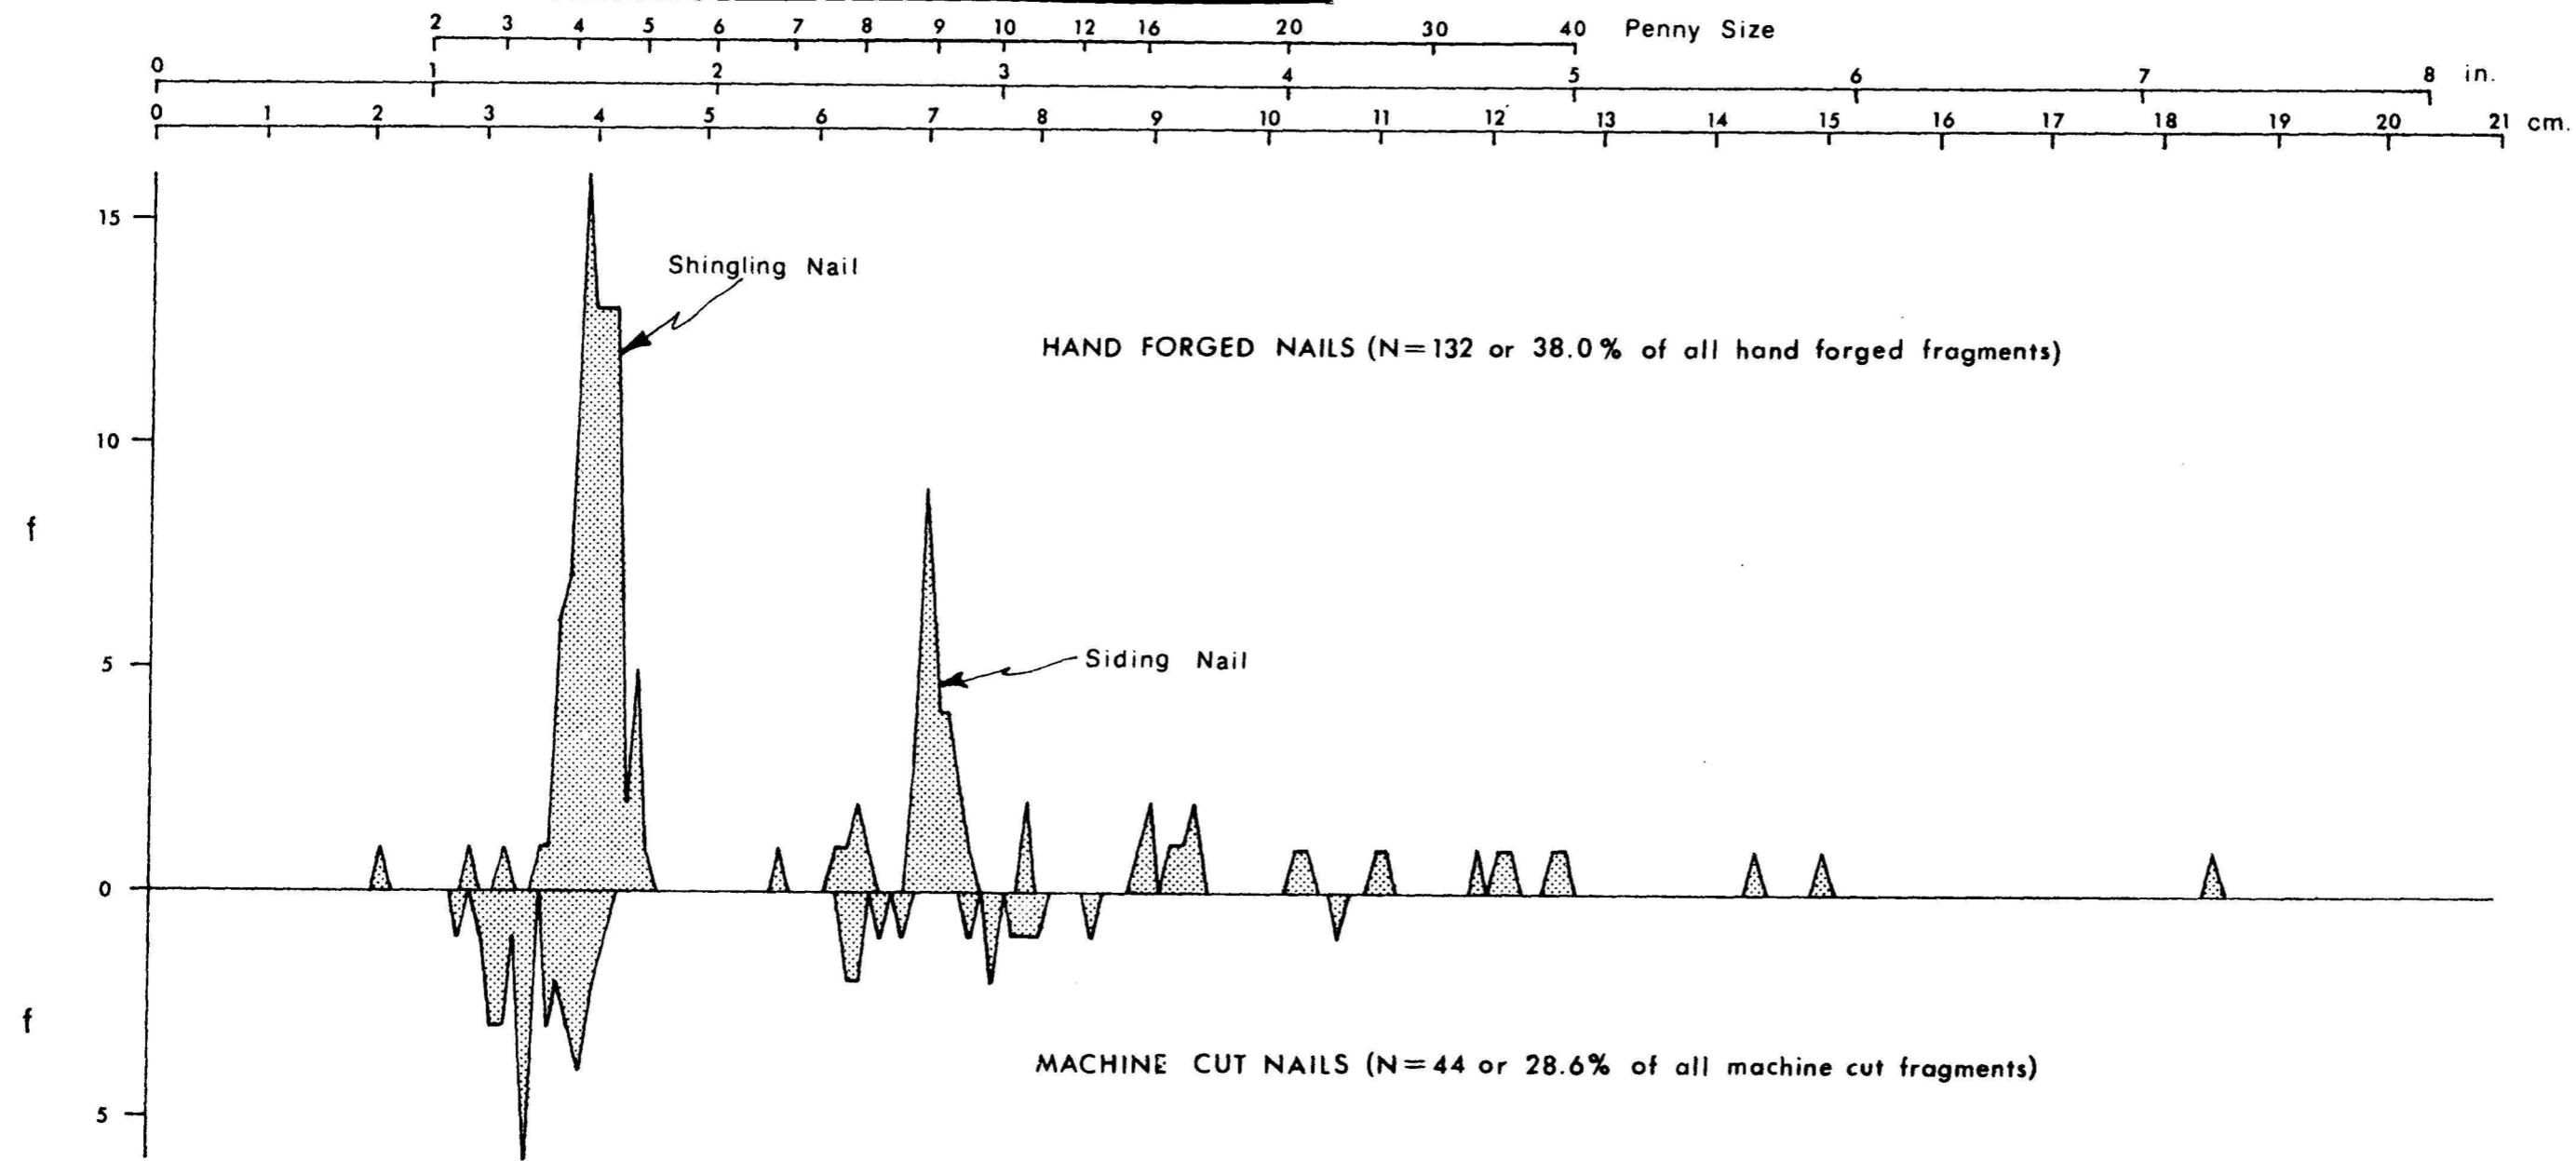
Fig. 17 - Frequency distribution of all complete Hand Forged and Machine Cut Nails(Powder Magazine).

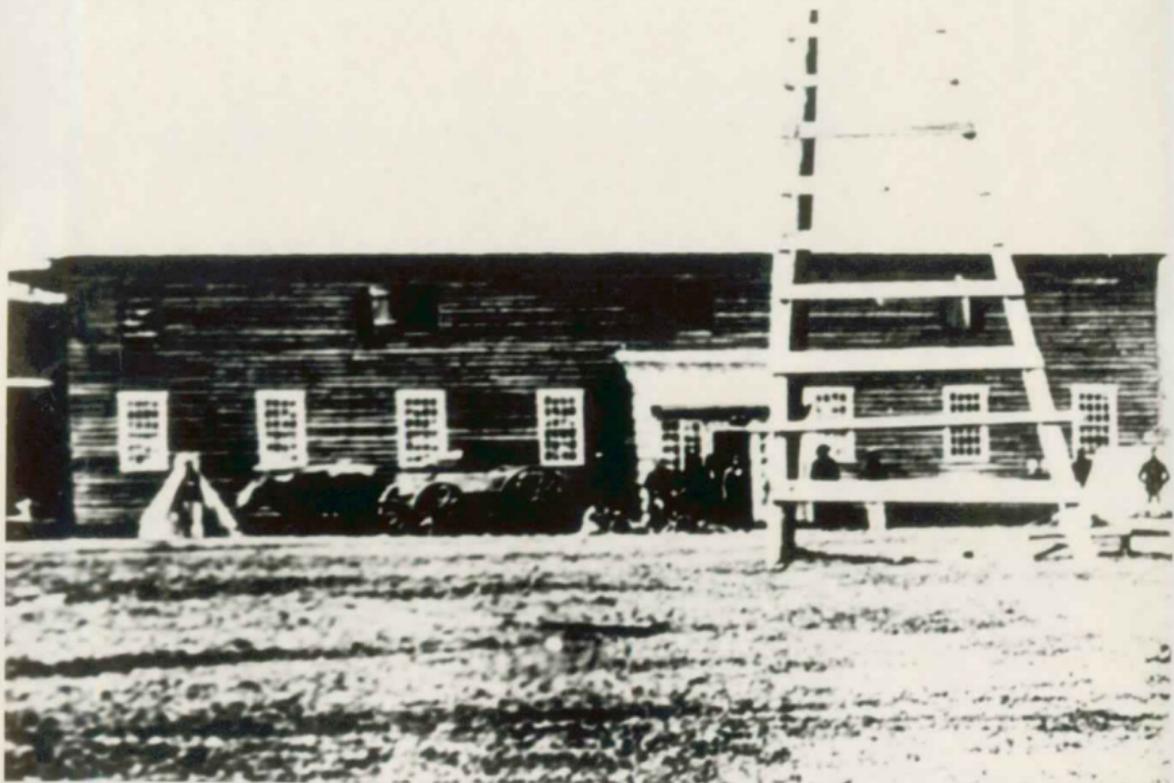
Fig. 18 - Eastern elevation of the Sales Shop as photographed in May of 1860. Roof details are bleached out in order to enhance wall details. Object in foreground is a tripod bell tower (FOVA neg. 974.7, H-3.F, FV-2).

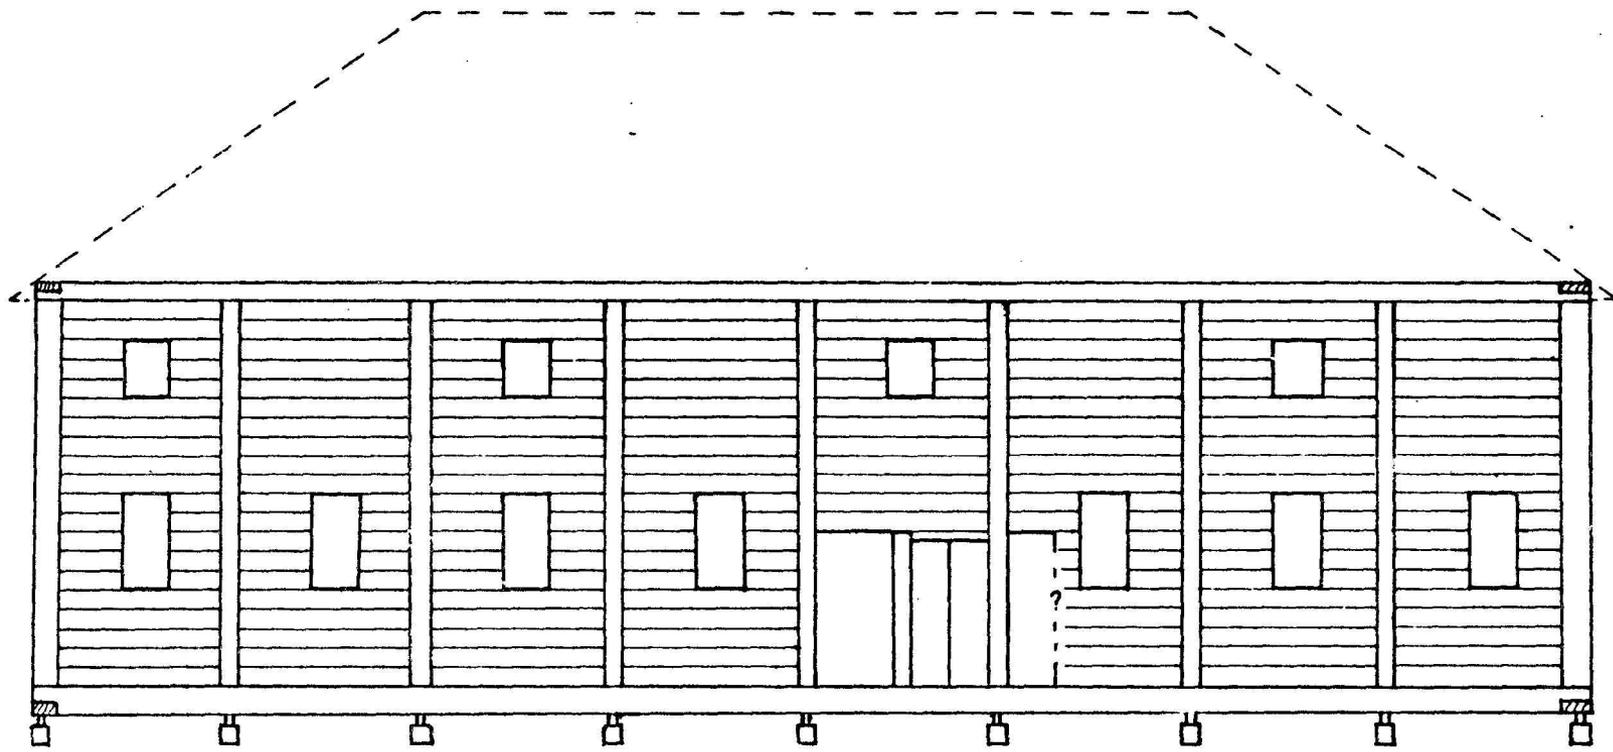
Fig. 19 - Deduced framing of the Sales Shop at the eastern wall.

The archeological evidence indicates that the basic plan of the eastern wall consisted of footings, thus upright posts, set at intervals of 10 ft. on centers. For post-in-sill construction, a length of 81 ft. broken into 10 ft. intervals requires 9 posts -- 2 corner posts and 7 spacer posts that form 8 "bays" of horizontal timbers or "fillers." This basic plan is graphically shown as Fig. 19.

The smaller windows of the upper story were spaced 20 ft. apart on centers. They were also slightly offset from the centerlines of their bays. One northern and two southern windows were set directly in line with the first floor windows below them. Again excluding

trim and framing, each upper story window was 2.5 ft. wide, 3 ft. high, and had its bottom 5 ft. above the tops of the first floor windows (Fig. 19).

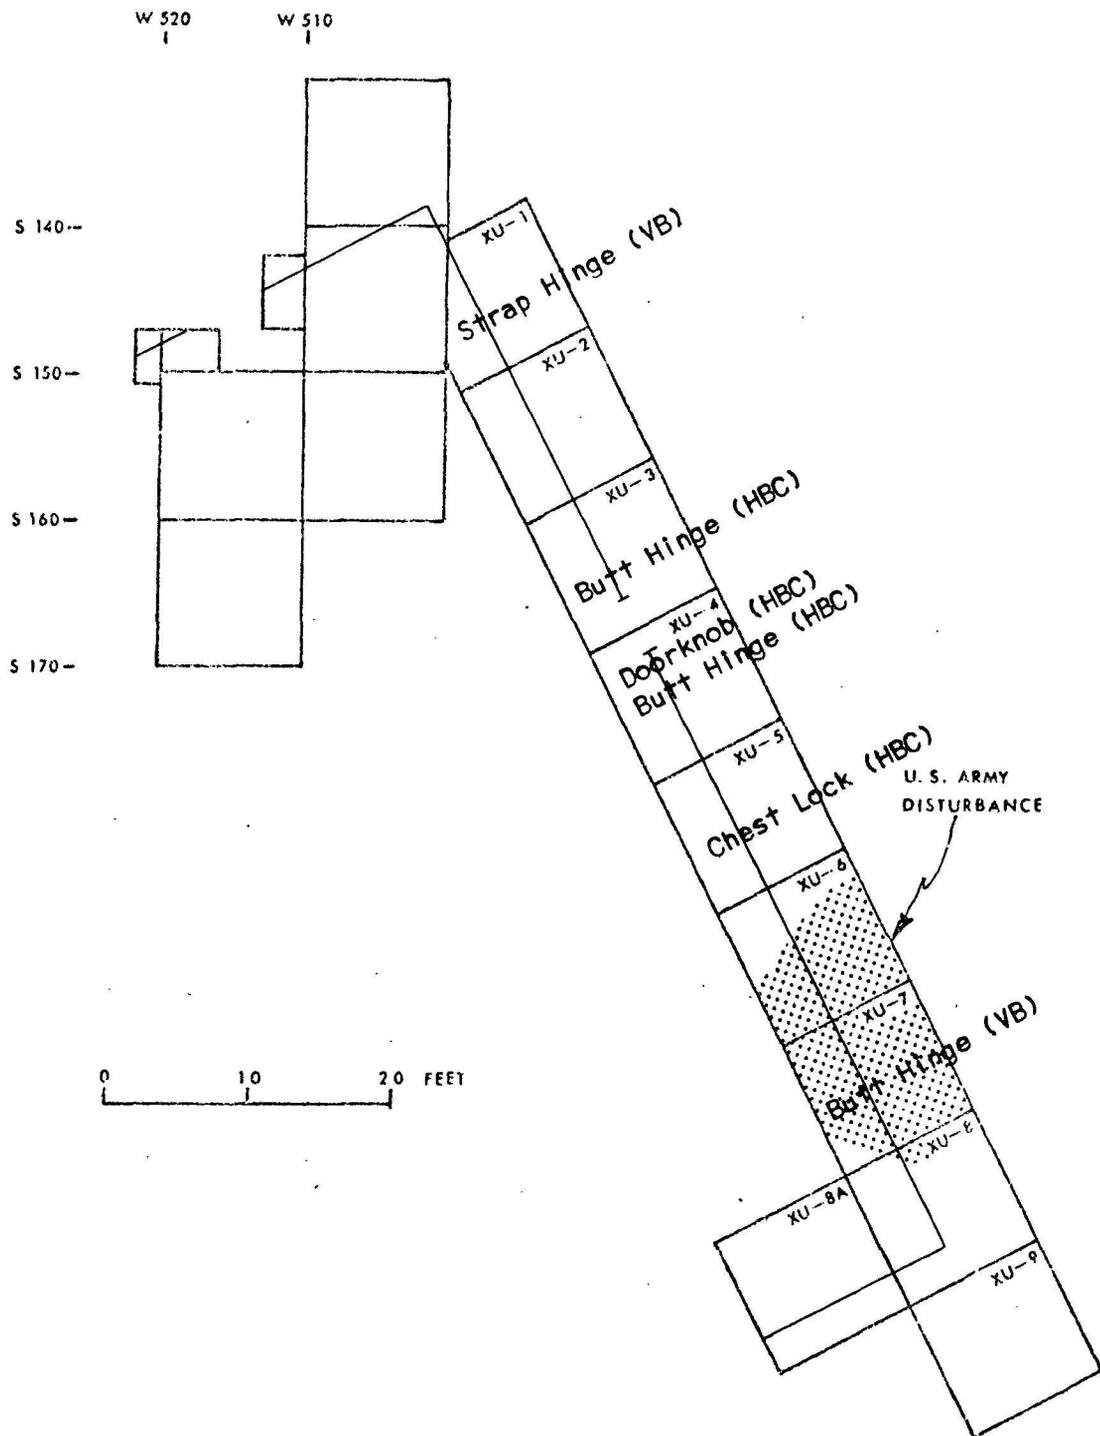
Fig. 24 - Distribution of hardware fragments in the Sales Shop excavations (f/ft³).

Other items of building hardware were found exclusively along the eastern wall (Fig. 24). Two of the hinges were recovered from

Vancouver Barracks deposits but were included in the distribution because of their stylistic similarity to other HBC hinges. Most interestingly, fragments of a single ceramic doorknob were found adjacent to the historically deduced position of the door (Fig. 24).

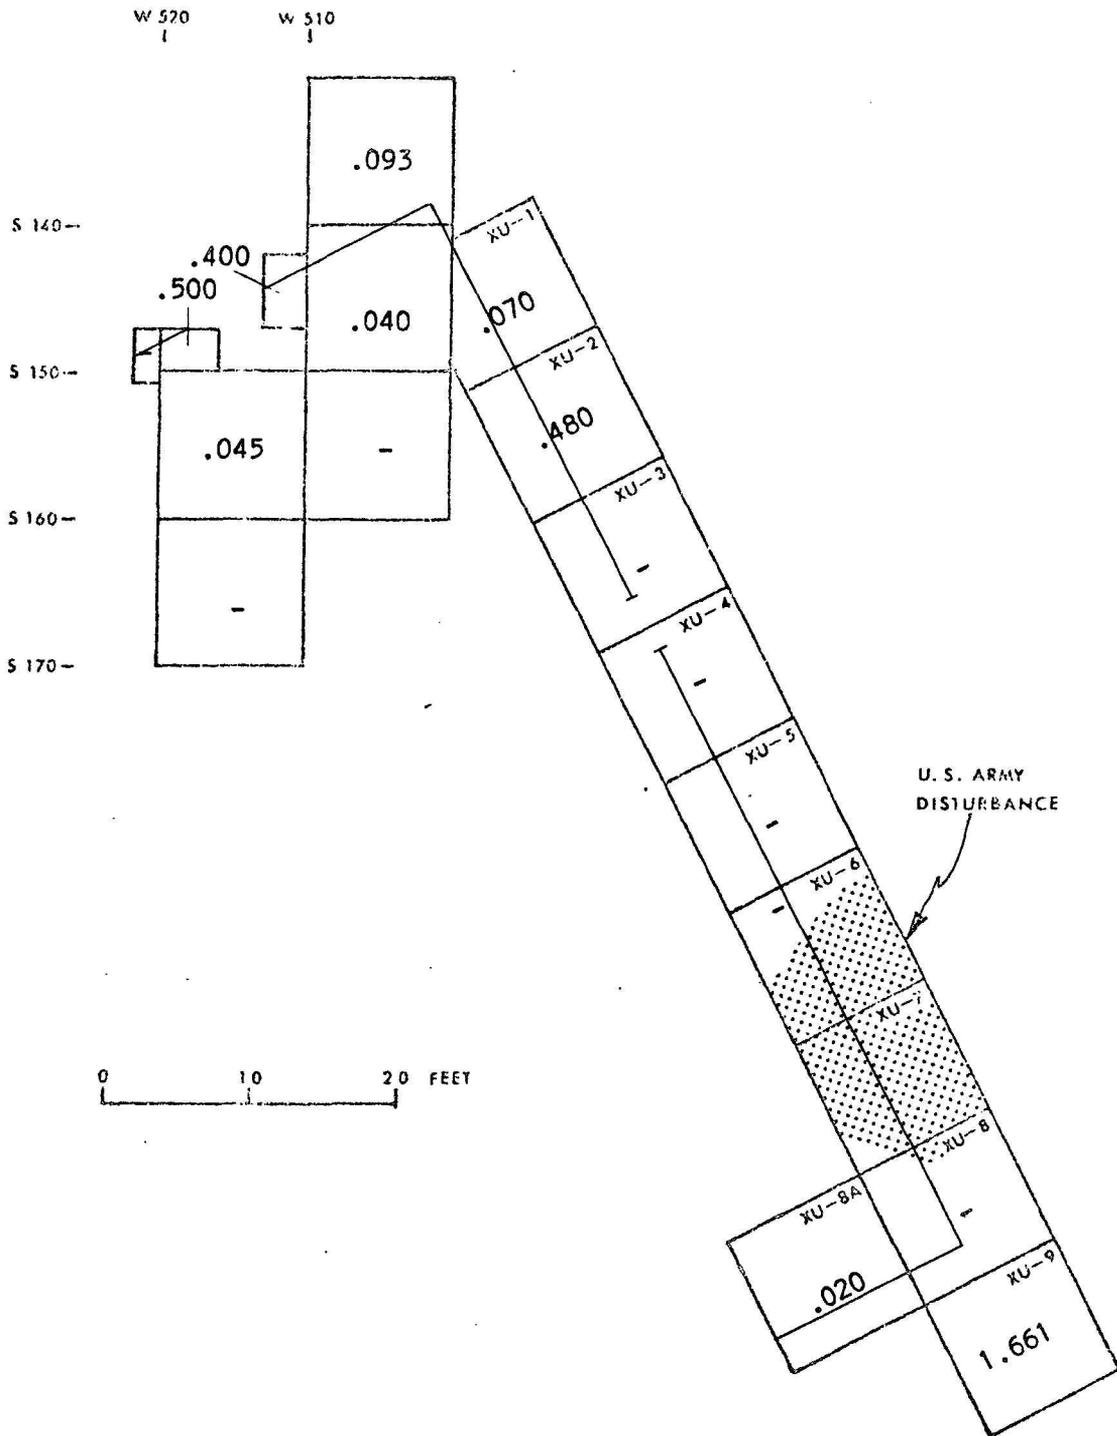
Fig. 28 - Distribution of brick fragments in the Sales Shop excavations (f/ft³).

Frequency and distribution of brick fragments indicated that this material had no structural significance to the Sales Shop (Fig. 28). Only 14 pieces were recovered (Table 4). Most were imported brick of British manufacture. The thin scattering at the northern and southern ends of the excavation appear to have been trash dispersal activities not necessarily related to the Shop.
