FORT VANCOUVER EXCAVATIONS - VI

Sales Shop and Powder Magazine

United States Department of the Interior

March 1974

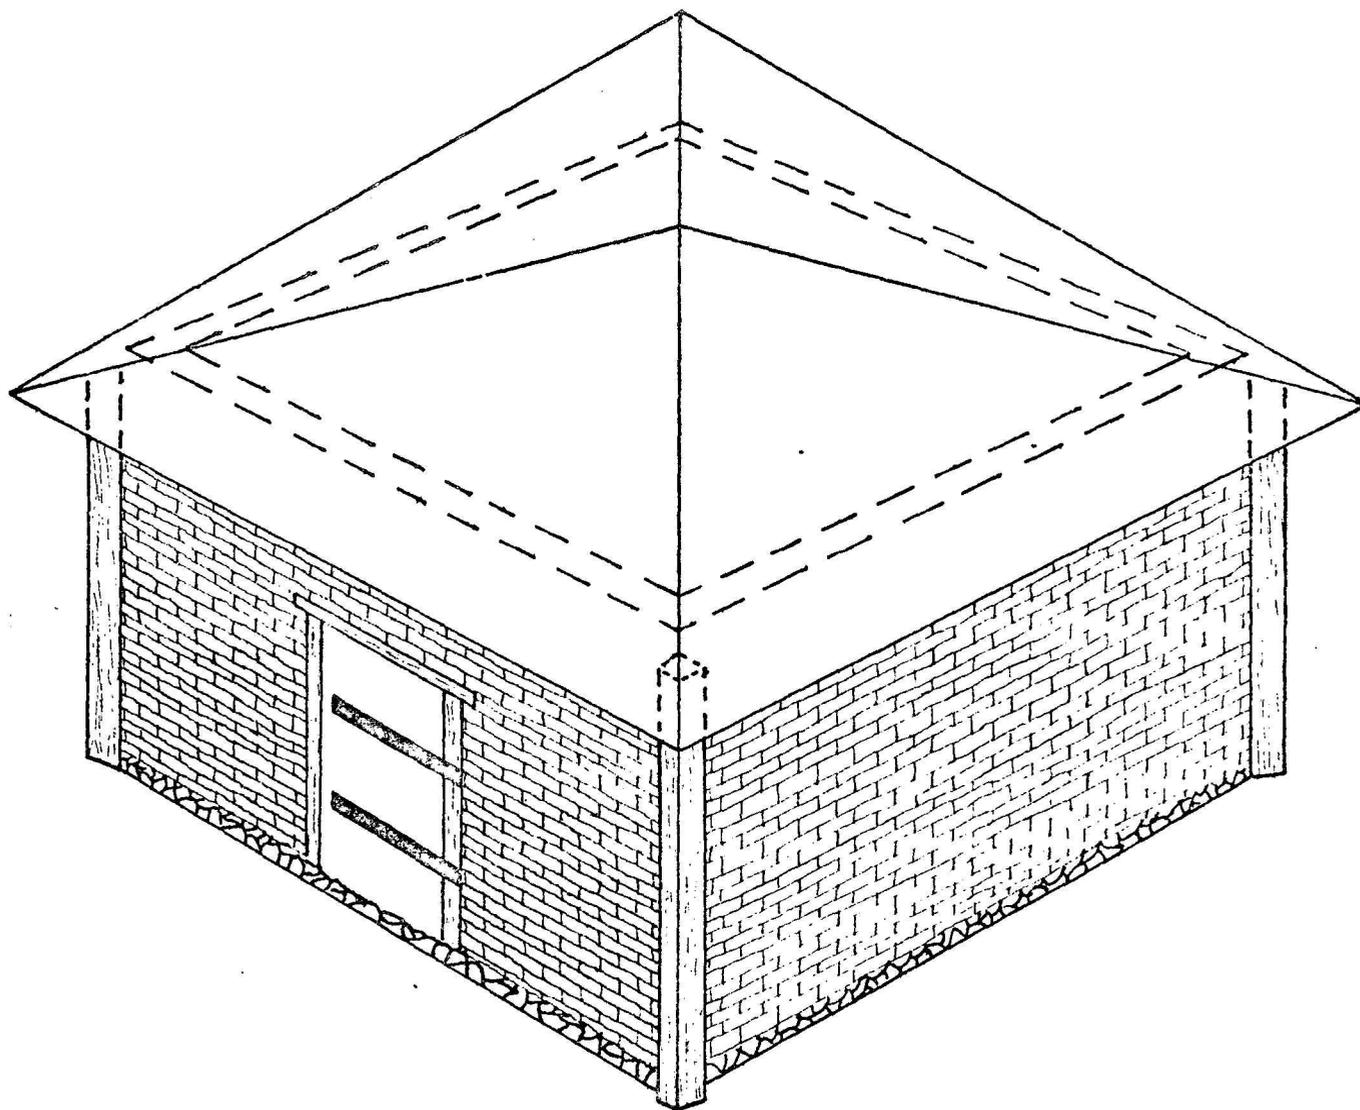
Fig. 30 Hypothetical view of the Magazine (not to scale).

Freestanding roofs were no novelty at Fort Vancouver. A gable roof of this type is depicted outside of the northern Stockade for the period of about 1846-48 (Hussey 1972:Pl. XV; 1957:frontis). There are some ambiguous examples of pyramidal or hipped freestanding
