Fort Vancouver

Historic Structures Report

Historic Structures Report Historical Data Volume I

by
John A. Hussey
Historic Preservation Team

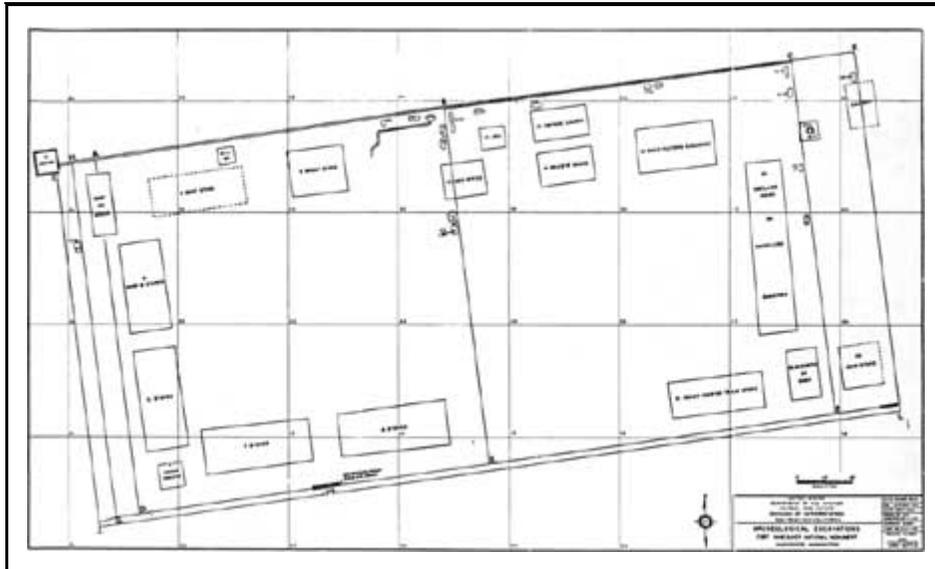
Plate I. Summary Sheet, Archeological Excavations, Fort Vancouver National Monument, [1947-1952]. (From Louis R. Caywood, *Final Report, Fort Vancouver Excavations*, Map No. II.) (click on image for an enlargement in a new window)

In order to follow the discussion presented below it will be necessary for the reader to refer frequently to the plan, "Summary Sheet, Archeological Excavations, Fort Vancouver National Monument," dated September 1, 1954, which is [plate I](#) in the present report. Stockade walls designated by letters such as HD and CF will be found delineated on that map.

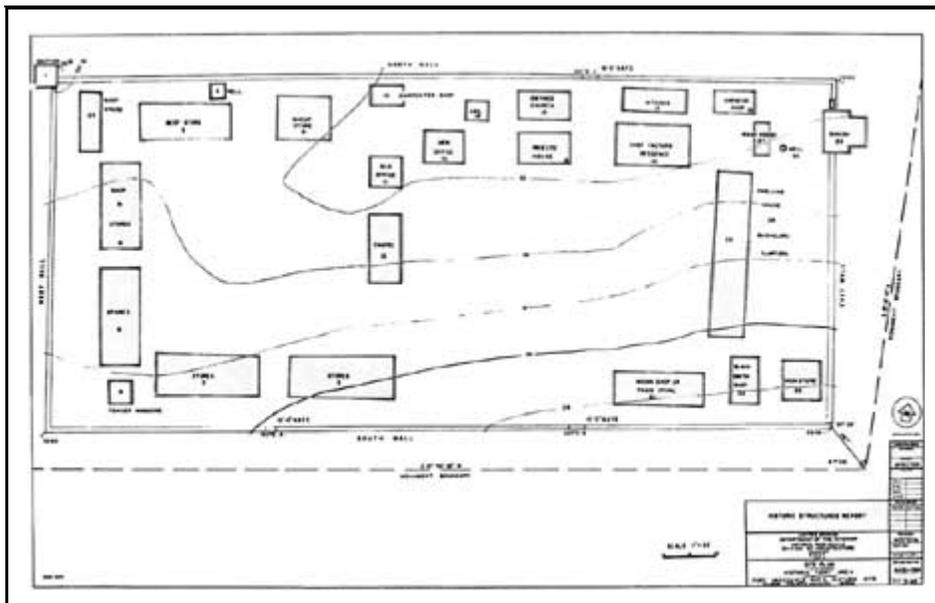
Plate II. Site Plan, Historic Fort Area, Historic Structures Report, Fort Vancouver National Historic Site, July, 1965. (National Park Service Drawing No. NHS- VAN) (click on image for an enlargement in a new window)

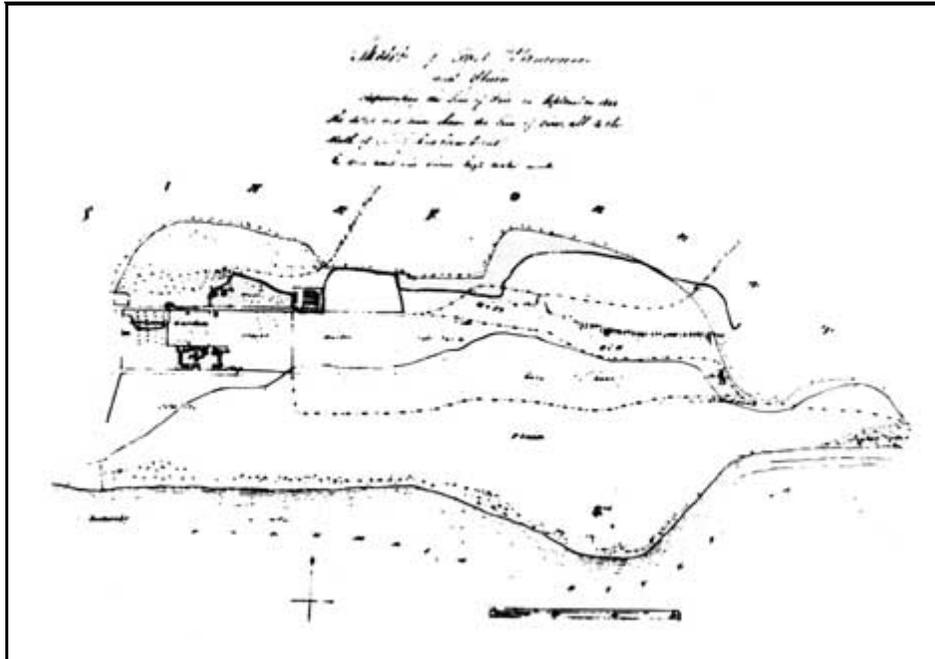
Plate V. Sketch of Fort Vancouver and Plain, representing the Line of Fire in September, 1844. (*From the original map in the Hudson's Bay Company Archives; reproduced by permission of the Hudson's Bay Company*)

4. Expansion to the east, c. 1844. On the Emmons map of 1841 the east stockade wall is shown as being only a short distance - - about 20 feet- - east of the Bachelors' Quarters. The line of Fire Map, showing conditions as they existed at the very end of September, 1844, places the east wall about 75 or 80 feet east of the same building. This new location corresponds almost exactly with that of the outer eastern wall as revealed by archeological excavations (wall KL less a short addition made when the southern fort wall was later pushed outward about five feet). This shortened version of line KL was found to be, on the average, 56 feet east of wall CF.

It is clear from the Line of Fire Map, then, that the outer east wall was erected prior to September 24, 1844 (the date of the breaking out of the fire). But the construction date can be assigned to a still earlier time. It will be noted that the Line of Fire Map shows a building incorporated in the northern end of the east wall. This structure, as proved by the Vavasour map of 1845 (see [plate VII](#)) and other evidence, was the bakery.

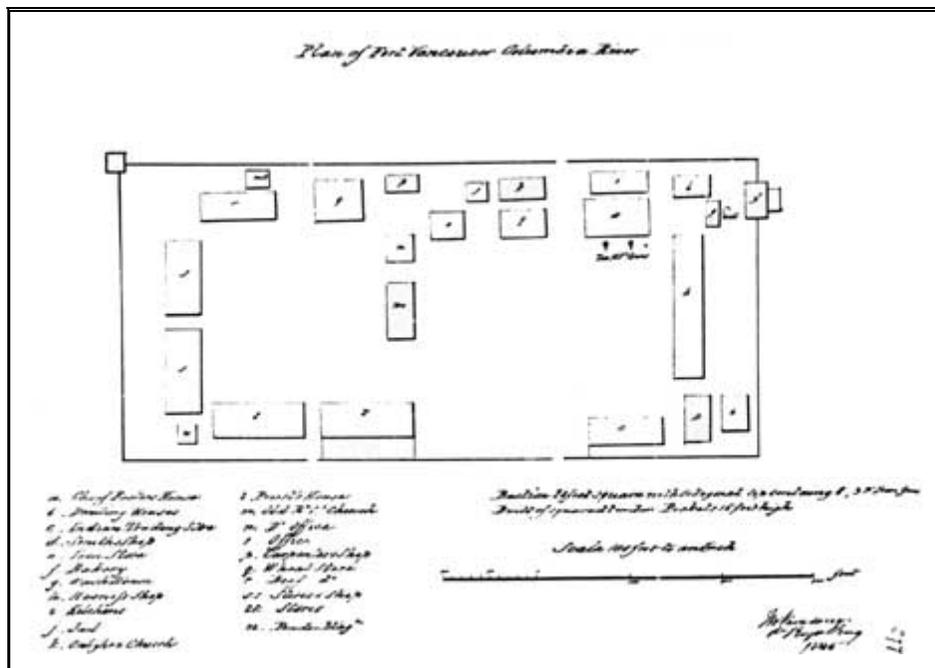
Plate VII. Plan of Fort Vancouver, 1845, drawn by M. Vavasour. *(From the original in the Public Record Office, London, copy courtesy of Mr. Thomas Vaughan)*

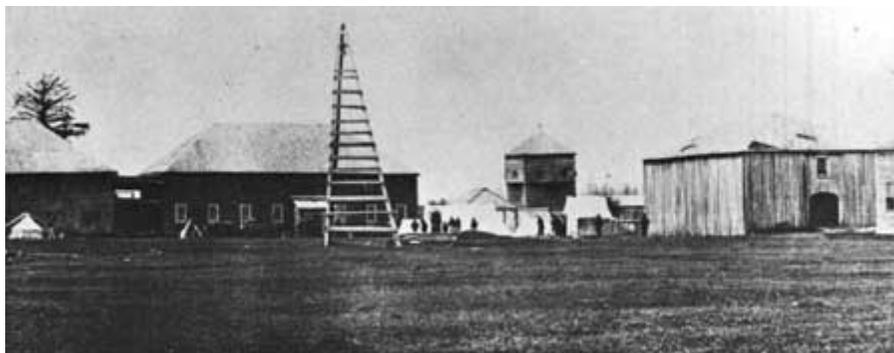
Plate XXVII. Fort Vancouver Courtyard, View toward Northeast Corner, Photographed by British Boundary Commission Party, May, 1860.

The buildings visible are, left to right, the Priests' House, the Big House, and the Bachelors' Quarters. The belfrey is in the center foreground.

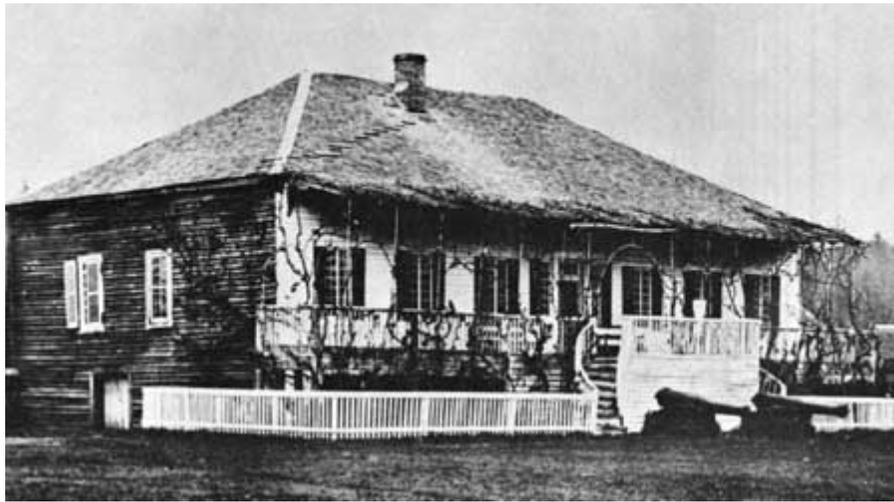
Plate XXVIII. Fort Vancouver Courtyard, View toward Northwest Corner, Photographed by British Boundary

The buildings visible are, left to right, the New Store, the sale shop, an unidentified structure, the root house (with gable roof sloping to ground level), the bastion, the granary, and the New Office.

Although the structural details of the "New Store" are rather indistinctly visible in the 1860 photograph, a careful study of the best prints available fails to produce any signs of chinking between the timbers. Here again we must conclude that the practice in this regard differed from that at many other Company posts. Sawed timbers evidently did not require visible chinking.

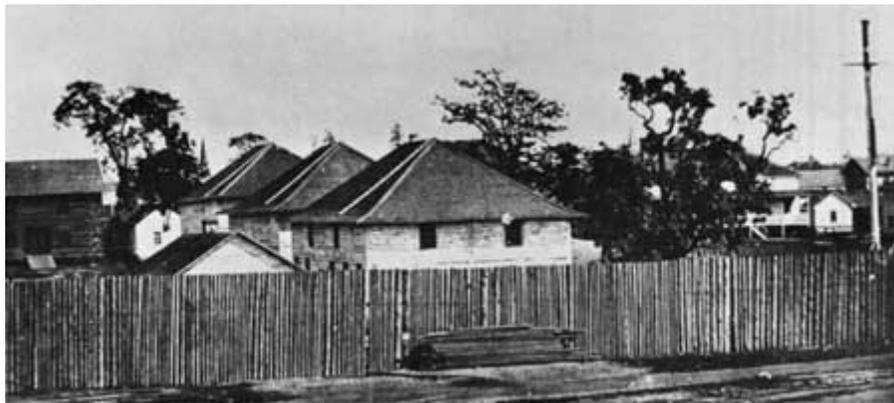
Plate XXXI. Bastion and Stockade at Fort Langley, British Columbia, 1862.

The stockade pickets are clearly shown with flat tops. They also appear to be peeled.

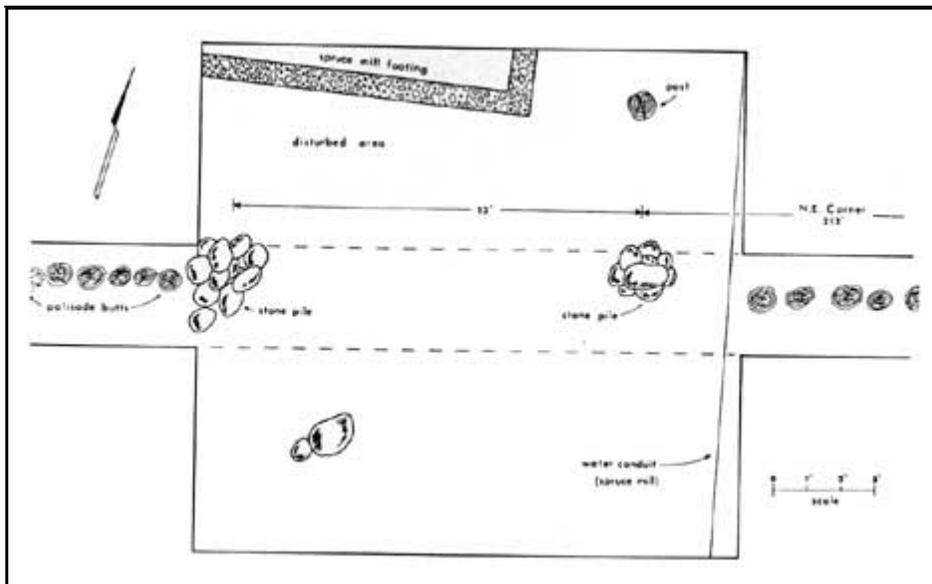
Plate XXXIX. Diagram of North Gate Foundations, Fort Vancouver, as Excavated in 1966. (From John D. Combes, *A Report of the Fort Vancouver Archaeological Excavations of the North Wall*, figure 4.)

[XXXIX](#). Diagram of North Gate Foundations, Fort Vancouver, As excavated in 1966.

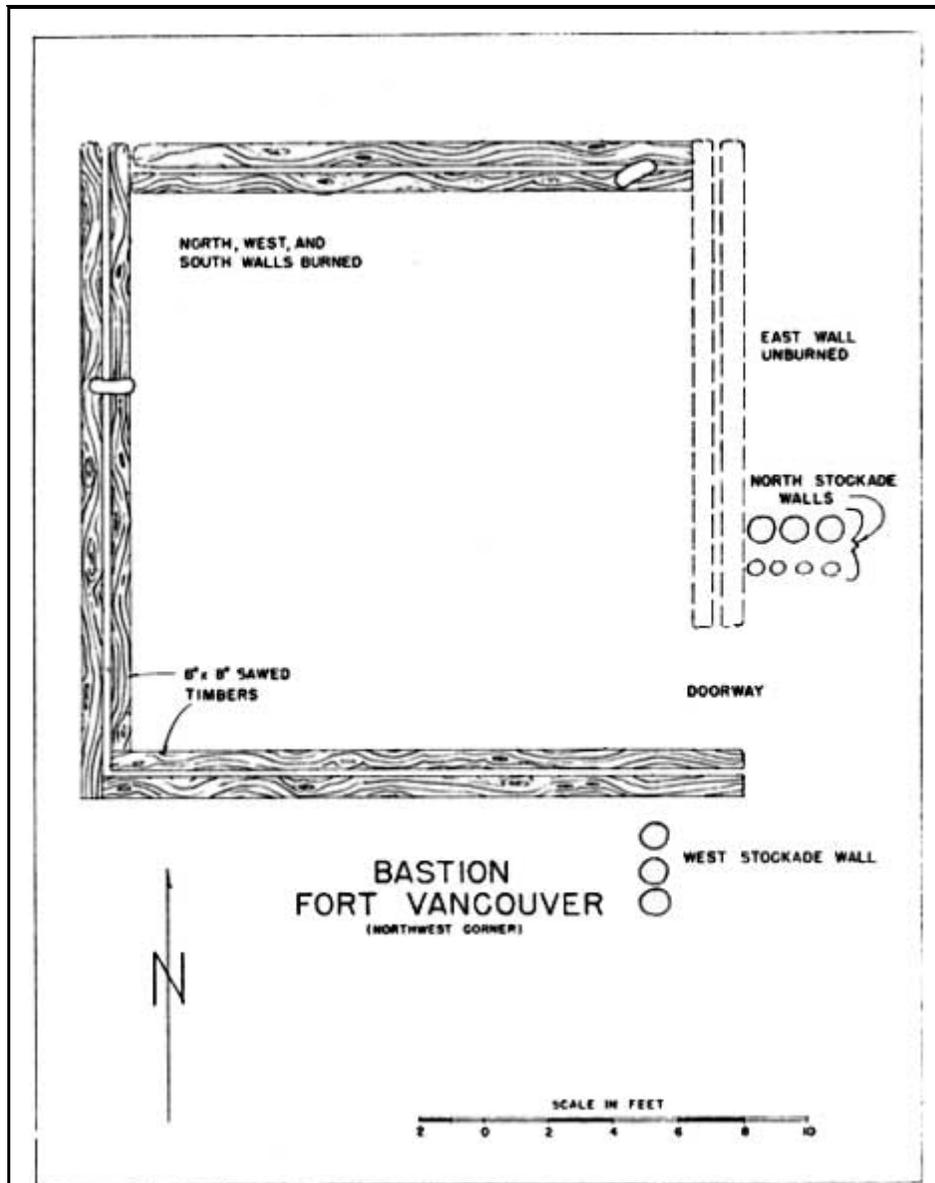
Plate XLIII. Plan of Foundation Timbers, Fort Vancouver Bastion, As Excavated in 1947. (From Louis F. Caywood, *Exploratory Excavations at Fort Vancouver*, plate 4.)

[XLIII](#). Plan of Foundation Timbers, Fort Vancouver Bastion, as Excavated in 1947.

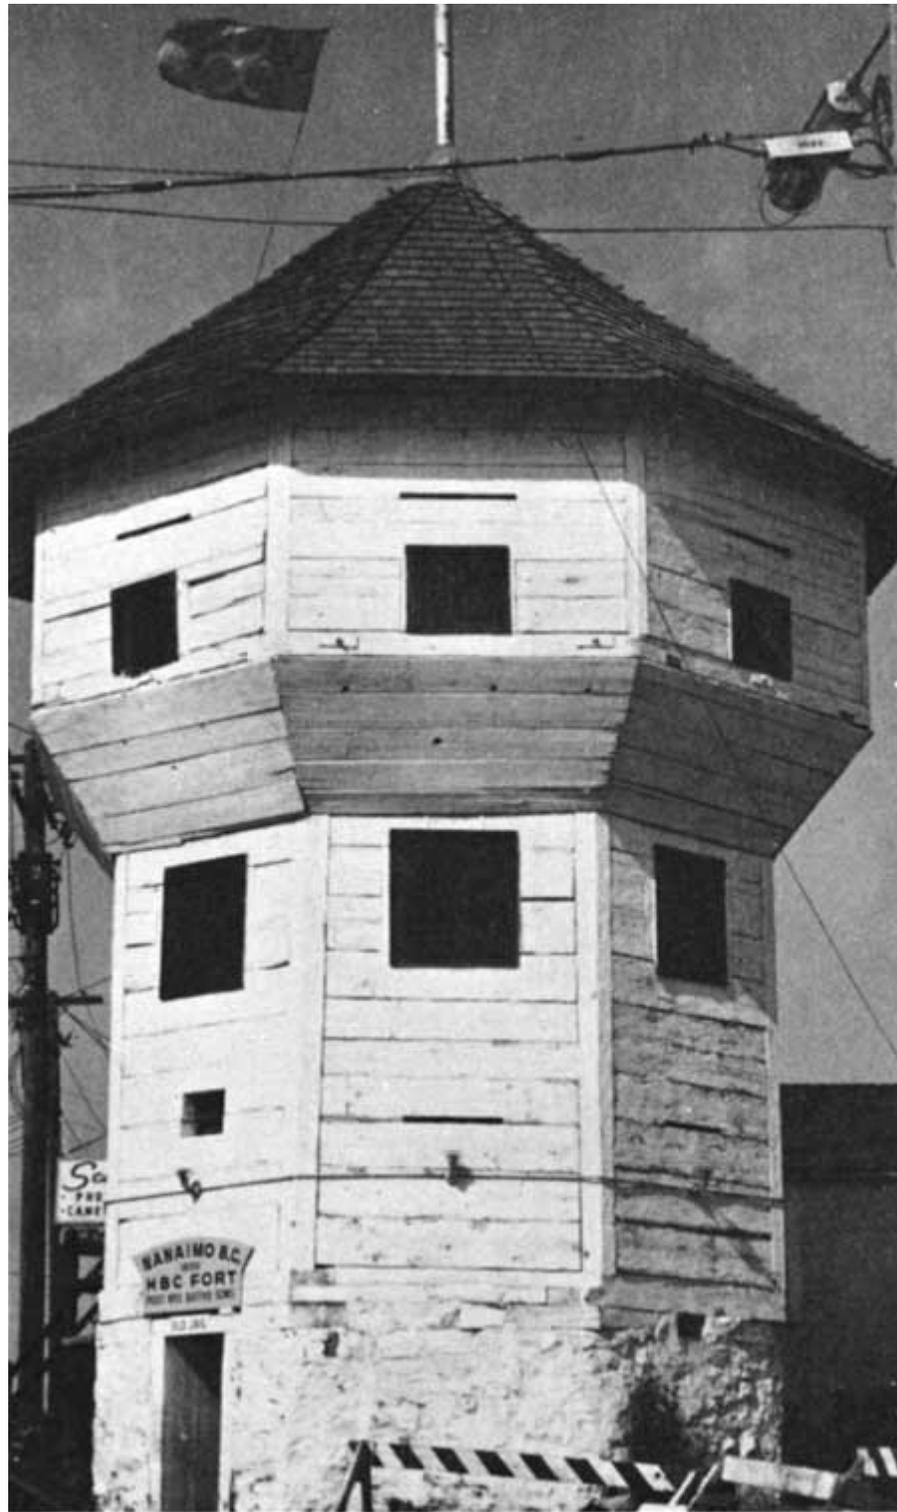
Plate XLV. Bastion at Fort Victoria, British Columbia.

The gun slits are observable as dark lines above each cannon port and about midway between the lower cannon ports and the ground.

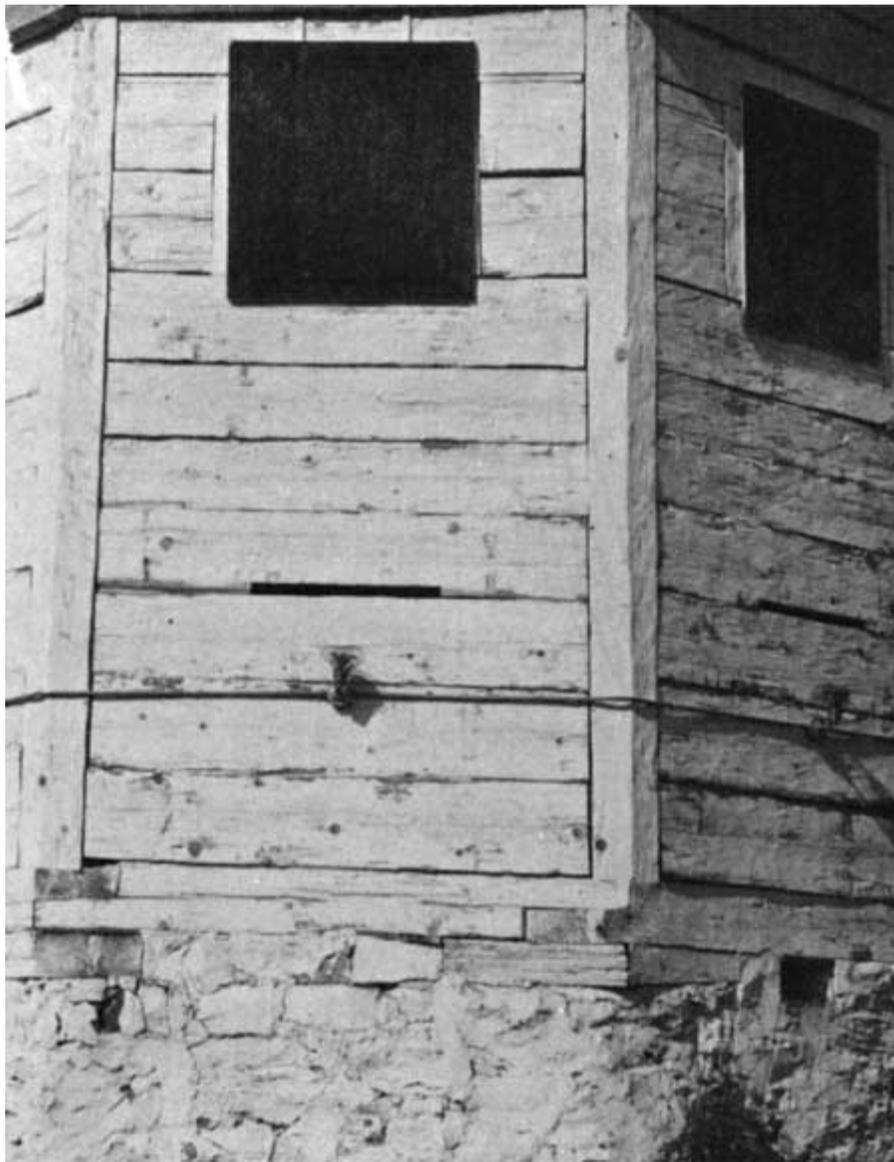
Plate XLVII. Construction Details, Fort Nanaimo Bastion.
(National Park Service photograph by J. A. Hussey, September,
1971.)

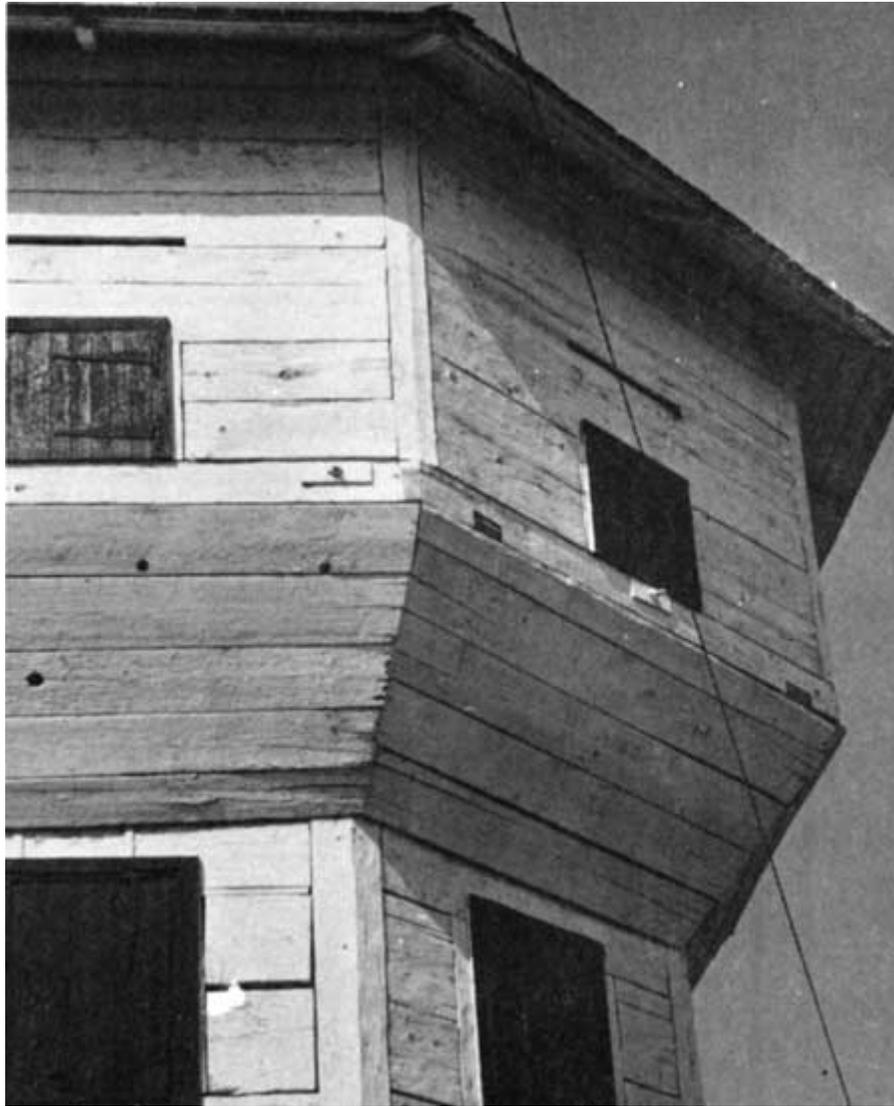
Plate XLVIII. Shutter Details, Fort Nanaimo Bastion. (*National Park Service photograph by J. A. Hussey, September, 1971.*)

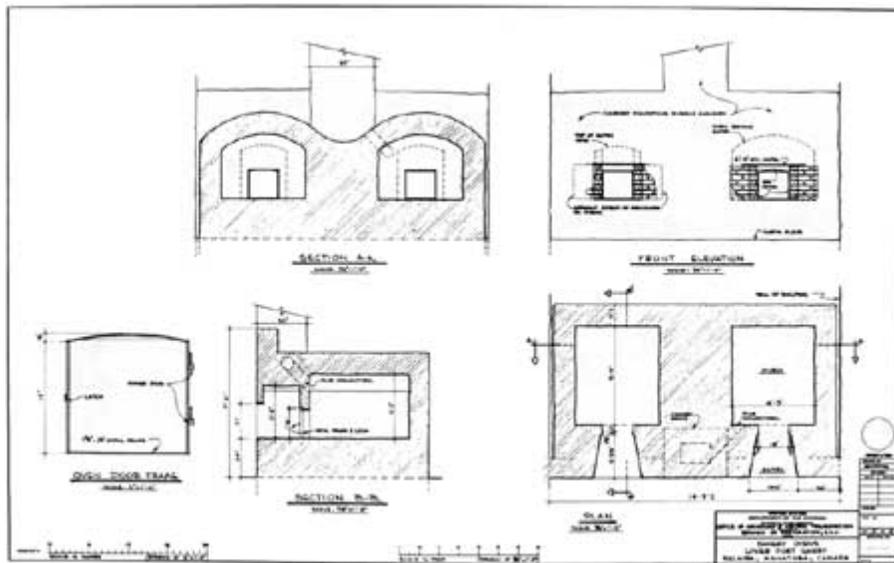
Plate LII. Plan of Bakery Ovens, Lower Fort Gerry. *(National Park Service Drawing by Architect Richard Mehring.)* [\(click on image for an enlargement in a new window\)](#)

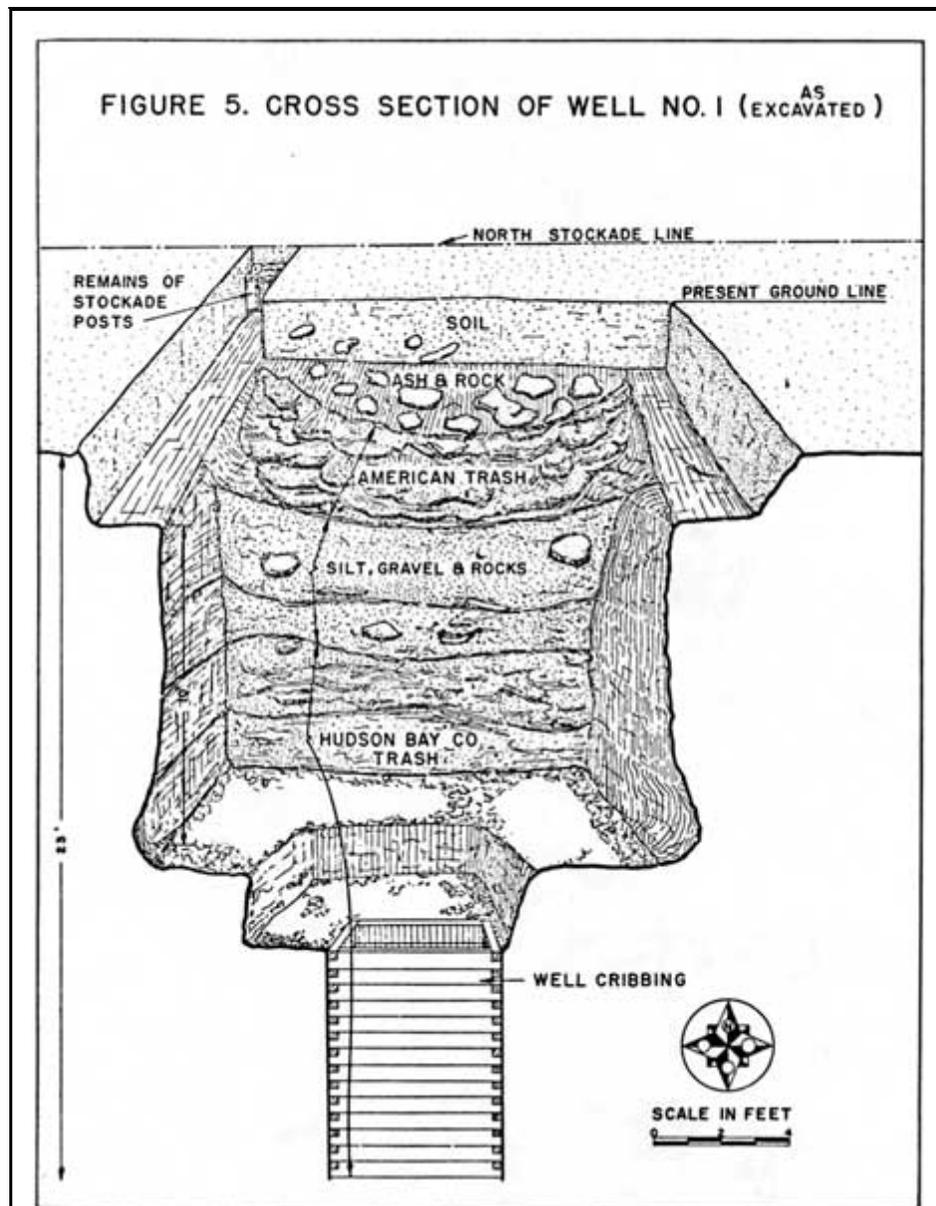
Plate LVI. Cross Section of Well No. 1, Fort Vancouver, As Revealed by Archeological Excavations in 1952. (From Louis F. Caywood, *Final Report*, figure 5.) (click on image for an enlargement in a new window)

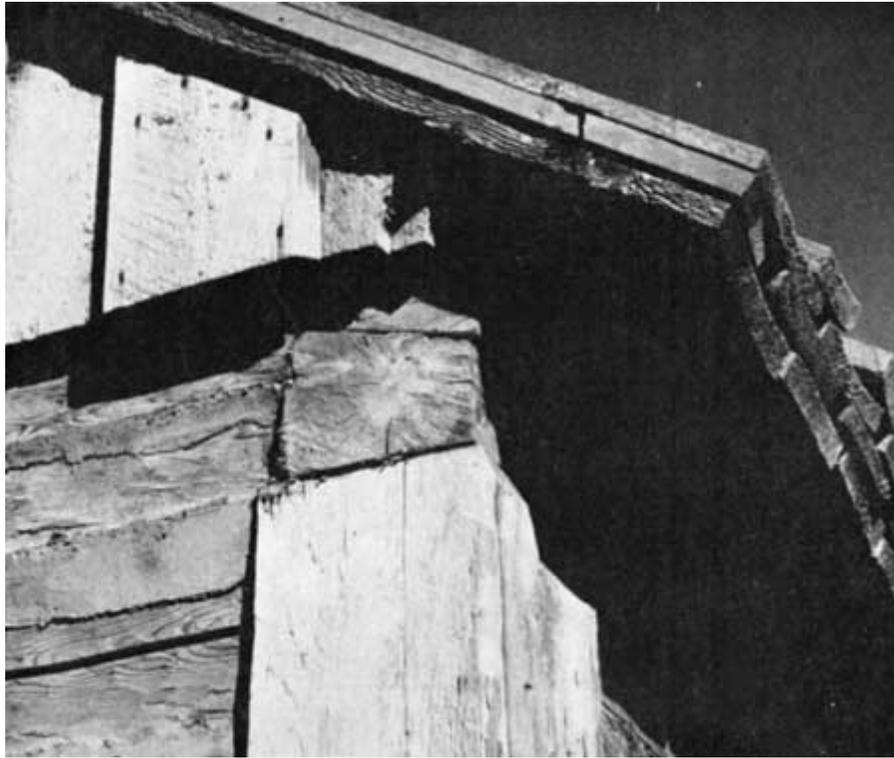
Plate LVIII. Jasper House, H. B. C. Post, 1872.

This photograph of a small Hudson's Bay Company structure well illustrates the technique of applying roof boards.

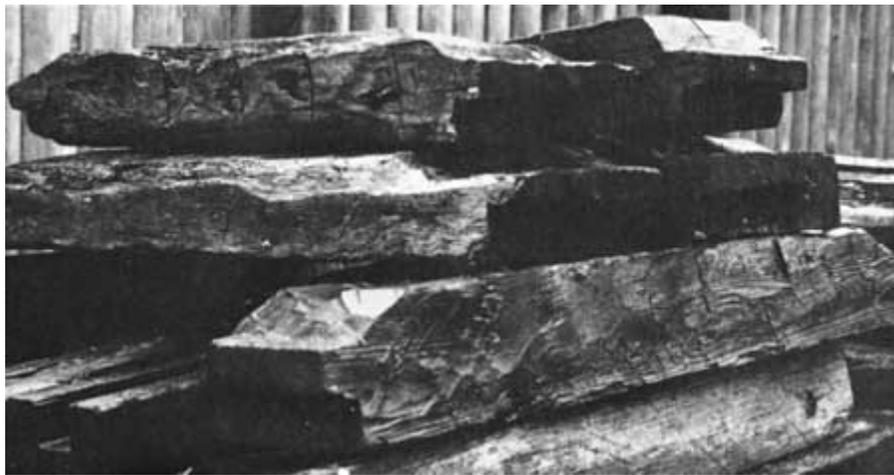
Plate LXXVI. Assorted Timbers from Original Fort Victoria Cook House, Fort Victoria Museum, 1967.

A grooved corner post is clearly visible in the center of the picture. The thinner "filler" timbers are ranged to the left.

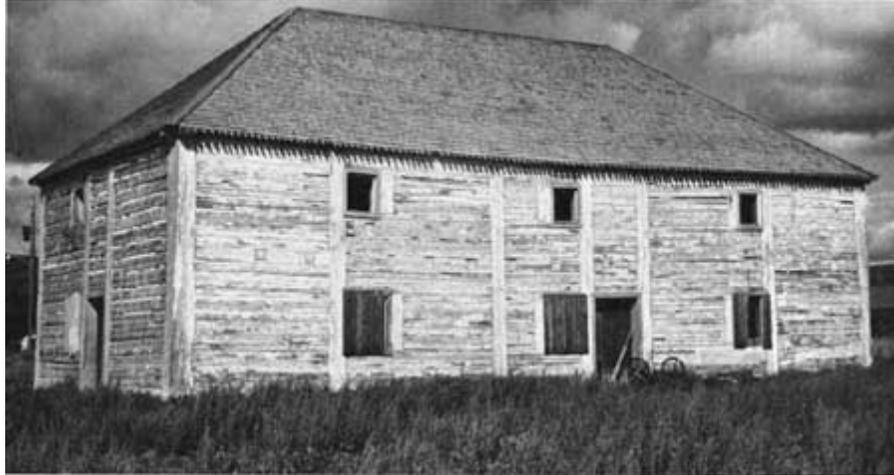
Plate LXXVIII. British Columbia. Old Hudson's Bay Company Warehouse, Fort St. James, *(National Park Service photograph by J. A. Hussey, September, 1967.)*

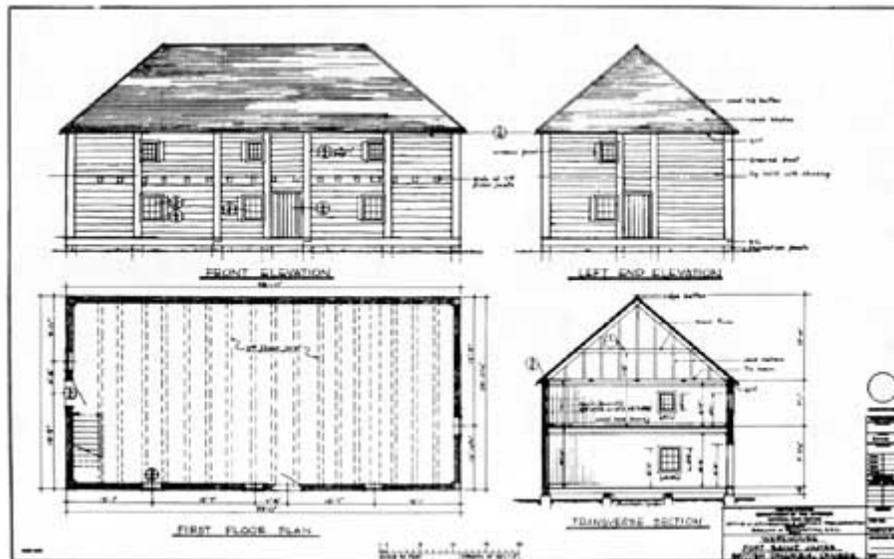
Plate LXXIX. Measured Drawings, H. B. C. Warehouse, Fort St. James, Sheet 2. *(National Park Service drawing by Historic*

Architect A. L. Koue.) (click on image for an enlargement in a new window)

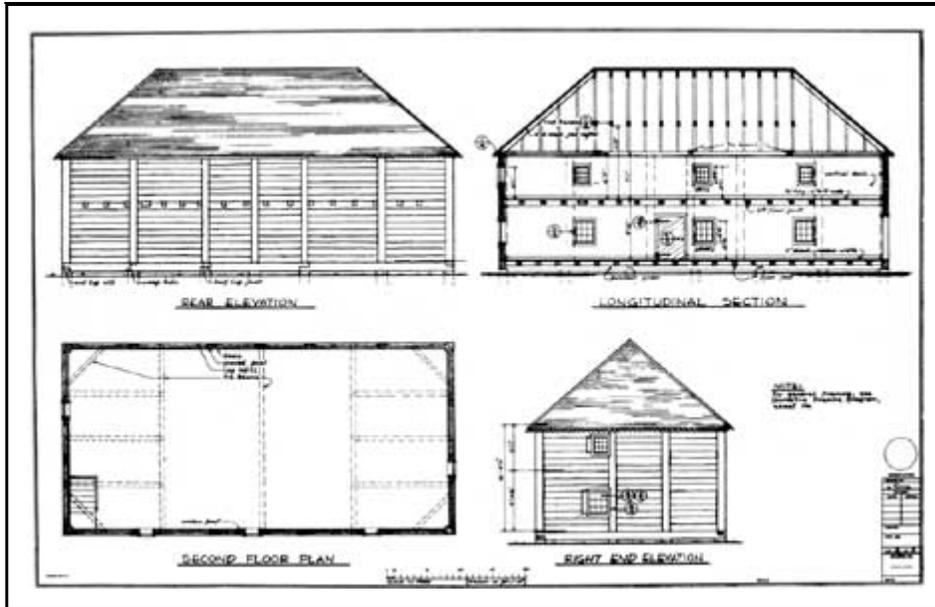
Plate LXXX. Measured Drawings, H. B. C. Warehouse, Fort St. James, Sheet 3. (National Park Service drawing by Historic Architect A. L. Koue.) (click on image for an enlargement in a new window)

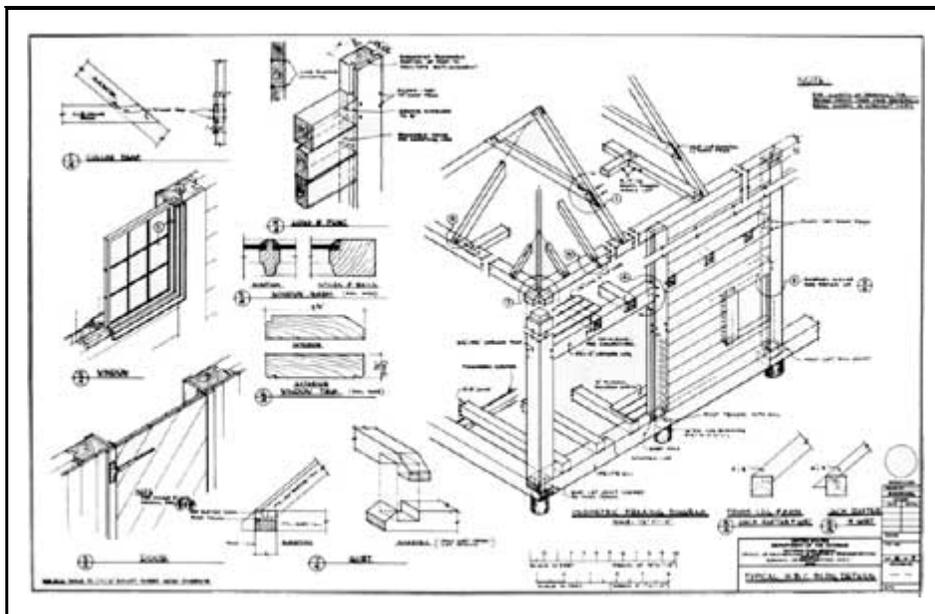
Plate LXXXI. Typical H. B. C. Building Details, Warehouse, Fort St. James, Sheet 4. (*National Park Service drawing by Architect F. Mehring, based on measurements by A. L. Koue, September, 1967.*) ([click on image for an enlargement in a new window](#))

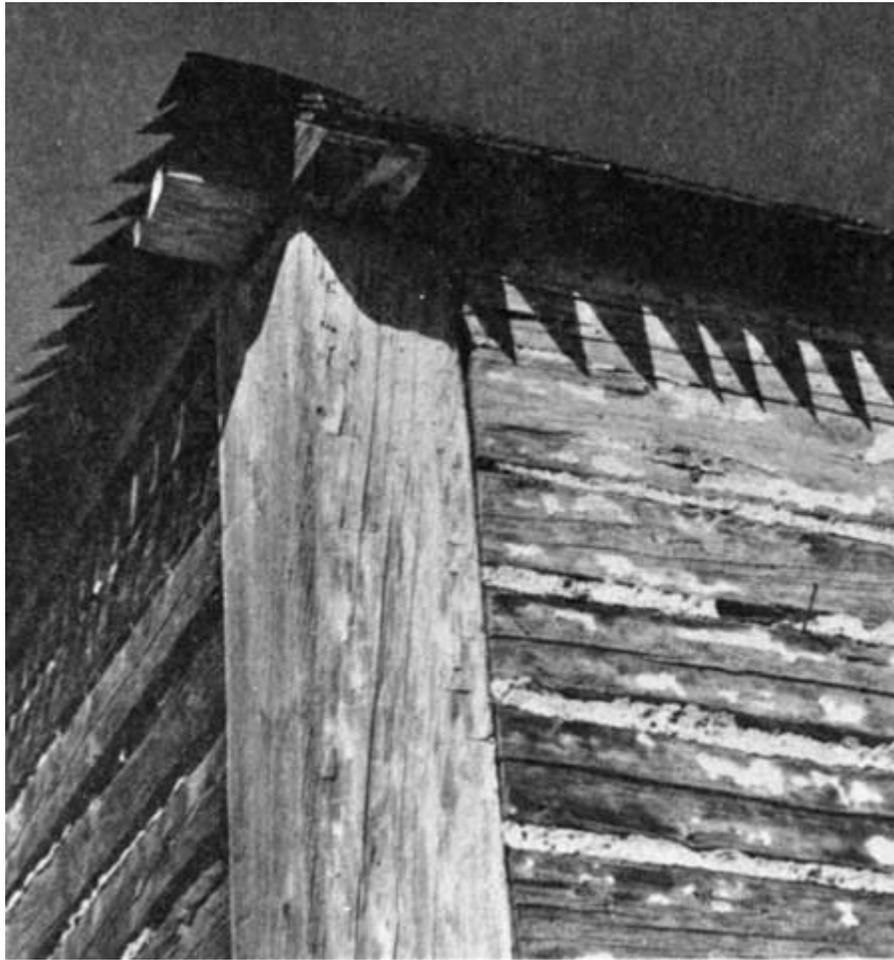
Plate LXXXII. Eaves Detail, Warehouse, Fort St. James. (*National Park Service photograph by J. A. Hussey, September, 1967.*)

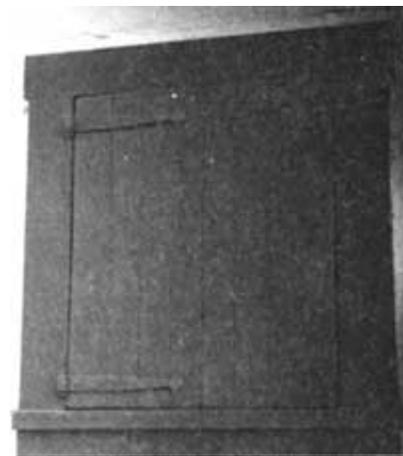
Plate LXXXVII. Shutter on Lower Story Window, Surviving Original H. B. C. Structure, Fort Langley.

The hinges are 13- 1/2 inches long overall.

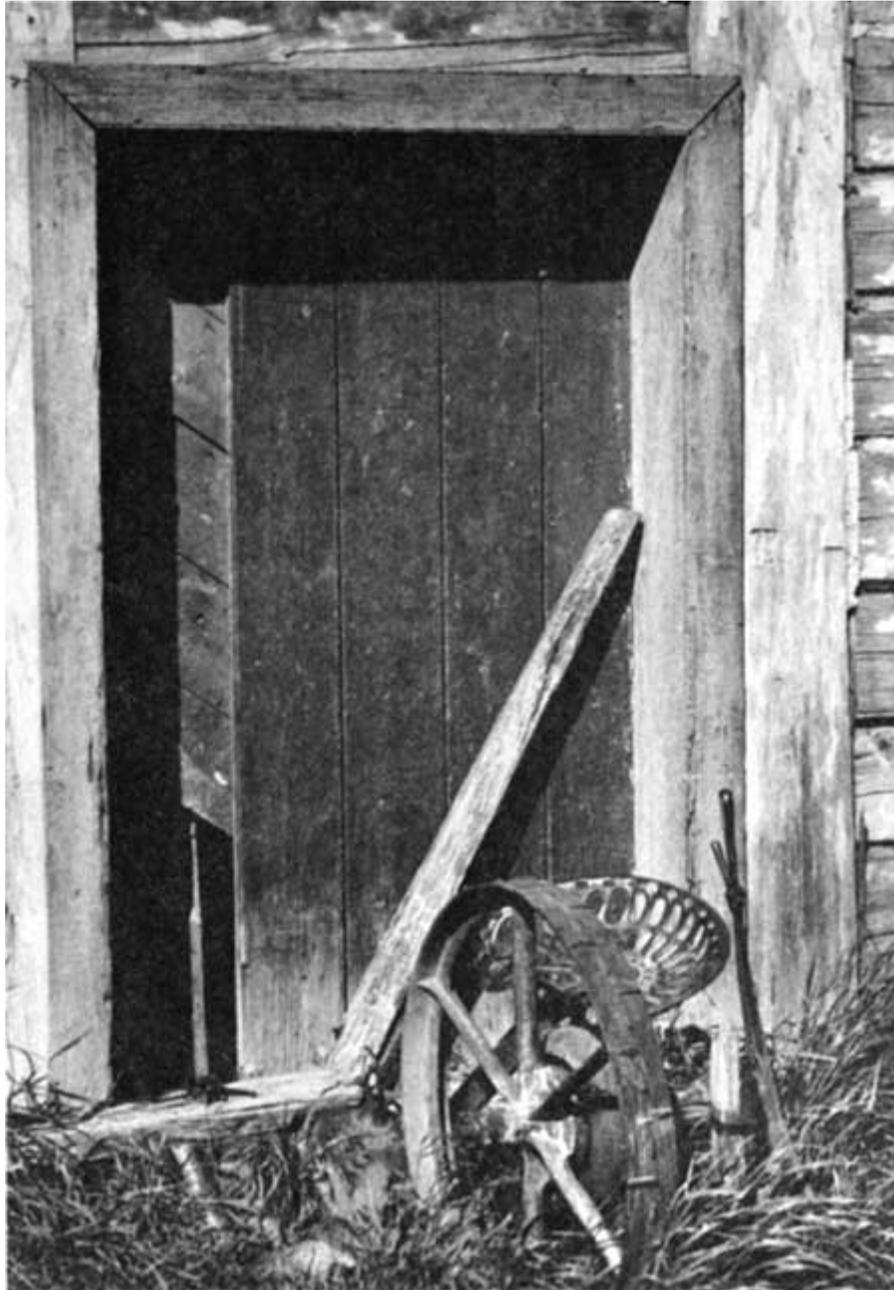
Plate LXXXIV. Main Door, H. B. C. Warehouse, Fort St. James.
*(National Park Service photograph by J. A. Hussey, September,
1967.)*

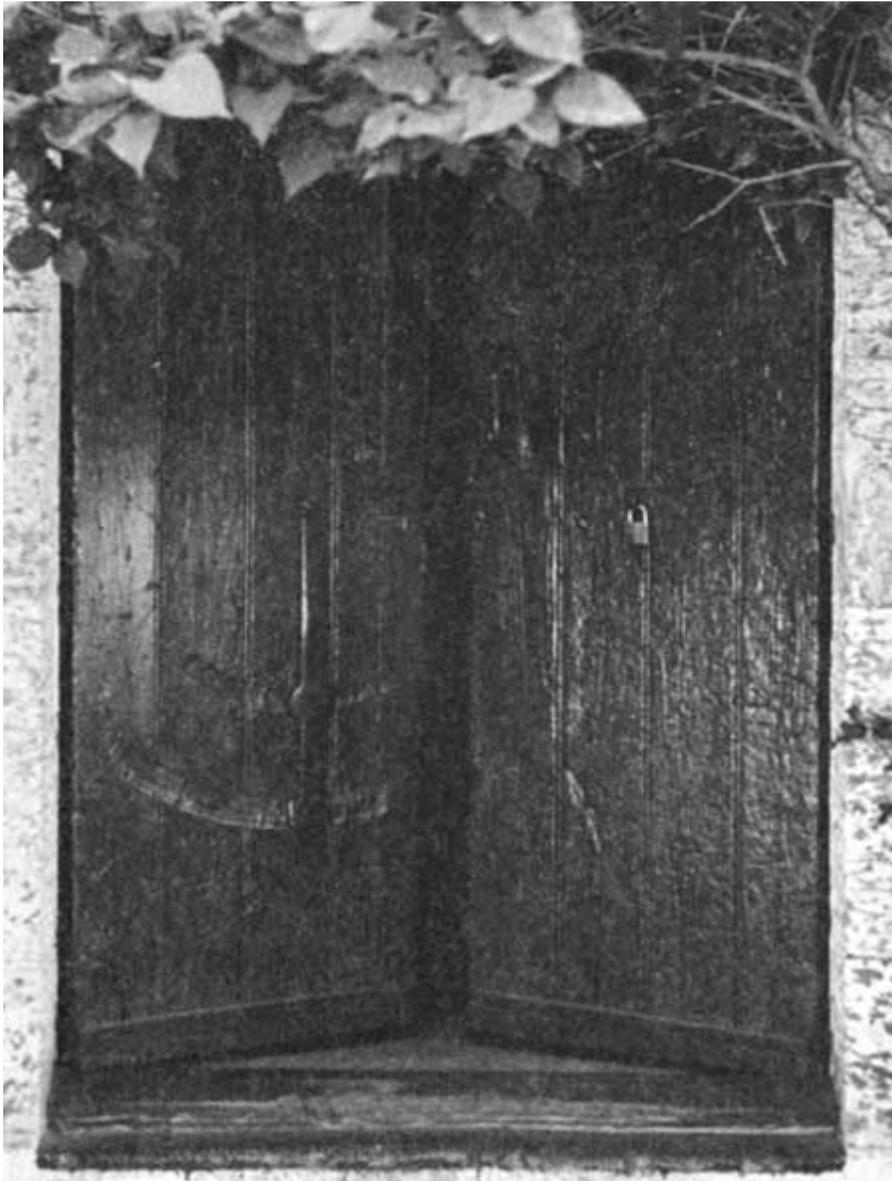
Plate LXXXV. Double Door, H. B. C. Warehouse, Lower Fort Garry. (*National Park Service photograph by J. A. Hussey, September, 1967.*)

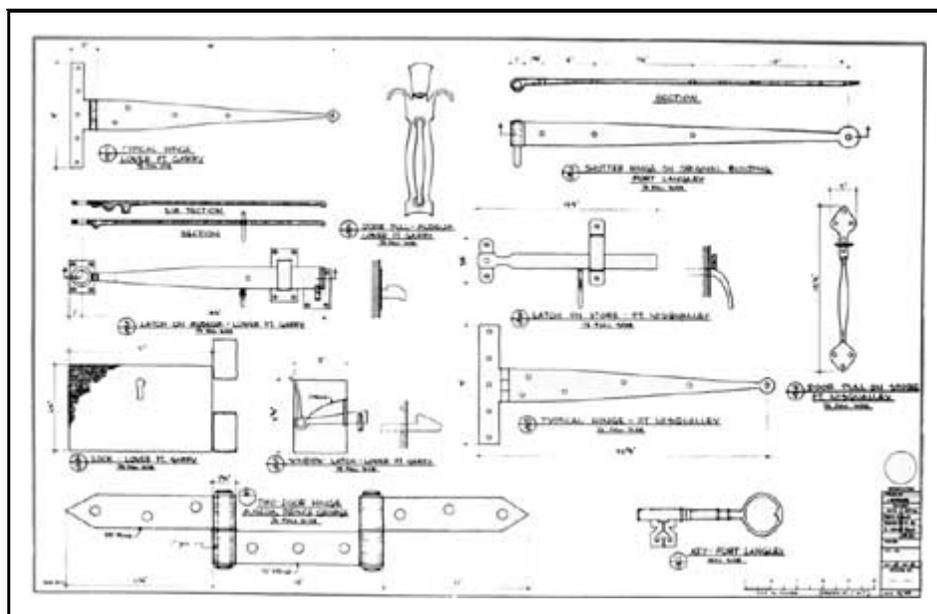
Plate XCI. Typical Hardware, H. B. C. Structures, Sheet 5.
(National Park Service drawing by F. Mehring, based on field
data by A. L. Koue, April, 1969.) (click on image for an
enlargement in a new window)

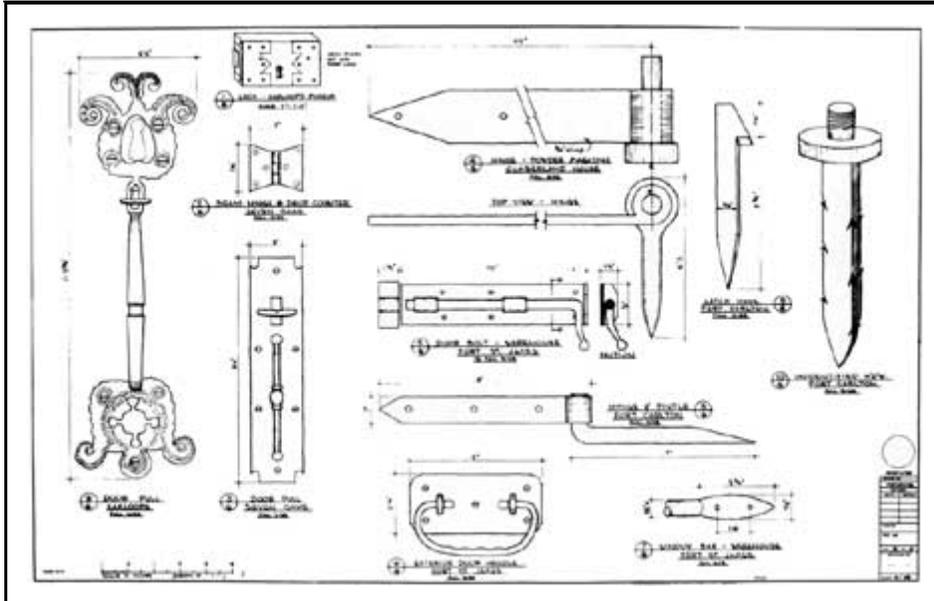
Plate XCII. Typical Hardware, H. B. C. Structures, Sheet 6.
(National Park Service drawing by R. Mehring, based on field
data by A. L. Koue, April, 1969.) (click on image for an
enlargement in a new window)

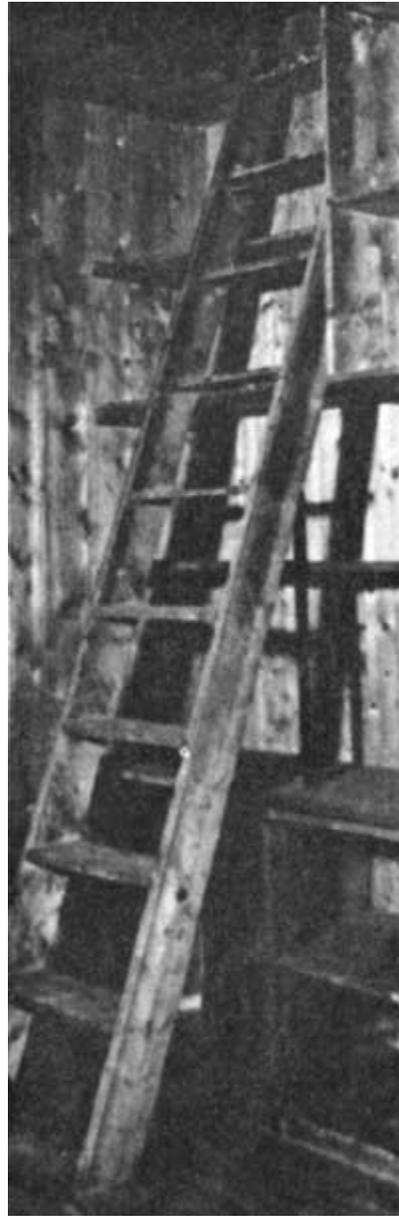
Plate XCVII. Shelves and Ladder in Shop or Warehouse, York Factory, c.1970. (Courtesy of Technical Services Branch, Department of Indian Affairs and Northern Development, Ottawa.)
