National Park Service
Cultural Landscapes Inventory
2007 Revised for Conditon 2013

Frederick Douglass Nat'l Historic Site
Frederick Douglass National Historic Site

FREDERICK
 DOUGLASS NHS
 SITE PLAN
 2007

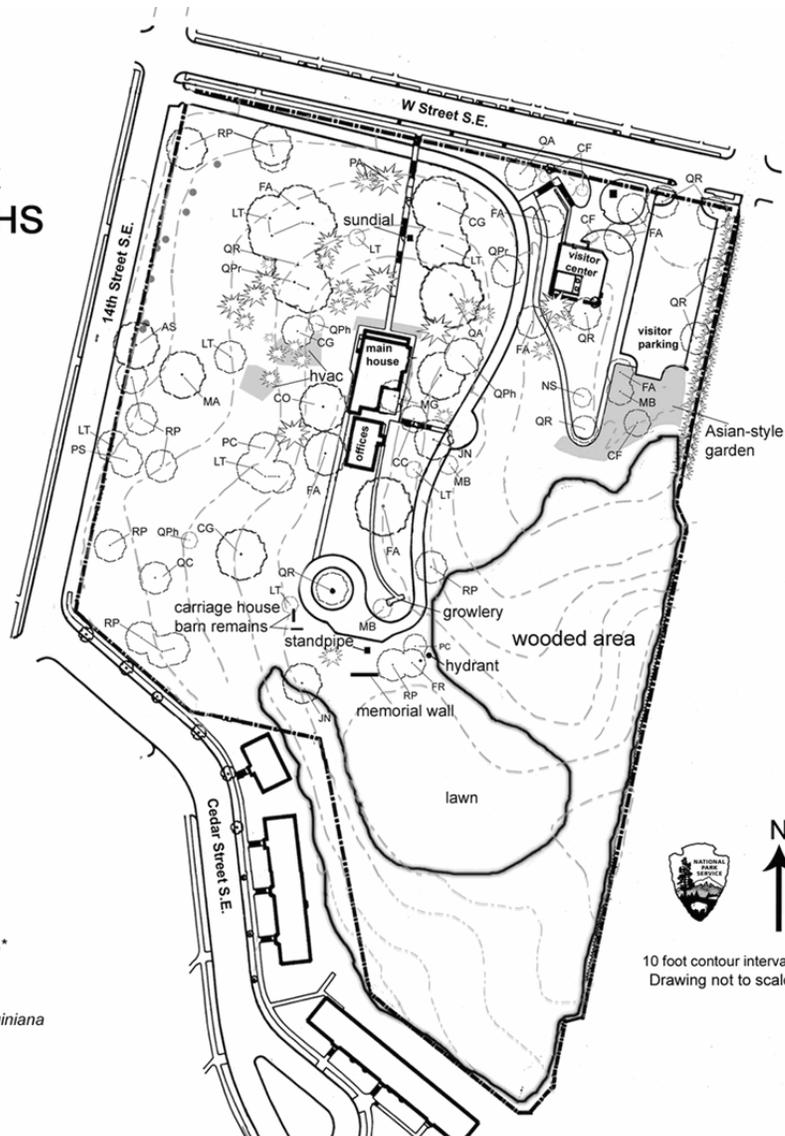
Frederick Douglass National Historic Site site plan. (NCR CLP, 2007).

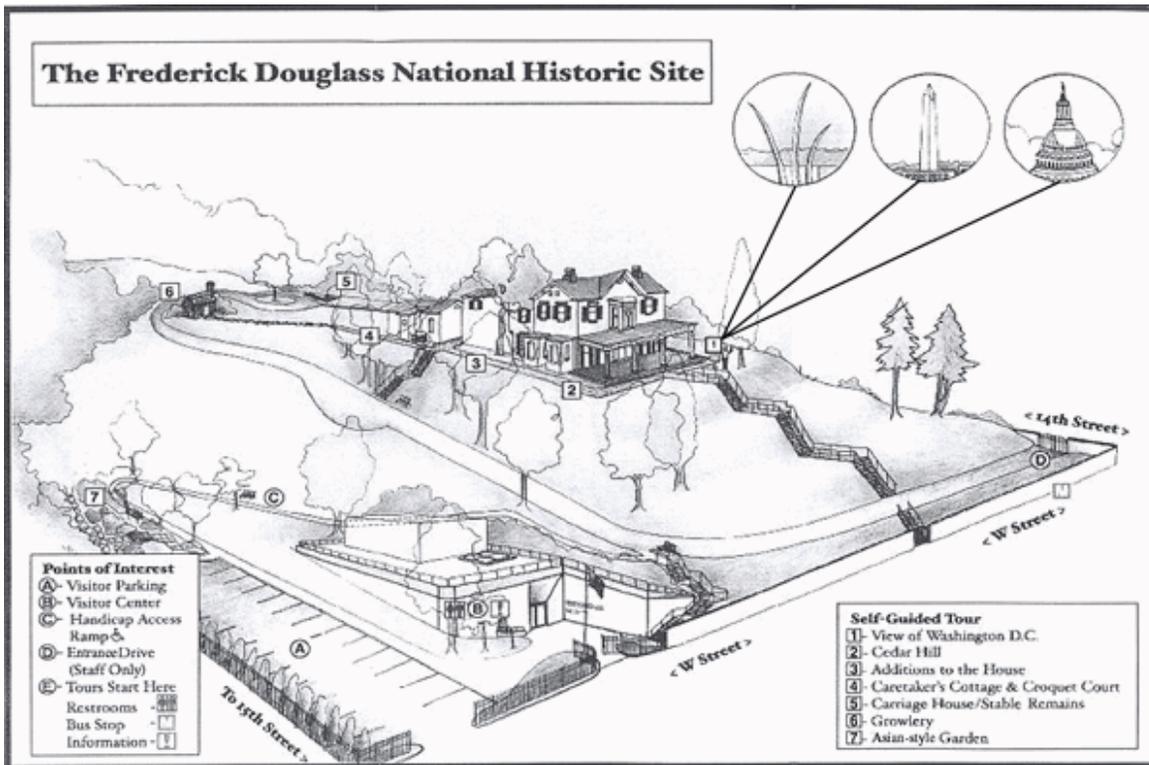
This illustrative site plan of the FRDO NHS illustrates the considerable elevation changes between the street and the home. (NPS).

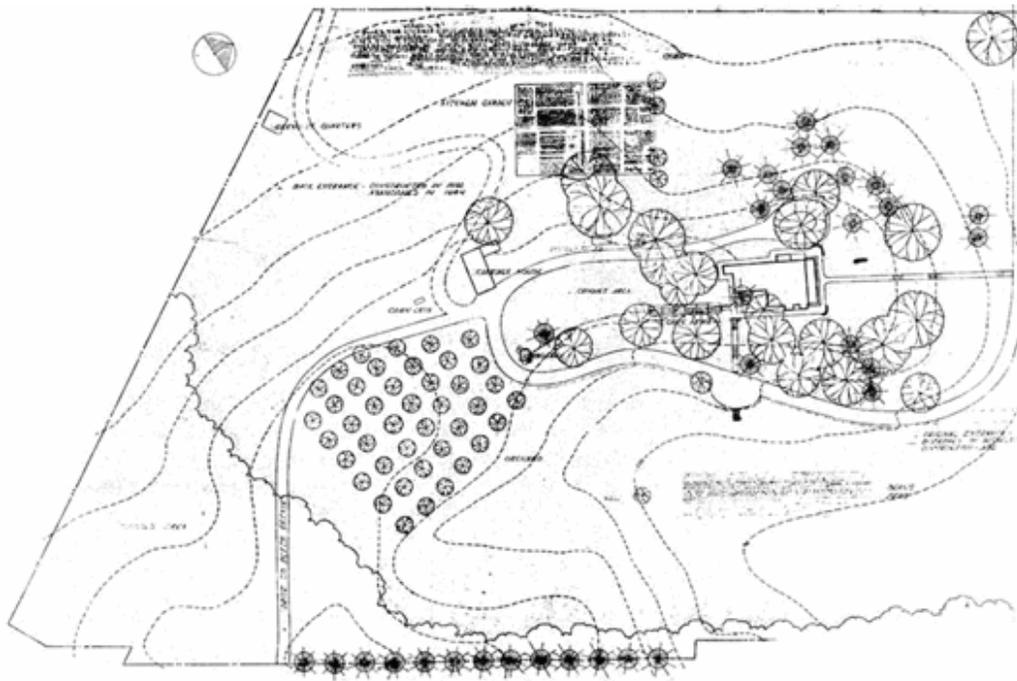
Craven Reeves' 1976 Landscape Restoration Plan is considered the best representation of the historic layout of the Cedar Hill grounds. (Reeves, 1976).

A report on the restoration of the grounds was issued by Craven Reeves in 1976. The plan drew from the historic configuration of the landscape during the time of Douglass, and was intended to be installed in two phases. The first phase included the planting of several trees, mainly cedars, and the installation of shrubs, including flowering quince, strawberry bush, and winter jasmine, which were used as to screen utilities including an air conditioning unit and an electrical box on the west side of the house. Small planting beds on both corners of the east-west walkway in front of the house were also installed. Planting was completed by fall of 1978. The second phase was intended to be implemented after removal of the caretaker's cottage, which, as of early 2007, is still standing and serves as the park staff headquarters. Phase II installations included the reconstruction of a path that led from the stairs on the east side of the top terrace to the west, grape arbor and rose trellis installation, and reconstruction of the orchard behind the Growlery.

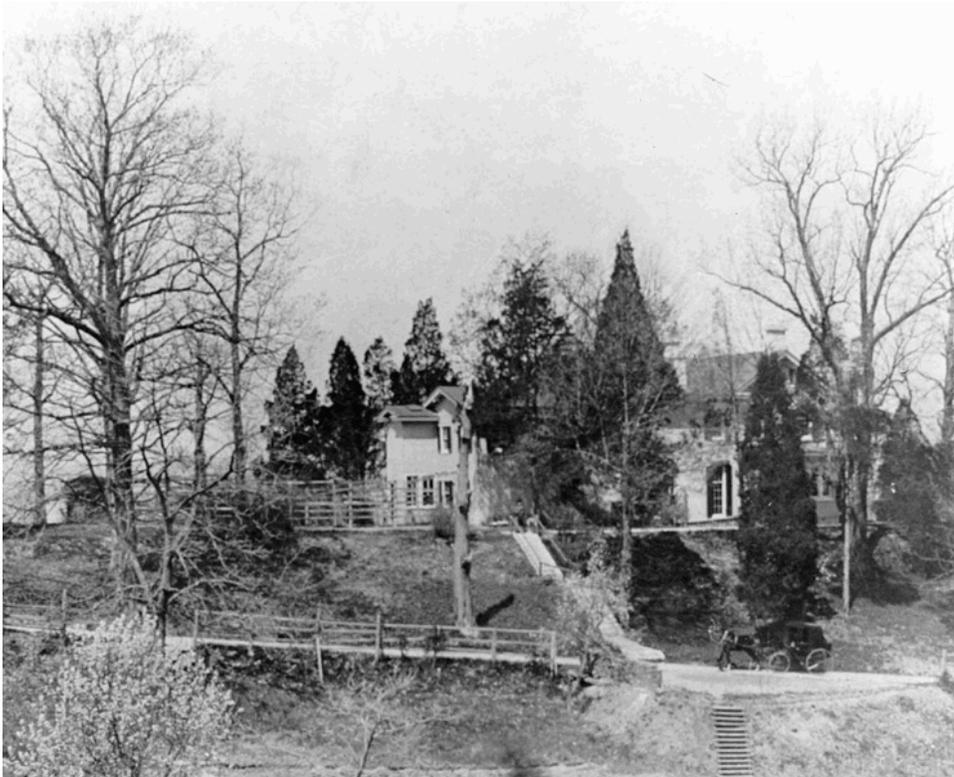
A horse-drawn carriage makes its way up the hill towards the Douglass home at Cedar Hill c. 1890. (Historic American Buildings Survey Russell Jones, Photographer June 1963 EAST VIEW ca. 1894-1900 HABS DC, WASH,166-1).

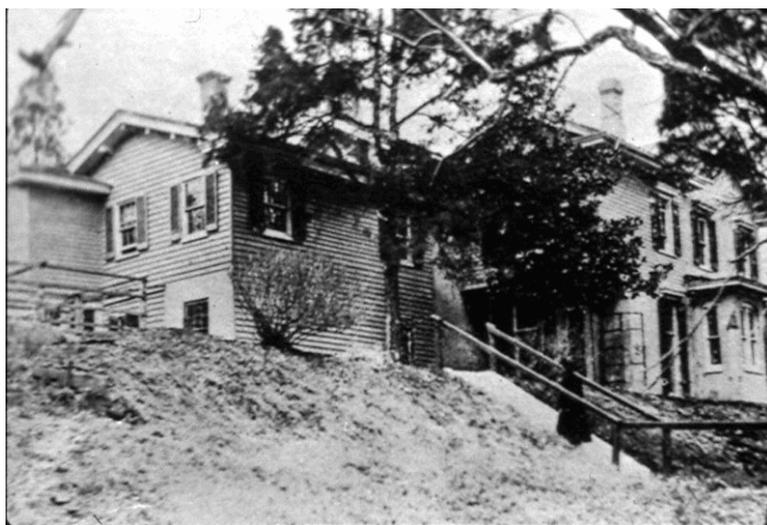
A figure ascends the staircase on the east side of the house in 1893. Handrails, an arbor, a trellis, and a magnolia tree characterize the landscape during this period. (Source unknown).

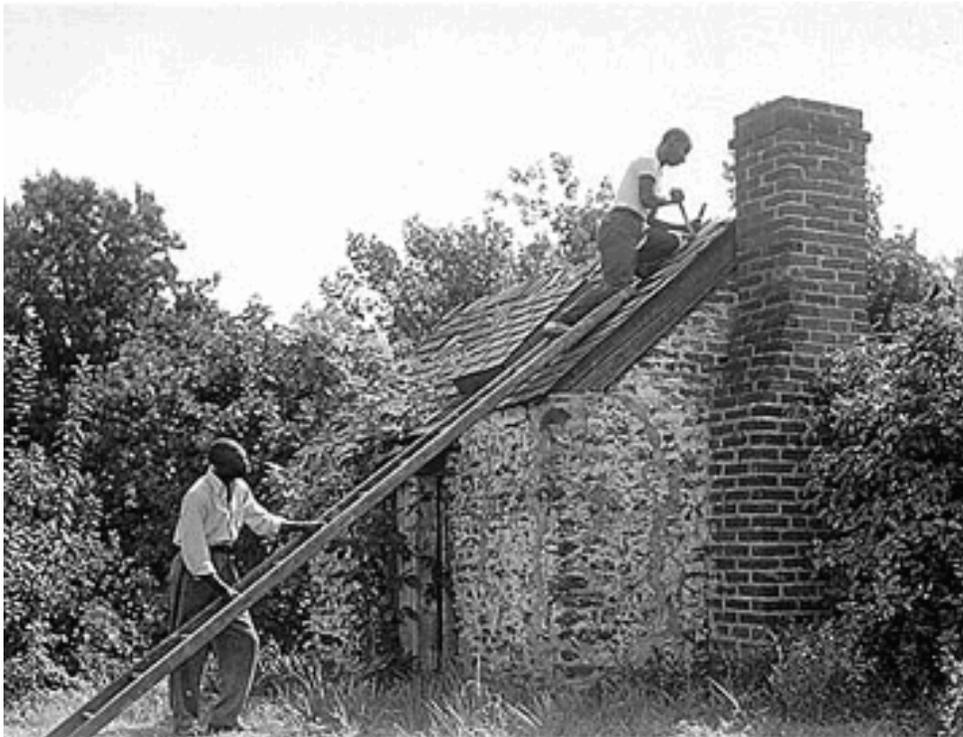
National Youth Administration workers repair the original Growlery as part of improvements made to the Douglass property in the 1930s. (Image from New Deal Network, owner U.S. National Archives and Records Administration Still Picture Branch).

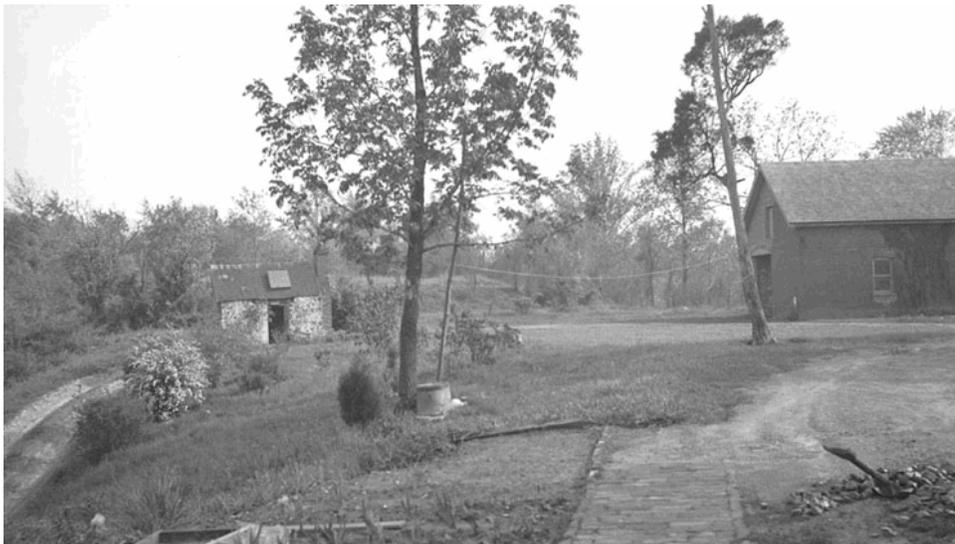
During the preservation years, structures like the barn and Growlery seen here were neglected and vegetation at Cedar Hill diminished due to lack of funds for upkeep on the property. (Division of History Files).

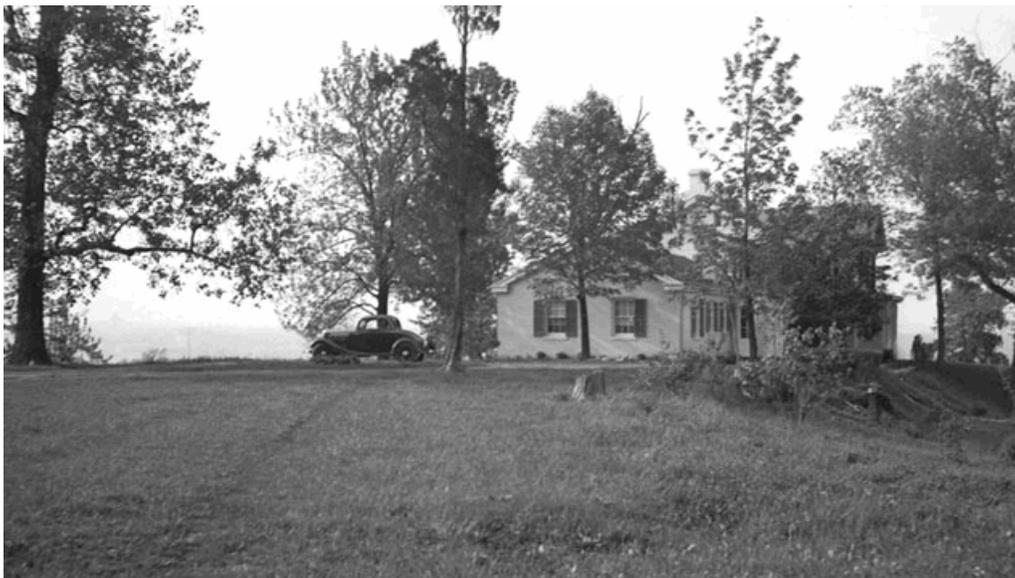
In 1938, a caretaker's cottage was built behind the south end of the Douglass mansion. (Division of History Files).

and the implementation of an underground drainage system at the caretaker's cottage. Water from the roof of the structure flows from the downspouts and underground into two outlets in the ivy beds on the west side of the slope, and one on the east.

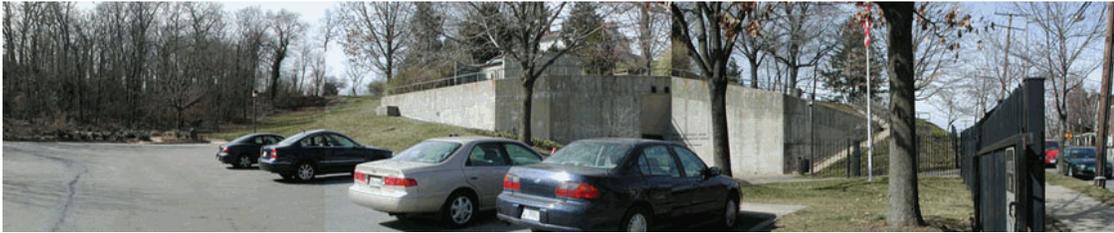
A view into the property from the northeast edge of the property reveals the visitor center, parking lot and the edge of the non-historic contemplative garden (NCR CLP 2007).

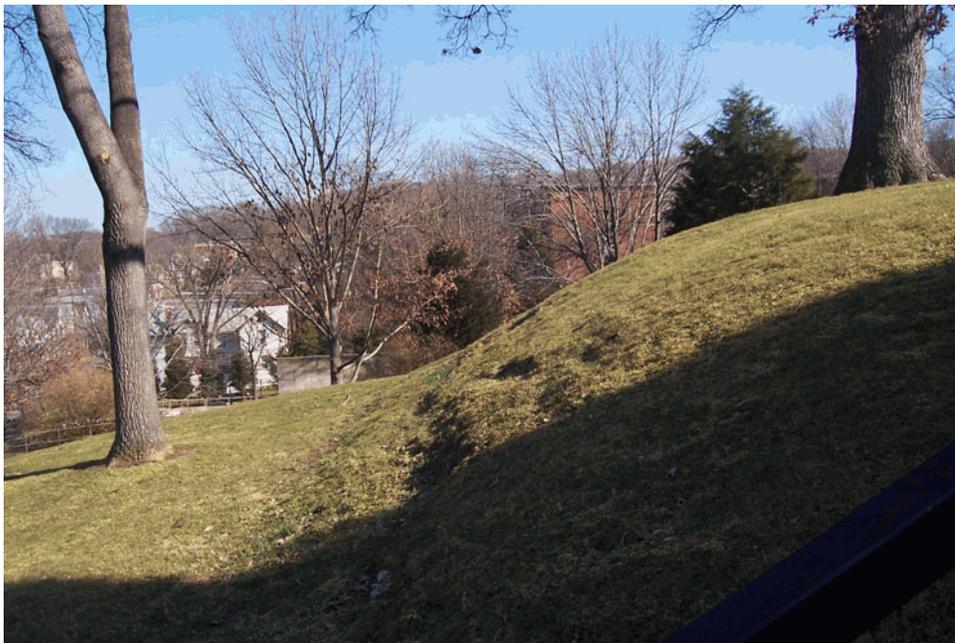
The terraced slopes at Frederick Douglass NHS are subject to erosion. On-going maintenance is needed to correct and prevent future erosion and protect the cultural landscape (NCR CLP 2006).

The landscape at the Frederick Douglass NHS is in good condition. (Indicates the inventory unit shows no clear evidence of major negative disturbance and deterioration by natural and/or human forces. The inventory unit's cultural and natural values are as well preserved as can be expected under the given environmental conditions. No immediate corrective action is required to maintain its current condition). It retains integrity for the period of significance (1877-1895). The most pressing issue on-site may have to do with stormwater management, and the erosion of the grassy terraces.

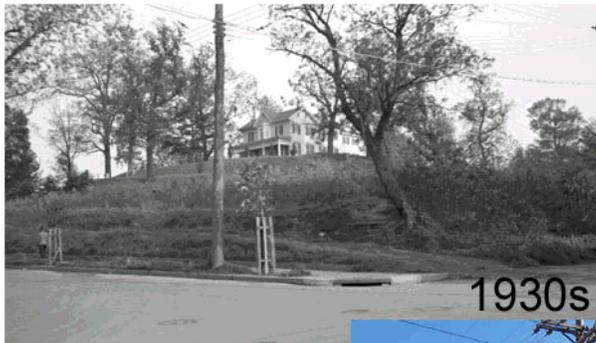
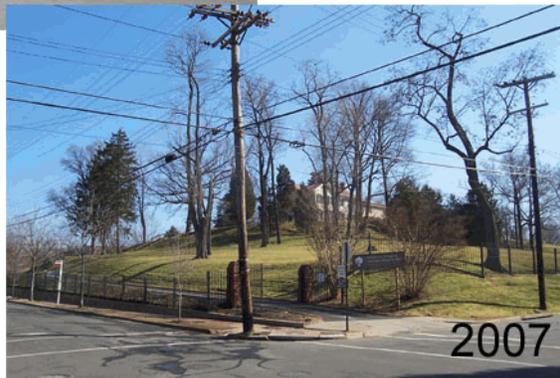
Land use at Frederick Douglass NHS has evolved from a family home to a memorial site to its present state as a historic house museum, visitor center and cultural landscape managed by the NPS (Division of History files, NCR CLP 2007).

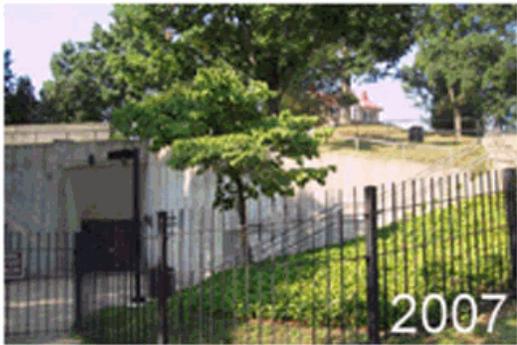
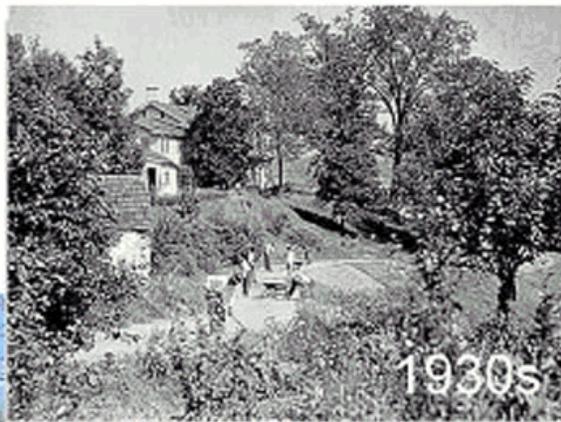
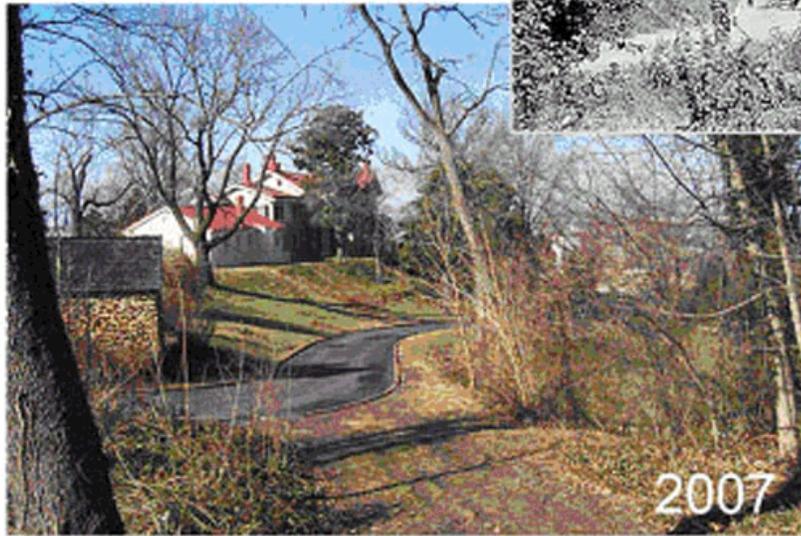
Circulation along walkways and the drive are largely true to the historic period. New circulation has been added to access to the visitor center and parking lot. (1930s Image from New Deal Network, NCR CLP 2007).

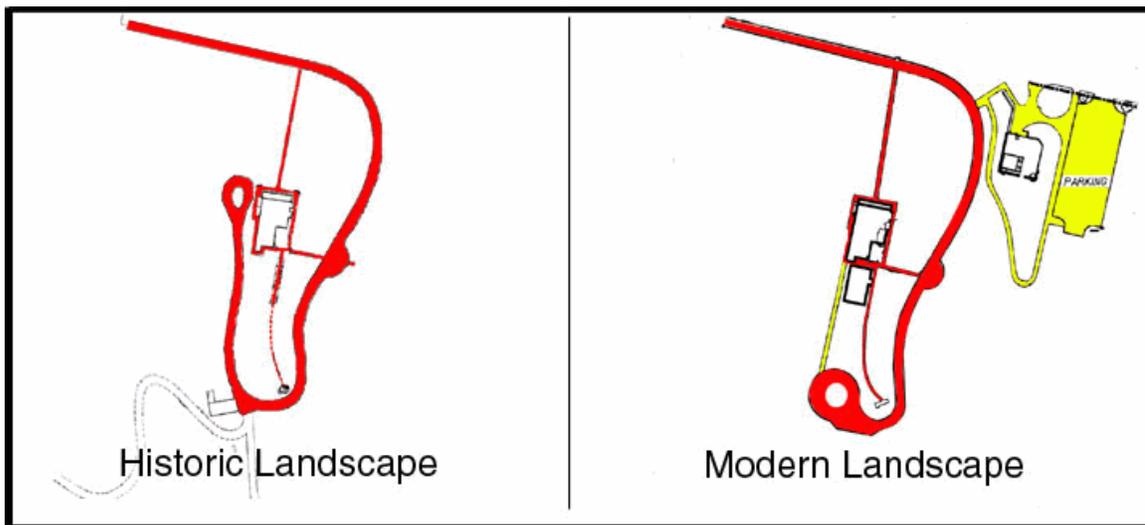
The red lines in the graphic above illustrate similarities in circulation from past to present. The yellow in the Modern Landscape depicts paths and parking installed after the historic period

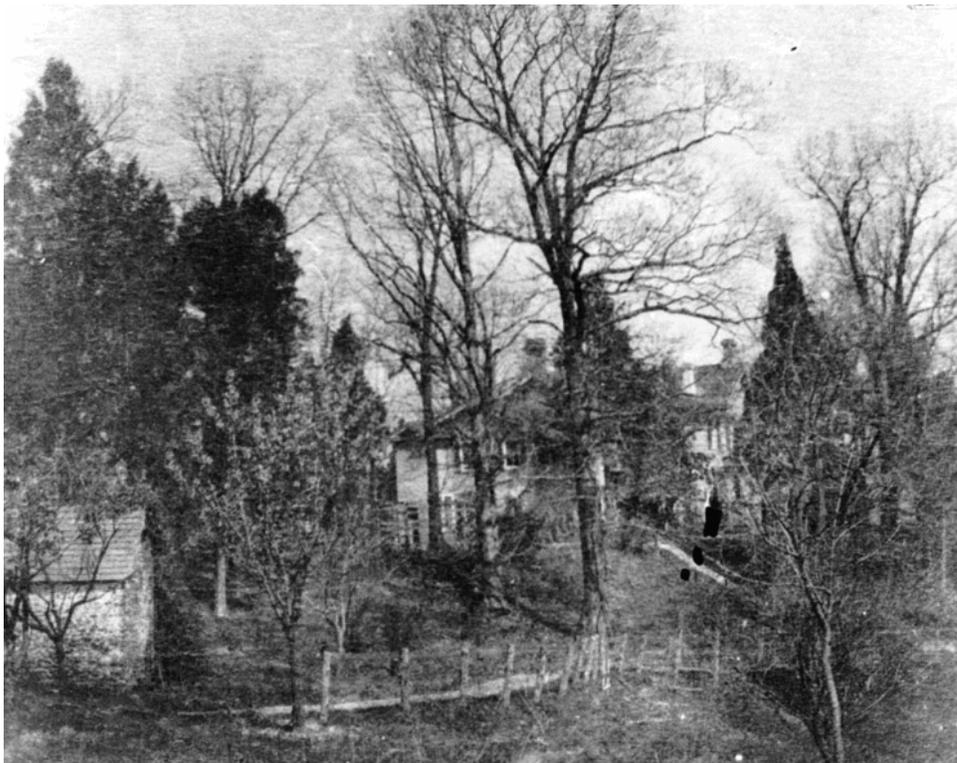
The cedar trees, seen here during the 1890s, inspired the name "Cedar Hill". Variations in the trees may be due to use of hybrids or the existence of two types of cedars. (National Park Service, FRDO NHS # 5216).

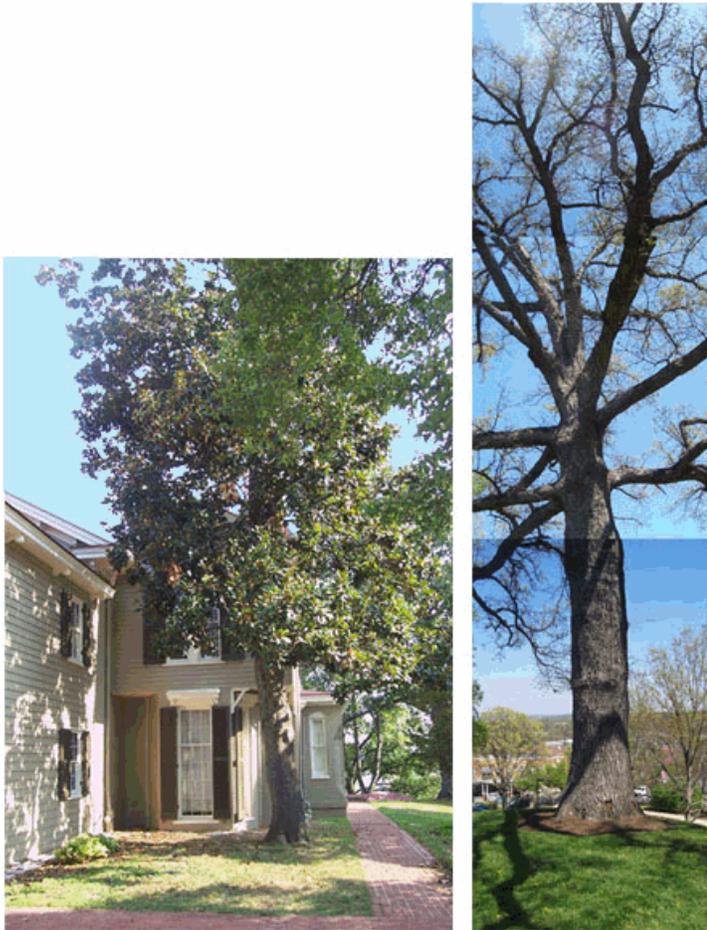
One of the largest trees in the district, the oak tree in front of the house (right) may be the only vegetation deriving from the historic period. The compatible magnolia tree (left) is located on the east side of the home. (NCR CLP 2007).

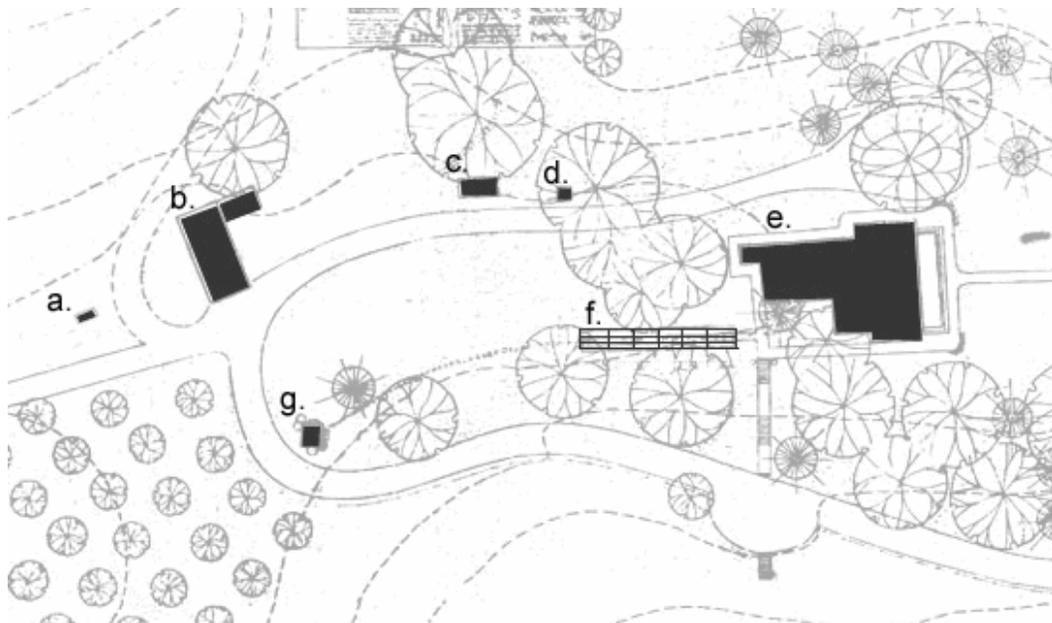
(Clockwise from top left) a. corn crib, b. carriage house cluster, c. unidentified structure, d. the privy (no archeological evidence to support this), e. house, f. grape arbor g. the Growlery. (Reeves, 1976).

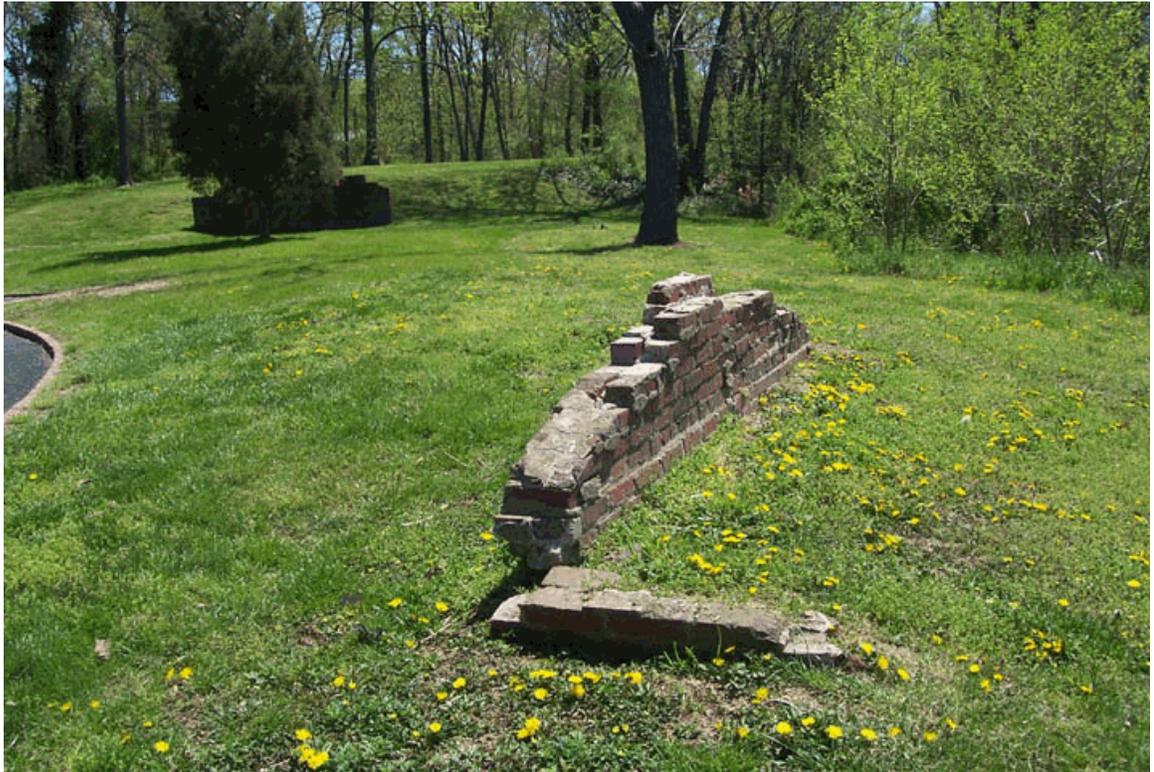
Current photo of the remains of the carriage house, stable, chicken coop, and barn cluster building cluster on the southwestern side of the top terrace. (NCR CLP 2007).

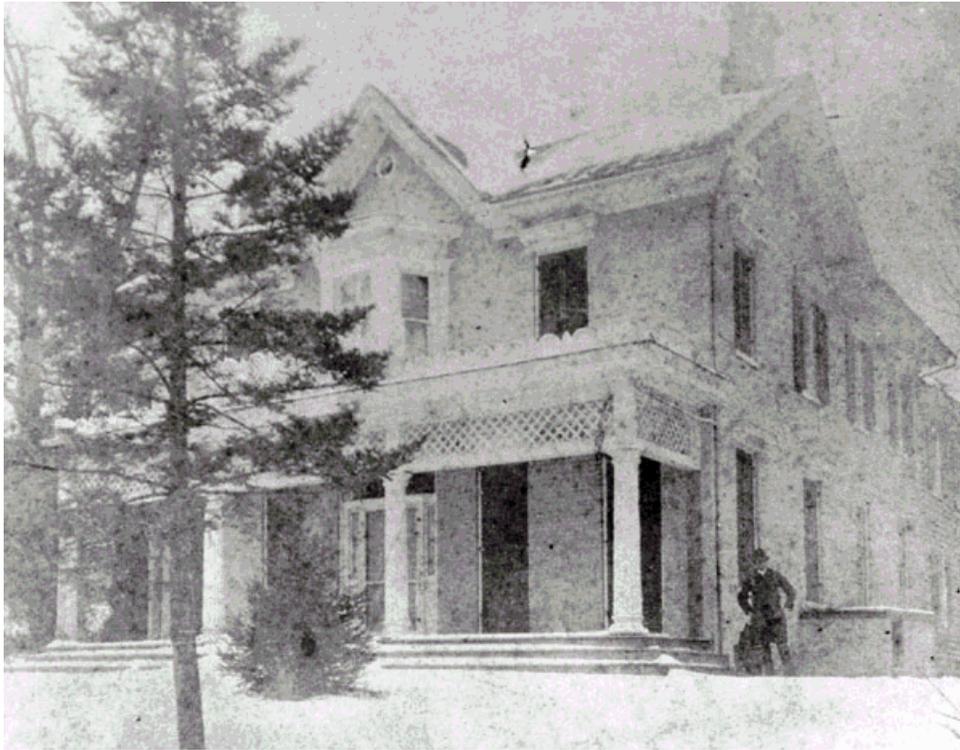
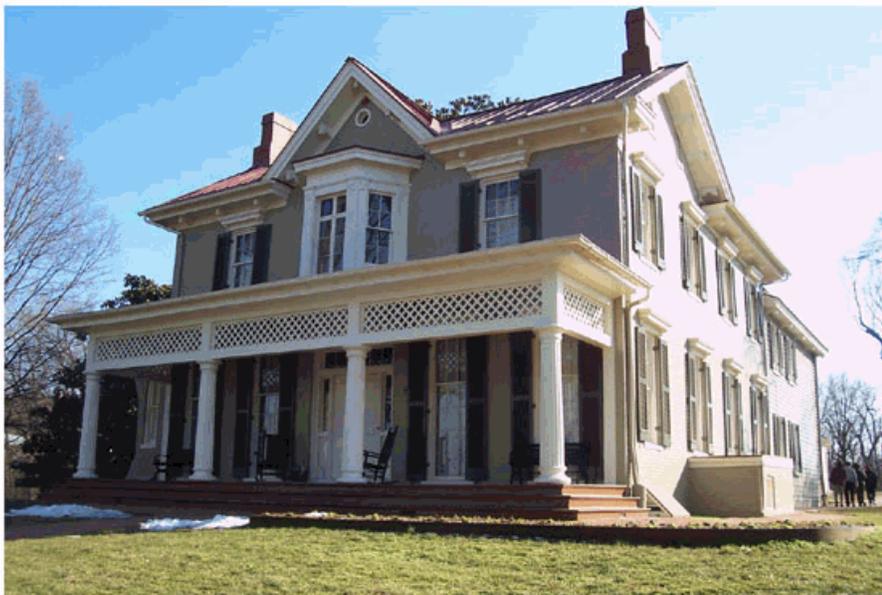
The north façade of the Douglass home is much the same today as it was in 1877 as seen in the black and white photo above. (HABS Russell Jones, Photographer June 1963 NORTH VIEW ca. 1887 HABS DC, WASH, 166-5, NCR CLP 2007).

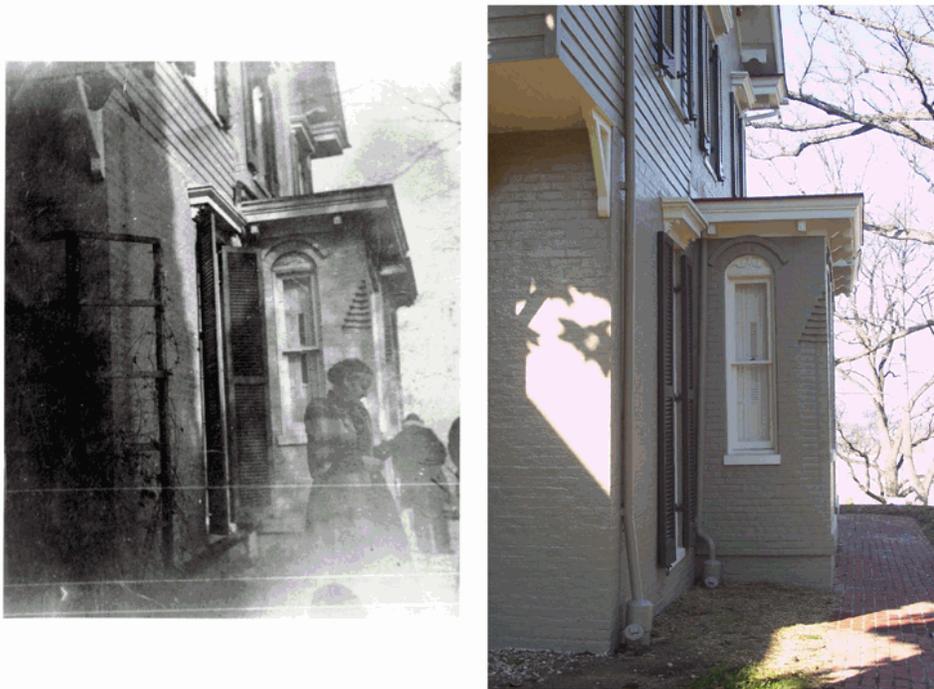
The house itself has been preserved to closely match the state it was in during Douglass's time, seen c. 1890 on the left. (Left, National Park Service, FRDO NHS, FRDO #2921, right, NCR CLP 2007).

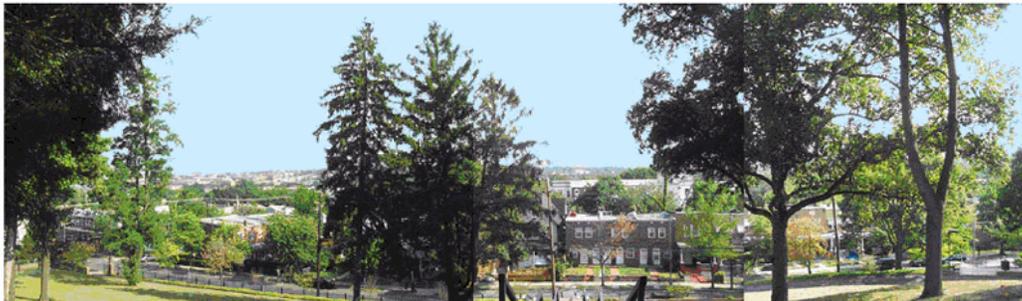
The 2007 view, includes downtown Washington, D.C. and the Anacostia River, just as it did during the historic period. (NCR CLP 2007).

Feature: Views from top terrace of property
Feature Identification Number: 121188
Type of Feature Contribution: Contributing

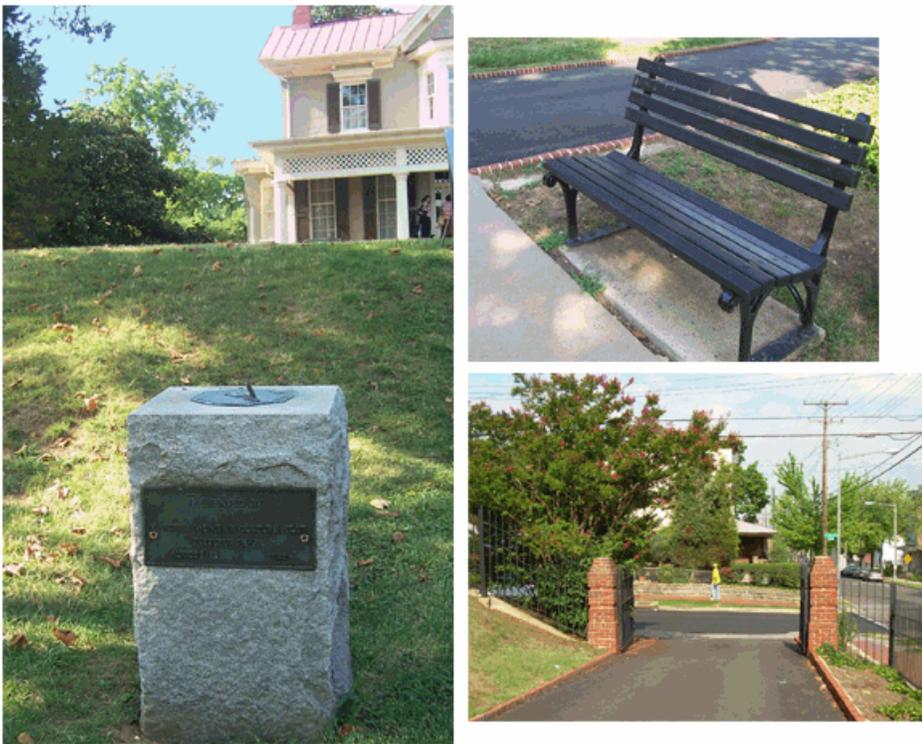
Small-scale features on-site are modern additions which include, among others, (from top left) the sundial and pedestal, benches and curbs, and brick piers and fencing. (NCR CLP 2007).
