# At the Foot of the Belton Hills

A Cultural Landscape History of the Headquarters Area, Glacier National Park

January 2012

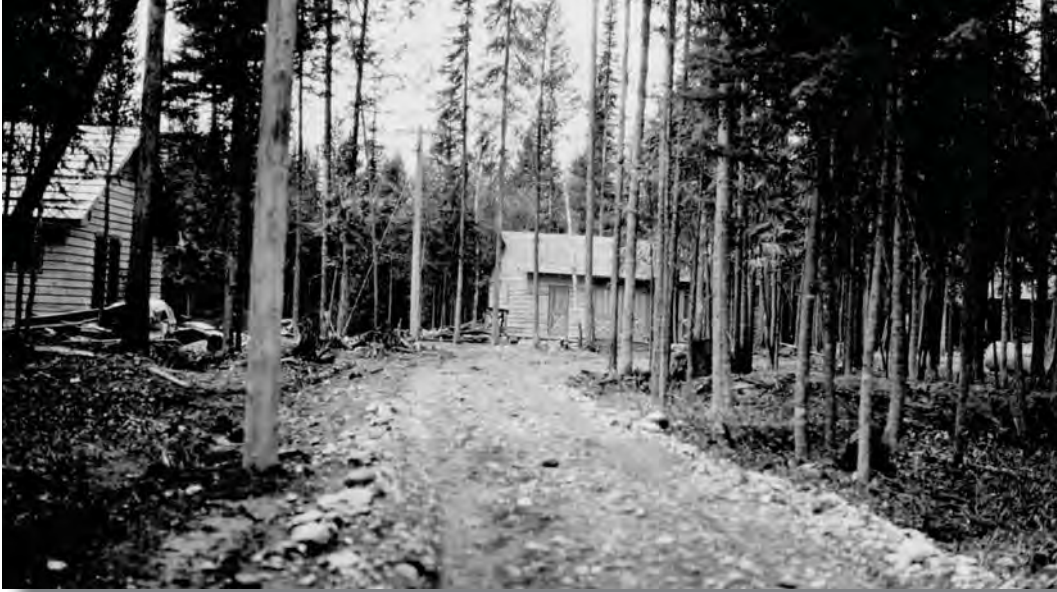
PHOTO NO. GLAC 15502-C

Figure 2. The headquarters site featured level ground and a “dog-hair” growth of lodgepole pine, as seen in this 1929 construction photo. The road is probably today’s Ruhle Drive.

The area is located within a forest of “dog-hair” lodgepole pine (Figure 2) that flourished following fires that swept along Lake McDonald and through the Apgar Mountains and the Belton Hills in 1927 and 1929, destroying the dense western red-cedar and hemlock forest at the foot of the lake. Lodgepole pine live only about 80 years and do not germinate in the shade. Shade-tolerant Douglas-fir, white pine, Engelmann spruce, and western red cedar seedlings are now slowly replacing the dog-hair lodgepole. During late September and early October, the western larches, which can be seen along the ridges, turn a bright yellow. The larch is a deciduous conifer, losing some of its needles each autumn and turning a vivid yellow. In addition, during the spring and early summer, less densely shaded areas on the forest floor support a variety of flowers, including the bright, white daisies, pinkish-purple blooms of the erect fireweed, and white strawberry blossoms (Hufstetler et al. 2002, 236). Numerous stands of mature trees were preserved as the headquarters area developed, and today the forest not only bounds the area but permeates it, as well.

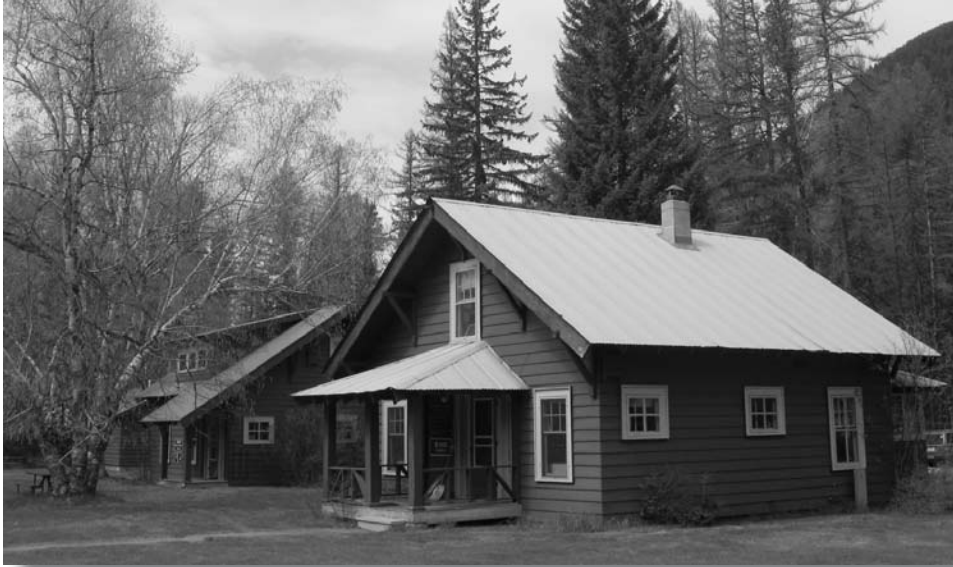
Figure 6. View north of two offices and former ranger residences (Buildings 3 and 4) showing the forest and mountain-view setting. Photo taken on the park's centennial anniversary, May 10, 2010.

While the Snyder property was converted into temporary administrative offices, four employee cottages (Buildings 1–4; Figure 6) were partially constructed in the fall of 1917; the interiors were completed in the following year. The building plans were perhaps the first residential designs produced by the fledgling agency and exhibited Craftsman Style architecture (Figure 7).

Each cottage contained a living room, bedroom, kitchen, and bathroom on the main floor and two small bedrooms on the second floor. While the plans consisted of a single floor plan, changes in roof direction and

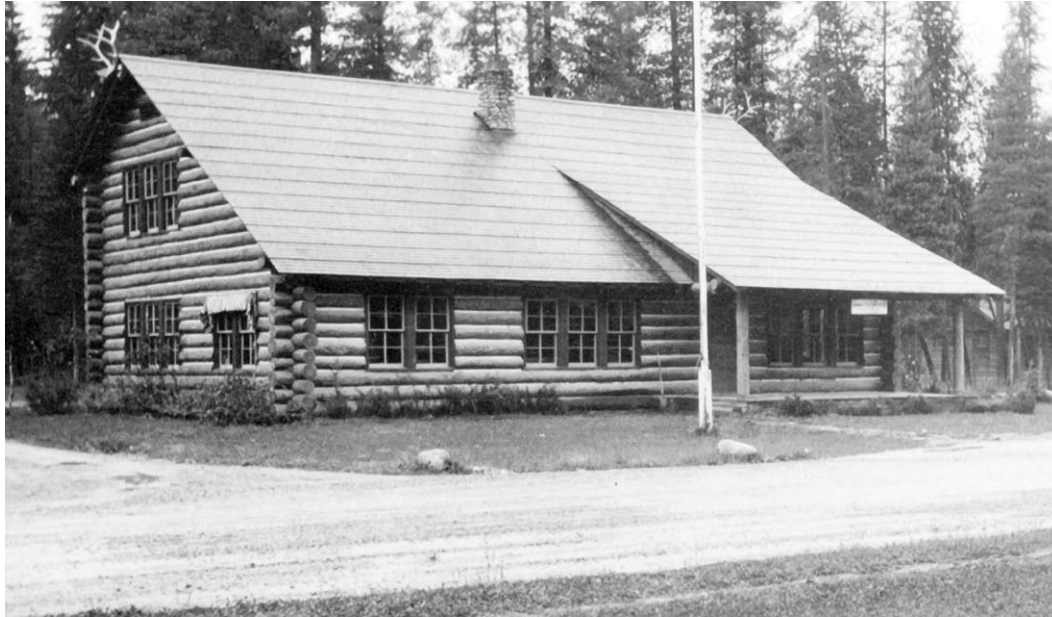
PHOTO NO. GLAC 15507-C

Figure 9. Administration Building (Building 222), 1927.

as well as visitors who came to see the superintendent on official business. Still, it was not an ostentatious residence and it ably exhibited the park service's emerging architectural style, known as Park Service Rustic. Similarly, the administration building (today's West Lakes Ranger Station), completed in the spring of 1924, had a handsome design that was not ostentatious or out of proportion with the four small cottages that stood on the opposite side of the street. The salt-box roof design created the appearance of a one-story structure while providing a well-lit space on the second floor for a drafting room (Hubber 1995, 45). The log construction and cobble facing on these buildings reflected a maturing of the Rustic Style from the more traditional Craftsman Style of the wood-frame residences.

Landscape naturalization was initiated in the headquarters area with fall planting of shrubs around the base of the administration building (see Figure 9). It was also in evidence in the planting of aspen trees in front of the superintendent's house, which were grouped in clusters of three, an aesthetic number. Under this program, landscape architects also identified trees that were to be left standing in the course of construction, making the protection of standing trees part of the building specifications. Trees were often used for screening development, and photos of the headquarters area from this period suggest that just such an effort was made to screen the utility area from what was then the main park road. Other design elements dating from this period include a network of flagstone paths, which was the rusticated equivalent of a residential sidewalk system. As historian Linda Flint McClelland writes, "The program of landscape naturalization enabled park designers to create or maintain the illusion that nature had experienced little disturbance from improvements and that a stone water fountain or flagstone terrace was as much at home in a park as a stand of hemlock" (McClelland 1998, 262–263; Photos GLAC 15504-C, HPF 1903).

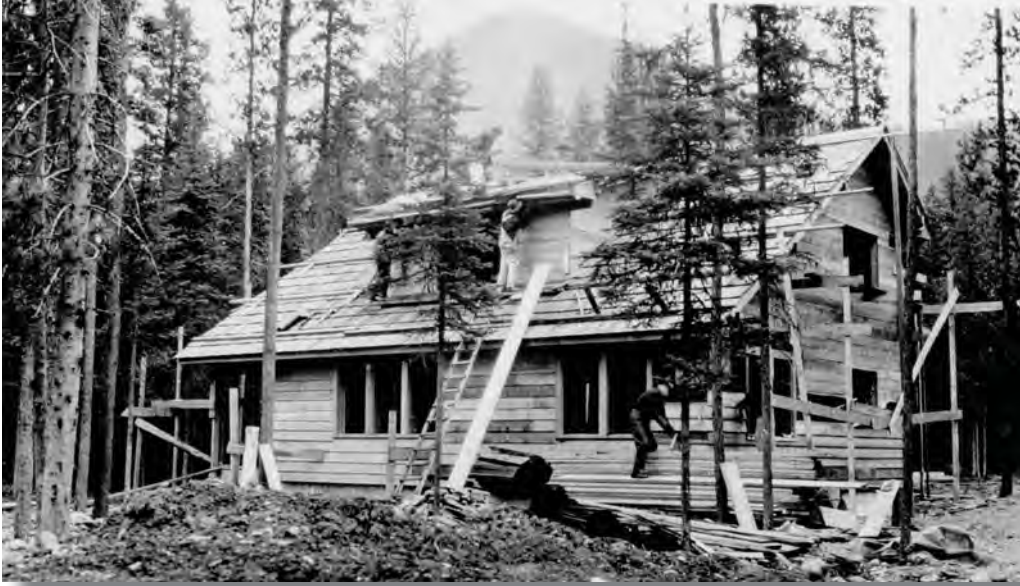
PHOTO NO. GLAC 15502-B

Figure 10. U.S. Commissioner's residence (Building 9) under construction in 1929. Trees were preserved during site development, and 80 years later, the cultural landscape is still dominated by the deep forest setting.

Expansion of the residential area continued with the commissioner's residence (Building 9; Figure 10), completed in 1929, the assistant superintendent's house (Building 16; Figure 11), completed in 1930, and four more small

employee residences. The first two buildings were two-story houses with multiple upstairs bedrooms, the floor plans being on a similar scale with the superintendent's house. The commissioner's house was situated beyond the existing row of employee residences and extended the residential area to the north. The assistant superintendent's house occupied a site near the former Snyder hotel, which had been razed three years earlier, and

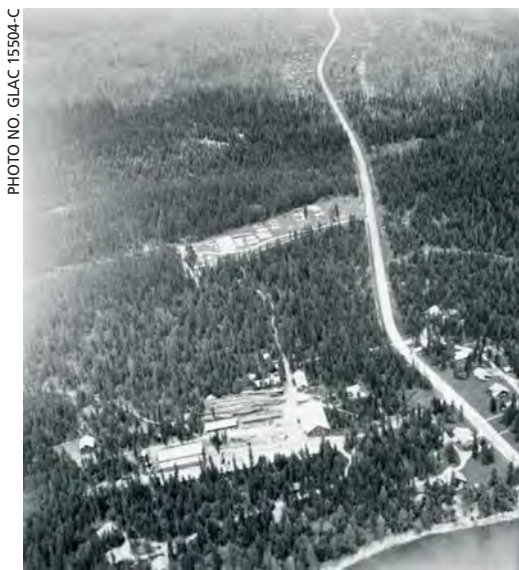
PHOTO NO. GLAC 15504-C

Figure 12. Aerial view of headquarters area in 1932.

All of this development had occurred without the benefit of a formal master plan and might be said to constitute a foundation in the first phase of development of the headquarters area. The buildings were essentially arrayed in three groups: an administrative group, consisting of the superintendent's house and the administration building, which were the first two buildings that visitors saw as they drove into the area; a residential group that was mostly strung along the north–south axis of the park road and designed to resemble a pleasant residential street; and a utility area that was set back from the road and situated along the east–west axis of the utility yard. The spatial relationships between the three areas can clearly be seen in an aerial photo taken in 1932 (Figure 12).

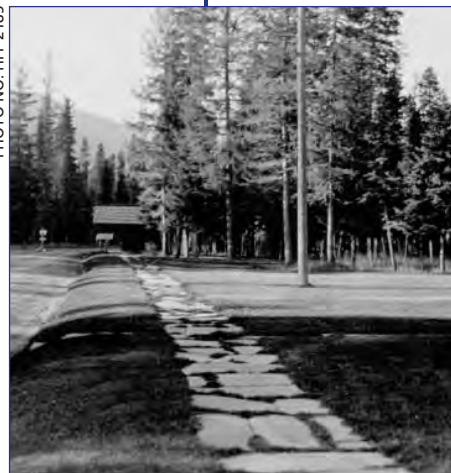
PHOTO NO. HPF 2185

Figure 13 (above). Flagstone path, likely built by CCC camp NP 1. View north on Mather Drive, September 1934.

The CCC proved to be a valuable source of labor for finishing the work of landscape naturalization begun in the late 1920s. Laborers from CCC Camp NP-1 built a network of flagstone walkways in the summer of 1934 (Figure 13). The same crew may have erected the street lamps, which featured glass lanterns hung from sturdy log posts and crossbeams (Figure 14 and Photos HPF 1902 and 1903). Presumably, it was also CCC labor that lined many of the footpaths and driveways in the area with cobbles that can be seen in several photos from this period (Photos HPF 724, 728, and 857). Historic photographs also show that numerous seedlings were planted around the residences and protected from deer and other animals by wire enclosures (see Figure 11 and Photo HPF 208).

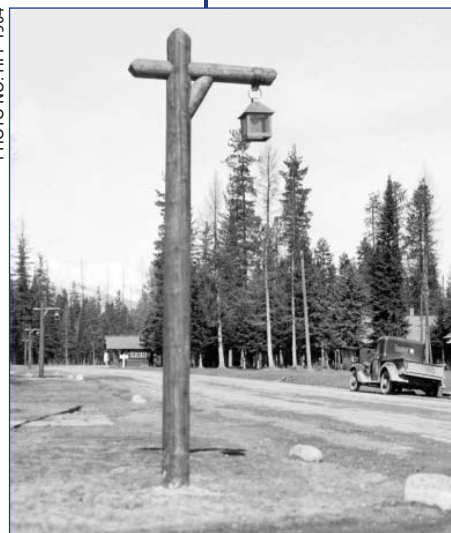
PHOTO NO. HPF 1904

Figure 14 (below). Street lights. View north along Mather Drive.

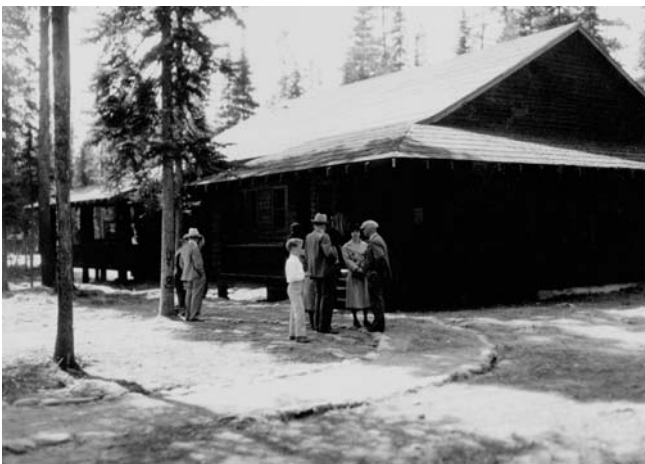
PHOTO NO. HPF 857

Figure 16. Community Building. Again, note the cobble-lined walkway.

In 1938, the headquarters area acquired a community building (Building 215, Figure 16). This building originally stood in Apgar. Built by the Gold Brothers as part of the Transmountain Hotel complex in 1923, it had been known as "Gold's Bungalow" and functioned

trators found a way around that regulation by defining the building as a “conference training center.” A CCC crew cut the building into sections and moved it from Apgar to the headquarters area in 1938. The building was then reassembled and remodeled. While it did see much use for training of personnel (and still does), it was used more regularly for a variety of community functions, including a weekly movie screening during the summer months and children’s roller-skating in the dark and damp winter months (Hubber 1995, 51–52; Emert 1950). Situated by the naturalist’s office, bunkhouse, and mess hall, it completed the cluster of buildings oriented toward seasonal employees.

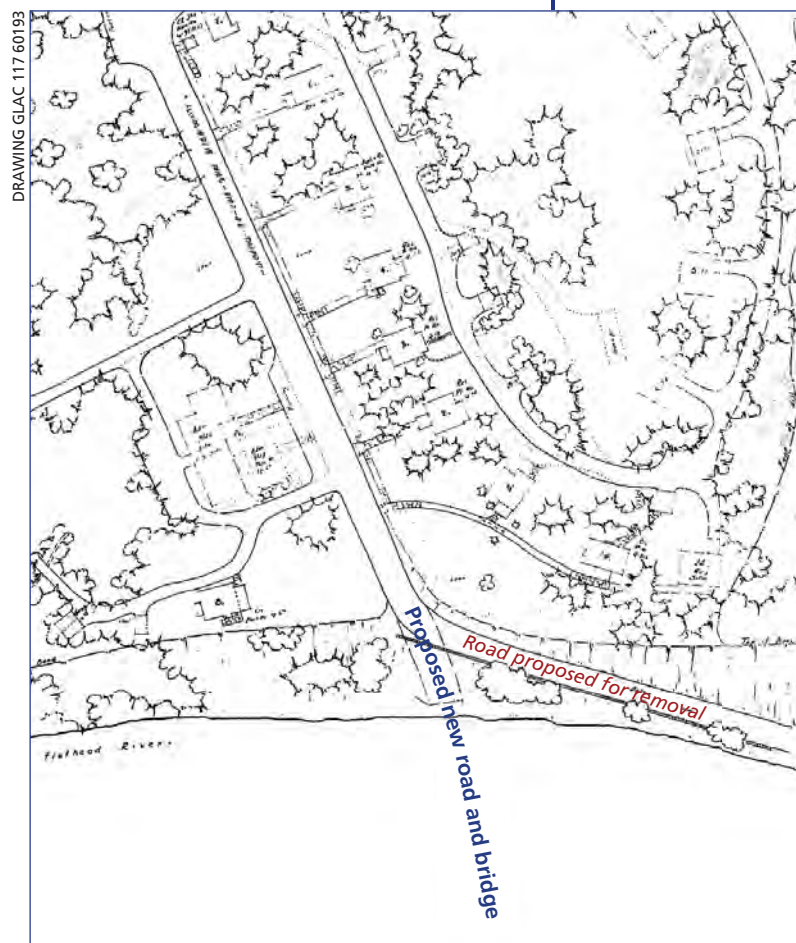
Figure 17. The 1933 master plan showed the headquarters area prior to the re-alignment of the Sun Road. Note the projected new bridge, which would have preserved the original road through the headquarters area.

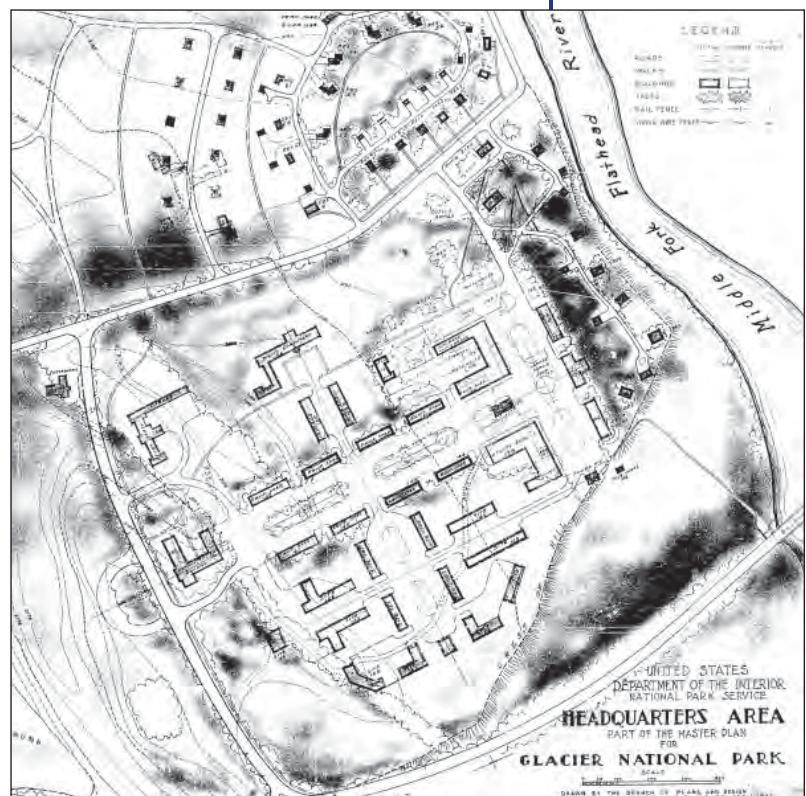
Figure 20. This detail from the master plan in 1942 shows the entrance road, administrative building, and expanded utility area.

The plan for an expanded utility area followed from the location of the future administrative building. From the rear of the administrative building, a new maintenance yard would extend on a north-south axis perpendicular to the present maintenance yard, intersecting

the older yard to form a T. The new maintenance yard was to be bordered on each side by a row of equipment sheds, just like the older maintenance yard. The monotony of the yard itself would be broken by a row of three (later two) oval-shaped tree islands located down the center line, creating a boulevard entrance.

The 1942 plan also called for the removal of both the auto repair shop and the warehouse from the older maintenance yard and the potential addition of plant or tree islands in that large space, as well (see Figure 20). The first four equipment sheds (Buildings 217, 220, 231, 244) were built by the CCC in 1941 (Hubber 1995, 40). These sheds are still standing, as are the trees on the southernmost extant tree island. The other one or two tree islands (nearer the administrative building) do not remain; in fact, it is not known whether they were ever constructed, nor is it known whether the trees on the existing island were planted or constitute a remnant patch of forest. The existing tree island has diminished in size over the past several years to allow for more parking. One drawing of the headquarters area in 1959 was accompanied by an oblique-view sketch that suggests there was a design intent to retain many patches of forest within the developed area (Drawing GLAC 117 60041).

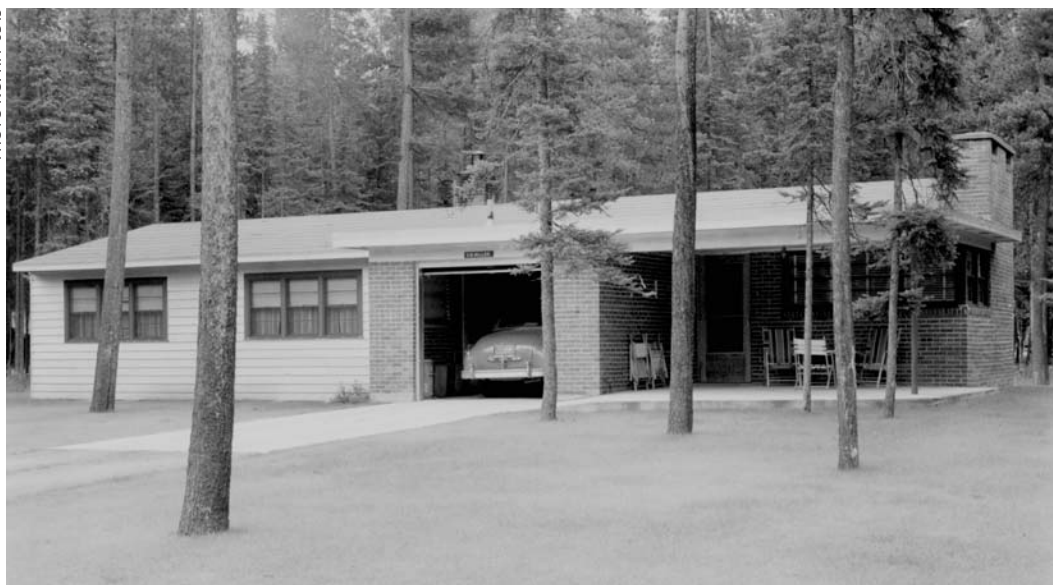
PHOTO NO. HPF 6345

Figure 21. Building 41, first of three residences built between 1949 and 1953.

Figure 22. Building 80, one of three employee housing units built between 1949 and 1953, exhibiting the Midcentury Modern architectural style that would characterize Mission 66.

ran through the mid-1960s. It began with one new residence built in 1948–1949 (Building 41; Figure 21), and two more in 1952–1953 (Buildings 77, 80; Figure 22). These three residences were architecturally significant because they marked the first break with the Park Service Rustic style that had characterized the complex up to that time. The first residence was a three-bedroom, two-bath Ranch Style house with an attached single-car garage, constructed for the assistant superintendent. The attached garage was a new feature in park housing. The outdoor living area included a covered porch. The house had a partial basement and was equipped with a hot water oil furnace. The house had distinctly modern lines when viewed from the street; the north façade was dominated by the centrally located garage and porch, while the flat roof of the garage and porch formed a strong horizontal element paralleling the ridgeline of the gable roof. The two houses built in 1952–1953 were even more modern in style, with low, almost flat roofs. Each was built according to a split-level L-plan and featured a detached, flat-roofed, one-car garage connected to the house by an open breezeway (Wheaton 2006, 3).

An interesting feature of the two residences built in 1952–1953 was that each came with a landscape plan. These plans seemed to blend the landscape naturalization efforts instituted by Chief Landscape Architect Vint in the late 1920s with the park service’s newer goal of

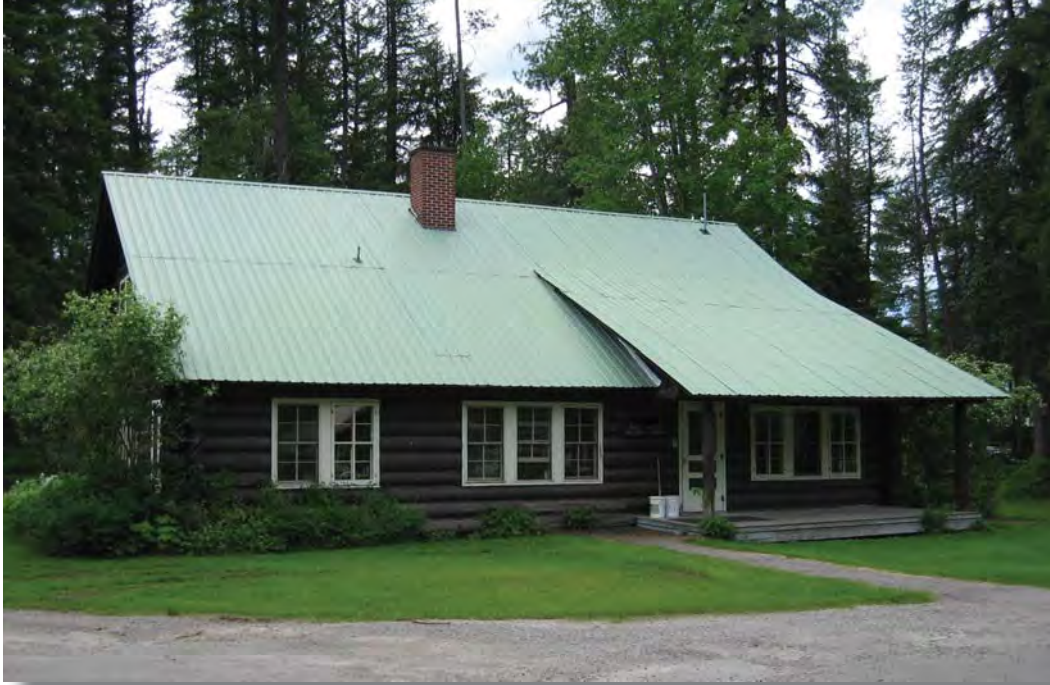
Figure 27. West Lakes District Office in 2011.

The original portion of the building rests on a metal-sheathed foundation. The addition is on a concrete foundation and contains a basement, reached by an exterior concrete stairwell (Hubber 1995, 30).
