Fort Barry Balloon Hangar and Motor Vehicle Sheds

Abbreviated Historic Structures Report

Golden Gate National Recreation Area
San Francisco, California

Produced by the Cultural Resources and Museum Management Division
National Park Service

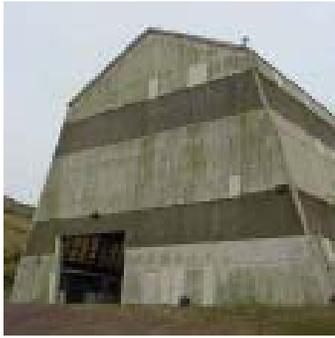
The north elevation of the Balloon Hangar showing the existing 15' x 20' opening and the two tiers of corrugated glass fiber sheets. (Jane Lehman, 2002)

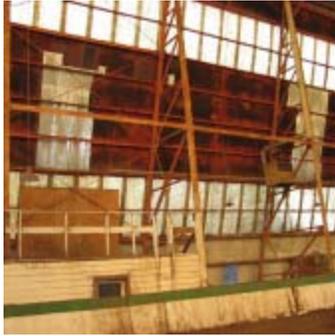
The vertical trusses form bays along the sides of the Balloon Hangar and the glass fiber sheets let in an ample amount of natural light. (John Martini, 2004)

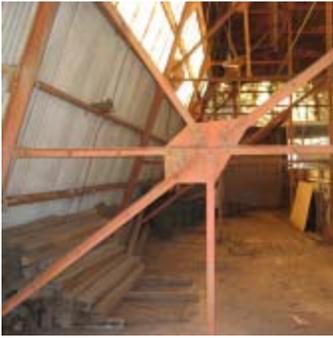
Current Building - The lowest tier of the Balloon Hangar siding is corrugated cement asbestos siding in approximately 3' x 6' sheets. They are 3/8" thick with a 4.2" profile in the corrugations. This siding is cracked and broken in many places and has a great deal of green algae on the exterior. Where sheets of siding have broken, an attempt to patch the surface with corrugated metal siding has been undertaken. The upper tiers of siding are the original corrugated asbestos coated iron sheets. These are generally in very poor condition.

An attempt is made to patch the asbestos board siding with corrugated metal siding of the incorrect profile. (John Martini, 2004)

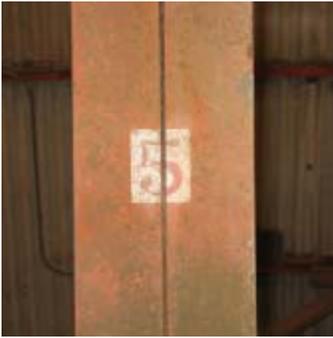
The structure's original field-assembled trusses are clearly visible. (John Martini, 2004)

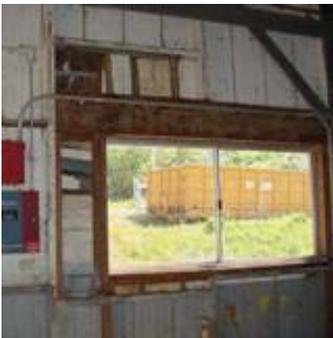
Aluminum sliding window installed in the area of former wood double-hung window. Note former rough opening. (Jane Lehman, 2004)

There was at least one wood frame, double-hung window in each end of the Vehicle Sheds. Several of them have been replaced with aluminum sliders of a different proportion than the original.

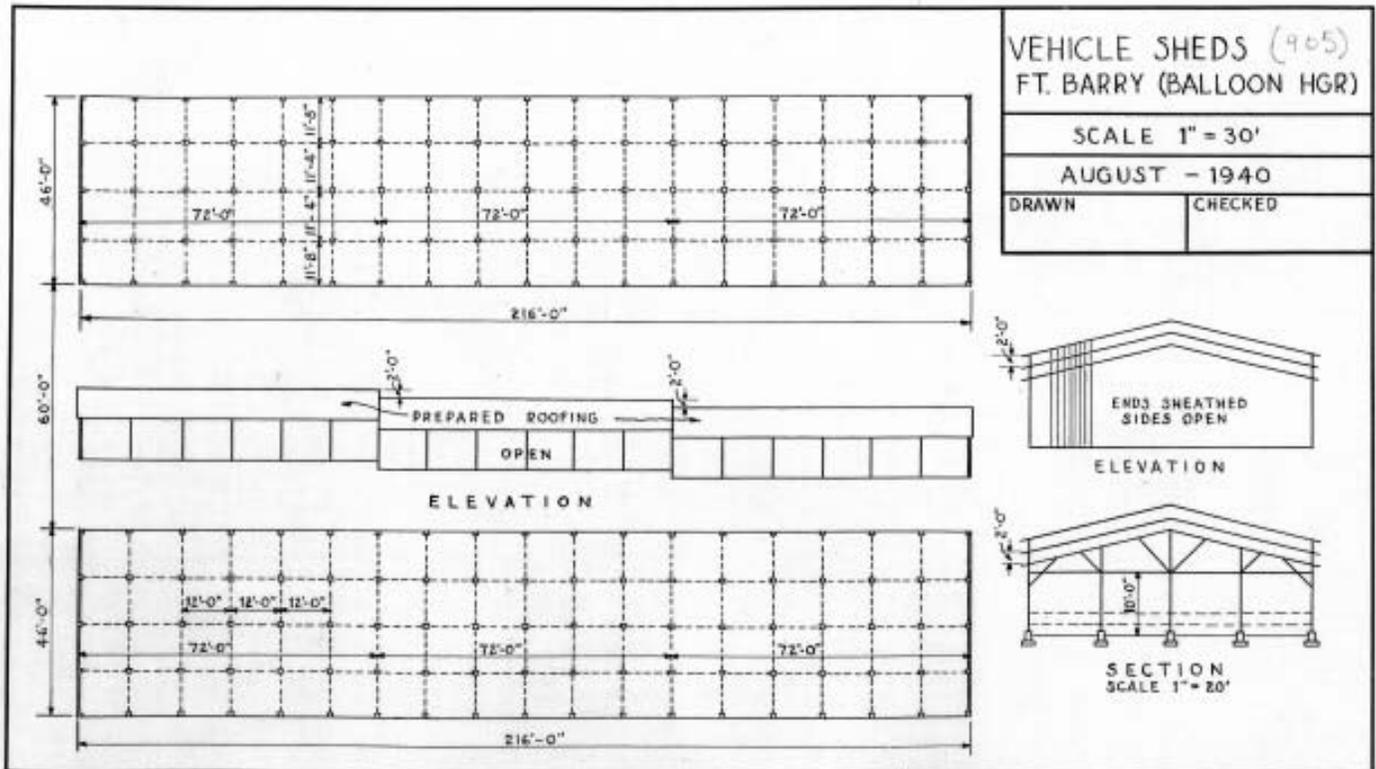
The vehicle sheds are constructed of 4x4 posts and beams, 12'-0" on center in both directions. There are 4x4 cross braces at the corners of all the columns. The foundations are individual precast concrete piers. The roof framing is 2x4 @ 16" on center with 2x6 sheathing on top.

Plans of the original Motor Vehicle Sheds, August 1940. Part of the "Series 700" mobilization structures constructed just prior to the beginning of World War II.
