***Small-Scale Features - Main Road***

**Table 16: Small-Scale Features - Main Road - Figure 3-229**

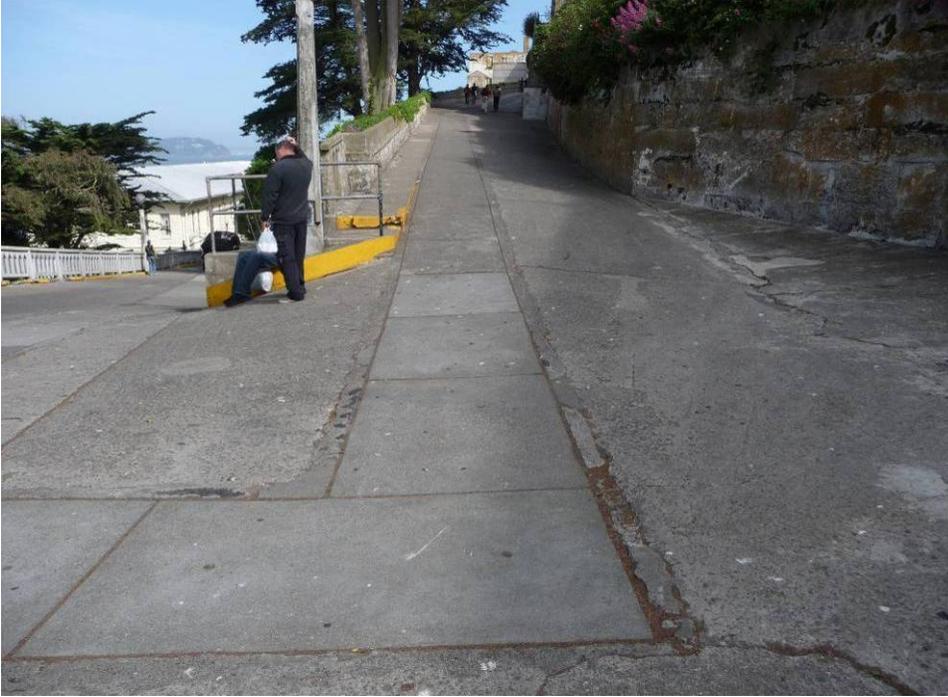
**Figure 3 - 151.** Main Road: Switchback Three with Concrete Covered Utility Trenches – Concrete Chase and Sidewalk on the east side of Main Road in center of photo (MBD P1010229.JPG)

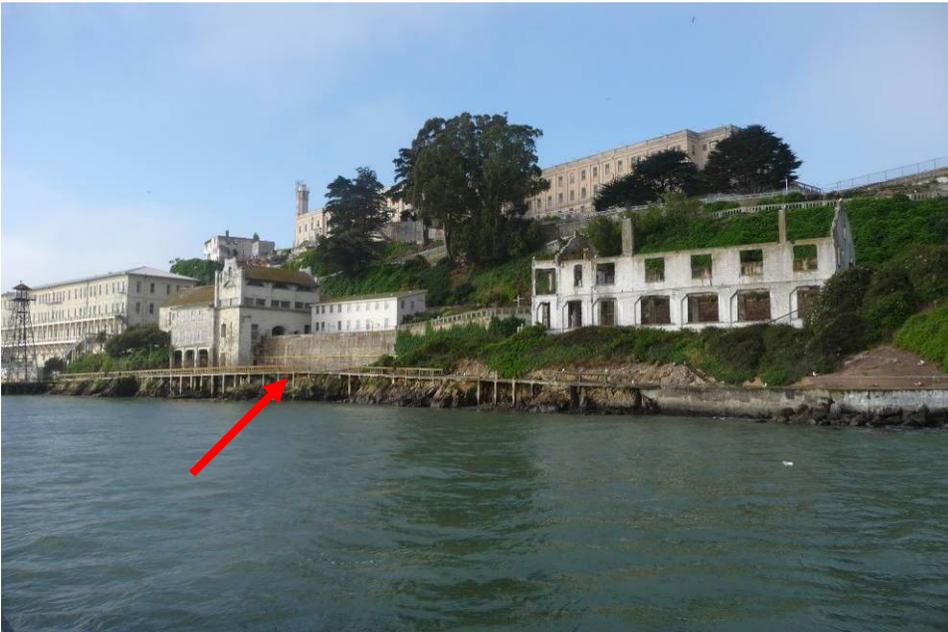
**Figure 3 - 152.** Perimeter Sentry Walk along northeast shoreline (MBD P1010016.JPG)

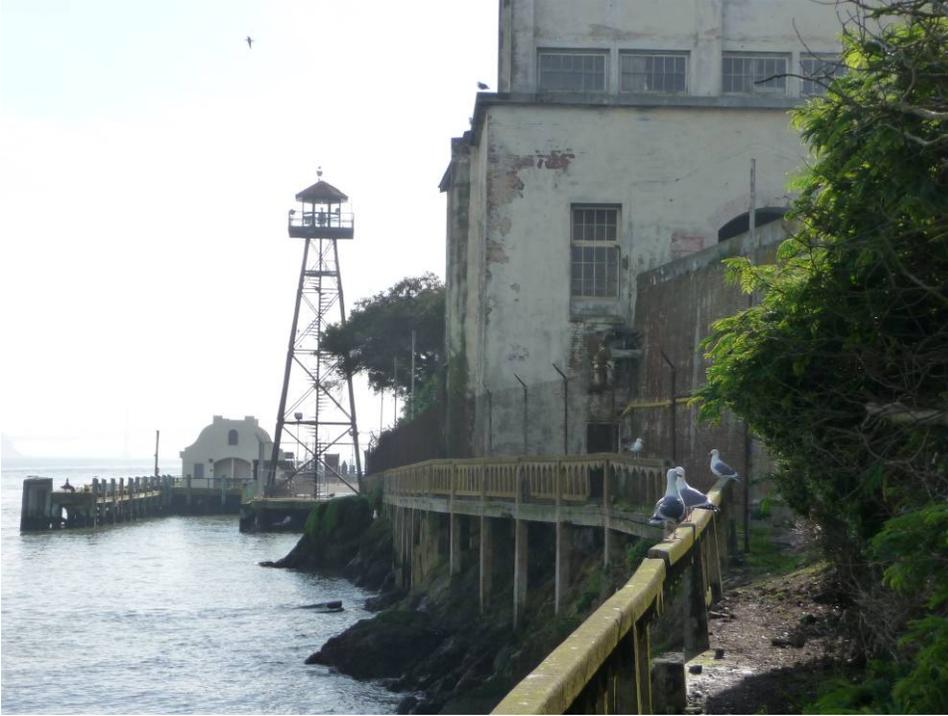
**Figure 3 - 153.** Perimeter Sentry Walk north of Guardhouse Complex looking south towards Wharf (MBD P1030446.JPG)

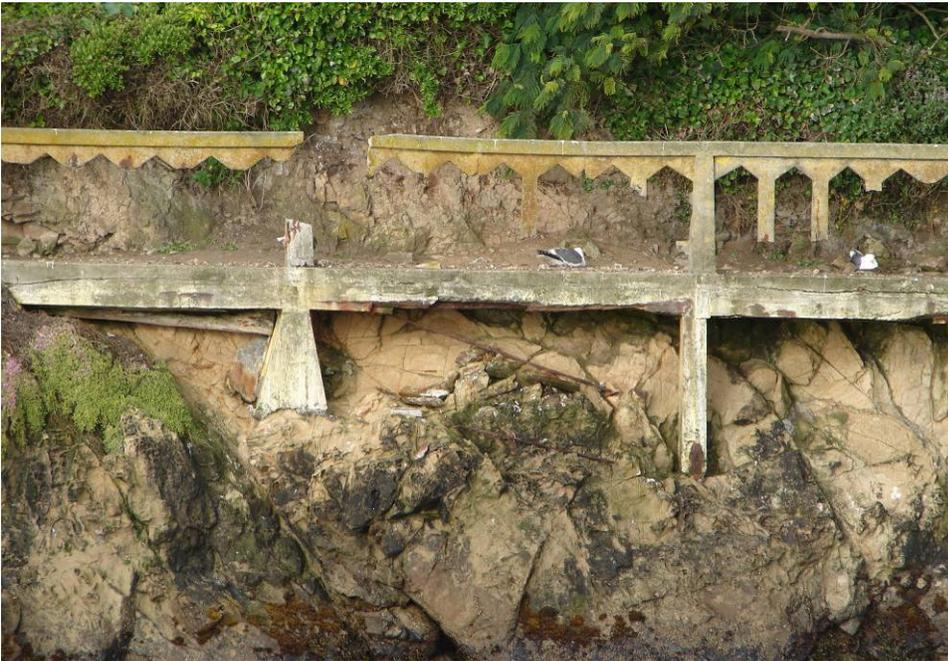
**Figure 3 - 154.** Perimeter Sentry Walk concrete piers, decking, and railing, viewed from water. (MBD DSC03003.JPG)

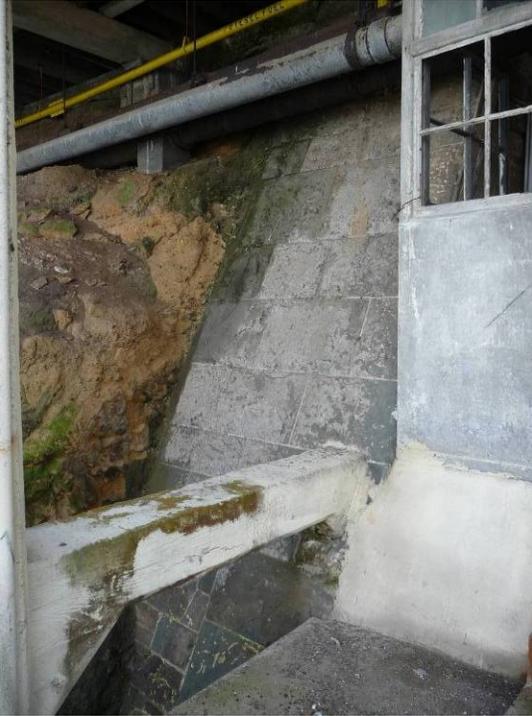
**Figure 3 - 155.** Angel Island Bluestone Retaining Wall underneath Guardhouse Complex, South of Dry Moat at Guardhouse. (MBD P1030425.JPG)

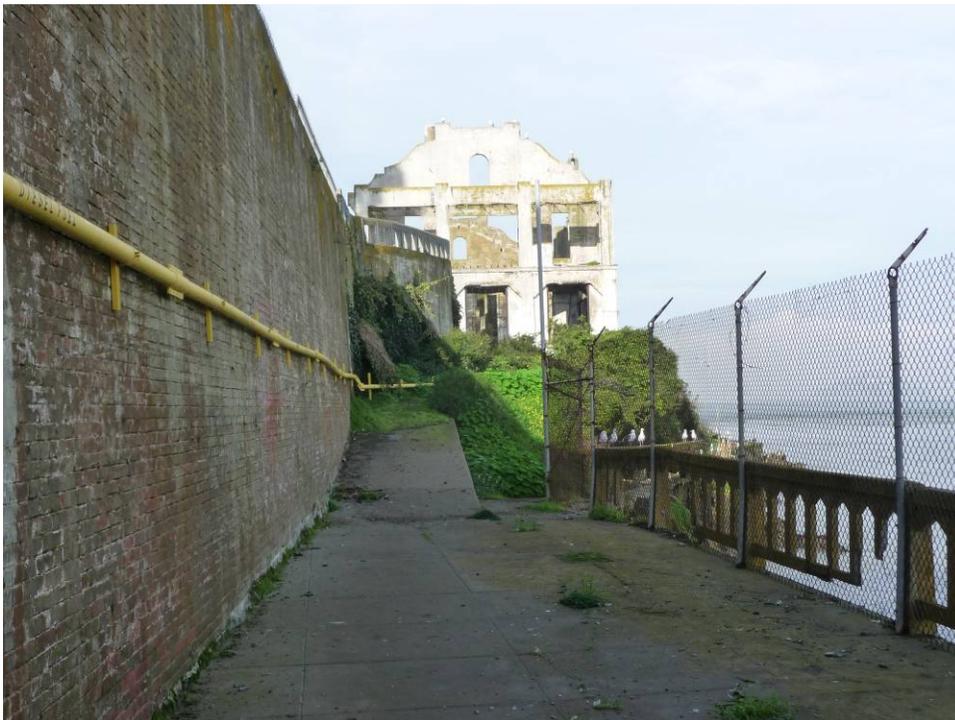
**Figure 3 - 156.** Concrete Ramp to Post Exchange from Perimeter Sentry Walk; looking north from walk north of Guardhouse Complex (MBD P1030433.JPG)

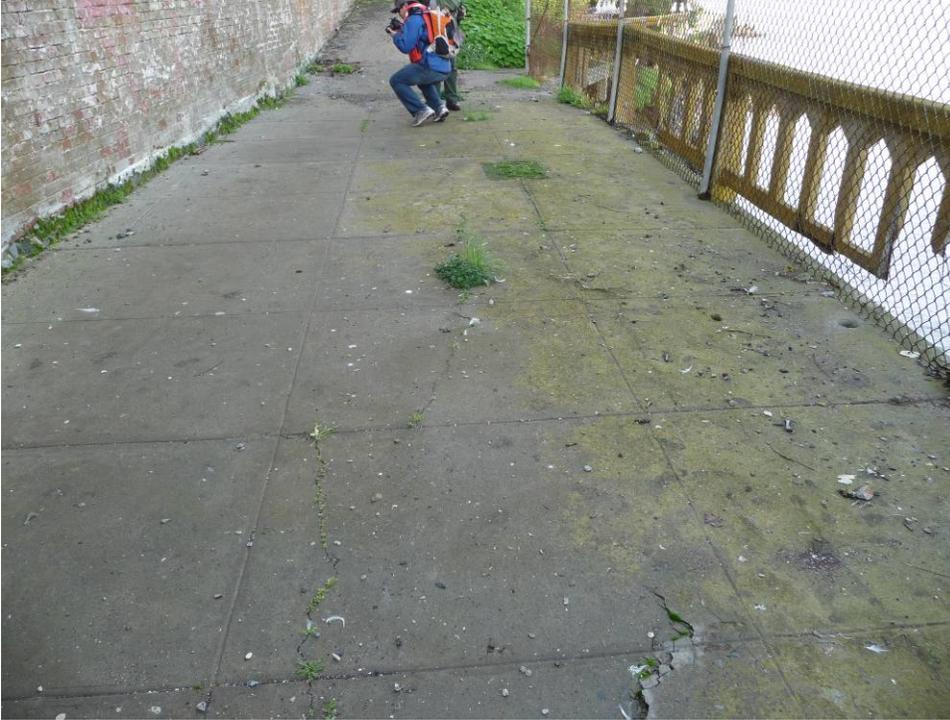
**Figure 3 - 157.** Perimeter Sentry Walk Concrete Paving in area north of Guardhouse Complex (MBD P1030439.JPG)

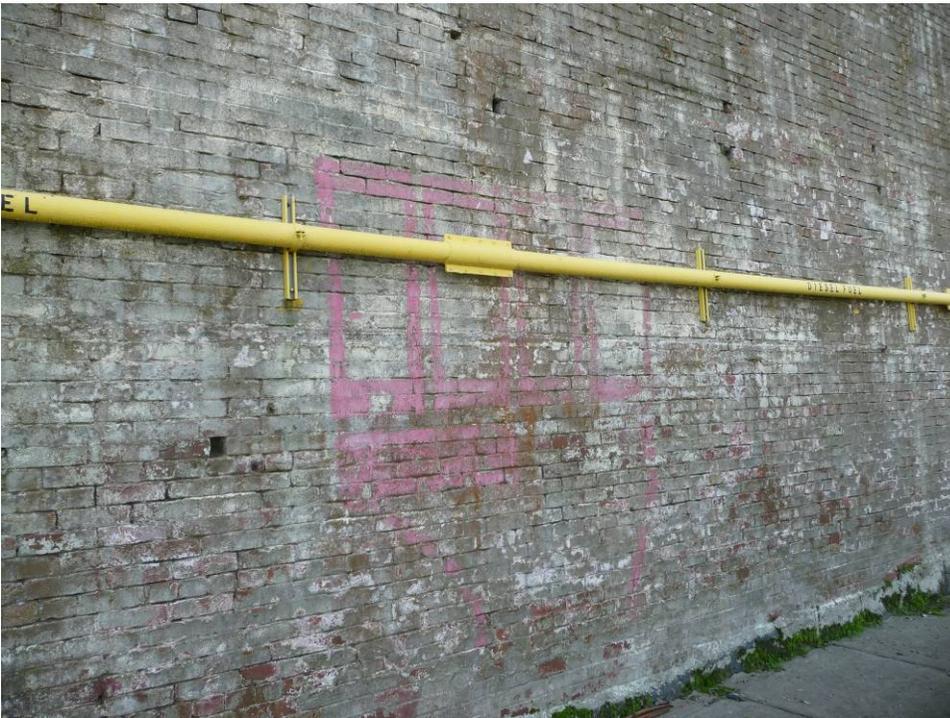
**Figure 3 - 158.** Indian Symbol-fist for “Indian Power” on Fortification Wall north of Guardhouse Complex. Viewed from Perimeter Sentry Walk (MBD P1030437.JPG)

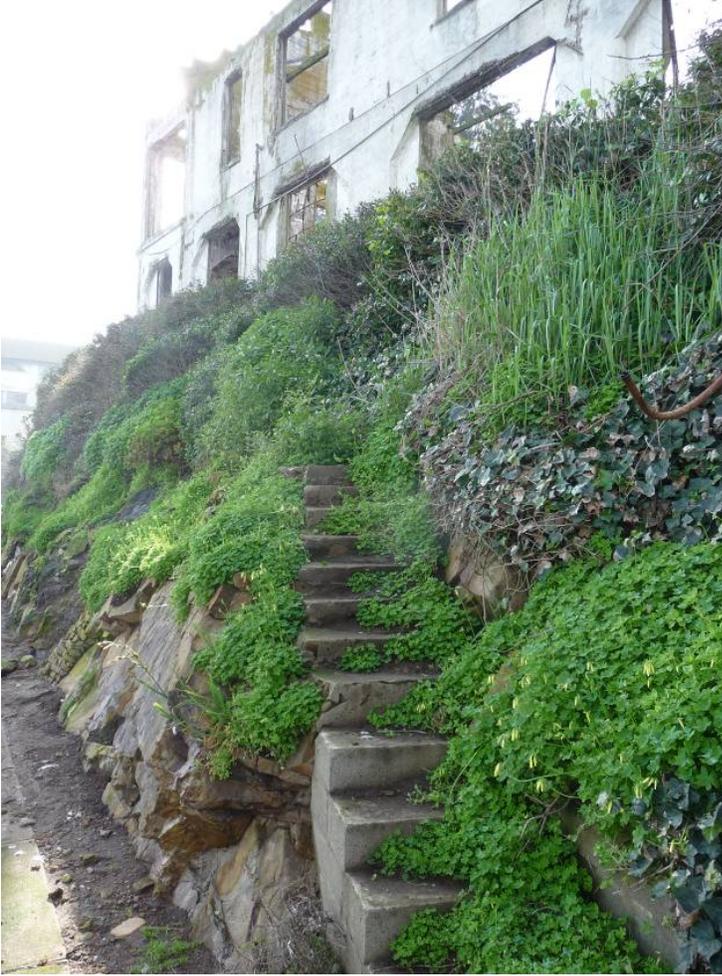
**Figure 3 - 159.** Cobble Wall and Staircase to Post Exchange, viewed from Perimeter Sentry Walk (MBD P1010019.JPG)

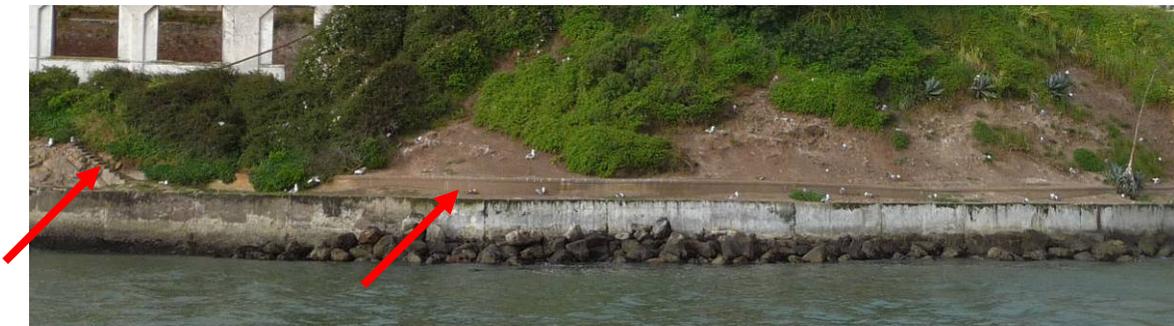
**Figure 3 - 160.** Staircase to Post Exchange, Concrete Retaining Wall, Perimeter Sentry Walk, Boulders (MBD PSW\_Concrete Retaining Wall.JPG)

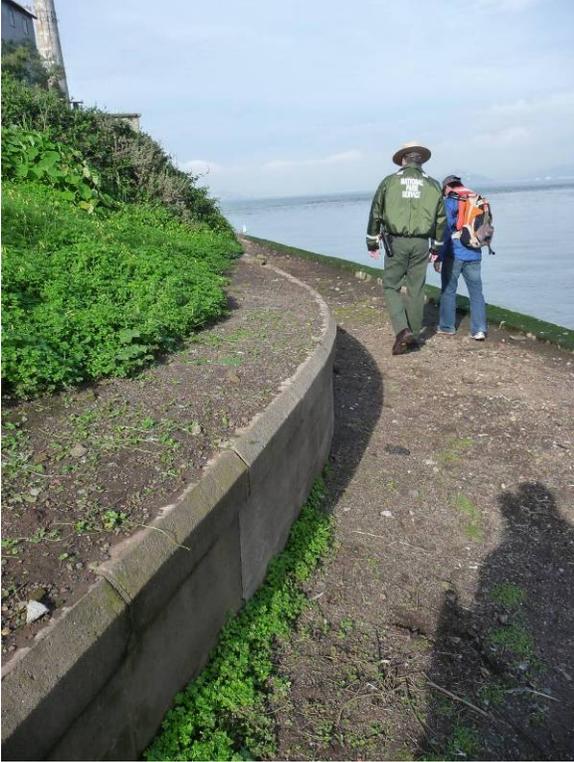
**Figure 3 - 161.** Concrete Retaining Wall along west side of Perimeter Sentry Walk, north of Post Exchange (MBD P1030457.JPG)

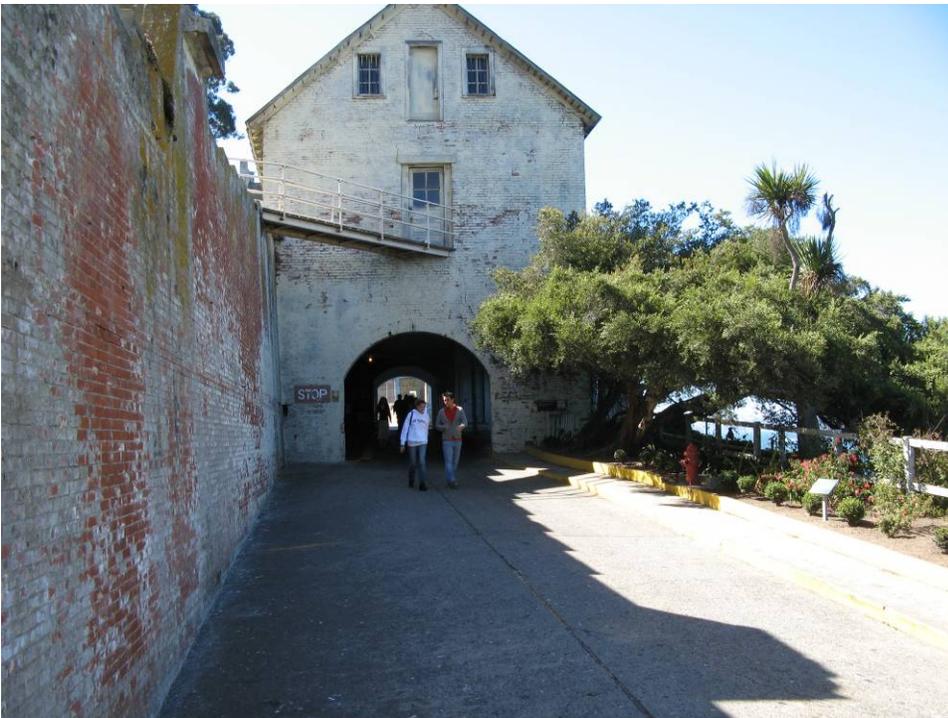
**Figure 3 - 162.** Main Road: Wharf to Guardhouse Complex (MBD IMG\_4244.JPG)

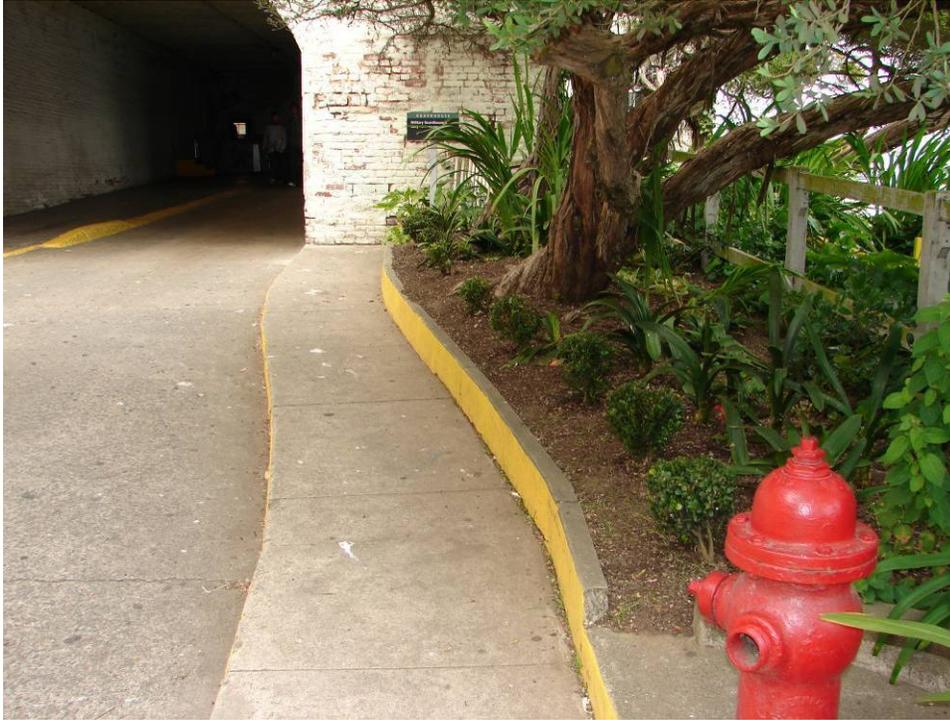
**Figure 3 - 163.** Main Road: Wharf to Guardhouse Complex, Sallyport Curb and Sidewalk, and fence (MBD DSC02491.JPG)

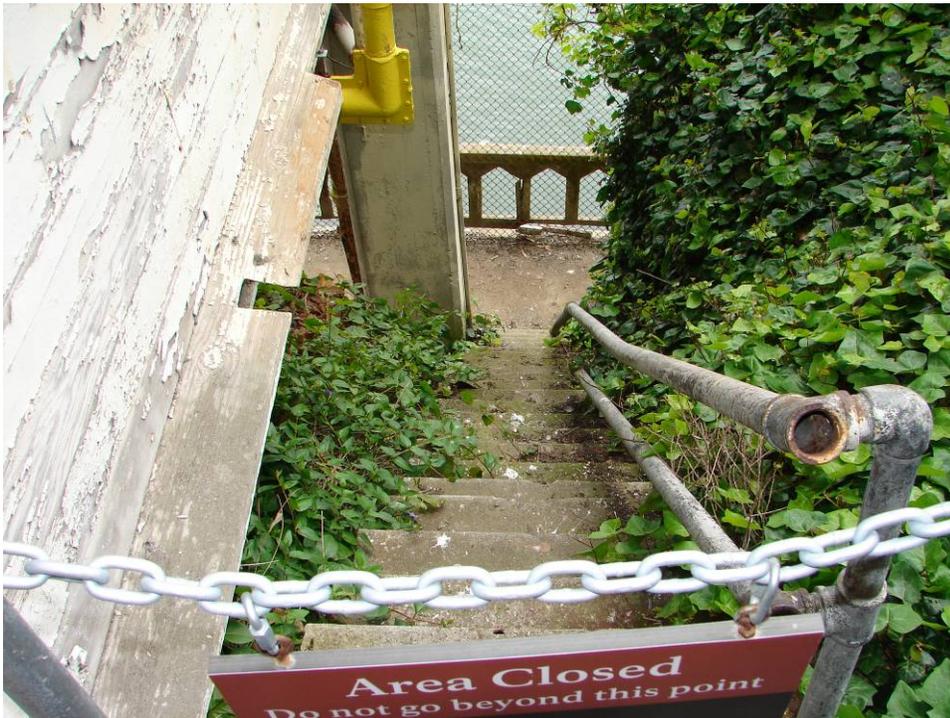
**Figure 3 - 164.** Staircase to Perimeter Sentry Walk, Concrete Retaining Wall, Perimeter Sentry Walk, Boulders (MBD DSC02495.JPG)

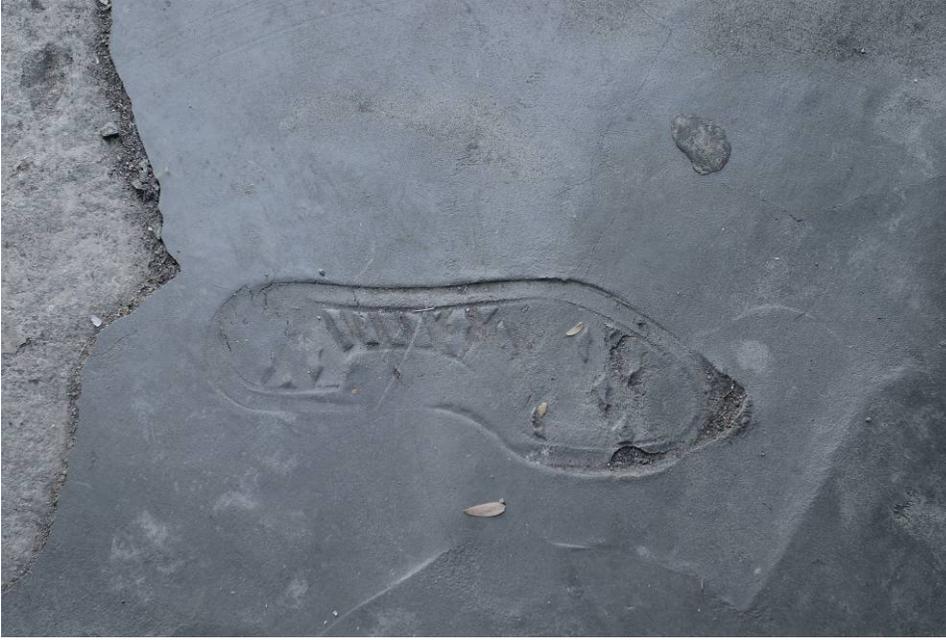
**Figure 3 - 165.** Shoeprint in concrete on sidewalk inside Guardhouse Complex (Photo Courtesy of John Martini (Tennis shoe footprint1.jpeg))

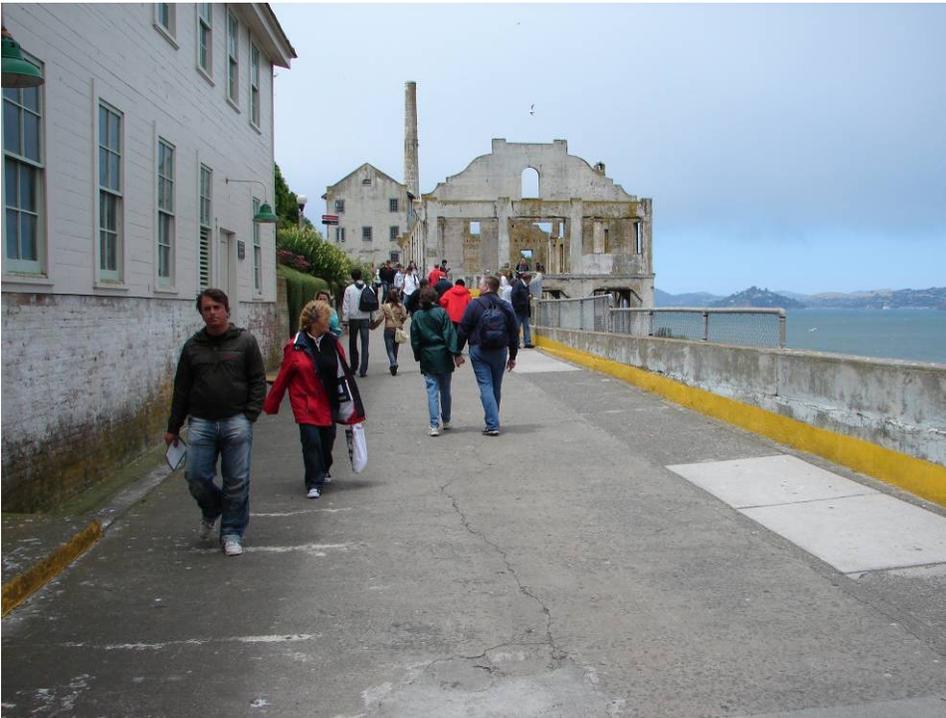
**Figure 3 - 166.** Main Road: Guardhouse Complex to Switchback One, curb on left and utility trench on right (MBD DSC02507.JPG)

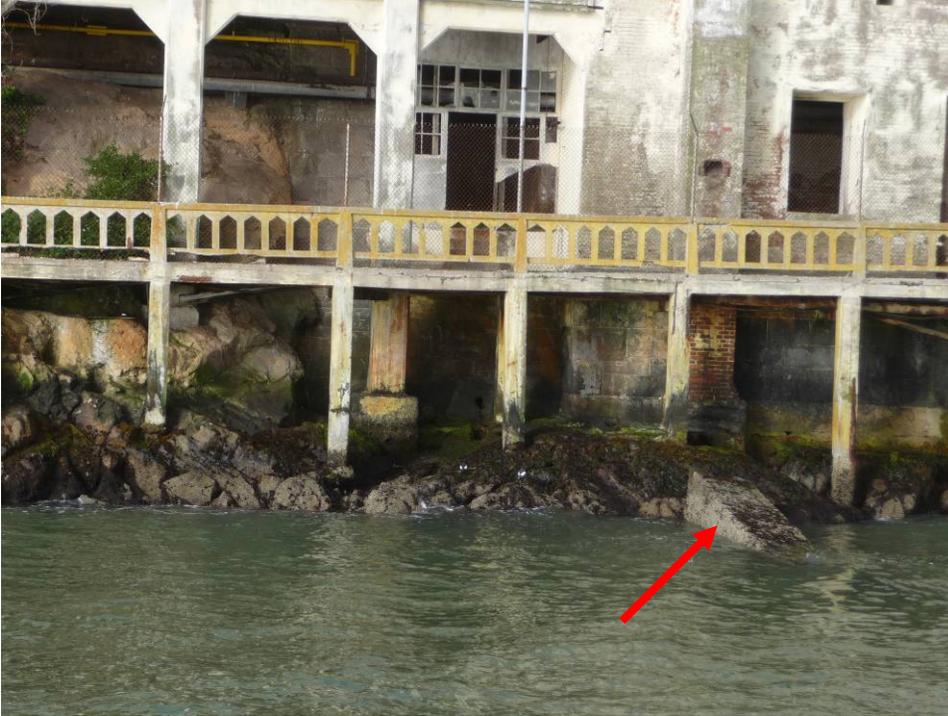
**Figure 3 - 167.** Concrete square collapsed chimney (after 1940), Perimeter Sentry Walk, SR11, and Guardhouse Complex (MBD P1010024.JPG)

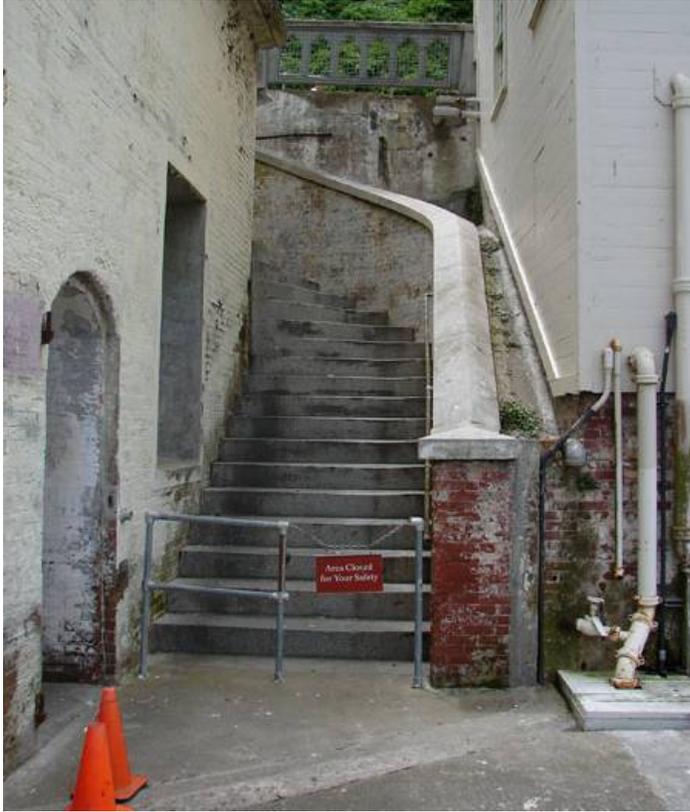
**Figure 3 - 169.** Granite Staircase at Guardhouse Complex, with brick walls and granite caps (MBD Guardhouse Stairs.JPG)

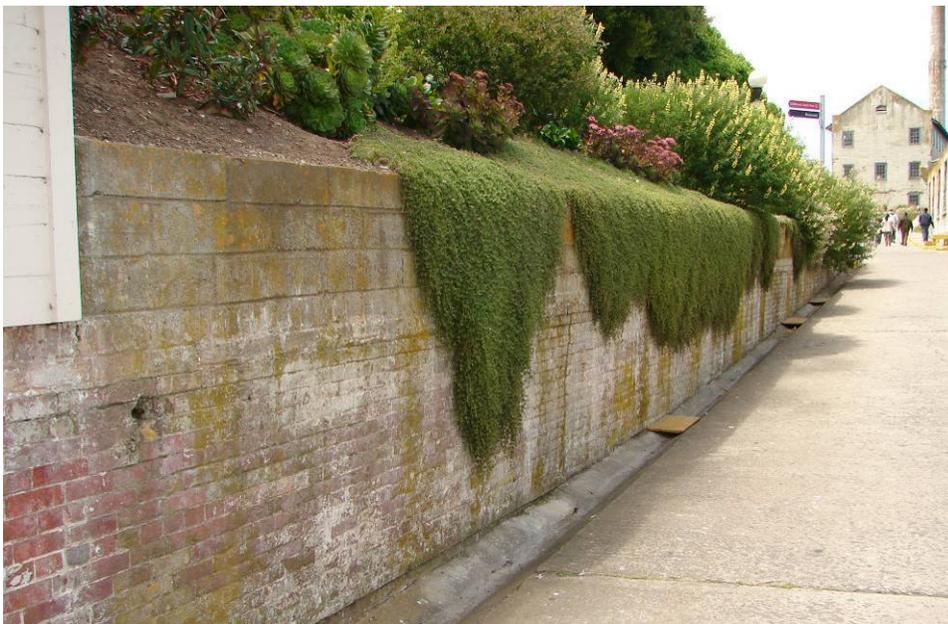
**Figure 3 - 170.** Trench along west side of road at base of Electric Shop Wall looking north on Main Road from Guardhouse Complex to Switchback One (MBD DSC02509.JPG)

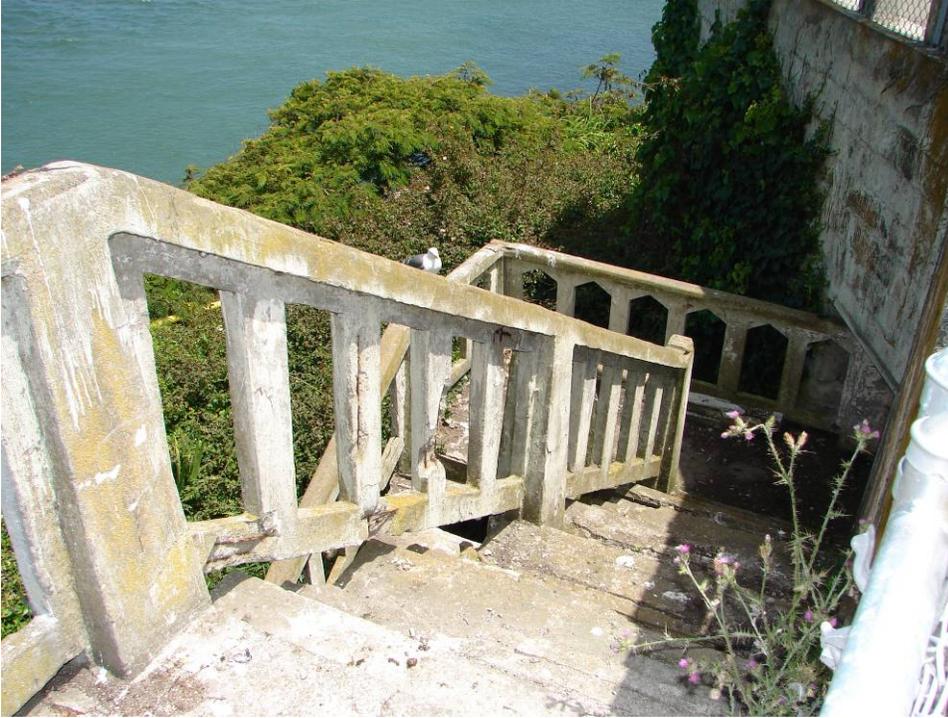
**Figure 3 - 171.** Staircase from Main Road to Perimeter Sentry Walk with decorative concrete railing (SR15 and SR16) (MBD DSC02517.JPG)

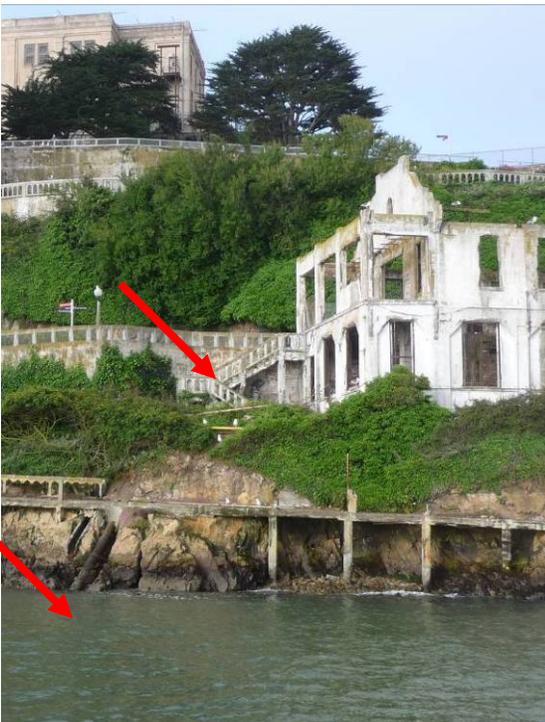
**Figure 3 - 172.** Drainage Pipe in lower left of photo; Perimeter Sentry Walk in lower center; Staircase from Main Road to Post Exchange with decorative concrete railing (SR15, SR16) (MBD P1010020.JPG)

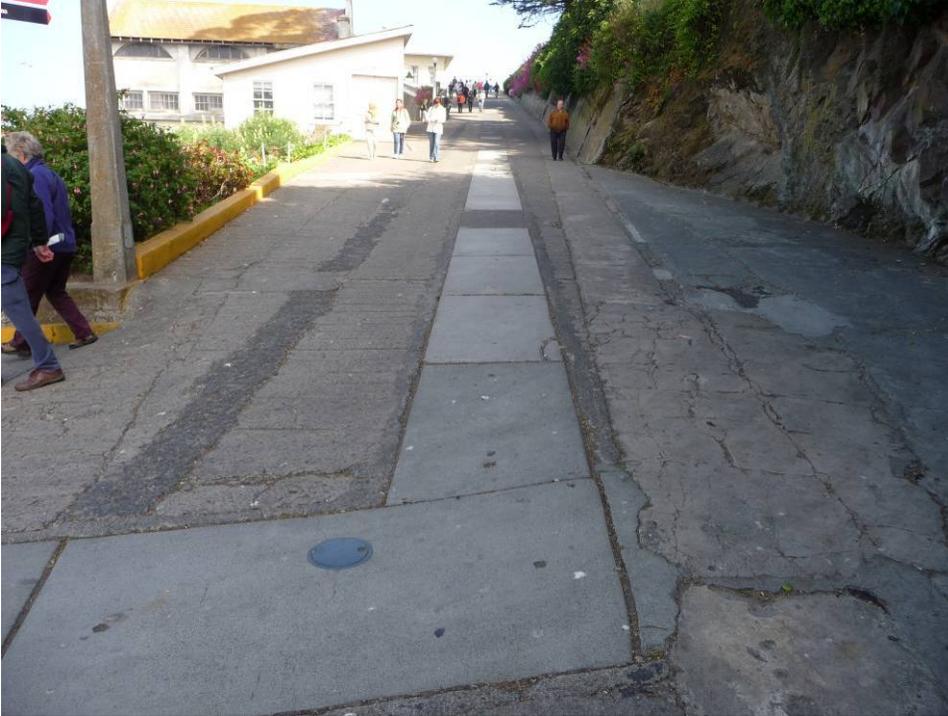
**Figure 3 - 173.** Main Road: Switchback One to Switchback Two, with Utility Trench in center note the multiple patches. (MBD P1010209.JPG)

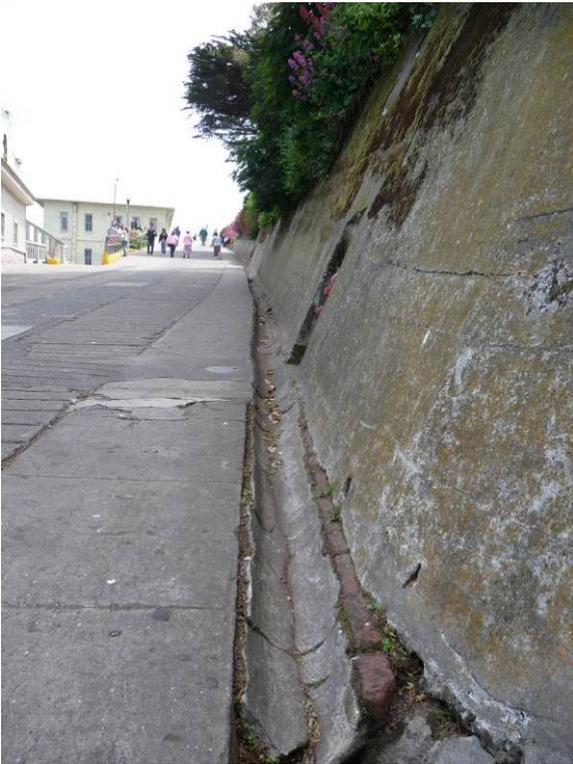
**Figure 3 - 174.** Sidewalk and gutter along west side of Road from Switchback One to Switchback Two (MBD P1000276.JPG)

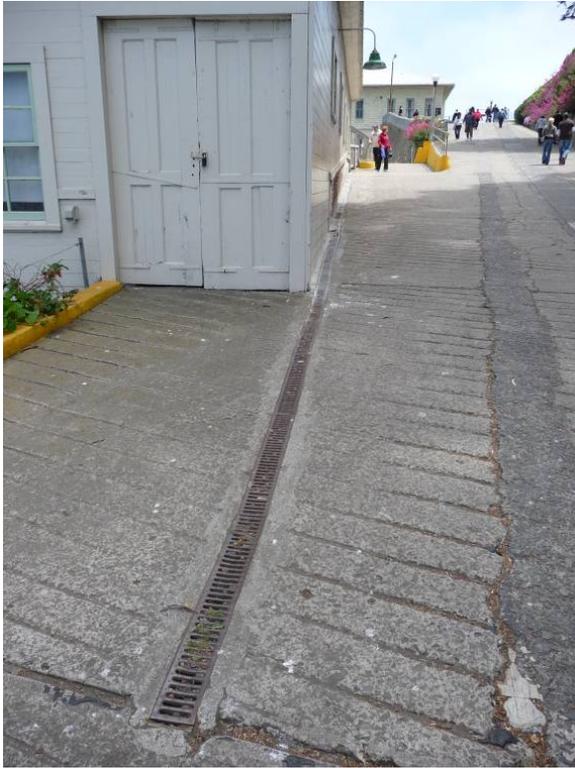
**Figure 3 - 175.** Trench Drain along east side of Electric Shop (MBD P1000285.JPG)

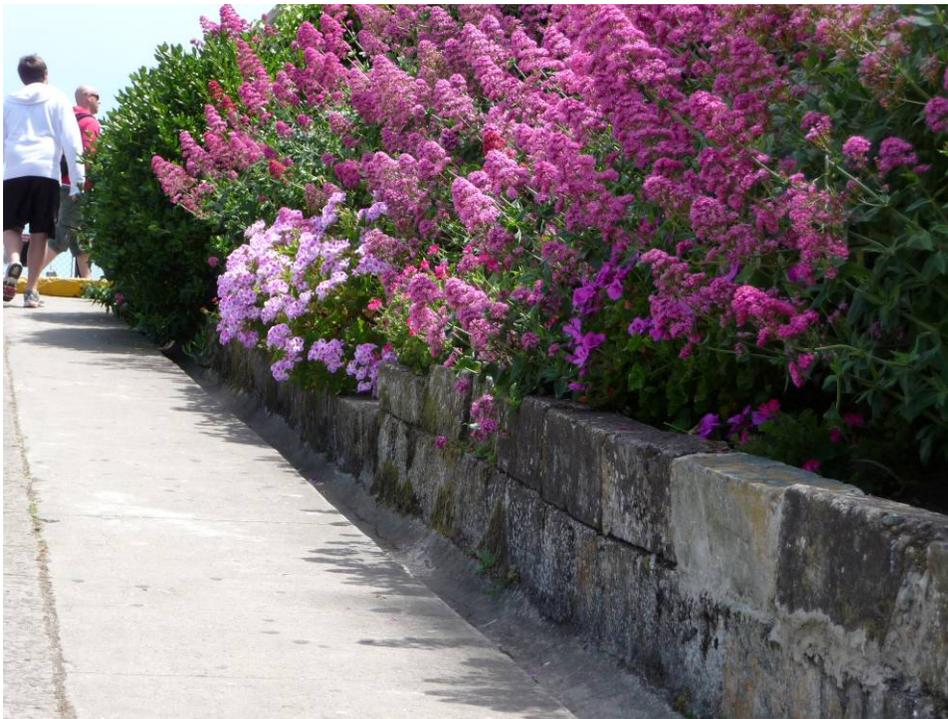
**Figure 3 - 176.** Block Curb wall, north of Switchback Two (MBD P1000316.JPG)

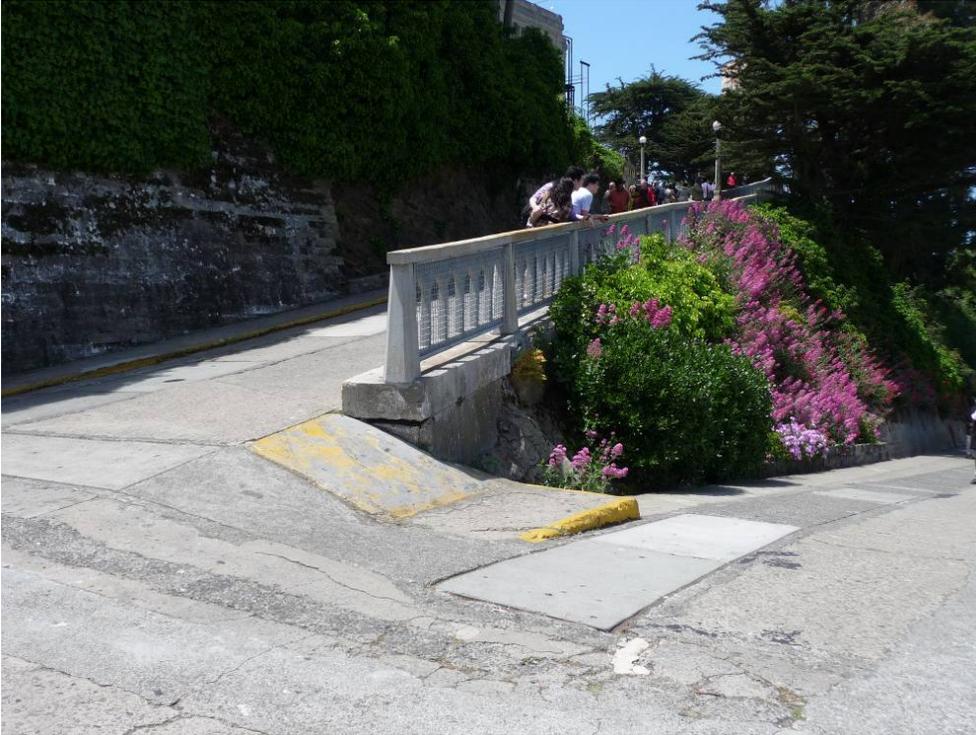
**Figure 3 - 177.** Curb and Ramp at Switchback Two (MBD Pl000307.JPG)

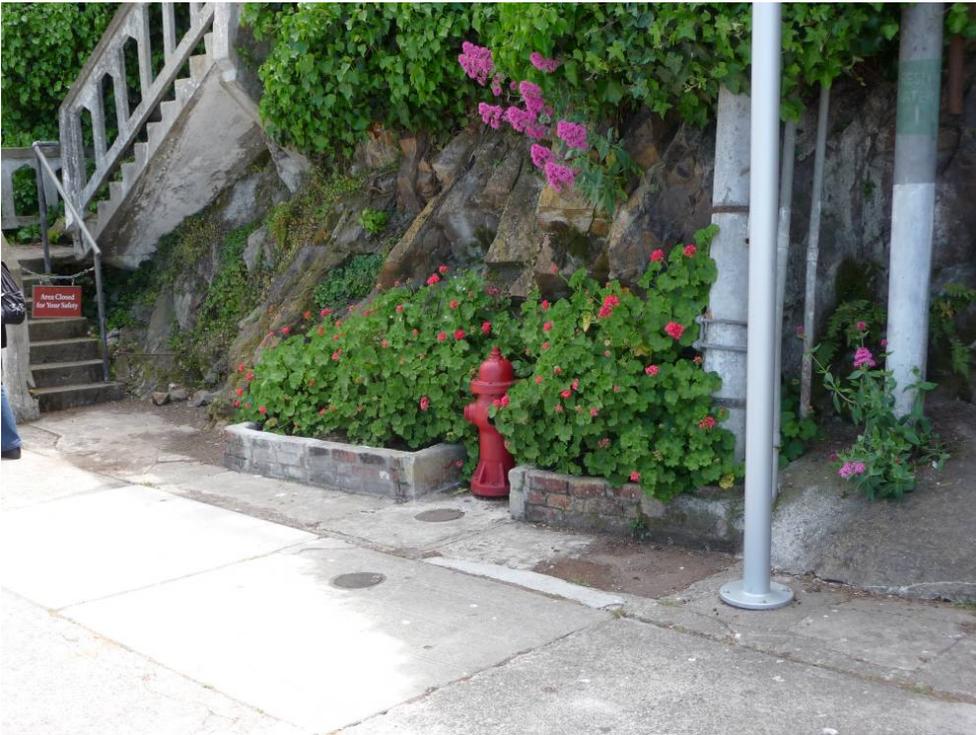
**Figure 3 - 178.** Staircase at Switchback Two to Officers' Row, Brick Planters on both sides of fire hydrant (MBD Pl000332.JPG)

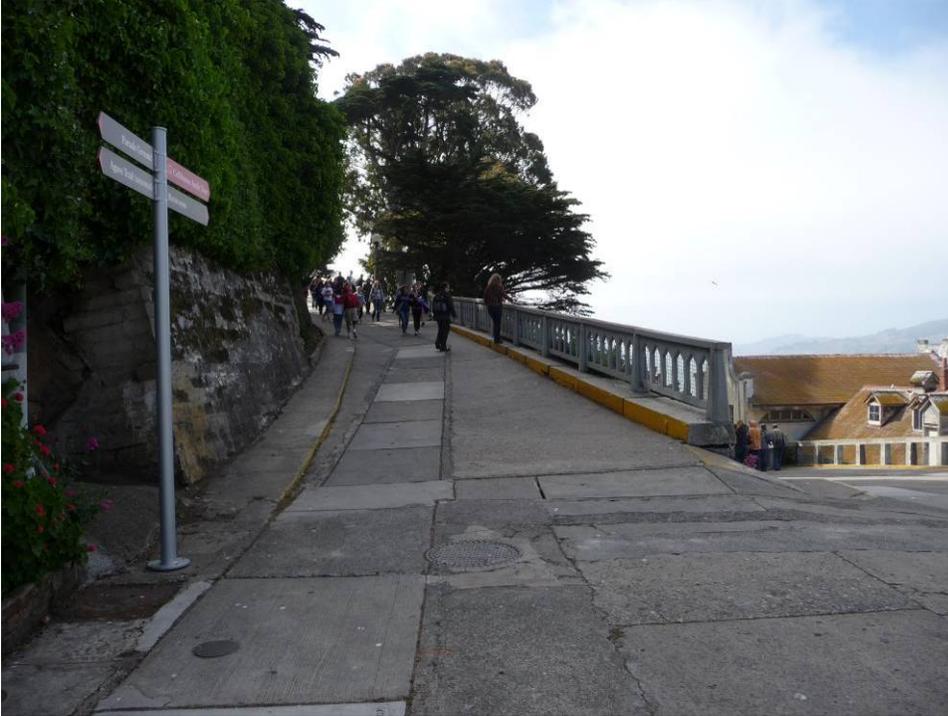
**Figure 3 - 179.** Main Road: Switchback 2 to Switchback 3, with utility chase and sidewalk (MBD P1010214.JPG)

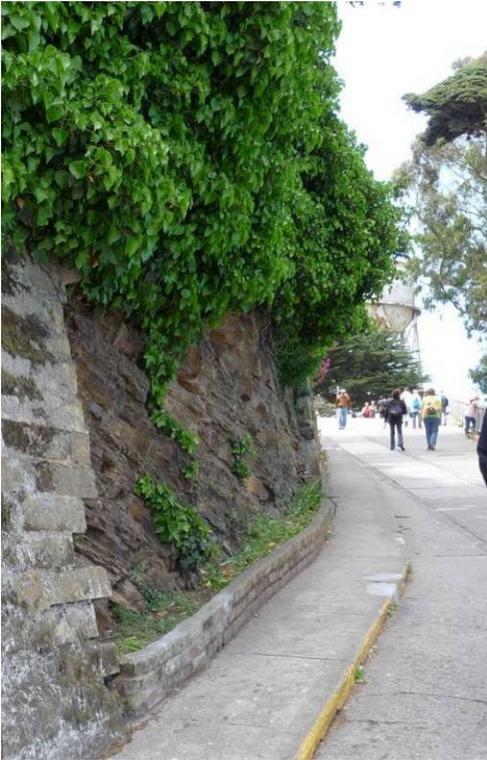
**Figure 3 - 180.** Brick Curb lining planting area along west side of Main Road from Switchback Two to Switchback Three, concrete sidewalk and curb in center of photo (MBD Brick Curb.JPG)

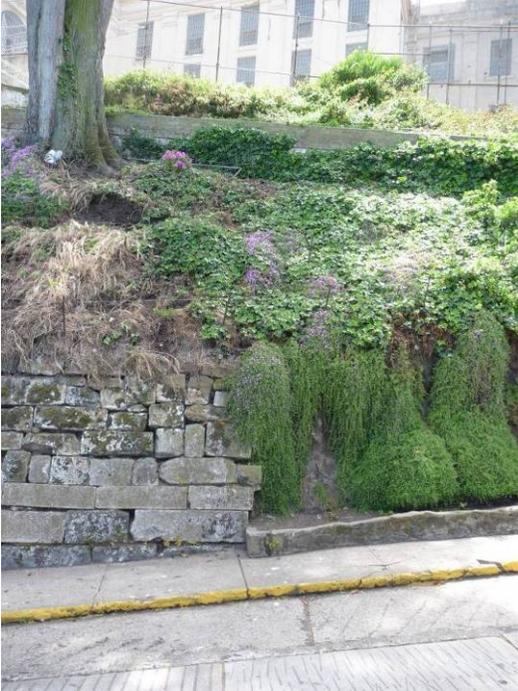
**Figure 3 - 181.** Concrete Curb lining planting area along west side of Main Road from Switchback Two, with concrete sidewalk and curb painted yellow in front, to Switchback Three (MBD P1000356.JPG)

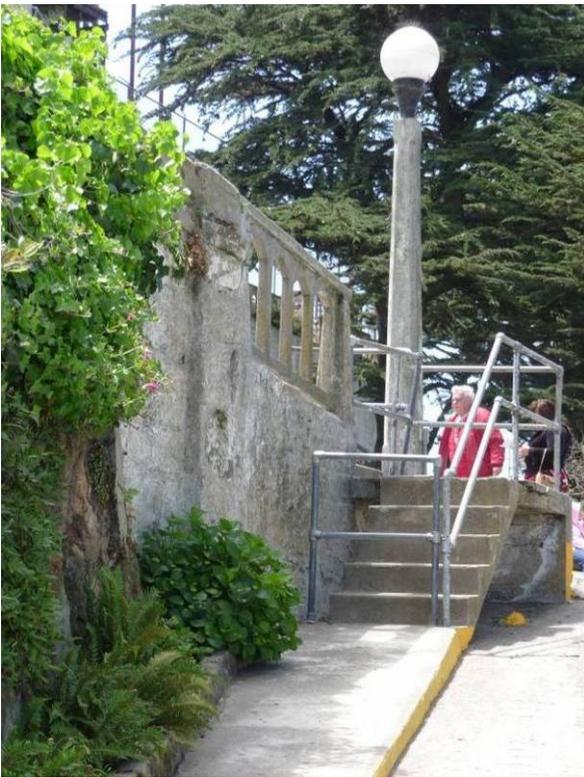
**Figure 3 - 182.** Staircase and Sidewalk at Switchback Two with metal pipe railing (SR29) (MBD P1000359.JPG)

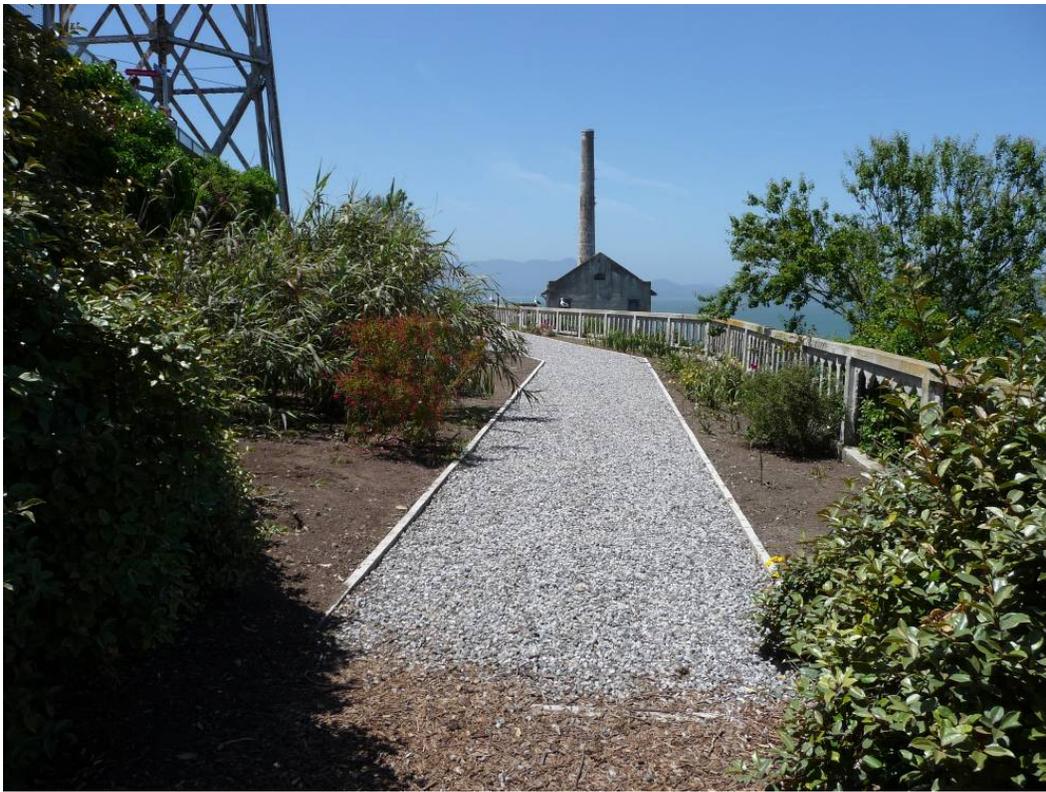
Gravel Path 2		3-184	Eight foot wide path with new gravel on south portion of Rose Garden	Good
Remnant Foundation of Greenhouse		3-185	Remnant six inch concrete foundation outline approximately 20'x15', at northern most end of Rose Garden. Reconstructed Greenhouse built in 2009/2010	Fair
Staircase to Water Tank Terrace with MBSR20		3-186	Concrete Stairs leading from Rose Garden to Water Tank Terrace with steel pipe rail (MBSR20)	Staircase: Fair MBSR20: Fair
<b>Road to Parade Ground from Switchback Two</b>				
Road to Parade Ground with MBSR25, MBSR27, MBSR26		3-187	Concrete paved surface with utility trench in center (trench extends into Parade Ground); long linear patch. Road extends from SB2. NPS cyclone safety railing, four foot height on west side.	Road: Fair MBSR25: Good, MBSR27: Poor, MBSR26: Good

Figure 3 - 184. Gravel Path 2 (MBD P1000770.JPG)

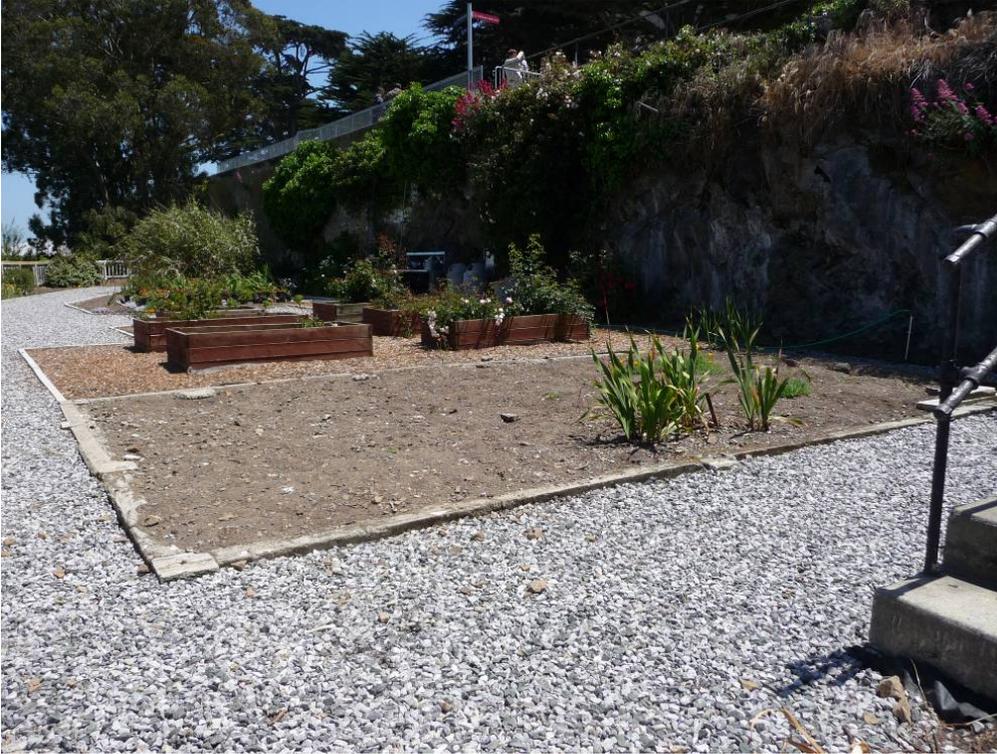
**Figure 3 - 185.** Remnant Greenhouse Foundation. Reconstructed Greenhouse c2010 now sits on these foundations (see Main Road – Structures) (MBD P1000789.JPG)

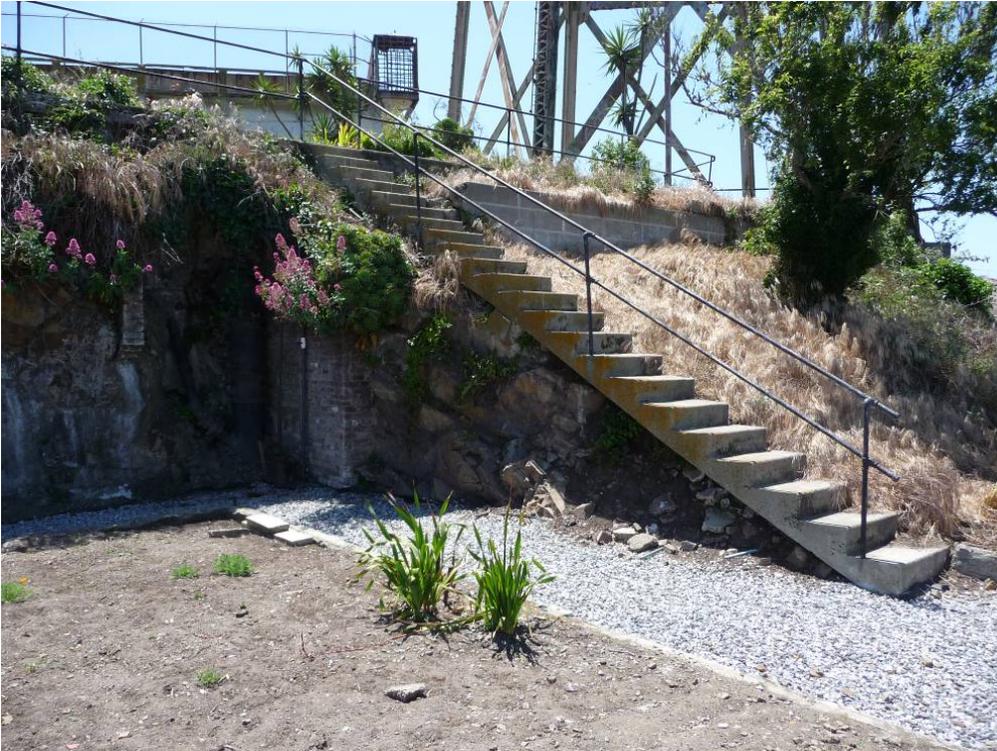
**Figure 3 - 186.** Staircase to Water Tank Terrace, in Rose Garden with metal pipe railing (MBSR20) (MBD P1000784.JPG)

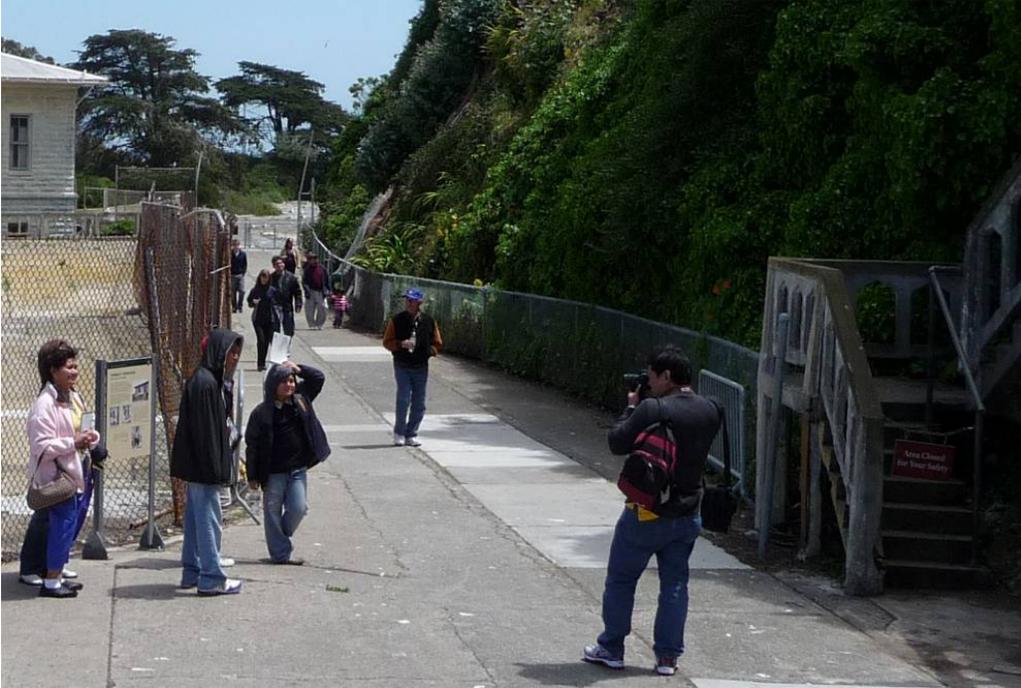
**Figure 3 - 187.** Road to Parade Ground from Switchback Two with cyclone safety railings on left MBSR25, MBSR27, MBSR26 (MBD P1000770.JPG)
