***Small-Scale Features - Main Road***

**Table 16: Small-Scale Features - Main Road - Figure 3-229**

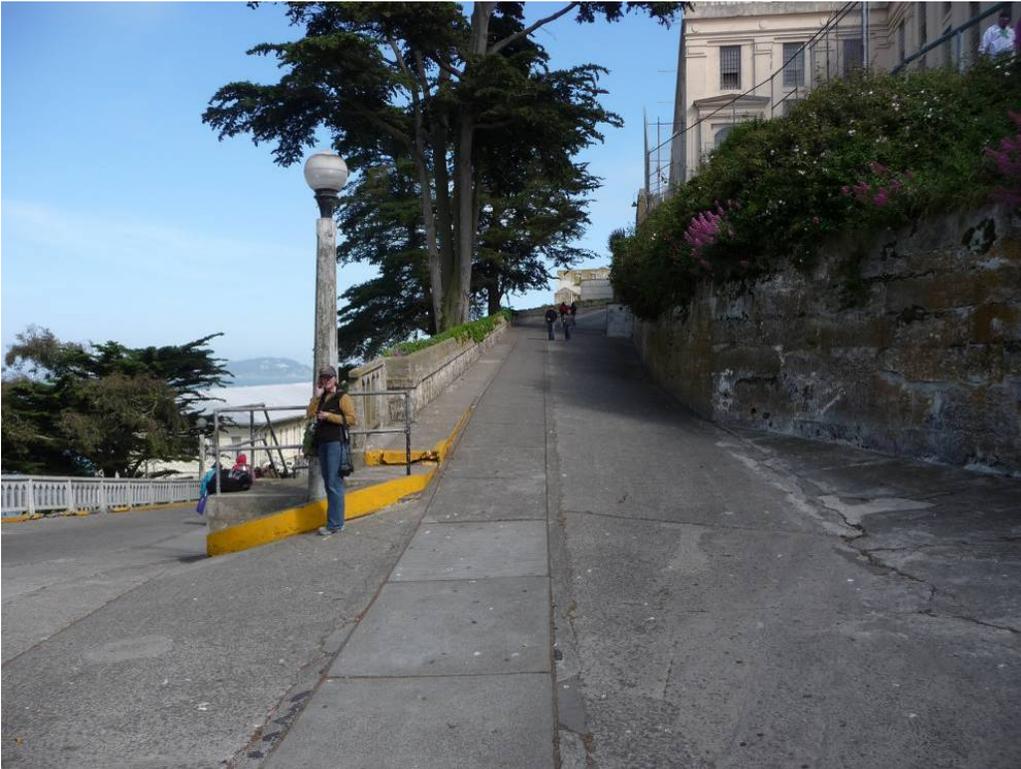
**Figure 3 - 188.** Main Road: Switchback Three to Prison, with utility chase and sidewalk (MBD P1010226.JPG)

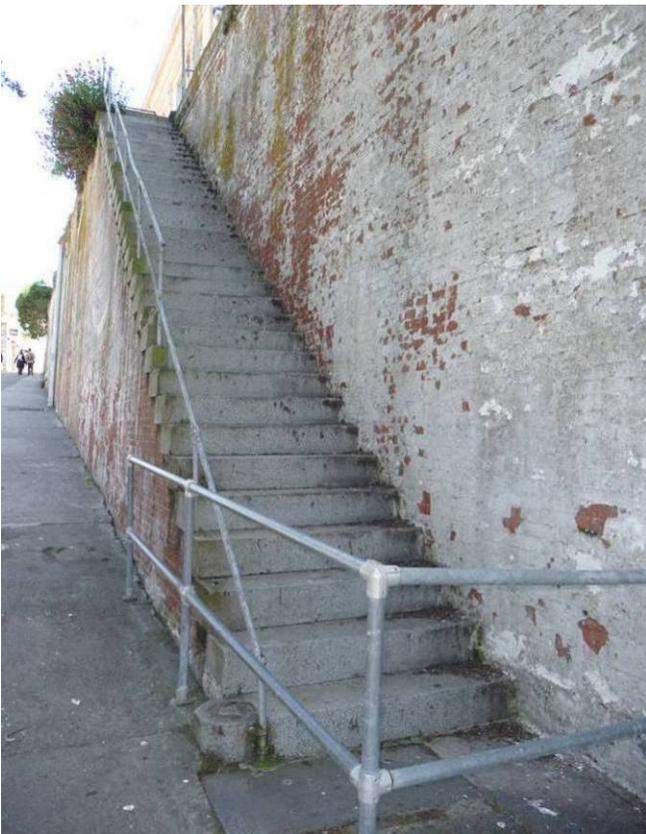
Figure 3 - 190. Citadel Retaining Wall and Staircase (MBD P1000407.JPG)
