### *Land Use – Alcatraz Island*

### *Small Scale Features – Alcatraz Island*

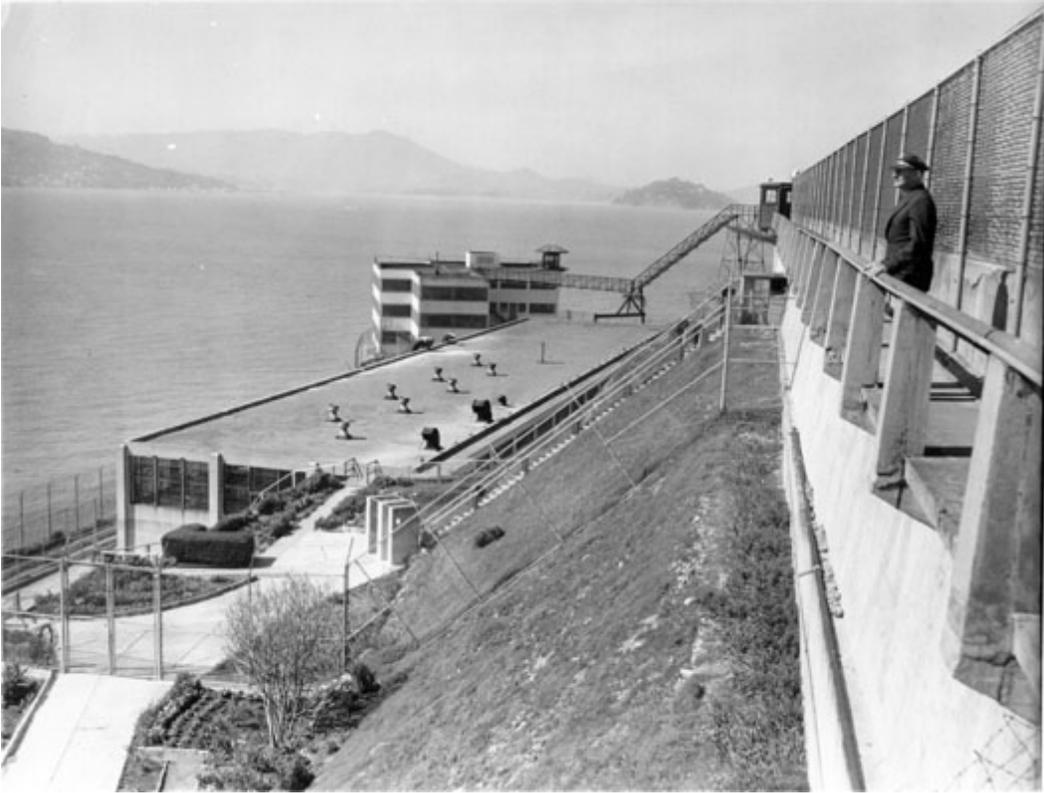
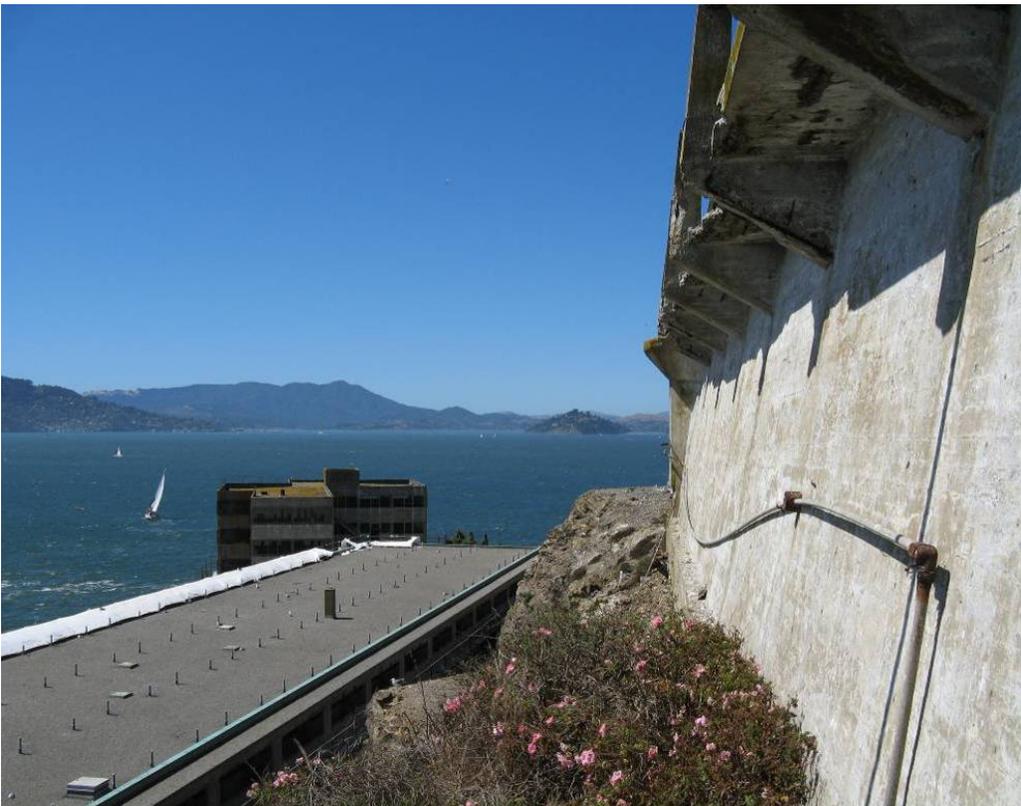
**Figure 4 - 5.** Fencing, Sentry Walk and Catwalk from Stockade/Recreation Yard, top (AAC-9261 sflib 1956 recyd.jpg); bottom, (2009) (MBD IMG\_4102.jpg)

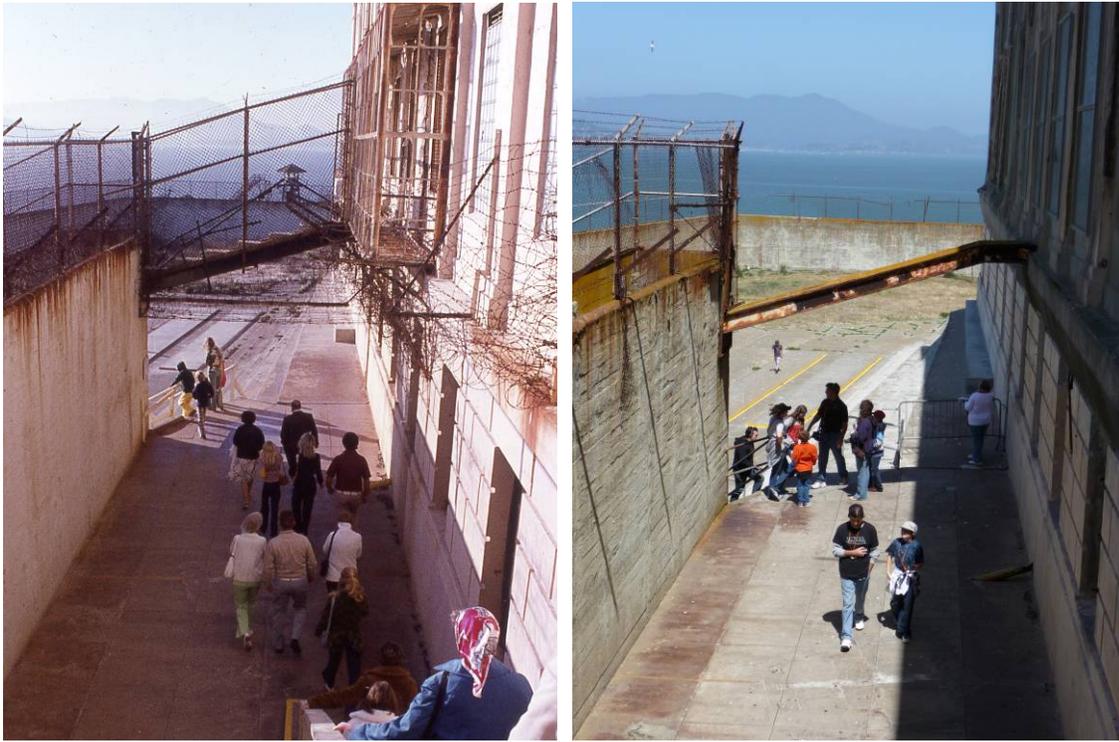
**Figure 4 - 6.** Security features are being lost due to a lack of maintenance, such as a catwalk feature in the Stockade/Recreation Yard, fencing along top of Stockade wall, and Hill Tower in distance; left, (c 1974) (Courtesy of J. Martini); right, (2009) (MBD P1000663.jpg)

The collection of small scale features from the Island’s period of significance contributes to its significance as a cultural landscape. There remains evidence of each historic period’s small scale features, and therefore these features have integrity. However, there has been a substantial loss of small scale features since the end of the period of significance due to the harsh climate of Alcatraz Island as well as deferred maintenance. Large areas of the Island are closed seasonally for waterbird breeding resulting in damage from bird use as well as limiting access for maintenance. The loss of small scale features is on-going and is accelerating, and measures for immediate stabilization are needed.
