Treatment Recommendations

Parade Ground Treatment Recommendations

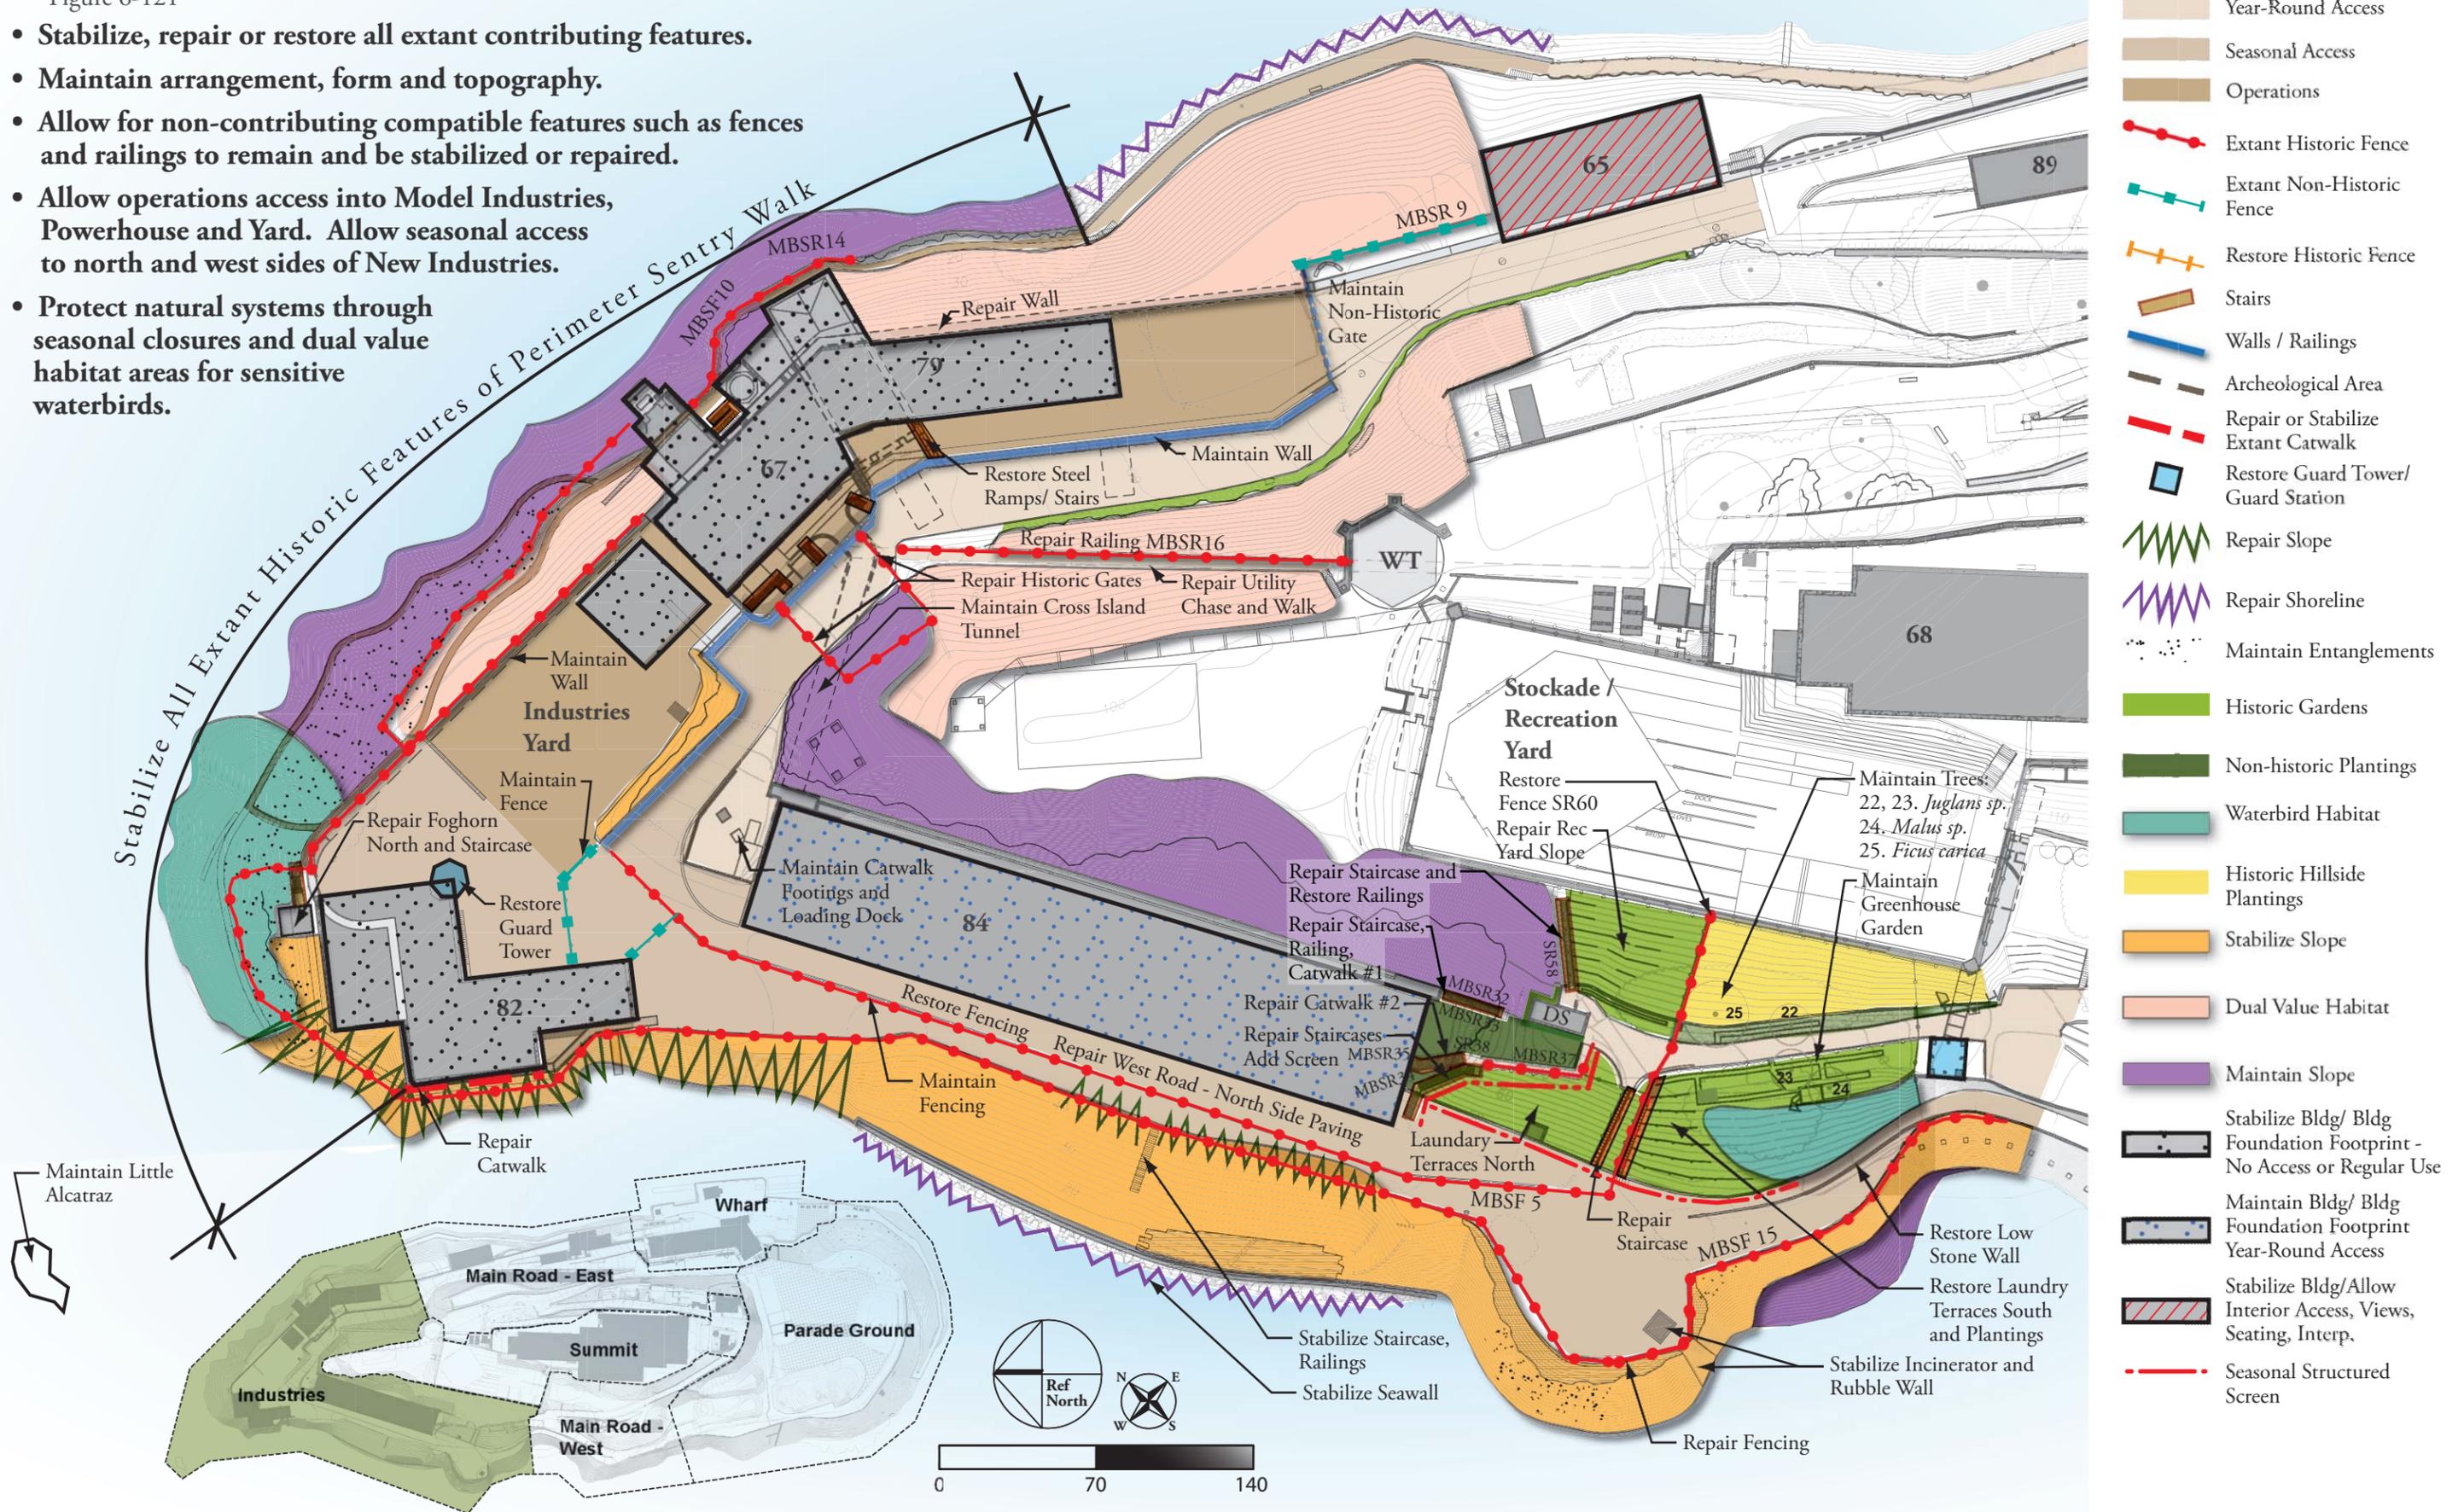
Figure 6-121

- Stabilize, repair or restore all extant contributing features.
- Maintain arrangement, form and topography.
- Allow for non-contributing compatible features such as fences and railings to remain and be stabilized or repaired.
- Allow operations access into Model Industries, Powerhouse and Yard. Allow seasonal access to north and west sides of New Industries.
- Protect natural systems through seasonal closures and dual value habitat areas for sensitive waterbirds.

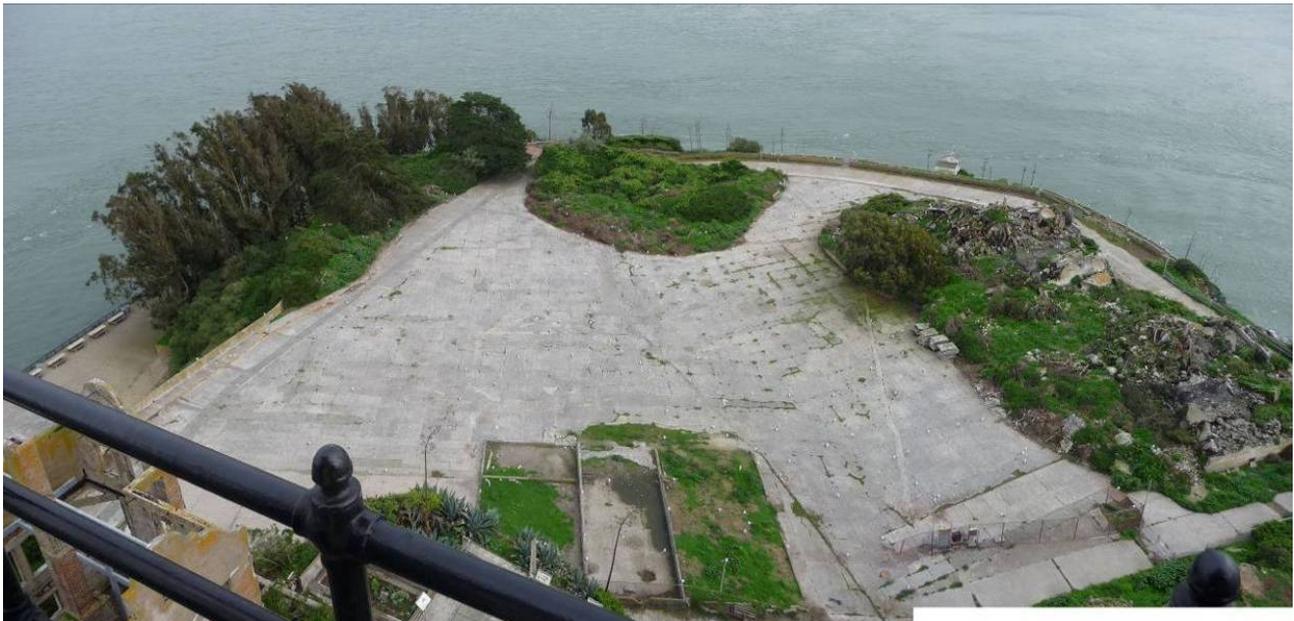
Figure 6 - 122. Repair historic form of Parade Ground. Remove select debris from extant building foundations of Officers' Quarters 72, 73, 74, 75, and Apartments B and C. Integrate habitat for waterbirds. (c 2010) (source: MBD); (ParadeGround-Meged-Panorama1.jpg)

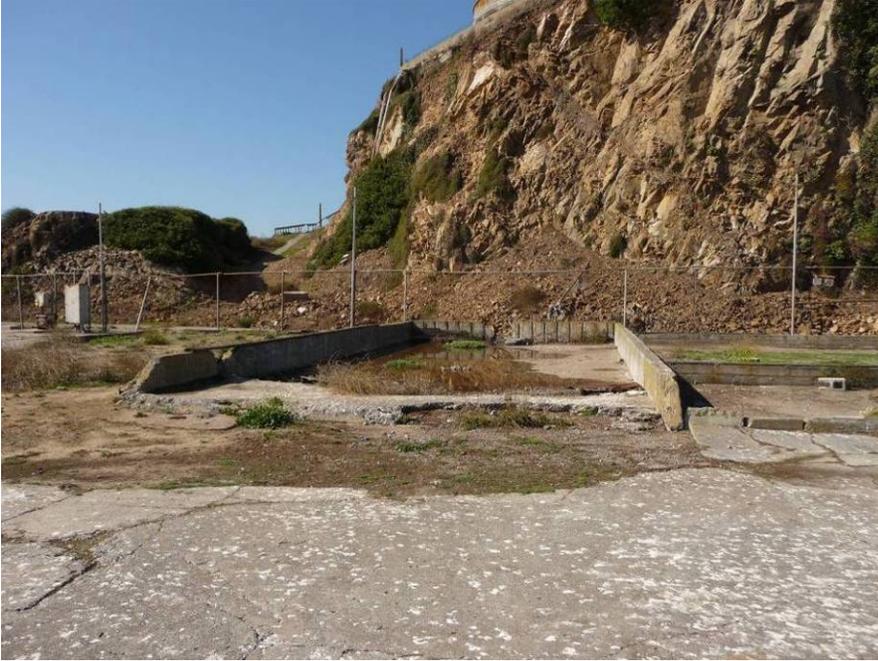
Figure 6 - 123. Repair Gymnasium and Playground foundations and spaces. Restore Federal Penitentiary period security fencing and stabilize Escarpment Slope. (c 2009) (source: MBD); (P1020885.JPG)

- Repair extant remnants of Play Area and Gymnasium including foundations, walls and building spaces.
- Stabilize Escarpment Slope to allow for repair of walls, railings, paving and gardens on Summit.

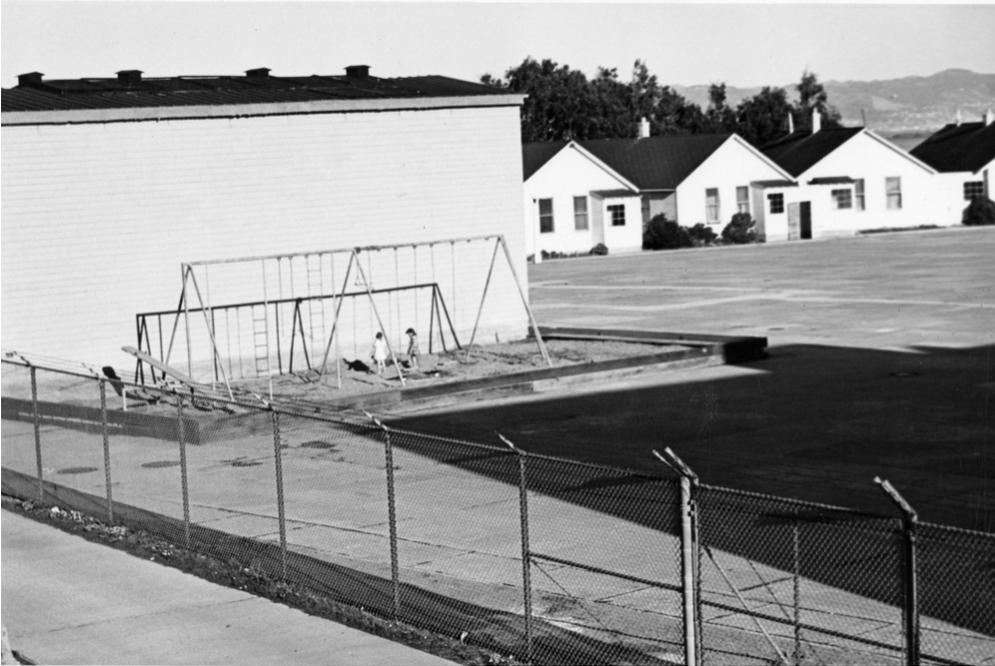
Figure 6 - 124. Repair remnant building foundations and spaces associated with the Gymnasium and Play Area. Restore Federal Penitentiary period security fencing. (c 1940) (source: GOGA); (GOGA 40024 Alcatraz bldgs with playground.tif)

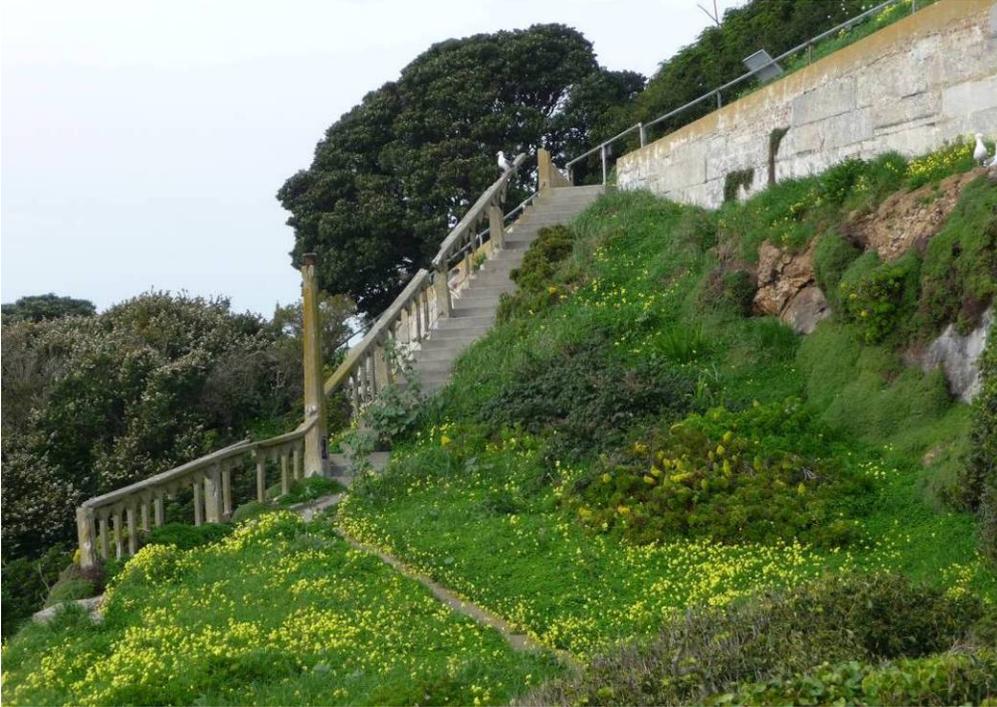
Figure 6 - 125. Repair Windy Gulch staircase, railings, and pedestrian lights. Repair trail to connect to Summit. Repair concrete wall and maintain habitat on slope to Upper West Road. Add new compatible railing from staircase to Parade Ground. Allow year round visitor access. (c 2010) (source: MBD); (P1030636.JPG)

- Repair Foghorn South and maintain Foghorn Staircase.
- Repair Windy Gulch Trail for visitor access. Repair staircase and decorative concrete railing that connects the Parade Ground to the Upper Main Road and the Summit. Restore concrete railing from bottom of staircase along Windy Gulch Trail, See Figure 2-93. Add

new compatible railing from the endpoint of that historic railing down to the Parade Ground to improve visitor safety.

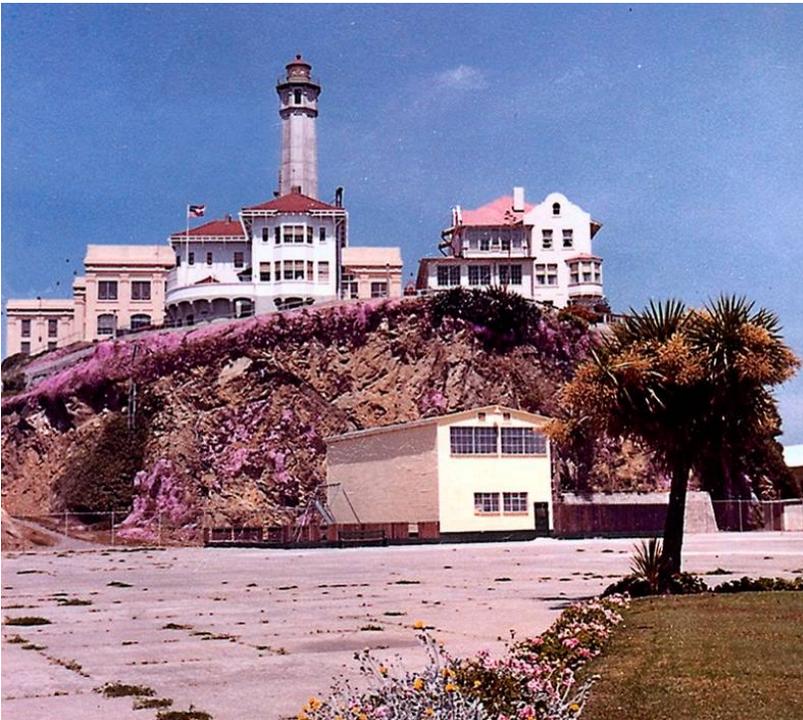
Figure 6 - 126. Stabilize Escarpment Slope and repair remnant walls and foundations associated with the Gymnasium and Play Area (c 1955) (source: Parks Conservancy); (032 view from parade ground #2 (stucker).jpg)

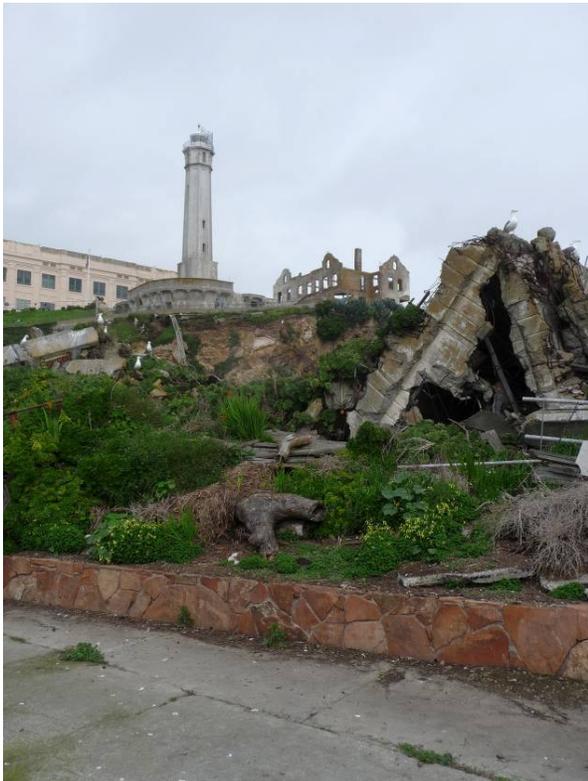
Figure 6 - 127. Remove non-contributing flagstone seatwall (c 2010) (source: MBD); (P1040001.JPG)

- Selectively remove debris from rubble mounds. Stabilize extant elements of the remnant buildings including foundations, building and site walls, window and door frames, landscape spaces, and any extant historic vegetation.
- Remove non-contributing flagstone seatwall.

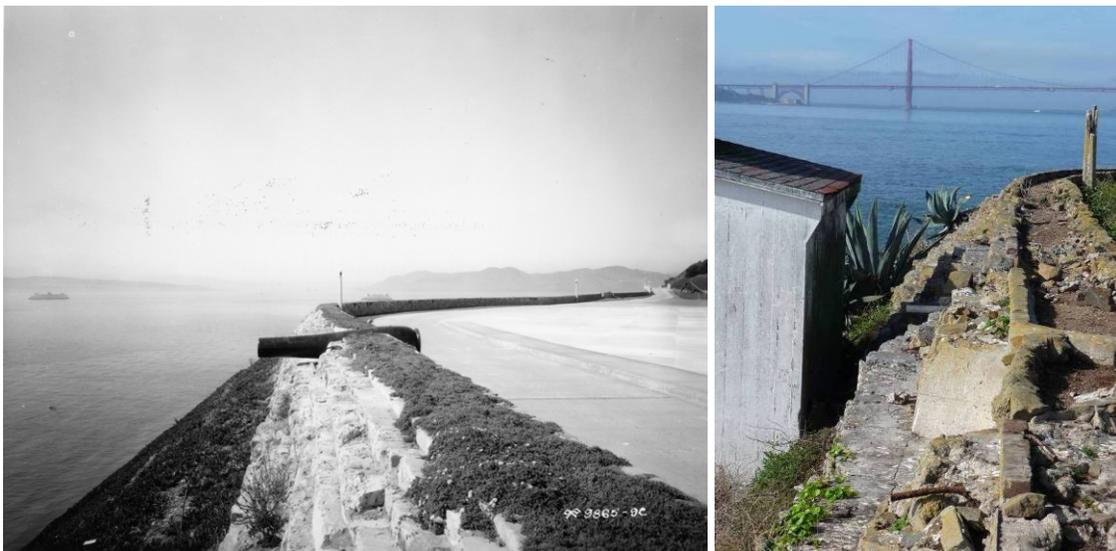
Figure 6 - 128. Repair Seawall Planter, road, curbs and sidewalks. Restore pedestrian lighting and plant iceplant in top of Seawall Planter (c 1933, 2009) (source: GOGA); (GOGA 19200 Parade Ground looking north to Sausalito Oct 1933.tif, P1020780.JPG)

- Plant roses in the planting bed in front of the Seawall Planter to discourage visitor access to the wall. Allow other plantings such as *Aeonium* and *Pelargonium* in the planting bed. Plant iceplant in the Seawall Planter, after the walls have been repaired, as was done historically.

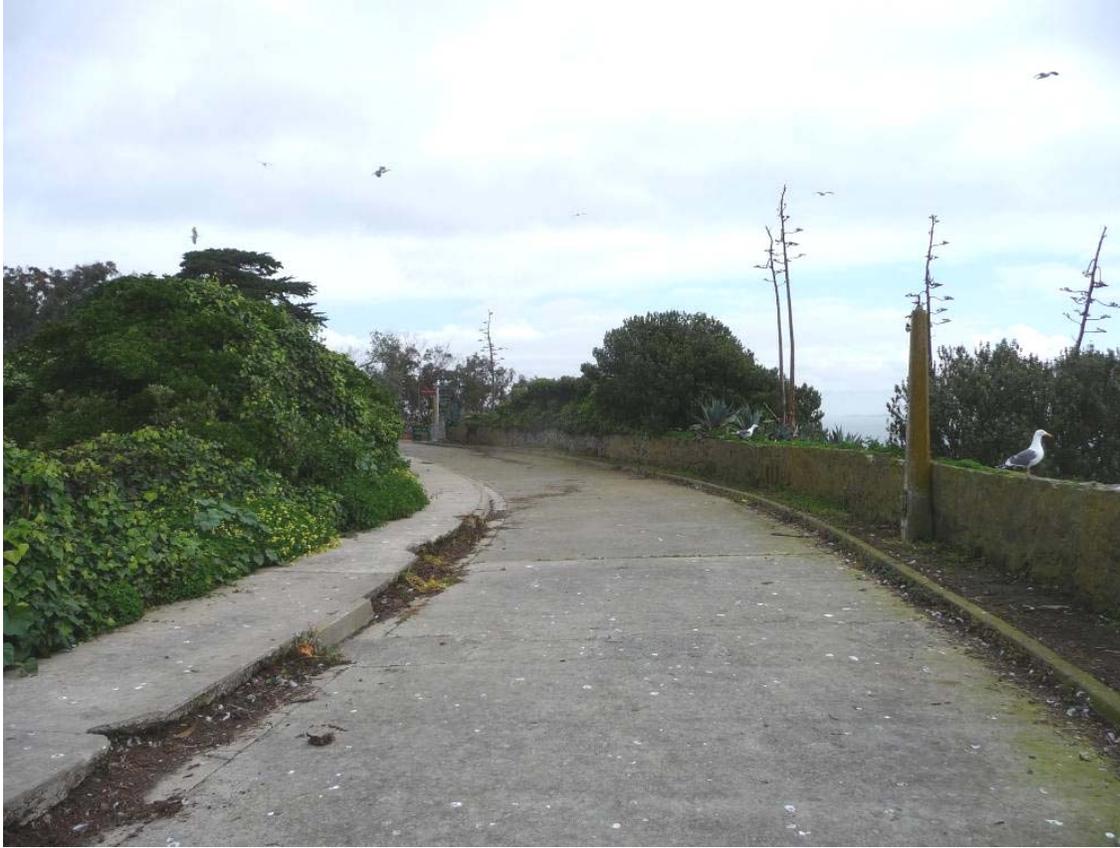
Figure 6 - 129. Repair Parade Ground Road, sidewalk, curbs, pedestrian lights, and Seawall Planter (c 2010) (source: MBD); (P1030993.JPG)

- Restore Federal Penitentiary period security fencing. Allow select segments of existing non-contributing fencing to remain for visitor management.
- Repair Parade Ground road and its associated features including paving, curb, sidewalks, and pedestrian lights.

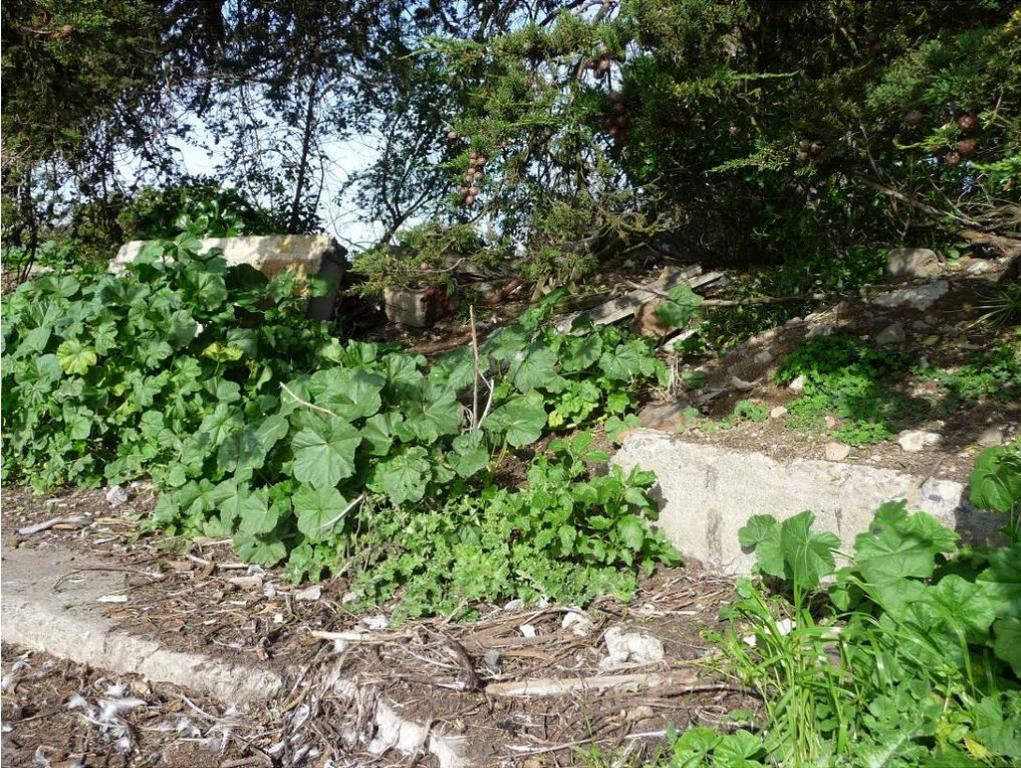
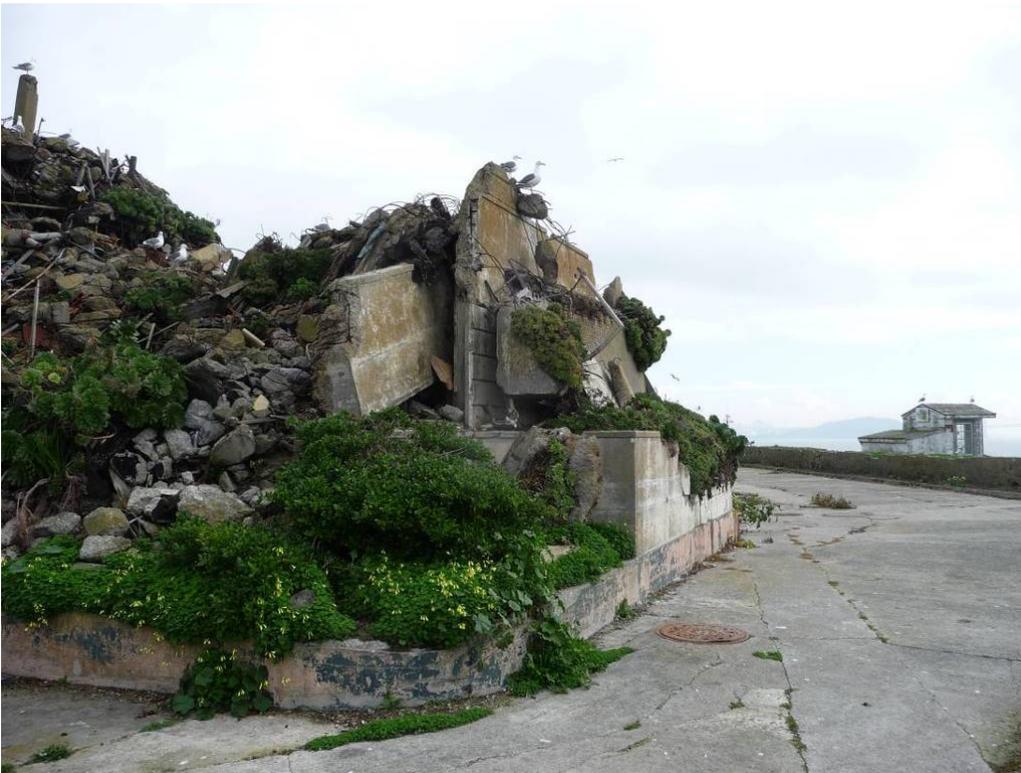
Figure 6 - 130. Remove areas of building rubble and stabilize areas extant building foundations and walls, site walls, landscape spaces and historic vegetation. At Officers' Quarters 74, top and at Apartment C, bottom (c 2009, 2010) (source: MBD); (P1040233.JPG, P1040003.JPG)

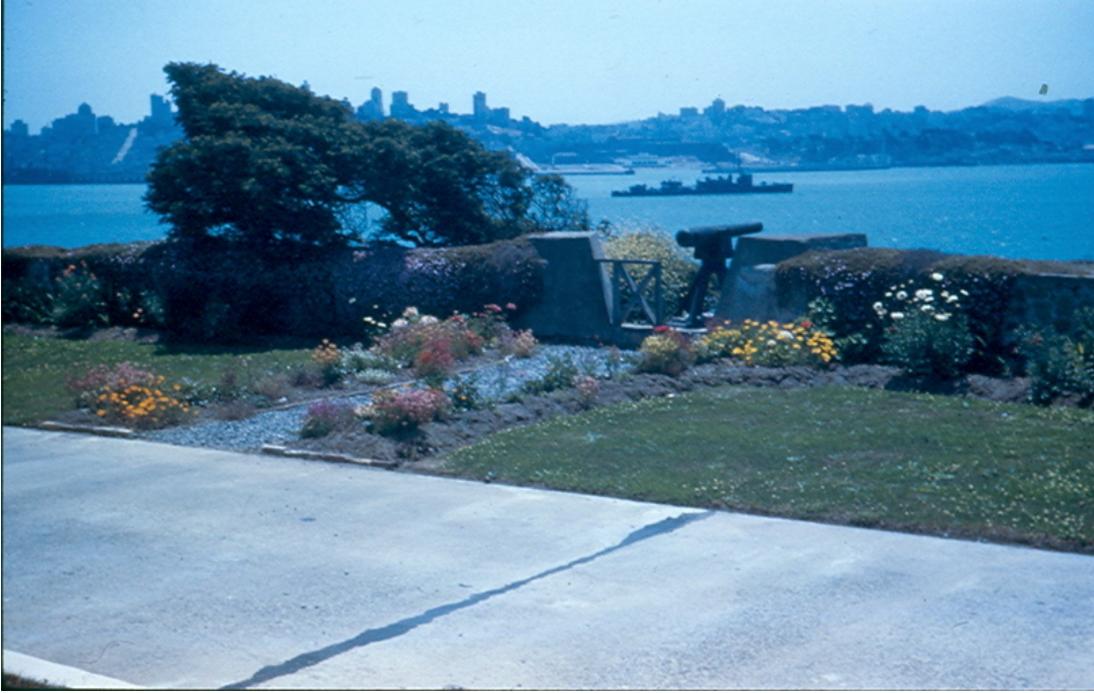
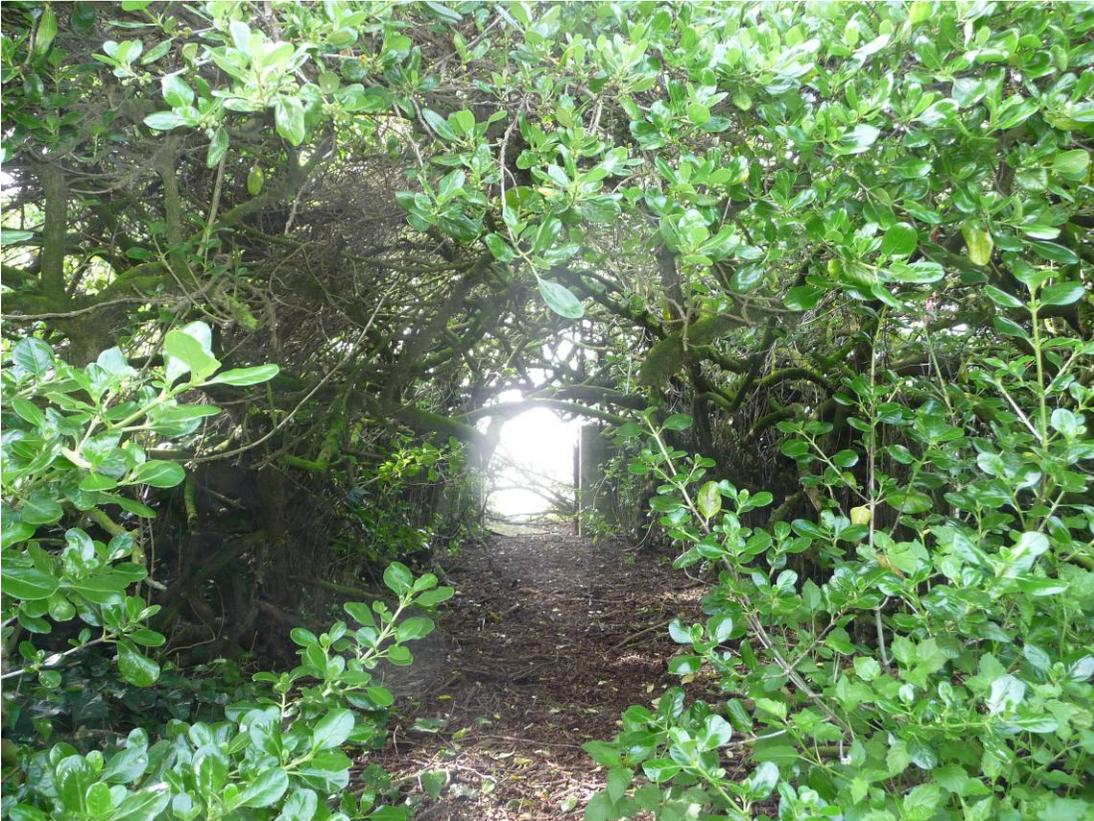
Figure 6 - 131. Cannon Garden - Maintain vegetation as Black-crowned Night Heron and Snowy Egret habitat, and protect historic topography. (c 1934-1943, 2010) (source: Parks Conservancy, MBD); (seawall (simpson-13).jpg, P1040033.JPG)

- Maintain Cannon Garden and vegetation for Black-crowned Night Heron and Snowy Egret habitat. Protect the historic topography of the Cannon Garden and surrounding area.
- Remove Monterey Cypress trees 27, 28 and 30.
- Refer to specific buildings for treatment of vegetation and gardens associated with these buildings.

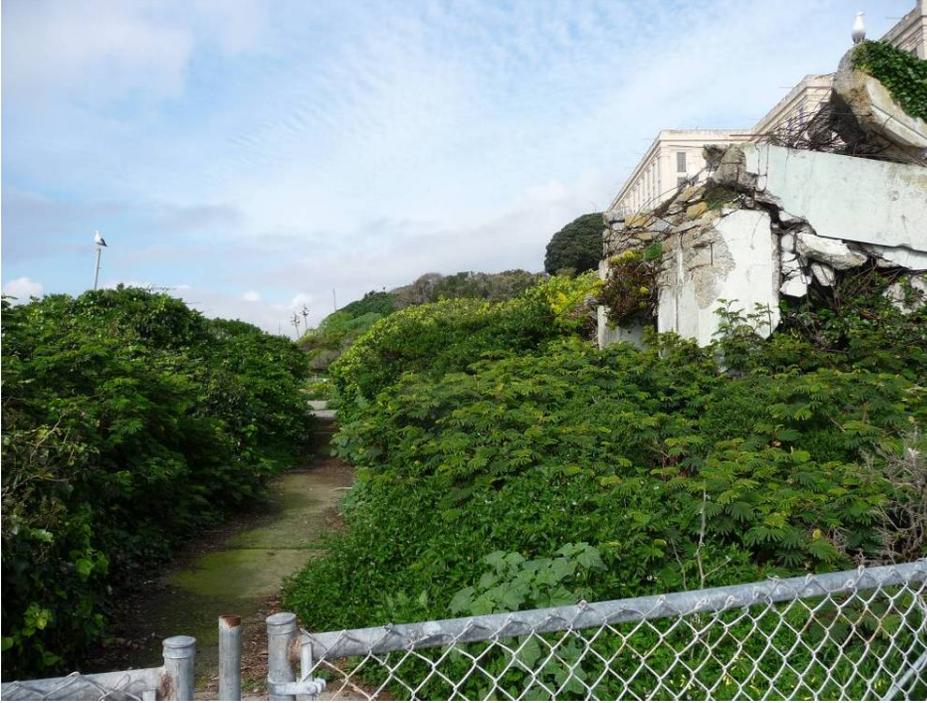
Figure 6 - 132. Maintain vegetation along road and around Apartment A as Black-crowned Night Heron and Snowy Egret habitat. Maintain extant non-historic gate and fence for use by GGNRA and GGNPC staff operations. (c 2010) (source: MBD); (DSC_0421.JPG, DSC_0441.JPG)

- Maintain vegetation around Apartment A, and between Apartment A and Windy Gulch Trail for waterbird habitat for Black-crowned Night Heron.
- Repair slope from Wharf to Parade Ground by removing invasive and overgrown species. Reveal historic extant features and repair garden terrace walls, railings, and staircase. Restore

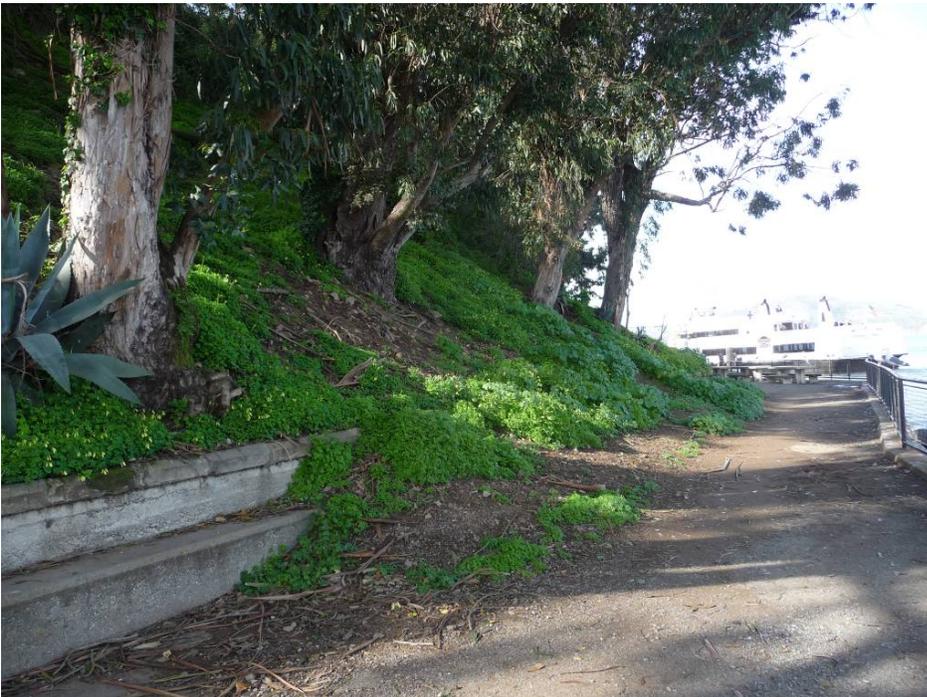
Figure 6 - 133. Repair Eucalyptus Grove slope and adjacent paving. Remove debris on walkway and slope, remove Eucalyptus trees and plant new Eucalyptus species in historic pattern. Remove non-contributing railing. (c 2010) (source: MBD); (P1040245.JPG)

- Cut and remove all extant trees in Eucalyptus grove and plant a new Eucalyptus species that is sturdier and hardy. Plant new trees in a pattern similar to the original plantings, but space trees for a more open character.

- Thin new Eucalyptus trees as needed to create the straightest, most vigorous trees to grow as replacements for the trees originally planted by U. S. Army. Continue with the tree topping practices used by the U. S. Army to control the height and wind breakage of the Eucalyptus trees.¹²

- Repair the slope by removing debris and rubble, removing invasive plant species, grading to a manageable slope, and adding new understory plantings. Allow stumps to remain to assist in slope stabilization. If stump removal is preferred and consistent with stabilizing the slope, flush out and treat stumps or grind in place.

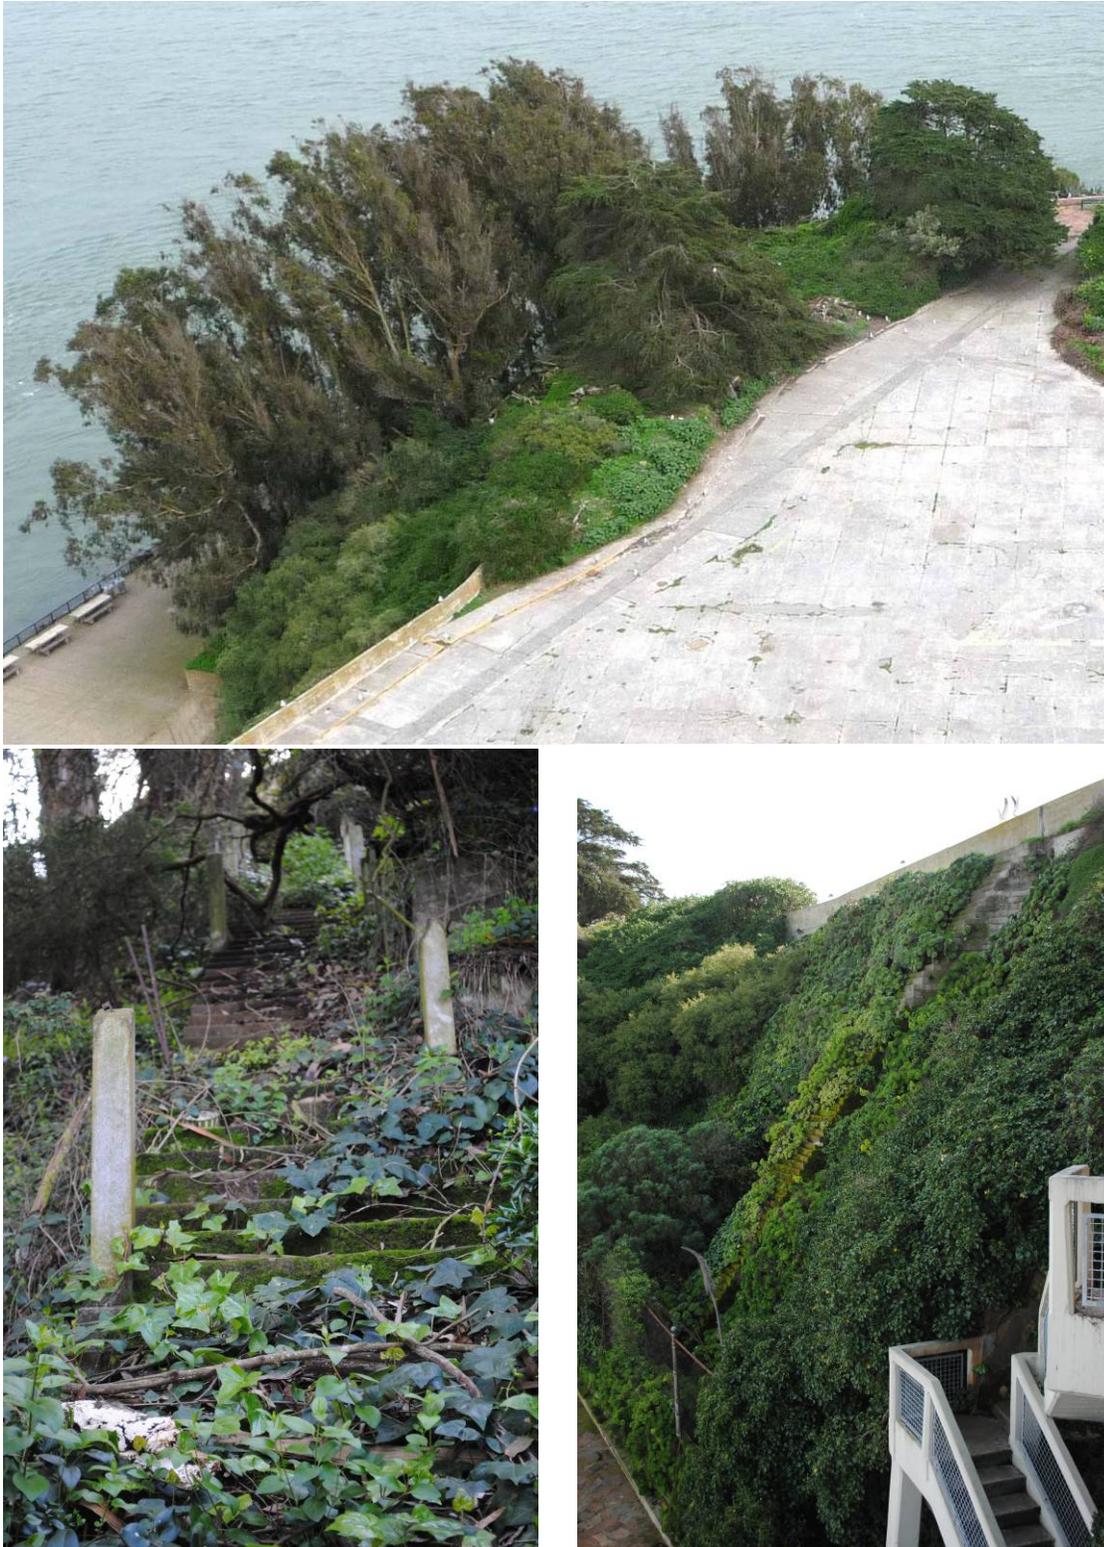
Figure 6 - 134. Remove overgrown and invasive vegetation. Repair all extant features including staircase, terrace walls, and railings. Maintain buttresses. Manage as dual value habitat on south portion of slope. (c 2010) (source: MBD); (P1030924-Crop.jpg, DSC_0421.JPG, DSC_0441.JPG)

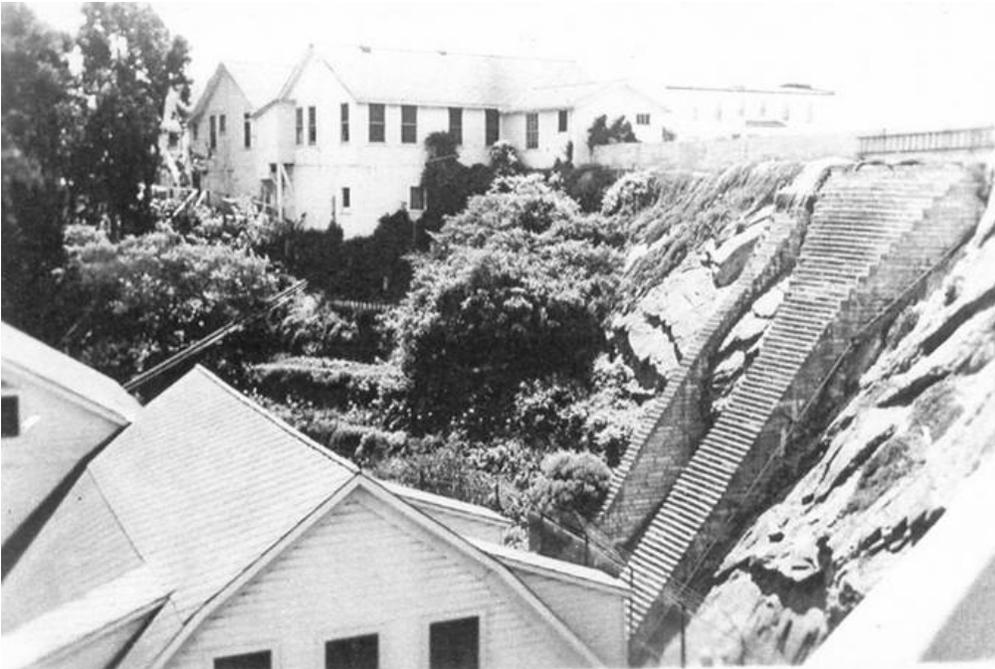
Figure 6 - 135. Repair slope from Wharf to Parade Ground. Remove overgrown vegetation. Repair staircase, railing, and garden terrace. Stabilize buttresses. Maintain decorative railing at top of slope. (c 1940-1943) (source: Parks Conservancy); (AZgardens04 1940-43 (Vesterfelt).JPG).

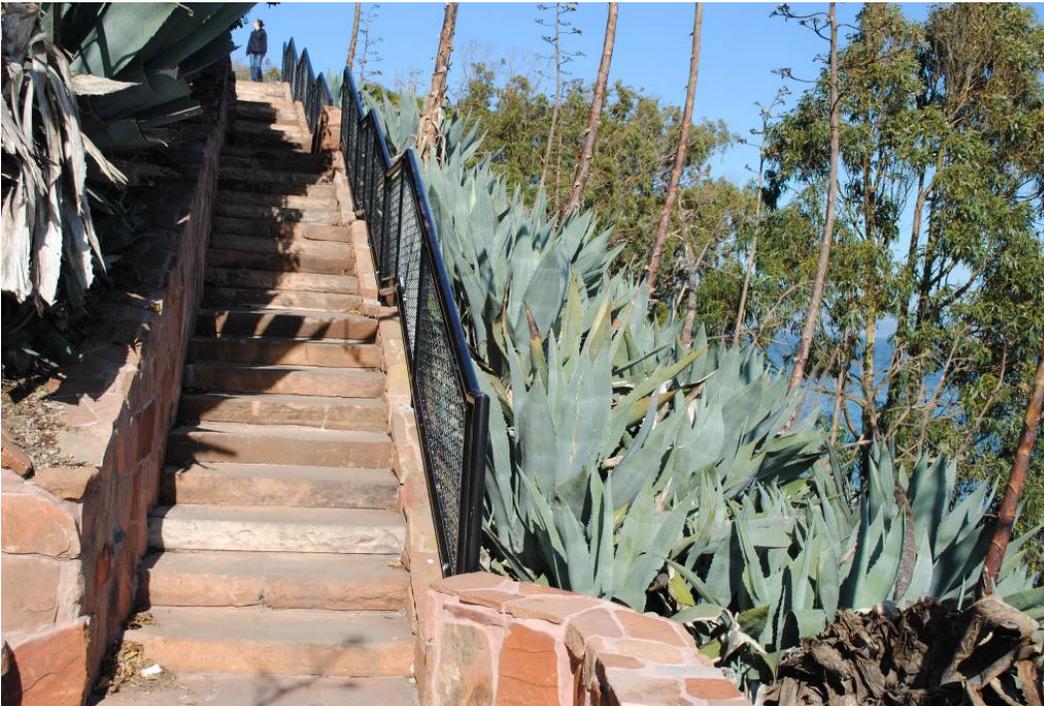
Figure 6 - 136. Allow seasonal access along shoreline and Agave Walk. Maintain Agave Walk features including walls, staircase, plantings, and railings. (c 2010) (source: MBD); (DSC_0421.JPG, DSC_0441.JPG)

- Maintain extant plantings on the Agave Walk slope as dual value habitat; maintaining as original historic vegetation and allowing non-historic species to provide Black-crowned Night Heron habitat.

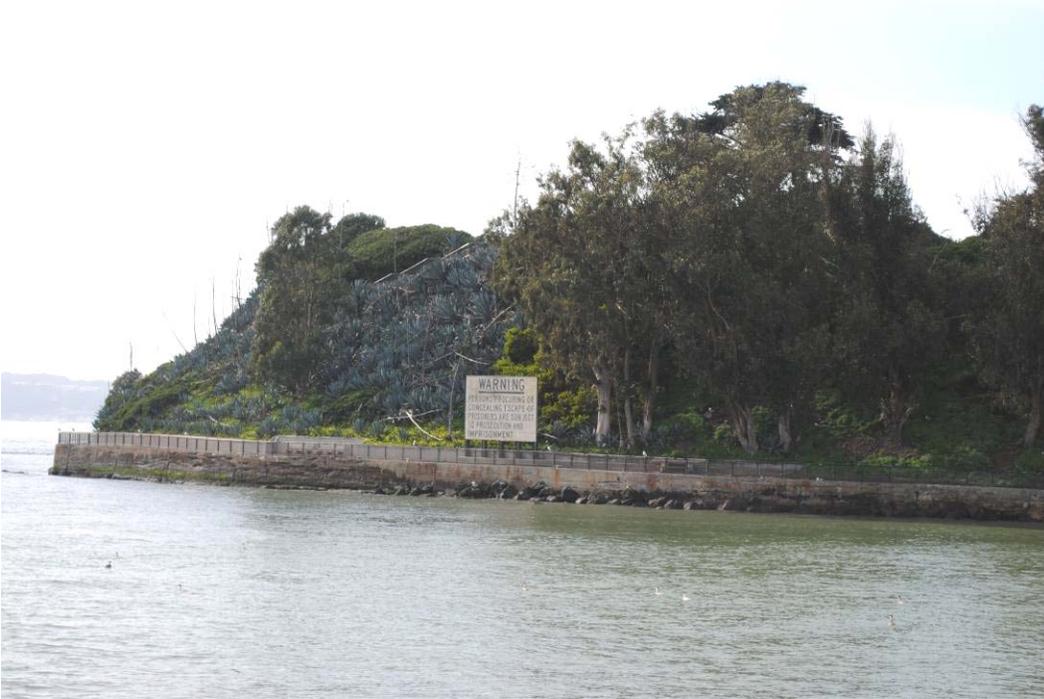
Figure 6 - 137. Repair seawall and remove non-contributing metal railing. Repair Federal Penitentiary period 'Warning' sign. (c 2010) (source: MBD); (DSC_0389.JPG)

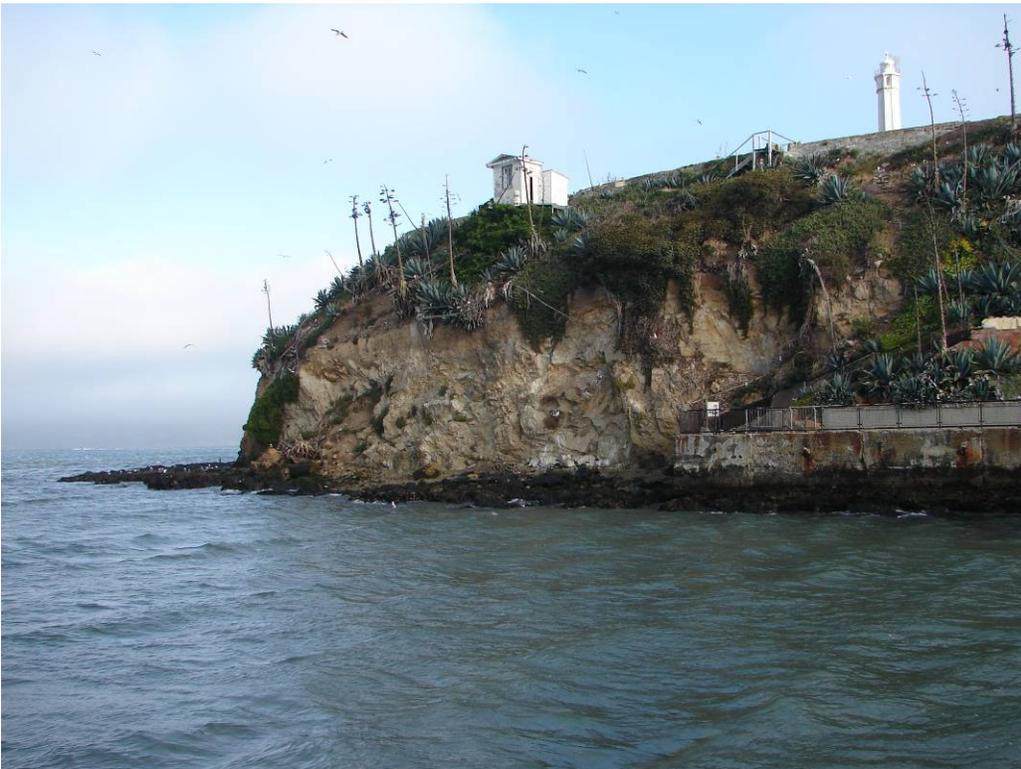
Figure 6 - 138. Protect tidal pools and stabilize seawall slope, repair Foghorn South, and maintain wooden stairs to Foghorn South. (c 2010) (source: MBD); (DSC02927.JPG)

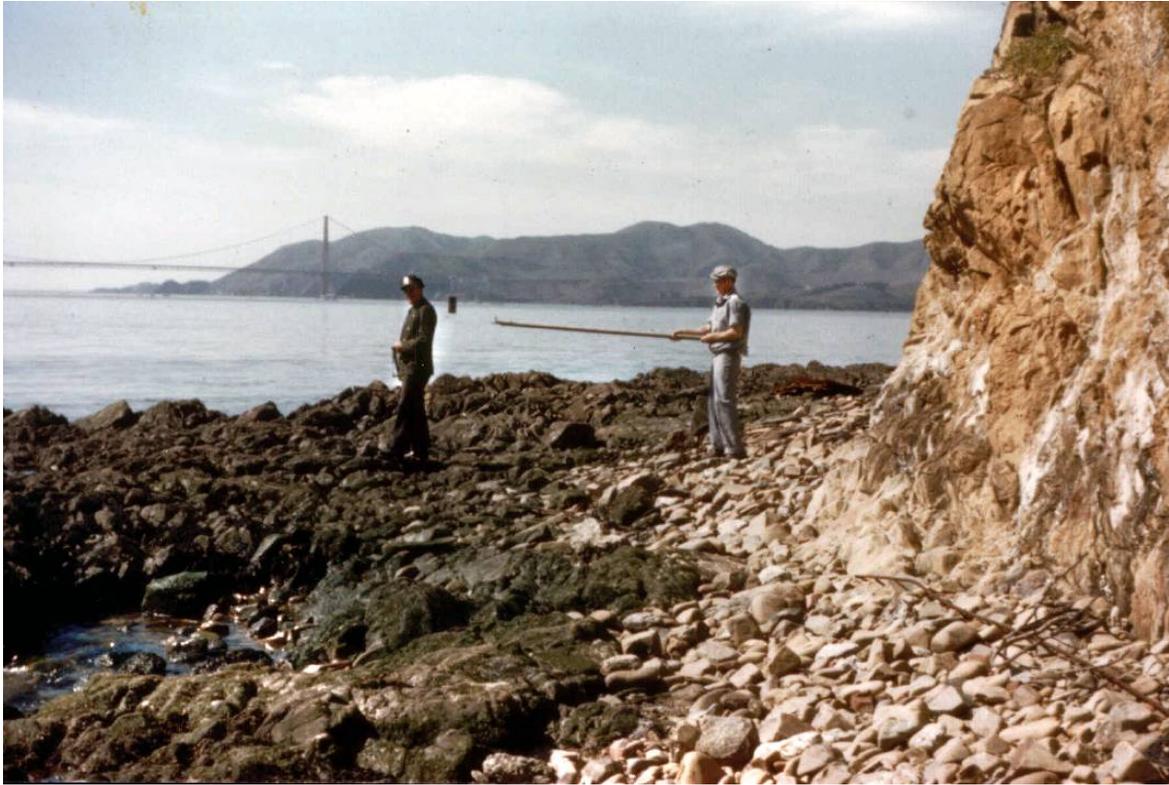
Figure 6 - 139. Protect tidal pools (c 1950s) (source: GOGA); (Tidepools, guard & con (GOGA Heaney).jpg)

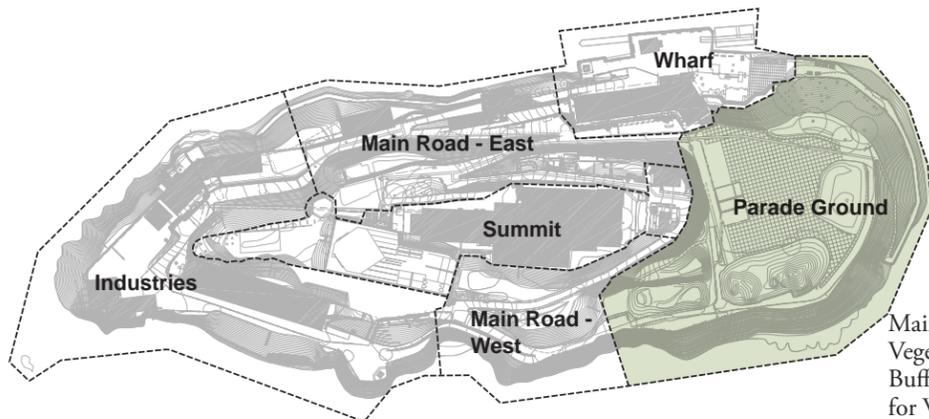
- Repair, maintain or stabilize all extant contributing features
- Repair the historic form, topography, and arrangement of the Parade Ground
- Allow seasonal visitor access on Agave Walk,
- Year-round on Road to Parade Ground, Windy Gulch Trail into Parade Ground, and access at gate SR67 from Road to Parade Ground
