Treatment Recommendations

Parade Ground Treatment Recommendations

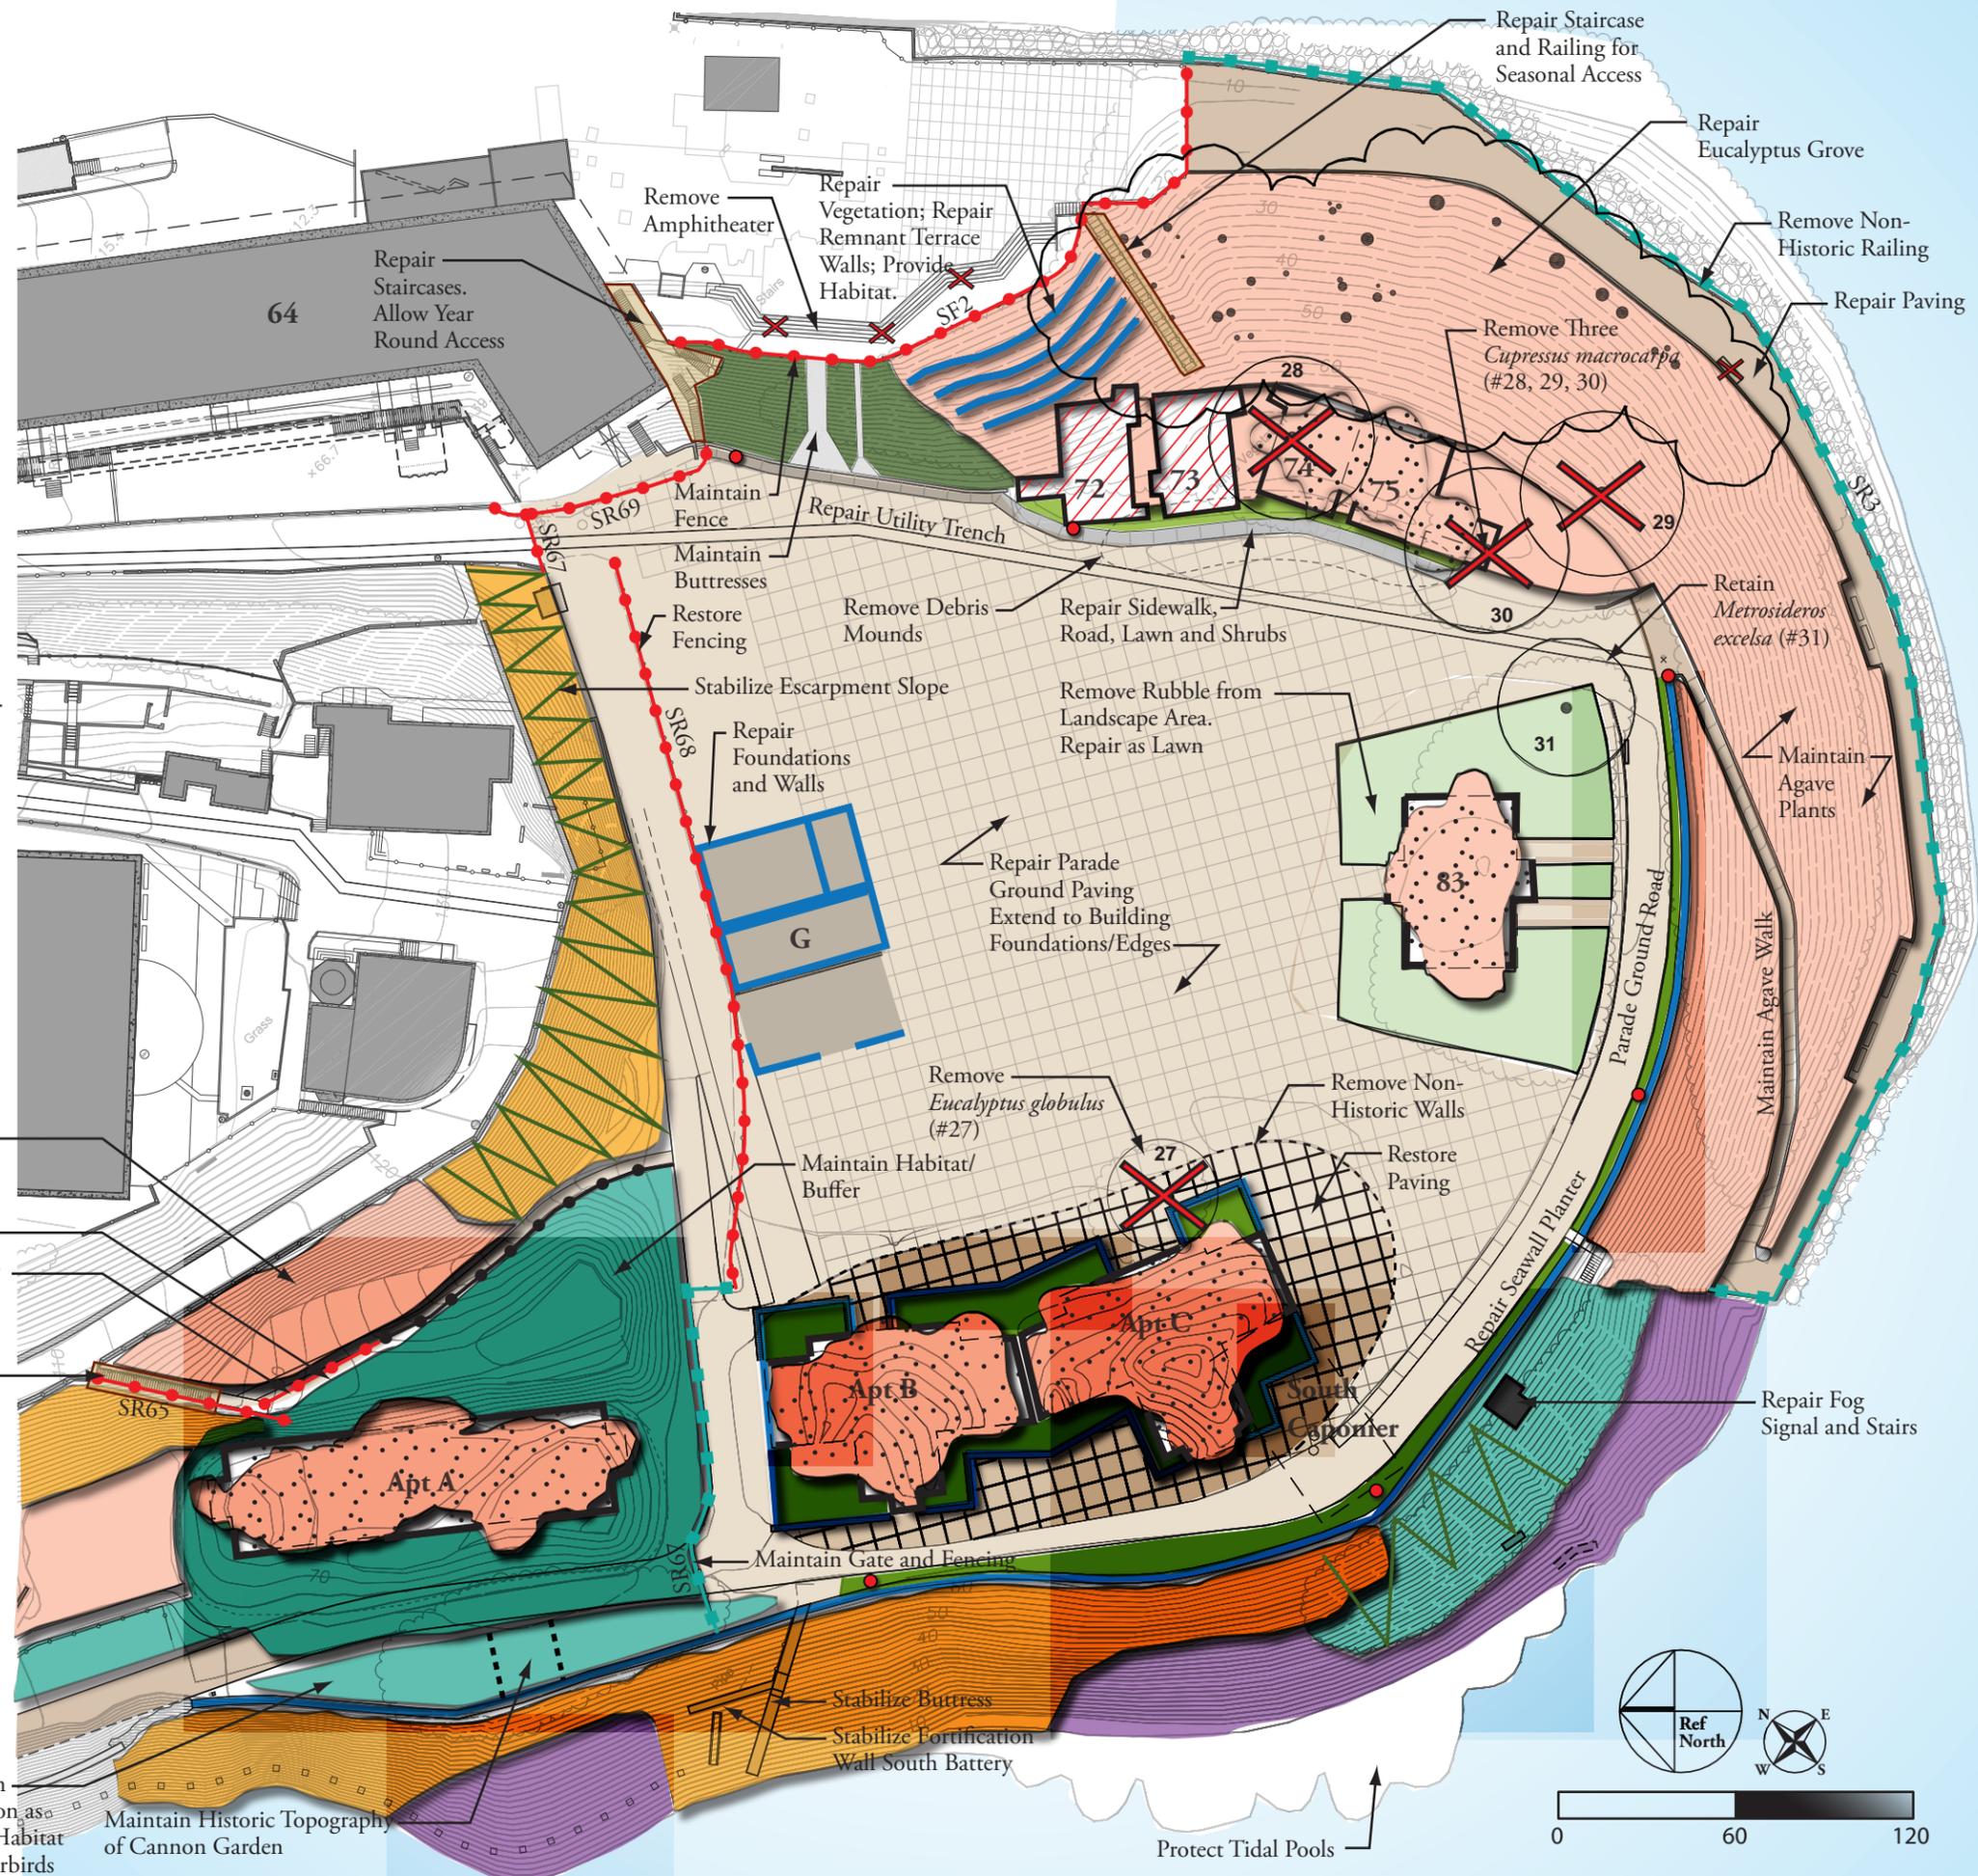
Figure 6-140

- Repair, maintain or stabilize all extant contributing features
- Repair the historic form, topography, and arrangement of the Parade Ground
- Allow seasonal visitor access on Agave Walk,
- Year-round on Road to Parade Ground, Windy Gulch Trail into Parade Ground, and access at gate SR67 from Road to Parade Ground

The Parade Ground (Figures 6-140, 6-2, 6-6, 6-7, 6-8, 6-16, and 6-17) is the large, flat plateau and shoreline on the south end of the Island. It extends from the Escarpment Slope at the Summit, to the Bay on the west and south sides, and to the Wharf on the east.

- Remove all English, Algerian and cape ivy from existing vegetation and structures.
- Create dual value habitat areas as noted on Figure 6-140, including those at Officers' Quarters terraced gardens and gardens, Eucalyptus Grove, slope at Agave Walk, and in the rubble of Building 83 and Apartments A, B and C. Restore extant historic vegetation, and plant non-historic species to provide structure and density for Black-crowned Night Heron habitat.
