White Grass Ranch Grand Teton National Park, Wyoming

August, 2008

Cultural Landscape / Historic Structures Report

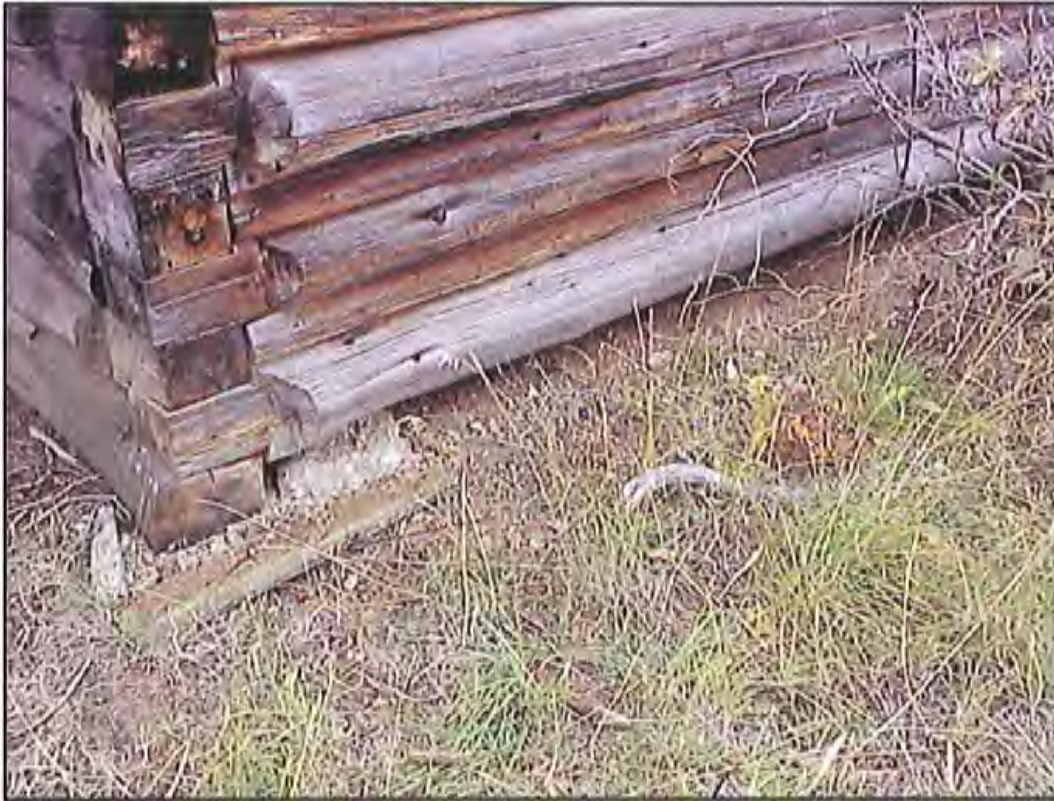
Figure 28. Detail of deteriorated foundation pier, HS-1155, Cabin 15. Source: A&E Architects, 2004.

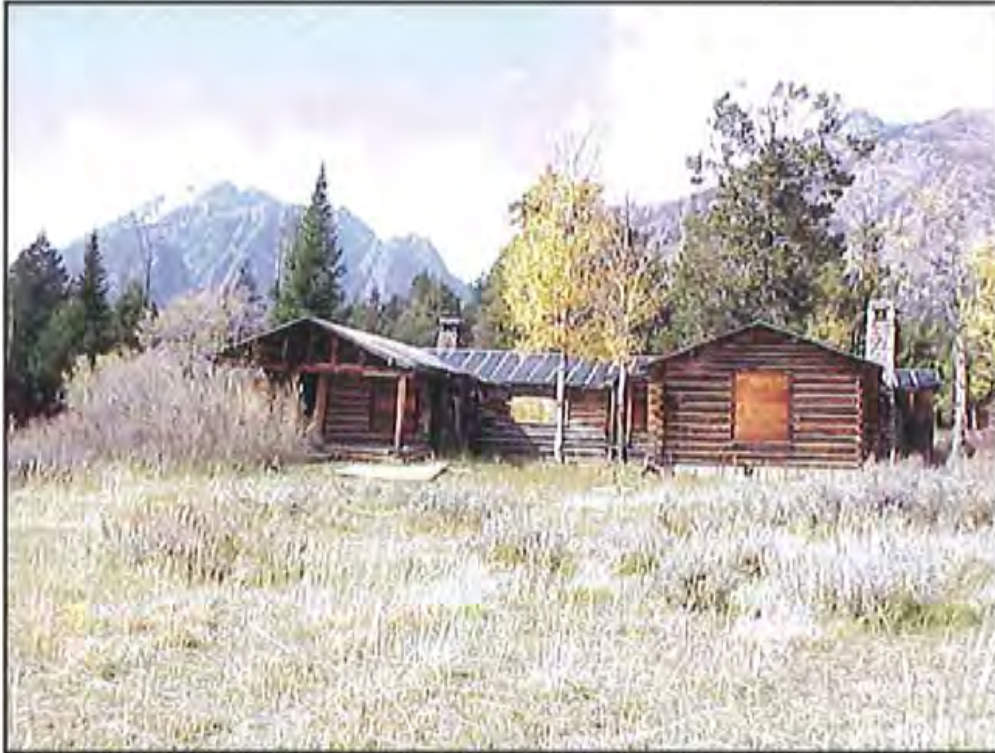
Figure 30. Front (east) wall of HS-1156, Hammond Cabin. The open porch visible at the south end of the building is part of the original building. Everything north of the porch is an addition. Source: A&E Architects, 2004.

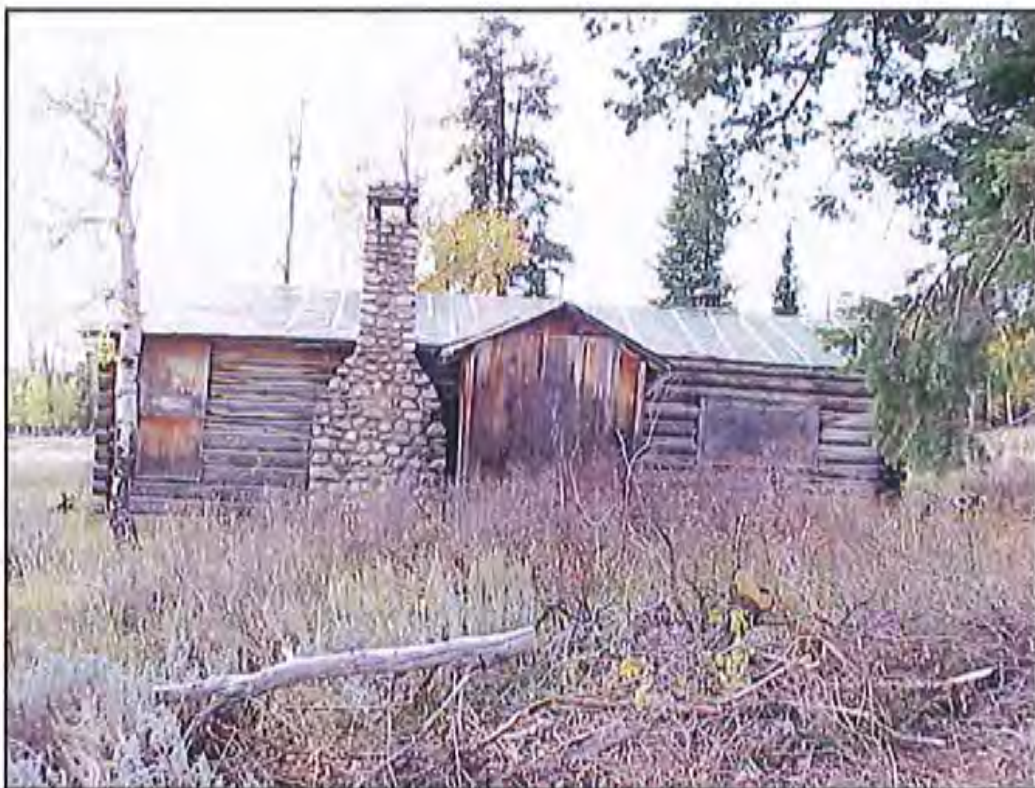
Figure 32. North wall of HS-1156, Hammond Cabin; the frame addition in the approximate middle of the wall contains a bathroom. Source: A&E Architects, 2004.

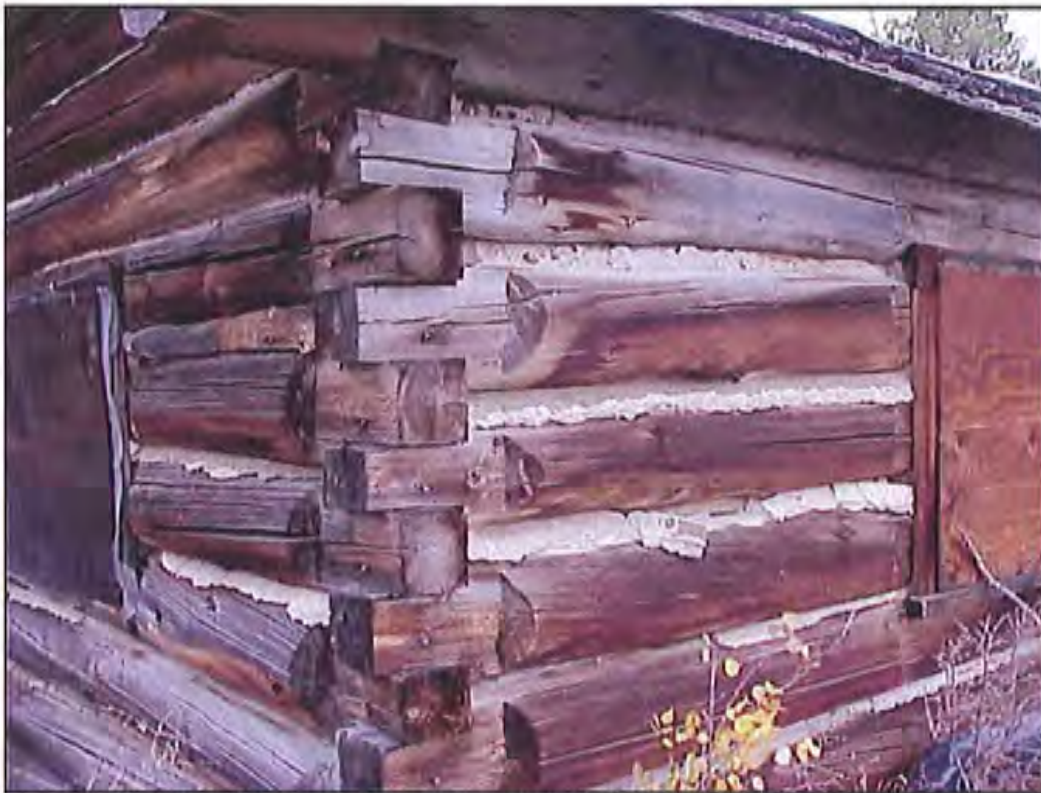
Figure 42. Detail of the corner notching and wall daubing in HS-1157, Cabin 12. Source: A&E Architects, 2004.

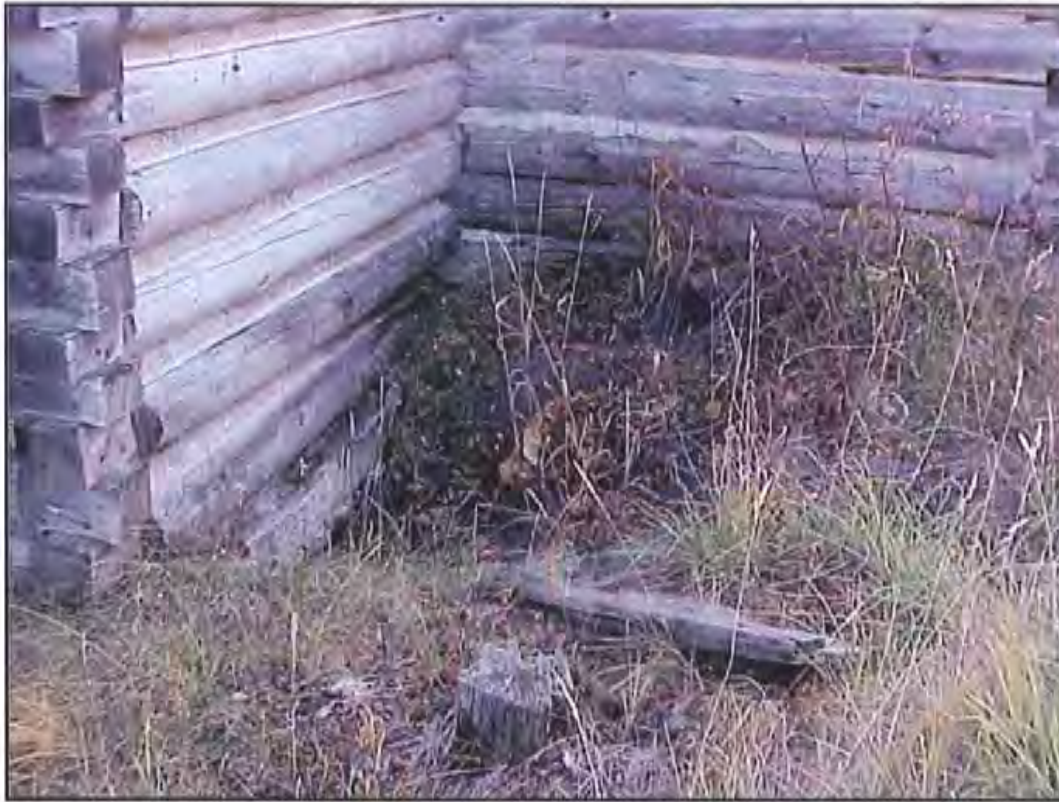
Figure 63. Detail of the junction of the addition (left) and the main volume (right), showing differences in daubing. Source: A&E Architects, 2004.

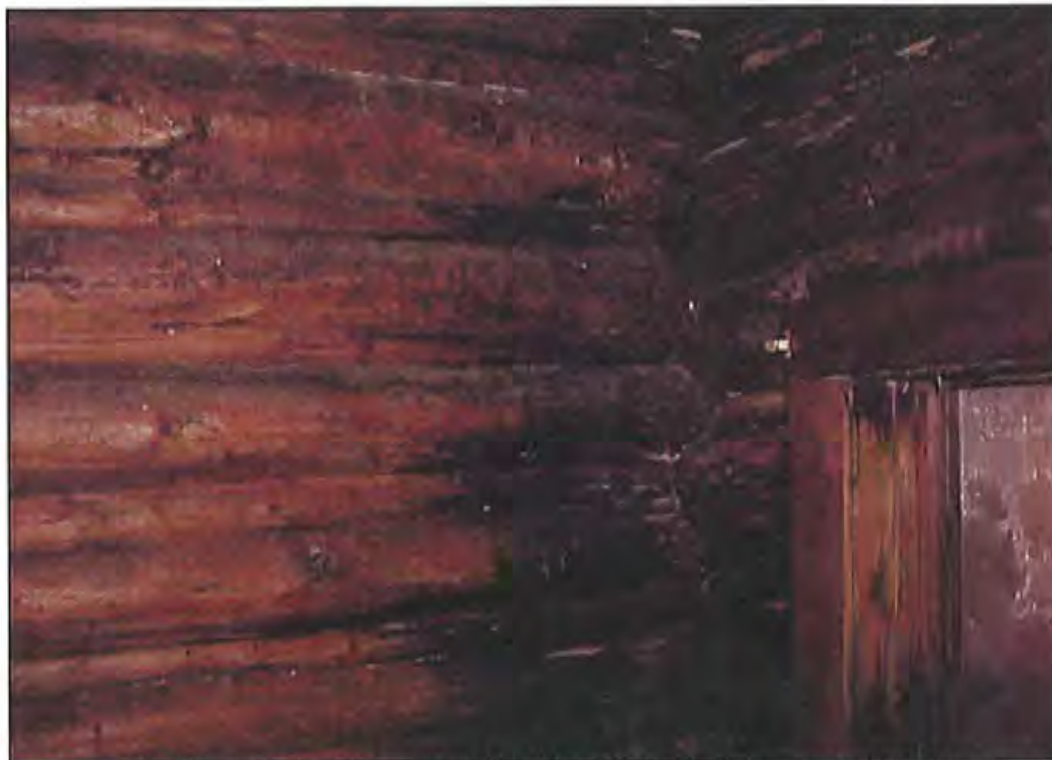
Figure 75. Interior wall showing water staining, HS-1163, Cabin 7. Source: A&E Architects, 2004.
