Preservation Treatment Guide for the AMK Ranch

Prepared for the
University of Wyoming- National Park Service Grand Teton Research Center
Grand Teton National Park, Wyoming
April 2012

This report was prepared by the University of Wyoming American Studies Program
Mary Humstone, Principal Investigator
Carly-Ann Anderson, Graduate Student Intern
Sheila Bricher-Wade, Andrea Lewis, Cassie Loveland, Students

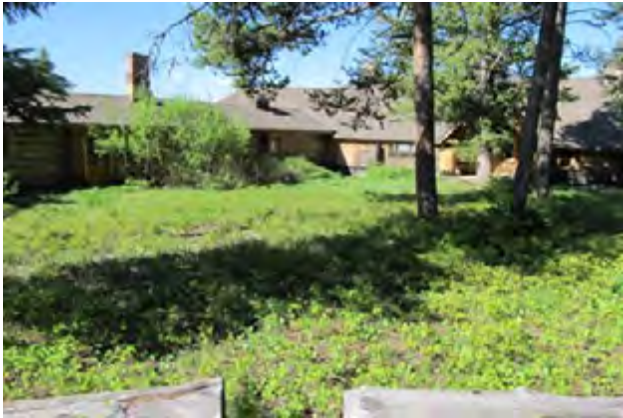
Berol Lodge Problem Areas, Drainage, East Side

Water drains down hill directly under building

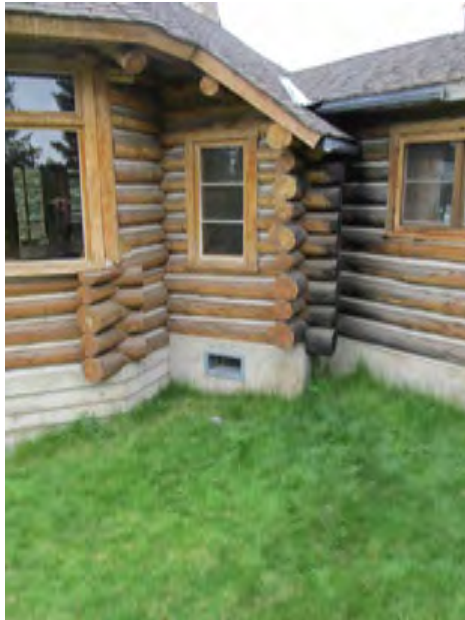
Berol Lodge Problem Areas, Drainage South Side

Water is dripping down wall instead of gutter causing black fungal growth on log

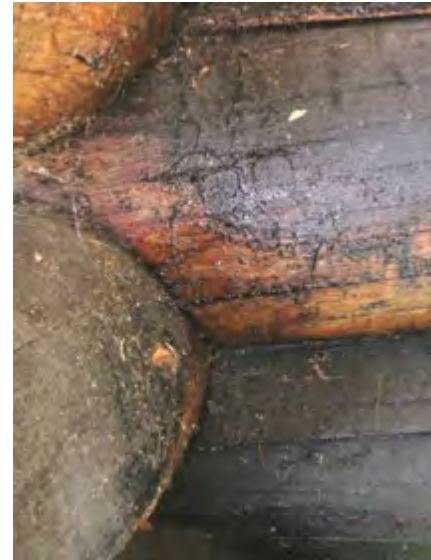
Corner has lots of black fungal growth and is constantly moist.

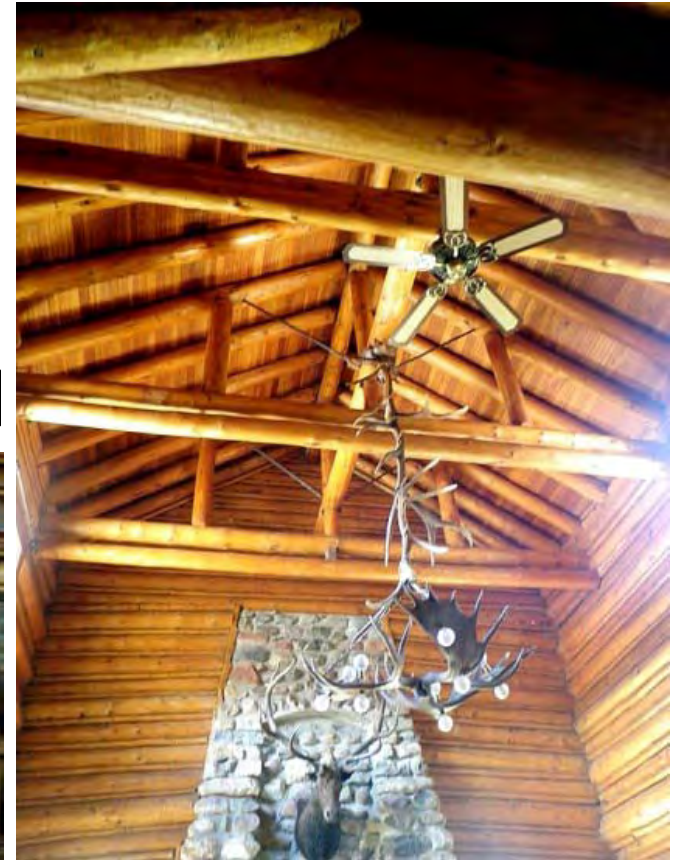
Detailed interior woodwork, including half-log staircase with polished burled log handrail, ceiling trusses, beadboard ceiling, and sapling chinking.

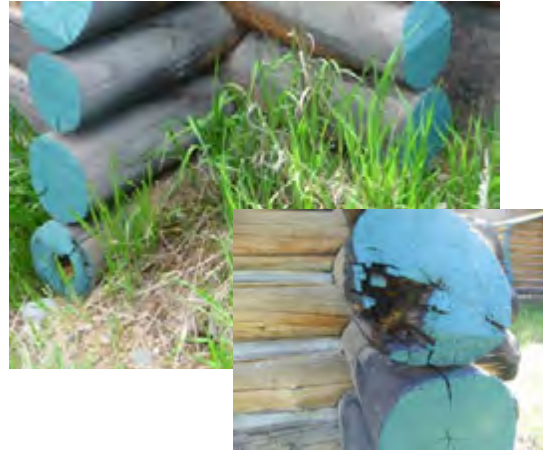
Well/Pumphouse, Problem Areas

1. Grade problems at NE corner 2. Log crowns rotting due to soil build up. 3. Log crowns collect run-off 4. Sills collect debris.

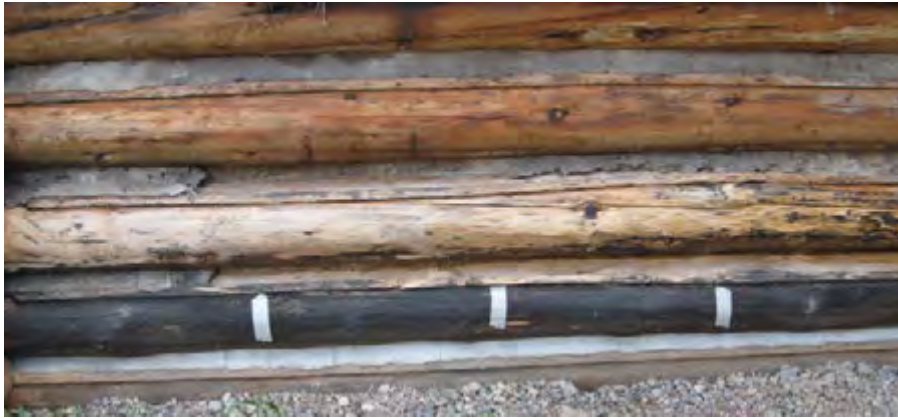
This photograph shows the average condition of logs in buildings at the AMK Ranch, all of which have been treated with log oil. The bottom log in particular shows a high level of fungal buildup.

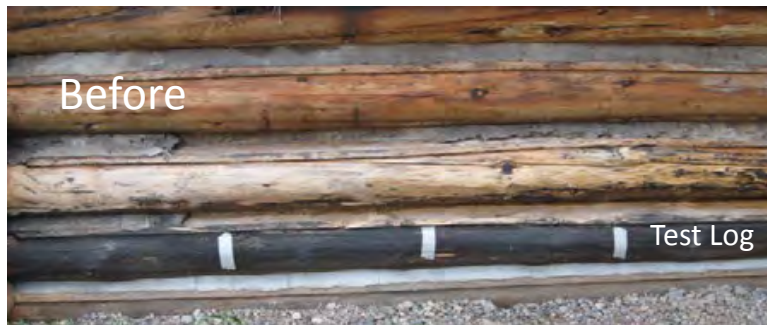
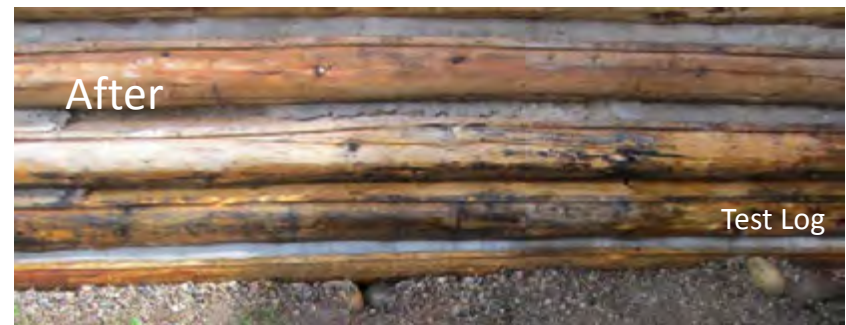
Only the bottom sill log was cleaned. By removing the black fungal growth, the log can be returned to its original color.

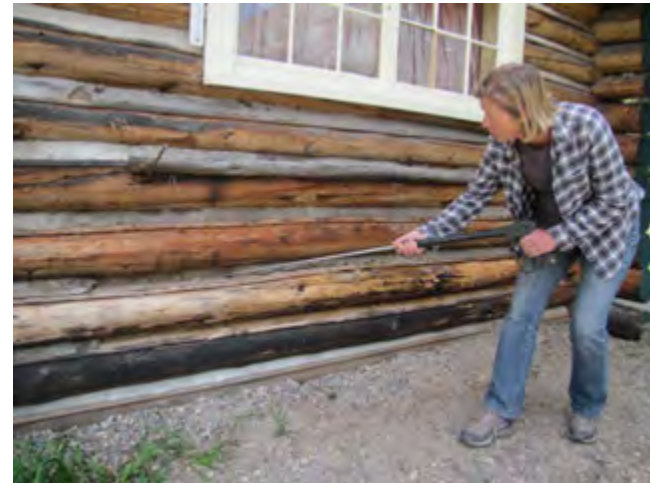
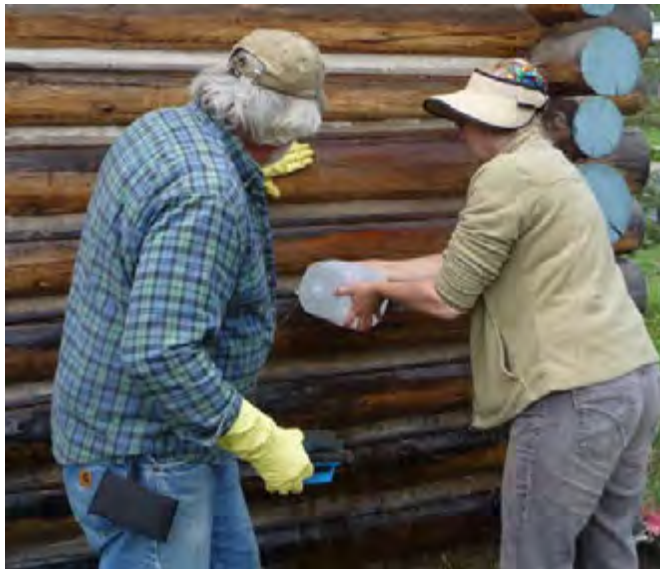
Checks are the v-shaped notches that form in the log as it dries. Checks collect water and debris and can be the entry point for rot and insects. If properly installed, the checks on a log should be facing down so they do not collect water and debris. Never fill checks with epoxy or caulk. If pockets of decay are found within a check, use *ConServ Flexible Epoxy 100* to consolidate the wood decay.

When rinsing after cleaning, rinse all cleaning solution out of cracks and checks. When applying preservative, thoroughly saturate the log checks in order to get the product inside the log.

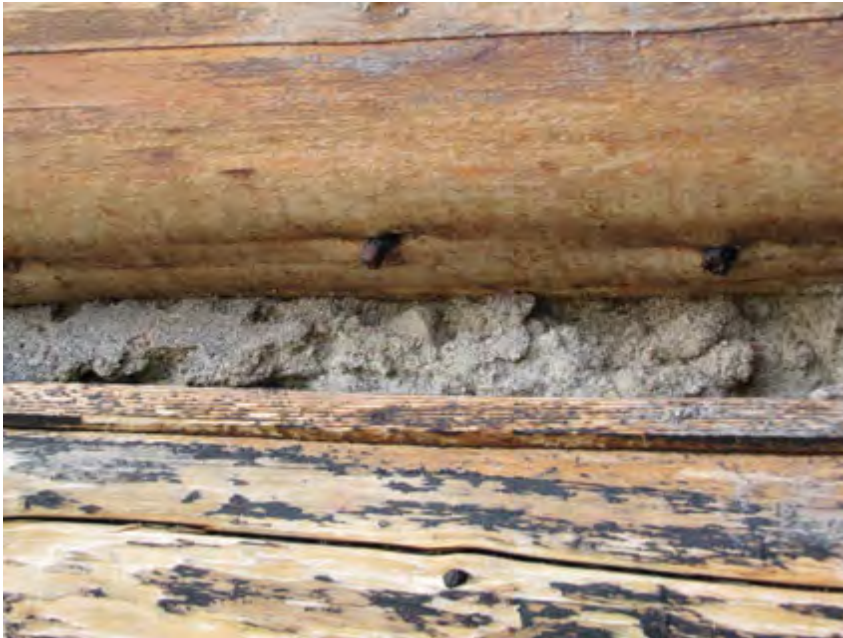
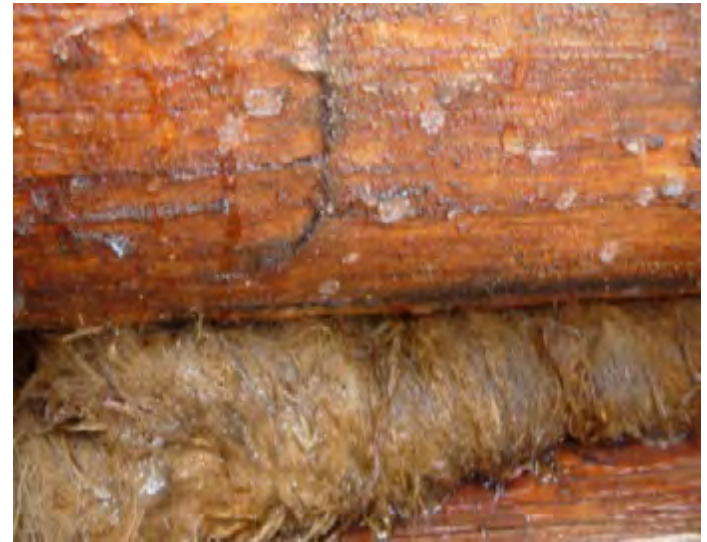
Filler Material: Filler material can be just about anything that will create insulation. In this case the filler is oakum. Oakum can be found dry or curated with oil.

Step 1: Remove loose or deteriorated existing daubing, leaving the filler materials between the logs.

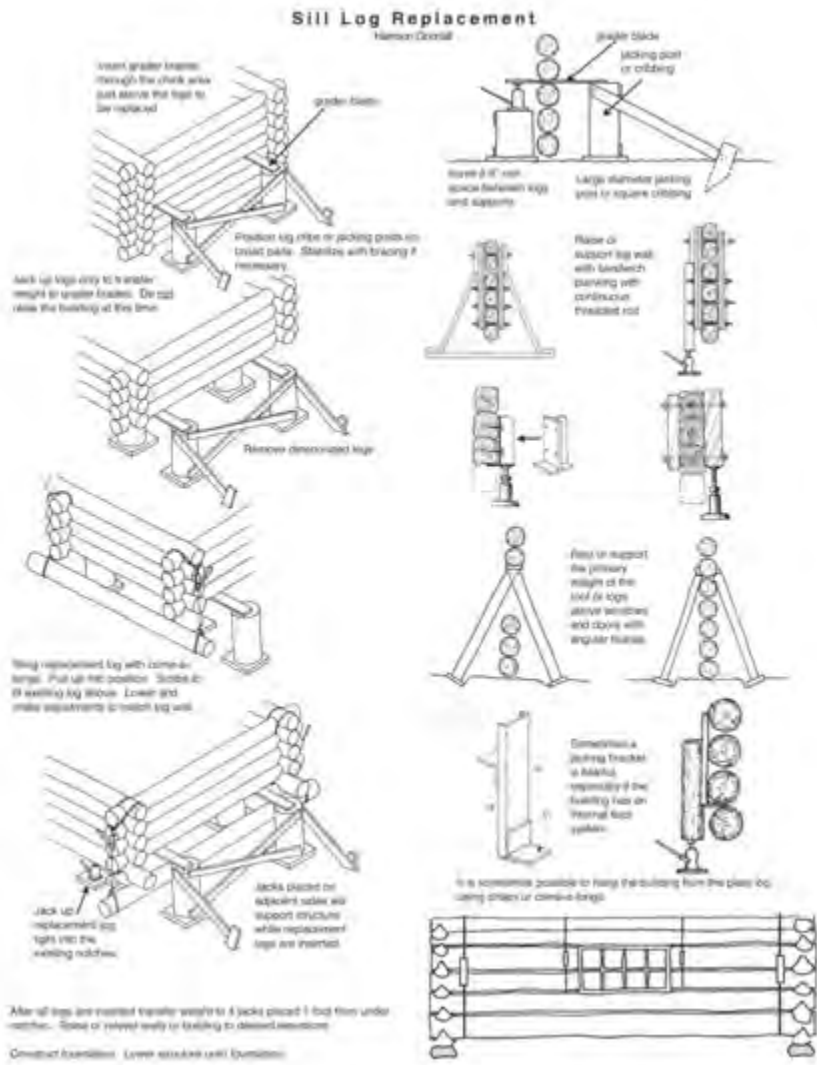
Procedure for Replacing Sill Logs

As the bottom log in a log wall, the sill log is critical to the structural integrity of the building. If a significant portion of the sill log is rotten, it should probably be replaced. This is **not** true for other (upper) logs, which can be repaired by log splicing (see next page). Methods for replacing sill logs depend on the construction of the log building, the type of corner notching, whether or not there is a foundation and/or an interior floor, etc. The critical first step in replacing a sill log is jacking up the building. This diagram shows different methods of jacking up a building to replace the sill log. Replacement log should match the original in wood type, size and method of hewing.

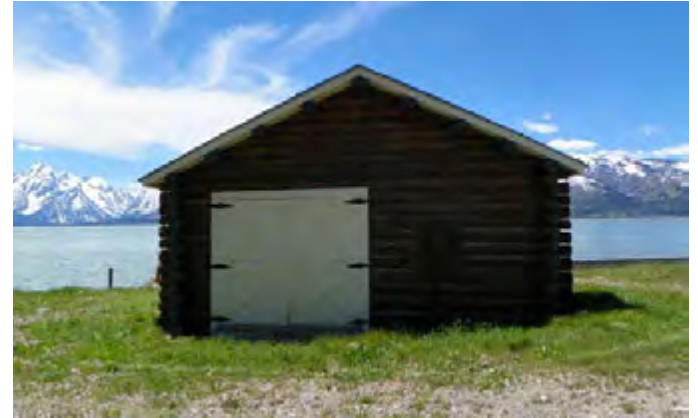
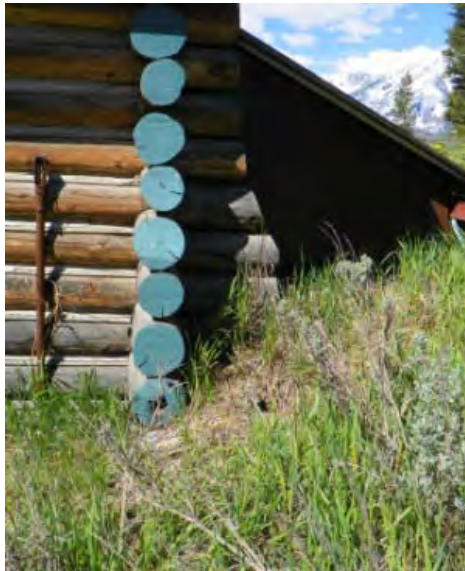
- Several buildings have problems with grading and drainage. Water runoff deposits sediments which cover the lower logs of buildings, causing them to deteriorate over time and compromise structural integrity.

- Re-grading the site around the building and diverting water away from the foundations of the buildings will keep the logs in better condition and over time will save money. Diverting water can also help to avoid issues with erosion, which can compromise foundations.

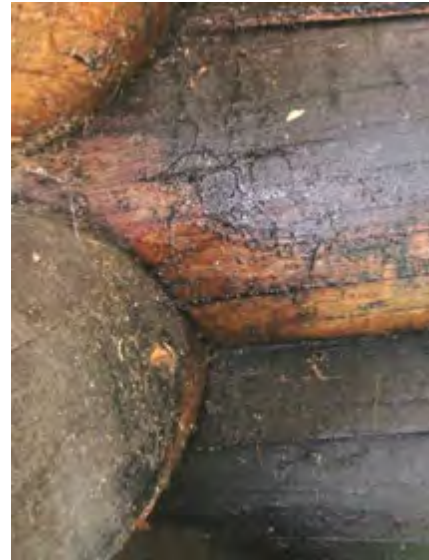
Water is dripping down wall instead of gutter causing black fungal growth on log

Corner has lots of black fungal growth and is constantly moist.

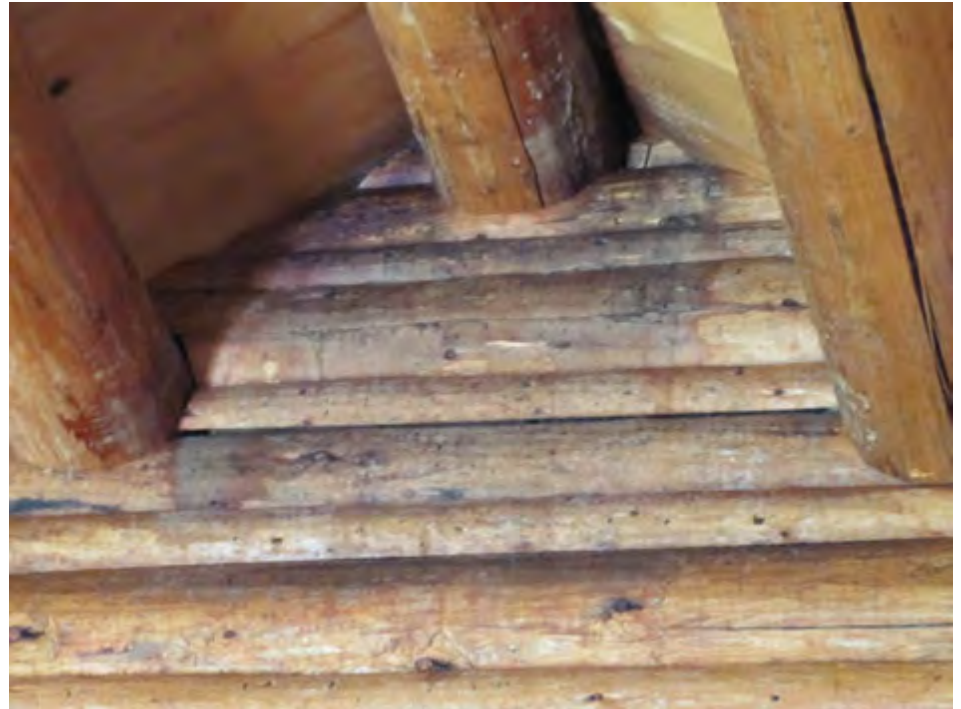
Damage to the upper logs in the Berol Lodge living room.

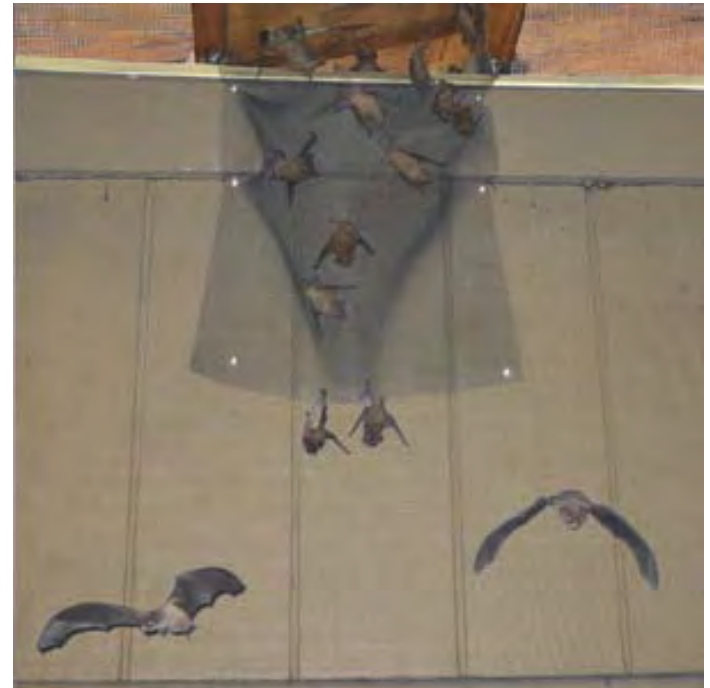
Correct exclusion netting in place. Netting should be draped over the hole to allow bats to fall carefully out, but not allow them back in.

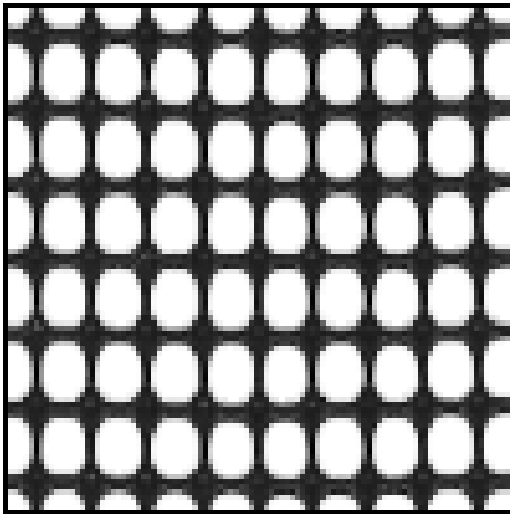
Bat netting should be 1/8th inch or less, like the one on the left, to prevent bats from becoming caught in it. The one currently installed is 3/8th inch, the size of a dime, allowing bats to get trapped in it.

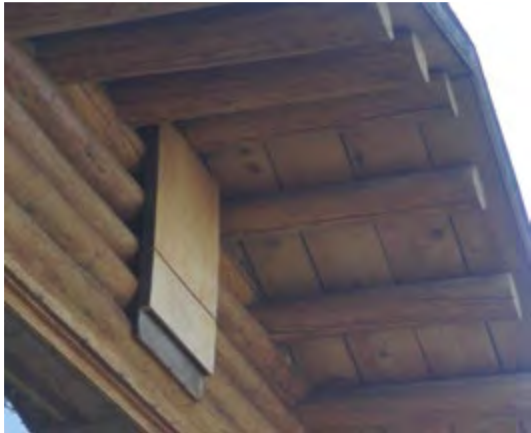
Bat house placed on the north end of the west side of the Berol Lodge, which appears to be vacant. The NPS should be consulted for ideas on other designs that may be more successful.
