National Park Service
Cultural Landscapes Inventory
1999

Revised 2006

Mormon Row Historic District
Grand Teton National Park

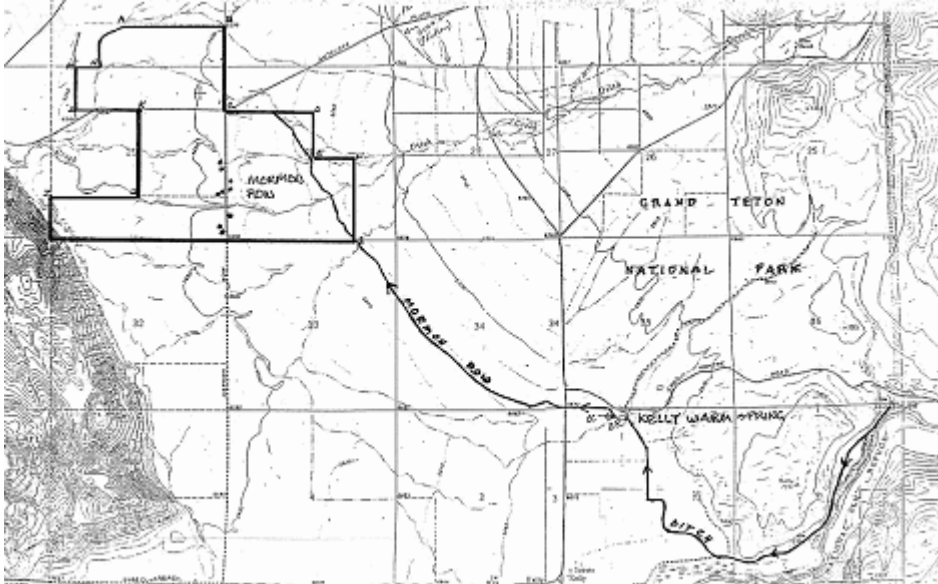
Site Plan

Mormon Row Historic District boundary. (Ref National Register nomination)

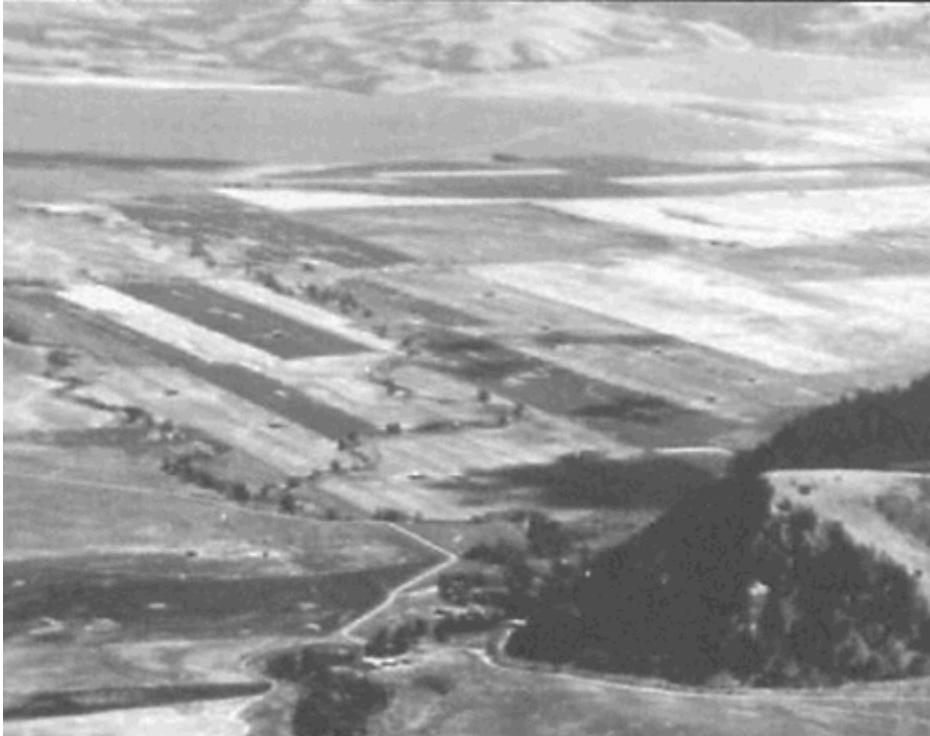
Aerial View of Mormon Row Historic District. Photo from the 1999 NPS Mormon Row Historic District Management Alternatives and Environmental Assessment.

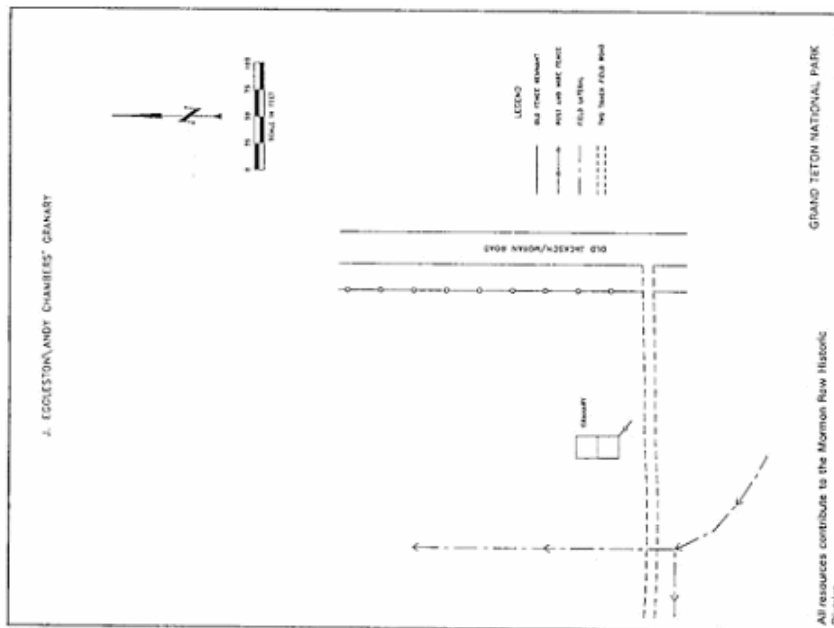
J. Eggleston/Andy Chambers' Granary (HRA 1995 graphic)

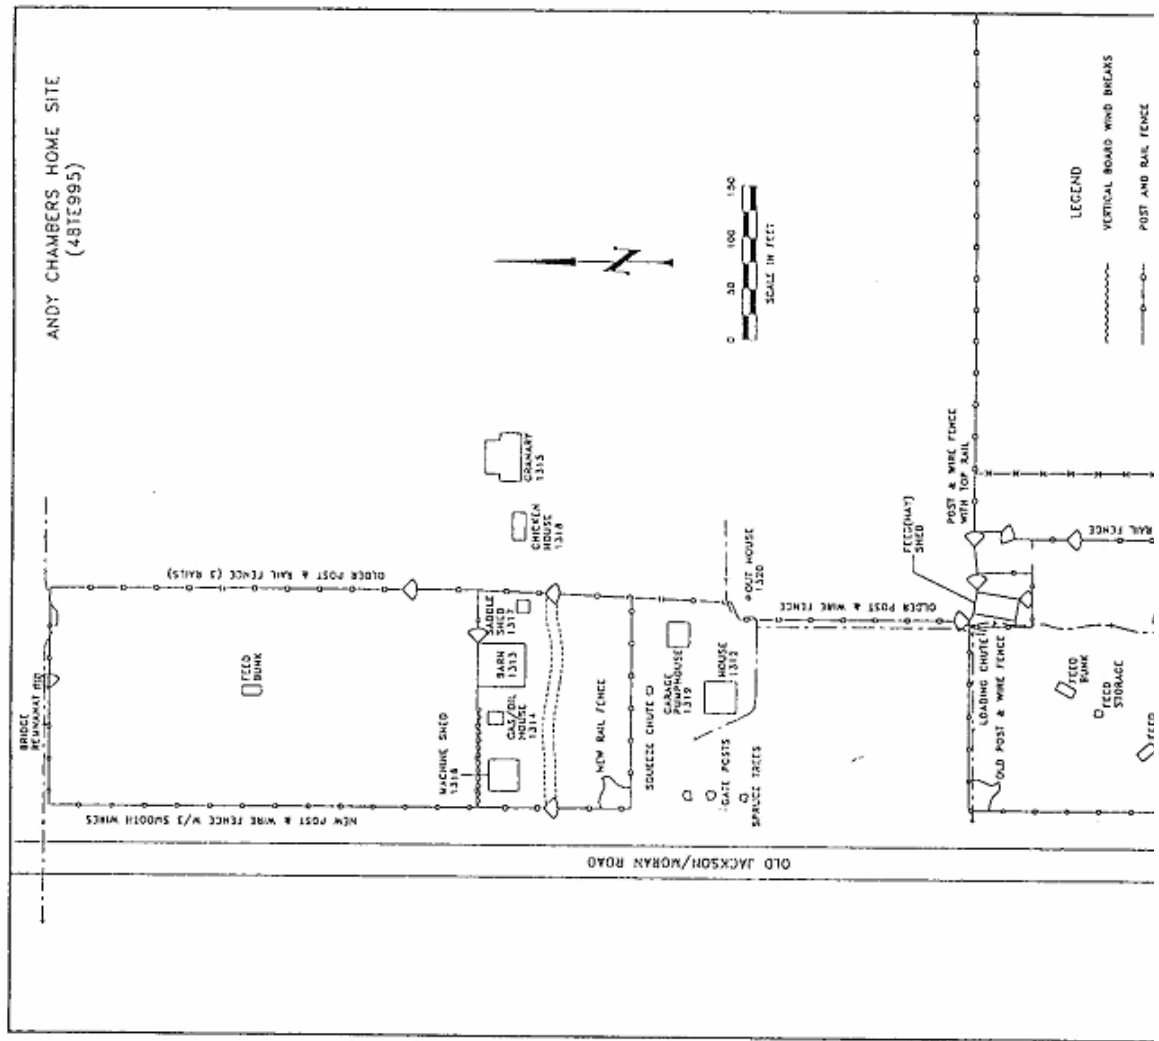
Andy Chambers Home Site (HRA 1995 graphic)

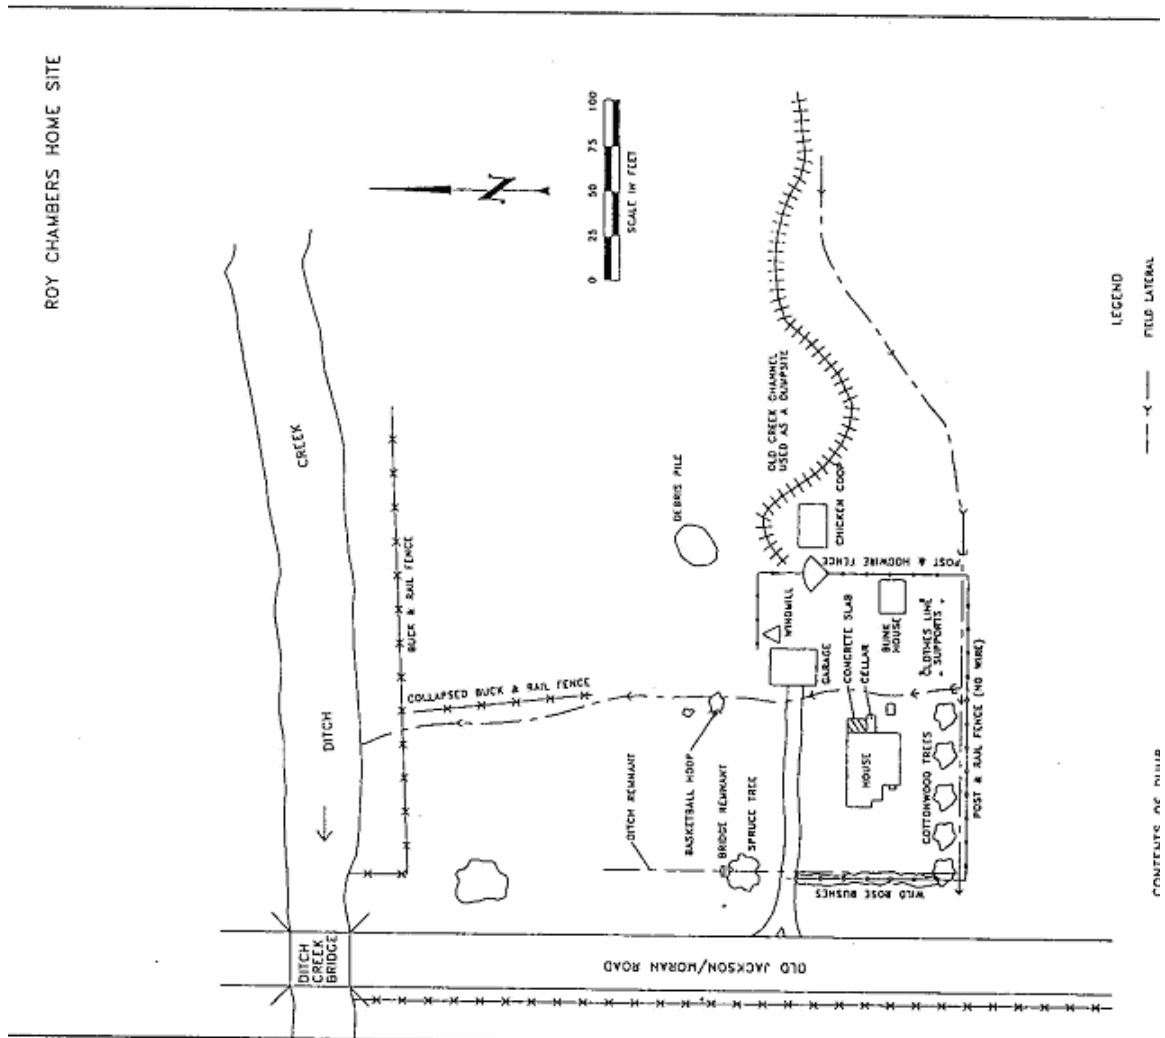
Roy Chambers Home Site (HRA 1995 graphic)
