**Archeological Investigations of the
Ice House and the Summer Kitchen/Stone Building
at Ulysses S. Grant National Historic Site,
St. Louis, Missouri**

Midwest Archeological Center
Technical Report No. 69

United States Department of the Interior
National Park Service
Midwest Archeological Center
Lincoln, Nebraska

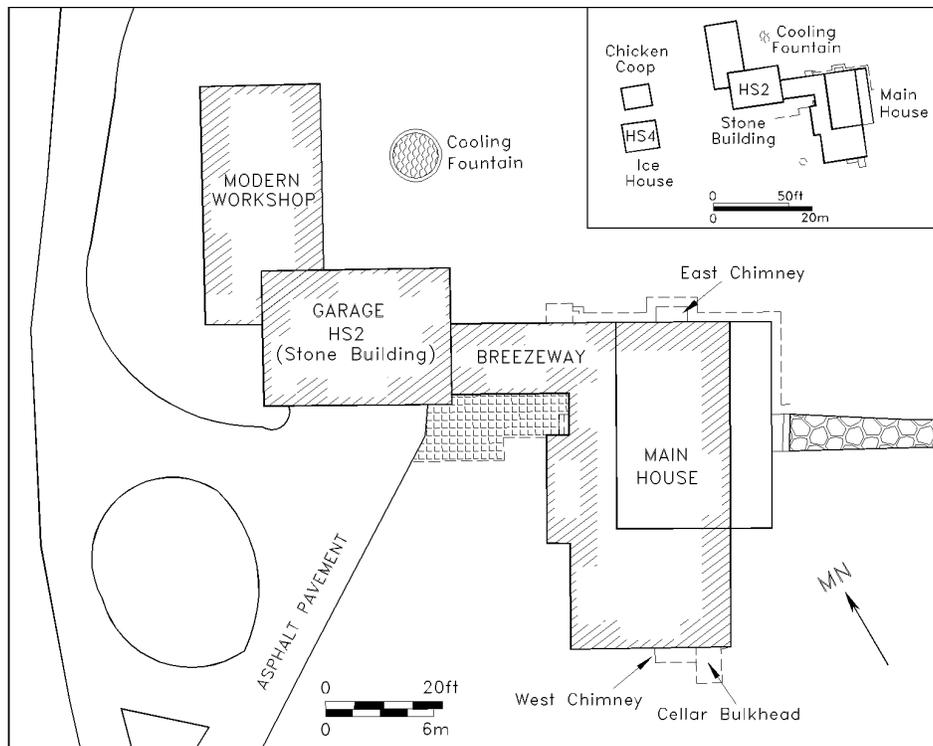
Figure 4. The main house in relation to HS-2, Summer Kitchen/Stone Building, and other structures.

At the crest of the hill sits White Haven’s main house, a two-story frame structure. Adjacent and to the north is a massive stone structure that was most recently used as an automobile garage but is reputed to have been a slave cabin. However, not only is its original function in question, historic photographs indicate that it was smaller in size before it was rebuilt by subsequent owners of White Haven. A large room added sometime in the 1950s extends eastward off the rear of the stone structure and served as a workshop for the last private residents of White Haven until it was removed in October 1999 during HS-2 restoration. And behind the main house, generally toward the north, are two outbuildings that stand side-by-side on the slope leading down to the ephemeral stream that demarcates the north property line. One is believed to have served as an ice house/smoke house, and the other is commonly identified as a chicken house (Figures 2 and 4).

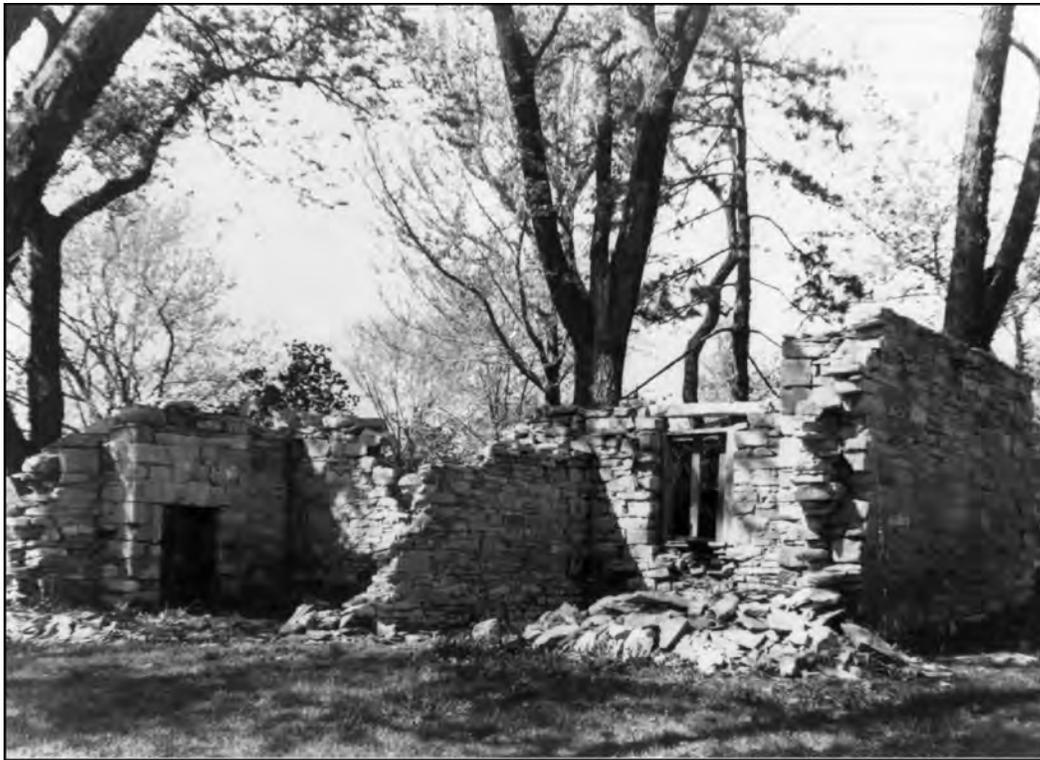
Figure 5. An early-twentieth-century photograph of the ruins of HS-2, Summer Kitchen/Stone Building.

It is unknown how long the Stone Building served as a summer kitchen, but by the time the property was purchased by Albert Wenzlick in 1913 a permanent, first-floor kitchen had been established in the Main House. The Stone Building remained intact until at least 1875 and possibly well into the 1890s, but it had partially collapsed prior to 1913 (Figure 5). It is possible that the Stone Building deteriorated when the property was virtually abandoned and no longer maintained between 1905 and Albert Wenzlick's purchase in 1913. One possible reason for abandonment was the collapse of the west wall, which might be due to a tornado that swept through the St. Louis area on May 27, 1896. An earthquake may be another explanation for the wall's collapse, since one strong tremor was recorded as occurring on October 31, 1895 (O'Bright 1999:3.23).

According to O'Bright (1999:3.23) the Stone Building functioned as a seldom-used storage shed during Albert Wenzlick's ownership until his death in 1937. Sometime around 1930 a shed roof partially collapsed or was damaged by a tree limb but was repaired by 1940. Delbert Wenzlick began planning for renovation of the Stone Building upon receiving the White Haven property in 1940. Not long thereafter,

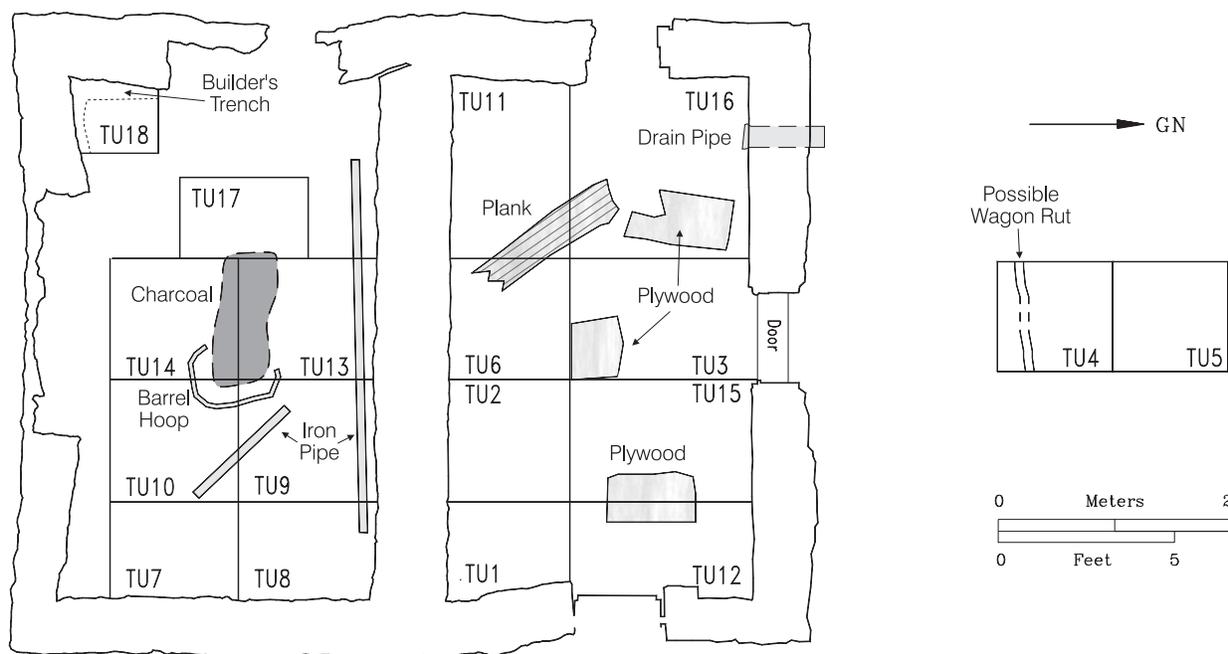
Figure 6. Plan of excavation of HS-4, Ice House.

rubble limestone foundation walls measures about 23 ft by 18 ft, with a stone partition that divides the interior into two equal-sized rooms (Figure 6). The north portion of the foundation wall is mostly above ground, while the south portion is below the ground surface. The superstructure that existed prior to restoration was a light wood-framed gable roof bearing asbestos shingles laid over roll roofing and board sheathing, while the gable ends are sheathed in machine-sawn, beveled clapboard siding. These structural elements had been removed at the time of the archeological investigations, leaving only the foundation walls in place. At the time of the archeological investigations the park maintenance staff had erected a wood-framed plastic-covered shelter around and over the foundations to protect them and the workers from inclement weather.

The Ice House was excavated using a series of 18 test units placed in and around the building (Figure 6). As previously noted, the superstructure had been removed prior to the archeological team's arrival. The stone foundation walls were in good shape in the north room and in poor condition, nearing the point of collapse, in the south room (Figure 33). For safety reasons, test units in the south room, were laid out up to 50 cm away from the west and south walls (those in poor condition).

Two excavation units (TUs 4 and 5) were aligned with the doorway but placed 1.7 m north of the building (Figure 6) in an effort to locate evidence of a pathway to the building. No pathway evidence was found in the square, 1-by-1-m units, although a possible wagon rut was noted and mapped in the south end of TU-4. The units were dug to a depth of 20 cm, at which point a yellow, culturally sterile clay was encountered on the gently sloping ground.

A fragmentary barrel hoop from a large barrel and a charcoal concentration were located just north of the center of the room (Figure 6). The charcoal staining or concentration was elliptical in shape. It began in the southwest corner of TU-9, continued in the northwest corner of TU-10, and ran the length of TUs 13 and 14, ending in the northeast side of TU-17. The concentration is approximately 1.5 m long and 0.75 m wide. This charcoal concentration may represent the remains of the fires stoked by the Wenzlicks when they used this room as a smoke house.

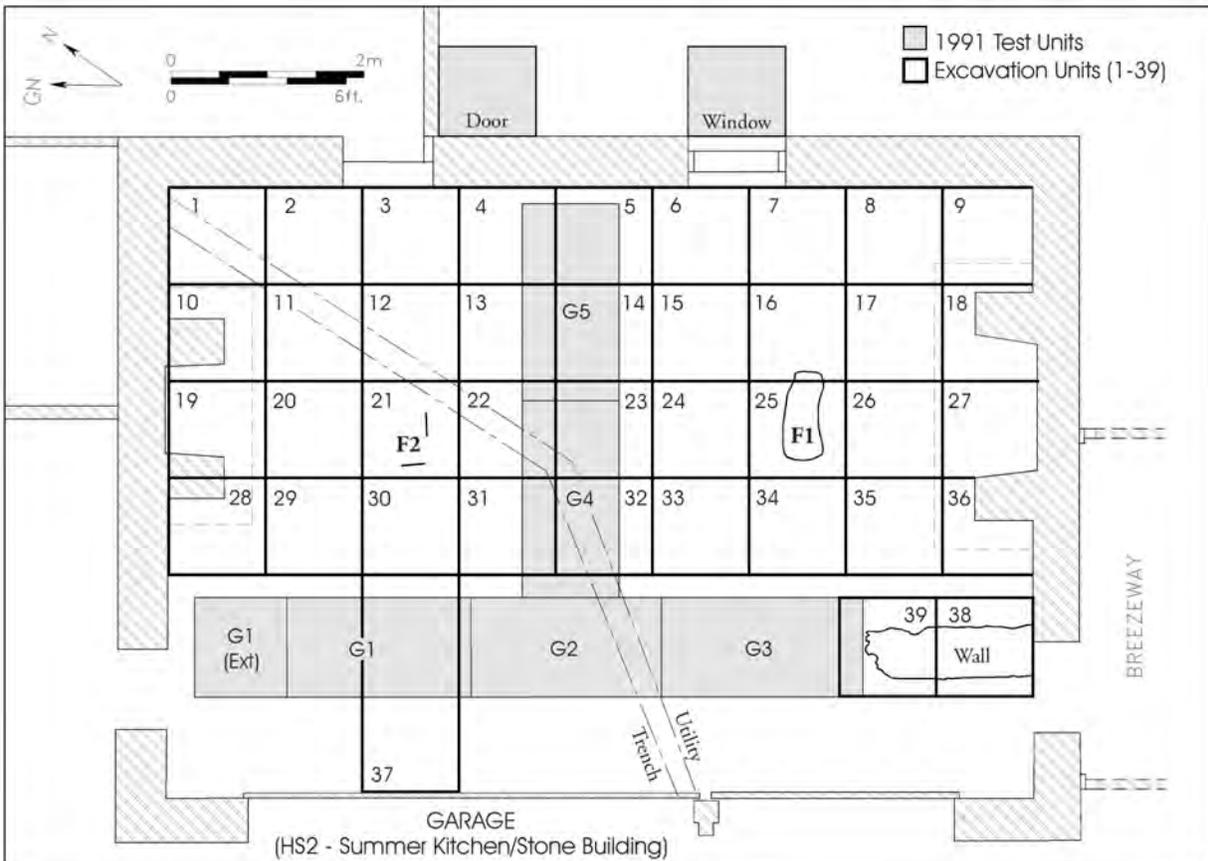
Figure 7. Plan of excavation of HS-2, Summer Kitchen/Stone Building.

The last private owners of White Haven converted the Stone Building for use as an automobile garage. That conversion required removal of the structure's collapsed west wall for installation of two large garage doors, and the interior central wall for installation of a concrete and brick floor. Doorways were added on the north and south ends of the building. A third doorway at the northeast corner is in all likelihood modern in origin, for it provides communication between the Stone Building and the 1950s workshop. A single window brings light into the room through the east wall (Figure 7).

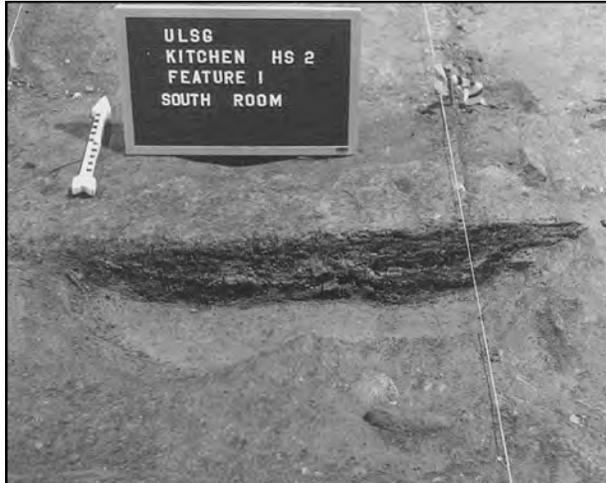
Figure 8. Profile of Feature 1, a floor hearth in the south room of HS-2, Summer Kitchen/Stone Building.

Two features were recorded during the excavations. Feature 1 is a fire pit measuring 50 by 80 cm and 10–15 cm deep (Figure 8). It is located in TU-16 and TU-25, near the middle of the south room. The fill was nearly devoid of artifacts, and diagnostic artifacts were entirely absent. The fill constituted ash, charcoal, and small burned logs. The sides of the pit were fire reddened, indicating the firing indeed occurred in the pit. The fire pit's date and purpose cannot be determined with the available information.

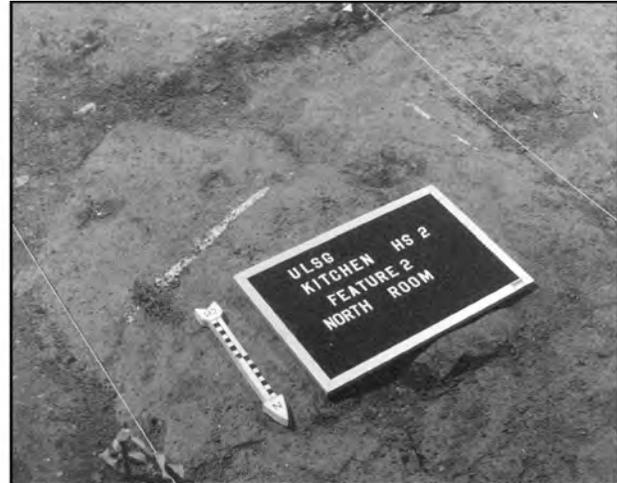
Figure 9. Feature 2, a glazing compound found in the north room of HS-2, Summer Kitchen/Stone Building.

Feature 2 was a right-angled alignment of a white lead-based window-glazing compound (Figure 9). It was found in TU-21. A rodent burrow had disturbed the corner contact. The remaining elements were about 1 cm wide and 45 cm long north-south and 32 cm east-west. It is possible a window frame fell or was stored at this location, as there was a large quantity of broken window glass associated with the glazing compound, and also recovered in adjacent units.

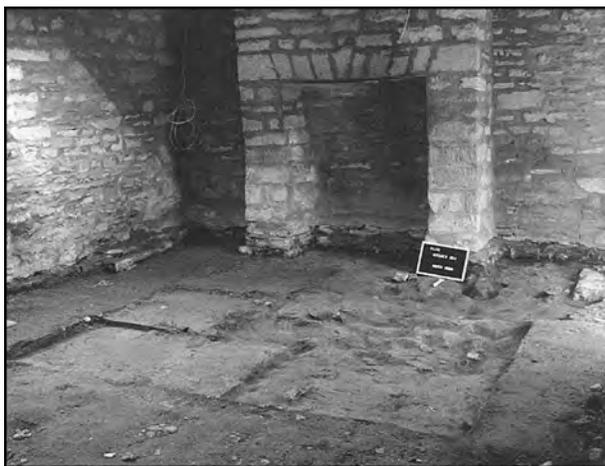
Figure 10. South room fireplace and excavation units in HS-2, Summer Kitchen/Stone Building.

Both fireplace hearths were extensively disturbed. Only limestone rubble remained in the area of the firebox and hearth aprons of both fireplaces (Figures 10–11). The south fireplace firebox was nearly devoid of rubble, but the clay substrate was fire reddened as the result of heat passing through the stone firebox and heating the soil for long periods of time.

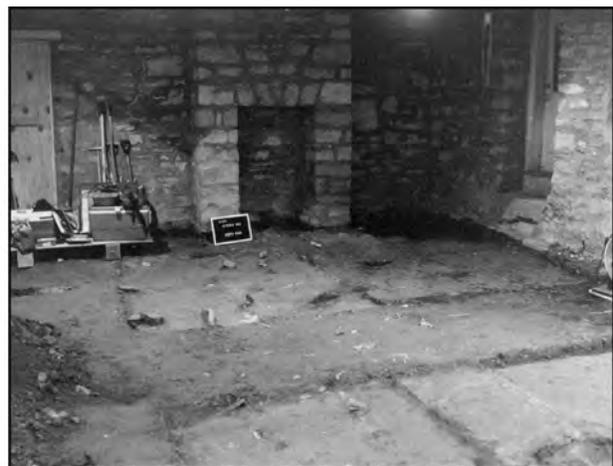
Figure 11. North room fireplace and excavation units in HS-2, Summer Kitchen/Stone Building.

The north fireplace showed a similar heat reddening of the clay, but there was more limestone rubble present around and in the fireplace. Soil stains and rubble suggest the fireplace apron was 18–20 in wide around the fireplace. Two dressed stones were found *in situ* on the east side of the fireplace in TU-10. These stones show considerable wear on the eastern exterior surface. The top surface is dressed but not especially well. These stones were probably part of the base of the fireplace apron, and they suggest that one or more courses of limestone were laid above them to form the apron's surface. Their presence and placement help to confirm the probable apron width of 18–20 in.

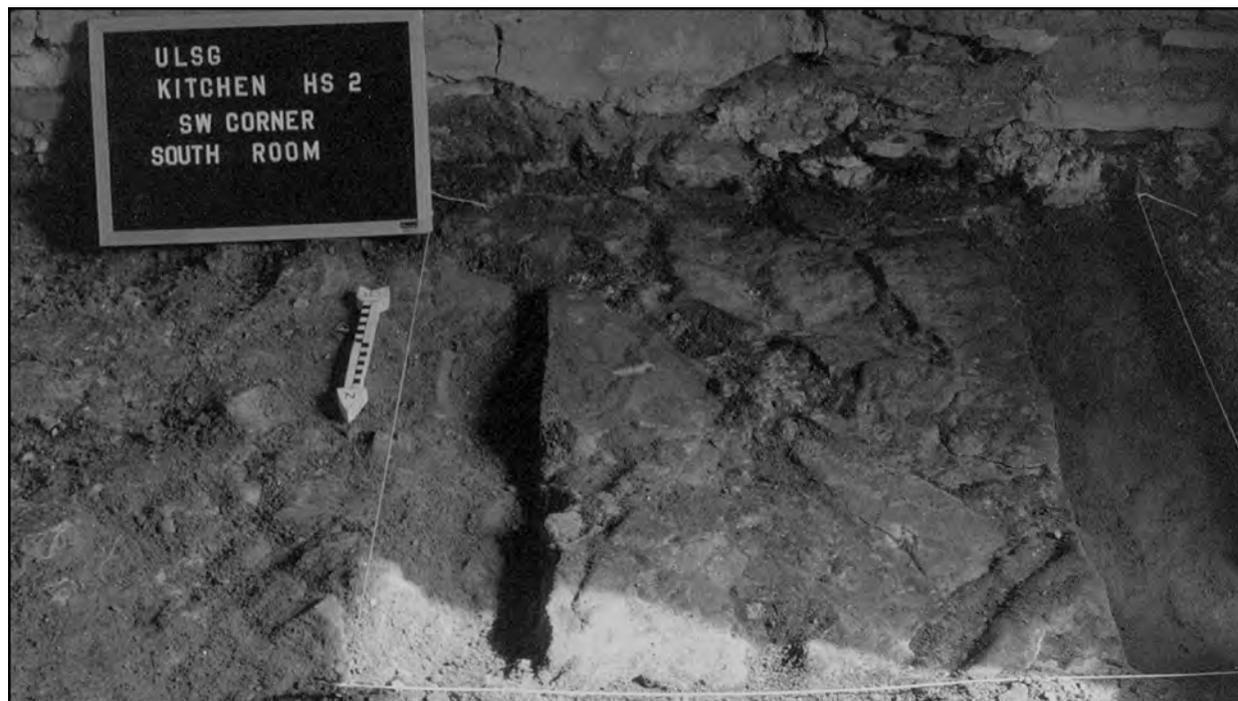
Figure 12. The remaining western foundation wall of HS-2, Summer Kitchen/Stone Building.

TUs 38 and 39 revealed the presence of a fairly well preserved segment of the Summer Kitchen's west wall foundation and southwest corner (Figure 12). The remaining wall foundation is limestone, one course thick, and 60 cm (24 in) wide. The exterior or west side of the foundation was laid on and against the red/orange sterile clay. The interior or east side suggests that a builder's trench was dug and the stone foundation laid up against the trench's west side. Noble (1997) located other remnants of this builder's trench in his 'G' units.

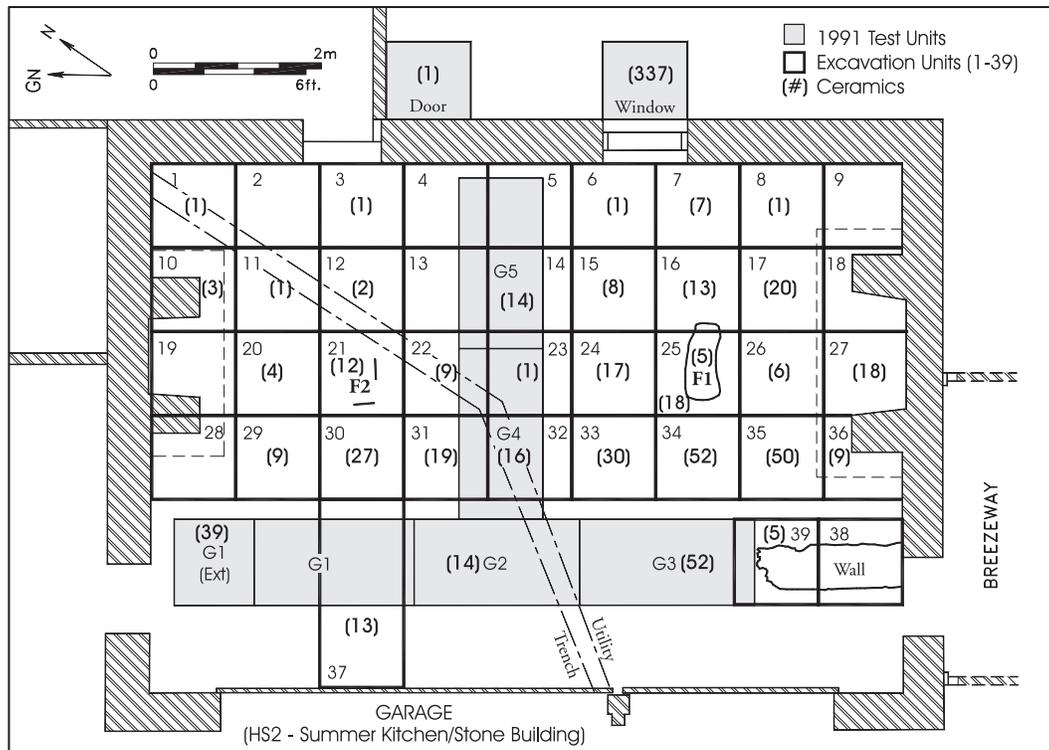
Figure 14. Distribution of all ceramics from HS-2, Summer Kitchen/Stone Building.

Ceramic sherds were found in nearly every excavation unit in the building, but there is a higher concentration of sherds in the western half of the structure and in the south room in particular (Figure 14). However, this may be a function of deeper artifact-bearing deposits and extensive rodent burrowing in these areas rather than a completely cultural or functional explanation. Figures 15 to 20 show the distribution of ceramics by type, and Figure 21 displays the distribution of sherds by vessel form.

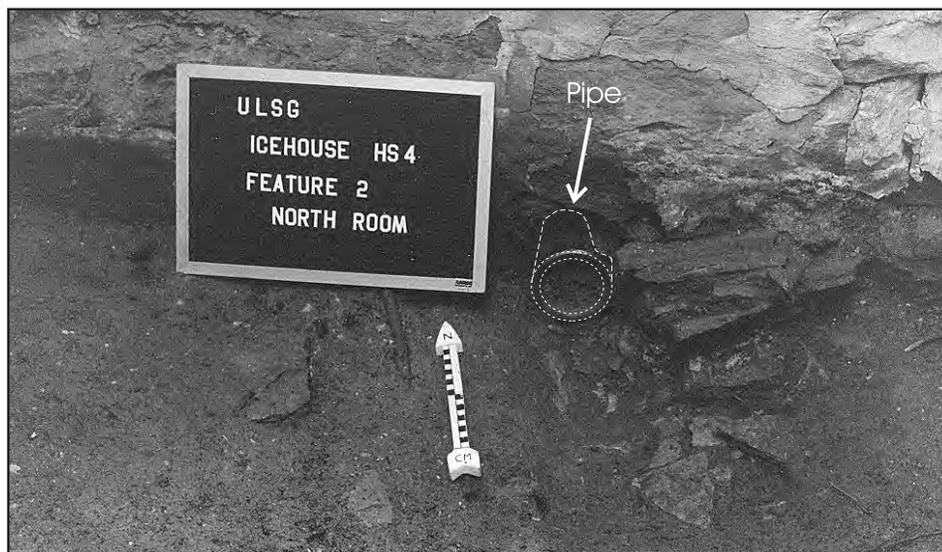
Figure 34. Drainpipe in the north wall of the north room of HS-4, Ice House.

A drainage tile pipe was located running through the north wall about 25 cm west of the doorway (Figure 34). The pipe is a red-glazed clay with a simple bell on one end. The pipe was removed during the building's restoration and was found to be about 150 cm long and 8 cm in diameter and had a St. Louis maker's mark on it. That mark indicates it was twentieth century in origin. The red-glazed drainage tile may have been a replacement for an earlier pipe that was found in the fill on the exterior of the north side during restoration. This second pipe is also about 8 cm in diameter and about 150 cm long. It is a light-brown unglazed clay with a simple bell on one end, and it is unmarked.

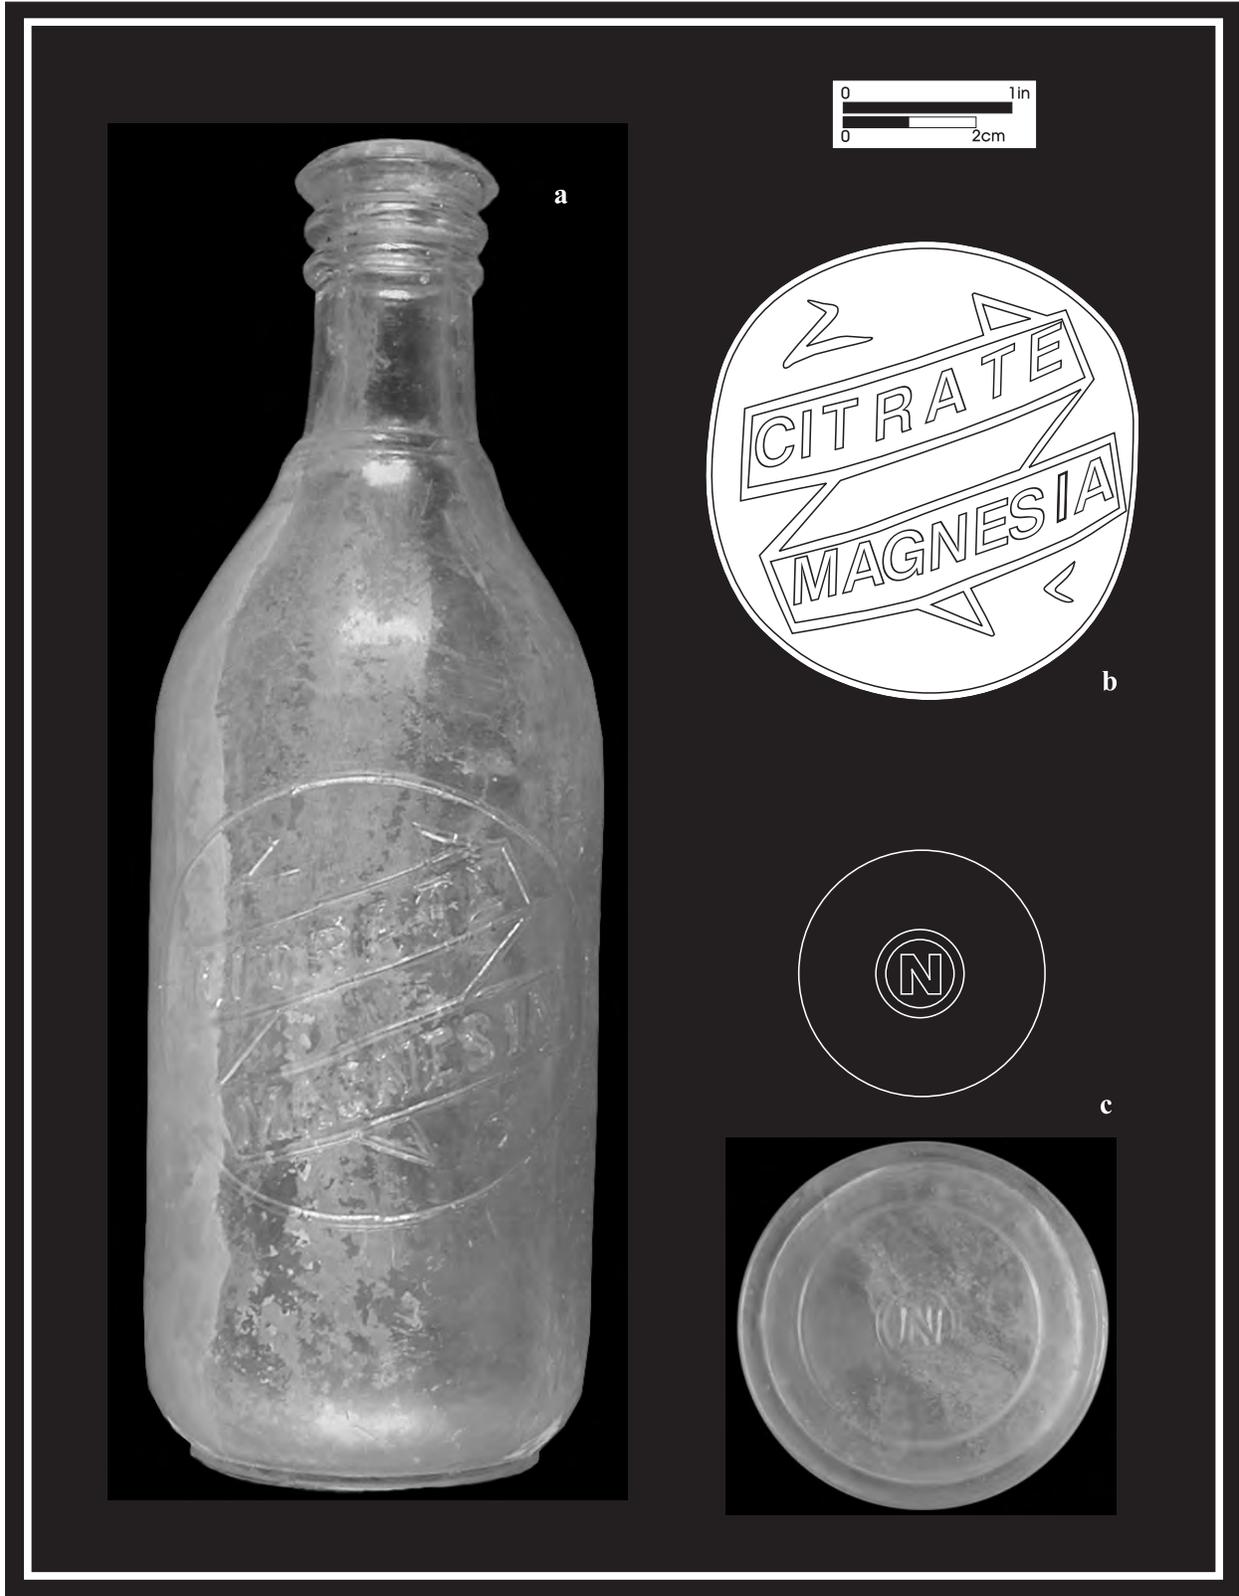
Figure 35. Complete soda bottle with the name Citrate Magnesia (a, b) and a base mark of a circle and an 'N' (c) found in excavations in HS-4, Ice House.

The most diagnostic artifacts found in the fill were complete and fragmentary bottles (Figures 35–38). TU-11 yielded a fragment of a milk of magnesia bottle which dates after 1906 (Fike 1987:106). A complete soda bottle with the name / CITRATE / MAGNESIA / and a base mark of a circle and 'N' (Figure 35) was found in TU-15. A fragmentary example was also recovered in TU-16. The base mark is for the Obear-Nester Glass Company, which used this mark from 1894 to 1915 (Toulouse 1971:372). Another bottle found in TU-15 was marked / Logan-Johnson-Ltd / with a base mark of an 'I' in a diamond (Figure 36). This base mark is for the Illinois Glass Company, which used the mark from 1916 to 1929 (Toulouse 1971:264). Several bottles were found clustered along the west wall during the restoration. One bottle base and one bottle were marked with the logo and name of / H. WETTER / SOUTH / ST. LOUIS /, a St. Louis Missouri firm (Figure 37). Herman Wetter was in business from at least 1877 to at least 1900 (Foland 1971:5). Another bottle fragment was marked / D^R PIERCE'S / GOLDEN / MEDICAL DISCO... /. Dr. R. Pierce bottled various medical compounds in Buffalo, New York, during the last quarter of the nineteenth century (Fike 1987:110, 120, 177, 232).

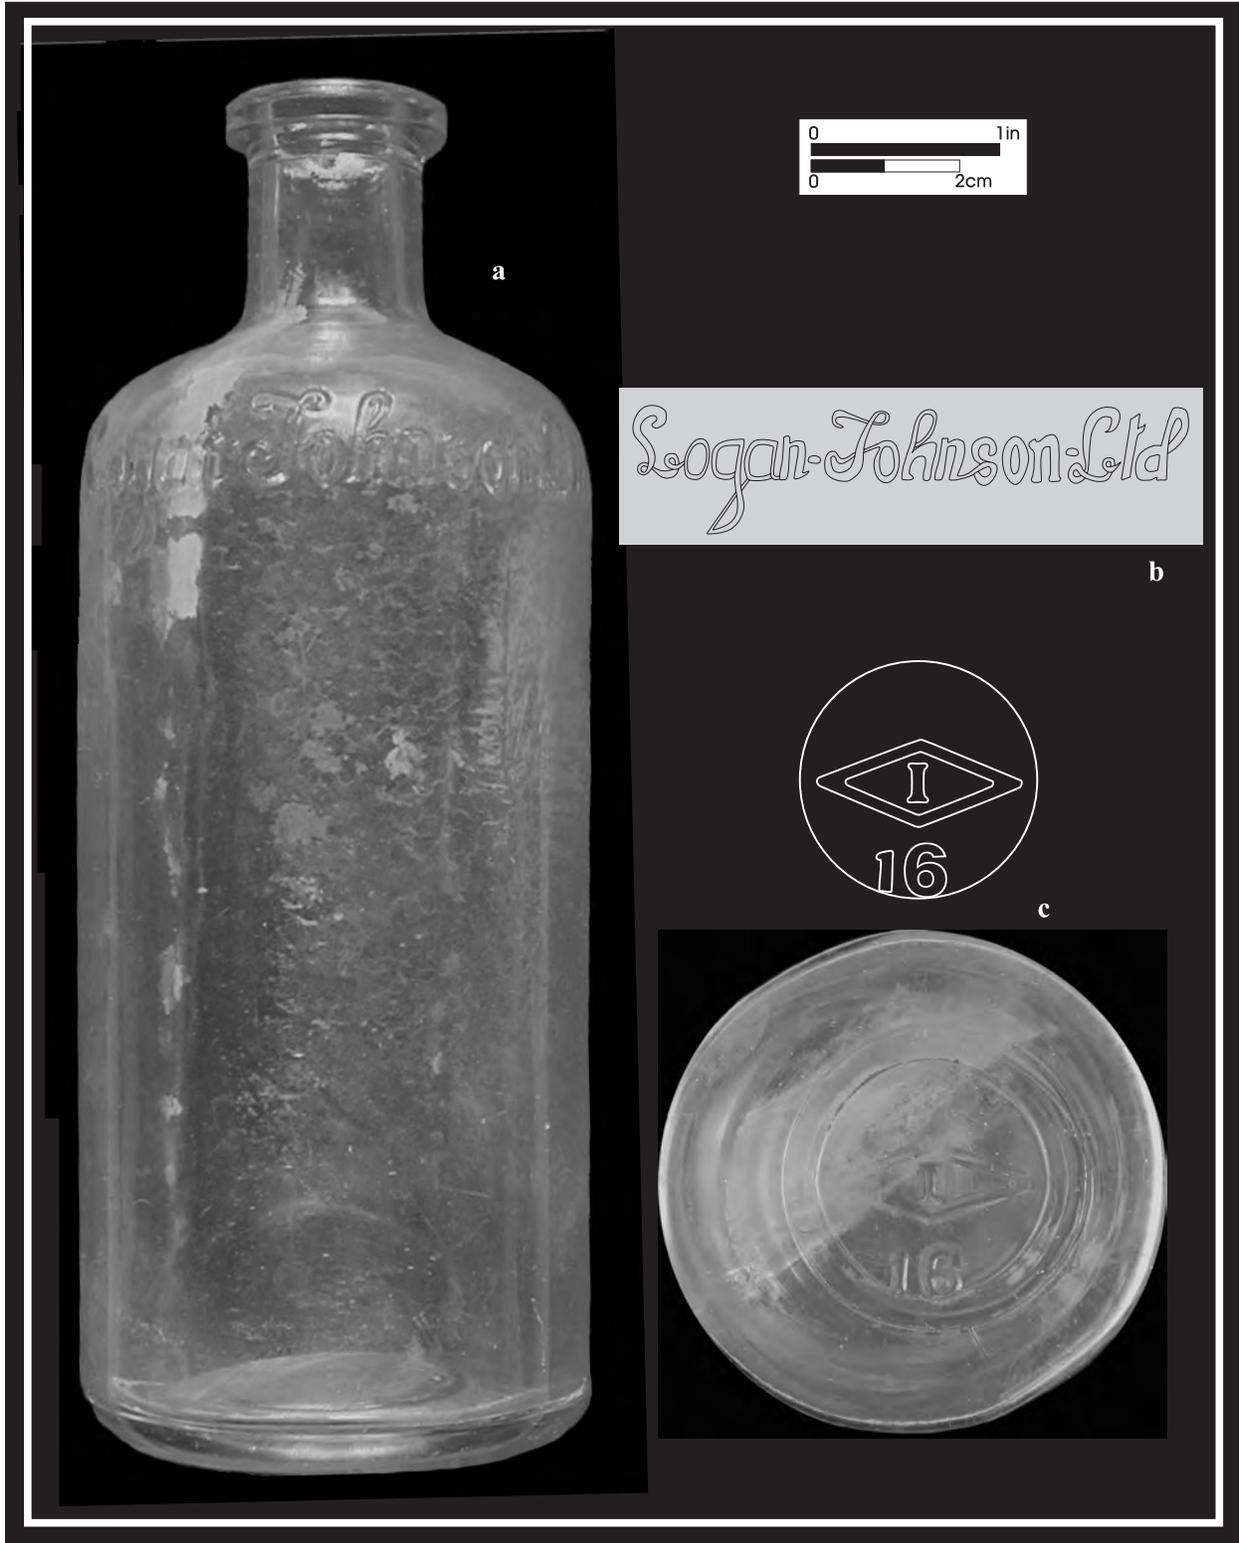
Figure 36. Complete bottle marked with the name Logan-Johnson-Ltd (a, b) and a base mark of an 'I' in a diamond (c) found in excavations in HS-4, the Ice House.

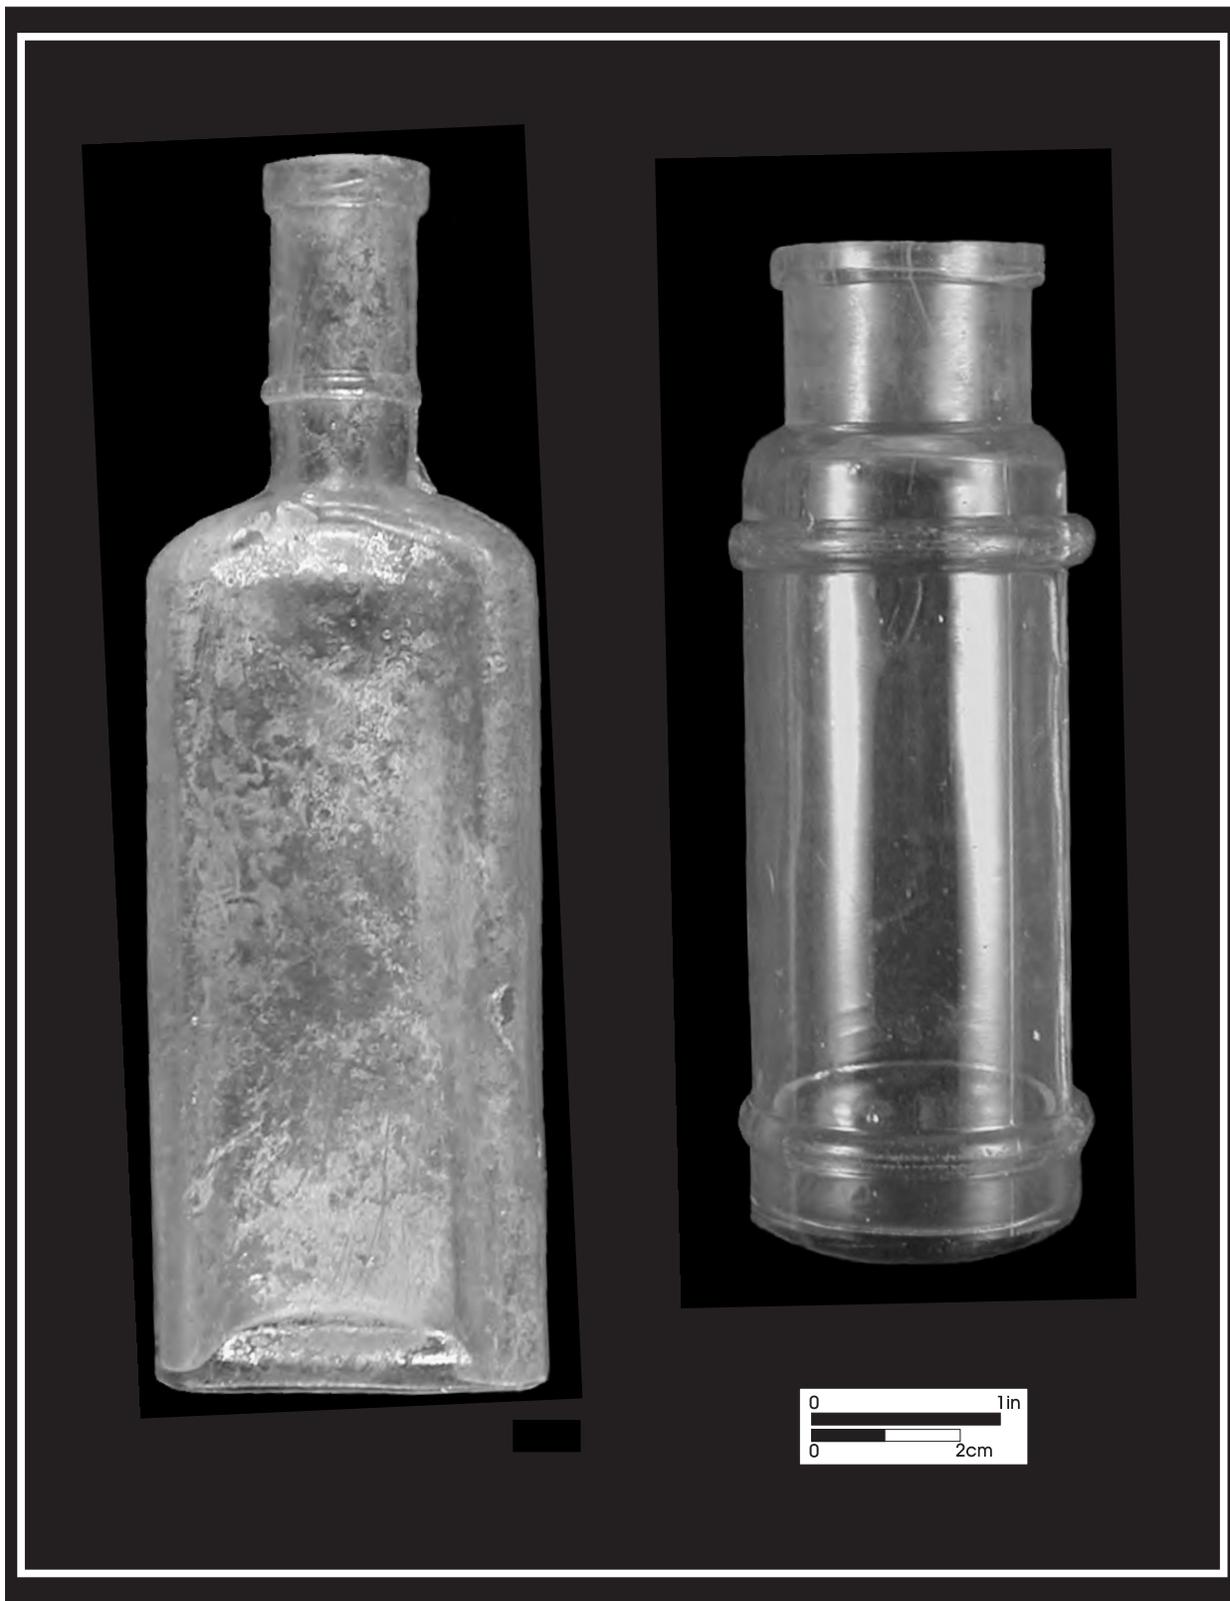
Figure 38. Unmarked bottles found in excavations in HS-4, Ice House.

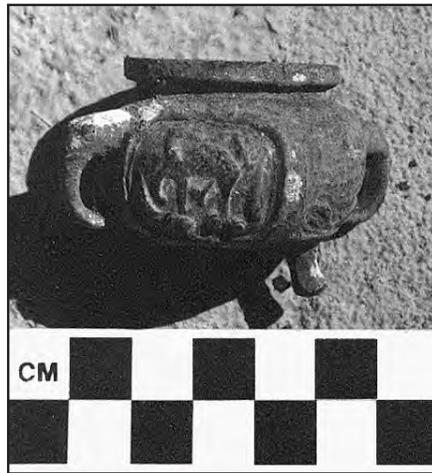
Figure 39. A small spelter metal pot found embedded in the wall of the south room of HS-4, Ice House.

During the initial superstructure removal, a rather unique artifact was recovered. It was found by park personnel while removing some loose wall stones in the south room. It is a small spelter metal pot (Figure 39). It is uniquely decorated with elephant head handles, and scenes of snakes, an elephant, and a crab in separate panels around the body. The pot is about 1 in (25 mm) in diameter. The pot's origin is not certain, but likely came from an Asian country, possibly India. The pot could date to the nineteenth century, although the technology used to produce the item is still in use today.
