Exterior Ramps

Preserving Historic Character

Details: Retaining Original Form & Integrity

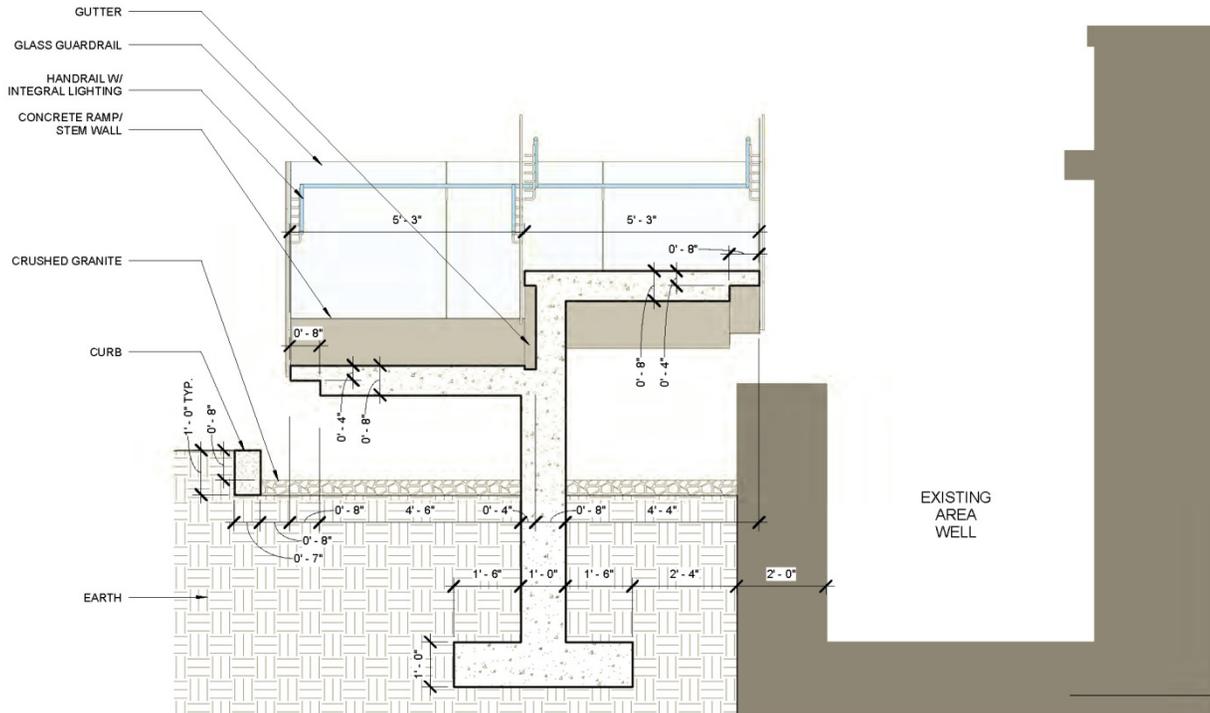
① WALL SECTION THRU EAST RAMP
1/2" = 1'-0"

Detail: Stem Wall

- avoiding conflict with top of moat wall
- Light touch on grounds (1 foundation wall)

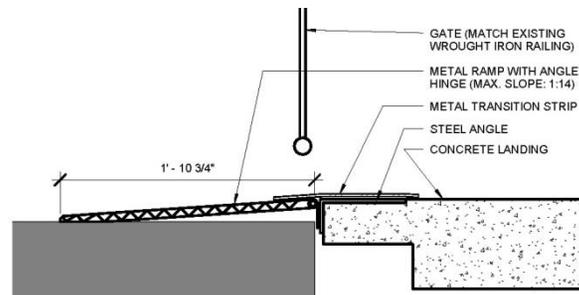
⑤ SECTION DETAIL OF RAMP AT PORTICO/GATE
1 1/2" = 1'-0"

Detail: Connection to Portico

- No/minimal attachment to existing building
- Anchored to new ramp, not portico

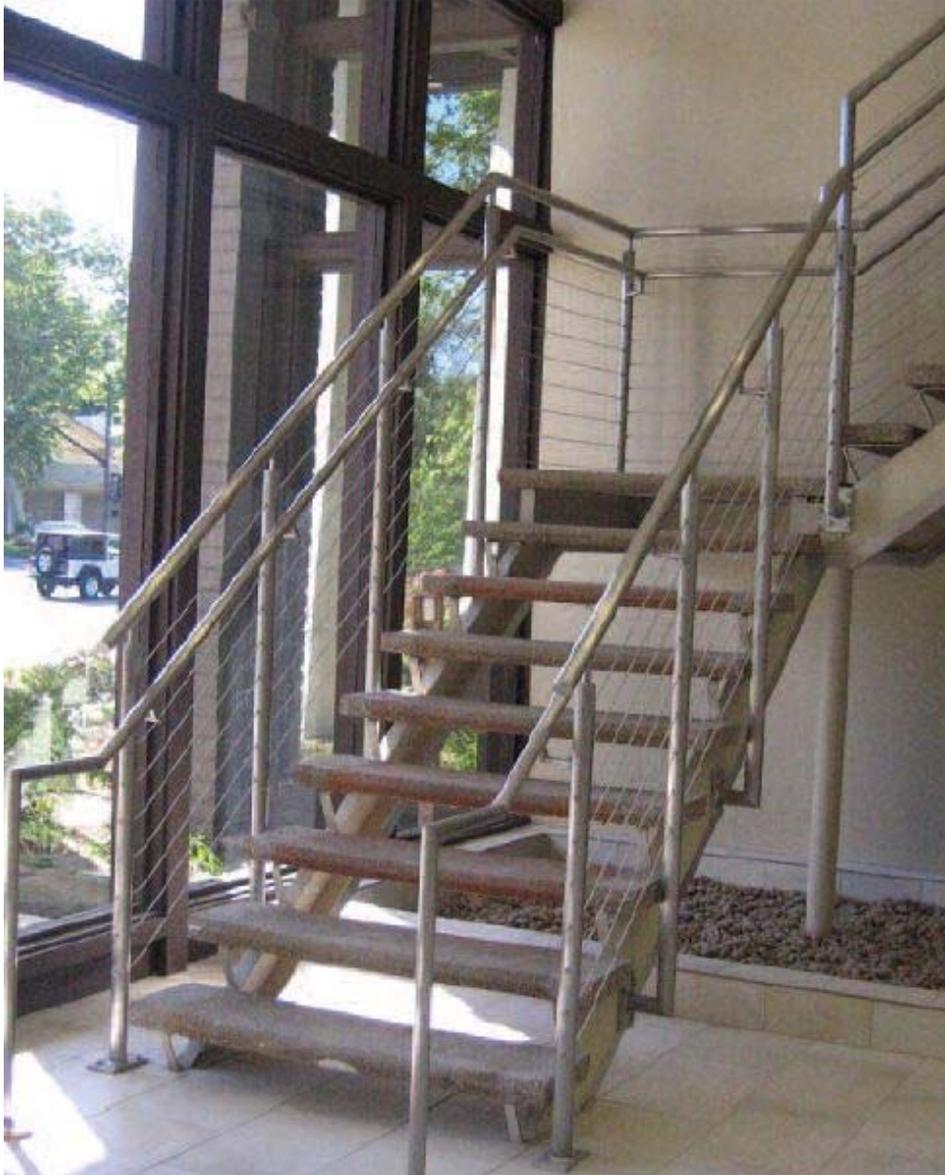
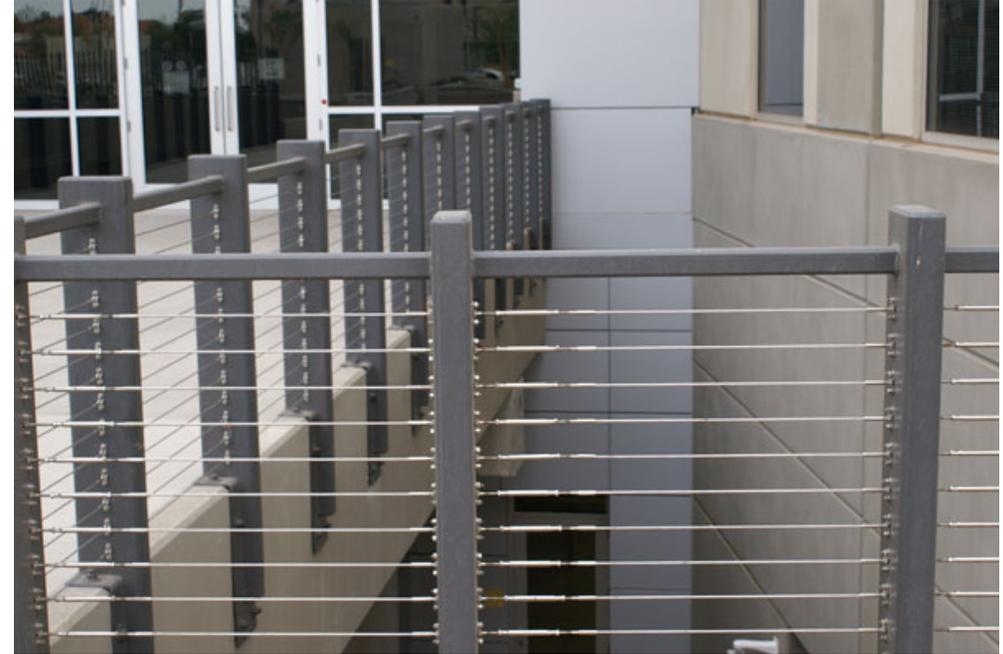
Cable Guardrails

- multiple attachments, intermediate posts, framing needed to ensure stability
- ladder style presents climbing/liability issues
- vertical installation presents tensioning issues
- maintenance difficult due to repetitive tightening for safety/appearance
- lessons learned from LKS guard rail design by MVVA
- **“less visible” option**
- **previous design needs to “blend better” with the Old Courthouse**

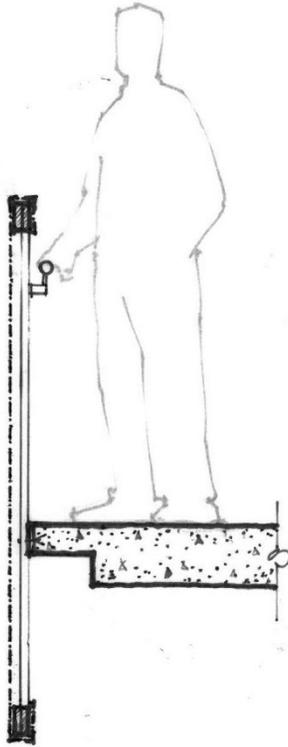
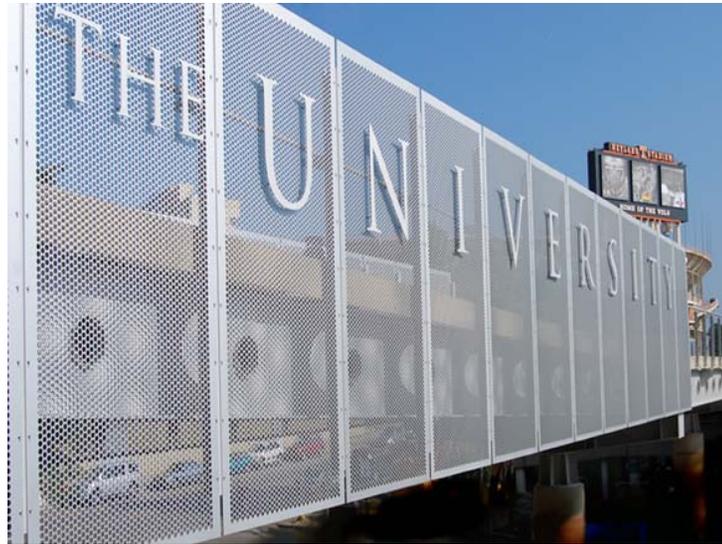
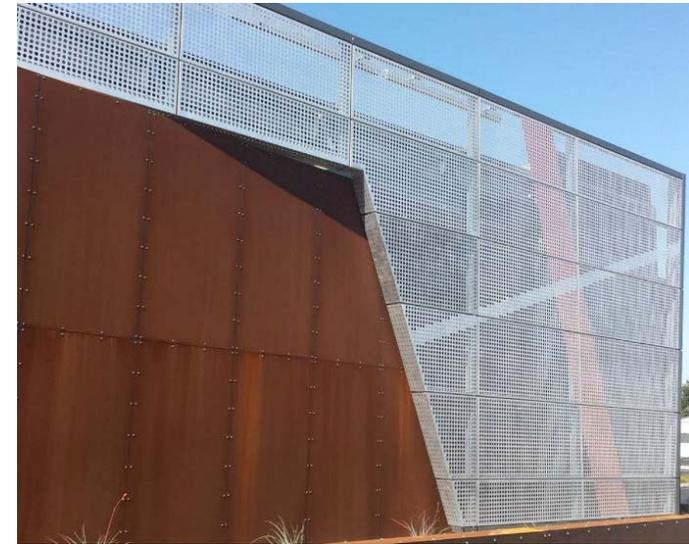
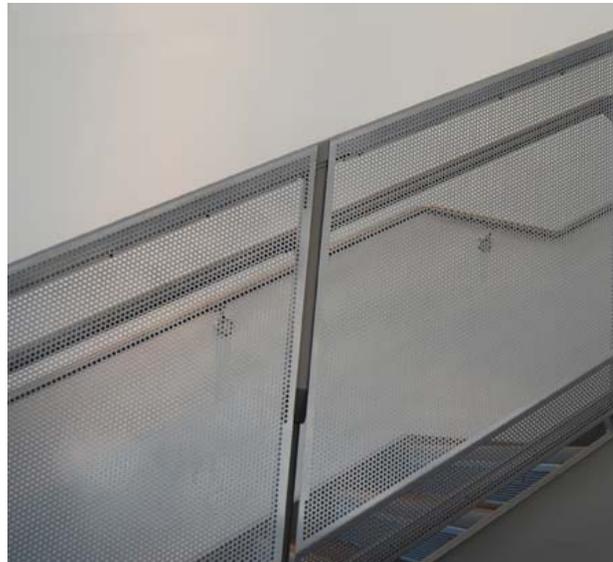
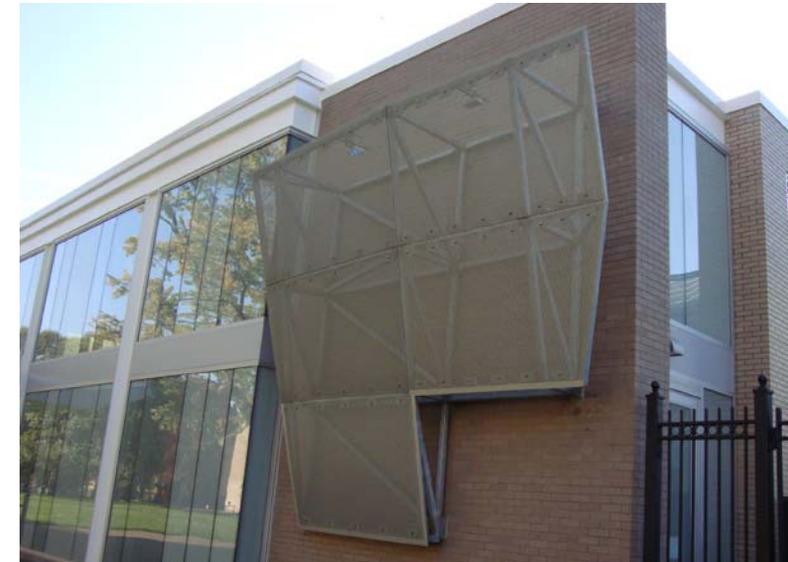
Metal Screen Guardrails (Option 1)

- perforated screens = “less visible” option
- woven mesh appears dark
- translucency
- allows OCH to read through
- minimal attachments
- clean corners
- wrap frame

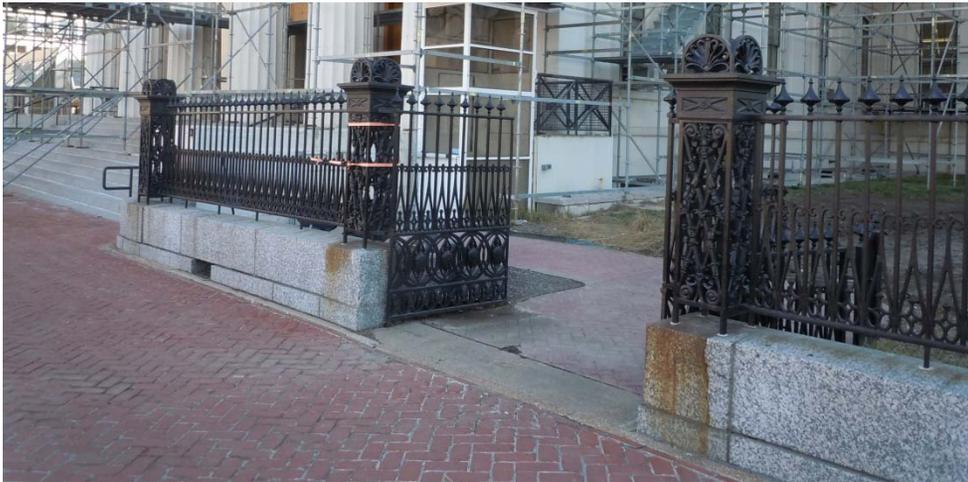
Picket Guardrails (Option 2)

In 1955 the NPS decided to rebuild an iron fence atop a granite base for durability. The turtle gates are not of historic design.

design a picket according to our design principles:

- minimal materials
- minimal connections
- avoid “faux historic”

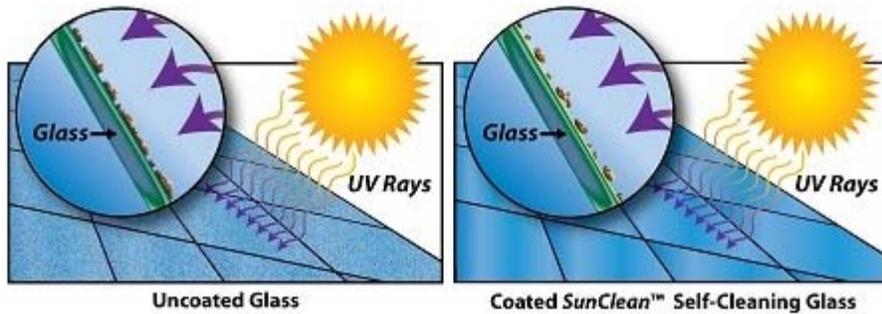
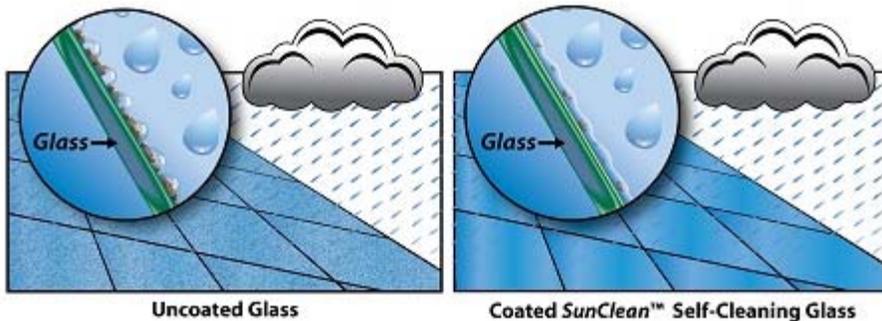
Self Cleaning Glass

- glass coating activated by ultraviolet rays from the sun
- causes organic material to gradually decay and be rinsed away with rainwater

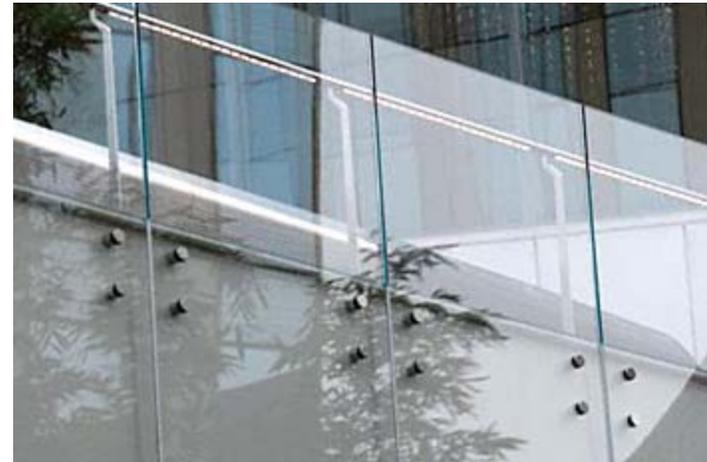
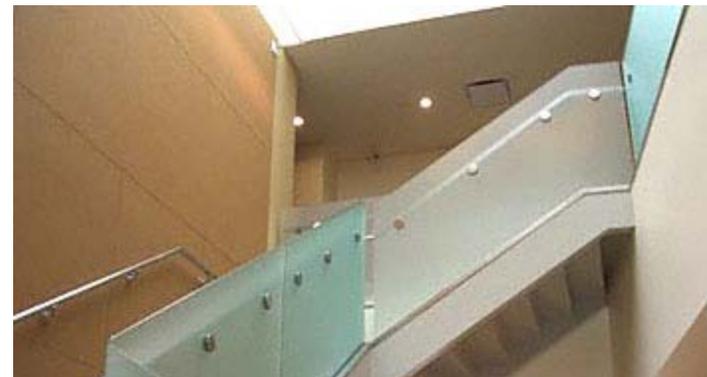
Finish Options

- laminated glass with translucent film sandwiched at center
- “velour” acid etched glass
