Cultural Landscape Report Manzanar National Historic Site

National Park Service
Pacific West Region
2006

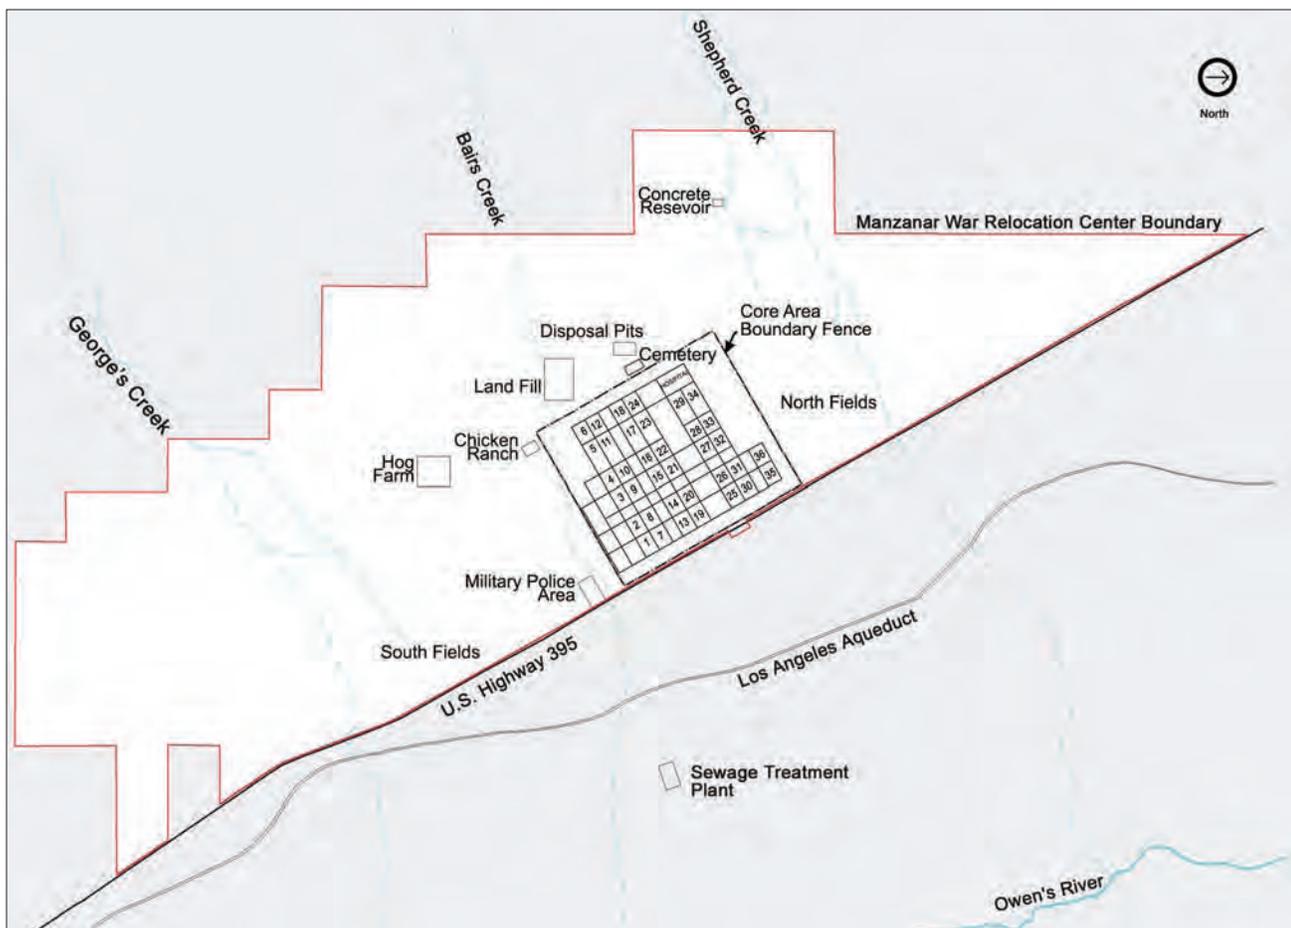
Figure 1. Study Boundary (Adapted from *Three Farewells to Manzanar*, WACC, 1996)

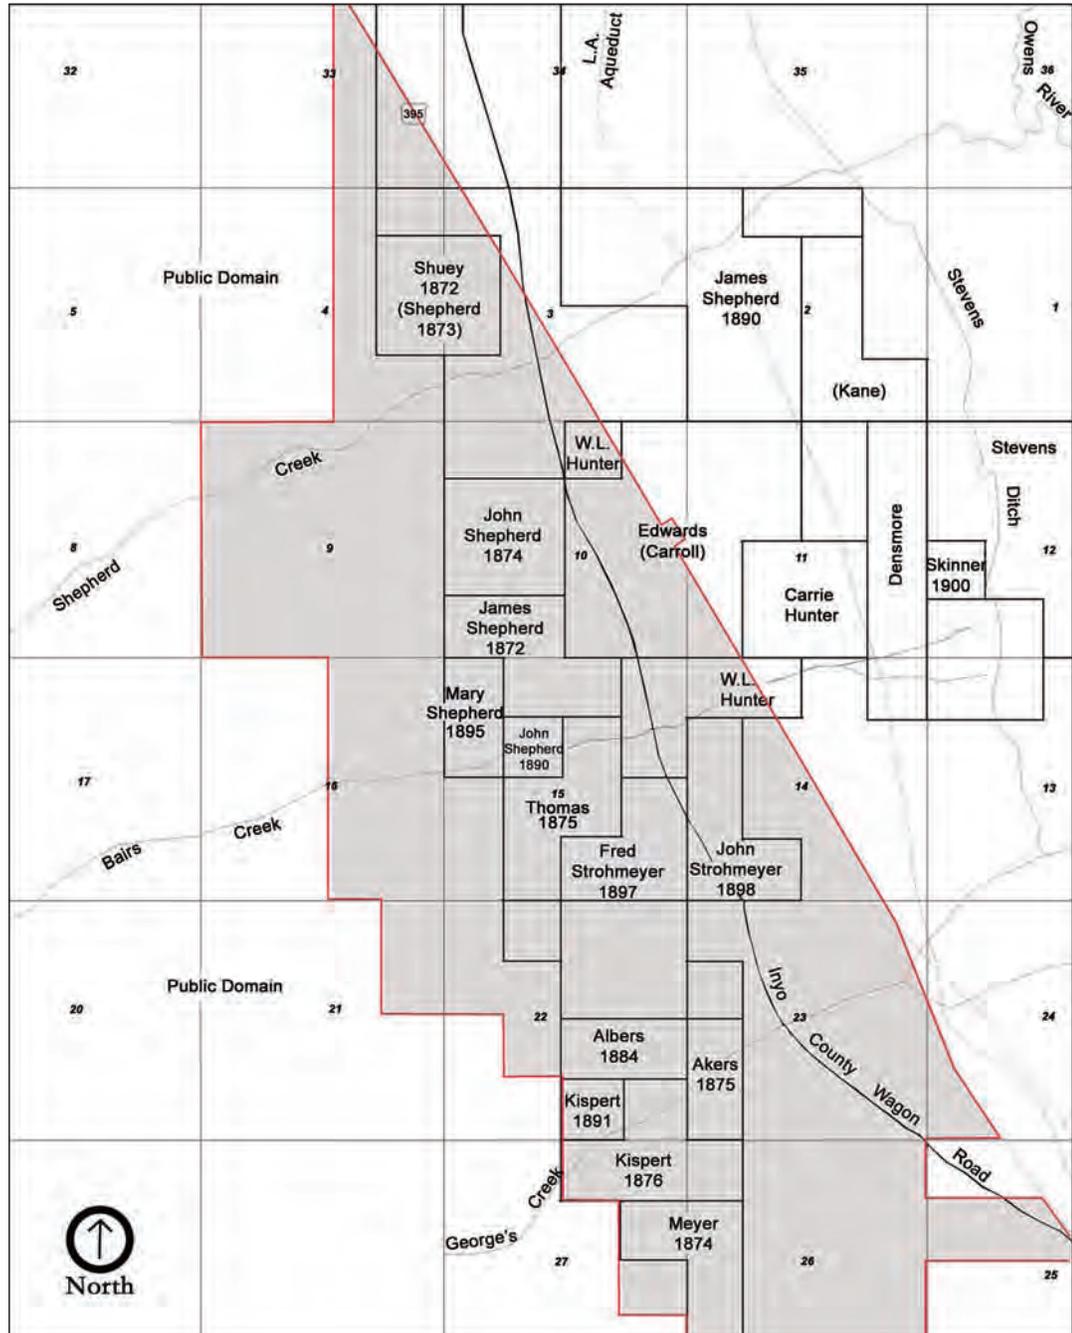
Figure 5. Map depicting land ownership in the Manzanar area, Owens Valley, ca. 1900. Shaded area shows the future boundary of the Manzanar War Relocation Center. (Adapted from *Three Farewells to Manzanar*, WACC 1966)

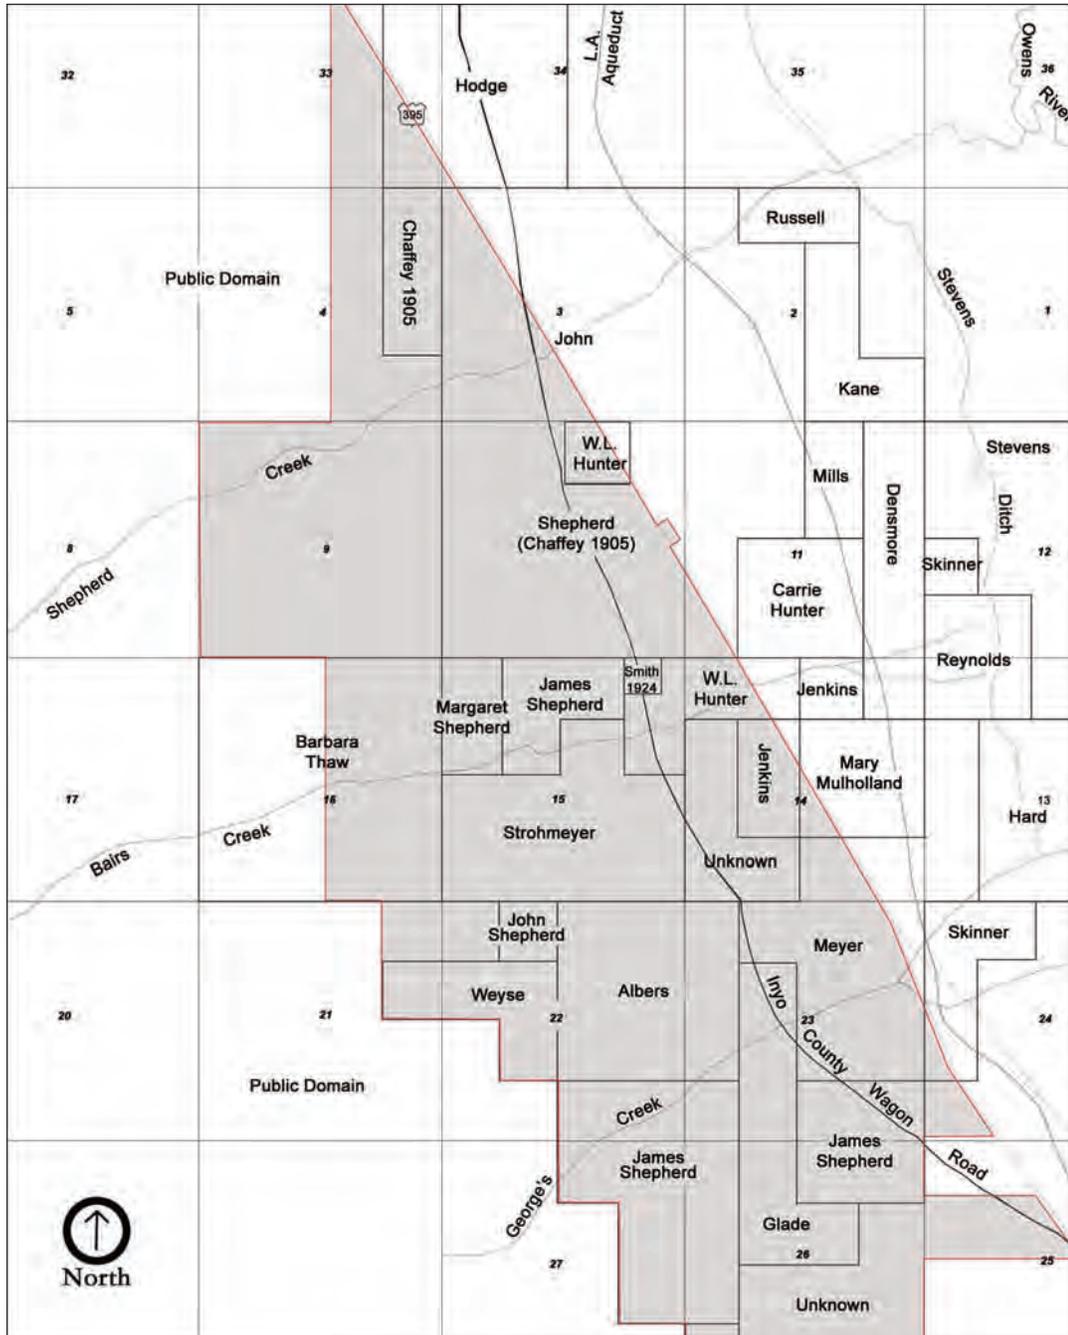
Figure 6. Map depicting land ownership in the Manzanar area, Owens Valley, ca. 1905. Shaded area shows the future boundary of the Manzanar War Relocation Center. (Adapted from *Three Farewells to Manzanar*, WACC 1996)

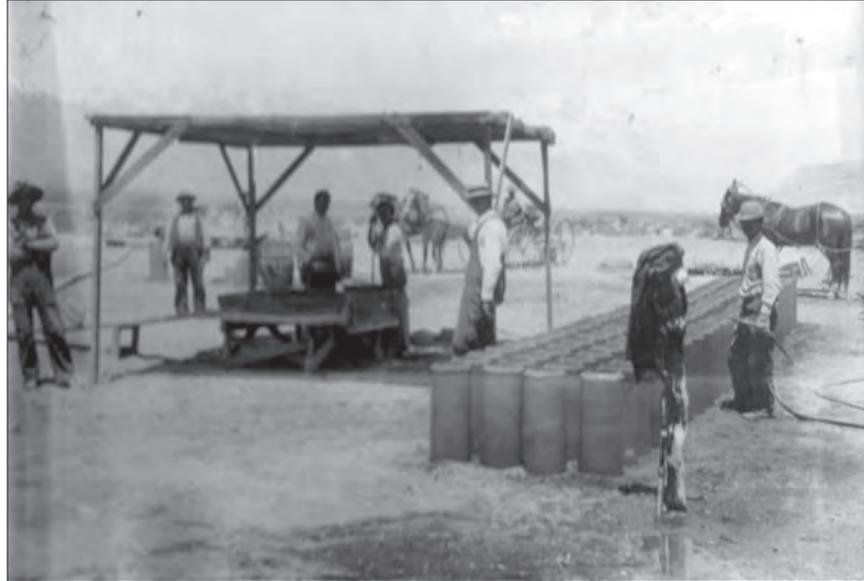
Figure 7. Concrete pipes were used to deliver water to orchards within the Owen’s Valley Improvement Company irrigation colony at Manzanar. (Courtesy of the Eastern California Museum)

In August 1910, the Owens Valley Improvement Company (OVIC) laid out the first portion of its proposed irrigation colony on approximately 1,000 acres, which they called "Manzanar," Spanish for apple orchard.³⁶ The OVIC plan was to develop an agricultural colony based on the production of apples. The company platted a town site and laid a system of concrete and steel gravity flow irrigation pipes to carry water to the town from Shepherd and Bairs creeks.³⁷ The irrigation system was unique in the area, in that it was designed to prevent alkali deposits, which had made large portions of the southern valley unproductive.³⁸ (Figure 7)

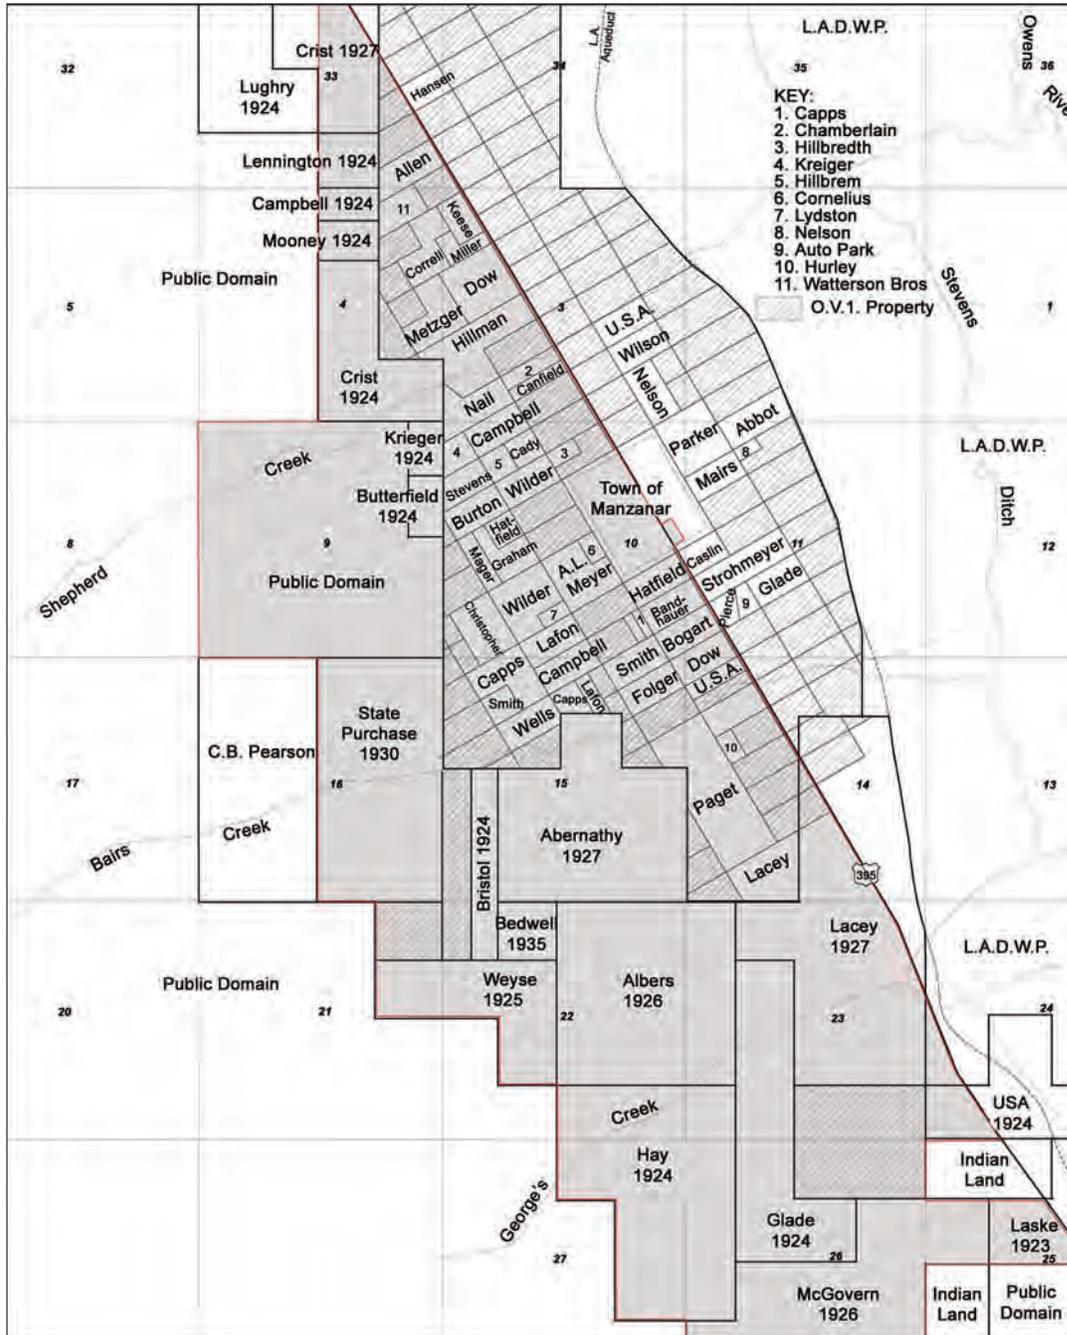
Figure 9. Map depicting land ownership for the town of Manzanar, 1927. (Adapted from *Three Farewells to Manzanar*, WACC 1996)

The development consisted of the 160-acre town site, divided into 312 lots, and two outlying subdivisions comprising 3,000 acres, which were divided into 140 lots. Independence Avenue (now U.S. Highway 395) and Francis Street (now the Manzanar-Reward Road) intersected near the center of town. East-west streets in the town were laid out at one-mile intervals, and north-south streets ran parallel to Independence Avenue.⁴¹ (Figure 9)

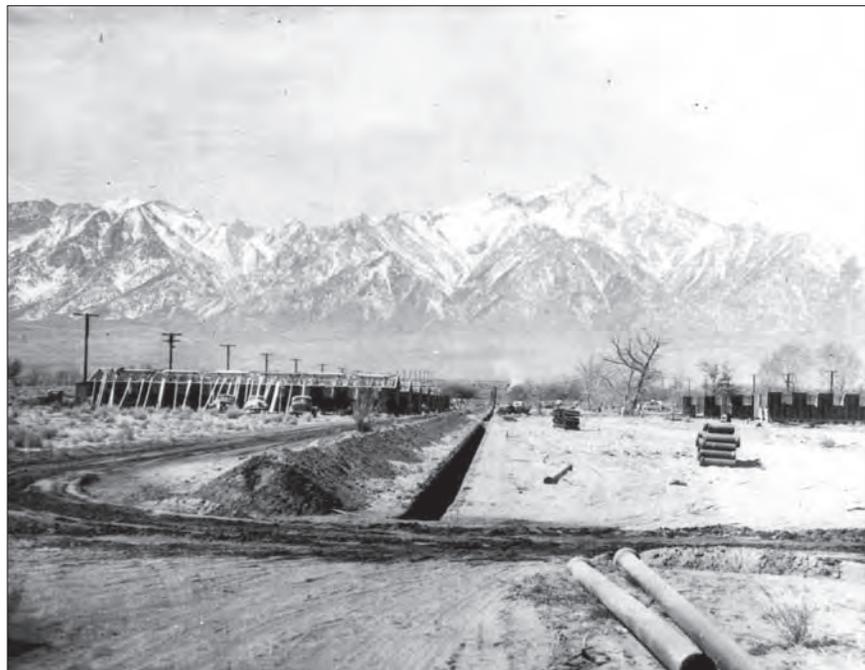
Figure 13. Water lines being installed along the camp roads as the barracks buildings are being constructed, March 1942. (Courtesy UCLA Special Collections)

vegetation, leveled areas south of the central camp area for irrigation and establishment of agricultural fields, and dug ditches for water and sewer lines throughout the central area of the camp.⁸⁰ (Figure 13)

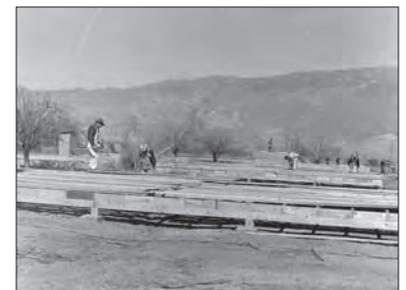
Figure 15. Contractors Griffith and Company of Los Angeles began the construction of buildings in March 1942, erecting barrack buildings at a rate of up to two buildings in one hour. (Courtesy UCLA Special Collections)

By March 17, the first buildings at Manzanar were under construction. On March 19, Silverman reported, “huge lumber trucks were roaring up the . . . highway from Los Angeles and 400 carpenters were already working a 10-hour shift.” Within days, an administration building was standing where the old Manzanar packing house stood and within one day workmen started on the first 25 city blocks. (Figures 14 and 15) According to Silverman, the workmen proceeded...

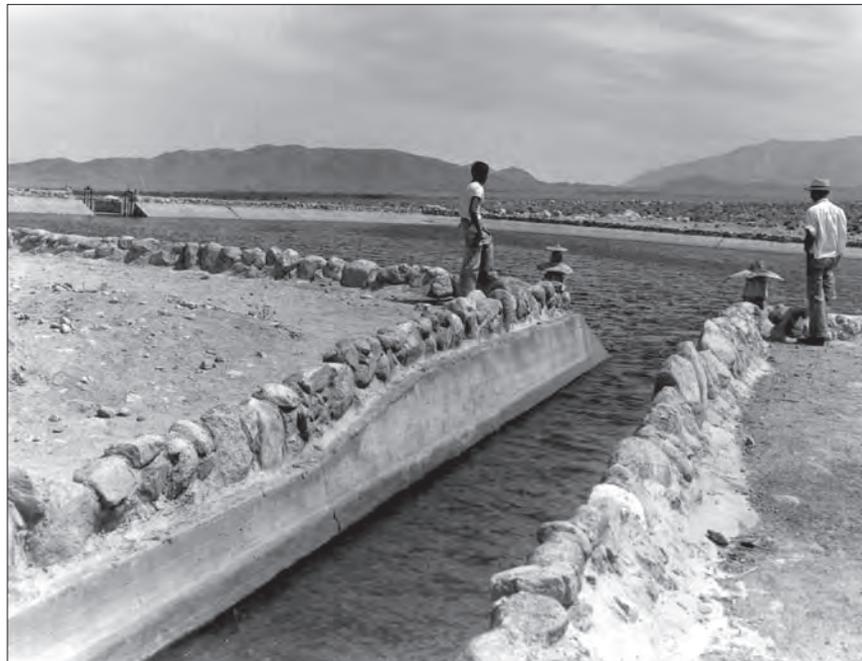
Figure 16. Internee laborers expanded the capacity of the camp reservoir and embellished the structure with ornamental rockwork, July 1942. (Courtesy UCLA Special Collections)

Working under the supervision of foreman Jiro Matsuyama, internee work crews from the Engineering Section expanded the capacity of the reservoir shortly after initial construction. The increased capacity was achieved by adding concrete and rock to build up the walls of the reservoir. By early July the expansion was complete and increased capacity of the reservoir to approximately 800,000 gallons.⁹⁹ (Figure 16) Although Shepherd Creek flowed year-round, and the capacity of the reservoir increased, the camp used an average of 1.5 million gallons of water a day, straining capacity. As a result, the Fire Department prohibited public use of the fire hydrants because the average water pressure was only 30 to 60 pounds, which was “not sufficient in case of a major fire.” The temptation to use water from the fire hydrants was too great for some to resist, as the hydrants provided an alternate source of water for irrigation of the lawns and personal gardens throughout the camp.¹⁰⁰

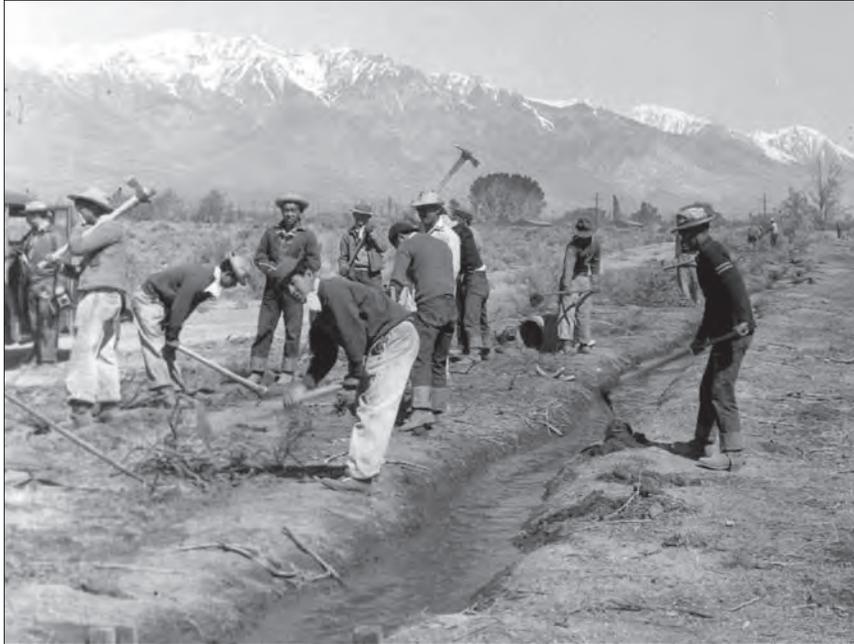
Figure 17. Extensive clearing of farm fields and development of irrigation systems was largely accomplished by manual labor provided by internees. (Courtesy UCLA Special Collections)

initial construction of the camp. Producing food for consumption in the camp was both an economic measure and a means to employ internees in a “worthwhile undertaking.” Extensive agricultural fields, eventually totaling approximately 400 acres, were developed north and south of the residential area at Manzanar. Internee laborers constructed an extensive ditch irrigation system to bring water to the fields. The camp labor force cleared some 120 acres in the south field in April 1942, reconditioned more than eight miles of old ditch (which had been constructed in conjunction with development of the town of Manzanar), and dug two miles of new irrigation canals.¹⁰¹ (Figure 17)

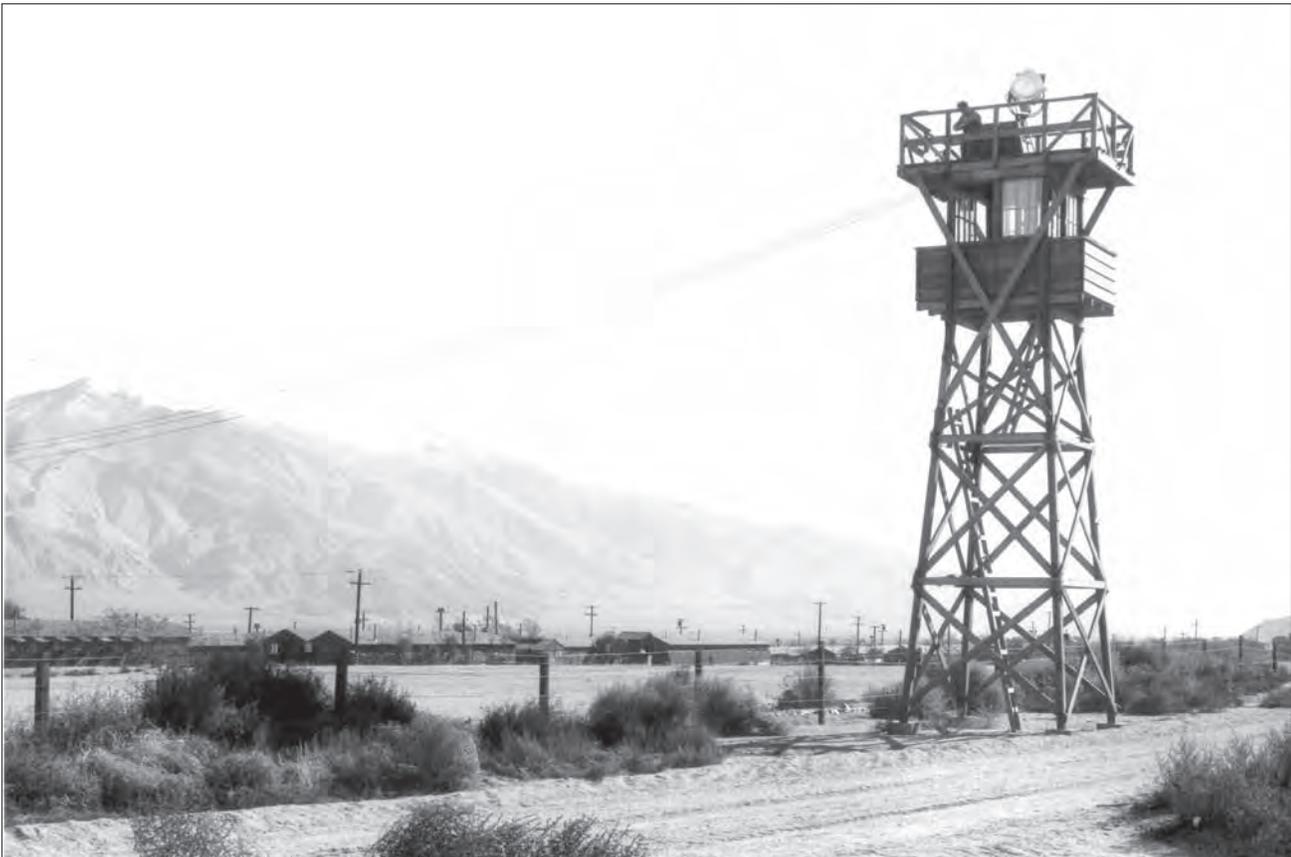
Figure 20. Guard towers at Manzanar were located at the corners and midway along each side of the camp perimeter fence. (Courtesy of Toyo Miyatake Studio)

The towers, built by local contractor Charles I. Summer of Lone Pine, were wooden structures supported on concrete piers embedded in the ground at “a sufficient depth to insure a sound footing to take care of the weight and wind load.”¹⁵¹

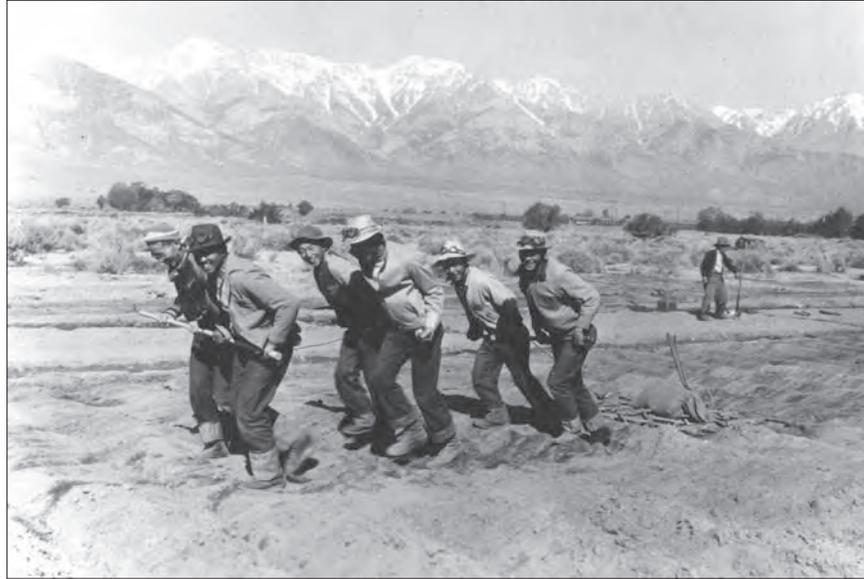
Figure 21. The development of agricultural fields north and south of the camp perimeter fence required extensive grading of the sandy soil. Eventually the camp administration provided the internee farm workers with a tractor, but initial grading was accomplished with a single harrow. (Courtesy UCLA Special Collections)

acres of cucumbers. Planting of radishes, carrots, beets, turnips, pumpkins, tomatoes, melon, onions, and potatoes continued through the month. By the start of July 1942, six fields totaling 126 acres were under cultivation. On June 18 the first harvest consisting of 12 crates of red radishes was distributed to the mess halls.¹⁷⁹ (Figure 21)

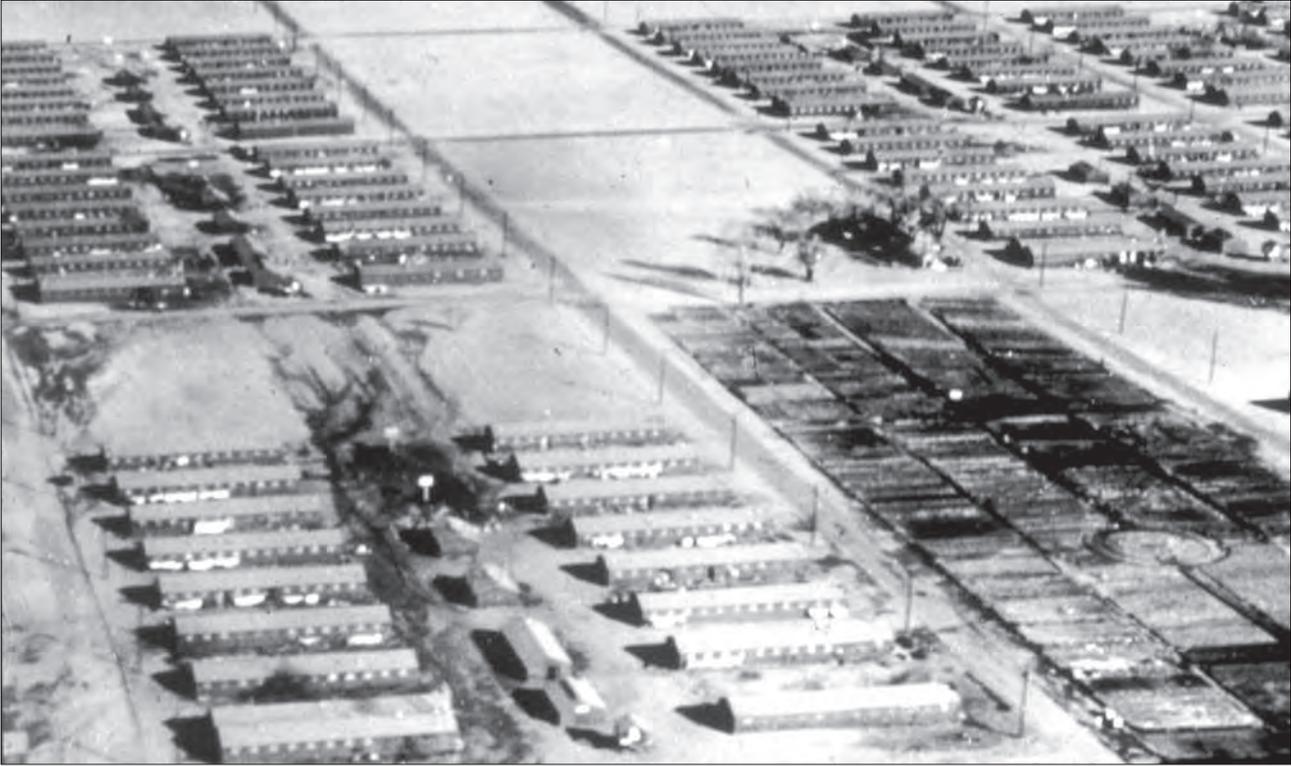
Figure 24. Victory gardens were established in the firebreaks between the barrack blocks. This large concentration of gardens was located in the firebreaks between Blocks 11 and 17 (pictured) and Blocks 12 and 18 in the western area of the camp. (Source unknown)

Internees acquired rights to garden plots for a nominal monthly rental fee of thirty-five cents for a 30’ x 50’ plot. They grew their own “vegetables for vitamins, flowers for morale, and gardening for recreation.”¹⁹⁵ The majority of plots ranged in size from 10’ x 50’ to 30’ x 50’. A few larger tracts were set aside as community gardens for some blocks where residents combined efforts and provided fresh produce for their own mess halls. Eventually, more than 120 families worked plots in the Victory garden. During the summers of 1942 and 1943, internee gardeners planted a flower border along the edges of the firebreak where the Victory garden was located; they dug and maintained all the Victory garden irrigation ditches, developed water schedules, and regulated irrigation hours.¹⁹⁶ (Figure 24)

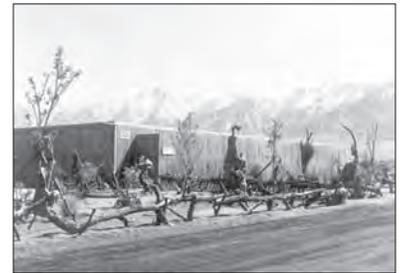
Figure 25. A special propagating nursery building was constructed as part of the WRA's experiments with guayule, a potential source of rubber during wartime. (Courtesy of the National Archives and Records Administration)

The chief goal of agricultural production at Manzanar was to provide foodstuffs to the camp population, but the internees were also able to assist in the war effort through participation in experimental crop projects. A significant program supported by the California Institute of Technology was devoted to cultivating the guayule plant, a small woody shrub native to the southwestern United States as a source of rubber or latex, needed for the war effort. The guayule project was not intended to produce raw material for the production of rubber but was meant to advance research into guayule production by identifying the species that would produce the best yields. A special propagating nursery building, called the guayule lath house, was constructed south of Block 6, between the edge of the central developed area and Bairs Creek. (Figure 25)

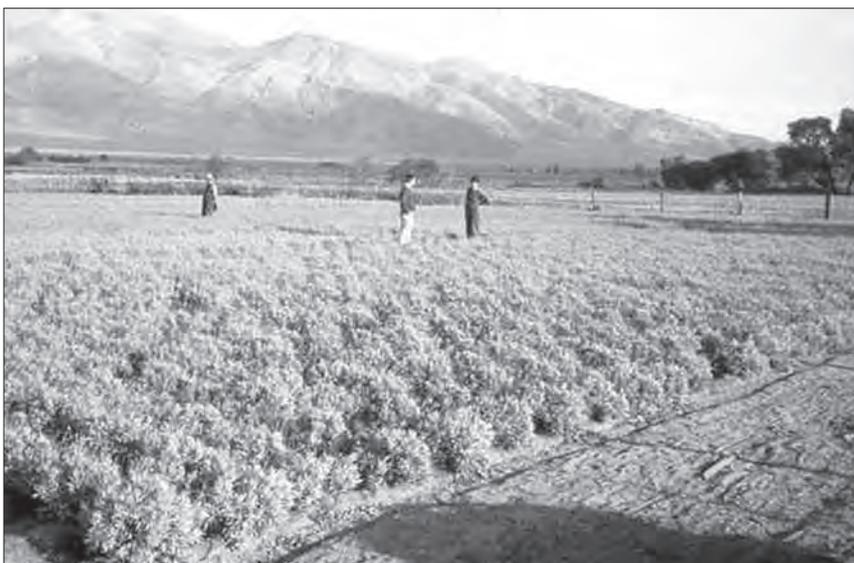
Figure 26. Guayule plants were moved from the propagating nursery to a section of the agricultural fields north of camp, 1943. (Courtesy of the Library of Congress, Prints and Photographs Division, Ansel Adams photographer)

By August 1942, more than 200,000 seedlings of seven species of guayule were growing at Manzanar. The lath house expanded in September 1942, nearly doubling in size to accommodate the propagation of guayule plants. Internee laborers staffed the project, which, in addition to the lath house, included a two-acre tract where seedlings were transplanted.²⁰⁰ (Figure 26)

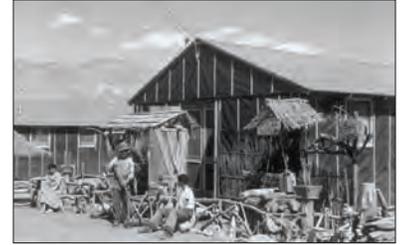
Figure 28. Using limbs and other found objects, a variety of structures such as awnings were built to shade barrack apartments from the hot summer sun. The Takemura family residence, shown here, was one of the more elaborately embellished barrack buildings at Manzanar. (Courtesy of the National Archives and Records Administration)

Many internees devised homemade awnings out of brush and scrap lumber to shield the apartments from the heat of the mid-day sun. (Figure 28) By September 1942, the proliferation of these window structures, and

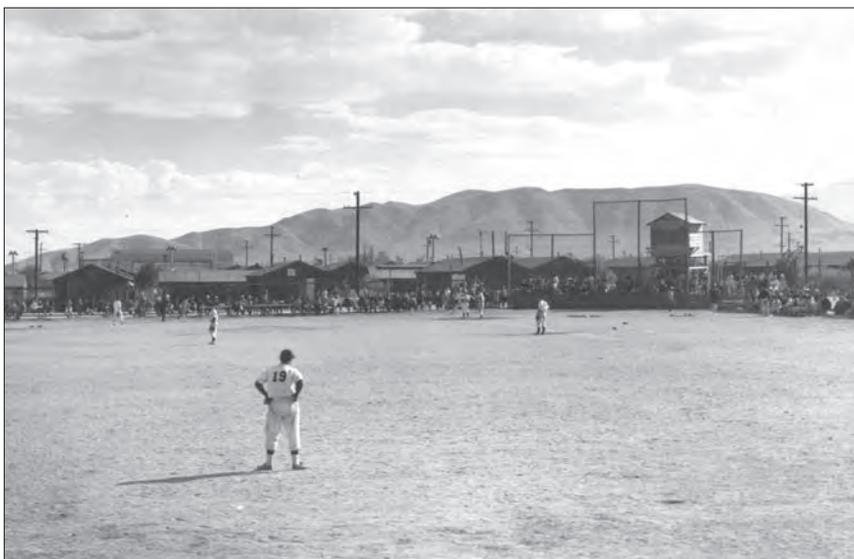
Figure 30. Baseball was perhaps the most popular sport at Manzanar and attracted many spectators. This field was located north of the auditorium, between Blocks 19 and 25. (Courtesy of Toyo Miyatake Studio)

By the spring of 1944, CACA provided funds for uniforms for eight baseball teams, and financed construction of a baseball diamond in the firebreak between Blocks 19 and 20. Double-header games were played on weekends and collections were taken at the field to purchase balls, bats and other necessary equipment. Baseball games attracted thousands of spectators on weekend afternoons. (Figure 30)

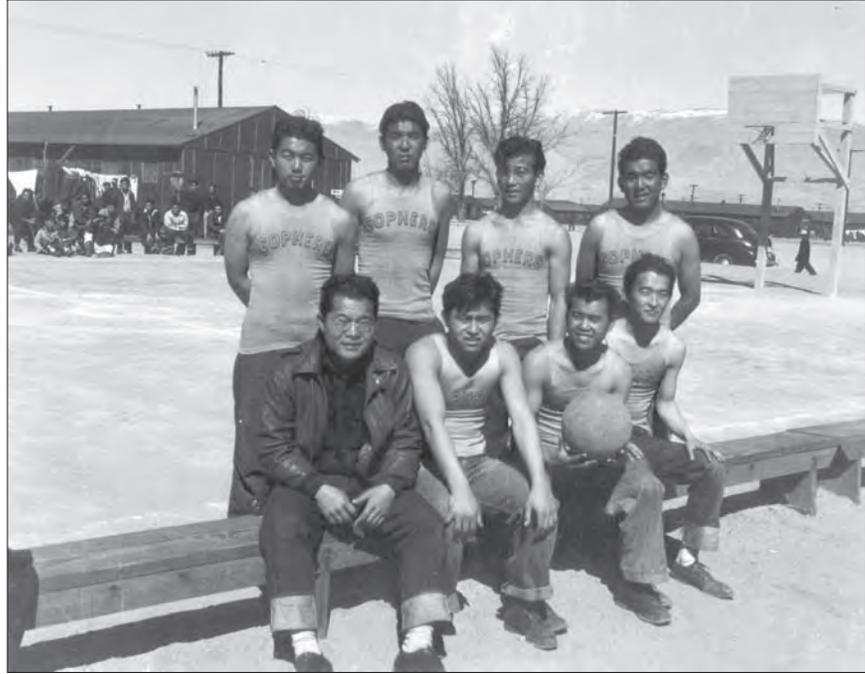
Figure 31. Basketball courts were laid out in the firebreaks as well as in the interior spaces of the barrack blocks. (Courtesy UCLA Special Collections)

Basketball was also very popular at Manzanar, and leagues were established for both girls and boys teams. Lacking any indoor facilities, the games were played in block courts or in courts that were built in the firebreaks. (Figure 31)

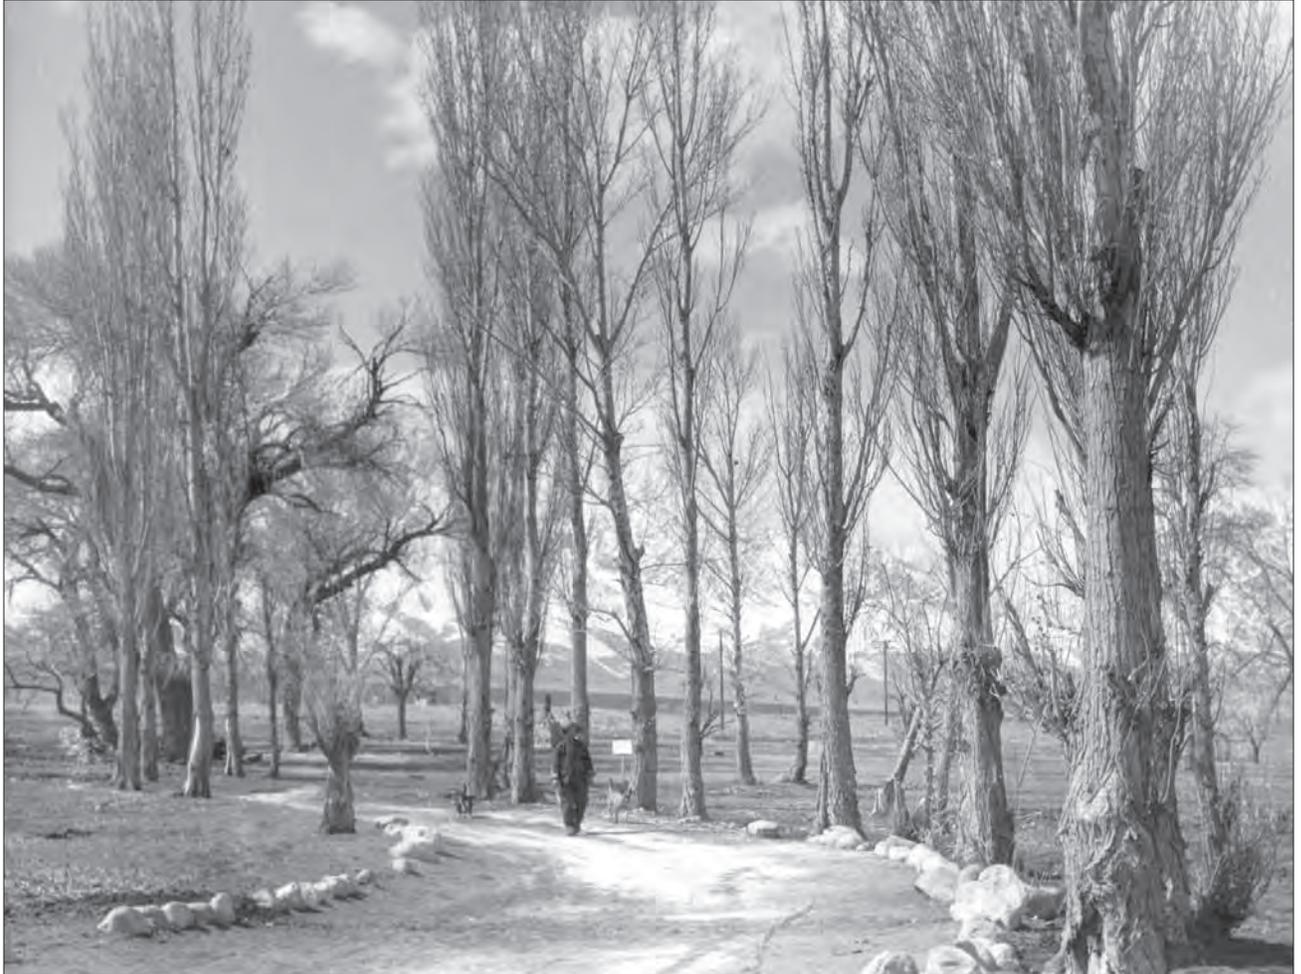
Figure 34. North Park picnic ground was developed on the former site of the John Shepherd Ranch, where mature trees dating from the ranch period provided shade for picnickers. An outdoor cooking structure can be seen in the center of the photograph, at the entry to North Park. View looking west. (Courtesy of Toyo Miyatake Studio)

In 1943, another picnic area was developed between Block 32 and the north boundary fence. Rock ovens were built under the shade of old cottonwood trees remaining from the Shephard Ranch. This picnic area was called North Park. (Figure 34) Later, as restrictions were relaxed and internees were allowed to leave the camp during daytime hours; two additional picnic areas were established in shady areas outside the camp fence. One picnic area was established along George’s Creek, about one mile from the south fence, and another about one-half mile north of the camp, near Shepherd Creek.²²⁷ Another informal picnic area with a rock oven was established among the ruins of a ranch north of George’s Creek and south of the hog farm.

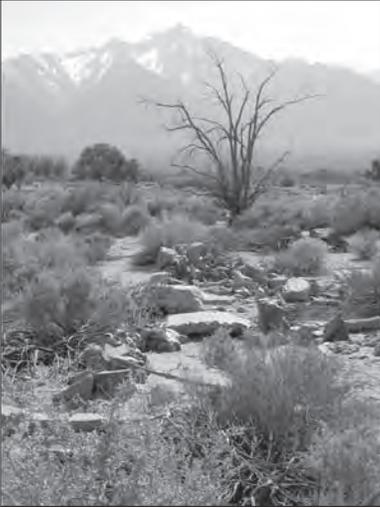
Figure 38. View of scrub vegetation spreading across a remnant rock and water garden in Block 35, barrack 2. View looking west. (NPS 2003)

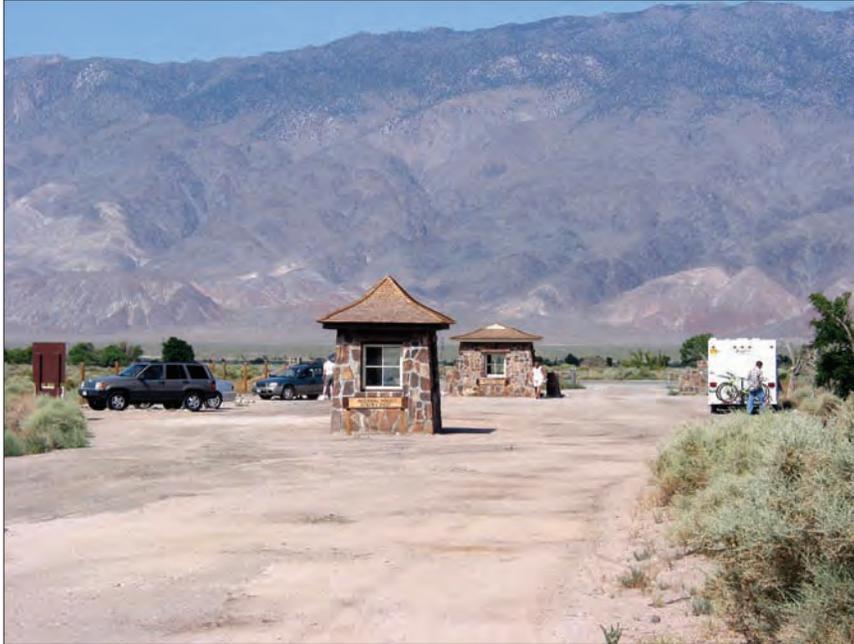
Figure 39. Internal Police Post (foreground) and Military Police Post at the entrance after restoration work. (NPS 2001)

In 2001, a NPS preservation crew undertook restoration of several historic structures at the site, including replacing the roofs and reconstructing the windows and doors on the two sentry posts, and reconstructing the locust fence around the cemetery. (Figure 39) Their work also involved masonry stabilization of both North Park oven structures as well as conservation of simulated wood-grain finishes on concrete structures including the two stanchions at the entry, the posts at the cemetery, and structures in the administration area, hospital, and chicken ranch. A replica of the historic camp entry sign was fabricated by a contractor using historic photographs, and installed by the preservation crew.³

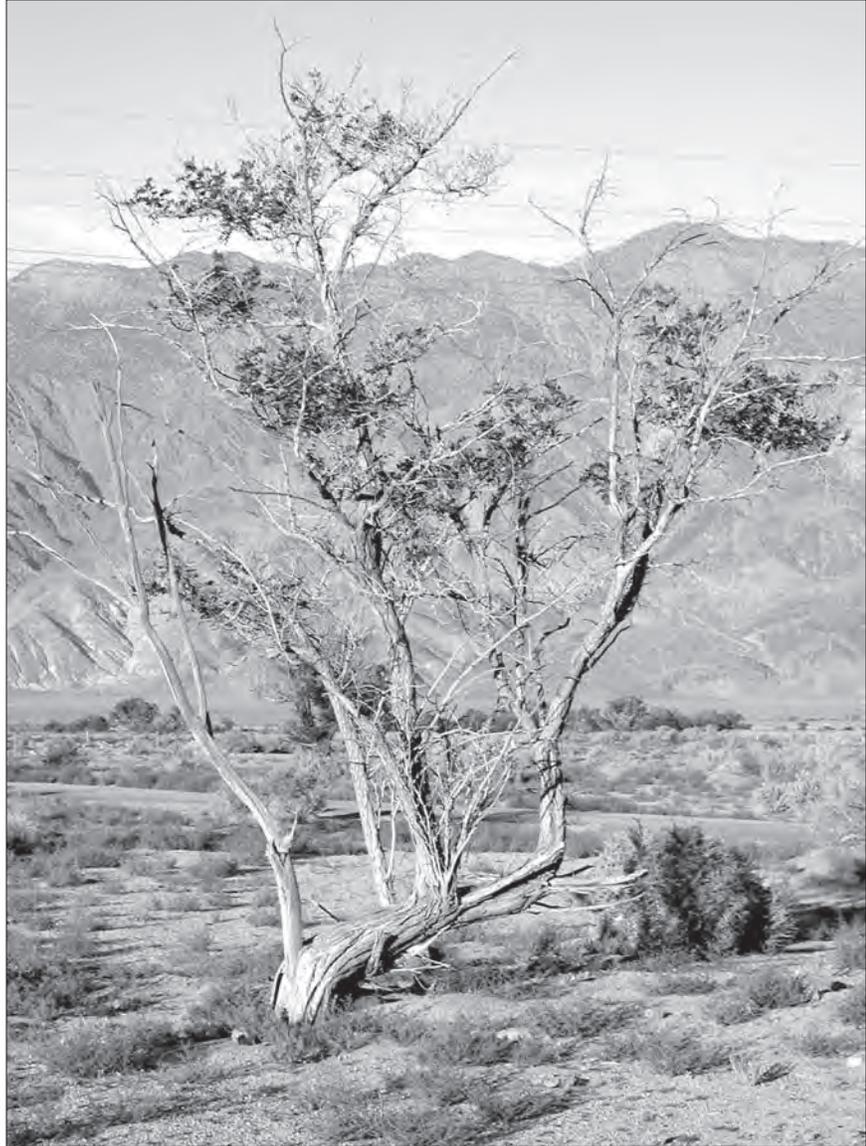
Figure 43. This locust tree in Block 7 was pruned into a traditional Japanese form with a horizontal trunk and three vertical branches. (NPS 2003)

The essential component of Japanese garden design is based on creating an ambient and scenic mood through asymmetrical balance.⁷ For example, the grouping of horizontal (Earth), diagonal (Man), and vertical (Heaven) elements which was typically reflected in the selection and arrangement of rocks and the training of trees based on horizontal, diagonal, and vertical lines can be seen in selected sites and gardens.⁸ (Figure 43)

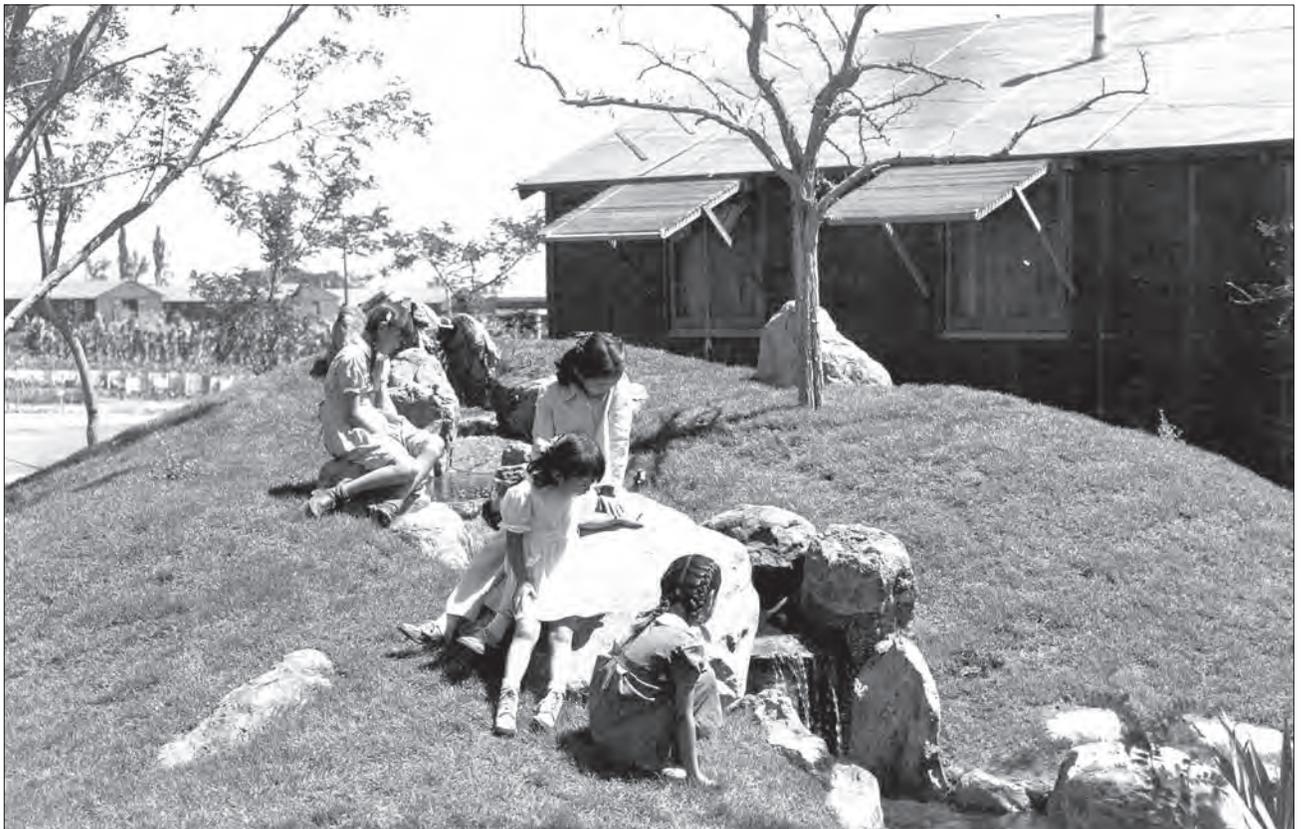
Figure 44. Oriented on a north-south axis with mounds and falling water, the Block 12 garden followed Japanese traditions dating to the Heian Period (AD 794-1185). (Courtesy UCLA Special Collections)

landscapes. As an island nation with generous amounts of precipitation and plentiful waterways, water played an essential role in traditional Japanese gardens. The majority of the pond gardens were laid out on a north to south axis, with water originating in the north, falling into a stream path, and then finally dropping into a pond in the southern portion of the garden. This style was developed over centuries, with origins in the *Sakuteiki*, the oldest garden design manual dating to the Heian Period (AD 794-1185). (Figure 44)

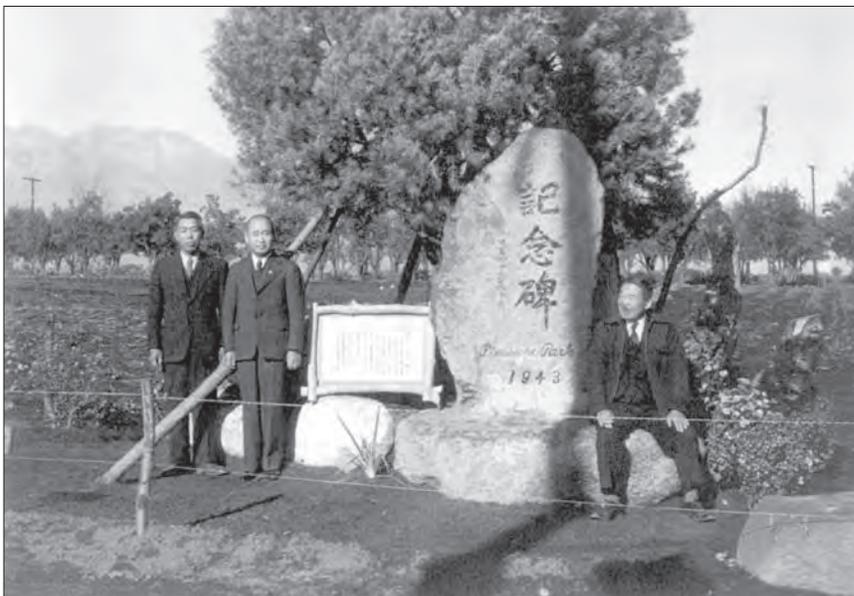
Figure 46. Monumental upright boulders, or stele, announced the southern entrance to Merritt Park. The inscription welcomed visitors to “enjoy this quiet, peaceful place.” Mr. Kuichiro Nishi is on the far left. (Courtesy of Toyo Miyatake Studio)

placed throughout the park. Two memorial steles were placed at the corners and functioned as entrance markers into the park. (A stele is an upright stone or slab with an inscribed or sculptured surface, used as a monument or as a commemorative tablet in the face of a building.) The massive stones were placed in an upright position and were similar to steles found in gardens in Japan. One of the steles was painted with Japanese characters and read “To the memory of fellow Japanese Immigrants, who, although ushered to ‘this place with the breaking of friendly relations between the two countries have come to enjoy this quiet, peaceful place.” The park was dedicated “for the enjoyment of the people and to the memory of the time of our residence here.”” (Figure 46)

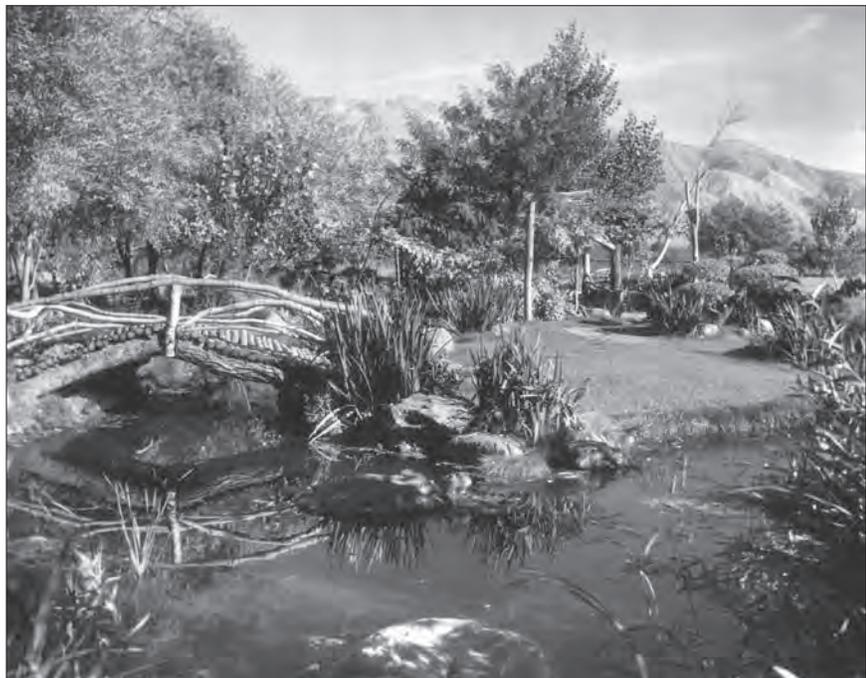
Figure 47. Rocks were carefully selected and placed in the pond garden at Merrit Park to represent traditional Japanese symbols, such as the turtle, seen below the bridge in this photo. (Courtesy of Toyo Miyatake Studio)

long life, and reflection.¹² Beneath a rough hewn wooden bridge, another turtle-shaped stone was placed to appear as if it was swimming in the pond. (Figure 47)

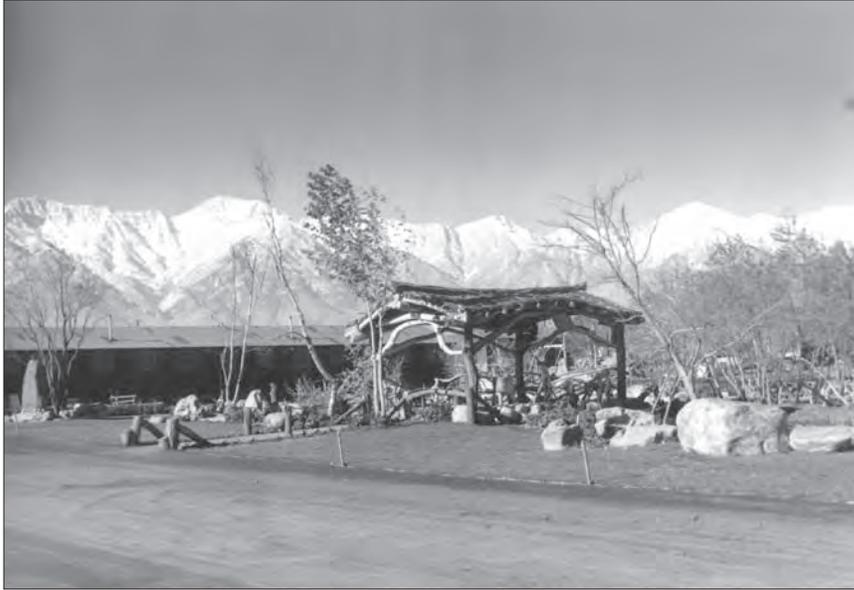
Figure 48. The tea house in Merritt Park was constructed of tree limbs and provided a focal point in the park. (Courtesy of Toyo Miyatake Studio)

The tea house located in Merritt Park was reminiscent of an important element in traditional Japanese gardens. Tea ceremony was a highly ritualized event that often took place in a secluded or unique location within a garden context. There is no written or oral record of tea ceremonies being performed in the tea house at Merritt Park. Rather, the tea house was an attractive feature at Manzanar and appreciated for its aesthetic value. The structure was built using locally gathered peeled and unpeeled logs to create a highly stylized rustic structure. Tree stumps connected by ropes defined the edge of the tea house and paths. The roof of the tea house appears to have been materials that were consistently used in structural elements located throughout the park: a combination of limbs, branches and twigs. (Figure 48)
