Cultural Landscape Report Manzanar National Historic Site

National Park Service
Pacific West Region
2006

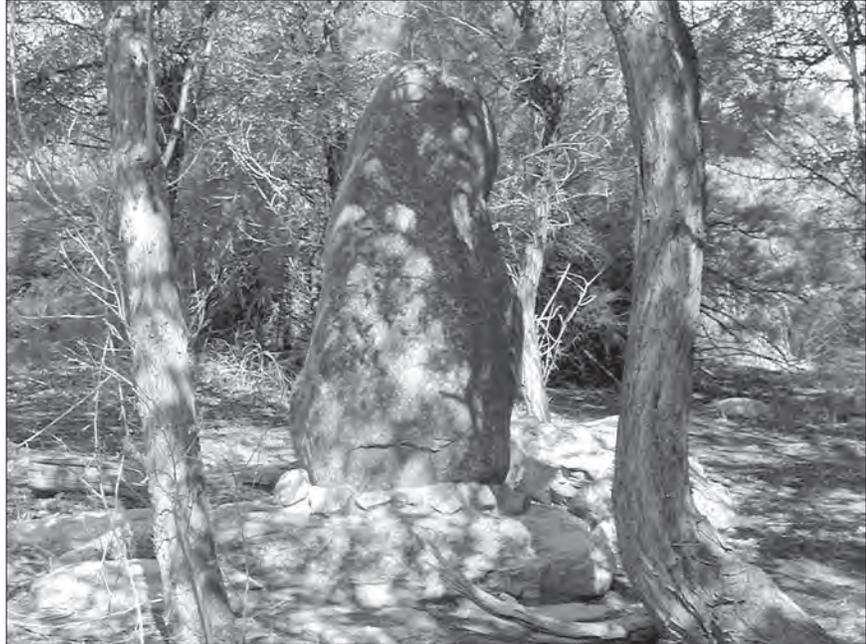
Figure 49. This stele remains from 1942 and is located in the southwest corner of Merritt Park. (NPS 2002)

publication, Merritt Park became a widely-recognized image of landscape gardening at Japanese American relocation centers. After the internment period, Merritt Park was abandoned. The tea house was torn down, and the water supply was cut off. The area was repeatedly flooded by snowmelt from the Sierras, grazing cattle and elk trampled the area over many years, and native and invasive plants have taken over the area. The most discernible remnants of Merritt Park include two steles at the southwest and southeast corners of the park, boulders and rocks, a streambed, the foundation of the teahouse, and remnant trees, primarily locust. (Figure 49)

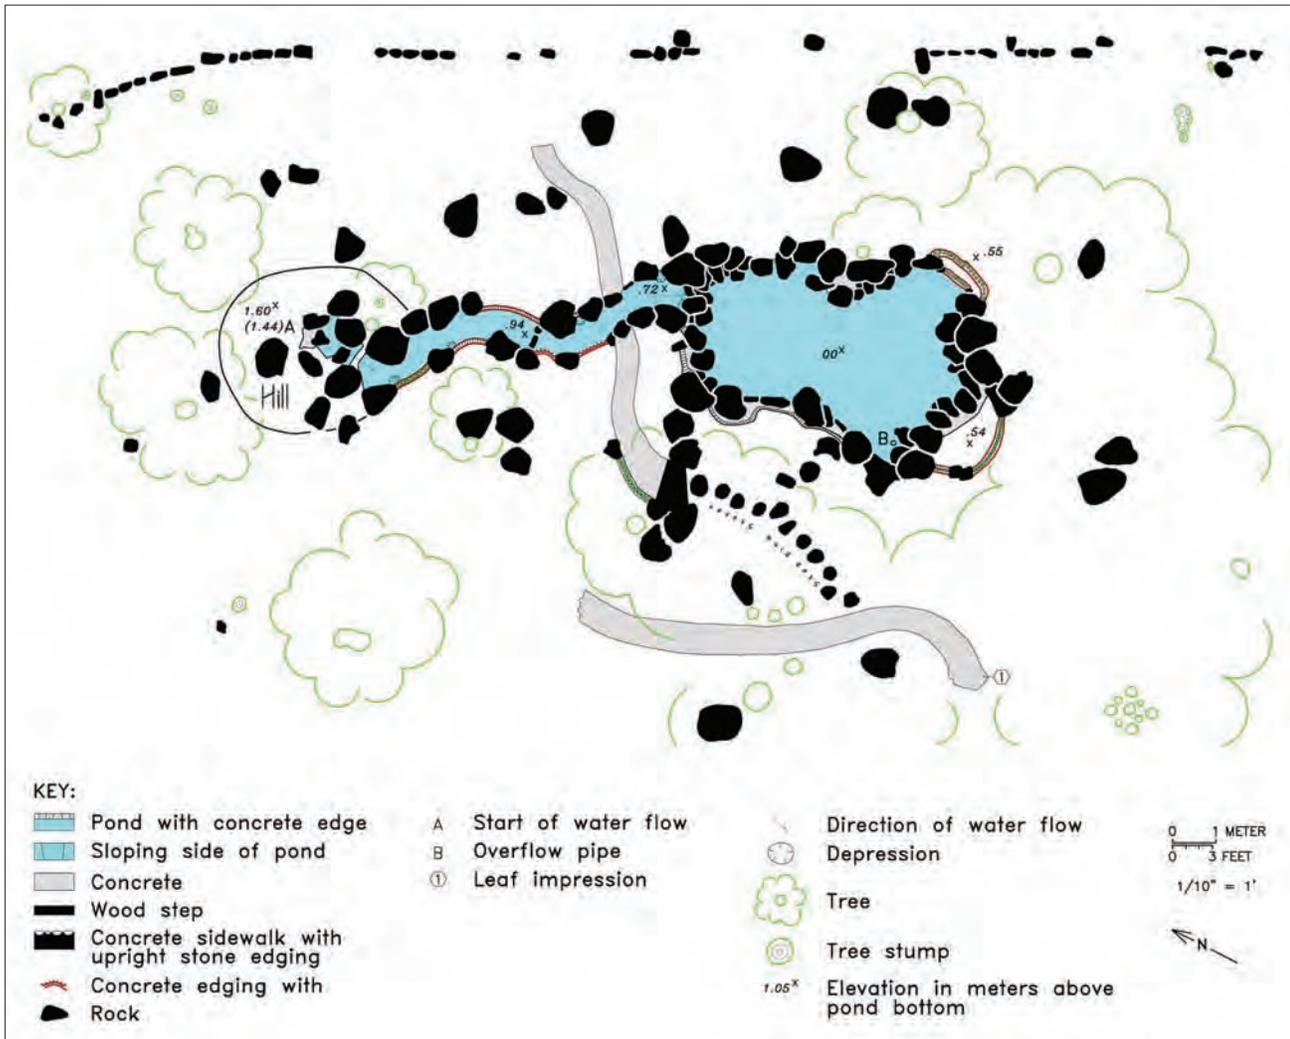
Figure 51. Archeological base map, Hospital Garden (Adapted from *Three Farewells to Manzanar*, WACC 1996. Drawing revised and updated by R. Beckwith, 1999)

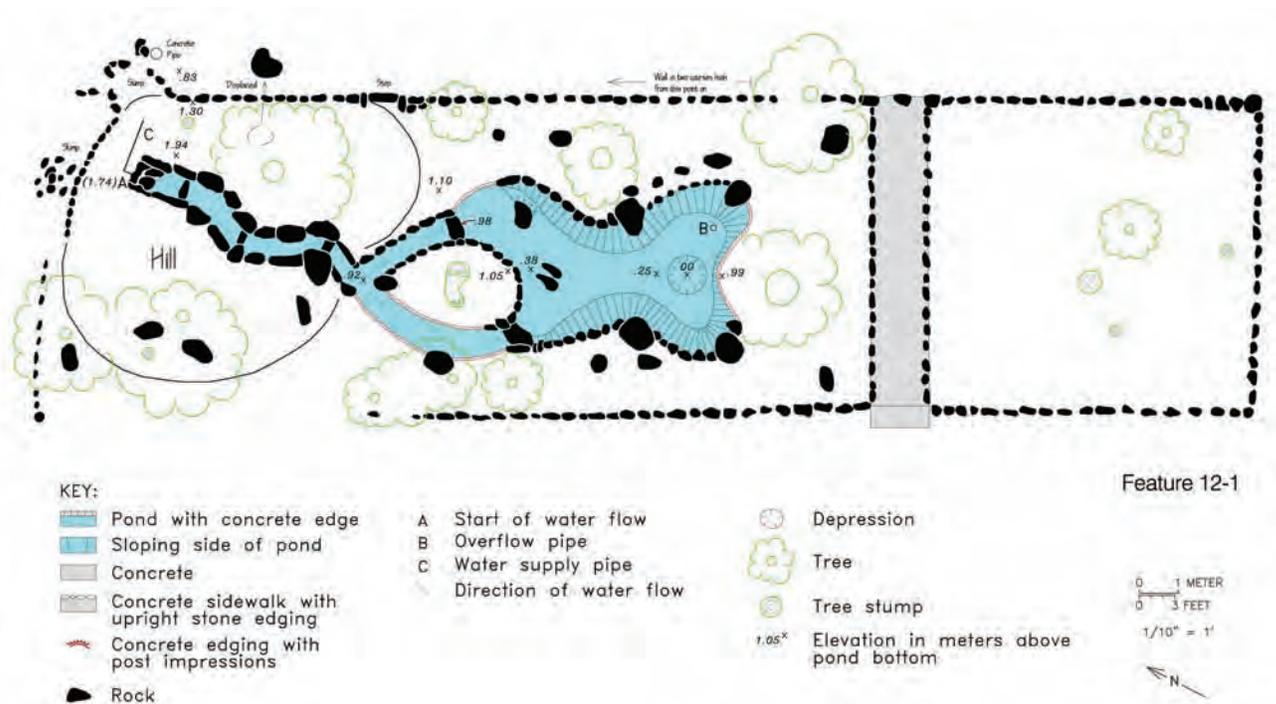
Figure 52. Archeological base map, Block 12 Garden. (Adapted from *Three Farewells to Manzanar*, WACC 1996. Drawing revised and updated by R. Beckwith, 1999)

The Block 12 garden contained a large concrete-lined pond, a stream with waterfalls, signature crane and turtle rock islands, a sidewalk, and rock alignments in the Momoyama style. Historic photos show the boulder-lined stream flowing out of a large earthen mound, covered primarily in grass, with a few locust trees for shade. This stream flowed around an island into the large pond.

guard the entrance to Buddhist temples. The garden is characterized by the symbolic *tsuru-kame* (crane and tortoise) rocks rising from the ponds surface, *tsuru-kame* represent long life.²⁶ *Tsuru-kame* are common symbols in traditional Japanese gardens. The shape of the pond is characteristic of a traditional Japanese style defined as a cloud shape.²⁷

The Block 12 garden was mapped in 1995 and retains a sense of the original design, materials, workmanship and feeling of the original gardens. (Figure 52)

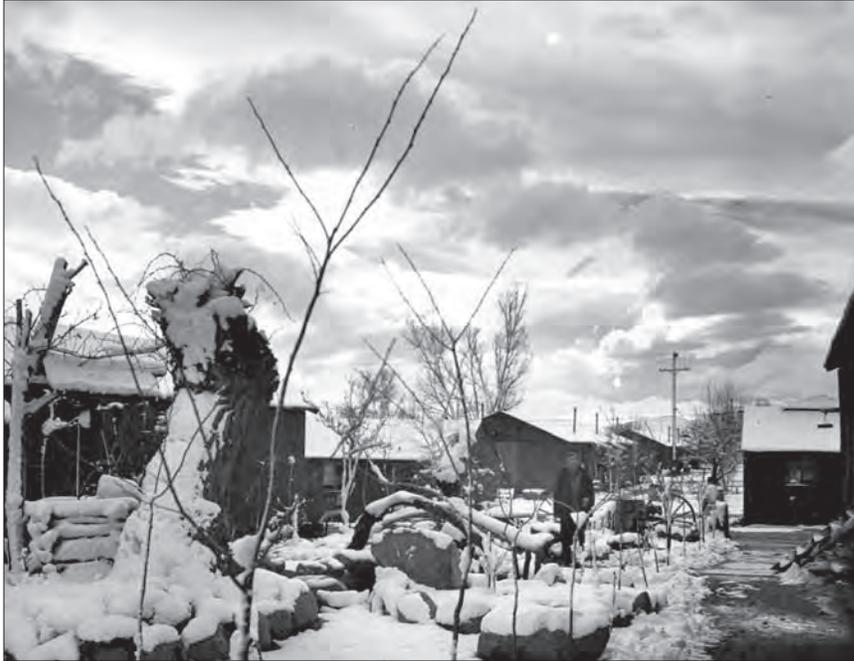
Figure 53. The Block 22 mess hall garden, *Otaba No Ike*, obtained its name and stylistic inspiration from *O to wa no Ike*, the sacred source of water that flows to the Kiyomizo Buddhist temple in Kyoto Japan. (Courtesy UCLA Special Collections)

The Block 22 garden had two nicknames. The first name, *Otaba no Ike*, derives from *O to wa no Ike*, the source of pure and sacred water that flows to the Kiyomizu Buddhist temple in Kyoto, Japan.²⁹ The second name, “Three Sack Pond,” was based upon the Manzanar administration’s rule that landscape projects were allotted only three sacks of cement. Ironically, the creators of “Three Sack Pond” successfully erased and forged paperwork, returning 8 times, collecting 3 sacks each time, to acquire 24 sacks of cement for their mess hall garden.³⁰ (Figure 53)

The garden was composed of various objects and plant materials from the Owens Valley. The group collected carp and trout in garbage cans for the pool, chicken wire for reinforcing concrete, and rocks from the mountains for creating structure within the garden. The dates of completion—“AUG. 9, 1942” and “8-7 1942”, are inscribed in the cement-lined pond. Ornamentation included an enormous cottonwood stump, a wagon wheel, and old barrels. Water in the garden was conveyed through a “wishing well” constructed by George S. Takemura, who had been called a “landscape artist” in Los Angeles before entering camp. Wishing wells were popular picturesque garden elements in the first Japanese-style gardens in North America in the 19th century, and their existence today is extremely rare.³¹

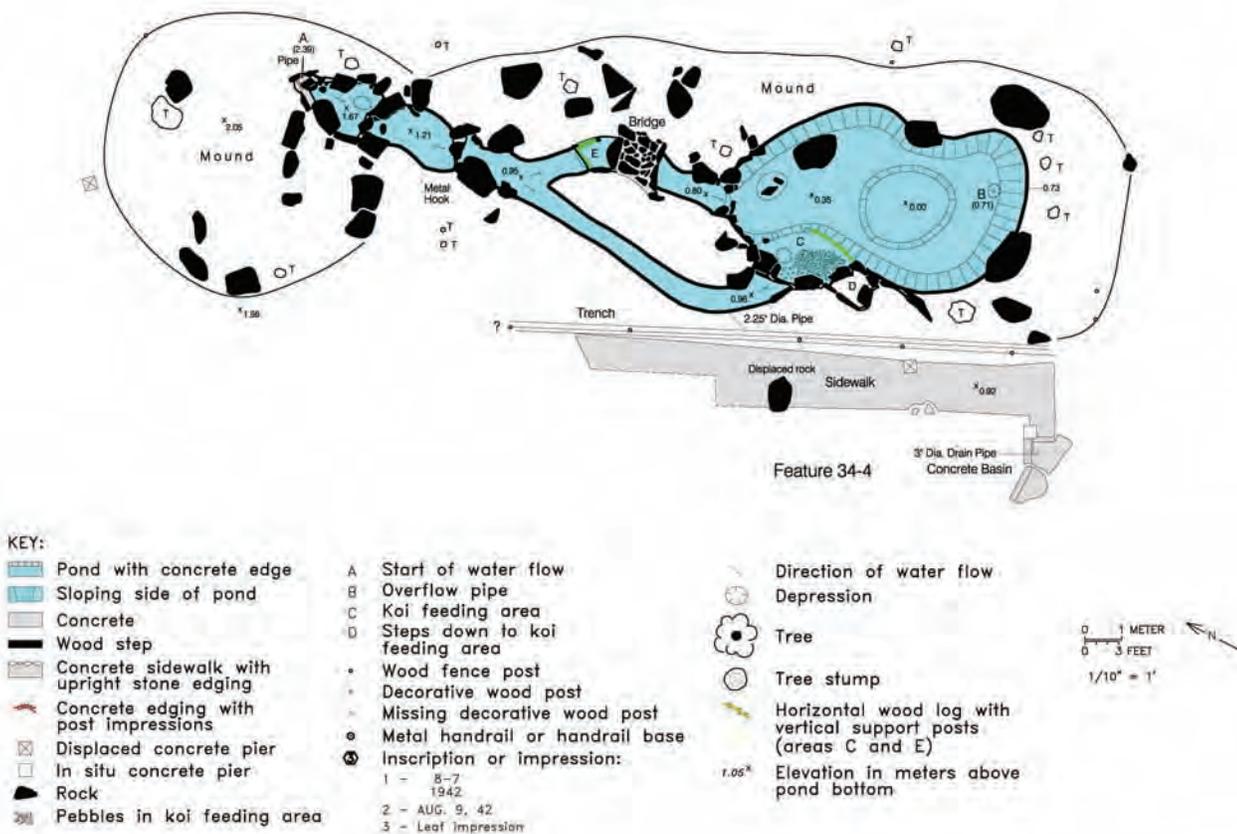
Figure 55. Archeological base map, Block 34 Garden. (Adapted from *Three Farewells to Manzanar*, WACC 1996. Drawing revised and updated by R. Beckwith, 1999)

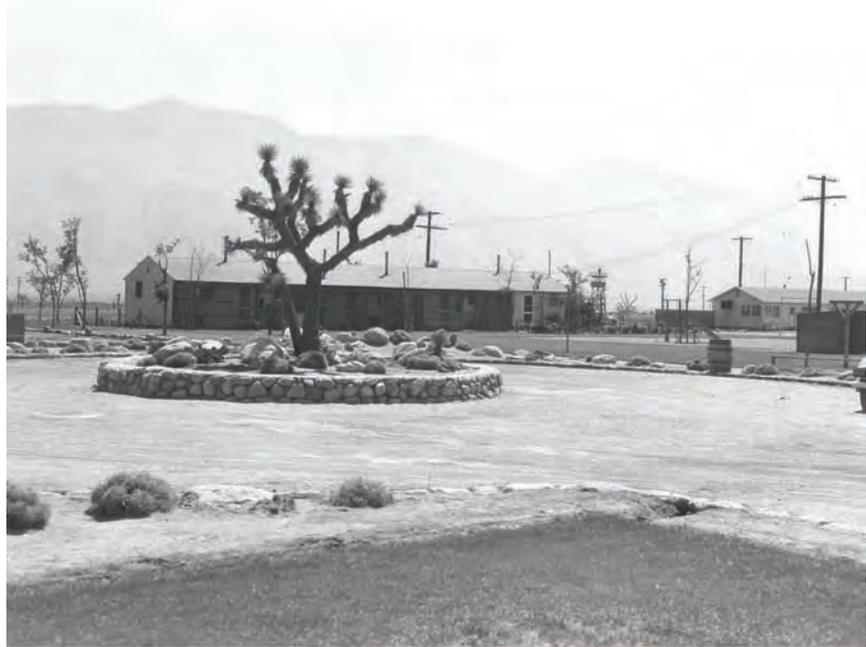
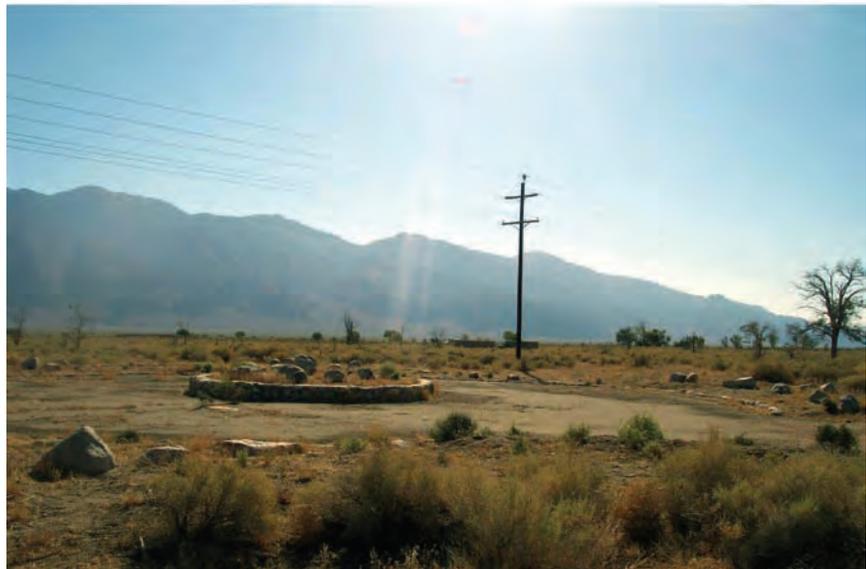
Figure 58. The traffic circle in the administration area retains the rock arrangement designed by Buneyoman Wada. Photo shows the traffic circle ca. 1943, and as it appeared in 2004. (Top: Courtesy UCLA Special Collections. Bottom: NPS 2004)

in the Administrative Area. The circle was comprised of a mortared stone retaining wall located at the end of the cul-de-sac and was one of the first beautification projects at Manzanar. Buneyemon Wada, director of the project, transplanted Joshua trees, cacti, and rocks from the Sierra into a Japanese-style dry garden.⁴³ The Joshua tree and cacti were transported from Death Valley. The rocks in the traffic circle have remained in place since the historic period but the vegetation is gone. (Figure 58)

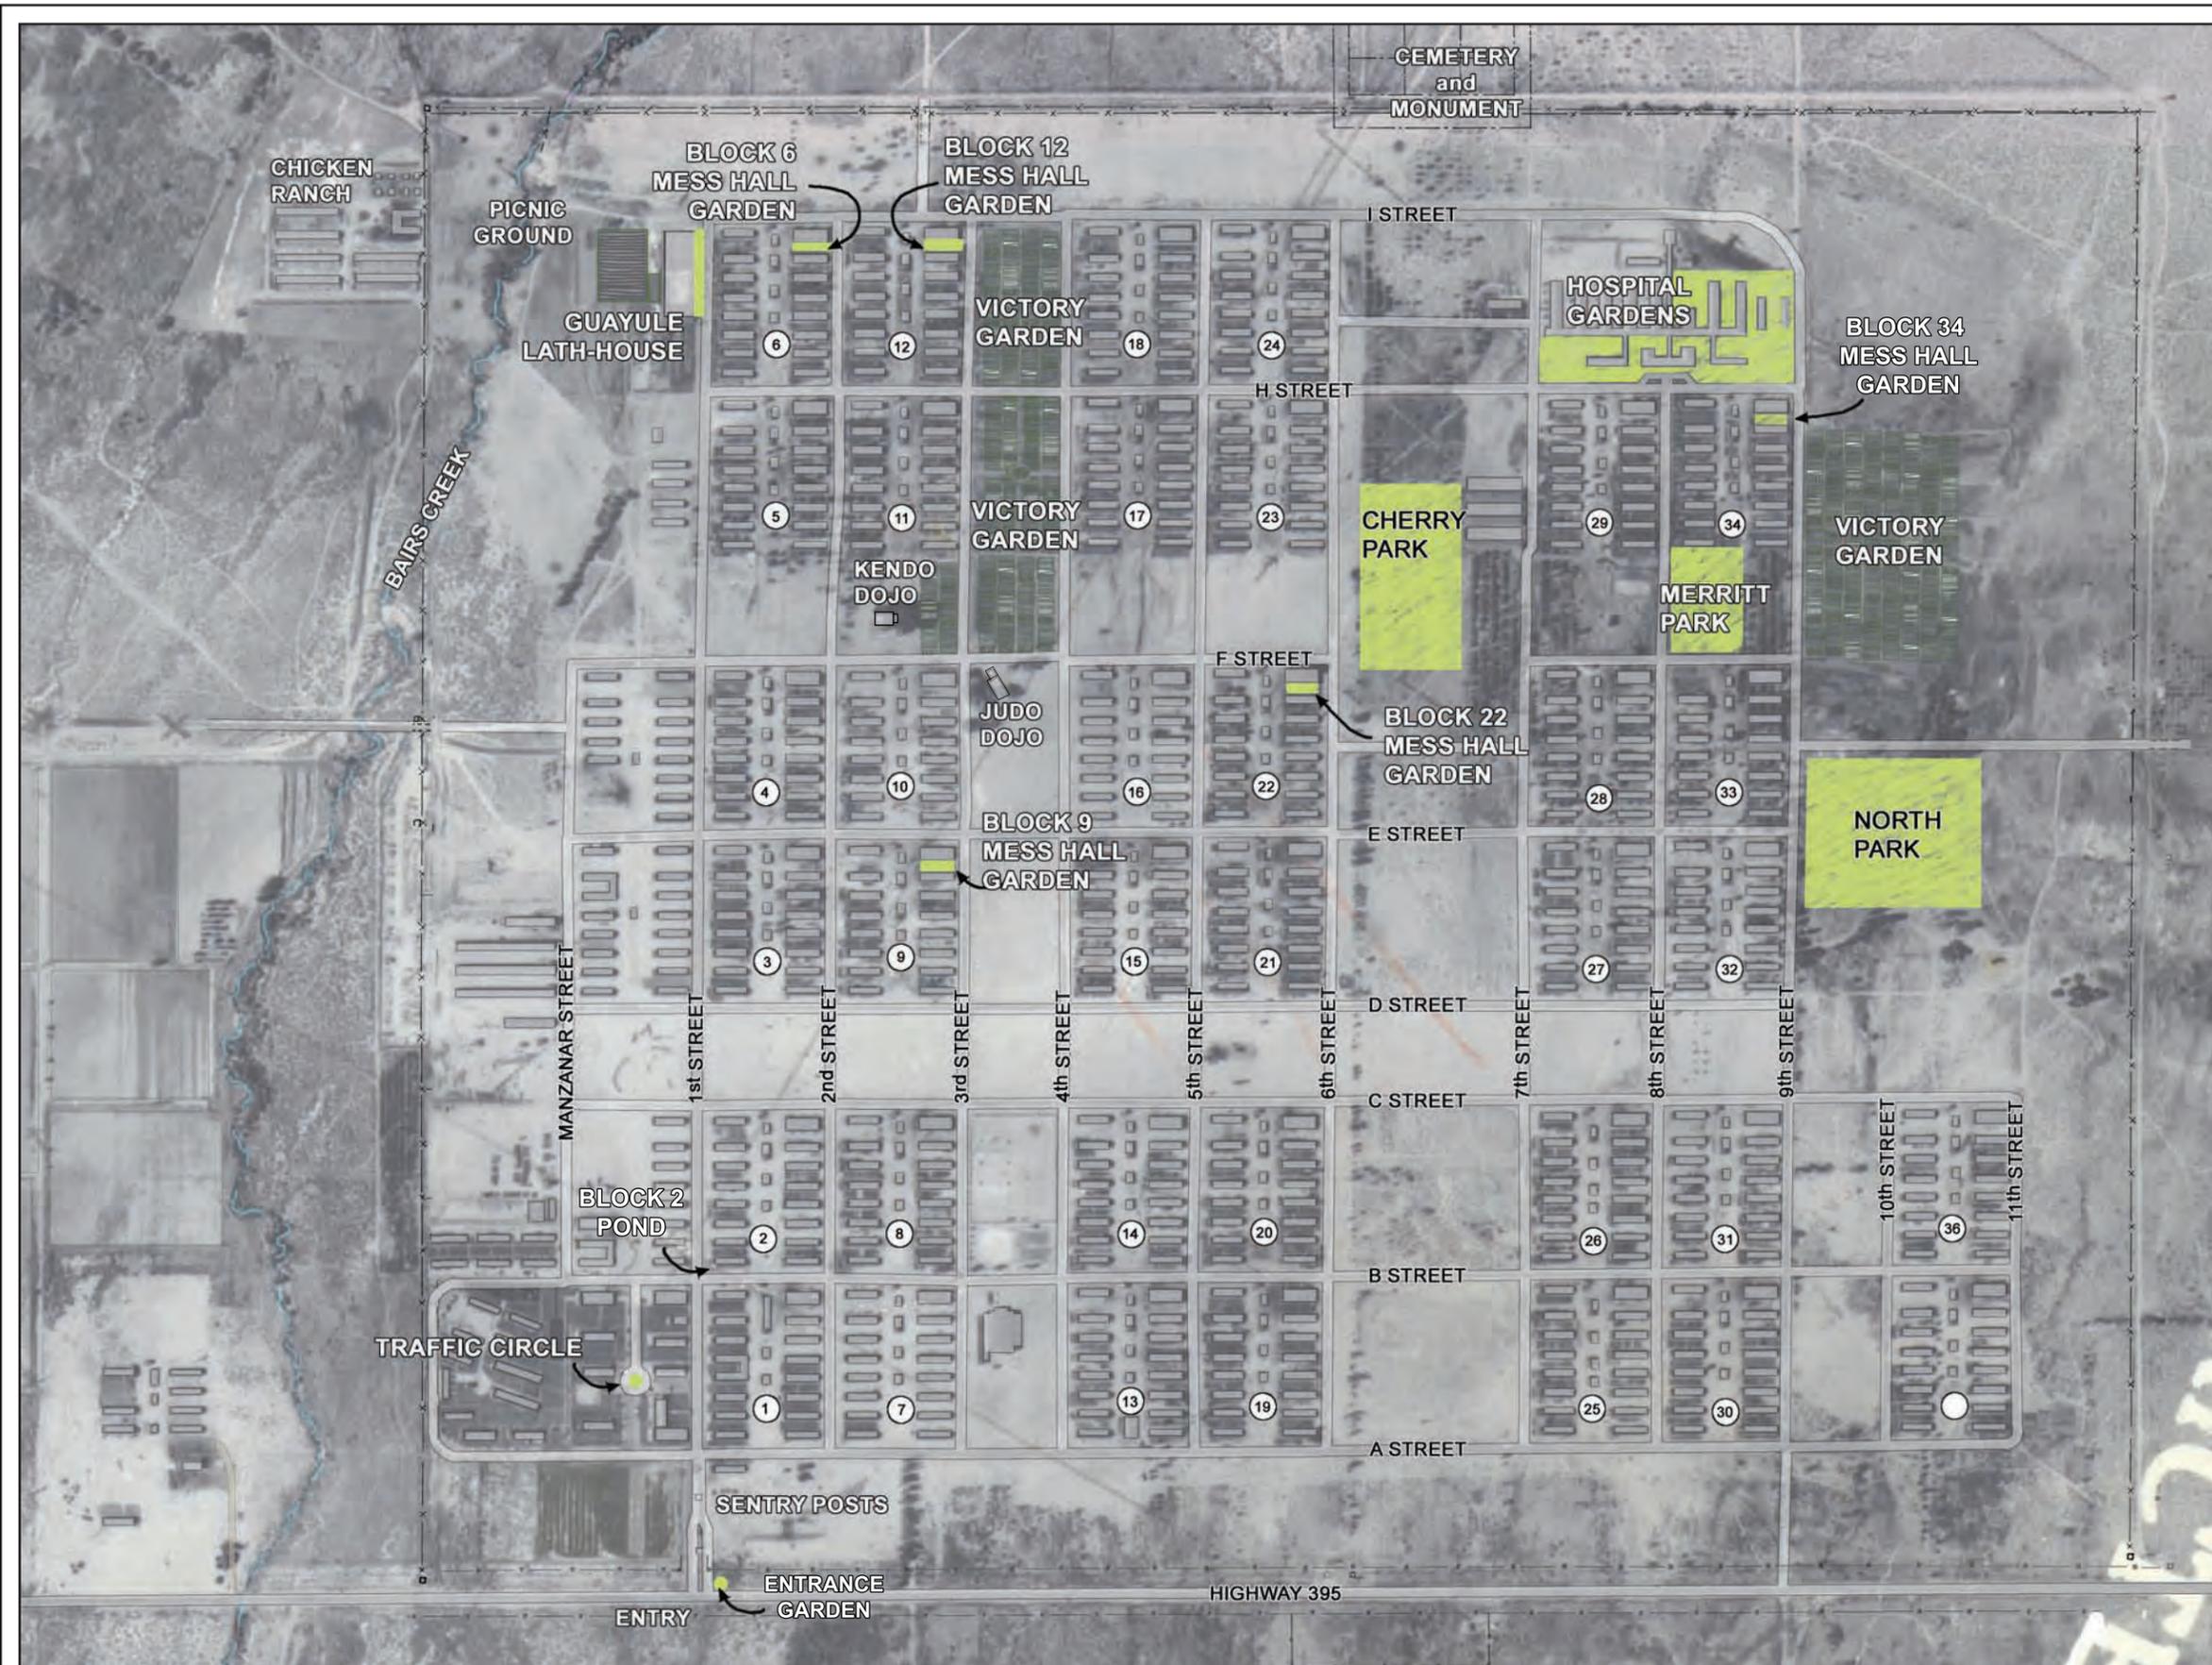
FIGURE 59

Manzanar Garden Areas

and boulders associated with specific gardens, a scattering of ornamental vegetation, and occasional landscape structures. Five historic gardens at Manzanar—the block gardens at Blocks 12, 22 and 34, one of the hospital pond gardens, and a pond in Block 2, the design, workmanship, and materials are still evident from the original design. These gardens were excavated and mapped by the Western Archeological and Conservation Center between 1993 and 1996.⁴⁴ (Figure 59)

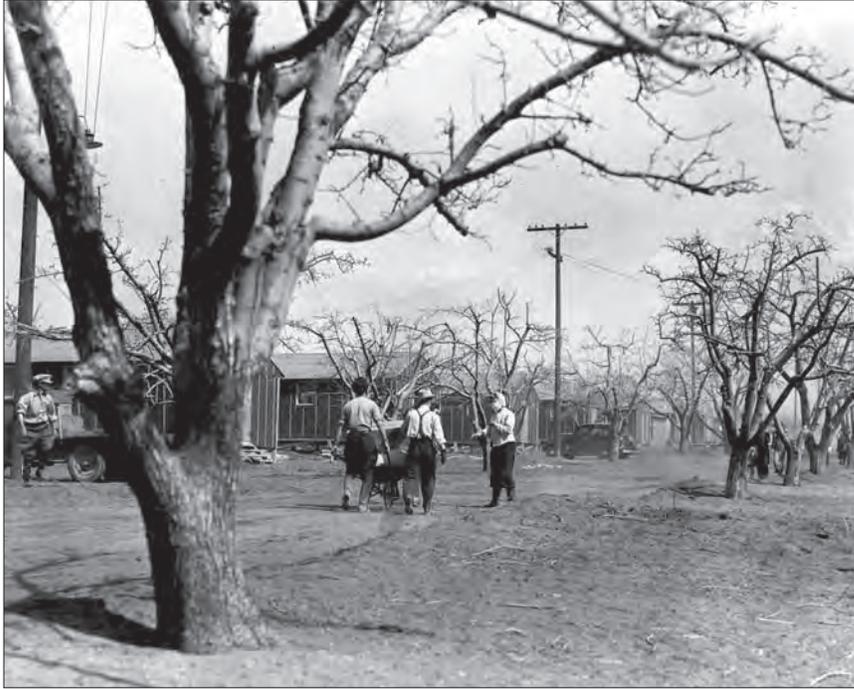
Figure 64. The orchards from the town period were incorporated as street trees and garden features when they were located within the grid of the camp. Note that after having been abandoned for over fifteen years, the trees have been carefully pruned to encourage fruit production. (Courtesy National Archives and Records Administration)

These trees were remnants of the Wilder, Lafon, Lydston, Hatfield, Christopher, Wells, Capps, Paget, and Meyer fruit orchards. (Figure 62) Where barracks buildings were sited within the orchards, trees were incorporated as garden vegetation or street trees. (Figure 63) The organization of the camp road system appears to have paralleled many of the orchards and allowed these orchard trees to function as street trees, providing shade and visual distinctiveness to the barracks that were fortunate enough to be sited nearby. (Figure 64)

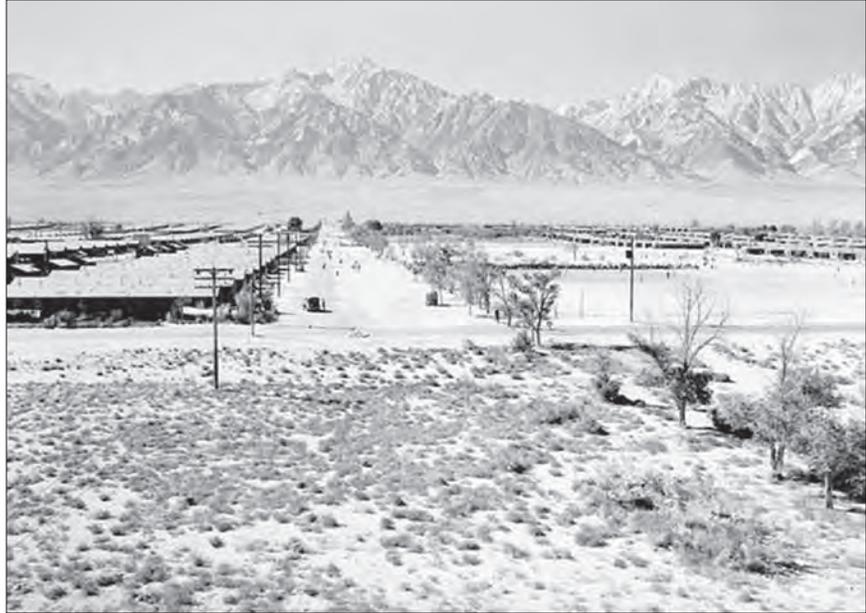
Figure 66. A row of black locust trees near 6th Street planted during the town period were incorporated into the camp layout. View looking west, 1943. (Courtesy of the Library of Congress, Prints and Photographs Division, Ansel Adams photographer)

Of the many town and ranch remnants that were integrated into the camp, one of the more prominent rows of trees was a row of black locust trees. (Figure 66) These trees were offset along the north side of 6th Street beginning at A Street and extended along the northern firebreak to its intersection with the western firebreak at F Street. Many of these locust trees along 6th Street remain today, although most are in fair to poor condition. Orchard trees were also used as street trees when their locations coincided with the edge of developed areas. Few of the orchard trees that were used for street trees are evident today.

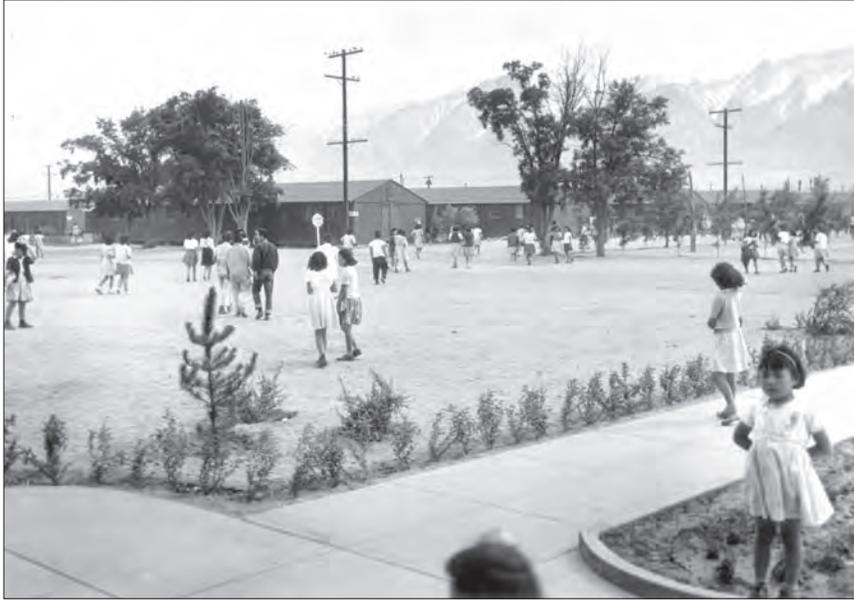
Figure 67. A hedge lined the walkway to the auditorium, with pine trees planted on either side of the entrance. Other historic photographs substantiate that the bed in the center of the entrance walk (lower right corner) was planted with annuals. (Courtesy of Toyo Miyatake Studio)

However, based on historical documentation, pine trees were established approximately 10 feet apart on each side of the entrance walkway near the plaza. The entrance walk itself was concrete and had a border of low growing (less than 2') shrubs on either side. (Figure 67) Two planting beds were added and located in the center of the main walkway with a flagpole located between the two beds.

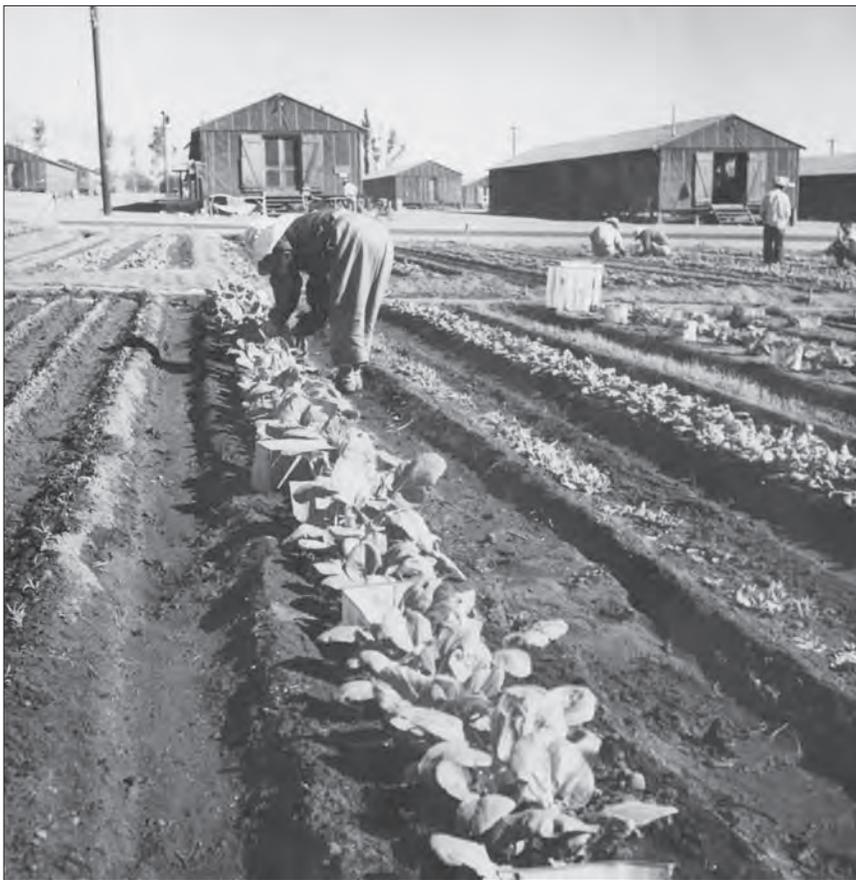
Figure 69. A system of earthen ditches and runoff from rain and snowmelt provided irrigation for the vegetables grown in the Victory gardens. The internees dug the ditches and established the watering schedules using gates to control the supply of water. (Courtesy of the National Archives and Records Administration)

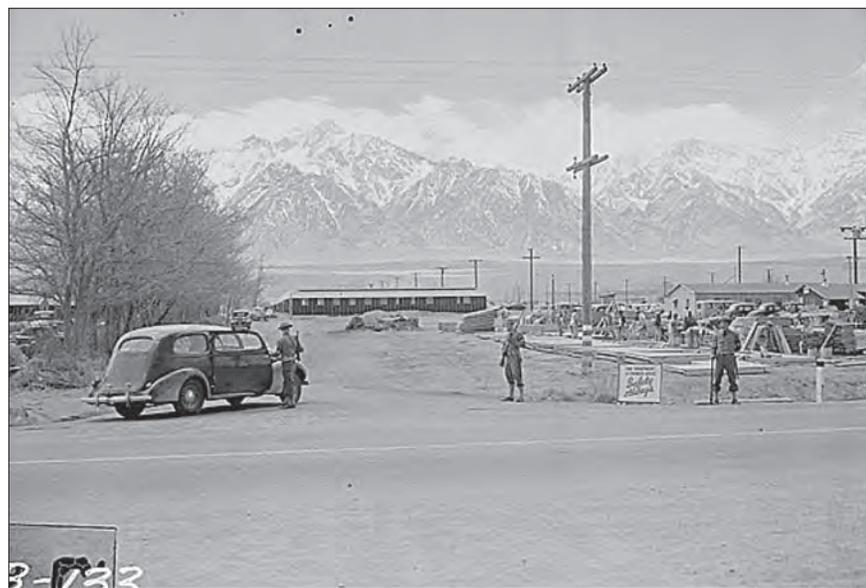
Figure 70. The original entry to Manzanar was located near Block 7. By August 1942, it was relocated south to its present location on 1st Street. (Courtesy of the Bancroft Library, University of California, Berkeley)

Initial access to Manzanar from U.S. Highway 395 was along a single lane road located approximately 650 feet north of 1st Street near Block 7. This road was in use until the fall of 1942, when the road was moved south to its present location, extending from 1st Street.⁵⁸ (Figure 70) The new entry included two, one-lane bituminous paved roads approximately 330 feet long from the edge of the highway to the police station. The northernmost road was aligned for vehicles entering the camp, and was separated and parallel to the other road, which routed vehicular traffic out of the enclosed camp area. The roads were divided by an open median, approximately 22 feet wide. Two sentry posts located in the median along these roads controlled access to the camp. Located at the east end near the highway, a sentry post manned by military police checked all visitors and directed supply carriers and goods to designated areas within the camp. Two concrete posts (fashioned to look like tree stumps) were located on either side of the Military Police (MP) sentry post and masonry stub walls flanked either side of the entry drive, narrowing the road bed and providing greater control over general access to the site.⁵⁹ Just beyond the MP sentry post the road widened slightly on the north edge to accommodate parking for visitors conducting business at the camp and needing security clearance before entering the housing area. Individual parking spaces as well as the

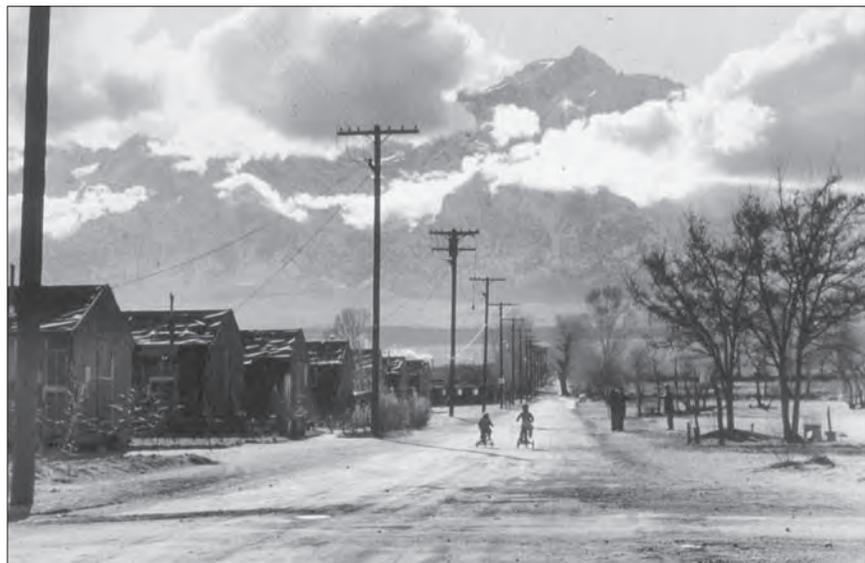
Figure 72. The camp roads were graded only slightly and surfaced with oil to control dust. This is a view looking west on 6th Street.

The roads were graded only slightly above the finish grade, with minimum sloping for drainage. No additional drainage structures were built, and what run-off did occur was absorbed on the surface. The roads were designed to be 20 feet wide and were surfaced over the native soils (which were primarily decomposed granite) with a penetration of asphaltic oil.⁶² Because the heaviest traffic and large freight trucks regularly used the main entry drive from U.S. Highway 395 and one block of 1st Street (leading to the warehouse blocks and motor pool area), this section of the street was wider (40 feet) and was surfaced with bituminous over compacted gravel.⁶³ (Figure 72)

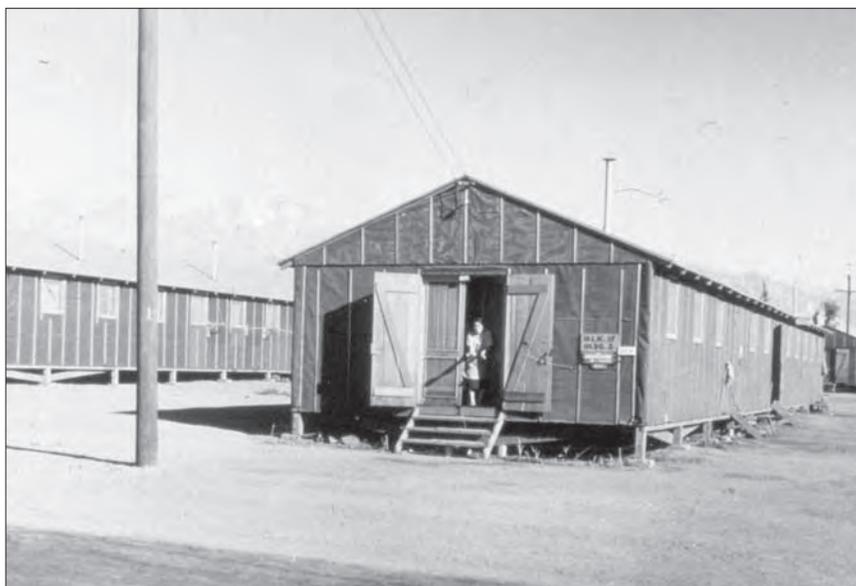
Figure 74. Historic view of residential barracks buildings. (Courtesy National Archives and Records Administration)

Of the 800 buildings constructed at Manzanar between 1942 and 1945, 504 were barracks buildings used to house internees. The barracks buildings were wood-frame structures, 20' X 100' in size set on pre-cast concrete block foundations. Gable roofs were covered with sheeting and finished with roll roofing. Siding was vertical board, covered with tarpaper, and

finished with lath or batten. Each barracks had 12 sliding windows, 36”x40” in size. Each barracks was divided into four apartments with doors located at the end of the barracks building and along the sides, providing entry into individual apartments. ⁶⁷ (Figure 74)

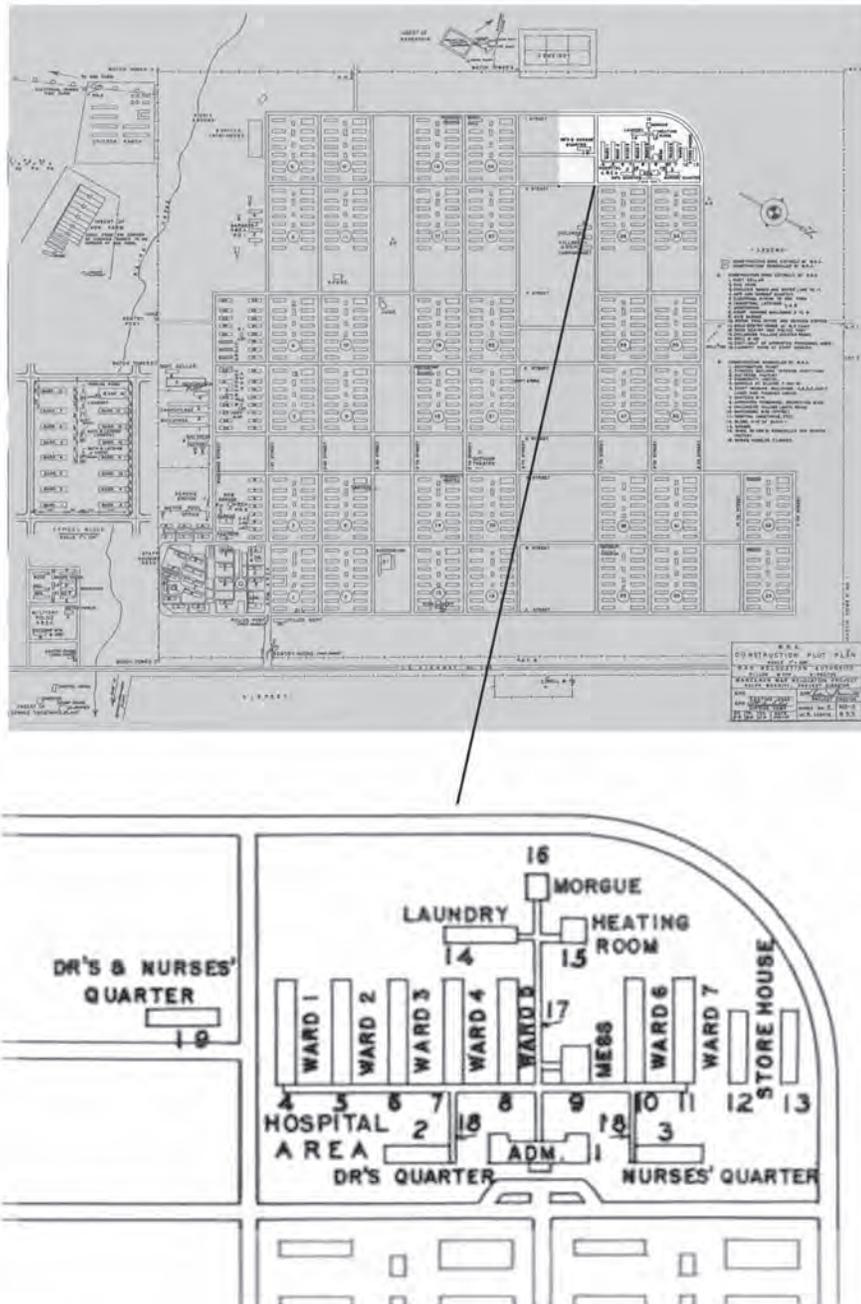
Figure 78. The hospital complex included seventeen structures. (Adapted from WRA Construction Plot Plan, 1942)

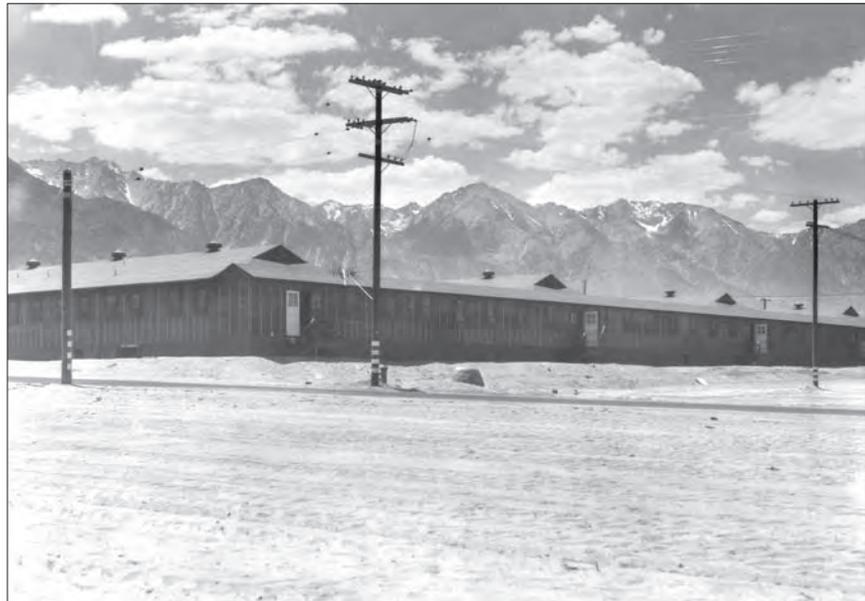
Figure 79. View towards the hospital looking northwest. (Courtesy National Archives and Records Administration)

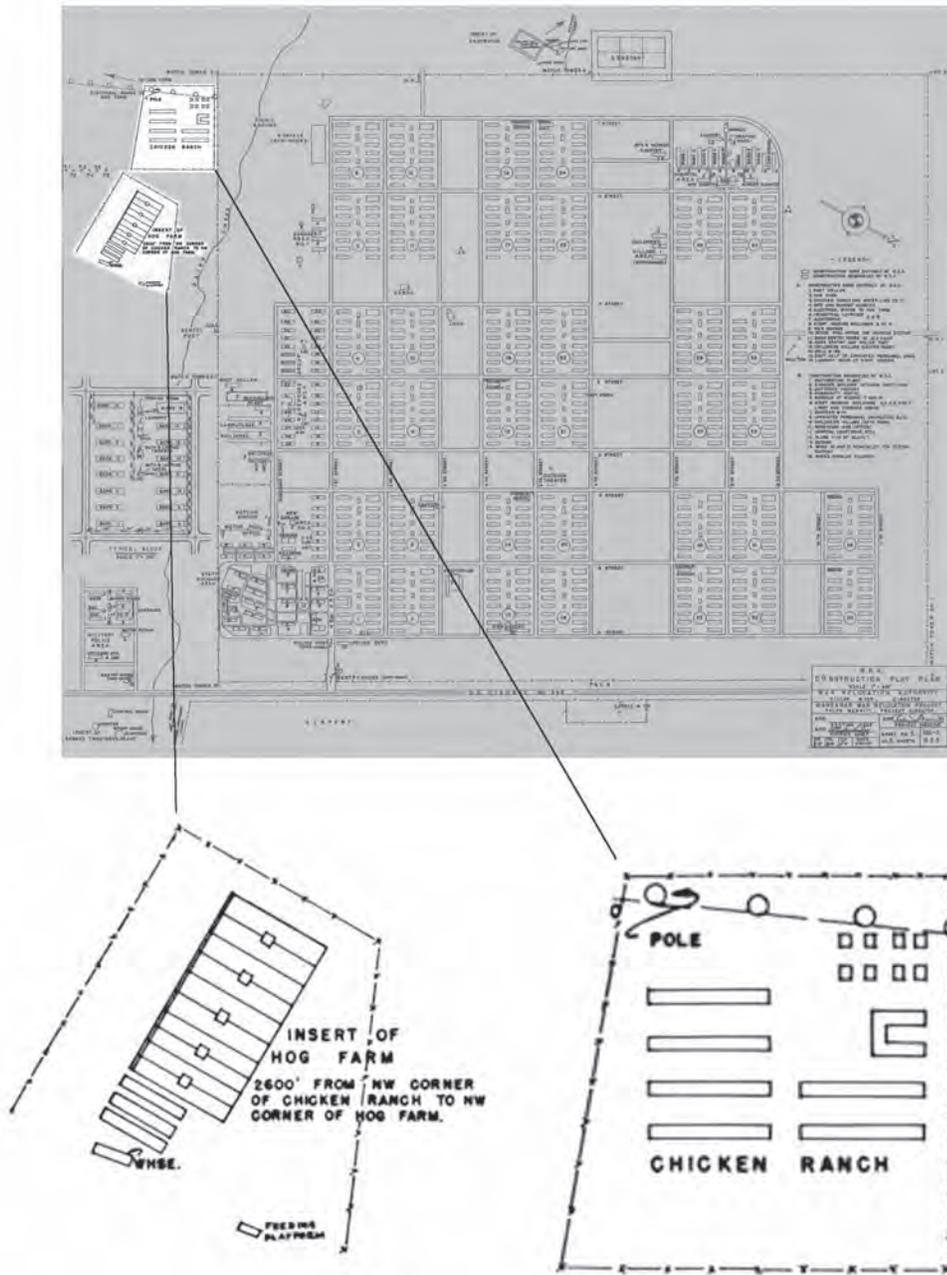
Figure 80. Agricultural buildings were located outside of the perimeter fence and included both a chicken ranch and hog farm. (Adapted from WRA Construction Plot Plan, 1942)

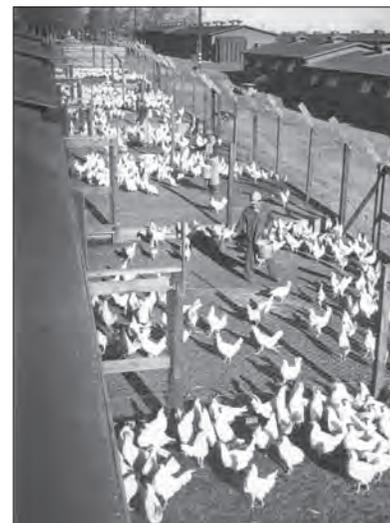
Figure 81. The Chicken farm was located outside the perimeter fence on the south side of Bair's Creek, 1943. (Courtesy of the Library of Congress, Prints and Photographs Division, Ansel Adams photograph)

The six hen houses were aligned in two rows on the eastern side of the cluster. Individual buildings were 20' x 192' in size and stepped down the gently sloping site. Each house was divided into eight units, with each unit measuring 20' x 24', providing room for 175 hens. Each section had a roof vent. Outside each section were 20' x 24' runs enclosed by 2" mesh chicken wire on wood posts. The floors and foundations were concrete. (Figure 81)

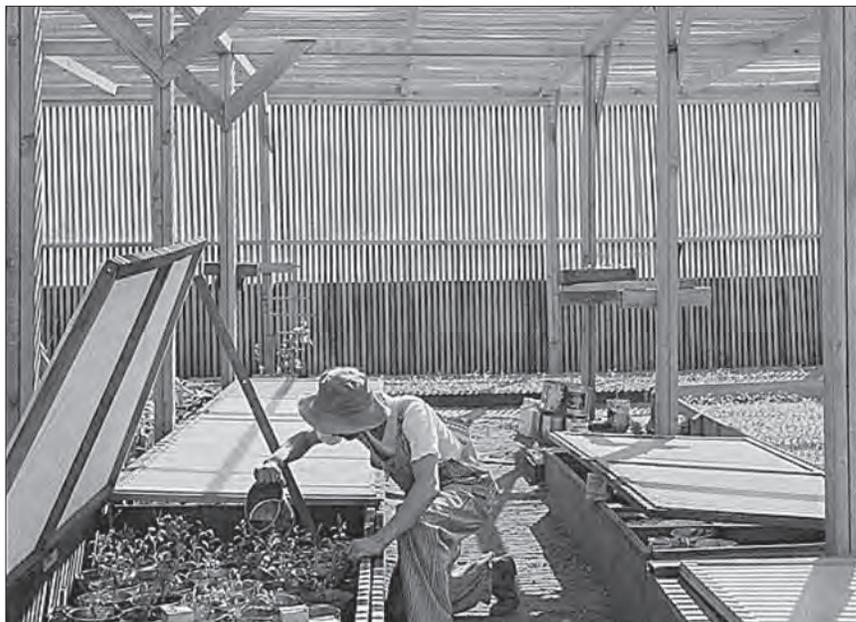
Figure 82. Interior view of the lath house, where guayule plants were sprouted from seeds. (Courtesy of the National Archives and Records Administration)

The guayule lath house (a special propagating nursery) was constructed south of Block 6, between the edge of the central developed area and Bairs Creek. The lath house was 104' x 136' in size and was a simple wood frame structure with lath on walls and roof. (Figure 82)

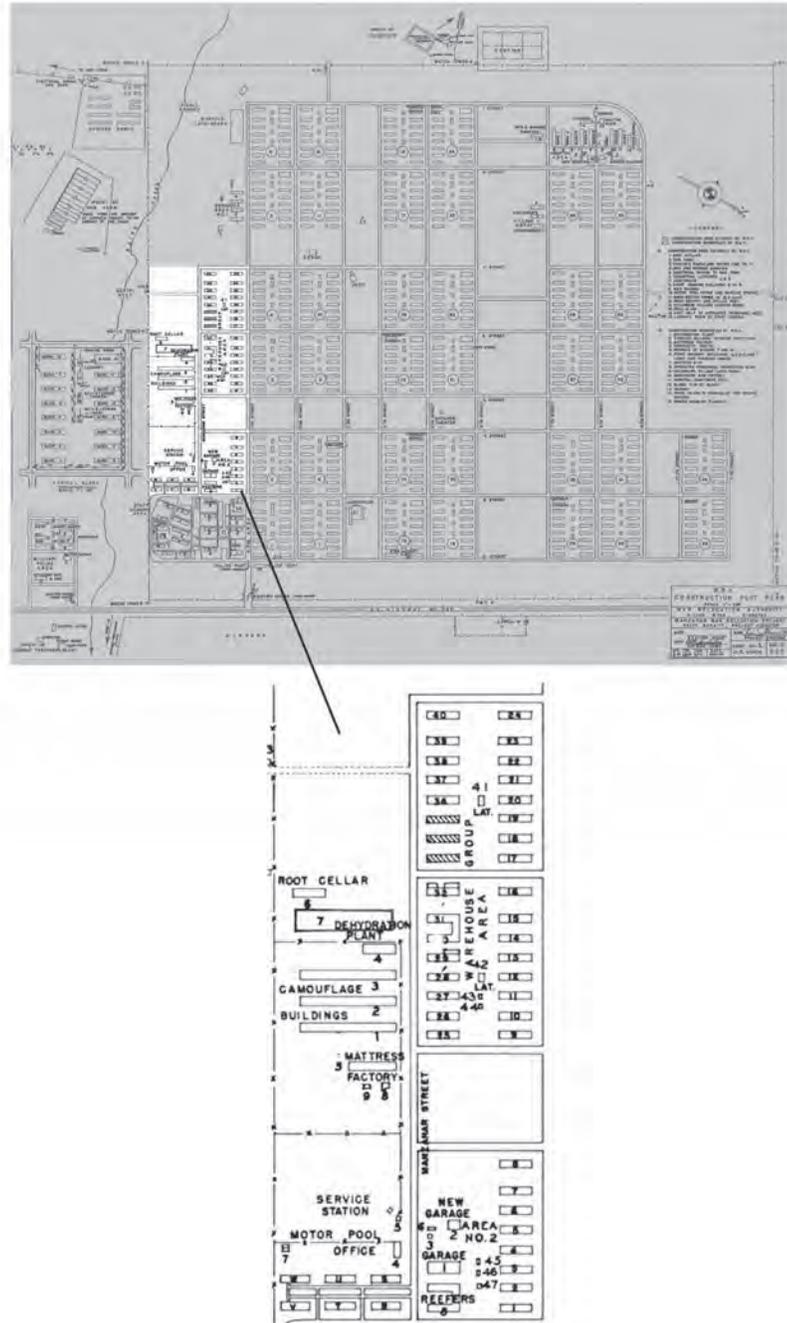
Figure 83. Industrial facilities included warehouses, maintenance buildings, and garages. (Adapted from WRA Construction Plot Plan, 1942)

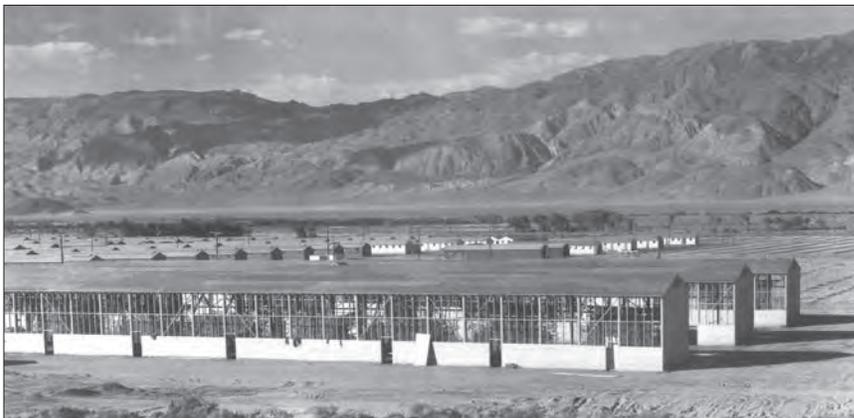
Figure 84. Camouflage nets were made by internees at Manzanar in three buildings located south of 1st Street. Warehouses were also located in this area. (Courtesy of the National Archives and Records Administration)

Three buildings, measuring 300' x 24' and 18 feet tall, were constructed to accommodate net production. They were built with 6" x 12" posts, set on 10-foot centers which supported a double set of 2" x 6" rafters bolted to each side of the posts. The roofs were covered with random-width sheeting laid diagonally and covered with 90-pound roll roofing. The exterior walls were covered with 10-inch drop siding extending between the floor to 10 feet above. The ends of the buildings were covered from floor to ridge. The floors were concrete. Two of the buildings had 12' x 20' additions with shed roofs that served as offices. (Figure 84)

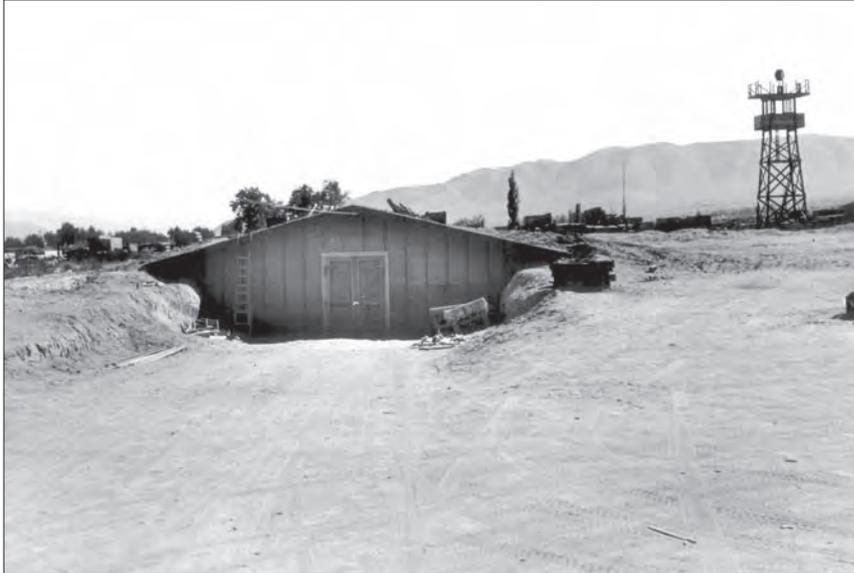
Figure 85. Historic view of the root cellar and guard tower. (Courtesy of Toyo Miyatake Studio)

Storage of root vegetables and other foods produced by the agricultural project were stored in a 100' x 26' root cellar. Constructed between July and October of 1943, it was located west of the former camouflage net factory complex. It was a wood-frame building with a concrete foundation. Three-fourths of the structure was below grade, and the gable roof was covered with dirt. (Figure 85)
