Cultural Landscape Report Manzanar National Historic Site

National Park Service
Pacific West Region
2006

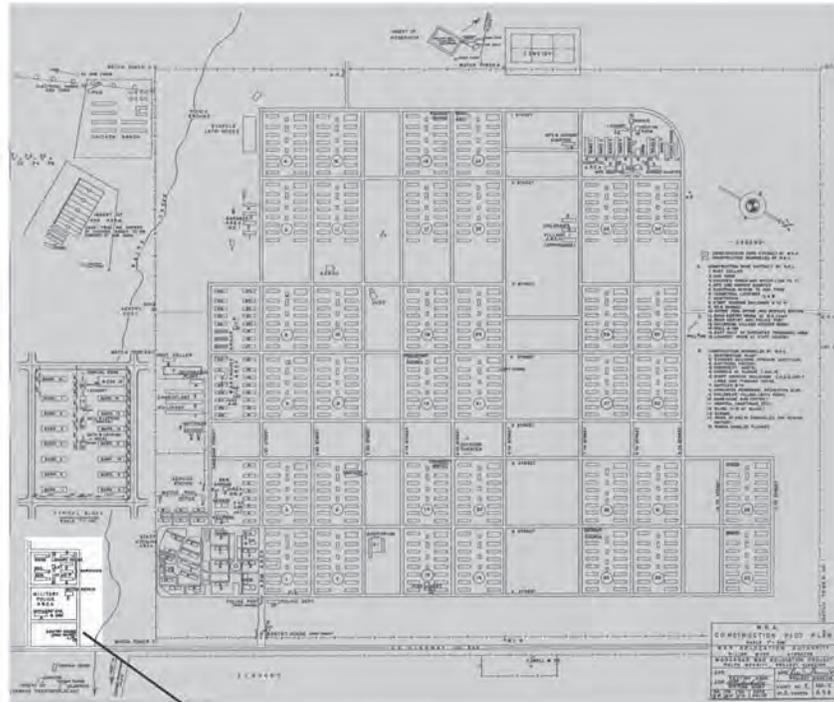
Figure 86. The military police complex included thirteen buildings located southeast of the main camp, outside of the perimeter fence. (Adapted from WRA Construction Plot Plan, 1942)

The military police cluster was comprised of 13 buildings located southeast of the camp, just south of the boundary fence and Bairs Creek. The large block that contained the complex was divided into three areas defined by short access roads. Eight of the 13 buildings in the cluster were basic barracks-style structures, with some modifications to the interior spaces. The western end of the compound contained the majority of structures. Enlisted soldiers were housed along the north side of the cluster, in four of the standard 20' x 100' barracks. These quarters were designed to accommodate 50 soldiers in each. South of the barracks were the administration building and storeroom, a mess hall, and a recreation building. A latrine, the guardhouse, and a first aid station were located between barracks and administration building. The middle area of the compound contained another barracks-style building providing seven quarters for officers and doctors. East of this building was the garage or motor repair building, with a shed for eight vehicles. Access to the complex was from the main highway, passing a rock sentry house located east of the building cluster along the access road to the military police compound. In this regard, general access to the military police area was highly controlled and physically separate from the main camp. (Figure 86)

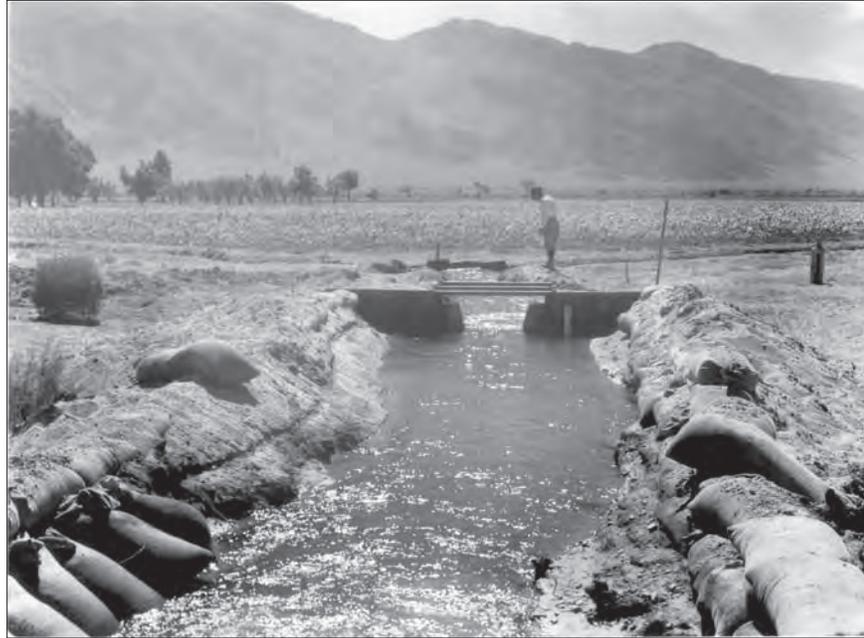
Figure 87. An extensive system of open ditches supplemented with pipes carried water to irrigate fields. (Courtesy of the National Archives and Records Administration)

Irrigating water was carried from a stream source through a system of concrete and steel pipelines, and open ditches lined with rock and concrete. The ditches were approximately six inches wide at the top, three inches wide at the bottom, and three inches deep, and a system of wood flumes were constructed over coulees in the ditches. (Figure 87) Within the farm fields, the irrigation system consisted of open ditches, approximately three inches wide at the top and one inch wide at the bottom. The ditches were lined with rubble and concrete and wood gates were installed to regulate the flow of water to the fields.

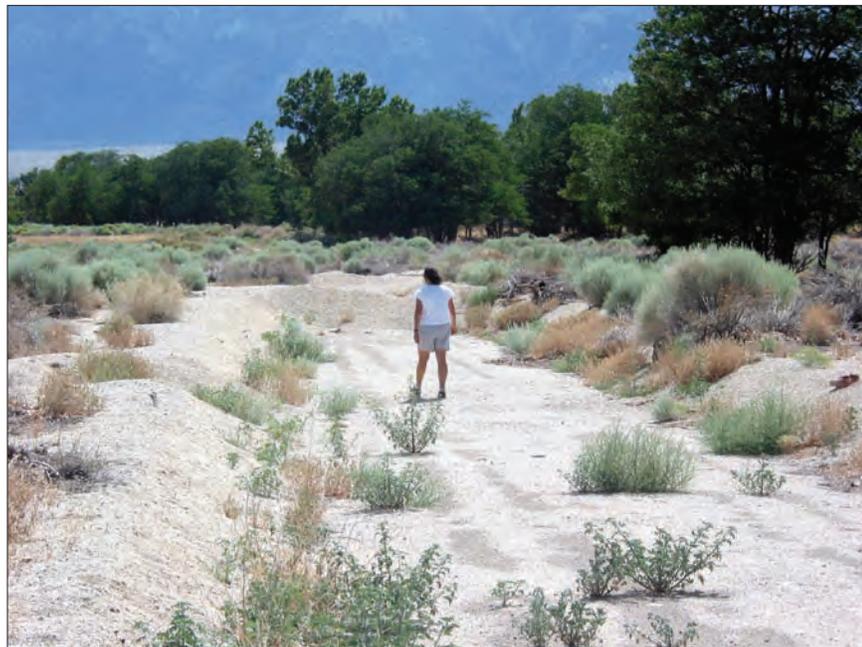
Figure 89. Portions of the historic road grid system are currently buried under alluvial deposits. (NPS, 2002)

covered by soil so that the road corridor is visually distinctive from the surrounding vegetation, permits use by visitors and NPS maintenance vehicles, and provides a visual connection with other exposed portions of the road system. The clearing of vegetation from the road corridors also supports fire management objectives for the site. (Figure 89)

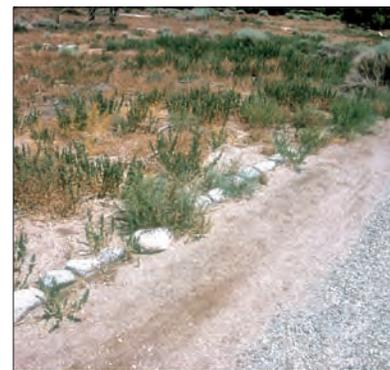
Figure 90. (above) Many features, like this stone curb, are obscured by accumulated soil along historic roads throughout the site. (NPS 2002)

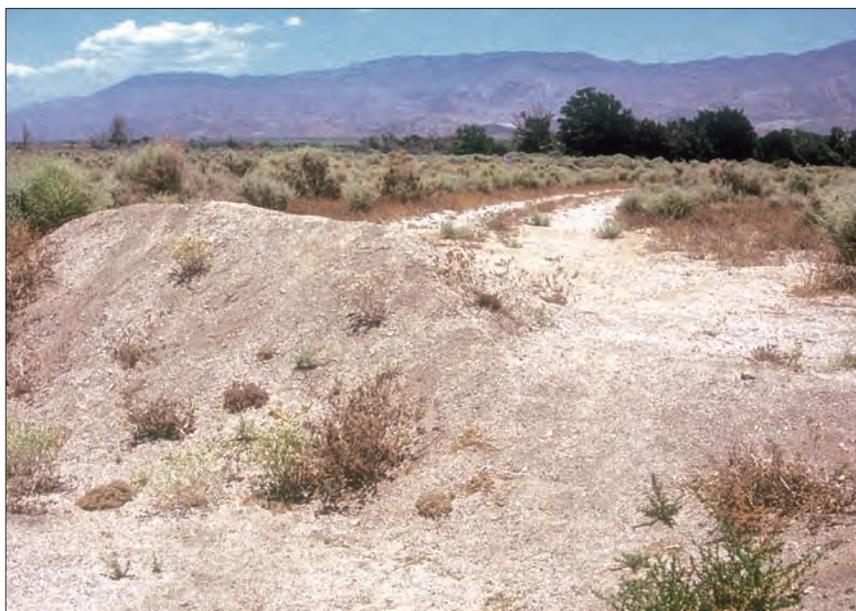
Figure 91. (left) Non-historic mounds of dirt, such as this berm along one of the historic roads, impact the integrity of the historic setting. (NPS, 2002)

6. Remove non-historic mounds of stockpiled soil along the road. (Figure 91)

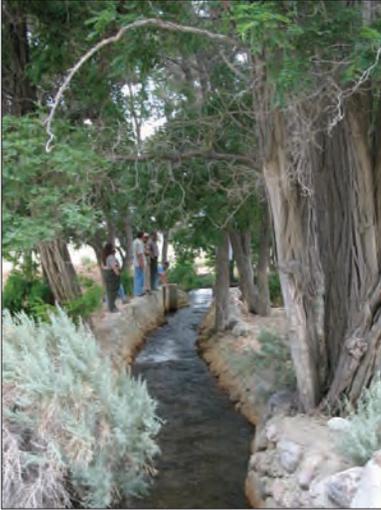
Figure 92. This historic mortared rock embankment along George's Creek is outside the NPS boundary. The NPS will work with other land owners and agencies to identify, inventory, and assess resources to ensure protection. (NPS, 2002)

7. Work in partnership with other land management agencies to document, evaluate, and manage historic dirt and gravel roads. These roads provide access and link historic sites and features related to Manzanar such as the camp reservoir and embankment structures at George's Creek. (Figure 92)

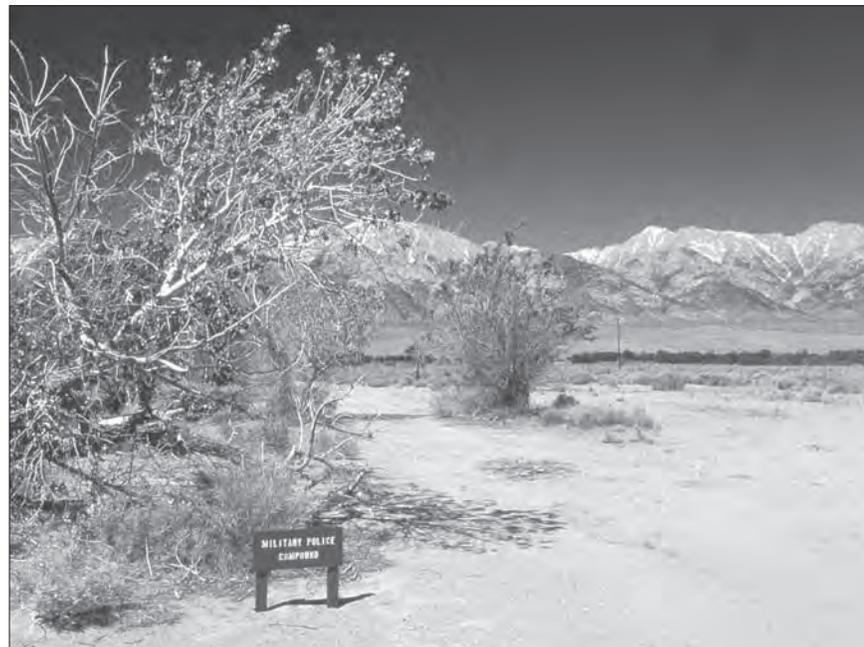
Figure 93. Non-historic roads, like this loop road at the Military Police compound, impact the integrity of the historic setting. (NPS, 2002)

8. Restore the historic circulation pattern throughout the Military Police compound. Eliminate non-historic loop by clearing the historic parking area in the compound for use as the turn-around. (Figure 93)
9. Discourage the addition of new roads within the historic site, unless specified in the GMP. If new roads are required they should be designed to be compatible with the character of historic roads (e.g. width, shoulder treatment, crowning, appearance, etc.).

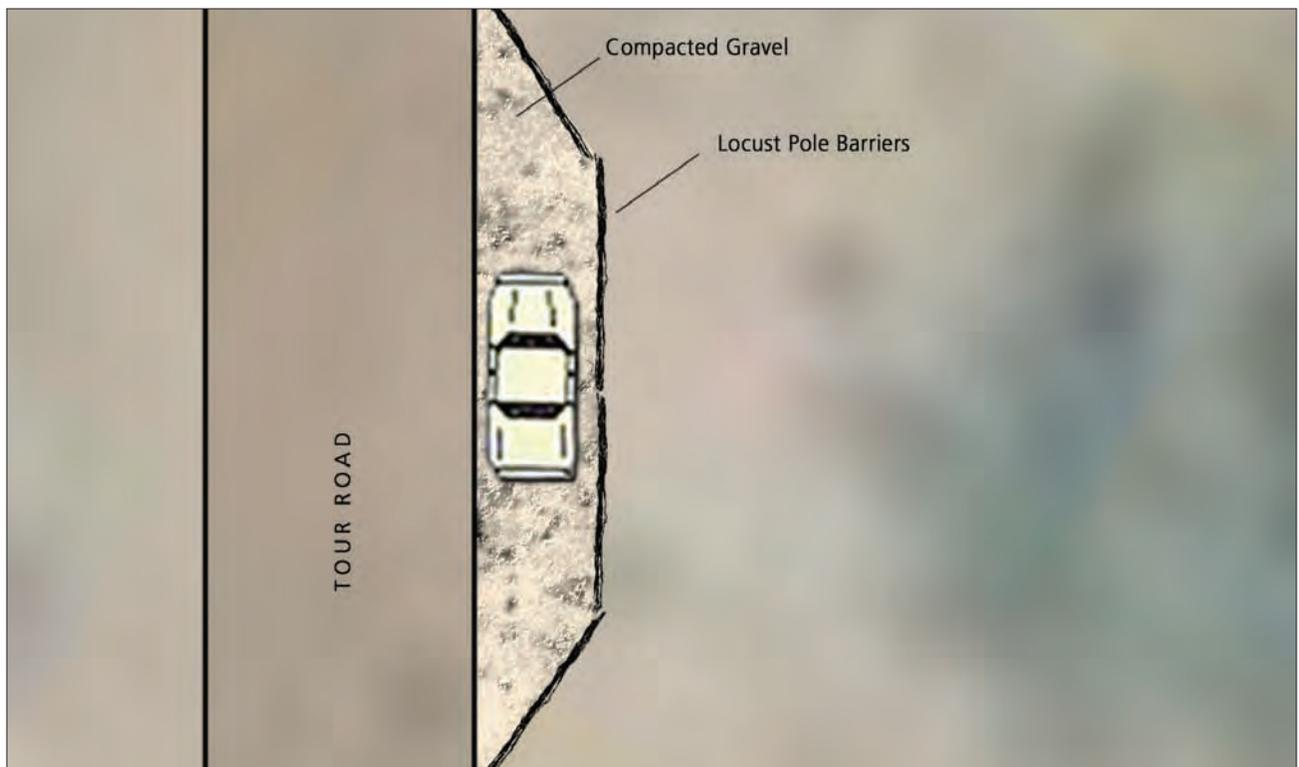
Figure 96. Gravel pullout. (NPS, 2005)

5. Based on site carrying capacity and interpretive priorities, a limited number of unpaved vehicular pullouts may be developed along road shoulders when historically paved areas cannot be adapted for parking (e.g. along 9th Street at North Park). If unpaved road shoulders are developed for vehicle pullouts the following design criteria applies:

- Ensure the location for new pullout is selected in consultation with an archeologist to minimize potential impacts to cultural resources.
 - Minimize grading to reduce potential impacts to archeological resources. (Figure 96)

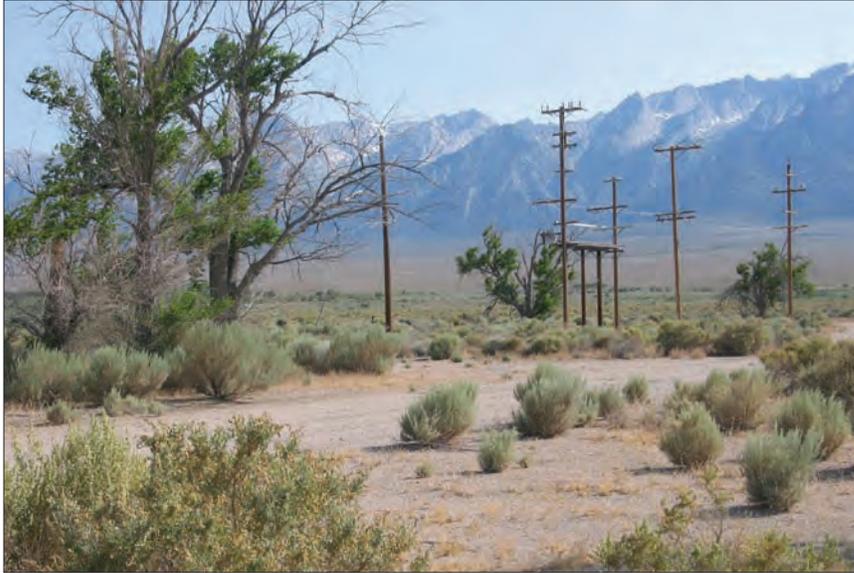
Figure 98. If feasible, non-historic utility lines at the military police compound should be relocated. (NPS, 2002)

3. All features should be closely inspected every year to identify any immediate maintenance needs related to vandalism, vegetation, concrete, stone or mortar deterioration, drainage, or wind erosion problems.
4. Significant preservation work should be undertaken by preservation masons or conservators (as appropriate) working under the direction of a historical architect.
5. Development of a new centralized maintenance facility or vehicle storage area within the historic site boundaries is strongly discouraged.
6. Considerations should be given to working with the utility company to remove non-historic utility lines within the historic site including the transformer structures (in military police area). Utility lines should be relocated in historic locations along Highway 395 or if that is not feasible, outside the historic site boundaries. (Figure 98, Figure 99)

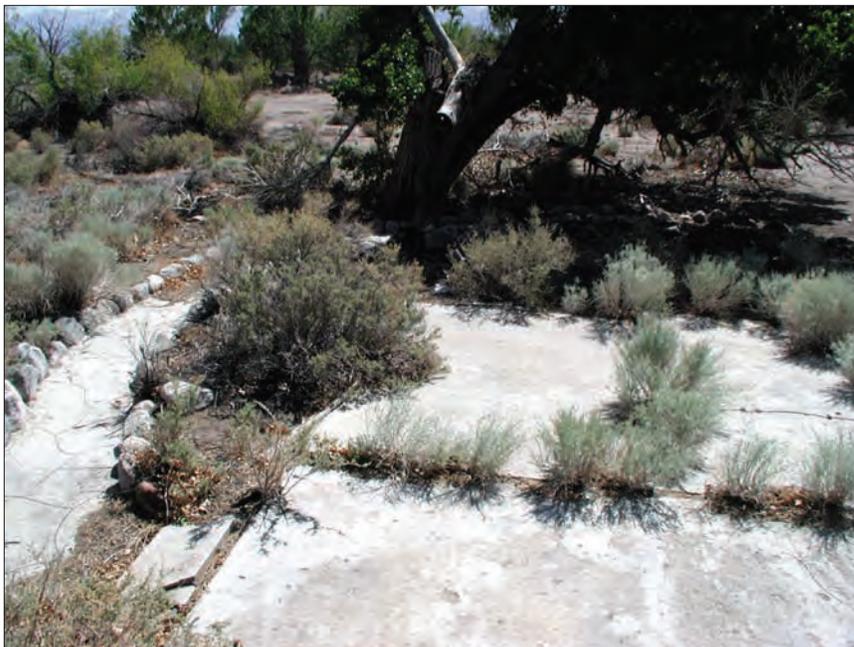
Figure 100. Non-historic vegetation obscures the historic foundations and can damage garden features if left unmanaged. (NPS, 2002)

Management (CRM) advisors. (Figure 100, Figure 101)

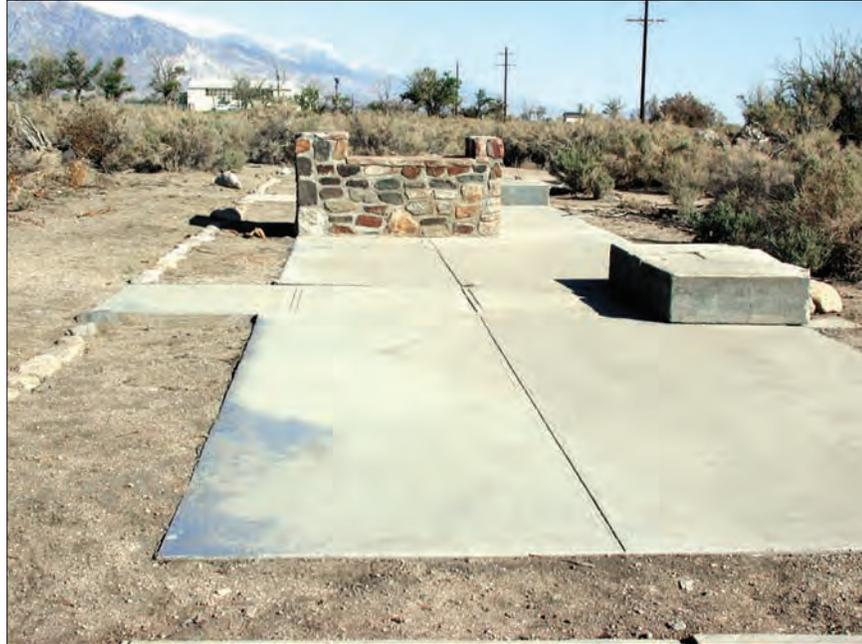
Figure 101. Building foundations and walkways cleared of vegetation allows visitors to better understand the physical character of the site. (NPS, 2002)

1. Annually clean and inspect exposed slabs and building foundations for damage caused by vegetation, soil build-up, or eroding soil undermining footings and foundations. Any soil removal should be done in consultation with an archeologist.
2. Remove non-historic vegetation from the edges and cracks of structural features. Removal of historic vegetation to protect buildings and structures should be done in consultation with the parks Cultural Resource

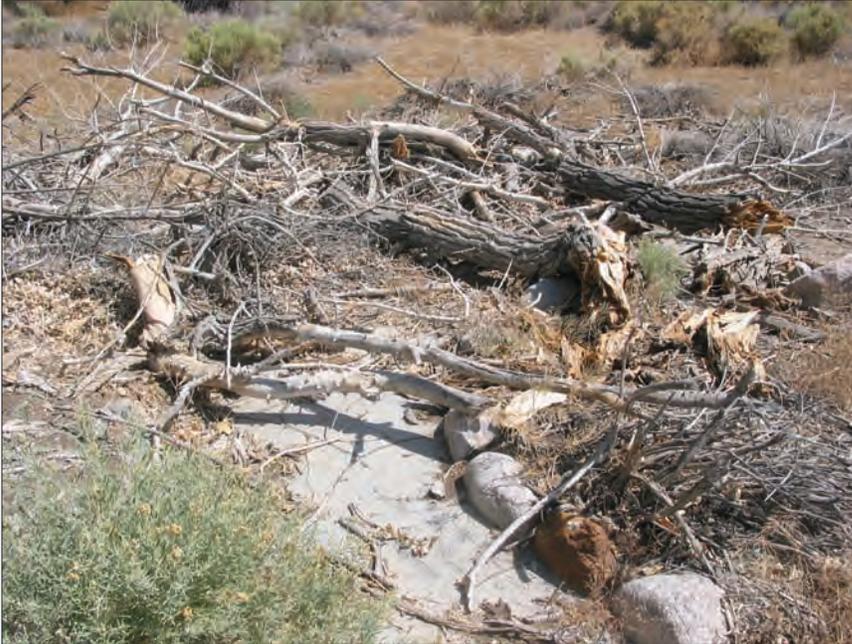
Figure 102. Accumulation of woody debris increases fuel loads, which threaten historic resources. (NPS, 2002)

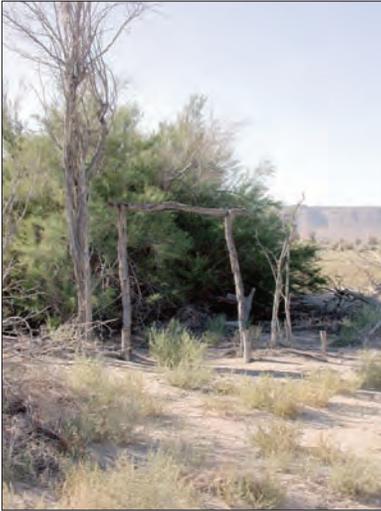
Figure 104. Active control of some non-historic invasive species, such as tamarisk, is required. (NPS, 2002)

10. Control the spread of historic invasive exotic vegetation such as alianthus (Tree of Heaven) and tamarisk beyond their historic plantings by such means as cyclic pruning/stump sprouting of historic materials and the removal of non-historic shoots. Preserve only those specimens that were obviously important features (e.g., a clearly delineated row) or part of a period design (e.g., block garden). (Figure 104)

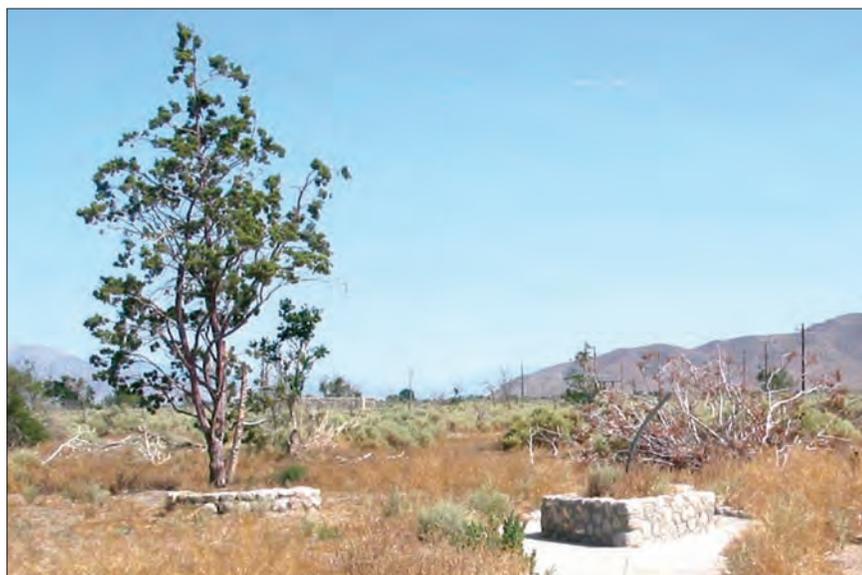
Figure 105. Replacement of unique historic vegetation, such as the dead cypress on the right side of the photo, can be considered as historic trees decline and die. (NPS, 2002)

11. Where feasible and supported by recommendations made in the CLR, replace in-kind unique historic vegetation that is damaged or destroyed (e.g., maintain historic cypress trees in the historic administration area and replace the one that was recently blown over using the same the specie). (Figure 105)

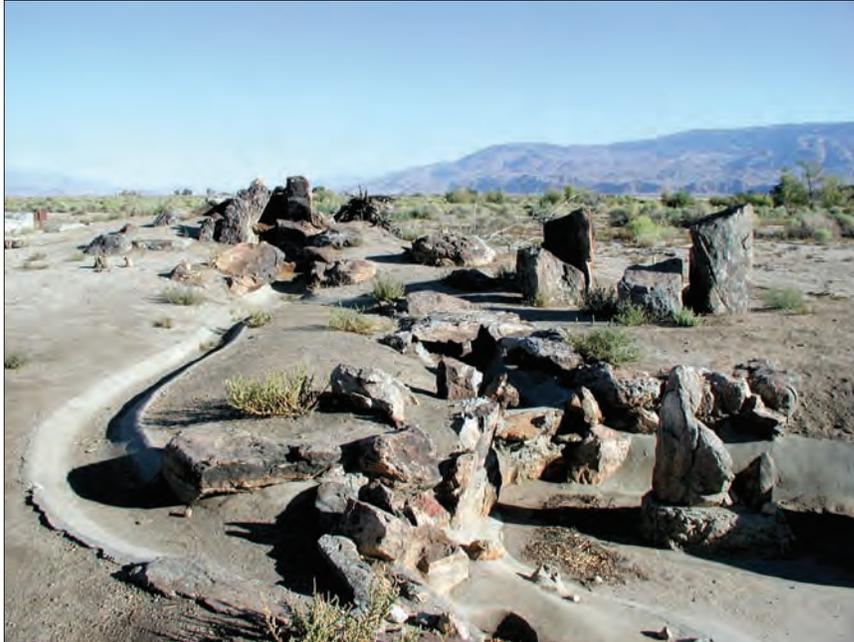
Figure 108. Stabilize eroding historic features, such as the berms and watercourse in the block 34 mess hall garden. (NPS, 2002)

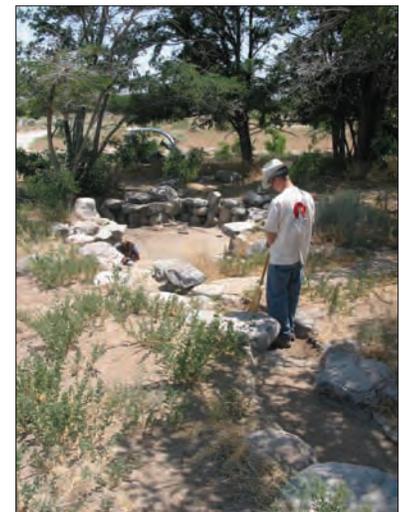
Figure 109. Cyclic maintenance practices, such as raking, weeding, and cleaning garden features, helps protect historic resources. (NPS, 2002)

- Restoration of features based on historical records, that are essential to understanding the garden and are easily maintained.
- Use of local soil to stabilize and restore eroded areas and protect threatened features as needed (e.g., to reestablish the top of the waterfall at Block 34).
- Use of soil stabilizers to retain historic grades and stabilize topographic features (e.g., the berm at Block 34). (Figure 108)
- Cyclic activities such as raking, clearing, weeding and vegetation management (e.g., removal of weeds from walks and paths). (Figure 109)

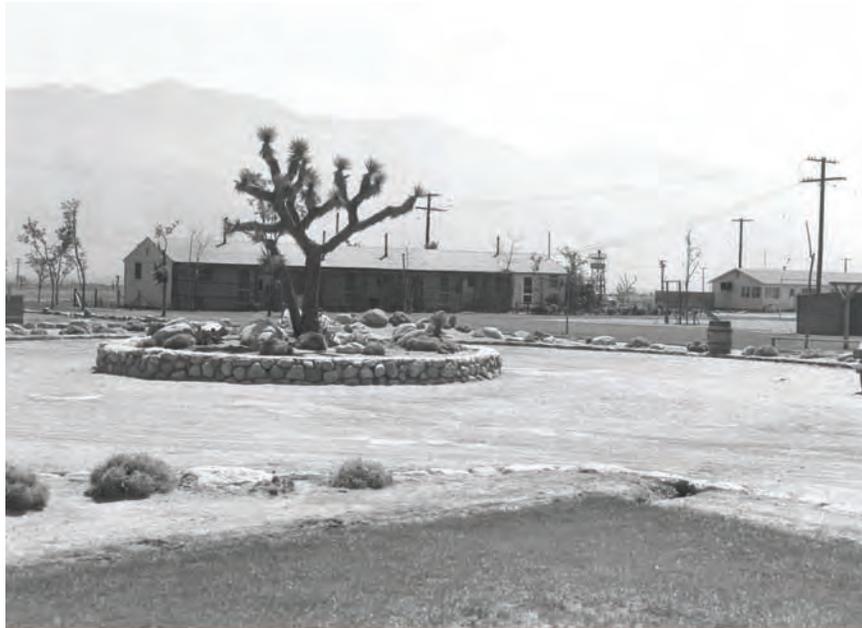
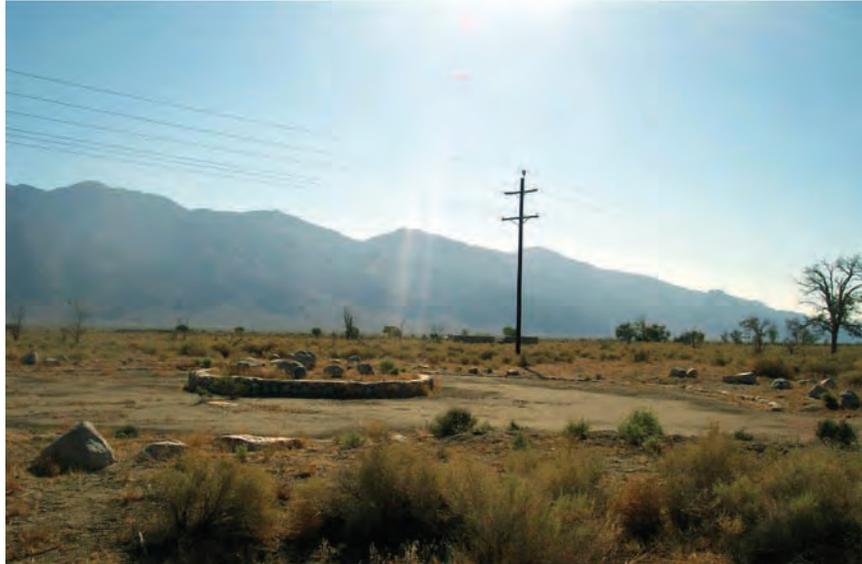
Figure 110. Restoration of missing vegetation, like the Joshua tree in this traffic circle, should be based on careful examination of historic documents. (Top: Courtesy UCLA Special Collections; bottom: NPS, 2002)

1. Treatment of historic features, including plant materials, should be based on historical documentation. Replacement or restoration is only appropriate when the exact nature of the feature is known. For example, reestablishment of the Joshua tree and cacti plantings in the traffic circle at the administration area is appropriate based on the use of historic photographs that can be used to establish historically accurate replacement of the features. (Figure 110)

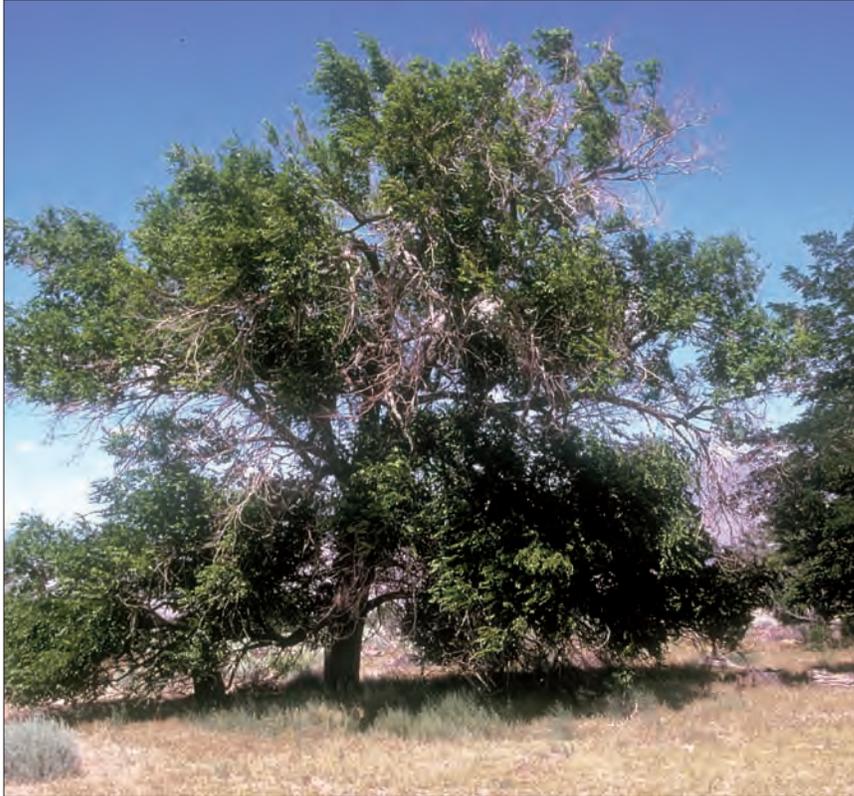
Figure 112. Removing dead wood from historic trees will help improve tree health and reduce fuel loads and hazards. (NPS, 2002)

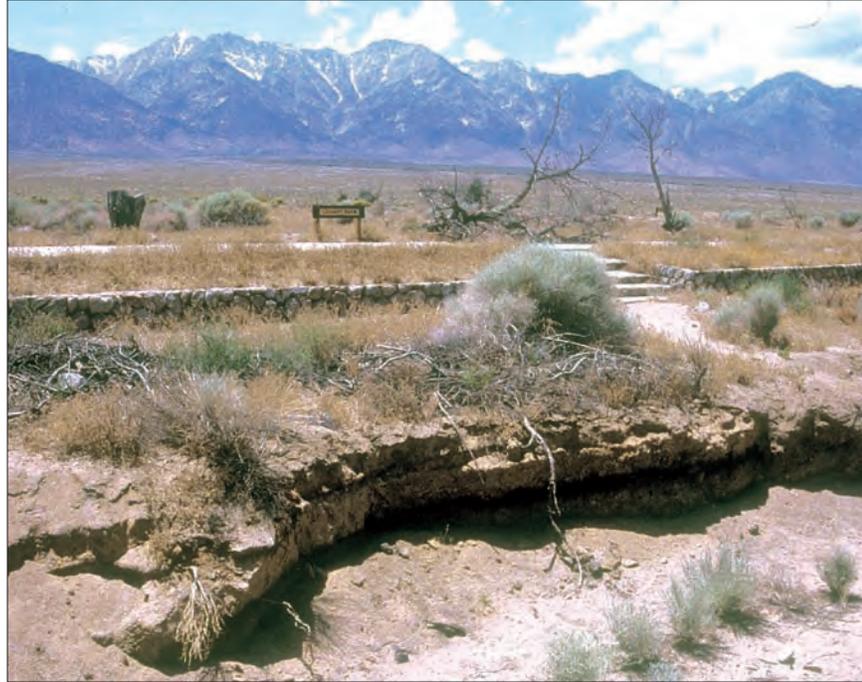
Figure 113. Stabilize eroding soil that threatens site features. (NPS, 2002)

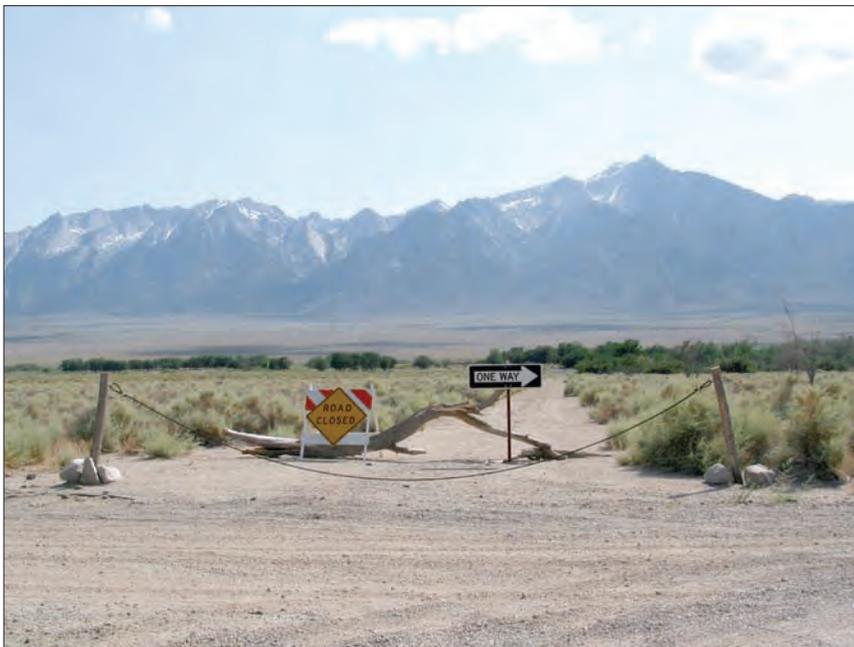
Figure 114. Developing an overall sign plan for Manzanar will improve consistency in the use of material and can clarify the appropriate design style for various types of signs used in the historic site. (NPS, 2002)

1. The use of new signs at the historic site is generally discouraged with the exception of safety, wayfinding, and interpretive signs.
2. New signs should use contemporary materials that are compatible with the historic site. Exact replicas of historic signs are not appropriate unless a specific historic feature is being restored (e.g., building identification signs on barracks block buildings).
3. The location of new wayside exhibits should be factored into existing and proposed pull-outs along the auto tour route to provide focused, accessible interpretation and minimize potential impacts to site. (Figure 114)

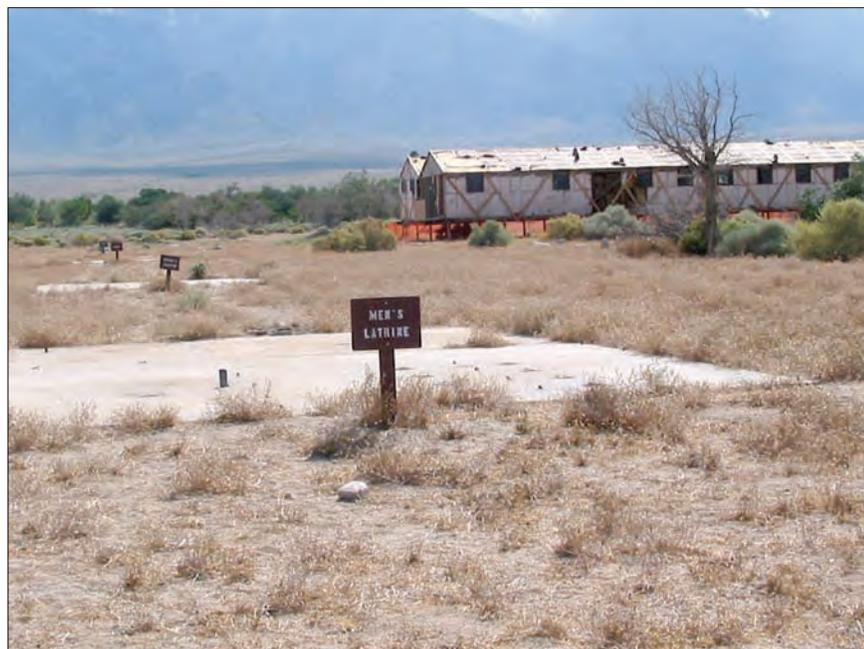
Figure 115. Contemporary signs like these in the administration block use compatible materials to reduce visual impacts to the landscape. (NPS, 2002)

4. Interpretive signs and wayside exhibits should not try to appear to be historic signs but should use contemporary materials compatible with the historic scene. (Figure 115)
5. Reduce the potential adverse effect of placing additional structures in the cultural landscape by limiting the number and siting of new site furniture (such as benches) to areas of concentrated visitor services or interpretive staging areas. If new site furniture is required it should be durable, low maintenance, and compatible with the character of the cultural landscape. Informal use of the site for gathering or picnicking could be accommodated in areas historically used for that purpose, (e.g. North Park, Shepherd Ranch) but should be consistent with recommendations in the GMP and should not require the addition of permanent non-contributing features to the site.

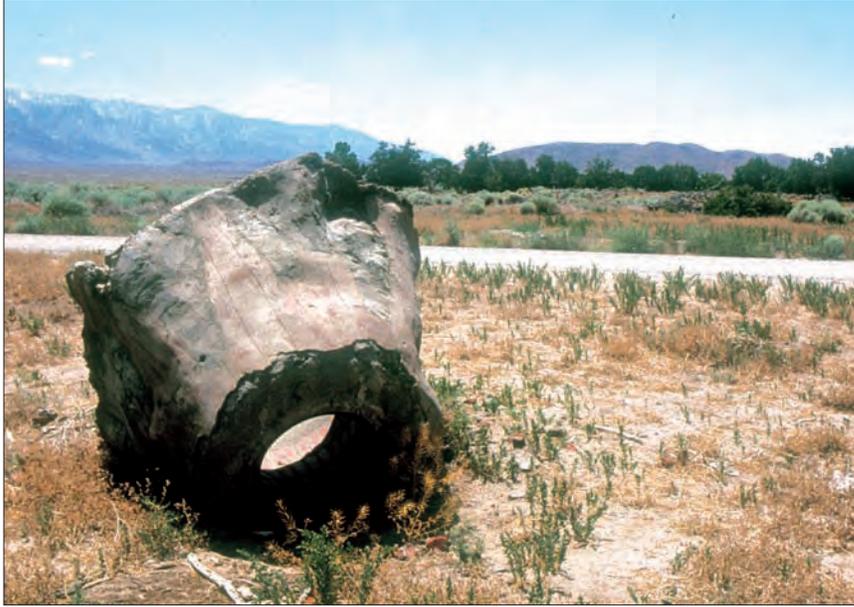
Figure 116. Relocation of displaced features to their historic locations, such as this concrete manhole cover made to look like a tree stump, can increase visitor understanding of the historic character of the site. (NPS, 2002)

6. Cover or cap all open and exposed manholes without contemporary covers to ensure visitor safety, but continue using historic covers in their original locations.
7. Historic utility poles, such as the one south of the administration building, should be retained in place and used as a model for the restoration of any additional utility poles at the Demonstration Block.
8. Replacement of the flagpole in the historic administration area is appropriate if and when additional information can be found to permit the accurate restoration of the feature.
9. Relocate displaced manhole structure to its historic location across the street from the Doctors and Nurses quarters. Bury to historic level leaving the faux-wood grain exposed. Confirm accuracy of the relocation site with an archeologist before moving. (Figure 116)

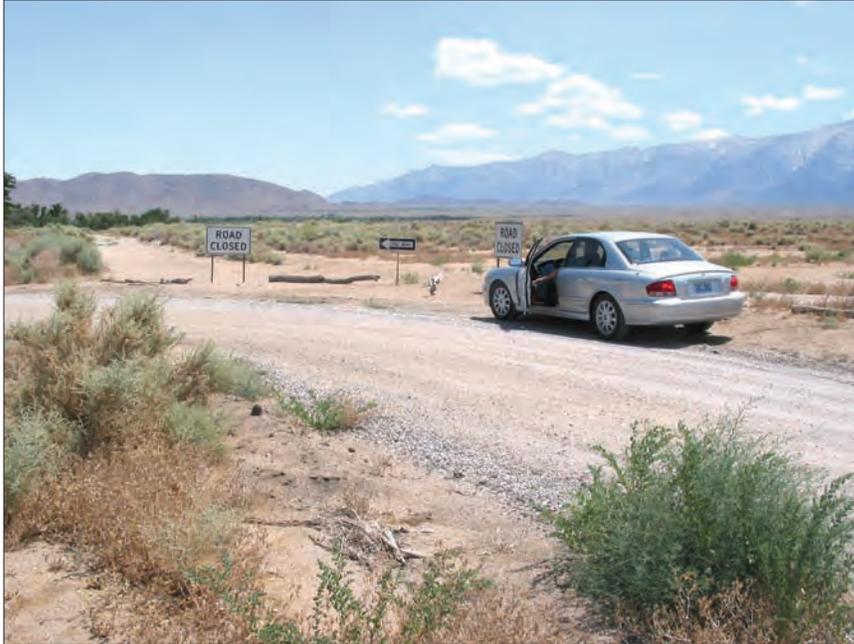
Figure 117. Minimize widening of the roadbeds along the auto tour route to preserve potential archeological resources and retain historic road character. (NPS, 2002)

4. Widening the road bed or enlarging the curve radius along the auto tour route (beyond the historic alignments and widths) is discouraged. Exceptions for widening the road should be based on requirements to meet the minimum turning radius for the maximum sized vehicles called for in the GMP or where FHWA guidelines are required to meet safety standards. (Figure II7)

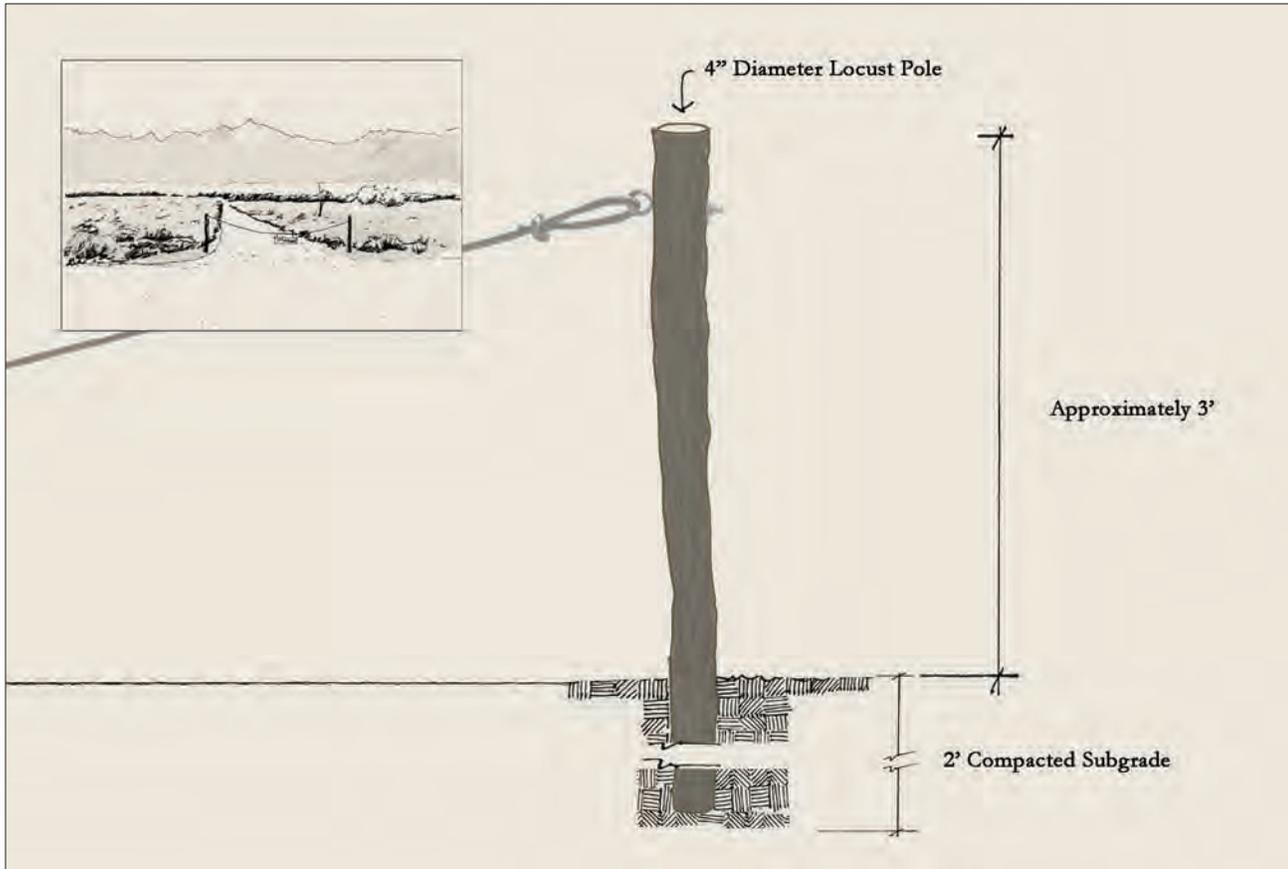
Figure 119. Circulation barriers.
(NPS, 2005)

8. Provide visually compatible road blocks to prevent public vehicular use of historic roads other than the auto tour route and designated parking areas. (Figure 119)

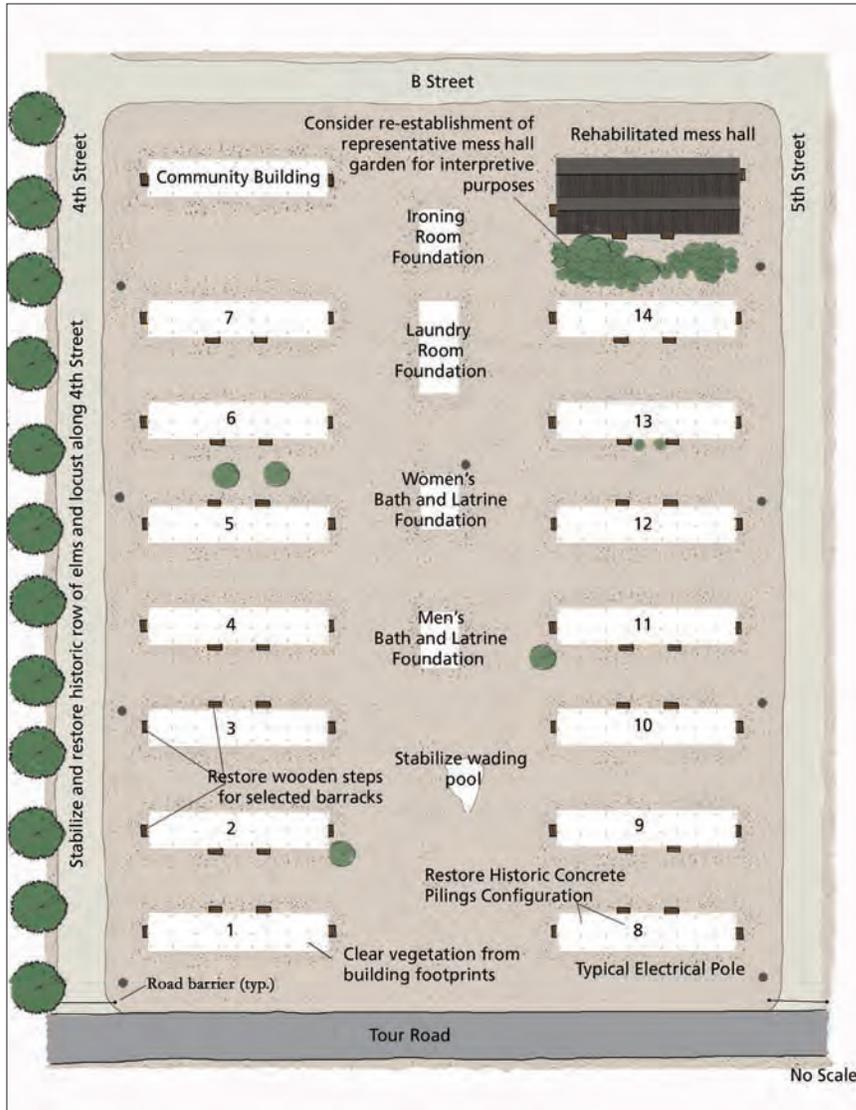
Figure 122. Demonstration block. (NPS, 2005)

It is important to note that the following recommendations, like other treatment concepts are based on current site staffing and funding allocations. In this regard, the design concepts may be considered the first phase of what may become a more extensive approach to development of the demonstration block based on the new Comprehensive Interpretive Plan (CIP). The following design concepts are consistent with the GMP and are compatible with the overall preservation philosophy and character of the cultural landscape. (Figure 122)

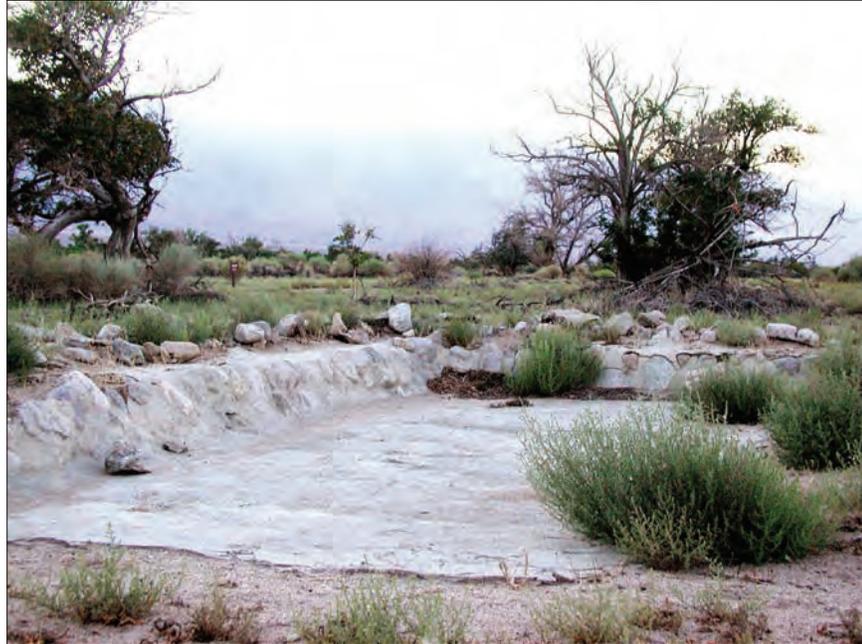
Figure 123. Stabilize and interpret unique historic features like the wading pool in the demonstration block. (NPS, 2002)

1. Stabilize, in consultation with historical archeologist and historical architect as needed, exposed remnant landscape features remaining in Block 14.
2. Restore as feasible, and based on archeological information, landscape elements that remain from the historic period but are ill-defined or obscured by vegetation or soils. These elements include but are not limited to the road system, concrete foundations, the wading pool, building entry features, and internal circulation. (Figure 123)

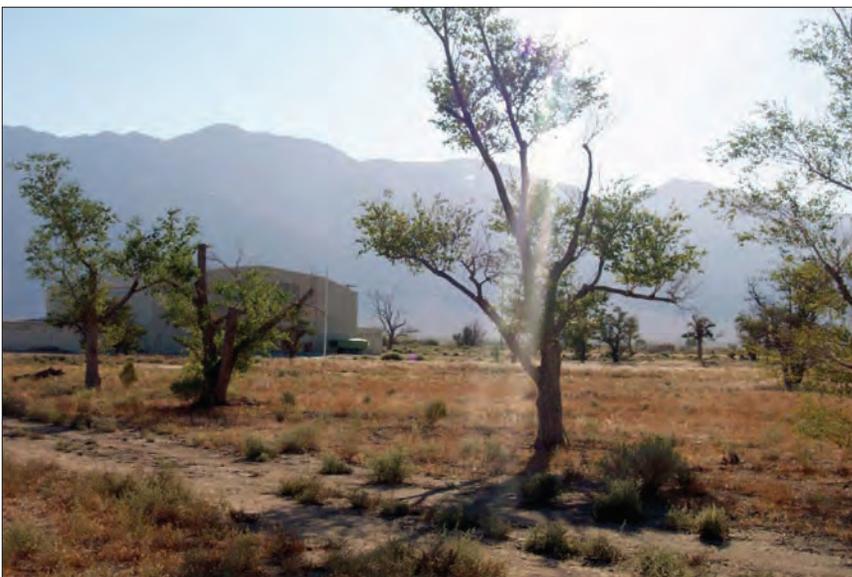
Figure 124. Stabilization and careful pruning of historic trees such as the row along the demonstration block, will promote the trees’ longevity. (NPS, 2002)

of 4th Street between B and C streets. Along with the stabilization of 4th Street, this will help define the edge of the Demonstration Block. This work should be done in connection with the stabilization of the trees around the entire block in the firebreak located in front of the Auditorium building. (Figure 124)

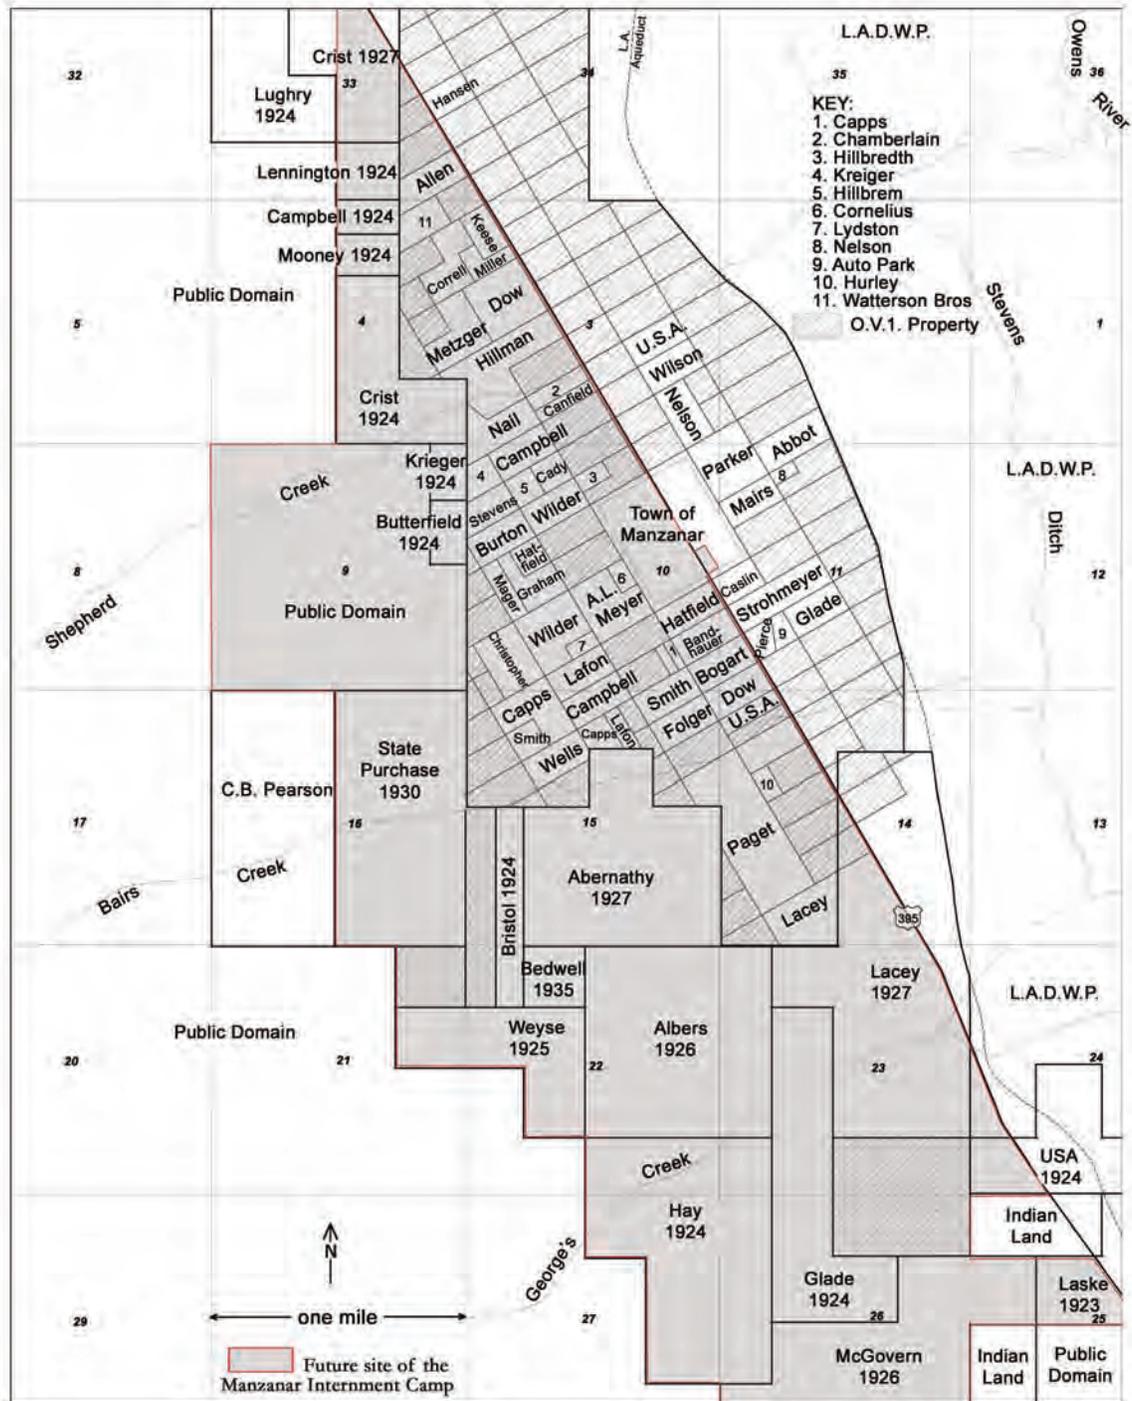
Land Ownership, Town period, 1920s. (Source: Figure 6.20, *Three Farewells to Manzanar*, Volume 1, Page 147)
