Beyond Basic Preservation:

Related Activities

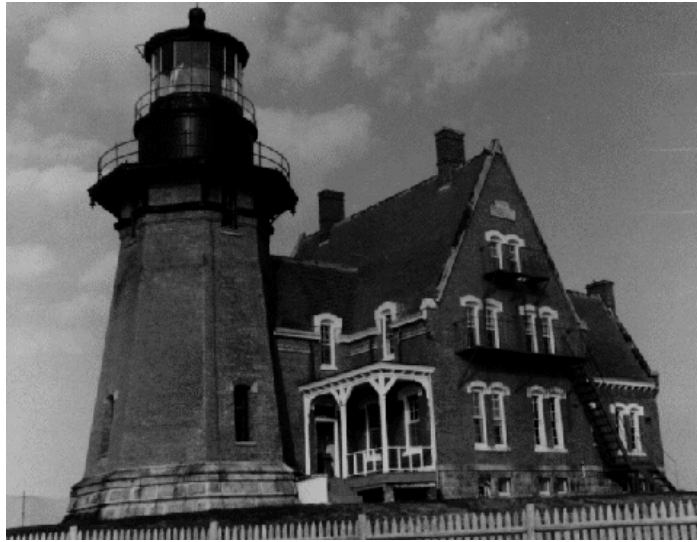
Figure 11. Block Island Southeast Light Station before the move.

the lighthouse to safety, back away from the edge of Mohegan Bluffs. The move was paid for with money raised by local sources and funding from the State of Rhode Island and the Federal Government. ICC's plan called for the entire lighthouse, complete with attached masonry building and upper portion of the original foundation, to be moved intact.

An ingenious and complex system was devised to move the lighthouse over its 360-foot journey. Pete Friesen, a noted consultant in the house-moving field worked with ICC to design the move. In simplified terms, the entire weight of the lighthouse (estimated at a total of 4,000,000 pounds) was to be transferred from its masonry foundation to a grid of

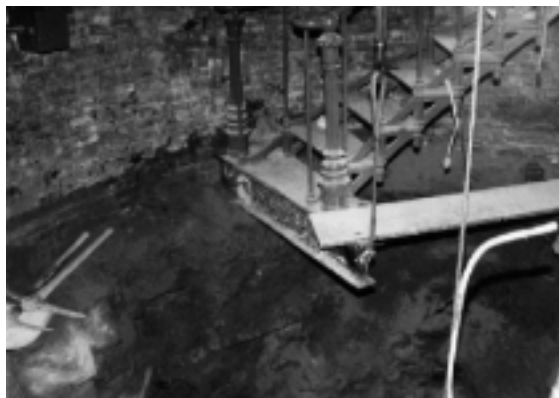
Figure 14. The concrete floor of the light tower was removed and earth excavated by hand in order to perform stabilization from the interior of the structure.

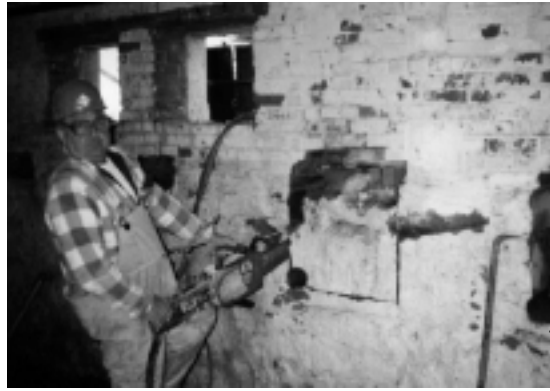
Figure 15. A hydraulic chain saw with industrial diamond teeth is being used to cut openings below the grade line for insertion of the steel beams.

through the original foundation, below grade level; then beams were inserted through the holes, in one side of the building and out the other. Multiple levels of beams were required. The lighthouse rested on an upper level of cross beams that were perpendicularly seated on four duplex main beams, which would house the hydraulic jacks. Thirty-eight hydraulic lifting/levelling jacks (capable of lifting 60 tons each) were installed to lift the lighthouse and to keep it level during the move. Thirty-eight 75-ton Hilman roller dollies were installed under the jacks. Once all the beams were in place, remaining portions of the foundation (the area between holes cut in the foundation) were removed. ICC worked in unison with Expert House Movers, a subcontractor experienced in moving large structures.

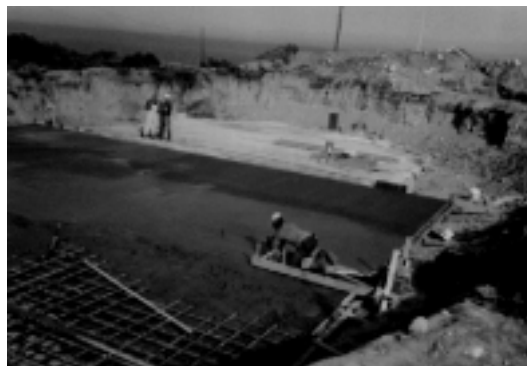
Figure 17. A foundation slab is being poured using 36 tons of rebar and 245 yards of concrete. This 18-inch-thick slab was designed to handle the dynamic load of the building travelling across the slab to its final position.

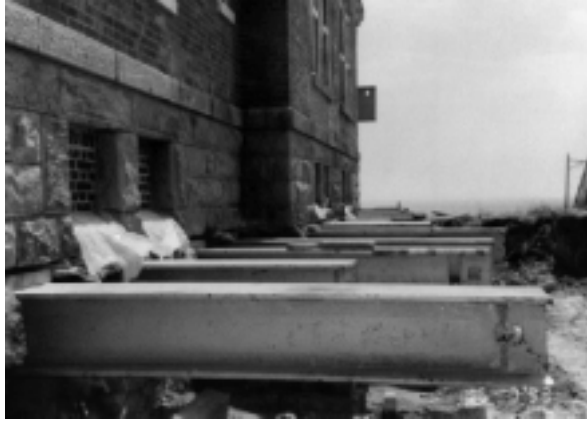
Figure 18. Large cross steel beams are inserted into the cut opening to form part of the grid that will carry the building.

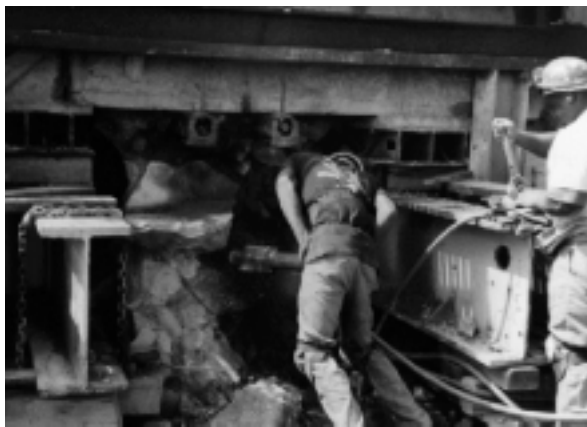
Figure 19. Once the initial lift was performed, the remaining foundation between the beams was removed.

Following the transfer of the lighthouse load from its foundation to the beam grid, all 38 hydraulic lifting jacks were activated in unison and the entire structure was raised vertically approximately 2 feet from its original elevation. The structure was then cribbed on oak timbers, tracks positioned below and parallel to the main beams, and the hydraulics for the jacks rerouted to three separate zones to allow for compensation on uneven surfaces during travel, i.e., no stress would be placed on the structure if a bump or soft spot was encountered, because the structure would roll like a ship rather than bend. By August 11, 1993, preparations were complete. The lighthouse was ready for the move.

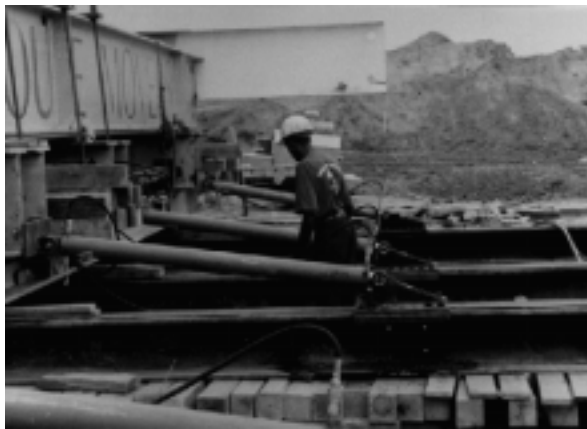
Figure 20. Four hydraulic rams set into the track steel pushed against the main steel to set the lighthouse in motion.

The move was accomplished by pushing the lighthouse along its newly installed track system in 5-foot increments with four hydraulic pushing rams (capable of pushing 30 tons each). After the lighthouse was pushed approximately 5 feet, all four pushing rams had to be retracted for the next 5-foot move. The lighthouse did not travel in a straight line from its original location to its new home. If this were done, loads on the network of beams under the lighthouse would have become too uneven. Instead, the move was accomplished in three separate stages (legs). Time was required between legs of the move for changes in the track system in preparation for the 90-degree change in direction the lighthouse was about to take.

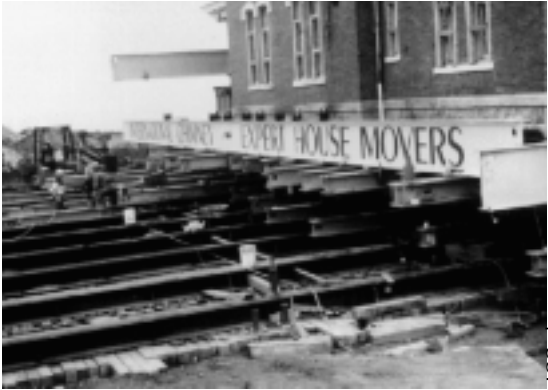
Figure 21. After the first leg of the journey was completed, the track steel was repositioned for a 90° turn.

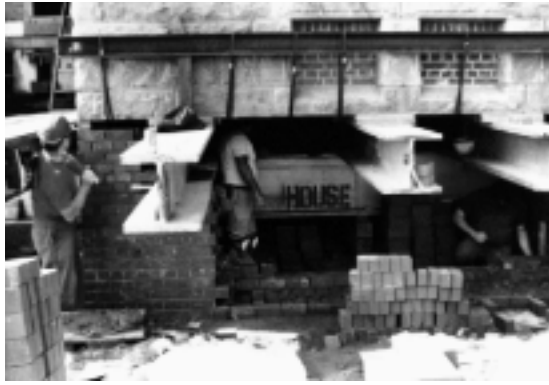
Figure 22. Construction of a new foundation around the support beams.

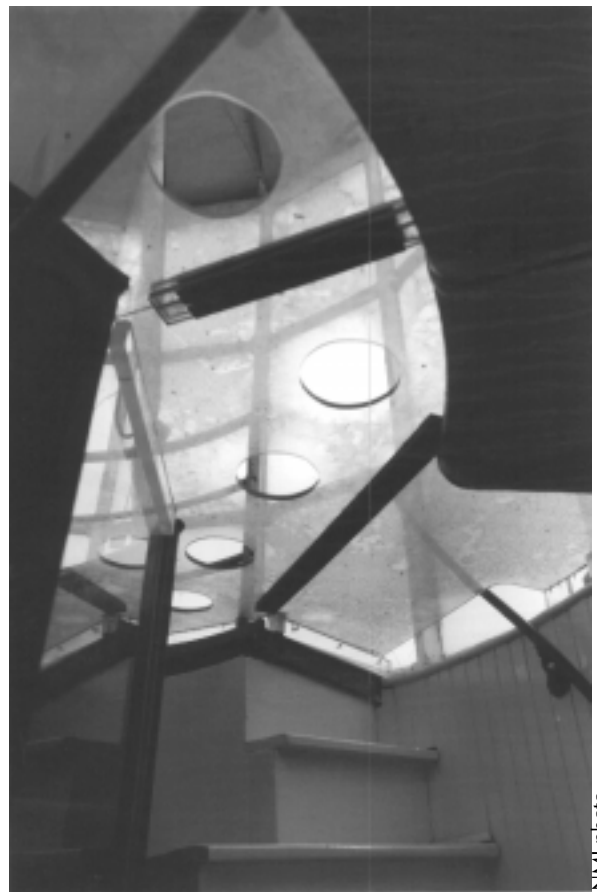
Figure 24. Visitors are prohibited from the Barnegat Lighthouse's lantern room; however, they can view it from the watch room through plexiglas sheets. While these protective sheets prevent access to the lantern room, they do collect dust and need periodic cleaning. In other lighthouses, a person is stationed in the watch room to prohibit access to the lantern room as well as control visitor behavior.

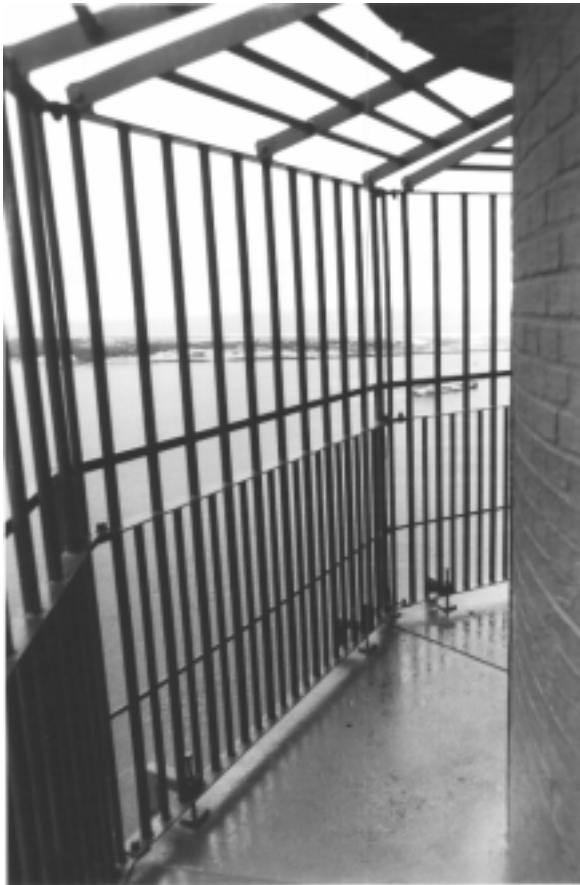
Figure 25. To protect visitors from falling or jumping from a lighthouse tower, a safety railing system or ‘cage’ is often built around the gallery decks. The cage at Barnegat Lighthouse was designed so that it has minimal impact on the historic structure and can be removed with little, if any, damage to the original fabric. Note that the cage is also enclosed to prevent climbing over the top.

method used by many lighthouse groups is to build a metal cage that fits around the gallery deck. The maximum space between pickets should be no more than four inches (BOCA, Building Officials & Code Administrators, International). The pickets need to completely extend to a structural element above or bend back to the tower/lantern wall so no one, even if deliberately climbing, could get over the top. One lighthouse suicide in 1995 was accomplished by climbing between overhead cage pickets with 9-inch spacing. Cages can be designed so they are attached reversibly to light towers without doing any permanent damage to the historic fabric of the structure.

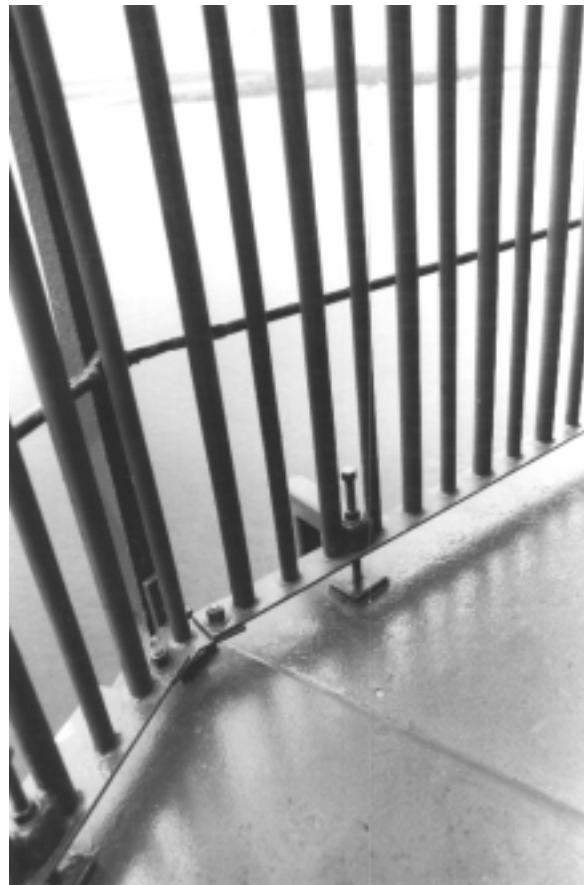
Figure 26. Note how the cage is clamped to the gallery deck, minimizing any impact on the structure's original fabric.
