# **New Fort Snelling Visitor Center: Response to Questions Raised during the Section 106 Consultation Process**

**Prepared by the  
Minnesota Historical Society**

**November 9, 2007**

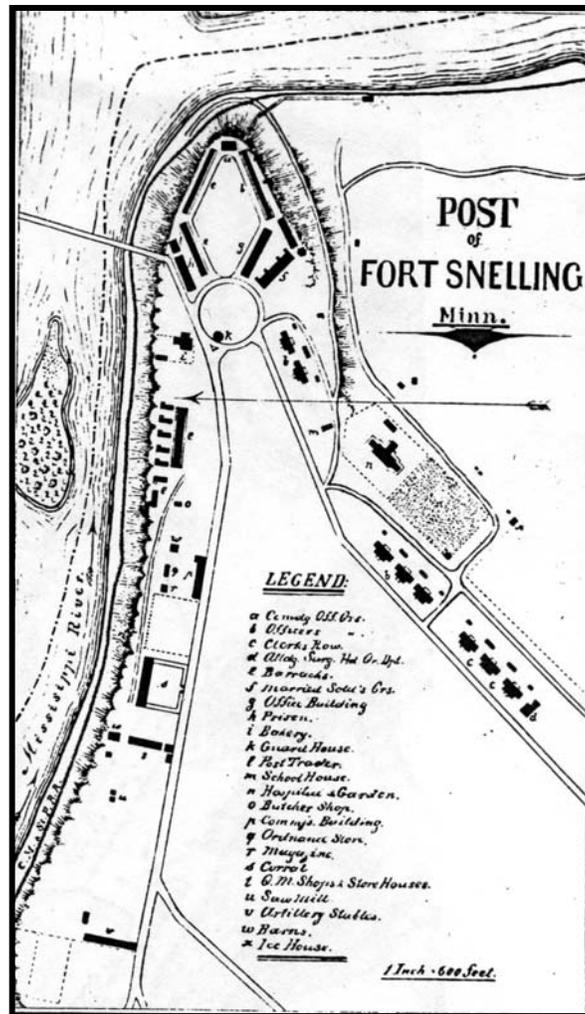
**Figure 1. Post at Fort Snelling, 1885, prepared by office of John Biddle, Engineer Corps, Chief Engineer Officer of the Department of Dakota.**

stood was the “prison for military convicts: one story stone, 129-3/4 x 33 feet” (h), with the bakery, 38 feet by 28 feet (i), aligned at its northeast end. Almost directly north of the Round Tower was the post trader, who apparently had a fenced yard surrounding a house of irregular plan and, at the back corner of the parcel, a stable or storehouse.

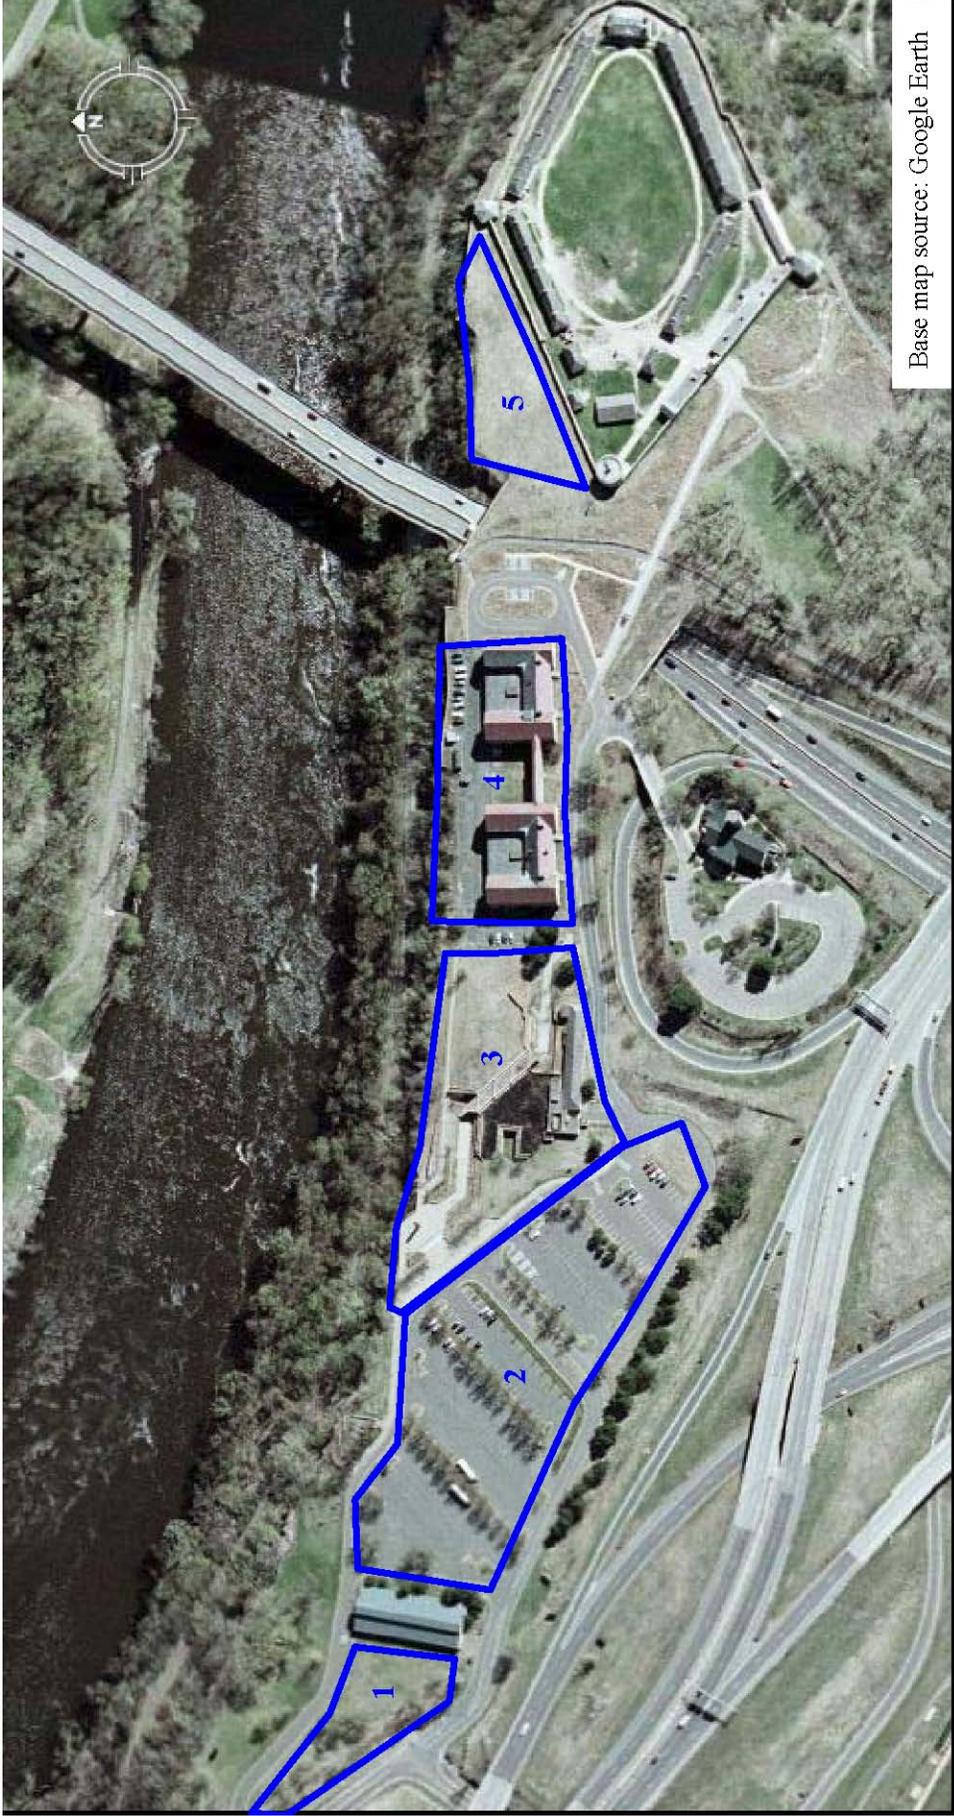
**Figure 2. Areas for Archaeological Investigation at Historic Fort Snelling.**

This portion of the property has been identified as having archaeological potential specifically related to the presence of a blacksmith shop here from 1904 to 1914. The location of this building is documented in several maps dating between 1904 and 1912, and by Quartermaster's records. Archaeological survey of this portion of the property is currently underway. The survey will consist of shovel tests at a 15-meter interval coupled with metal detector examination. If structural remnants or *in situ* artifact deposits are found in shovel tests, limited formal excavation will be conducted to better delineate the nature of the features or deposits. If any identified features can be clearly linked to the 1904 blacksmith shop, they will be recommended to be considered contributing elements to the Fort Snelling National Register District.

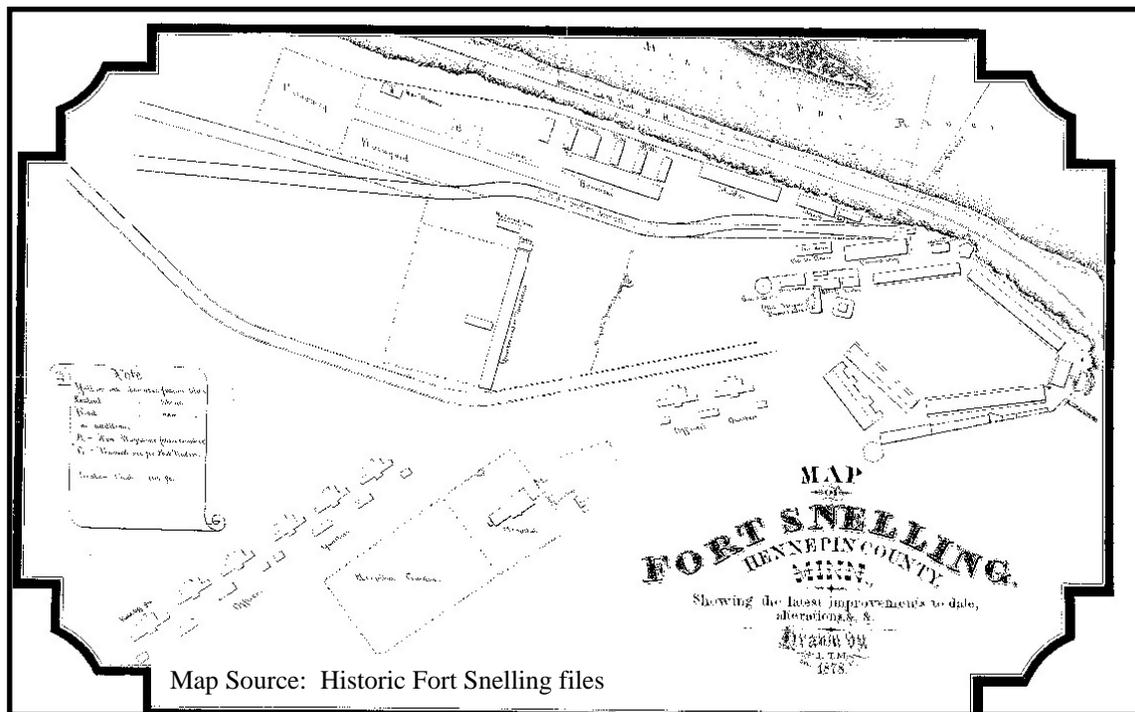
**Figure 3. 1878 Map of Fort Snelling, showing location of old post cemetery**

Many historic maps of Fort Snelling clearly delineate the location of the post cemetery. Two examples are shown in Figures 3 and 4. Additional documentation on the location of the 1800s post cemetery is found in a photograph dated 1905 (see Figure 5). This photo is described in the Society's Visual Resources Database as "looking east" at the old post cemetery. It depicts headstones in the cemetery, boundary fences on the east and north, and what is clearly the west side of Building 18 in the background. The building just beyond the fence is Building 9-K, a 12-foot by 18-foot stone magazine built in 1891 (shown as a small black rectangle in Figure 4). A portion of Building 22 - the ell at the east end of the building - is visible in the background on the far right of the photo. The location depicted in this photo for the post cemetery corresponds exactly with how its location is shown on numerous maps dating from the 1860s to 1904.

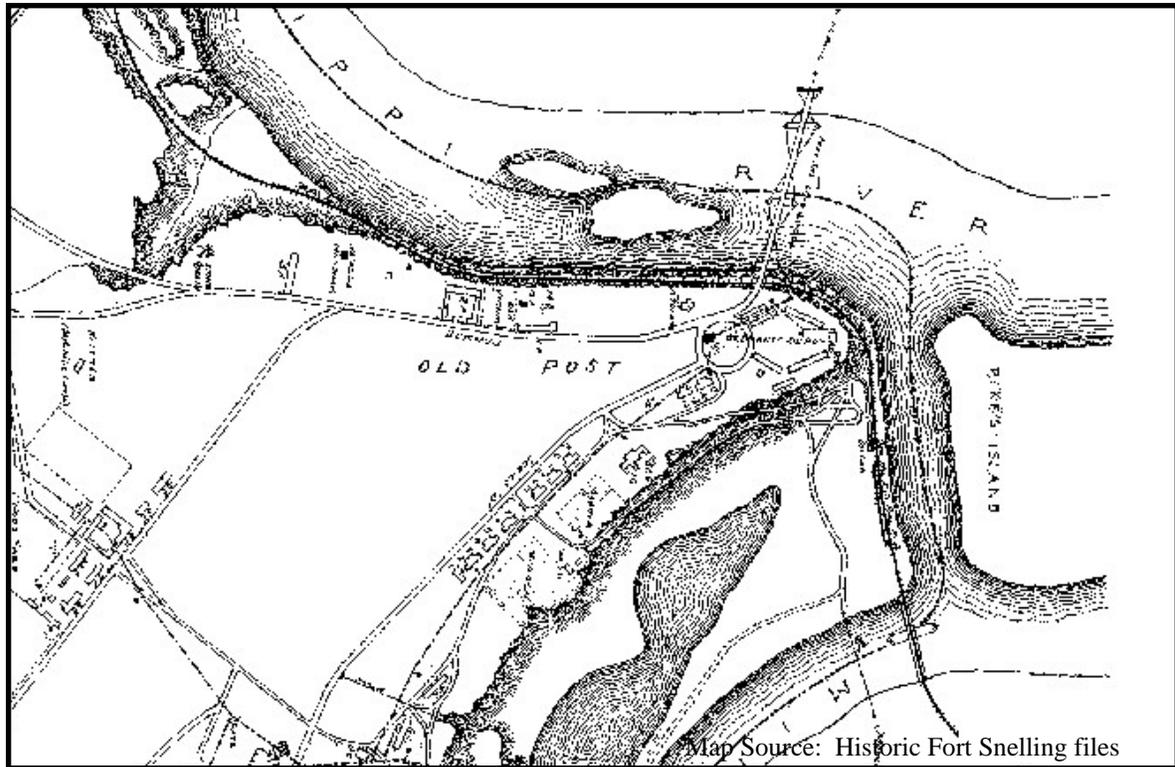
**Figure 4. 1895 Map of Fort Snelling, showing location of old post cemetery.**

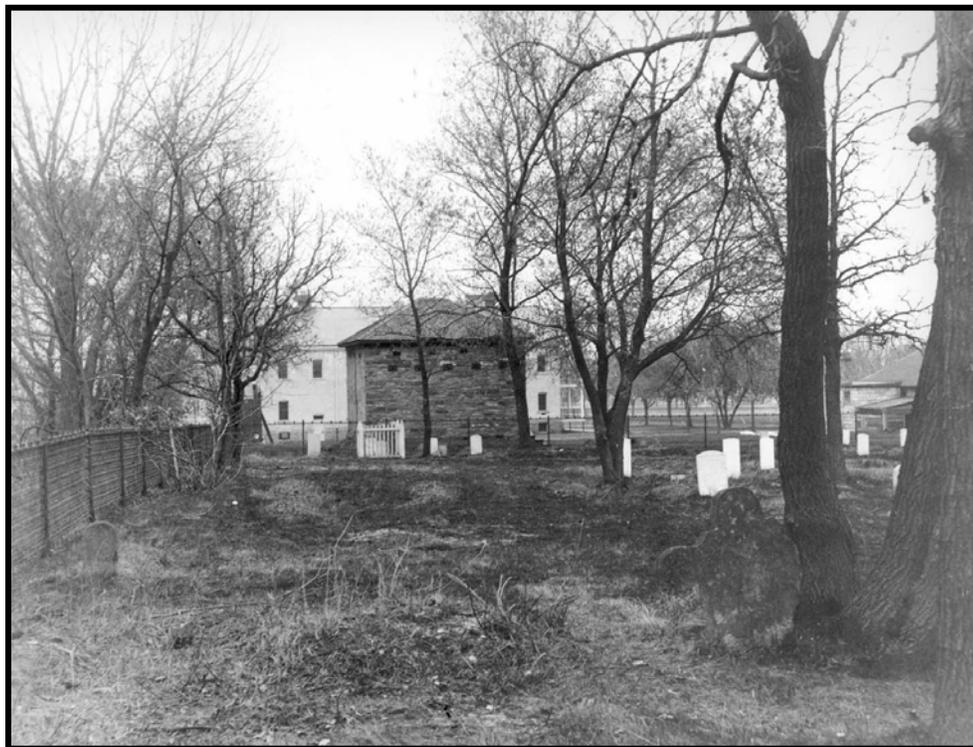
**Figure 5. 1905 photograph showing Fort Snelling cemetery (note Building 9-K in center background, north corner of Building 22 in far right background and Building 18 in far center background).**

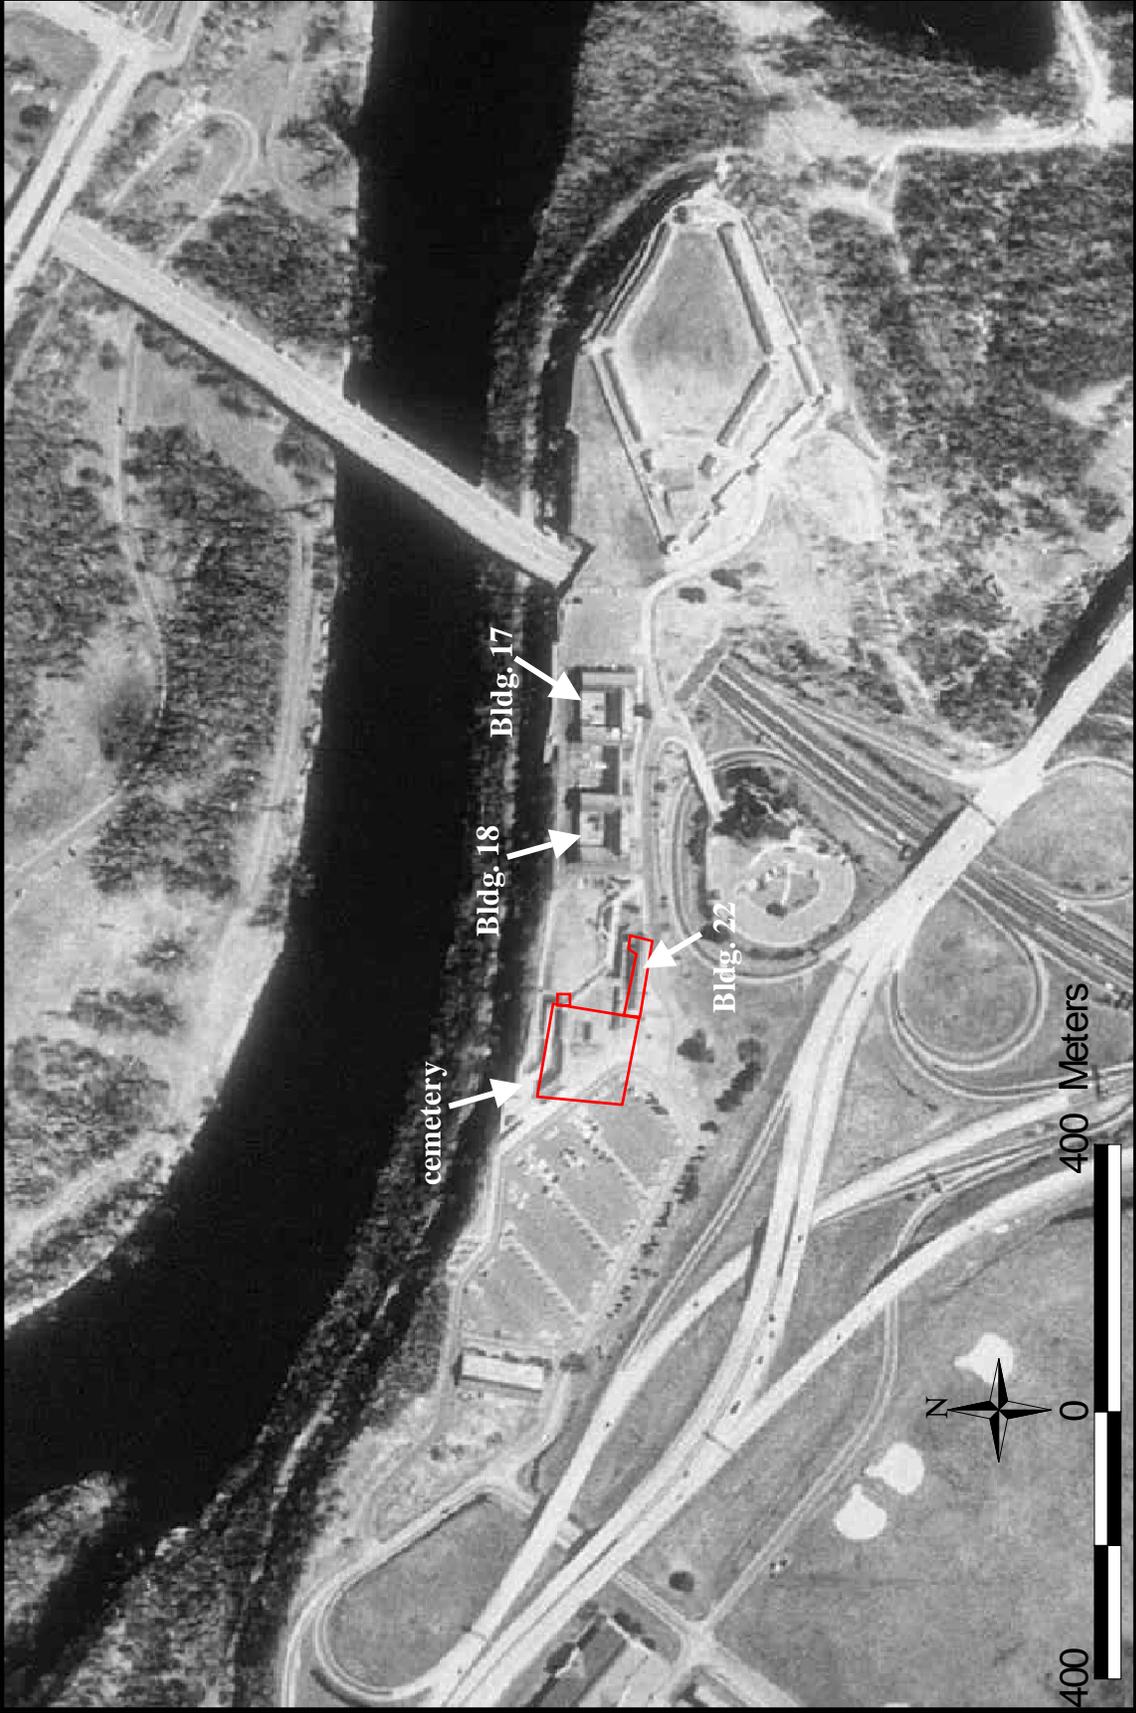
Base map: St. Paul West Digital Orthophoto Quadrangle, 1991.

**Figure 6. Location of Historic Post Cemetery Relative to Modern Landscape Features**

Figure 6 shows the location of the old post cemetery, taken from a 1904 map, as it appears overlain on a contemporary aerial photograph of Fort Snelling. Note that the location conforms to that shown in Figures 3, 4 and 5 – immediately to the west of Buildings 9-K and 22. Thus, we can see that the cemetery location encompasses terrain that today is occupied by the existing visitor center, the existing parking lot, and a small area of grassed lawn that lies just west of Building 22 and just south of the visitor center.

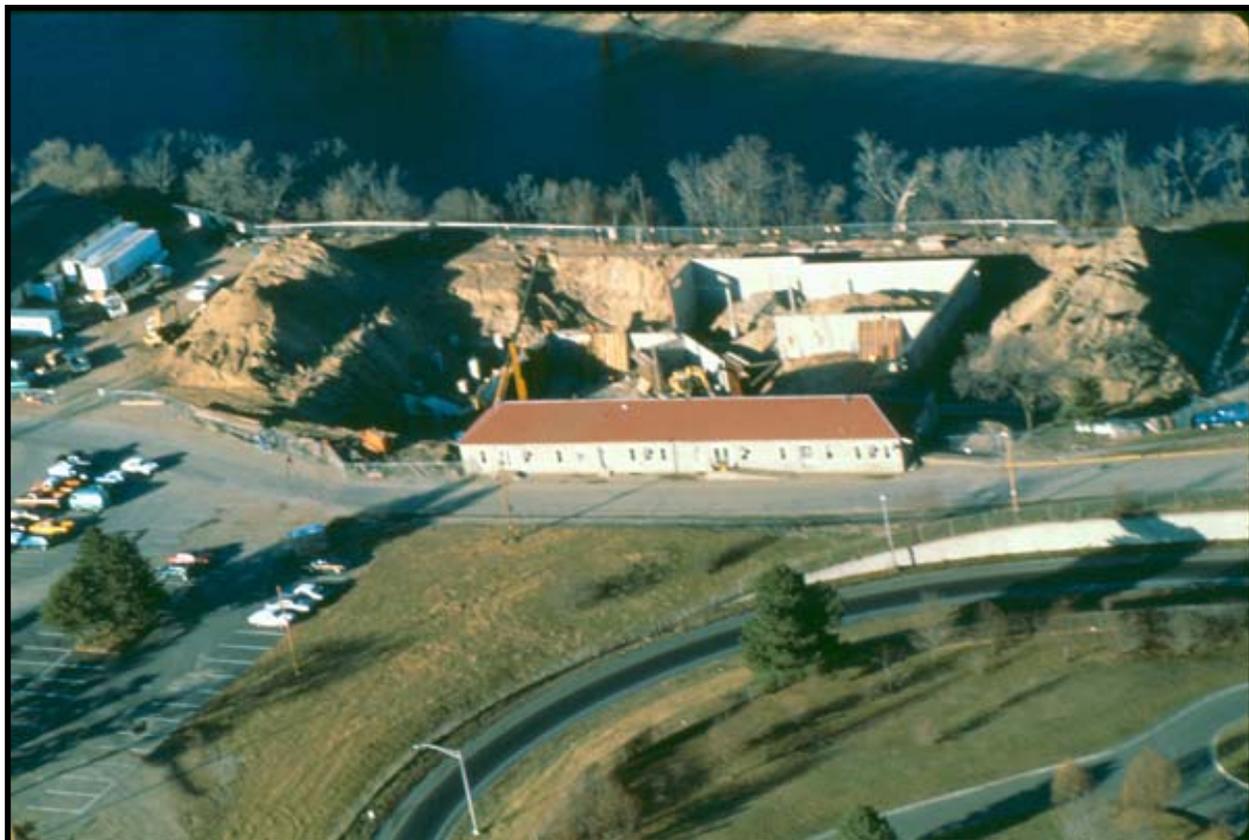
**Figure 7. Current Fort Snelling Visitor Center under construction in 1980.**

Figure 7 is an aerial photograph, taken in 1980, of the existing visitor center under construction. Building 22 is in the foreground, with Building 25 to the left. Note the extent of excavation to the west and riverward of Building 22. Any graves that remained in this portion the old post cemetery certainly would have been obliterated by the 1980 construction.

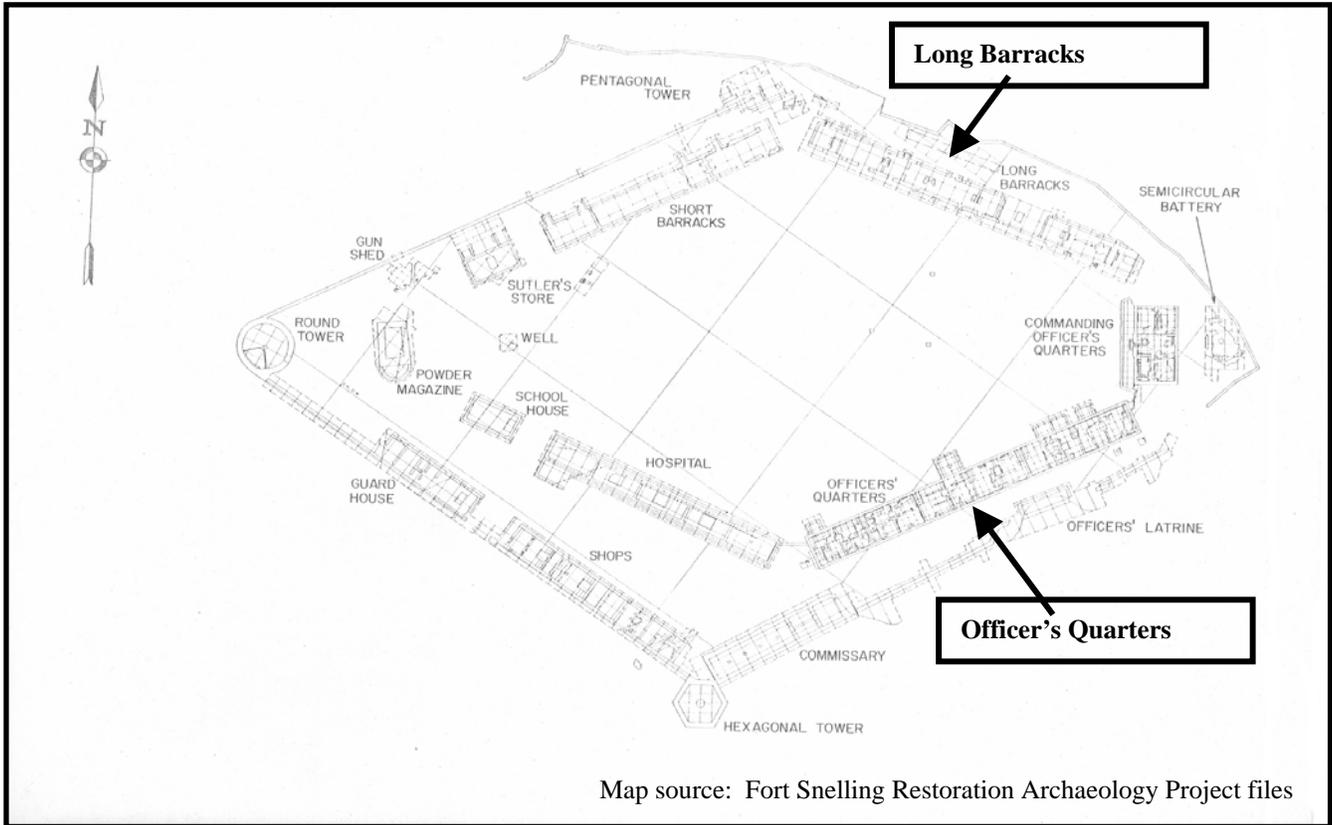
**Figure 8. Locations of Long Barracks and Officers Quarters within reconstructed Fort Snelling**

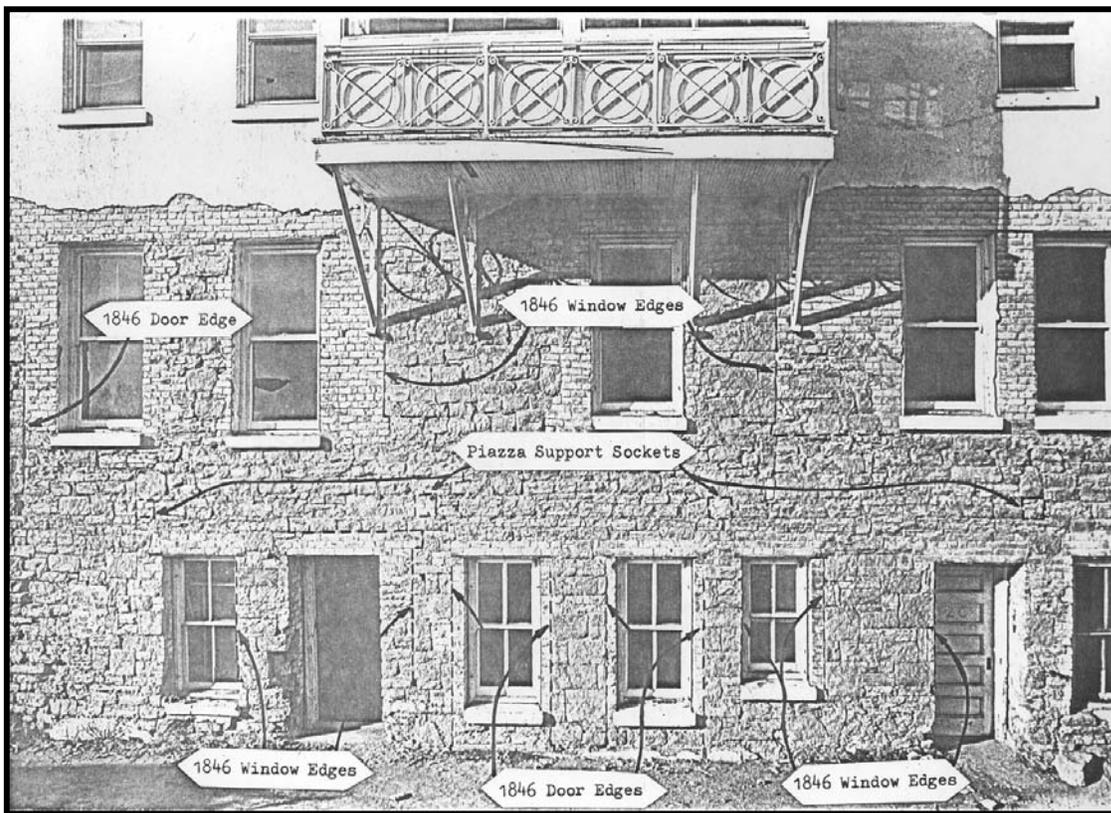
**Figure 9. Illustration from Clouse (n.d.) showing west wall of Officers Quarters in 1973.**

In essence, the excavations revealed that some features dating to the 1820s were still extant: remnants of the original north foundation wall and original interior partition walls were discovered under several layers of fill in the basement of the building, as were excavated trenches that apparently had held sleepers for the basement floor. It also appeared that a portion of the 1820s west exterior wall had been retained and kept in its original location during the 1845 remodeling of the building.

Obviously, with the change in internal configuration from fourteen apartments in 1824 to twelve in 1845, all original (1820s) interior walls must have been moved, but it is presumed that a good deal of the stone from those walls was used to create the “new” interior partitions. During the 1976 excavation, the major interior partitions built in 1845, those which separate the paired sets of apartments, were found to be still extant in every case. These are major support walls that continued unbroken from the basement floor to the top of the Parade Ground level floor. Some showed evidence of modification (abandoned door locations filled up with brick, for instance), but were considered by the excavators to be substantially as they had been built.
