National Park Service
Cultural Landscapes Inventory
2009

DC War Memorial
National Mall & Memorial Parks - West Potomac Park

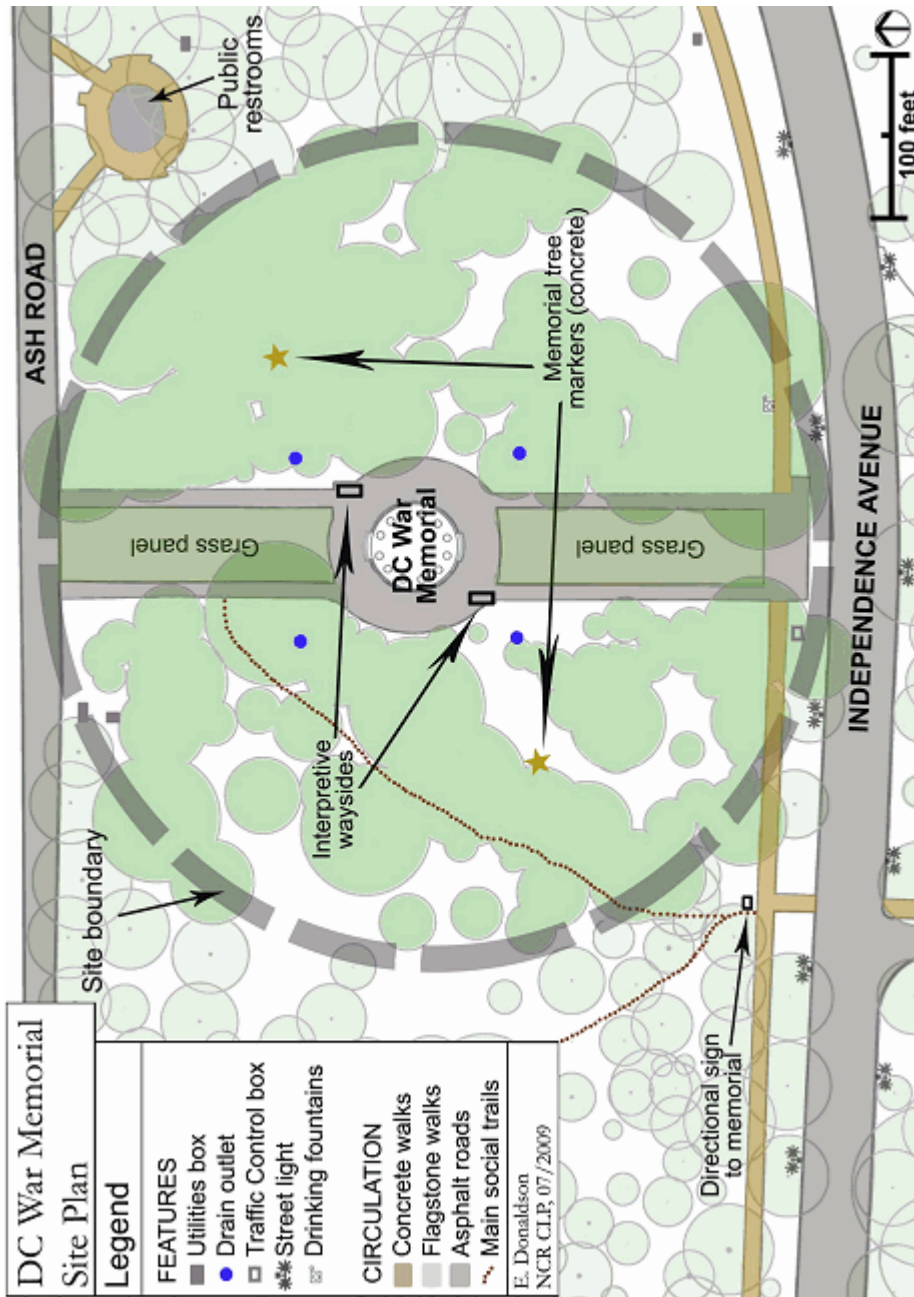
Figure 1. Site Plan of the District of Columbia War Memorial, illustrating the current layout of the cultural landscape (NCR GIS, 2009).

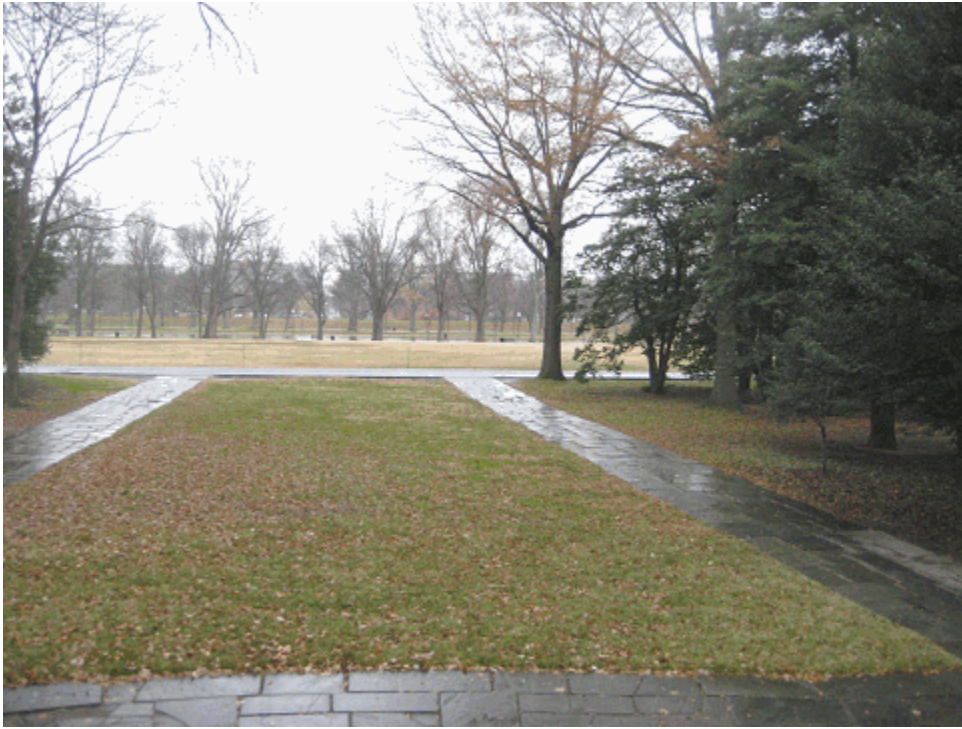
Figure 3. Looking north from the DC War Memorial, at the northerly grass panel, Ash Road and the Lincoln Memorial Reflecting Pool beyond (NCR CLP 2009).

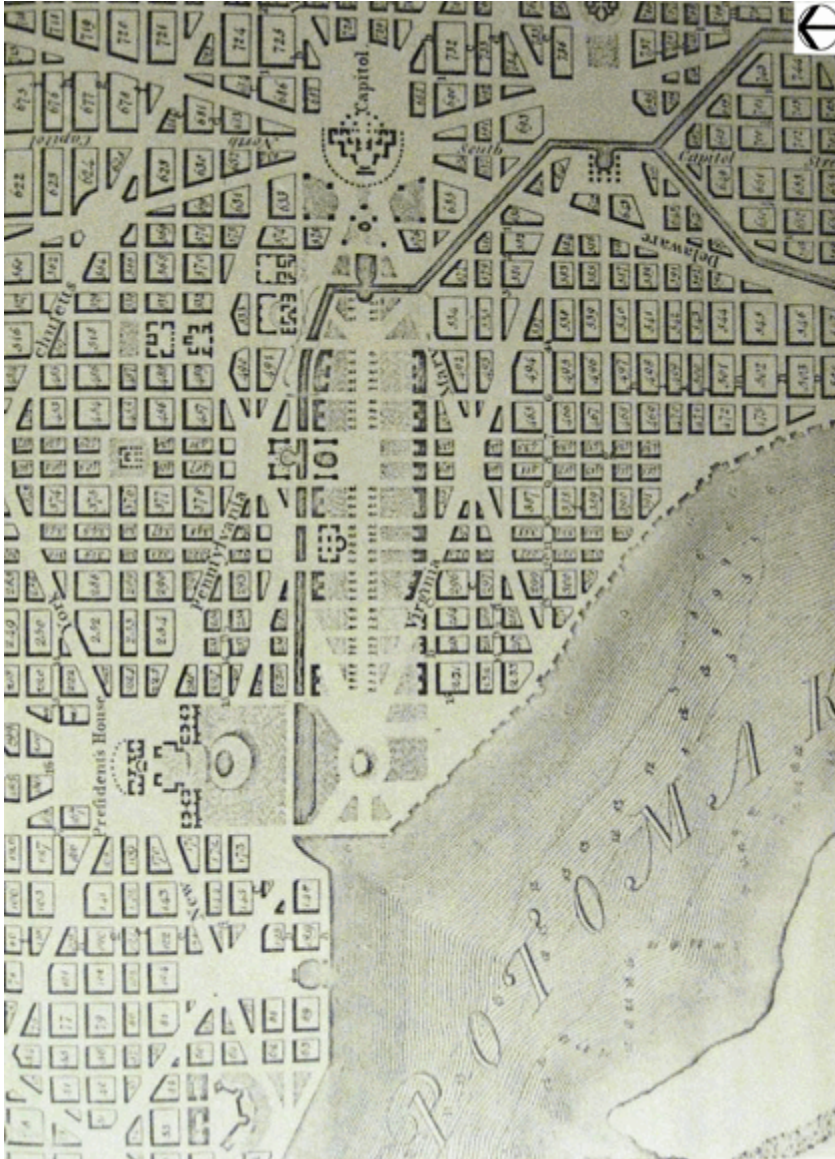
Figure 4. Pierre Charles L'Enfant's 1791 plan of Washington, DC, as revised by Major Andrew Ellicott in 1792 (Olszewski 1970: Plate II).

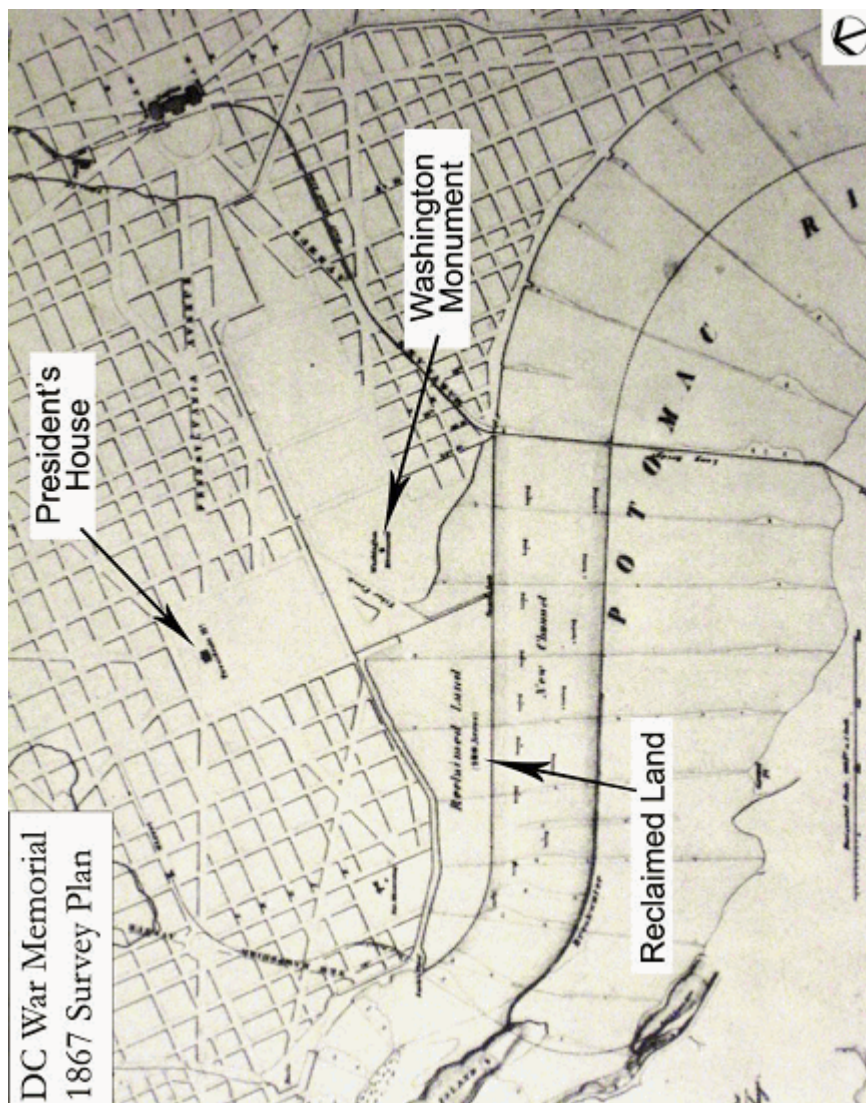
Figure 6. An annotated survey plan drawn up in 1867 for the reclamation of the Potomac Flats (Olszewski 1970: Plate VI).

The growing city quickly came to respect the volatility of the Potomac River along its edge, whose sharp turn and abrupt widening just below Easby's Point at the foot of New Hampshire Avenue caused a seemingly endless string of problems. Due to these factors, large volumes of silt were constantly deposited by the river across the flats west of the Capitol, and especially during floods this process posed a threat to the new metropolis (see Figure 5b). Despite extensive and ongoing attempts to dredge this area and maintain channels and canals, navigation along the river dwindled, even as the city's population burgeoned after the Civil War (KressCox and Associates 1986: 4). These issues prompted some of the early plans to control silt along the water course, and ultimately transform this problematic portion of the river into new land (Figure 6).

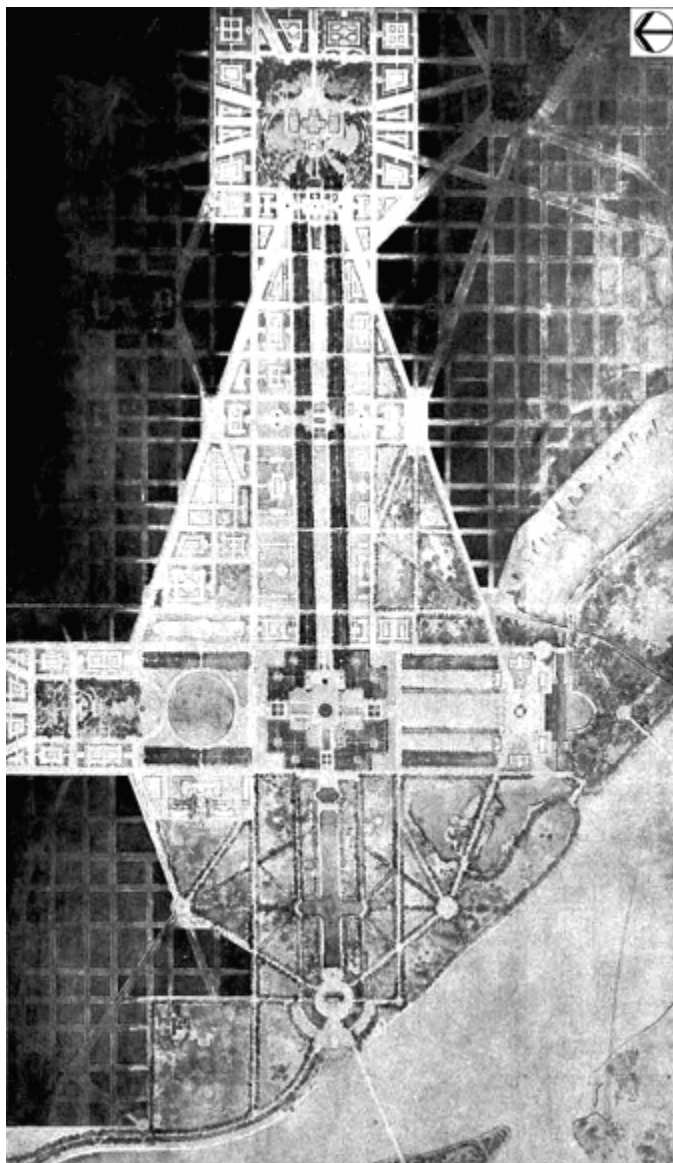
Figure 7. The McMillan Commission Plan of 1901, showing the planned reflecting pools and network of drives in West Potomac Park (Moore 1902: 54).

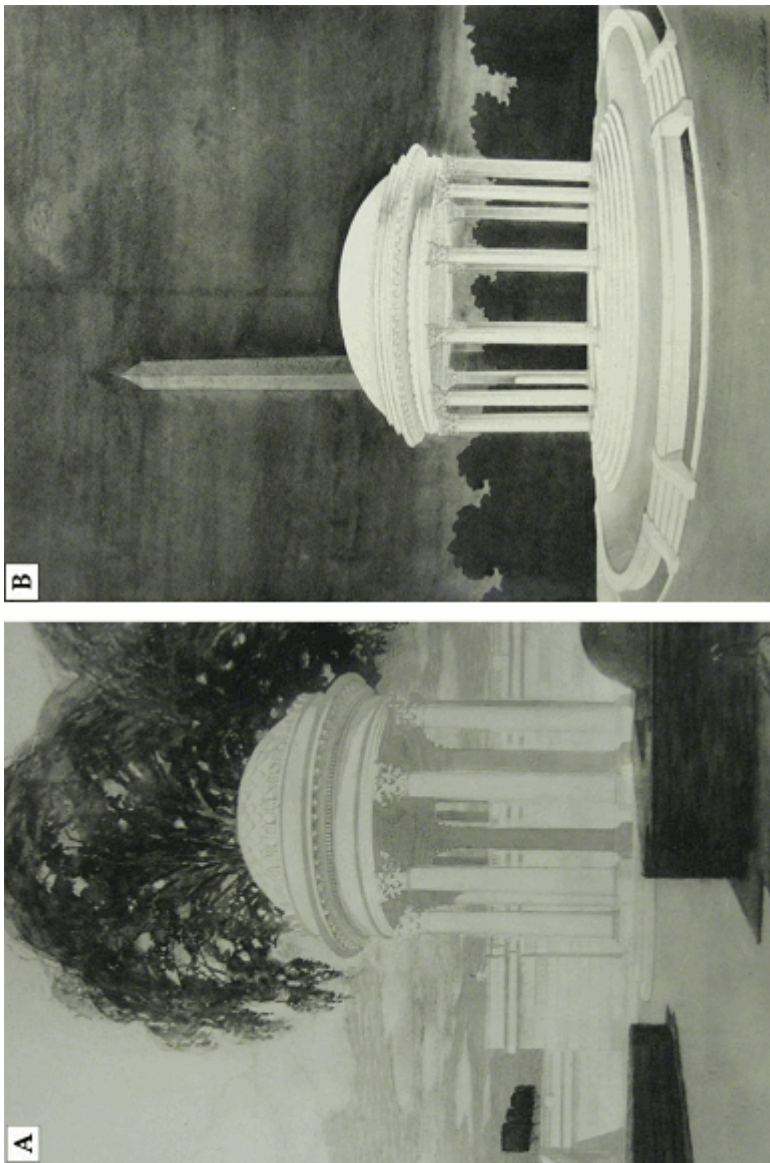
Figure 9. (a) Tempietto designed for the Washington Monument grounds, 1901; (b) Brooke's October 17, 1919 DC War Memorial plan, showing the original concepts behind its design, including the surrounding trees (Commission of Fine Arts, Washington, DC).

Brooke had studied architecture at Yale University, the University of Pennsylvania, and the Ecole des Beaux-Arts in Paris before coming to Washington, and thus came to the project with a solid foundation in classical styles. His design concept featured a circular, open-air temple of white marble with Corinthian columns, a stepped base, and a domed roof, standing in a geometric, carefully designed landscape. Indeed, his original idea for the memorial drew a strong parallel to the tempietto design that was considered for inclusion in the Washington Monument grounds less than two decades before (Figure 9a; Commission of Fine Arts files). In contrast, however, the band stand was conceived with the goal of accommodating the 80-member U.S. Marine Band. Although his earliest designs were smaller, Brooke’s eventual memorial building measured 40 feet in diameter (Waite et al. 2006: 6, 7, 10; Washington Post, May 26, 2002) (Figure 9b).

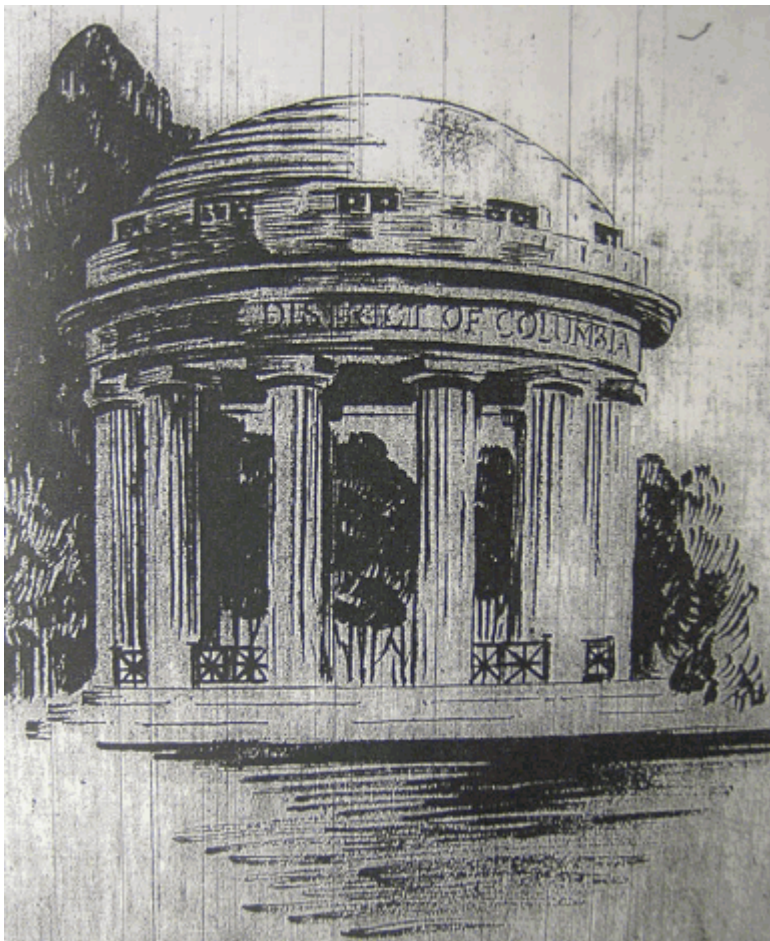
Figure 10. A drawing of the planned DC War Memorial in 1927 illustrates one of the final stages of its design, as part of the project's fundraising campaign (Evening Star, May 1, 1927). Once again, note the vegetation in the background.

The role of vegetation in the planning of the DC War Memorial was particularly important to its development, as even the early building sketches illustrate (see Figures 9 and 10). Indeed, the Commission of Fine Arts ultimately determined that the building's location in a grove of trees exempted it from any geometrical alignment with other constructed features of West Potomac Park, as suggested by the 1901 McMillan Plan. Thus, it was deemed unnecessary to balance the monument's presence on the south side of the basin with another structure on the north side. During the summer of 1928, the commission even went so far as to erect a life-size outline of the memorial at its proposed location in West Potomac Park, to insure that the site and stature of the new building would blend well with the surrounding landscape (Waite et al. 2006: 10). The site was laid out over roughly two acres, assuming an approximate oval shape that flared out from the central north-south axis formed by the two grass panels and parallel flagstone walks.

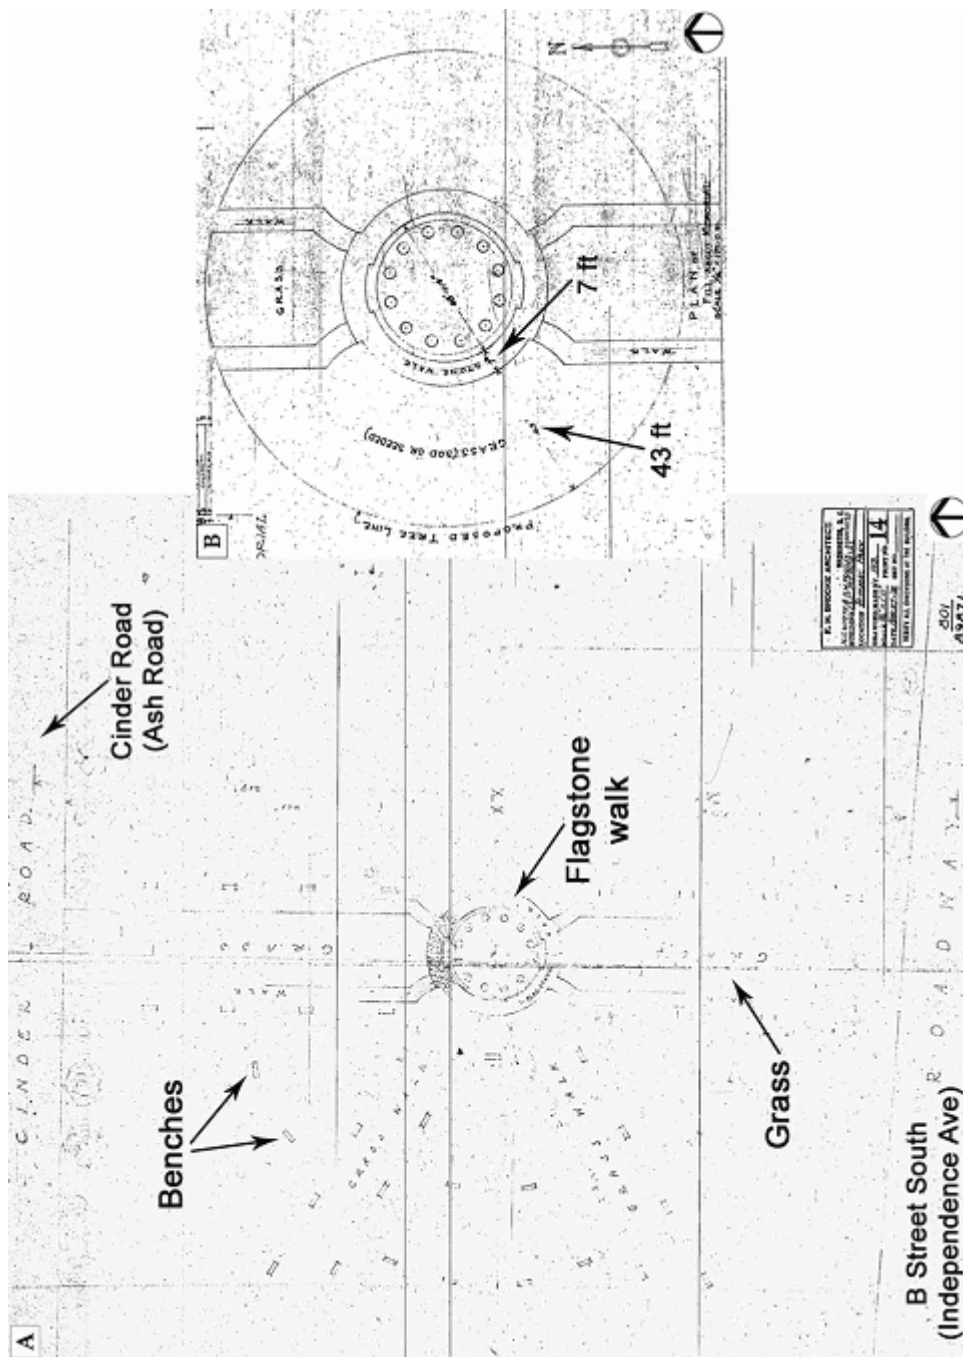
Figure 11. Two annotated 1931 drawings illustrate the original design for the DC War Memorial landscape (DSC TIC 801/89871, A, annotated; and 801/89873, B).

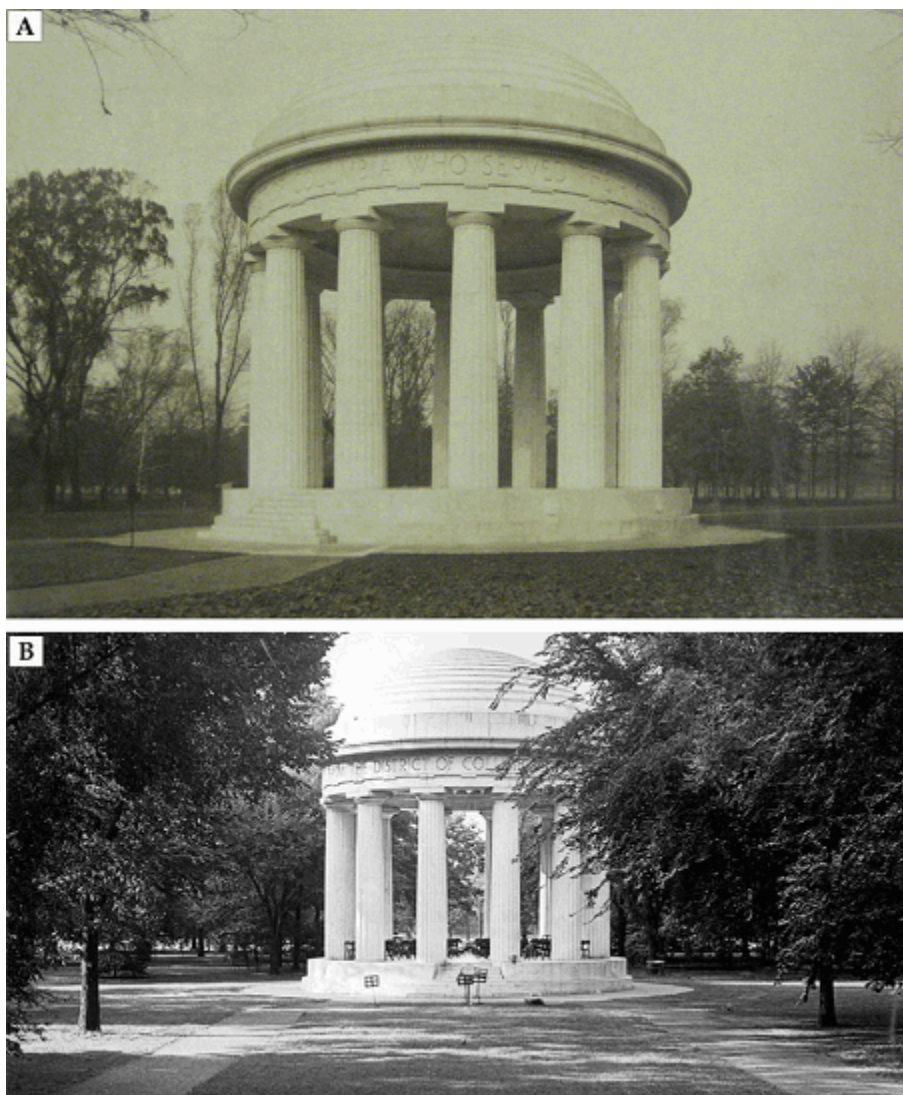
Figure 12. (a) The DC War Memorial soon after its completion, circa 1931 (Commission of Fine Arts, Washington, DC); (b) Looking south in 1939 (NCR MRCE 19.4-81). Note the lack of vegetation around the building and the gravel paths.

project took place (Evening Star, November 5, 1939). As a result, throughout the 1930s the area around the memorial retained an open aspect with only minimal understory, as is evident in historic photographs and several 1939 maps showing the existing vegetation at the time (see Figures 12, 13 and 15).

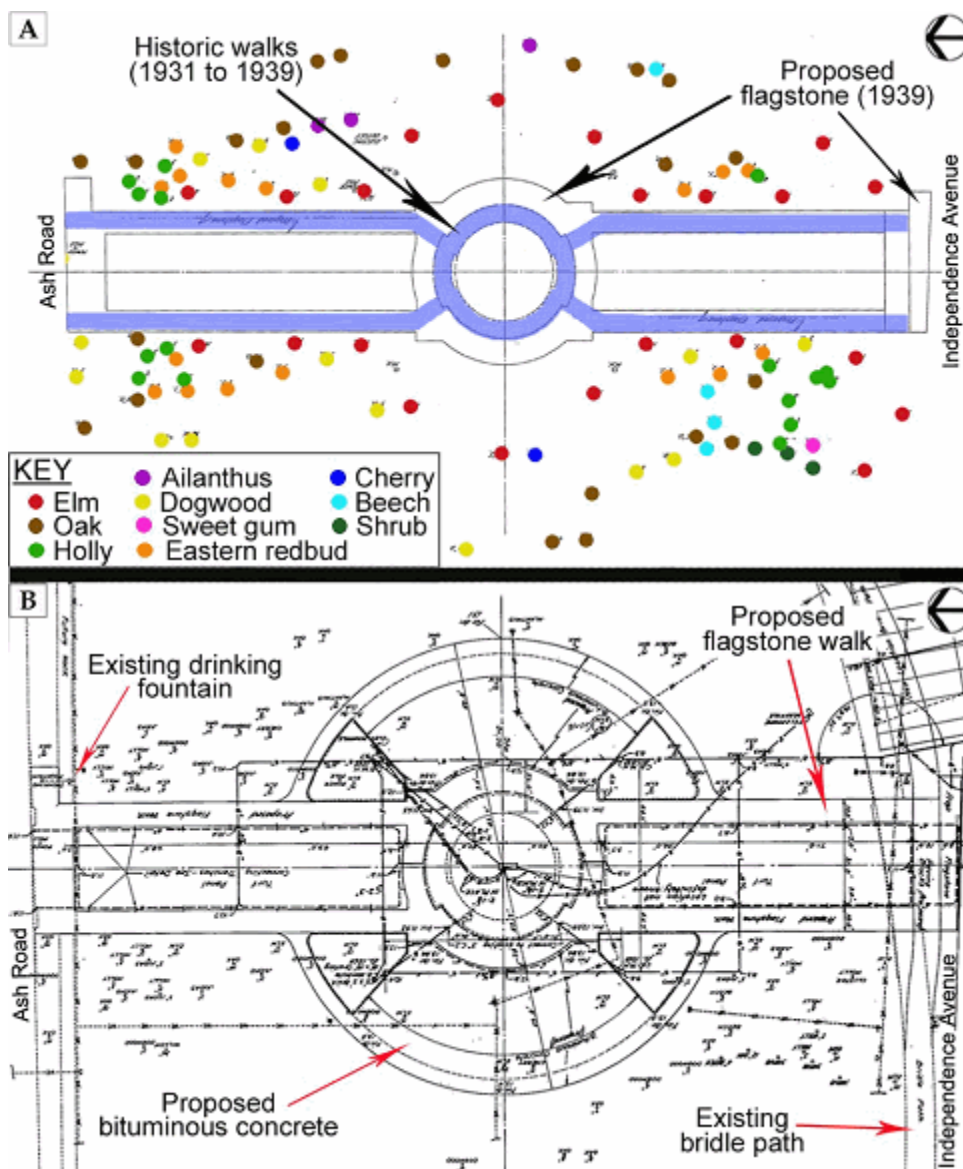
Figure 15. Two annotated 1939 plans show the vegetation present in the memorial landscape before rehabilitation of the site that year, illustrating the relatively sparse character that it had throughout the 1930s (DSC TIC 801/89888, A, and 801/89876, B).

At the DC War Memorial, the park management made additional plantings around the building including holly (*Ilex* sp.) and dogwood (*Cornus* sp.) trees (Washington Herald, December 29, 1933; Figures 14 and 15). Judging from plans of the site that illustrate the existing conditions of the landscape in 1939, these trees do not appear to have been planted along the immediate border of the memorial and parallel walks, but rather in locations slightly removed from these features (DSC TIC 801/89888 and 801/89889). This left the majestic hardwoods to act as the primary frame for the central north-south corridor and circular grassy area around the memorial itself. A number of Judas, or eastern redbud, trees were also likely planted at this time and situated in a similar manner to the dogwood and holly trees (DSC TIC 801/89888 and 801/89889).

throughout, a continuous network of walks was thus created around the monument. The new flagstone walks were “constructed with grass seams to lend a dignified and natural appearance to the memorial site,” a feature that can still be seen in some parts of the site today (Evening Star, November 5, 1939). The plans for this paving depict a cinder base topped with sand and capped with flagstones (DSC TIC 801/89876). The lights on the memorial were also likely replaced at this time, judging from the electric layout plans (Waite et al. 2006: 25, 27-8, 30; Evening Star, May 30, 1937; see Figure 15b).

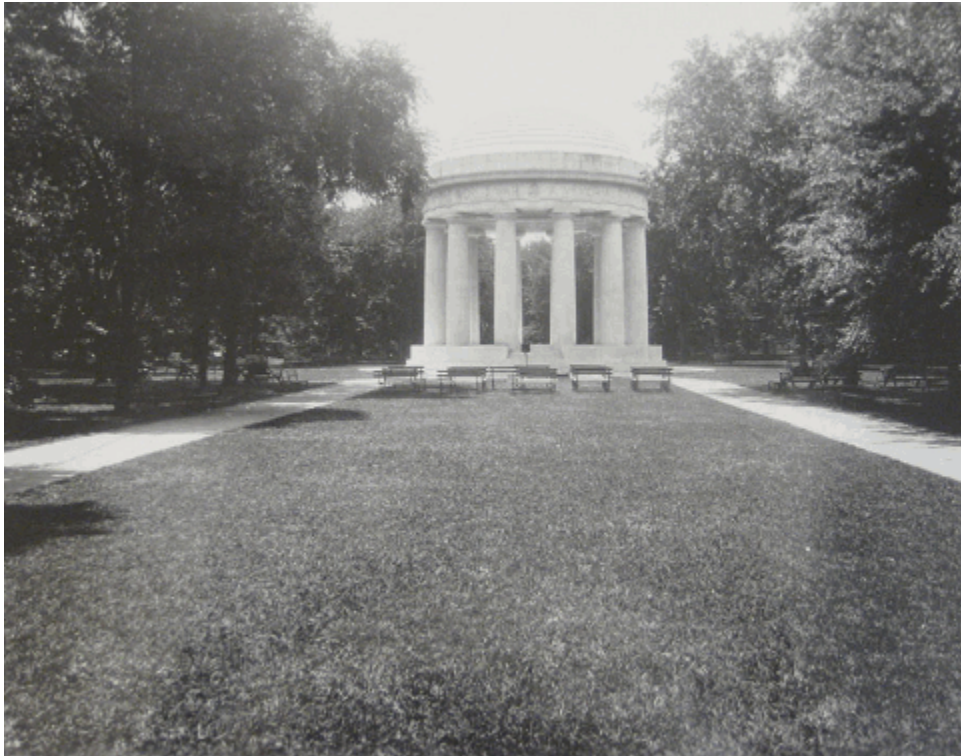
Figure 16. The memorial and associated benches, looking south around 1934 (Commission of Fine Arts). Note the paths on either side, which at this point were still paved with their original gravel.

The existing green benches mentioned in this article, and seen in a photograph from 1934 (see Figure 16), were of a light metal frame and wood-slat construction. The “rustic” benches that began to replace these as early as 1934 were of a heavier wooden design that later became known as the Washington bench (Figures 17a and 17b). Thus both this bench type and the lighter, more portable bench were present at the site during the 1930s (see Figure 17a). Still, it is difficult to discern whether any of the plantings and repairs mentioned by the Evening Star actually took place as anticipated, and if so, how many. Judging from the available documentation, it is most likely that the great majority of landscape alterations planned in 1937 were in fact deferred until 1939, when a similar but more extensive rehabilitation and planting

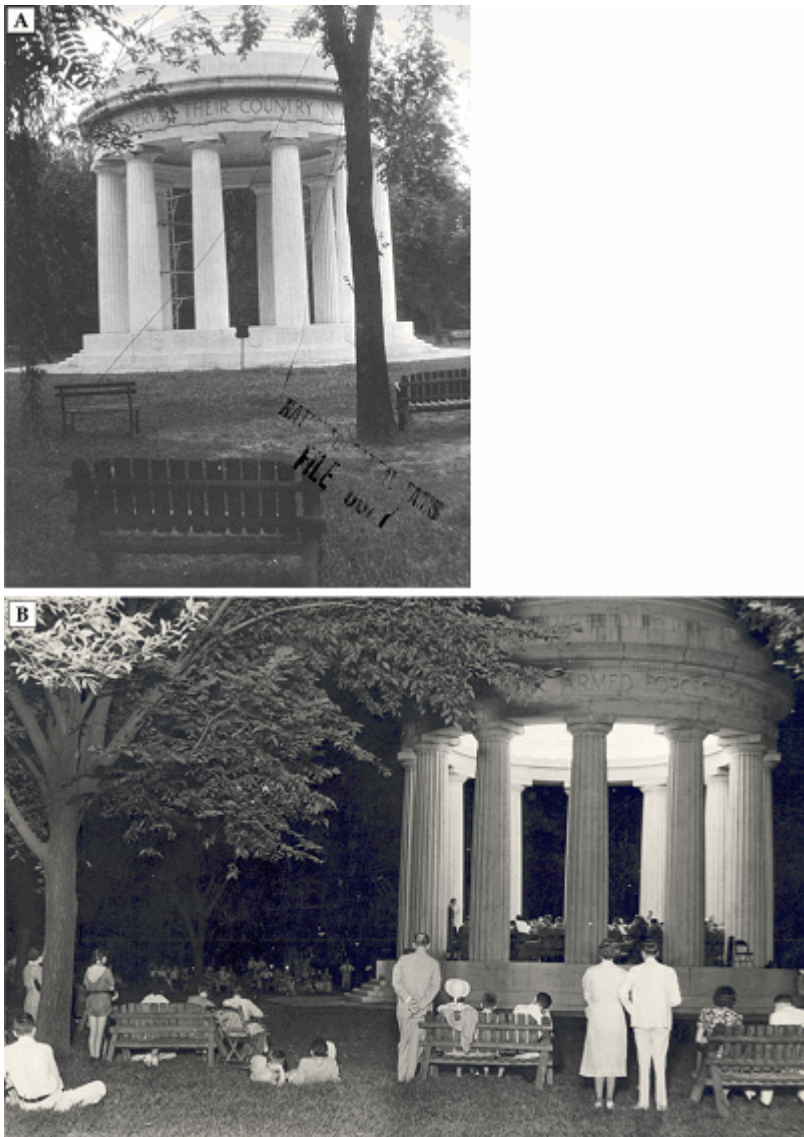
Figure 17. (a) Looking west in 1934; (b) An August 1938 photograph shows an evening band concert at the memorial, looking southeast (NCR MRCE 19.4-81). Note the “rustic” wooden benches, also known as the Washington bench, in the foreground of 17b.

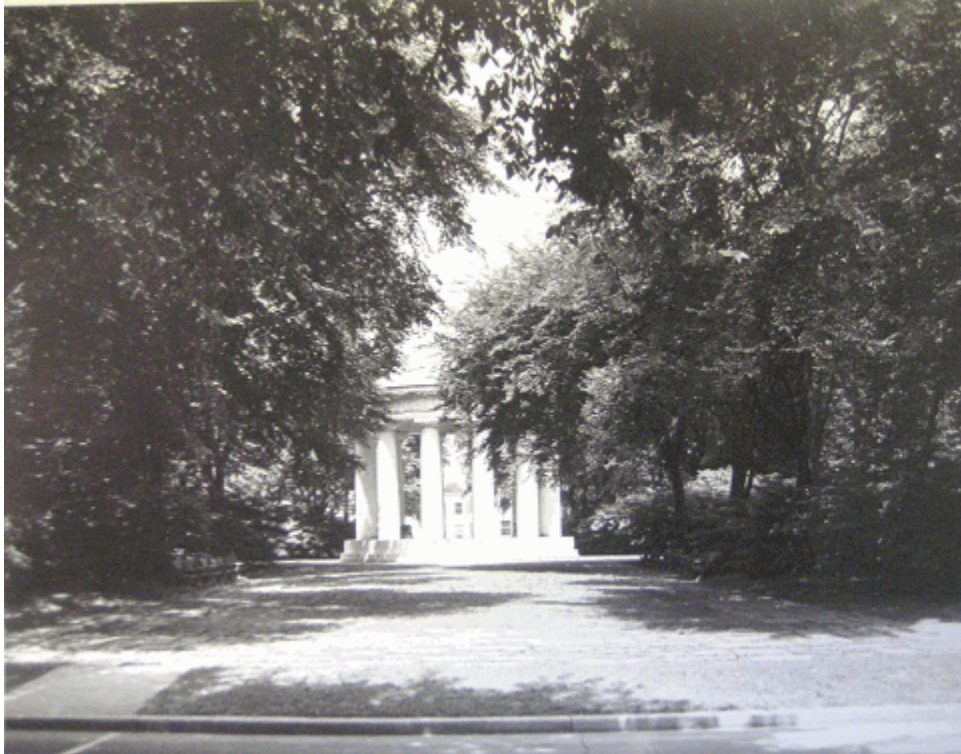
Figure 18. A view of the DC War Memorial looking north from Independence Avenue in July, 1946 shows the impact of the temporary World War II buildings on the landscape of the site, including views (NAMA files).

Unfortunately, these calls were to go unheeded for some years to come, during which time the memorial landscape continued to be negatively impacted (see Figure 18). The buildings on the south side of the Lincoln Memorial Reflecting Pool were not ultimately removed until the spring and summer of 1964 (“Buildings Demolished on Mall and Adjacent Areas, October 24, 1968, NCR files).

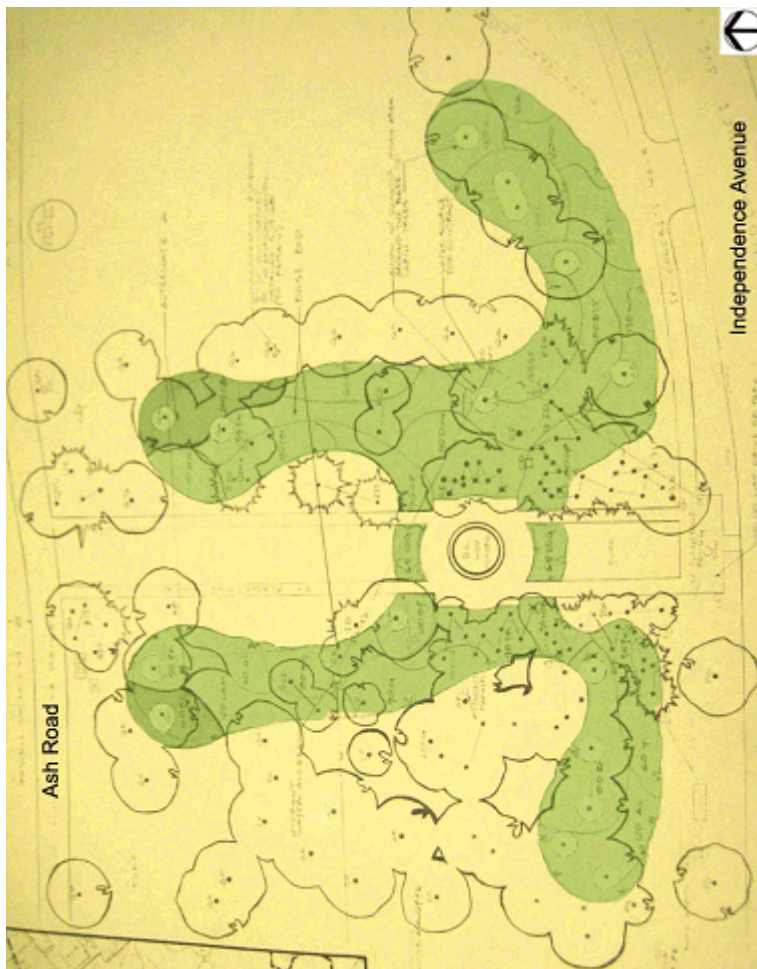
Figure 20. The planting plan for the installation of azaleas around the DC War Memorial in 1987, annotated with shaded areas showing locations planted with azaleas (DSC TIC 801/80912). Note the deviation from the original landscape plans for the site.

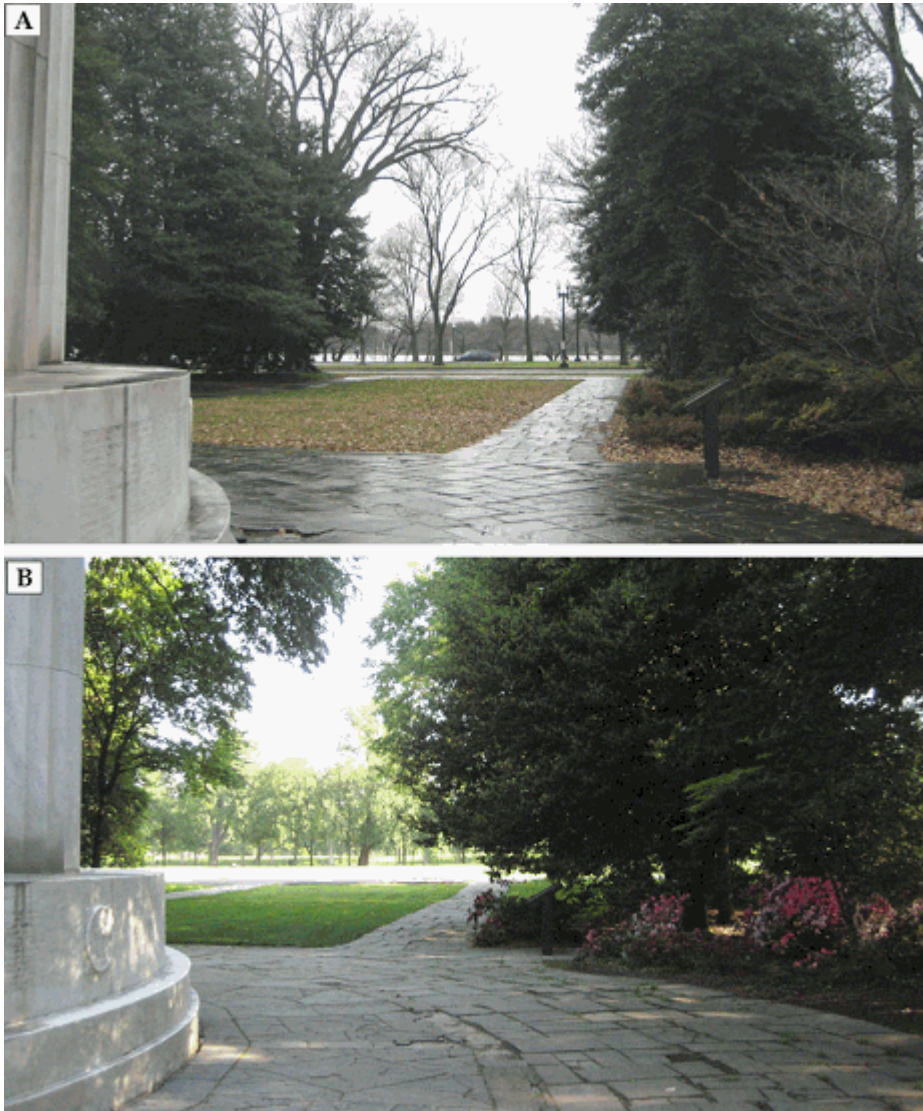
Figure 22. (a) View looking south past the memorial to Independence Avenue, illustrating the thick understory even in winter; (b) View looking north from the east side of the memorial (NCR CLP 2009). Note the broken flagstone paving in the foreground.

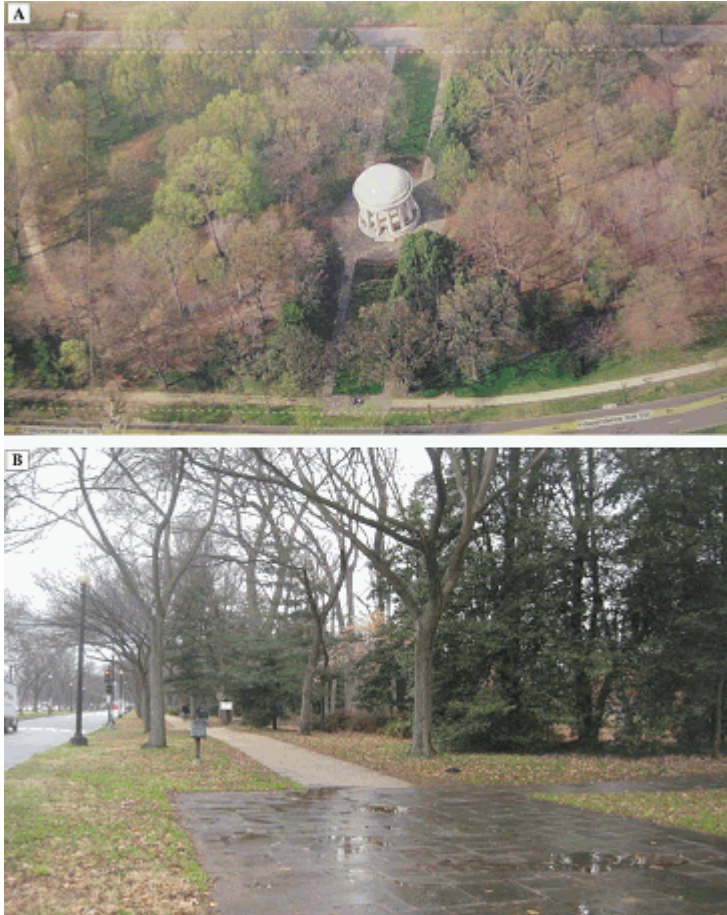
Figure 23. (a) Aerial view of memorial site in winter, showing circulation (Virtual Earth 2009); (b) Looking west along Independence Avenue from the flagstone pavement south of the memorial (NCR CLP 2008).

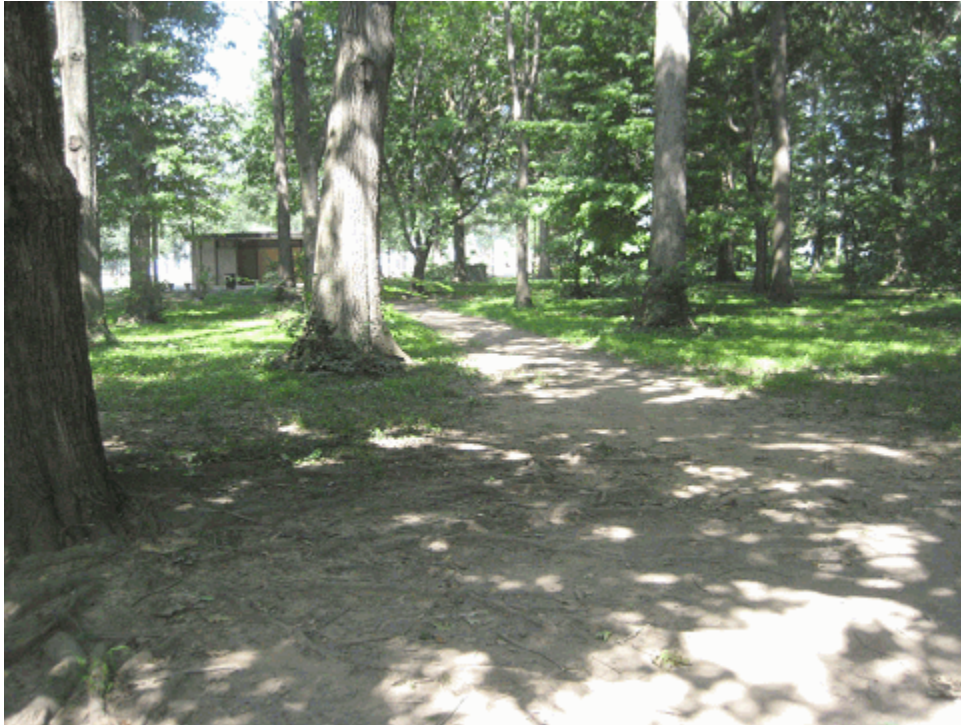
Figure 24. Looking northeast from the DC War Memorial, with social trails in the foreground (NCR CLP 2009).

Due in large part to reduced visitation levels and the rare use of the DC War Memorial, it has over the years become popular among the city's homeless. Those who know the site well and spend considerable time there have over time cut trails through the vegetation, leading more directly between points than the paved flagstone walks permit. These social trails are marked by compacted ground, exposed tree roots, lack of vegetation and sometimes a slight depression (Figure 24; see Figures 22b and 23a). As modern additions to the memorial that speak to its low visitation, these trails do not contribute to the historic character of the cultural landscape.

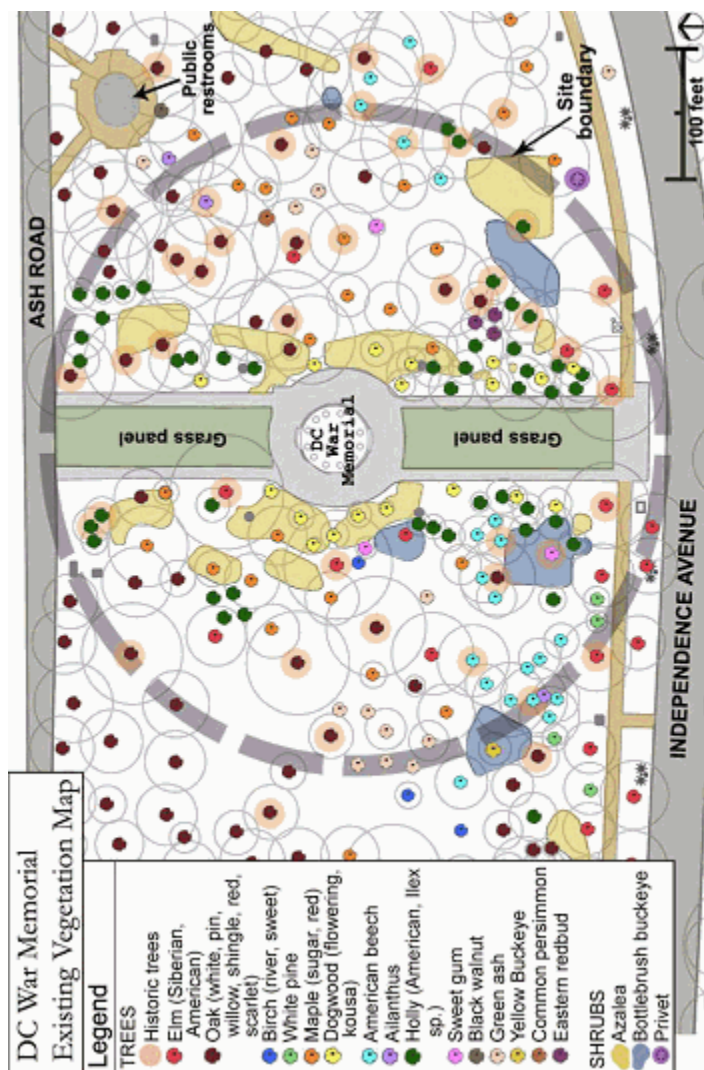
Figure 25. Map showing the existing vegetation at the DC War Memorial, including grass panels, trees, shrubs and volunteer growth.
